DRAFT
HISTORIC STRUCTURES REPORT FOR
RETIREMENT
TOWN OF ABINGDON, VIRGINIA

25 July 2014

DAVIS BUCKLEY ARCHITECTS AND PLANNERS

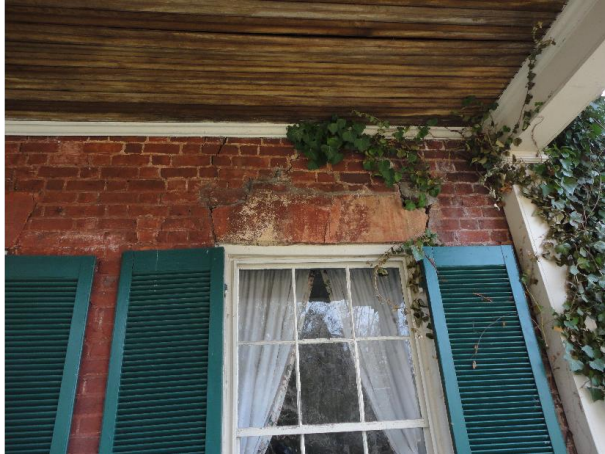
Figure A36: Lintel cracking at Northwest corner.

Most significantly, displacement of the foundation at the northwest corner of the building has caused cracking, particularly at first floor window lintels. At the first floor level, building shows signs of foundation displacement at the northwest corner, resulting in significant cracking at lintels and spandrels (Figure A36 and A37). Cracking also occurs over the main entrance door. At the second floor, splashes of pitch, from repeated low-slope porch roof applications, stain bricks, and water infiltration has cracked brick particularly significantly where the porch roof intersects with the masonry wall. There are areas of brick failure and missing mortar throughout the façade.

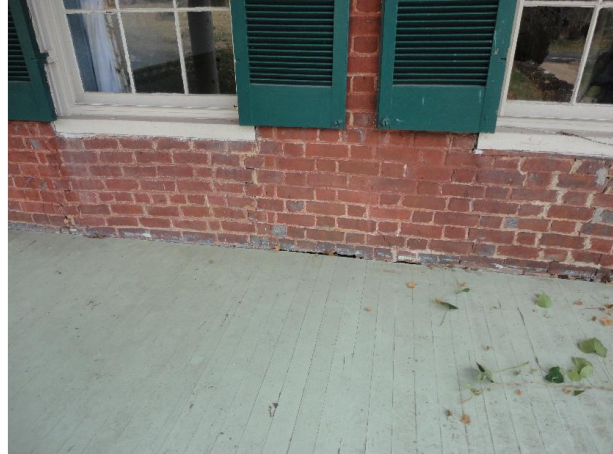
Figure A37: Sill cracking at Northwest corner.

The exterior brick walls at the masonry portion of Retirement are a soft red historic brick in fair condition. Some bricks are cracked, and many locations are in need of cleaning and repointing – mainly where Portland cement-based mortar has cracked the soft historic brick. Lichen, growing beneath most window sills, needs to be cleaned, and sources of water infiltration should be halted.

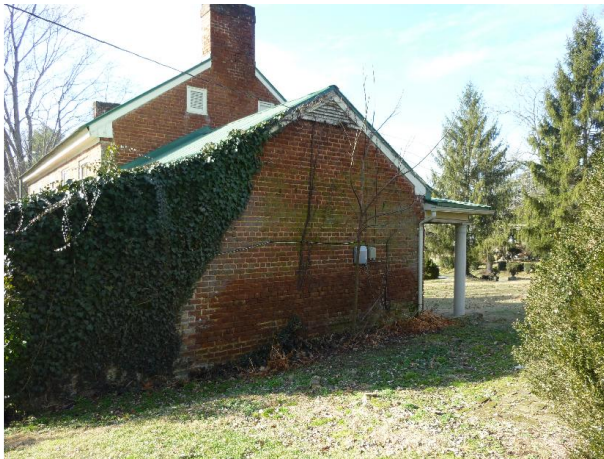
The east façade of the Judge's Chambers, and the upper portion of the east façade of the house show signs of Portland cement repointing and consequent cracking. At the ground level of the Judge's Chambers, visible rising damp has led to the deterioration of the mortar in the lower sixteen rows of bricks. Mildew is present in all but the upper courses. Ivy growing along the left side of the elevation, exacerbates moisture retention problems and damages brick (Figure A38).

Figure A38: Rising damp at east facade.

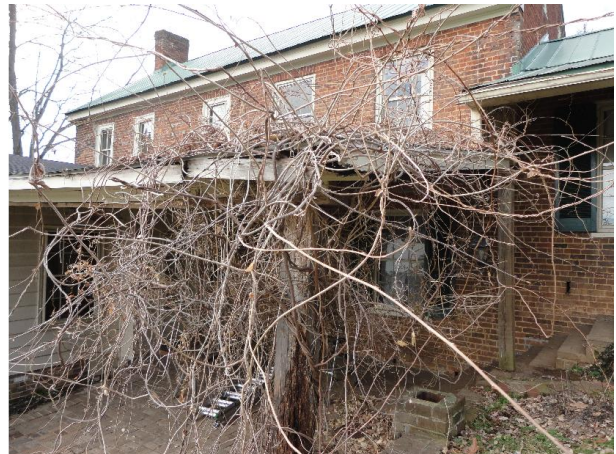
Figure A41: Rot at patio supports.

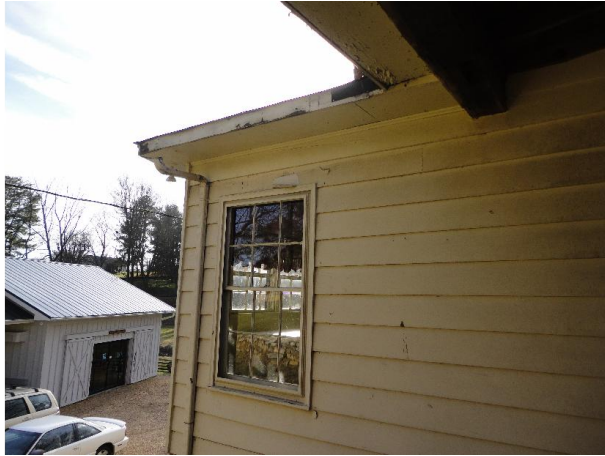
Figure A42: Typical pressed wood siding rot and paint failure.

The south façade of the rear addition is constructed of modern brick at the lower floor, with frame walls and pressed board wood siding above. The brick is in good condition, but requires cleaning. The pressed wood siding suffers paint failure and rot (Figure A42).

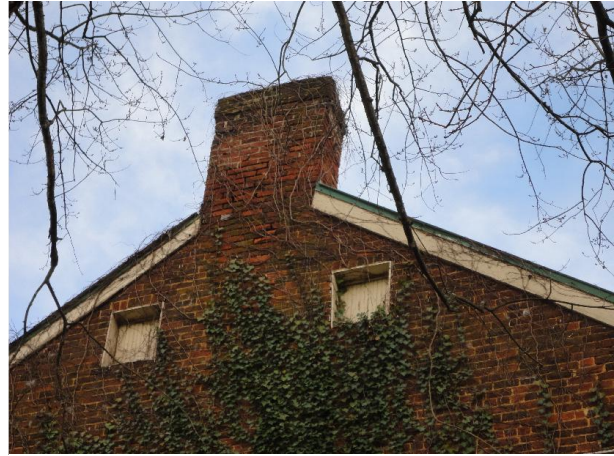
Figure A43: West chimney.

Heavy ivy growth limits visibility of the brick at the west façade, but it is possible to see brick cracking, related to the displacement of the northwest corner. The chimney is in need of repointing (Figure 43). A concrete foundation wall on the west side, composed of rough aggregate and debris, stands proud of the wall, its purpose unclear (Figure A44). The mid-twentieth century pressed board siding and soffits at the west façade of the rear frame addition display moderate to severe rot and paint failure, most significantly on the left side of the existing door at the first floor (Figure A45).

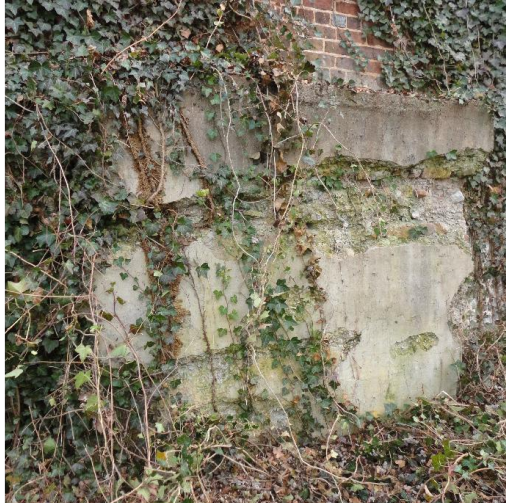
Figure A44: Concrete at west facade.

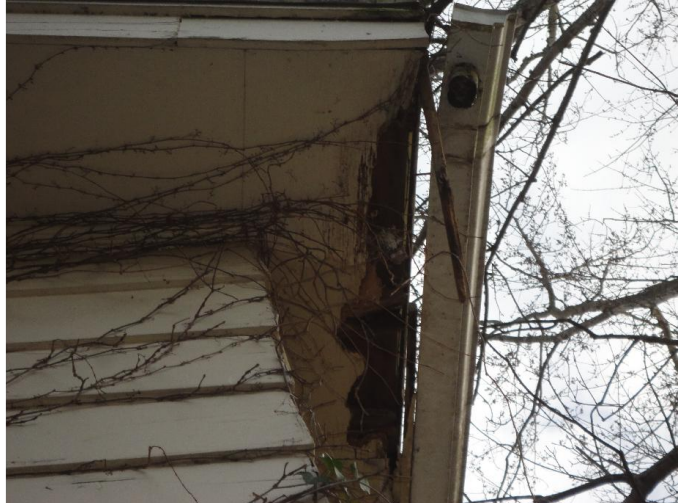
Figure A45: Rot at rear addition soffit and fascia.

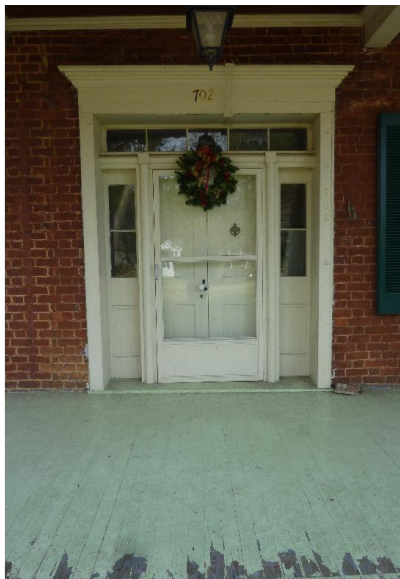
Figure A46: Door D1.

- b. Door D1: Paired solid wood doors with two raised panels each (Figure A46). A five lite transom is flanked by two lite sidelights, with a raised panel below matching the doors. These doors were installed during the Retirement II project, and show no sign of cracking or rot. A modern aluminum screen door has been added.
- c. Door D2: Four panel door topped by a three lite transom, also dating from the construction of Retirement II (Figure A47). There is one cracked pane and the door needs repainting. A wood screen door has been added.
- d. Door D3: Late twentieth century six raised panel door in good condition.

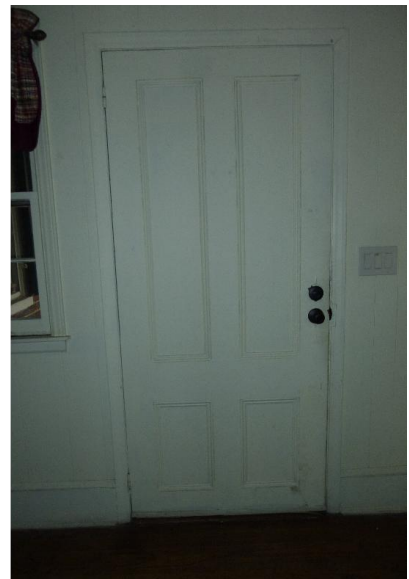
Figure A48: Door D4.

- e. Door D4: Early twentieth century four panel door with heavy panel trim, in good condition (Figure A48). Aluminum screen door is need of repair at lower weatherstripping.
- f. Door D5: Five raised panel basement door with a pedimented upper frame. Door is no longer operable, and is in poor condition, with significant water damage and consequent wood rot (See Figure A25).

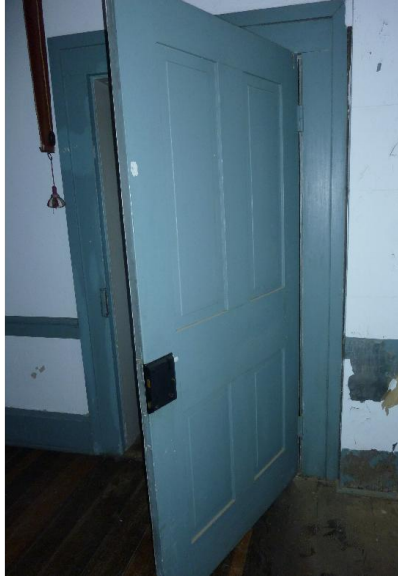
Figure A49: Door D10 showing raised panels.

- iii. D03 – Late twentieth century two paneled folding doors.
- b. First Floor
- i. Door D10: 4 panel door with raised panels facing into the Parlor (Room 101). There are cracks in the lower panels that should be filled and repainted (Figures A49 and A50).

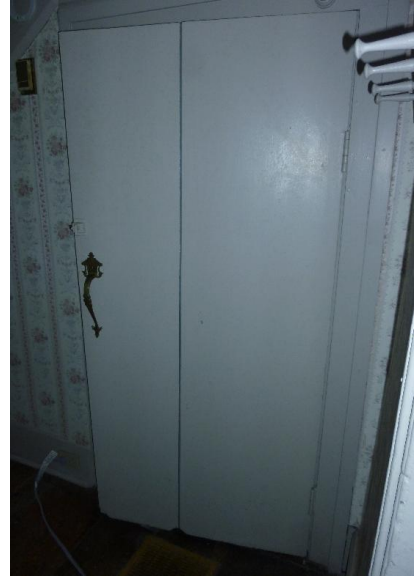
Figure A51: Door D12.

- iii. D12: The only board and batten door at Retirement, accessing the closet beneath the stair, likely dating from the Retirement II period (See Figures A20 and A51). In good condition.

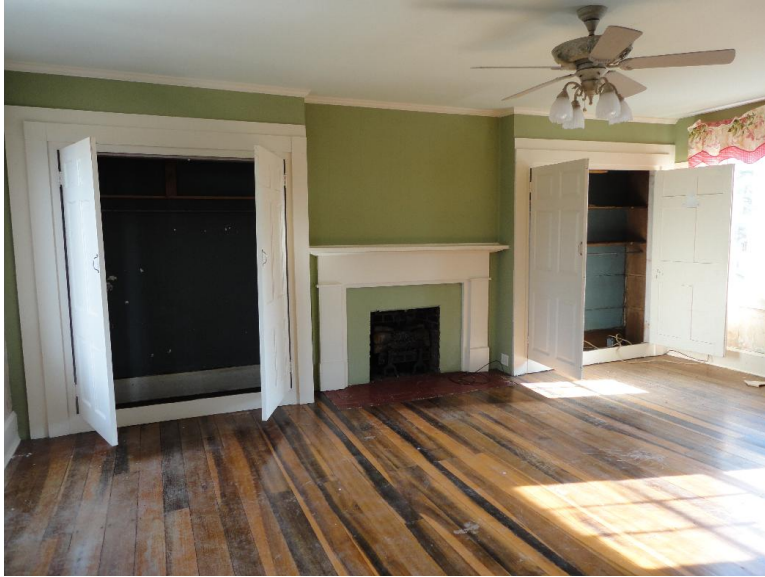
Figure A55: Doors D23 and D24.

- xiii. D22: A four-paneled installed during the Retirement II project, in good condition.
- xiv. D23: Paired six raised-paneled closet doors, likely dating from the Dunn occupation (Figure A55). Doors in good condition.

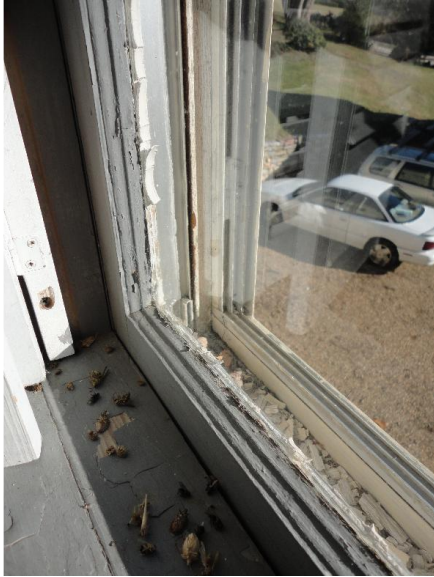
Figure A57: Putty Failure at W114.

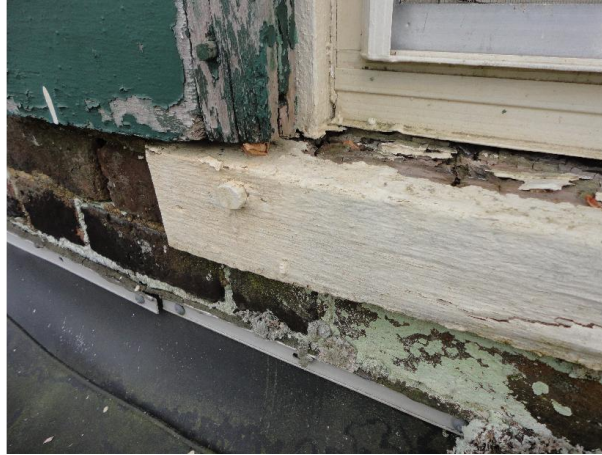
Figure A58: Sill Rot at W201.

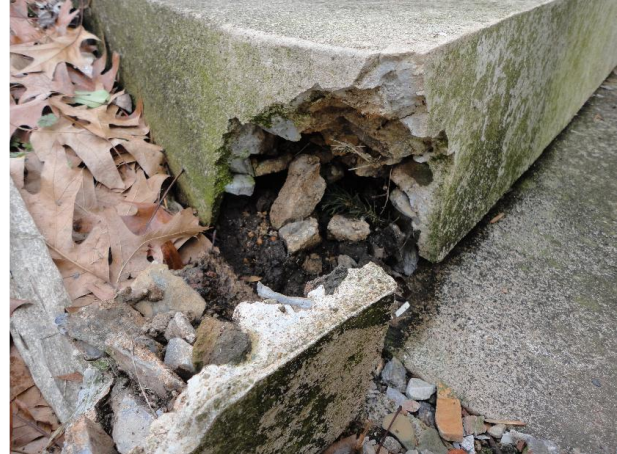
Figure A65: Failing concrete step at curving concrete stair from Main Porch to Judge's Chambers Porch.

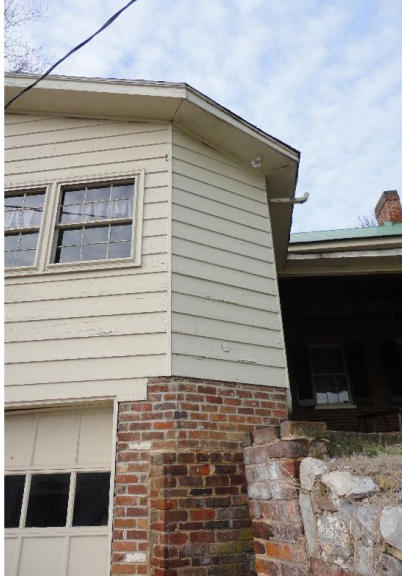
The drainage system on the building is in poor condition. The gutters and downspouts are typically rusted. Many are displaced, and some are missing entirely (Figure 66). At the rear, south façade, the some of the downspouts around the patio drain into a subsurface drainage system

Figure A66: Missing rainwater leader at south façade.

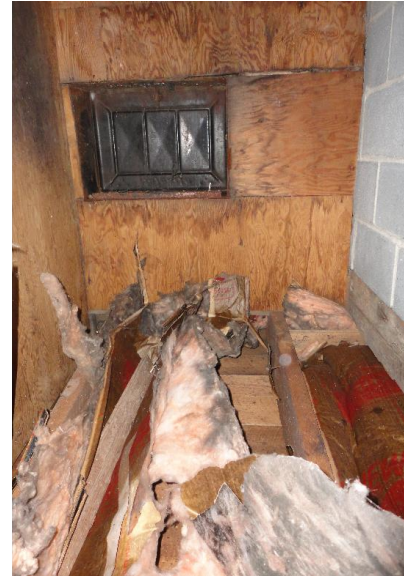
Figure A68: Deteriorated west wall and coal chute.

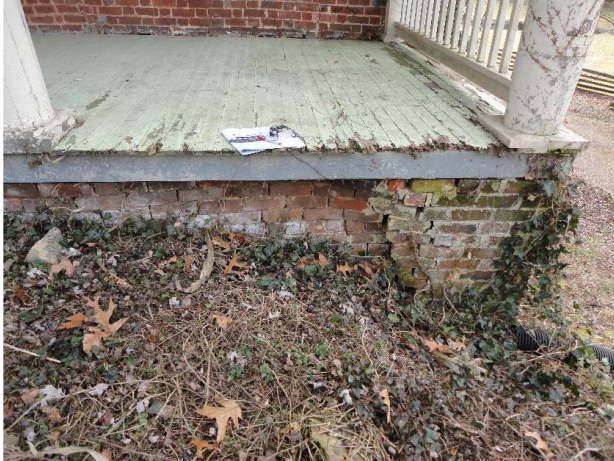
The front porch foundation walls are primarily brick with concrete and concrete block patches. There is significant, chronic cracking, failing and missing mortar at the northwest corner of the front porch area (Figure A69).

Figure A69: Brick foundation failure at northwest corner of front porch.

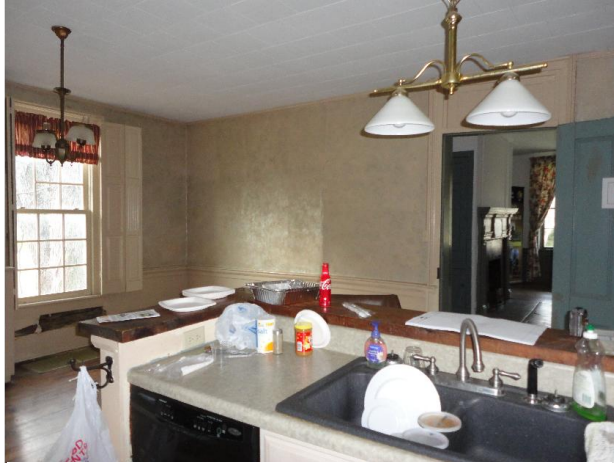
Figure A73: Kitchen 108

The north wall of the Kitchen is finished with some kind of modern smoothing product over the exterior brick wall of Retirement I (Figure A73). A large lump in the wall indicates an irregularity below. The west wall is plaster, dating from the Hurt-era, while the south and east walls were altered in the Dunn-era mid-century expansion, and are finished with faux wood paneling (See Figure A30). Water infiltration on the west wall has damaged large sections of the plaster, and the wood lath has been exposed in sections. The ceiling is an adhesive acoustic tile.

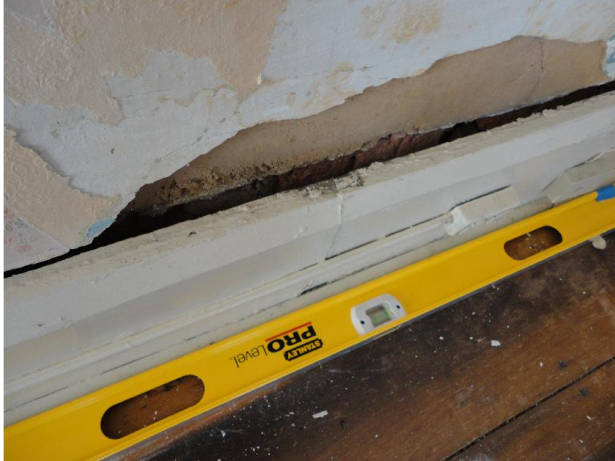
Bedroom 202 has a high wood baseboard, plaster walls and ceiling, and a wood floor with varied hues, installed in the Retirement II project. Mid-century closets 203 and 204 were built on either side of the fireplace on the east wall (See Figure 55). Cracking and baseboard wracking along the south wall, centered under the west window, indicates an area of wall movement, water infiltration and localized failure (Figure 75).

Figure A75: Separation at south wall of Bedroom 202.

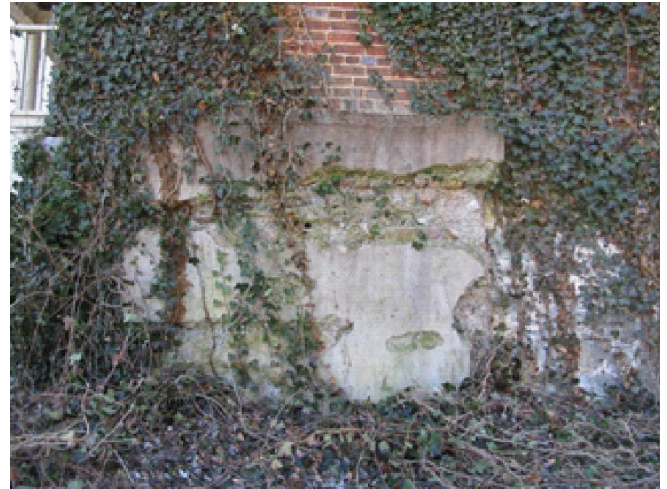
Figure S1: Concrete Cap at West Facade

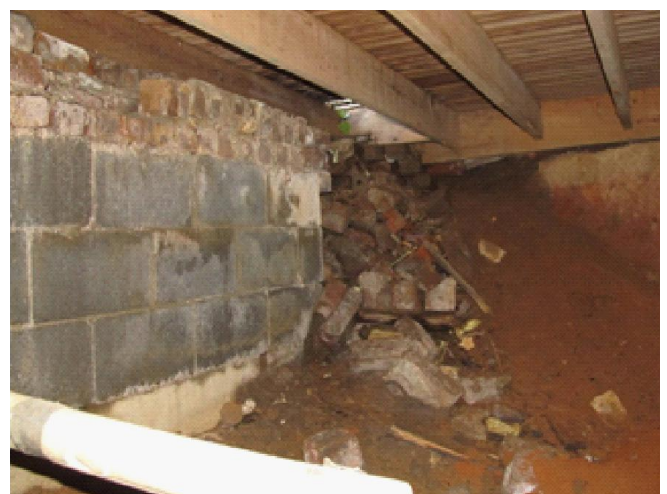
The front porch foundation wall is primarily brick. At the west corner, this brick is significantly cracked and in poor condition. A portion of this foundation wall is CMU and a small portion has collapsed creating a small hole in the porch deck (Figure S3). The porch framing appears to

Figure S3: Foundation wall at front porch

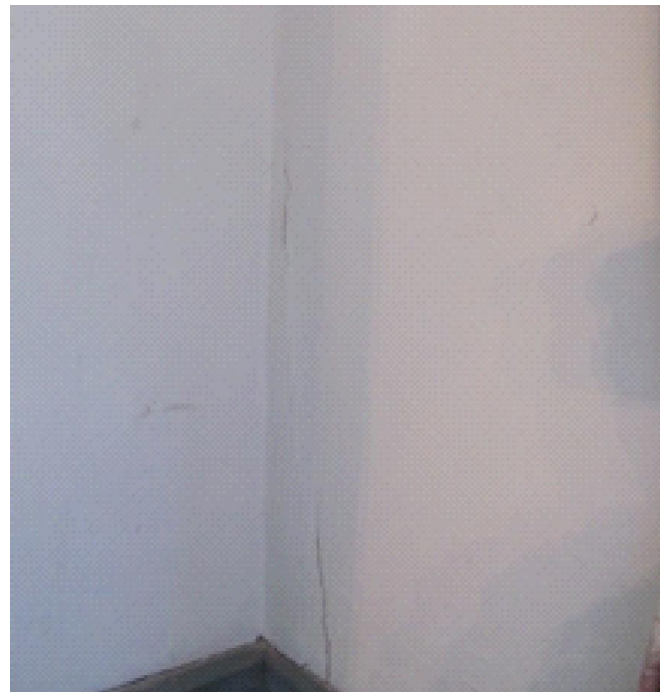
Figure S8: Cracking at northwest corner, first floor

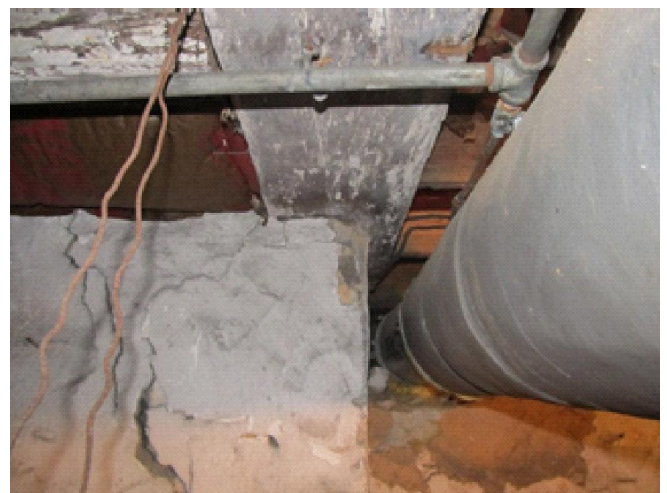
Figure S9: Floor Separation

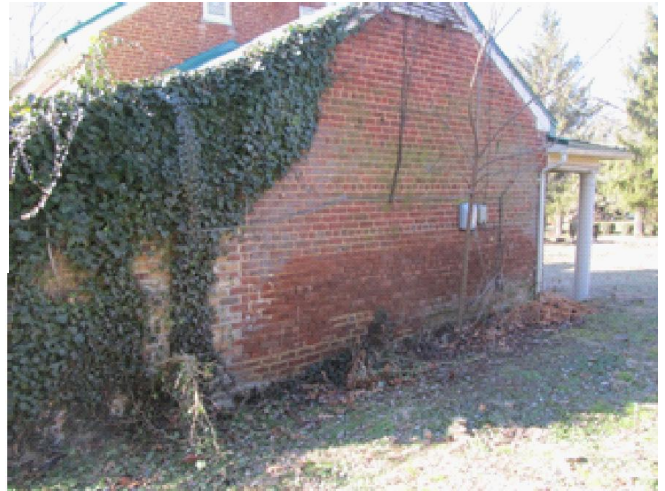
Figure S16: Rising damp at east wall of Judge's Chambers

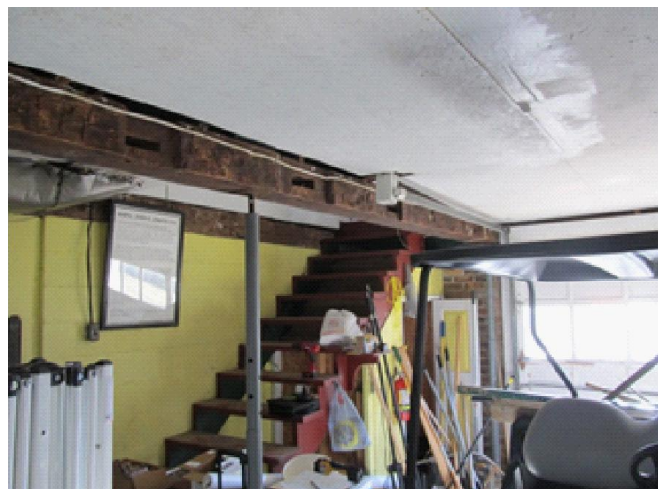
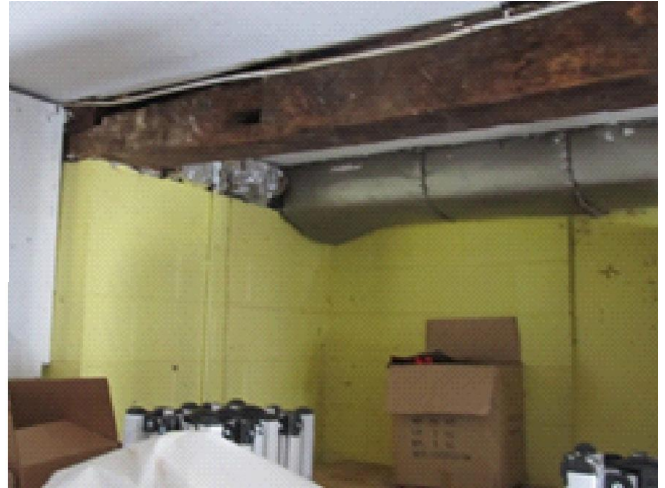
The supporting timber (very rough 7 in. x 7 ½ in.) is also bowed; which may or may not be associated with this loading. This timber is supported by screw jack columns bearing on the concrete slab (Figure S18 and S19).

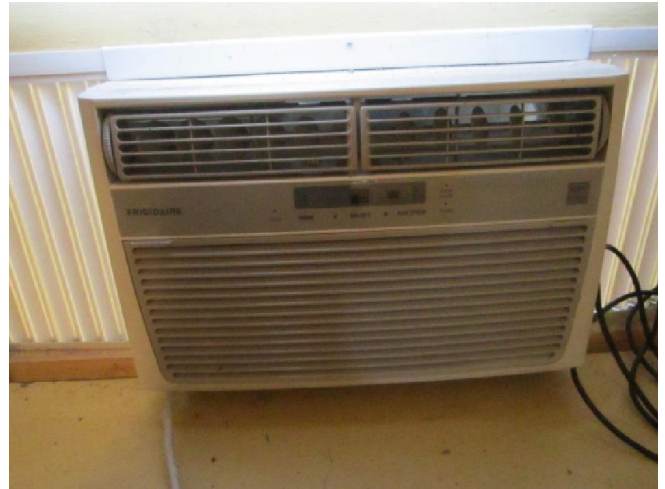
Figure M15

The Judge's Chambers 102 has an existing through the wall Frigidaire air conditioning unit which provides cooling for this space (Figure M15). The age of the unit is unknown but it appeared to be operational and in fair condition.

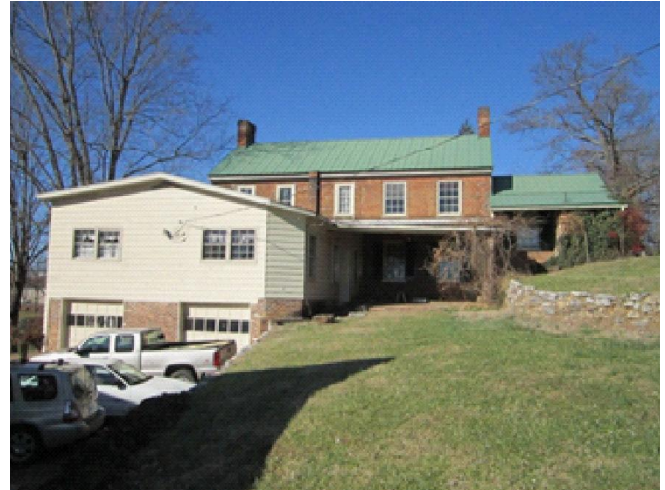
Figure E22

The electrical service to the House extends overhead from the utility pole shown in Figure E1 to the locations shown in Figure E22. The service enters the building through a weather head to a wireway above two service disconnect switches (Figure E23). The disconnect switch on the right is an older 200 Amp type switch that is in fair condition (Figure E24). This switch feeds a load center that is located in the basement of the house (Figure E25-E27). This load center is in good condition, but is dirty and starting to rust due to the unconditioned and dirt floor environment that it is located in. The disconnect switch on the left is a newer 100 Amp type switch that is in excellent condition (Figure E28). This switch feeds a load center that is also in excellent condition and that is located behind a sliding recessed wall panel in the bathroom adjacent to where these disconnect switches (Figure E29-E31).
