# Removal Report on Jordan's Point Concrete Dam and Timber Crib Dam: May 23-25, and May 28-30, 2019

Prepared for: The Virginia Department of Game  
and Inland Fisheries

Prepared by: Maral S. Kalbian, LLC  
Maral S. Kalbian, Architectural Historian  
Contributor: Dan Pezzoni, Architectural Historian  
September 6, 2019

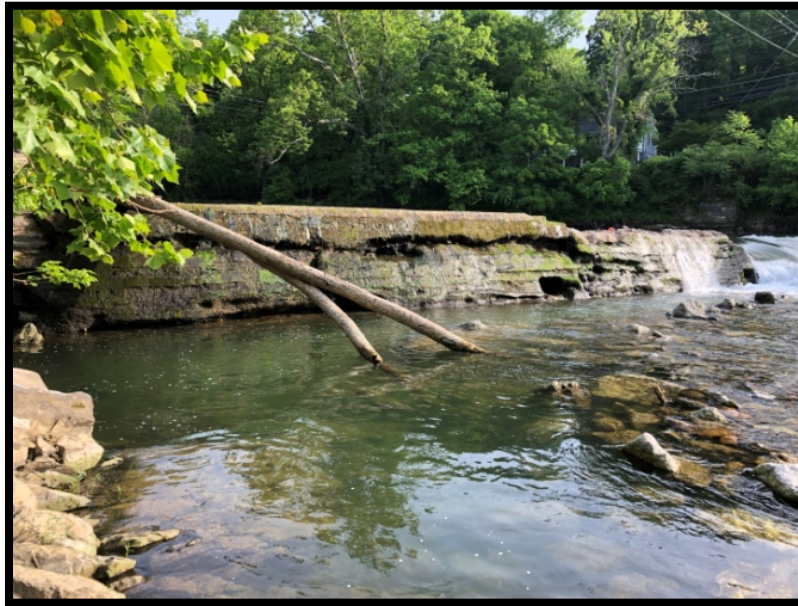
**Figure 16: View from downstream south end, showing poor condition of dam wall and distinct joint between wall of dam and the cap (May 24).**

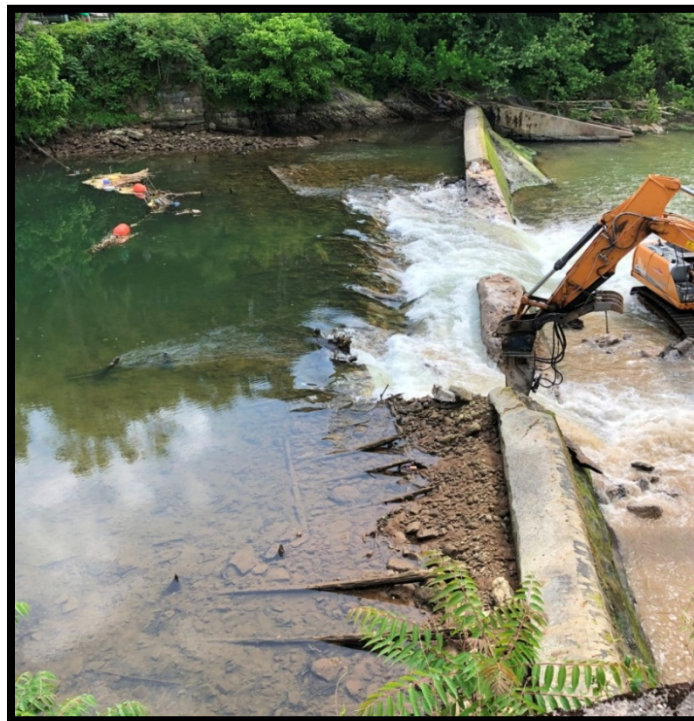
**Figure 17: View of dam removal from south abutment on May 24, showing the sloped concrete cap that was applied independently and the makeup of the concrete dam with stones of varying sizes used as aggregate. By this time, the timber crib dam directly upstream was beginning to be exposed.**

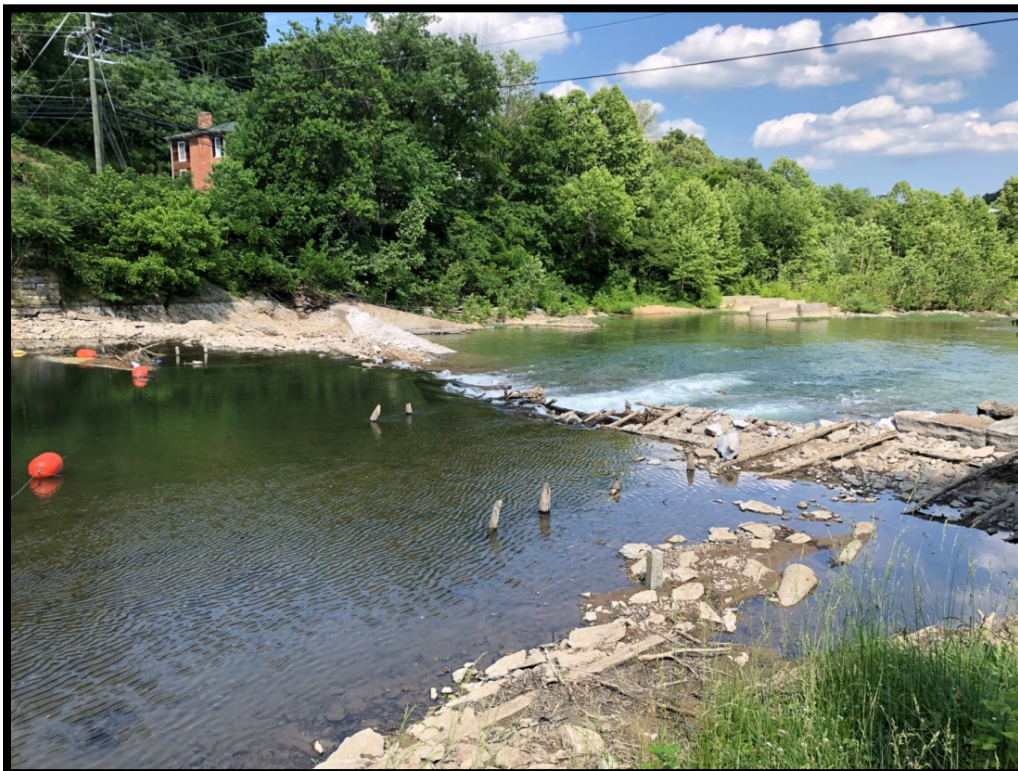
**Figure 19: May 28 view from south bank, upstream of dam. By that time, water had continued to drop and more remnants of the crib dam were exposed. Some of these included vertical pinning posts for the crib dam and the structural remnant near the south bank. The vertical posts were removed as part of the crib dam removal.**

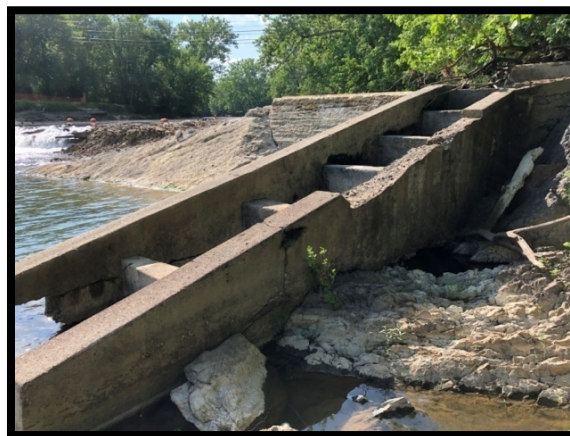
**Figure 21: Close-up view of fish ladder, showing deteriorated condition (May 2019).**

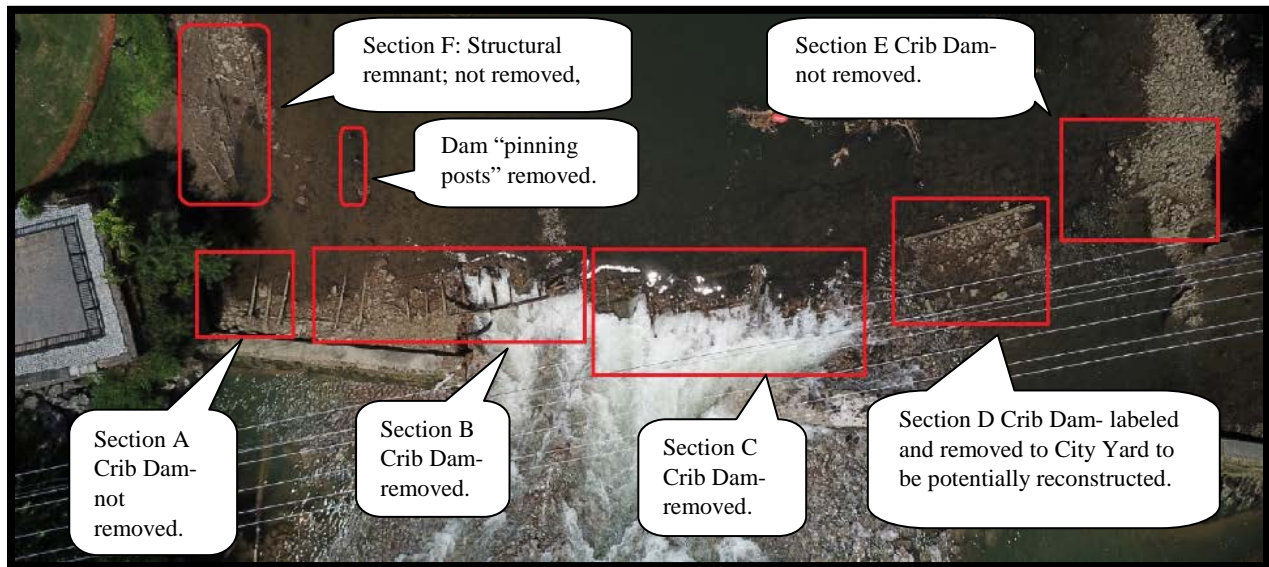
**Figure 26: This drone image taken on May 24 captures the five distinct features of the crib dam along with a structural remnant (F) that became exposed after the concrete dam was breached. Sections B and C of the crib dam were removed along with the associated pinning posts; Section D was tagged and moved to the City of Lexington public works yard; and Sections A and E were not removed and are still intact in the riverbed. The structural remnant (F) was also not removed. (May 24, 2019, James Fulcher).**

As shown in Figure 26, the different crib sections do not exactly line up with each other. One possible explanation considered at the beginning of the documentation (May 23-25) was that parts had shifted during floods or pulled back when the new concrete dam was built. As more of the crib dam was taken down, it became evident that some parts of the dam had been removed, either by flooding, deterioration, or to make room for the concrete dam. It also became evident that not all sections of the crib dam were constructed at the same time, although most of the timbers were red cedar. The wooden pieces were held together with large metal spikes and in a very few cases (from sections B and C) there was evidence of wooden pegs. This suggests that some of these pieces were reused from an earlier dam on the site, possibly the ca. 1806 one. The center sections (B and C) were in the poorest condition, with most of the downstream-facing portions already missing and the cribs reduced mainly to a few vertical posts upstream, parts of the crib, and some of the sloped pieces on top. These sections were mainly hewn timbers but some were also rough cedar logs. A few were saved and moved to the City's public works yard for future interpretation. Measured sketches were made of the exposed sloped cedar posts on the top of Section A. The rest of Section A was and remains covered by river material. It lies in the area directly adjacent to the south abutment where some historic drawings suggest there may have been a flume and then a lock of some sort. It does not appear to connect directly to the stone abutment.

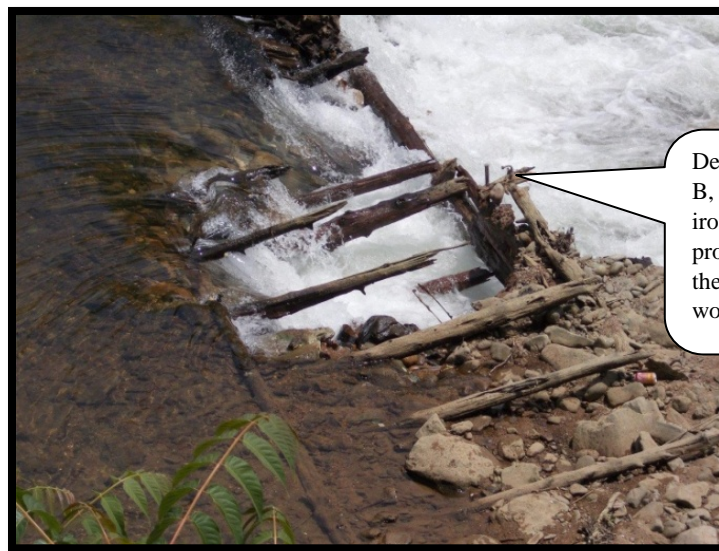
Detail of Section B, showing large iron spikes projecting from the exposed wooden structure.

**Figure 29: Remnant of Section B removed near the south end of the crib dam (May 24).**

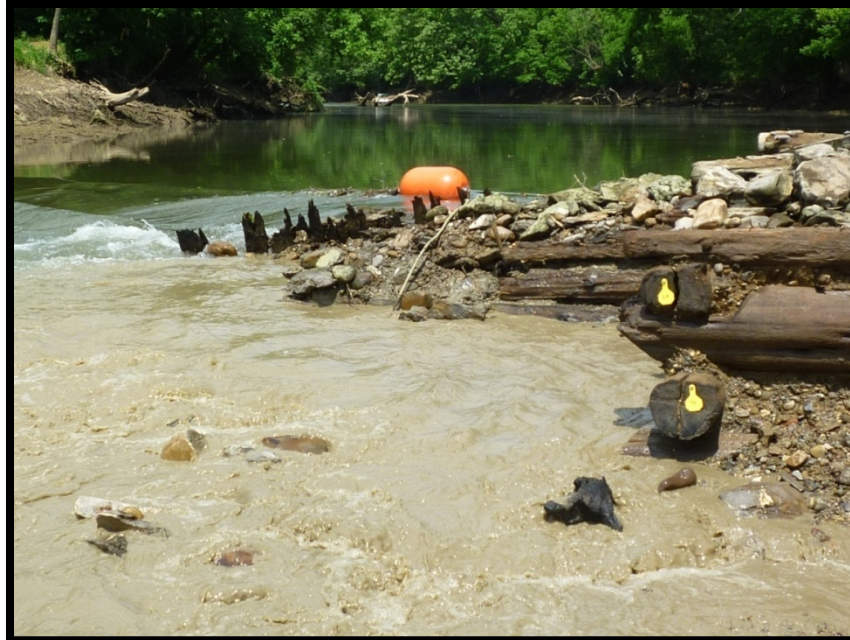
**Figure 32: Vertical planks attached to the upstream side of the Section C of the crib dam, and which were removed (May 29, 2019).**

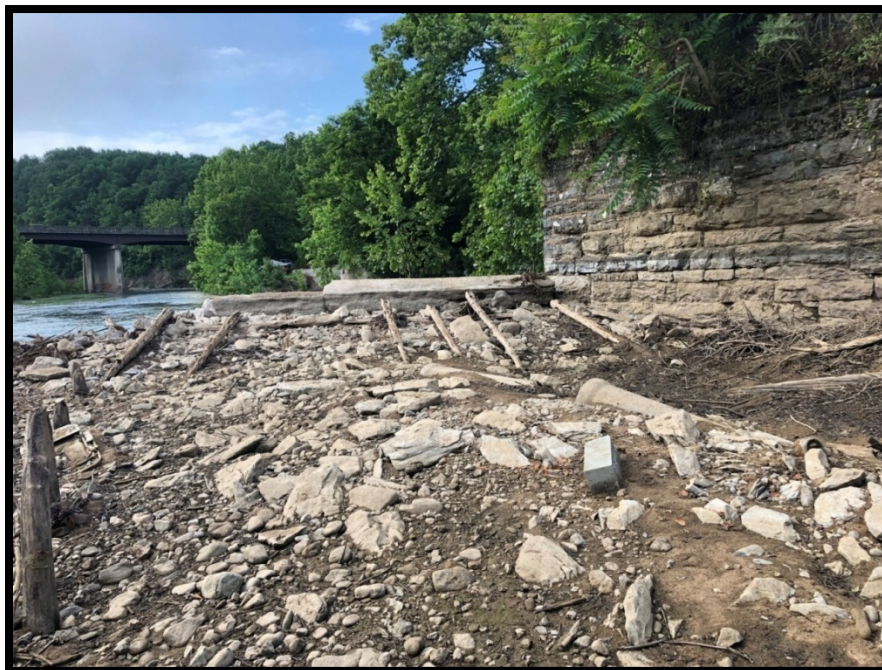
**Figure 33: The four angled posts to the left of the abutment are the remnant of the Section A of the crib dam before being covered over. The four vertical members at the bottom left of the photo were removed and are believed to have been “pinning posts” that helped secure the crib dam in place (May 30, 2019).**

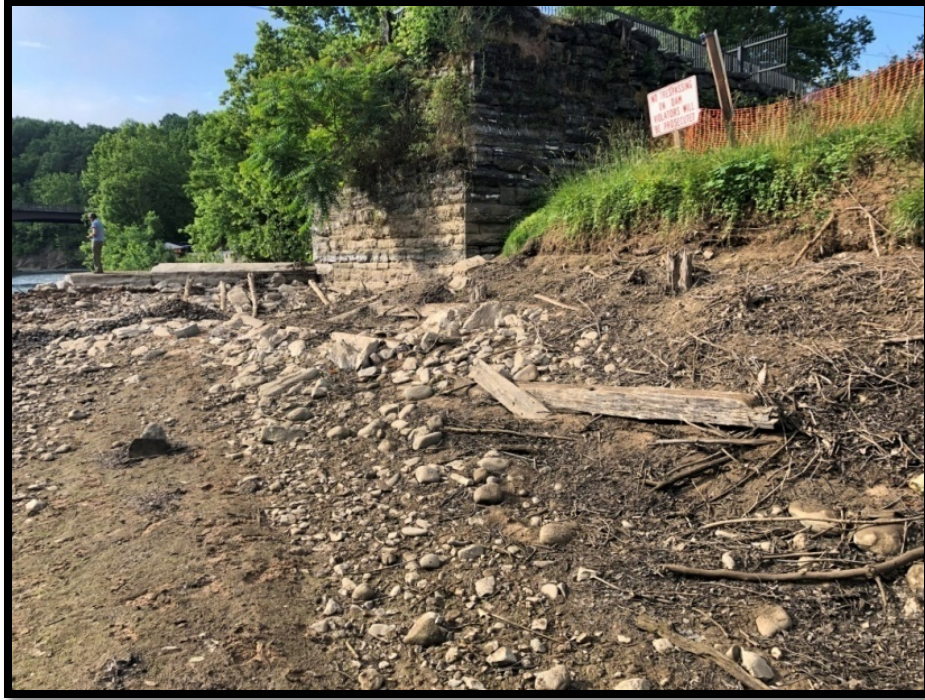
The structural remnant consists of a number of parallel beams built into the bank and former river bottom that define a linear structure aligned with the riverbank. At least two of the beams have pegs, which suggest they date at least in part to the earliest phase of river-related construction activity at Jordan's Point, possibly as early as ca. 1806. Adjoining one of the beams and parallel with it is a line of four vertical posts (originally thought to be three) extending about twelve and a half feet in length. This may be a remnant of a post-in-ground foundation, or it may have served to anchor the structure to the bank. A single post on the other side of the beam (the river-ward side), which is secured to the beam by a square-shafted iron spike, suggests the latter interpretation (anchoring and reinforcement). Though the posts are similar to the "pinning posts" observed in association with the crib dam, they are not believed to be associated with the dam. Several beams run perpendicular to the others, two of which are stacked one on top of the other at the upstream end of the structure.

**Figure 36: View of Section F looking east showing the series of timbers running parallel to the Maury River (May 30, 2019).**

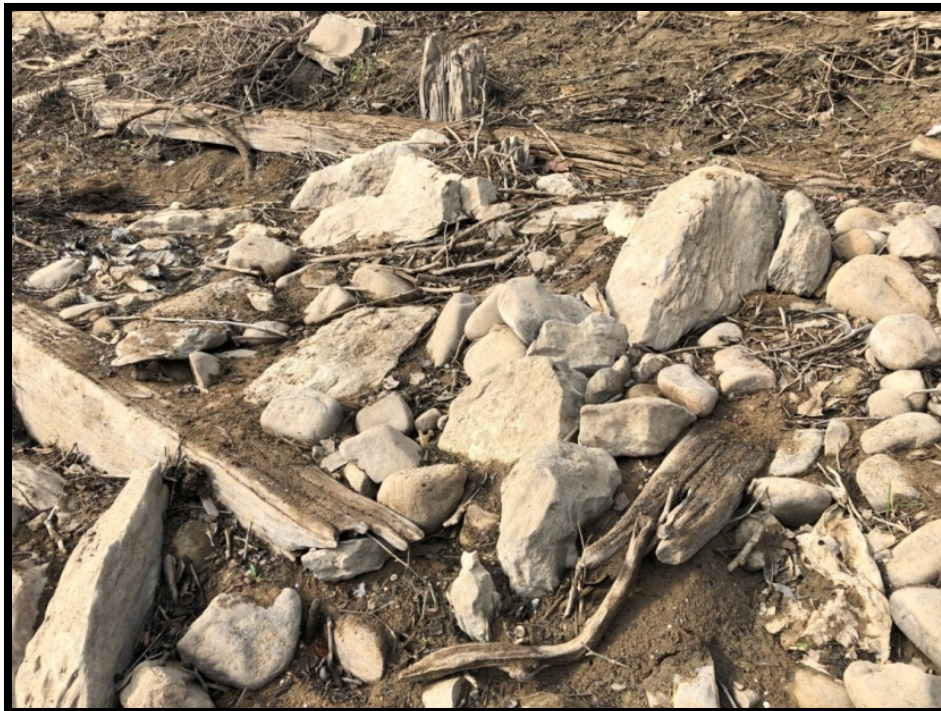
**Figure 37: Detail of some of the cross members located within this structural remnant, Section F (May 30, 2019).**
