DROMGOOLE HOUSE HISTORIC STRUCTURE REPORT

Old Brunswick Circuit Foundation
Valentines, Virginia

Report by Glavé & Holmes Architecture

March 25, 2022

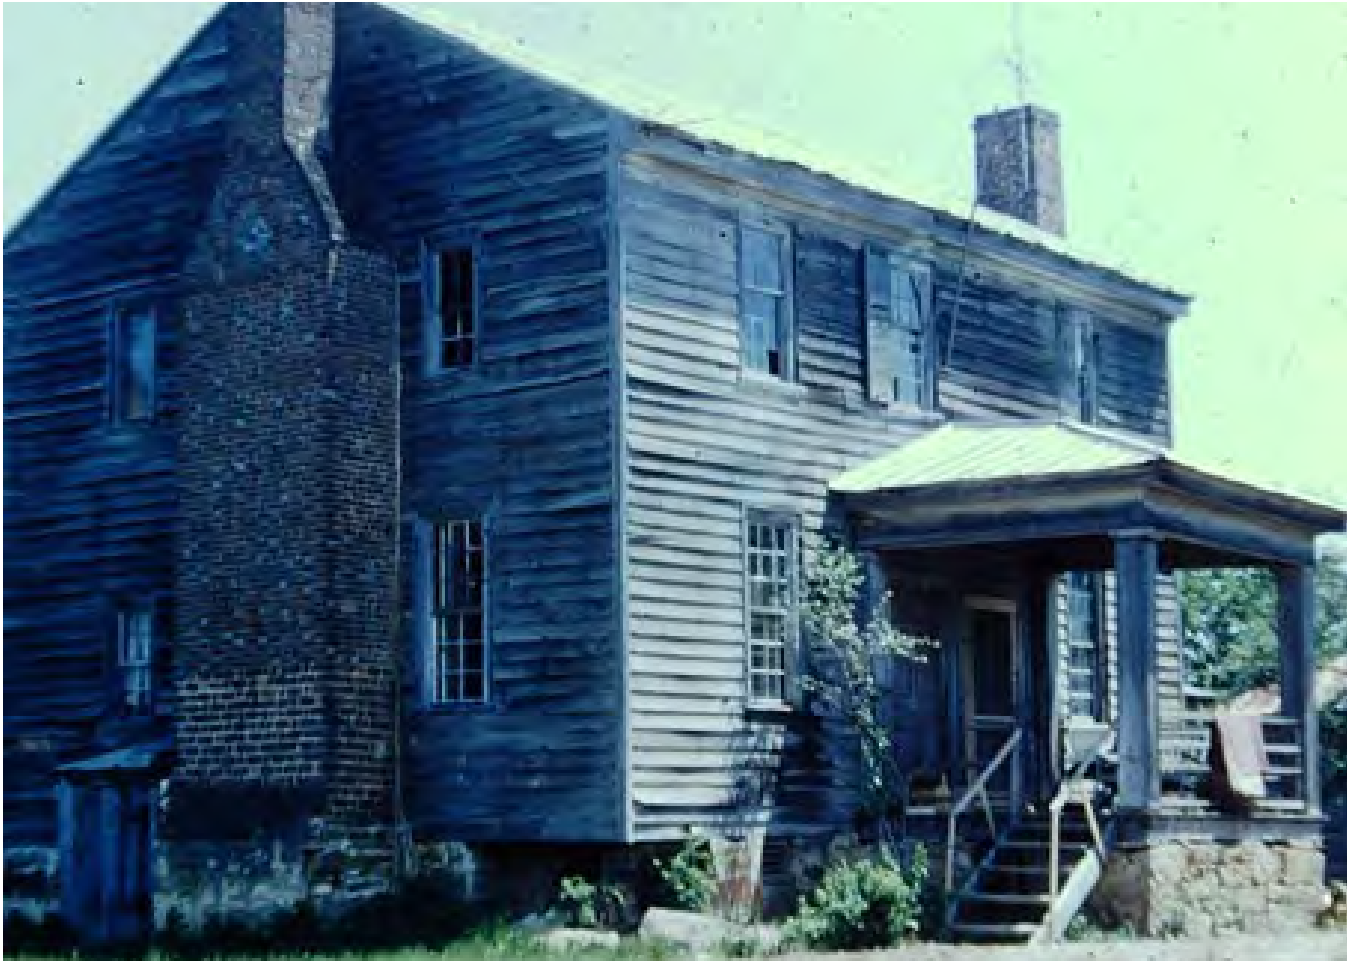
Southwest corner from southwest showing missing section of foundation, 1960s. A earlier basement entry is visible beside the chimney [Collection Old Brunswick Circuit Foundation].

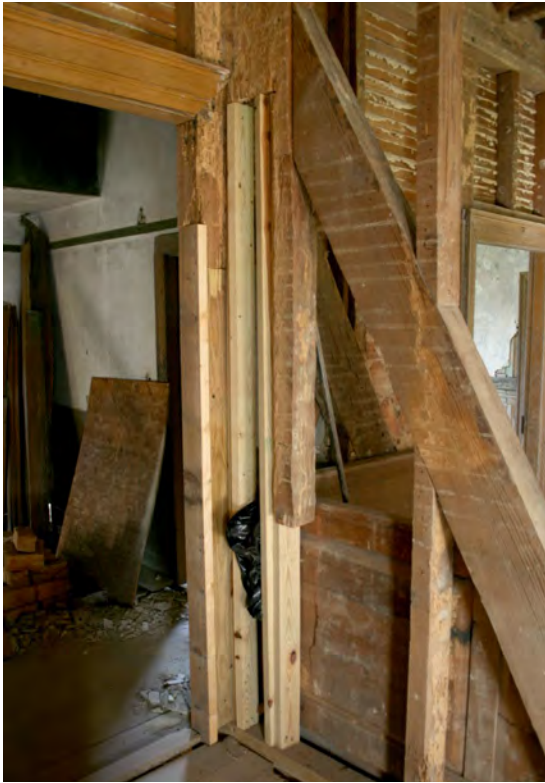
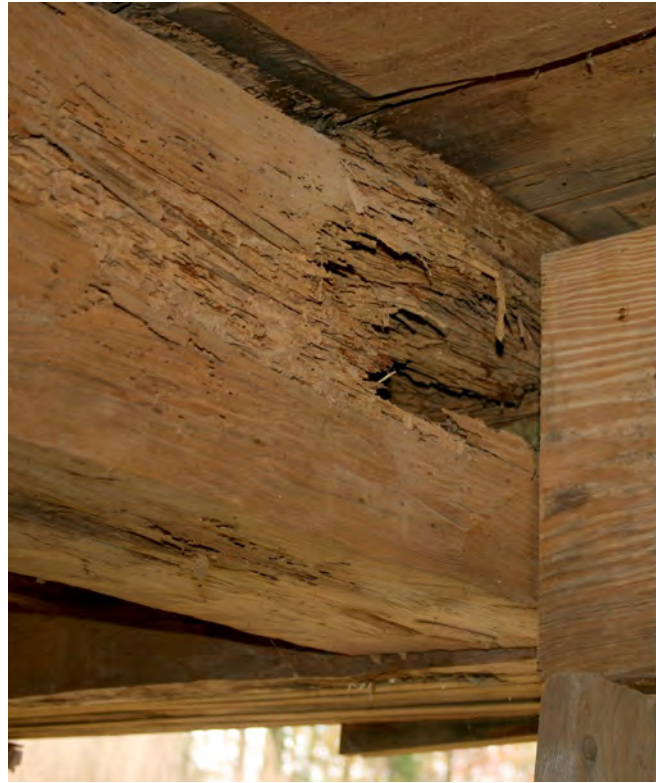
Rebuilt post at the north end of the first-floor partition between the Hall and the Parlor (left) and termite damage at the north end of a beam where it ends at the replaced sill under the north wall (right).

The frame is largely intact. There has been extensive termite damage, particularly along the north wall. The offset post at the intersection of the main dividing partitions (see above) was completely compromised, but has been reinforced with new wood. The sill under the east-west partition and some adjoining joists exhibit termite damage. The rear sill and the joists connected to it had partially collapsed into the Basement, but they have been replaced and repaired in the past decade.

- Damaged portions of the house framing should be repaired using the most sensitive techniques to avoid damaging original materials.
- Repair rather than replace wherever possible.
- Follow recommendations of structural engineer to assure the long-term safety and stability of the structure.
- Preserve the brick nogging in place to the greatest degree possible.
- There is significant deterioration of first-floor wood framing despite recent repair efforts. This will require a more comprehensive structural effort, both at the perimeter as part of an initial foundation reconstruction and at damaged locations on the interior.
- Masonry stack used for jacking appears to be crushing at base. Unclear if this element is still supporting load or was only used for jacking with load now transferred at other locations (according to Tom King, this never carried much weight).

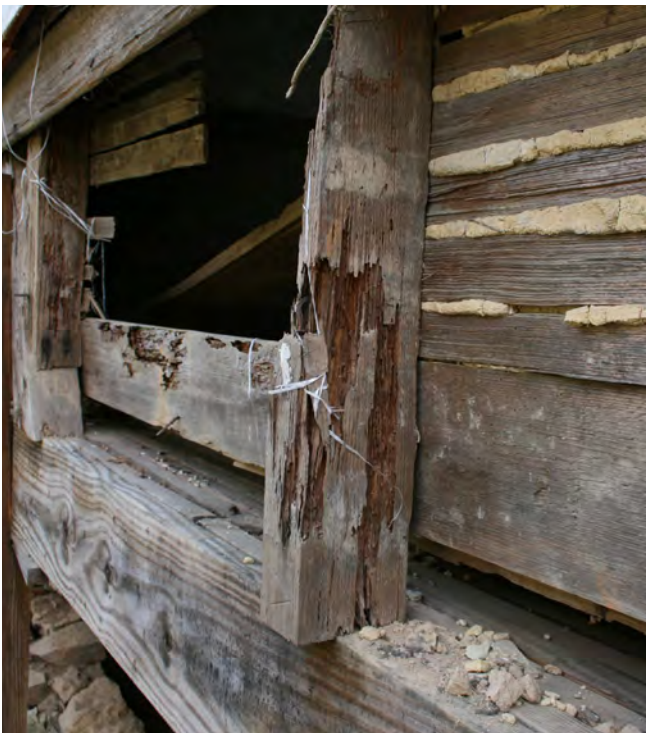
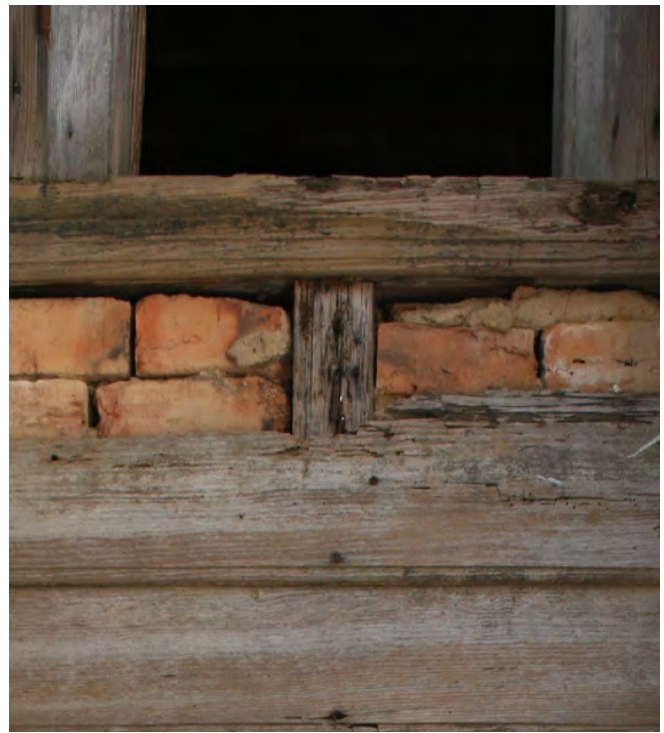
Soon after acquiring the house, the Foundation arranged for it be covered with OSB sheathing and protected from moisture by house wrap. This work was headed up by Bobby Clary using local labor in 2010. The house is still mostly obscured by the house wrap, but enough can be seen to realize that the weatherboard is in severely fragmentary and eroded condition. The window frames, sills, and trim are similarly degraded by years of neglect, but much of it is concealed by the OSB sheathing. Many window sashes are either missing or in need of repair. The cornice is missing much of the top member. Rake boards are missing. The roofing is keeping out water, but is not a long-term solution to the building's needs.

Damage to the sill on the north elevation (left) and typical brick nogging and weatherboards on the north elevation (right).

- The exterior weatherboards and trim should be repaired and replaced. Any intact sections should be maintained in situ.
- Window frames and sills should be repaired in place wherever possible.
- Window sashes should be repaired as possible or replaced with identical units.
- A new roof with adequate flashing should be installed, using either wood shingles to match physical evidence, including shingles found in the attic, or a replacement 5-V metal roof.
- Repair the porch trim, repair deteriorated portions of the porch ceiling, and replace the porch floor.
- After foundation work is complete, regrade the exterior to original levels.

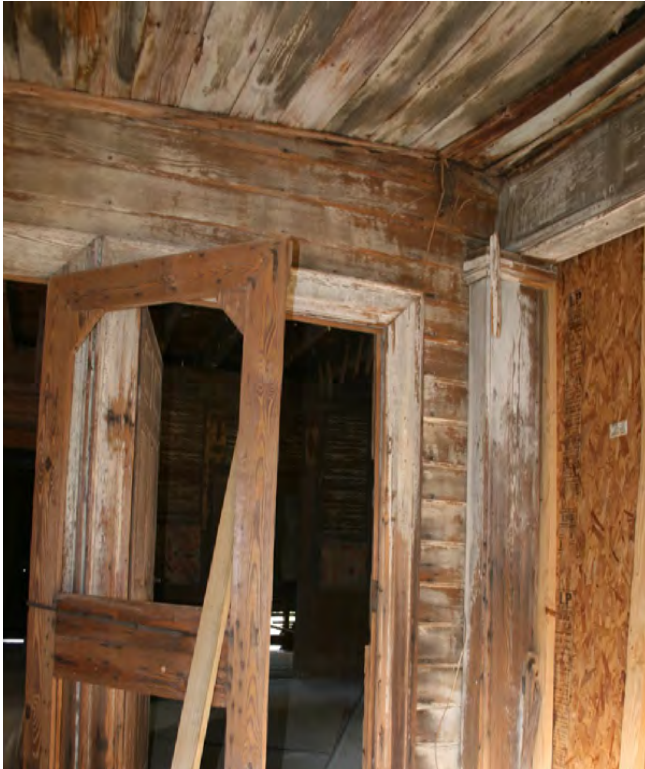
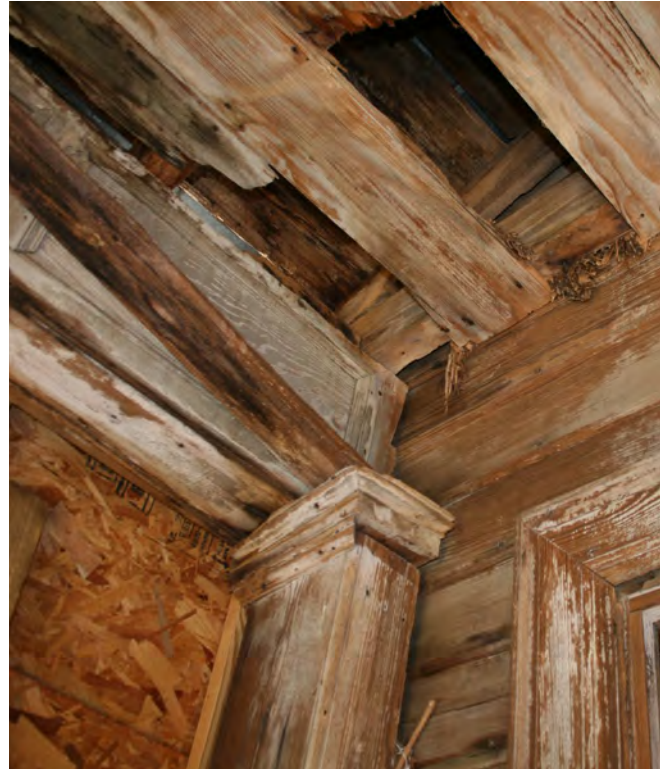
The porch needs a great deal of repair to make it safe for use by visitors. The foundation is fragmentary, the flooring is loose and unreliable, and the stairs are not usable by visitors. There are no porch railings, which is a hazard, even though the project probably doesn't need to meet code as an existing historic building. The historic photograph from 1929 on page 21 shows the porch with protective placement of two side benches to prevent people from falling off the sides of the porch.

South porch interior looking northeast (left) and south porch interior looking towards northwest towards ceiling (right).

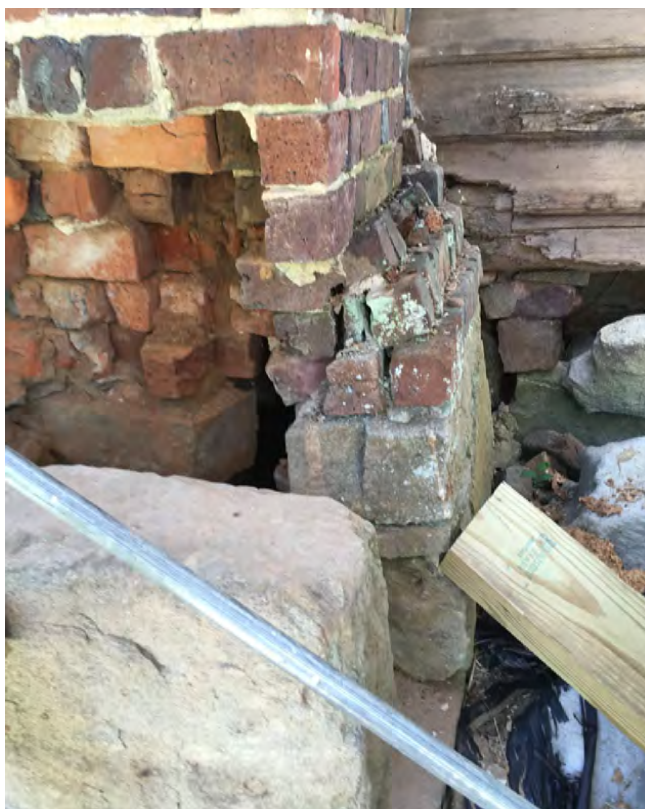
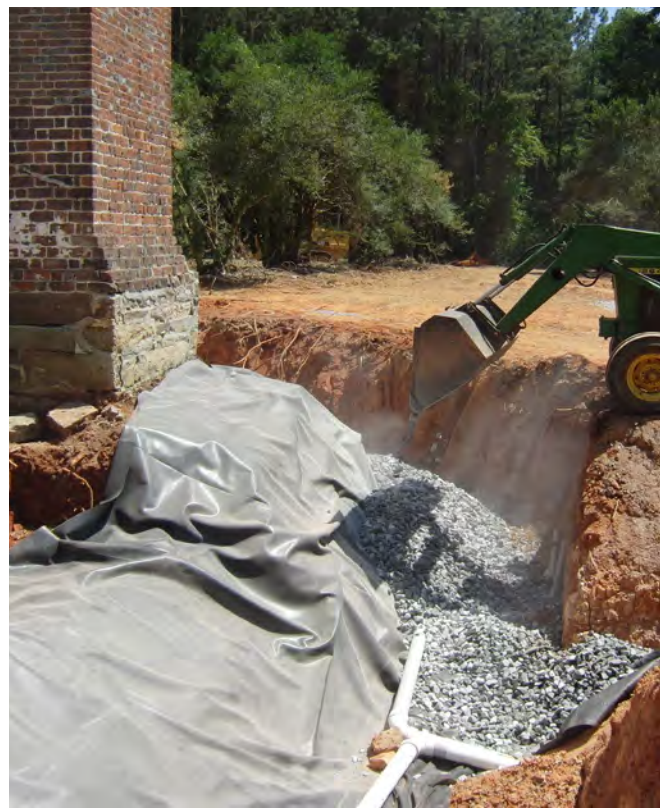
East chimney base during repair in 2013 (left) and west chimney during foundation drain installation (right).

The chimney at the east end was moving and collapsing at the base, as the outer layer of stone was forced to carry most of the weight of the brick chimney shaft above. Tom King repaired the base of the chimney and filled the void at the interior with concrete grout. The west chimney has similar problems that have not been addressed. Cracking and bulging at the base indicate that the stone outer face does not have capacity to carry the weight of the brick above. At both chimneys, the tile that originally shed water is missing from the shoulders and the upper shaft has lost integrity.

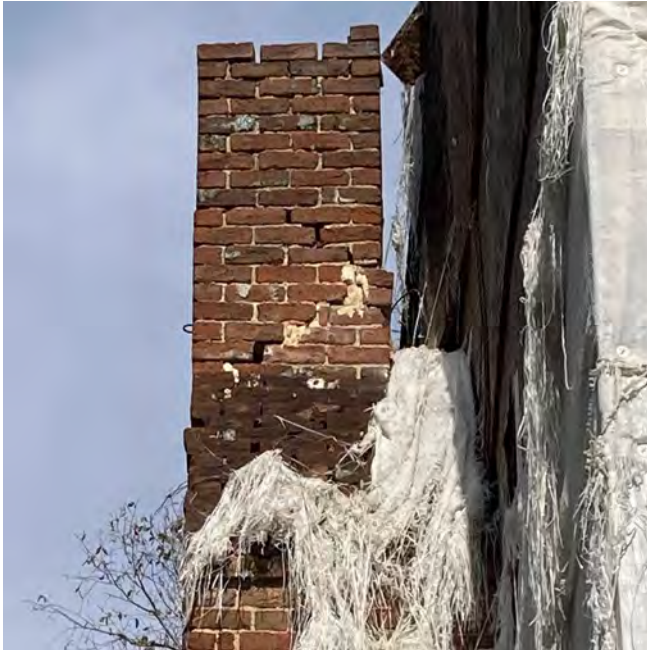
West chimney shaft looking north (left) and east chimney shaft looking north (right).

- West Chimney
 - * Rebuild from shoulder up (cracks and outward shift/lean). Document and salvage the decorative diapering pattern and put back to match existing.

- * Base appears to have been an outer wythe of mortared masonry with inner rubble fill which has become loose. Rebuild base in sections with clay bricks at interior, exterior wythe of stone masonry to match original. Similar to construction of main walls. Add new concrete footing installed in segments after repairing structural crack with stainless steel helical ties.

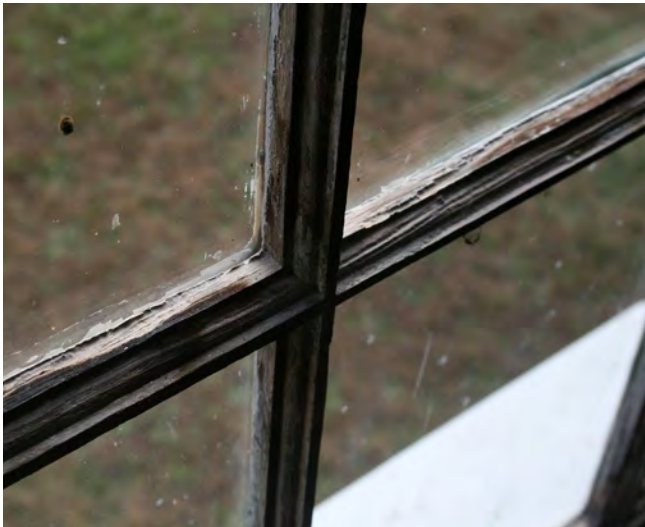
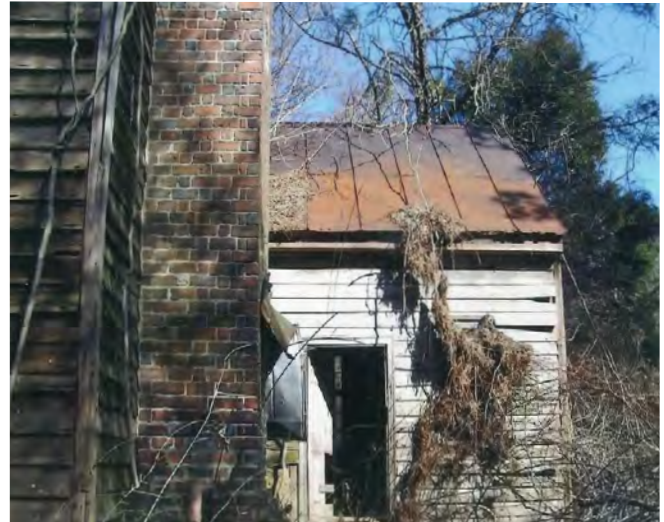
Details of the East Wing, window (left) and south front (right).

The exterior of the wing is in poor condition. Some of the weatherboards and trim elements are possibly reusable in place, particularly on the south, where they were protected for many years by the porch. The window sashes are missing. The floor framing is partially collapsed and the floor damaged. The north foundation wall is intact, although damaged by cracking. The east end and south foundation walls are in poor condition or missing entirely. The roof is sheathed with an unusual 2-V surface-nailed metal roof.

- The foundation, exterior trim, and weatherboard should be repaired or reproduced to restore the exterior to its c1810 appearance.
- Significant wood framing repairs / replacement required. Access should be closed until the flooring is sound. The floor structure should be repaired as recommended by structural engineer.

- The missing east wing chimney should probably be rebuilt, in order to make interpretive sense of the exterior of the building.
- Repair the exterior door.

- Repair surviving window sashes and reproduce missing window sashes and other elements as needed.
- Access should be provided to the door.
- Unless the porch can be shown to be an early feature of the wing, it should not be restored. This should become clear after the OSB sheathing is removed.

- Intact sections of the brick foundation (particularly under the north wall) should be repaired in place. Other damaged and missing sections of the brick foundation should be rebuilt on new footings using brick salvaged from the site.

- Underpinning of foundation is required due to deep trench adjacent (see previous discussion).
- Coordinate repair work with a new foundation for stoop or porch for access to east wing.

- Install a new wood shingle roof or a 2-V metal roof and new flashing against the two-story section.

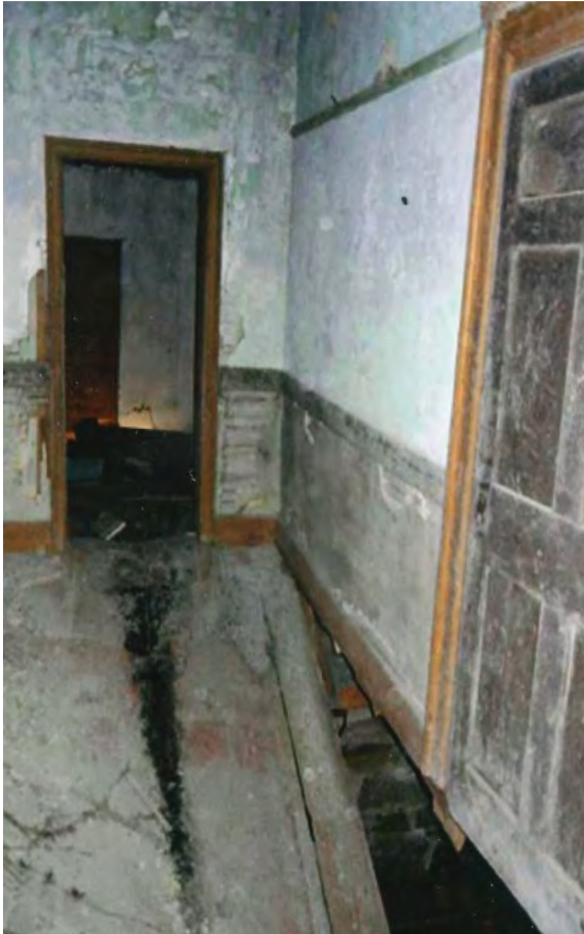
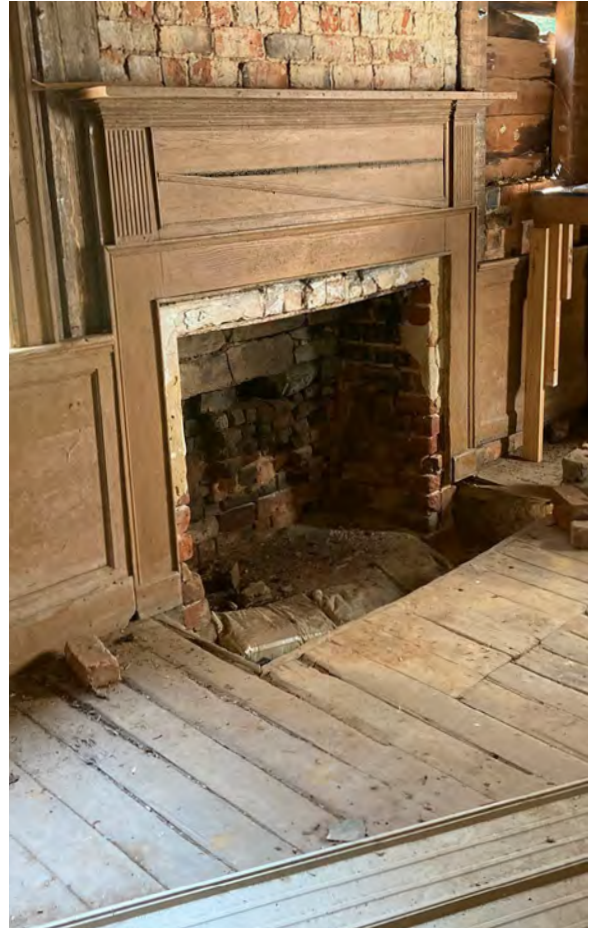
First Floor, Room 1) showing appearance before the floor was repaired c. 2013. The floor had dropped with the collapse of the rotted joists below (left). First Floor, Parlor, chimney breast showing damage to hearth, floor and fireplace interior (right).

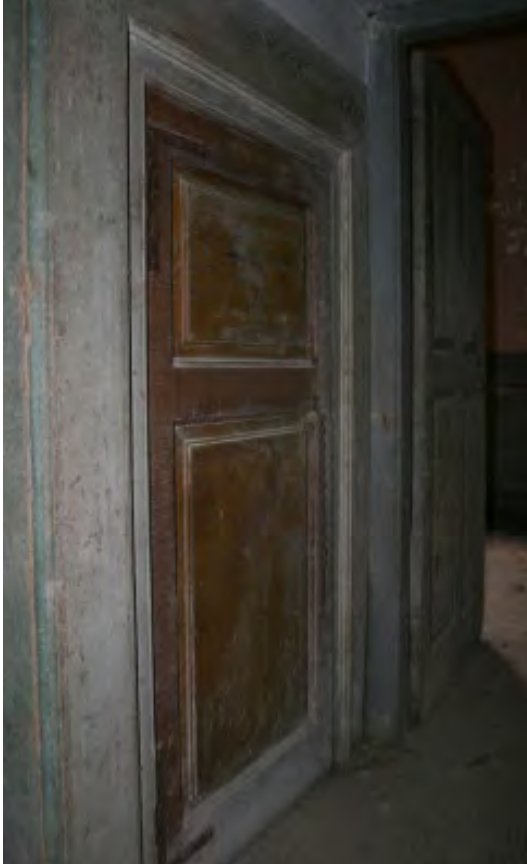
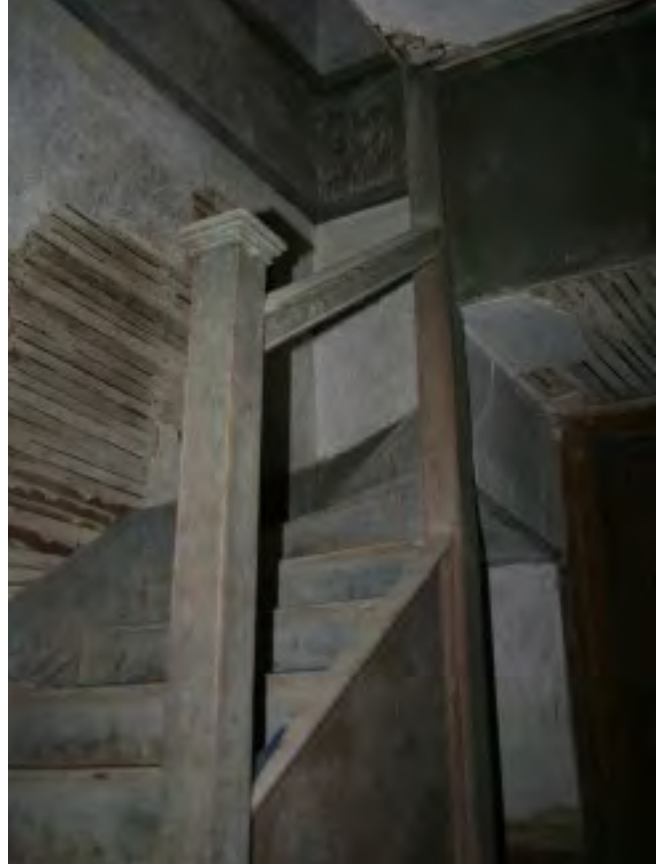
Decorative painting and graining at closet door under stair (left) and stair rail with missing balusters (right).

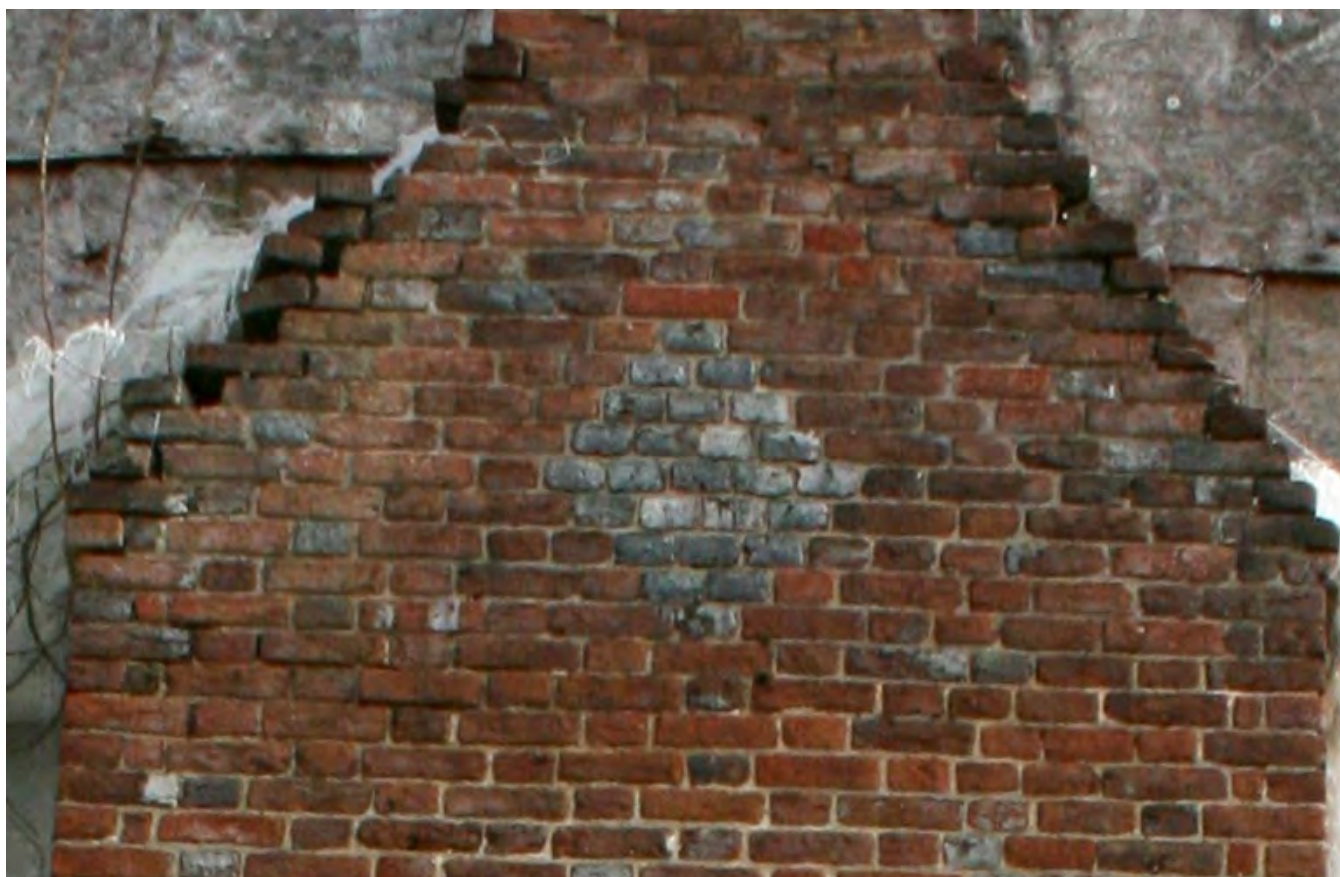
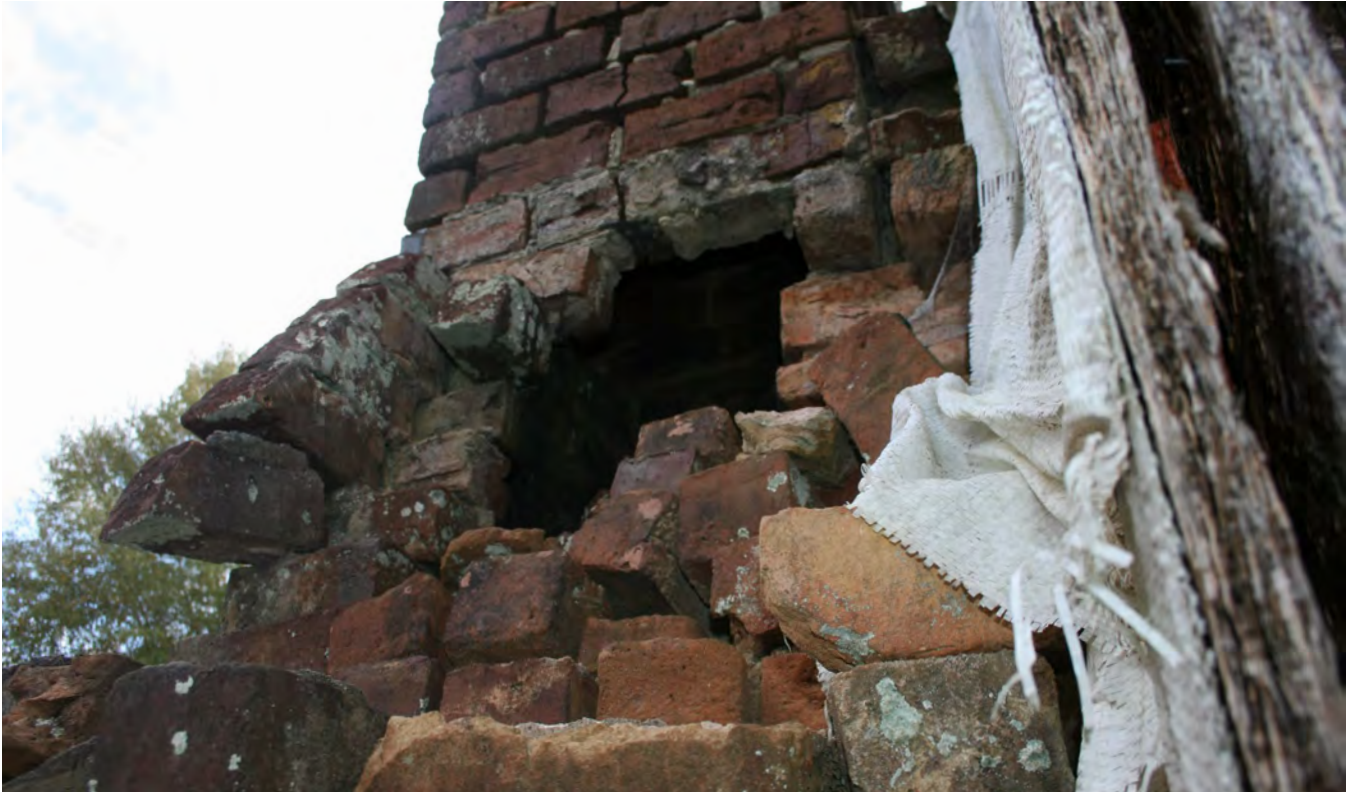
East Chimney looking south at shoulder level showing damage (above) and east chimney base looking east (below), 2021.
