Historic Structures Report for Bacon's Castle Surry, Virginia

Prepared for: Preservation Virginia

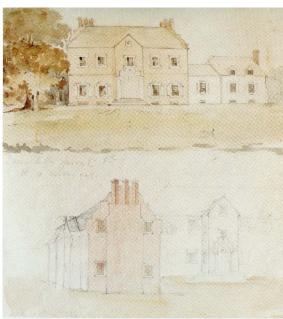
Figure 2.6: Watercolor of Bacon's Castle, by unknown artist, ca. 1815. Preservation Virginia.

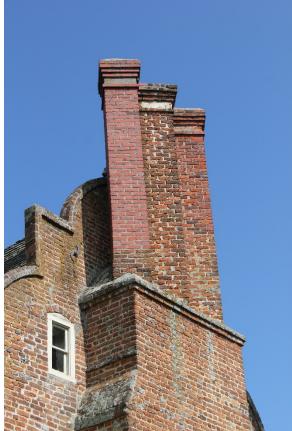
Figure 2.17: Bacon's Castle, West elevation. Photograph 26 July 2015. Two of the three chimney stacks reveal evidence of nineteenth-century restoration / reconstruction, as the two end stacks (on in part, the other in whole) have been reconstructed with modern pressed brick. The earliest surviving photographs of Bacon's Castle (late nineteenth-century) reveal this reconstruction to already have occurred by that date.

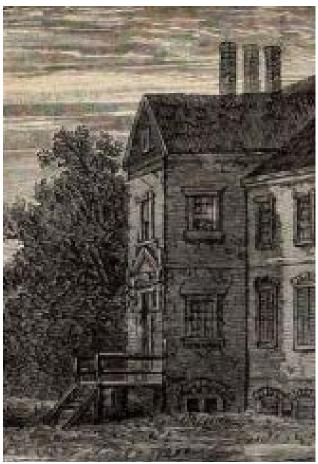
Figure 2.23: Detail, Bacon's Castle, from Frank Leslie's Illustrated Newspaper, 8 September 1868. While published in 1868, the view depicts a pre-1854 condition, before the relocation of 18C wing and the construction of the 1854 wing.

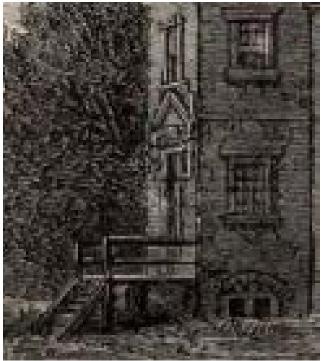
Figure 2.24: Detail, Bacon's Castle, from Frank Leslie's Illustrated Newspaper, 8 September 1868. While published in 1868, the view depicts a pre-1854 condition, before the relocation of 18C wing and the construction of the 1854 wing.

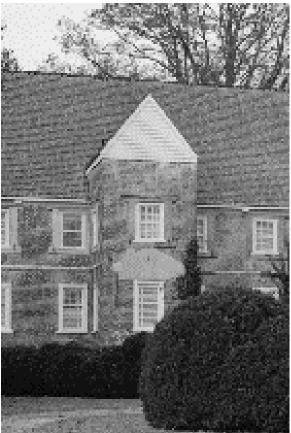
Figure 2.42: Bacon's Castle, South Elevation (detail). Photograph by HABS, 1972. The Library of Congress.

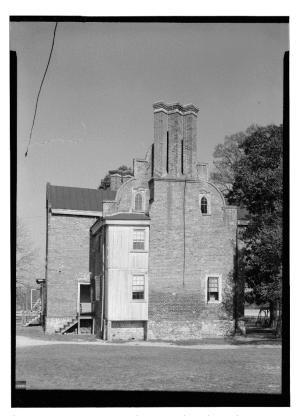
Figure 2.43: Bacon's Castle, west elevation, view to east. Photograph HABS, 1937. The Library of Congress.

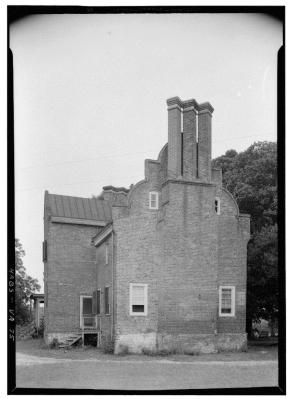
Figure 2.44: Bacon's Castle, west elevation, view to east. Photograph HABS, 1940. The Library of Congress.

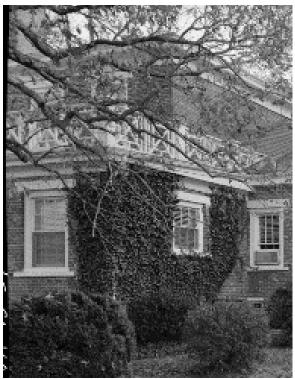
Figure 2.46 Bacon's Castle, north elevation, view to south (detail). Photograph HABS, 1972. The Library of Congress.

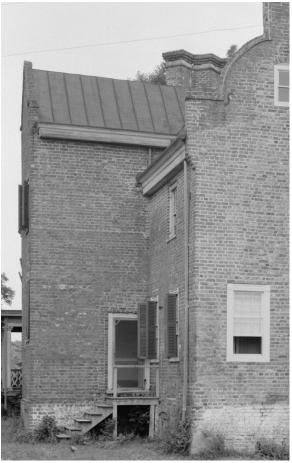
Figure 2.47: Bacon's Castle, west elevation, view to east (detail). Photograph HABS, 1937. The Library of Congress.

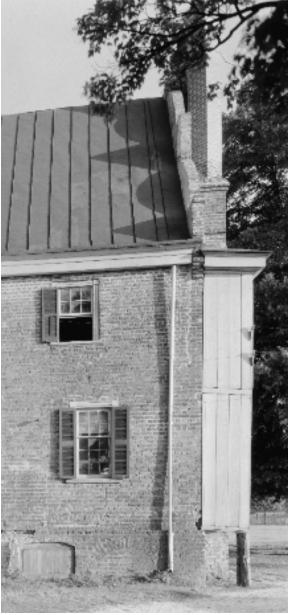
Figure 2.50: Bacon's Castle, north elevation, view to south (detail). Photograph HABS, 1937. The Library of Congress.

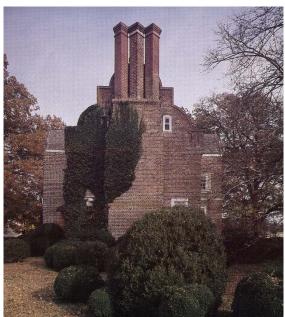
Figure 2.85: Bacon's Castle, west elevation, 1976. Virginia Department of Historic Resources.

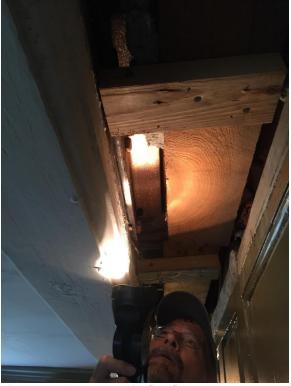
Figure 2.88: Bacon's Castle, first floor, east room (Hall). Material has been removed in vicinity of ceiling plaster crack and beam crack to reveal steel reinforcement. 31 July 2015. Commonwealth Architects

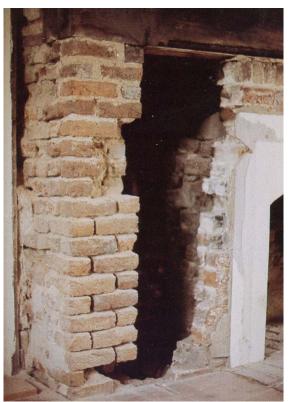
Figure 2.89: Bacon's Castle, North jamb of hall fireplace, ca. 1982. Preservation Virginia.

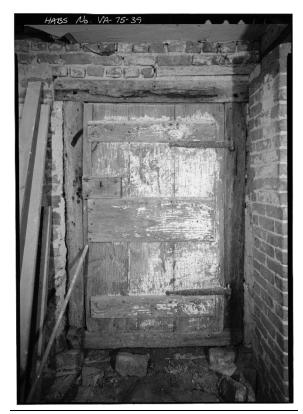
Figure 2.94: Bacon's Castle, Cellar, West Room, detail of door, view to north. Photograph HABS, 1972. The Library of Congress.

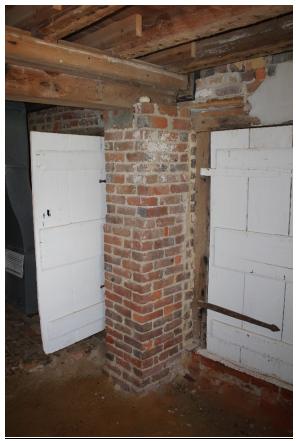
Figure 2.95: Bacon's Castle, Cellar, East Room, detail of door, view to north. Photograph Commonwealth Architects, 2015.

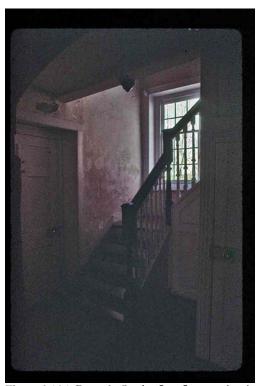
Figure 2.106: Bacon's Castle, first floor, stair, view to south, 1976. Virginia Department of Historic Resources.

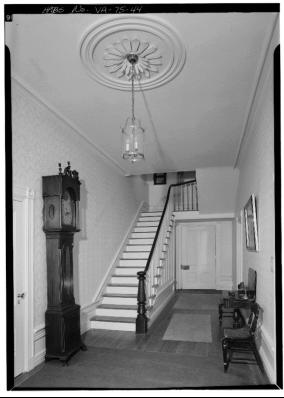
Figure 2.116: Bacon's Castle, First Floor, 1854 addition, central passage, view to north. Photograph HABS, 1972. The Library of Congress.

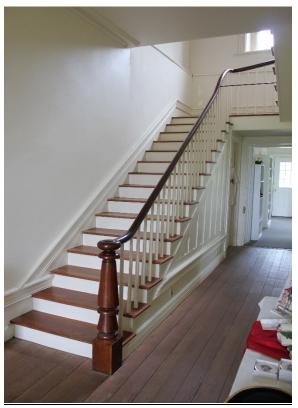
Figure 2.117: Bacon's Castle, First Floor, 1854 addition, central passage, view to north. Photograph Commonwealth Architects, 2015.

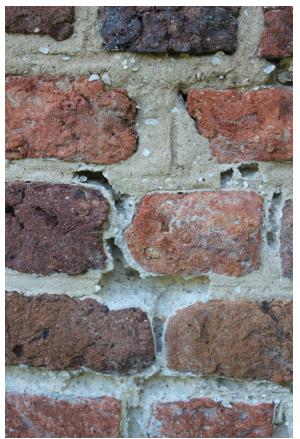
Figure 2.124: Bacon's Castle, South elevation, restoration repointing failure. Commonwealth Architects, 16 July 2016.

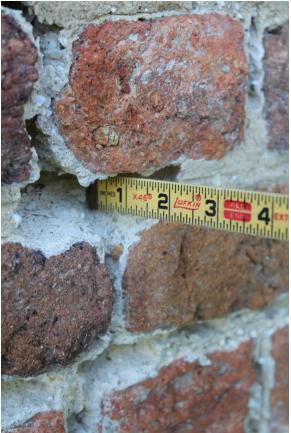
Figure 2.125: Bacon's Castle, South elevation, restoration repointing failure. Commonwealth Architects, 16 July 2016.

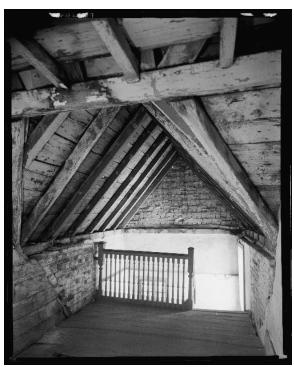
Figure 2.130: Bacon's Castle, Garret, stair tower (north) view to north. Photograph Frances Benjamin Johnston, 1936. The Library of Congress.

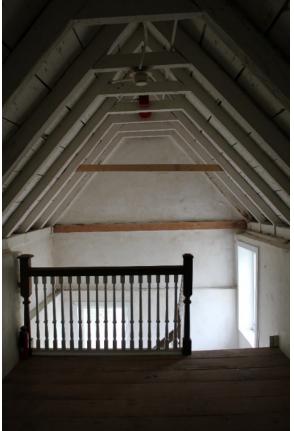
Figure 2.135: Bacon's Castle, Garret, stair tower (north) view to north. Photograph Commonwealth Architects, 2015.

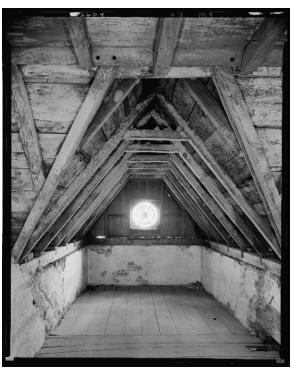
Figure 2.136: Bacon's Castle, Garret, south tower (south) view to south. Photograph Frances Benjamin Johnston, 1936. The Library of Congress.

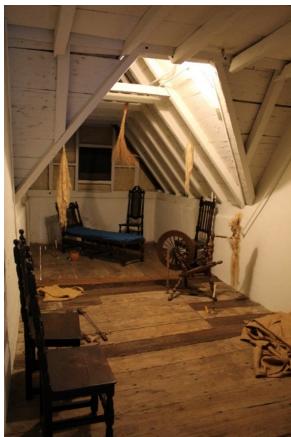
Figure 2.138: Bacon's Castle, Garret, south tower (south) view to south. Photograph Commonwealth Architects, 2015.

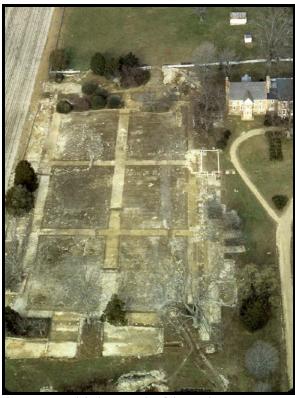
Figure 3.5: Aerial photograph of the garden at Bacon's Castle, facing north.

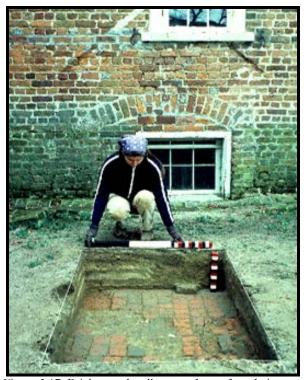
Figure 3.17: Brick-paved walkway and step foundations for cellar kitchen.

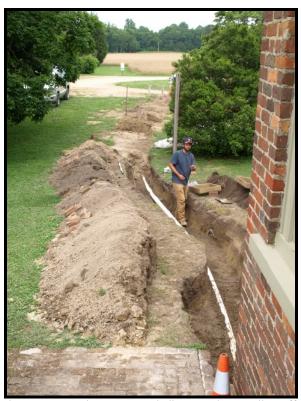
Figure 3.21: Replacement septic line trench extending off the northeast corner of the 1854 wing, ER800.

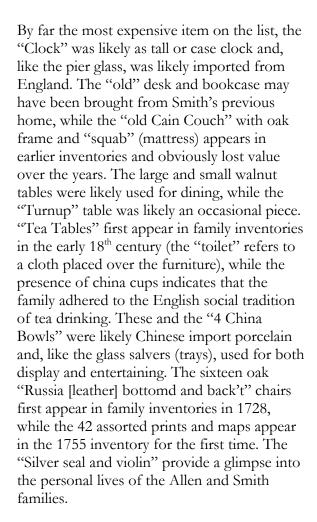
Interpretation of Architecture

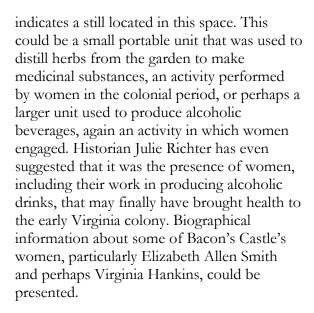
Alternatively, this space could be used to interpret rebel occupation of the house during Bacon's Rebellion. The rebels stuffed pillow cases with goods – this could be shown as well as loads of wine bottles (some broken on the floor) and cattle bones (the remnants of their meals). The room would be shown in great disarray. This interpretive choice would provide an opportunity to discuss the partisan views of the homeowner and the subsequent problems it caused him, as well as wider discussions of 17th-century politics in Virginia. If not used in this area, the Rebellion should be interpreted somewhere in the house

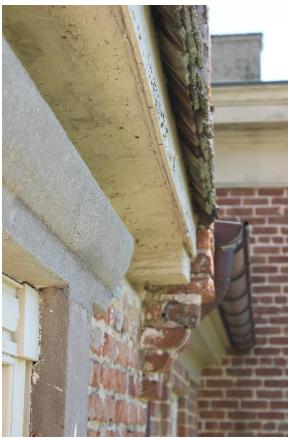
Figure 5.3, Bacon's Castle, South elevation ca. 1665 building, note the profile of the window trim, the beginning of the stepped parapet wall, the lack of gutters on the ca. 1665 building, and the gutter located on the hyphen.

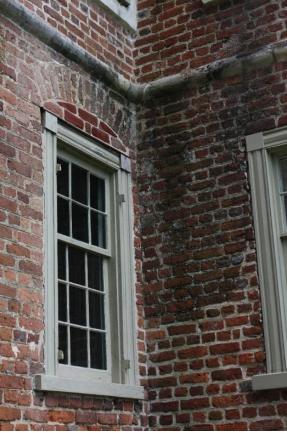
Figure 5.8, Bacon's Castle, South elevation, ca. 1665 building, first floor window.

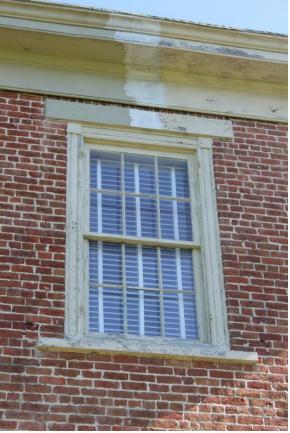
Figure 5.11, Bacon's Castle, South elevation, ca. 1854 addition, second floor window.

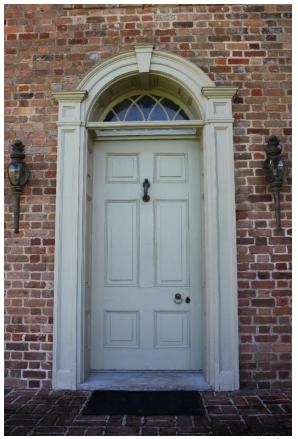
Figure 5.12, Bacon's Castle, South elevation, detail of main museum entry.

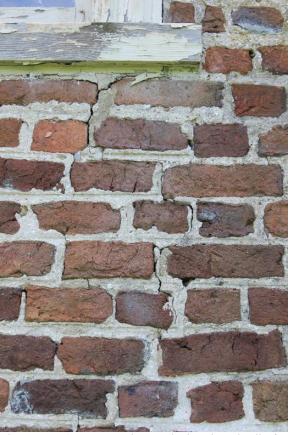
Figure 5.21, Bacon's Castle, North elevation, detail of masonry wall. Note the cracked mortar.

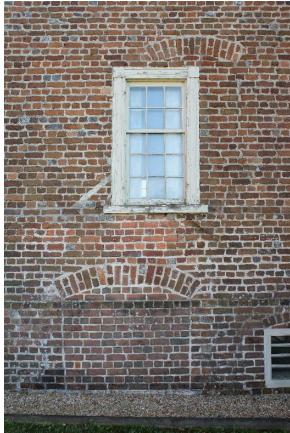
Figure 5.27, Bacon's Castle, South elevation, detail ghosting of previous porch. Note the bricked-in bulkhead door.

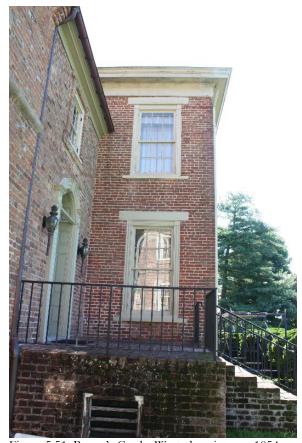
Figure 5.51, Bacon's Castle, West elevation, ca. 1854 addition.

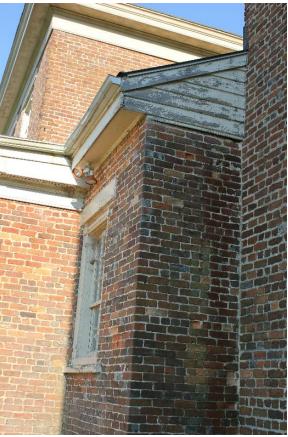
Figure 5.53, Bacon's Castle, West elevation, Hyphen cornice detail, ca. 1950s kitchen addition cornice detail, ca. 1854 addition cornice detail.

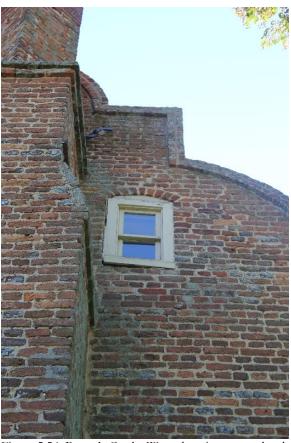
Figure 5.56, Bacon's Castle, West elevation, garret level window. Note how the fireplace mass is warping the west wall of the castle. The window is also being pulled with the wall.

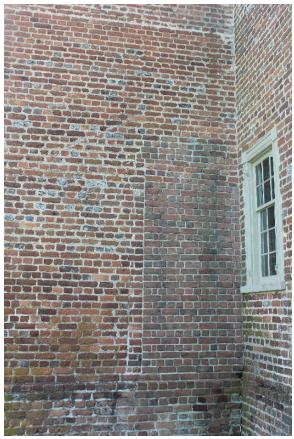
Figure 5.59, Bacon's Castle, West elevation, north tower, in-filled door opening and porch ghosting.

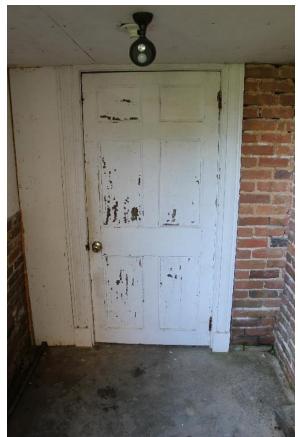
Figure 5.60, Bacon's Castle, West elevation, ca. 1950s kitchen addition, basement door. Note flaking and missing paint.

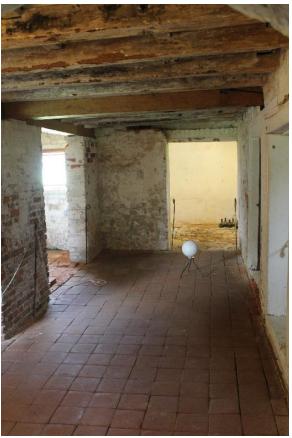
Figure 5.69, Bacon's Castle, ca. 1665 dwelling, Basement, Room 002, general view south.

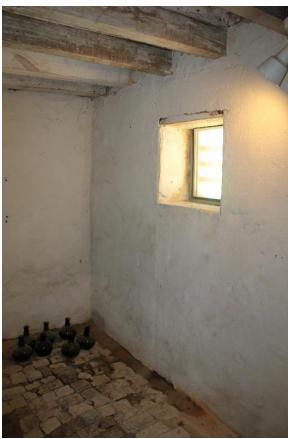
Figure 5.85, Bacon's Castle, ca. 1665 dwelling, Basement, South tower, Room 004, general view. Note the light fixture in the upper right hand corner.

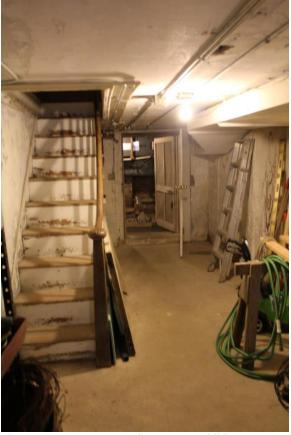
Figure 5.100, Bacon's Castle, ca. 1854 addition, Basement, Room 007, View north.

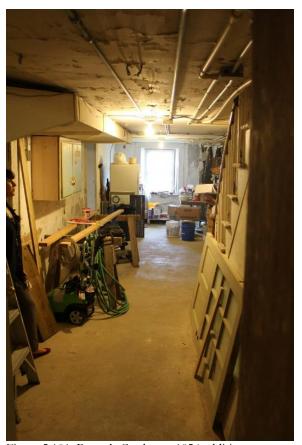
Figure 5.101, Bacon's Castle, ca. 1854 addition, Basement, Room 007, View south.

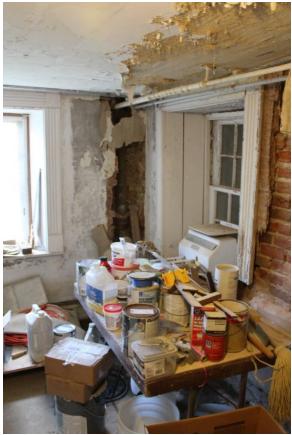
Figure 5.102, Bacon's Castle, ca. 1854 addition, Basement, Room 007, Window details. Note demolished portion of southwest corner, missing portion of window trim, and plaster ceiling damage.

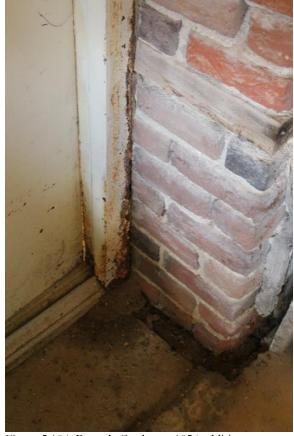
Figure 5.104, Bacon's Castle, ca. 1854 addition, Basement, Room 007, Note the rust on the door frame and door panel.

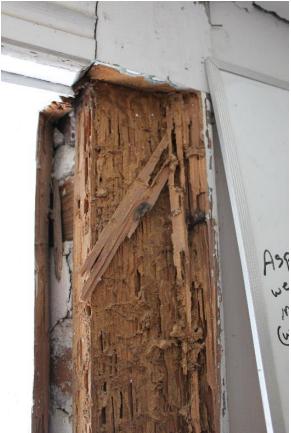
Figure 5.109, Bacon's Castle, ca. 1854 addition, Basement, Room 008,009, eastern window, south wall. Note extreme termite damage.

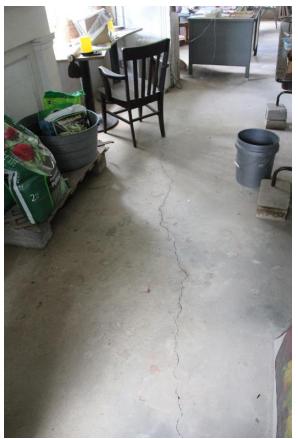
Figure 5.110, Bacon's Castle, ca. 1854 addition, Basement, Room 008,009, concrete floor. Note the large crack. Also note the gardening supplies. They have been elevated above the floor with concrete masonry units and a board.

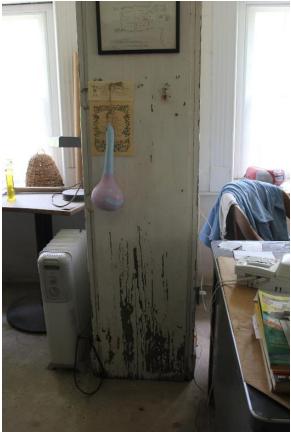
Figure 5.112, Bacon's Castle, ca. 1854 addition, Basement, Room 008,009, View east. Note the water damage at the base of the cased opening.

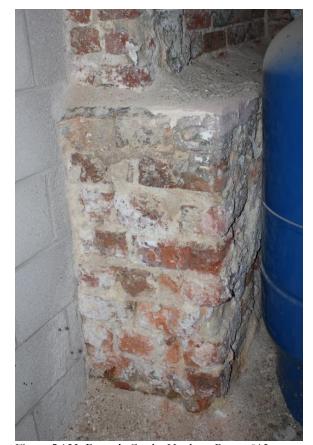
Figure 5.123, Bacon's Castle, Hyphen, Room 012, ca. 1665 chimney water table and modern concrete masonry unit wall.

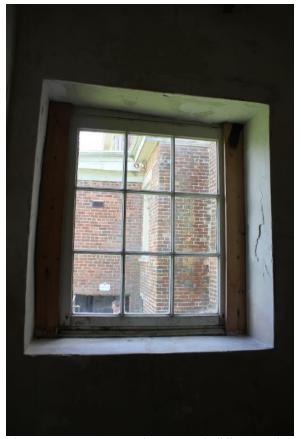
Figure 5.128, Bacon's Castle, ca. 1665 building, North Tower, Room 101, fixed nine light window located on the second landing.

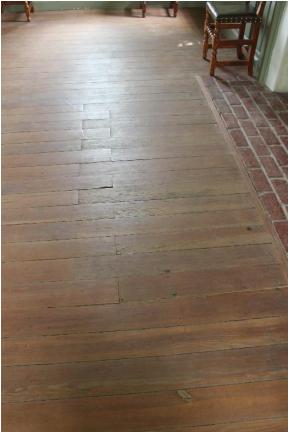
Figure 5.144, Bacon's Castle, ca. 1665 building, West Room, Room 103, detail of floor. Note the sawn and replacement floorboards.

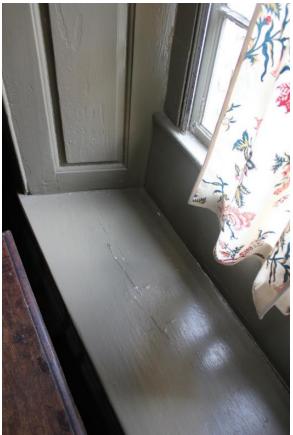
Figure 5.153, Bacon's Castle, ca. 1665 building, East Room, Room 105, detail of paneling and window trim.

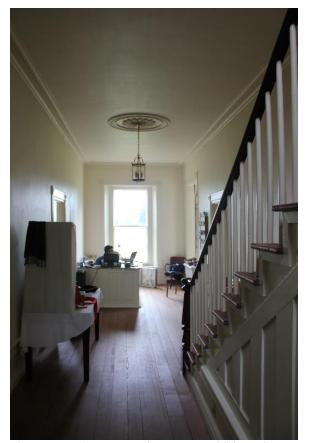
Figure 3.162, Bacon's Castle, ca. 1854 addition, First Floor, Room 107, general view south.

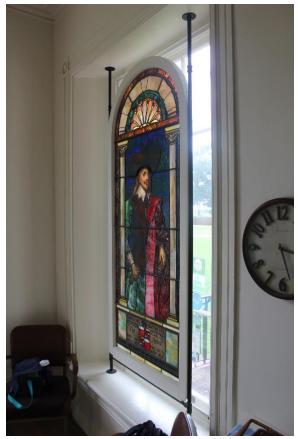
Figure 5.164, Bacon's Castle, ca. 1854 addition, First Floor, Room 107, detail of stained glass window.

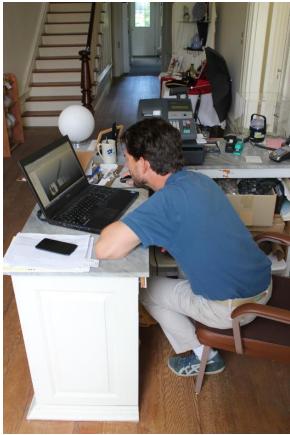
Figure 5.165, Bacon's Castle, ca. 1854 addition, First Floor, Room 107, detail of guest services desk.

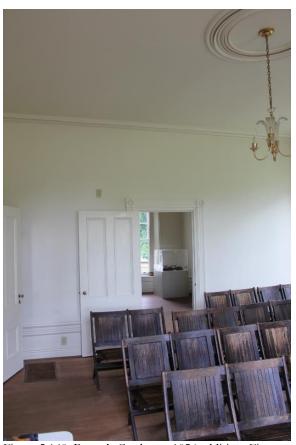
Figure 5.168, Bacon's Castle, ca. 1854 addition, First Floor, Room 108, view north.

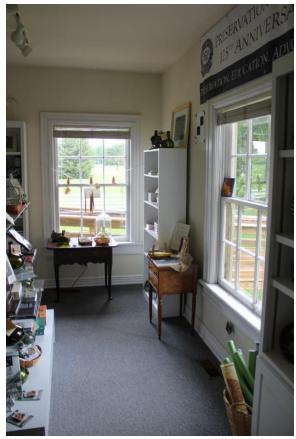
Figure 5.177, Bacon's Castle, ca 1950s addition, First Floor, Room 110, view north, window detail.

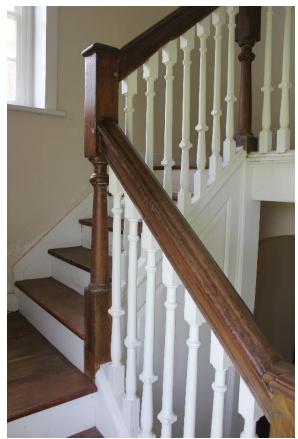
Figure 5.190, Bacon's Castle, ca. 1665 building, North Tower, Second Floor, Room 201, detail of baluster.

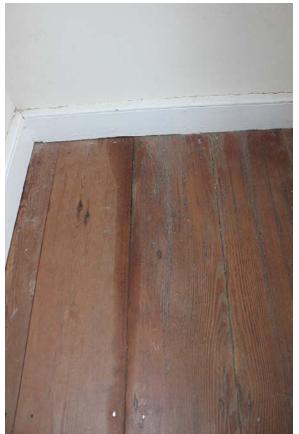
Figure 5.192, Bacon's Castle, ca. 1665 building, North Tower, Second Floor, Room 201, detail of floor boards showing water damage.

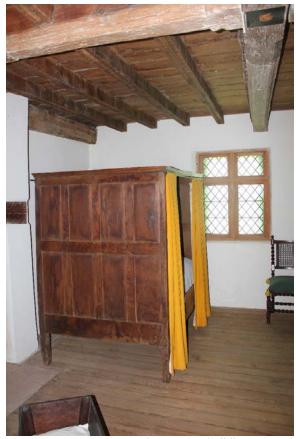
Figure 5.196, Bacon's Castle, ca. 1665 building, Second Floor, West Chamber, Room 203, view northwest.

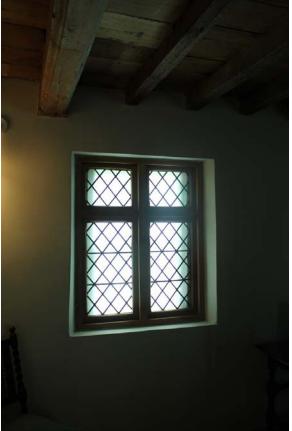
Figure 5.197, Bacon's Castle, ca. 1665 building, Second Floor, West Chamber, Room 203, window detail.

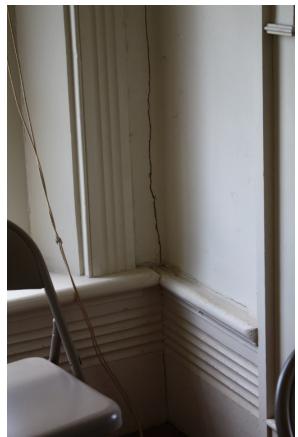
Figure 5.220, Bacon's Castle, ca. 1854 addition, Second Floor, Room 208, detail of crack in southwest corner of the room.

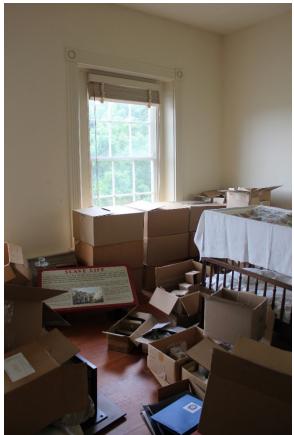
Figure 5.223, Bacon's Castle, ca. 1854 addition, Second Floor, Room 209, view of northeatern window.

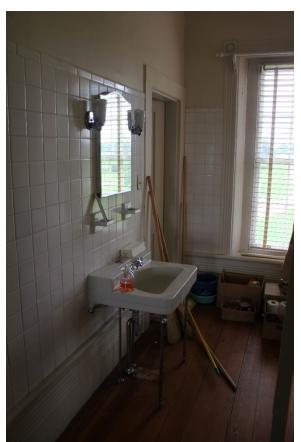
Figure 5.226, Bacon's Castle, ca. 1854 addition, Second Floor, Room 210, view of sink.

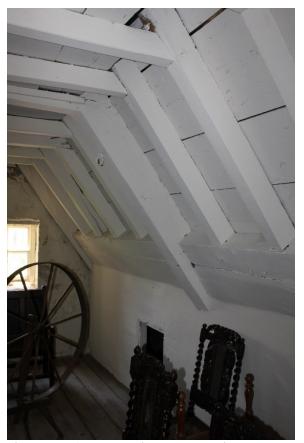
Figure 5.237 Bacon's Castle, ca. 1665 portion, Garret Floor, Room 302, detail of framing members and roof sheathing.

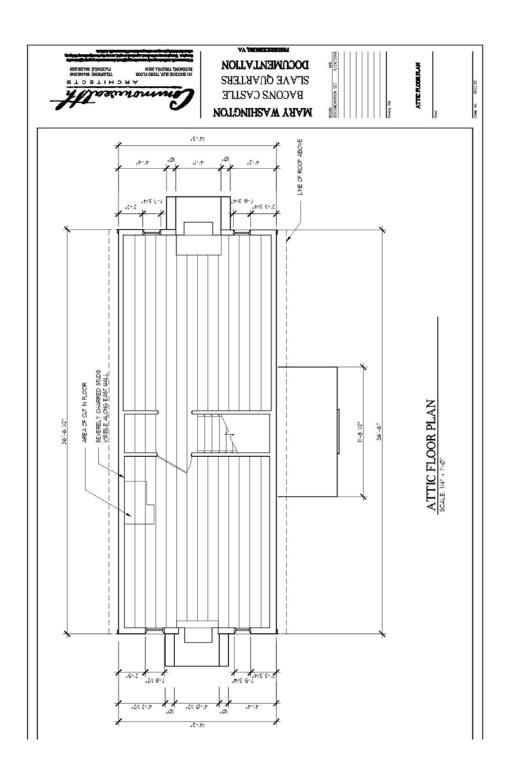
Figure 1: Bacon's Castle Quarters, Attic Plan, 2008.

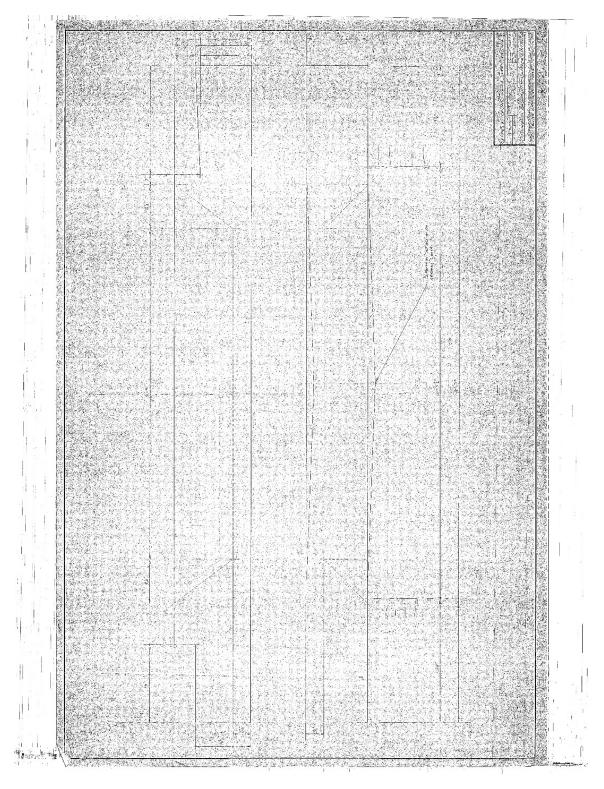
Figure 61: Bacon's Castle, repairs, outline of basement fireplace lintel, Derek Ogden, 1982.

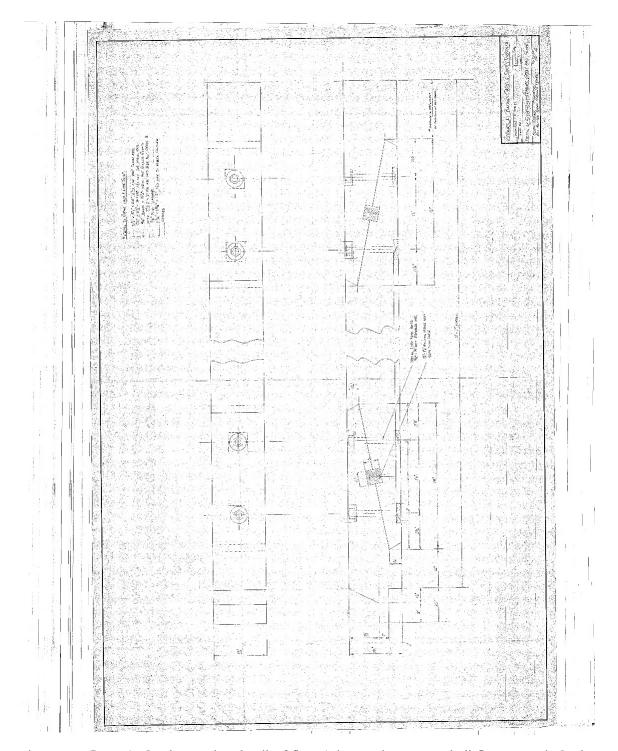
Figure 62: Bacon's Castle, repairs, detail of floor joist repairs at great hall floor, Derek Ogden, 1982.

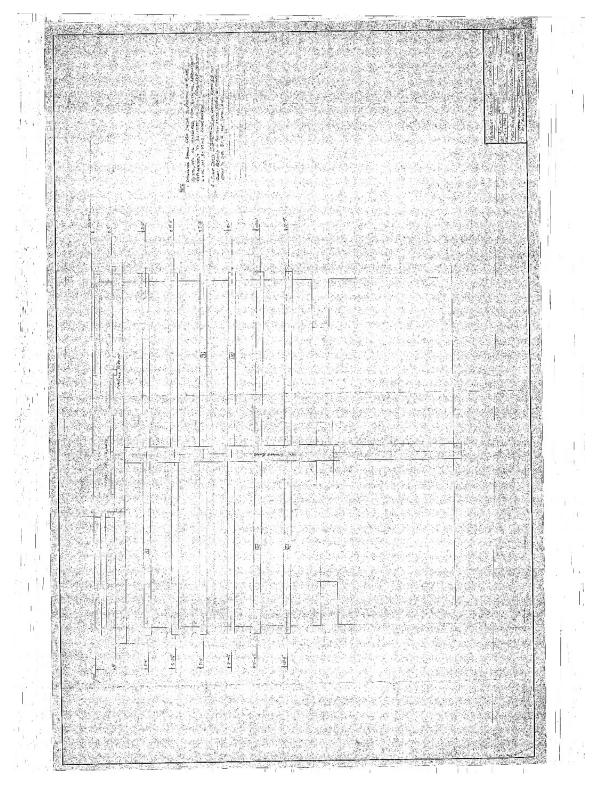
Figure 63: Bacon's Castle, repairs, first floor framing, great hall, Derek Ogden, 1982.

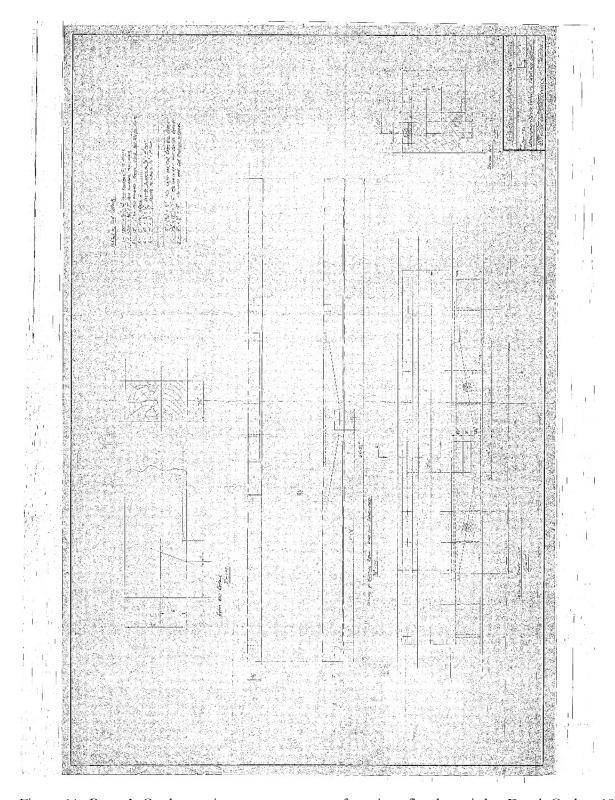
Figure 64: Bacon's Castle, repairs, arrangement scarf repair to fireplace girder, Derek Ogden, 1982.

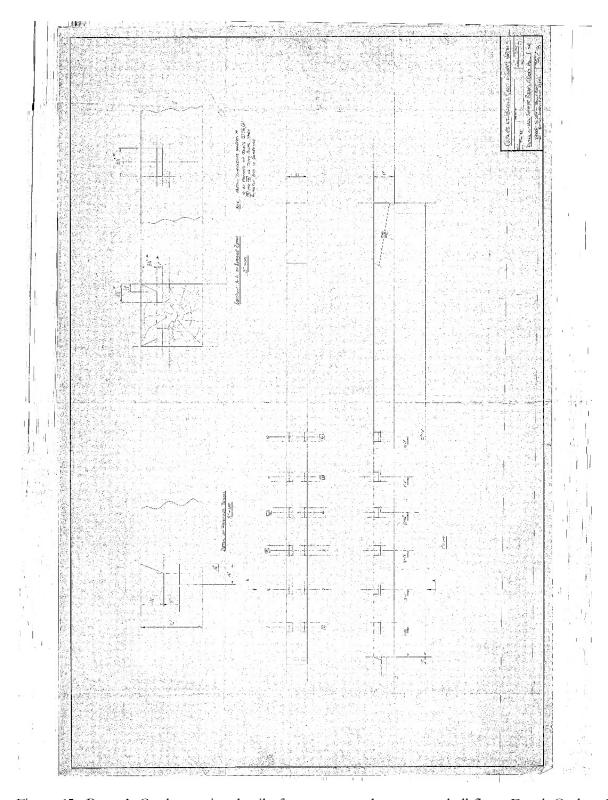
Figure 65: Bacon's Castle, repairs, detail of new summer beam, great hall floor, Derek Ogden, 1982.

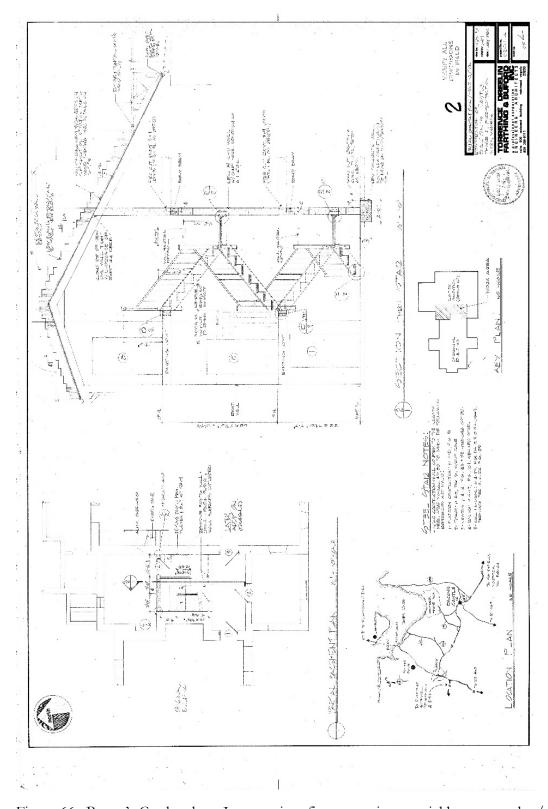
Figure 66: Bacon's Castle, phase I restoration, fire protection, partial basement plan/stair section, Torrence Dreelin Farthing & Buford, Inc., 1982.

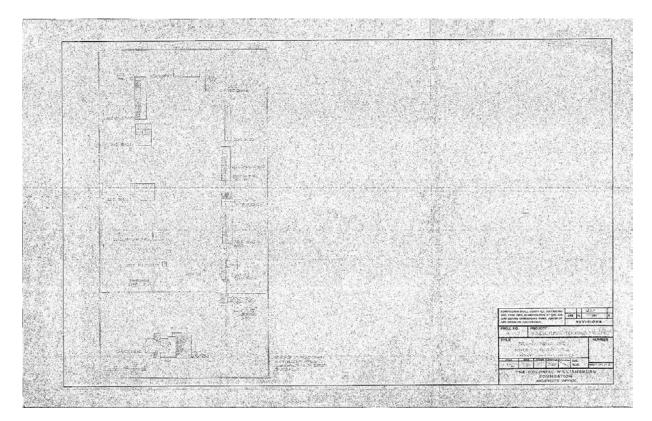
Figure 20: Agricultural buildings project, drawing depicting Bacon's Castle and outbuildings, Colonial Williamsburg Foundation, 1981.

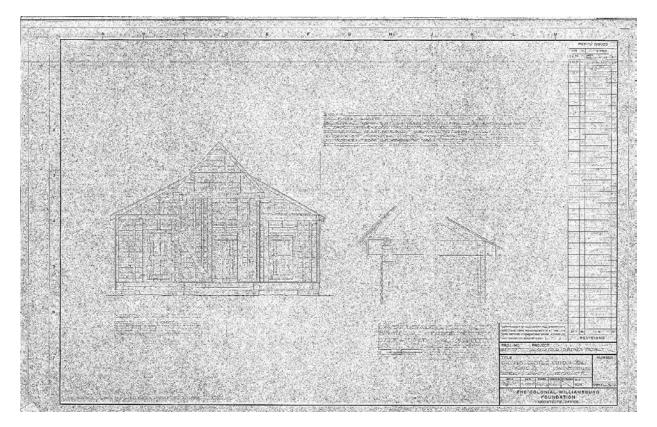
Figure 21: Agricultural buildings project, section of barn, Colonial Williamsburg Foundation, 1981.

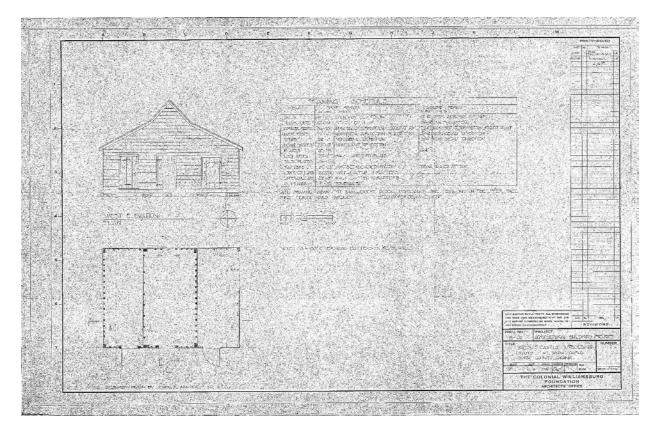
Figure 22: Agricultural buildings project, west elevation and plan of barn, Colonial Williamsburg Foundation, 1981.

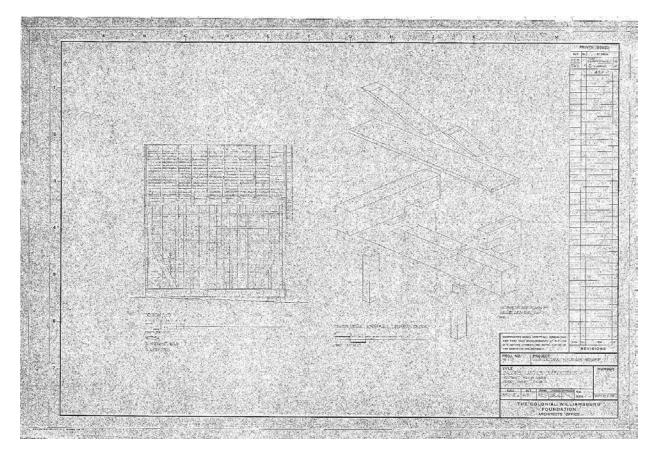
Figure 23: Agricultural buildings project, section of barn, Colonial Williamsburg Foundation, 1981.

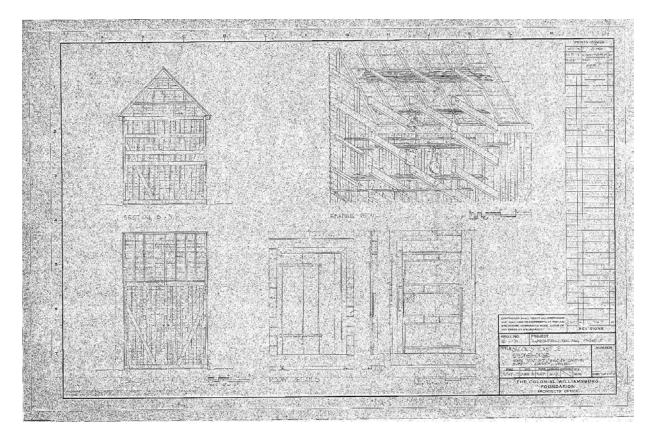
Figure 24: Agricultural buildings project, smokehouse, sections and details, Colonial Williamsburg Foundation, 1981.
