**NATIONAL REGISTER OF HISTORIC PLACES  
REGISTRATION FORM**

historic name **Anderson-Doosing Farm**  
other names/site number VDHR File No. 080-0009

street & number 7474 Blacksburg Road (State Route 785) not for publication N/A  
city or town Catawba vicinity X  
state Virginia code VA county Roanoke code 161 zip code 24070

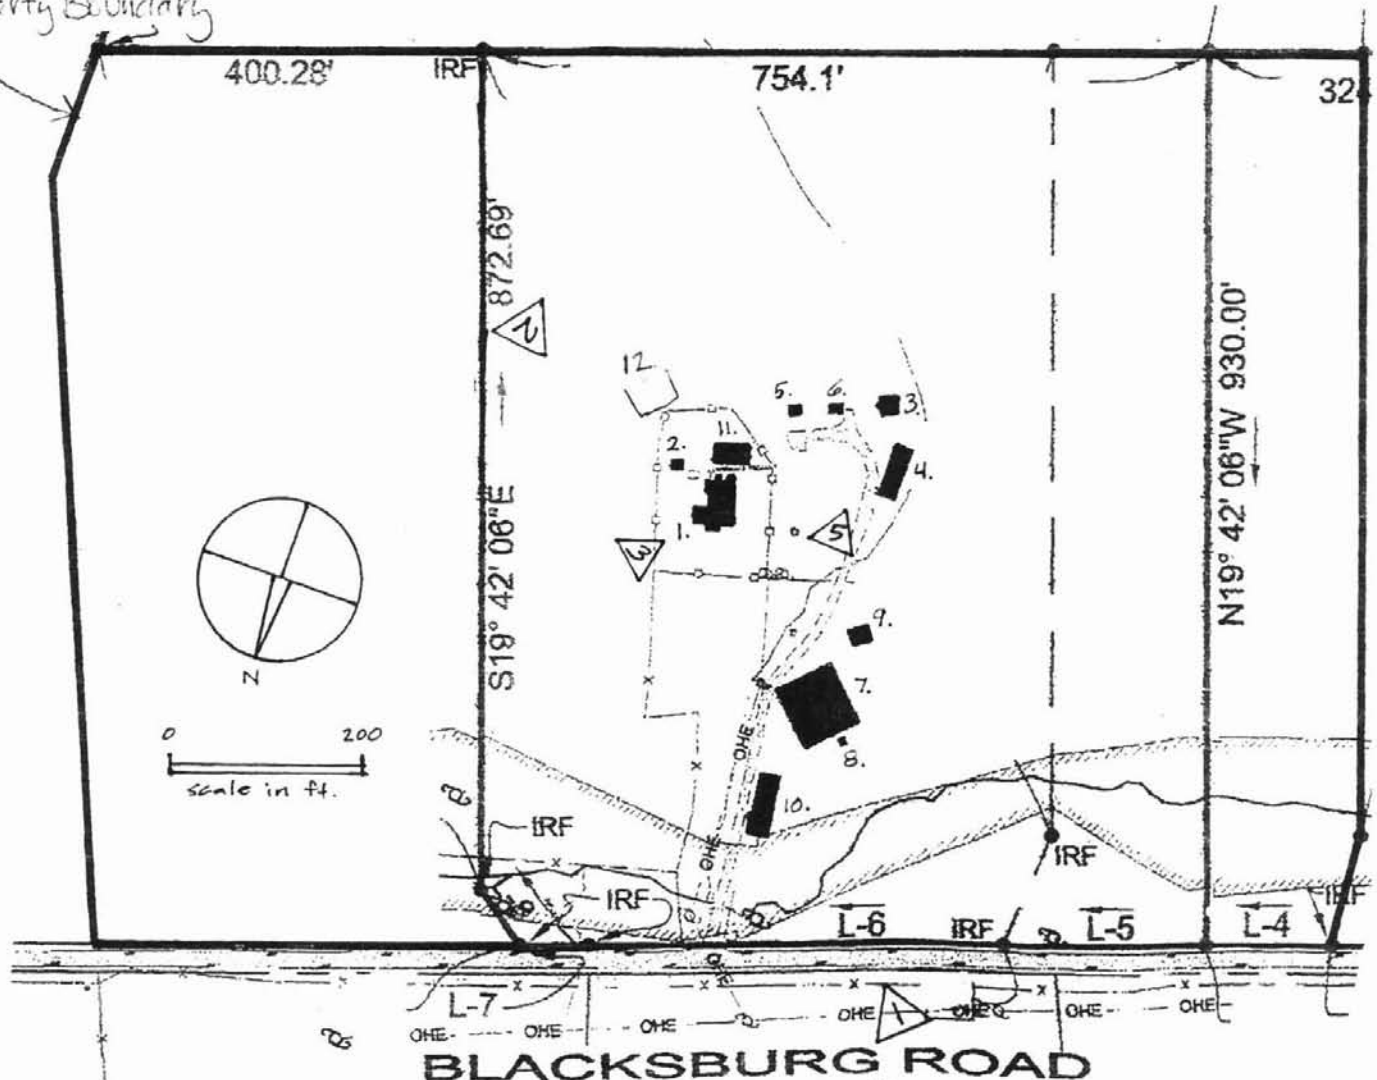
Property Boundary

1. John and Barbara Doosing House. Ca. 1883. Contributing building.
2. Meat house. Early to mid-19<sup>th</sup> c. Contributing building.
3. Log cabin. Mid-19<sup>th</sup> c. Contributing building.
4. Equipment shed/blacksmith shop. Early 20<sup>th</sup> c. Contributing building.
5. Chicken house. First half 20<sup>th</sup> c. Contributing building.
6. Chicken house. First half 20<sup>th</sup> c. Contributing building.
7. Barn. Ca. 1830. Contributing building.
8. Privy. Ca. 1940. Contributing building.
9. Corn crib. Early 20<sup>th</sup> c. Contributing building.
10. Milking parlor. 1940s. Contributing building.
11. Utility building. Late 20<sup>th</sup> c. Noncontributing building.
12. Site 44RN0251. Prehistoric Noncontributing site.
