PORTSMOUTH SHIPWRECK (44PM52)

*Archaeological Documentation of the Remains
of a Late Eighteenth- or Early Nineteenth-Century Vessel
Located in the Elizabeth River Ferry Docking Facility,
City of Portsmouth, Virginia*

Technical Report Series No. 6

2006

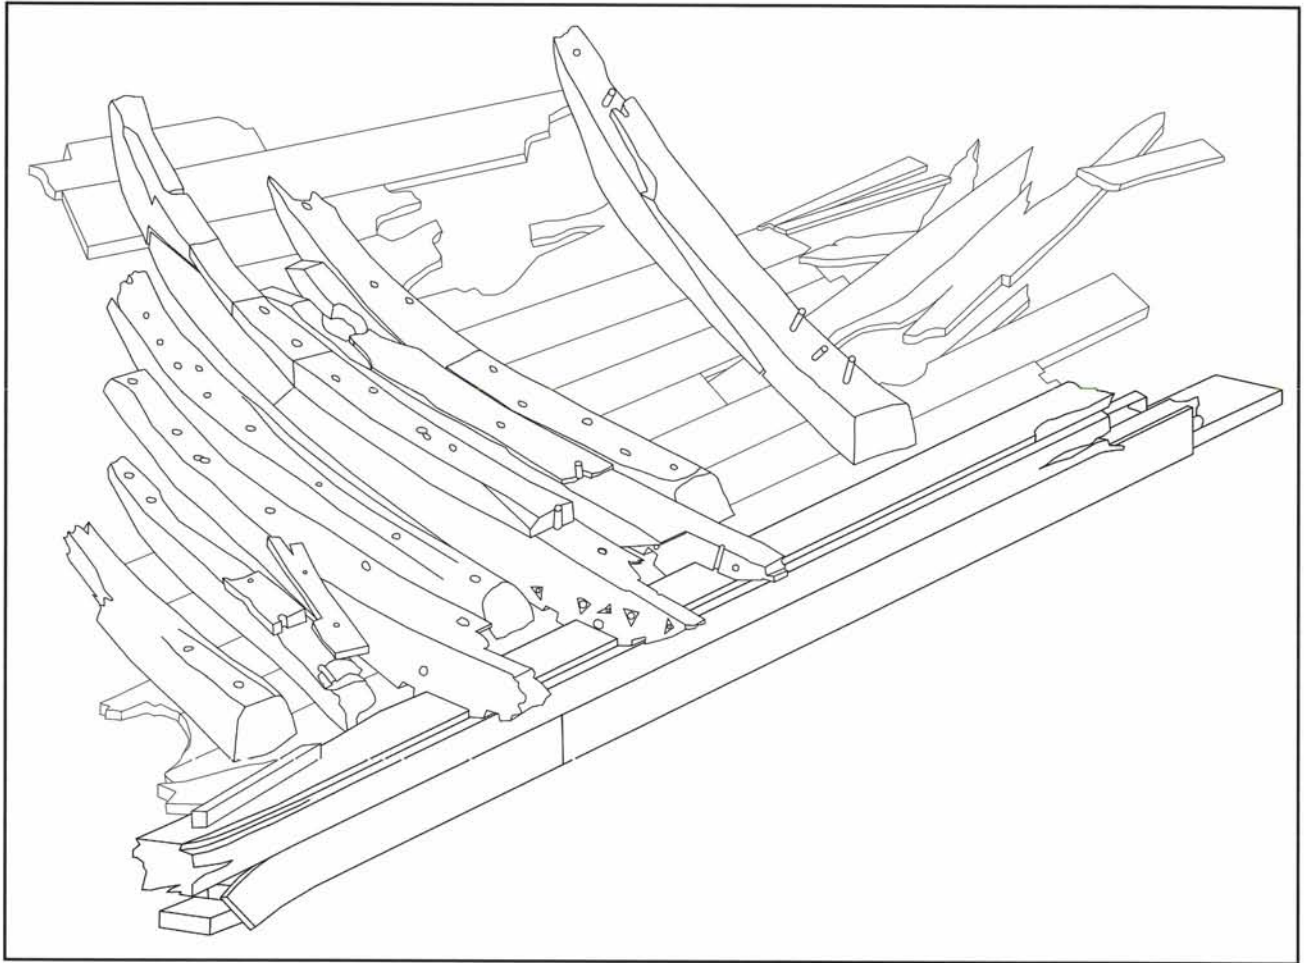
• *Figure 16. Isometric projection of the forward section of wreck structure.*

Frame 1 was a 5-ft.-10-in. futtock (see Figure 16). The sided dimension varied from 14 in. at the inboard end to 12 $\frac{1}{2}$ in. outboard before the timber was broken (Figure 33). The futtock was molded from 10 $\frac{1}{2}$ to 14 in. at the inboard end. Both the top and bottom of the futtock contained the remains of fasteners used to attach bilge ceiling and hull planking. Pine was used to fashion the futtock.

Frame 5 was composed of a half floor, a futtock, a futtock fragment, and several fillet pieces (see Figure 16). The half floor was 9 ft. 7 in. long, and was molded from $5\frac{1}{2}$ to 9 in. and sided 10 in. (Figure 39). The inboard end of the half floor was notched diagonally on the aft face to accept a port half floor (Figure 40). Immediately outboard of either end of the rebate for the keel, the bottom of the half floor was notched to create limbers 2 in. deep and 3 in. wide. A rebate was also cut in the inboard end to accommodate the keel. Fastener remains in the rebate for the port half floor included both trunnels and $3/4$ -in. iron bolts. Over the keel and limber rebates, triangular cuts had been made in the forward face of the half floor to serve

Frame 8 was the aftermost futtock and had been partially dislodged by excavation (see Figure 16). It was 10 ft. long and was molded from 7 to 9 in. and sided 10 in. (Figure 43). A fillet piece was em-

Seven fragments of bilge ceiling survived in association with the forward hull remains (see Figure 16 and 41). Those intact planks were located along the turn of the starboard bilge. With one exception, the forward end of each plank was broken by a cluster of pilings driven through the hull structure. The largest ceiling plank, C1, was 6 ft. 6 in. long, 10 in. wide, and 2½ in. thick (Figure 45). It was lightly fastened to the frames by two trunnels and six ¾-in.-square shank spikes.

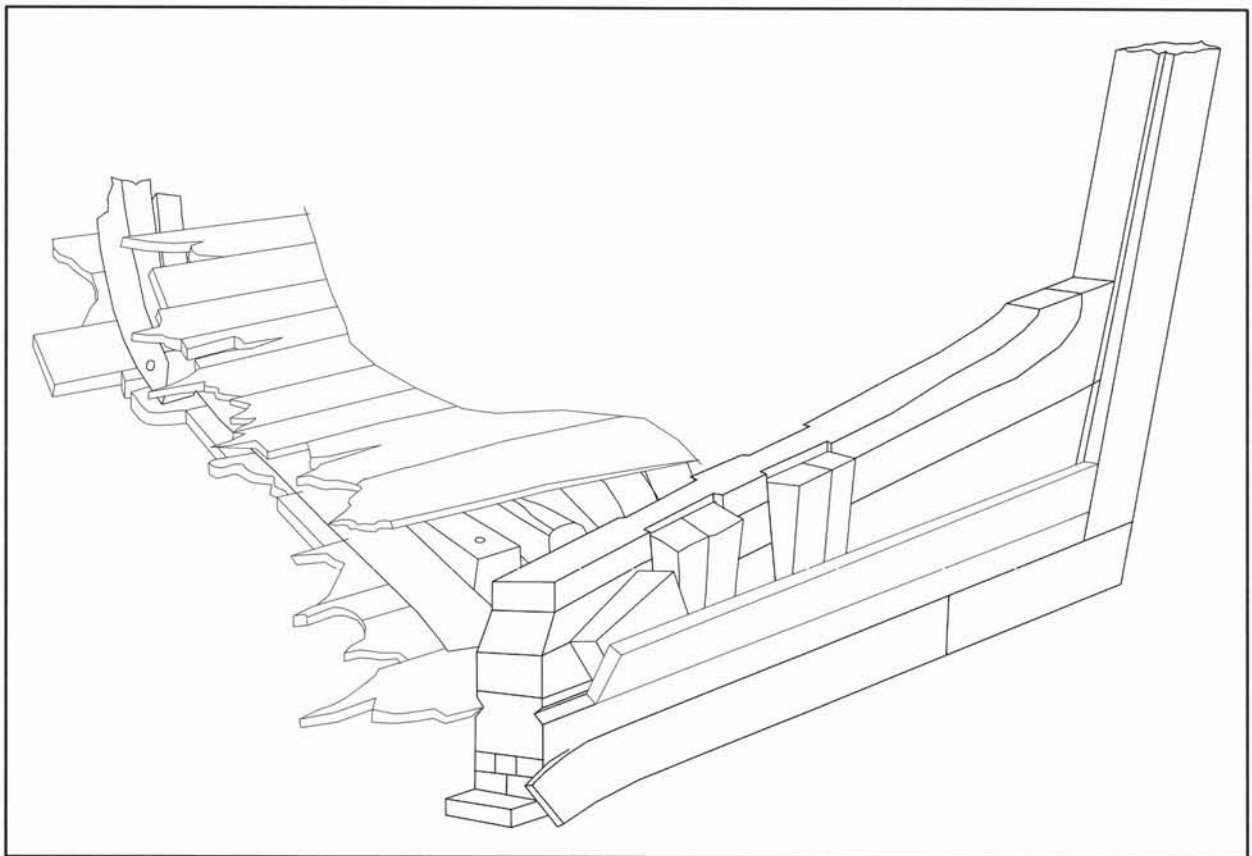
Figure 21. Isometric projection of the aft section of wreck structure.

Ceiling on the starboard side of the stern section consisted of the remains of six pine strakes (see Figures 21, 23, and 24). Those planks measured 2 in. thick and varied in width from 4 in. to 1 in. Ceiling planking on the port side of the stern section was entirely missing. Tool marks on the planks indicated that they had been cut using a pit saw and partially dressed using a plane. Planks were attached using a combination of 1-in. trunnels and 3/8-in. spikes. Much of the ceiling had been destroyed by pilings driven through the stern of the wreck. The following table provides the width of each plank:

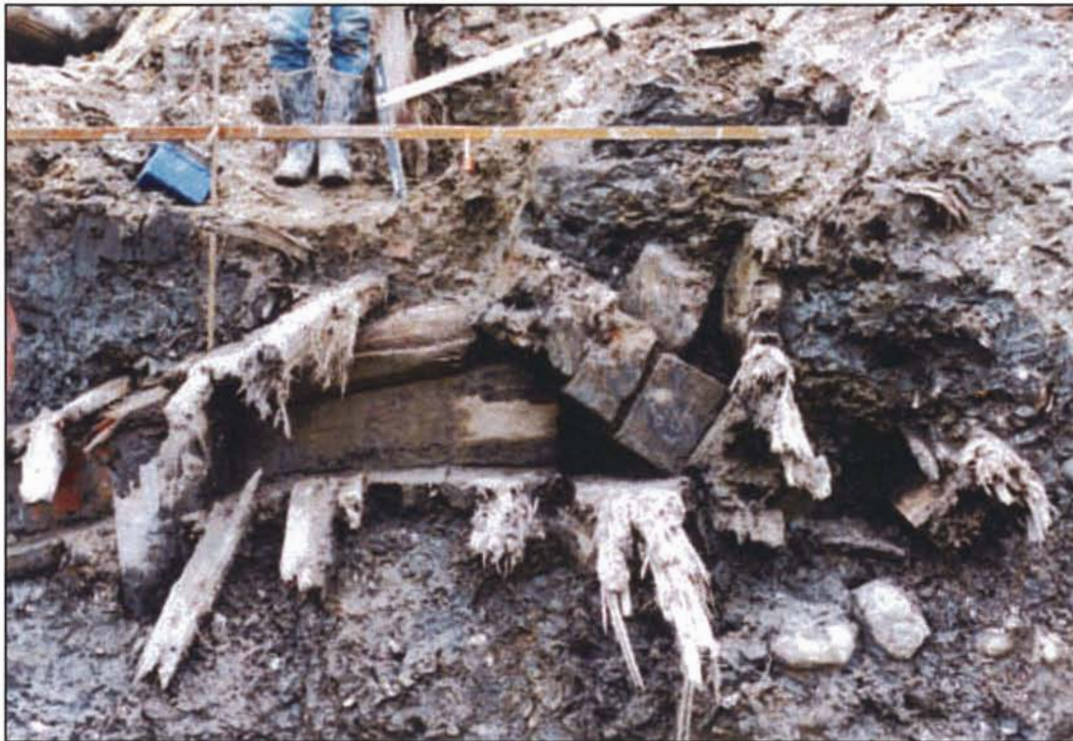
Figure 23. Aft keel, deadwood, cant frames, ceiling and hull planking.

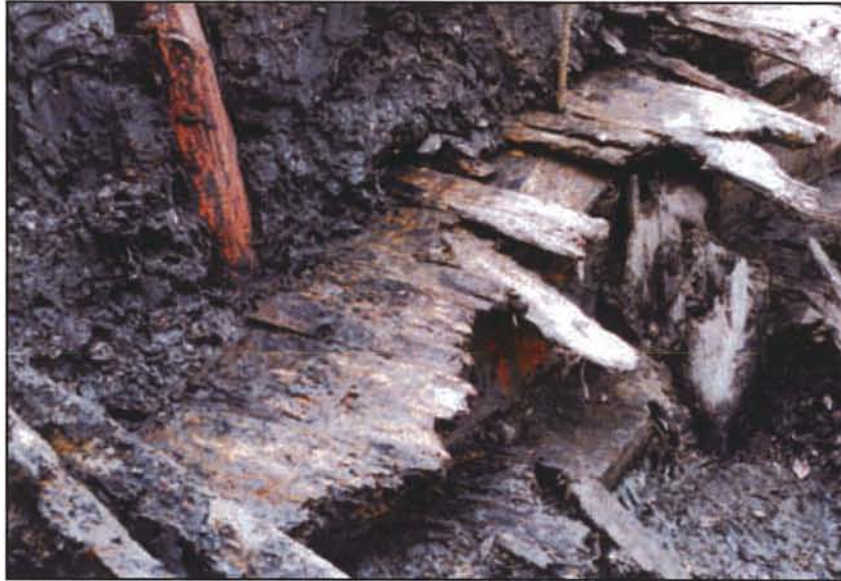
Figure 24. Intact ceiling planking on the starboard side of the stern section of wreckage.

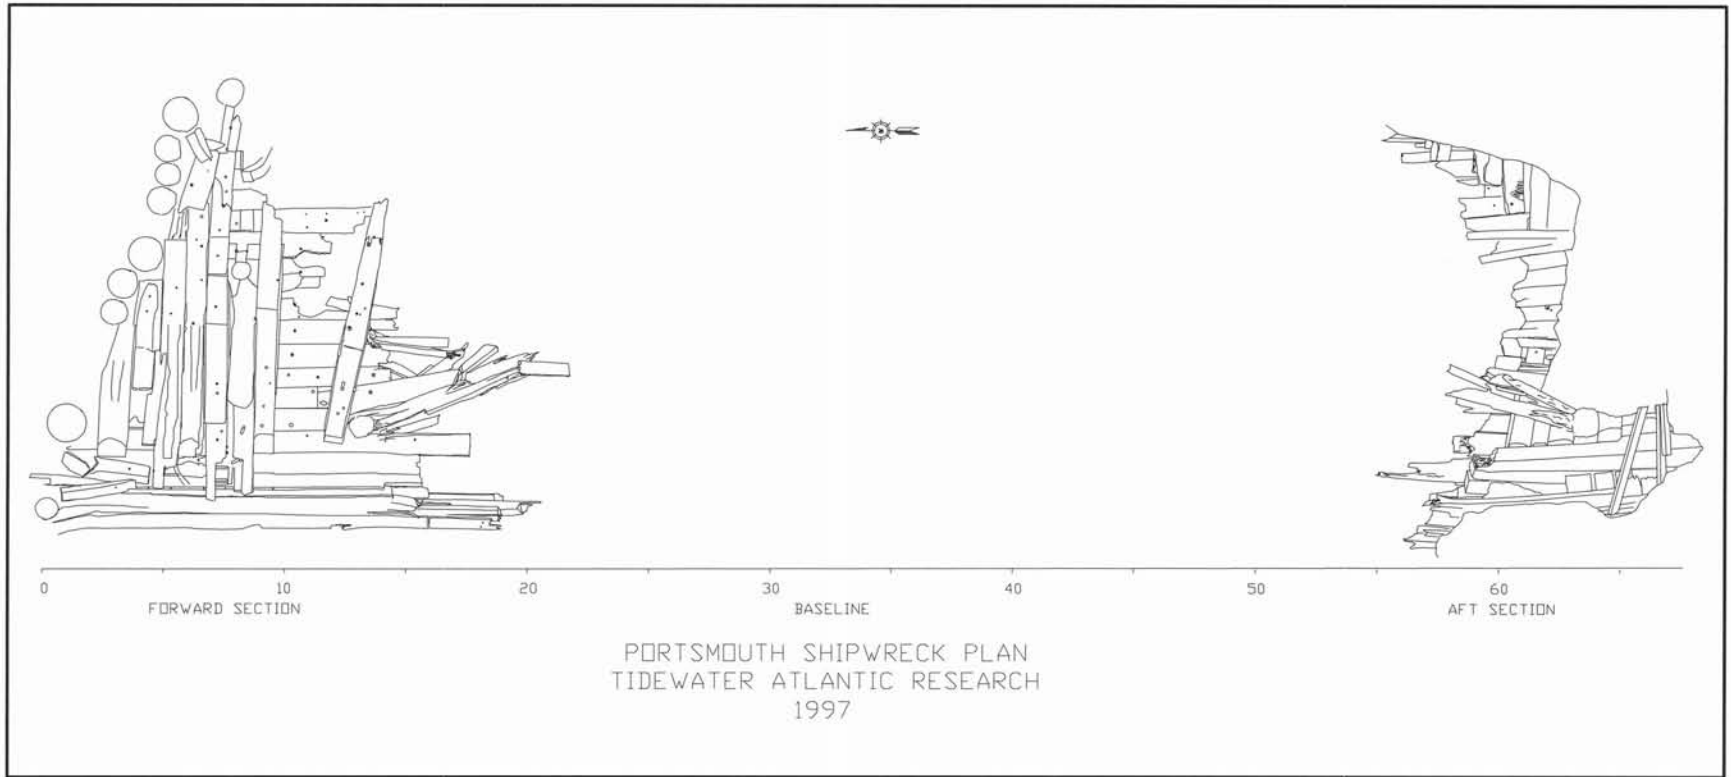
Figure 26. Plan of the surviving wreck structure.

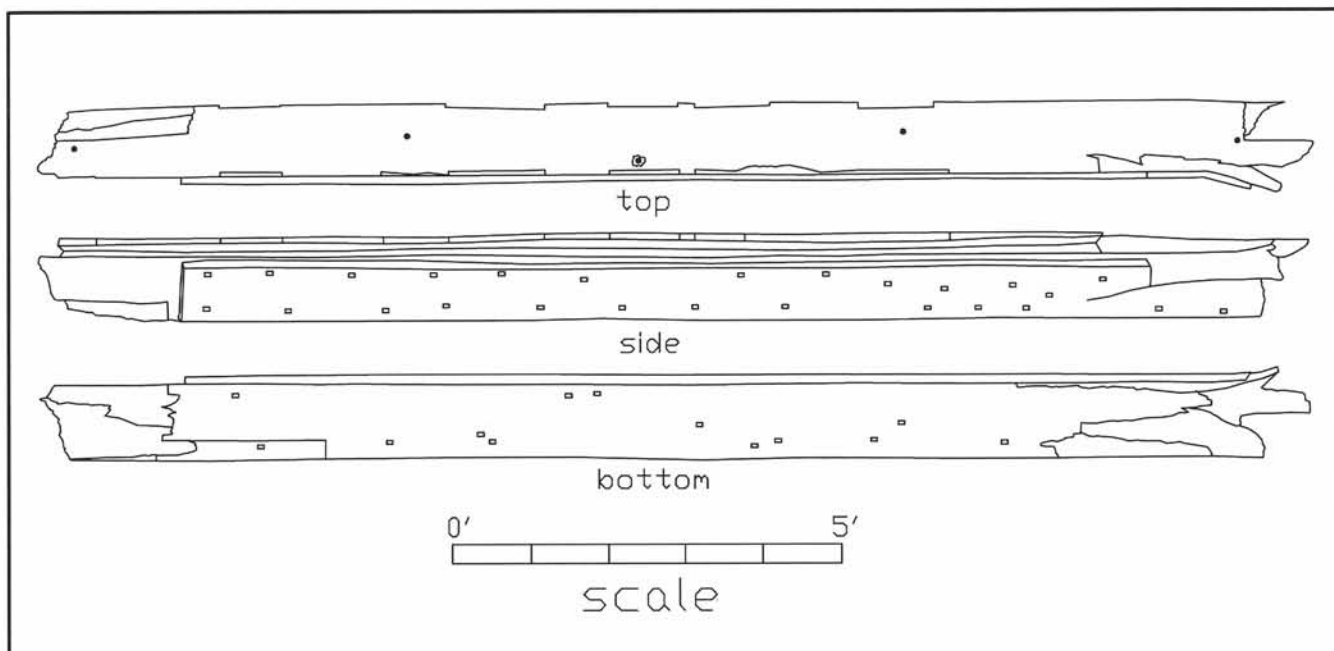
Figure 27. Facets of the keel.

The lower two planks were 4 in. thick and 11 1/2 in. wide. The sides of the aft end of the bottom plank were cut away to leave a tenon 4 in. wide and 3 in. long to provide a scarf joint with the next plank aft. The upper of the two lower planks had a 4-in.-wide, 3-in.-deep mortise cut out of the forward end to provide a scarf joint with the next plank forward. The upper planks measured 3 in. thick. The port plank measured 3-3 1/2 in. wide, and the starboard plank measured 7 1/2 in. wide. A space varying from 1/2 to 1 in. wide separated the two planks and helped make up the 11 1/2 in. sided dimension of the false keel. The planks of the false keel were fastened using 3/8 in. square shank iron spikes. The upper two planks were attached to the bottom of the keel. The upper 4 in. plank was fastened to the planks attached to the keel, and the bottom 4 in. plank was fastened to the upper 4 in. plank. A random staggered pattern was used in fastening the elements of the false keel. Like the keel, the false keel was protected by 1 in. pine sheathing over felt and tar, and attached with small square iron nails placed in a staggered diagonal pattern.

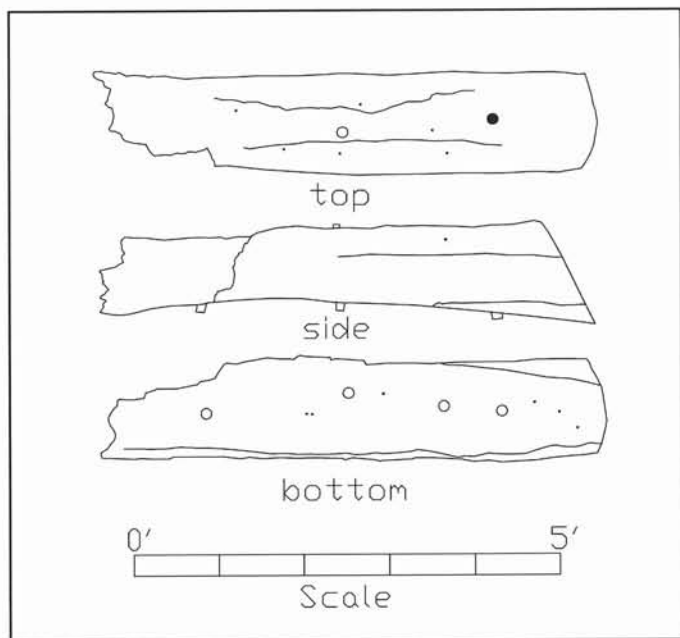
Figure 33. Facets of Frame 1.

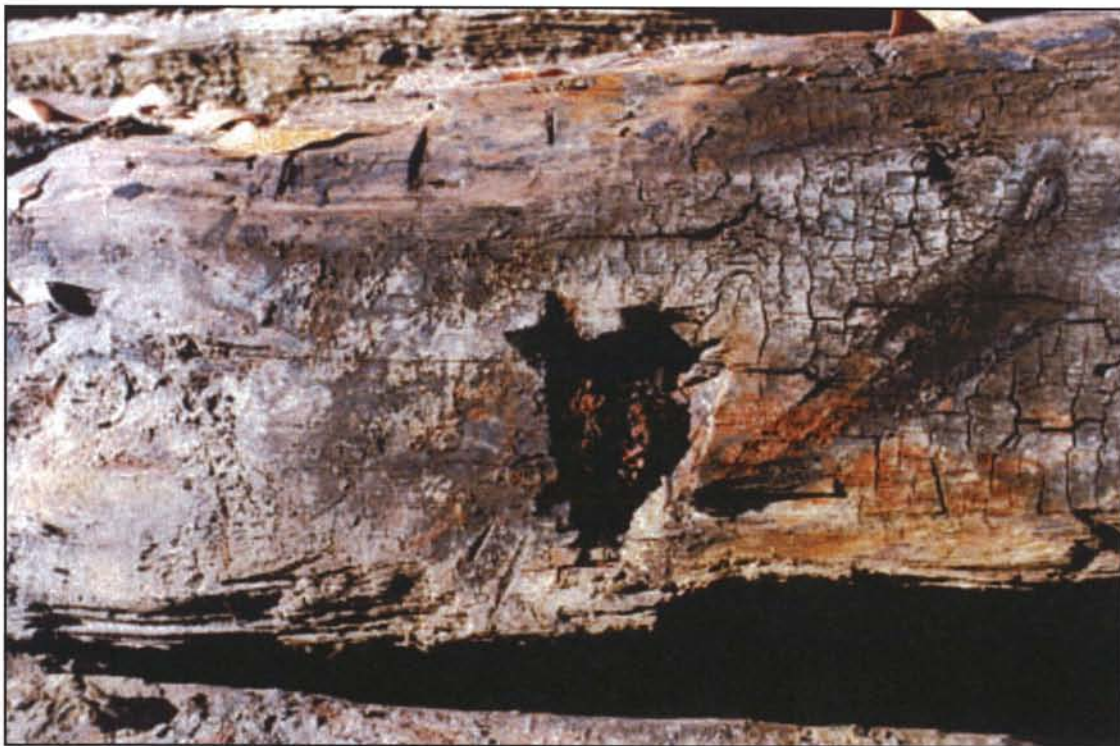
Figure 36. Triangular notch to start a spoon bit.

end was undercut diagonally to accommodate an adjoining futtock. Both the top and bottom of the futtock contained the remains of fasteners used to attach bilge ceiling and hull planking. Pine was used to fashion the futtock. Two fillet pieces had been employed in conjunction with Frame 2 to bring the molded dimension up to the level of the bilge ceiling (Figure 35). The first was 4 ft. 3 in. long, 7 in. wide, and 1 $\frac{3}{4}$ in. thick. Both the top and bottom of the fillet contained the holes that were used for trunnels and a drift bolt used to attach bilge ceiling. The second was 4 ft. 1 in. long, 10 in. wide, and 2 $\frac{3}{4}$ in. thick. Both the top and bottom of the fillet contained a trunnel and the holes that were used for trunnels and a drift bolt used to attach bilge ceiling. A triangular depression had been cut at the drift bolt to start the spoon drill (Figure 36). Pine was used to fashion both fillets.

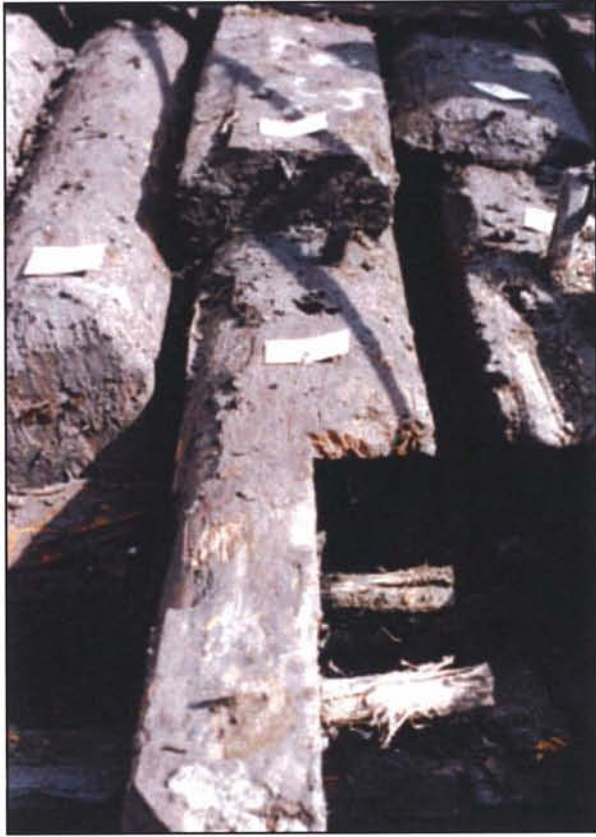
Figure 40. Scarf in a starboard half floor to accept a port half floor.

as starter holes for drilling for the trunnels and drift bolts that attached the port half floor. The outboard end of the half floor was fitted with a rider sided 10 in. and molded from 4 to 5½ in. The top and bottom of the half floor and rider contained the remains of fasteners used to attach bilge ceiling and hull planking. Both the half floor and futtock were fashioned from pine.

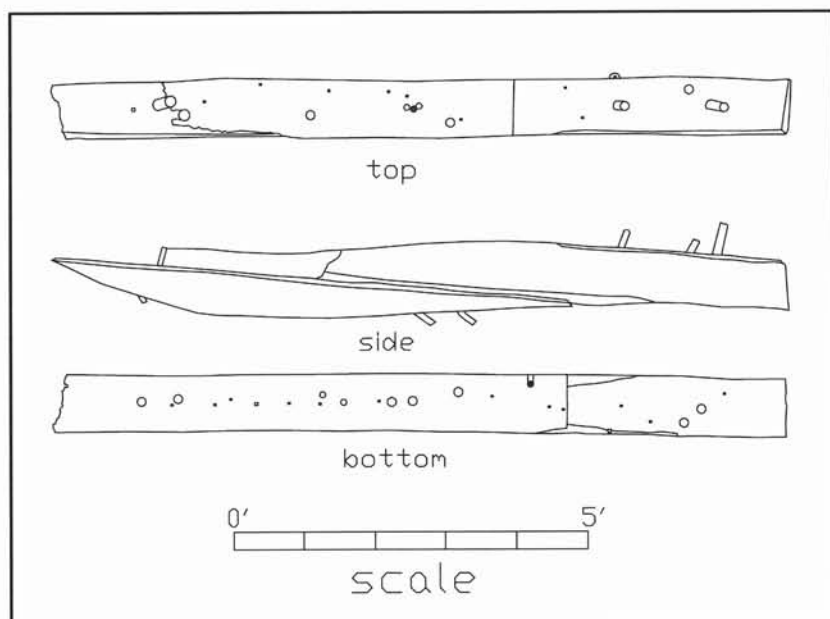
Figure 43. Facets of Frame 8.

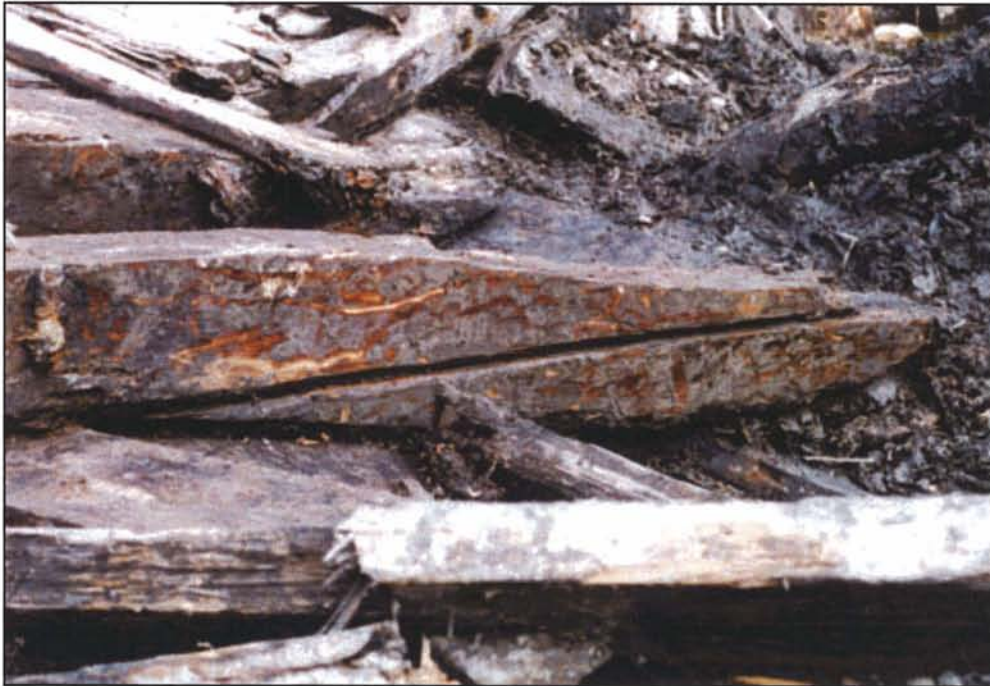
Figure 44. Bottom fillet employed to contour the turn of the bilge.

ployed under the frame to achieve the desired contour of the hull (Figure 44). A second fillet piece was apparently fitted to the top of the inboard end of the frame. Although it was missing, three trunnels used to secure it survived. The top and bottom of the frame contained the remains of fasteners used to attach bilge ceiling and hull planking. Both pieces of the frame were fashioned from pine.

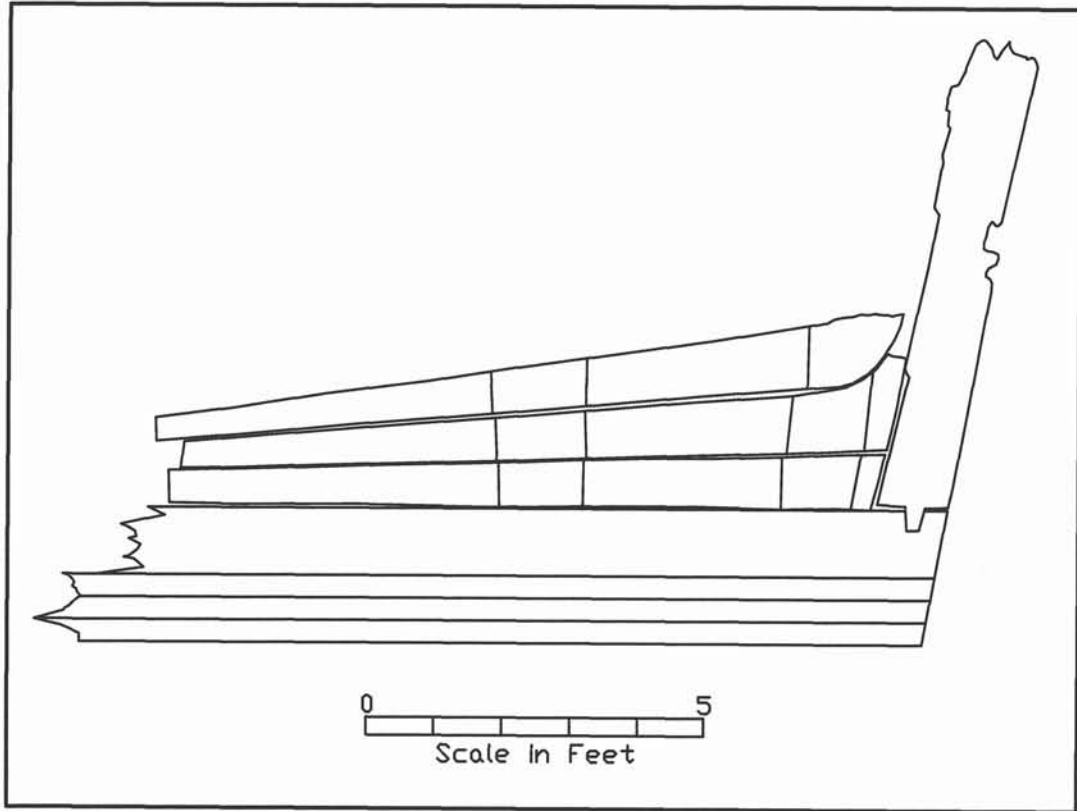
Figure 46. Elements of the keel, false keel, deadwood and sternpost assembly.

The first piece of deadwood rode on top of the keel and was butted against the sternpost (see Figure 46). It was 13 ft. 6 in. long and was sided 11 in. at the forward end and 6½ in. at the aft end (Figure 48). The molded dimension varied from 8 in. at the forward end to 12 in. at the aft end.

The base of the sternpost was also preserved at the site (see Figure 46). It measured 9 ft. long and was sided 11 in. and molded 15 in. (Figure 51). The base of the post was cut at an angle of 12 degrees and contained a 5-in.-long, 4-x-4-in. tenon to fit in a mortise in the keel. A 3-in.-wide, ½-in.-deep rebate for the lower gudgeon strap was cut into the sides of the post 16 in. above the keel. A second 3-in.-wide, ½-in.-deep rebate for another gudgeon strap was cut into the sides of the post 6 ft. 7½ in. above the keel. Both sides of the base of

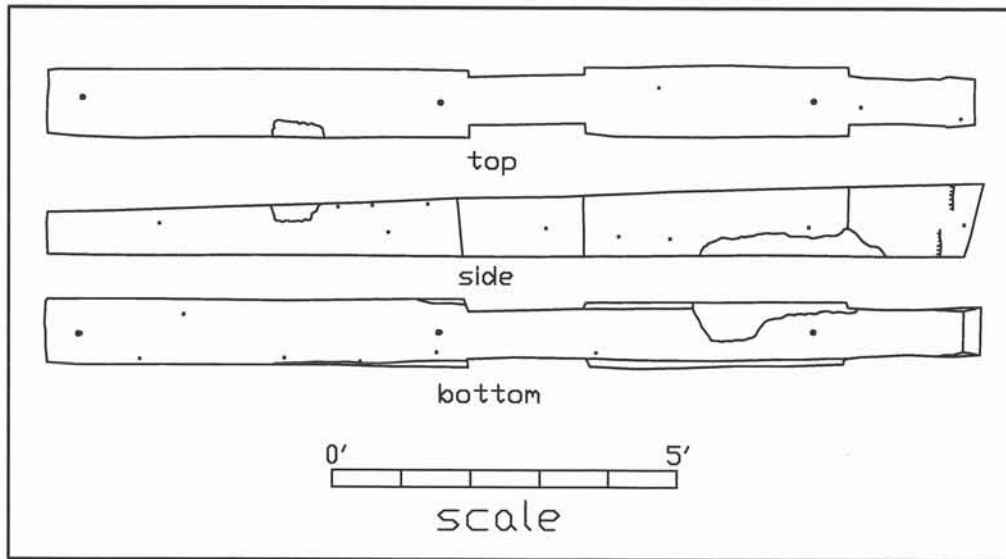
Figure 48. Facets of Deadwood 1.

The aft end was cut diagonally to accommodate the rake of the sternpost. Two rebates were cut across each side of the timber. The first extended from 6 ft. 2 in. to 7 ft. 9 in. aft of the forward end, and the second extended from 11 ft. 7 $\frac{1}{2}$ in. to 13 ft. aft of the forward end. At the aft end of the timber, the sided dimension reflected the location of a made rabbet. The top and bottom of Deadwood 1 contained evidence of both $\frac{3}{4}$ in. drift bolts and $\frac{1}{2}$ in. spikes employed to secure the timber to the keel and the next deadwood timber. The sides of the timber contained evidence of $\frac{1}{2}$ -in. spikes used to attach the cant frames. Pine was used to fashion Deadwood 1.

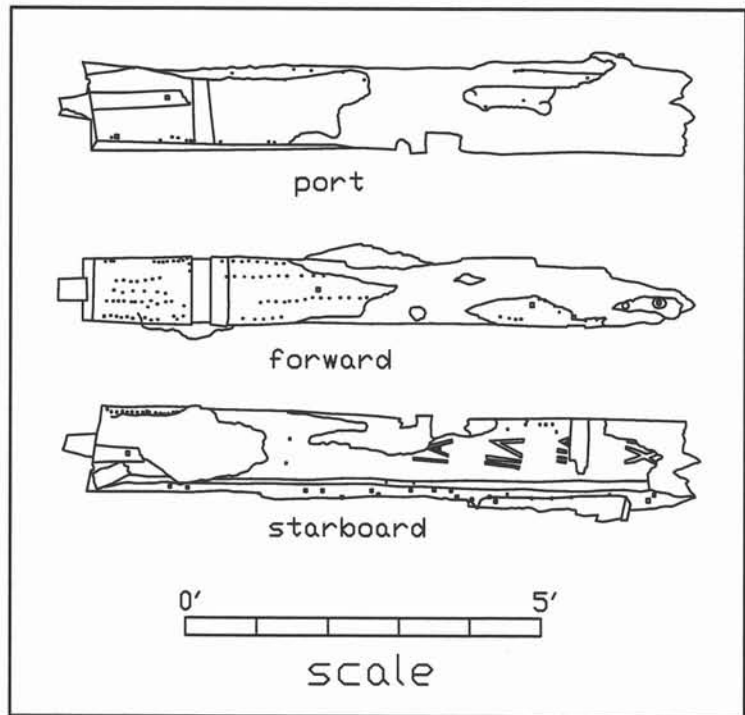
Figure 51. Facets of the sternpost.

the sternpost were rebated for a 1/2-in.-thick, 3-in.-wide fish plate. On the starboard side of the sternpost, the Roman numerals VI, VII, VIII, and IX were used to identify the draft. A series of 3/4-in. drift bolts had been employed to fasten the sternpost to the deadwood. The remains of lead sheathing and tacks employed to attach sheathing were readily apparent on both sides and the aft face of the post.

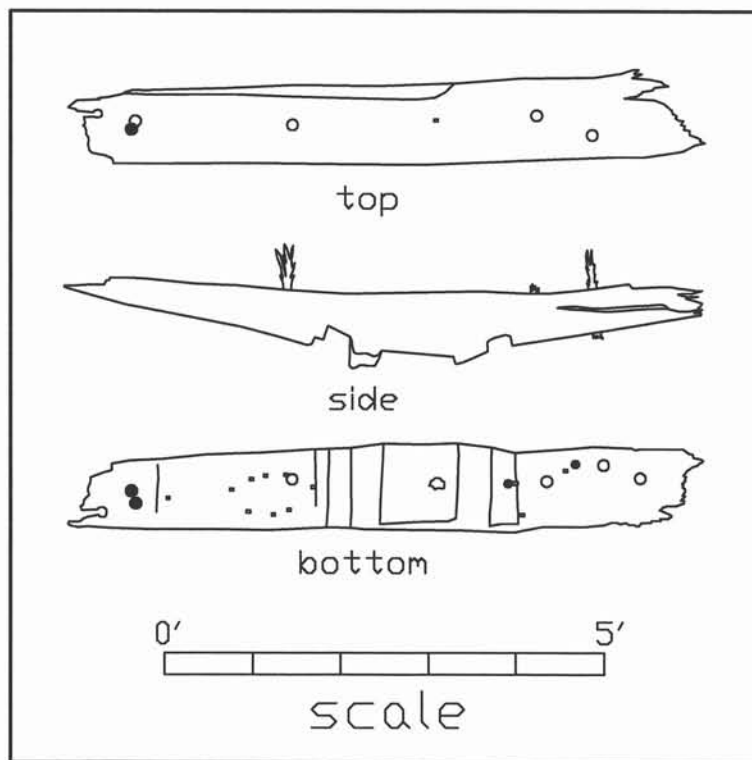
Figure 56. Facets of Disarticulated Floor 6.

Disarticulated Floor 6 consisted of the bottom timber from a set of two that formed a floor (Figure 56). It measured 7 ft. 3 in. long and was sided 11 in. The bottom of the timber contained a 2- to $1\frac{1}{2}$ in. deep, 10 in. long rebate for the keel. Limbers had been cut 3 in. outboard of either side of the keel rebate. Both limbers measured 3 in. wide, and one was cut 3 in. deep, while the other was cut 2 in. deep. The ends of the bottom timber were broken off, precluding the possibility of determining their configuration and association with the missing top timber. The bottom face of the bottom timber contained evidence that iron spikes and trunnels had been employed to fasten hull planking. The top of the timber contained the re-

mains of one iron spike and trunnels that were used to attach the top timber and planking. The angle of deadrise was 15 degrees excluding the hollow outboard of the garboard strake. Pine was used to fashion the timber.

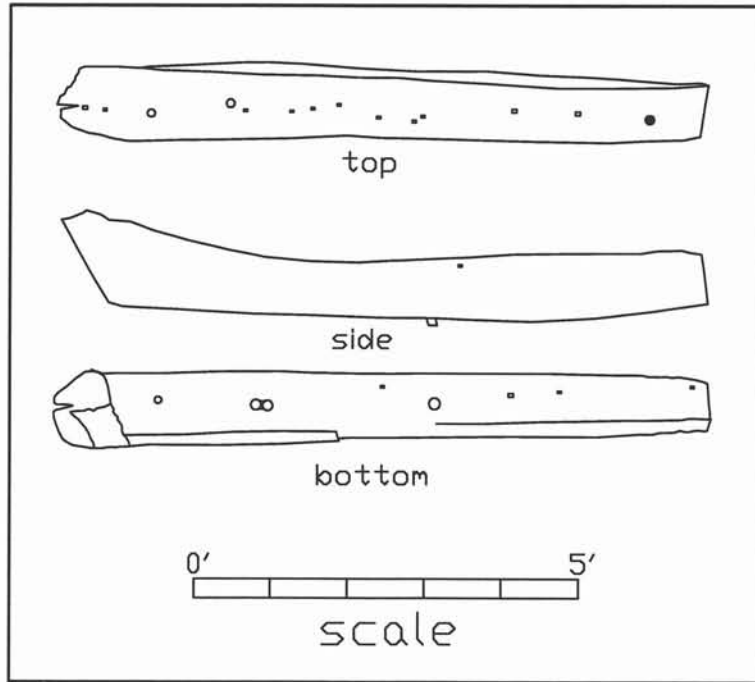
*Figure 59. Facets of
Disarticulated Half Floor 2.*

Disarticulated Half Floor 2 was 8 ft. 6½ in. long and was molded from 15 in. adjacent to the keel to 9 in. at the outboard end (Figure 59). The frame was roughly sided from 9 to 10 in. The inboard end was cut diagonally, and the outboard end was cut vertically to interface with a futtock. The top

and bottom of the half floor and fillets contained the remains of iron spikes and trunnels used to attach bilge ceiling and hull planking. Pine was used to fashion the half floor.

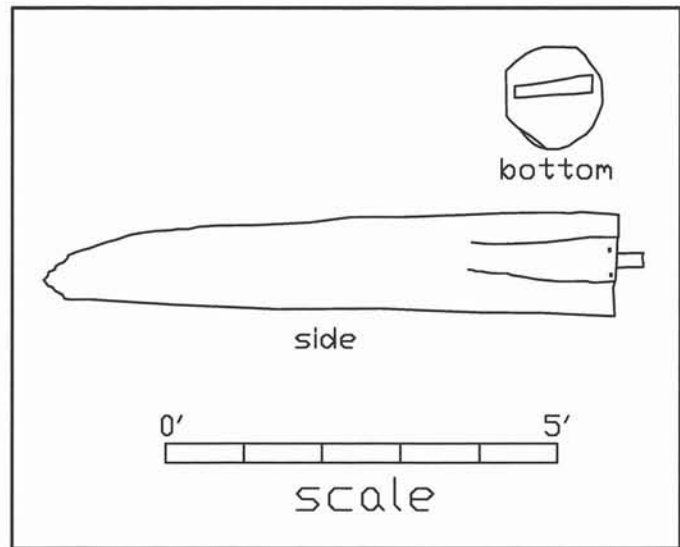
Figure 64. Facets of disarticulated mast.

facets at the base. The bottom of one of those facets had the remains of two $\frac{1}{4}$ in. iron spikes. An offset tenon on the bottom of the mast measured 12 in. long and $2\frac{1}{2}$ in. wide. Unlike most of the wood on the vessel the mast was fashioned from oak.

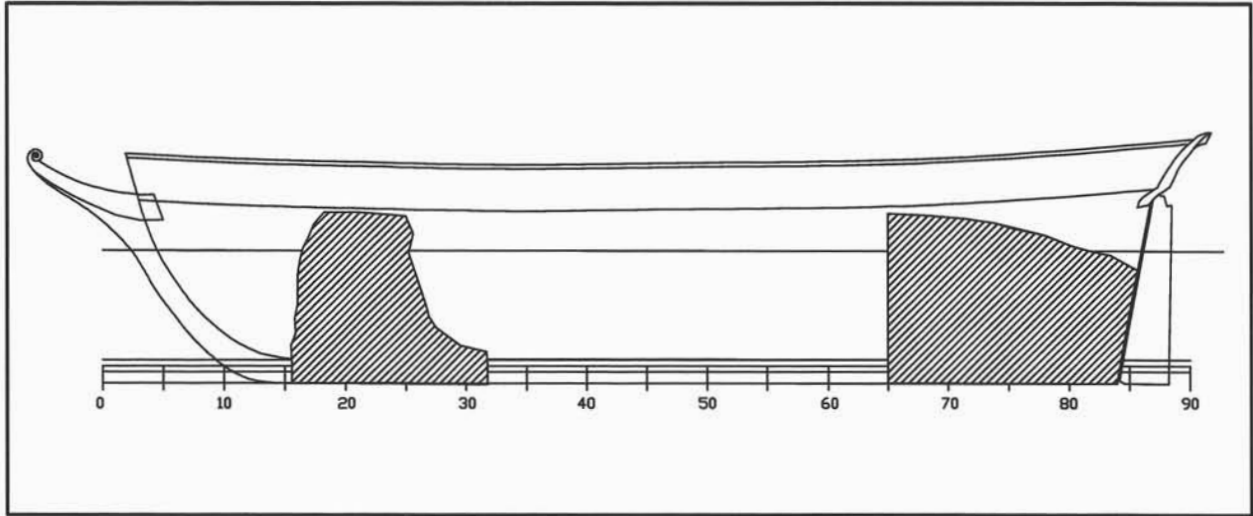
Figure 65. Hull profile showing surviving sections of hull structure (shaded).

Although the amount of surviving hull structure available for analysis was limited to small sections at the forward and aft ends of the keel (Figure 65), some conclusions can be drawn from the extant vessel fabric. From the 70 ft. length of the keel, it is apparent that, given a traditional sweeping stem, the ship was perhaps 82 ft. long between perpendiculars. Although determining the beam

was impossible, reconstruction of the hull configuration using the disarticulated floor with the least amount of deadrise and the only available bilge futtock, a beam of 26 ft. might be considered reasonable. The remains of the sternpost and sides of the hull fore and aft indicate that the depth of hold must have been in the vicinity of 9 ft. with only one deck.

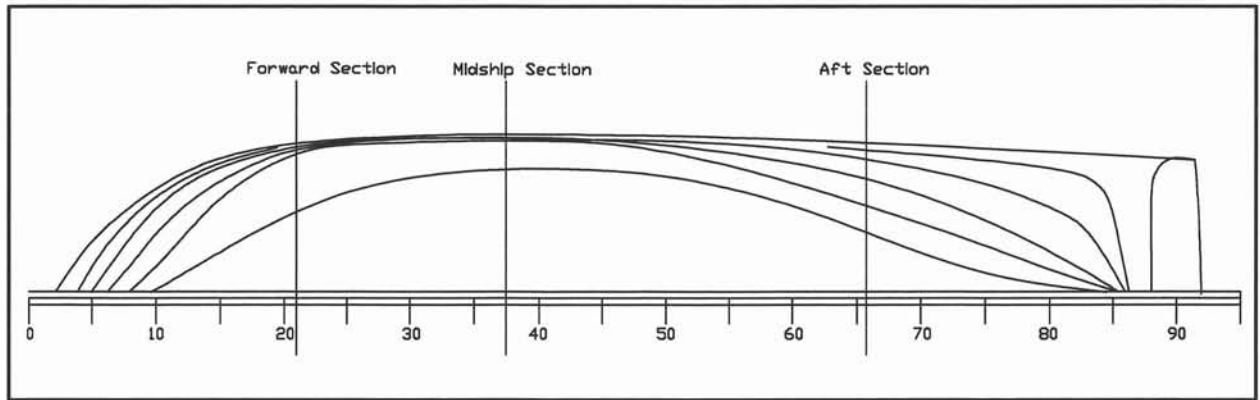
Figure 66. Waterlines generated from surviving structural evidence.

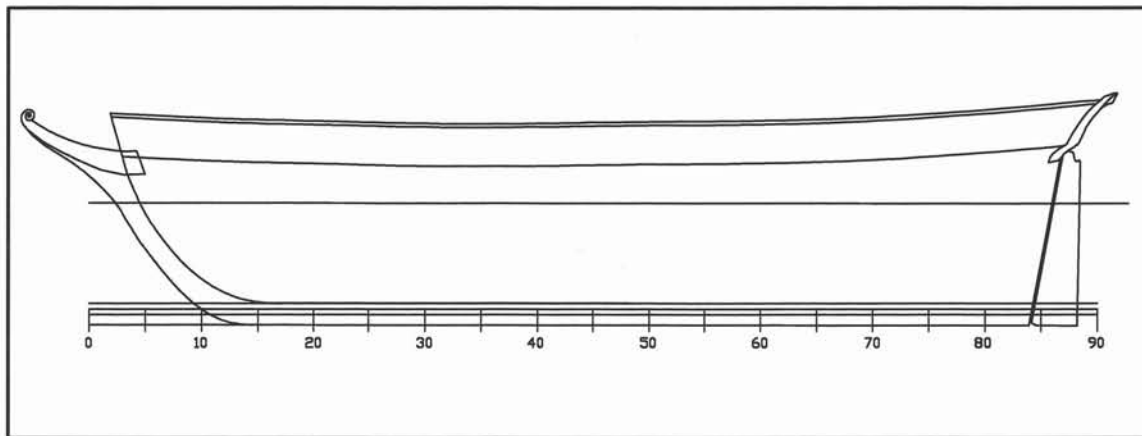
Figure 67. Hull profile generated using data from surviving hull structure and historical evidence associated with late eighteenth-century vessel design.
