**AN ARCHITECTURAL SURVEY UPDATE
IN
ARLINGTON COUNTY, VIRGINIA**

PHASE I

Final Report

**Arlington County, Virginia
Department of Community Planning, Housing and Development**

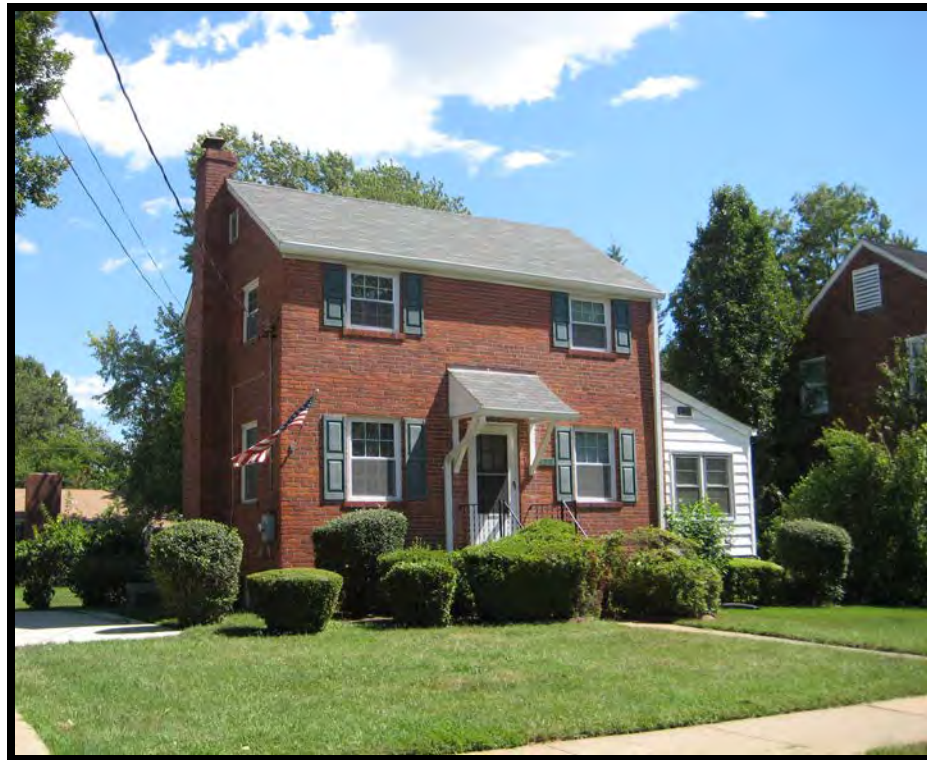
Figure 4: Single Dwelling, 823 North Greenbrier Street, 000-4214-0357 (EHT Tracerics, 2010)

Individuality within this repetition of form and style was commonly gained simply and often solely by varying the detailing framing the primary entry on the façade. Builders would often utilize the same house plan throughout a subdivision or neighborhood, presenting distinctiveness with the Colonial Revival-style entry surround. The 1940s houses in the 800 block (odd) of North Greenbrier Street, for example, were constructed by a number of builders familiar with the housing desires and tastes of the mid-twentieth-century homebuyer. Thus, these buildings are notably similar. Constructed of concrete block with a brick veneer, the houses stand two stories in height on slightly raised foundations. The buildings are three bays wide with a central entry and side gable roof punctuated by an exterior-end brick chimney. Stylistic ornamentation is minimal at best, with central entries covered by shed roofs with straight knee brackets or pedimented porches with square posts. The symmetrically placed window openings have rowlock brick sills and are traditionally framed by inoperable shutters, both paneled and louvered. The entry and window openings lack surrounds, a feature often ornamenting mid-twentieth-century houses. Actually, the second-story windows on the façade abut the narrow frieze or, depending on the builder, bed molding of the overhanging eaves. The gable ends are dressed with a narrow raking cornice, which tends to be one of the more stylistic

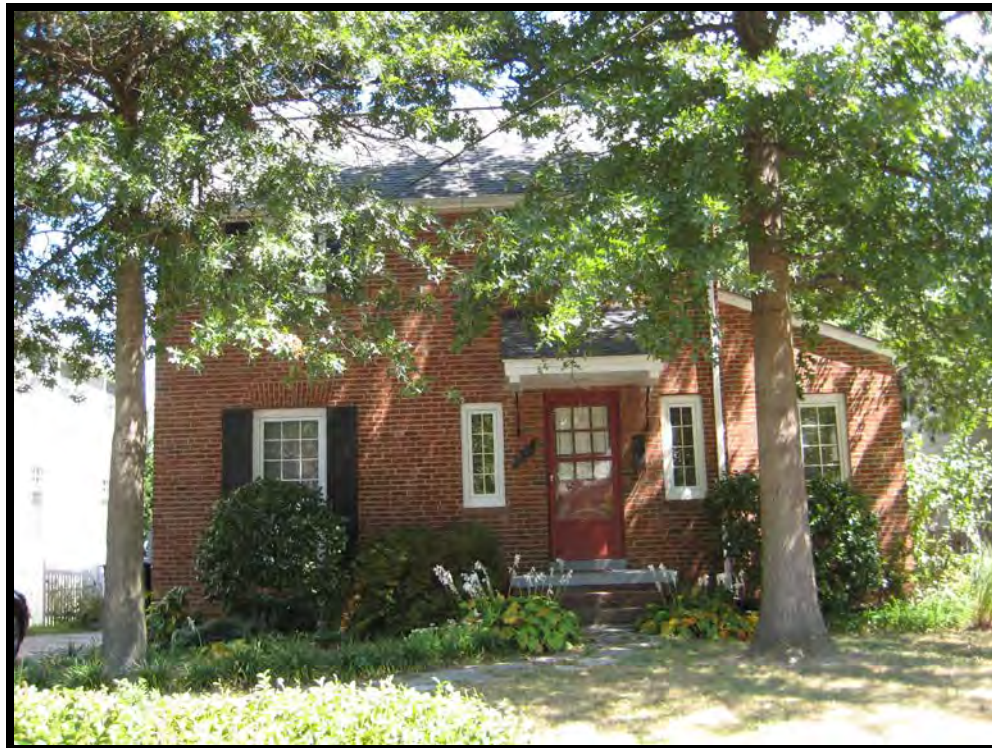
Along North Harrison Street in Bluemont are similar Colonial Revival-style dwellings that show the influences of the Modern Movement. The concrete-block structures are dressed in six-course Flemish-bond brick, a popular coursing pattern for the pre-war years. The two-bay-wide structure has a side entry covered by a shed roof supported by metal brackets. The single-leaf door is framed by narrow lights that pay homage to the sidelights of the Georgian, Federal, Classical Revival, and Colonial Revival styles. Yet, these narrow openings are spaced beyond the shelter of the shed roof, about 16 inches to either side of the door. Like the window openings, they have rowlock brick sills, but they lack the splayed jack arches over the double-hung sash on the first story. Again, the second-story windows abut the narrow frieze of the cornice line and are framed by inoperable shutters. The one-bay side wings on the side elevations are original, enclosed several years after construction. The house at 851 North Harrison Street (000-4214-0364) is one of several examples constructed by builder L.C. MacPherson in the late 1930s that modified the traditional elements of the Colonial Revival style slightly to reflect modernity of construction. Similar examples, lacking the narrow windows framing the main entry, are found in the 400 block (odd) of North Frederick Street. These buildings have front-gabled roofs with straight knee brackets over the single-leaf entry in the center bays.

Figure 5: Single Dwelling, 851 North Harrison Street, 000-4214-0364, (EHT Tracerics, 2010)

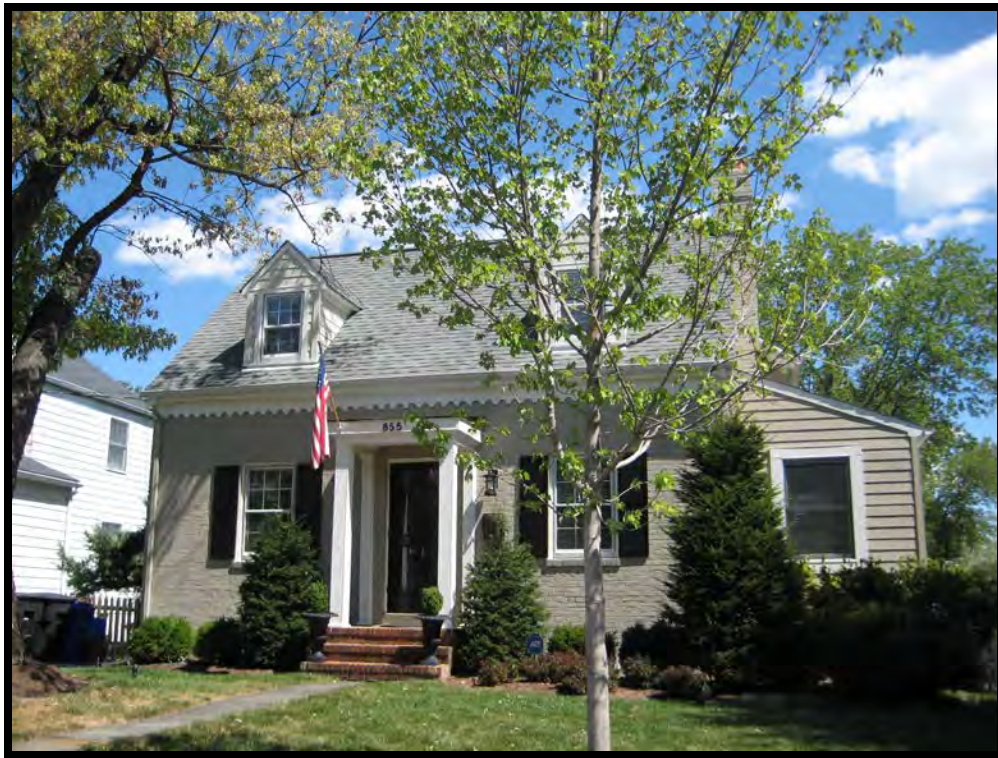
Elements closely associated with the Colonial Revival style were also commonly applied to the popular Cape Cod form, traditionally a one-and-a-half-story dwelling that is three bays wide with a side gable roof often pierced by dormers. One of the best examples is the house at 855 North Harrison Street (000-4214-0365), which was erected in 1939 by MacPherson. Constructed of brick that has been painted, the house is three bays wide and two bays deep covered by a side-gable roof of asphalt shingles. The exterior-end brick chimney on the side elevation abuts the now-enclosed side porch. The central entry of the house is a single-leaf opening sheltered by a flat-roofed porch that is just one bay wide. Set on a masonry stoop finished in brick, the porch has square Tuscan posts and pilasters that have fluted shafts. They support a narrow frieze with an ogee bedmold and a boxed cornice. The symmetrically placed window openings to either side of the entry are double-hung, set on rowlock brick sills with inoperable shutters. The narrow surrounds of the replacement sash are molded, finished at the top by a stretcher course of the building's six-course Flemish-bond brick veneer. The roof is pierced by two front-gabled dormers, which are clad in siding with corner boards. The dormers, holding double-hung sash, have boxed cornices with narrow friezes and bedmold, closed tympanum, and raking boards. The cornice of the building along the façade is equally stylized with a wide frieze edged at the bottom with oversized nebuli and a boxed cornice that supports the metal gutter.

Figure 6: Single Dwelling, 855 North Harrison Street, 000-4214-0365 (EHT Tracerics, 2010)

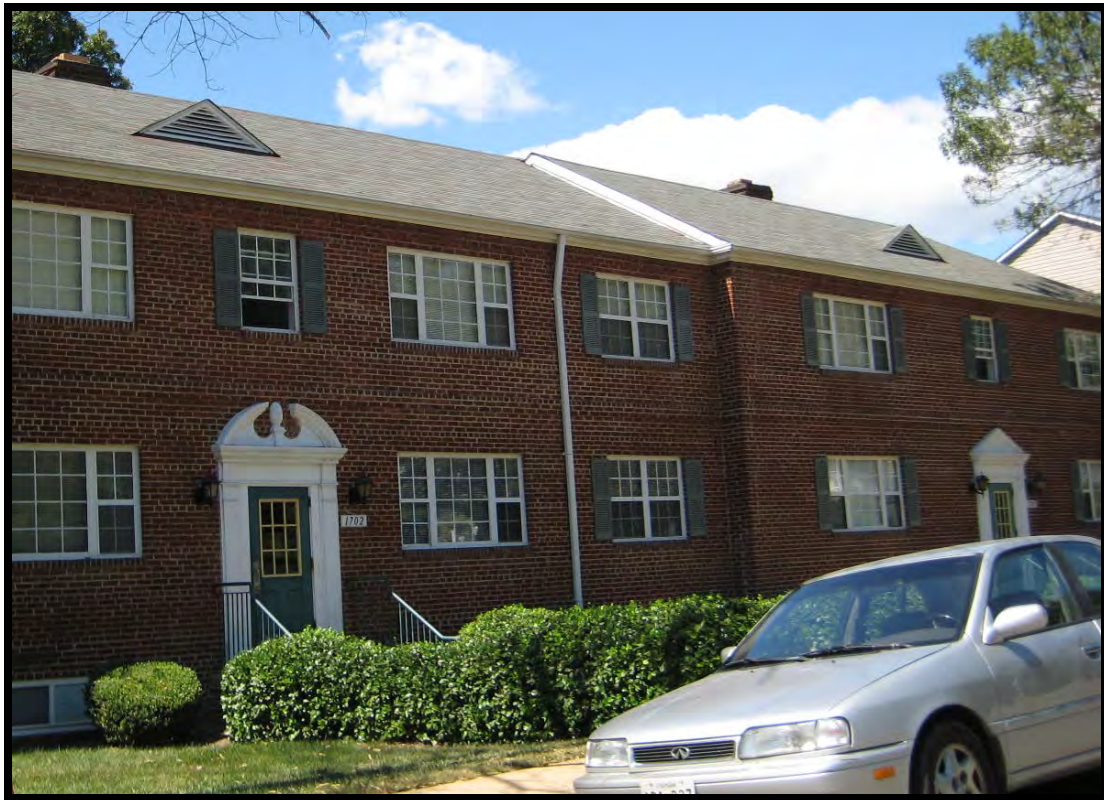
Figure 7: Virginia Gardens Apartments, 000-4412 (EHT Tracerics, 2010)

The three remaining buildings that make up the garden apartment complex, historically known as Virginia Gardens, present the truest expression of the Colonial Revival style in the survey update area of Douglas Park. Constructed in 1948 by H.J. Korzendorfer Co., Inc., for Virginia Gardens, Inc., the complex is typical of mid-twentieth-century garden apartments. The buildings are concrete block faced in brick laid in six-course American bond with a three-course brick belt course. The shallow-pitched hipped roof is finished with an ogee-molded cornice and brick dentil cornice, and pierced by short front-gabled vents with louvers. The Colonial Revival-style building is symmetrically fenestrated with main entry openings on the east elevation fronting the parking areas. The entry openings have stylized surrounds of wood with pilasters and pediment set on a narrow frieze. Those in the center bays have broken segmental-arched pediments with pineapple finials; those in the outer bays have closed gables with plain tympanums. The windows, presumably originally holding metal-sash (probably double-hung), have vinyl sash. The single double-hung openings have 6/6 sash while the larger openings (originally holding picture windows) now have a center window of 12 fixed lights flanked by 4/4 sash. The openings have rowlock brick sills and most have inoperable louvered shutters.

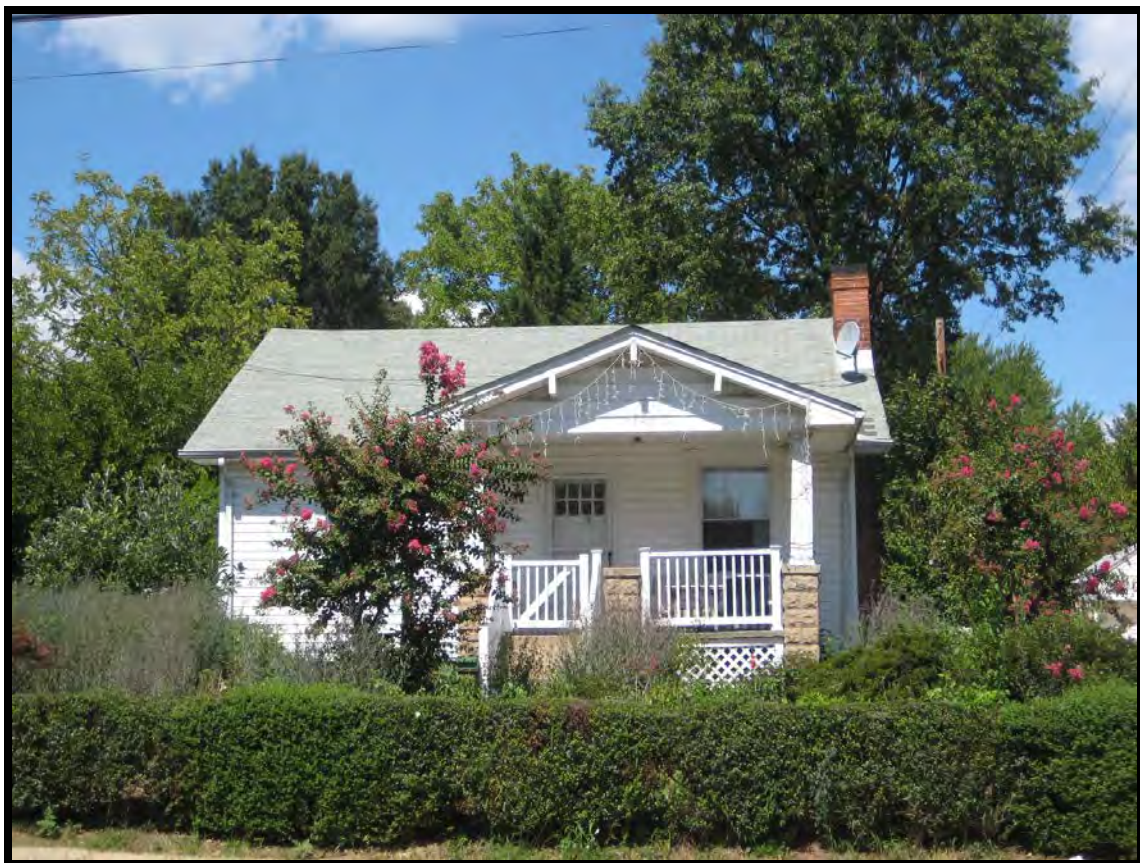
An excellent example of the Craftsman style, ornamenting a modest side-gabled structure, is located at 5503 Wilson Boulevard (000-4214-0369) in Bluemont. Constructed in the mid-1920s, the one-story building is wood frame set on a raised rock-faced block foundation of concrete. The side gable roof has the character-defining overhanging eaves with square-cut brackets that read as exposed rafter ends. The house is fenestrated with 8/1, double-hung sash windows with wide square-edge surrounds completed by molded back banding. Paired four-light wood casement windows are located in the upper gable ends. The main entry, located off-center on the façade, consists of a single-leaf paneled wood door with eight fixed lights set over two vertical panels. The entry is sheltered by a one-story porch set on a rock-faced concrete-block pier foundation infilled with wood lattice. The open front-gabled roof of the porch is supported by Craftsman-style wood posts on rock-faced concrete-block piers; the center pier does not have a wood post. The porch is finished with square-post wood balusters and wood steps.

Figure 8: Single Dwelling, 5503 Wilson Boulevard, 000-4214-0369 (EHT Tracerics, 2010)

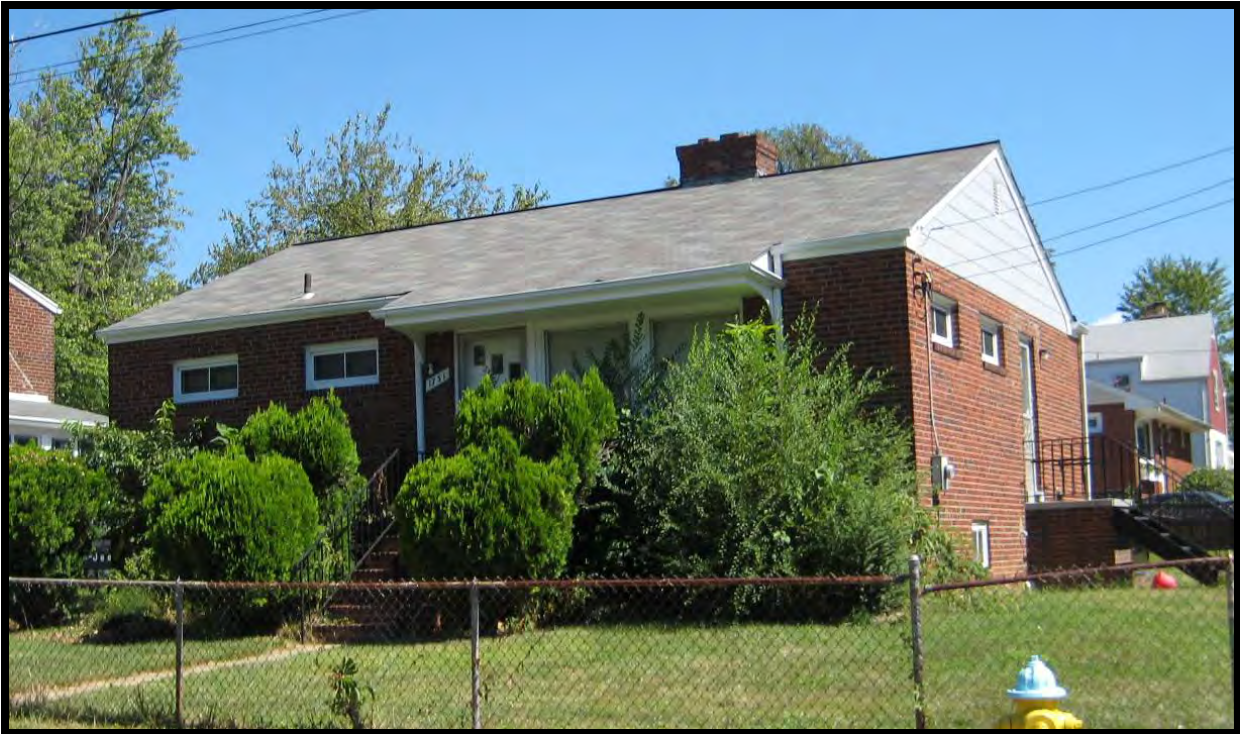
Figure 9: Single Dwelling, 1731 South Nelson Street, 000-4484 (EHT Tracerics, 2010)

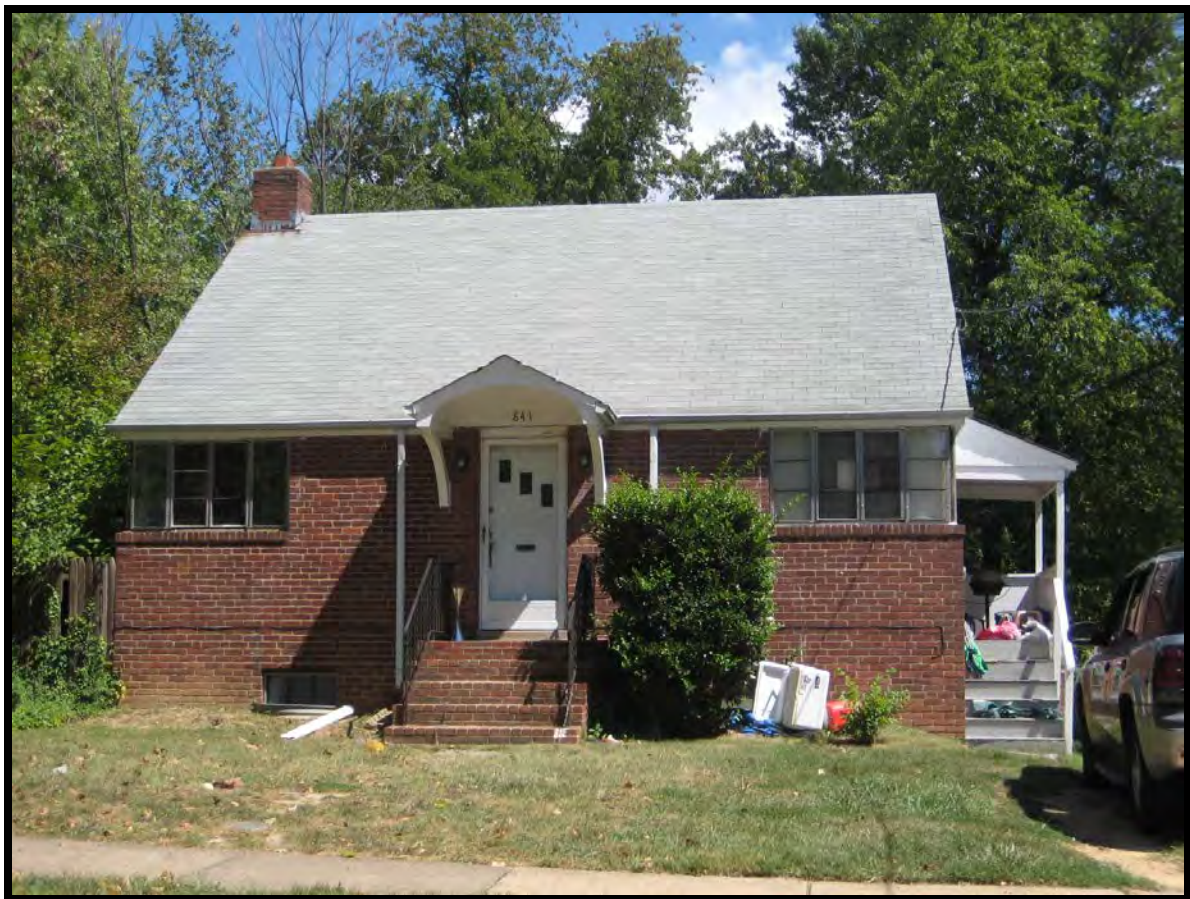
In the neighborhood of Bluemont is a noteworthy example of Modern Movement elements dressing a traditional Cape Cod form, which continued to be embraced by homebuyers until the 1950s. Located at 847 North Jefferson Street (000-4214-0372), the rectangular structure, veneered in six-course Flemish-bond brick, was constructed in 1939 by builder Ernest W. Riley. It is one of seven dwellings on this block that show the design and construction skills of Riley. Prolific with elements of the Modern Movement, Riley began with the conventional Cape Cod form, set on a slightly raised foundation and covered by a side-gabled roof, lacking dormers. The steeply pitched roof is punctured by an interior-end brick chimney balanced on the opposite elevation by a wood-frame porch leading to the secondary entry. The building has a central entry sheltered by an open front-gable roof supported by slightly curved knee brackets. What makes this building so distinctive are the original three-light paired casement windows of metal that wrap around the corners of the structure to either side of the main entry. Additionally, the entry holds a three-light (set diagonally) flush door, which is an original feature.

Figure 10: Single Dwelling, 847 North Jefferson Street, 000-4214-0372 (EHT Tracerics, 2010)

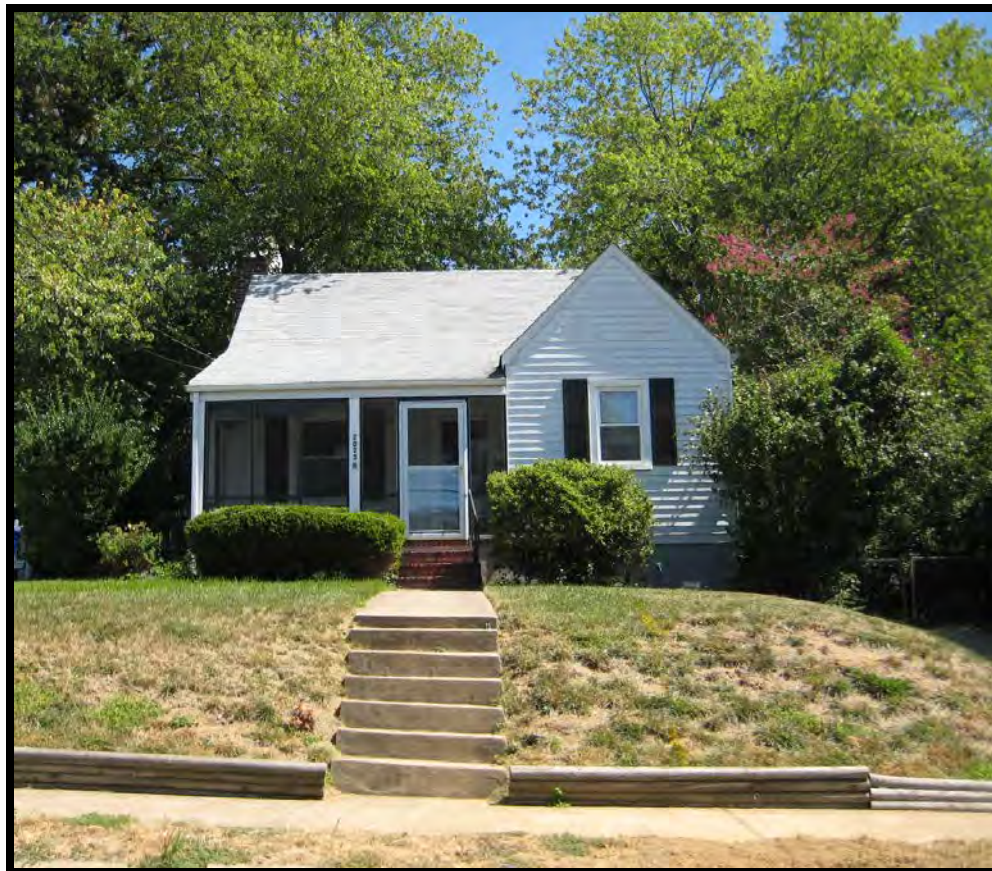
Figure 11: Single Dwelling, 2025 South Randolph Street, 000-4246 (EHT Tracerics, 2010)

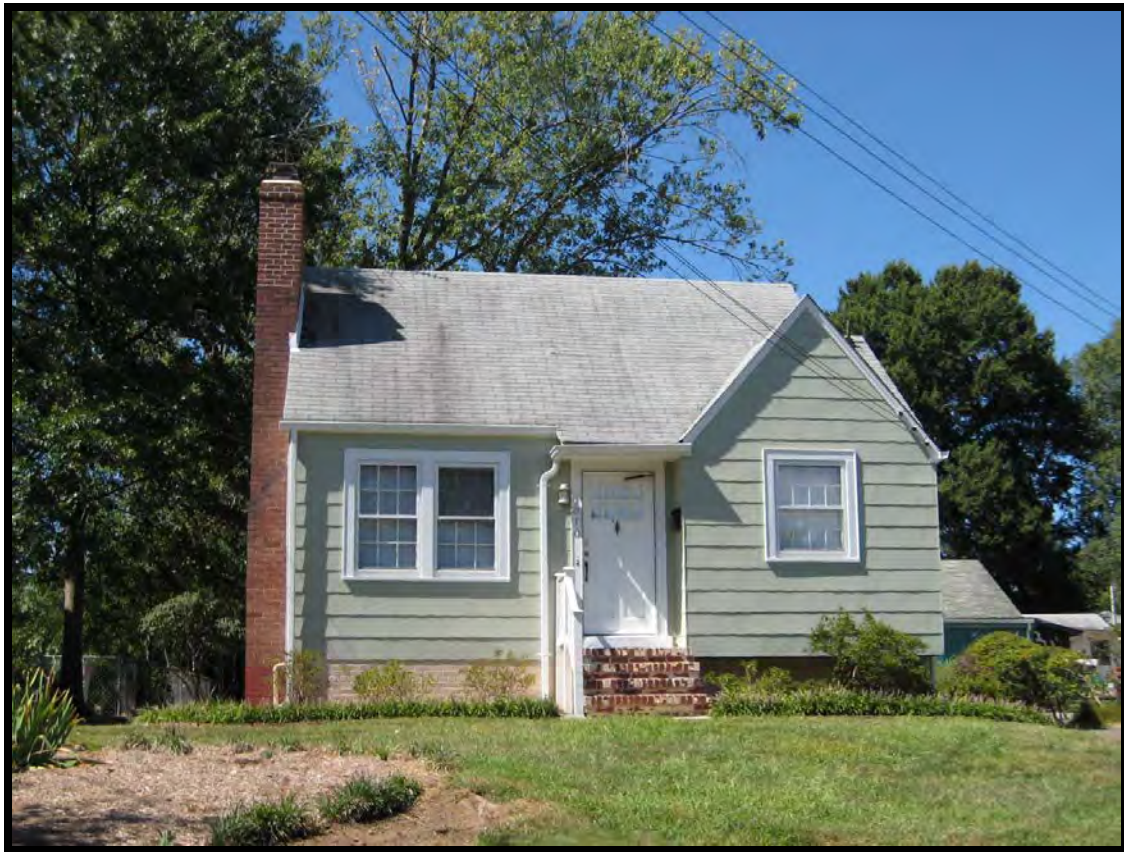
Figure 12: Single Dwelling, 1810 South Pollard Street, 000-4369 (EHT Tracerics, 2010)

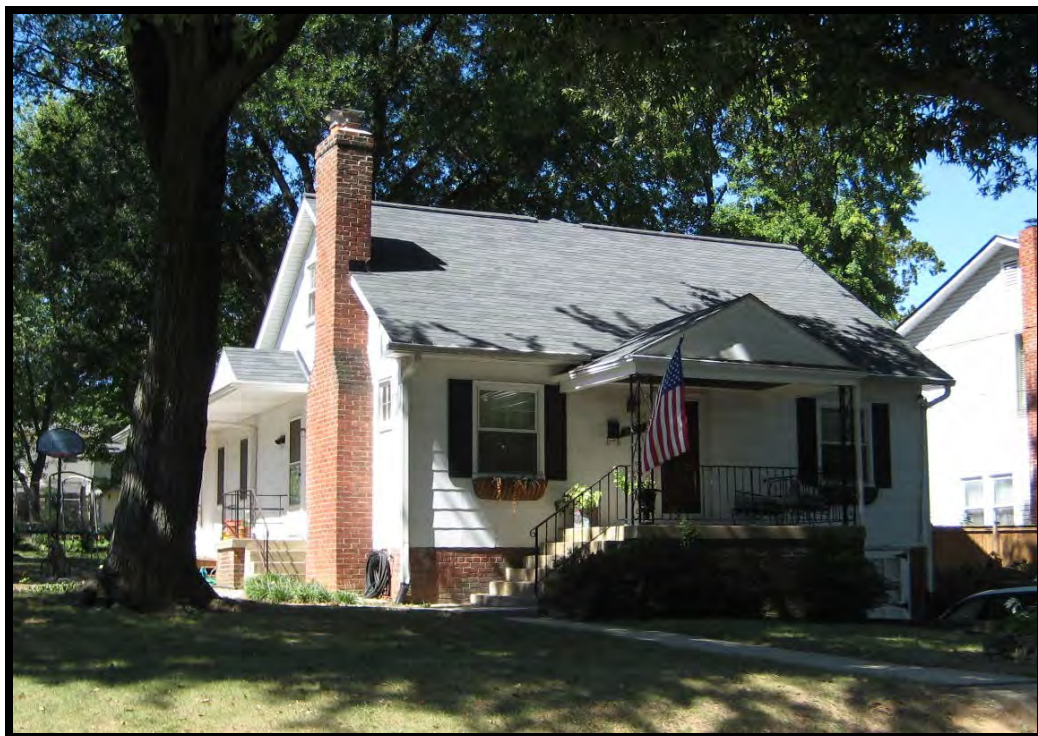
One of the most popular forms of the early and mid-twentieth century in Arlington County was the Cape Cod. Inspired by its colonial predecessor, the Cape Cod house of the twentieth century is a one-to one-and-a-half-story dwelling characterized by a side gable roof, three- to five-bays wide typically with a central entry, fenestrated with double-hung windows, and often augmented by dormers. This basic, popular form allowed for mass production by builders seeking to benefit from the tremendous need for housing in the late 1930s and early 1940s in Bluemont and Douglas Park. Additionally, while it could easily be constructed quickly, easily, and thus inexpensively, the Cape Cod form invited modification. Variations, while sometimes minimal, often included adjustments to the porch. Front porches, while one bay wide over the main entry, could be wider than the central bay. As the 1938 house at 1625 South Pollard Street (000-4459) demonstrates, the imposing, although shallow-pitched gable of the side-entry front porch is supported by metal filigree posts, a popular mid-twentieth-century element traditionally not associated with the pure Cape Cod building.

Figure 13: Single Dwelling, 1625 South Pollard Street, 000-4459 (EHT Tracerics, 2010)

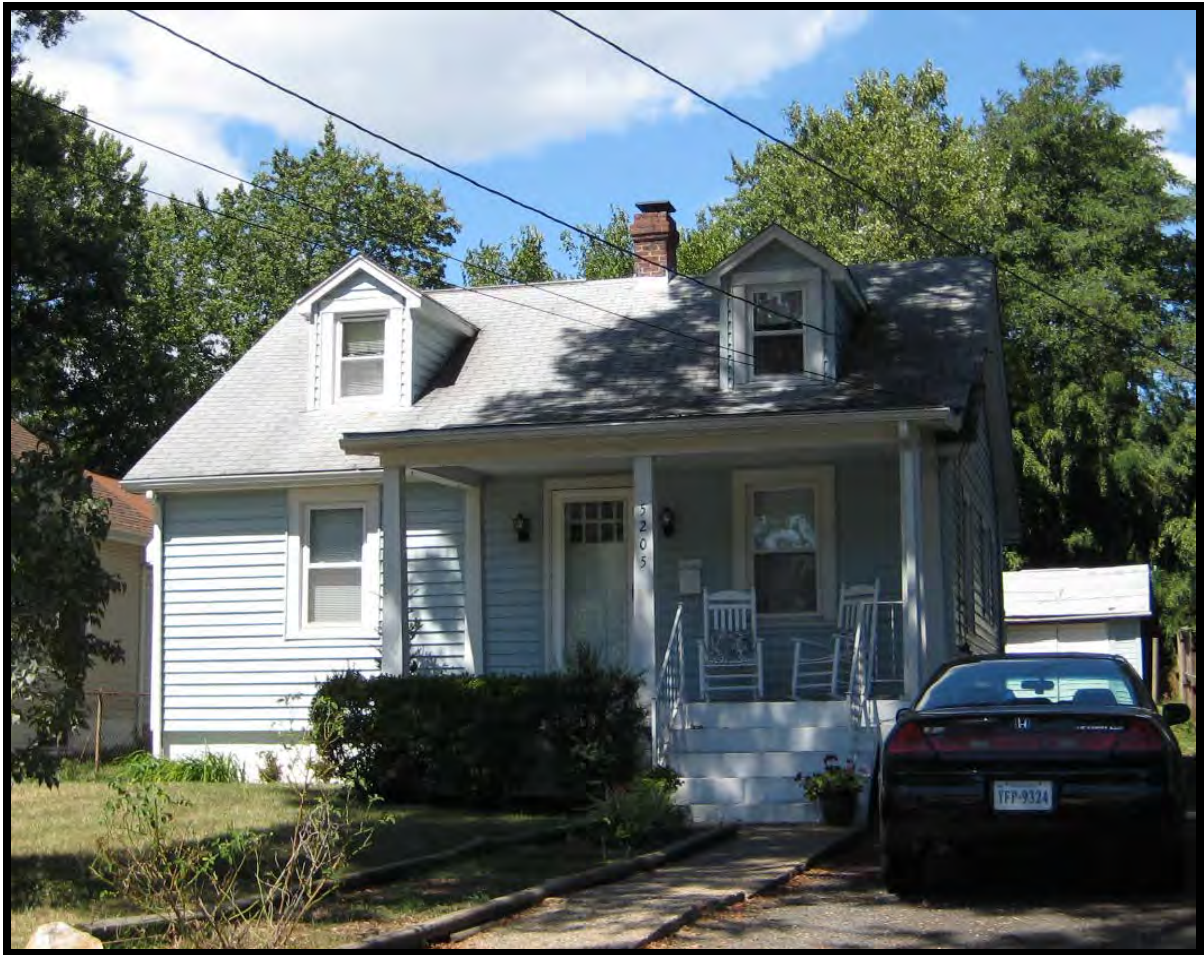
Figure 14: Single Dwelling, 5205 5th Street North, 000-4214-0341 (EHT Tracerics, 2010)

The house at 5205 5th Street North (000-4214-0341), constructed in 1938 by F.H. Battin in Bluemont, presents the traditional three-bay-wide Cape Cod form, augmented by a two-bay-wide porch on the façade. Covered by a shed roof that extends from just above the cornice line of the main block, the open porch has square posts supporting a narrow frieze with an overhanging ogee-molded cornice. The wood-frame porch sits on a concrete-block pier foundation. The porch shelters the central entry opening and one of the end bays, leaving the opposite end bay exposed. The building is covered by a side gable roof with a corbeled interior chimney of brick and front-gabled dormers. It is fenestrated with 1/1, double-hung, vinyl-sash windows and a single-leaf paneled wood door with eight lights set over two vertical panels (Craftsman style). The openings have wide square-edged surrounds and wood sills. A one-story, full-width porch that has been screened projects from the rear elevation.

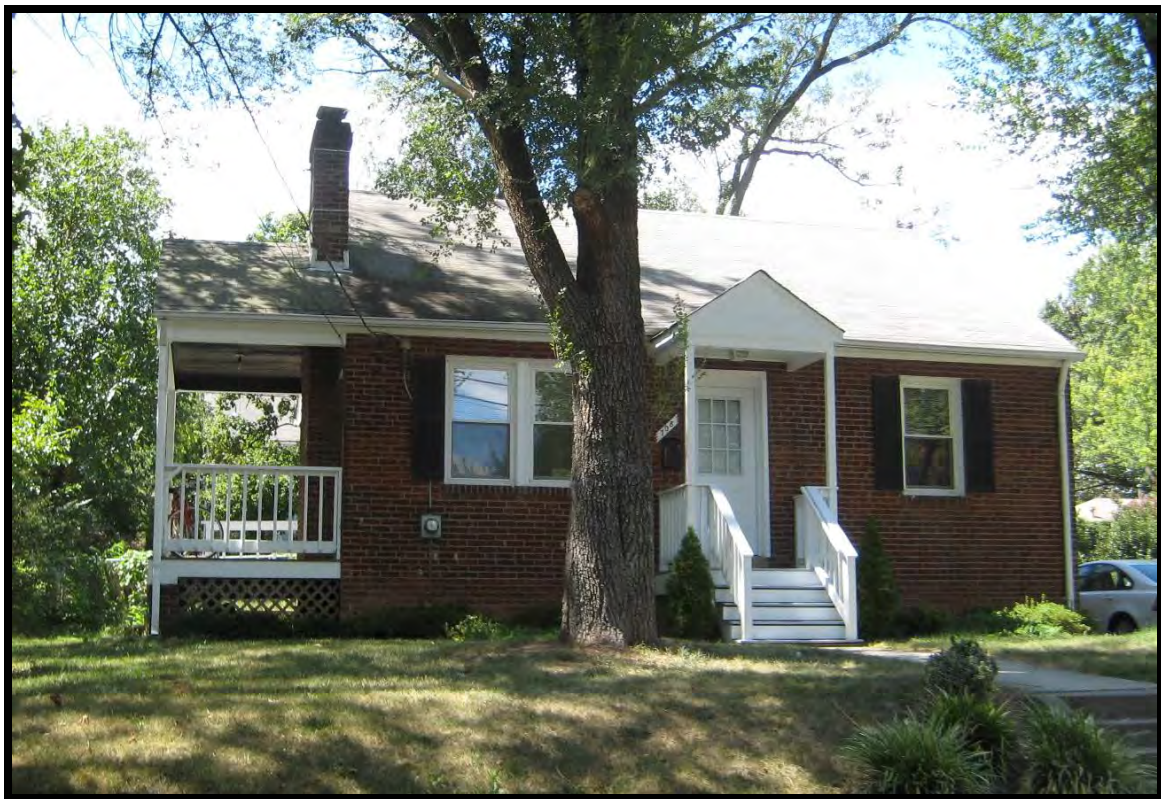
The three-bay-wide dwelling at 708 North Greenbrier Street (000-4214-0354) was constructed in Bluemont in 1939 by N.G. Gianpa with a slightly wider Cape Cod form. This shows the influences, albeit minimal, of the broader rectangular form of the ranch house, which was beginning to change suburban housing nationwide. Set on a slightly raised foundation, the building is constructed of concrete blocks veneered in six-course, Flemish-bond brick. The side gable roof, lacking dormers, is edged by a narrow frieze and slightly overhanging cornice. The centrally placed entry opening is accented by a wood-frame porch with a front-gabled roof supported by narrow square posts; the one-bay-wide porch appears diminutive at the center of this wide structure. The form is enlarged by the side porch, an original feature covered by a gable roof set below the raking cornice of the upper gable end. Like the front porch, this side porch has narrow square posts and balusters that visually support the wide frieze and overhanging cornice that join the façade of the main block. Fenestration on this single-family dwelling includes double-hung sash windows, both single and paired. The use of paired or picture windows set within a larger opening followed the precedent set by the ranch house as a means of falsely enlarging the interiors by providing unobstructed exterior views.

Figure 15: Single Dwelling, 708 North Greenbrier Street, 000-4214-0354 (EHT Tracerics, 2010)

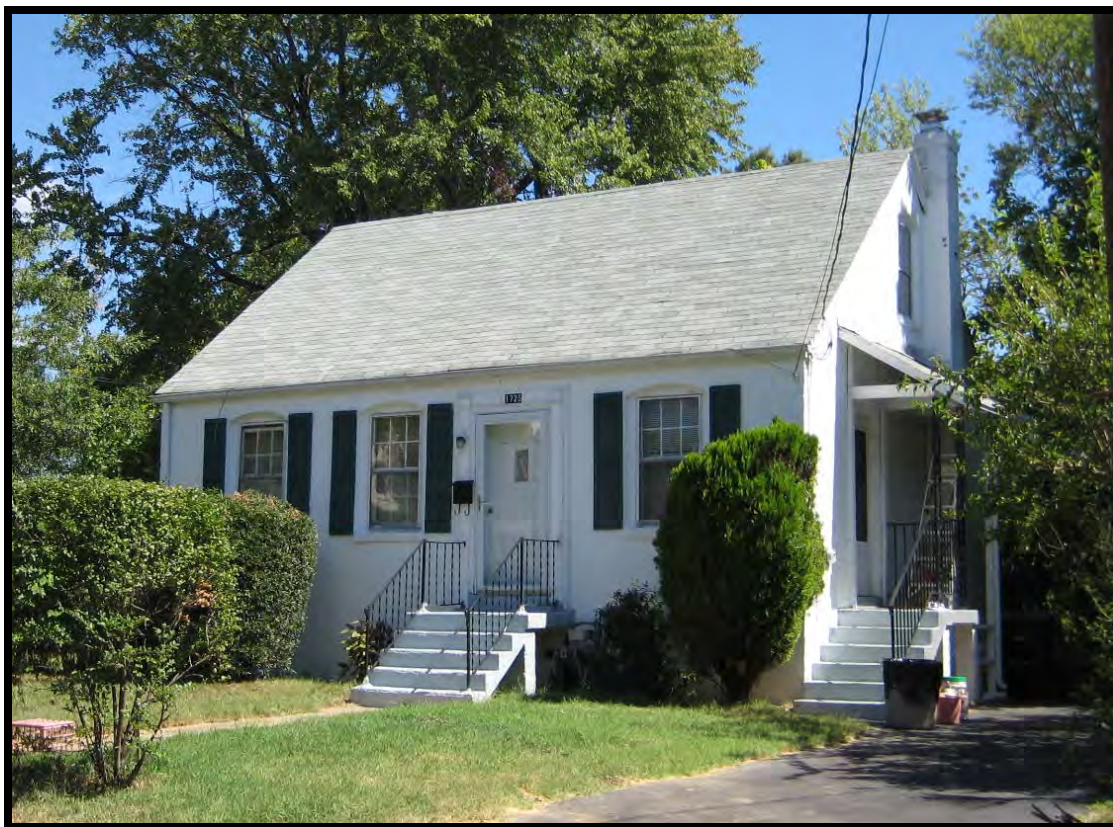
Another change to the Cape Cod in the World War I to World War II period, when mass-produced housing was in dire need, is the construction material of the structure. As the house at 1725 South Oakland Street (000-4465) illustrates, the unnecessary expense of the cladding material was often abandoned, leaving the concrete-block structure exposed, although painted. Constructed in 1944 by Allen C. Minnix, this one-story house is one of at least three in Douglas Park with the material of the structure exposed and fashionably ornamented at a limited cost. The four-bay-wide façade has double-hung window openings framing the single-leaf entry. Minimally adorned, the openings provide stylistic ornamentation by the segmental arches, which are visually amplified by the flat sash and contrasting color of the framing shutters.

Figure 16: Single Dwelling, 1725 South Oakland Street, 000-4465 (EHT Tracerics, 2010)

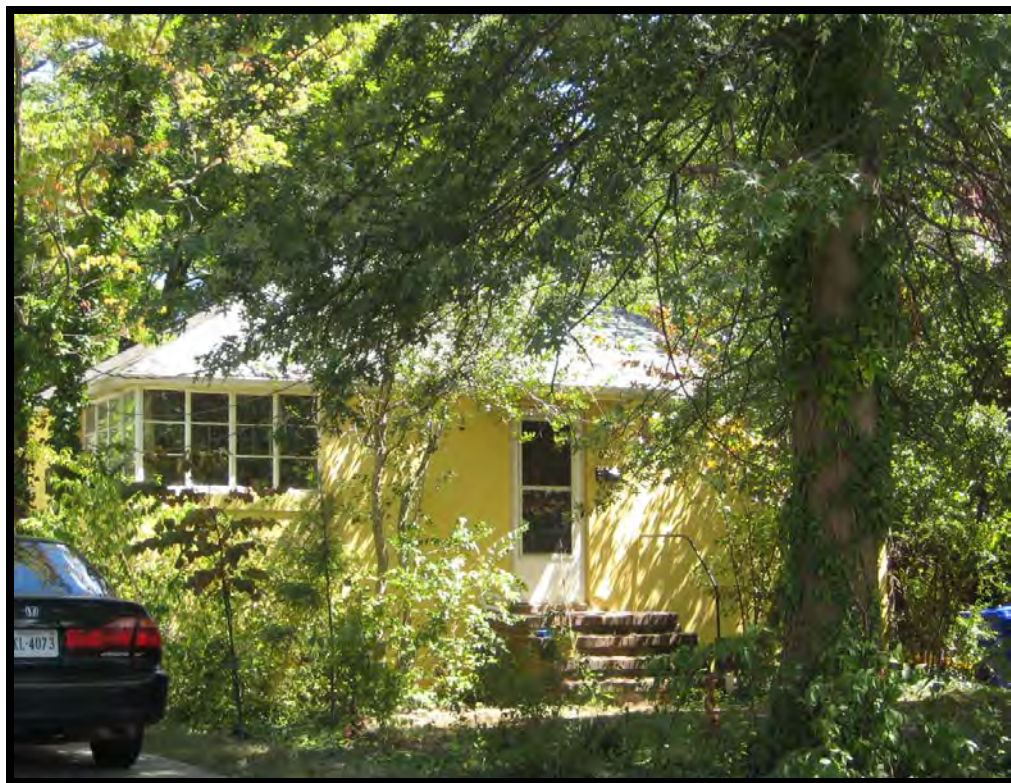
Figure 17: Single Dwelling, 851 North Jefferson Street, 000-4214-0373, (EHT Tracerics, 2010)

Clearly one of the imitator buildings the American Homes Corporation warned buyers about, the house at 851 North Jefferson Street was constructed by prolific Modern Movement builder Ernest Riley. It is a modest square structure capped by a pyramidal hipped roof pierced at the apex by a brick chimney cap. The concrete-block structure is covered in smooth stucco that has been painted.

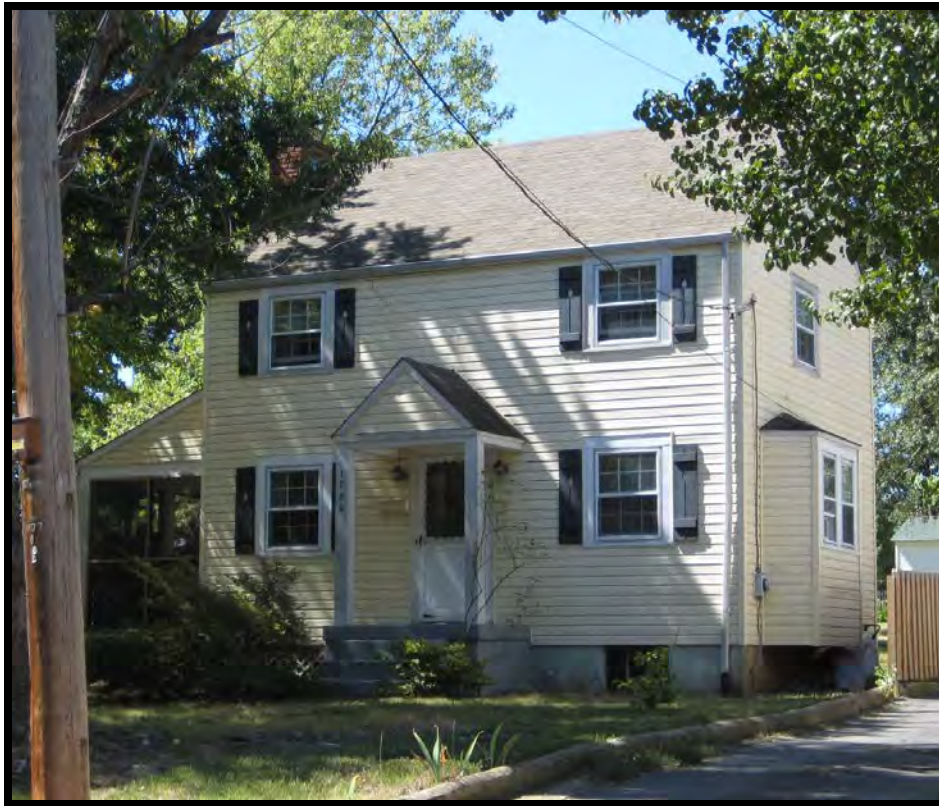
The house at 1732 South Pollard Street (000-4426) in Douglas Park is one of the few wood-frame examples of this common domestic form. The two-story dwelling was erected in the fall of 1938 by the American Homes Company. It has a solid masonry foundation of concrete blocks with a wood-frame structure, which has been reclad in vinyl siding but was most likely originally covered in weatherboard siding. The side-gable roof is covered in asphalt shingles with a shallow raking cornice, which is typical of the second quarter of the twentieth century. The central entry holds a single-leaf door of wood covered by a one-bay-wide porch. Like many of the brick-veneered versions of this popular form, the porch has a front-gabled roof supported by square posts. Flanking the entry are the symmetrically placed window openings, each holding 6/6, double-hung, wood sash. The openings have squared-edge surrounds clad in vinyl and undersized, inoperable shutters pierced with an ornamental design. Original to the structure is the one-story screen porch on the south elevation; it is one of the few side porches in the survey update that has not been enclosed. A unique feature is the canted bay window on the first story of the side elevation. The historic maps suggest it was added, but such a minimal projection may not have been properly captured by cartographers in a neighborhood celebrated for its mass-produced housing.

Figure 18: Single Dwelling, 1732 South Pollard Street, 000-4426 (EHT Tracerics, 2010)

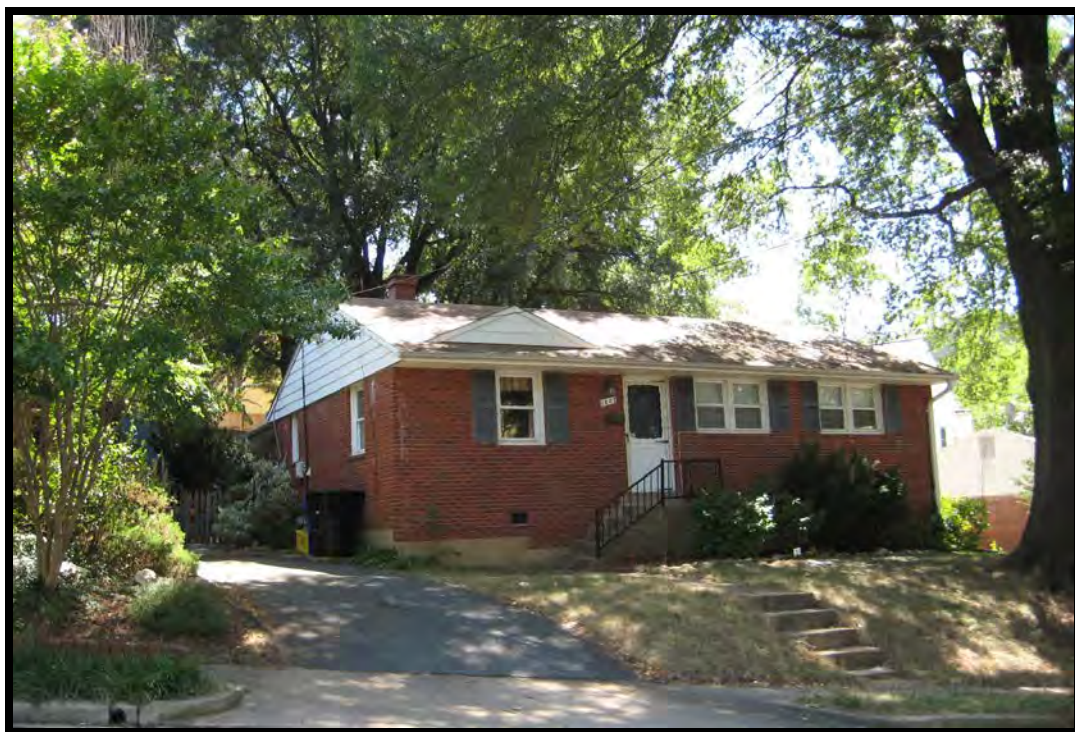
Figure 20: Single Dwelling, 1807 South Stafford Street, 000-4397 (EHT Tracerics, 2010)

The elements of the ranch house noted in Douglas Park are the low-lying, one-story structure with a rectangular form that is composed of a four-bay-wide main block. Set on a raised foundation, often exposed as a full story because of the sloping topography, the masonry structures are veneered in brick laid in stretcher bond. The upper gable ends, which show off the shallow pitch of the side gable roof, are finished in a siding. All of the examples noted in the Oxford Heights subdivision of Douglas Park have shallow-pitched enclosed pediments over an end bay, which holds a window opening. This pediment, not serving a structural or ventilating purpose, merely pays homage to the Minimal Traditional form and the revival styles, which are denoted by their gables. The house at 1807 South

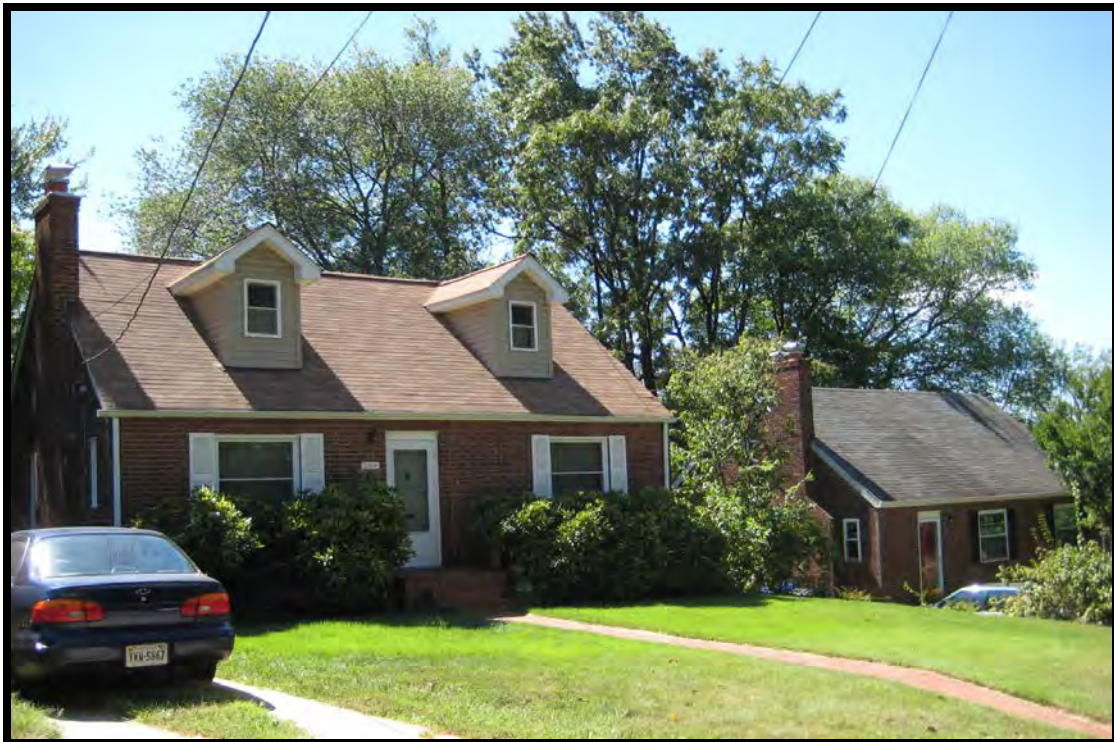
The Modern Movement's influences on established forms, such as the Minimal Traditional and the Cape Cod, were commonly noted throughout the survey update area. The houses by Michael Pomponio & Sons in the 3900 block (even) of 19th Street South, for example, document how the Cape Cod form was stretched in width, but continued to maintain its three-bay-wide plan. This slight alteration in the form is clearly apparent when examining the side-gable roof, which becomes a dominating feature of the low-lying form. The standard-sized dormers added to 3908 19th Street South (000-4331), for example, appear undersized on the wider, expansive roof. Although the traditional form was illuminated with double-hung windows, the openings are notably larger and more reminiscent of the picture window with their uninterrupted 1/1 sash. The application of shutters, although inoperable, presents the allusion of the narrow operable windows that often frame picture windows to provide fresh air.

Figure 21: 3900 block (even) of 19th Street South (EHT Tracerics, 2010)

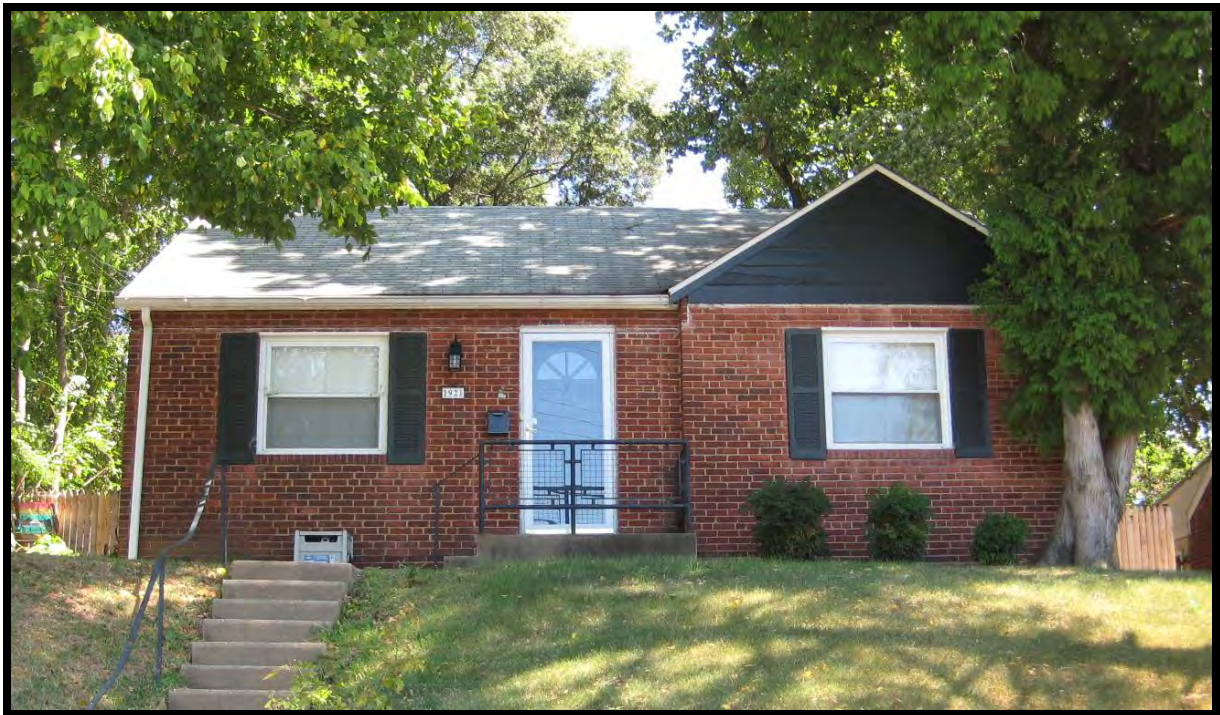
Figure 23: Single Dwelling, 1921 South Quincy Street, 000-4311 (EHT Tracerics, 2010)

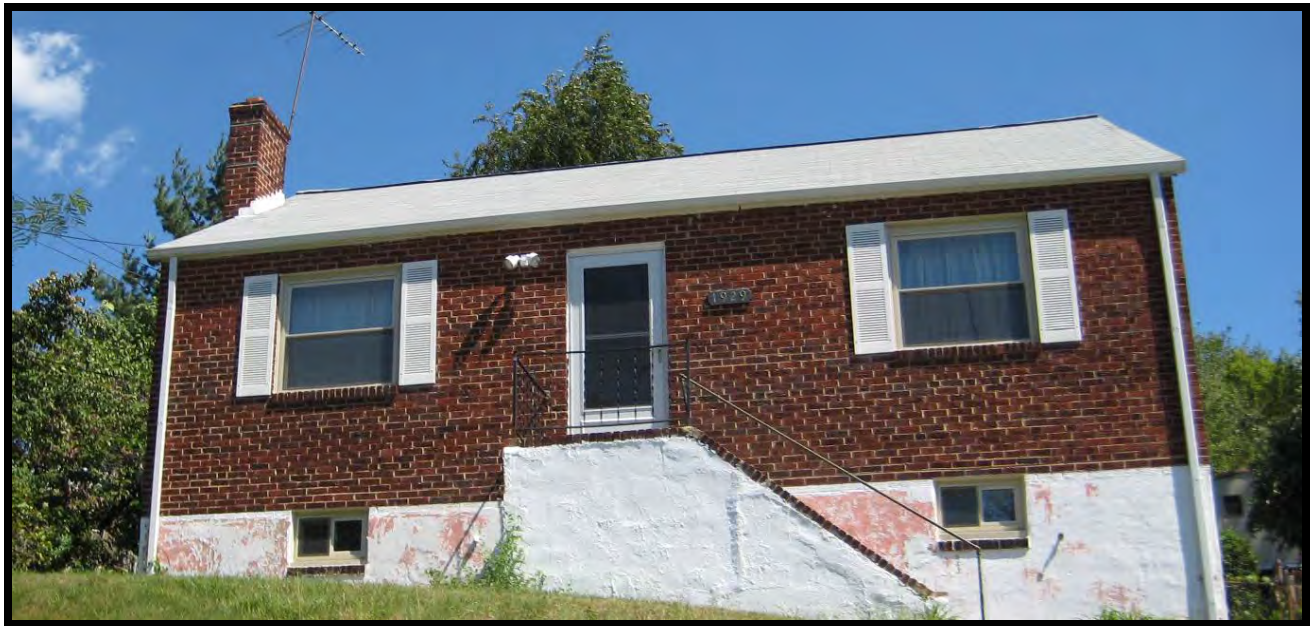
Modification of this form did not include the projecting bay, which made the resulting house more in keeping with the ranch house but reminiscent of the two-story rectangular box form identified so often with Arlington County. The modest house stands just one story in height, sometimes on a raised foundation pierced by basement windows. The concrete-block structure is veneered in stretcher-bond brick with a side gable roof of asphalt shingles. The upper gable ends of the side elevations have raking boards rather than molded cornices and the façade is covered by overhanging, albeit shallow, eaves. The off-center entry is flanked by exceptionally broad double-hung windows, framed by inoperable louvered shutters that make the openings appear even wider. The unpretentious house at 1929 South Quincy Street (000-4308) is another excellent example of this.

Figure 24: Single Dwelling, 1929 South Quincy Street, 000-4308 (EHT Tracerics, 2010)

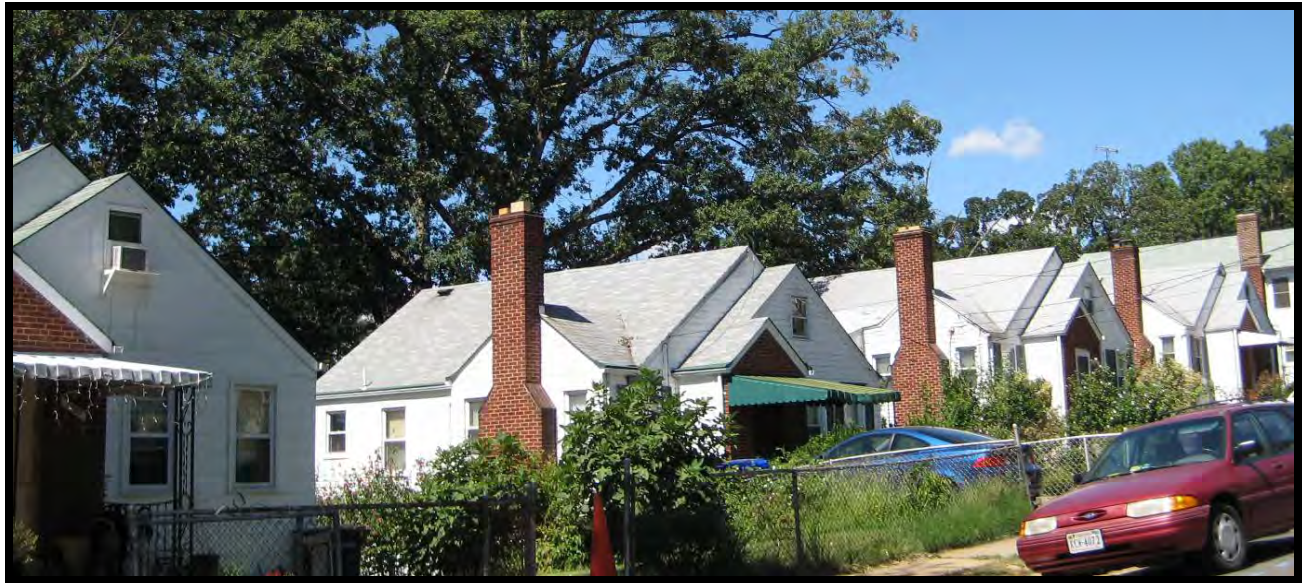
The one-and-a-half-story house at 2100 South Quebec Street (000-4262) is an excellent example. The building is set on a slightly raised concrete block foundation, a necessity of the steeply sloping site. The modest, wood-frame single-family dwelling, reclad in vinyl siding, has a double-pitched, front-gabled roof covered in asphalt shingles with a raking cornice of metal. The exterior-end brick chimney is located on the south elevation. The projecting front-gabled entry vestibule is veneered with stretcher-bond bricks on the face and the sides are covered in vinyl siding. The varying of the cladding materials with synthetic siding and a brick veneer is original. The building is asymmetrically fenestrated with double-hung openings holding replacement 1/1 vinyl sash. Notably, the location and size of the window openings were clearly dictated by the interior uses rather than symmetry.

Figure 25: 2000-2100 block (even) of South Quebec Street (EHT Tracerics, 2010)
