**AN ARCHITECTURAL SURVEY UPDATE
IN
ARLINGTON COUNTY, VIRGINIA**

PHASE I

Final Report

**Arlington County, Virginia
Department of Community Planning, Housing and Development**

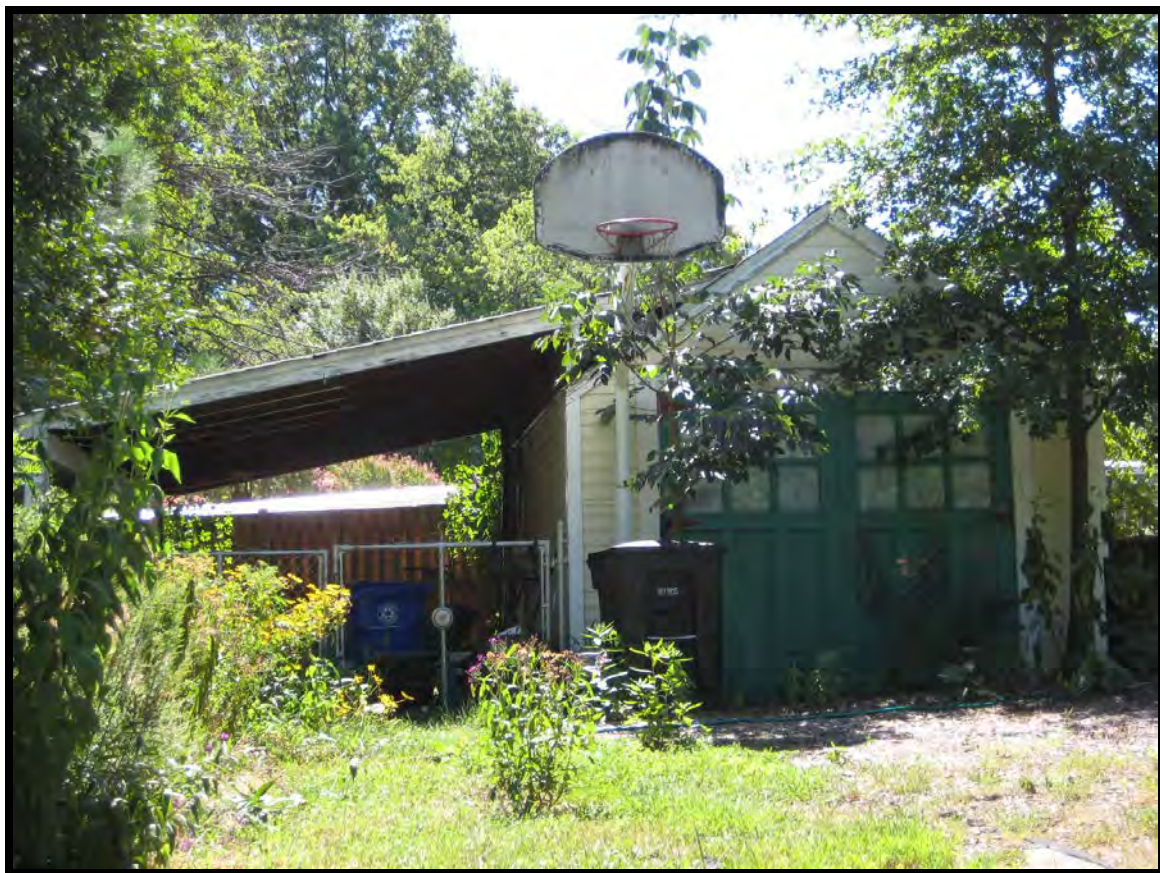
Figure 26: Garage, 1800 South Pollard Street, 000-4371 (EHT Tracerics, 2010)

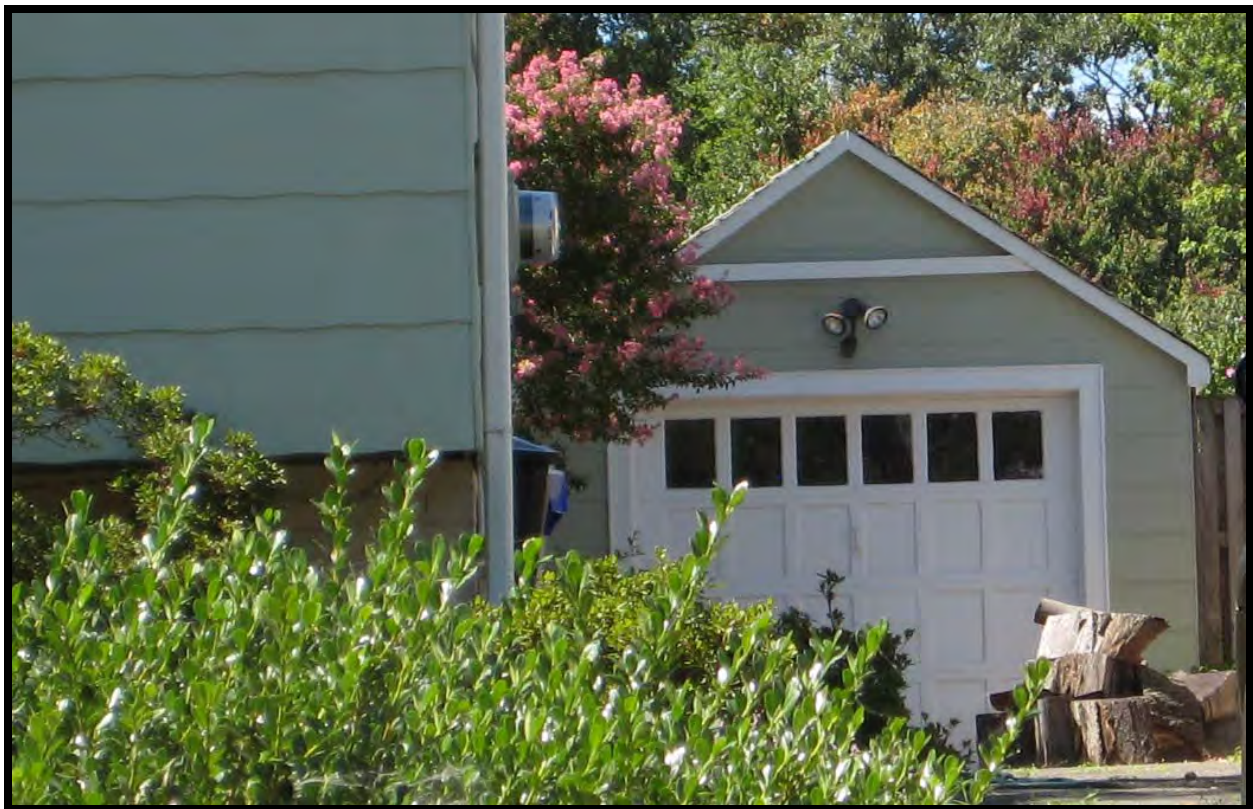
The building at 1810 South Pollard Street (000-4369) is an example of a freestanding garage constructed simultaneous to that of the main dwelling. Thus both buildings are similar in form, scale, style, and cladding material. The front-gabled garage, set back behind the main dwelling, is one story in height. Constructed of wood frame clad in wavy asbestos shingles, the garage has a swing-up door of wood with recessed panels and a row of fixed lights at the top.

Figure 27: Garage, 1810 South Pollard Street, 000-4369 (EHT Tracerics, 2010)

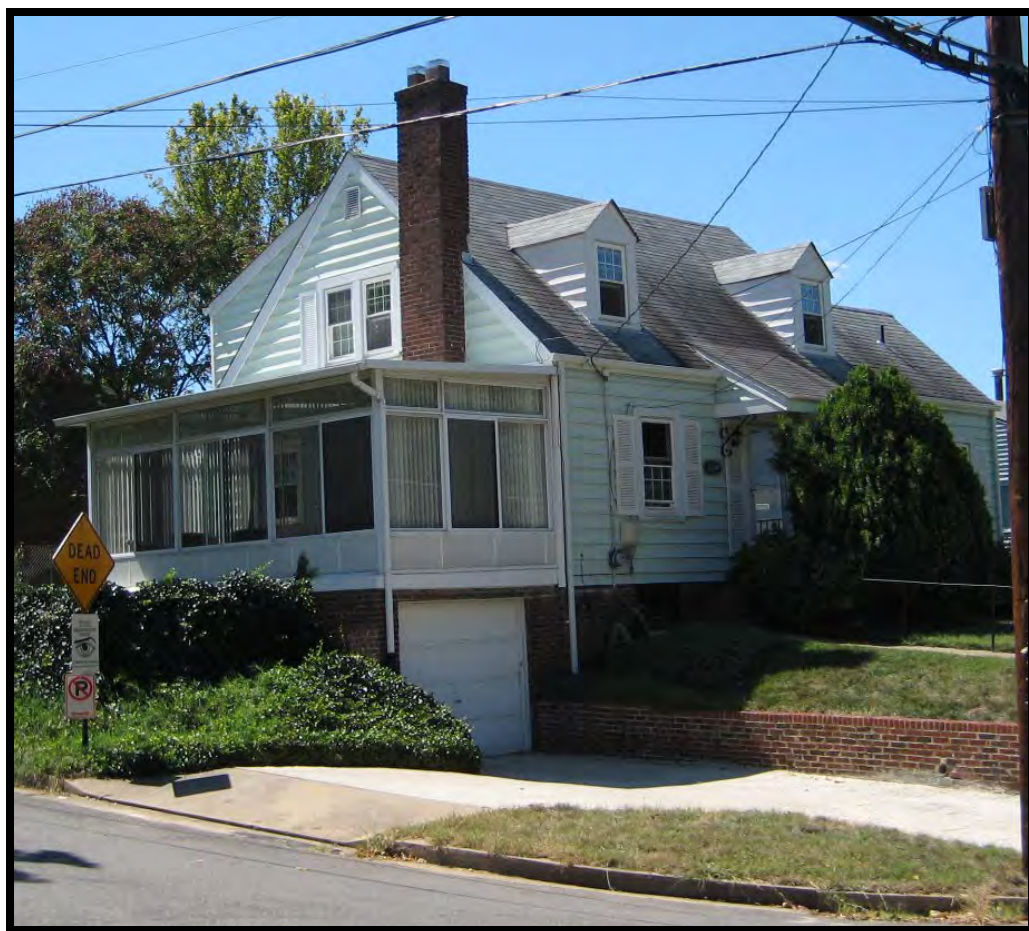
In an attempt to attract upper-middle-income residents, many of the dwellings were constructed with the associated garage as part of the main block. This was notably rare in survey update areas of Douglas Park and Bluemont. The house at 4100 16th Street South (000-4417), located at the intersection of South Randolph Street, has an integrated garage. This example is located in the side wing; the other examples presented the integrated garage in the projecting bay on the façade. Original to the house built in 1941 by R.J. Stalker in the Mary E. Whitehead Subdivision of Douglas Park, the garage is located in the exposed foundation of the porch wing. The open porch above has since been enclosed. The single-family dwelling, including the garage wing, has a solid masonry foundation of concrete blocks veneered in stretcher-bond brick. The one-car garage has a roll-up door of wood with panels.

Figure 28: Integrated Garage, 4100 16th Street South, 000-4417 (EHT Tracerics, 2010)

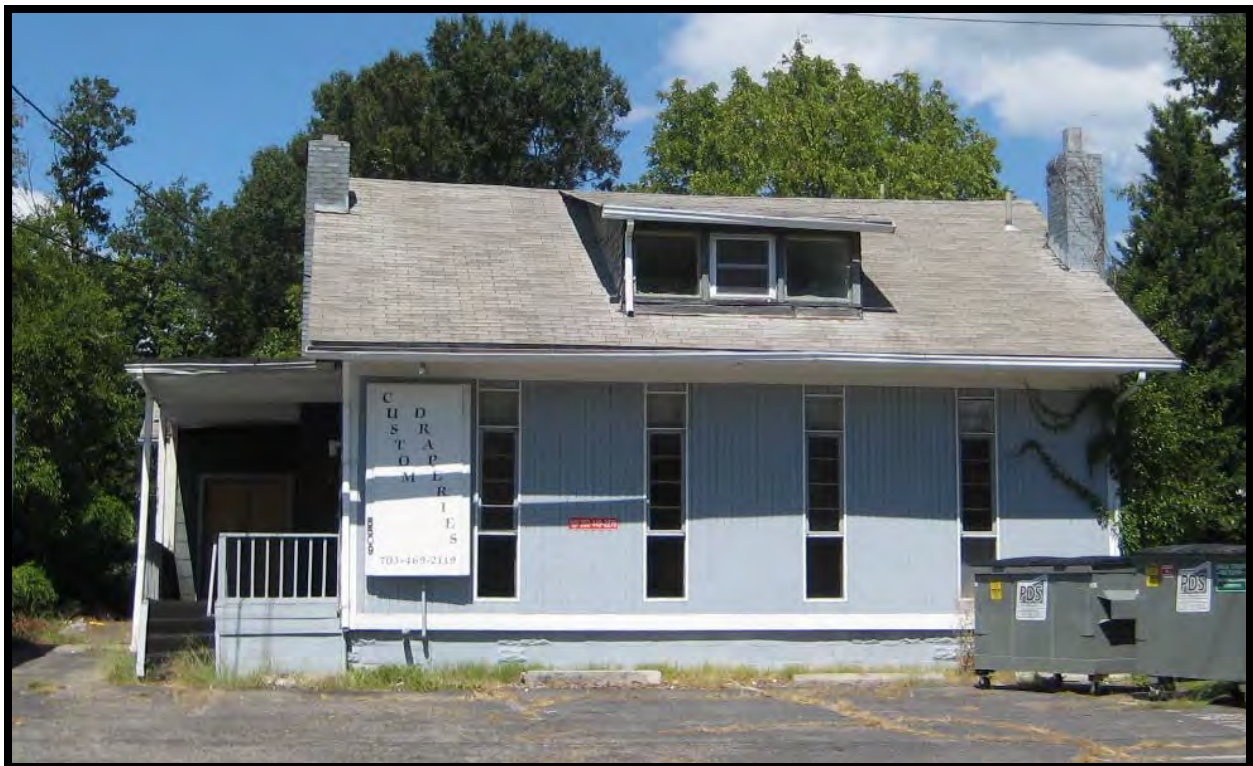
The single example of the commercial building identified in the survey update is located at 5509 Wilson Boulevard (000-4214-0370). The complicated history of this building, a recognized commercial building fronting a busy transportation corridor running east-west through Arlington County, begins with its construction ca. 1925 as a single-family dwelling. In 1940, according to the building permit cards, the building was moved to its current location from 5117 Wilson Boulevard. The Craftsman-style bungalow was relocated to allow for the construction of the neighborhood grocery store and expansive parking lot. The Sanborn Fire Insurance Map indicates that in 1959, the displaced building was used as a store, although remnants of its historic past as a stylized dwelling were evident. Set on a solid rock-faced concrete-block foundation, the wood-frame structure is now clad with T1-11 siding on the façade with the original asbestos shingles on the secondary elevations and square-butt wood shingles in the upper gable ends. The side-gabled roof has wide overhanging eaves and a shed-roof dormer. The commercial façade that reflects the building's relocation and later renovation is marked by narrow double-hung and fixed windows placed in vertical spandrel that extend from the foundation to the eaves. Secondary elevations are fenestrated with double-hung windows that include 6/1 and 6/6 wood sash and 1/1, double-hung, vinyl sash that are paired in the upper gable end. The one-story, full-width porch on the rear elevation was enclosed in 1942. It wraps around to the side elevation where it has a shed roof. In 1962, the porch on the façade was replaced and a new entry was added to the west side of the main block, which is now boarded.

Figure 29: Former Single Dwelling, now Commercial Building at 5509 Wilson Boulevard, 000-4214-0370 (EHT Tracerics, 2010)
