HISTORIC STRUCTURE REPORT
HANOVER COUNTY COURTHOUSE AND JAIL

HANOVER, VIRGINIA

AUGUST 1, 2004

HISTORIC STRUCTURE REPORT

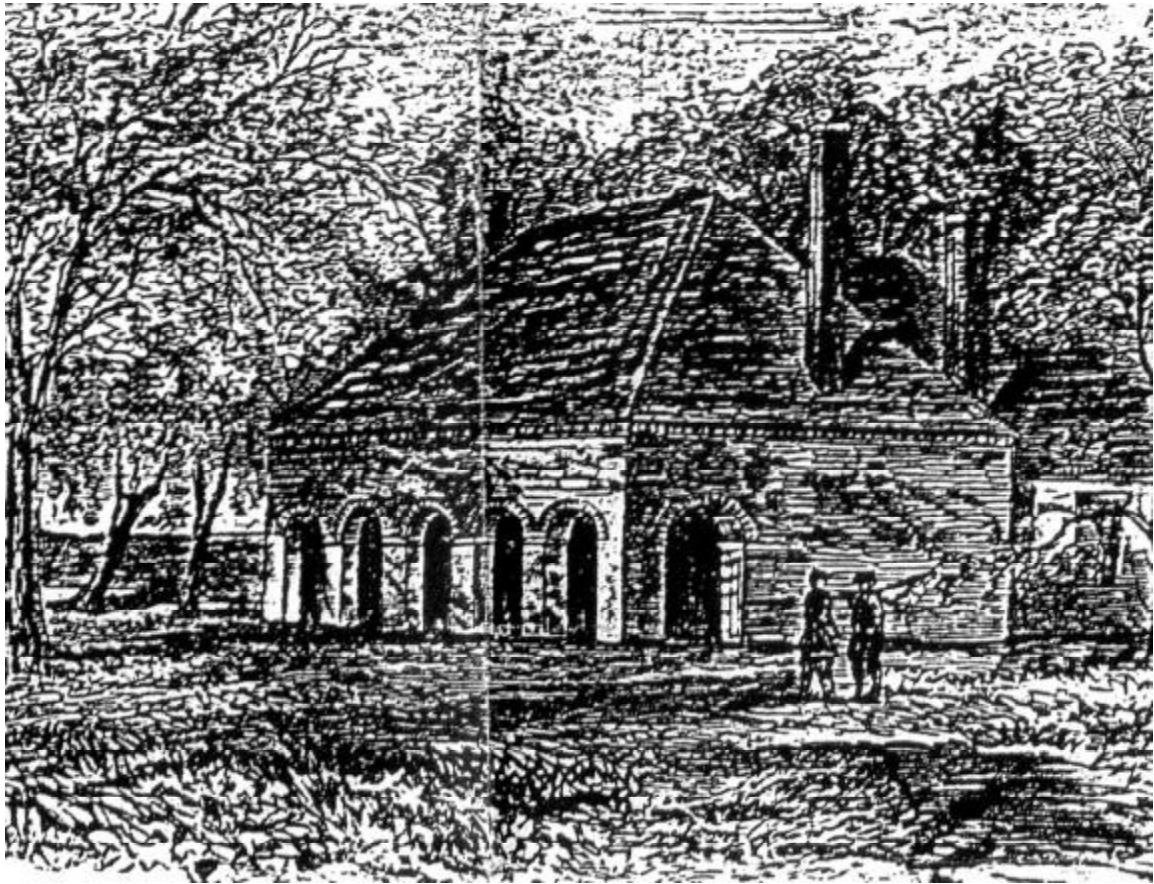
Figure 8: Sketch of the Hanover County courthouse included by Robert Knox Smeden in one of his scrapbooks.

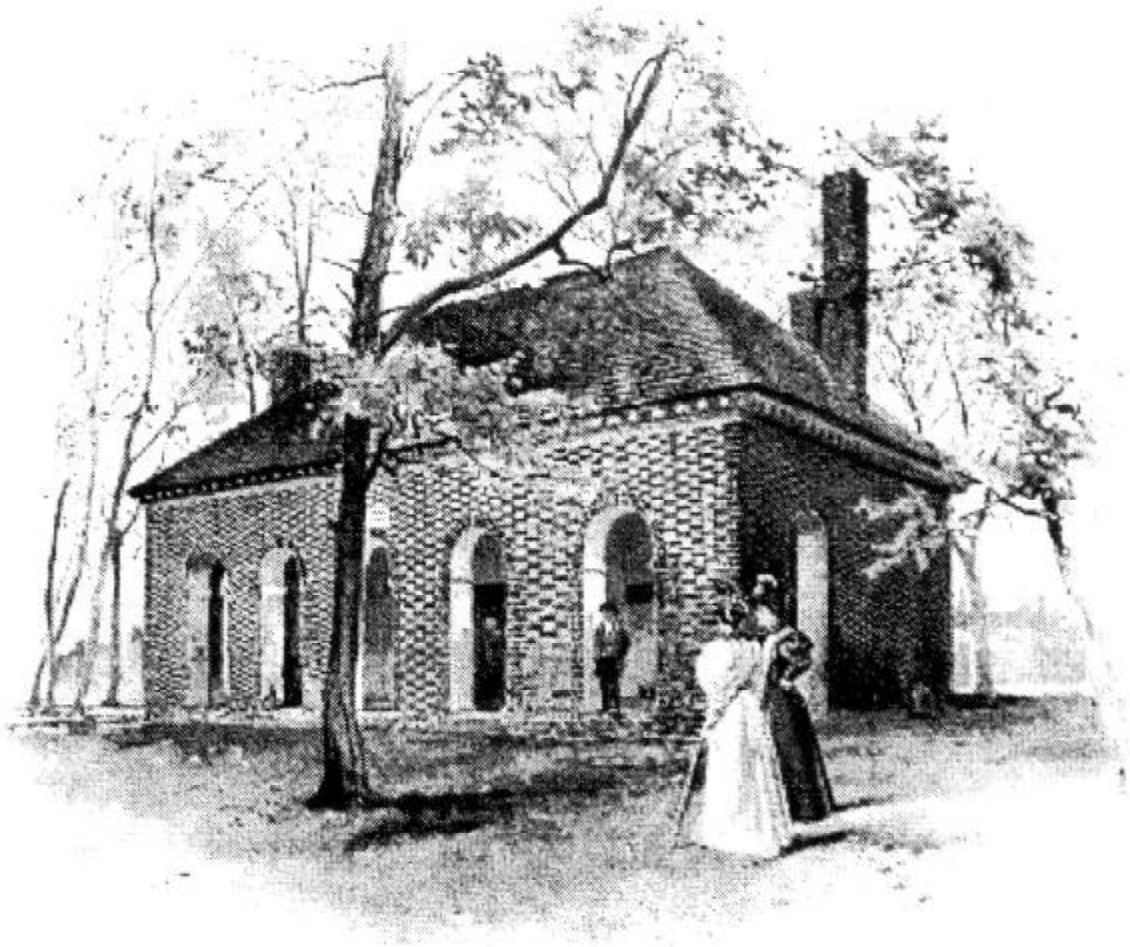
HANOVER COURT-HOUSE.

Figure 13: The Hanover County courthouse as depicted in the May 1896 issue of Harper's New Monthly Magazine.

According to the 1894-1895 minutes of St. Paul’s Church, after the parish’s mid-nineteenth century church burned in December 1893, its bricks were sold to several people. Among the purchasers was Peter or P. T. Bowles, who was hired to make repairs to the Hanover County courthouse. On April 12, 1895, Bowles purchased ~~\$36 50 worth of bricks~~ and on July 17th he bought another \$3.00 worth. Finally, on December 18, 1895, the county treasurer paid Bowles for 4,000 bricks “for use of County ct. house” (Cross n.d.:13). An engraving of the Hanover County courthouse was used as an illustration in an article by Woodrow Wilson, which was featured in the May 1896 issue of *Harper’s New Monthly Magazine* (Wilson 1896) (Figure 13).

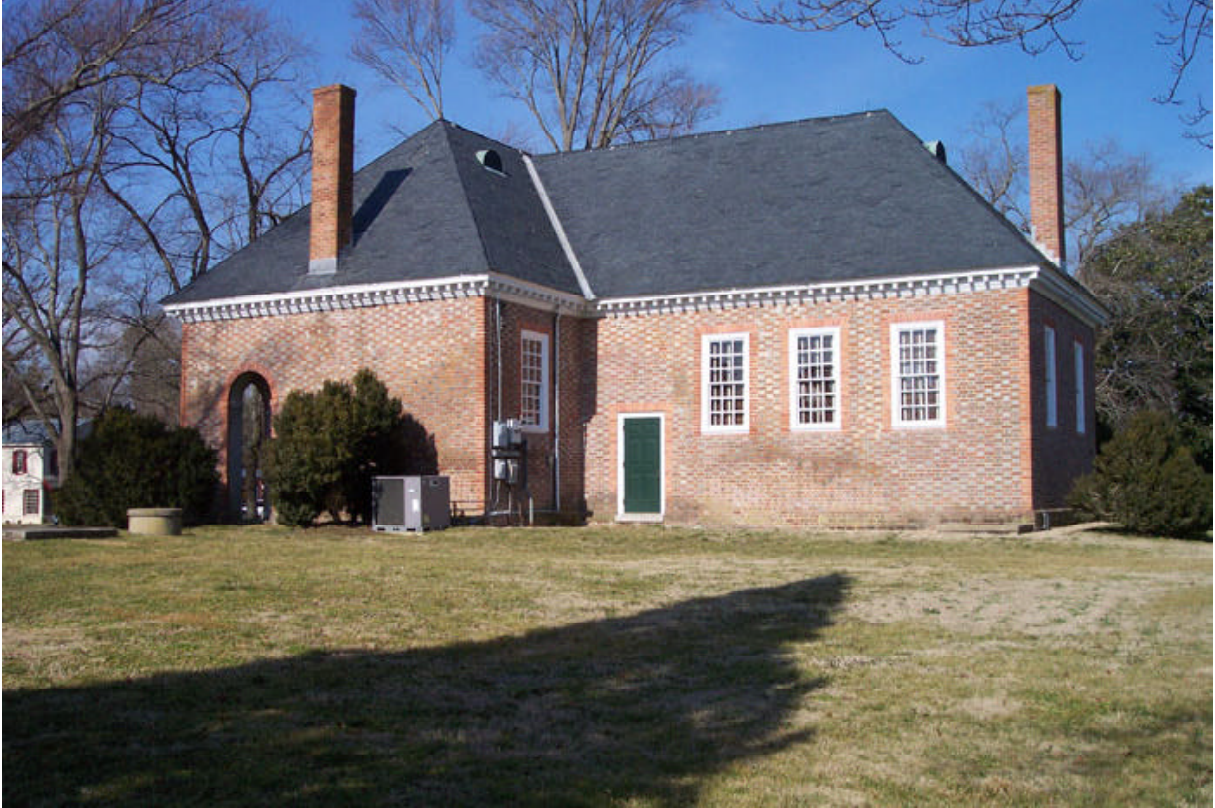
Above: South elevation of courthouse.

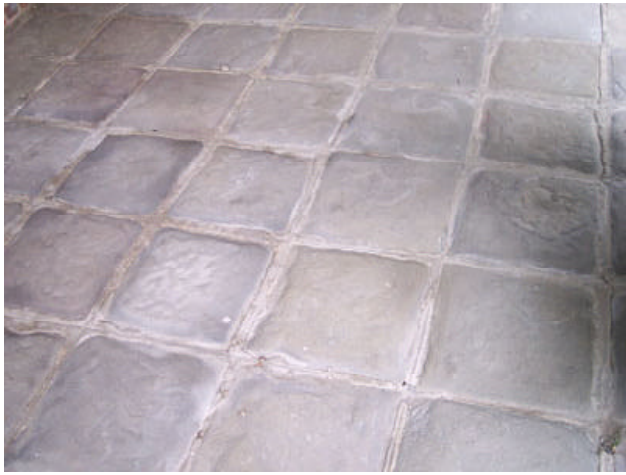
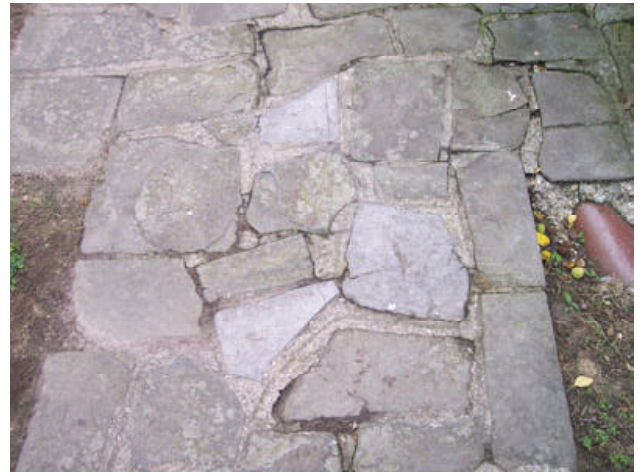
Above: Paving - Piazza (left) and Jail (right).

Within the bar, the courtroom was most often floored with pine plank. Outside the bar, the public area of the courtroom was typically paved with stone, sometimes identified as “Bristol stone” in contemporary accounts, perhaps in reference to some quarry nearby that city, or a reflection of the customary shipment of this stone through the port of Bristol. In any case, the pavers are usually grayish or reddish sandstone. Those now visible in the piazza may have been part of the original courtroom paving, though a 1929 measured plan shows paving in the courtroom and in the piazza at that time.⁴ Other pieces seem to have been reused in the walk by the entrance to the jail.

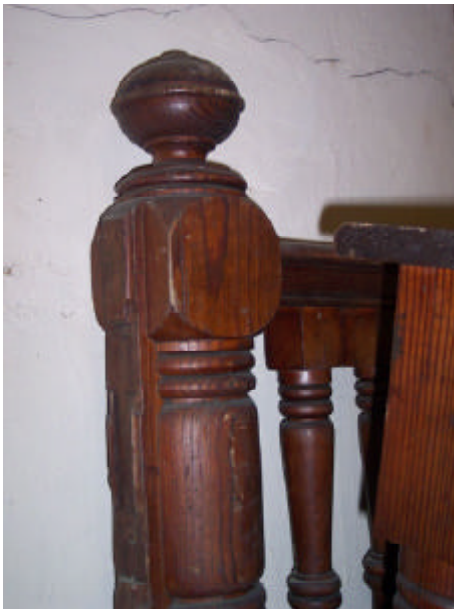
A photograph of the courtroom interior, taken prior to the restoration, leaves no doubt that this artifact, along with other courtroom fixtures present at the time, probably dated from this last episode of repair.

The photo looks eastward toward the upper end of the courtroom. Late nineteenth century courtroom fittings are visible here, including the railing now displayed in the jail, the partition separating the litigants from the judge, the judge's rostrum, and the wainscoting behind, mostly executed in matchboard. Also visible are some of the tables displayed in the jury rooms and jail, and also some of the oak chairs presently used in the courtroom.

Behind the judge's seat, the window sills appear lower than at present. These were almost certainly built this way in the 1895 extension of the courtroom, the sills of the older windows being lowered to correspond.

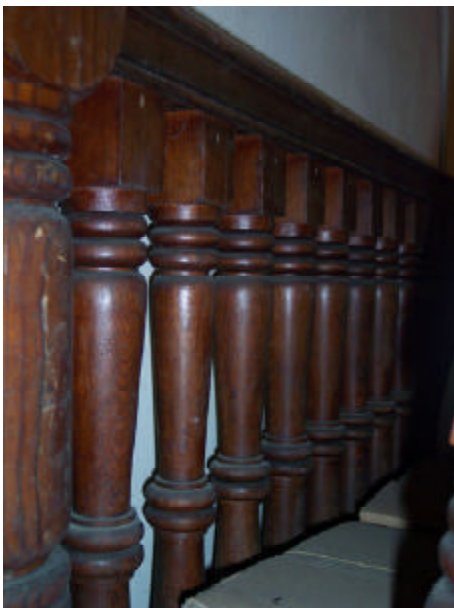
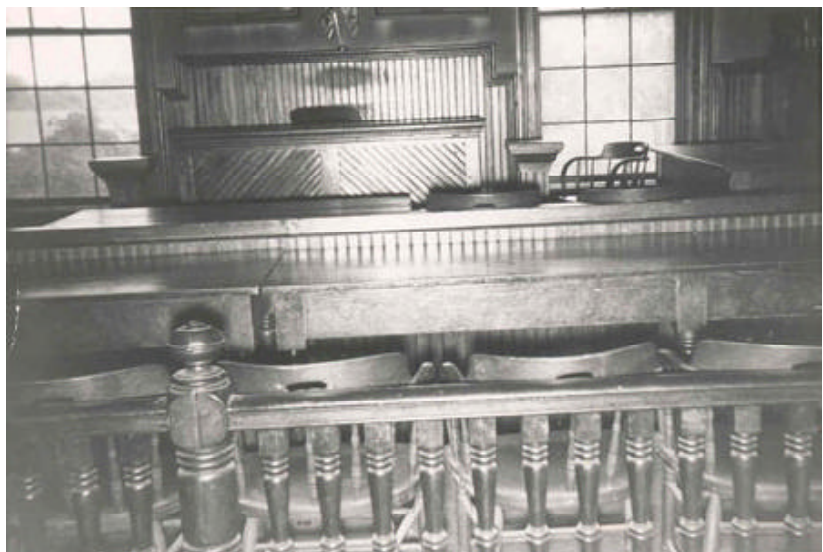
Top Left and Above Left: Newel and balustrade of bar removed from courtroom in 1954-5. Above Right: Eastern end of 1895 courtroom - bar now displayed in the jail.

VII)—the large, lower member that now spans where the rear wall of the courtroom was removed is circular-sawn, indicating that it probably dates from the second half of the nineteenth century. (However the member above this one has two wrought nails in it, together with a series of square holes for large bolts, suggesting it was once part of a composite beam. It must have spanned the courtroom at some earlier time, possibly on axis with the rear walls of the jury rooms).

The unspecified work to be done by Bowles may have included far-reaching changes, the small appendage on the eastern end of the building was probably demolished at this time and the courtroom extended eastward a distance of 9' - 3 1/2". No doubt, this change reflected the changing character and growing amplitude of the county court. To avoid an overabundance of windows in the elongated courtroom, the central opening on each side was closed up, as were the fireplaces. The courtroom extension must have undone the courtroom fixtures at the eastern end of the space, and new fittings were created to replace them. The pre-1955 bar, salvaged from the courtroom at the time of the restoration, is now displayed in the Jail.

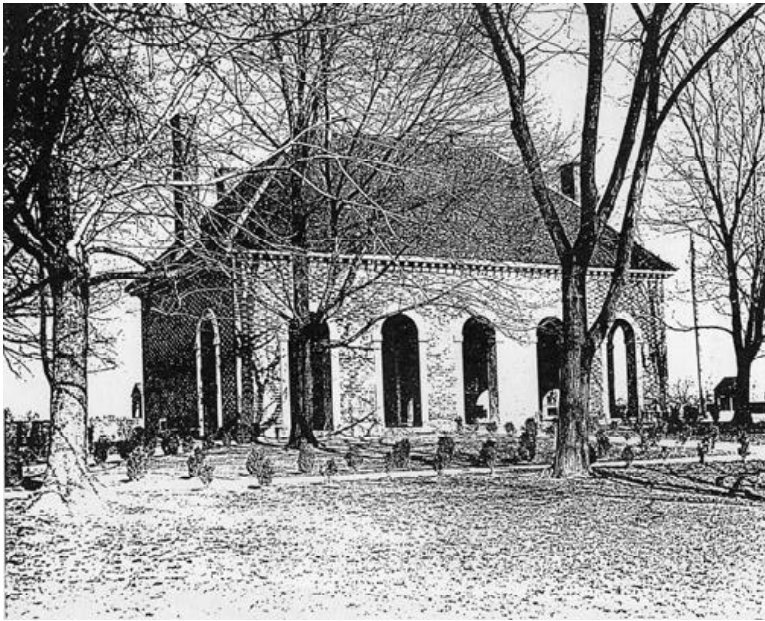
By 1926, the rubbed dressings of the piazza arches were evidently spalling,

Above: Stuccoed openings of piazza, 1929-32

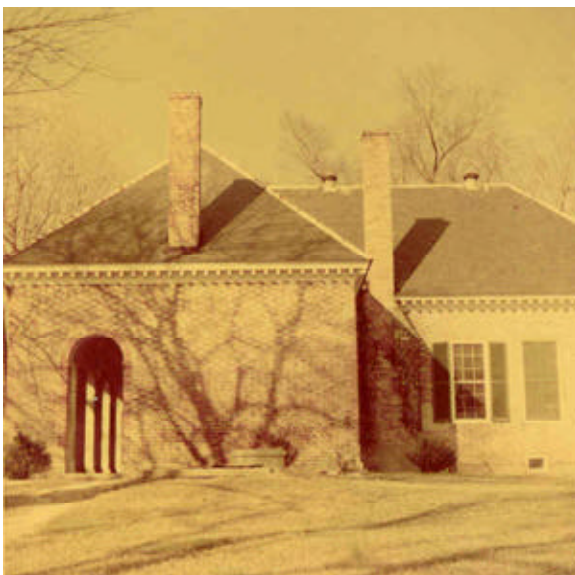
Above: South elevation - c. 1954

Shown in this photo to the left is one of the mid-nineteenth century chimneys, added where there had earlier been doorways for the convenience of the attorneys. The chimney had a single set of weatherings and a narrow stack that ascended against the wall, penetrating the eave. The shutters are closed on the middle window of the courtroom, believed to have been blocked up in the late nineteenth century.

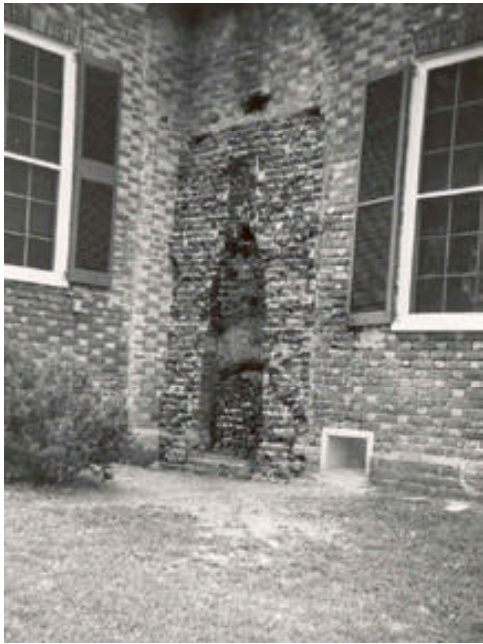
Above: Removal of chimney, 1954-5.

Taken after removal of the south chimney, the photograph to the left shows cut bricks on the south wall of the courtroom where the mid-nineteenth century chimney stood. Ghosts of the weatherings and stack are visible above, and a ghost on the back wall of the jury room shows that the chimney was about 1'-9" deep.

The arched head and the clean west jamb of the blocked fireplace are visible, together with what was probably the late-nineteenth century infilling of the opening. The bottom of this infilling represents the floor level in the public area of the courtroom during the mid-nineteenth century. If, as reported by Lois Wickham, the original paving of the courtroom was still in place at the time of the restoration, this infill would locate the original floor level about three brick courses below the top of the watertable.

The sills of the windows had been lowered to the height seen here. Thus, neither the window frames nor the shutters visible in this photo can be original. To the right of the chimney, down at the ground, is a nineteenth century ventilation hole.

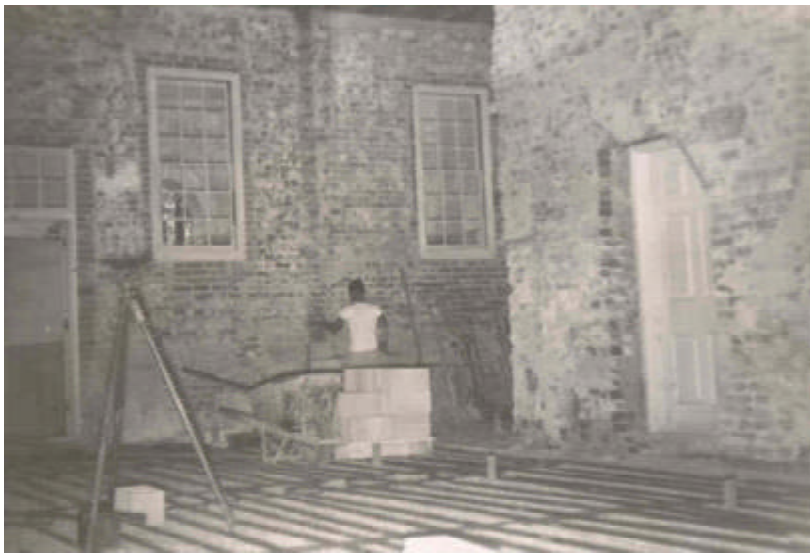
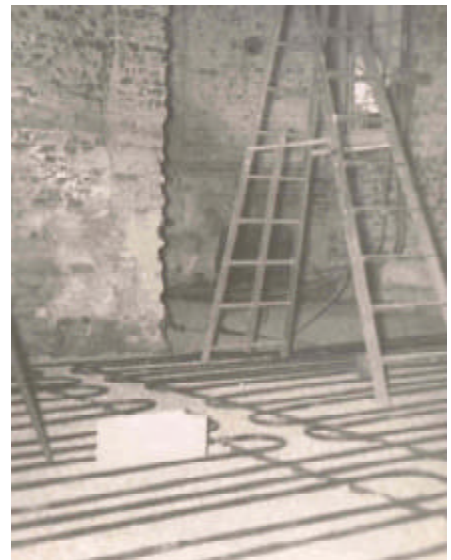
Above Left: Courtroom interior - looking west. Above Right: Courtroom interior, looking southwest.

When the photograph to the above left was taken, the wall between the courtroom and the north jury room had already been demolished, but not the west or front wall. Thus, the ghost of the jury room partition is still visible on that front wall. The pre-1955 doorway, window frames, and sash of both rooms are visible in this west wall. On some previous occasion, the masonry had been rebuilt around these openings, indicating that the frames were probably not original. In the north wall, the present exterior doorway and the 1955 raised-panel door are visible. On the floor is piping for the under-floor heating system. The east jamb of the exterior doorway appears to have been rebuilt at some earlier date.

Piping for an under-floor heating system is visible in the photograph to the right, set over a concrete slab. The jury room wall had been taken down, making it possible to see the fireplace in that room, with its arched head. Evidence for earlier finishes on these brick walls is ambiguous, but there seems to be a horizontal ghost about 5 or 6 feet above the floor. Perhaps this represented finishes associated with the 1895 remodeling.

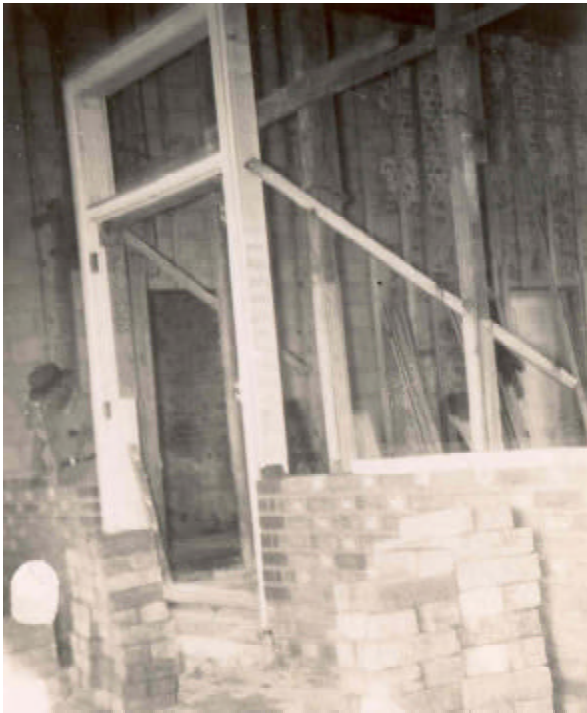
Above: Front room of the courtroom under construction, looking northeast.

Taken from inside the piazza, the photograph on the upper left shows reconstruction of the front wall in progress. The frame of the present front doorway has been set in place and the masonry laid to it. In the background, it appears that the jury room partition has already been rebuilt in concrete block, and furring strips have been applied to the entire wall. The status of the floors at this time, in the piazza and in the courtroom, remains unclear.

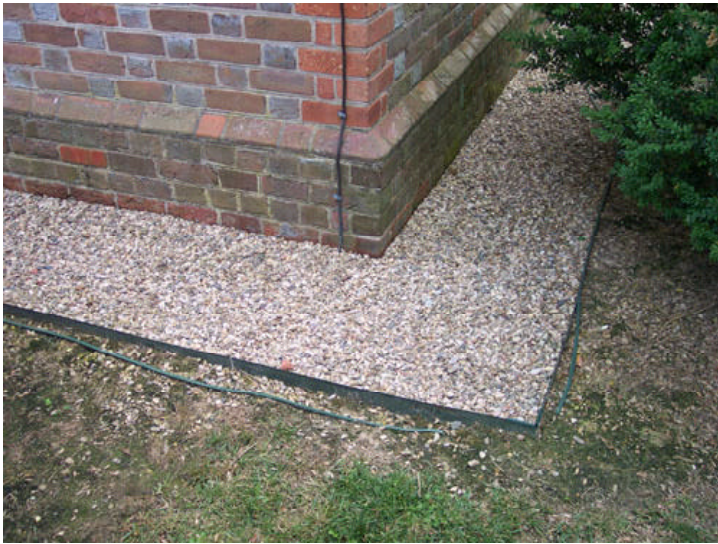
In 2002, foundation drains were installed around the perimeter of the building, with archaeological monitoring performed in concert with the work.¹ The drains were bedded in gravel behind a metal spline or stop. To prevent

Above: Foundation drainage system.

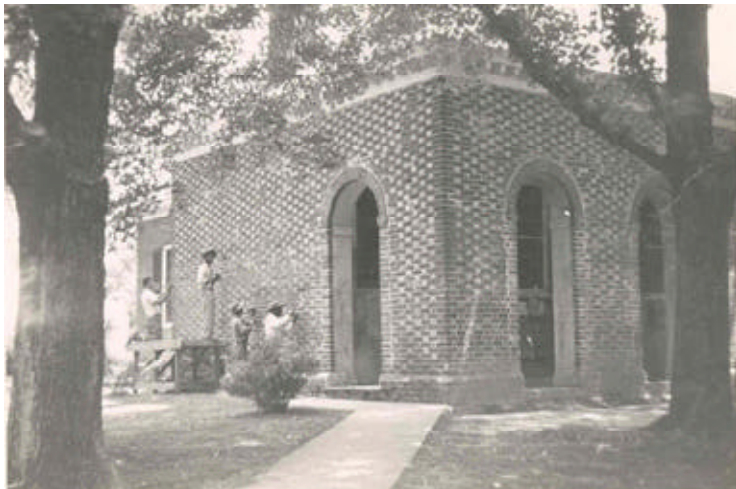
Above: Repainting the Courthouse walls, c. 1955.

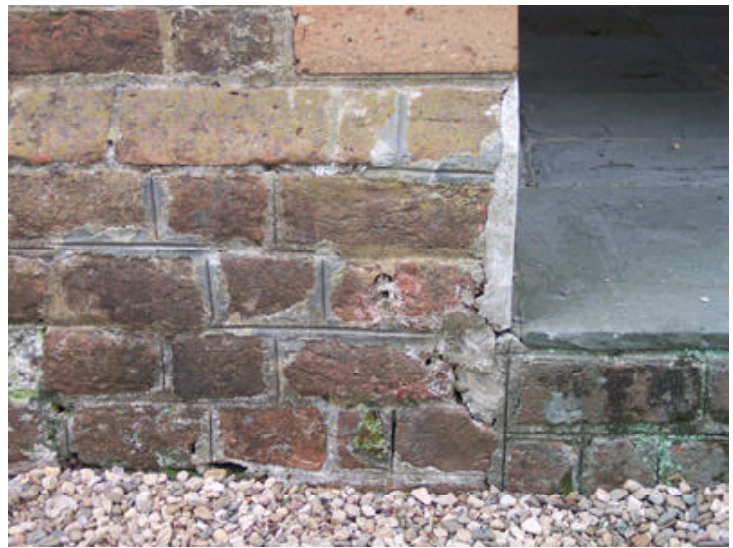
In the photograph below, we can see the poorly executed repairs were made on the jambs of the arched openings. To correct this problem all rubbed brick on the openings, up to and including the rubbed imposts, was replaced in the 1955 restoration. However, the new brick had prominent, yellowish inclusions, and so did not replicate the original work as well as one might wish.

The rubbed arches are all original, except the northernmost, which shows indication of having been partly rebuilt. The rubbed jambs and the piers between the arches are heavily rebuilt, as are the areas above the arches. Early work in the lower zone of the wall is mostly repointed. On the northwest corner of the building, the rubbed work, beginning with the watertable, is rebuilt to a height of 13 courses.

Above: North jamb of arched opening.

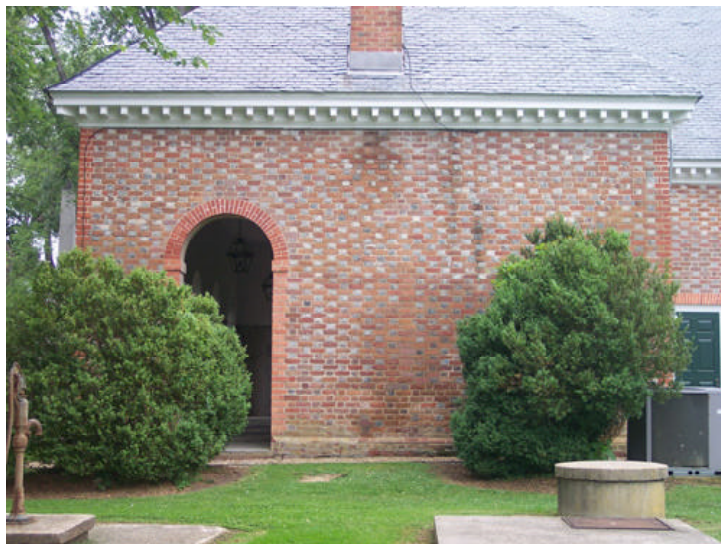
Pre-1955 photos show a ventilation opening in the foundation, which was closed up in the restoration. This and other repairs are recorded on the measured elevations that accompany this report (drawing A6). The repairs are especially prevalent over the arched opening, and in the middle of the wall, where a nineteenth century foundation vent was closed up in the 1950s restoration.

The rubbed corners of the building are rebuilt to a height of 27 courses on the southwest corner and 14 courses on the opposite corner.

In the upper zone of the wall, the masonry remains in remarkably good shape, and so provides a reliable example of the original workmanship.

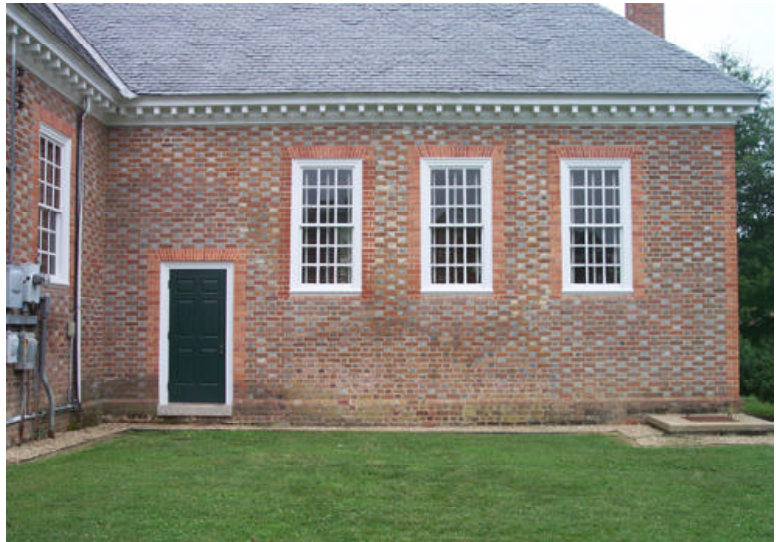
Following removal of an antebellum chimney at the interior angle formed by the jury and court rooms, the cornice was completely rebuilt from that intersection out to a point about 7'-4" from the corner. From this point to the southeast corner of the Period I courtroom, the cornice is entirely original. Beyond that point, the cornice on the courtroom extension is composed almost entirely of original material, probably reused during the 1895 renovation. To assist in ventilating the attic, eight holes have been drilled in the soffit.

Above: South elevation - Courtroom.

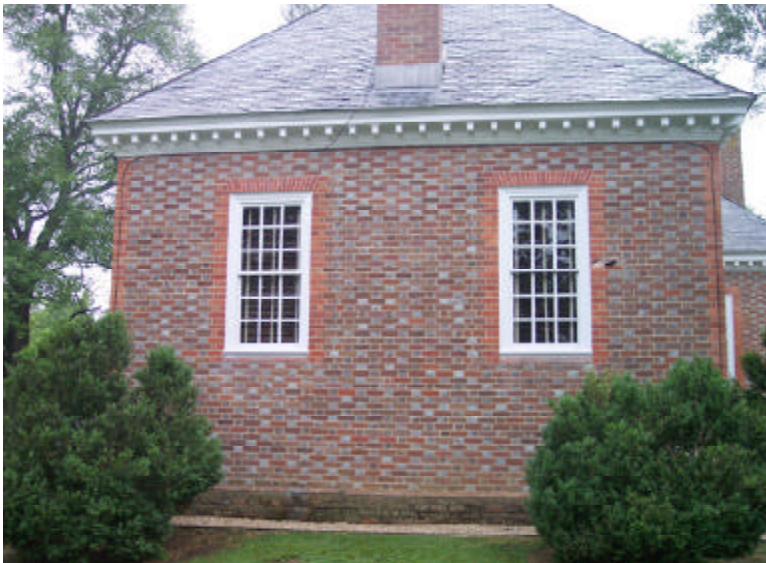
Above: East elevation - Courtroom.

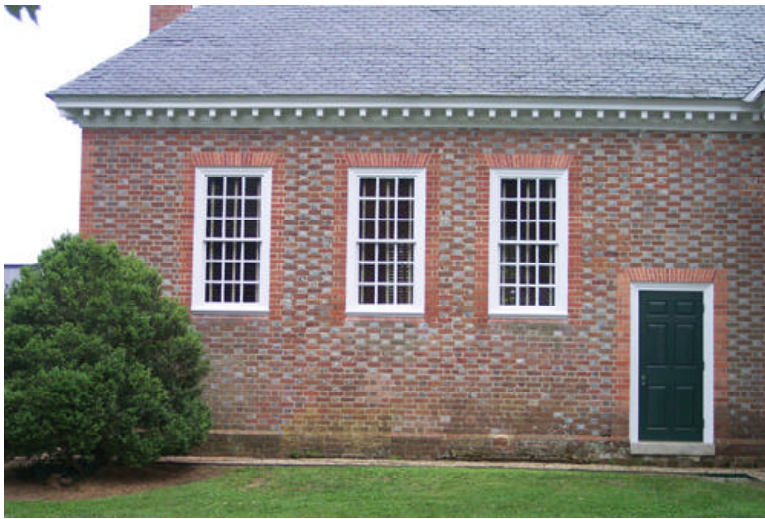
Above: North elevation - Courtroom.

Previous observations concerning the walls of the south courtroom elevation are applicable here. The outline of the original chimney stack can be read in the repairs above the present doorway.

In contrast with the south windows of the courtroom, the early windows on this northern side all retain their original rubbed returns, with the original mortar intact. Curiously, the eastern side of the easternmost window also incorporates what may be early rubbed brick, though the mortar is late. This cannot be an early jamb if the extension of the courtroom occurred in the late nineteenth century. The likely

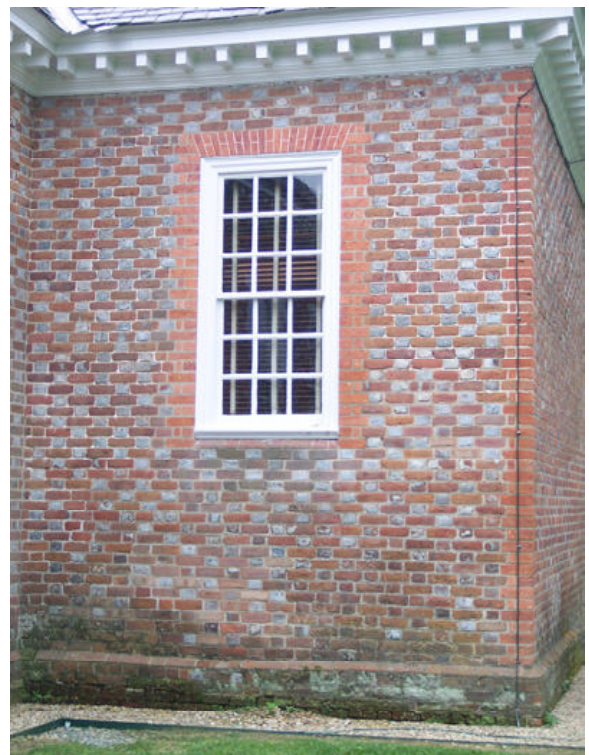
East Elevation – North Jury Room

Above: East elevation - North Jury Room.

The cornice is original from the bottom of the bed molding up to and including the soffit. The plain fascia and the cyma recta crown molding date from the 1955 restoration. Pre-restoration photos indicate that the antebellum chimney on the side of the courtroom did not impinge on this area. However, the repairs may be a consequence of moisture problems associated with the chimney. To assist in ventilating the attic six holes have been drilled in the soffit.

This wall remains largely intact, but as on other elevations, a large ventilation hole had been punched through the foundation at some point and was closed back up in the restoration. Much of the watertable has been rebuilt, especially at the end adjacent to the courtroom. Lower courses of the foundation are in need of cleaning and repointing.

To return the window sill to its original height, the area below the window also had to be rebuilt. It follows that the throating below the wooden sill also dates to the restoration.

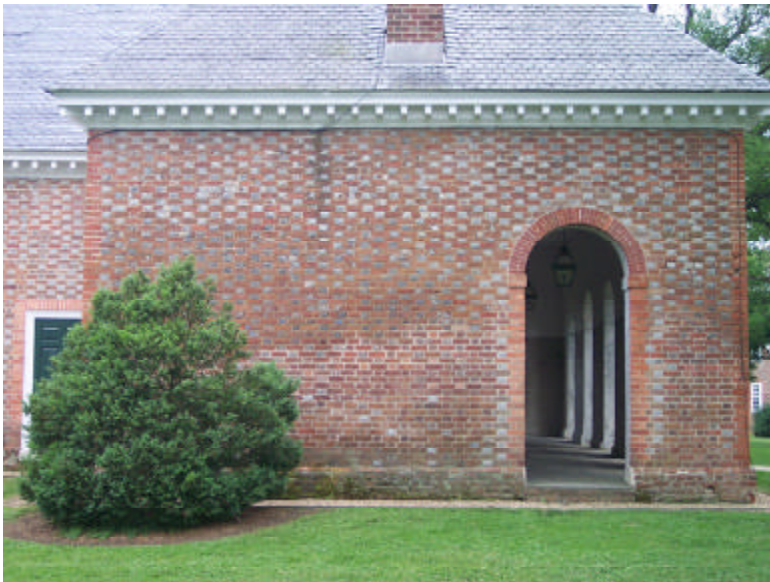
North Elevation – Piazza and North Jury Room

Above: North elevation - Piazza and North Jury Room.

The chimney stack is rebuilt, dating from the 1955 restoration. In plan the stack is three stretchers and a header wide by two stretchers and a header deep. This layout is based on a surviving remnant of the original stack, still visible in the attic. The chimney appears to have been flashed in recent times with stainless steel.

Much of the original brickwork remains, especially up high. The wall has been heavily repointed in the lower two thirds of its height. In the lower half of the wall, there are very few glazed headers, perhaps indicative of massive repairs on the lower wall—or simply spalling of the glazed finish. Curiously, the headers seem to be darker in the middle third of the wall, than in the upper third.

Most of the rubbed arch has been rebuilt at some unknown date, probably prior to 1955, as the repairs are not consistent with the 1955 work. The rubbed return and impost on the east side of the opening date to the restoration. On the west side of the opening, the rubbed work is largely intact.

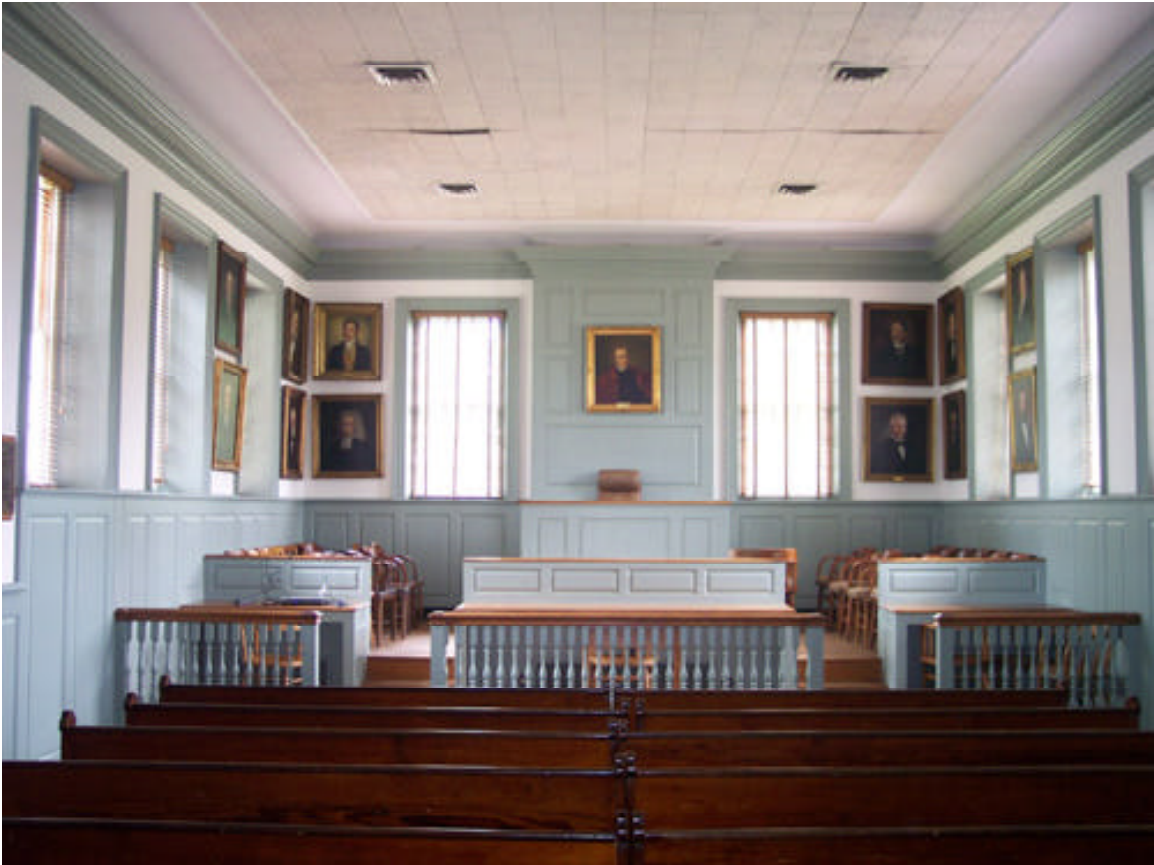
Above: Courtroom interior, looking east.

Some time after the restoration, eight supply and four return registers were punched through this ceiling, perhaps in the mid-1970s when the present air conditioning equipment was installed. The supply registers are evenly spaced on both sides of the courtroom, over its entire length. The four return registers are grouped at the west end of the room, over the front windows. An area of the tile ceiling, six by six tiles in extent, had been replaced but later damaged again by water, presumably condensate from the air handler.

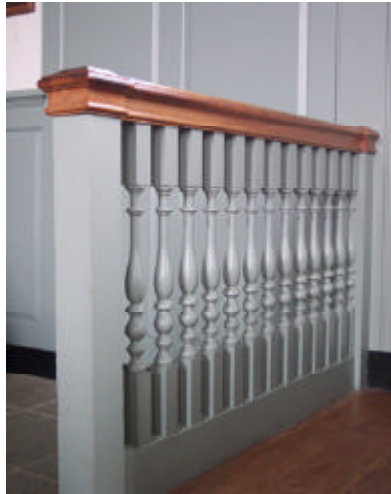
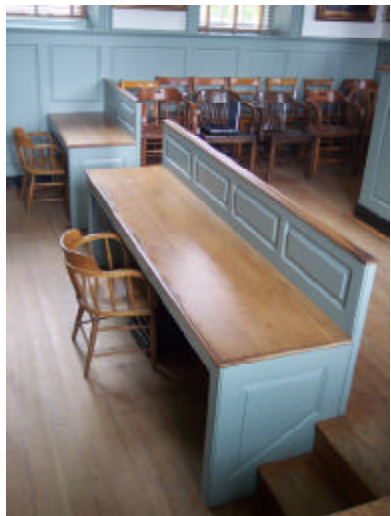
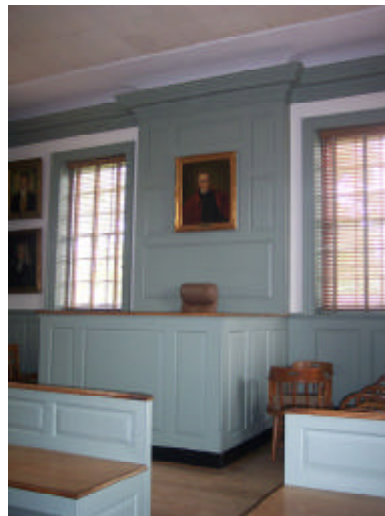
The eastern end of the courtroom is cordoned off by the bar, which consists of a molded railing, newels, and turned balusters, the latter being similar to those at the Nelson House, in Yorktown, VA.

Within this balustrade, the lower platform stands one riser above the stone floor of the courtroom. The wooden flooring is clear, edge-grain southern yellow pine in varying widths. Here and on the upper platform the flooring is face-nailed with finish cut nails.

On the lower level of the platform are three desks for lawyers, plaintiffs, defendants, etc. These have oak tops; the sides and front are raised-panel wainscoting. On the front of each desk a low wainscot screen shields books and papers from the view of judge and jury. Under each desk and on the front as well, are microphone jacks. Also located below these desks, against the face of the second platform, are registers for convection of warm air from a radiant heating system under the platform.

The second level of the platform stands two risers above the first, and was reserved for the use of jurors, who apparently sat to either side of the judge’s rostrum. Under the windows on the second platform were a series of sixteen registers to allow for the convection of warm air from the heating system below.

The judge’s rostrum consists of a third platform raised two risers above the second. On this upper platform, the judge was seated behind a wainscot desk and side bar. Behind the judge’s seat is a projecting wall, resembling the breast of a chimney. This is finished, floor to ceiling, with paneling—flush boards below the surbase and raised-panel wainscot above.

Clockwise from top: Bar, Judge’s Rostrum and Desks.

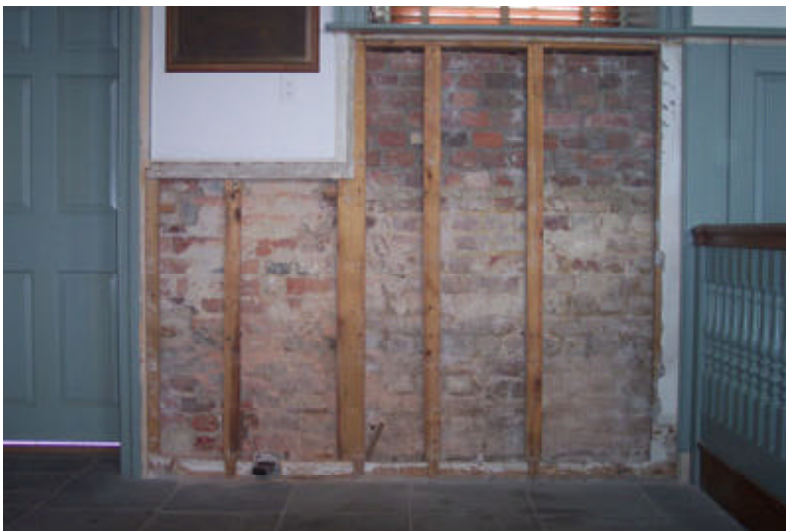
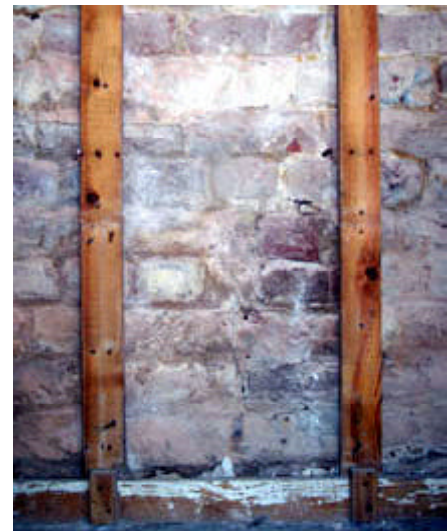
Wainscoting was removed from the north wall of the courtroom, in that portion between the bar and the north exterior doorway. Furring strips for the blueboard mounted behind the paneling were not removed. At a point 5'-1" east of the exterior doorway, beginning two courses above the floor, was a filled joist pocket. This anomaly corresponded with no opening or other feature on the exterior. Possibly, the pocket was associated with some earlier feature of the courtroom, such as a sheriff's box. The masonry jamb of the doorway appeared to have been rebuilt.²

Below the bronze plaque, two courses below the top of the opening in the wall finish are two glazed headers with oversized mortar joints around them. These bricks probably filled an earlier void, perhaps for a nailer associated with some sort of early finish - a chair board, perhaps.

Above Left: North wall revealed. Above Right: Detail of joist pocket.

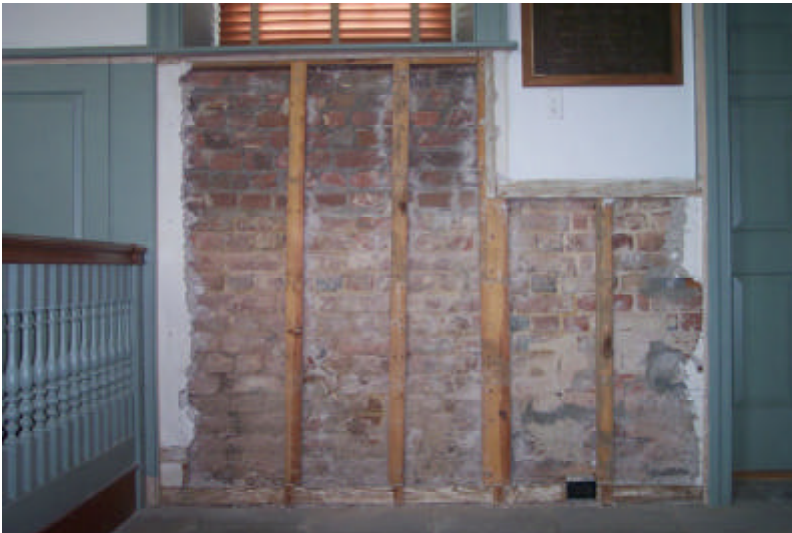
Also uncovered were three joist pockets, two on the south wall and one on the north. They do not relate to an earlier raised floor in the courtroom:

Above Left: South wall revealed. Above Right: Detail of filled joist pocket.

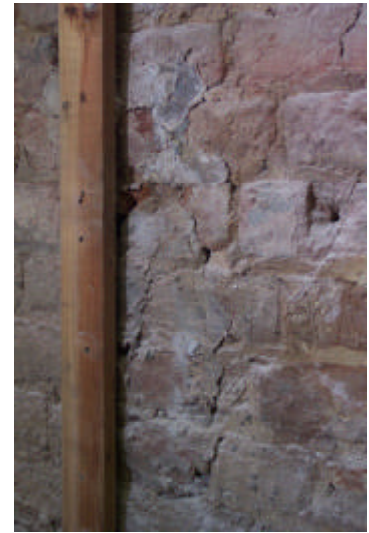
- Since the pockets were closed *prior to* the 1950s, they *cannot* relate to the raised floor present in 1954. (This floor had probably been installed in 1895, contemporary with cutting in the foundation vents and blocking the antebellum fireplaces).

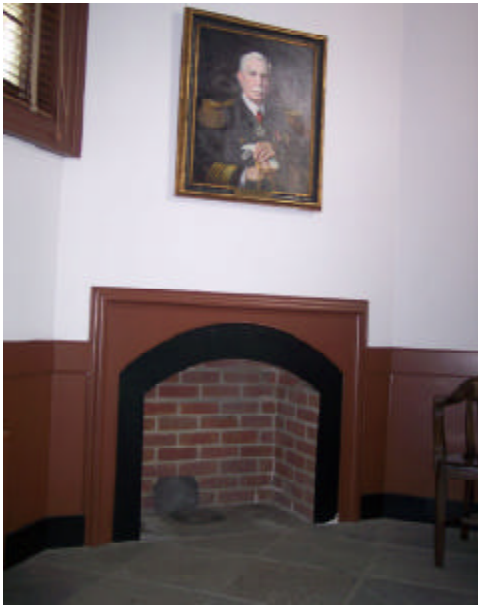
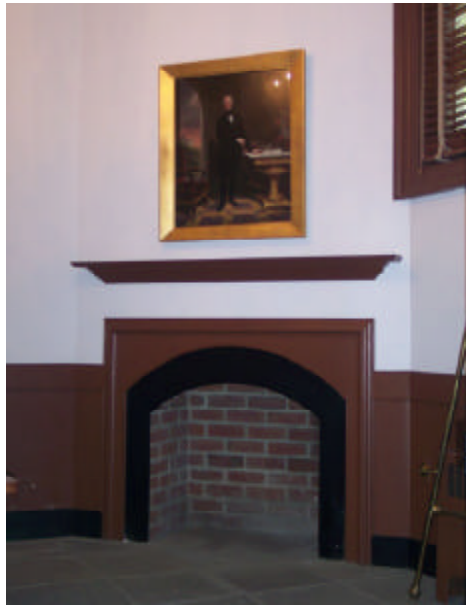
Far Left: North jury room fireplace, facing northwest.

Left: South jury room fireplace, facing southwest.

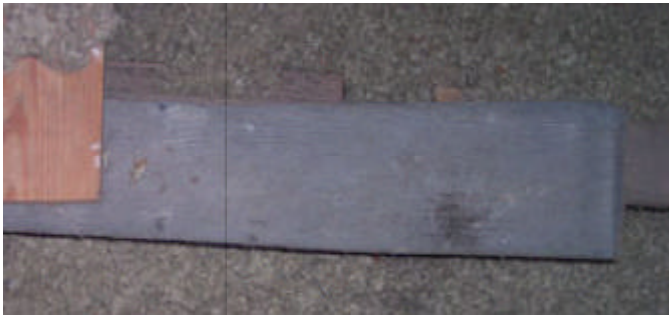
Fragment – Door Panel

At the east end of the courtroom attic is a fragment of an early door panel used to shore up one of the A/C supply ducts. Both edges are lost but the panel was originally 2'- 1 ½" long. It is very weathered and so was once part of an exterior door. It seems to be covered with white paint. This paint stops were the rails and stiles once covered the margins of the panel.

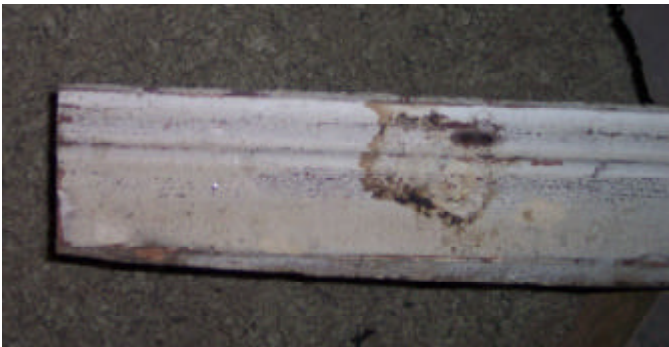
Fragment – Crown Molding

Close by the panel fragment was a piece of crown molding. It appears to have been part of the exterior cornice, as the paint is quite alligatored, with reddish brown under later coats of white, precisely the sequence of colors reported by Frank Welsh for the exterior cornice in 1989. The remnant is 7'-5 ¼" long.

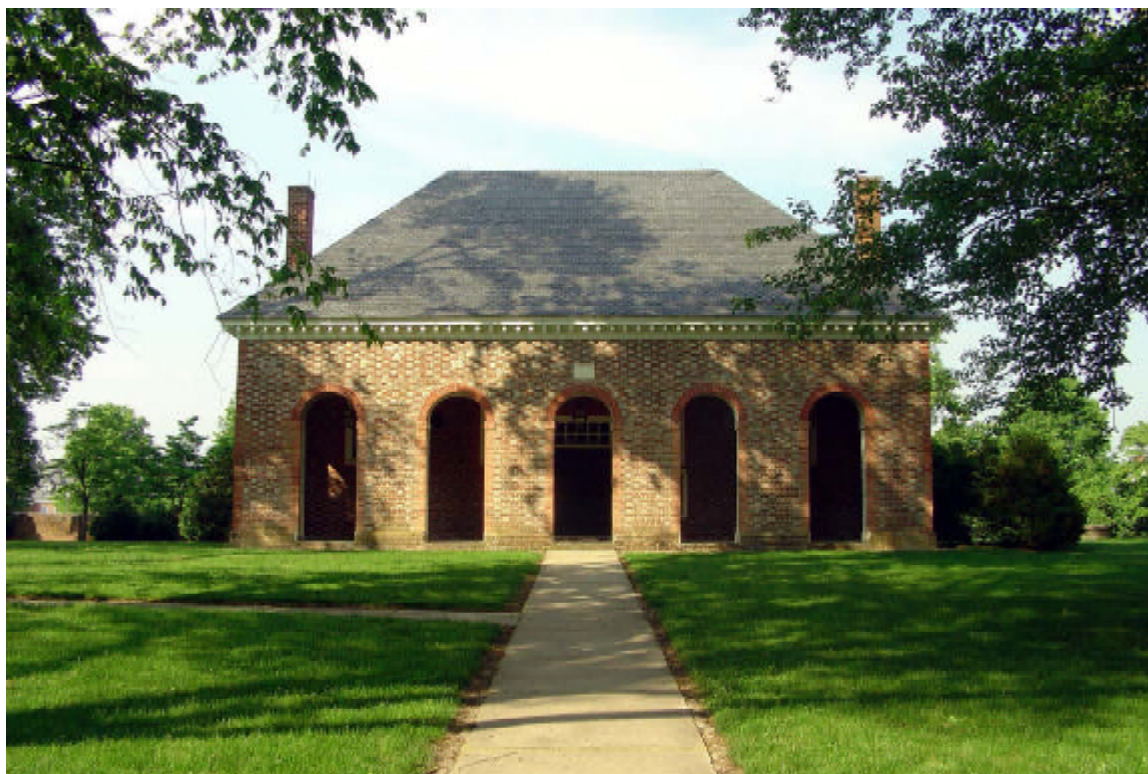
West Elevation of the Hanover County Courthouse

All roof surfaces have been covered with Buckingham slate, although it is quite likely that the original roof was covered with rounded butt wood shingles. The slate roof appears in photographs dating to the turn of the twentieth century, but evidence found in the courthouse suggests that the first slate roof was removed and reinstalled during the 1955 restoration project. The weathered appearance of the slates may be evidence that the earlier shingles were removed and later reused on the roof, perhaps interspersed with modern shingles. In raking light, it can be discerned that there are many areas or patches of slates that differ from the surrounding slates. The slates within these areas are both thicker and wider than the uniformly narrow (approximately 6" or so) surrounding slates and since these characteristics are commonly associated with modern slate preparation practices, it is likely that these patches are areas where original slates have failed and have subsequently been replaced.

Buckingham slate is considered to be one of the most durable slates available, and if it is properly installed it should last well over 125 years. However, it is clear that many areas of the slate roof have been replaced over the years, and this may be attributed to hairline cracks that may have formed when the slates were removed and reinstalled. In any event, it is clear that at some time, the roof should be replaced in its entirety. While repairs and patches can be continuously applied to the roof for the foreseeable future, there will come a time when economics will demand that the roof be replaced. It is difficult to forecast when this time will come, but based on past performance, one can expect that this roof should be replaced within the next 15 years.

When the roof is eventually replaced, we recommend that a new slate roof be reinstalled. Although the slate roof is not accurate to the original period of the building, it will provide greater durability and potentially less maintenance than a wood shingle roof. It is further recommended that the copper roof ventilators be reused during the roof replacement effort. These ventilators appear to be in good condition, although they may require a small amount of soldering and will certainly require repainting.

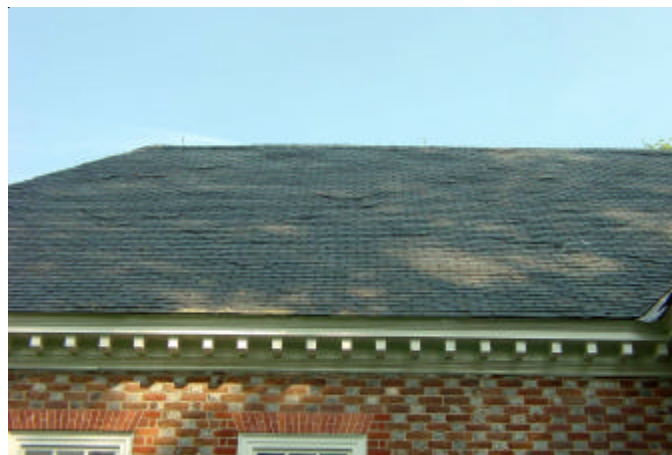
It is apparent that all of the roof flashings and details date from the 1954 restoration or later. The valley flashings (or pans) are copper, and each has an

Above: In raking light many patches of roof shingles can be easily discerned because the later shingles do not match the thickness of the earlier shingles.

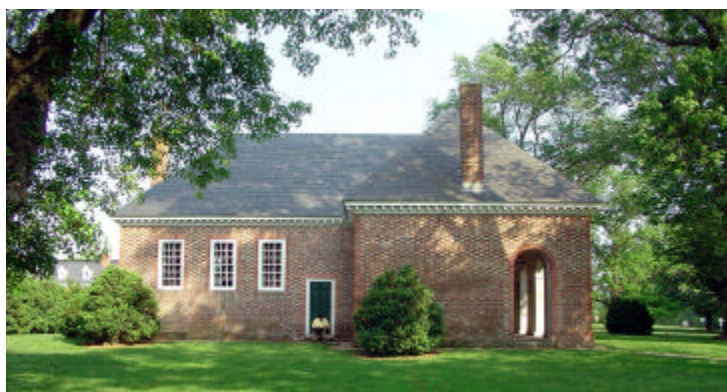
There are three chimneys on the roof. Two of these chimneys, one on the north wall of the north wing, and one on the south wall of the south wing, were reconstructed in 1955, while the one on the east wall of the building sits within the late nineteenth century addition and substantially dates from that period. Each of these chimneys are flashed at the roof with modern copper step flashings (step flashings generally did not appear until the mid to late nineteenth century).

Above: North elevation of the courthouse. The chimney to the right is in its original location, but the chimney has been reconstructed.

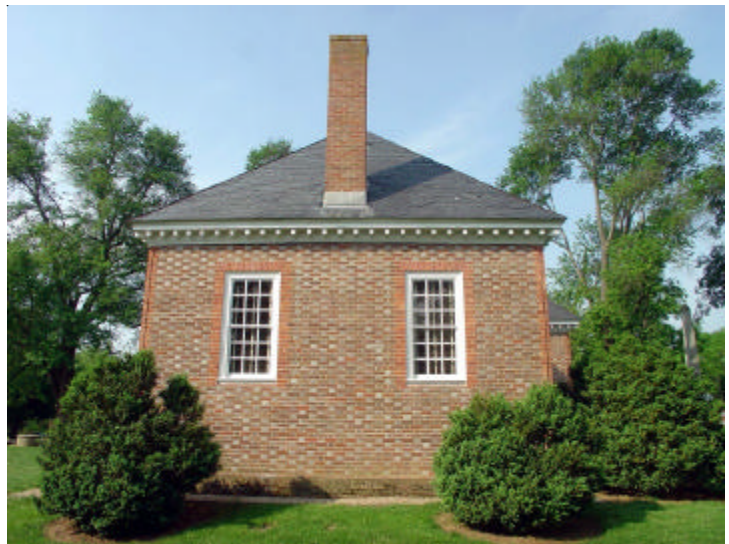
All chimneys appear to be in good condition, and each chimney has been properly ventilated at the top. However, no provision has been made to ventilate the chimneys at the bottom to encourage air flow, and it is recommended that some provision be made for bottom ventilation. While the brickwork of the chimneys is in good condition, it is estimated that approximately ten percent of the brick joints will require re-pointing. Mortar tests should be performed at the chimneys to insure that the proper mortar is used during the re-pointing operations. It is likely that the modern reconstructed chimneys are constructed in Portland cement based mortar, while the east chimney is certainly laid in pure lime mortar in areas that have not been rebuilt.

Above: The east end of the courthouse was added to the building in the late nineteenth century. There is a modern roof ventilator directly behind this chimney.
