HISTORIC STRUCTURE REPORT
HANOVER COUNTY COURTHOUSE AND JAIL

HANOVER, VIRGINIA

AUGUST 1, 2004

HISTORIC STRUCTURE REPORT

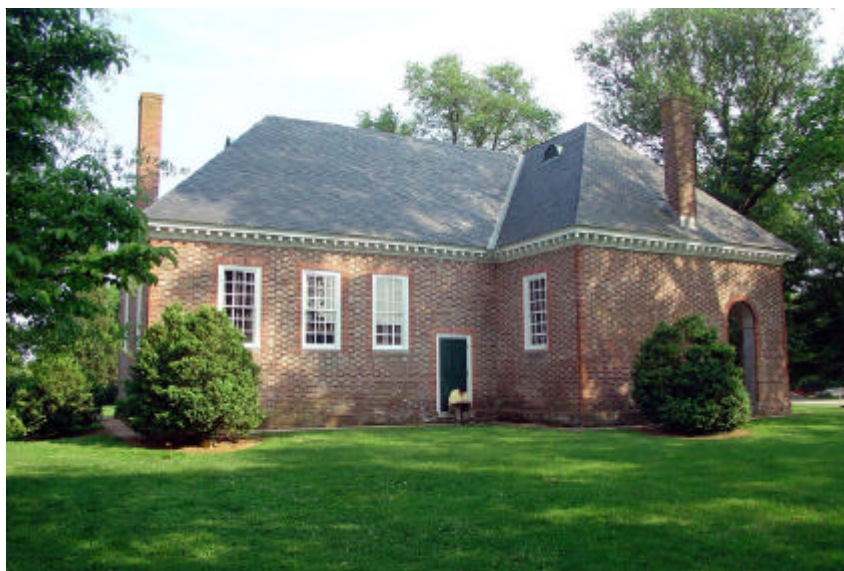
Above: The courthouse from the northeast. The roof ventilators date from the 1955 renovation.

It is recommended that the entire system be inspected by a Factory Mutual certified inspector to insure that the system conforms to modern code requirements. It is likely that the system will be replaced when the slate roof is replaced.

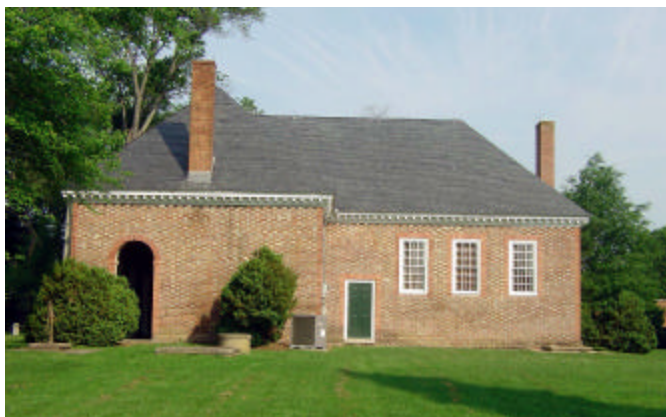
The roof section of this study has described that water is continuing to enter the courthouse beneath the north and south doors. The most serious problem appears to be at the south door. This problem was also observed by the authors of the 1989 study, and they recommended that weather-stripping be installed beneath the doors and a new platform be installed outside the doors. While a water diverter should be installed at the edge of the roof above, the doors should have new weather-stripping installed beneath the doors. The splitting of the door panels is likely more of an annoyance than a significant problem, the doors may eventually be replaced with old growth recycled heart pine doors if it is found that the doors are deteriorating in the future. At this time, it is recommended that the cracks be carefully filled, sanded and the doors repainted.

Above: South elevation of the courthouse.

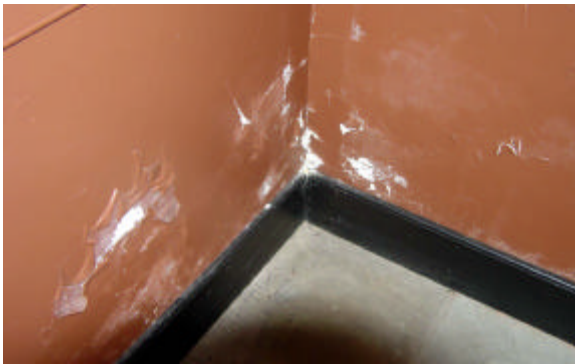
Above: Rising dampness is destroying the plaster in the north and south wings.

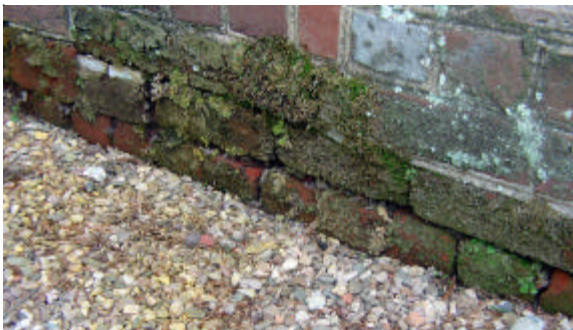
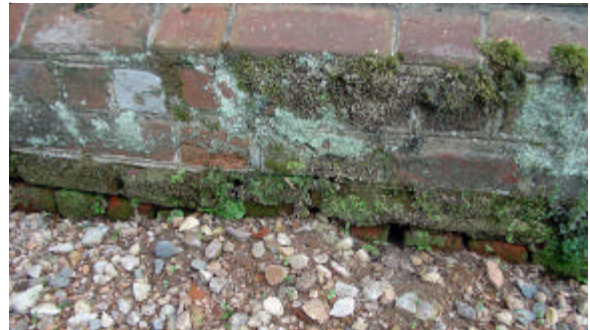
The rising dampness within the walls is clearly being caused by water at grade being absorbed into the porous clay brick masonry at the base of the walls. Although probes should be made to determine the depth of the

Above: Moss and lichen is growing on the brickwork, indicating that these areas are consistently damp. The lack of mortar in the head joints at the lowest course of brickwork may indicate that the foundations do not extend deep into the ground.

original walls, it appears that the eighteenth century walls nearly rest on grade. If this is the case, it is possible (although uncertain until probes can be made) that the 1991 footing drainage system may have actually exacerbated the problem by introducing water beneath the bottom of the walls. Evidence observed on the walls of the building reveal that at one time grade may have been somewhat higher than it is today, and if this was so, the clay soil around the building may have protected the bottom of the walls from water infiltration. Once the grade was lowered, water was allowed to enter beneath the walls, and the warm air within the heated courthouse encouraged rising dampness. If it is found that the footing drain is lower than the brick walls, the porous washed stone at the base of the walls would allow water to flow beneath the walls before it is captured by the drain pipe, and rising dampness would be the result.

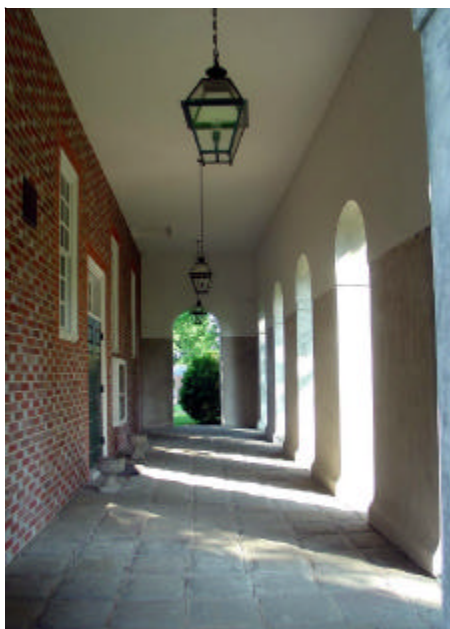
The entire interior of the piazza has been plastered. It is likely that this space was always plastered, yet the present day plaster appears to date from the 1955 renovation of the building. The plaster has been patched over the years, particularly where the plaster meets the brickwork of the arches, but with the exception of a cracked area at the east corner of the south archway, the plaster is in good condition.

Left: Overall view of the piazza from the north. The plaster and light fixtures date from the 1950s renovation.

Above Right: A detail of plaster damage at the east jamb of the south arch within the piazza.

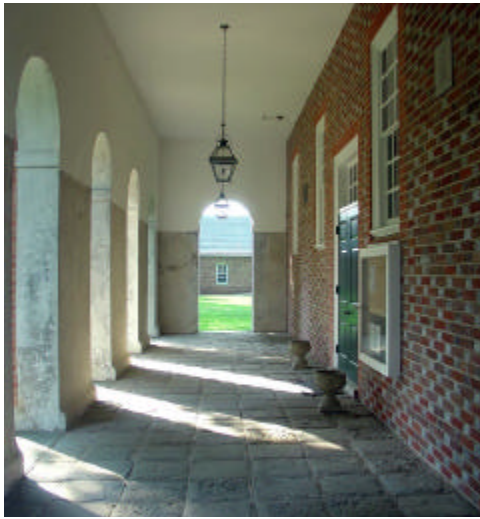
Above: A view of the piazza from the south. Although the pavers may be original and are very worn, it is recommended that they remain in place. Note the bulletin board to the right.

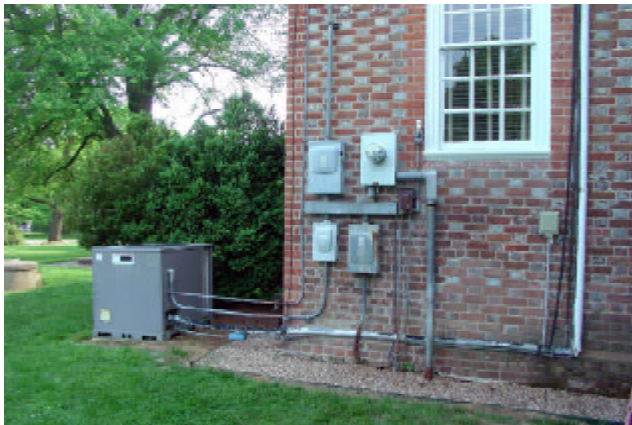
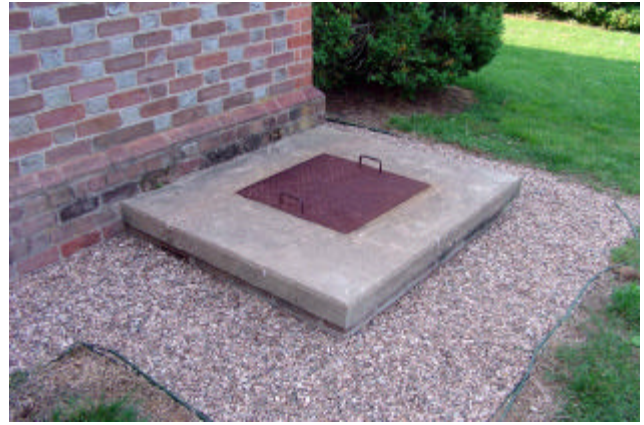
Above Left: It is recommended that the modern mechanical equipment be moved away from the building. The unsightly meters, piping and conduit should be removed from the face of the exterior walls.

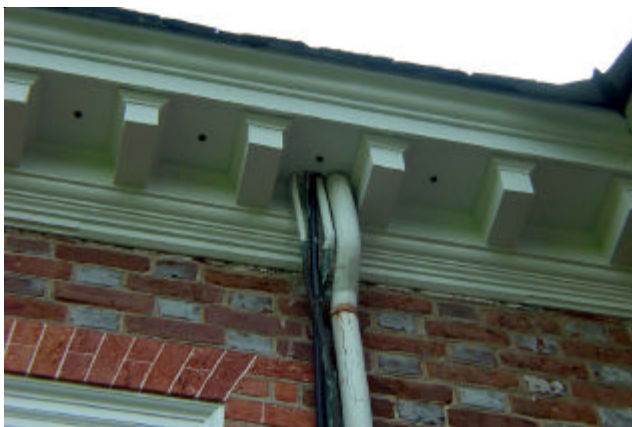
Left: A detail of the modern piping as it passes through the main cornice to the air handlers in the attic.

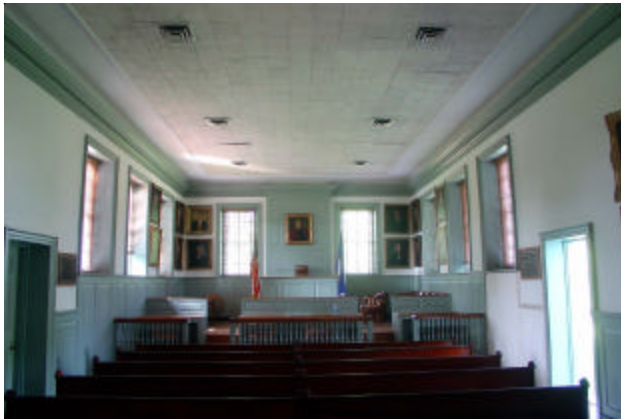
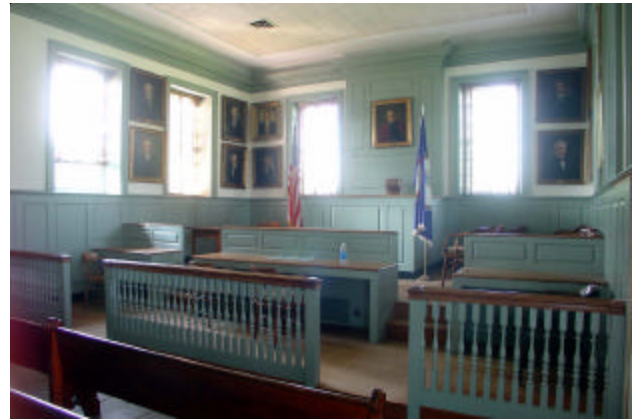
Above Left: Overall view of the main courtroom looking east. The entire interior dates from the 1955 renovation work. Above Right: A detailed photograph of the c. 1950s courtroom bench.

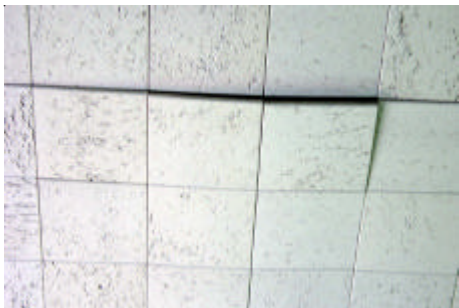
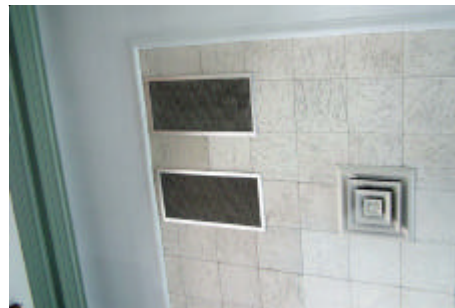
Above Left: Many of the acoustical tile ceiling panels have lost their adhesion to the skim coated drywall substrate. Above Right: Modern air conditioning grilles in the ceiling of the courtroom are functional yet unsightly.

The installation of the acoustical tiles on the ceiling is an unfortunate event in the life of the building. Since these tiles have now lost their adhesion and are generally unsightly, it is recommended that they be removed in their entirety. It is expected that the skim-coat plaster ceiling beneath these tiles will be damaged during the removal

process, and it is therefore recommended that this ceiling be newly skim-coated and generally reinstated.

The 1955 skim-coat ceiling will be particularly successful if a more elegant solution can be found for the location and design of the cooling system grilles.

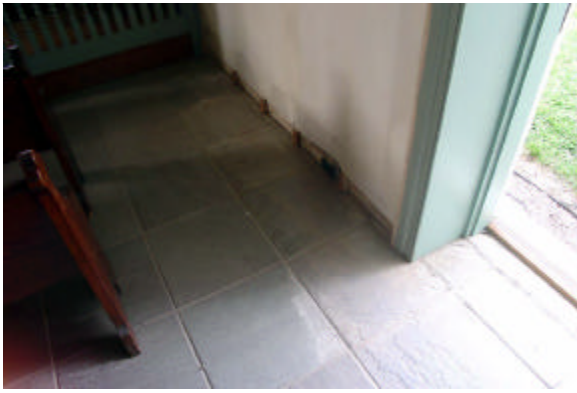
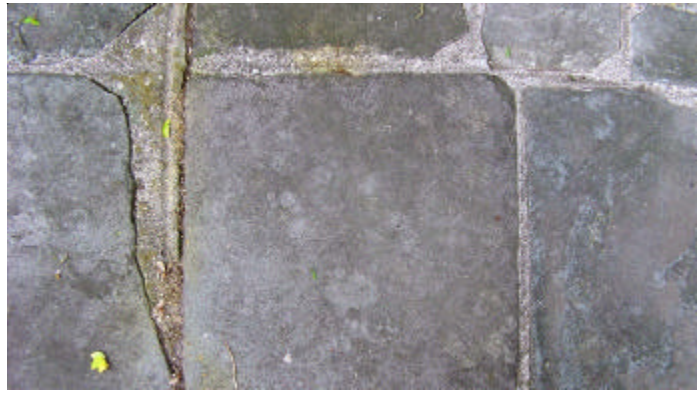
Above Left: Some staining and deterioration of the c1950s bluestone floor has occurred near the south door. Above Right: These sandstone pavers found in the walk near the jail door may have been salvaged from the original courtroom floor.

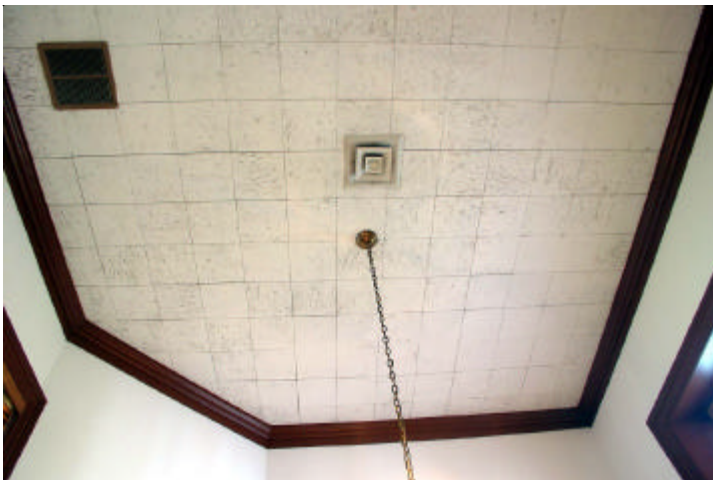
Above: Both the north and south jury rooms now have acoustical tile ceilings. It is likely that they were Imperial plaster ceilings after the 1955 renovation work.

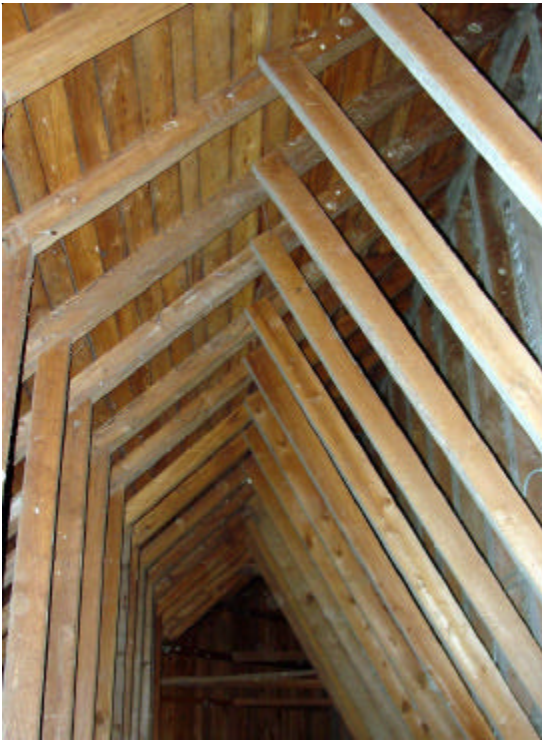
Left: Overall photo of the framing above the piazza. The diagonals to the right were very likely installed to support the heavier load imposed by the slate roofing.

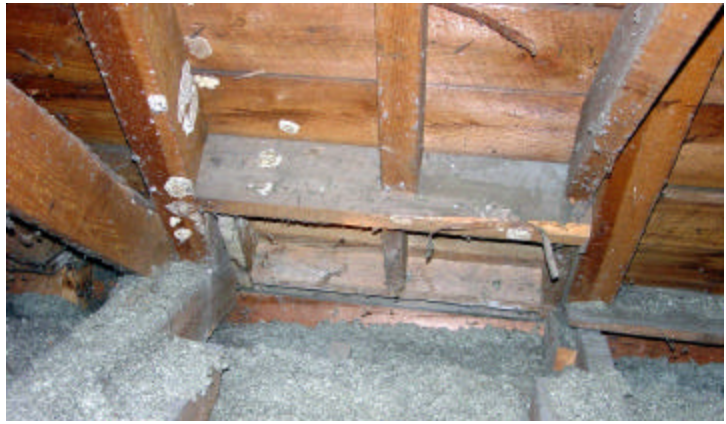
Above Right: Before the late nineteenth century addition was added, there were chimneys situated at the juncture of the main body of the building and the north and south wings. Evidence for these chimneys can still be observed in the attic where the framing once circumscribed the brick chimney.

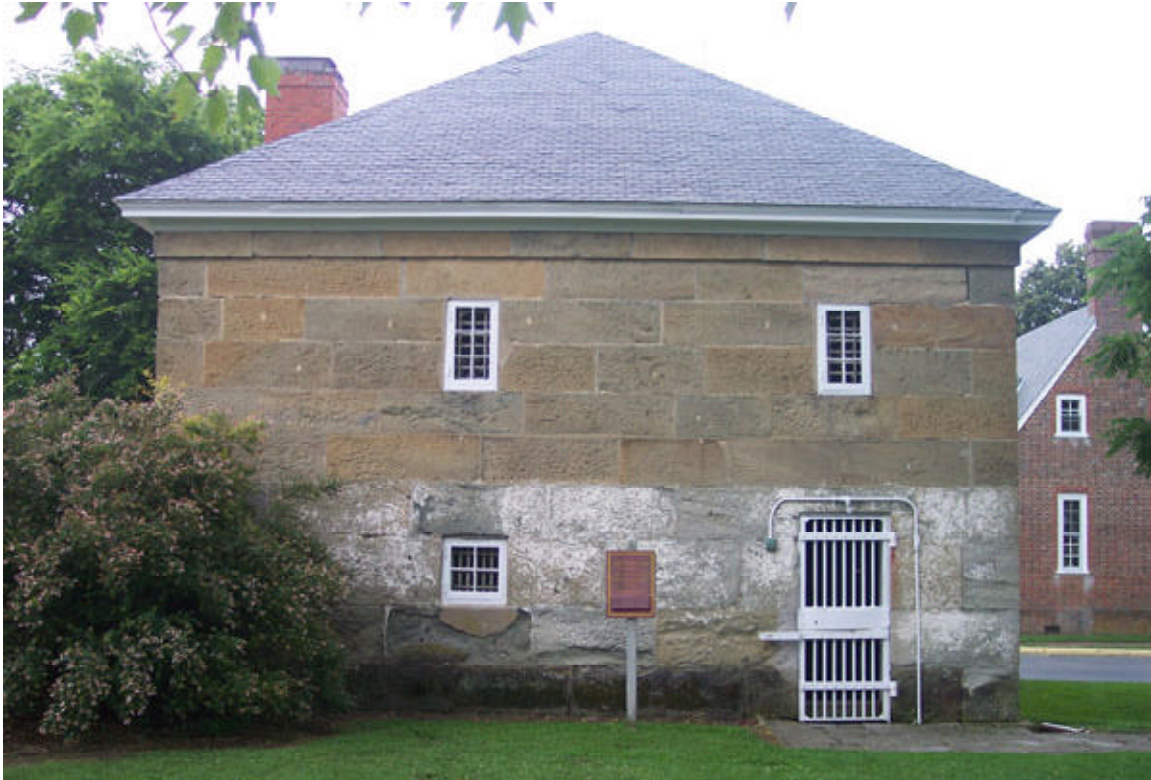
Above: South elevation of jail

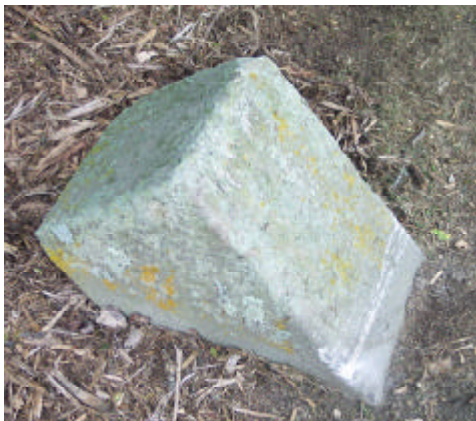
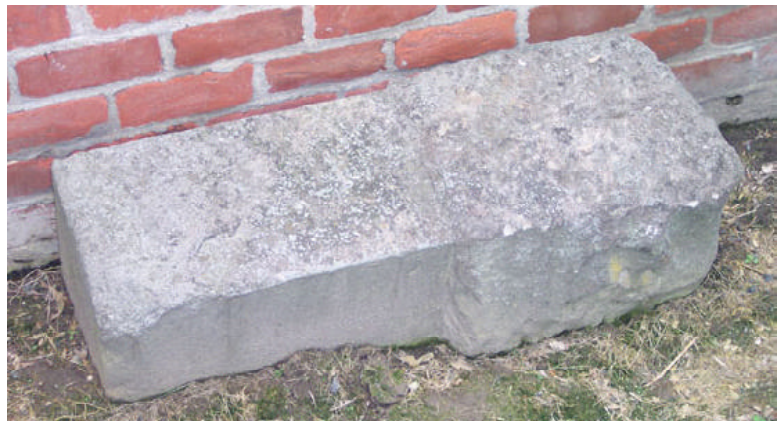
The jail stands near the corner of the courthouse bounds, the corner of which is demarcated by a stone marker just across the drive and in front of the present Library. (Another of these markers stands across the opposite drive, beyond the clerk's office. Still another lies in the grass beside the gatehouse east of the jail). The jail faced the courthouse, and with the earlier clerk's office it formed a kind of forecourt in front of the courthouse. The Benson Lossing sketch of 1851 (Figure 5, *The County Seat*) shows that some sort of wall, seemingly of brick, ran behind the building, probably on axis with the stone marker. The view also shows a path leading from the

Above Left: Northwest boundary marker and loose boundary marker to the right.

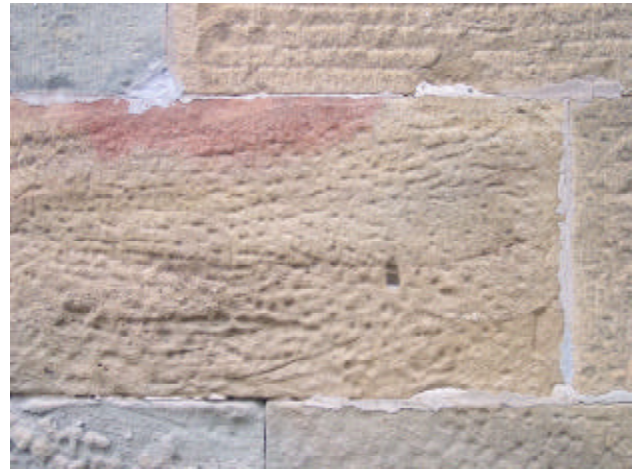
Above: Stonework, note the range of color.

The walls are two feet thick on the ground floor and 1’-8” thick on the second floor. Individual stones in the superstructure of the building are crudely dressed on the edges to improve the precision and appearance of the joints. In some cases, indentations in the edges of the stones bear witness to the quarrying process, while sloping holes in the face of nearly all show the method of lifting and manipulating the stones. These holes have all been pointed up, probably at the time of construction.

Some of the stones appear to have been laid with their bed faces turned up and so are more vulnerable to weathering than would normally be the case. Significant spalling has occurred on some, especially where the work has been pointed with Portland cement mortar. The mortar seems originally to have been tooled to form beak joints, being cut at both edges with the trowel.

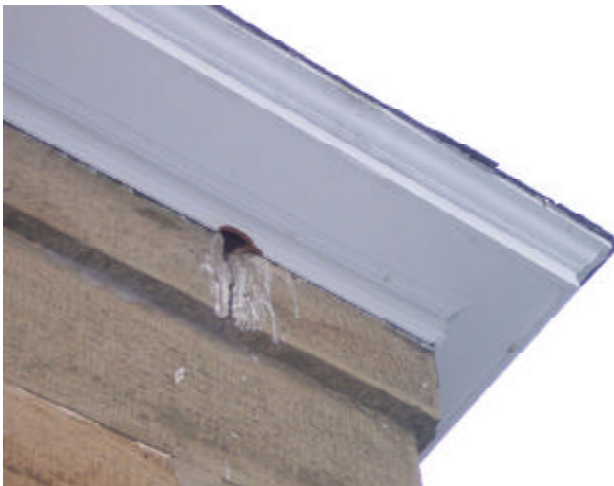
Above: Modern Jail cornice.

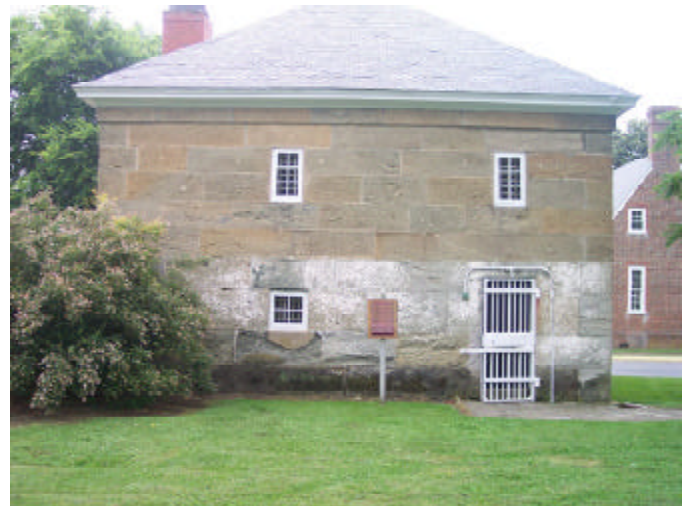
The surface of the stone directly below the window is entirely gone, having spalled after the stone was patched with Portland cement mortar. Most of the stones in this course are badly spalled as well. The stone above the window is also badly deteriorated. The east jamb of the front doorway has been crudely parged with Portland cement.

Above: North elevation of jail.

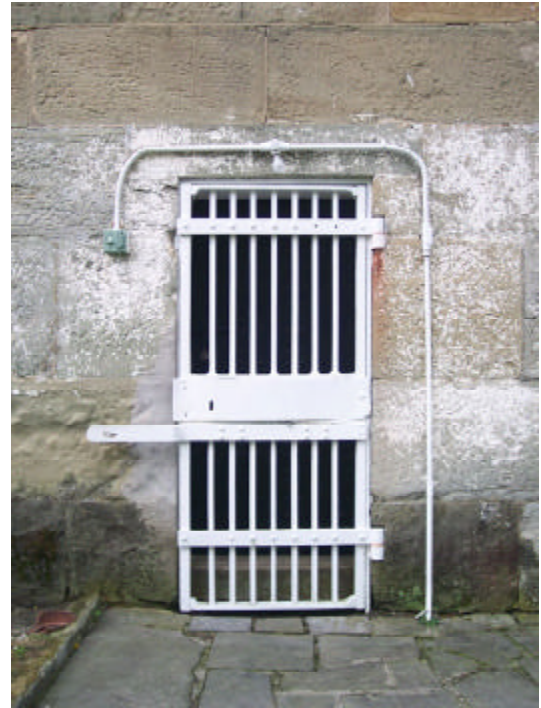
The outer, barred door is composed of two 1 ½” square verticals or stiles with seven 1” square vertical bars between. The smaller verticals are further reinforced by the straps of two hinges riveted to them, and also by the hasp, which is riveted to the smaller bars as well. Four horizontal bars, each ¾” x 3” lie in a flat orientation, forming the top and bottom of the door, and also a kind of lock rail near the center. The top and bottom bars of the door swell at the ends to provide a method of attachment to the verticals.

*Uppermost: Barred outer door to jail.
Above: Stone walk to entrance of jail.*

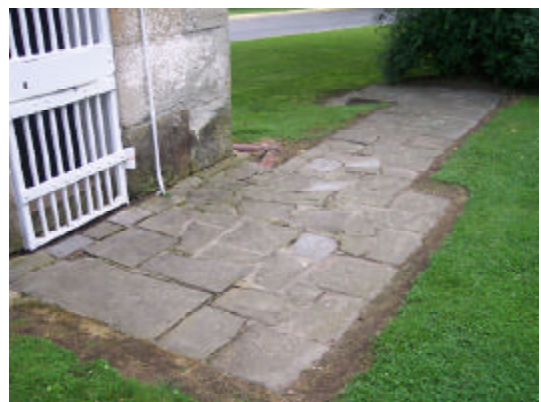
Before the front doorway of the jail is an area paved with stone flags. Some of these flags may have come from the courthouse, being similar in size, shape, color, and texture to those now in the courthouse piazza. At the eastern edge of this pavement are a

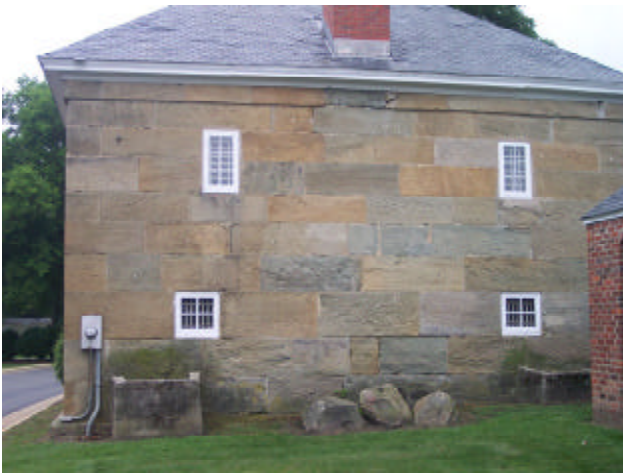
Above: East elevation of jail.

casements that are two lights wide and three lights high, while those below are two lights each way. The existing casement sash and window frames are modern. The four windows visible on this elevation serve the four prison cells within, two upstairs and two below.

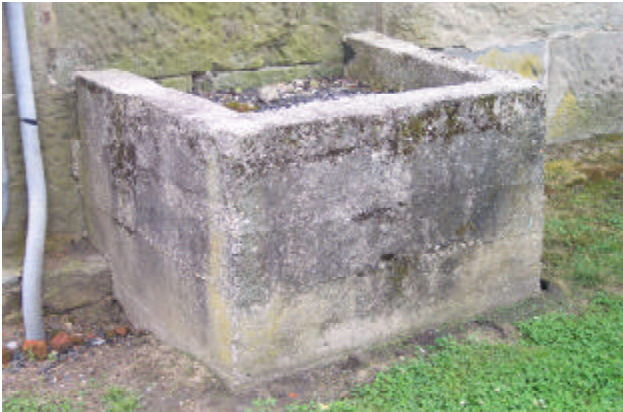
Above: Cesspit for south cell.

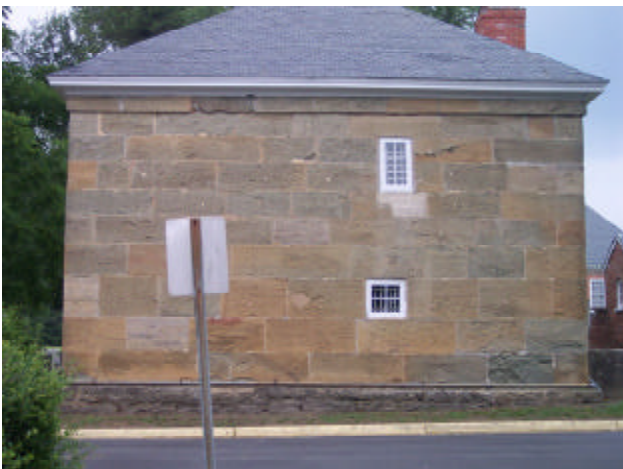
Comments concerning the west wall are applicable here. There is some spalling on the first course above the foundation, and a badly deteriorated patch below the second-floor window was patched with concrete, having been formed up with horizontal boards. This work is similar in character to the cesspits and is surely contemporary with them.

Above: South elevation of jail.

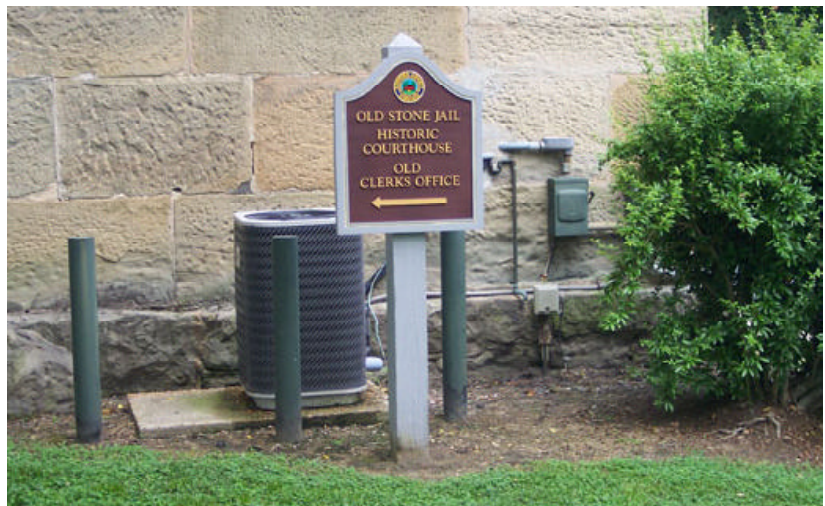
A disconnect for the compressor and a telephone interface panel are mounted on the stone wall near the buildings southwest corner. From the disconnect a conduit penetrates the wall. Supply and return lines for the air handler also penetrate the wall here, and two condensation drain lines besides. A telephone line also goes through the wall in this area. The condenser stands on a concrete pad where it is protected by three bollards set into the ground.

Above: Electrical devices and panels mounted on stone wall of jail.

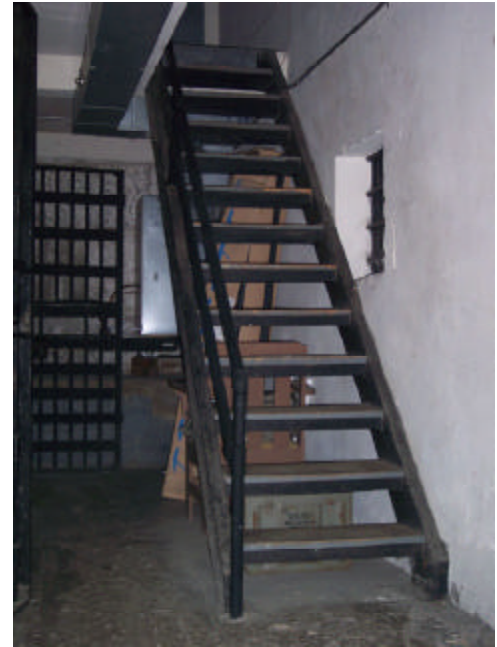
Except for the rear wall of the passage, and a small area of the front wall west of the exterior doorway, the stone walls of this space are entirely plastered at this level and finished with what may be simulated whitewash. The latter could date from the late 1960s when the Hanover Historical Society leased the building from the county.

Above: First floor interior.

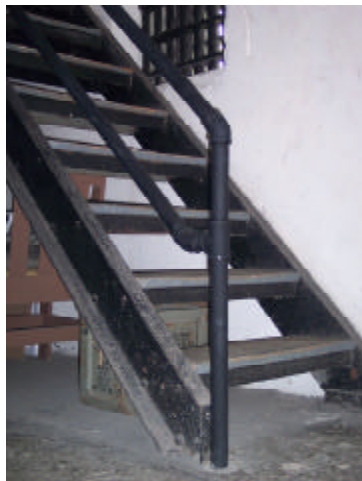
The stair dates to the installation of the present concrete floors. The stringers are rolled steel channels and the treads, also channel sections, stand on angle clips bolted through the stringers. The railing incorporates two tiers of steel pipe, assembled with standard fittings—flanges, elbows, etc. The lower section of this railing and the newel at the first floor appear to have been replaced in recent times, these components having little of the rusted texture evident higher up the stair.

Above: Stair at first floor landing.

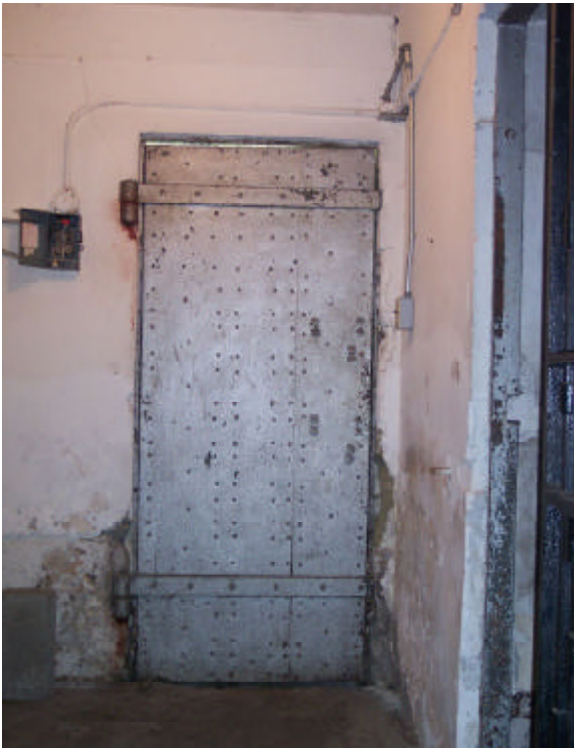
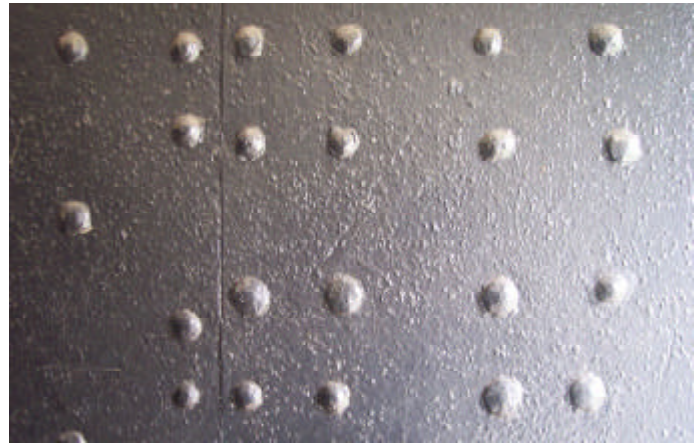
The exterior doorway is secured by a barred door on the exterior and a hollow-core iron door on the interior. The outer door is described in the discussion of the north elevation. The inner door was originally secured by two sliding bolts operated from the outside, and there is no device by which to pull the door open

Clockwise from left: Inner door - exterior doorway, Inner door - detail, Cell door - ground floor.

from the inside. Clearly, the door was operated from the exterior, yet the loops that bore the bolts were secured with large nuts on the inside, and so were removable from within the building.

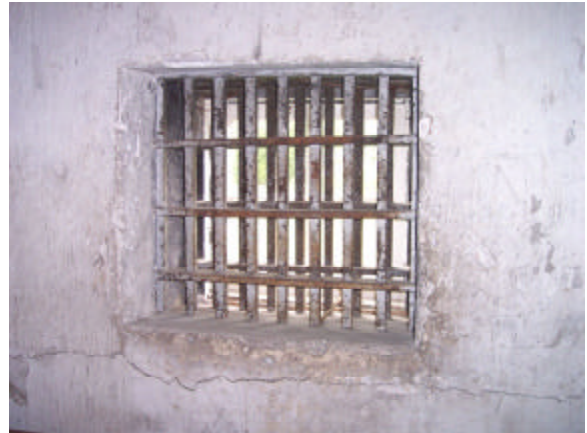
One window centered on the west wall of the passage lights this space. The exterior casement window is modern. The opening was originally secured by two barred grates, an inner and an outer. The present grates are both original, having been set into the stonework at the time of construction. Both are fabricated in the same manner having four horizontal bars, each measuring $\frac{3}{4}$ " x 3," set edgewise into the stone jambs of the opening. A series of nine vertical bars, each measuring 1" square, penetrates the vertical members to complete the grid. These grates differ from those in the first floor windows in that the flat bars are set into the jambs, and the second floor openings are nearly square. Here, and at every other window, the sill has been rebuilt in concrete so that it slopes to the exterior. Cracks below the sill show the extent of this repair.

Above: Cell window - first floor passage.

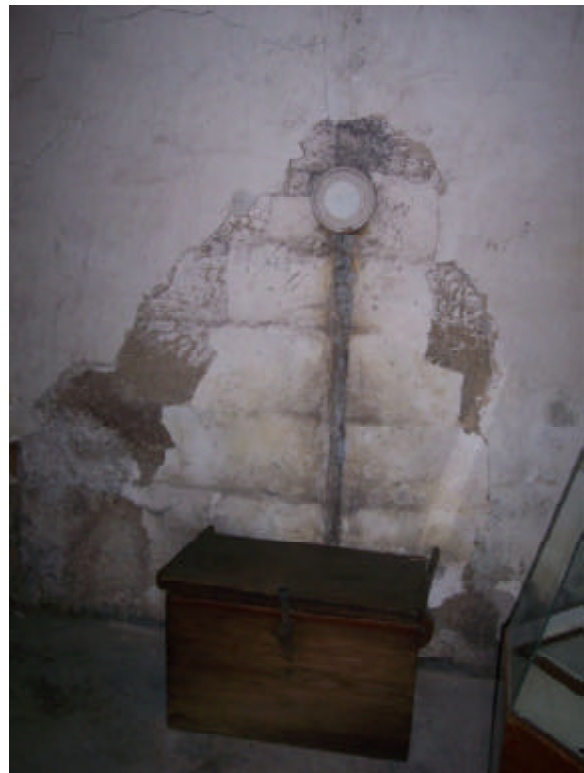
Above: Chimney breast - Front cell - Ground Floor.

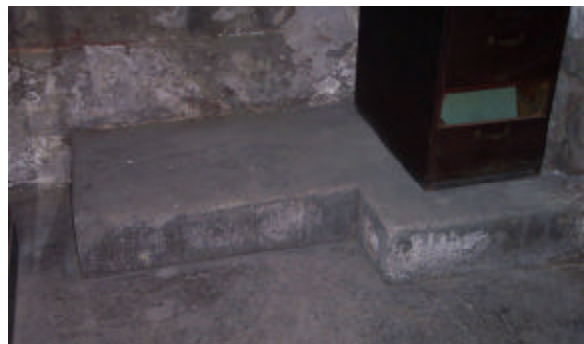
Above: Concrete platform, front cell.

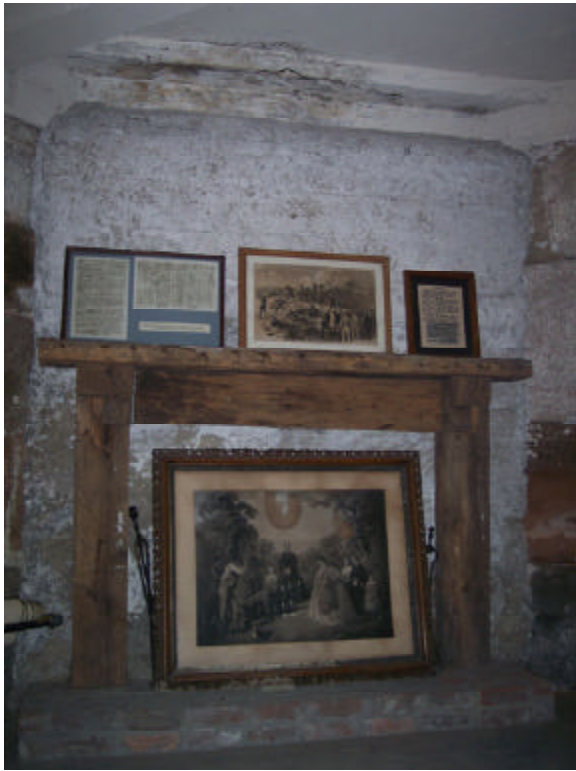
Above: Chimneybreast - Rear cell - Ground Floor.

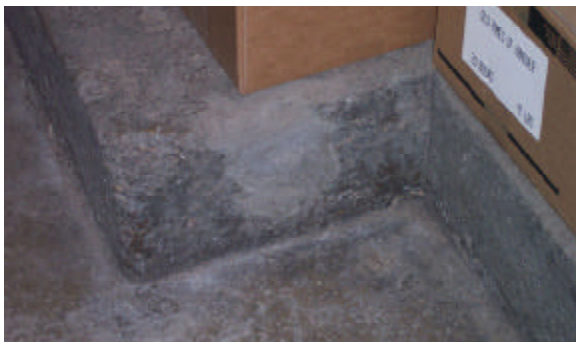
Above: Platform in rear cell, plugged clean out hole.

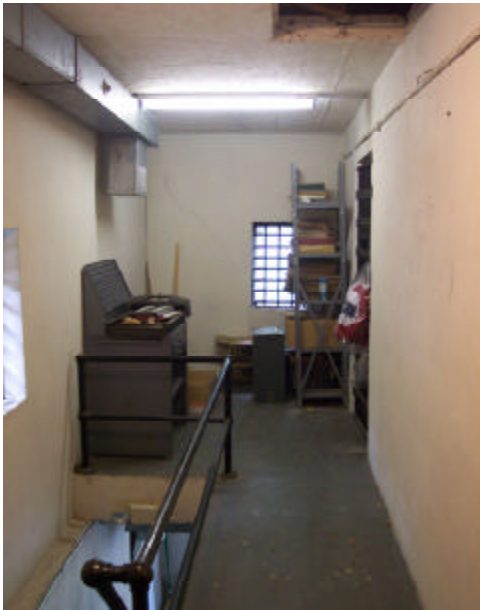
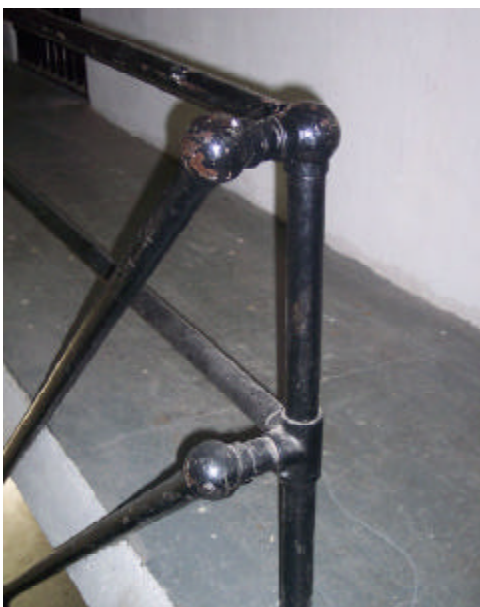
*Uppermost: Second floor passage.
Above: Stair railing - second floor.*

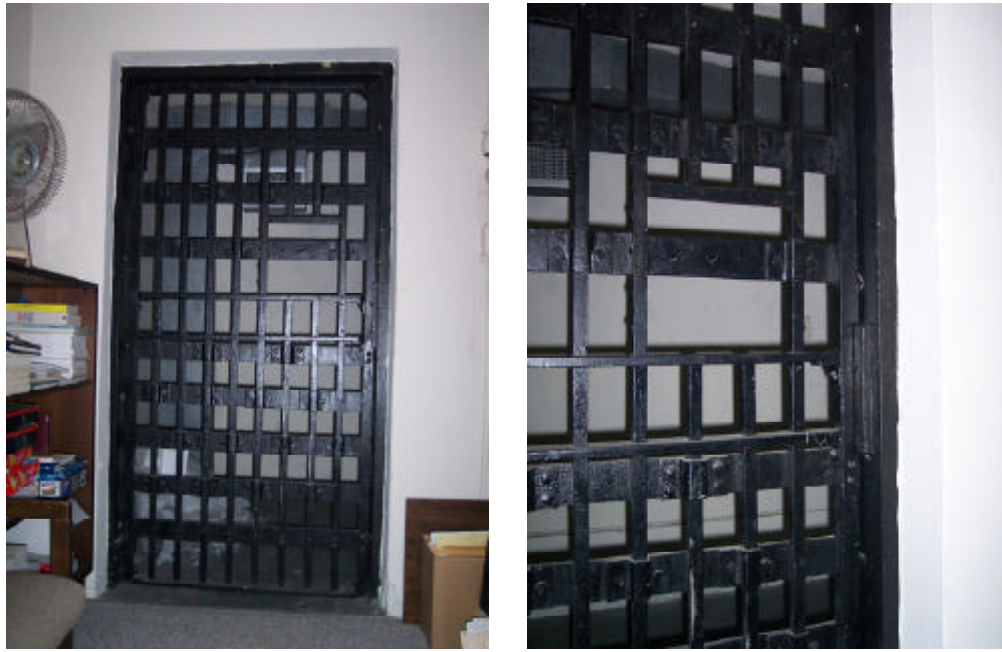
Above left and right: Door of rear cell and detail of door at second floor.

These second floor doors are composed of two 1 ½” square verticals with eight more 1” square verticals between. Four horizontal bars, each ¾” x 3” and laid in the flat orientation form the top and bottom of the door, and also a kind of lock rail near the center. These smaller verticals are further reinforced by a series of eight horizontal bars each ¾” x 3,” affixed with riveted clasps to the passage face of the door. Two of these horizontal bars are hinge straps. Above the lock rail, two of the small verticals are interrupted to provide a pass-through for food.

The large hasps that now serve as the mechanism for locking the doors are original, yet it is also clear that each door was originally secured by an iron rimlock. Judging from remaining screw holes, this lock was mounted on the inside face of the door. The hasp has been cut off of the front door with an acetylene torch.

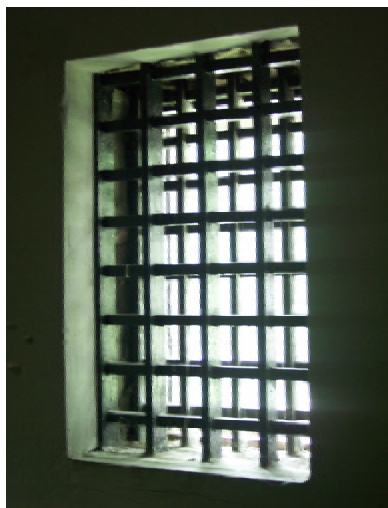
Above: West window - second floor passage.

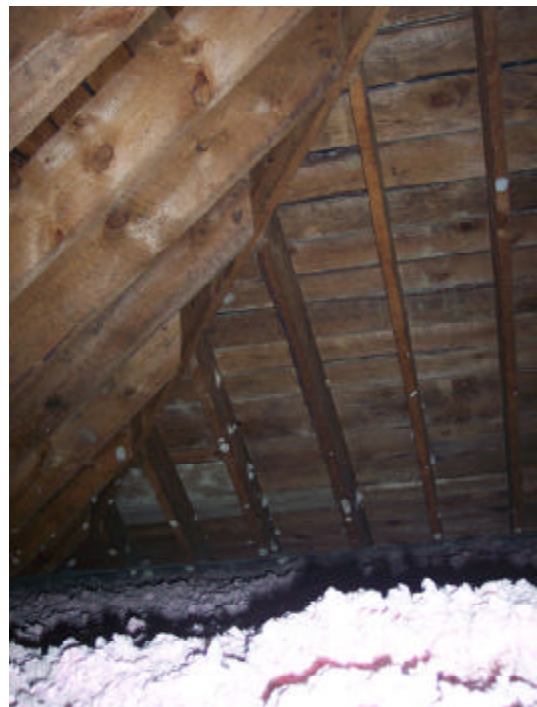
Above: Attic in jail.

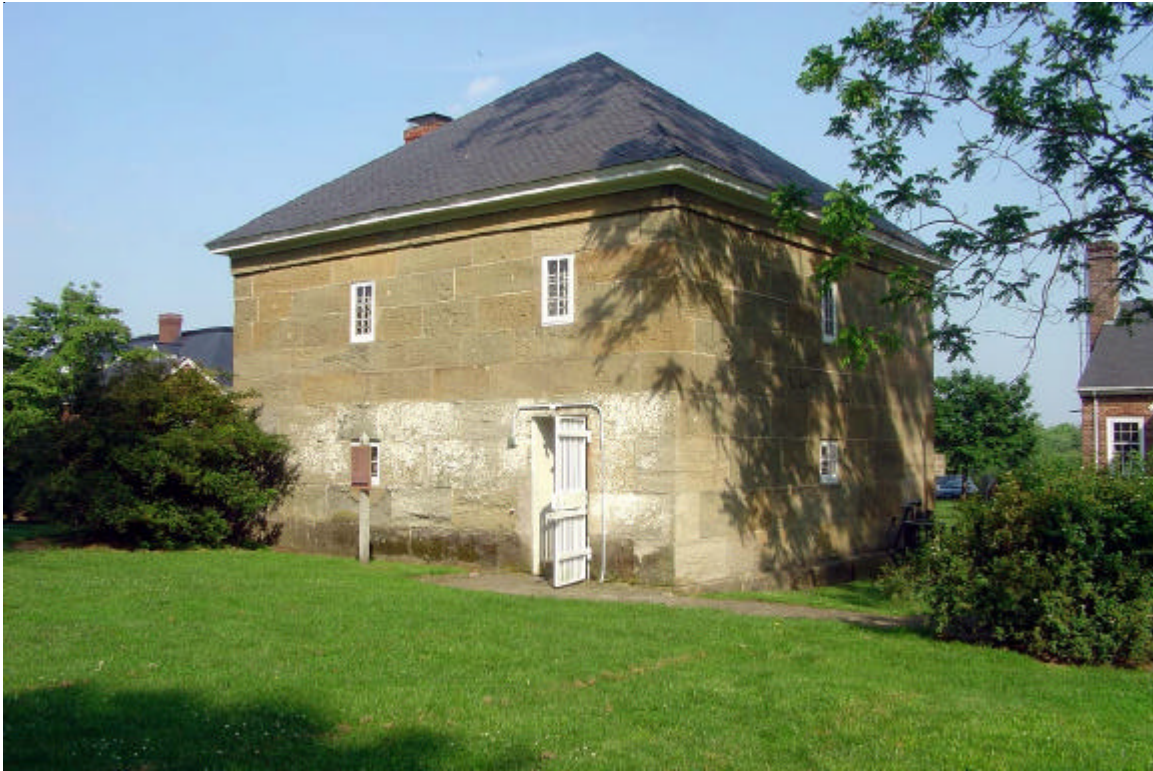
Above: Overall view of the jail from the northwest. The roof appears to be contemporary with that on the main courthouse.

The roof of the jail appears to be absolutely contemporary with the roof of the courthouse. The roof is covered with the same Buckingham slate shingles and modern copper flashings, and there are patched areas of larger, thicker shingles on the main courthouse. Like the main courthouse, the hips are “battered” with asphalt-based roofing compound, and it is not known if secret woven flashings were installed beneath the hip shingles to improve performance.

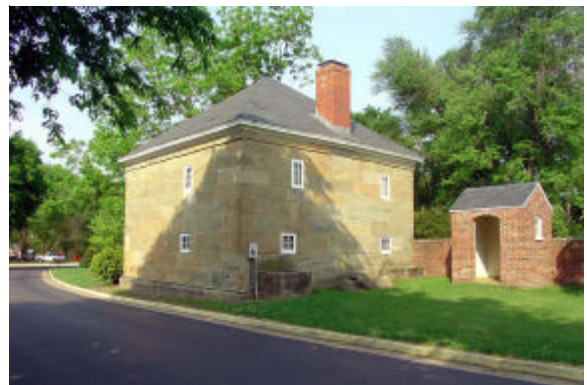
Above: View of the jail from the southeast.

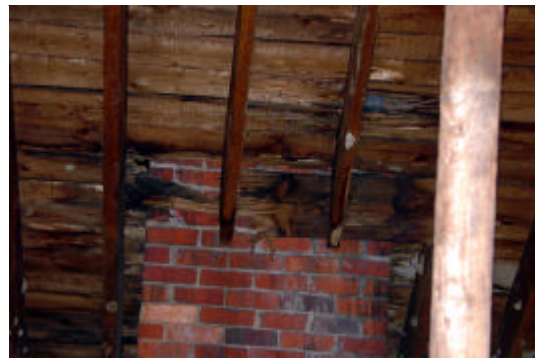
From the attic side, the entire roof deck appears to be in good condition, except on the up-slope side of the chimney, where historic leaks have severely damaged the roof deck to the point where the decking no longer exists in close proximity to the chimney. This condition may be long standing, because it appears that the problem was addressed by the insertion of a cricket designed to cover over the damaged area. However, the extent of the damage to the deck around the chimney is such that it is very unlikely that the slate nails could be well fastened to the deck boards, and while it was not possible to inspect the roof closely during the current effort, it can be surmised that this roof is nearing the end of its useful life.

Above: A close view of the roof deck deterioration around the chimney within the attic.

Since it appears that the damage to the roof deck around the chimney may be long standing, present efforts to keep the roof watertight appear to have been effective. However, at some point remedial repairs will become increasingly difficult, and it should be expected that the roof will need replacement in five to ten years. If it is not possible to replace both the courthouse roof and the jail roof simultaneously, preference should be given to the jail roof. When this roof is replaced, the roof deck boards around the chimney should be replaced with similar material to the surrounding roof deck. Funds should also be put aside to make repairs to the rafters at or near the chimney. It is further recommended that the main roof be once again replaced with Buckingham slate matching the smaller widths of the earlier shingles. All slates should be fastened with stainless steel nails (if the flashings are terne coated stainless steel, if they are copper, the nails should be copper also), and all flashings should be either copper or terne coated stainless steel.

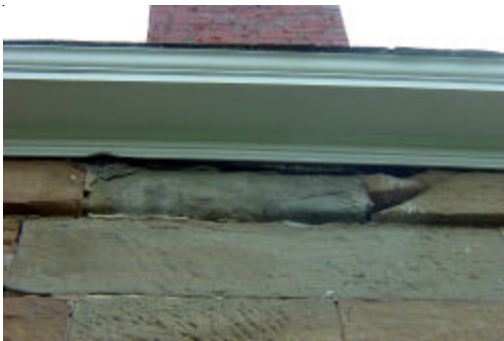
Above: The stone beneath the chimney deteriorated when water was allowed to flow around the flashings of the chimney. This leak does not appear to be active.

The chimney has been pointed on several occasions, and from the ground it appears that some Portland based cement mortar has been used. It is recommended that all loose and deteriorated mortar within the joints on the chimney be removed and re-pointed using a pure lime based mortar. Cement based pointing mortar should be carefully cut and removed, the work re-pointed with the same lime based mix. It appears that approximately fifty percent of the chimney joints require re-pointing.

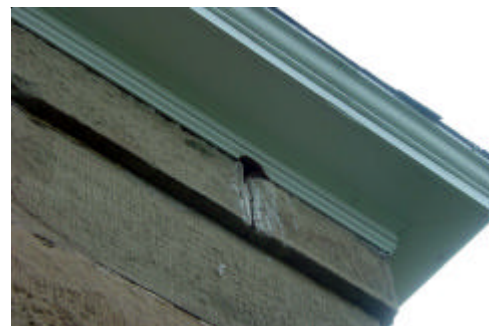
There are several small areas of the main cornice that should be attended to, but these may be considered to be maintenance items in their scale. The most important of these is the hole carved by birds into the bed molding on the northeast corner of the building. At this time, these birds have nested within the attic and may be

Above: A detailed view of a hole in the cornice created by nesting birds.

causing more damage within the framing supporting the cornice. It is recommended that this hole be closed with a Dutchman as soon as practicable. There are a series of other small areas of damage to the cornice, caused either by birds or insects, which should be attended to at the same time. After these localized repairs are made, it is expected that those areas will be painted.

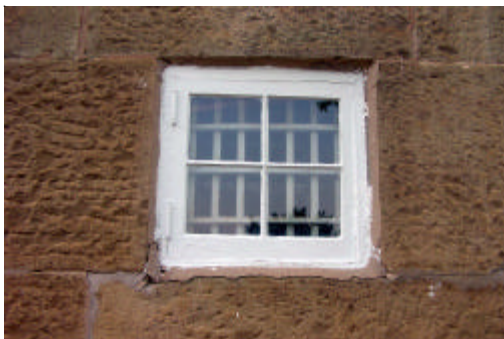
The wooden sash and frames on the jail appear to have been installed later in the life of the building. It is evident that originally, there were only iron bars fitted in the window openings, and while these still survive, they have been covered over by wooden sash. The sash and frames appear to date from the late nineteenth to the early twentieth century, but further research may date these more precisely. Though not original to the jail, they serve a useful purpose and it is recommended that they remain in place.

The sashes have been coated with many layers of paint over the years, and most if not all of them have been painted shut. Since the jail is air conditioned, it may not be necessary to have the windows operable, but in those areas where the paint has failed, it should be scraped and sanded to allow the new paint to adhere to the substrate. The glazing putty on several sash lights has failed, and it is now necessary to remove it so the sash can be re-glazed. This should be accomplished with great care so that the existing glass is preserved. Once the putty has been replaced, the sash will require repainting.

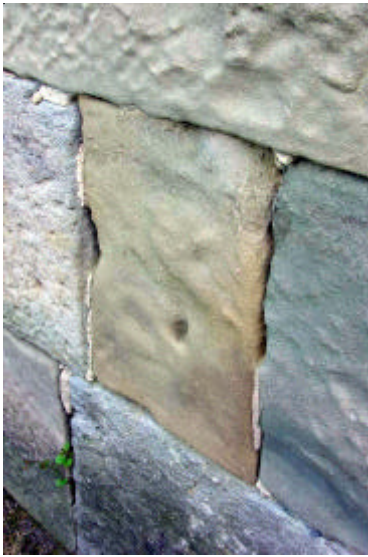
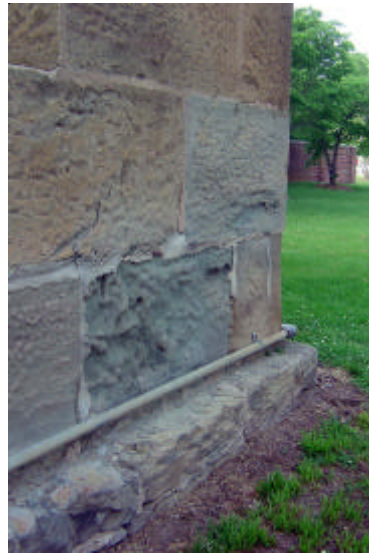
Clockwise from above left: An example of poor stone within the building. The stone to the extreme left is still in remarkably good condition. Next, several stones have deteriorated because they were not well chosen when the jail was constructed. Lastly, this cement based stone patch has faded and is now an unsightly repair to the building.

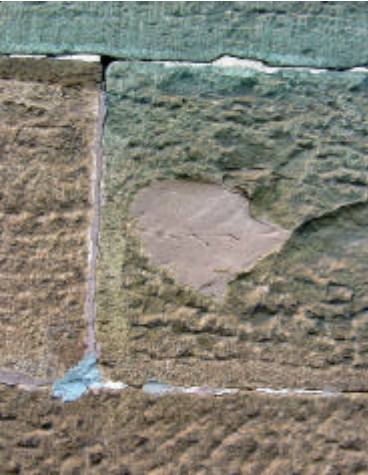
While most of the stones within the jail are in very good condition, there are many that are in varying states of decay. This decay can be traced to a variety of causes. In several cases the stone has decayed because the bedding planes are vertical or nearly vertical to the surface of the wall. Since sandstone is a sedimentary stone, this material should be laid in the wall in the same way that it was found in the earth: the bedding planes should be horizontal or parallel with grade. If sandstone is laid so that these bedding planes are vertical or perpendicular to grade, water can enter between the bedding planes and cause exfoliation. Curiously, the bedding planes in several of the stones found on the jail are in varying directions within the same block of stone. As a result, those exposed planes that are perpendicular to grade have failed, while other portions of the stone are in good condition.

Another type of stone failure found within the jail is a loss of cohesion. It is evident that some stones were quarried from a denser grade of rock than others, and the result is that the weaker stones have eroded in the presence of water.

Further stone damage has occurred because of improper repairs that have been made to the building over many years. There are several areas where a cement based colored mortar was used over the exfoliated areas of stone. As water has entered the porous sandstone around the immediate area of the patch, the impermeable cement patch has trapped the water behind it. When the water froze and expanded behind the patch, the patch simply popped off of the building. In some cases the dense cement patch took surrounding sandstone with it, extending and widening the damaged area of stone.

In a building of this type, it must be recognized that any stone repair or pointing material must exactly match the compressive strength, vapor permeability and appearance of the original material. The best and simplest way to achieve these characteristics is to make repairs using the same material and technologies originally employed in the

construction of the building. In other words, it is not recommended that synthetic stone repairs or modern cement based mortars be used in the repair of this building. All repairs to the stone should be Dutchman type repairs using sandstone matching the original and pure lime based mortars.

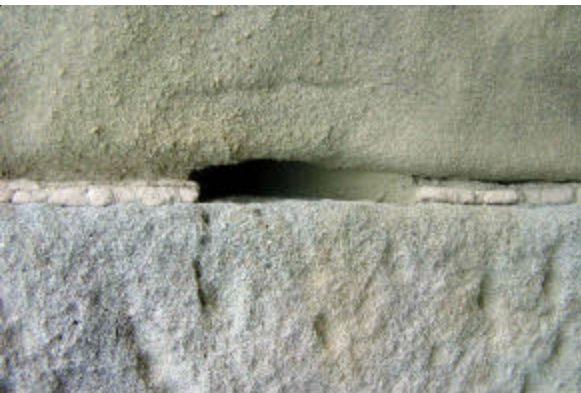
Above: Many mortar joints have completely deteriorated and require re-pointing.
