HISTORIC STRUCTURE REPORT
HANOVER COUNTY COURTHOUSE AND JAIL

HANOVER, VIRGINIA

AUGUST 1, 2004

HISTORIC STRUCTURE REPORT

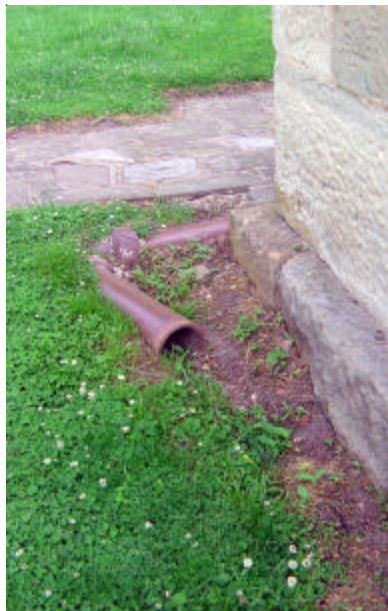
It is likely that the original grade around the building was lower than it is today. Evidence for this may be the concrete dam at the main entrance door. This dam was clearly placed to prevent water from flowing down the hill to the north and entering the building through the doorway. The fact that it is concrete indicates that it most likely dates from the very late nineteenth century or perhaps sometime during the twentieth century. While grade was probably lower near the walls of the jail, it is as likely that some provision was made to prevent water from running down the hill from the north (toward the courthouse). This provision may have been in the form of a swale or some similar grading technique. At this time, surface water is allowed to flow directly down the northern slope toward the jail walls unimpeded. Although the terra cotta drain line is an attempt to keep water away from the main entry, no similar provision appears to have been made for the remainder of the north wall. Once the surface water reaches the porous sandstone jail walls, it is then wicked up into the wall through capillary action and evaporates through the inside and outside surfaces. Once this water evaporates, salts and other minerals crystallize in the walls and exfoliate the stone in the evaporative zone. This water may also freeze and similarly deteriorate the stone. It is therefore important to re-grade around the north side of the building to prevent water from wicking up the walls.

Above: This concrete raised threshold was created to prevent water from flowing into the building.

Left: It is likely that this terra cotta drainpipe near the main door is now ineffective.

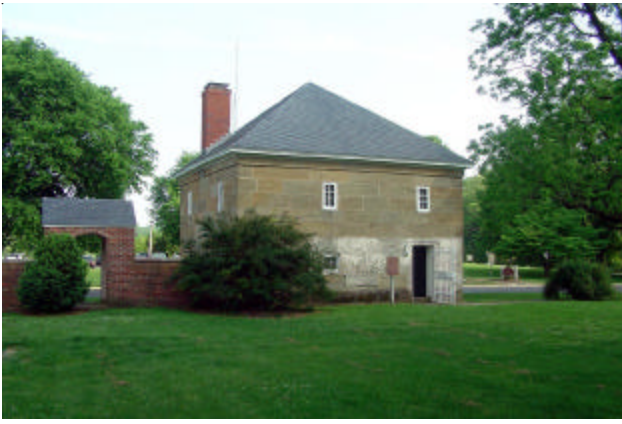
Upper Left: Water now flows down the slope to the north of the building directly to the wall of the jail.

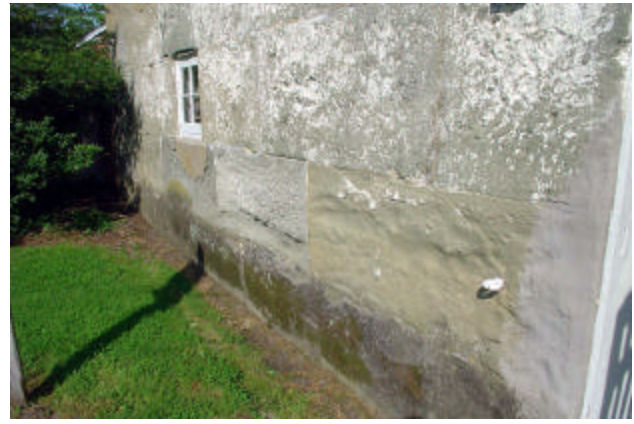
Upper Right: A view of the damage caused by rising dampness at the north wall.

It is very possible that re-grading the area of earth at the north of the jail may be sufficient to prevent further deterioration. Assuming that there is no desire to install eaves troughs at the roof cornice, roof run-off will then flow away from the walls of the building. If this initial step proves ineffective, it may be necessary to provide waterproofing and a foundation drain around the north side of the building. Although this will certainly capture most of the surface run-off entering the walls, it will be ineffective in the unlikely event that water is entering the walls from a high water table. Test probes should be performed around the jail to determine the level of the water table. If it is found that water is in fact entering the walls from beneath the walls, a damp-proof course will be required. Presumably, this would be in the form of a concrete underpinning beneath the entire wall. Since there is no cellar beneath the jail, it is very likely that the stone walls do not extend very deep below grade, and it is therefore equally likely that water entering the walls is surface water.

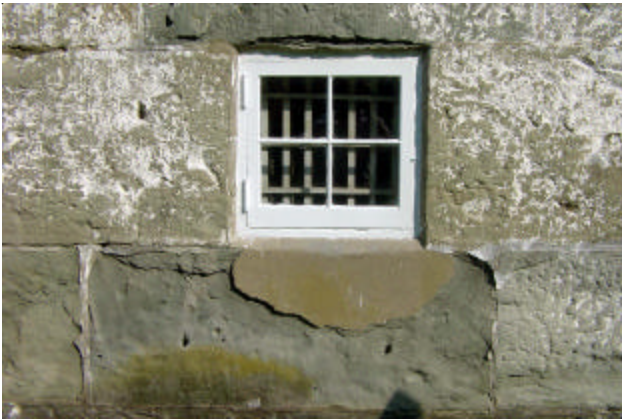
Left: It is evident that water has continued to deteriorate the block of stone beneath the window after the stone had been patched with cement mortar.

There are many failed and poorly filled mortar joints on the jail, and these joints are allowing water to enter the walls. As previously stated, these joints should be well raked and pointed using pure lime mortar matching the original mortar found in the building. Similarly, all cement and synthetic based patching compounds should be removed from the building. This will allow water to enter and exit the stone unimpeded. Additionally, all ferrous metal conduits and fasteners should be removed from the building to prevent them from rusting and expanding, which eventually causes the stone to chip at those locations.

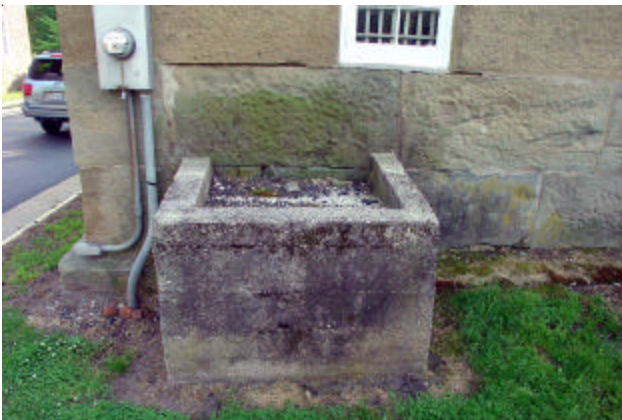
Above: This is one of two cesspits that once served the cells within. These are now keeping water against the original stone walls and causing deterioration.

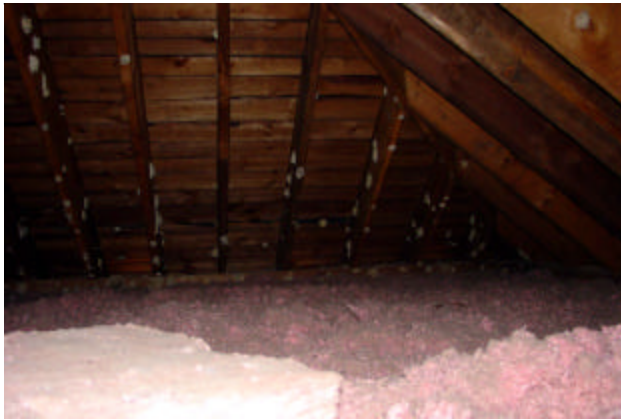
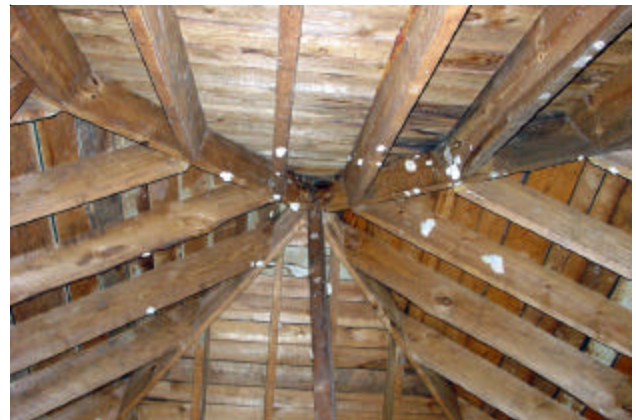
Left: A view of the attic structure looking east. The jail was likely insulated when the building was air conditioned. Right: An overall view of the peak of the attic structure.

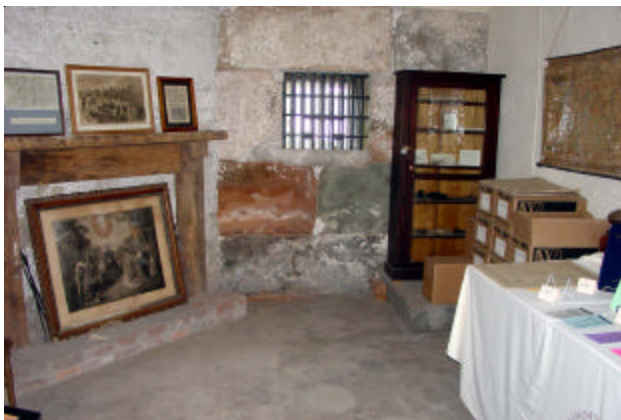
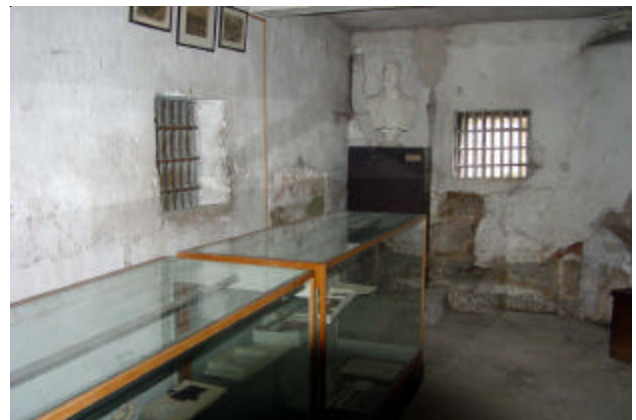
Left: This photo, looking toward the east wall of the south room, illustrates the damage caused to the walls from the former cisterns. Right: A view of the northeast corner of the northeast first floor cell. The damage beneath the window was also caused by the cistern on the opposite side of the wall beneath the window.

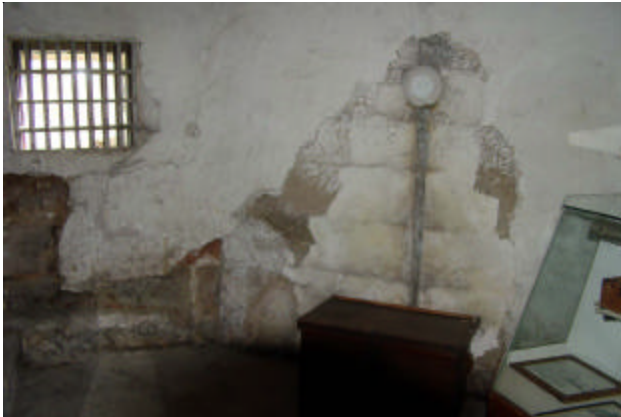
Left: This firebox in the northeast cell should once again be opened to allow air to circulate within the chimney flue.

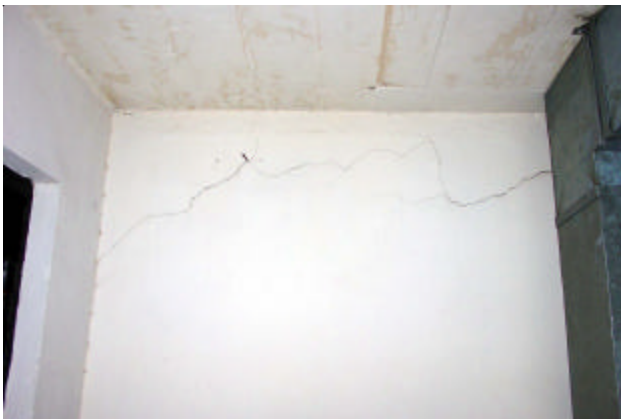
Below left: Plaster cracking along the ceiling of the south wall.

After the water infiltration has been arrested on the exterior of the building, it will be possible to plaster the interior surfaces of the walls. It is recommended that pure lime plaster be used for this work. This material, when used together with a lime based white wash finish, will encourage vapor permeability and vastly diminish

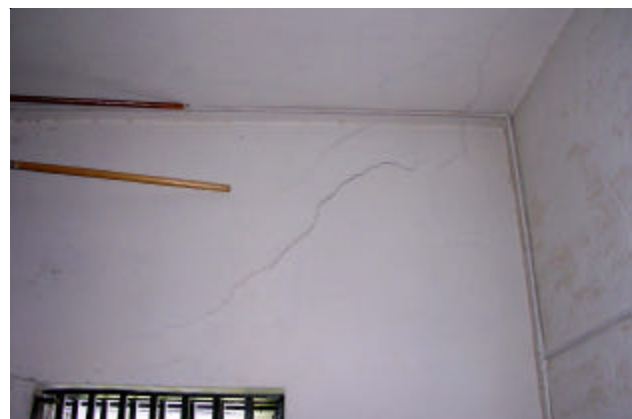
Below right: Plaster cracking in the upper corners of the second floor can be repaired after the exterior problems have been addressed.

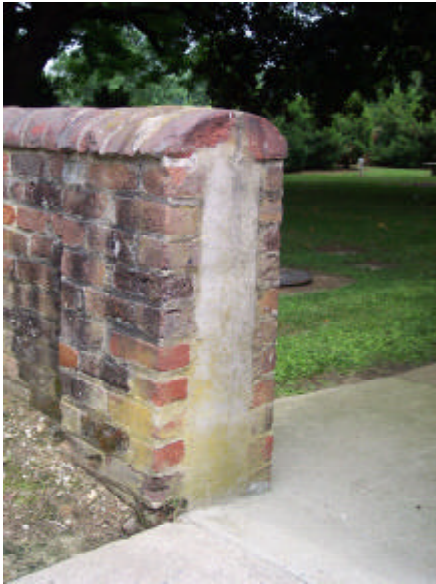
Above: Brick wall with modern patching.
