**SECOND PHASE
OF AN ARCHITECTURAL SURVEY
OF
SPOTSYLVANIA COUNTY, VIRGINIA**

**HISTORIC ARCHITECTURAL SURVEY
OF
SPOTSYLVANIA COUNTY, VIRGINIA**

PHASE II

Final Report

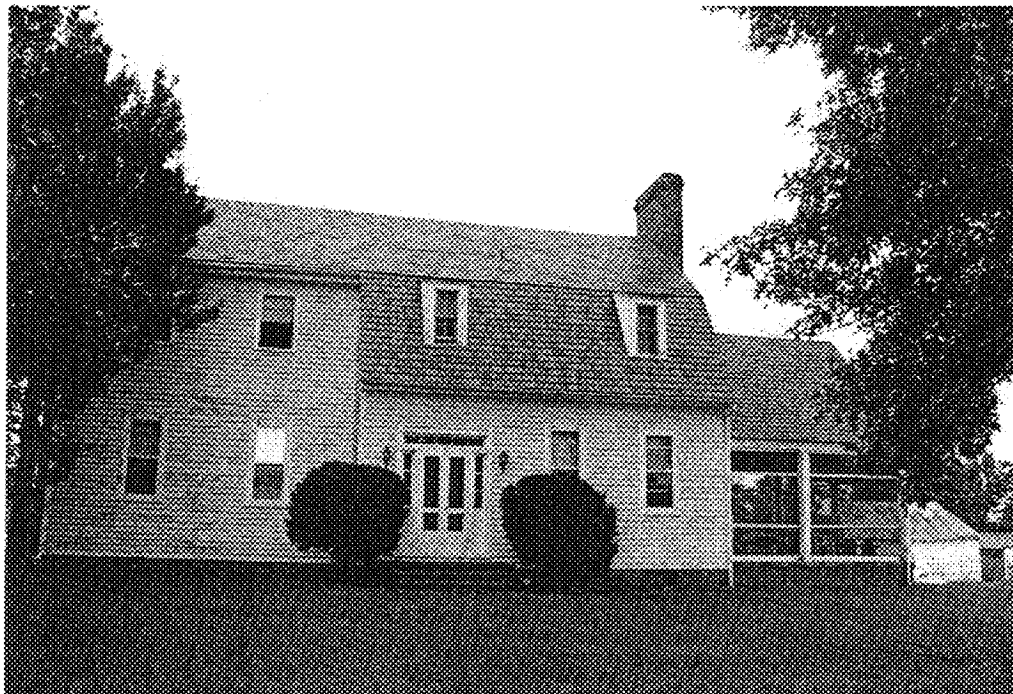
Figure 1: Hazel Hill (088-0079)

This wood frame dwelling presents a hall/parlor plan on a Flemish bond brick foundation with a massive exterior end brick chimney. It is covered by a slate-tiled gambrel roof, the only example of this roof form documented in the Phase II survey.

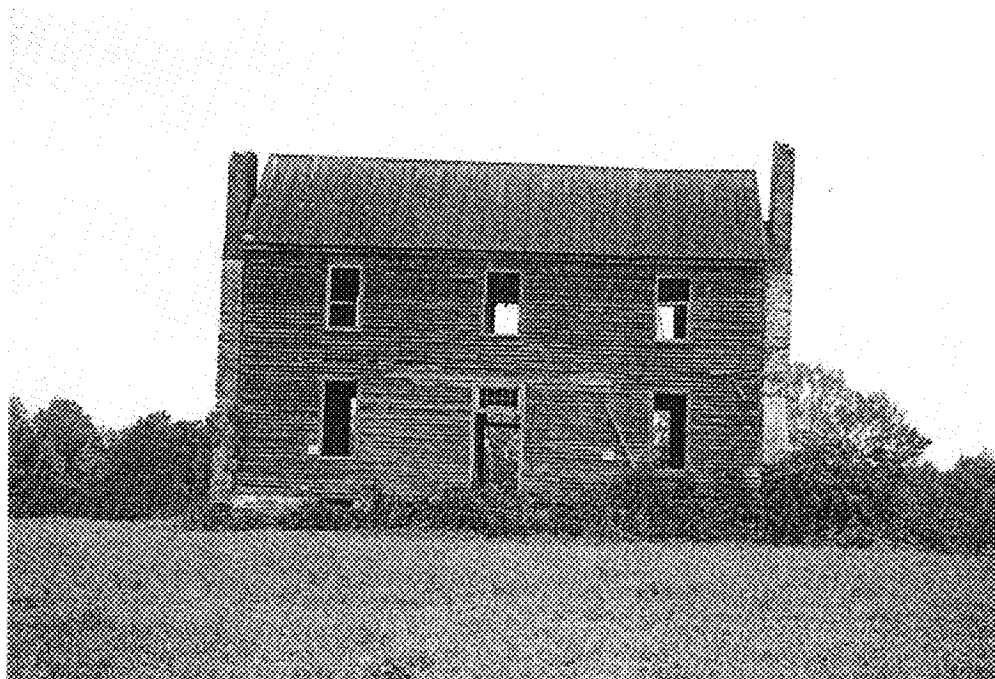
Figure 2: William Swift House (088-0116)

The majority of these dwellings, including those recorded at the reconnaissance level, measured three bays wide. The width of the rectangular, three-bay-wide buildings is nearly equal to those with five entry and window openings. Often, projecting wings or attached dependencies augmented the main block of the buildings. Although two wings or dependencies traditionally balanced the buildings noted from this period, those dwellings recorded in rural Spotsylvania County displayed a single wing on the side elevations. This was noted, for example, at Oakley (088-0052) and Cherry Grove (088-0018). Exhibiting Georgian and Federal-style detailing, the buildings all stand two stories in height on slightly raised foundations of stone or brick. The

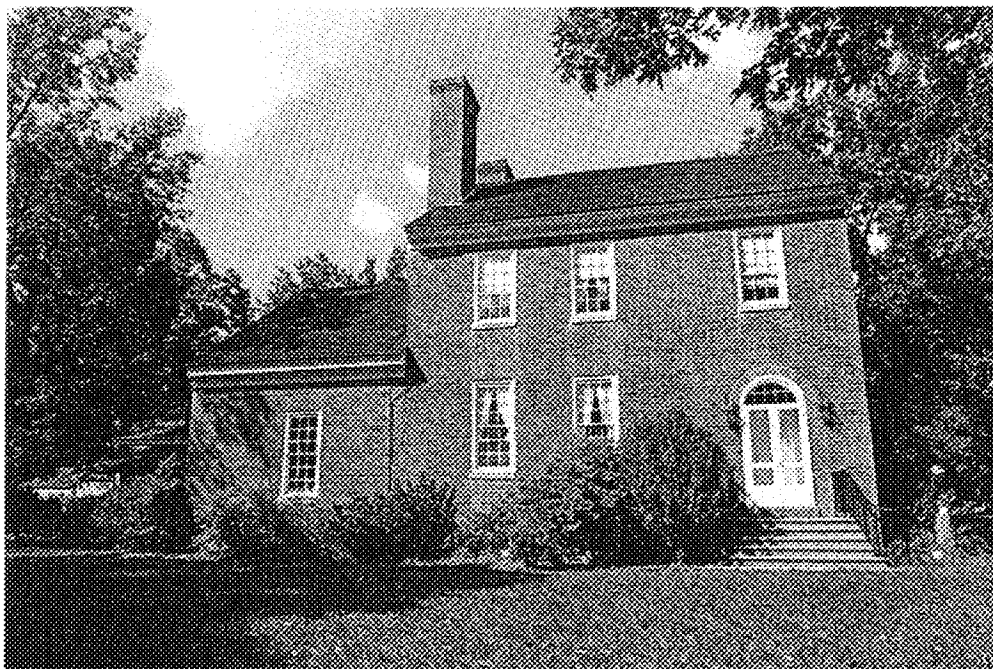
Figure 4: Oakley (088-0052)

Oakley, located on 4,000 acres, is one of three dwellings from this period (1828) owned and built by Samuel Alsop, Jr. for his daughter.¹ Clementine Alsop began her married life with Thomas Coleman Chandler at Oakley in 1826, thereafter moving to Fairfield. The two other properties owned by Alsop are Kenmore Woods (088-0038) and LaVue (088-0039), both of which are listed on the National Register of Historic Places. Like the other two dwellings, Oakley is constructed of brick laid in Flemish bond. The three-bay-wide main block, square in plan, is augmented by a one-and-a-half-story side wing. The two-and-a-half-story dwelling illustrates the high-style detailing and plan of the Federal style. It has a side-passage, double-pile plan. The elongated 9/9 double-hung, wood sash windows of the first story are ornamented with gauged brick flat arches, stone sills, and beaded surrounds. It has a double-leaf door of wood panels capped by a multi-light transom set in a semi-circular brick arch. The second-story openings, symmetrically spaced above, hold 9/6 double-hung, wood sash windows with gauged brick flat arches that abut the ornate wood entablature that extends across the front of the building. The interior of Oakley is ornamented with semi-circular niches, crown and egg-and-dart moldings, molded casings, picture molding, chair rails, reeded baseboards, and beveled panels under the window openings. The tall mantels in the parlors are adorned with Tuscan pilasters, molded shelves with bedmolding, and ornate sunburst motifs on the panels. The stair has a hollow newel form, with scrolled stringer brackets, turned newel posts and landing newels, stringer panels, and a wall stringer.

¹ The construction date of Oakley is based on the 1829 Spotsylvania County Land Tax Book B, which documents that the total value of the 849 acres and buildings was \$7,624.50 with a notation that \$3,139.50 had been added to the assessment because of the construction of the main dwelling.

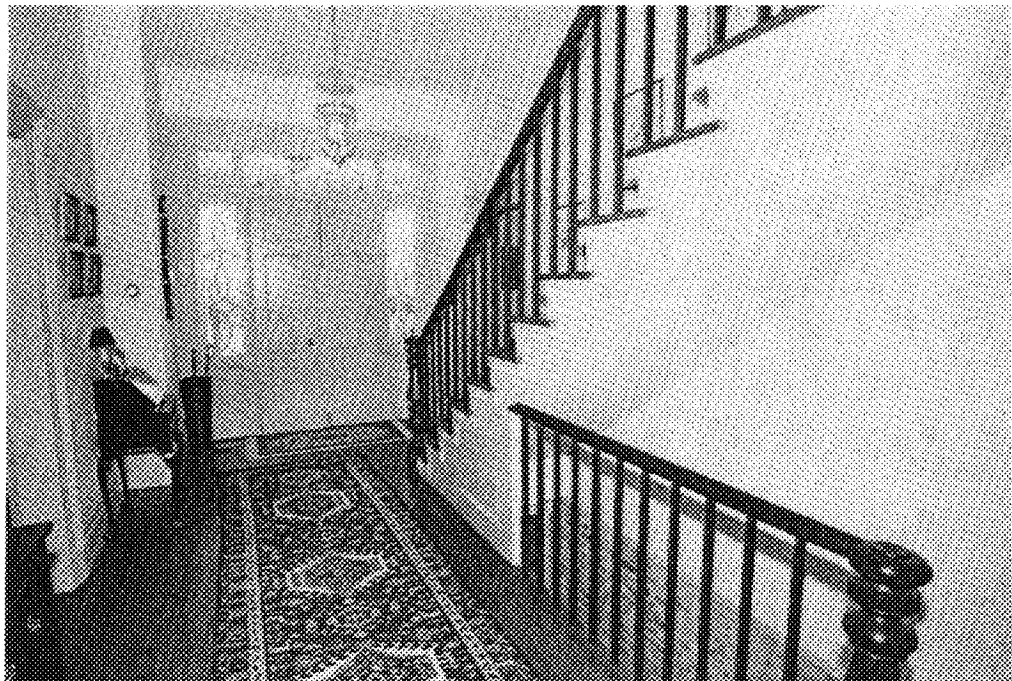
Figure 5: Center Passage at Walnut Grove (088-0112)

Another excellent example dating from this period is the dwelling known as Walnut Grove (088-0112). Constructed in 1829, the wood frame building is five bays wide with a central-entry, three-room plan. Walnut Grove was erected for Jonathan Johnson II on property historically associated with the Beverley family. Johnson was married to one of the daughters of William Beverley, and it is perhaps this association with such a prominent figure in the history of Spotsylvania County, and Virginia, that accounts for the formal interior plan. The center passage holds a finely detailed hollow newel stair ornamented with scrolled stringer brackets, panels, thin balusters, a round rail, and turned newel posts. The straight-flight stair to the English basement is finished with a turned newel, round rail, and thin square balusters. This basement stair is unlike contemporary stairs recorded in Spotsylvania County, as it is open, rather than a closed stair. The passage is further ornamented with heavily molded surrounds with angled base blocks and crosssetted lintels. The main entry, balanced by a similar double-leaf entry on the rear elevation, has sidelights and a transom with finely detailed tracery in a scrolled pattern and scalloped medallions. The two flanking parlors are finished with simple unadorned wood mantels that contrast their ornamental surrounds. These surrounds have panels under the window openings, molded casings, base blocks, and wide entablature-like lintels with projecting caps. In the north parlor, the baseboard and panels under the windows are marbled. The rear parlor, set on the northwest corner of the L-shaped structure, represents the evolution of the interiors to include a dining room or attached kitchen.

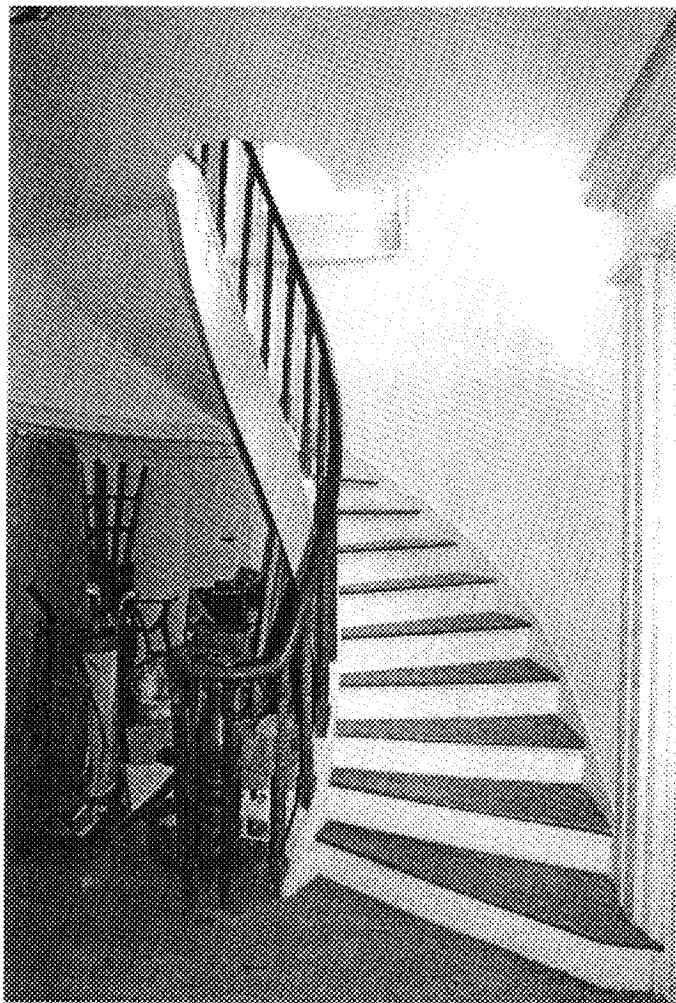
Figure 6: Circular Stair at Edgewood (088-5058)

One of the most outstanding interior details was found at Edgewood (088-5058), a Federal-style dwelling constructed in 1827 for Rueben Lindsay Coleman. The building was significantly altered in the 1870s to illustrate the Italianate style. These alterations were restricted to the primary façade, thus the form and interior detailing dating from the dwelling's original construction are intact. This center-passage, single-pile dwelling, completed by a rear ell, has a finely detailed winding circular stair. This self-supporting stair has nubby molding on the stringboard of the closed stringer, a round rail supported by turned balusters, and a heavy landing newel. This newel is set to the side of the stair carriage, and is connected to the stringboard by the volute of the rail. It has an exaggerated turned base and urn-like shaft. The detailing seen throughout the interior of the building include Tuscan pilasters with recessed center panels and lintels consisting of wide friezes and heavily molded caps with ogee molding.

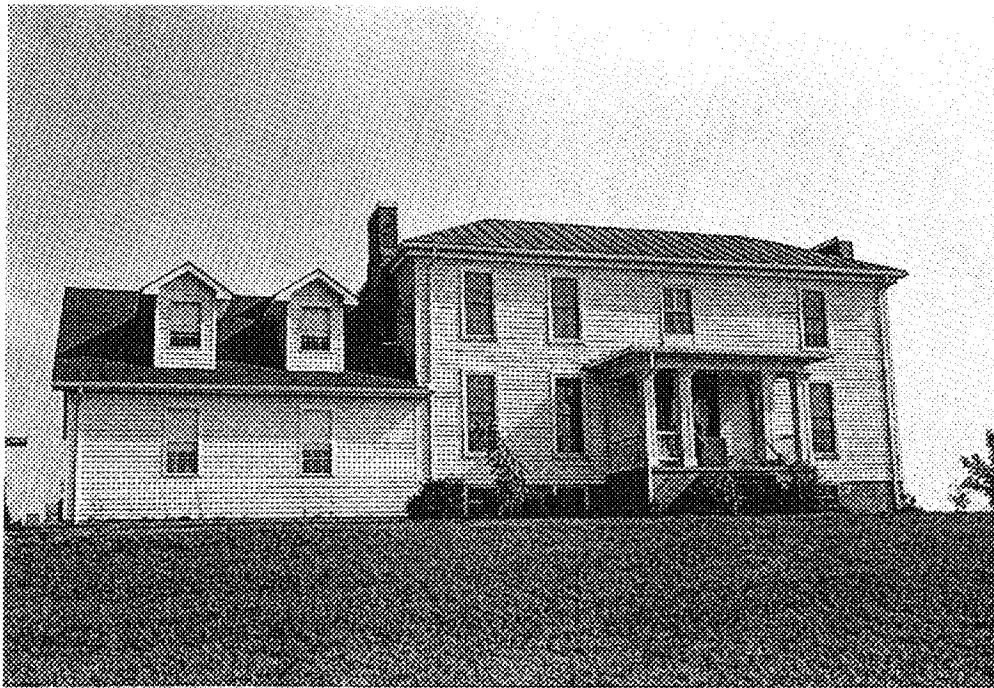
Figure 7: House at 6801 Lake Point Drive (088-5061)

Overwhelmingly, the dwellings erected during this period in rural Spotsylvania County illustrated vernacular interpretations of the Greek Revival style of architecture, which was widely spread through carpenters' guides and pattern books. As expected, the dwellings from this period noted in the rural survey area tended to be less ornate and smaller in form than those recorded in the Primary Settlement Area of the Phase I survey. The common rural form took the box plan adorned with columns and porticos, which often provided the only stylistic references. Examples noted within the survey area included the three-bay-wide Belle Font and the hipped roof dwelling at 6801 Lake Point Drive (088-5061). These dwellings feature a large Georgian form of the turn of the 19th century with the classical revival detailing more commonly found on houses built during the middle part of the century. This includes large, square Tuscan posts with

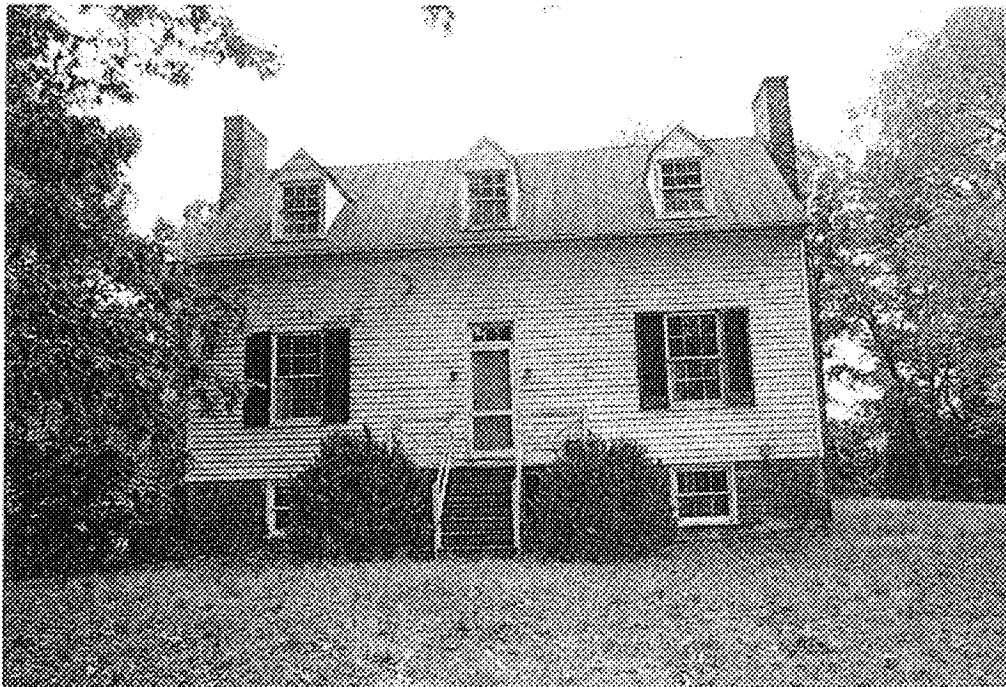
Figure 8: Woodside (088-0072)

A rare example of a once-common form for this period is presented at Woodside (088-0072), a single-family dwelling at 16220 Days Bridge Road. History recounts that the property was associated with the Holladay family. Dating from the early 1840s, the rectangular building has a central-passage, single-pile plan set under a side gable roof. The wood frame structure is sitting on a five-course American bond brick English basement. The steep pitch of the roof, English basement, and two exterior end chimneys with slab shafts give the one-and-a-half-story building a more imposing scale than the "colonial" form traditionally presented. This illusion is greater on the side and rear elevations than on the façade. The basement is illuminated by wide 3/3 sash, while the first story has symmetrically placed 6/6 sash. Three front gable 6/6-sash dormers continue the balance at the roof, now covered with standing seam metal.

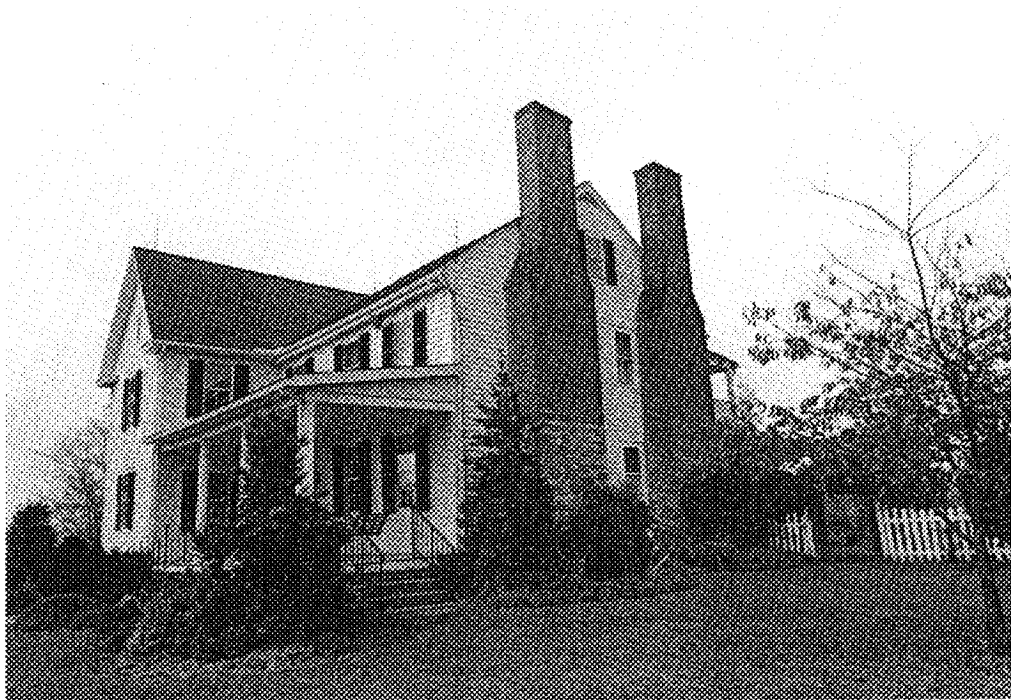
Figure 9: Goodloe Plantation (088-0015)

Goodloe Plantation, purchased by Henry Goodloe, Jr. in 1720, presents an imposing 1840s dwelling set on 260 acres. Despite its subsequent enlargement in 1910, the original side-passage, double-pile plan is discernable, presenting a transitional Federal-Greek Revival. The wood frame building is set upon a brick and stone foundation, with paired exterior end brick chimneys and a steeply pitched side gable roof. The interior, renovated in 1983, retains much of its original detailing. This includes Federal-style mantels, a straight-flight stair, and chair boards. In the raised basement of the original main block is the milk safe. This wood frame enclosure, erroneously documented during previous survey efforts as a slave jail, was erected specifically for the storage of milk, butter, and cheese. It is constructed of vertically placed wooden boards spaced apart to allow for ventilation. The practice of storing dairy products within the house is an English tradition that was generally abandoned by the third quarter of the 17th century in favor of separate, detached dairies or milk houses. A similar milk safe has been documented at the Fawcett House, a circa 1755 building on Prince Street, in Alexandria, Virginia.

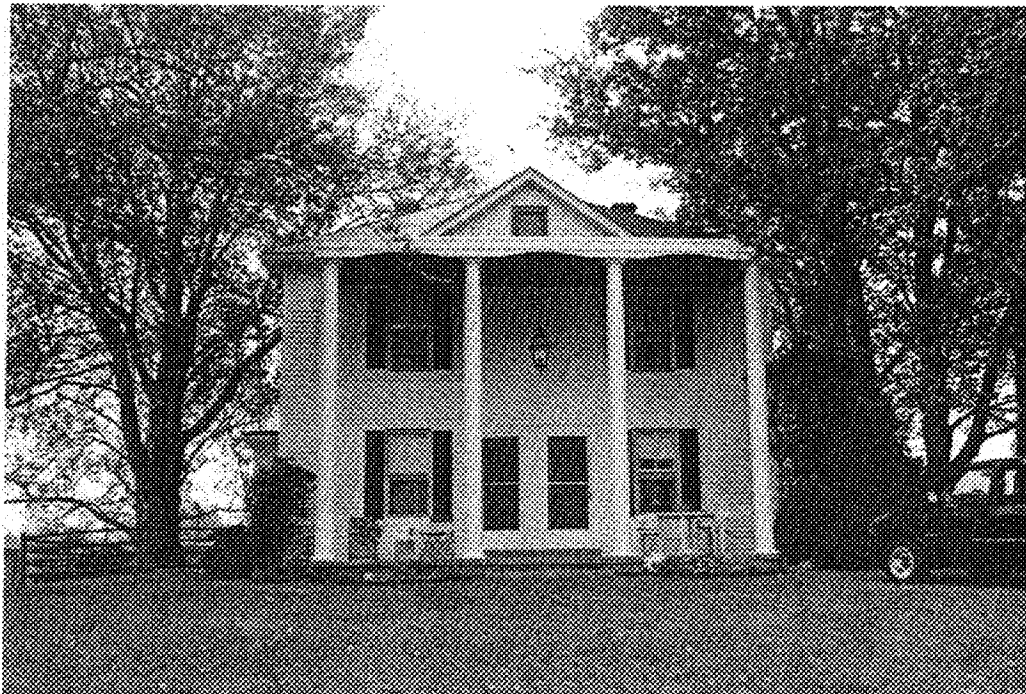
Figure 12: House at 7032 Belmont Road (088-5125)

Another similar example is the square dwelling at 7032 Belmont Road (088-5125), which was constructed after the turn of the 20th century on a stone foundation. This wood frame building rises two-and-a-half-stories in height under a shallow pitched hipped roof. A two-story front portico, supported by Tuscan columns, emphasizes the verticality of the structure. The plan consists of four rooms with a centrally located, narrow enclosed stair located in the rear of the main block. The interior is accessed through two single-leaf entries set side-by-side on the façade. Each entry leads to one of the narrow front parlors, both originally serviced by interior chimneys.

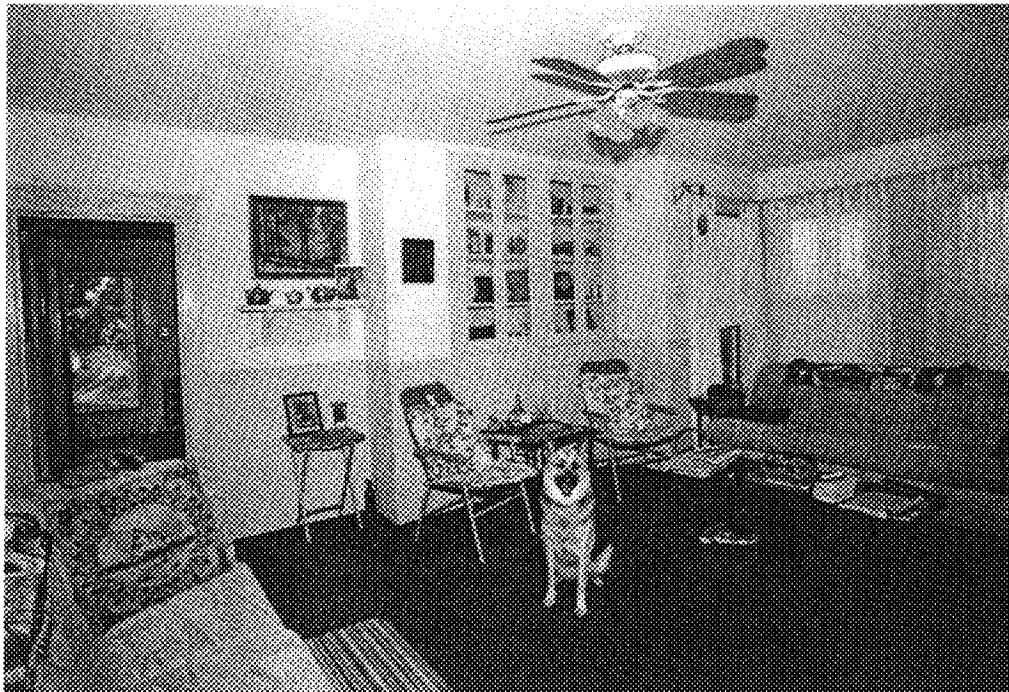
Figure 13: Interior of 7032 Belmont Road (088-5125)

The interior detailing is typical of the period and features square-edged surrounds that measure 6-8" in width, projecting lintels with ogee molded caps, built-in cabinets with glass doors, vertical board wainscoting, and square-edged chair rails. Mantels commonly are unadorned with Tuscan pilasters and a plain frieze. The stairs are typically straight-flight with turned or square balusters, molded railings, stringer brackets, and heavy turned newel posts. This was noted at two of the properties recorded at the intensive level -- Rose Hill (088-0176) and 10925 Post Oak Road (088-5123).

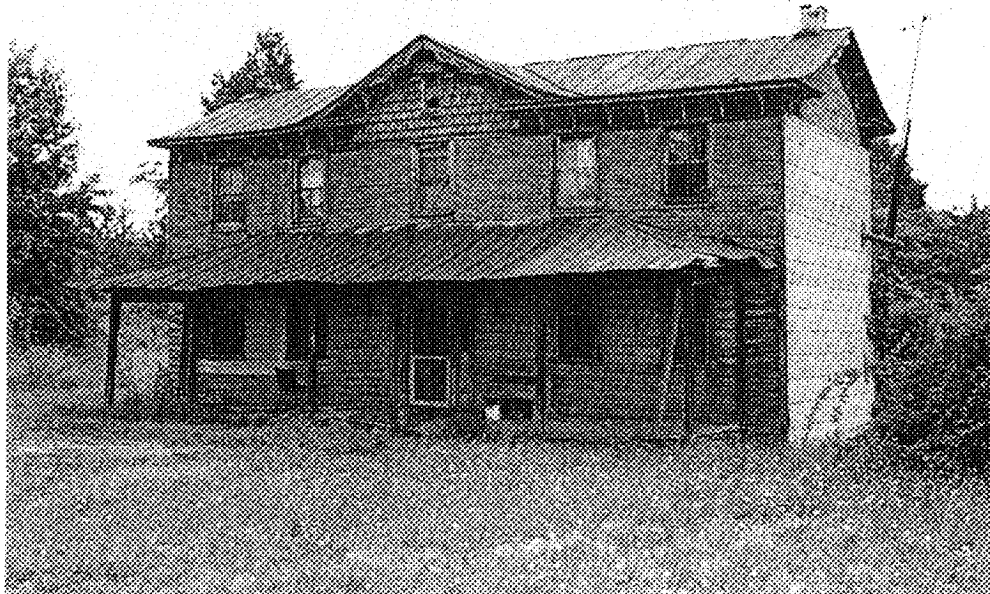
Figure 14: House at 3621 Shepherd Road (088-0046)

The use of a central front gable on the side gable or hipped roof of a house was noted a number of times throughout the county. These front gables, an interpretation of the fashionable Gothic Revival style popular in the latter part of the 19th century throughout Virginia, were finished with ornate wood shingles, brackets, and ventilating attic openings. Excellent examples of houses with central front gables, including both open and closed tympanums, are found at 7901 Belmont Road (088-0171), 10114 Piney Branch Road (088-0033), 22534 Partlow Road (088-5114), and 3621 Shepherd Road 900-0046). Three of these examples have openings in the gable, either an oculus or narrow double-hung sash, or D-shaped windows. The dwelling at 7901 Belmont Road, which has been reclad in aluminum siding, retains its original wood shingle cladding in the front gable and brackets. This cladding is ornamental with square and chiseled shingles. The ornate detailing at 3621 Shepherd Road is particularly notable, as the dwelling has been reclad and is

presently vacant and in a severe state of deterioration. Nonetheless, the building retains its fish-scale wood shingles, brackets, modillions, and ornately sawn bargeboard in the front gable.

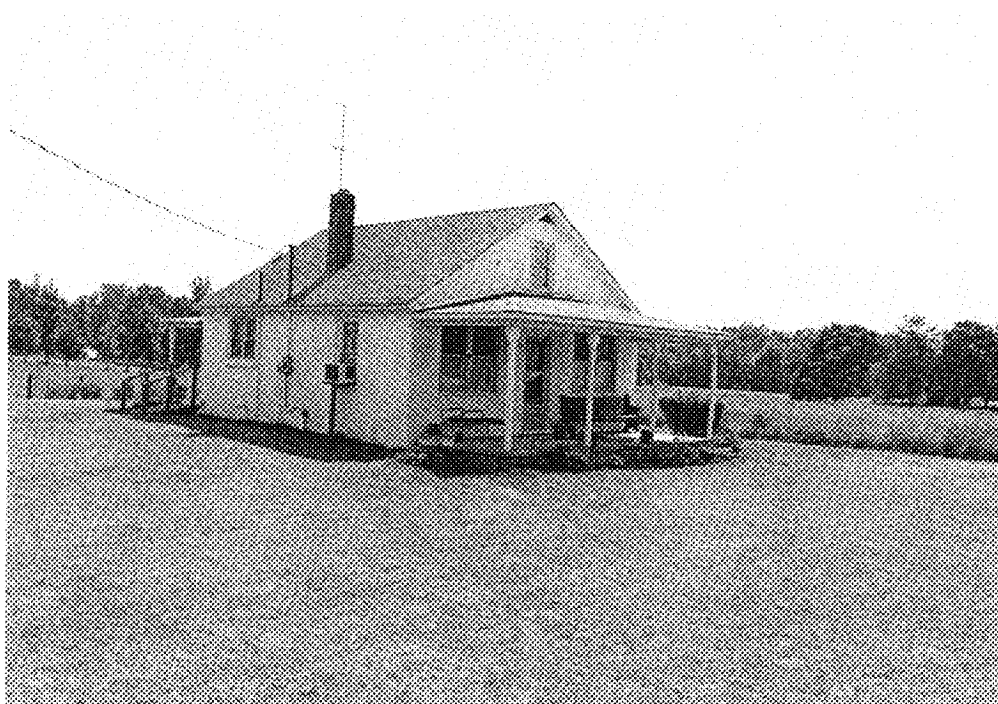
Figure 15: House at 7114 Marye Road (088-5122)

Dating from the second quarter of the 20th century, the wood frame buildings at 6707 Marye Road and the house on Daniel Road illustrate the two-bay-wide form. Now enlarged, the two-story buildings originally were square in plan, covered by side gable roofs of standing seam metal. Two 2/2 double-hung, wood sash windows and single-leaf side entry openings pierce the facades. The contemporaneous one-and-a-half-story building at 7114 Marye Road is more typical of the bungalow form that was marking the rural landscape of Virginia during the second quarter of the 20th century. This interpretation of the fashionable form is rectangular in plan, with a front-gable roof. A full-width front porch shelters the three-bay-wide façade. Ornamentation is restricted to the paired window openings, overhanging eaves, corbeled interior brick chimney, and porch supports. The structure is constructed of smooth-finished concrete blocks, an inexpensive building material that was used in the building of structures by the second quarter of the 20th century. Previously, this material was limited to foundations and/or porch supports, often with an ornamental finish.

Although a substantial number of dwellings were constructed during this period, the Phase II survey did not focus on domestic resources erected after 1920. Thus, only six domestic properties from this period were recorded to illustrate the various building forms and styles – 8701 Brock Road (088-0028), House on the west side of Daniel Road near Holladay (088-5056), 6707 Marye Road (088-5099), 3049 Partlow Road (088-5113), 10231 Wallers Road (088-5115), and 7114 Marye Road (088-5122).

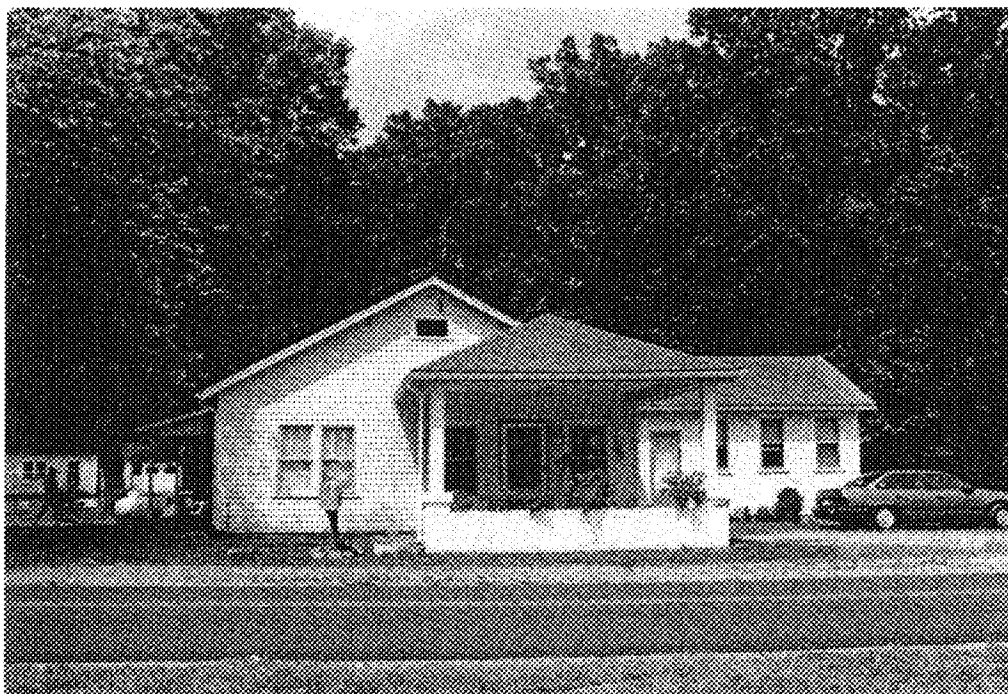
Figure 17: Service Station and House at 8701 Brock Road (088-0028)

to gain new customers by offering an ever-wider range of services such as oil checks, window cleaning, and car repairs. Early filling stations frequently resembled small dwellings with the high glass-topped pumps in front to serve as the chief means of identification for the high-speed travelers. Many of the buildings were front-gable cottages with a store and an extension, or canopy, leading out to the pumps. The modest wood frame building at 8701 Brock Road (088-0028) is an excellent example of this building type and form. Dating from the 1920s, the one-and-a-half-story building has the front-gable roof, projecting canopy, and commercial space on the interior indicative of a small grocery store. A portion of the building is devoted to domestic space, allowing the property owner to live on site. The original mixed-use of the building is expressed in its form, which is larger than the typical canopy-form service stations, and in the Craftsman style detailing exhibited in the single and paired window openings.

The lack of 18th and 19th century commercial properties included in the survey is the result of confined growth countywide, as well as the replacement of these resources in the 20th century with modern facilities such as those associated with refrigeration and the automobile. The Phase II survey recorded eight commercial resources, specifically stores and service stations. The house at 8701 Brock Road (088-0028) demonstrates the need for these commercial spaces in residential crossroads and neighborhoods. Discussed under the Domestic theme, the building was constructed as a service station with domestic space to the rear.

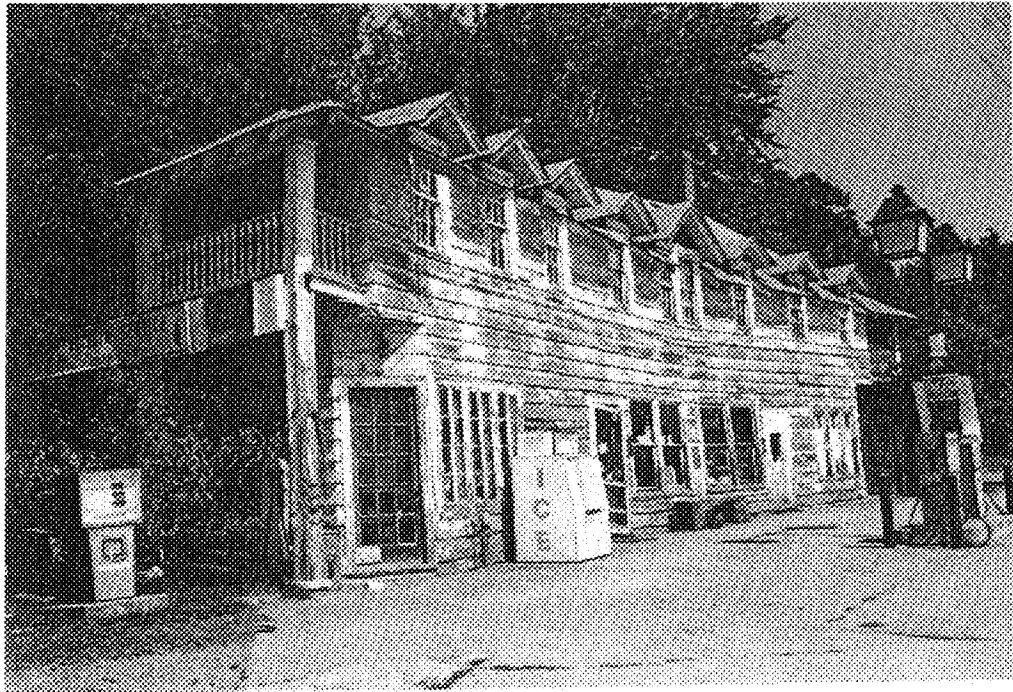
Figure 21: Arcadia Commercial Building (088-0007)

With the advent of the automobile, the form of commercial buildings evolved to accommodate the needs of tourists and their cars. This was clearly demonstrated at the Arcadia Commercial Building at 5411 Jefferson Davis Highway at Arcadia Road (088-0007). The two-story commercial building, erected in the second quarter of the 20th century, was designed to meet the varying needs of the community. The first story was originally divided into four separate stores, each with a private entry. The upper story was designed to provide meeting space, storage, housing, and a tearoom. The multi-purpose building was erected for the Jerome family. The evolution of the automobile is recorded at this property, which includes a variety of gasoline pumps dating from the 1930s to the 1970s. To attract attention of high-speed travelers at this three-way intersection, the wood frame commercial building has a curved façade that follows Arcadia Road. The Craftsman style of the period is represented in the multi-light casement windows, the exposed rafter ends, overhanging eaves, and wall dormers with front gable roofs.

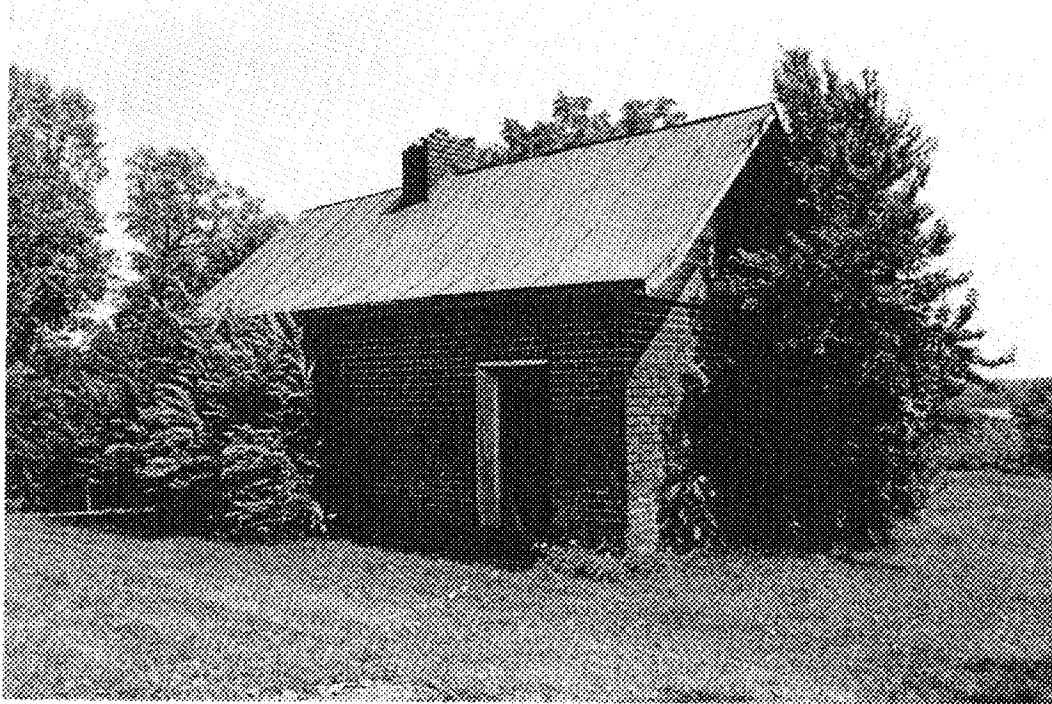
Figure 22: Schoolhouse at Edgewood (088-5058)

One of the most remarkable educational-related resources documented is the one-room schoolhouse at Edgewood (088-5058). Located along Days Bridge Road, the property was first improved in the second quarter of the 19th century by Reuben Lindsay Coleman. It is now owned by the Dickinson family, and includes log sheds, the brick school, a mid-18th century dwelling, and an antebellum dwelling updated with Italianate detailing in the third quarter of the 19th century. The schoolhouse is located to the south of this Italianate-style dwelling. The one-and-a-half-story schoolhouse is constructed of brick laid in an American bond varying from three to five courses. The structure is two bays wide and one bay deep. It has expansive eaves and a flared gable roof, now clad in standing seam metal. The roof is pierced at the northeastern end

by a massive interior brick chimney that currently is in a state of disrepair. The gable ends of the building are finished with weatherboard and pierced by large standard-sized window openings. The single-leaf entry on the north elevation of the building faces the primary dwelling. Although the door is no longer present, the opening retains its beaded surround and rowlock-header lintel.

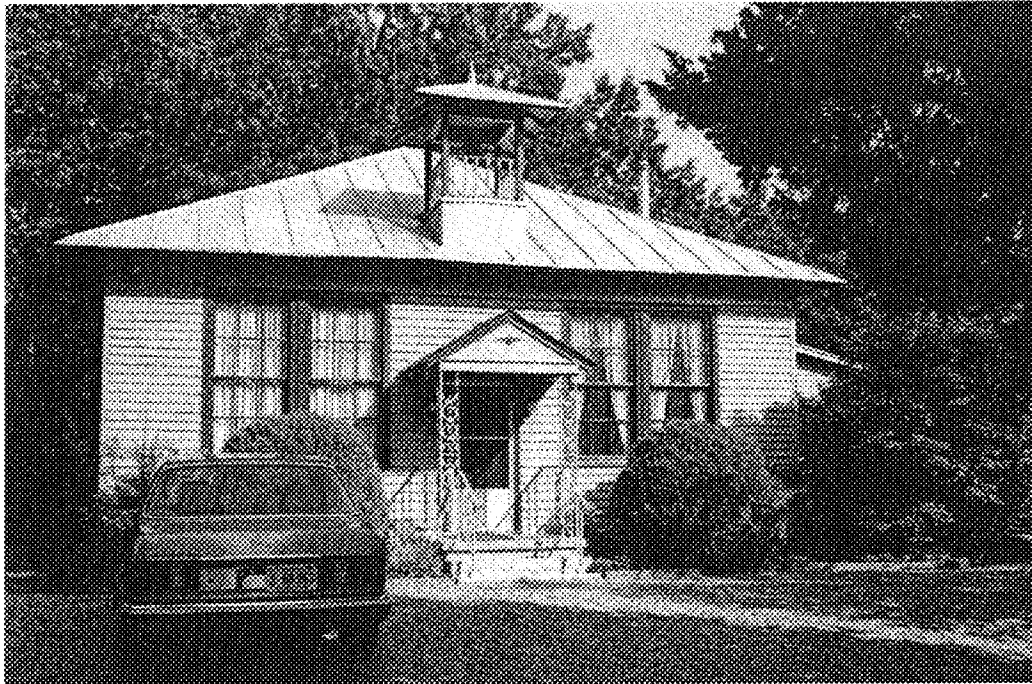
Figure 23: Todd's Tavern School (088-0165)

The three buildings constructed under the tenure of the Board of Education reflect the variety of educational buildings popular during the early 20th century. Remarkably, none of the buildings serve as schools today. The modest square building known originally as Todd's Tavern School (088-0165) was constructed about the turn of the 20th century. This wood frame building stands one-story in height, covered by a shallow pitched hipped roof with a wide overhang and hipped dormers. The façade, which fronts Catharpin Road, measures three bays wide. It has a central entry covered by a front gable portico. Flanking the entry are paired 6/6 double-hung, wood sash windows with thin muntins and square-edged surrounds. Set directly over the entry is a bell tower. This wood frame structure has vertical board cladding on the base, a balustrade with turned balusters and square posts, and a very shallow hipped roof that has exposed rafter ends. The bell hangs from the center of the roof. The side elevations have tall 6/6 windows, both single and triple openings. The building was renovated to serve as a single-family dwelling in the latter part of the 20th century.

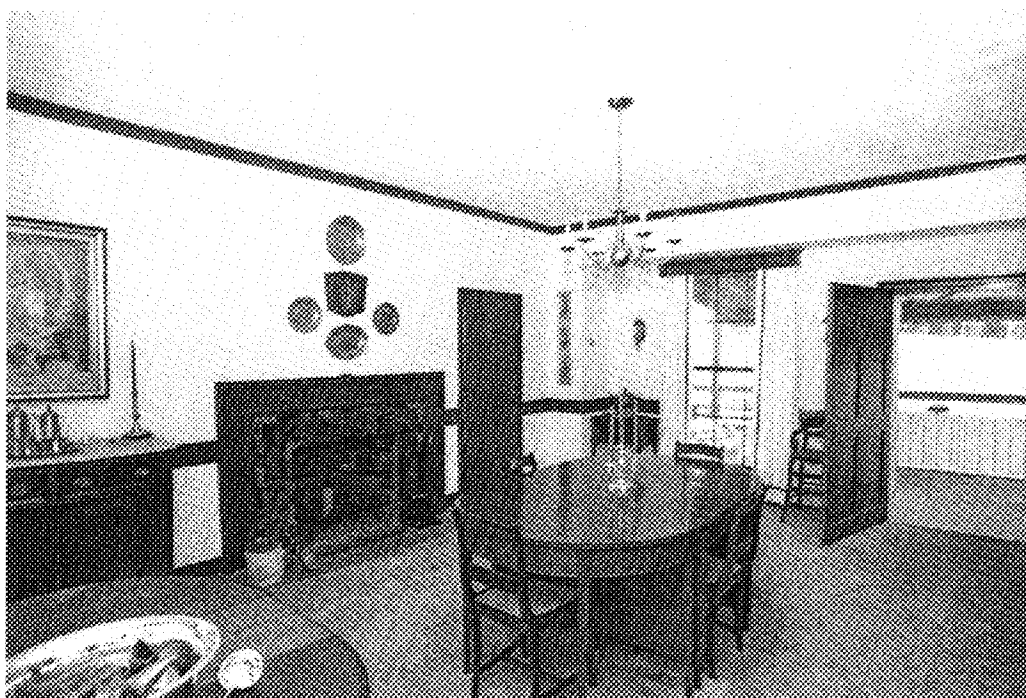
Figure 24: Former Post Office in Waller Holladay House (088-5124)

The single-family dwelling at 5801 Private Road near Belmont on Lake Anna served as a post office in the late 19th century. The owner of the adjacent mill constructed the Waller Holladay House as a one-room dwelling in the 1790s. In 1831, Holladay purchased the property and proceeded to enlarge the structure to its present I-house form. It was during the tenure of Mary Christian Holladay, a descendent of Waller Holladay, that the original portion of the house, now the dining room, was used as a post office for the surrounding community. This room was perfect for such use, as it maintained a separate exterior entry and easily could be closed off from the family living space. The old post road was located to the south of the house, along Anna Creek (now Lake Anna). Mary Holladay served as postmistress from 1887 until her death in 1933.

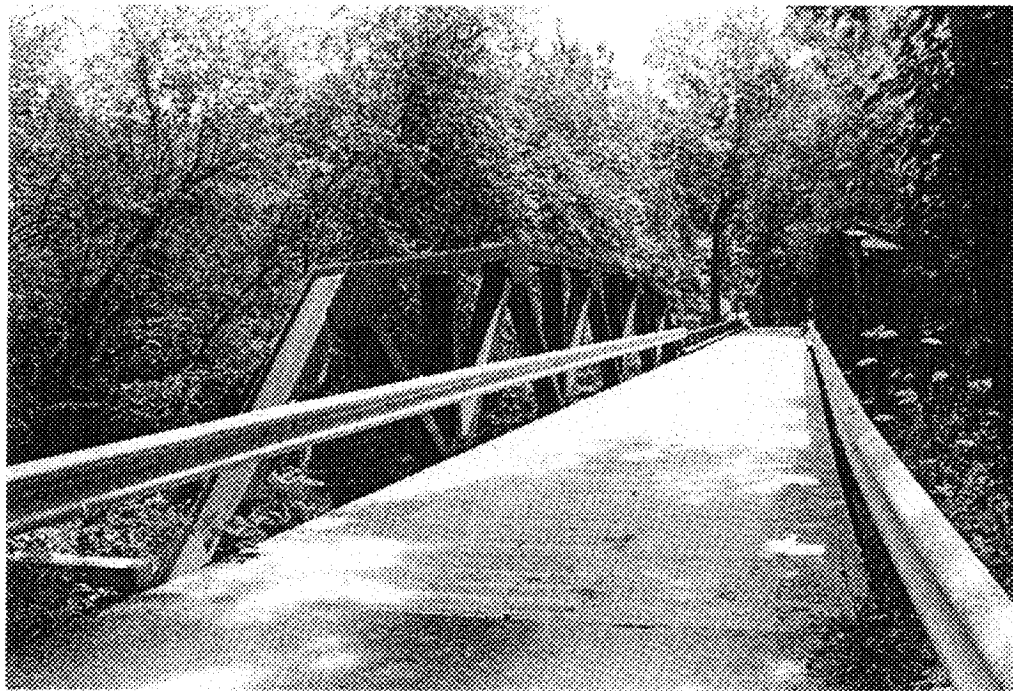
Figure 25: Davenport Bridge (088-5040)

Reflecting the growth patterns of the county and the dependence on automobiles by the middle part of the 20th century, a single road-related transportation resource was documented – Davenport Bridge (088-5040). This mid-20th century structure, one of the few remaining in the southern part of the county, spans the Anna River between Spotsylvania and Hanover Counties. The portion of the bridge in Spotsylvania County has a Warren pony truss with vertical supports. The southern half of the bridge, located in Hanover County, is composed of a flat wood deck supported by steel girders. A low guardrail secures this deck.

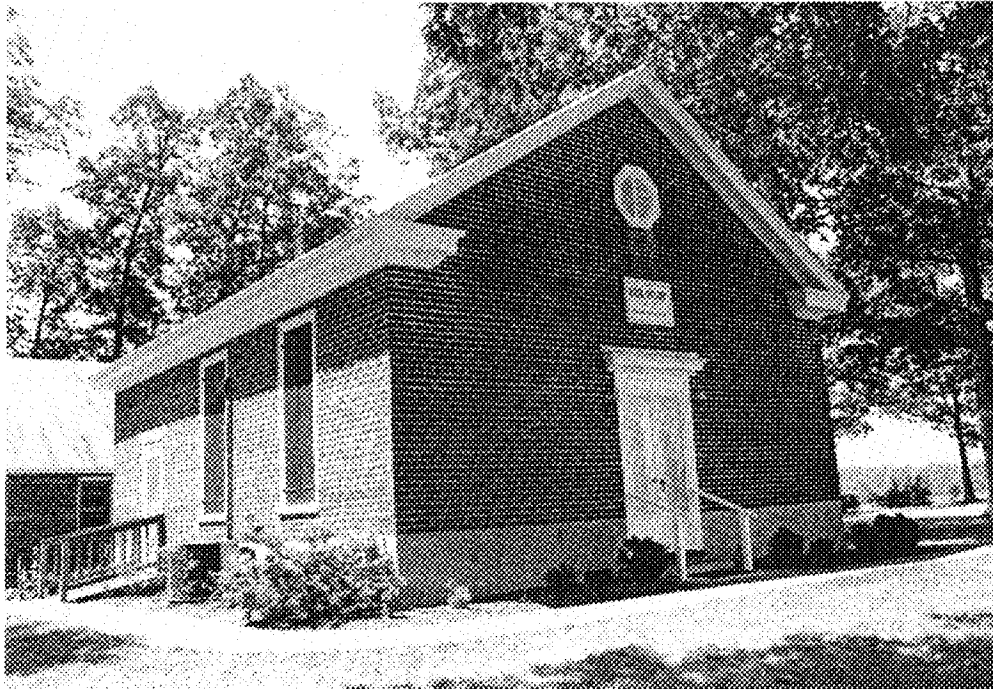
Figure 26: Kirk O'Cliff Church (088-0104)

The one-and-a-half-story Kirk O'Cliff Church is one of few masonry examples of this form, constructed of brick laid in a nine-course American bond. Erected in 1876, soon after the founding of the congregation, the rectangular building is one bay wide and three bays deep with an open nave plan. The front gable roof, clad with pressed metal sheets, has a wide overhang with ogee-molded bed molding, a boxed cornice with narrow ogee profile, and returns. A projected lintel that consists of a boxed ogee-molded cornice with narrow bed molding caps the primary entry. The side elevations of the building are marked by elongated window openings that nearly extend from the watertable to the cornice. The openings are framed with wide molded surrounds and secured with vertical board shutters.

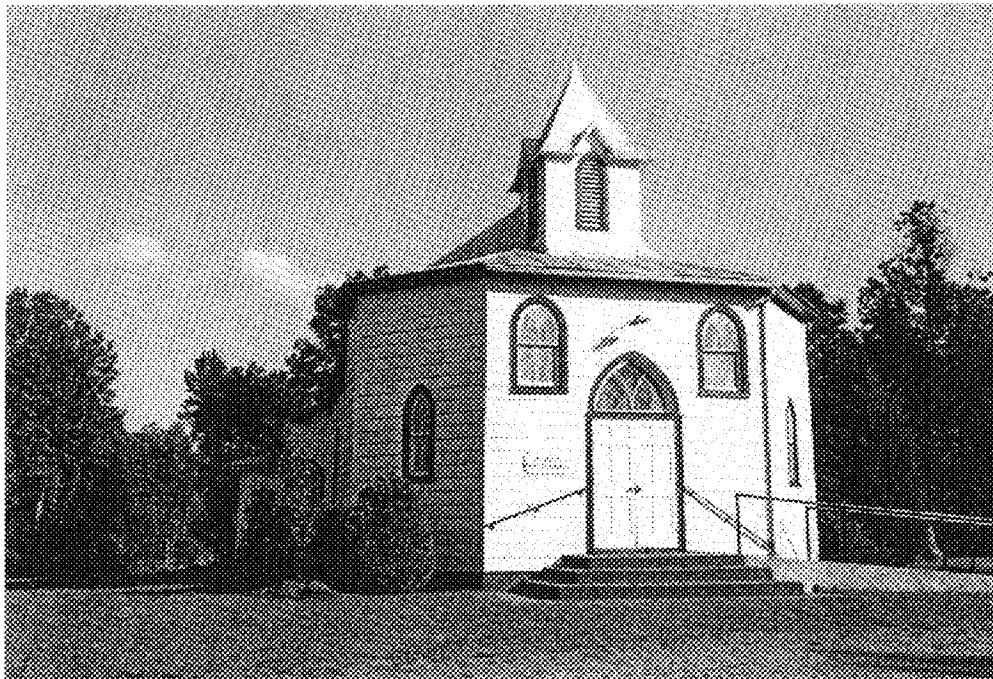
Figure 27: Mount Olive Baptist Church (088-5076)

The congregation of Mount Olive Baptist Church had the church at 10411 Log Cabin Road erected in 1897. This rectangular building has a wood frame cupola that is square in plan. Capped by a steeply pitched pyramidal roof, the cupola has elongated lancet-arched openings holding louvered vents. The metal clad roof is finished with wide overhanging eaves and front gabled pediments that cap the louvered openings. The building is also ornamented with lancet-arched double-hung, wood sash windows holding stained glass.

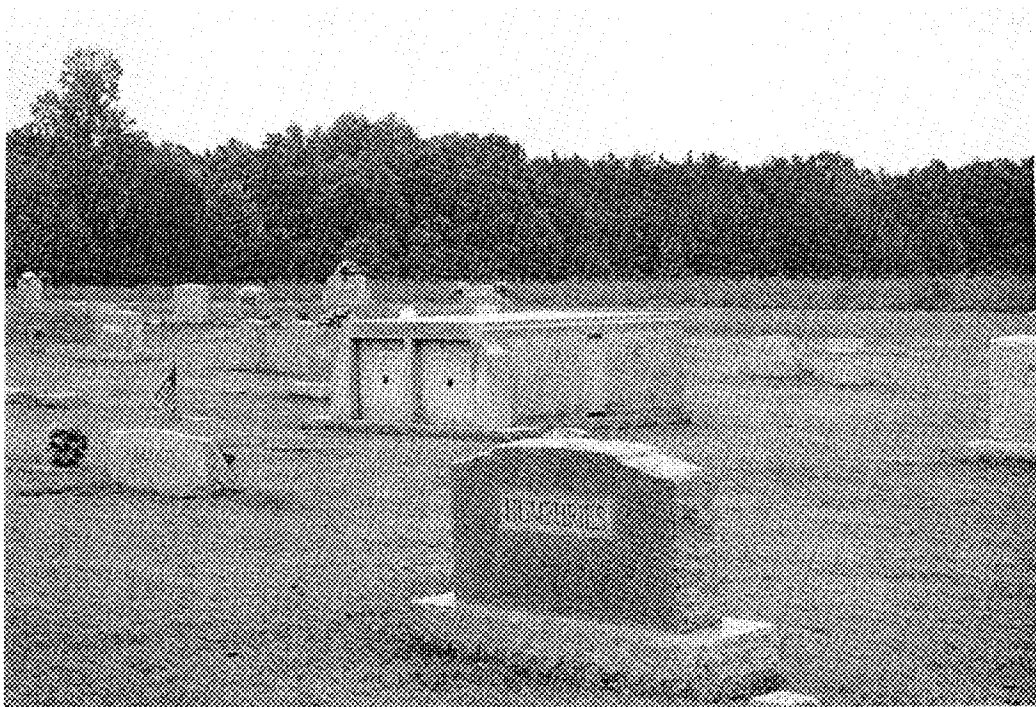
Figure 28: Waller's Baptist Church (088-0094)

Of the nine Baptist cemeteries included in the survey, Waller's Baptist Church (088-0094) was the largest, containing approximately two hundred markers set in eleven primary rows. Primarily constructed of granite, the markers include headstones, beveled markers, and flush markers. The most notable monument is the Marks family chest marker, which is a solid, rectangular raised gravemarker resembling a chest or box-like sarcophagus. This marker holds two graves from the 1950s. The oldest recorded marker in the cemetery was that of Thomas Lewis Chewning (1839-1908), while interments continued well into the 21st century.

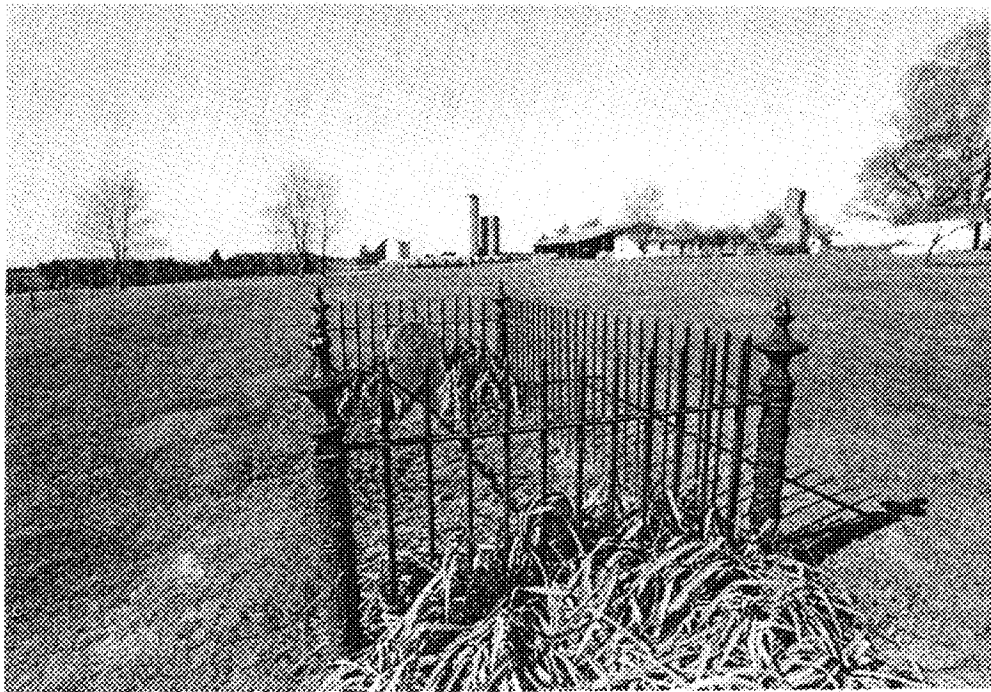
Figure 29: Grave Site at Walnut Grove (088-0112)

The majority of the family burial grounds recorded during the survey are small plots with ten or fewer interments. They are typically surrounded by a metal fence or stone wall and are often situated on a high, well-drained point of land. Walnut Grove (088-0112) has perhaps the smallest cemetery with only one gravestone surrounded by an ornate metal fence. This is the final resting place for Joseph W. Johnson, who died November 10, 1887. Johnson was the second owner of the property, inheriting it from his uncle, Jonathan Nathan Johnson, II.

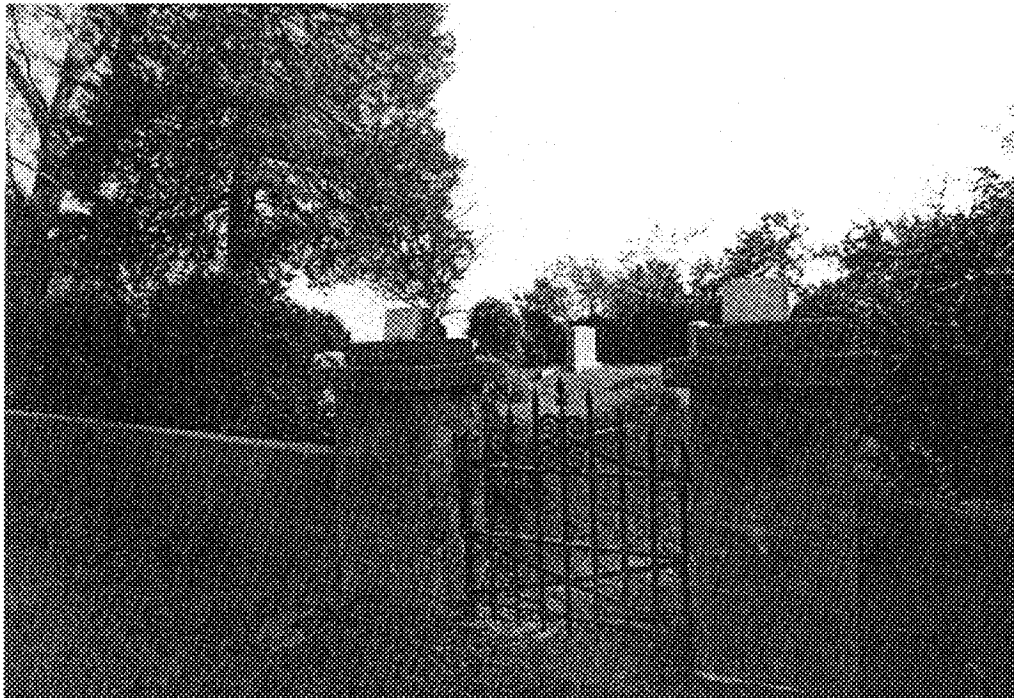
Figure 30: Cherry Grove (088-0018)

The family plot at Cherry Grove (088-0018) contains over ten graves and is surrounded by a low wall with an iron gate. Boxwood hedges encircle the interior of the plot, which is located northeast of the primary dwelling. The cemetery contains markers of the Harris and Walker families, descendants of the present owner. The granite markers are generally set on rectangular bases with segmental-arched headstones set in three rows. A few slant flush markers were noted. The oldest headstone marks the grave of Charlotte Pryor Harris, who died May 29, 1883. Interestingly, this family cemetery has been used well into the 20th century, with the most recent burial in 1992.
