**SECOND PHASE
OF AN ARCHITECTURAL SURVEY
OF
SPOTSYLVANIA COUNTY, VIRGINIA**

**HISTORIC ARCHITECTURAL SURVEY
OF
SPOTSYLVANIA COUNTY, VIRGINIA**

PHASE II

Final Report

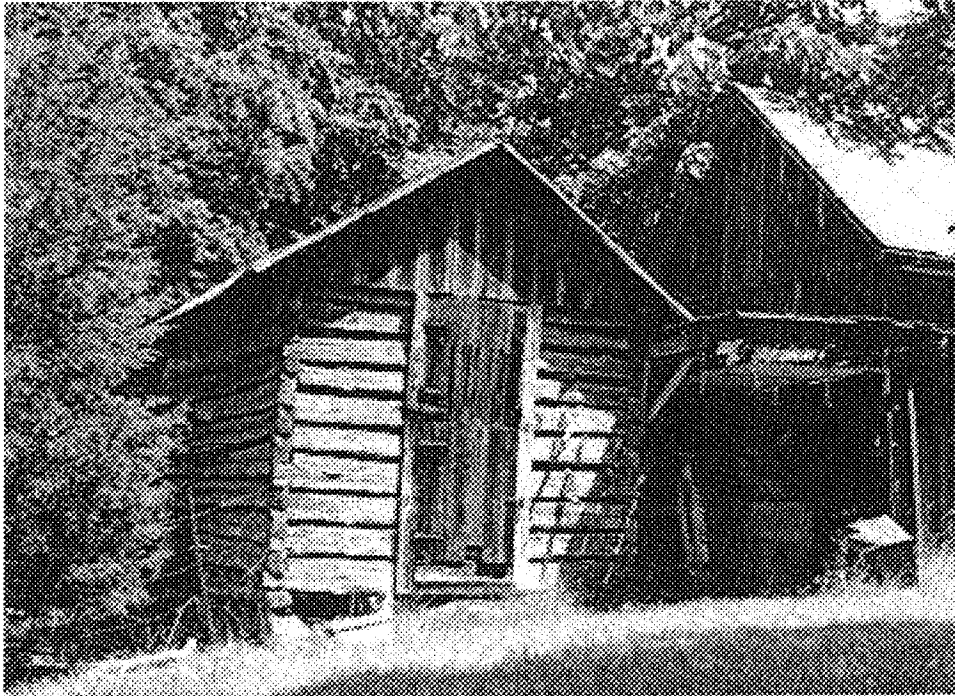
Figure 32: Corner crib at 16129 Monrovia Road (088-5053)

The front-gabled corner crib at 16129 Monrovia Road (88-5053) is particularly worthy of note as the structure dates from the third quarter of the 19th century. The one-bay-wide rectangular structure is set upon a rubble stone pier foundation. It is constructed of logs with half-dovetail notching.

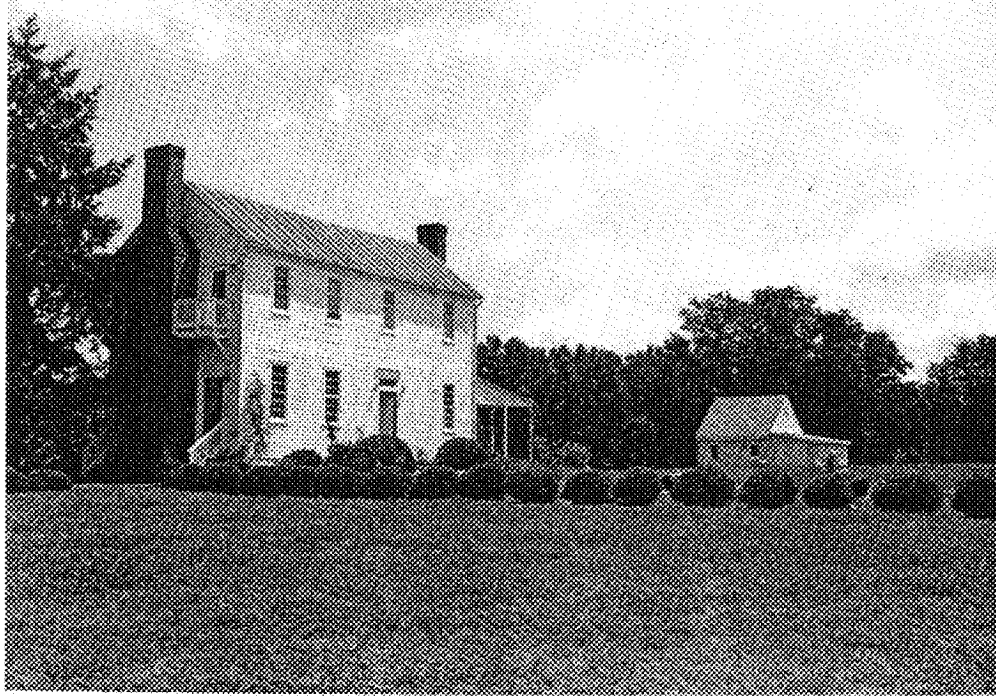
Figure 33: William Waller House (088-5039)

The majority of Federal-style examples noted in the Phase II survey feature three-bay-wide, side-passage plans, topped by side gable roofs. The William Waller House (088-5039) in Chewnings Corner and Mercer Hall (088-5126) in Belmont are excellent examples of the larger central-passage, single-pile plan, measuring four to five bays in width. The popularity of the style prompted many late-18th-century dwellings to be enlarged. The Waller Holladay House (088-5124), for example, was enlarged in the 1830s from a one-room plan to the central-passage, single-pile plan and is now three bays in width.

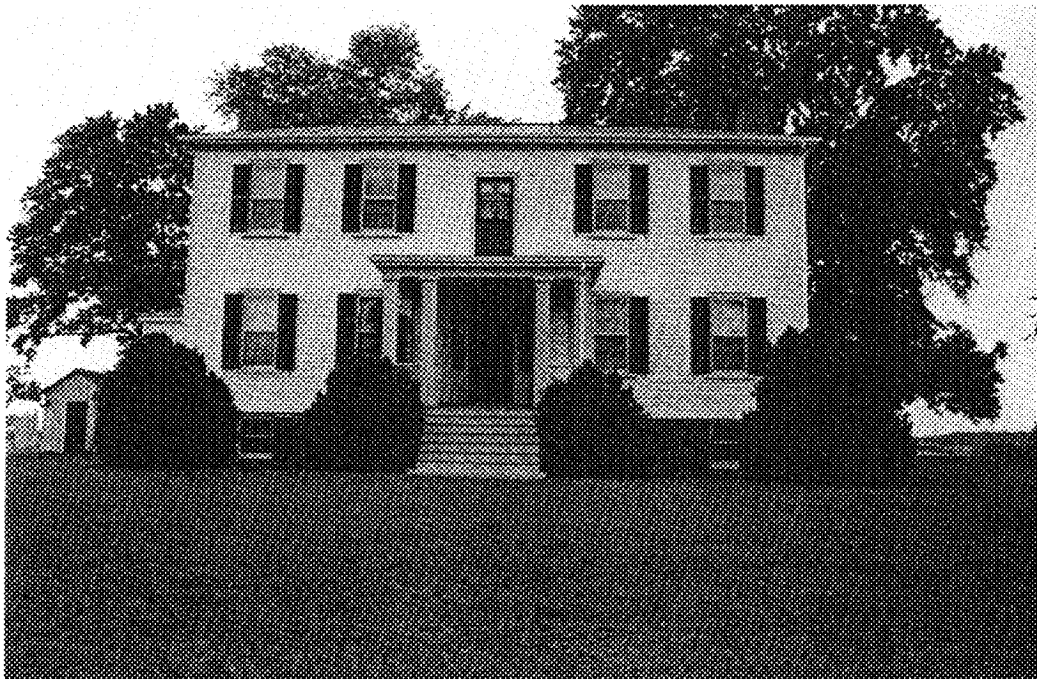
Figure 36: Walnut Grove (088-0112)

The imposing dwelling known as Walnut Grove (088-0112), located on Belmont Road, was constructed in 1829 on property owned by the Beverley family. This wood frame dwelling stands two stories in height on a full English basement finished in eight-course Flemish bond. The dwelling has an L-shaped form set under a very shallow hipped roof. Three slab interior end chimneys of brick pierce the roof. The most distinct Greek Revival-style influence is the entry portico on the façade, which faces northeast. The raised entry porch is constructed of wood frame on brick piers. Paired square posts support the flat roof, which was once edged with an

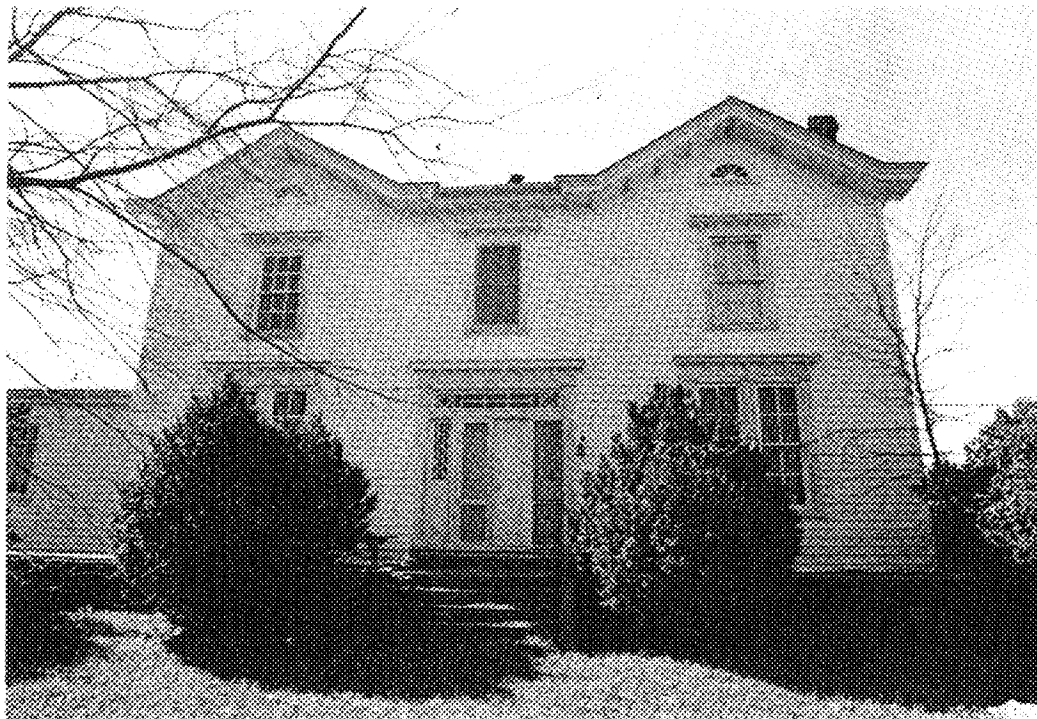
Figure 38: Italianate Façade of Edgewood (088-5058)

The most significant expression of the Italianate style is the single-family dwelling known as Edgewood (088-5058). This two-story wood frame building was erected in 1827 for Reuben Lindsay Coleman as a Federal-style dwelling. In the 1870s, the primary façade, facing northeast, was substantially altered to reflect the Italianate style, which had become fashionable in the middle part of the 19th century. The main block of the building, which is supported by a contemporaneous rear ell, has a three-bay-wide form, with a central-passage entry flanked by single-pile parlors. The shallow hipped roof was altered on the northeast elevation to provide two steeply pitched open gables with expansive overhanging eaves. The molded cornice, returning on the side elevations, was ornamented with a frieze board and exposed rafter ends that read as brackets. Between the two gables, the roofline is flat with modillions and a molded cornice. The double-leaf entry was dressed with raised molding that created segmental-arched

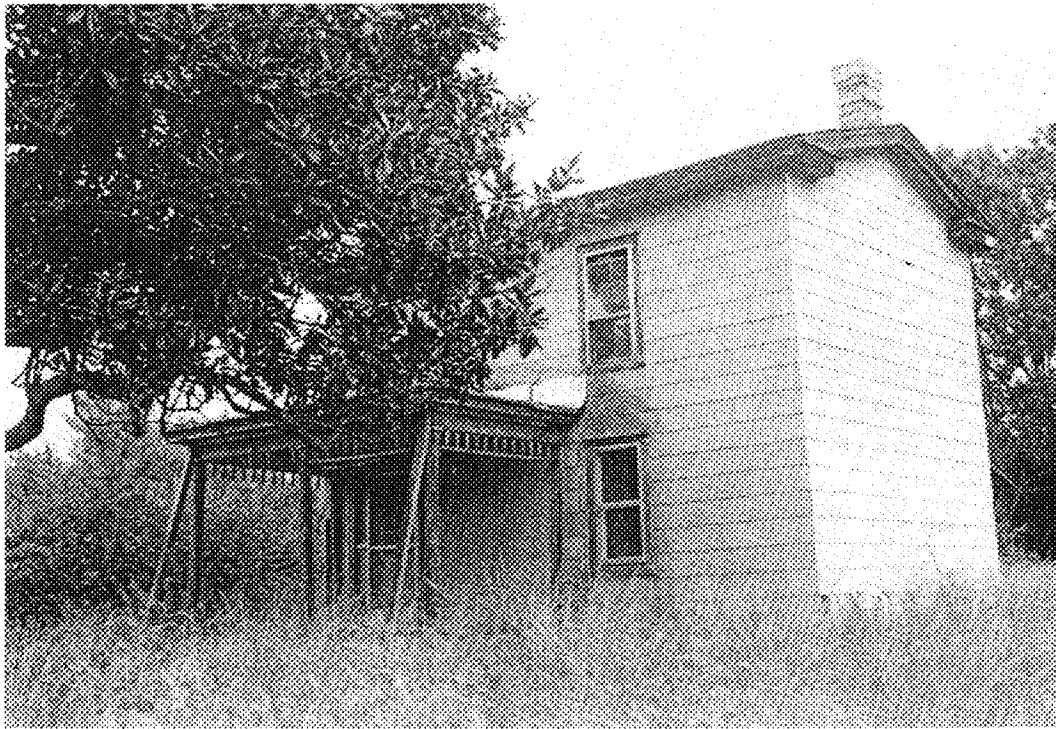
Figure 39: House at 7117 Grand Brooks Road (088-5051)

The now vacant dwelling at 7117 Grand Brooks Road (088-5051) exhibits many of the traditional Queen Anne-style elements popularized during the Victorian era, albeit minimally. The main block of the building is based on the traditional I-house form, although subsequent alterations now obscure the original three-bay-wide fenestration. The side gable roof is trimmed with an ogee-molded boxed cornice with returns and bed molding. An ornately corbeled brick interior end chimney rises from the side elevation. A two-bay-wide porch with a half-hipped roof shelters the side entry. Although the porch is presently in a state of deterioration, it retains the thin supporting Tuscan posts and spindle frieze. A similar frieze was noted on the porch of the building on the east side of the 7300 block of Lawyers Road.

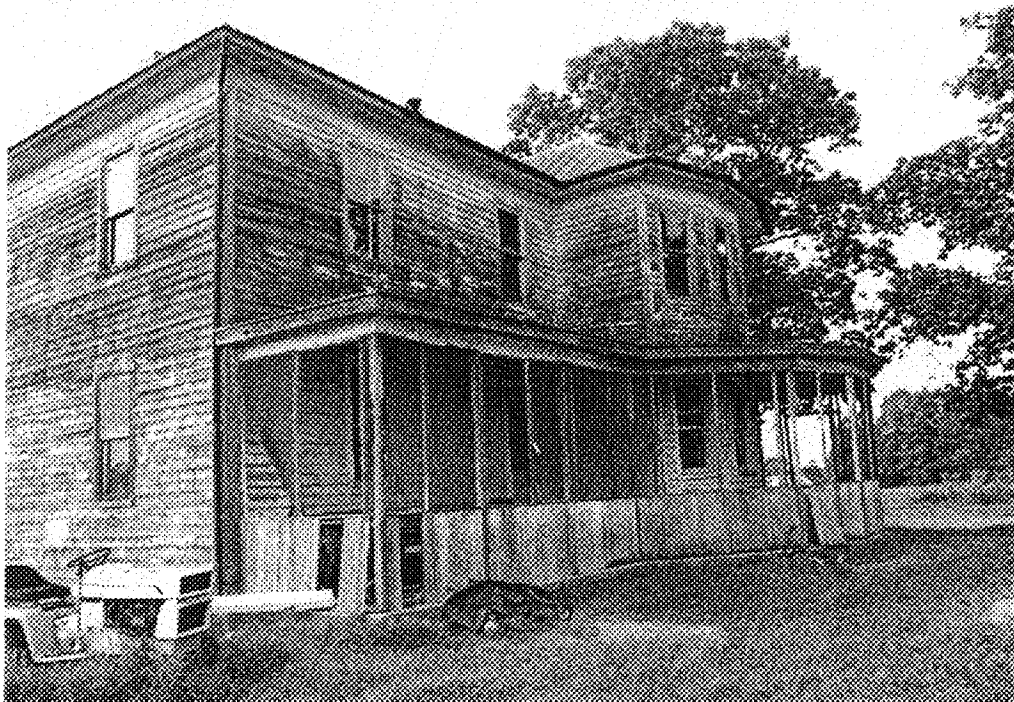
Figure 40: House at 3120 Winding Road (088-5109)

The wood frame dwelling in Winding Road, now vacant, has a square form with a projecting canted two-story bay on the side. The sections of the building are united by a porch that extends across the two bays of the main block and wraps around the three sides of the projecting bay. The porch has thin turned posts supporting a half-hipped roof with a molded cornice. The building's design and original materials are reputed to have been the product of Sears, Roebuck and Company. This mail-order house was purchased at the turn of the 20th century for \$700, shipped by railroad to Beaverdam in pieces, and assembled on Winding Road by local builders for \$100.

The large wood frame building at 3120 Winding Road (088-5109) stands two-and-a-half stories in height with a square plan augmented by a projecting six-sided bay. The building is set on a stone foundation and is clad in weatherboard siding edged with corner boards. A one-story porch, supported by turned posts, extends around the projecting bay and façade. The wrap-around effect of the porch and the canted bay are reminiscent of the Queen Anne, albeit a vernacular illustration of the style.
