ARCHITECTURAL SURVEY REPORT

ABINGDON, VIRGINIA

THOMASON AND ASSOCIATES
PRESERVATION PLANNERS
P.O. BOX 121225
NASHVILLE, TENNESSEE
37212
615-385-4960

DECEMBER, 1998

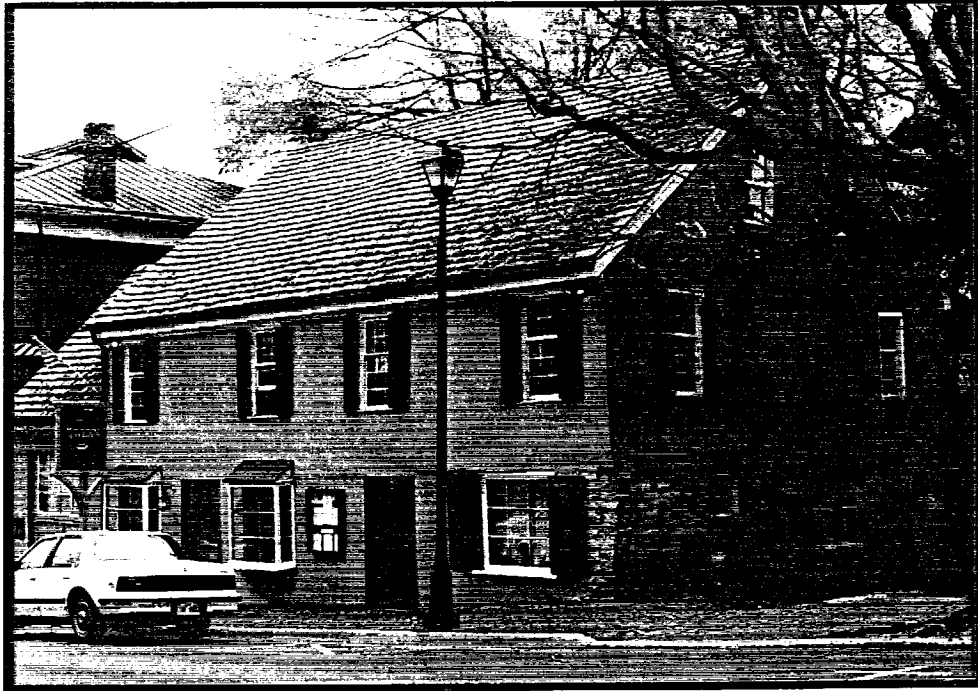
Figure 1: Vance's Tavern at 222 E. Main Street (140-2).

Extant commercial buildings from this time period include Vance's Tavern at 222 E. Main Street (140-2, Fig. 1). Vance's Tavern is likely Abingdon's oldest existing building and it appears to date as early as 1788. This two-story log and stone building was originally a tavern and residence, and over the years has been used as a bakery, general store, and other commercial uses. At some point in the 19th century, the exterior was covered with stucco and the original windows were replaced. The interior has been remodeled several times and now houses a restaurant.

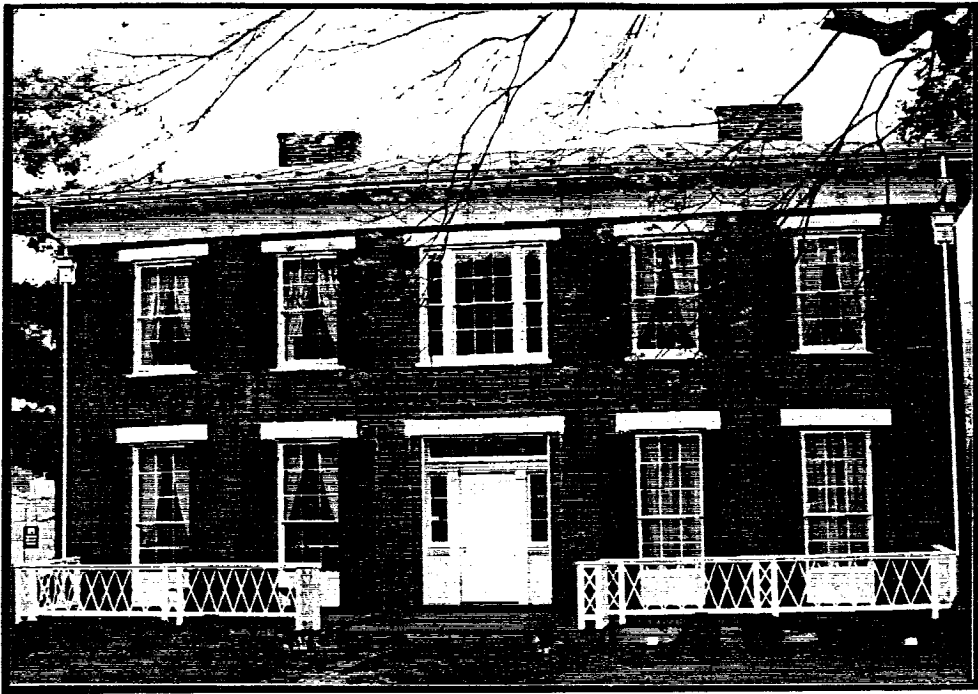
Figure 3: James Fields House at 208 W. Main Street (140-7).

Dwellings were also built during the 1840s and 1850s which combined elements of the Italianate and Greek Revival styles. One of these was the James Fields House completed in 1859 at 208 W. Main Street (140-7, Fig. 3). This two-story brick dwelling was designed with a one-story entry porch which has since been removed. The house has paired eave brackets, sidelights and transoms at the main entrance, and original multi-light sash windows with lintels. This dwelling is now owned by the Town of Abingdon and is operated as a house museum by the William King Regional Arts Center.

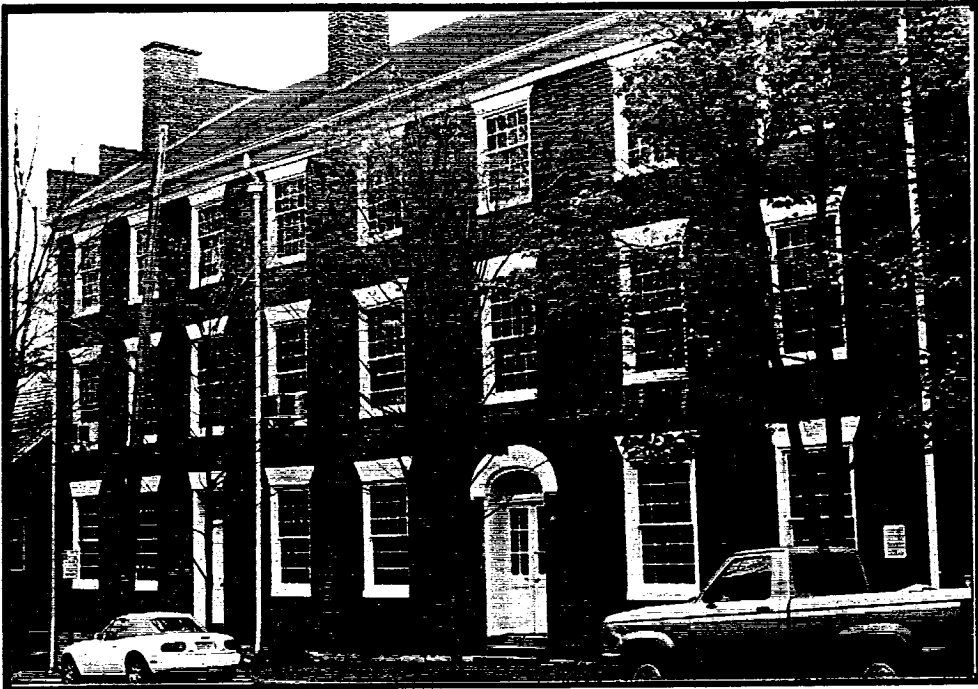
Figure 4: Virginia House Hotel at 208 E. Main Street (140-14).

The Washington House Hotel was constructed at 230 E. Main Street in 1835 (140-39-150). This building served as the city's first formal hotel and it was designed with influences of the Federal style. The building has a central bracketed cornice at the main entrance and twelve-over-twelve sash windows with jack arches. Two storefronts were later added to the building. At 208 E. Main Street, John Dunn built a large three-story brick hotel building in 1846 (140-14, Fig. 4). This building was designed in the Federal style to house businesses in the east section and the hotel in the west section. The building's main entrance has an arched doorway with a fanlight transom and windows have twelve-over-twelve sash windows with jack arches. The building was later known as the Virginia House Hotel and the Arlington House. The building is presently used to house law offices.

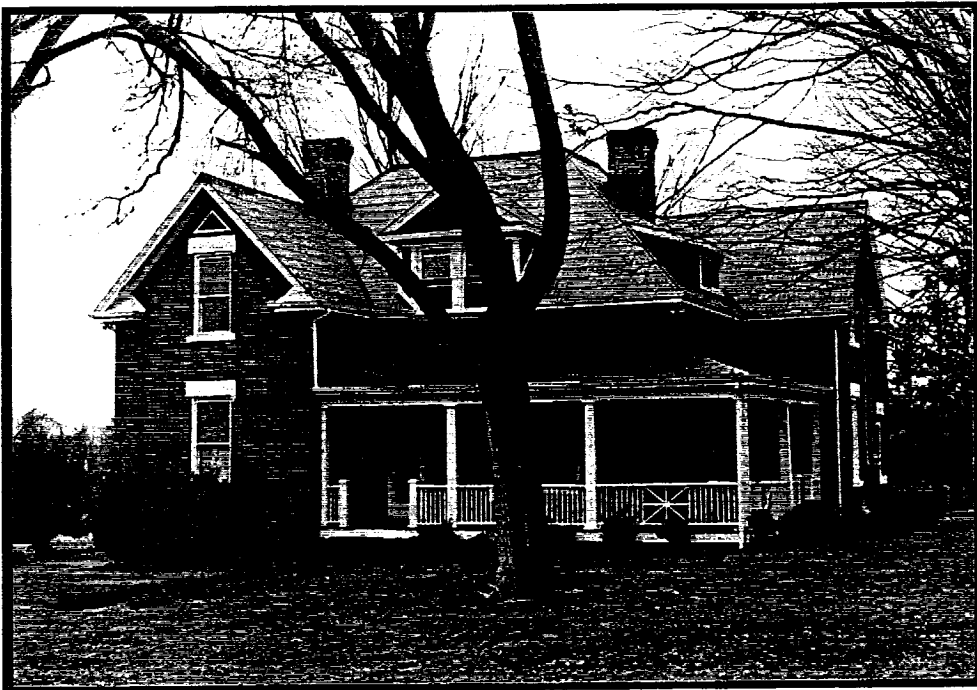
Figure 6: Gabled Ell dwelling at 315 Jamison Street (140-109).

Folk Victorian forms are primarily one-story, balloon-frame dwellings which were originally built with brick foundations and chimneys, and exteriors of weatherboard siding. The most common Folk Victorian form in Abingdon is the Gabled Ell, or T-plan. Most examples in the city are one-story, two-bay structures with projecting bays, and either gable or hipped roofs. A representative example of this house form is the William G. Hagy House completed in 1910 at 163 W. Valley Street (140-39-107). This frame dwelling has a projecting bay on the main facade, a porch with milled columns, and a hipped roof. A brick example of a Gabled Ell dwelling was built ca. 1905 at 315 Jamison Street (140-109, Fig. 6). This dwelling retains its original porch columns, hipped roof of pressed metal shingles, and gable dormer at the roofline.

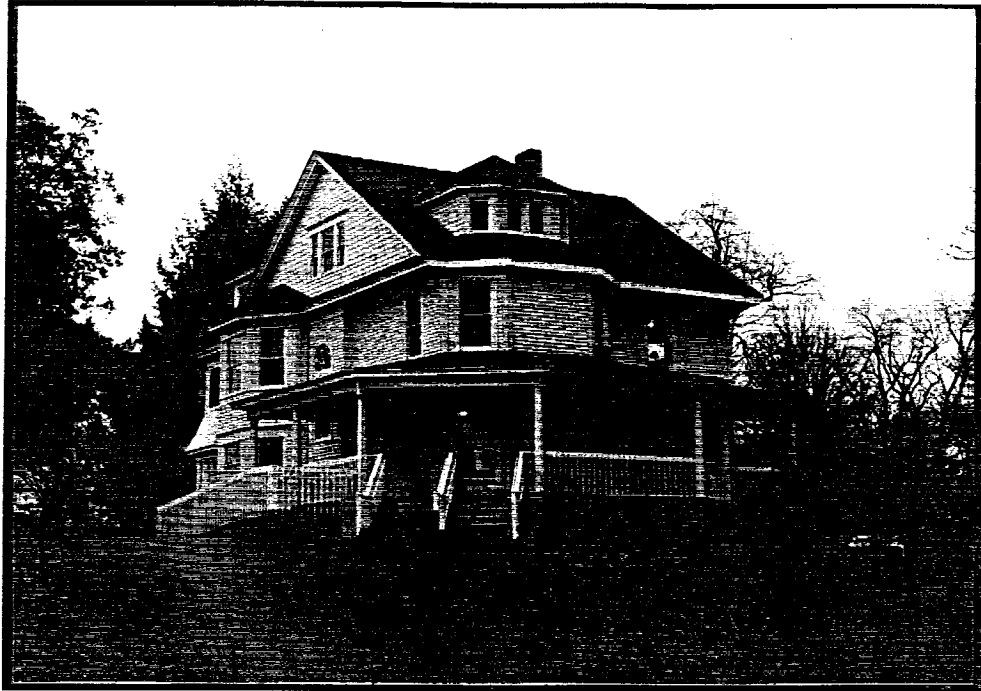
Figure 7: William A. Hassinger House at 333 Cummings Street (140-111).

Another notable example of the Queen Anne style is the William A. Hassinger House which was built at 333 Cummings Street in 1906 (140-111, Fig. 7). The two-story frame building features a wraparound porch with Tuscan columns, an exterior of weatherboard and wood shingles, and a large two-story bay window on the east facade. The building served as a dwelling during much of the 20th century but now houses the Abingdon Convention and Visitor's Bureau.

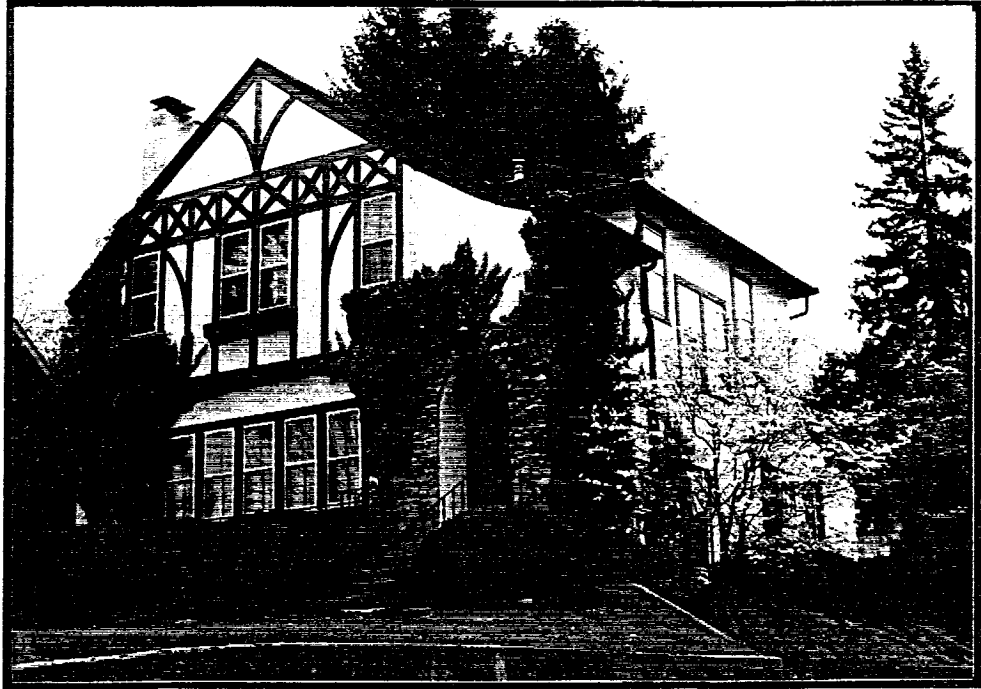
Figure 9: William R. Cline House at 111 W. Valley Street built in the Tudor Revival style (140-39-92).

often display high pitched roofs, prominent wall chimneys, rounded arch doorways, casement windows, and exteriors of stone, brick, stucco, and half-timbering. The William R. Cline House at 111 W. Valley Street is a notable example of this style and has a stone and stucco exterior, arched entrance, and half timbering on the main facade (140-39-92, Fig. 9).

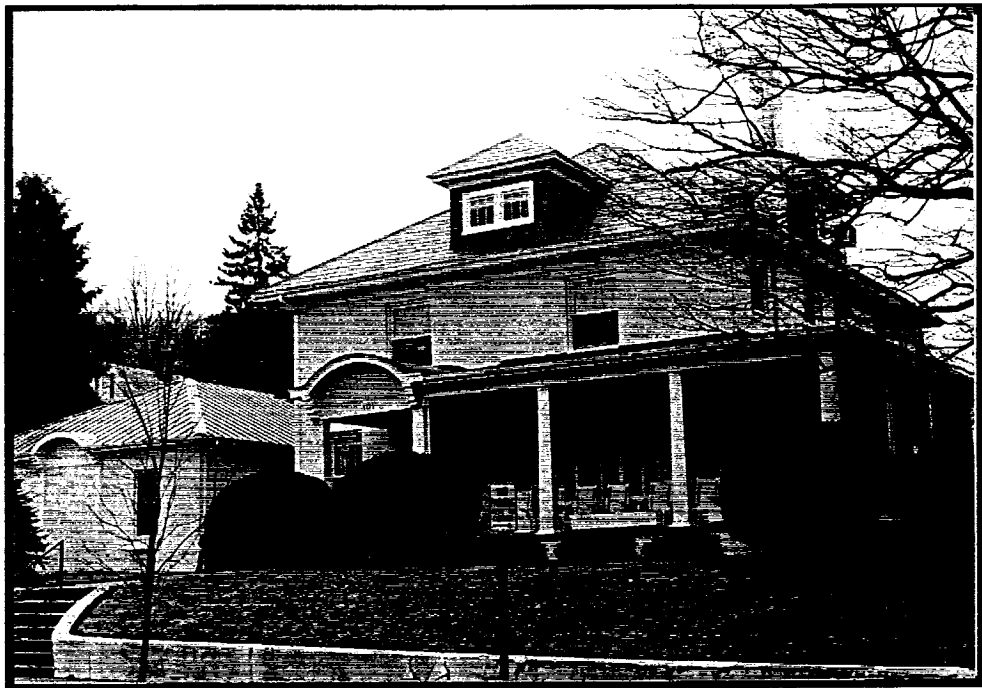
Figure 10: John L. Bradley House at 101 W. Valley Street (140-39-89).

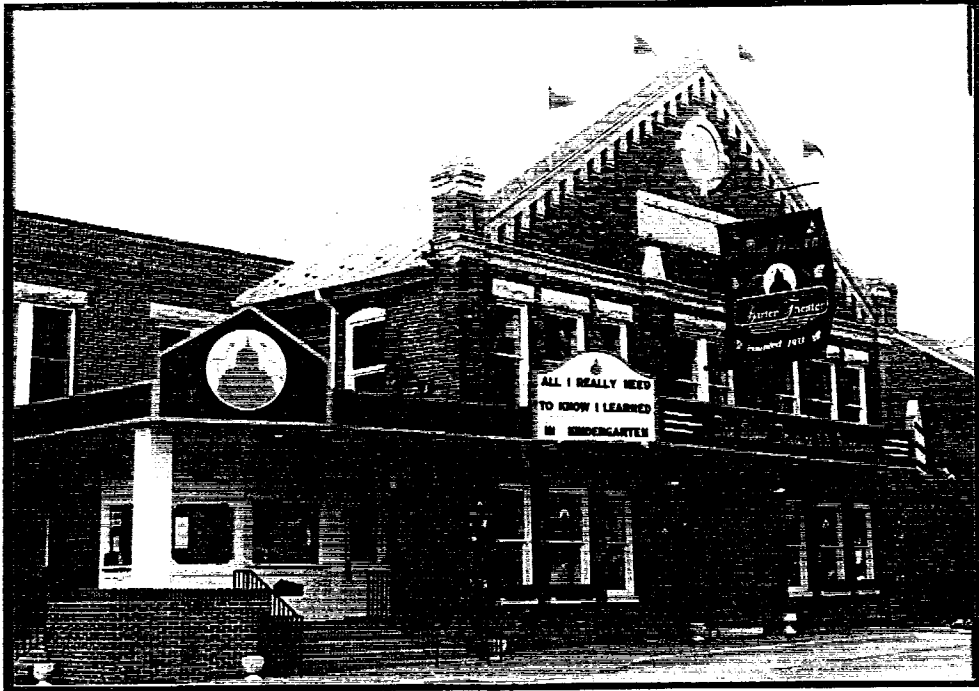
Figure 11: Barter Theatre on W. Main Street (140-5).

Abingdon is well known as the home of the Barter Theatre, the State Theatre of Virginia (Fig. 11). Located on W. Main Street, the theatre is housed in a two-story brick building which was originally the Sinking Spring Presbyterian Church. This 1832 church building was remodeled into its present form in the early 1900s when it was converted into a Town Hall (140-5). In addition to housing offices, a large central portion of the building was used for performances and known as the "Opera House." In 1933, a group of out-of-work actors came to Abingdon through the efforts of Robert Porterfield. Plays were performed at the Opera House in exchange for produce or other goods. These "bartered" arrangements gave the theatre its name and it became a well known and popular theatre over the next decade. During the 1940s and 1950s, the Barter Theatre acquired the buildings of Stonewall Jackson College on E. Valley Street as dormitories and shops. Today, the Barter Theatre plays to thousands annually and is the designated State Theatre of Virginia.

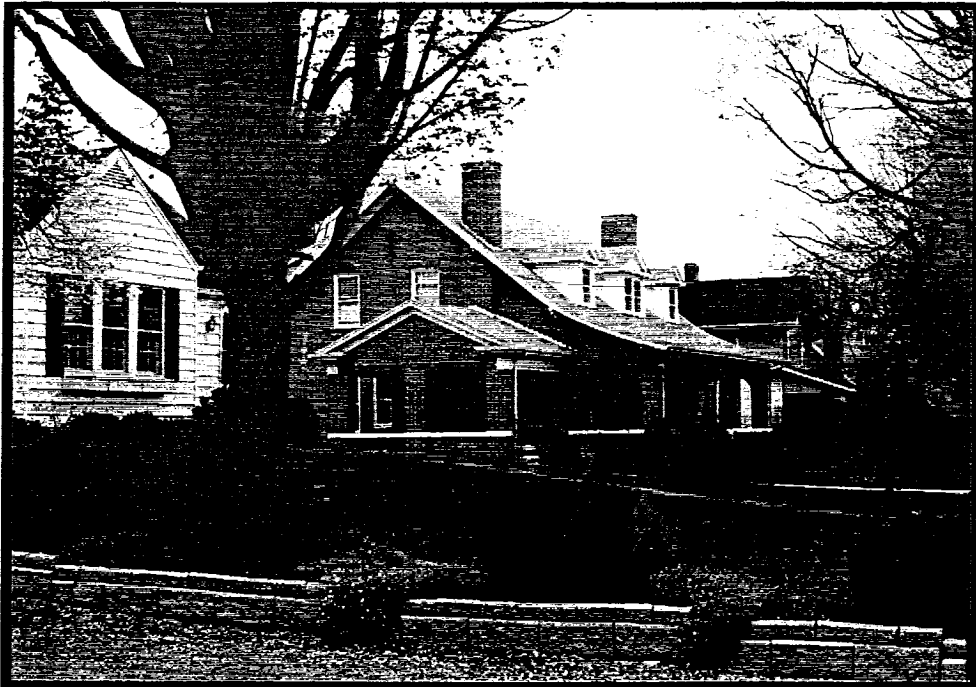
Figure 14: Streetscape on Stonewall Heights.

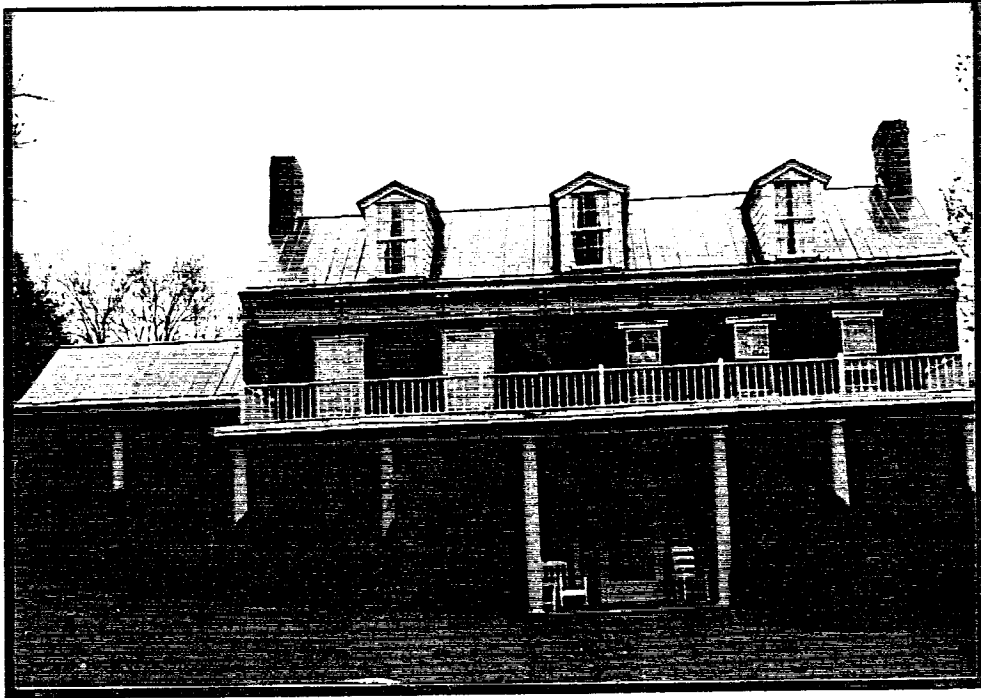
Figure 16: Retirement at 702 Colonial Road (140-6).

1. Retirement, 702 Colonial Road (DHR Inventory # 140-6). This two-story brick dwelling was constructed ca. 1808 as the residence for Captain Robert Craig. The dwelling was enlarged with a brick wing in 1857 and a frame addition was added at the rear ca. 1900. On the main facade is a ca. 1910 porch with Tuscan columns and a wood balustrade. the dwelling retains a wood paneled entrance with sidelights and transom and six-over-six wood sash windows. At the roofline are gable dormers. Retirement may be eligible for the National Register under criterion C for its architectural design (Fig. 16).

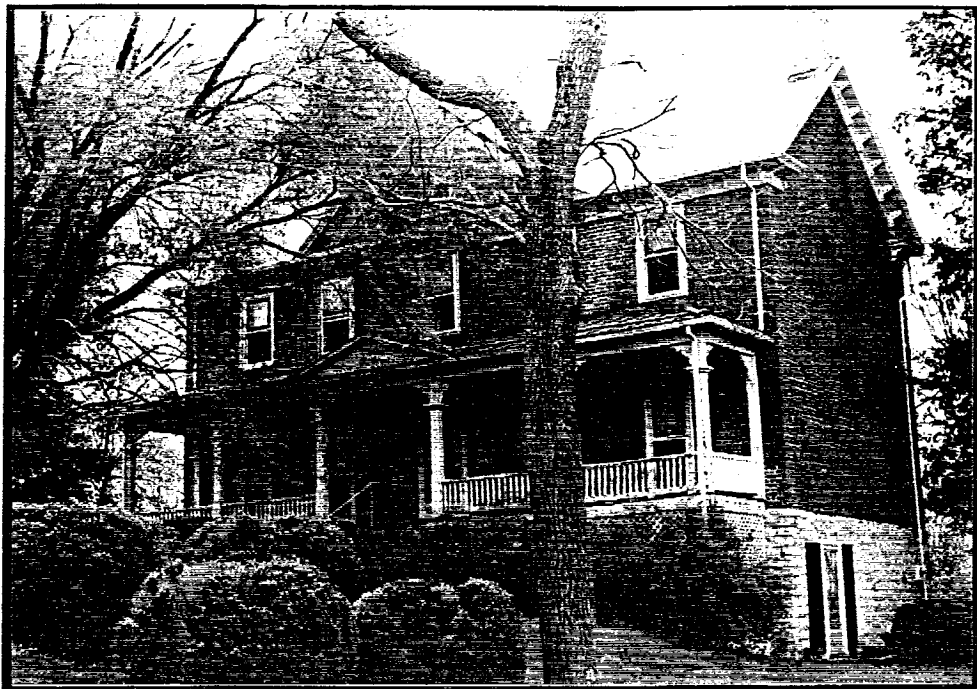
Figure 18: Dr. Earl Clapp House on Route 794 (DHR Inventory # 24/Washington County).

5. Dr. Earl Clapp House, Route 794 (DHR Inventory # 24/Washington County). This two-story brick dwelling was completed in 1828 for Dr. Earl Clapp. The house was modified ca. 1880 with a full width porch with milled columns, eave brackets, and windows with border glass lights. At the roofline is a central gable wall dormer. Nearby is an original brick smokehouse. This dwelling may be eligible for the National Register under criterion C for its architectural design (Fig. 18).

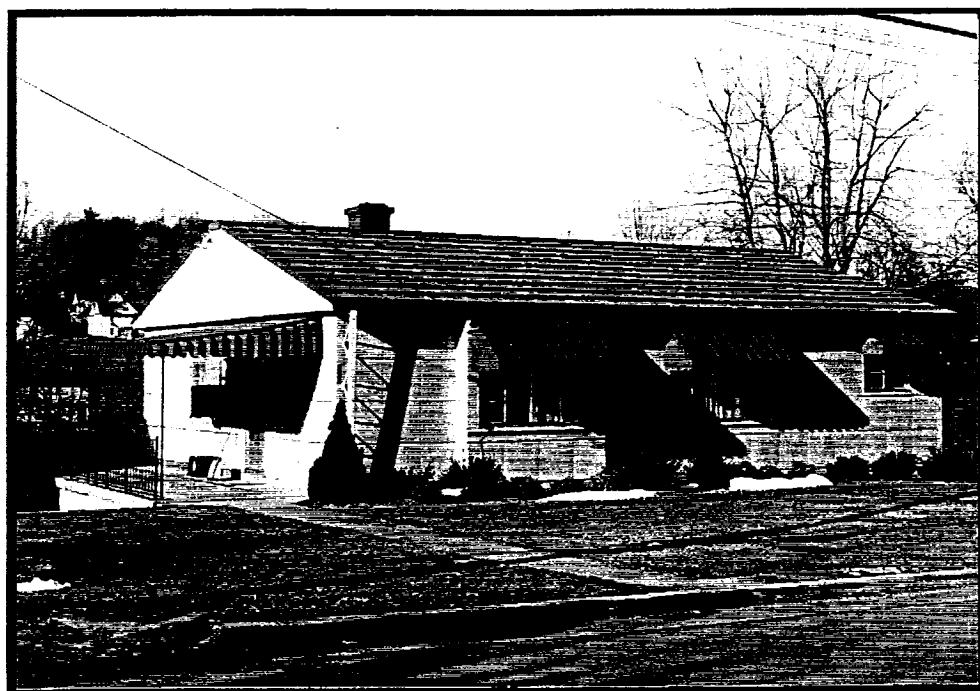
Figure 19: Lustron House, 253 Bradley Street (DHR Inventory # 140-101).

6. Lustron House, 253 Bradley Street (DHR Inventory # 140-101). This dwelling was constructed in 1950 and is the city's only example of an all-metal Lustron House. This dwelling was built of porcelain panels and manufactured by the Lustron Company of Columbus, Ohio. This company produced similar plan designs from 1947 until it went bankrupt in 1950. This Lustron House may be eligible under National Register criterion C for its architectural significance. Its eligibility would be based upon further research and comparisons of integrity with other Lustron Houses in Virginia (Fig. 19).
