**NATIONAL REGISTER OF HISTORIC PLACES
REGISTRATION FORM**

historic name Ware Neck Store and Post Office

**Ware Neck Store and Post Office
Gloucester County, Virginia**

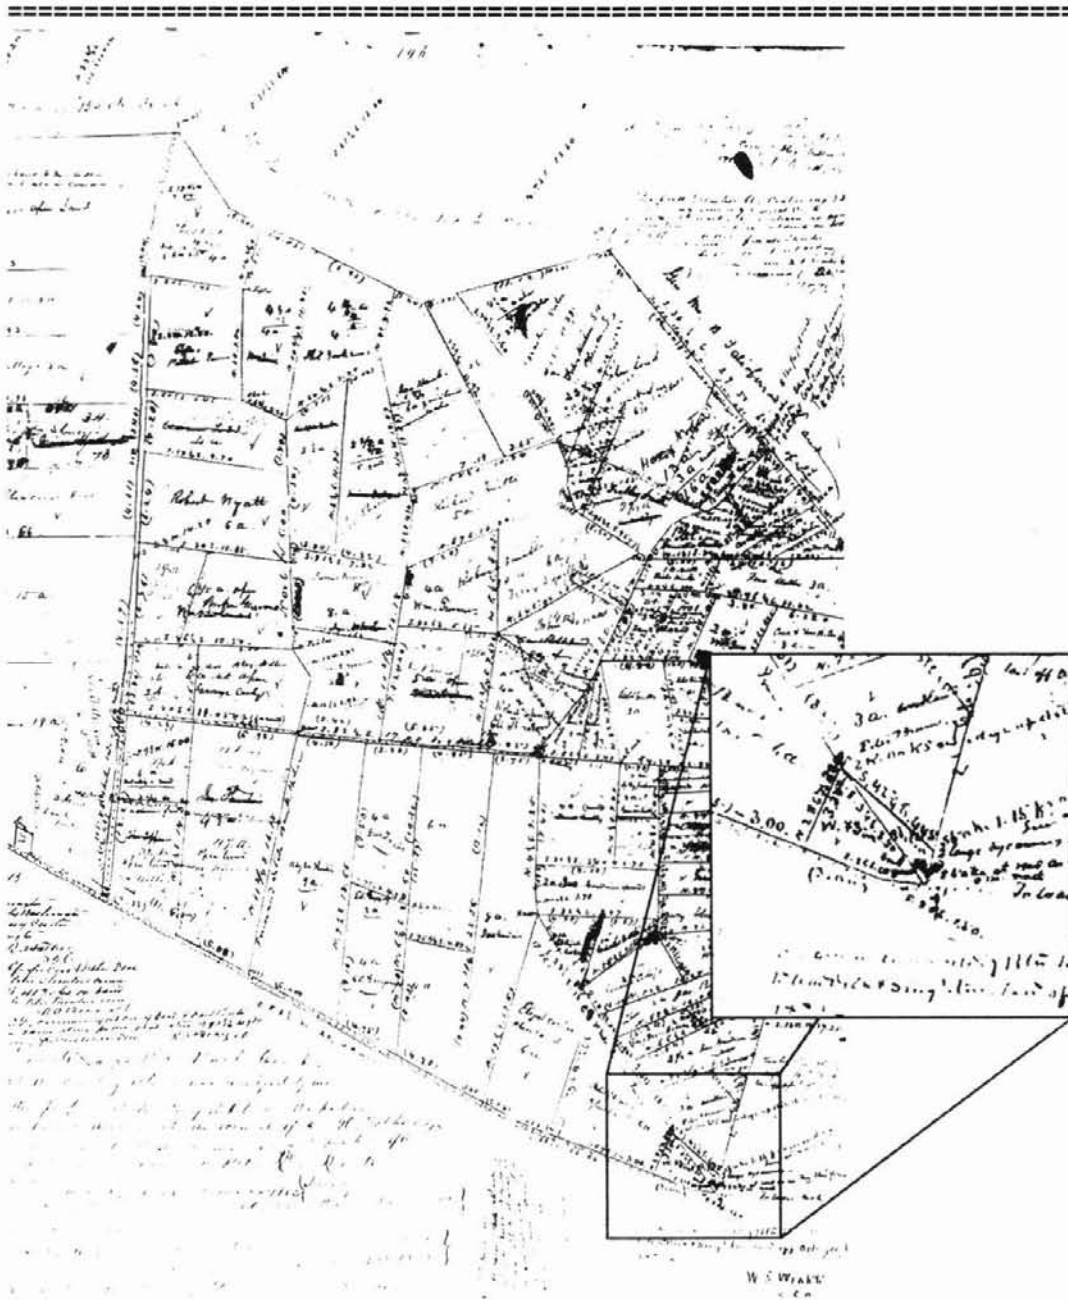
Figure 2. 1870 plat of the division of Back Creek Plantation, showing a detail of the future site of Ware Neck Store (Clerk's Plat Book 2 page 196).

The history of the Ware Neck Store and Post Office (036-5016) began in 1876 when the heirs of J. H. Tabb sold a nine-acre portion of his Back Creek Estate to Arthur W. Tabb.¹ Back Creek estate was more than 450 acres in size, but was significantly subdivided following the Civil War with a large portion of the property bordering the Ware Neck Store lot sold to former slaves, documenting the transformation of a local African-American community, and signifying the tremendous changes in land patterns and economy of post-bellum Virginia. Ware Neck Store is located about six miles east of Gloucester Courthouse on an historically rich expanse of land called Ware Neck. Ware Neck was one of Gloucester County's earliest settled areas, and it contains many large estates with histories stretching back to the mid-seventeenth century. The neck is bisected by one primary road, Ware Neck Road (Rt. 623), and bounded to the north and south by the North River and Ware River, respectively. The land Arthur Tabb purchased occupied a strategic intersection at the corner of Dunham Massie Lane (Rt. 692) (leading to a large historic property) and Hockley Wharf Lane, leading to the most important steamboat landing on Ware Neck. Taking advantage of these qualities, Arthur Tabb built his store in 1877.² Goods were offloaded at the wharf and transported the half-mile to the store by horse and wagon. Other stores were also built in this vicinity to take advantage of the commercial opportunities, including Tazewell Thompson Store (036-5032) located across the street from Tabb's store, which operated until recently and still stands.

Figure 2. *1870 plat of the division of Back Creek Plantation, showing a detail of the future site of Ware Neck Store.*

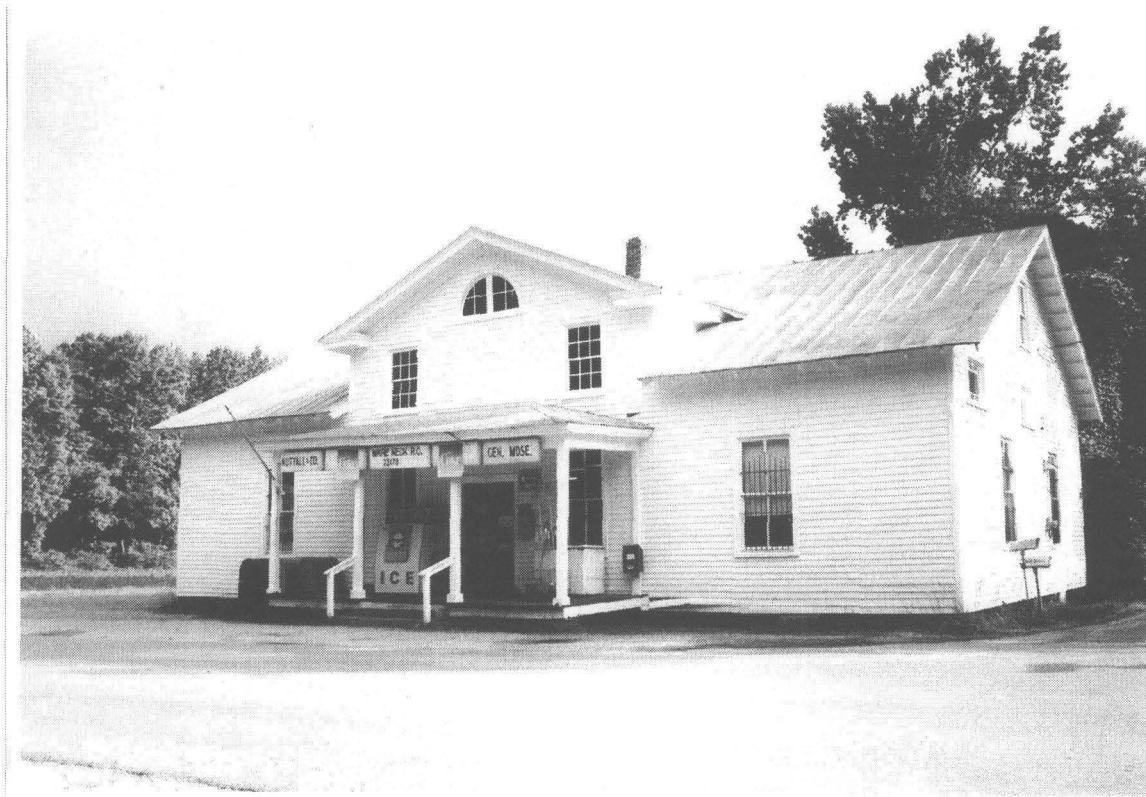
Figure 4. 1990s photograph of the south façade of Ware Neck Store and Post Office.

The store has a three-bay south façade with a central two-story block flanked by 1 ½ story wings. The central block has a centrally placed double-leaf wood door flanked by two-over-two wood, double-hung sash windows. The south façade of each wing has one centrally-placed two-over-two wood, double-hung sash window, matching those flanking the doorway. All of the first floor windows on the main store building are also fitted with iron bars to prevent forced entry. The bars appear on an early twentieth-century photo, indicating they are early elements of the building. A one-story porch extends across the central block. This is also seen in the early photograph, extending two bays further west than the current porch. Today, it is covered with a standing-seam metal, hipped roof, and supported by square wood posts. The porch floor is tongue-and-groove boards supported on brick piers. Two wooden stairs lead up to the central part of the porch, and they are flanked by simple wood handrails made of 2" x 4" stock lumber. Multiple signs are affixed to the porch entablature including the post office and former store name.

Figure 4. *1990s photograph of the south façade of Ware Neck Store and Post Office.*

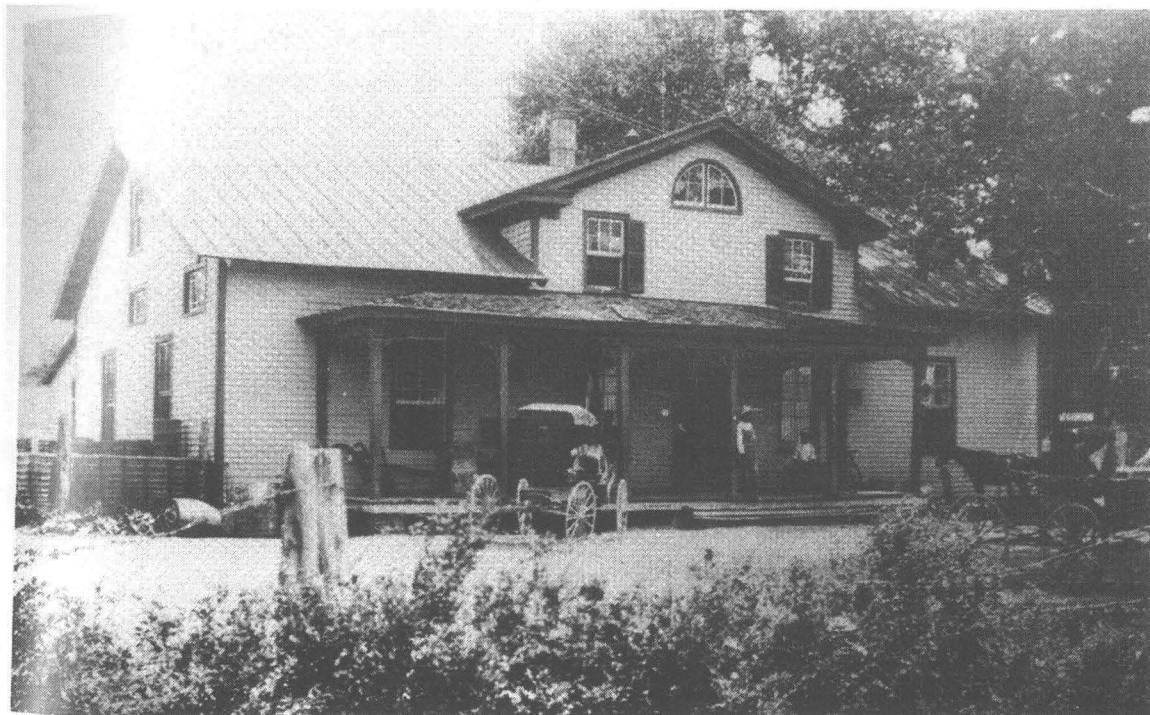
Figure 5. 1914 photograph of the south façade of the Ware Neck Store and Post Office (Sinclair 1991:77).

Tabb's store began as a two-story rectangular building, with the short façade facing south. The second floor was initially used for additional stock, and at a later date housed a millinery shop.³ He operated the store until 1884, when brothers Richard P. and H.E. Taliaferro purchased the 9 ½ acre parcel.⁴ Based on increasing building value recorded between 1892 and 1894, it appears that the one-story flanking wings were added to the original store at this time. A further addition to the north side of the store, extending the original two-story block, as well as residential space, were likely added during the 1890s or first decade of the 1900s. In 1886 the Taliaferros established the Ware Neck Post Office in their store. Richard P. Taliaferro served as postmaster from 1886 until 1897, and later postmasters include Thomas Cooke (1897-1909), James B. Cooke (1909-1914,1921), and Charles Bernard Anderton (1914).⁵ In 1902, R.P. and H.E. Taliaferro divided the 8.1 acre property between themselves, with R.P. retaining the store and majority of the property.⁶ The building value increased during the first two decades of the twentieth century, possibly a combination of additions to the residential portion as well assessment increases. In 1919 Taliaferro sold 6.33 acres, retaining just 1.17 acres around the store.⁷

Figure 5. *1914 photograph of the south façade of the Ware Neck Store and Post Office.*

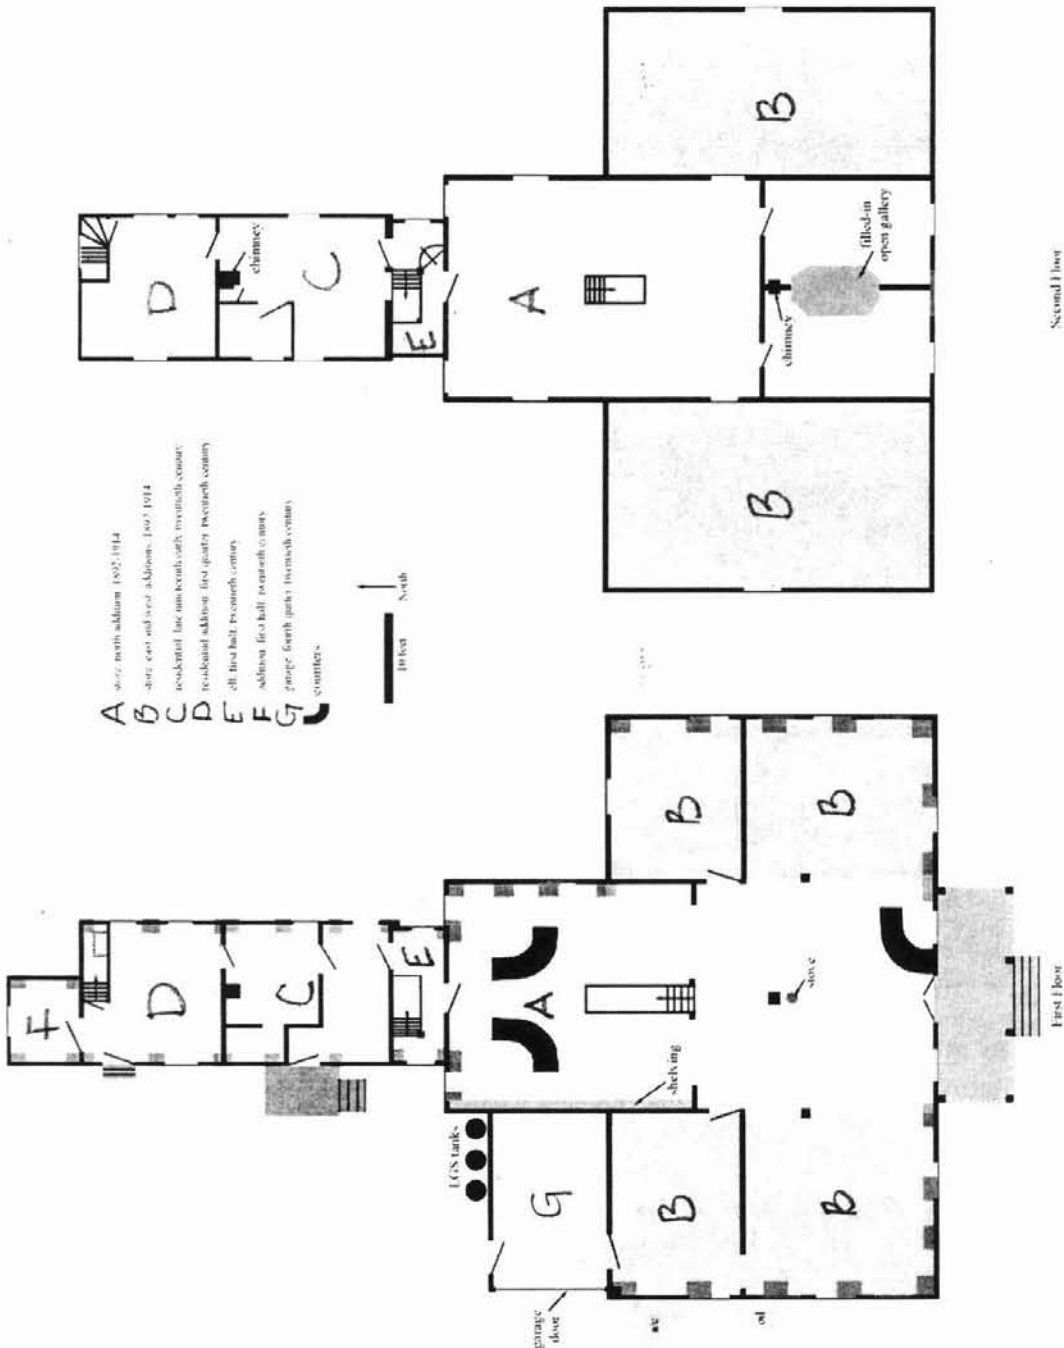
Figure 6. Floor plans for the Ware Neck Store and Post Office.

The interior of the store is a very large T-shaped space. The floors are narrow hardwood boards, likely pine, and the walls and ceilings are covered with white painted narrow beaded boards (channel at the joint, tongue and groove). Modern shelves full of merchandise run east to west across the south room of the store, with a wide central aisle allowing access further into the store. Foodstuffs are located on the west side, while dry goods and gift items are on the east side. A deli counter is along the west wall. Modern refrigerated units are located near the main entrance and in the northern part of the store. An early curved wooden counter to the east of the door is one of the original store counters, though its position may have changed. Directly north of the entrance is a tall, cylindrical metal heating stove. A metal flue runs up from the stove to the brick chimney directly north of it. Beyond the chimney is a large centrally placed staircase leading up to the second floor. The stairway is open to the room and runs in one straight flight to the second floor. There are two square wood newel posts to support the molded wood handrails, and a pair of turned balusters is on each stair tread. Drop finials decorate the base of the upstairs newel posts. The finials are missing from the lower newel posts, but these appear to have been removed and stored in a back room. Upstairs the stairway opening is surrounded by another balustrade similar to that along the stairs, but most of this was covered with insulation and difficult to observe. The back part of the store space contains shelves lining the west wall and free-standing racks containing additional merchandise. Two large and original curved wooden counters sit near the back of the room, placed on either side of the central aisle, allowing access to the north door. The north door is an original wood door with thick strap hinges. It has four panels on the north side, while the south side is covered with diagonal boards.

The ceiling of the central part of the store is lower than that in the wings, in order to accommodate the second floor above this section. The ceiling in the wings is very high and spacious. Two additional rooms are accessed from the main large room. On the right is the Ware Neck Post Office, and on the left is a storage room currently used as preparation kitchen and work space for the store. The walls in the left room are unpainted beaded boards and there is an early wood racking system for holding spindles of rope in the northwest corner. A door through the north wall of this room leads into the garage.

The north (back) door of the store leads into the narrow ell that connects to the residential space. This ell contains a doorway on the east side to provide access to the house, and a staircase leading to the second floor of both the store and house. The second floor of the store contains three rooms: one large room comprising the north two thirds of the space, and two rooms dividing the southern third. The partition walls were likely added during the mid-twentieth century, and it is unclear if there were additional partitions at an earlier time. The door leading into the second floor is a four-panel wood door. Additional four-panel wood doors, one painted green with reddish grain painting within the panels, lead into the partitioned rooms. They may be

original doors from the store, or may have been moved here from other buildings. The original part of the store (the south two thirds of the second floor) is lit by two windows in the south façade, as well as two additional windows located on the east and west walls that have been covered by the flanking wings.

The frame for the east window still exists, but there is no frame for the west window. The north wall of the original store is clearly visible in the upstairs because most of the plaster was removed some time ago, exposing the wall studs, ceiling joists, and rafters. The framing for the north addition was abutted to the existing frame of the store. A portion of the original north gable with painted clapboard still exists at the attic level, and the roof of the north addition was extended from the original cornice. The walls in the southern portion of the second floor, north to the line marked by the closed-up windows, are covered with white painted boards. It is not clear if this is an original wall treatment or a later modification. From the closed-up windows to the north wall, there is evidence for original lathe and plaster walls. The flooring is narrow width tongue-and-groove pine boards. The large staircase from the first floor enters the second floor in the north addition, implying the staircase was added at the same time. A large pile of documents relating to the late nineteenth- and early twentieth-century transactions at the store is also stored in this room. This material has not been researched, but has the potential to illuminate much about the history of the store.

An additional feature was found in the original portion of the second floor. Four metal support bars run from the floor to the ceiling joists above, surrounding an octagonal opening or gallery that has been floored over. The tenon holes for wood balusters and a handrail are still visible along the edge of the former opening. It is not clear when this original gallery opening, a common feature of late nineteenth- and early twentieth-century stores, was closed, but the beaded boards covering the ceiling below show no evidence of this alteration. The gallery may have been filled at the same time the staircase and additional second floor space was added.

Figure 6. *Floor plans for the Ware Neck Store and Post Office.*
