Phase III Investigations and Historical Study of the Spring Hill Plantation

LOCATION > Chesterfield County, Virginia

DATE > MARCH, 2015

Dutton+Associates, LLC

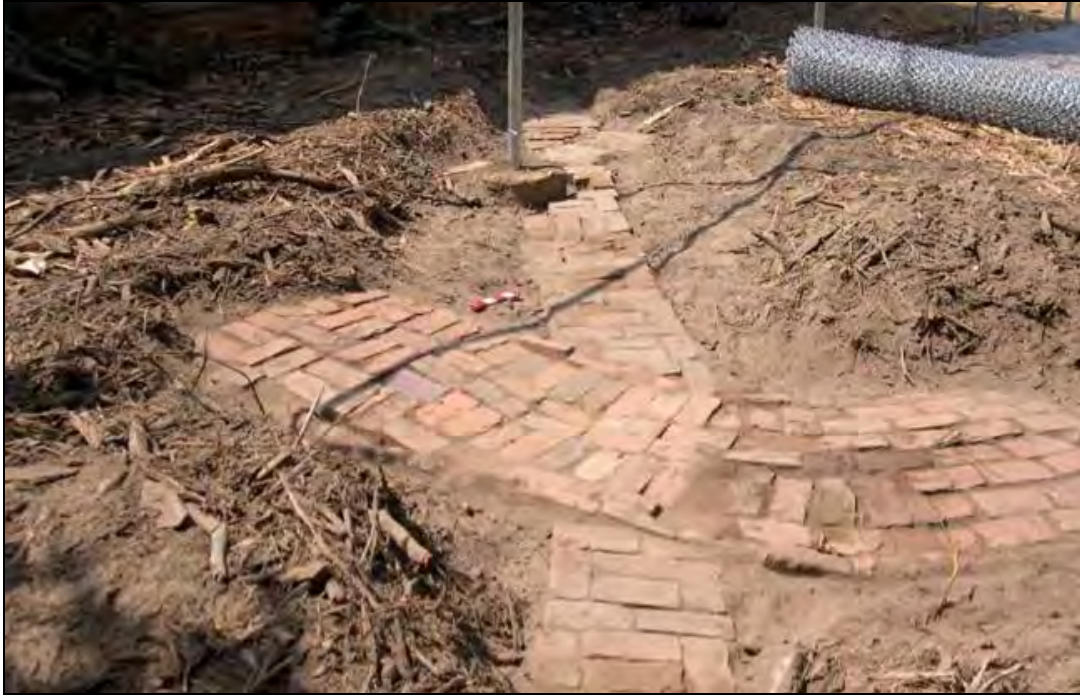
Plate 4-1. Walkways uncovered during Phase II investigations. Source: TRC.

Examination of the bricks and patterning associated with the walkways suggests they are contemporary with other twentieth-century renovations to the house and property. The bricks themselves appear to be a mixture of machine made and reused handmade brick, likely from earlier renovation work on the property. Photographic evidence provided in the Phase I and Phase II survey report illustrates walkways dry set in a combination of a basket weave and half basket weave pattern (Plate 4-1).

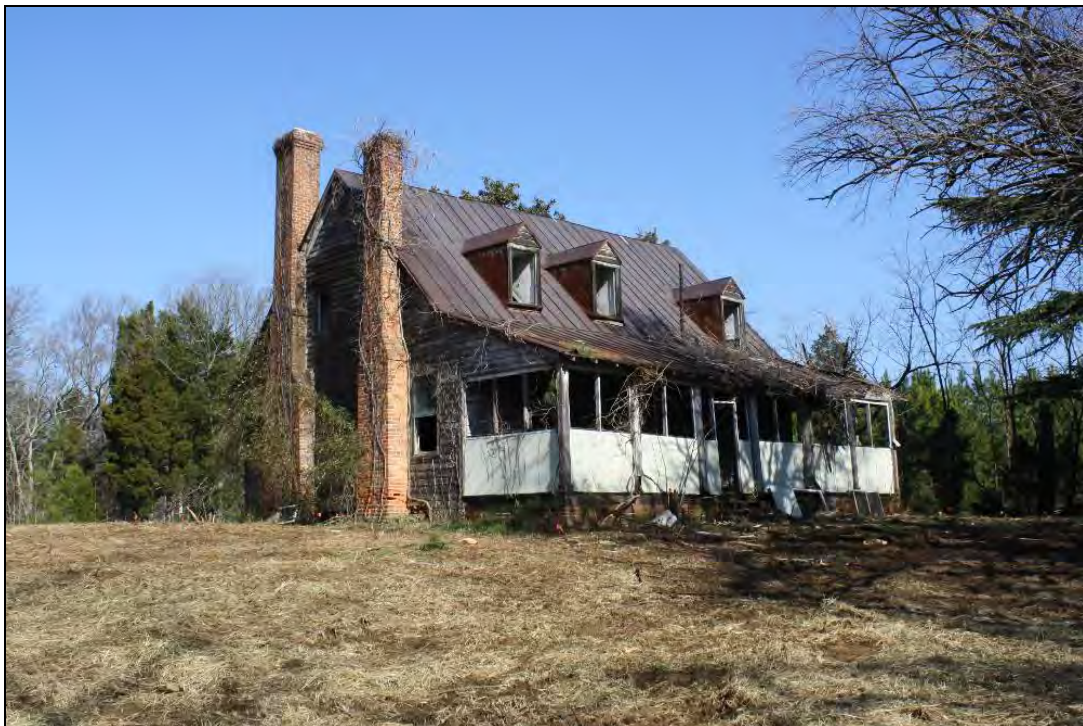
Figure 8-1. Spring Hill house, front and west side

The Spring Hill house in its current state is what can best be described as a wood-frame, one-and-a-half story, double-pile, side passage dwelling with double end chimneys and a two-story wing addition with a full-width front porch that spans the two blocks. Dendrochronology reveals that the original block of the building was constructed in 1767 and originally had a different layout consisting of one end chimney serving a full-width room in the northern half of the house, and an internal chimney serving two rooms in the southern portion of the house. Testing was not conducted on the wing or porch additions; however, construction details indicate they were likely added in the early-twentieth century at the same time as the reconfiguration of the original block to its current layout, likely circa 1905. The original block of the house measures approximately 7.9 meters (26 ft) wide by 9.1 meters (30 ft) deep. The wing addition measures approximately 4.2 meters (14 ft) wide by 6.0 meters (20 ft) deep and is set back only one foot from the front façade of the main block roughly nine feet from the rear wall. The full-width front porch extends out approximately nine-feet from the front facade. The building is oriented towards Proctors Creek, and therefore the front façade is to the south (Figure 8-1).

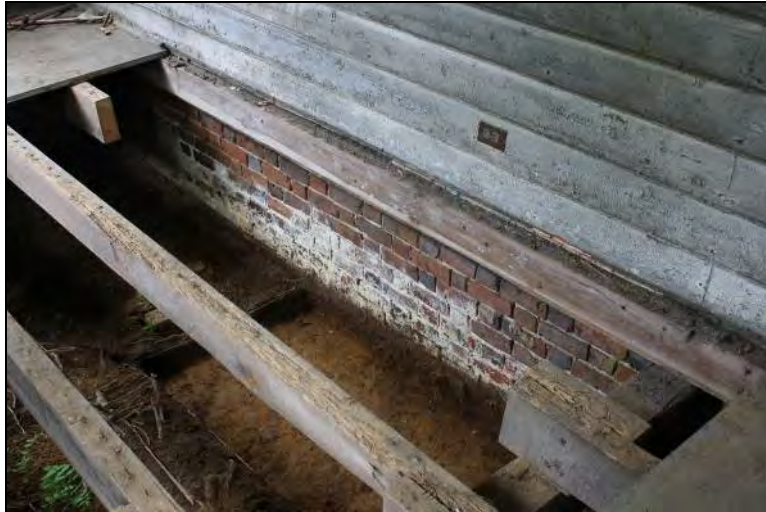
Figure 8-2. Original foundation laid in Flemish Bond

The building is set on continuous brick foundations in various bonds and configurations. The foundation walls of the original block of the house are laid in Flemish bond with glazed headers but have been covered with a thin concrete veneer on the north and west sides (Figure 8-2). The rear half of the house is underlain by a full basement, and therefore the foundation walls extend

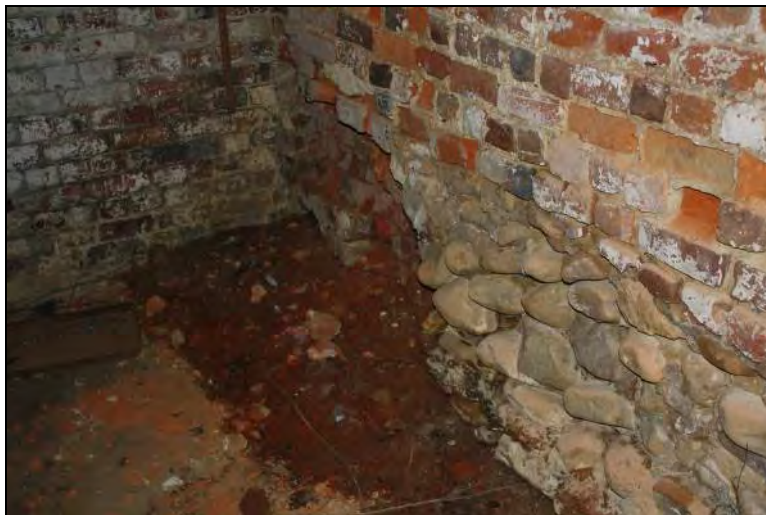
Figure 8-3. Cobbles in cellar wall

down further whereas the front half of the house has only a crawlspace. The foundation walls inside the full-basement exhibit an English bond pattern, which appears to be a later veneer over the original structural foundation wall. The center division wall, which also supports the central girder, is laid in a patchwork of bonds and appears to have been laid or repaired in several phases. A small area of this wall near the floor several feet away from the chimney base consists of stacked cobbles, and it cannot be determined whether they predate the wall or if they were inserted into the wall later as a repair. It appears that they likely pre-date the brick wall over top from the presence of integral “closer” bricks, and may have been laid as a security measure against moisture after it was discovered during excavation for the basement (Figure 8-3).

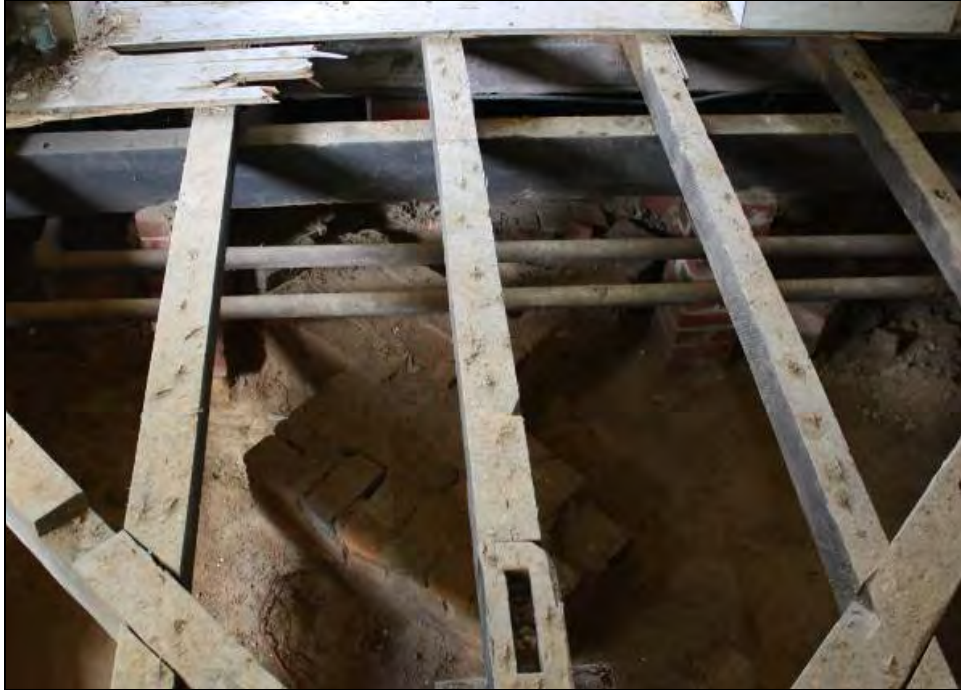
Figure 8-4. Original interior chimney base

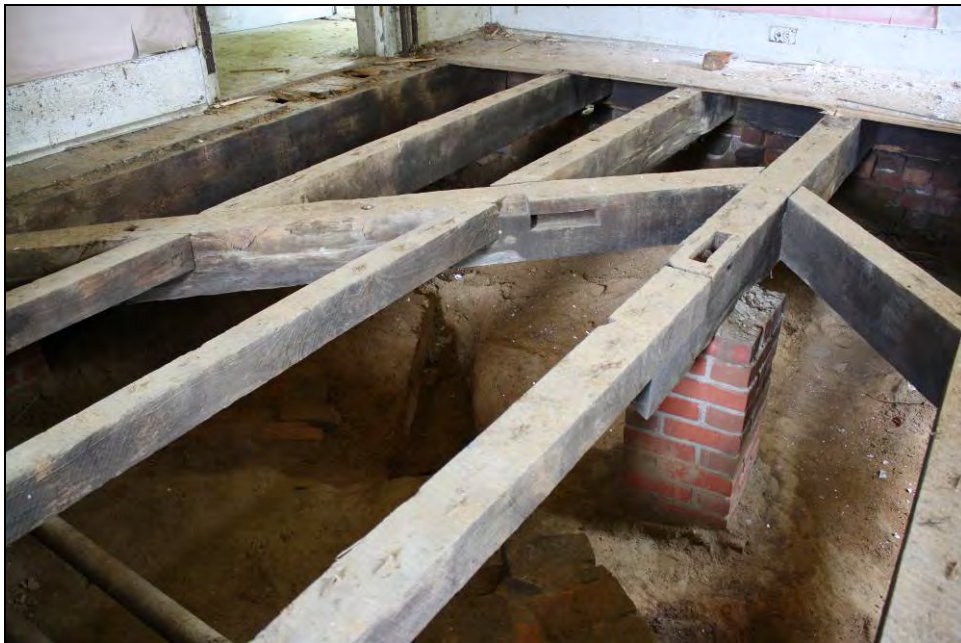
Figure 8-5. Brick piers reinforcing framing over removed internal chimney

piers, intermixed with the original chimney base and likely dating to the early-twentieth century, reinforce the floor framing over the crawlspace area that originally would have been tied into the internal chimney (Figure 8-5). These brick piers match the foundation of the wing addition and porch and therefore were likely installed contemporaneously to the construction of those additions, indicating the internal chimney was removed at the same time.

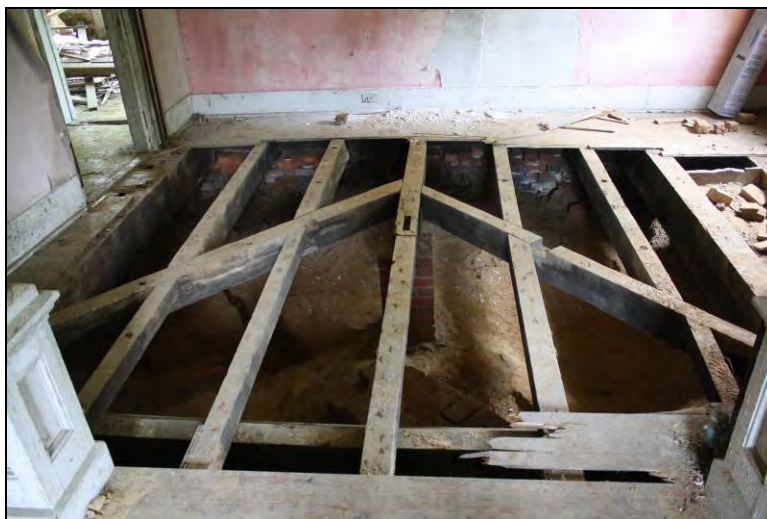
Figure 8-6. Dragon beams with later infill sub-joists.

The original block of the building is constructed of heavy timber frame clad with twentieth century beaded clapboards. At the base of the house are massive hewn pine sills set atop the brick foundation walls. The floor is framed by a series of heavy 15.2 cm (6 in) by 33 cm (13 in) hewn joists in the outer bays supported centrally by a pine girder on top of the brick partition wall. The joists have been notched down to just 22.8 cm (9 in) thick in the full-basement portion to allow more headroom. The floor framing in the central area of the building consists of joists that only span the half of the building above the full basement while the area above the crawl space is framed with a dragon beams that originally tied into the internal chimney and supported its hearths, but have subsequently been infilled with sub-joists to frame in the floor over where the chimney no longer exists (Figure 8-6). The walls are formed by heavy guttered cornerposts with down braces and two primary posts delineating the wall bays and to which the doors and windows are attached (Figure 8-7). Between the primary posts are a series of common studs. These posts and studs are topped by a heavy plate on which the roof joists sit. The roof joists, which also function as the second story floor joists, continue beyond the wall plates where the roof rafters tie onto them via a flat board falseplate, and form a boxed cornice on the exterior (Figure 8-8). The roof rafters join at the ridge where they are half-lapped. Collar beams on each truss form the attic floor/second story ceiling. Knee studs form the second story walls under the angled roofline (Figure 8-9). All of the joinery for the original framing is accomplished with mortise-and-tenon or half-laps, and are held together with a combination of wood pegging and wrought nails. The wing addition is built with balloon frame composed of dimensional lumber. The walls are set atop small sills and are supported by a system of common studs. Fasteners include a mixture of cut and wire nails. The exterior walls are covered with plain clapboards.

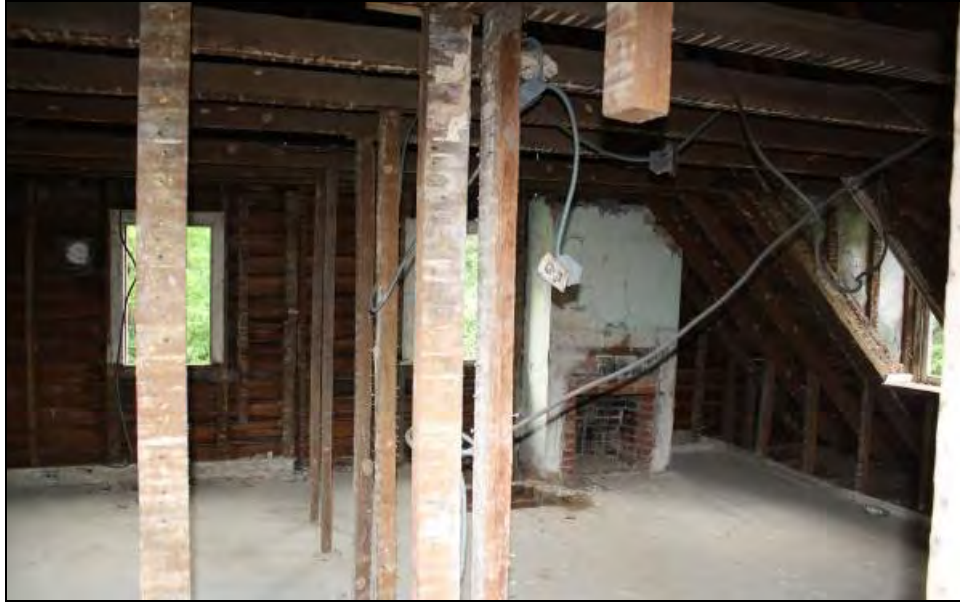
Figure 8-9. Second floor framing showing collars and knee walls.

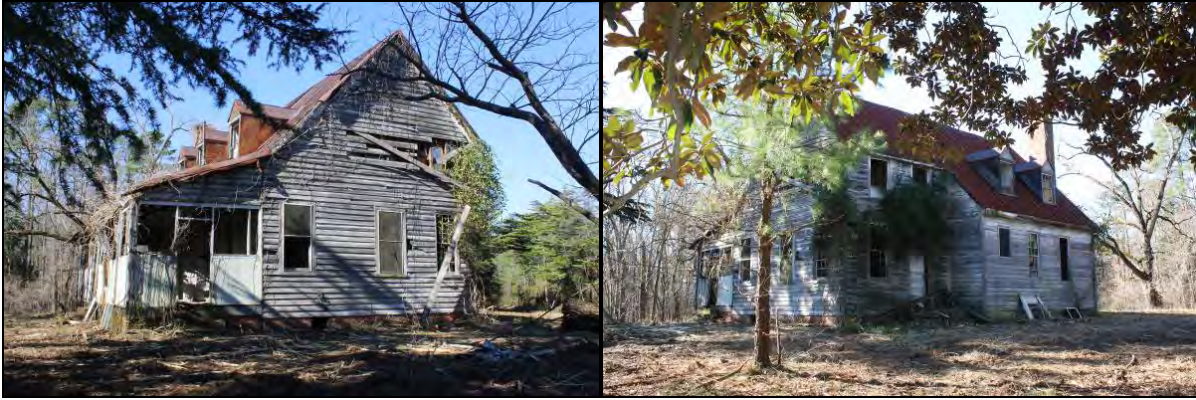
Figure 8-10. Gable roof over wing Addition, 1.5-story on front (Left) and 2-story on rear (Right).

The entire building is covered by a relatively steep-pitched gable roof with a continuous ridge that extends over both the original block and the wing addition. The way in which the roof system over the addition ties into the original block and covers the wing is unusual in that the wing was constructed to match the one-and-a-half story design on the front (south) of the house, and to be a full two-stories on the rear (Figure 8-10). As a result, the roof joists in the addition form the second story floor, but tie into a wall girt on the rear instead of the roof rafters. The rafters themselves are notched onto the first floor wall plate on the front façade and the second story wall plate on the rear façade. The front slope of the roof is pierced by three gable dormers, two of which are spaced over the original block while one is set on the addition. The dormer on the addition is contemporary to its construction, while those on the original block appear to be earlier, likely sometime in the nineteenth century. The rear slope is pieced by two gable dormers spaced over the original block. These dormers appear to be contemporary to the demolition of the internal chimney and reconfiguration of the first floor, as the original partition wall studs were reused to frame these dormers as evidenced by their matching the height of the first floor and the presence of tenons on each end. The entire roof is clad with standing-seam metal; however damaged sections indicate it is laid over hexagonal asphalt shingles applied in a floral pattern on at least the wing portion of the dwelling.

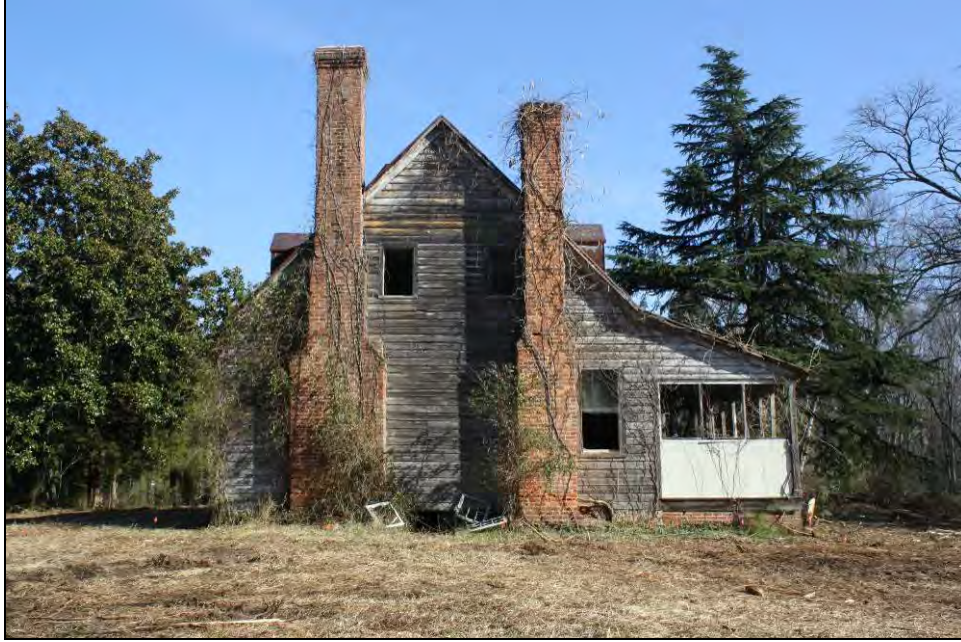
Figure 8-11. West side end chimneys.

The roof at the gable end of the original block is interrupted by two brick end chimneys flanking the ridge (Figure 8-11). The northern chimney is slightly engaged into the wall of the house while the southern chimney is set against the exterior wall and therefore only interrupts the roof overhang. The northern chimney is constructed of brick laid in a Flemish bond adorned by a chevron pattern created by glazed headers in the lower portion of the stack. Just above the first story, it narrows with matching brick shoulders and haunches and continues beyond the roofline where it is capped by a six-course corbeled capital. Dendrochronology on framing for the hearths on this chimney and flanking closets indicate that it was original to the house in 1767. The southern chimney is rebuilt, and is built atop an older chimney base which extends up three or four several courses from the ground before the new stack begins (Figure 8-12). The older base is assumed to be contemporary to the demolition of the internal chimney and reconfiguration of the house circa 1905. The new stack is narrower than the original by roughly four stretchers, and is laid in a common bond with cement mortar. It too tapers just above the first story with brick shoulders and is capped by a simple two-course capital. A newspaper clipping found in the hearth box from the first (wider) southern end chimney dates from 1925, indicating that is likely the date it was torn down and replaced by the narrower chimney. As the beaded clapboarding overlaps where the wider chimney would have been, and is set inside the standing chimney, the siding was likely replaced at this same time as well.

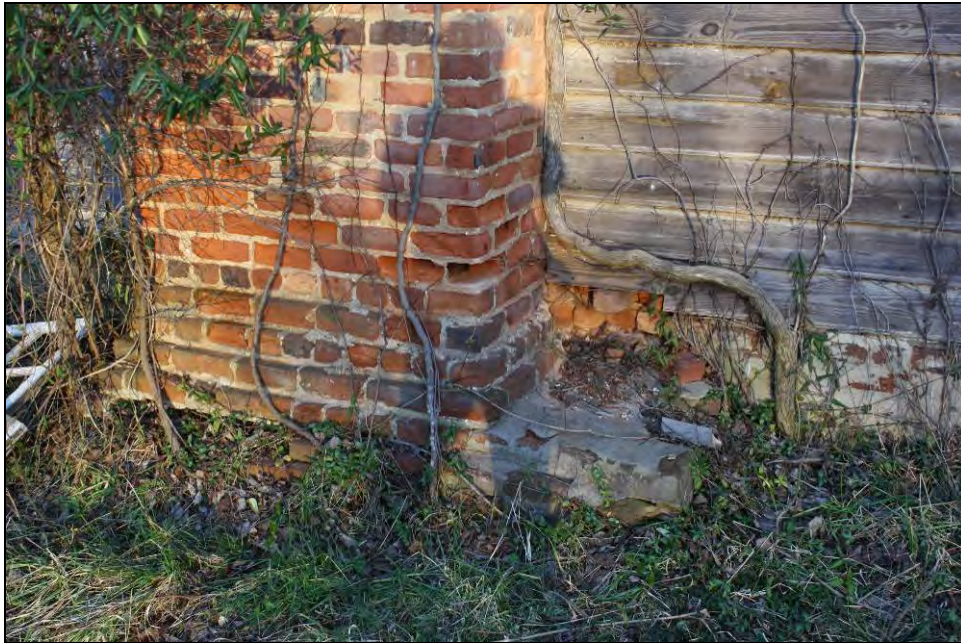
Figure 8-12. Southern end chimney with replacement stack over older base.

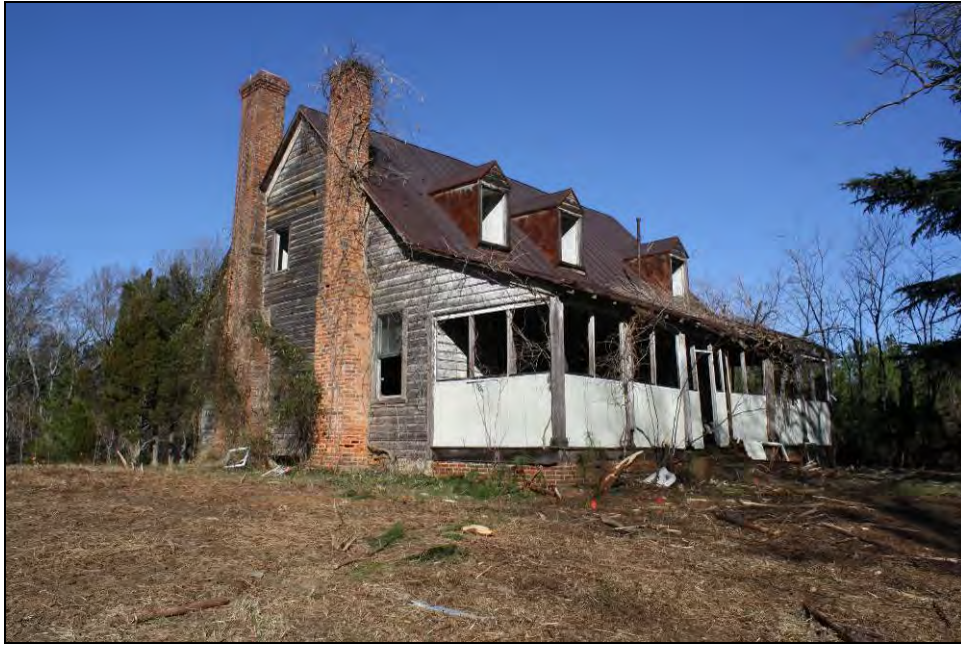
Figure 8-13. Full-width front porch.

A full-width porch set on a continuous pressed brick foundation stretches along the front of the building and was added contemporaneously to the wing addition (Figure 8-13). The porch has a wood floor with simple aprons that wrap around the foundation. It has been nonhistorically partially enclosed with foamboard kneewalls, likely in the 1950s or 60s, and was screened above the foamboard; however, all screening has been removed. An aluminum storm-type door provided access to the porch from a set of poured concrete steps. The porch is covered with a shed roof that ties into the front slope of the building just above the original eave, thus creating an integral roof, although the slope of the porch roof is slightly shallower than that of the house.

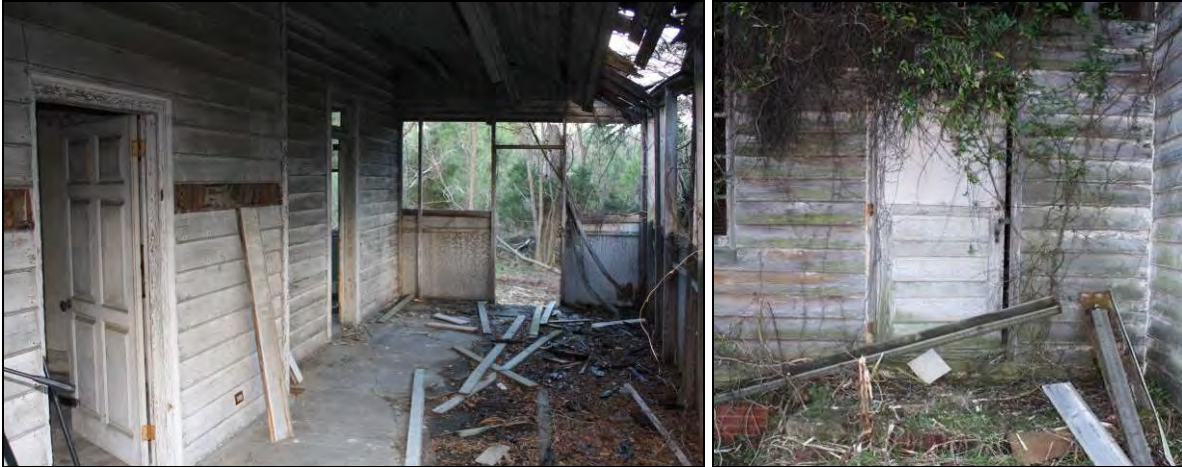
Figure 8-14. Front entrances (Left) and rear entrance (Right).

The front porch shelters two entrances into the house; the main entrance which is located in the eastern bay of the original block, and a secondary entrance set centrally on the wing addition (Figure 8-14). The main entrance consists of a single, six-paneled wood door set within the original pegged frame. The exposed frame has a beaded corner and functions as the architrave along with cove molding that has been added around its juncture with the later clapboarding. The secondary entrance into the wing has a single door with a large fixed pane of glass above three full-width panels. Above the door is a single fixed-pane, Victorian-type transom. The door and transom are set in a simple frame with flat board architraves. A third entrance into the house is located on the rear of the wing addition. This entrance is offset and approached by an open brick stoop that appears to be later than the addition. The door for this entrance appears to be mid-twentieth century with a single fixed pane of glass above three full-width panels. The door is set within a simple frame with flat board architraves. This rear entrance leads into what appears to have been originally an inset porch that was later enclosed. A fourth entrance leads into the basement from a bulkhead located between the two chimneys. This entrance holds a paneled wood door and is approached by a twentieth century concrete bulkhead with stairs.

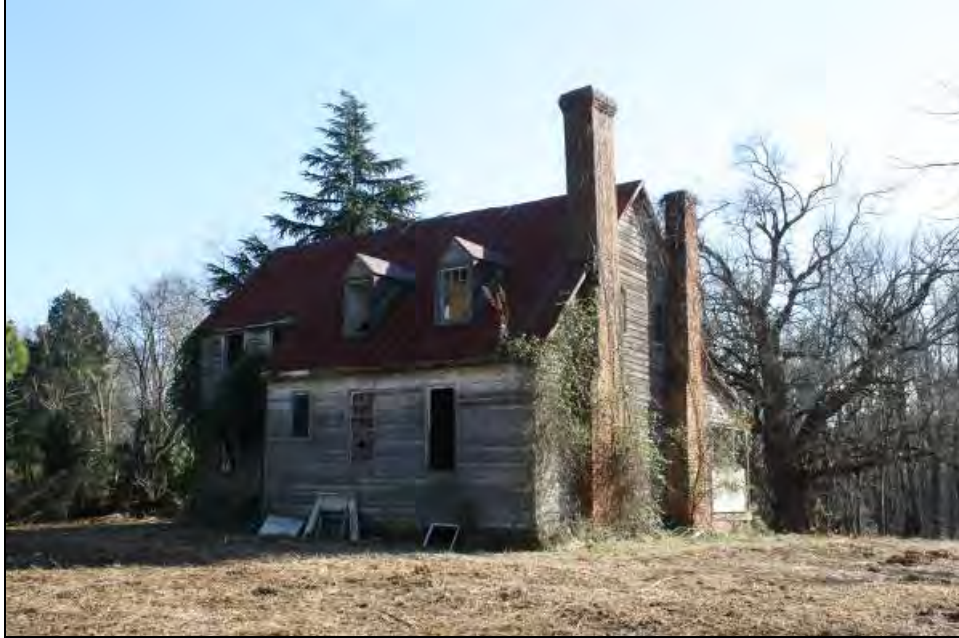
Figure 8-15. Fenestration on original block.

Window fenestration on the building consists solely of individual, double-hung sash openings. The windows on the original block are set within the original frames, but the sashes appear to be later replacements. The windows on the wing addition also appear to be replaced as they are identical in construction technique and muntin details to those on the enclosed inset porch, as well as those on the original block. Nearly all of the first floor windows have nine-over-nine light configurations with the exception of one small window on the rear of the original block that is six-over-six (Figure 8-15). The few second floor windows are all six-over-six. The original block has a single double-hung sash window located in the western bay of the front façade under the porch. There was originally a second window on this façade adjacent to the doorway, although it was later removed and covered with beaded clapboard. The rear façade of the original block is divided into three bays with two taller double-hung sash windows in the central and western bays and a shorter window in the eastern bay lighting the stair landing inside the house. The west side of the original block is pierced by a single window on the outer corner of first floor immediately adjacent to the replaced chimney. This window could not have been placed here until the current, narrower chimney was added circa 1925. It is possible this window was borrowed from the front façade under the porch and moved to this side location to allow more light after the full-width porch was added. The west side of the original block also has two smaller windows set between the two chimneys on the second floor. Fenestration on the north side of the wing addition consists of a single double-hung sash window adjacent to the rear entrance (one the enclosed inset porch) with two evenly-spaced windows on the second floor wall above. The east side of the wing has three unevenly spaced windows on the first floor (two one main mass and one on the enclosed porch portion) and no fenestration above (Figure 8-16). All of the dormers are later additions and hold double-hung sash windows with six-over-six light configurations. All of the window surrounds appear to have been replaced contemporaneously to the recladding of the house in the early-twentieth century. They are a simple flat board design with no trim or molding.

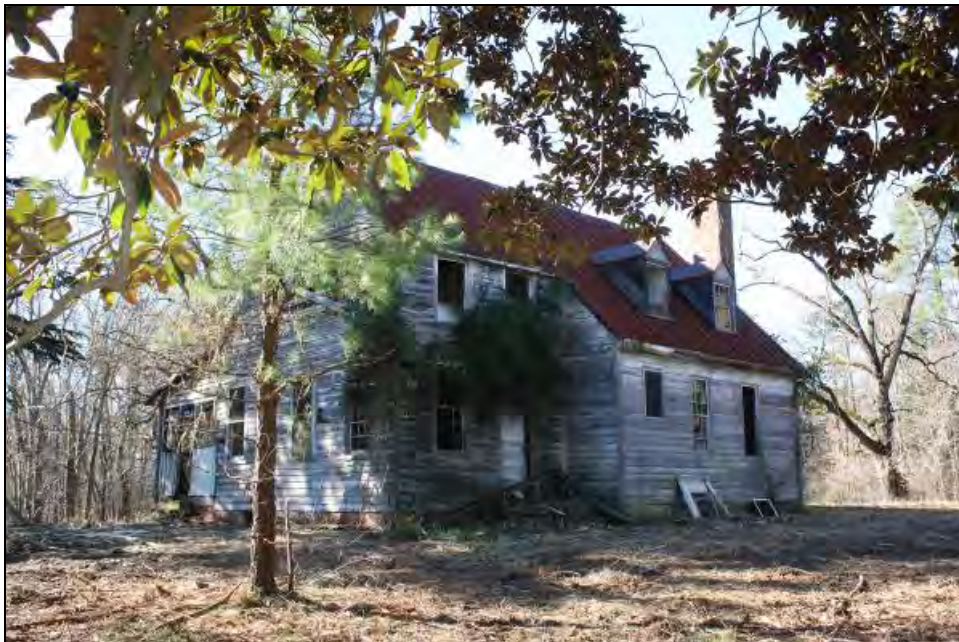
Figure 8-16. Fenestration on wing addition.

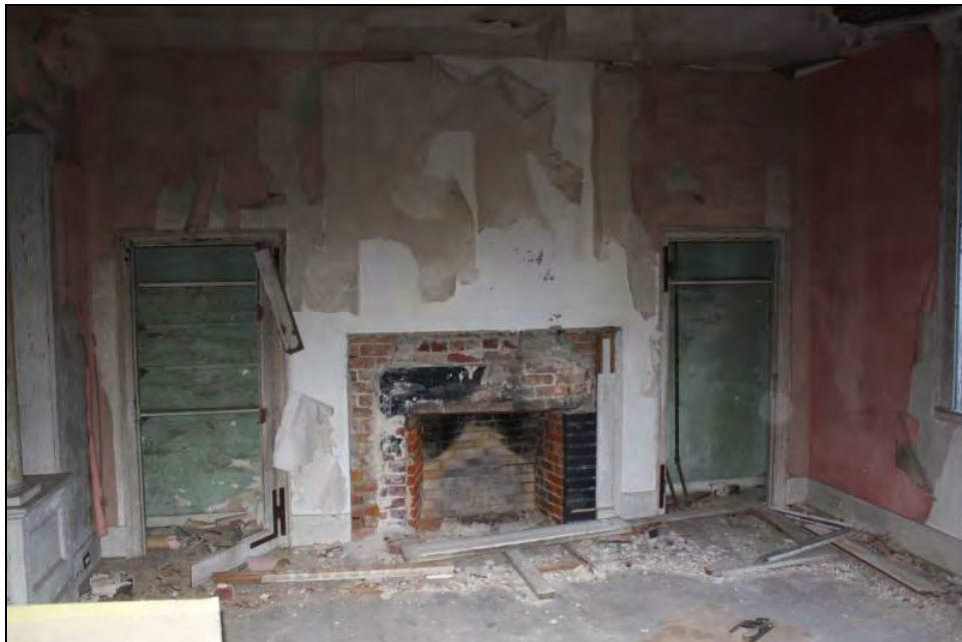
Figure 8-18. Fireplace in northern room with flanking closets.

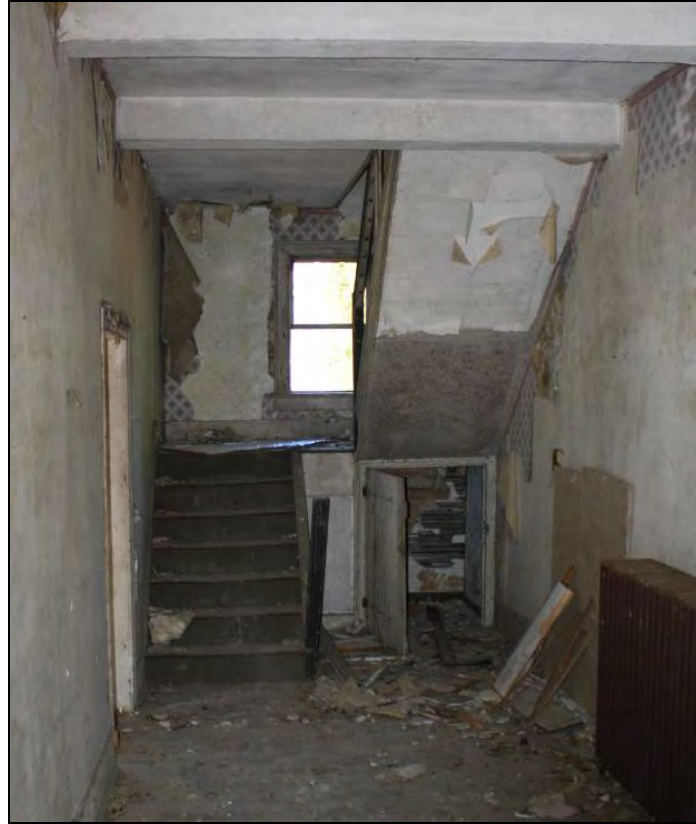
Figure 8-20. Stairway at end of side passage.

The second floor of the house is accessed by U-shaped run of closed stringer stairs set in the rear of the hallway (Figure 8-20). Ghosts in the plaster underneath these stairs, as well as mortises in the floor joists indicate that in their original configuration, these stairs had a single dogleg and opened into the northern room along the rear wall. When the floor plan was reconfigured and the hallway partition wall built, the lower flight of stairs were turned 90 degrees, and the landing extended so that the stairs could open into the hallway. Currently, the lower flight of stairs and landing encloses a small closet that is accessed by a board and batten door. At an unknown, but early date, a bulkhead and flight of stairs leading to the basement was cut through the floor under the upper stairs and landing (this bulkhead was subsequently closed at a later date, reportedly in the 1940s). The upper flight of original stairs feature molded trim along the side of the stringer. A molded railing with square balusters lines the stairs and terminates at a square newel.

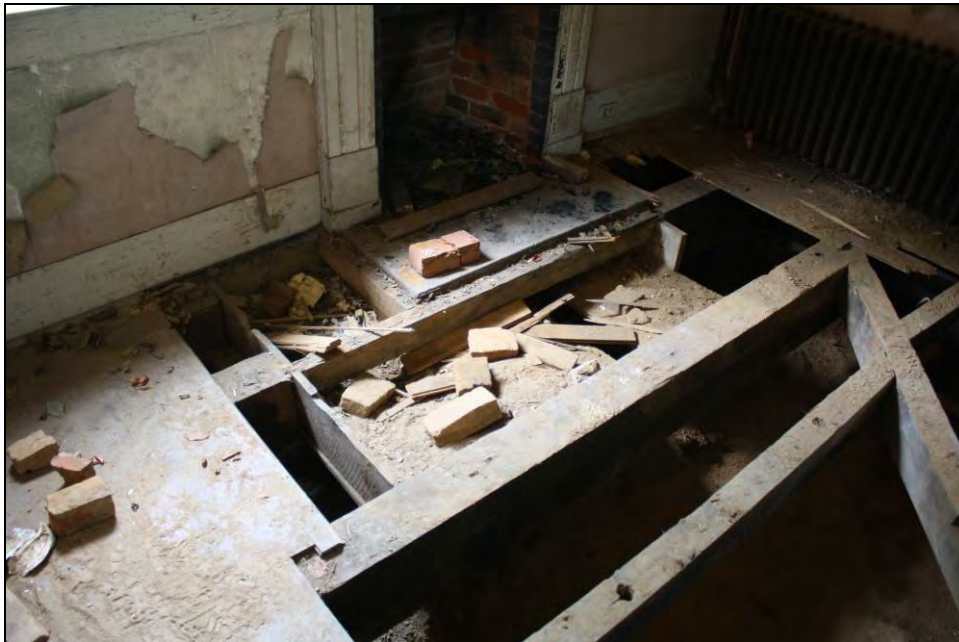
Figure 8-25. Hearth framing for first (Larger) and second (Smaller) southern end chimneys.

addition was installed to cover the floors after removing the internal chimney. When the end chimney built at that time was torn down roughly twenty years later in 1925 and replaced by a narrower chimney and fireplace, the gap from the smaller hearth was covered with narrow-width pine that was carried across the southern portion of the room (Figure 8-25). This narrow-plank floor was carried under the hallway partition wall and installed in front of the front door as well, likely to replace the floor just inside the door that may have had severe wear from over 150 years of dirt and sand being tracked in. Several courses of the narrow-plank floor were also installed between the two first floor rooms when the wall partition was opened in 1925. The floors throughout the wing addition are medium-plank pine. The floor in the enclosed rear porch kitchen is covered with asbestos tiles. The second story floors also reflect the various periods of renovation. The majority of the original block has original wide-plank floors although the gap where the internal chimney projected through is covered with medium plank floors matching the addition. The hearth from the first southern end chimney torn down in 1925 is infilled with narrow-width flooring.

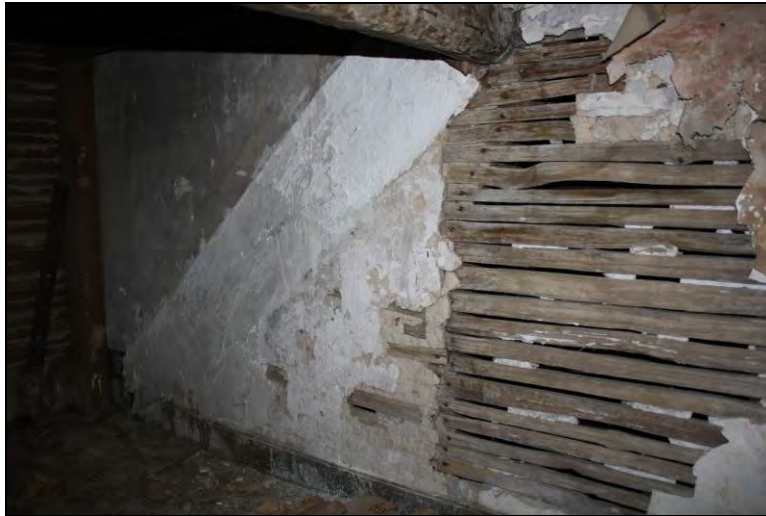
Figure 8-26. Original split pine lath under stair landing.

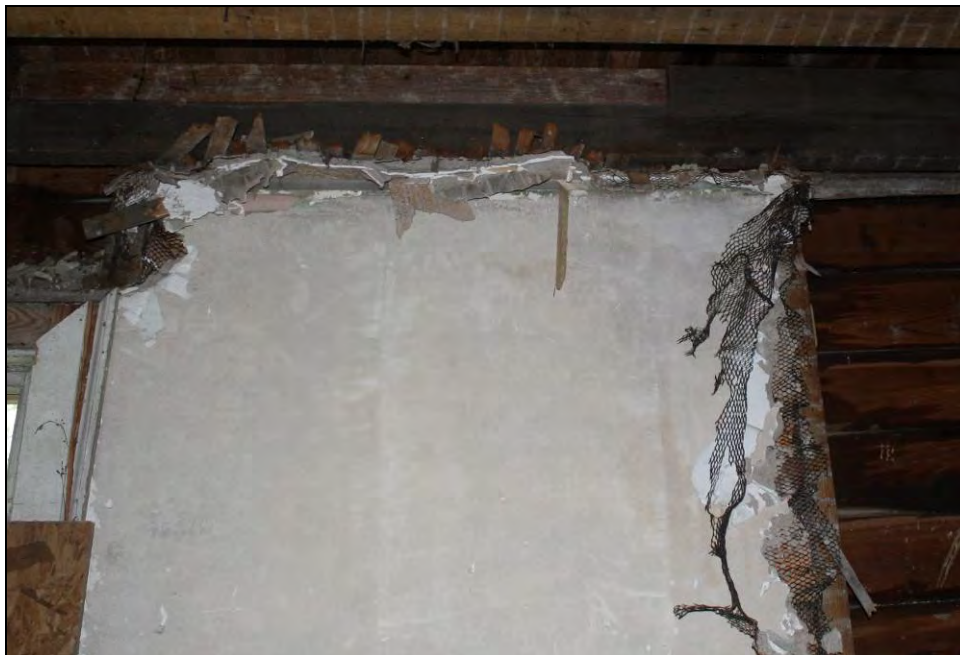
Figure 8-27. Remnants of metal lath under plaster on 1925 chimney.

plaster applied to 1920s metal mesh lath with wire nails (Figure 8-27). Summer beams in the ceiling of the hallway and an enclosed plumbing-run, also in the hallway, have been covered with gypsum board and metal corner beading.

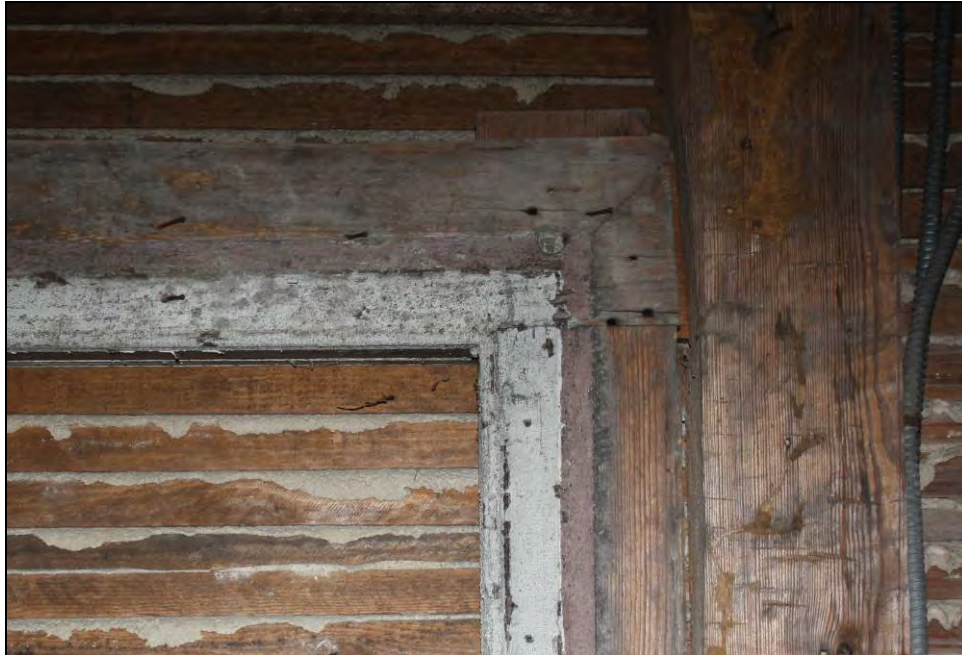
Figure 8-28. Detail of original pegged door frame.

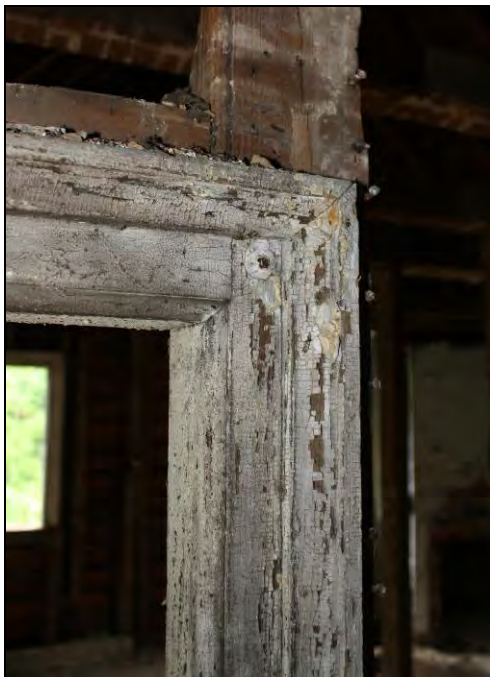
Figure 8-29. Greek Revival molding on original door frame.

The majority of doors and doorframes throughout the house, including the two from the passage into the first floor rooms, and the two from the second floor landing into the rear bedroom and bathroom, appear to be original and were simply moved and reused when the layout was reconfigured in the early twentieth century. The frames and jambs in the original block are of solid construction with beaded corners and pegged at the corners (Figure 8-28). Single-tier cyma reversa trim with subtle Greek Revival influence has been added around the edges, and may date to the mid-nineteenth-century (Figure 8-29). The doors themselves are mortise and tenoned six-

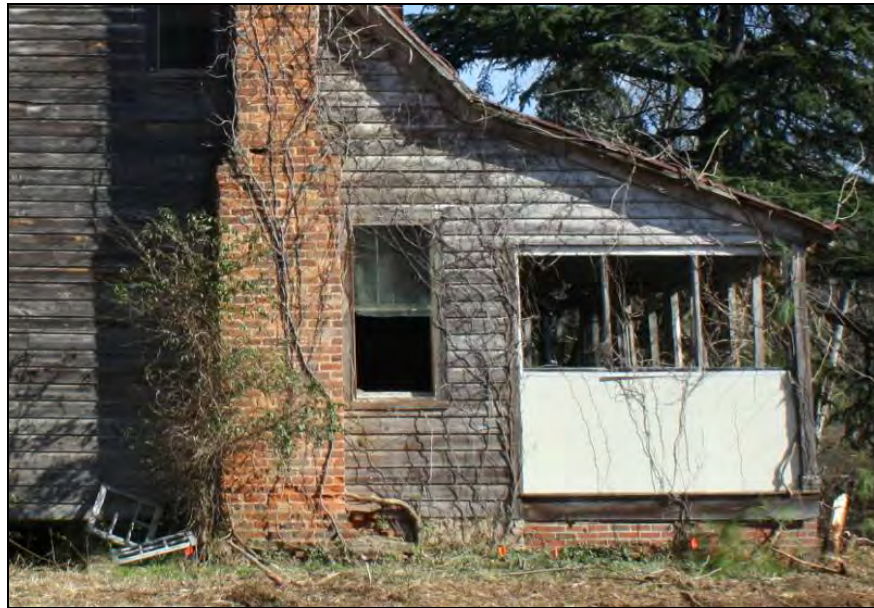
Figure 8-31. Window added to west side.

All windows appear to be in their original locations with the exception of one window added next to the replaced 1925 chimney in the front room of the original block (Figure 8-31). This window was likely relocated from the front (south wall) next to the doorway. The window frames also appear to all be original; however as stated previously, the sashes are replacements. The windows are minimally ornamented with only single tier cyma reversa molding around the edges of the frame, which are likely a mid-nineteenth century application. The windows in the original block sit on bullnosed sills atop a plain apron. The windows in the wing are ornamented only with plain board surrounds and sit on a square sill.

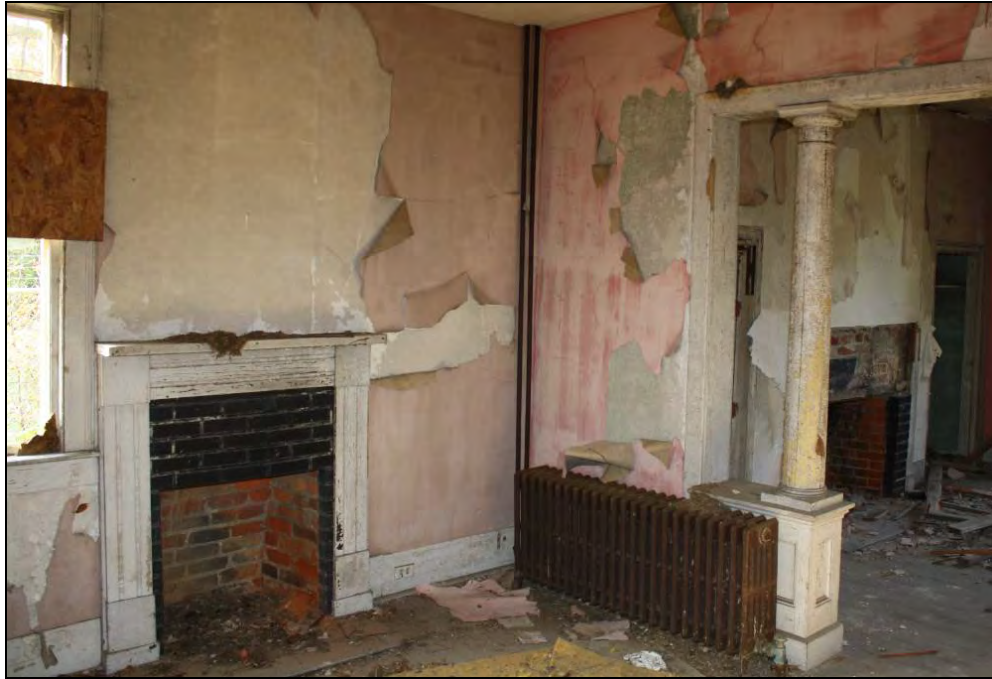
Figure 8-32. Matching fireplaces in first floor rooms.

Revival mantels consisting of fluted architraves, blank corner blocks, and a bull-nosed mantel (Figure 8-32).

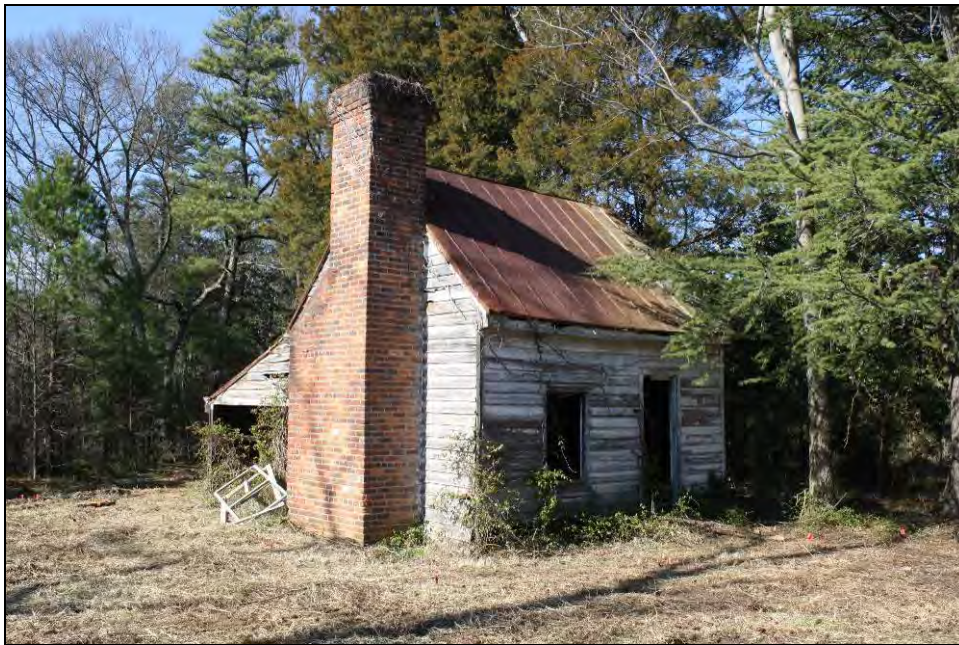
Figure 8-33. Reconstructed kitchen outbuilding.

In the yard to the northwest of the main house is an outbuilding that was reconstructed in the twentieth century (Figure 8-33). The exact date cannot be determined, however it appears to be from the second half of the twentieth century as evidenced by materials and construction techniques. The building seems to have been intended to lend the appearance of a nineteenth century kitchen with a large chimney stack. This small one room building is constructed on a continuous poured concrete foundation and has a dimensional lumber frame structural system with wood clapboard cladding. It is topped by a steep pitch side-gabled roof covered with standing seam metal. Fenestration consists of a single door and single window on the front (eastern) façade, a window adjacent to the chimney on the south side, and small windows on the second floor gable ends. All of the window sashes have been removed. The building features a large brick chimney on the south side with a single brick shoulder inside the gable. It is set on a heavy concrete base, and is laid in an irregular English bond ranging from six to eleven courses of stretchers between rows of all headers. Above the shoulder it transitions to all stretchers and is capped by a six-course corbeled capital. An enclosed shed is appended to the rear of the building, although appears to be original from the continuity of the foundation.

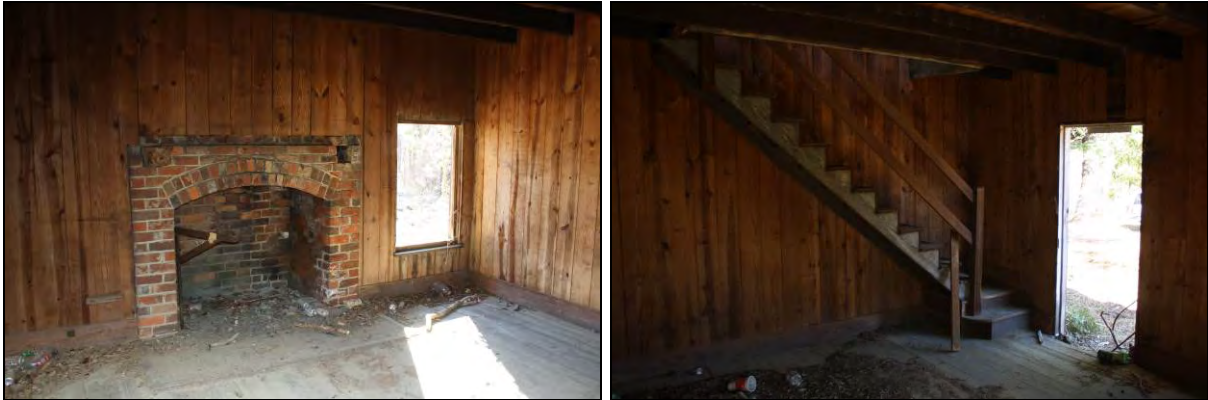
Figure 8-34. First floor fireplace (Left) and stairs (Right) in the kitchen outbuilding.

a “period” building. A narrow flight of steep dogleg stairs in the front corner provides access to the attic above which has a wood floor, but is otherwise unfinished (Figure 8-34).
