Phase III Investigations and Historical Study of the Spring Hill Plantation

LOCATION > Chesterfield County, Virginia

DATE > MARCH, 2015

Dutton+Associates, LLC

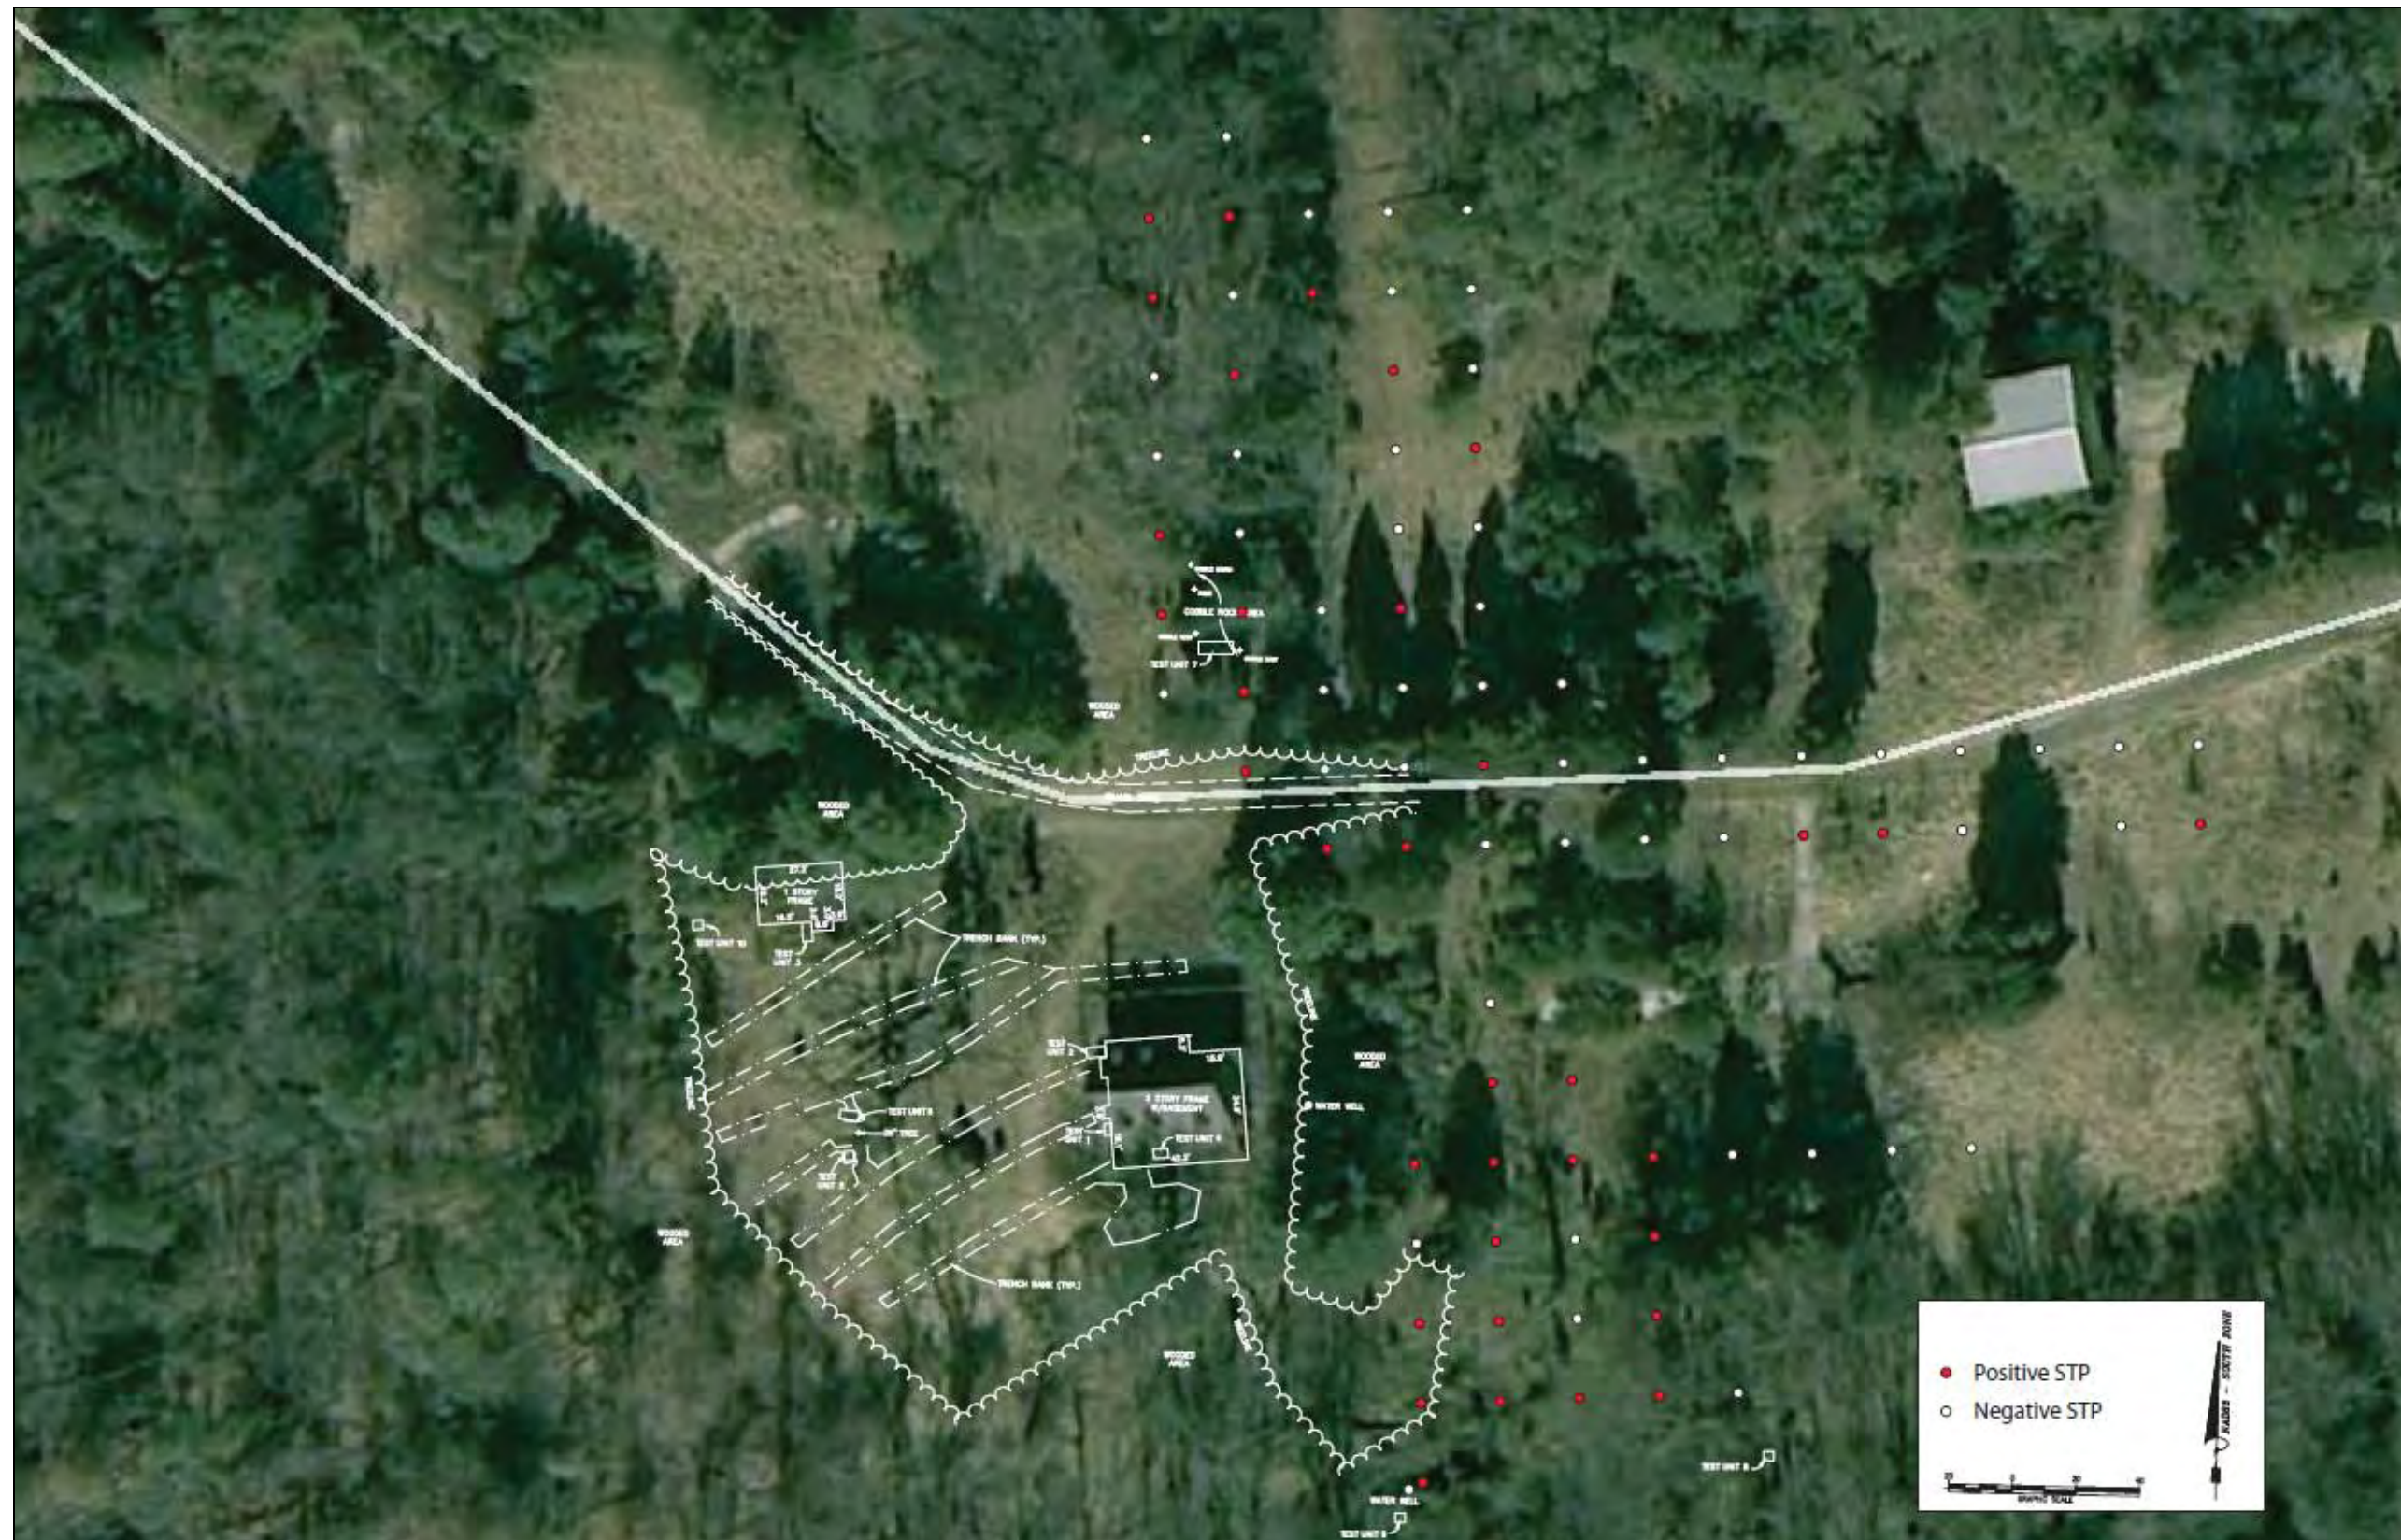
Figure 8-35. Aerial view of data recovery excavations illustrating locations of trenches, test units, and shovel test pits.

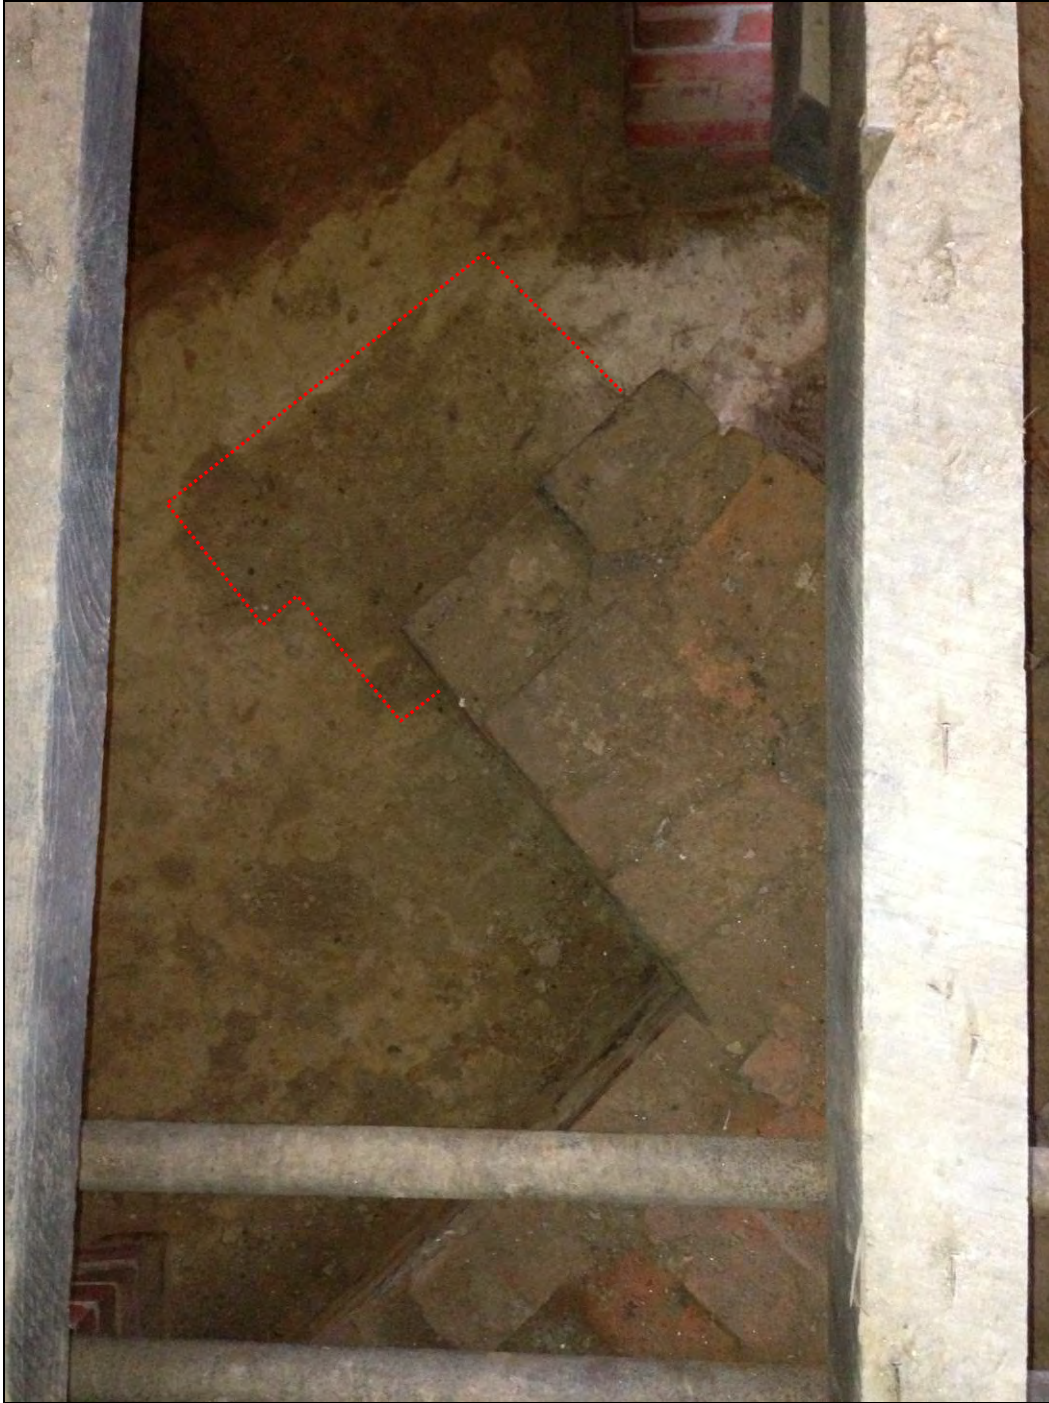
Figure 8-37. Plan view of Feature 45.

Immediately adjacent to the brick chimney base, a dark brown (10YR3/3) extremely loamy soil was visible. The feature measured approximately 27cm (0.9 feet) by 24.3cm (0.8 feet) (Figure 8-37).

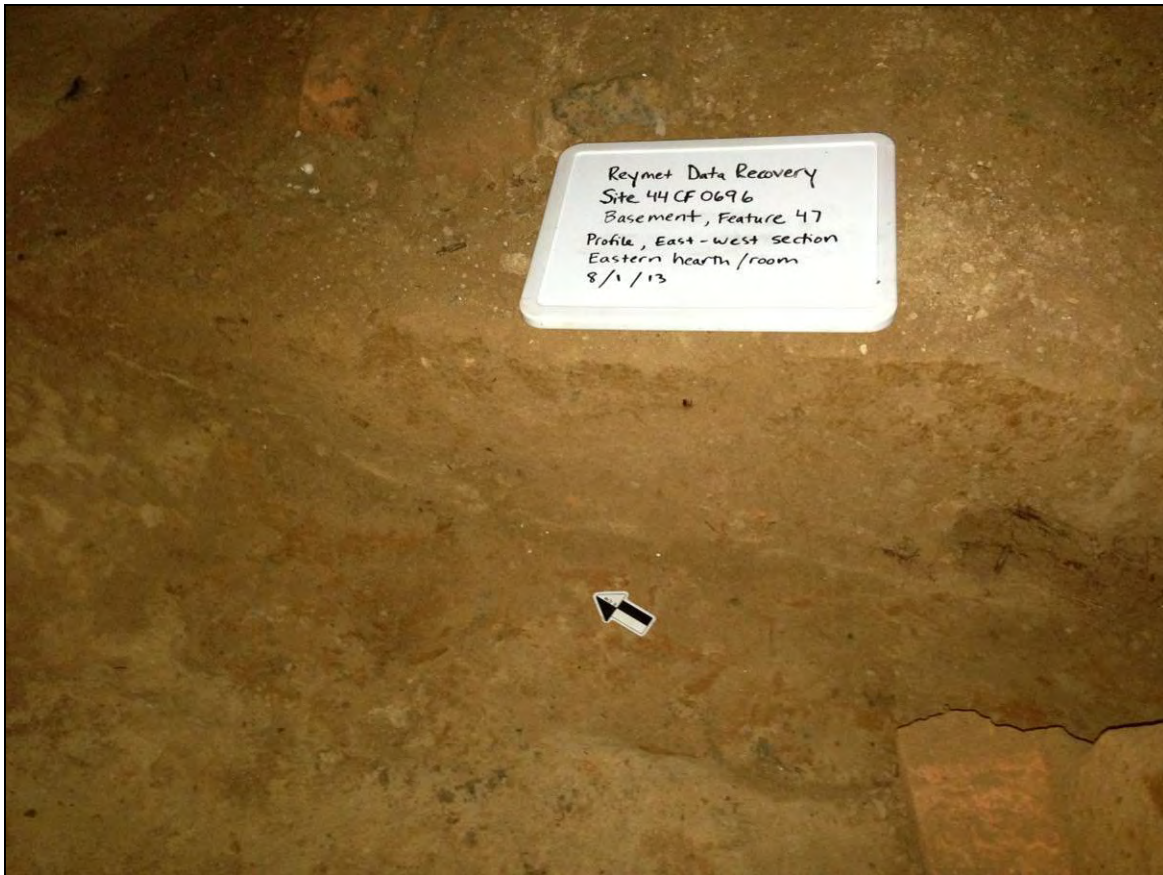
Figure 8-38. Profile view of Feature 47.

The eastern part of the feature was more accessible, and was tested. An exploratory trench was excavated through the center of the feature in order to determine the vertical limits. This was determined to be 24.3cm (0.8 ft) deep (Figure 8-38). Excavation of the feature continued in order to examine a larger sample size; however, very few artifacts were recovered. At the surface, several pieces of brick were found, but beneath this, artifacts were limited to three wrought nail fragments, a piece of flint, a brick fragment, 4 pieces of plaster, and 2 pieces of sand mortar. The very sandy soil also had very small inclusions of brick that appeared to have been over-fired and very friable. Based upon the size and composition of the feature it is interpreted as a shallow pit related to the construction of the building. The lack of artifacts suggests that the feature was excavated prior to the occupation of the property or from demolition of the interior chimneystack, when surface scatter would likely have been incorporated into the fill.

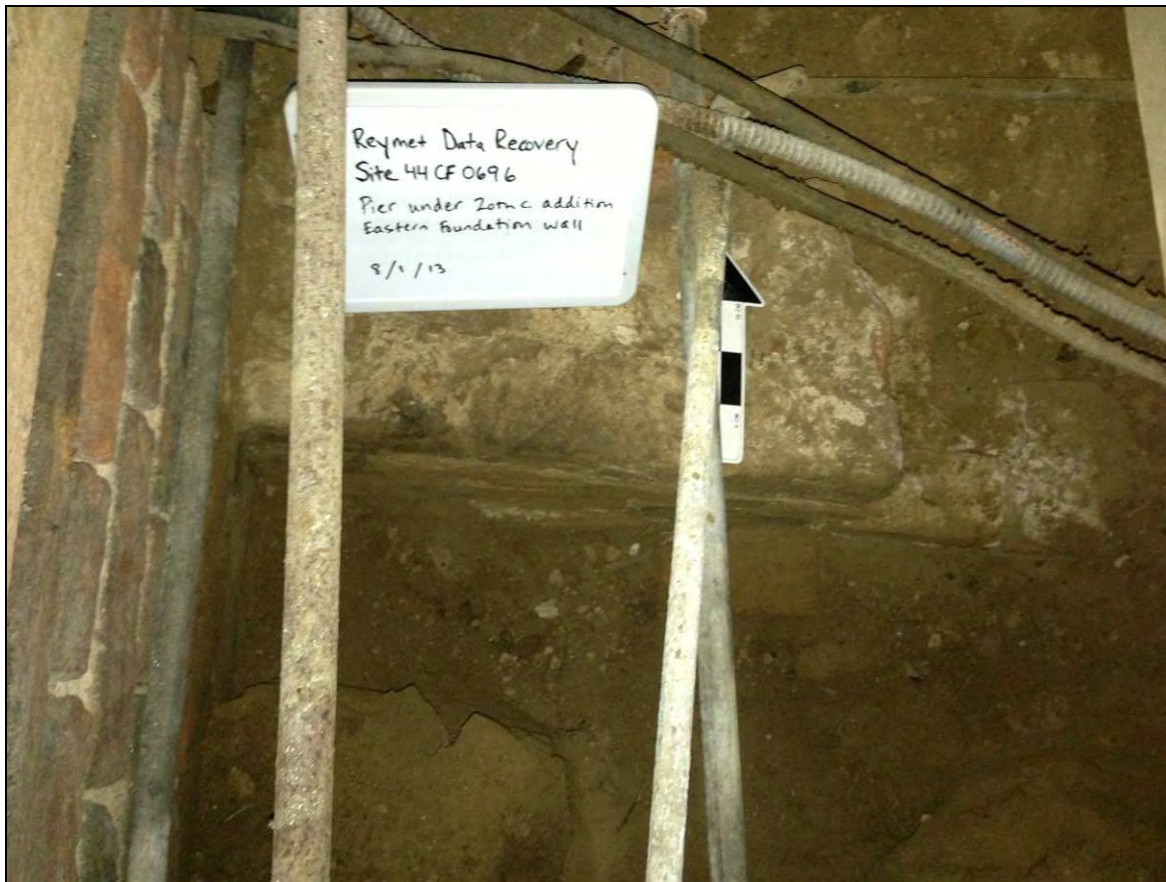
Figure 8-39. Wing wall east side of house.

Once the area was somewhat exposed, a section of a brick wing wall or pier was visible abutting the original foundation of the building (Figure 8-39). This articulated section of brick would have served as a support for stairs leading to the entry door. Only the brick on the southern side of the door was accessible due to the piers for the addition, but it is likely that another wing wall or pier would have been located on the other side of the door.

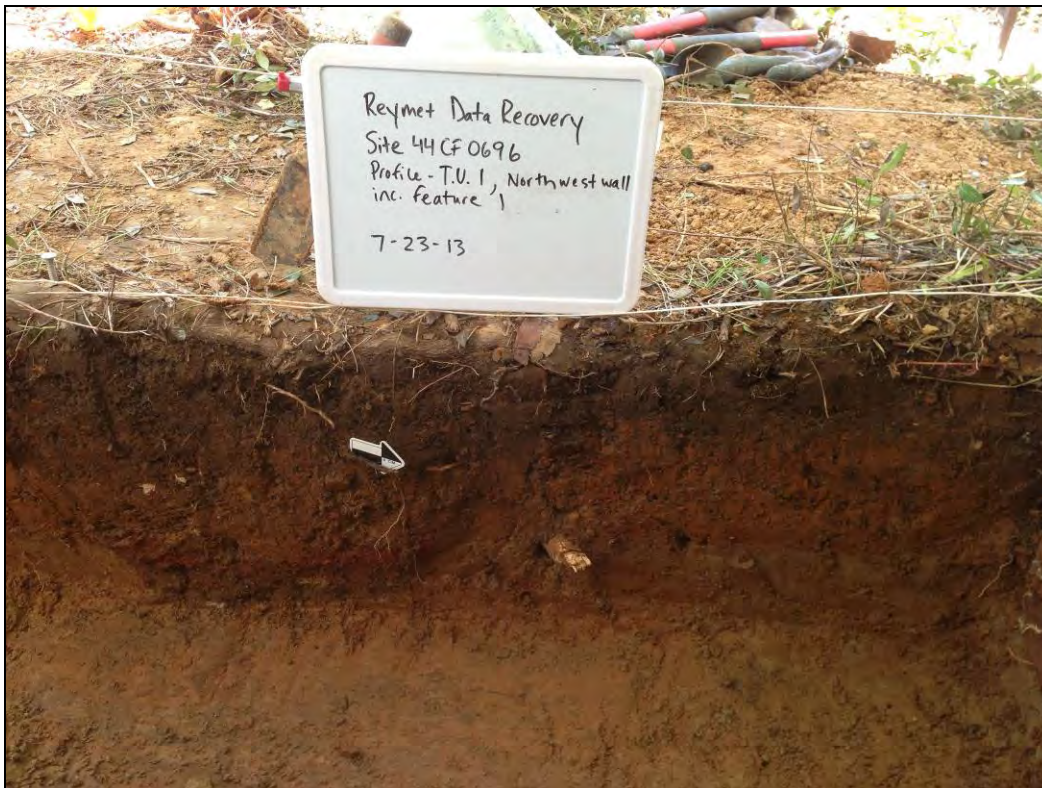
Figure 8-41. Profile of Test Unit 1.

Removal of the first level of soil, consisting of dark brown (10YR4/3) silty clay loam and measuring 12cm (0.3 ft) in depth revealed a series of irregular disturbances that appeared to be rodent burrows. The disturbed soils were removed and excavation of the first level of soil proceeded but was removed as a new Level B, which was slightly less organic, but had the same soil color value. Both Level A and what was removed as Level B were very disturbed. In addition to the rodent burrows, the soil appears to have been impacted by roots and water collecting at the foundation of the building. At approximately 30cm (1 ft) below ground surface, the base of the topsoil was reached, and a feature was identified cutting the subsoil (Figures 8-41 and 8-42).

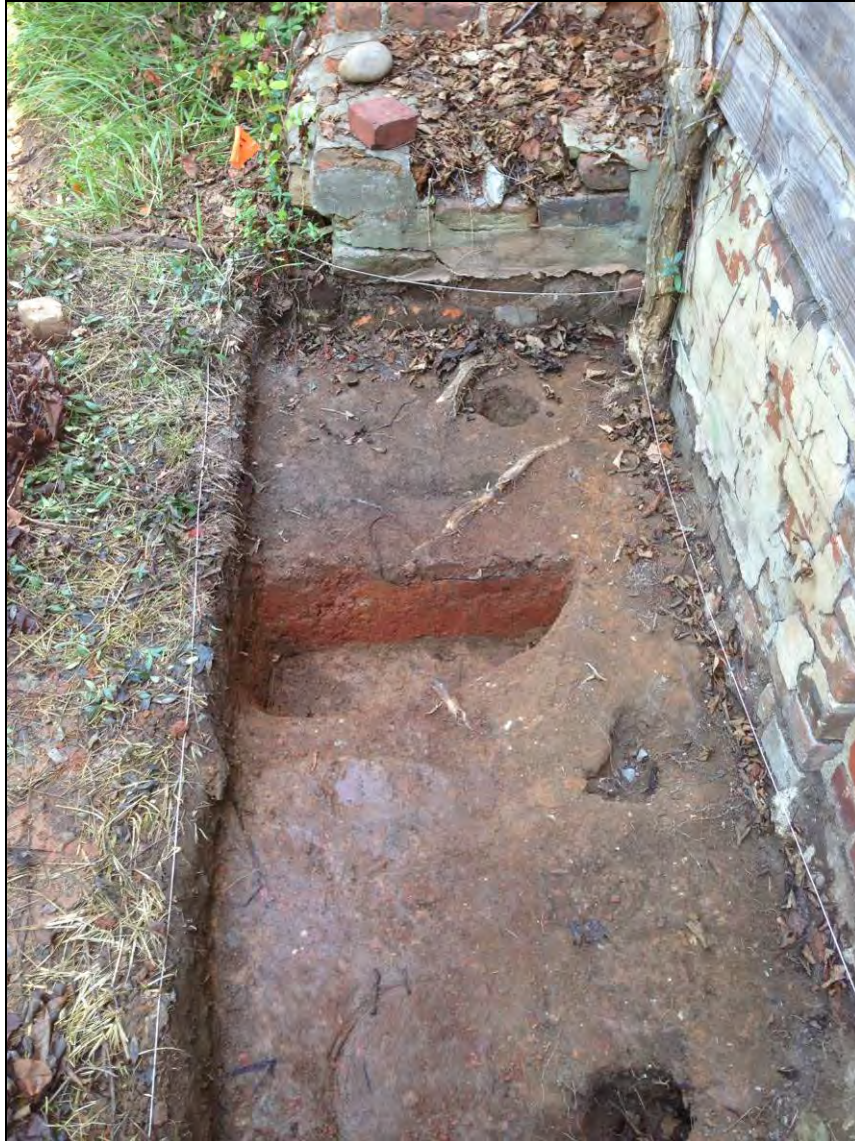
Figure 8-43. Feature 1 Profile facing north.

Feature 1 consisted of a shallow, generally oval pit. The soil consisted of a dark reddish brown (2.5YR3/4) sandy clay cap that was 5.0cm (0.1 ft) deep and sealed a second layer of dark red (2.5YR3/6) clay. Overall, the feature was 24.3cm (0.8 ft) deep (below topsoil) (Figure 8-43).

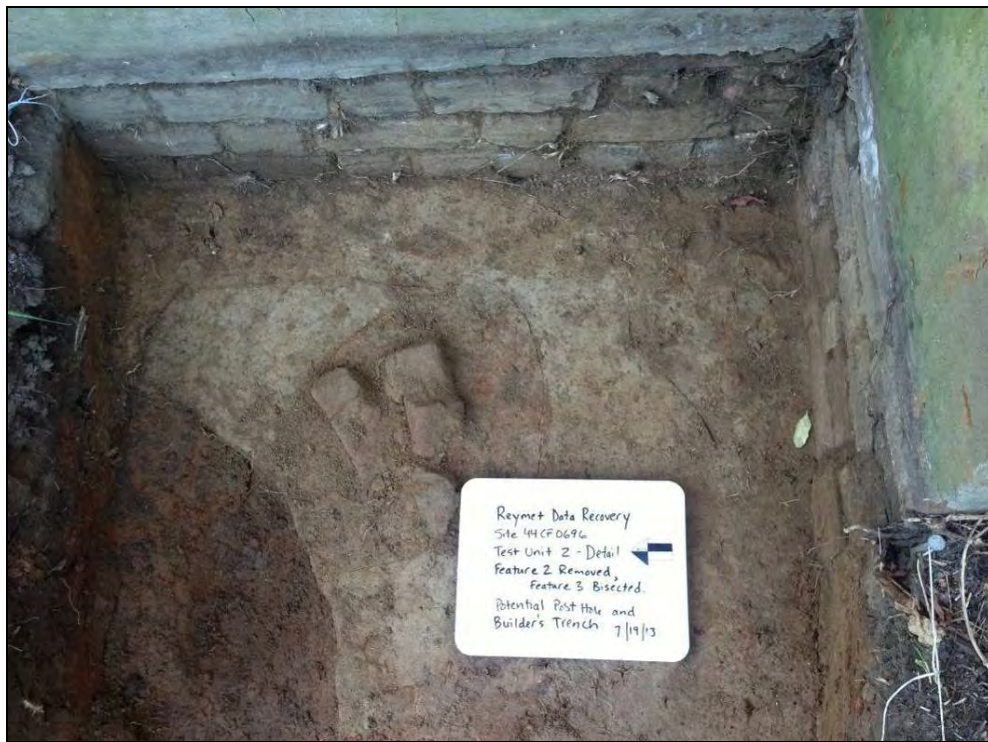
Figure 8-44. Plan view of Test Unit 2 with detail of Feature 2 removed and Feature 3 bisected.

Once Level B, which consisted of (10YR5/2) silty clay loam was exposed, two features were identified in the test unit. Feature 2, in the northern portion of the test unit and Feature 3, a trench-like feature in the western portion of the test unit and cut by Feature 2. Once Feature 2 was removed and Level C was exposed, an additional feature, Feature 44, was visible. Level C, subsoil, showed evidence of standing water and had gley characteristics. It consisted of mottled (10YR3/6) and (10YR5/1) soils (Figures 8-44 and 8-45).

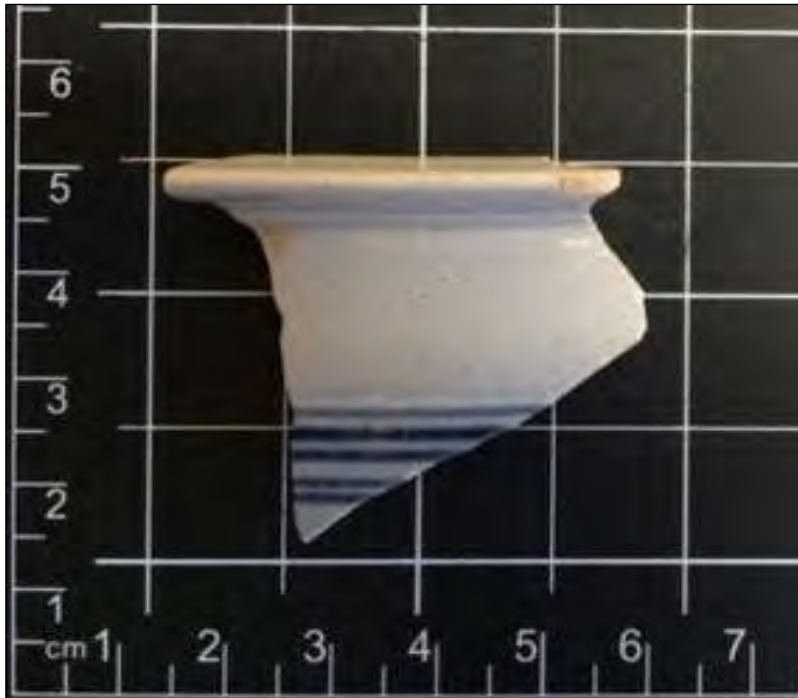
Figure 8-46. Rim fragment from scratch-blue chamberpot.

Artifacts recovered from Feature 2 consisted of a sherd that appeared to be from the rim of a chamber pot made of white saltglazed stoneware with a “scratch blue¹⁶” decoration (Figure 8-46), along with a portion of a creamware cup handle, a piece of window glass, a terra cotta flowerpot sherd, four nail fragments, and a sherd of whiteware.

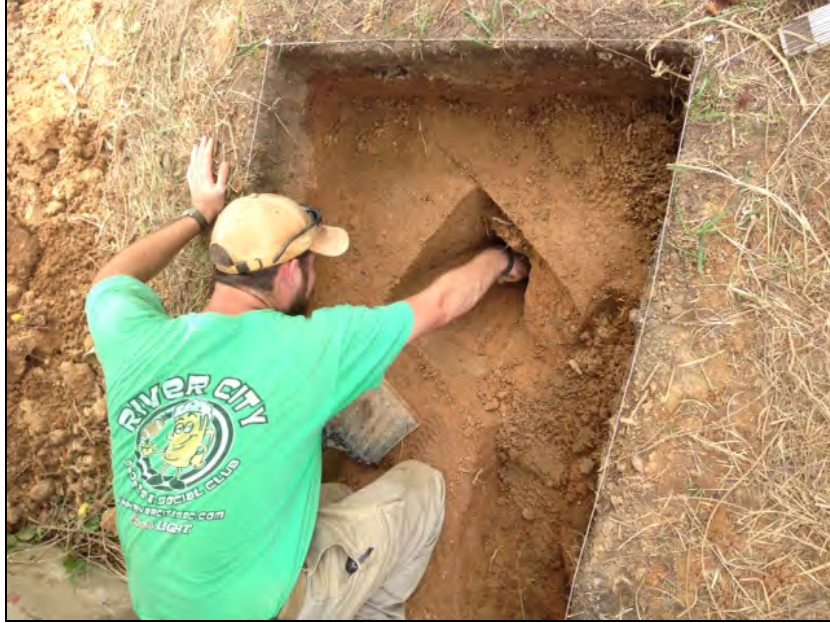
Figure 8-47. Excavation of Feature 3 in Test Unit 2.

Feature 3 consisted of a linear feature of dark yellowish brown (10YR4/4) very silty clay loam (Figure 8-47). Only one nail fragment was recovered from the feature, making its interpretation difficult. Based on its location, soil texture, and shape, it is possible that the feature is related to drainage issues at Spring Hill and that it served to draw rainwater away from the foundation.

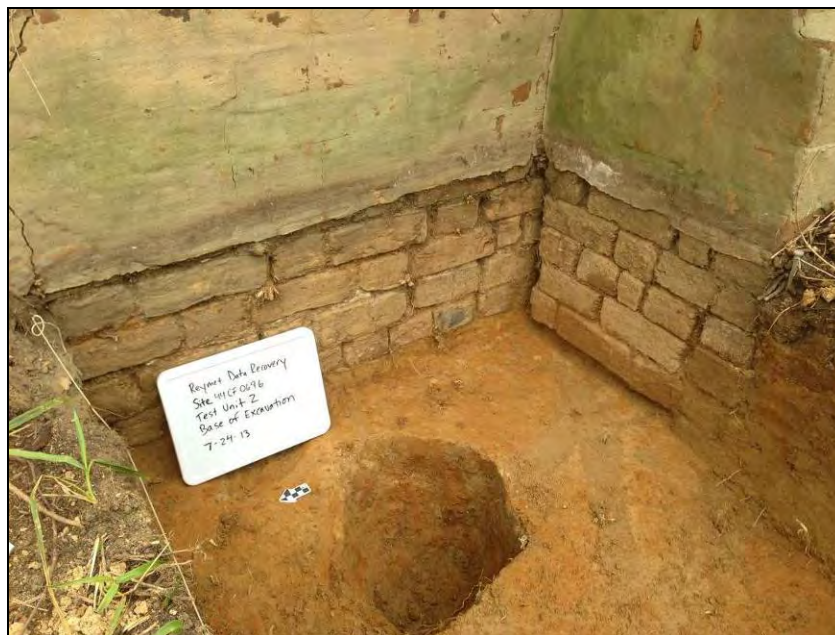
Figure 8-48. Test Unit 2 base of excavation with Feature 44 removed.

In the eastern portion of Test Unit 2, a posthole was found very near the building foundation. The feature was sealed by the topsoil and had yellowish brown (10YR4/4) compact silty clay loam. Once removal of the fill began, the northern quarter of the feature was quite shallow, while the remainder of the feature had relatively steep sides. The feature measured 36.5cm (1.2 ft) in diameter and extended to a depth of 33.5cm (1.1 ft) into subsoil, for a total of 73.1cm (2.4 ft) below ground surface (Figure 8-48).

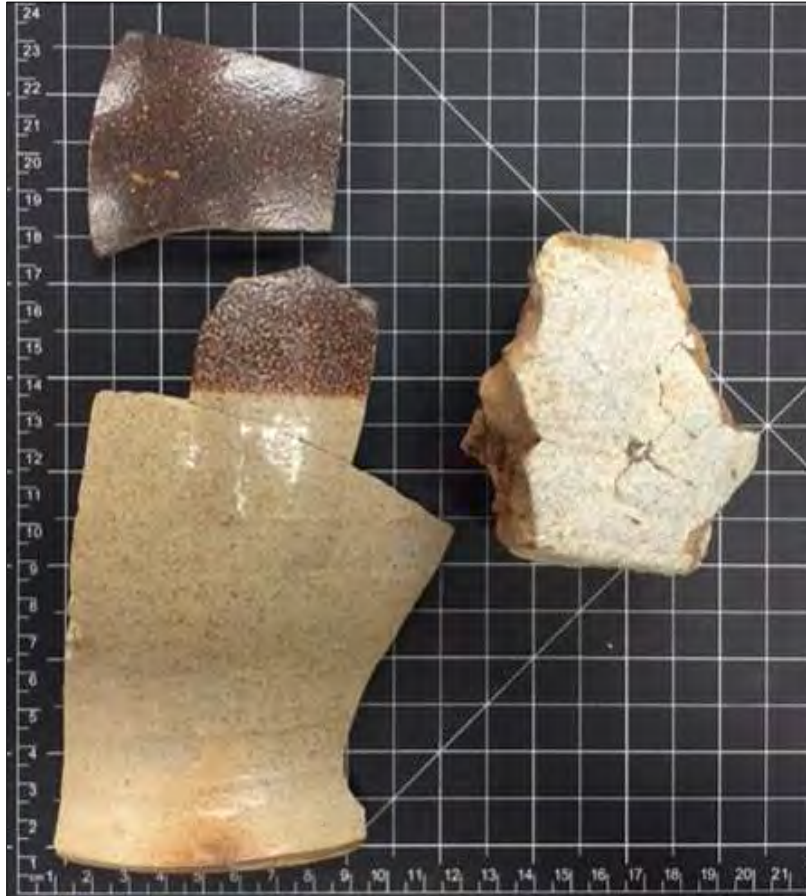
Figure 8-49. English Brown Stoneware sherds and a vitrified brick fragment recovered from Feature 44.

The posthole had several pieces of brick filling it, and also contained two English brown stoneware sherds that appear to be from the same ovoid-shaped vessel, with a taupe body and iron oxide dipped top and a pink interior (Figure 8-49). The stoneware pieces are some of the largest artifacts recovered during the data recovery, and the breaks in the sherds are not worn, indicating that they are at this location as a result of a primary deposit.

English brown stoneware was produced over a long period, with a range of 1671 and 1800. The median date is approximately 1735, suggesting that it was present during the first period of the occupation. One of the brick fragments recovered from near the base of the feature was also vitrified on four surfaces, which is indicative of the brick being a “waster,” and was at the site during construction and then discarded. Based on the location of the feature and the condition, age, and nature of the fill, that Feature 44 is a posthole that was used for scaffolding during the construction of the northern end chimney.

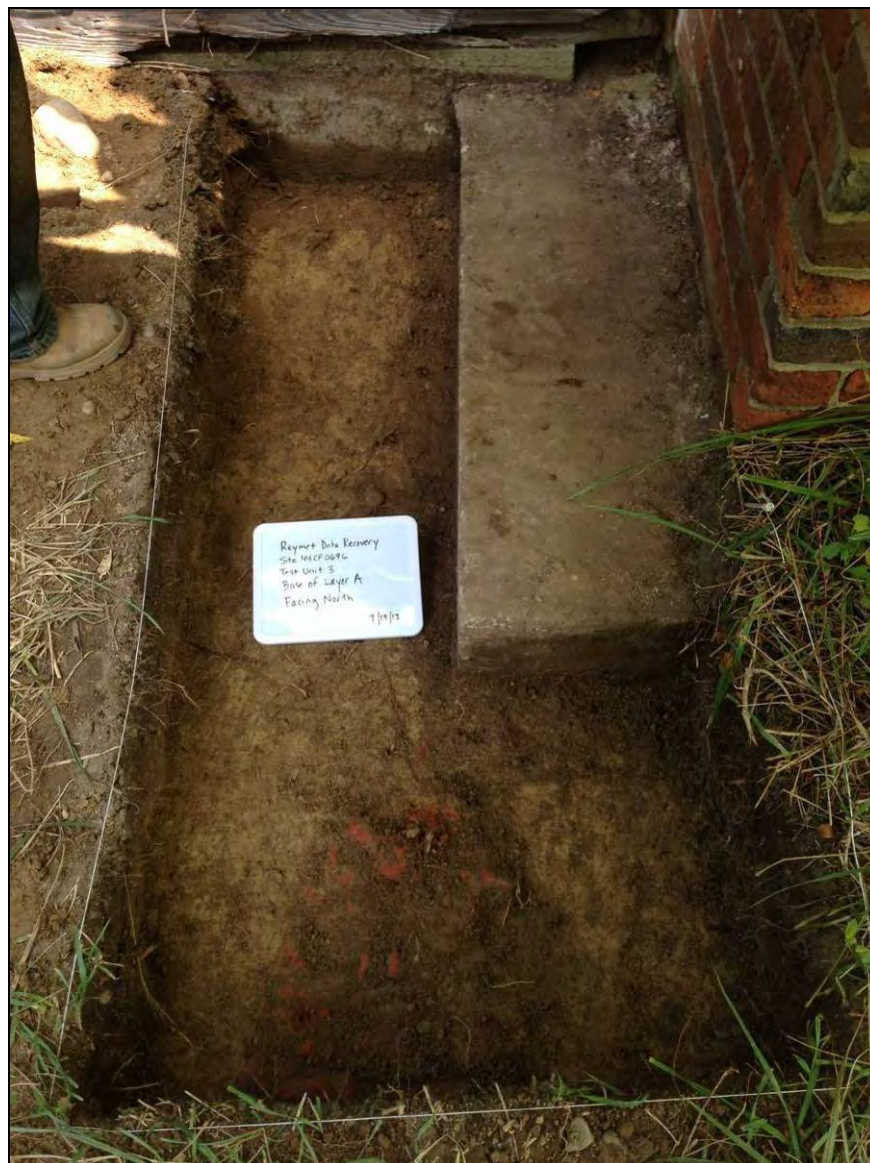
Figure 8-50. Plan view of bottom of Layer A in Test Unit 3 showing Feature 22.

by 1.8 meters (6 ft) and extended north/south from the corner where the chimney and the frame structure meet on the western side of the chimney (Figure 8-50).

Feature 22 was located at the southern edge of Test Unit 3 and consisted of a brick-filled posthole. The soil consisted of dark brown (10YR3/3) silty clay and had several large brick fragments. Small brick fragments were also recovered from the fill. The base of the feature extended 60.9 cm (2 ft) beneath the present ground surface.

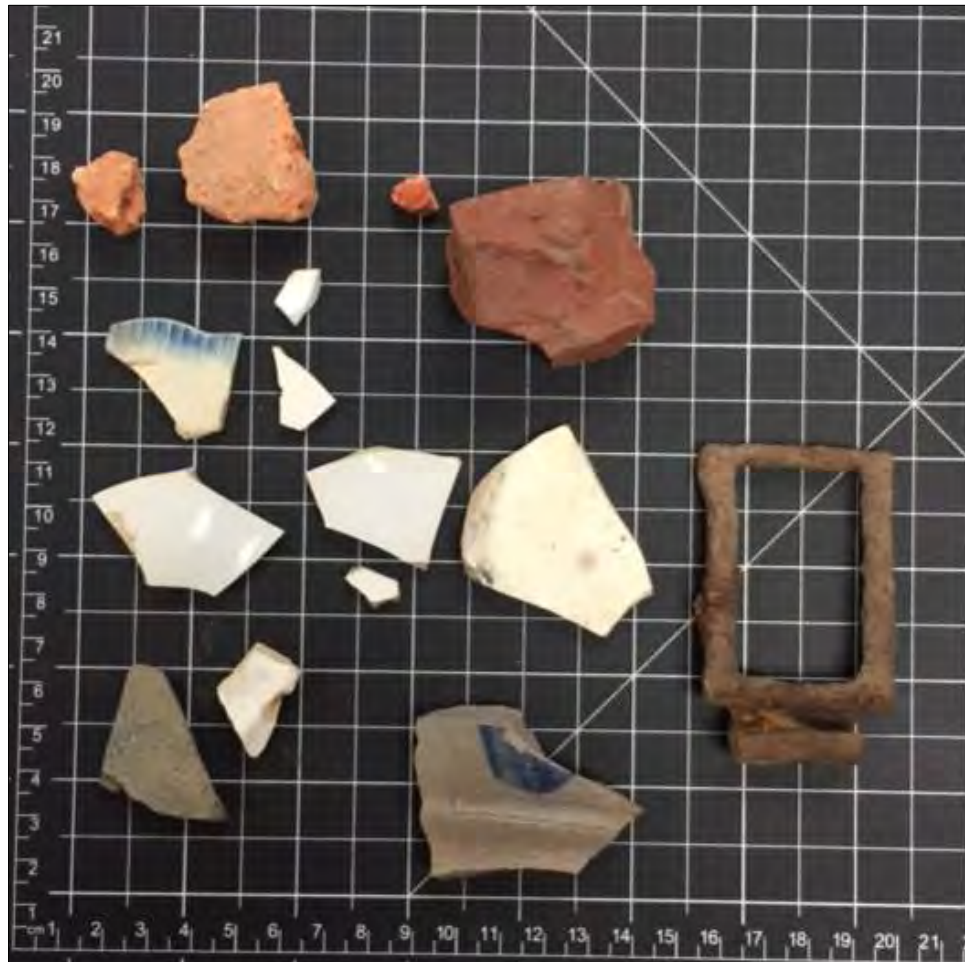
Figure 8-52. Sample of artifacts recovered from Feature 22, Test Unit 3.

Additional artifacts recovered from the feature consist of ceramics including pearlware and white ware (n=3 each), two sherds of stoneware, and 1 sherd of porcelain. A large quantity of glass was found (n=87), the majority of which was window glass. Five pieces of dark green bottle glass were also recovered along with several pieces of molded glass and two pieces of opalescent depression glass. While the recovered artifacts have a relatively wide date range of popularity usage, the quantity of early twentieth century materials suggests a twentieth century date for the feature (Figure 8-52).

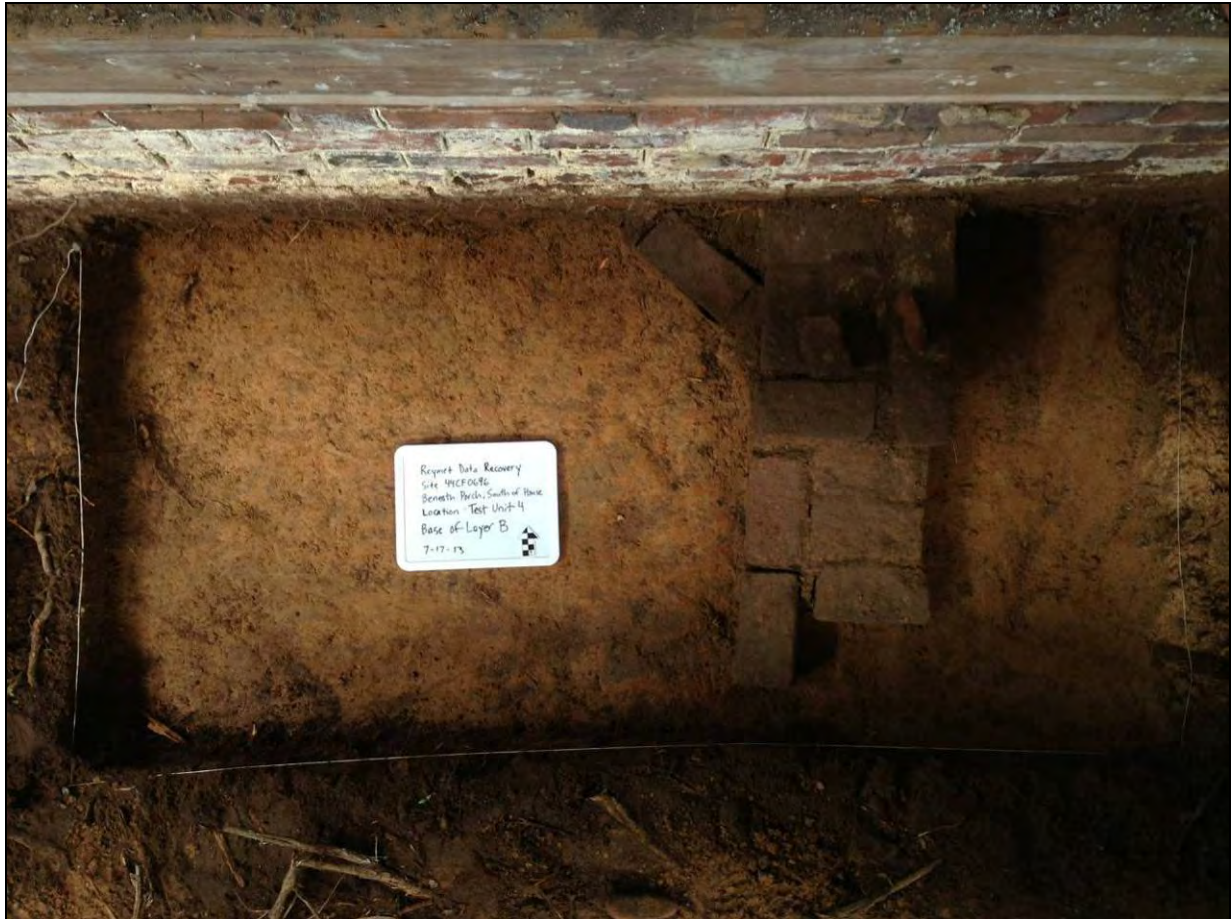
Figure 8-53. Plan view of base of Unit 4 with brick piers/stair support.

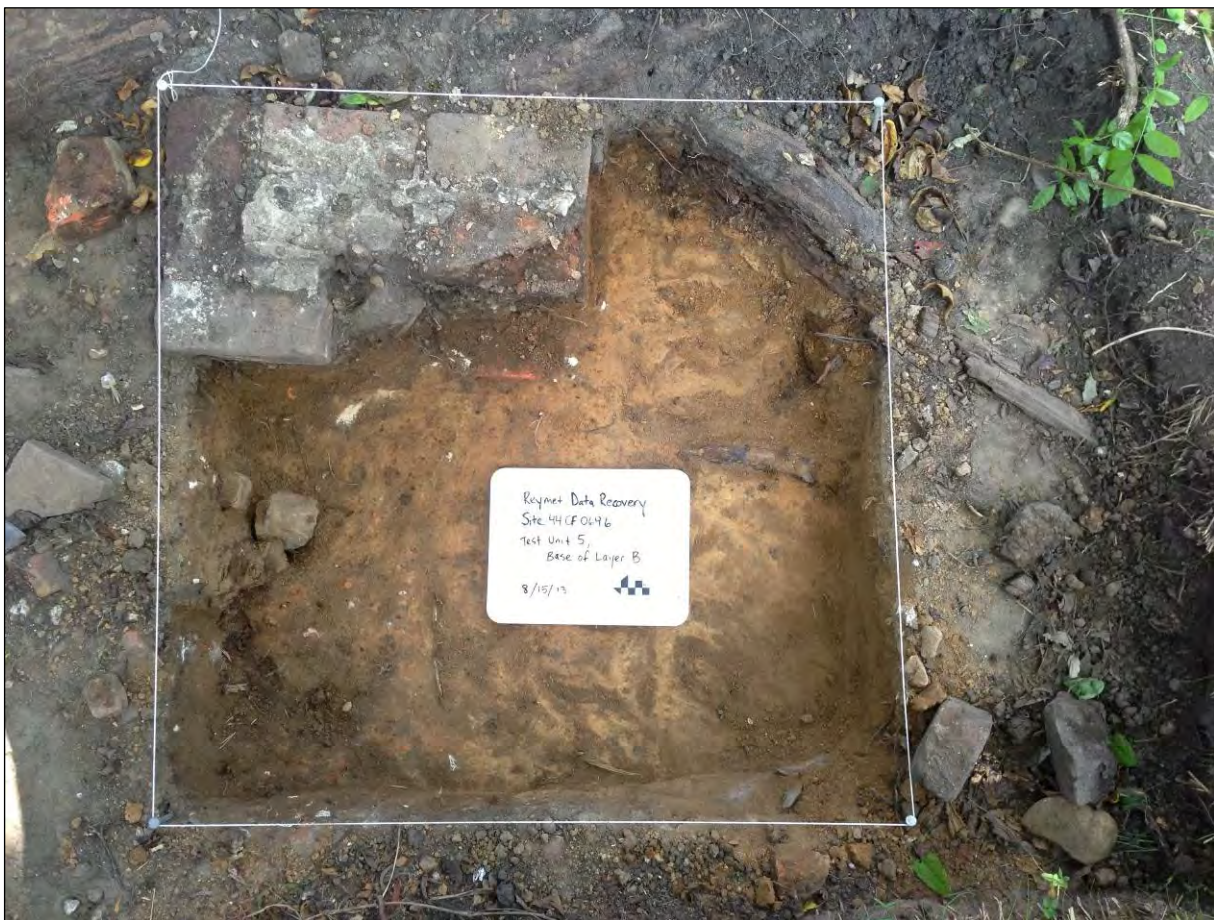
Figure 8-55. View of Test Unit 5 at base of Layer B.

Test Unit 5 measured 3 feet by 3 feet. The roots from the adjacent walnut tree intruded into the test unit, which was laid out to include the brick foundation (Figure 8-55).

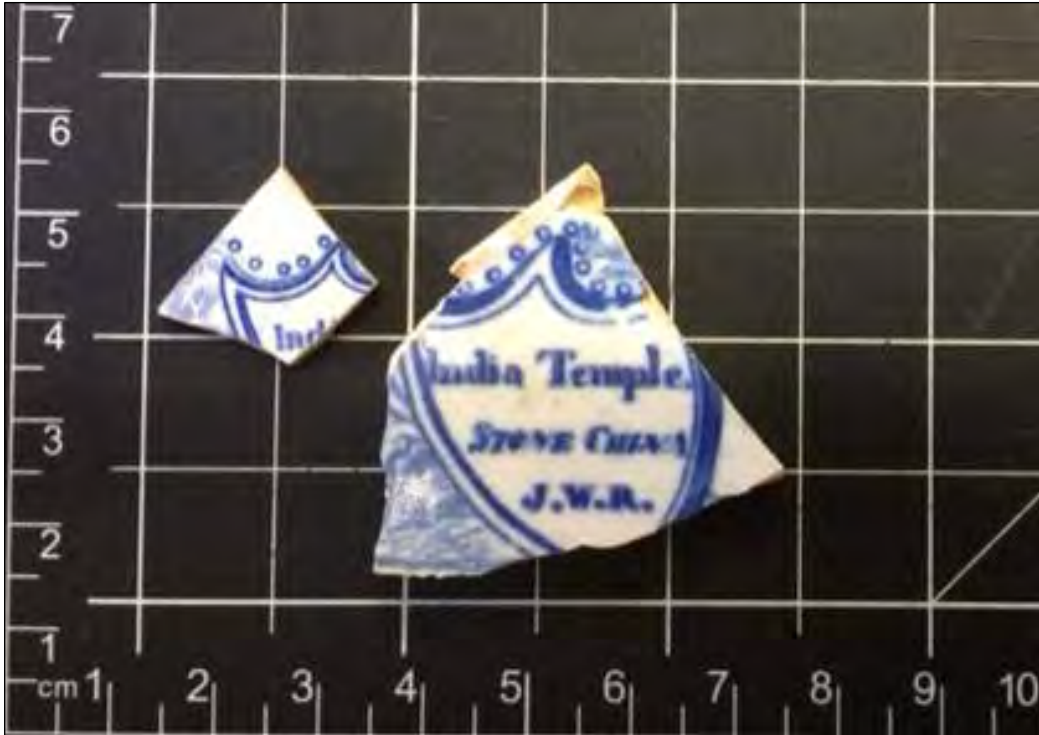
Figure 8-57. Indian Temple mark on sherd from Test Unit 6.

North of Test Unit 5, a second test unit, Test Unit 6, was placed in the location of the suspected chimney fall to determine if any structural remains were located beneath the brick rubble. Artifacts recovered from Level B of the test unit consisted of 10 sherds of pearlware, 8 sherds of graniteware, 4 sherds of stoneware, and one sherd each of creamware, lead-glazed redware, and porcellaneous porcelain. These ceramics, as a group, have a mean ceramic date of 1845. Two of the sherds of pearlware had maker's marks identifying them as the India Temple pattern produced by the firm of John and William Ridgway (Figures 8-57 and 8-58). The maker's mark provides a very concise time of production as John Ridgway and his brother William were only in a partnership between 1815 and 1830.

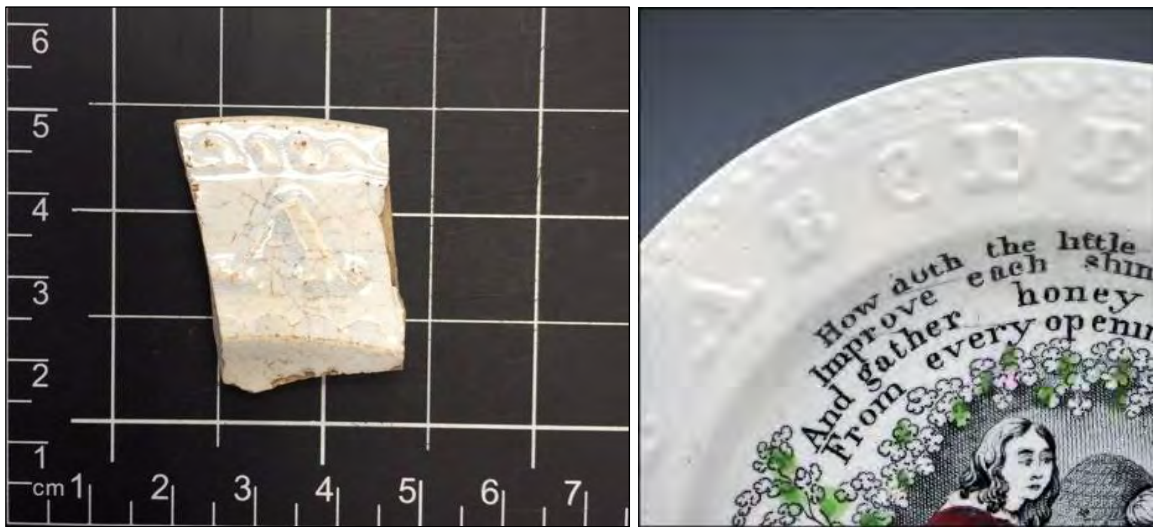
Figure 8-59. (Left) Child's plate rim, (Right) Detail of Staffordshire child's plate (1830s-1840s).

The soil level sealing subsoil, Level C, contained 5 ceramic sherds. These consisted of one sherd each of graniteware, creamware, and Nottingham stoneware and two sherds of pearlware, one of which was a burned rim section with an embossed edge known to have been produced around 1820-1830. The mean ceramic date of Level C was 1796, which is earlier than most other contexts encountered at Spring Hill. It is likely that the depth of this context and the fact that it was directly adjacent to the walnut tree prevented it from being impacted during earth moving and grading at the site, as was the case with several other contexts.

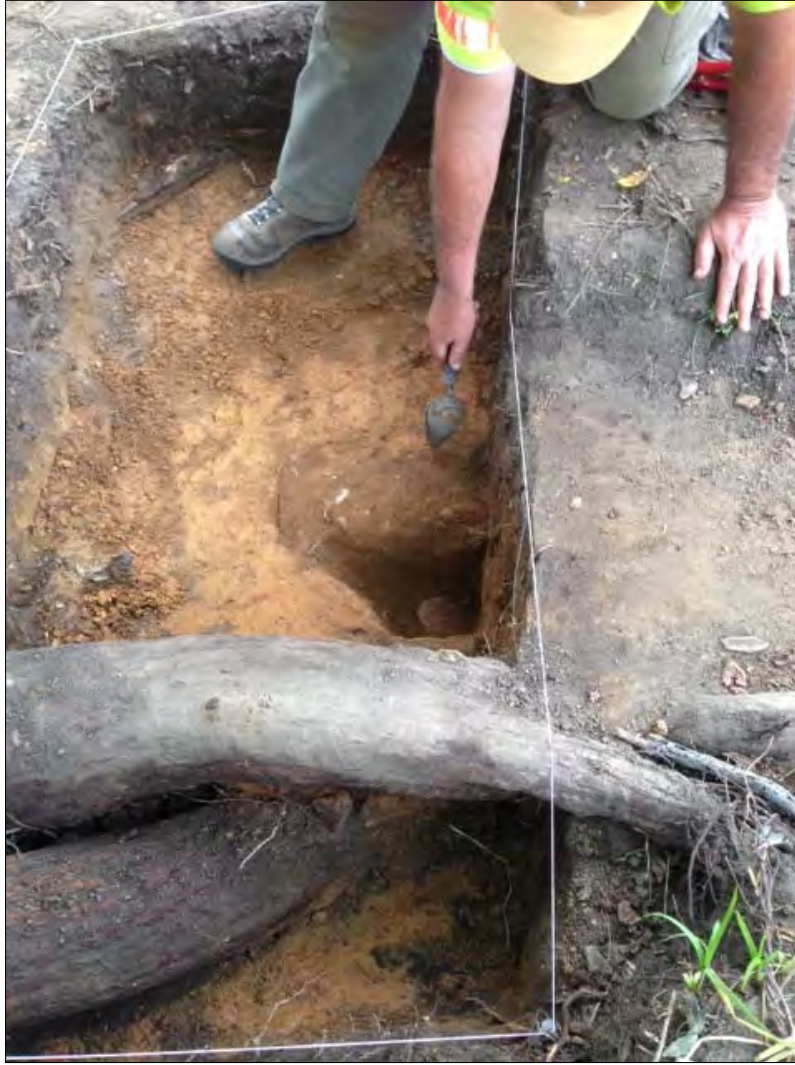
Figure 8-60. View of Feature 50 excavation in progress.

Feature 50 was identified in the northern half of Test Unit 6, just east of the chimney fall from the remains of the structure archaeologically identified in the domestic yard (Figures 8-60 and 8-61). The feature cut into subsoil and was located in the center of the test unit, where it was bounded on the east by a large root from the adjacent walnut tree. In plan, Feature 50 measured 30.4 cm (1.0 ft) by 39.6 cm (1.3 ft). The soil consisted of brown/dark brown (10YR4/4) silty clay. The feature was bisected, beginning with removal of the eastern half. As the depth of the feature increased and due to the size of the adjacent root, excavation of the fill as one context proceeded.

The maximum depth of the feature was 65.5 cm (2.15 ft) from the ground surface and had a base that was stepped slightly, with the eastern portion being slightly shallower than the west.

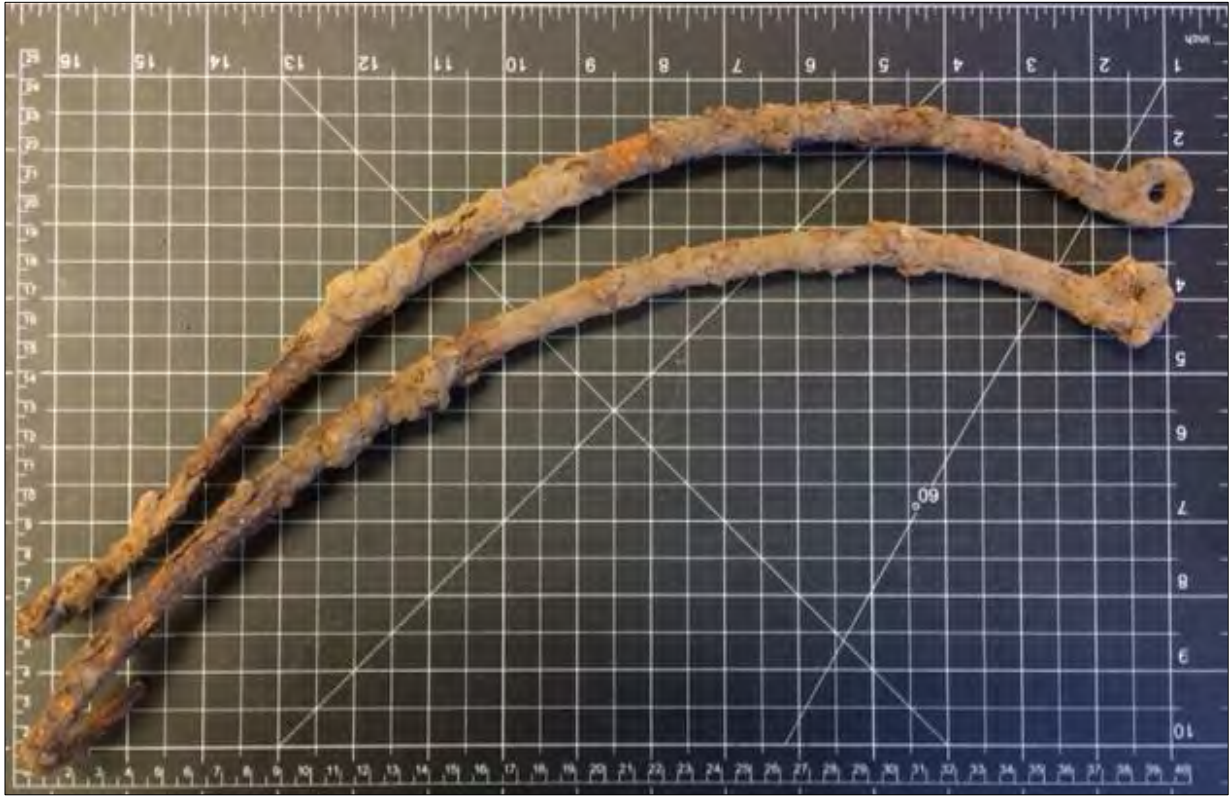
Figure 8-62. Iron pot hooks recovered from Feature 50.

Artifacts recovered from the first level of Feature 50 include 17 pieces of ceramic, including pearlware (n=9), graniteware (n=5), creamware (n=2), and whiteware (n=1). Three (3) brick fragments and two (2) pieces of marl were also found along with two (2) nail fragments. Also found in Level A of Feature 50 were two large iron hooks which are a matched pair of pot hooks that would have been used for cast iron cooking pots or wash tubs (Figures 8-62, 8-63, and 8-64).
