Phase III Investigations and Historical Study of the Spring Hill Plantation

LOCATION > Chesterfield County, Virginia

DATE > MARCH, 2015

Dutton+Associates, LLC

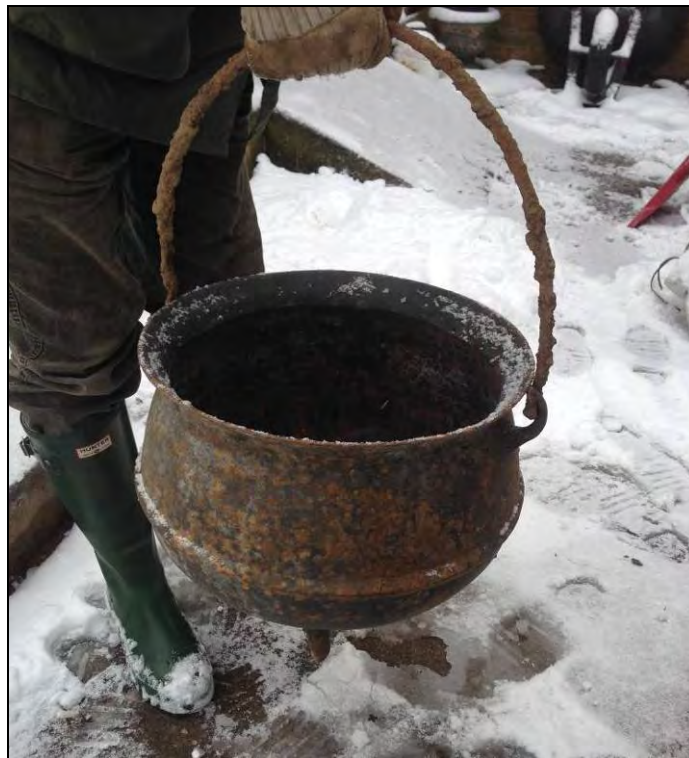
Figure 8-63. Iron pot hooks from Spring Hill holding a pot.

Artifacts recovered from the first level of Feature 50 include 17 pieces of ceramic, including pearlware (n=9), graniteware (n=5), creamware (n=2), and whiteware (n=1). Three (3) brick fragments and two (2) pieces of marl were also found along with two (2) nail fragments. Also found in Level A of Feature 50 were two large iron hooks which are a matched pair of pot hooks that would have been used for cast iron cooking pots or wash tubs (Figures 8-62, 8-63, and 8-64).

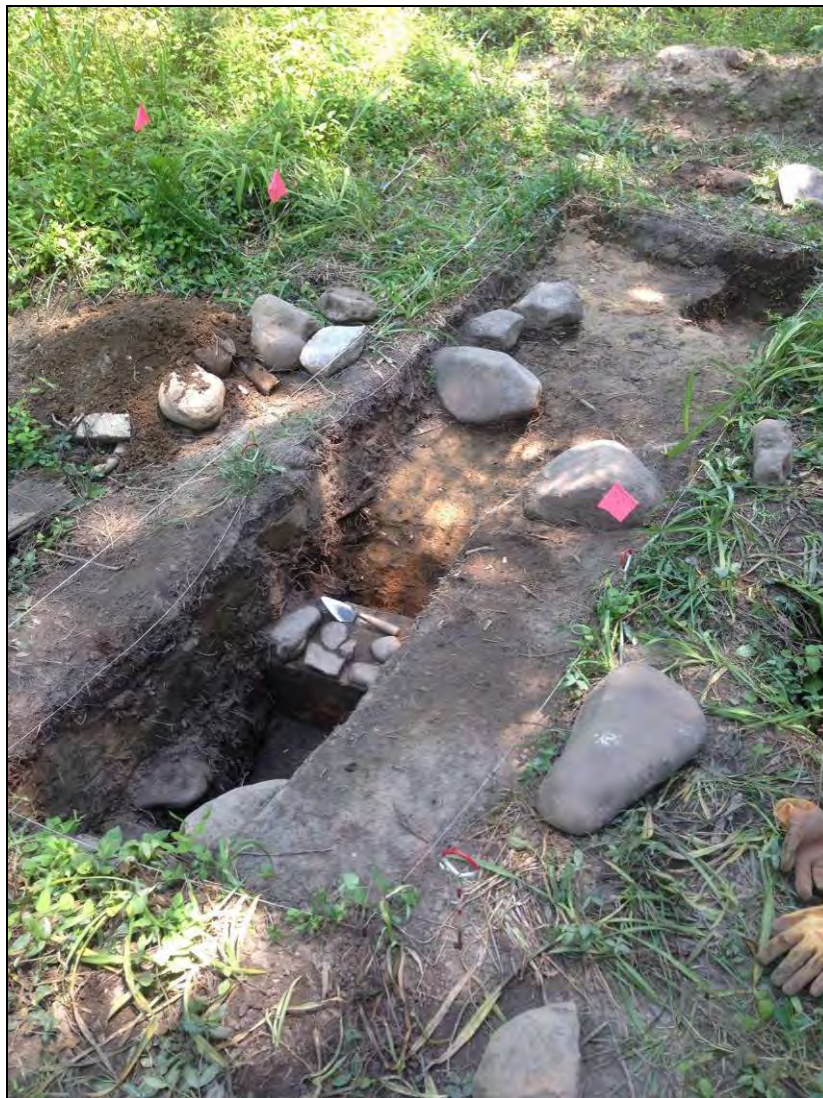
Figure 8-65. Test Unit 7 base of excavation.

In May 2014, a test unit measuring 0.9 meters (3 ft) by 2.7 meters (9 ft) was placed within the concentration of cobbles across the road north of the Spring Hill house. Initially, the test unit was laid out to measure 0.9 meters (3 ft) by 1.8 meters (6 ft), but was expanded in order to more fully expose the cobble-filled feature. The first level of soil consisted of brown/dark brown (10YR4/3) sandy loam, and a number of cobbles were exposed just beneath the root mat (Figures 8-65 and 8-66).

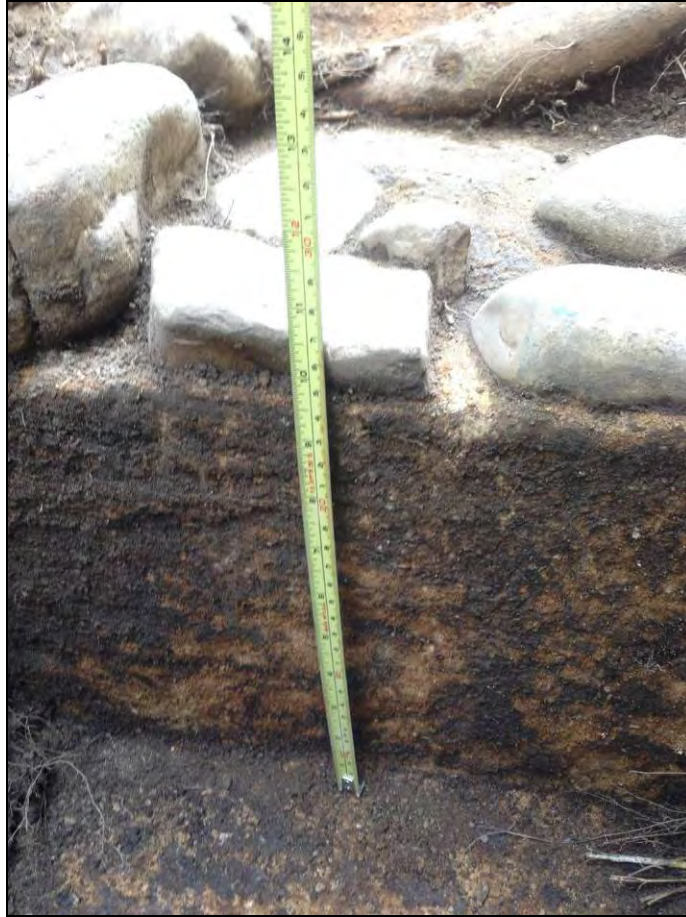
Figure 8-67. Profile view of Feature 53 with concrete foundation.

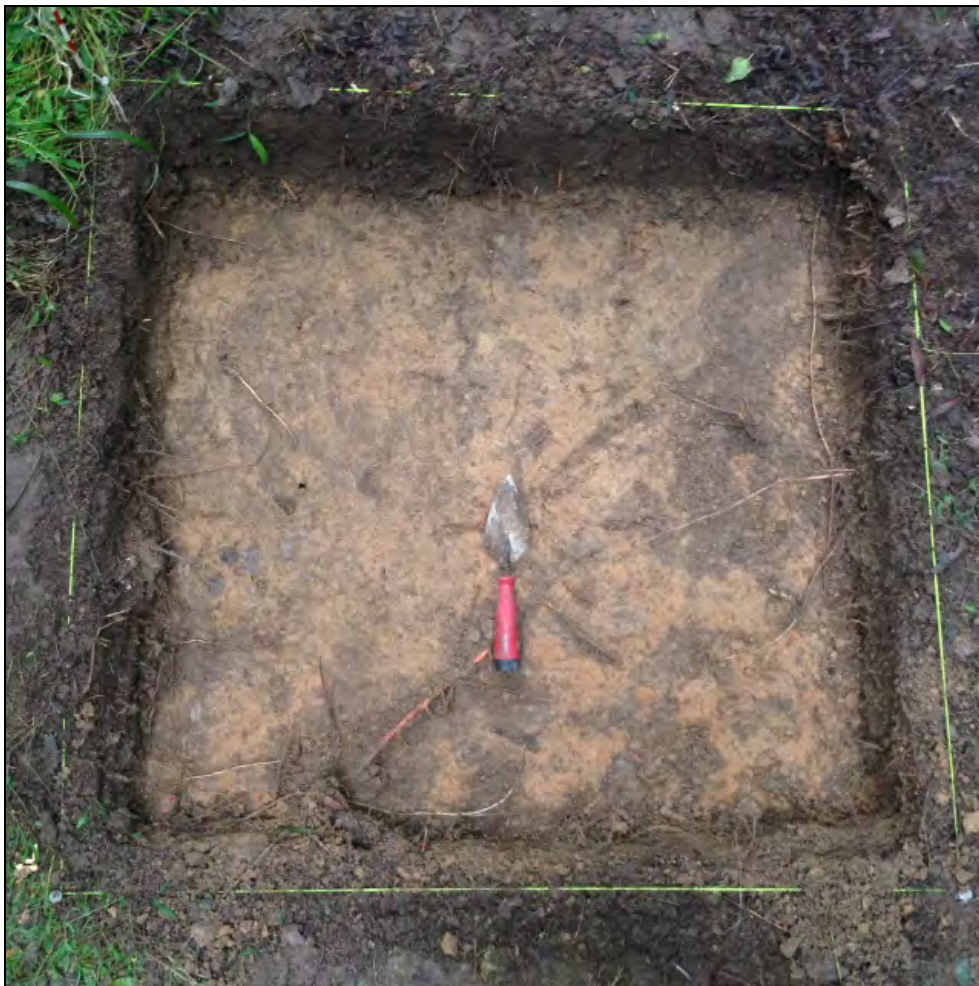
Figure 8-68. Test Unit 8 base of excavation.

The topsoil, measuring 17.9cm (0.59 ft) in depth, consisted of brown/dark brown (10YR4/3) silty clay loam with small inclusions of charcoal. The plowzone below this was 27.1cm (0.91 ft) deep reddish yellow (7.5YR6/8) silty clay. While very small flecks of charcoal and brick were evident in the subsoil, these were likely due to the roots in the test unit (Figures 8-68 and 8-69).

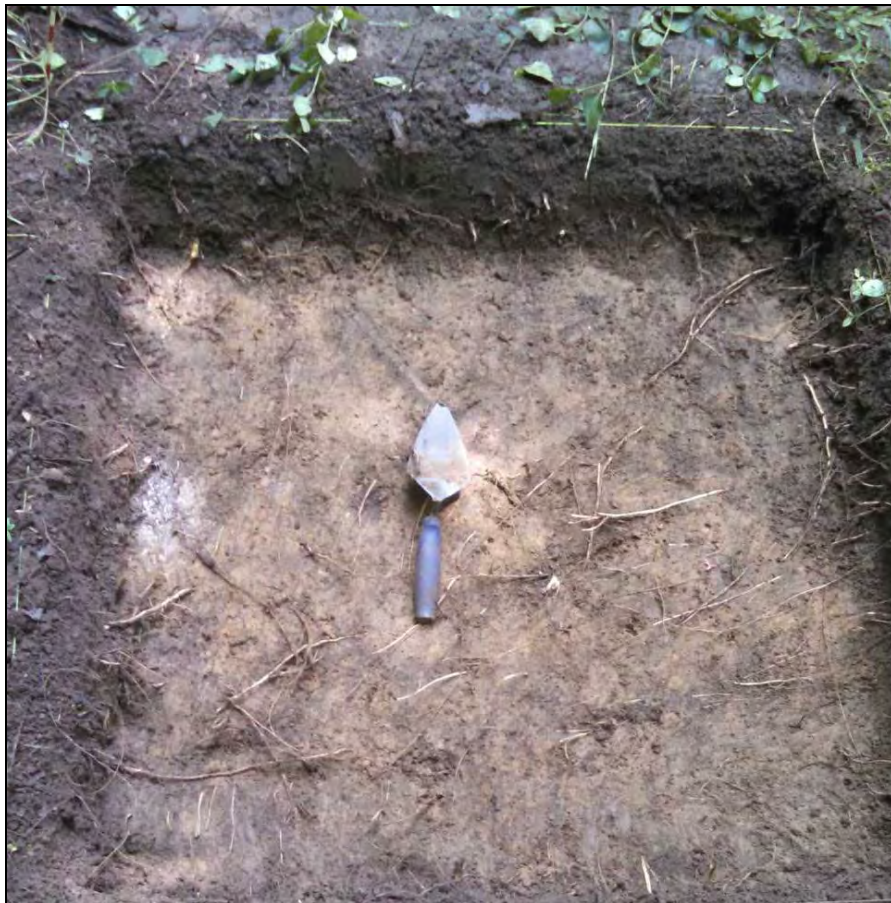
Figure 8-70. Test Unit 9 base of excavation.

Test Unit 9 consisted of three soil strata. Stratum A was a 10YR4/3 silty loam overlying a 7.5YR6/8 clay loam, which sealed subsoil. No artifacts were recovered and no cultural features were identified (Figures 8-71 and 8-72).

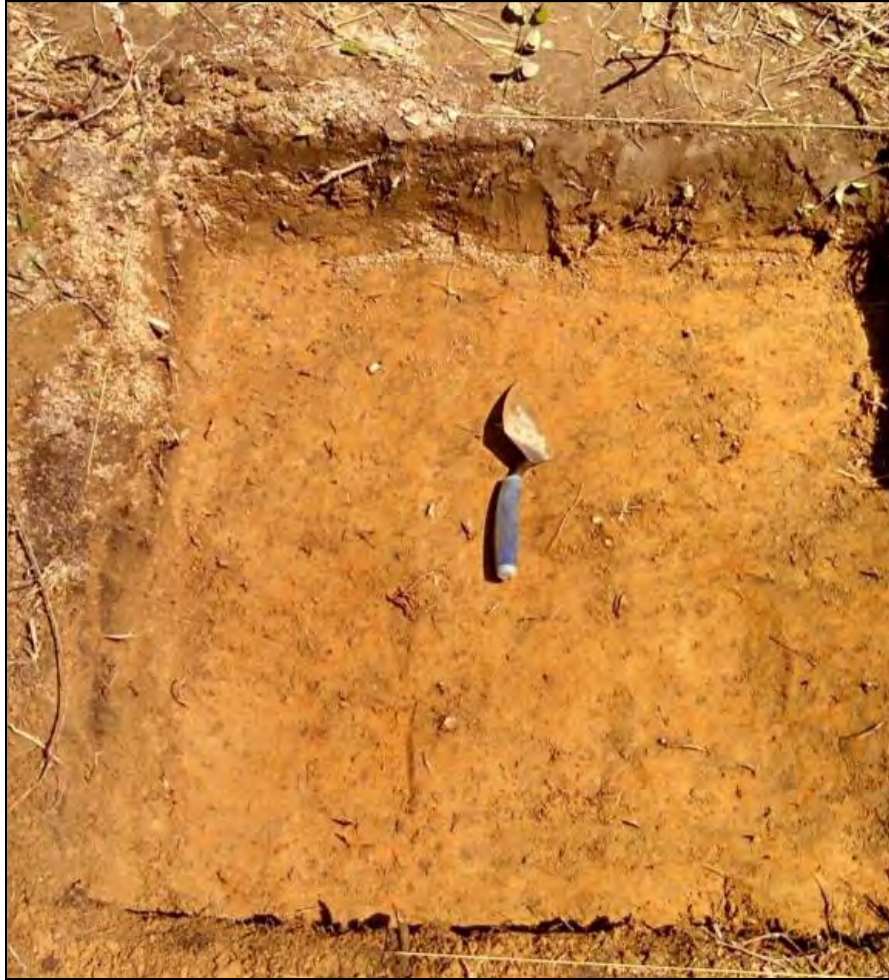
Figure 8-72. Test Unit 10 base of excavation.

Test Unit 10 was placed west of the reconstructed outbuilding. The unit measured 0.9 meters (3ft by 0.9 meters (3 ft). Level A, including the root mat, measured 21.9cn (0.72 ft) in depth and consisted of brown/dark brown (10YR4/3) silty clay loam. No features were identified in the test unit, and Level A sealed sterile subsoil (Figures 8-72 and 8-73).

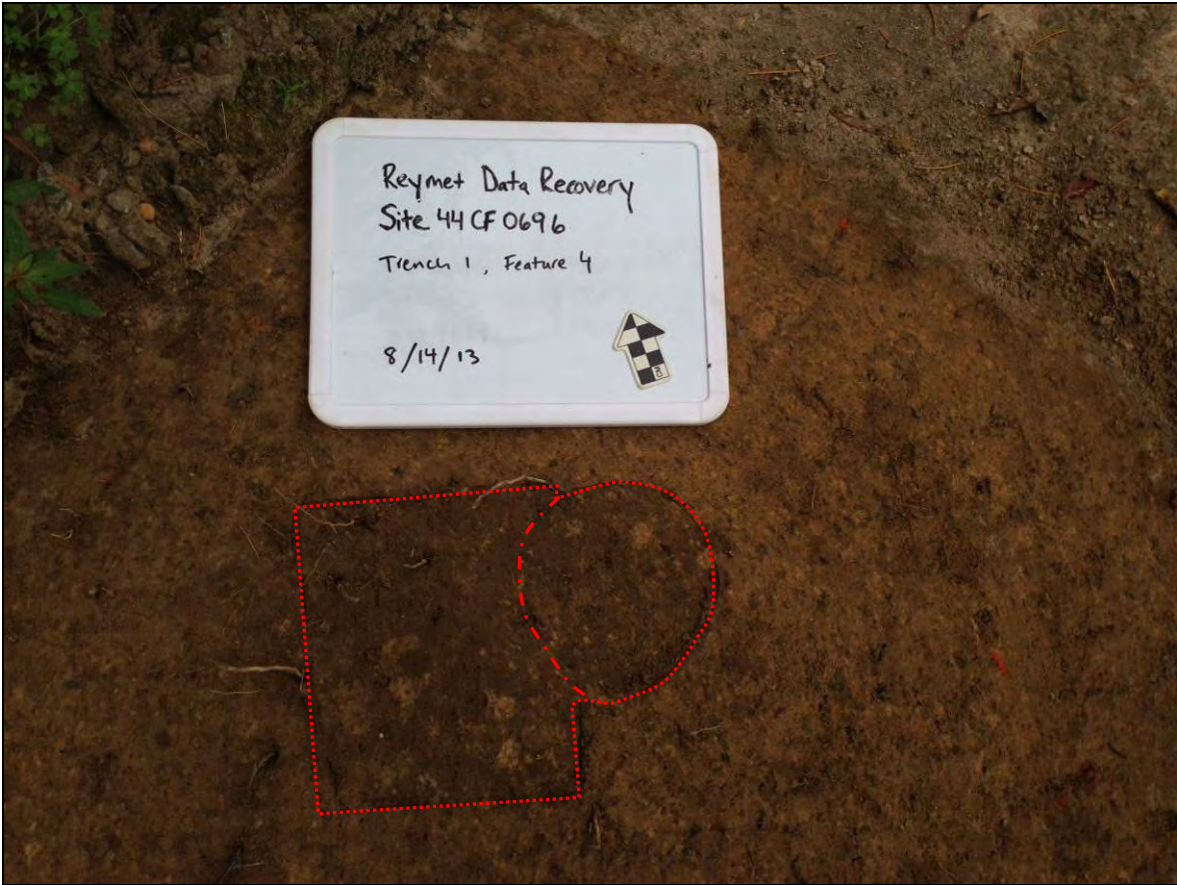
Figure 8-75. Plan view of Feature 4, Trench 1.

Feature 4 consisted of a small, poorly defined posthole with possible evidence of repair. The roughly square feature measured 17.6 cm (0.58 ft) by 17.6 cm (0.58 ft) (Figure 8-75). The northeast corner of the posthole had a circular area that appeared to represent repair to the post. Artifacts found in the feature included one piece of dark green bottle glass and a copper alloy button cover. In profile, the posthole extended only 15.2 cm (0.5 ft) into the subsoil, indicating that the topsoil in this area has been disturbed in the time since the feature was in use as this depth would not have been enough to give much support.

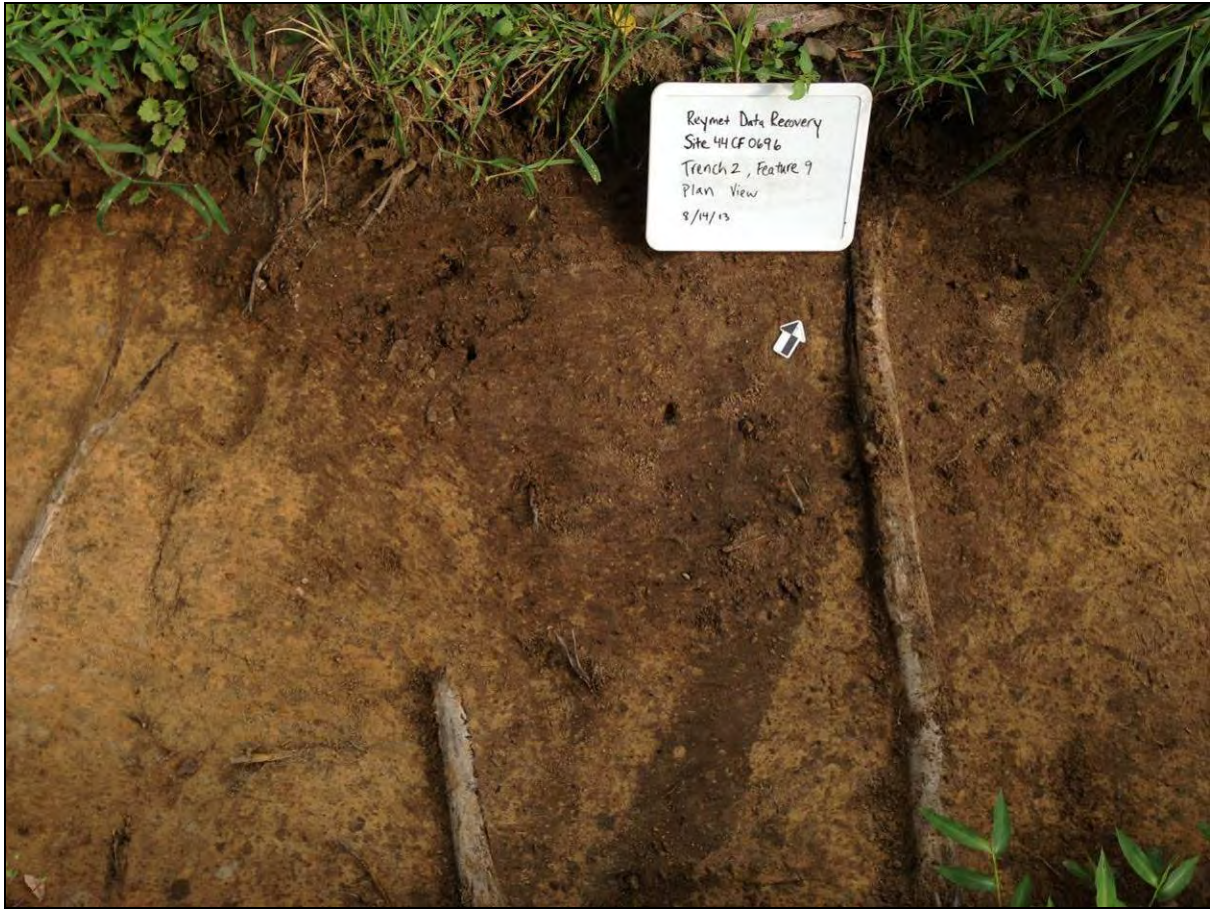
Figure 8-76. Plan view of Feature 9, Trench 2.

Feature 9 was a large amorphous feature covering an area of approximately 1.4 meters (4.6 ft) along the northern wall of Trench 2 (Figure 8-76). The portion of the feature exposed by the trench extended approximately half the distance 0.60 meters (2 ft) across the width of the trench.

The soil in Feature 9 consisted of dark yellowish brown (10YR4/4) silty clay loam. The soil on the borders of the feature contained some mottled inclusions of brownish yellow (10YR6/6) silty clay loam. The feature had significant root disturbances, but was notable when it was exposed because it appeared to have a number of artifacts.

Excavation of the feature revealed that it was very shallow, only extending approximately 4.5 cm (0.15 ft) into subsoil with a few deeper pockets. It is likely that the feature is actually an area that had been lower in elevation and that soil washed into it.

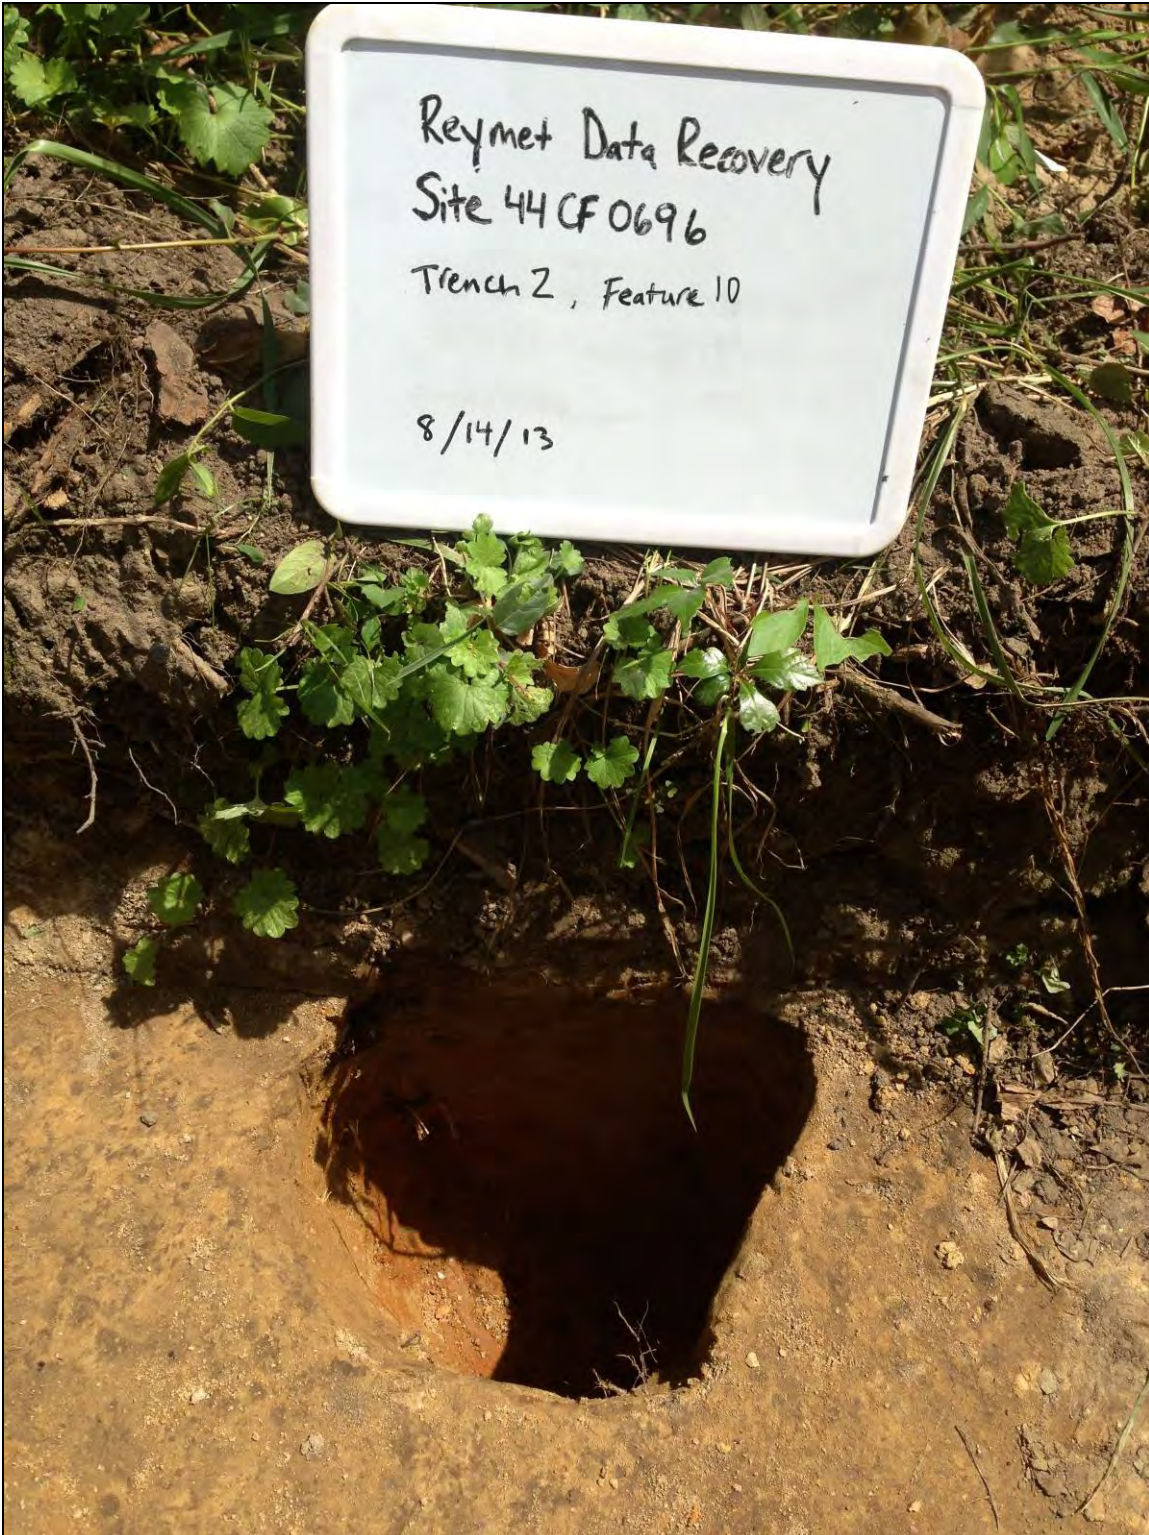
Figure 8-77. Plan view of Feature 10, Trench 2 following excavation.

Feature 10 was located in the southern portion of the Trench 2 wall. The feature measured 19.8 cm (0.65 ft) north/south and the portion that was exposed in the trench was 33.5 cm (1.1 ft) east/west. The soils consisted of dark yellowish brown (10YR4/6) silty clay loam, with soil along the northern edge mottled with clayey yellowish red (5YR4/6) soil and what appeared to be a post mold in the center of the feature (Figure 8-77).

In Feature 10, some root disturbance was present, but once the soils in the upper portions of the feature had been removed, the mottled soil comprised the post mold and the homogenous soil comprised the posthole. The post mold measured 15.2 cm (0.5 ft) in diameter. Excavation continued and at a depth of 24.3 cm (0.8 ft), the post mold was no longer visible, and at 27.4cm (0.9 ft) the feature fill changed in color and texture, becoming notably sandier and a slight lighter yellowish brown (10YR5/6). Subsoil was reached at 30.4 cm (1.0 ft) below the grade of the trench.

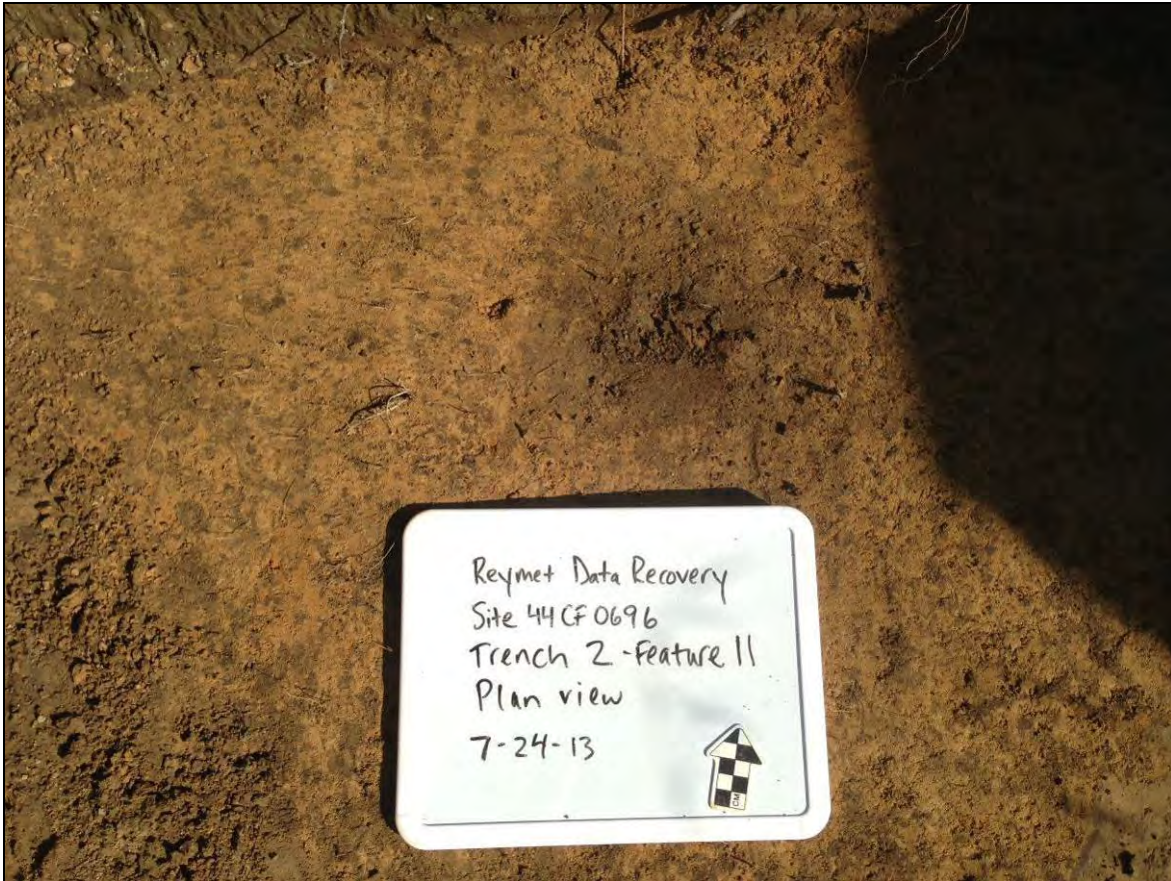
Figure 8-78. Plan view of Feature 11, Trench 2.

Feature 11 was located 12.1 meters (40 ft) south of the extant outbuilding, and was fairly round in shape. The feature measured 27.4 cm (0.9 ft) by 24.3 cm (0.8 ft) and had soil that was dark brown (10YR3/3) silty clay loam (Figure 8-78). The posthole was quite shallow once excavated, extending only 12.1 cm (0.4 ft) into subsoil.

Six brick fragments, seven window glass fragments, and three pieces of whiteware were recovered from the feature. The mean date for the feature is 1904, which, when considered along with the relatively small size and shallow depth of the feature, suggests that the posthole is likely part of a fence line from the early twentieth century.

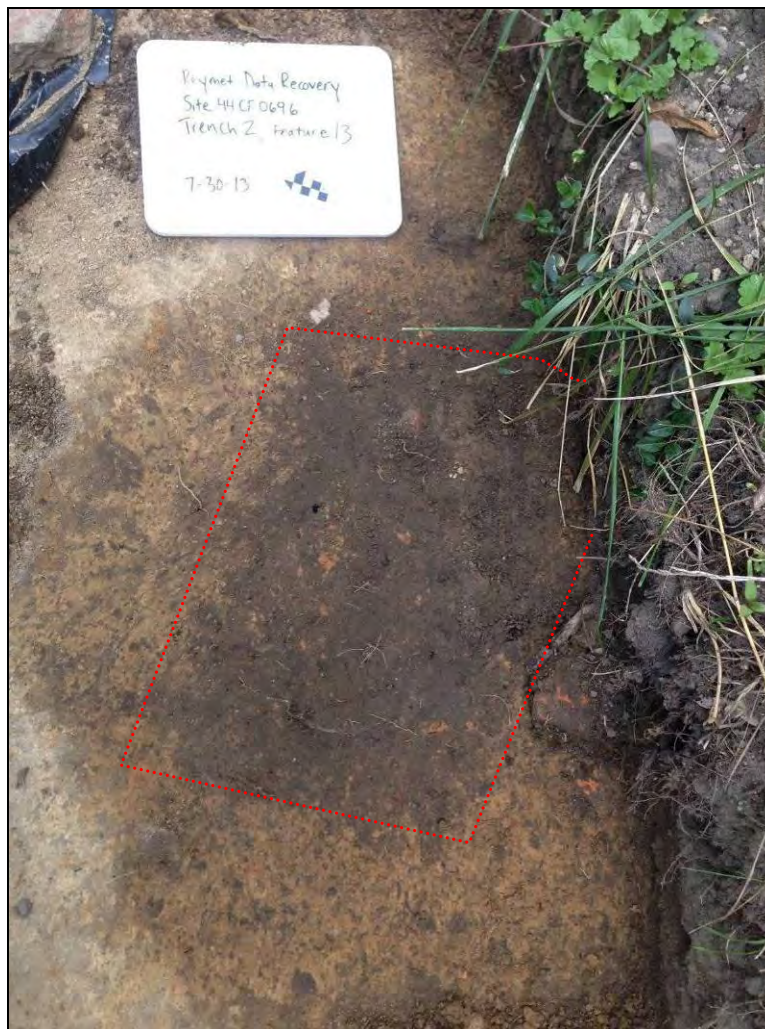
Figure 8-79. Plan view of Feature 13, Trench 2.

Feature 13, a posthole in Trench 2, measured approximately 33.5 cm (1.1 ft) by 48.7 cm (1.6 ft), with one corner of the feature extending into the sidewall (Figure 8-79). The fill consisted of dark brown (10YR3/3) silty clay loam and appeared homogeneous in plan view. Once the upper portion of the fill was removed by troweling, however, a post mold was also visible, and these two contexts were removed separately. The soil in the post mold consisted of dark grayish brown (10YR4/2) silty clay loam. The entire feature measured 30.4 cm (1.0 ft) in depth, with the posthole slightly shallower than the mold.

The depth and size of the posthole, especially when compared to other features found at the site, indicate that this was a quite substantial feature, and that it may have been related to a structure. Six meters (20 ft) south of Feature 13, Feature 20 (discussed below) is very similar in size, shape, and depth. The distance between these two posts is also consistent with the spacing of structural posts related to a building.

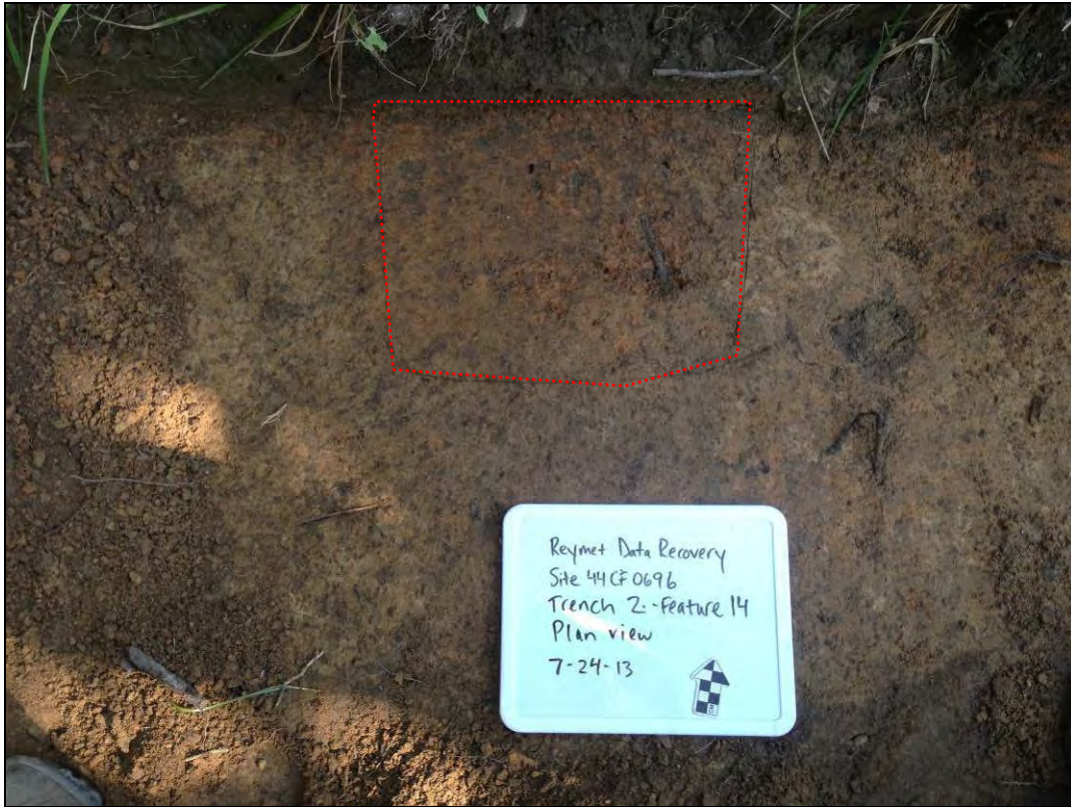
Figure 8-80. Plan view of Feature 14, Trench 2.

Approximately 0.6 meters (2 ft) south of Feature 13, a second posthole was identified, and also consisted of a posthole and mold (Figure 8-80 and 8-81). Feature 14 extended into the northern sidewall of the trench, and was roughly rectangular in shape. The dimensions of the portion of the feature exposed measured 45.7 cm (1.5 ft) by 24.3 cm (0.8 ft). Since the majority of the post mold was visible, it appears that the bulk of the feature was within the excavation area.

The soil of the posthole consisted of yellowish red (5YR5/6) silty clay loam and the mold was strong brown (7.5YR5/6) silty clay. The feature was taken out as a single context since the mold was too small to effectively remove separately. It was quite shallow, and extended only 0.6 feet into subsoil.

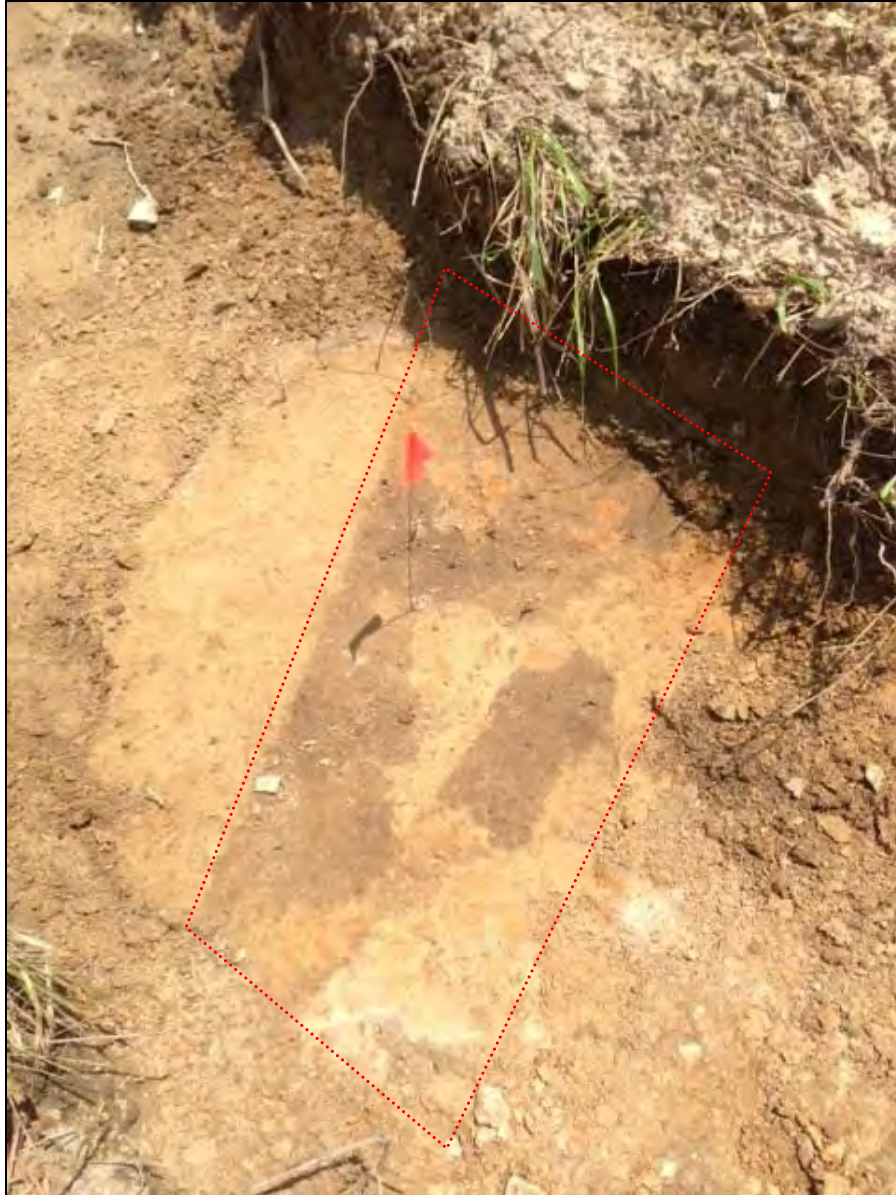
Figure 8-82. Plan view of Feature 15.

Very few features were identified in the eastern portion of Trench 3, and the area north of the Spring Hill house was considered to have been significantly disturbed at the time of the TRC survey. The shallow topsoil and lack of features or artifacts seemed to confirm this. Feature 15 consisted of what appeared to be a tire rut or disturbance related to excavation of the topsoil (Figure 8-82).

The fill of the feature was mottled dark brown (10YR3/3) silty loam mixed with brownish yellow (10YR6/6) and dark yellowish brown (10YR4/4). The feature was irregular, and ranged in width from approximately 0.7 meters (2.6 ft) to 1.0 meters (3.4 ft). The feature was bisected, revealing an irregular base, and soils were siltier in texture. The feature did not contain any artifacts and is consistent with a tire rut.

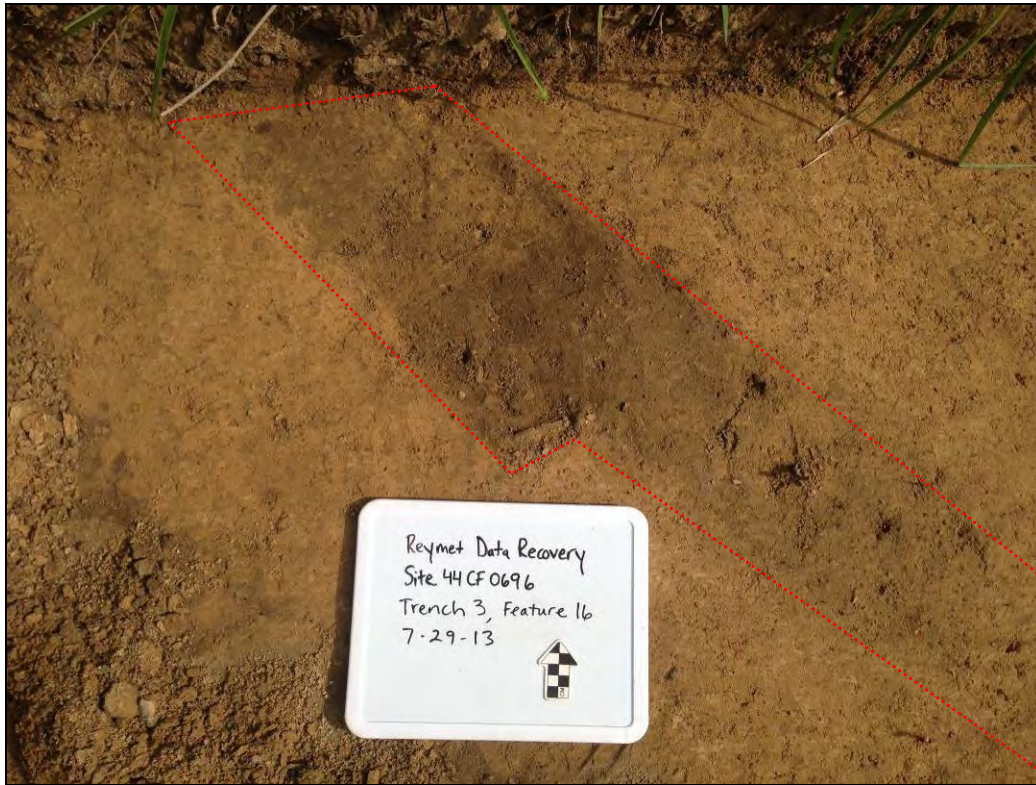
Figure 8-83. Plan view of Feature 16, Trench 2.

Feature 16 was located just west of Feature 15, and had an irregular shape in plan view (Figure 8-83). The feature was approximately 1.0 meters (3.6 ft) long. The soil consisted of dark brown silty sand and had a large amount of gravel mixed with the soil, which was heavier in

concentration near the base of the feature. Upon excavation, the feature measured only 9.1 cm (0.3 ft) in depth.

No artifacts were recovered from Feature 16, and it appears that it is either a drainage feature or that it was filled with gravel to prevent erosion. It is likely related to Feature 15, and represents episodes of parking and the formation of tire ruts and the subsequent filling of these depressions.

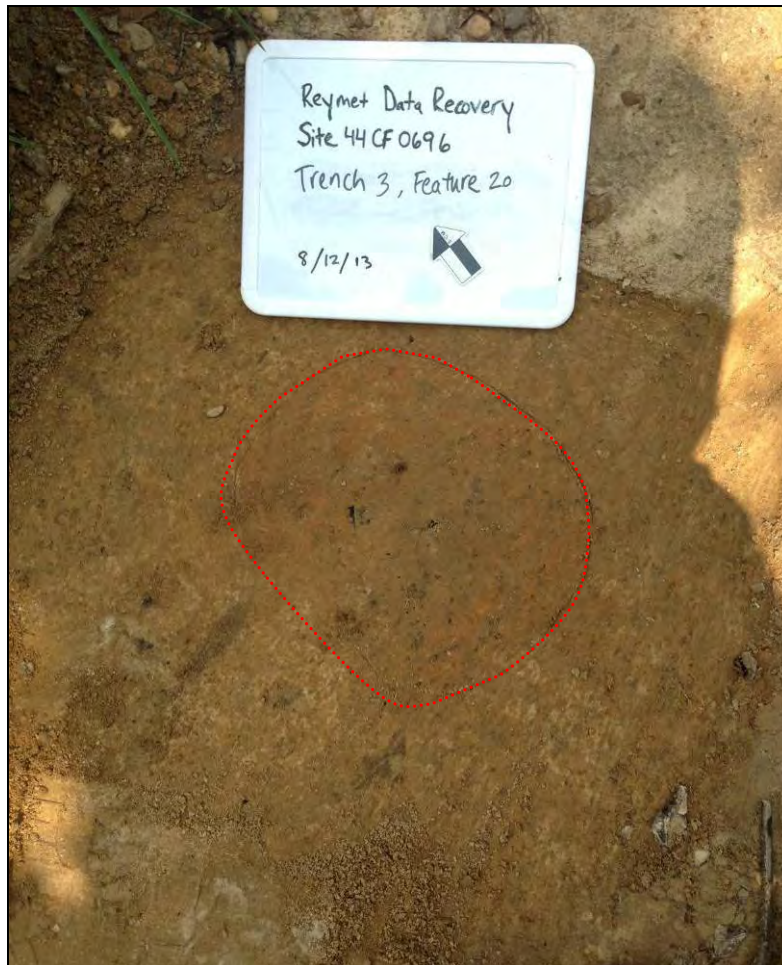
Figure 8-84. Plan view of Feature 20, Trench 3.

Feature 20 consisted of a deep posthole and postmold. In plan, the feature measured 30.4 cm (1.0 ft) by 24.3 cm (0.8 ft) with the hole consisting of yellowish-red (5YR4/6) silty clay and a mold of brown (10YR4/4) silty clay loam (Figure 8-84 and 8-85). Several large brick fragments were in the fill, and a large root extended through the bottom of the feature, which extended 33.5 cm (1.1 ft) into subsoil.

Feature 20 is quite similar in size, shape, depth, and appearance to Feature 13, a posthole located 6.0 meters (20 ft) northeast. It is possible that these two features are related.

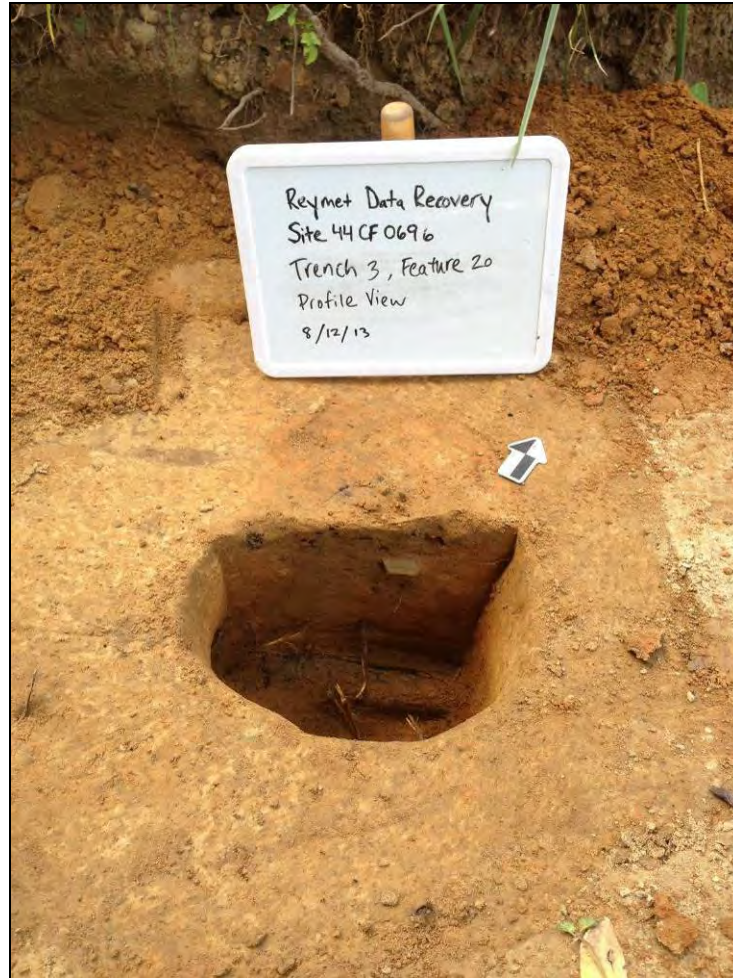
Figure 8-85. Profile view of Feature 20, Trench 3.

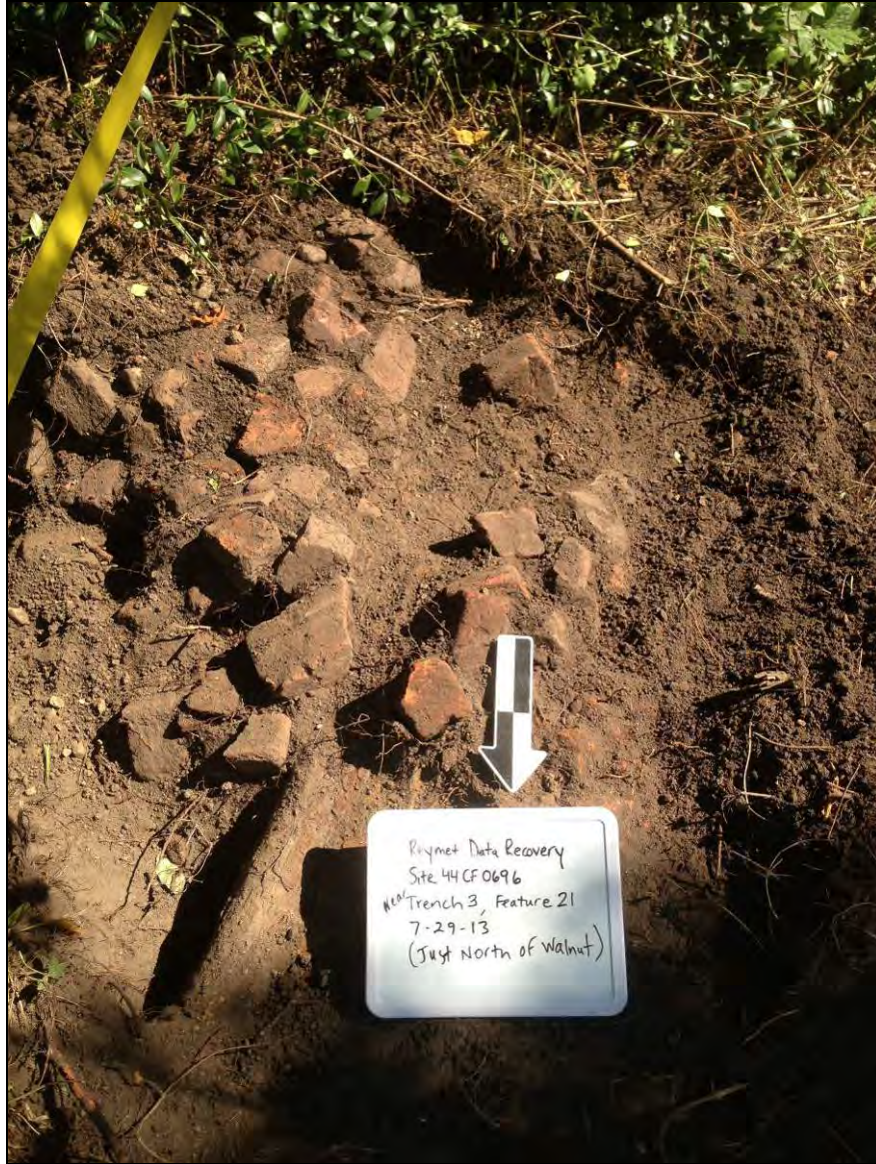
The elevation of the soil around the base of the tree was significantly higher than other areas of the yard. Removal of the soil revealed large quantities of artifacts around the base of the tree including bricks, many of which were whole (Figure 8-87).

Figure 8-87. Plan view of Feature 21 (chimney fall), Trench 3.

Once the chimney fall had been exposed, further testing was conducted to locate the boundaries of the building that the chimney was part of. Using a soil probe, shovels, and trowels, several small concentrations of brick were located. As shown in Figure 8-86 above, some of these areas of brick are consistent with building piers, but the amount of ground disturbance prohibited the full delineation of a building. The combination of the pier locations, however, suggests that more than one episode of construction is represented, and that two buildings were constructed in this area but that the footprints of the buildings were not placed in exactly the same location as the piers do not align and appear to be of different ages.

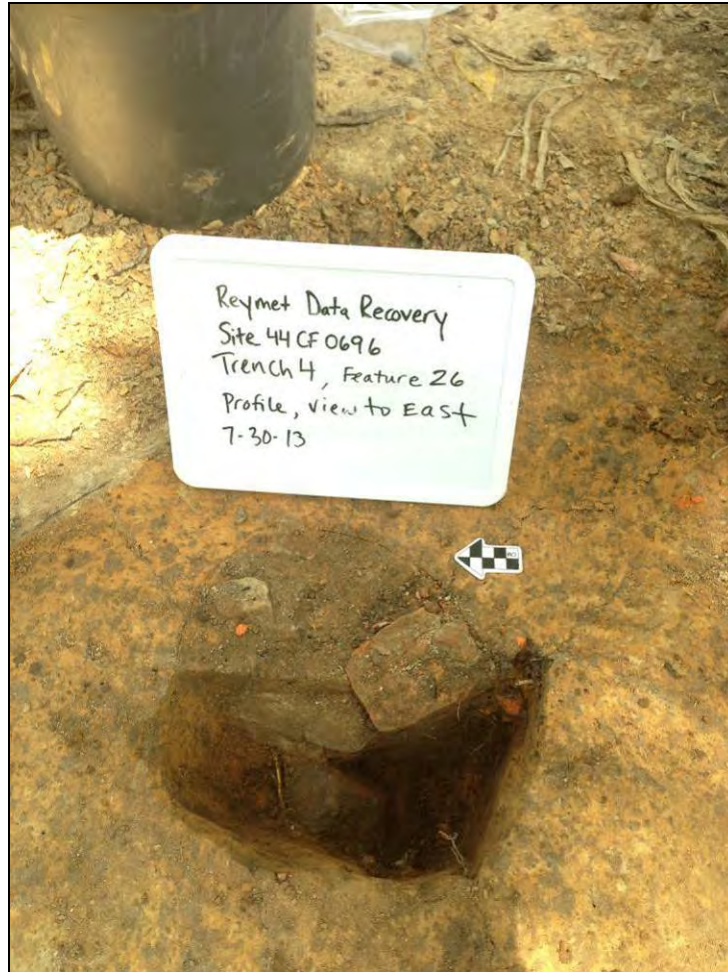
Figure 8-90. Plan and profile view of Feature 26, Trench 4.

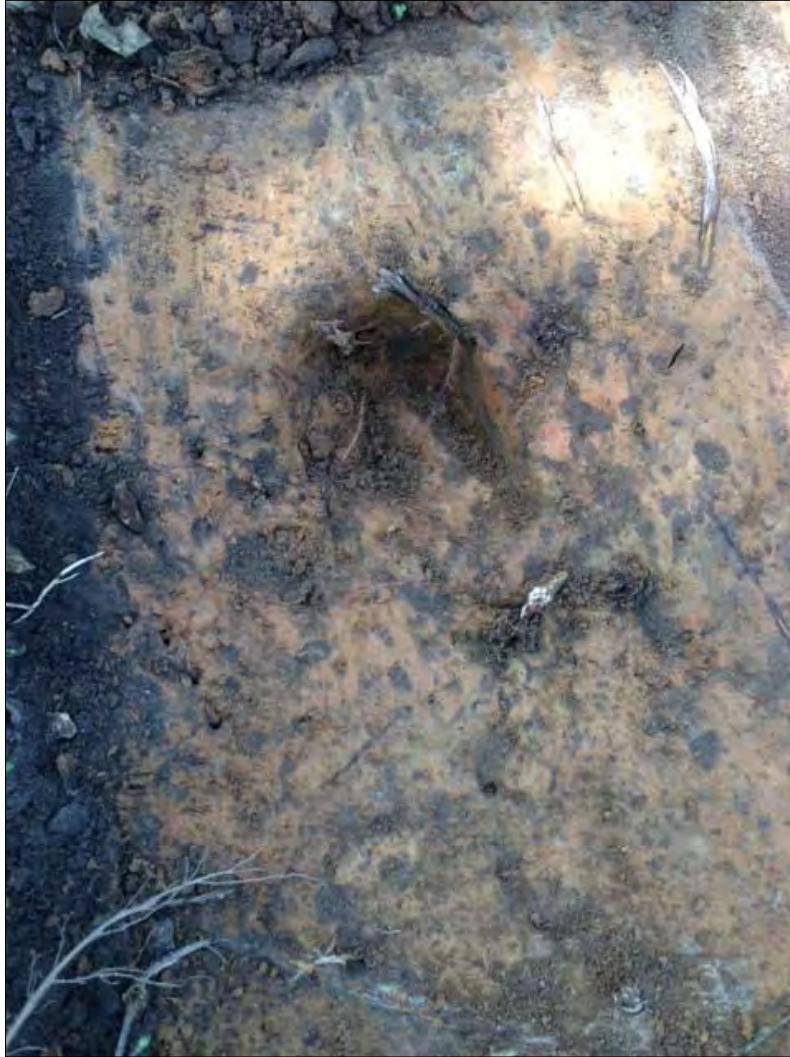
Figure 8-91. Plan view of Feature 27.

A shallow posthole in Trench 4, identified as Feature 27, contained dark brown (10YR3/3) silty clay with small inclusions of brick. The feature measured 21.3 cm (0.7 ft) by 21.3 cm (0.7 ft) and extended into the sidewall of the trench. Excavation of the portion that was exposed showed that the feature was only 10.6 cm (0.35 ft) in depth and contained no artifacts other than brick flecks (Figure 8-91).

It is possible that this feature dates to the early occupation of the property, as it did not contain artifacts. In most cases, features contain artifacts that were present on a site at the time that the feature was created and were simply incorporated into the backfill. When an area is first occupied, however, there is little to no refuse on the surface, and features are less likely to have artifacts. There is no additional information to substantiate this, however, and without additional, related postholes there is no way to verify.

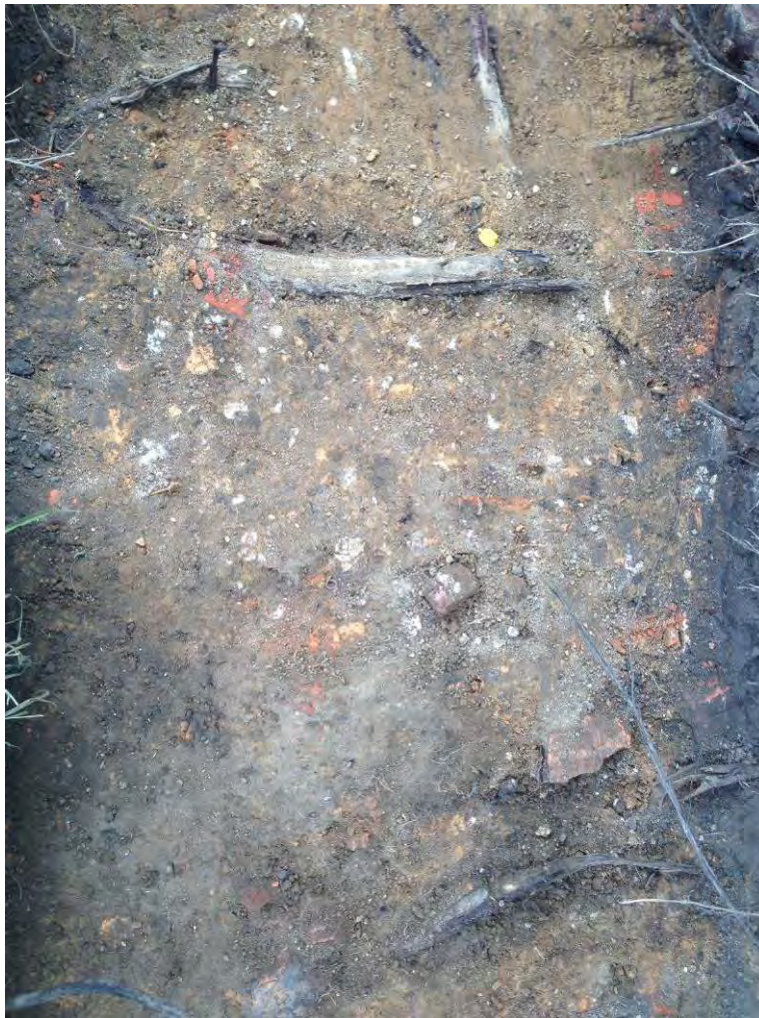
Figure 8-92. Plan view of Feature 28, Trench 4.

In the eastern end of Trench 4, an area with heavy mortar/plaster flecking was recorded after removal of the topsoil (Figure 8-92). The shallow topsoil sealed subsoil, but the mortar/plaster inclusions were pressed into the subsoil. The soil in this area was extremely compact, however,

and the mortar/plaster was included in the matrix with no visible boundaries. Feature 28 was a lens of mortar/plaster likely related to the remains of the outbuilding identified in Trenches 5 and 7 discussed below.

While a kitchen or most other types of outbuilding would not likely have interior wall surfaces finished with plaster, the exception is a dairy or milk house. Structures used to store milk products necessitated clean, cool spaces, and were therefore often plastered.

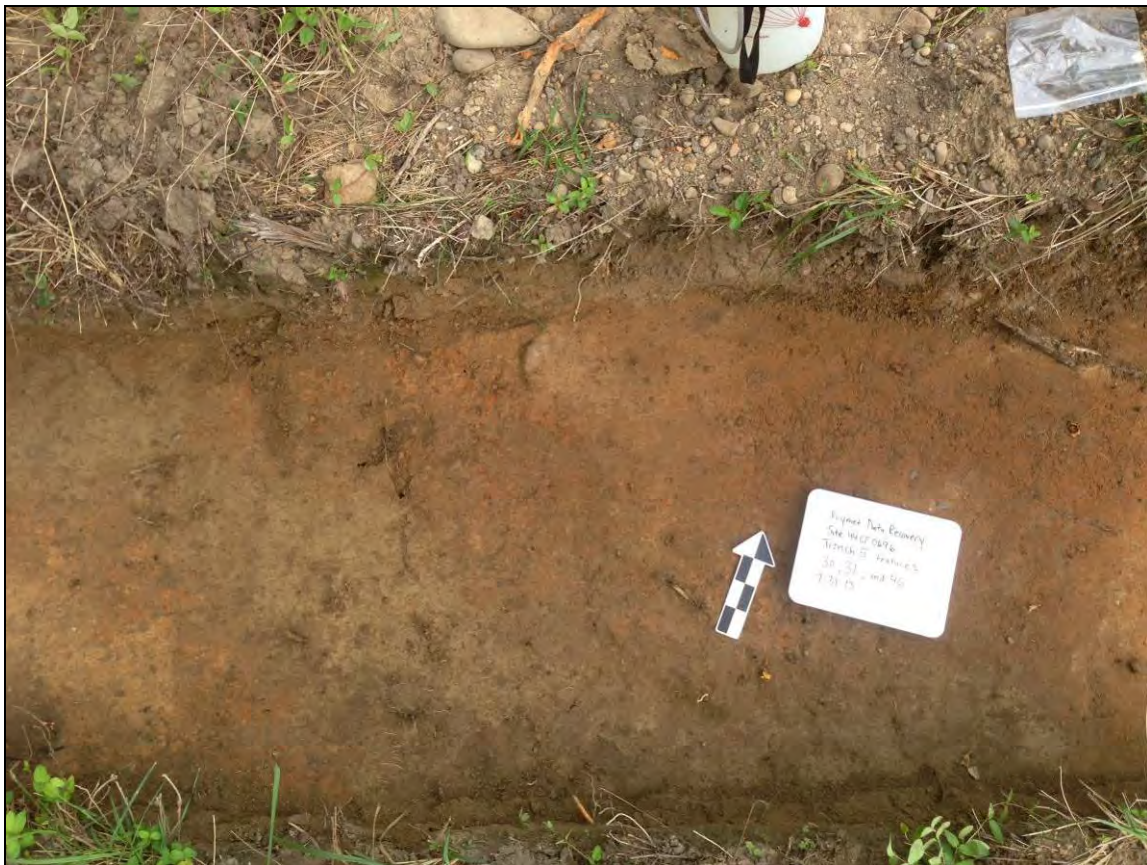
Figure 8-93. Plan view of Features 30 and 31
