Phase III Investigations and Historical Study of the Spring Hill Plantation

LOCATION > Chesterfield County, Virginia

DATE > MARCH, 2015

Dutton+Associates, LLC

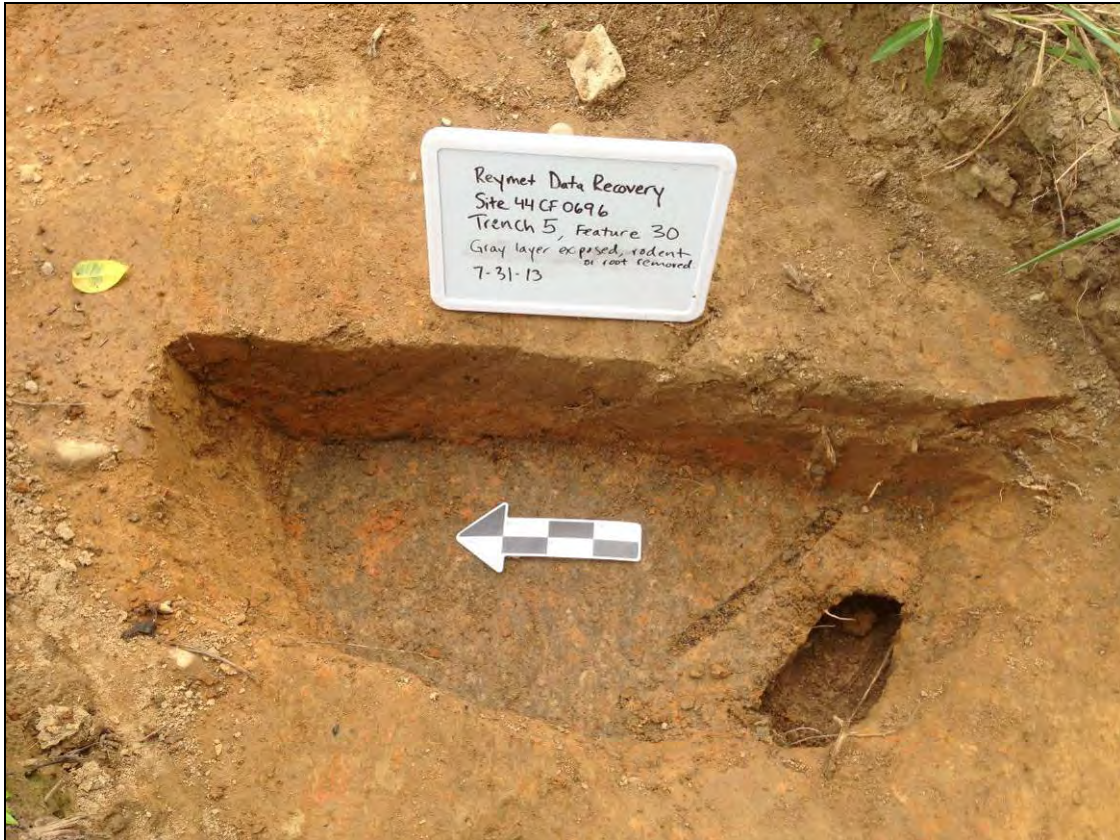
Figure 8-94. Feature 30, Trench 5, in Profile.

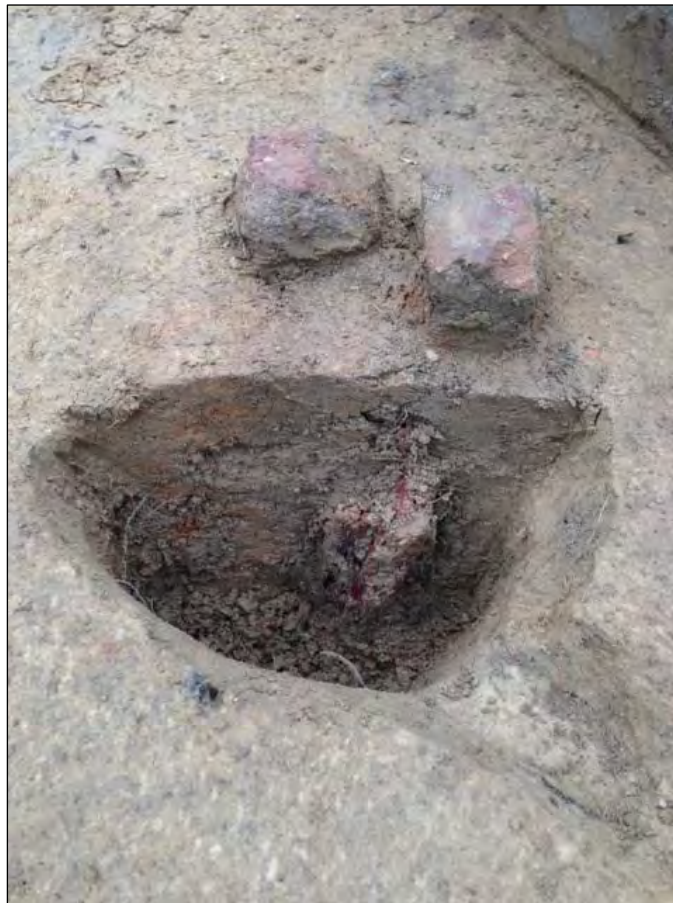
Figure 8-95. Profile view of Feature 32, Trench 5.

Feature 32 appeared to be a brick-filled posthole when first identified. The feature measured 27.4 cm (0.9 ft) by 33.5 cm (1.1 ft) in plan. Two pieces of brick were in the top of the fill, and removal of the soil, however, showed that it was in fact a tree hole, possibly cedar, and that the root mass of the tree was in situ in the base of the hole (Figure 8-95). The bricks were likely added to the hole after the tree died in order to level the ground surface.

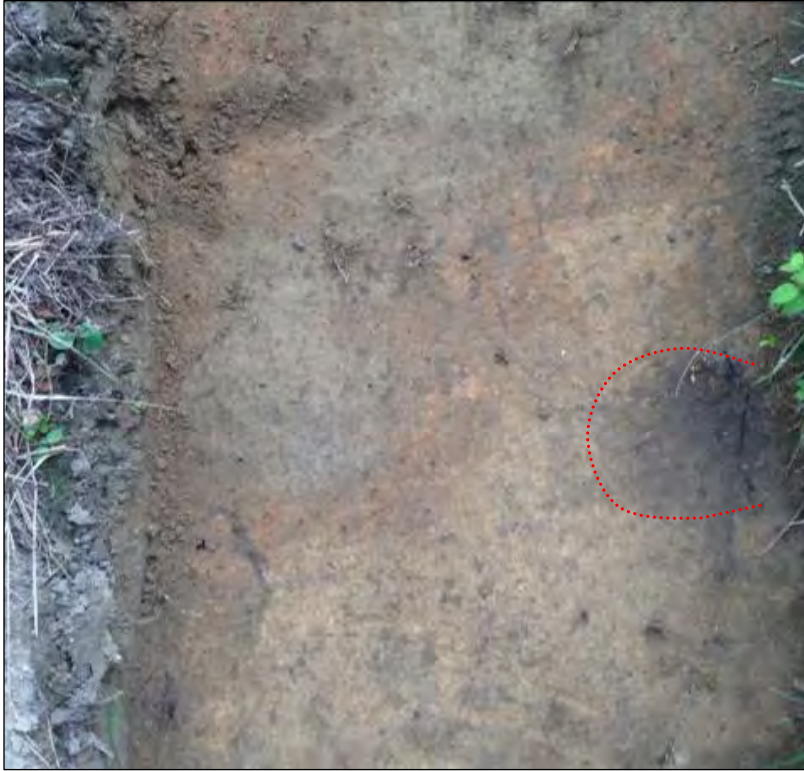
Figure 8-96. Plan view of Feature 46 outlined in red.

Feature 46 was identified adjacent to Features 30 and 31. The round feature was approximately 21.3 cm (0.7 ft) by 24.3 cm (0.8 ft) in diameter and had soil that was dark grayish brown (10YR4/2) sandy clay loam (Figure 8-96).

The depth of the feature once excavated was only 7.62 cm (0.25 ft), making it very shallow. No artifacts were recovered from the fill of the feature.

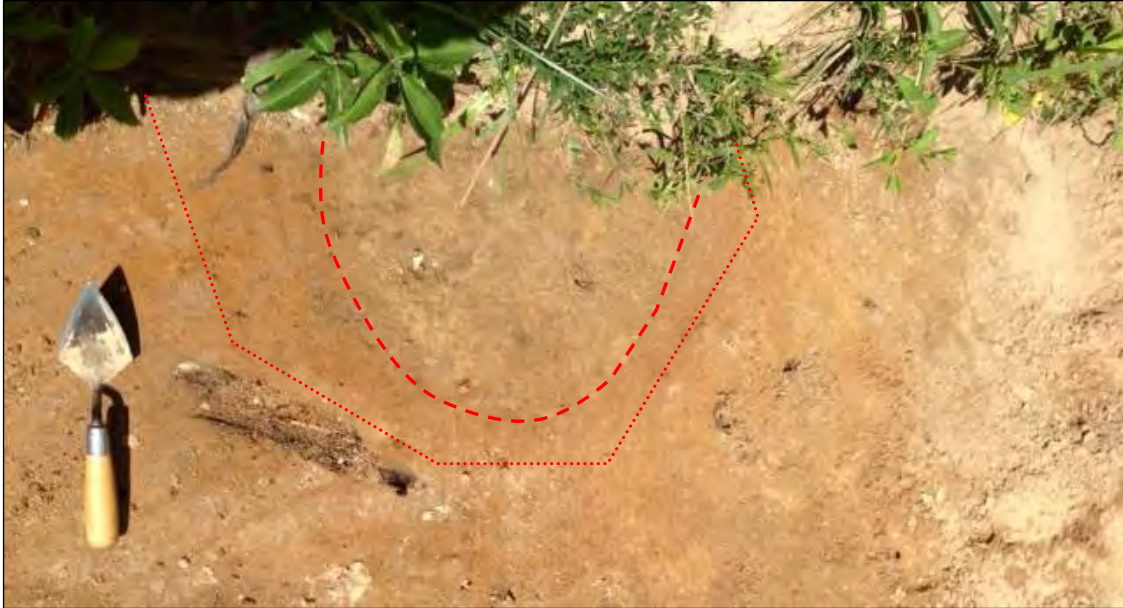
A posthole recorded as Feature 33 was identified in the eastern portion of Trench 5. The feature extended into the northern wall of the trench, but a section measuring 70 cm (2.3 ft) east/west by 33.5 cm (1.1 ft) north/south was exposed in the trench (Figure 8-97).

The soil was yellowish red (5YR4/6) silty clay on the outer perimeter of the feature and siltier reddish brown (2.5YR5/3) on the interior. In profile, the feature was 39.6 cm (1.3 ft) deep, with lenses of yellowish brown (10YR5/6) and brown (10YR3/3) silty clay beneath the reddish brown soil visible in the plan view.

Figure 8-97. Plan view of Feature 33, Trench 6. Post hole is light dashed line and post mold is heavy inner dashed line.

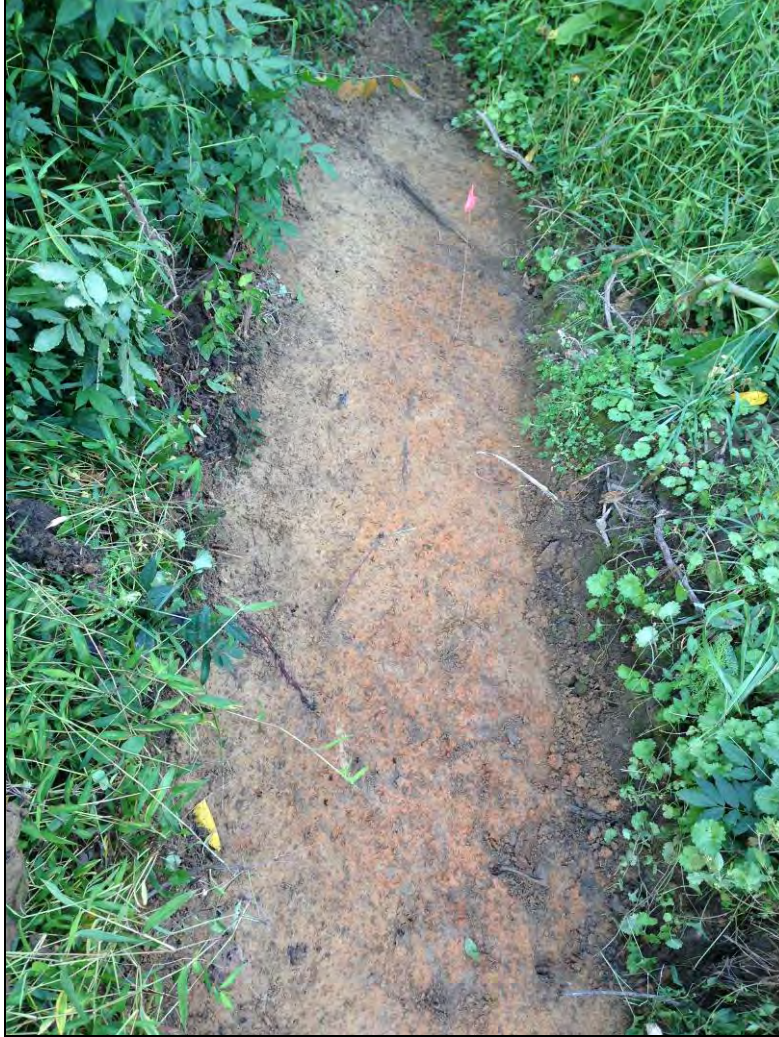
Figure 8-98. Overall view of compact orange clay.

In the western portion of Trench 6, a large area of orange clay was observed following removal of the topsoil. Recorded as Features 34, 35, and 36, the areas of clay were very amorphous and did not have clear boundaries (Figure 8-98). Once the area was carefully troweled, it was clear that these were not actually features cutting the subsoil but consisted of exposed subsoil that was very compact clay. The clay was the exposed subsoil in areas that were graded and also contained a circular driveway during the first half of the twentieth century.

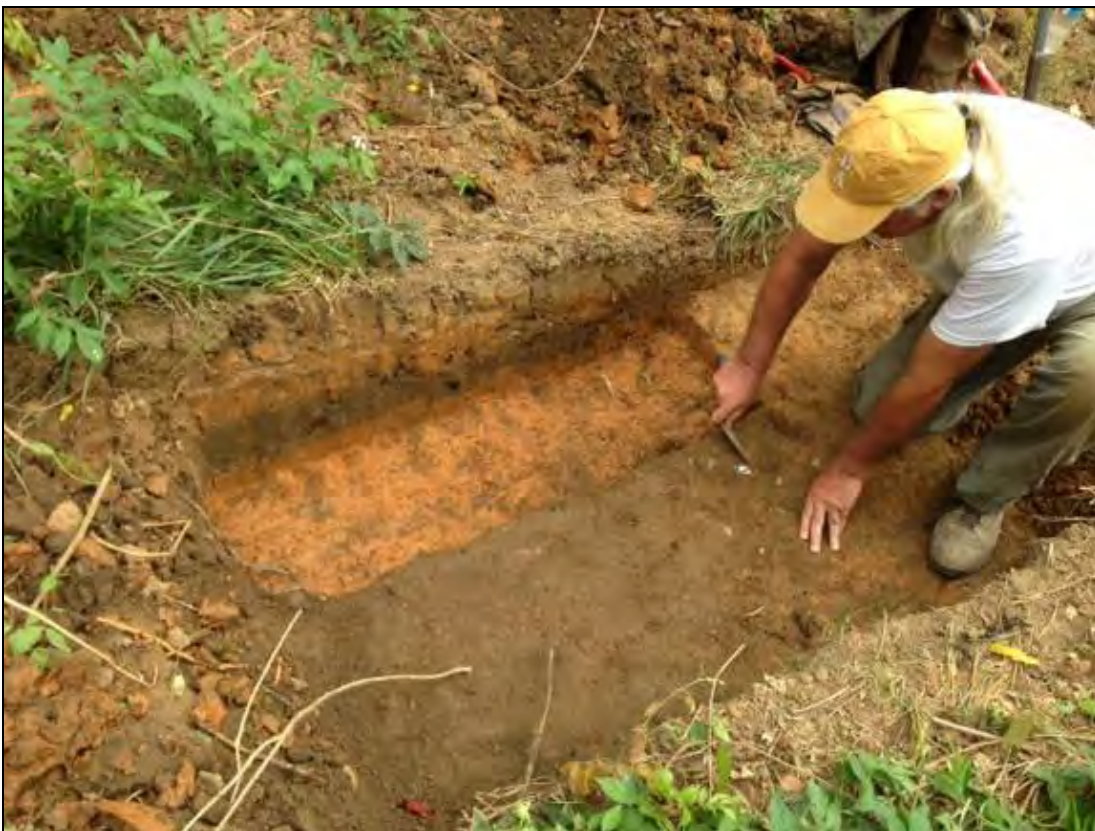
When first exposed, Feature 37, at the far western end of the trench, appeared to be a broad amorphous expanse of deep orange clay immediately beneath the topsoil (Figure 8-99). Unlike the area recorded as Features 34, 35, and 36, however, the clay was less compact, and additional troweling suggested that this area was not subsoil. Since no feature boundaries could be

Excavation revealed that the orange clay measured 23.7 cm (0.78 ft) in depth and consisted of a clay cap over what was natural topsoil. The natural topsoil measured 13.7 cm (0.45 ft) in depth and sealed the natural, sterile subsoil.

Figure 8-99. View of Feature 37, Trench 7, bisection in progress, with subsoil at top of excavation area .

It appears that in this far western portion of Trench 7, in the location where the terrain begins to slope to the south and to the west, fill was used to smooth the ground surface and make the yard area level. It is likely that the soil comprising the clay cap was scraped from another portion of the site, since several areas with very compact and shallow subsoil were also identified in the course of data recovery.

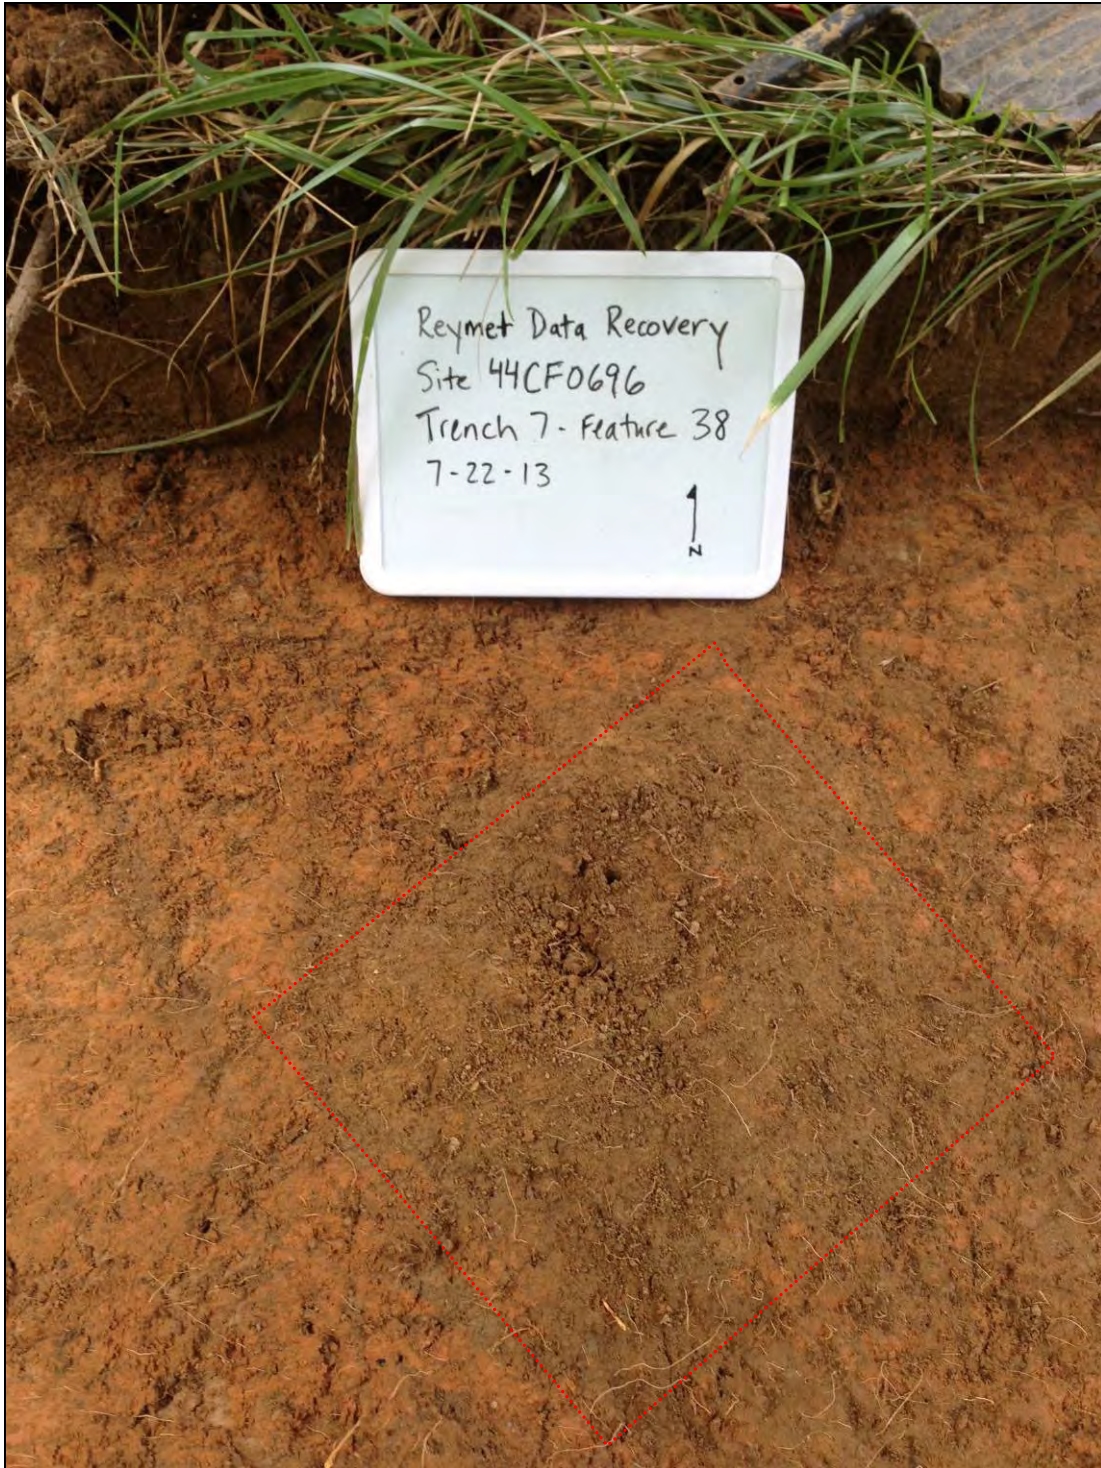
Figure 8-100. Plan view of Feature 38, Trench 7.

This feature consisted of a rectangular posthole comprised of light yellowish brown (10YR6/4) sandy clay loam. The feature measured 39.6 cm (1.3 ft) in diameter (Figure 8-100).

Feature 38 is challenging to interpret due to the lack of diagnostic artifacts and because there are no similar posts in close proximity. The overall size of the hole suggests that it could possibly have been related to a structure. The depth would not lend itself to supporting a structural post, but mechanical removal of topsoil in this area revealed that a significant amount of earth moving has taken place, and it is possible that this post was much deeper when first in use.

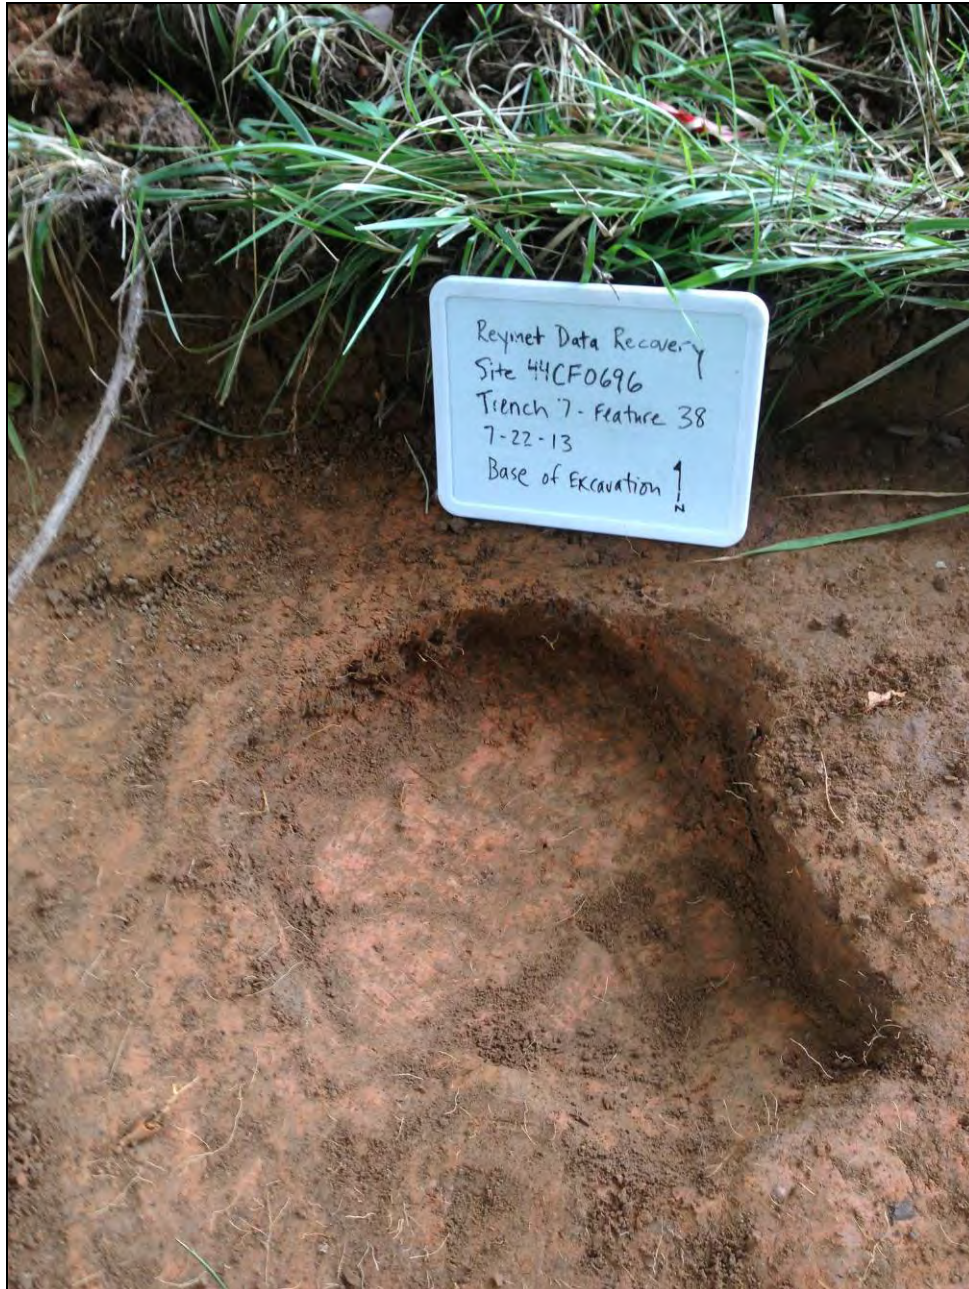
Figure 8-101. Feature 38, Trench 7, post excavation.

Upon excavation, the feature had a fairly flat bottom and proved to be quite shallow, extending 12.1 cm (0.4 ft) into subsoil (Figure 8-101). The only artifacts recovered from the area excavated consisted of 5 small, unidentifiable nail fragments.

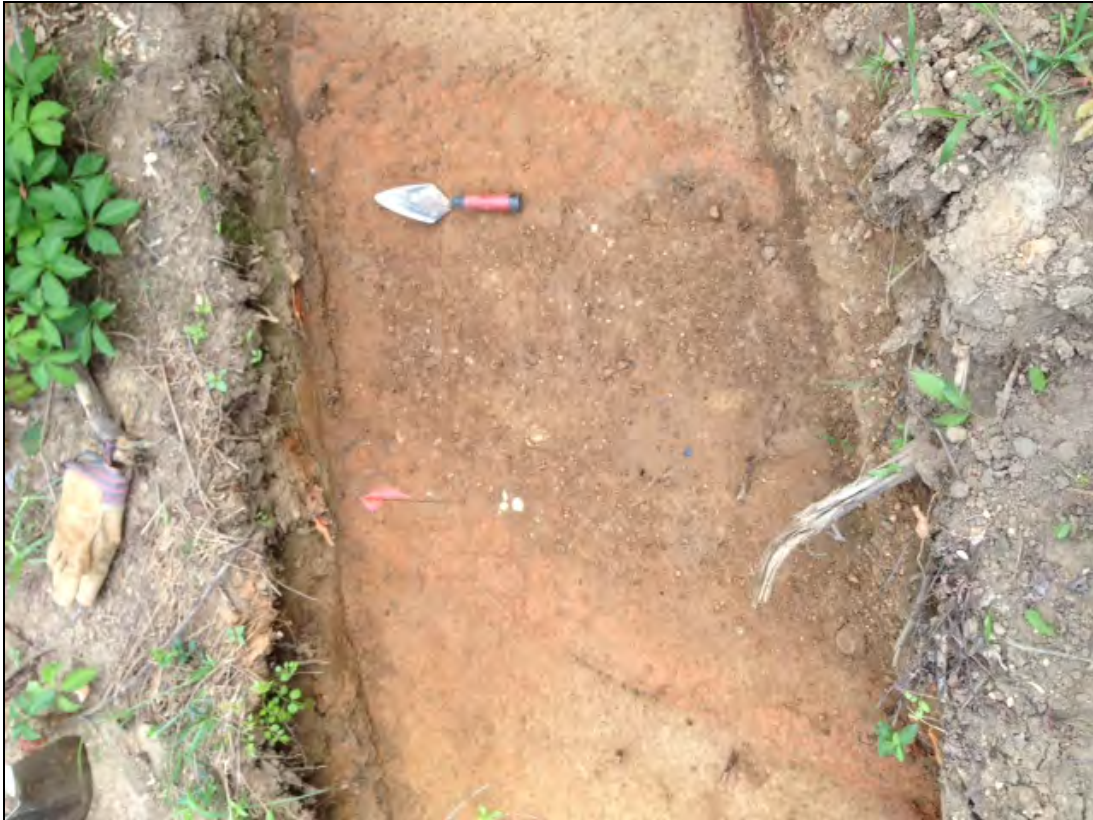
Figure 8-103. Plan view of Feature 40, Trench 7.

Located in the eastern portion of Trench 7, Feature 40 consisted of a wide, trench-like feature of brown/dark brown (7.5YR4/3) silty sand with a high percentage of gravel mixed with the soil

(Figure 8-103). The portion of the feature exposed in the trench was somewhat trapezoidal, extending north/south and measuring 39.6 cm (1.3 ft) at the northern section and 64.0 cm (2.1 ft) at the southern section. The eastern and western edges of the feature were bounded by dark yellowish brown (10YR4/4) clay. Once excavation was underway, the feature fill proved to be approximately 9.1 cm (0.3 ft) in depth and that the clay that had been visible on either side of the feature was sealed by Feature 40. Excavation continued by removing only a section of the clay to determine if there were any cultural layers sealed by the feature. No such indication was found and the excavation was terminated at 70 cm (2.3 ft) into subsoil, or 97.5 cm (3.2 ft) below ground surface.

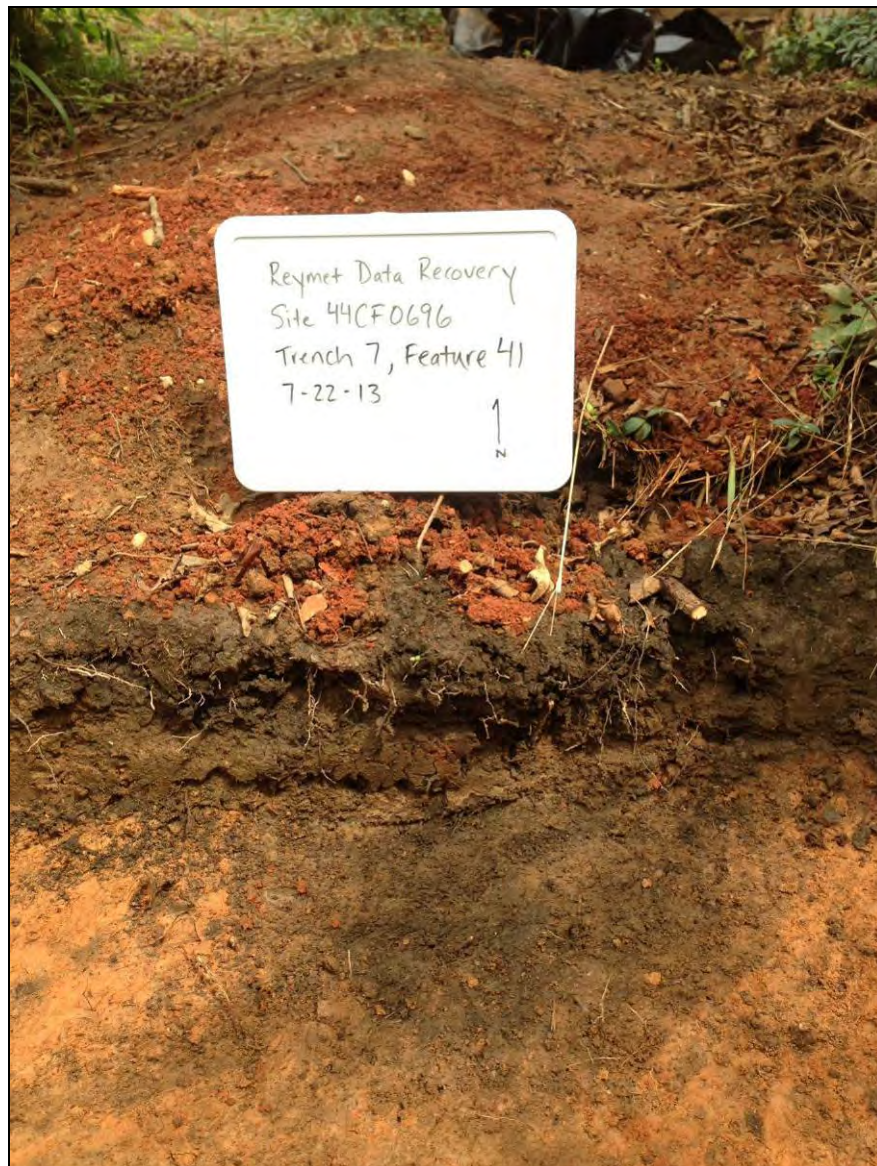
A feature recorded as Feature 41 was located in Trench 7 less than 0.9 meters (3 ft) from the house. The feature extended into the wall of the trench, but a portion measuring 45.7 cm (1.5 ft) east/west by 30.4 cm (1.0 ft) north/south was exposed (Figure 8-104). The feature was noted to contain a high proportion of gravel and very dark grayish brown (10YR3/2) silty loam. The feature was very shallow, with a depth of 12.1 cm (0.4 ft).

Figure 8-104. Plan view of Feature 41, Trench 7.

One sherd of whiteware was recovered from the feature. With its shallow, U-shaped profile and the amount of gravel, the feature appears to be a drip line resulting from rainwater coming off the

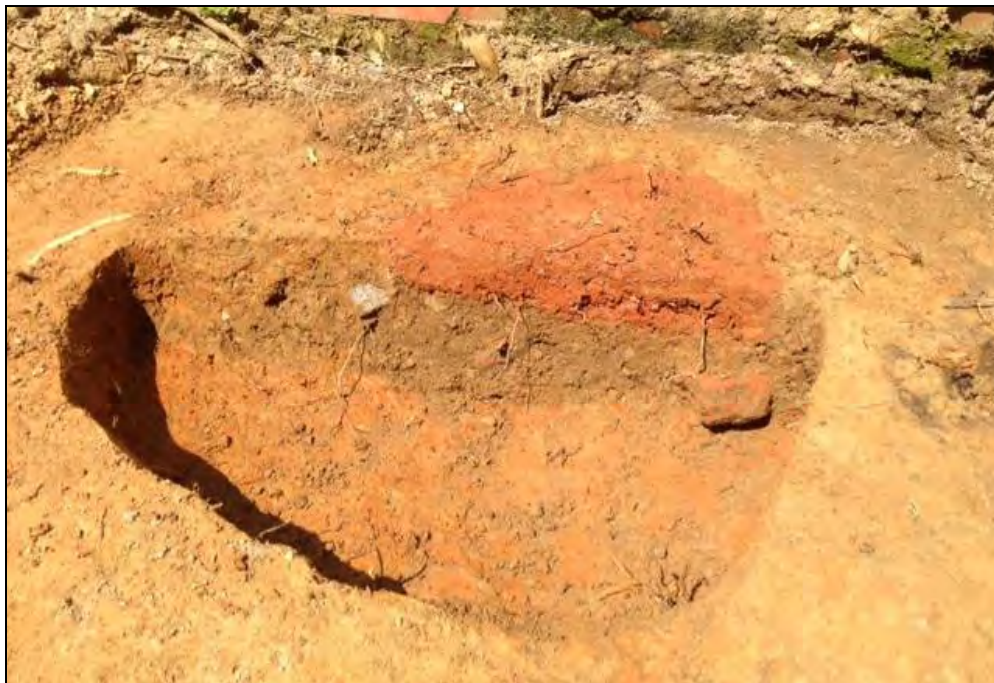
Feature 42 was characterized by very dark red clay and appeared to be a posthole. The feature measured 36.5 cm (1.2 ft) in diameter and was directly adjacent to the front porch south of the Spring Hill house. The red clay was quite shallow, measuring 6.0 cm (0.2 ft) deep, and beneath the clay, there was brown soil containing brick flecks. Once the brown soil was visible, it was apparent that the feature was actually significantly larger beneath the clay cap, and that the red clay cap appeared to be part of a post mold. Once the entire feature was exposed, it measured 76.2 cm (2.5 ft) in diameter. The feature was bisected since a portion was beneath the porch, and only the southern half was removed as it was a sufficient sample size (Figure 8-105).

Figure 8-105. View of Feature 42 in profile facing north.

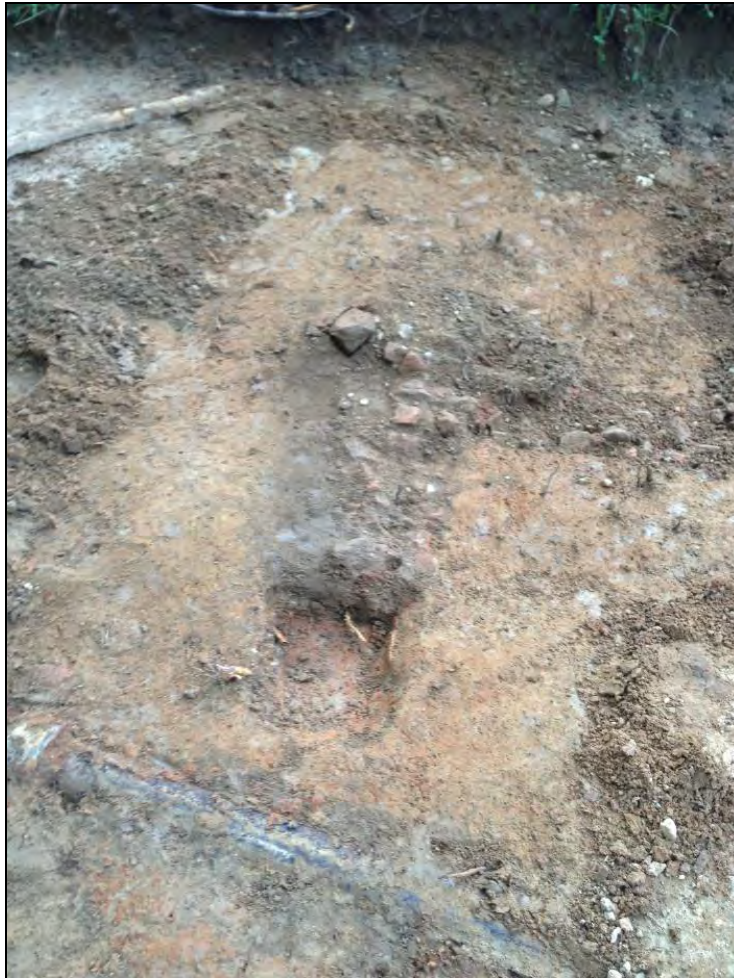
Located in excavation Area 8 and identified southeast of the house was Feature 43. An adjacent trench containing a cast iron drainpipe cut Feature 43 (Figure 8-106).

The feature first appeared roughly rectangular in plan and brick was found on the surface. Further delineation of the boundaries following troweling revealed that it actually consisted of a somewhat more amorphous shape and contained silty soil. Excavation showed that it had a U-shaped profile and was 9.4 cm (0.31 ft) deep. The brick was limited to the eastern portion of the feature.

Figure 8-106. View of Feature 43 looking north.

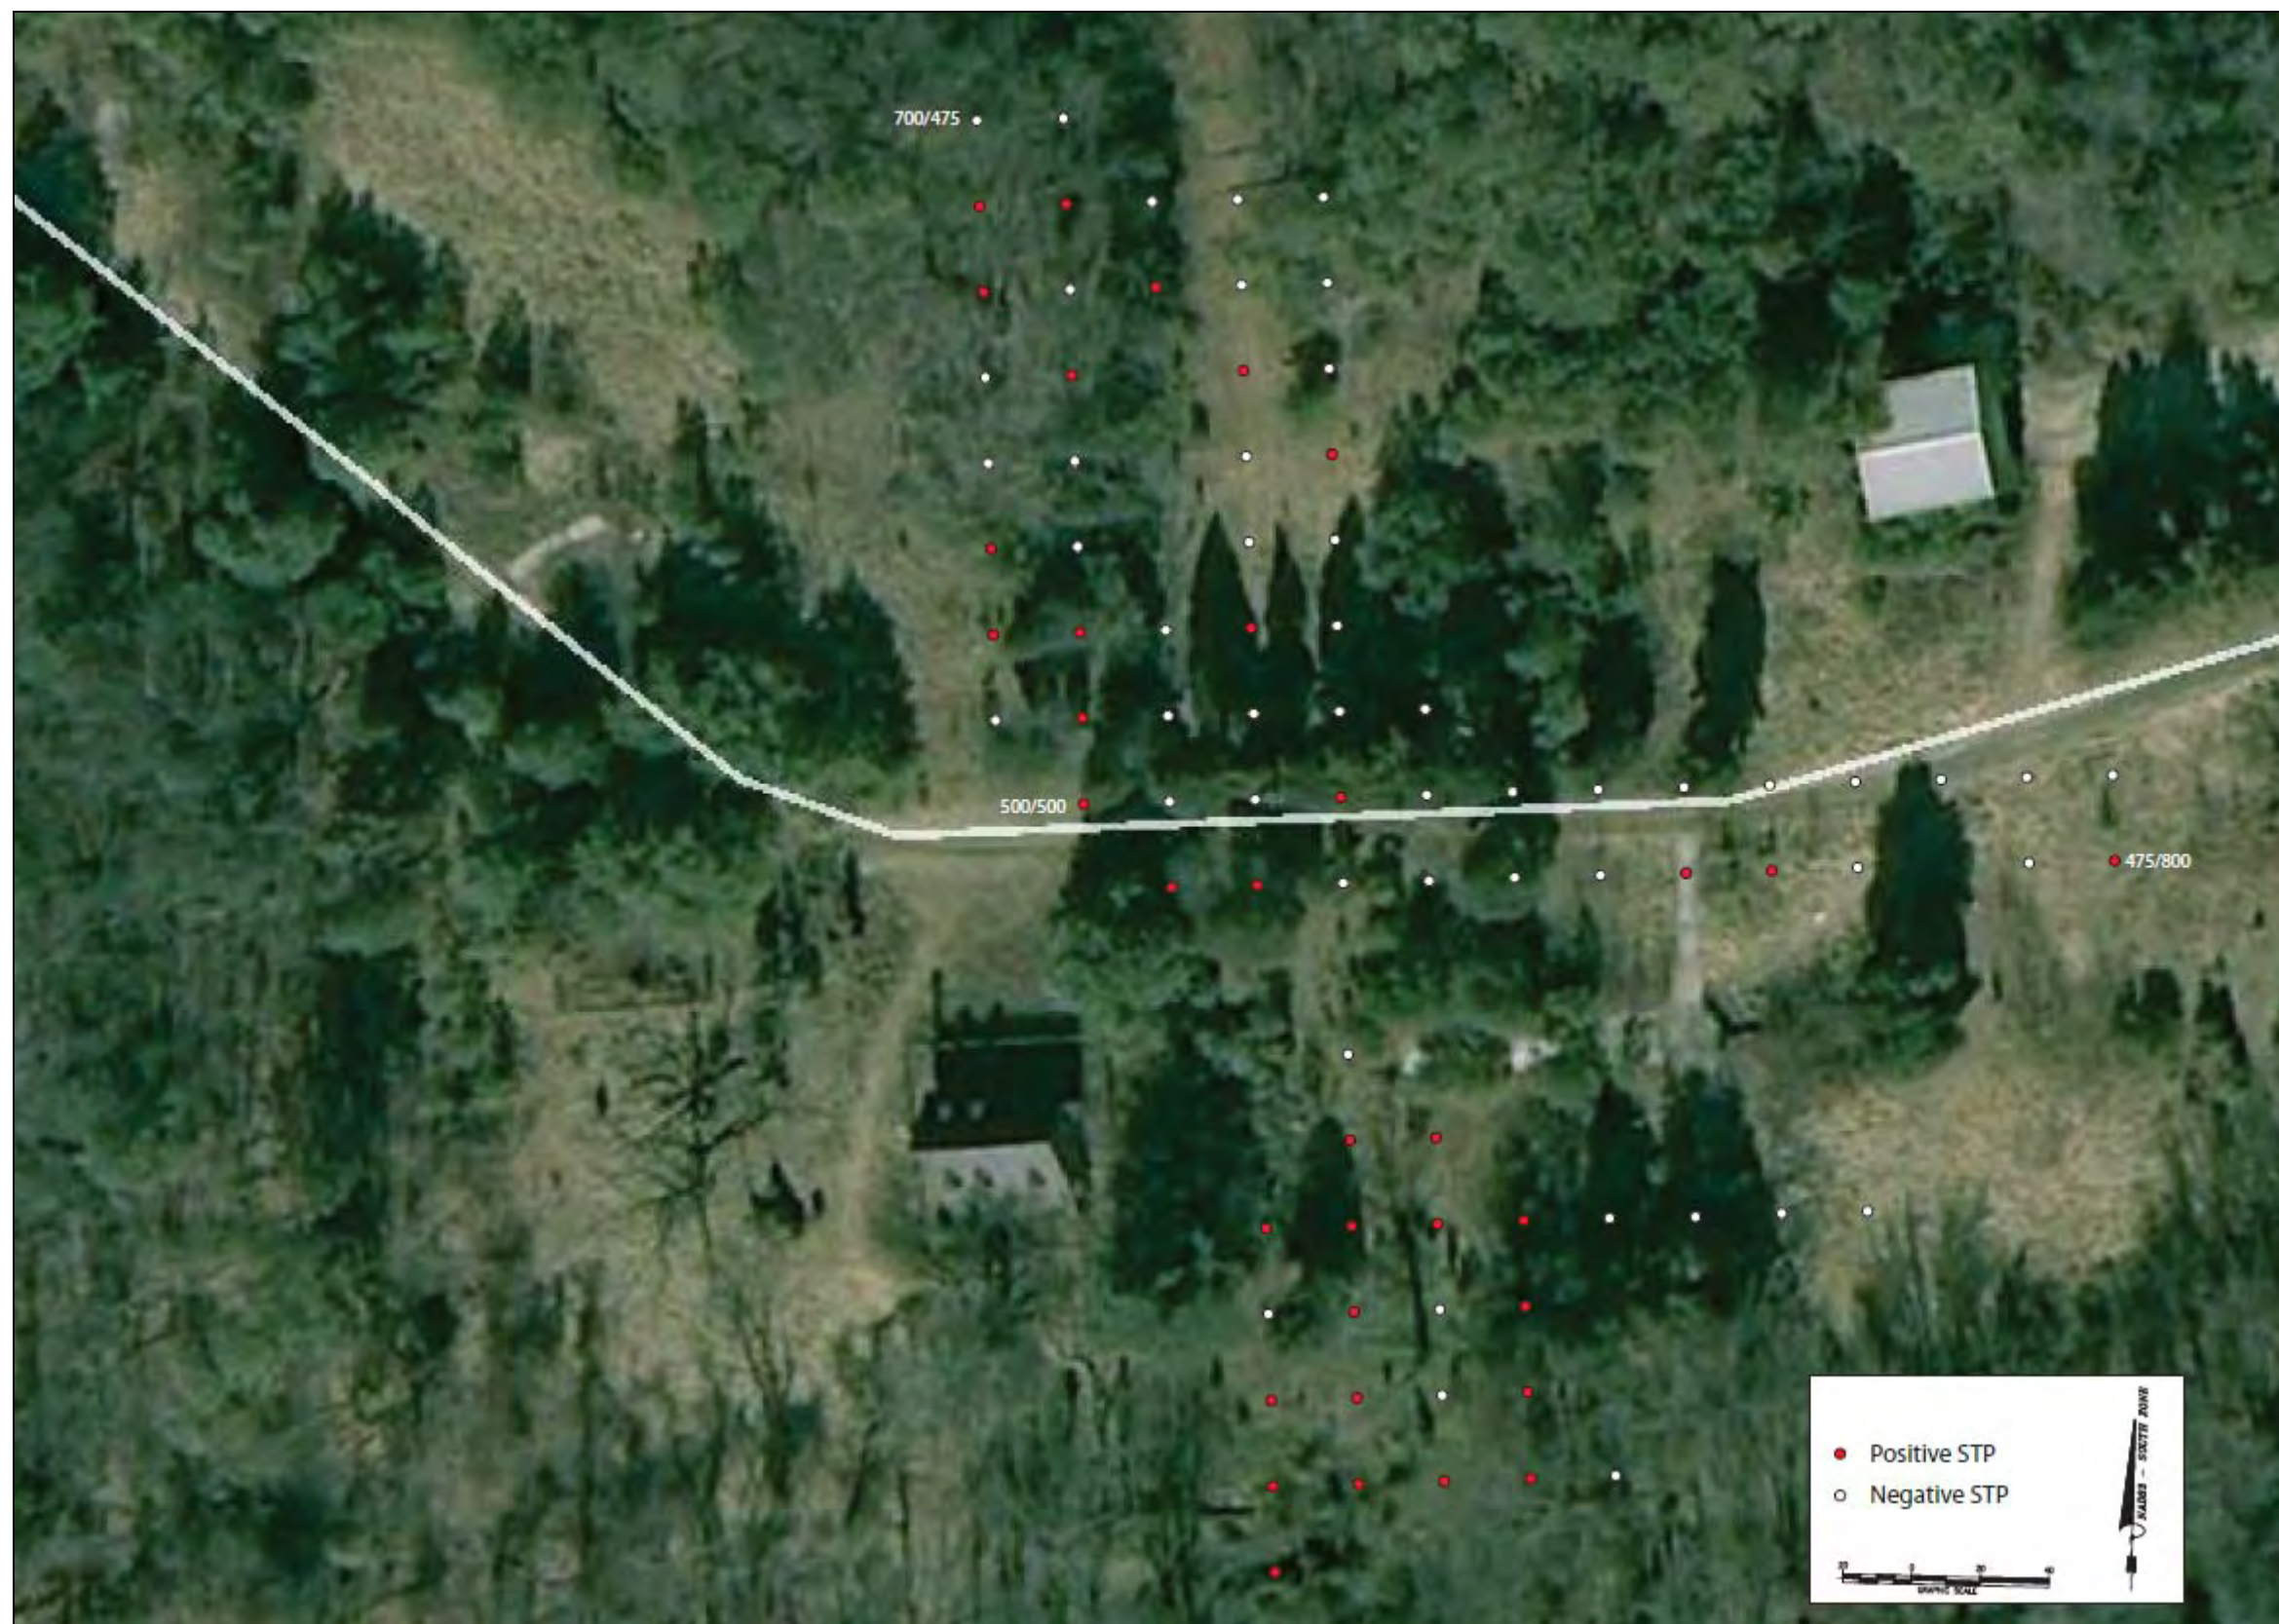
Figure 8-108. Plan view of additional shovel testing conducted during Phase III investigations of Site 44CF0696.

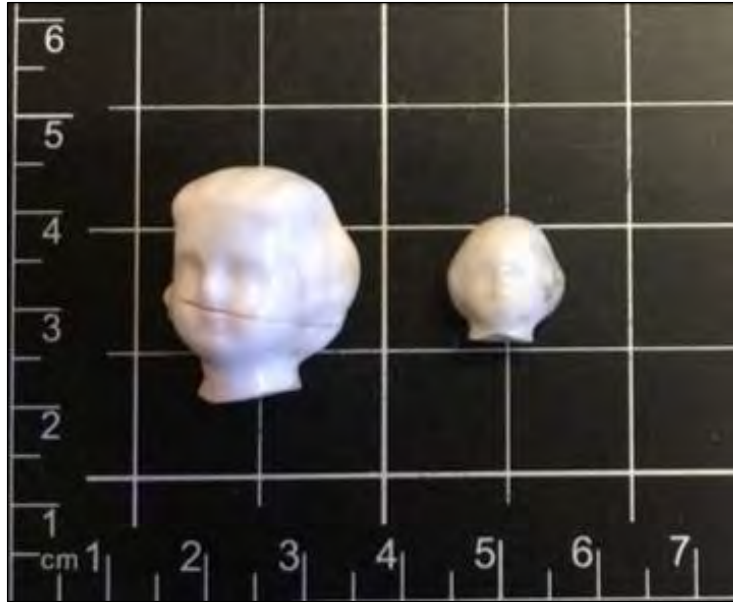
Frozen Charlotte dolls were produced in a variety of sizes, ranging from under one inch to over 18 inches and are characterized not only by their stiff bodies but also by their hairstyles²³. It is likely that the two small doll heads recovered from Spring Hill were from Frozen Charlotte dolls simply because of their small size (Figure 8-115).

Figure 8-115. Detail of doll heads recovered at Spring Hill.

One of the doll heads, which is approximately 2.5 cm (1 in) high, has smooth hair that falls into large curls, appears to be either the “Lydia” or the “Sophia” hairstyle. This style dates to the 1840s (Figure 8-116).

The second doll head, which is less than 1.2 cm (0.5 in) high, has a hairstyle known as the “Mary Lincoln,²⁴” which was seen on dolls from 1860 on, and is recognizable by the large “buns” on each side of the head. This particular head also has evidence of black paint on the hair and subtle remains of pink or red on the lips, similar to the example shown in Figure 8-116.

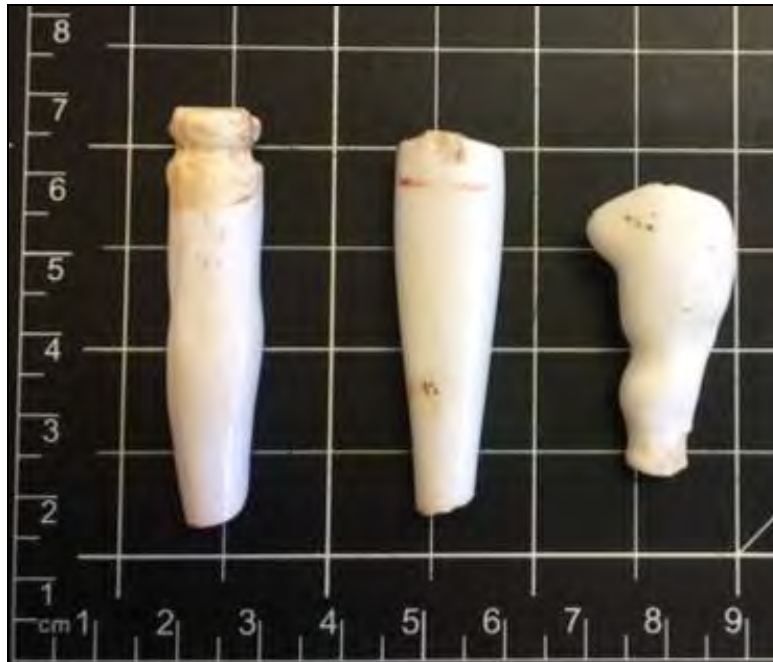
Doll legs are the most common doll parts found on archaeological sites. The styles of the legs found at Spring Hill, however, are quite different: one of the legs is very short and squat, while the other two are narrower (Figure 8-117). Some studies suggest that mid-nineteenth century doll legs are more likely to have straight calves and that the trend towards the end of the nineteenth century was for more rounded, bulbous calves²⁵.

Figure 8-117. Doll legs recovered at Spring Hill.

None of the legs includes a shoe, which can also be somewhat diagnostic. Of the two narrow legs, one is somewhat crudely molded and the other is not only finely molded, but also has a painted bow at what would have been the upper calf. The difference in quality is also interesting, and may be an indication of the shifting socioeconomic status of the residents of Spring Hill.

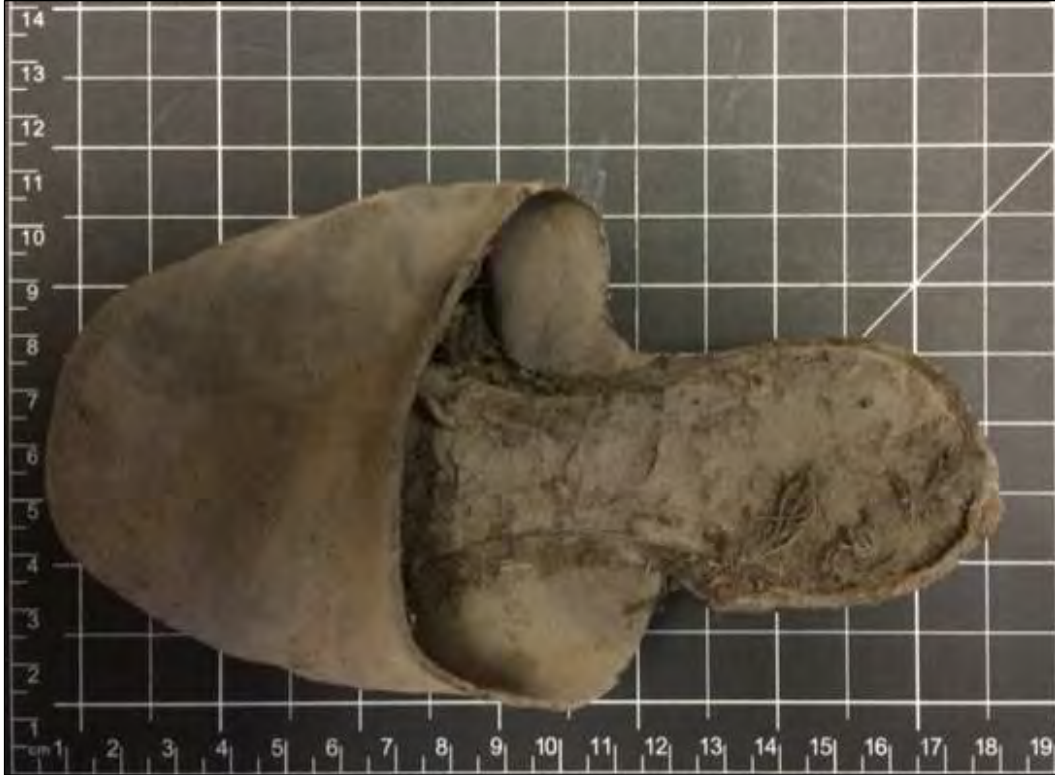
Another artifact found during the investigation of the Spring Hill house itself was a single shoe that had been intentionally placed on the south wall plate, roughly above the middle bay, concealed by second story knee wall near the dormer windows on the front (southern) elevation (Figures 8-118 and 8-119). The shoe was exposed after plaster and lathe that had concealed it since the mid-nineteenth century was removed.

Figure 8-118. Concealed child's shoe recovered at Spring Hill.

The concealment of shoes and other worn and ordinary personal artifacts—particularly shoes and clothing—behind walls or chimneys and in crevices around windows and doors is not terribly unusual, and is associated with warding off evil spirits and protecting the inhabitants of the house. Known as “apotropaic²⁶ concealments,” these hidden artifacts frequently consist of single, worn-out shoes or boots and most often, they are children’s shoes. The shoe was concealed during construction of the dormers on the southern elevation of the house and since the shoe dates roughly to the Civil War, it was likely placed there by the Gregory family.

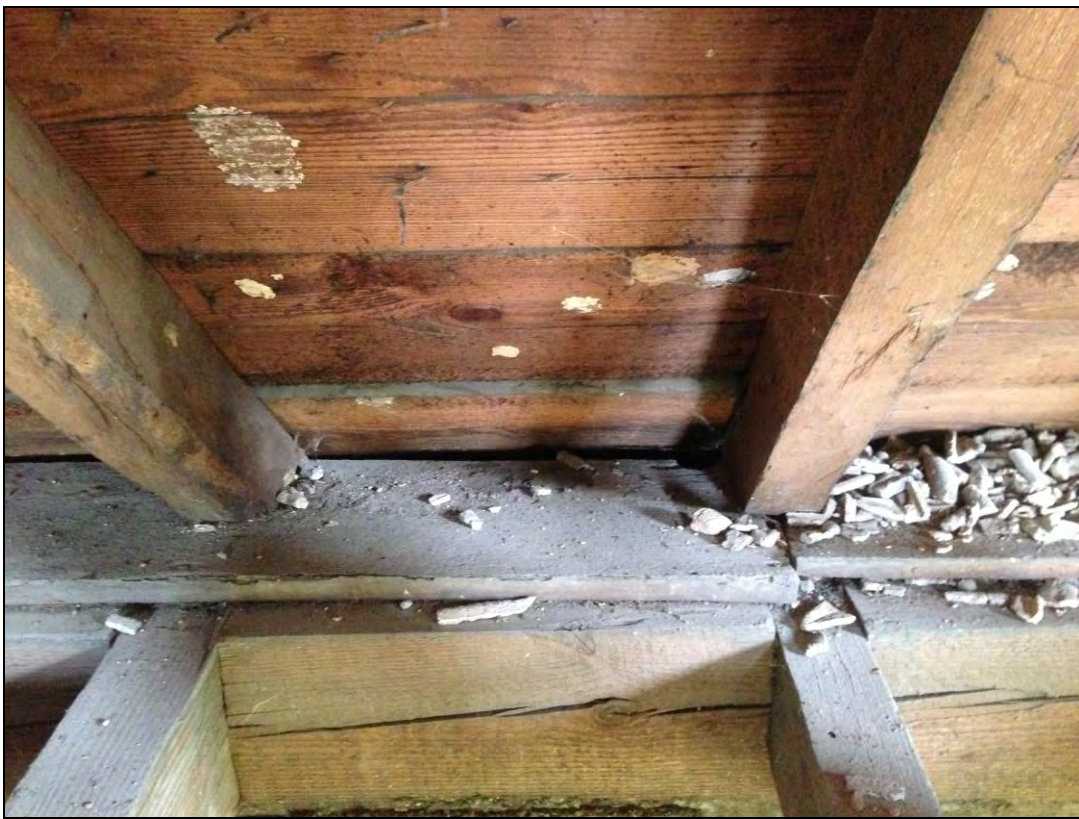
Figure 8-119. Location where concealed shoe was found.

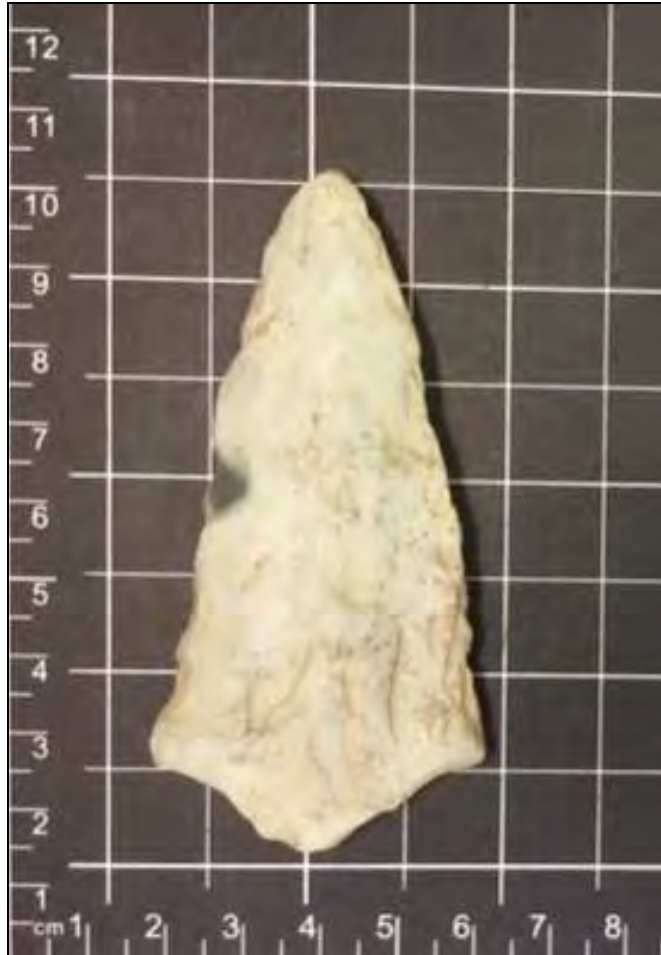
Spring Hill has been occupied for over 250 years since the Branch family land grant, but evidence of the area being used by Native Americans prior to colonization is also abundant, with numerous quartzite flakes and debitage from stone tool manufacture noted at the site during the previous investigations, as well as during data recovery. The number and type of artifacts was not significant enough, however, to suggest long-term prehistoric occupation around Spring Hill, but that the area was used for hunting. One prehistoric artifact, however, stood out as rather unique. In the topsoil removed from Trench 2, a projectile point made of Jasper was recovered. The point is 8.8 cm (3.5 in) in length and known as a Morrow Mountain I broad spear point²⁷, which is slightly larger than is normally the case for these tools, but all other characteristics, including the somewhat crude manufacture by direct percussion, profile, and shape are consistent (Figure 8-120).

The projectile point dates to the Middle Archaic period, 5100-4500 BCE and is greenish blue in color. The raw material used for this tool is unlike the raw materials found in other areas of the Reymet property where cobbles are known to have been worked into stone tools, including at a large prehistoric site approximately 0.6 km (2000 ft) from the Spring Hill house.

Figure 8-120. Projectile point recovered at Spring Hill.

While it is a possibility that the projectile point was discarded at the site thousands of years ago and became part of the archaeological record, it is more plausible that this object was a curiosity collected by one of the occupants of Spring Hill at some point during the past. Finding anachronistic artifacts like this at archaeological sites is sometimes referred to as “curation” by residents of a site. At some archaeological sites, these seemingly out-of-place objects are found together, as in the case of small caches of buttons, coins, shells, or other objects found in slave dwellings²⁸ or stone tools collected by eighteenth century colonists²⁹. The practice of “curation”

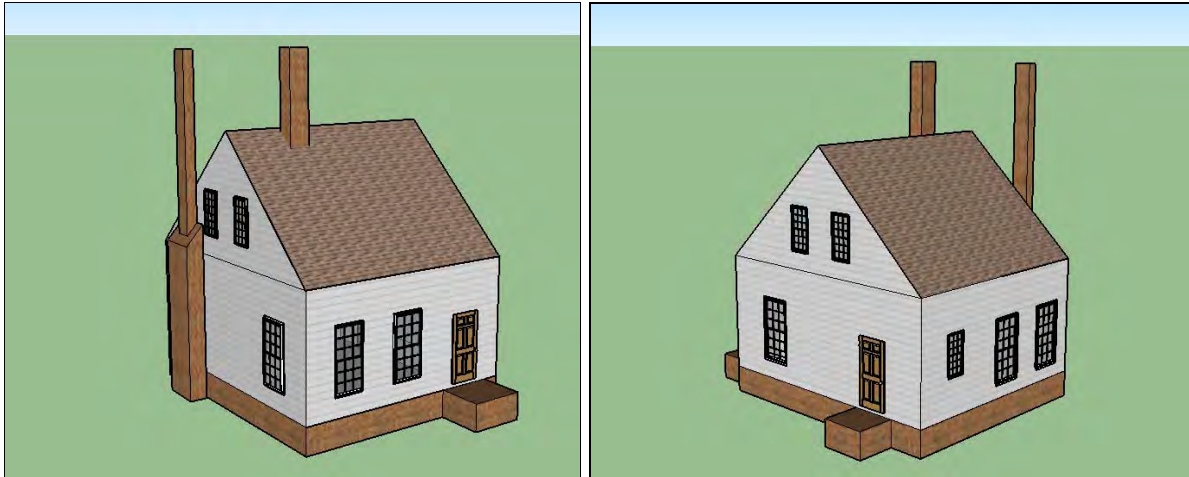
Figure 9-2. Conjectured rendering of original appearance, 1767, south front and west side (Left) north rear and east side (Right).
