Phase III Investigations and Historical Study of the Spring Hill Plantation

LOCATION > Chesterfield County, Virginia

DATE > MARCH, 2015

Dutton+Associates, LLC

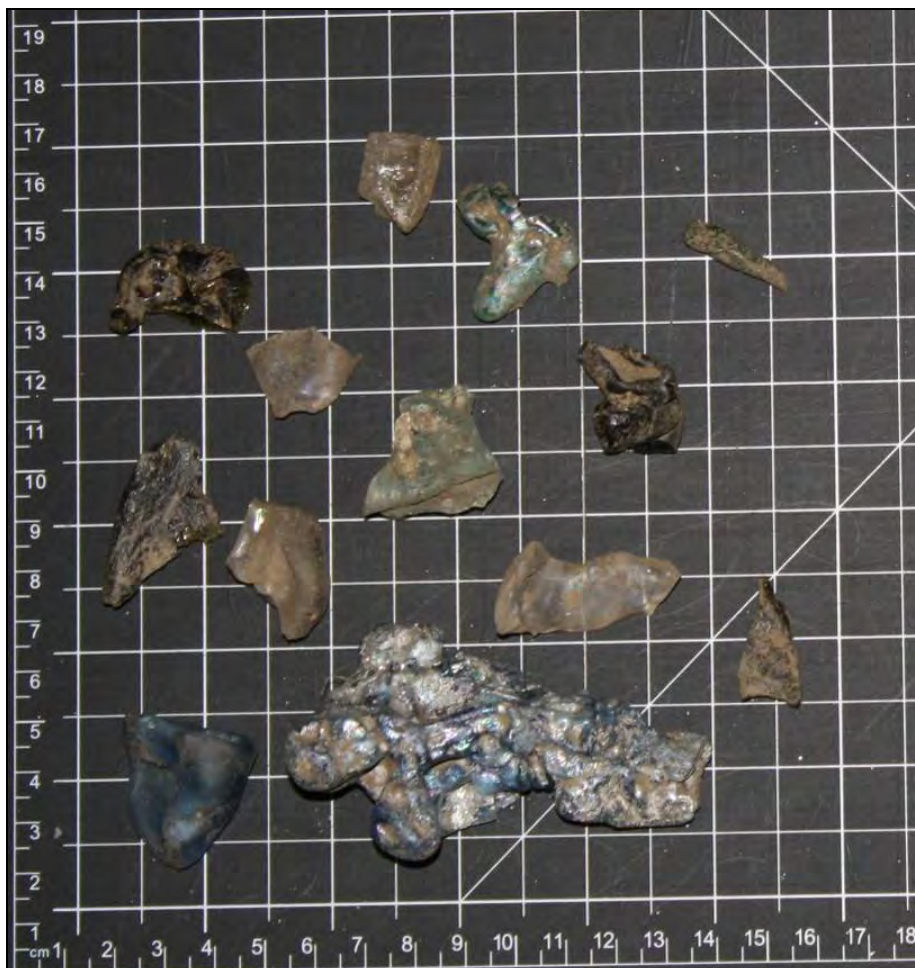
Archaeological evidence also suggests changes, specifically the kitchen outbuilding. According to an account from Margaret Gregory, her kitchen was burned as a result of Union artillery during the Civil War. The recovery of burned glass, nails and other fire damaged architectural and domestic materials supports this account (Figure 9-4). Archaeological features documenting at least two pier set buildings, one slightly off alignment with the other, suggests a second structure was built in roughly the same location following destruction of the first. The presence of a hearth remnant and evidence of a chimney fall document the final demise of the building sometime prior to 1898.

Figure 9-4. Burned glass recovered from Features 21 and 29 of the destroyed kitchen.

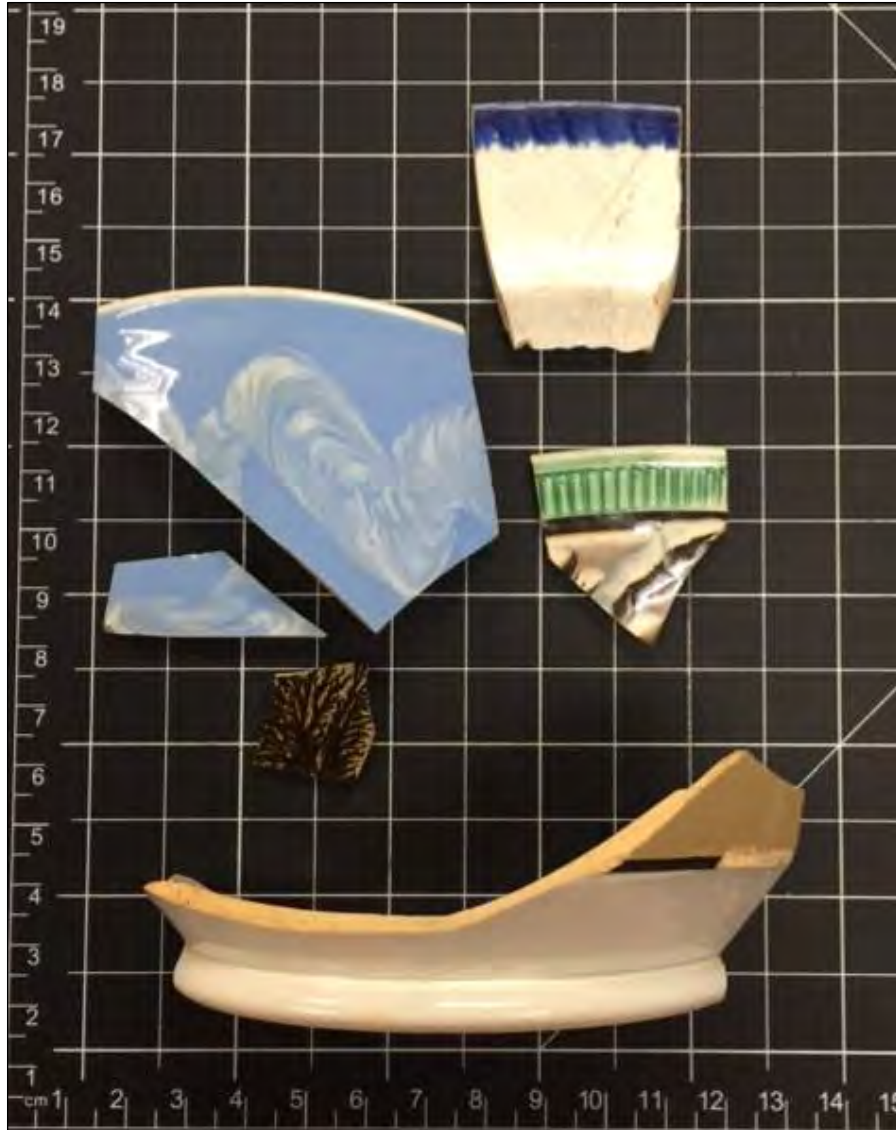
Archaeological investigations resulted in the recovery of substantial quantities of refined earthenwares dating to the Cox family period of ownership. Examples include hand painted pearlwares, mocha decorated pearlware, and a variety of transferprinted wares (Figure 9-18). With the increased availability of a wide range of ceramics, occupants of Spring Hill during the first half of the nineteenth century demonstrated their economic means and purchasing power through the acquisition and use of some of the more refined wares of the period. The absence of definitive vessel types of any quantity limits the ability of archaeology to further define social customs related to usage (i.e. tea consumption, service sets, etc.) and limits interpretation to ware type analysis. Even with this limitation, the archaeological record supports the documentary data, which establishes the Cox family as a prominent and wealthy family of the period.

Figure 9-18. Representative refined earthenwares from Cox family period of occupation.

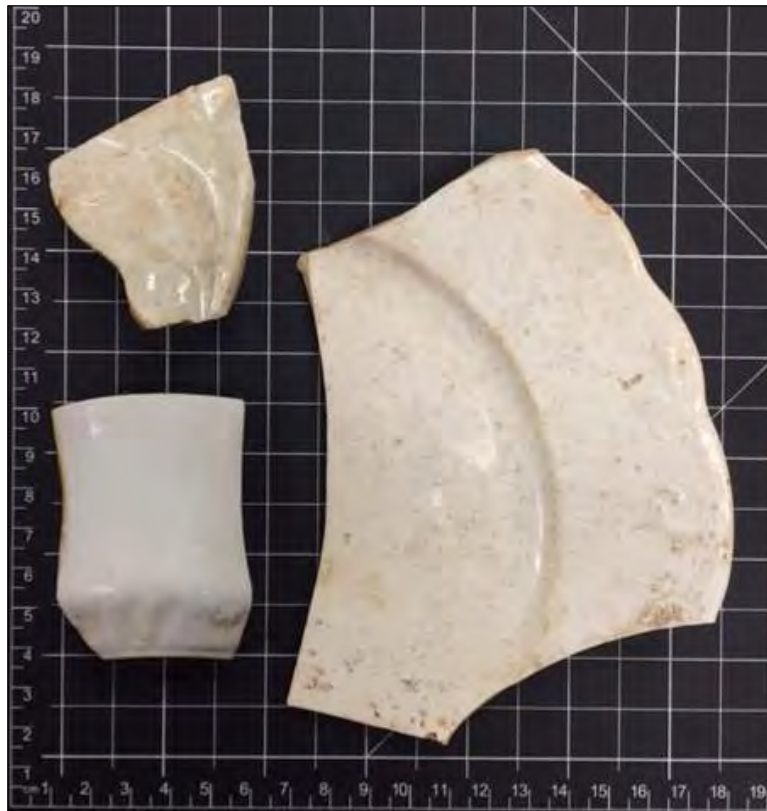
Archaeological investigations at Spring Hill, where Gregory lived throughout his productive life, provide some insight into his wealth and the material possessions he acquired. Unlike his predecessor George Cox. The preponderance of ceramics recovered from George Cox's period of occupation are undecorated heavy molded granitewares (Figure 9-19). This particular ware type was produced in mass quantities for sale to the growing population all over the United States. Graniteware was inexpensive, unrefined, and of substantially less value than the more

Figure 9-19. Representative granitewares from the Gregory family period of occupation.

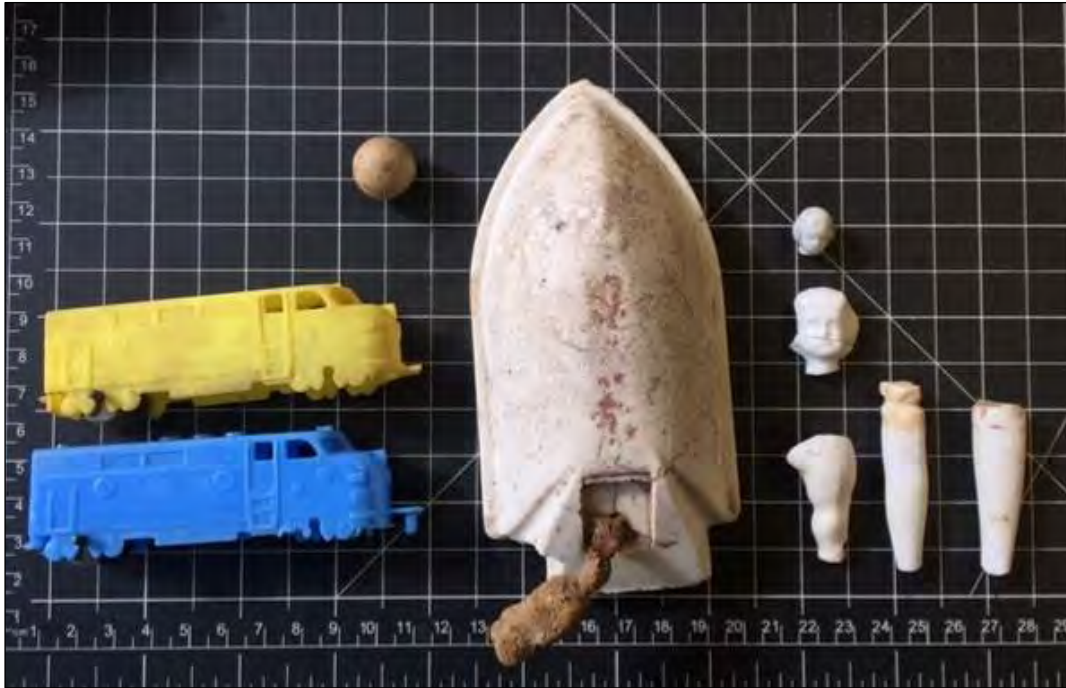
Figure 9-20. Representative toys recovered from the Spring Hill house including dolls, a Sad Iron, marbles, and toy trains.

By the twentieth century, women and children left a more imposing mark on the Spring Hill house and property. As opposed to the Gregory family who crammed their numerous children into the small rooms at Spring Hill, the Duval family in the early twentieth century took the opportunity to expand the living space. The large new addition permitted Frank and Ada Duval and their at least four children, to have larger and more comfortable living spaces. As the detached kitchen in the domestic yard appears to have not been rebuilt by the Gregorys or the Duvals, presumably the kitchen was moved into the home, accommodating family cooking without the assistance of slave labor. Evidence of the family was also found in the archaeological record by means of various toys, dolls parts, and a Sad Iron, recovered from the side yard west of the house (Figure 9-20)

Evidence of children living at Spring Hill following the Davis ownership, likely during the Murphey occupation, can be seen in the house through the application of airplane and transit inspired wallpaper in what was presumably a child's bedroom upstairs, and through the collection of plastic toys in the archaeological record (Figure 9-20).

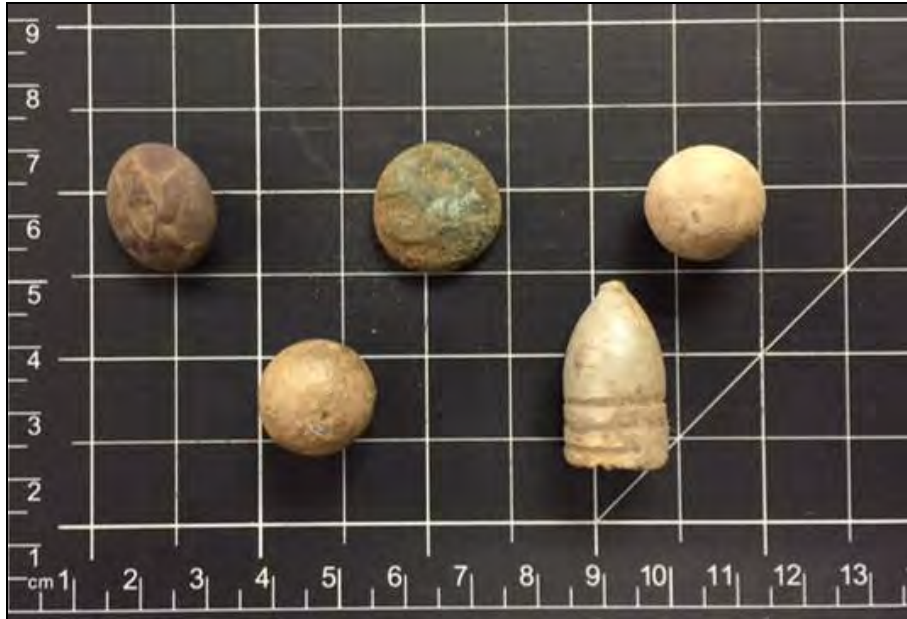
A few months later gunboats were bearing on Spring Hill, as Meg recounted “...the shells would fly over my house every time...at last the shelling became so bad I had to leave. The day after I left a shell weighing 132 pounds passed my chamber and went through my cook kitchen” and another shell “fell into my garden making a hole large enough to bury a horse” (Gregory 1865). Archaeological evidence supporting her account of the battle and events is limited, although Feature 31 is consistent with a large crater possibly the result of an artillery shell. Additionally, the presence of Union soldiers on the property is supported by the recovery of uniform buttons and unfired munitions (Figure 9-21). While recovered in small quantities, these items support Meg Gregory’s accounts of the battle.

Figure 9-21. Select Civil War artifacts recovered from Spring Hill including round shot, unfired Minnie balls, and Union uniform buttons.
