# National Register of Historic Places Registration Form

Historic name: Gardner House

Other names/site number: DHR No. 002-5310

City or town: Crozet State: VA County: Albemarle

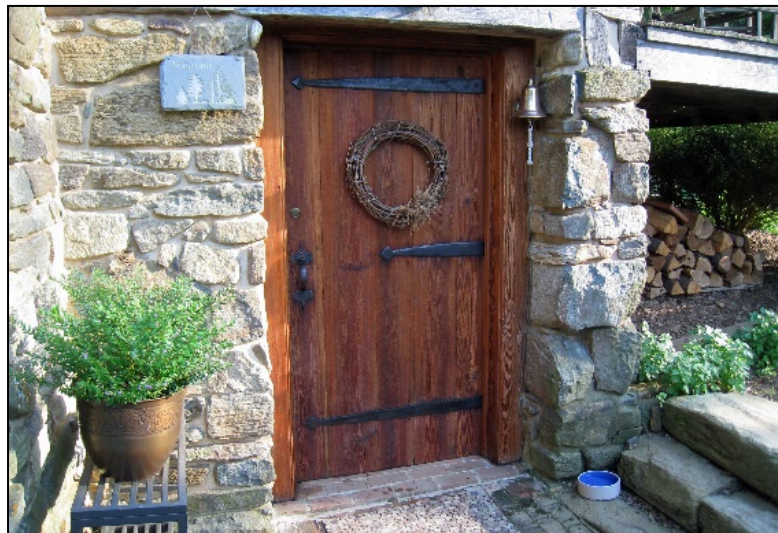
Figure 2. Basement-level entrance door on south elevation

In 1985, the board & batten entrance door at the basement's north side was removed, being too short to comply with local codes for re-occupancy. The new door (at left) was constructed taller but in the same manner, using vertical heart pine boards (beaded) with hand-forged strap hinges by Charles McRaven, author of *Country Blacksmithing*<sup>2</sup>, and a hand forged thumb latch by Newton Millham.<sup>3</sup> The original door has been retained and remains in storage on site.

The basement rooms are partitioned with standard framing. The foundation wall is constructed of random fieldstones, most likely supplied directly from the immediate area given the commonality of abundant stone at the site. Room height throughout the basement is 7½' from the floor to the ceiling (underside of main level flooring). The basement foundation stone walls are 18" thick and built into the slope of a hill. At the stone foundation's exterior southwest corner, the basement wall is 30" from ground level to the sill plate log. The southeast corner measures 36" inches from the sill plate log to ground. The stone foundation wall is entirely exposed at the north end of the basement where a ground-level entrance door exists. (Figure 2)

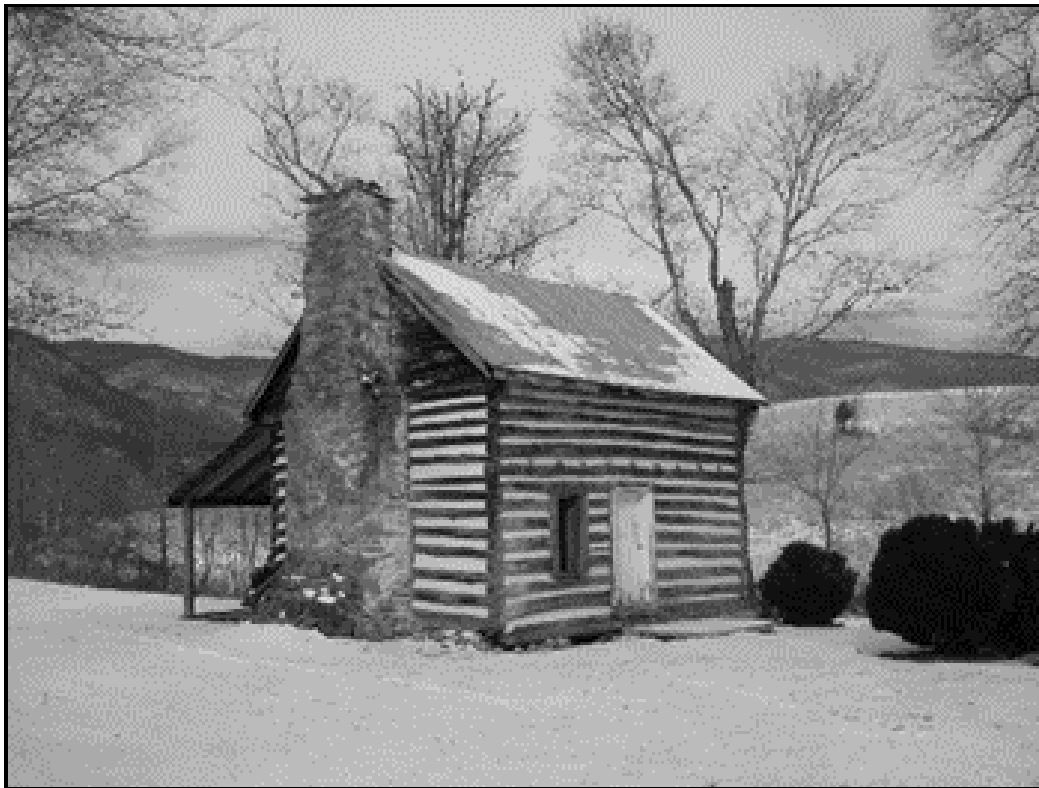
Figure 9: Neighbor's log dwelling west of the Gardner House

The nearest and most obvious example is an adjacent neighbor's log cabin that stands to the west along Buck Mountain Creek and measures a more typical 16 x 16 feet.<sup>22</sup> (Figure 9)

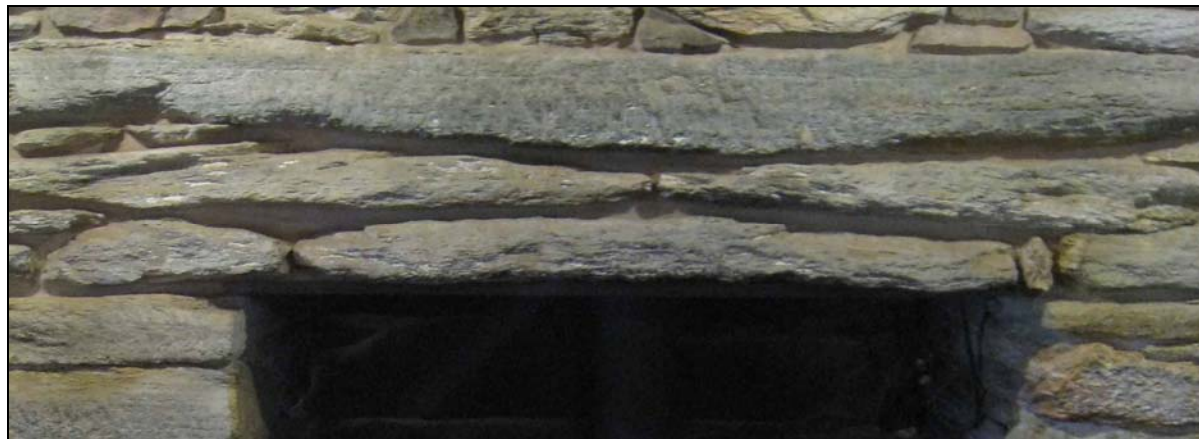
Figure 11: Kitchen fireplace stonework

stones. The swing-arm hinges for cooking are still in place and evidence the practice of cooking over a fire in a stone hearth. Several hand-forged S-hooks for cooking have been found around the dwelling's grounds. Just above the fireplace, two long stones are carefully aligned and placed to meet directly in the center of the fireplace. Set above these two stones is one remarkably placed 6' long stone with an unusual bluish hue, chiseled flush, 4" thick at the center and blended in perfectly with the three stones below it. (Photo 12 and Figure 11)

As with the exterior stonework and the use of quoins, this interior stonework conveys consciousness of aesthetics in addition to creating a structurally sound wall. The stonework, both inside and out, exemplifies a concurrent theme that this log house was carefully constructed using fine vernacular craftsmanship and methods.

The kitchen's stone fireplace is relatively large, measuring 4' x 4' and 2' deep. (Photo 12) The stones utilized for the fireplace are predominantly mylonite and phyllonite, chiseled square and flush. The hinges for what would have supported a cooking swing arm are still in place. Today, a wood stove used for supplemental heat sits on the hearth.

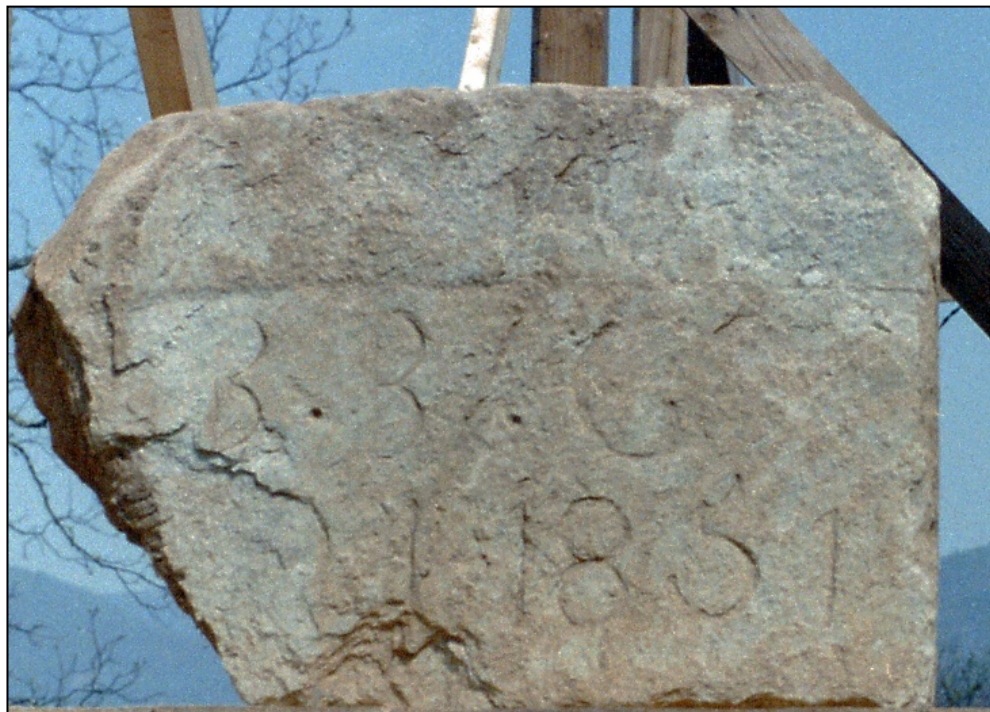
Figure 12: Stone engraved, "B.B.G. 1851"

First, concerning the 1851 construction date, this is known because during the 1983 rehabilitation effort, a stone was found in the rubble where the north side chimney had fallen. The stone was engraved, "B.B.G. 1851." (Figure 12)
