ARCHITECTURE IN VIRGINIA (AIV)

THE CLERESTORY DWELLINGS OF SOUTHEASTERN VIRGINIA
UNIVERSITY OF VIRGINIA

Elizabeth P. Hoge

Spring 1992

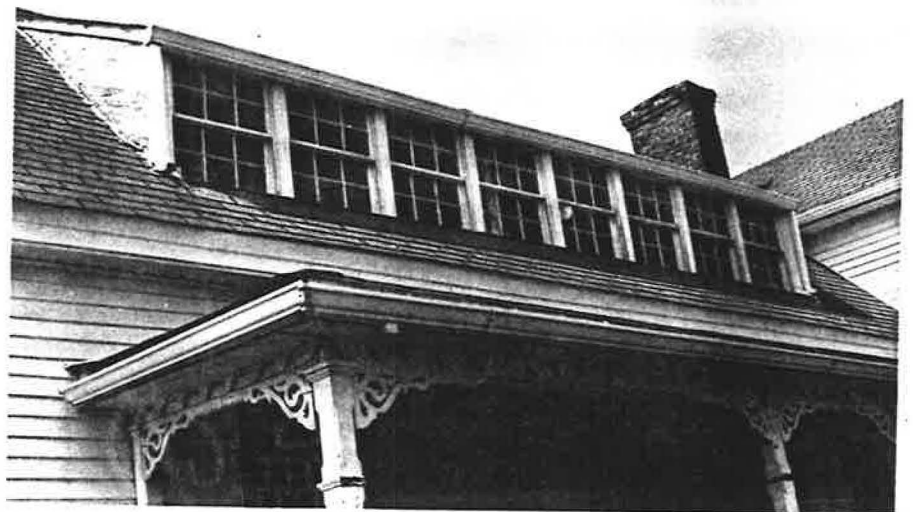
Clerestory Dormer detail

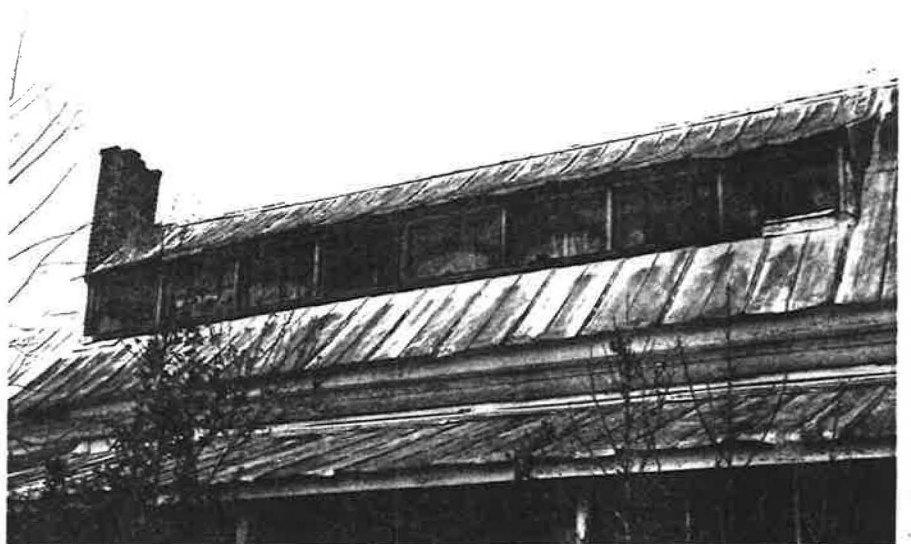
Clerestory Dormer detail

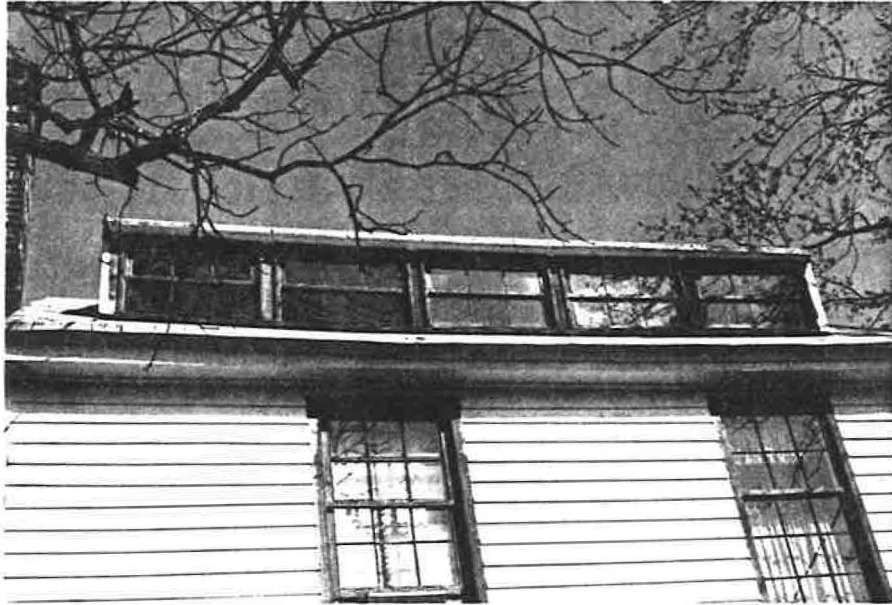
Clerestory dormer detail

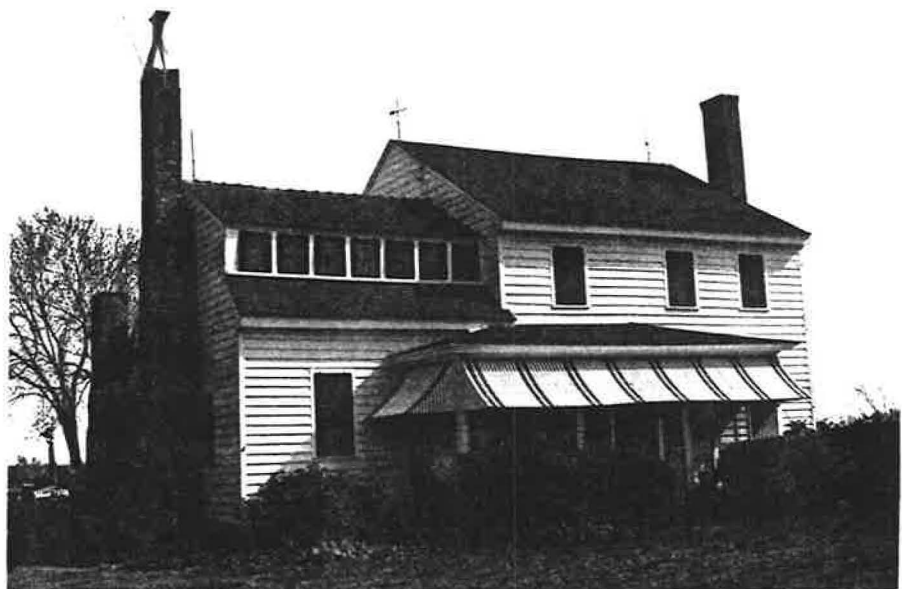
Clerestory
detail
