The Nansemond Ghost Fleet

Archaeological Investigations of a Vessel Abandonment Area in Suffolk, Virginia

ARCHAEOLOGICAL REPORT No. 24, DEPARTMENT OF HISTORIC RESOURCES
& Longwood Institute of Archaeology

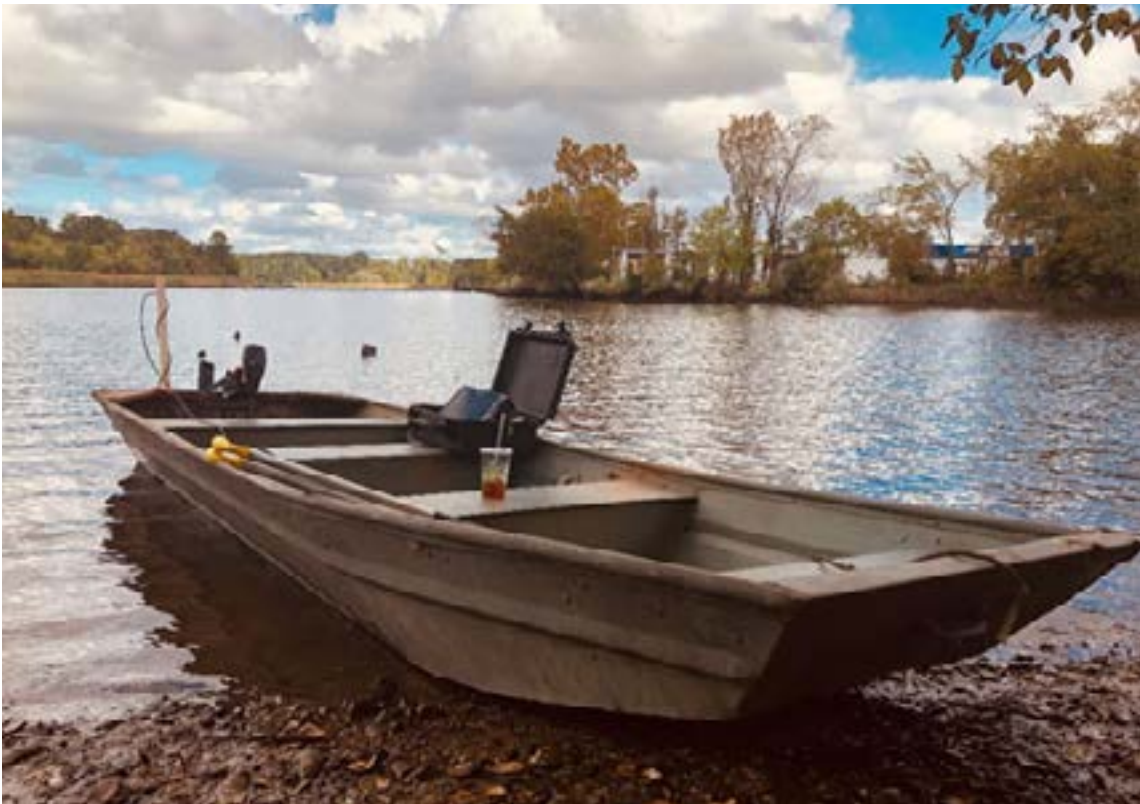
*Figure 4.
The R/V Nansemond
rigged for side-
imaging sonar. It
used a 30-lb thrust
trolling motor for
propulsion and a
secondary 12VDC
battery to power
the sonar unit.
Positioning was
acquired using a
built-in GPS antenna
and only collected
with an HDOP of
<1.1.*

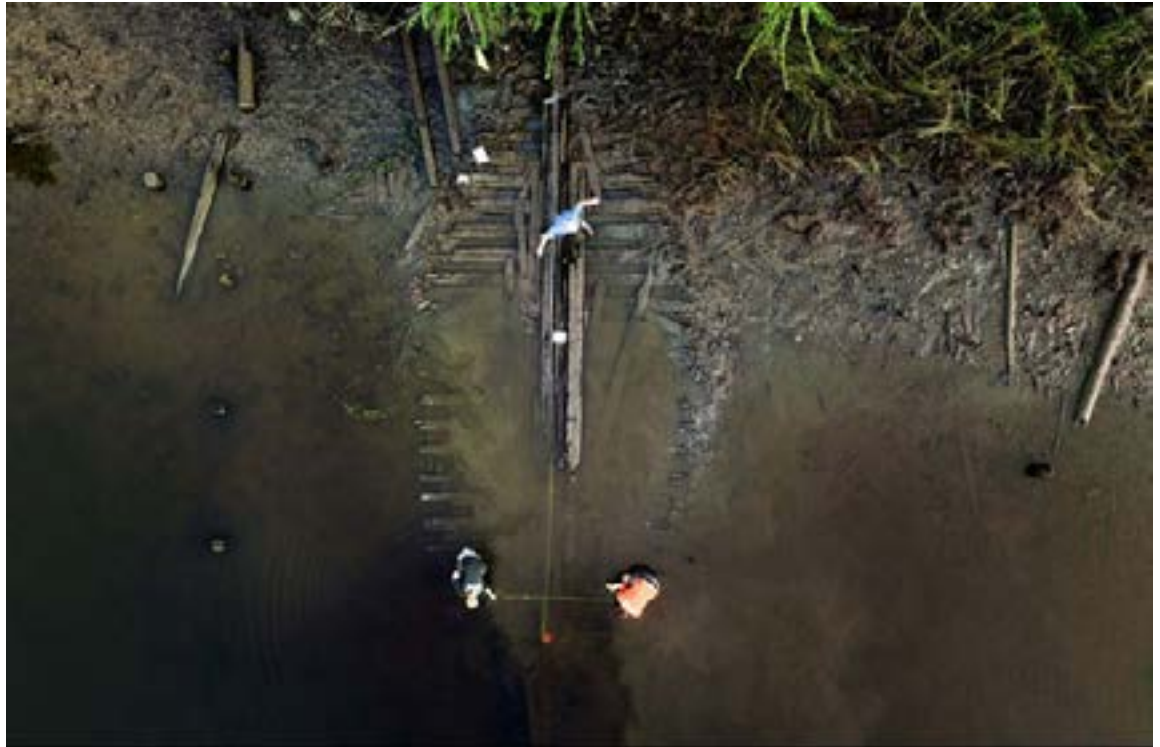
Figure 5.
The recording
team documented
vessel offsets during
the October field
expedition. (Courtesy
of the *Virginian Pilot*)

Six frame curves were recorded along the starboard side (Figure 45). Curves of the port side were tested; however, these frames were noticeably distorted and only measures of the starboard side were taken for each set. The offset measure was taken at periodic intervals along the frame. Spacing between offset measures ranged between 30cm and 5cm depending on the obstacles encountered and the steepness of the curve being recorded. These measurements were recorded and the curves later sketched to assess their accuracy. Frames were labeled 1 through 28 from bow to stern and curvatures were recorded for frames 1, 6, 13, 18, 23 and 28. Note that after the frames were numbered and recorded, the bow section was further exposed for recordation and another pair of frames was identified forward of Frame 1. This frame was labeled Frame 0 to keep the numbering system intact, resulting in a total of 29 surviving frames at the Hobbs Site numbered 0-28.

Frames 1 and 28 were the fore and aft-most frames identified at the time; frame 18 is the master frame; frame 13 is the longest frame length surviving and near the centerline of the hull; frames 6 and 23 filled the gap between the fore and aft-most frames and the next measured pairs. In the future, these frame curves combined with the other hand measures, the photogrammetric data, the highly accurate geometric data from the laser scanner, and construction data from similar ship types will allow a set of ship's lines to be reverse engineered for the vessel. This enables archaeologists to reconstruct the original curvature of the vessel and better understand the ship's sailing characteristics and hull design as engineered by the shipwrights a century ago.

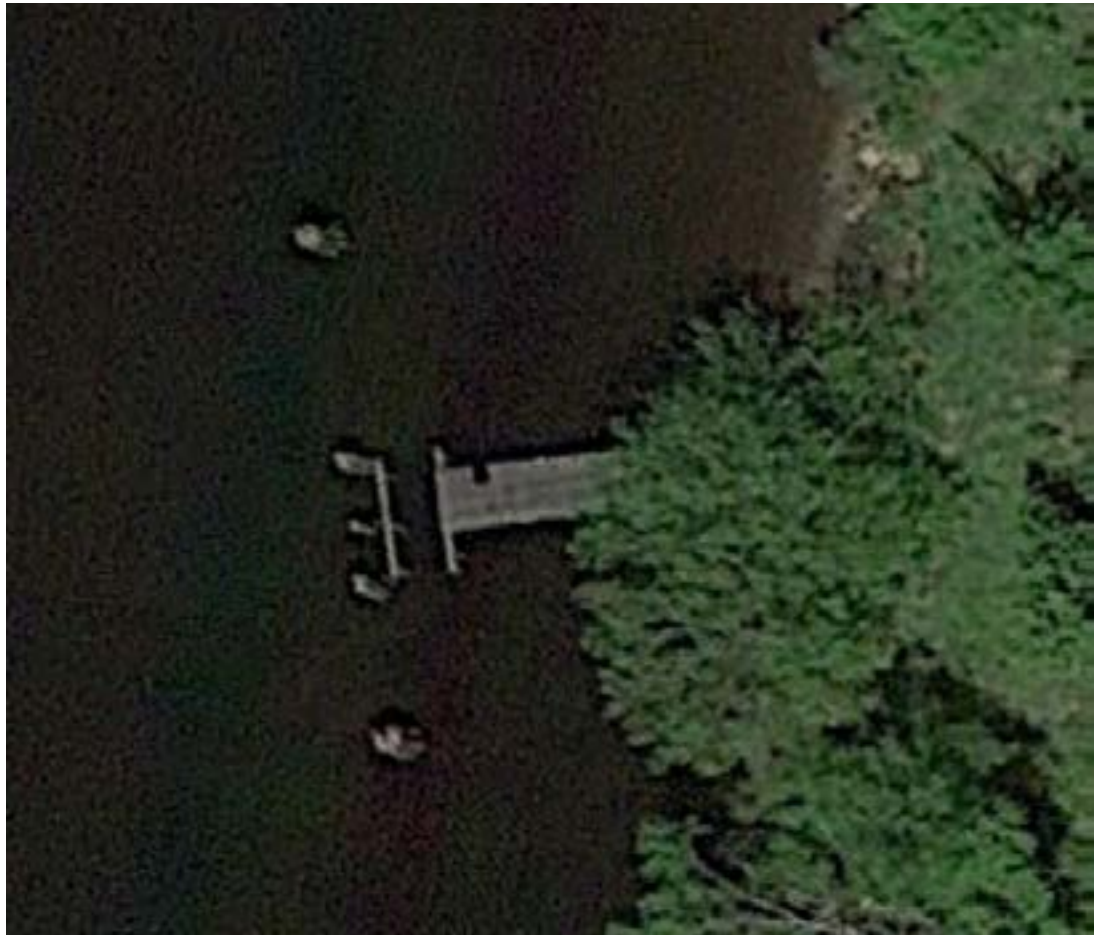
Heavy pilings and a wharf structure were identified on the September 30 canoe survey (Figure 17), on the north/east bank of the river. Forming a T-headed wharf, this structure may relate to a mid-20th century fuel dock constructed and operated by the Standard Oil Company. Dolphins (numerous pilings driven together and lashed as one fender piling) appear to the north and south of the wharf face, forming a length of approximately 20 meters. This structure is consistent with wharf infrastructure built to handle liquid-carrying barges. Since only a small portion of a fuel barge necessitates access to load or

Figure 17.
Feature 1 as it appears in
2014 Google Earth aerial
imagery.

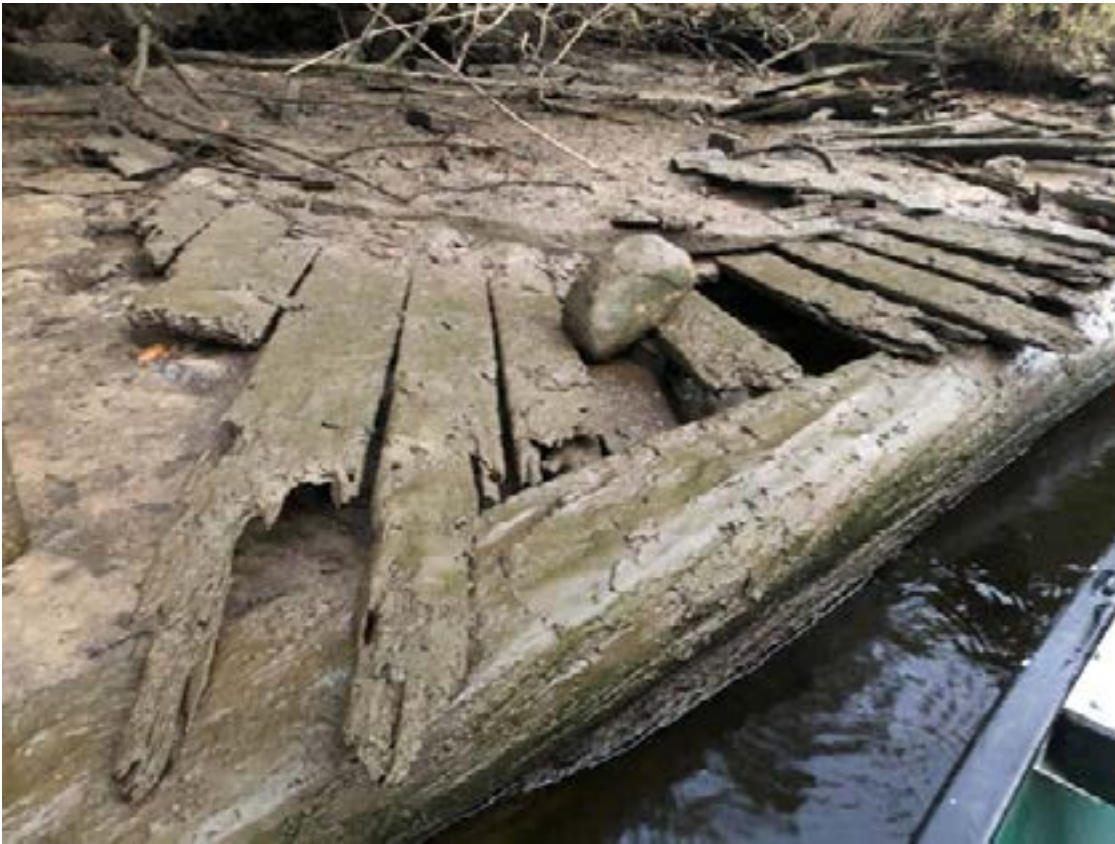
Figure 19.
Feature 2 vessel remains.

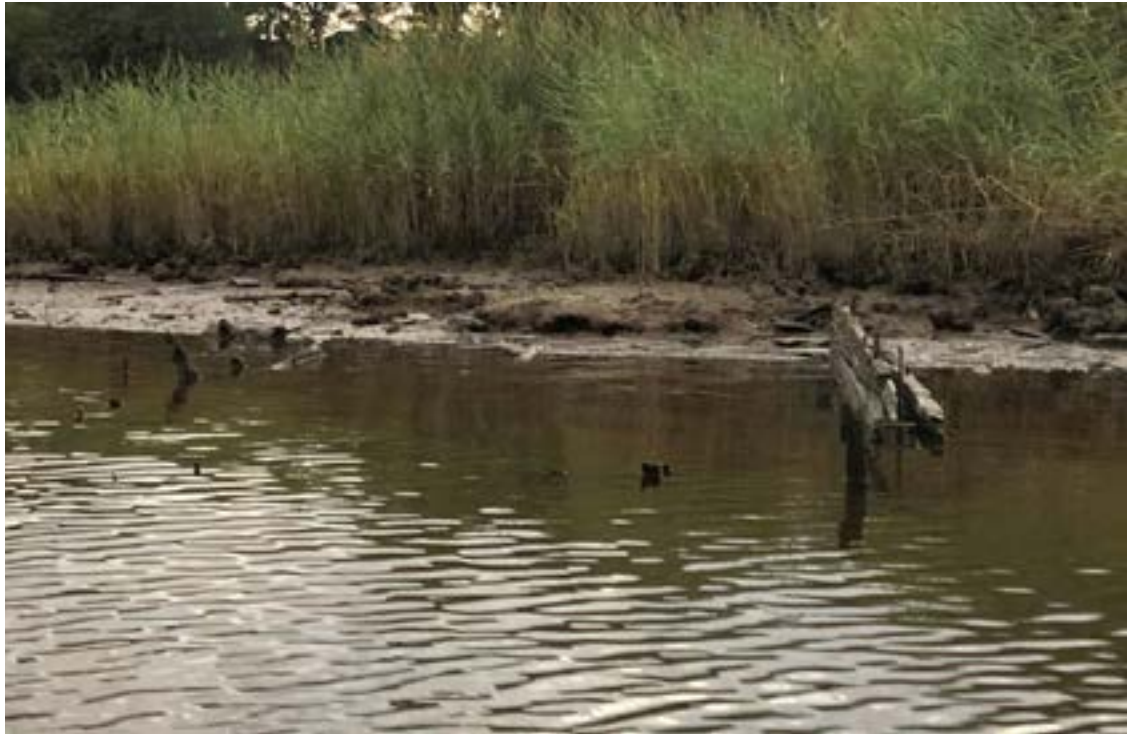
Figure 21.
Feature 3, remains of a
small wood barge.

Barges are probably the most ubiquitous type of historic watercraft. Feature 3 represents a wooden barge measuring approximately five by three meters. The barge is the northernmost vessel identified in the site and resides on the western bank. During normal tidal cycles, the barge remains are mostly submerged with the exception of one segment of hull (Figure 21). The feature was documented remotely due to the depth of mud surrounding vessel remains and limited low water during the October field phase. Further examination and documentation of this feature is recommended.

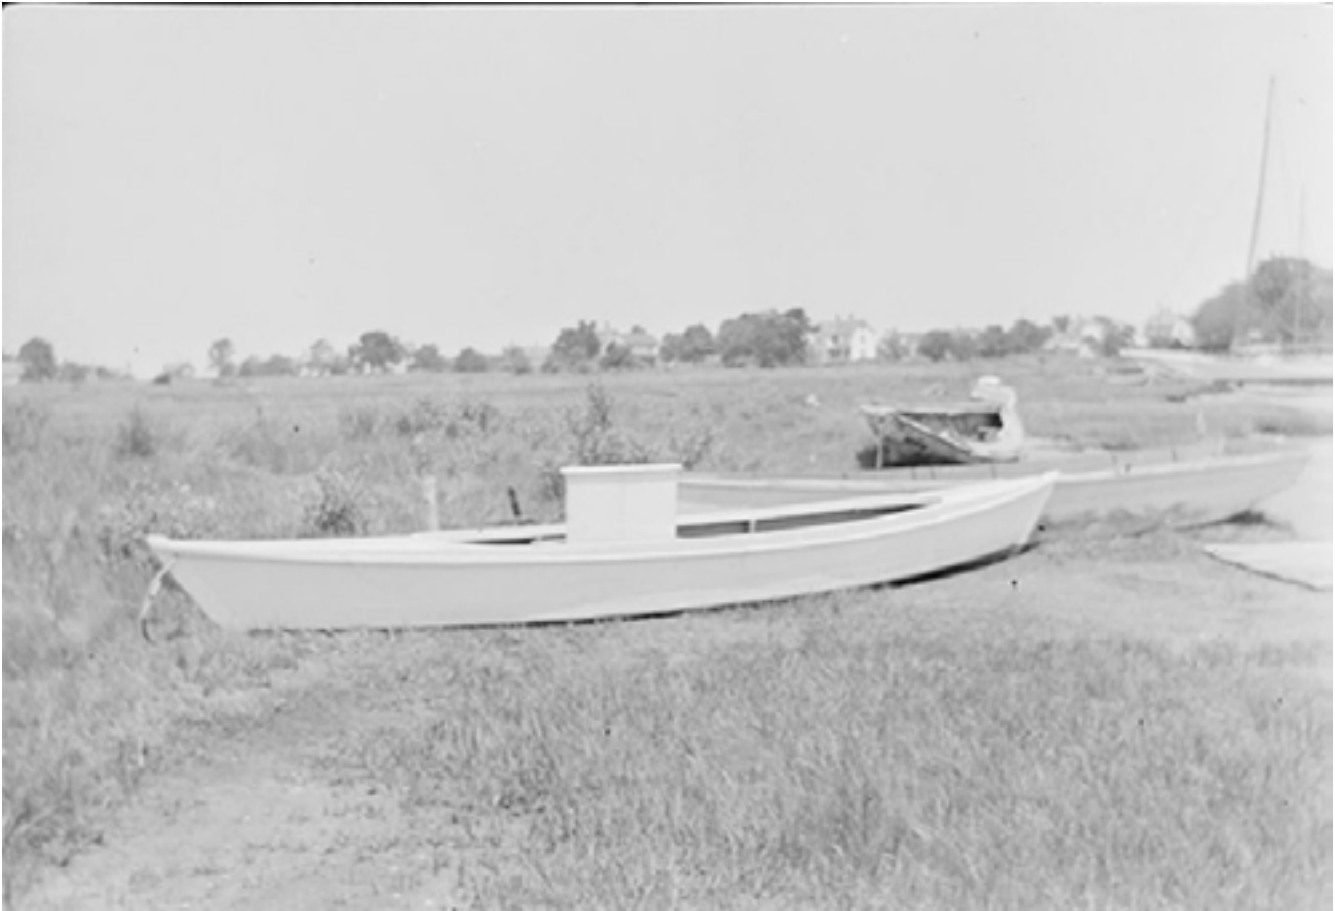
*Figure 23 (above).
In this 1941 photo by M. V. Brewington a double-ended skiff is shown out of the water. A trunk appears in this skiff, indicating it was rigged for sailing. (Courtesy, the Mariners' Museum)*

but should be re-checked. M. V. Brewington documented a similar skiff in Wenona, Maryland in 1941 (Figure 23).

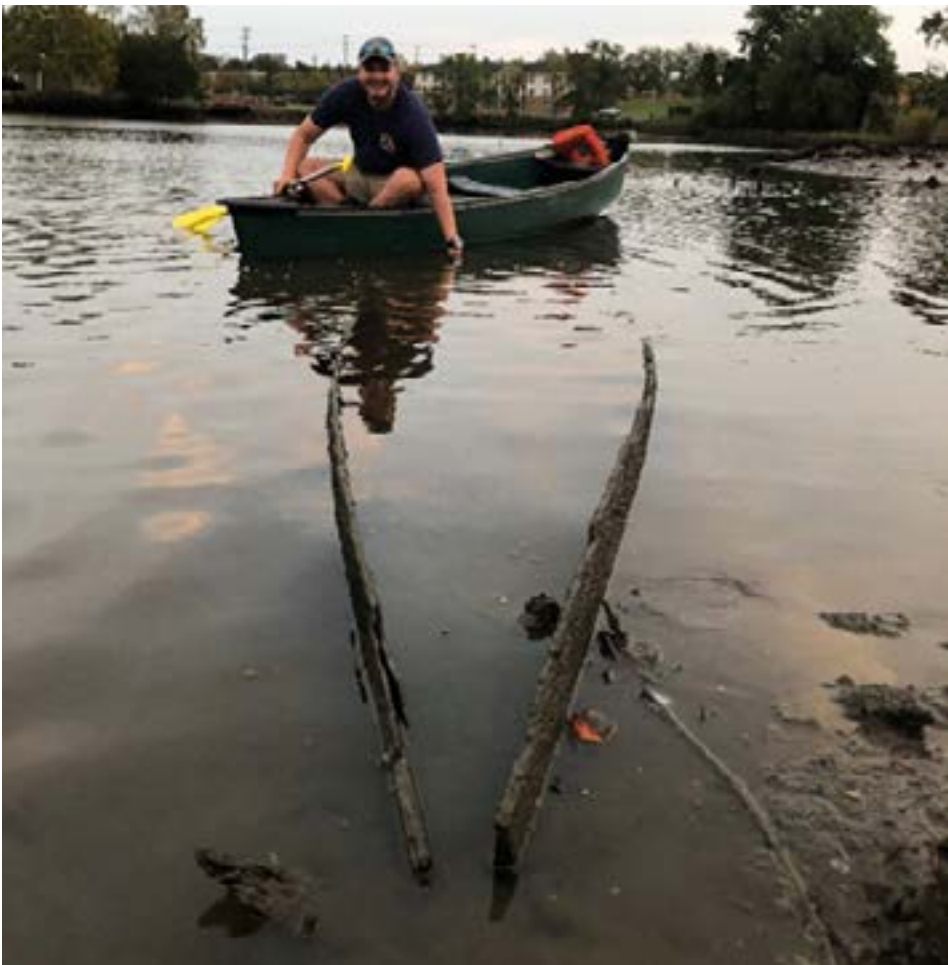
*Figure 22.
Feature 4, a double-ended skiff seen in the foreground.*

Throughout the Chesapeake Bay and its tributaries, people used such skiffs for transportation, crabbing, fishing, and sport. Lightly built, double-ended skiffs emerged as replacements for dugout canoes since they could be fashioned from common sawn lumber (Fleetwood 1995; Parker 1994). The double-ended skiff is one of several double-ended hull types endemic throughout the Chesapeake region. Other types of double-enders include the Hooper's Island sharpies, bugeyes, log sailing canoes, Petersburg boats, and brogans.

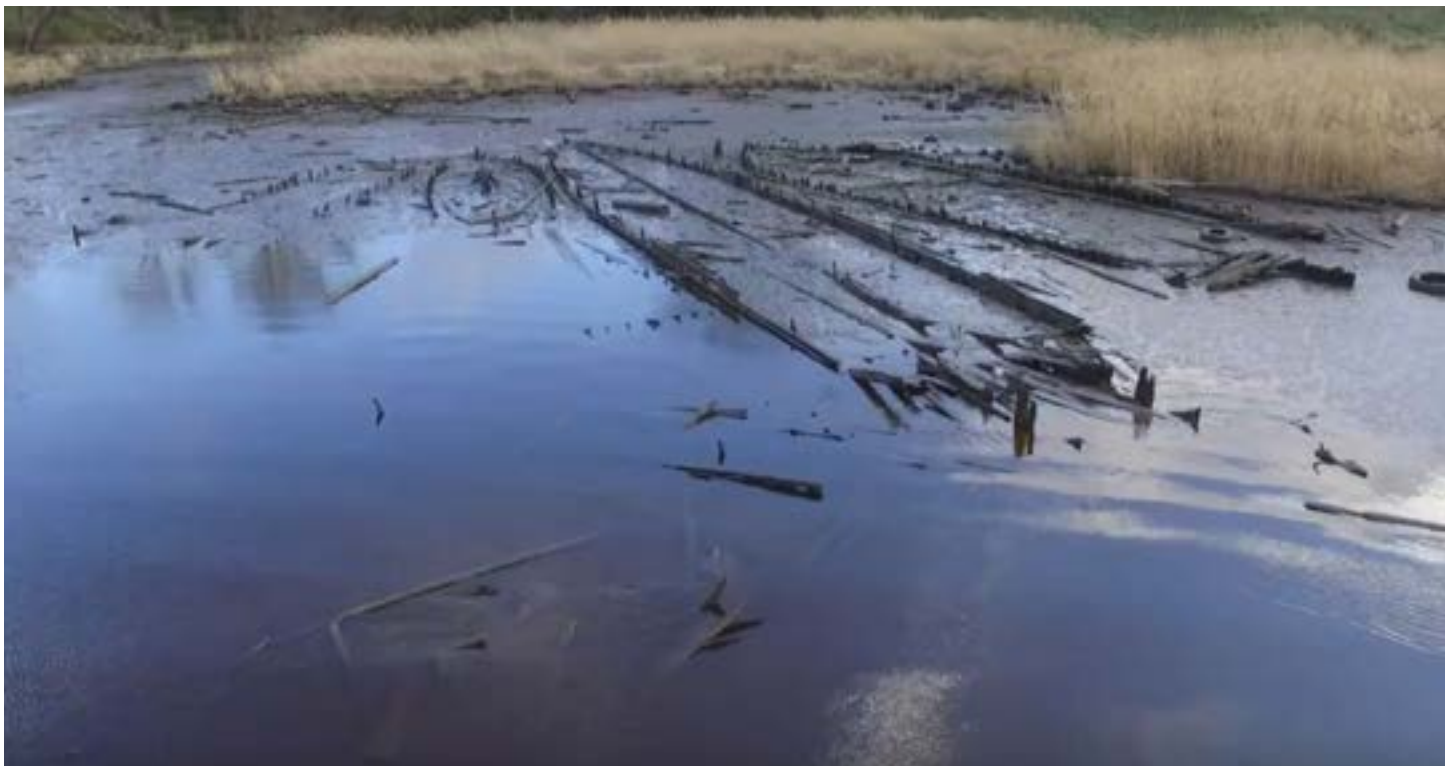
Feature 5 is the most complex area of site 44SK0631. A portion of the site is believed to be owned by the Funkhouser family, who granted access permission to their property from the water. The feature consists of at least six wooden vessels and appears to form a vessel abandonment area on the outside bend in the Nansemond River where the channel turns to the north. This area is presently a muddy foreshore adjacent to canebrake marsh. Timbers protruding from beneath the canebrake root structure, where eroded, indi-

Figure 25. Feature 5, the "Funkhouser Fleet." Kermit Hobbs shot this photo during the initial documentation of the Nansmond Ghost Fleet in 2017. It captures an exceptionally low tide and the remains of six vessels.

cates that this area was not marshland during the 19th and 20th centuries. A large diameter piling, located between the bows of vessels 1 and 2 was likely placed to moor derelict vessels and prevent them from coming adrift during periods of high water.

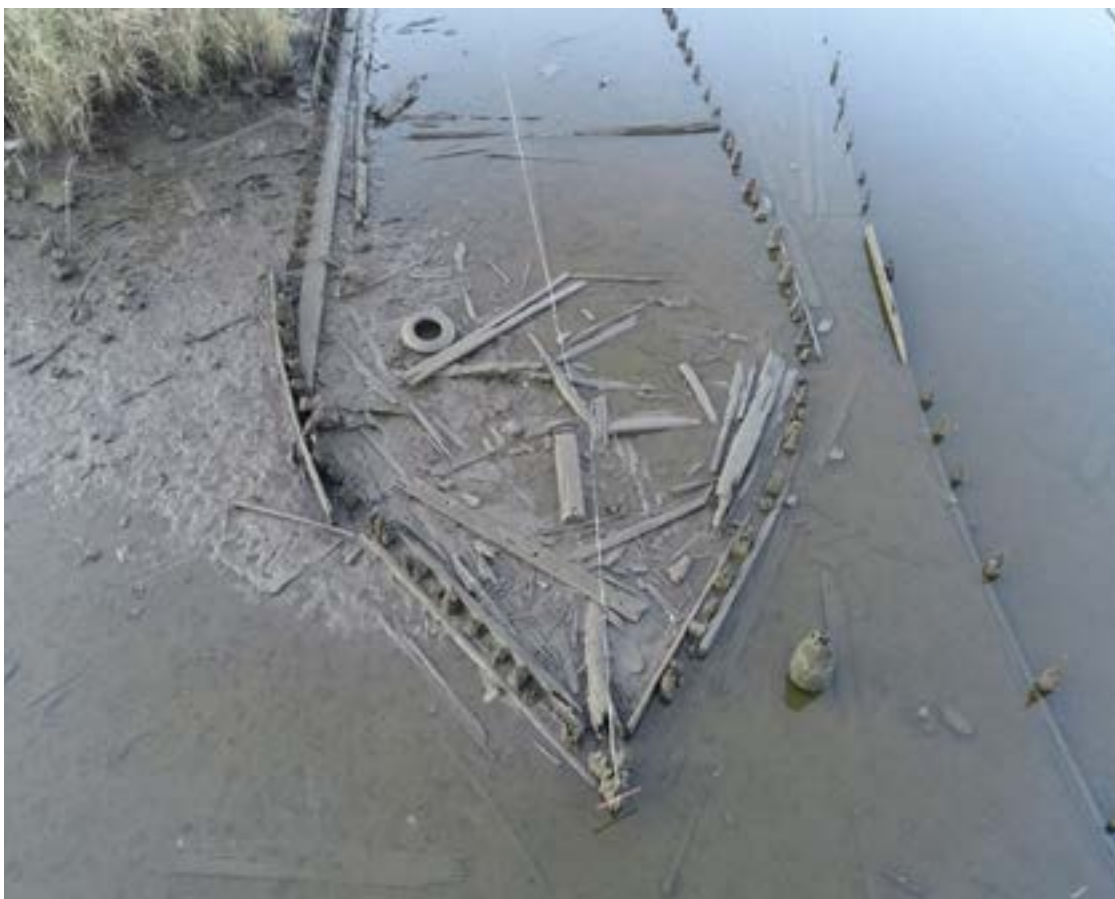
Figure 26. The bow of Vessel 1 of Feature 5, the Funkhouser Fleet. Note the piling on the port side of the bow, likely placed to keep the derelict vessels from coming adrift, hitting the bridge, or blocking the channel. Also note the chine log on the port side; it appears to run out at the break in the bow. A single heavy timber spiked to the top of the keelson may have served as part of a mast step. (Courtesy, the Fairfield Foundation)

This vessel (Figure 26) is likely a scow barge due to its heavy construction and flat bottom. Its length and breadth are 25.24 m by 6.72 m. Extant structural components include framing, a stem, cutwater, transom framing, chine logs, and a rider keelson. It shows crude construction throughout and all fastening observed was of iron, including chisel-tipped spikes. Planking and framing appeared to be cut from unidentified soft wood. The keel structure was

Vessel 1 is heavily framed and, with the exception of cant frames comprising the stern, frames appear to be plumb (Table 3. Vessel 1 scantlings). Patterning of good-condition frames alternating with very poor condition frames indicate sister framing throughout (Figure 27). Curvature of the bow was minimal and took on a primitive appearance of a nearly triangular bow attached to perpendicular sides. Initially, investigators thought that the bow had deformed in the process of rotting and falling apart but a chine log indicated otherwise. On the port side a heavy chine log, nearly square in profile, was fastened to the interior of the frames. The log ran out at the turn of the bow and was relieved to fit the inward curve of the bow. Probing mud inboard of the chine log found a flat bottom, likely ceiling timbers, although the presence of thousands of fragments of wood contained within the mud prevented reliable probe data.

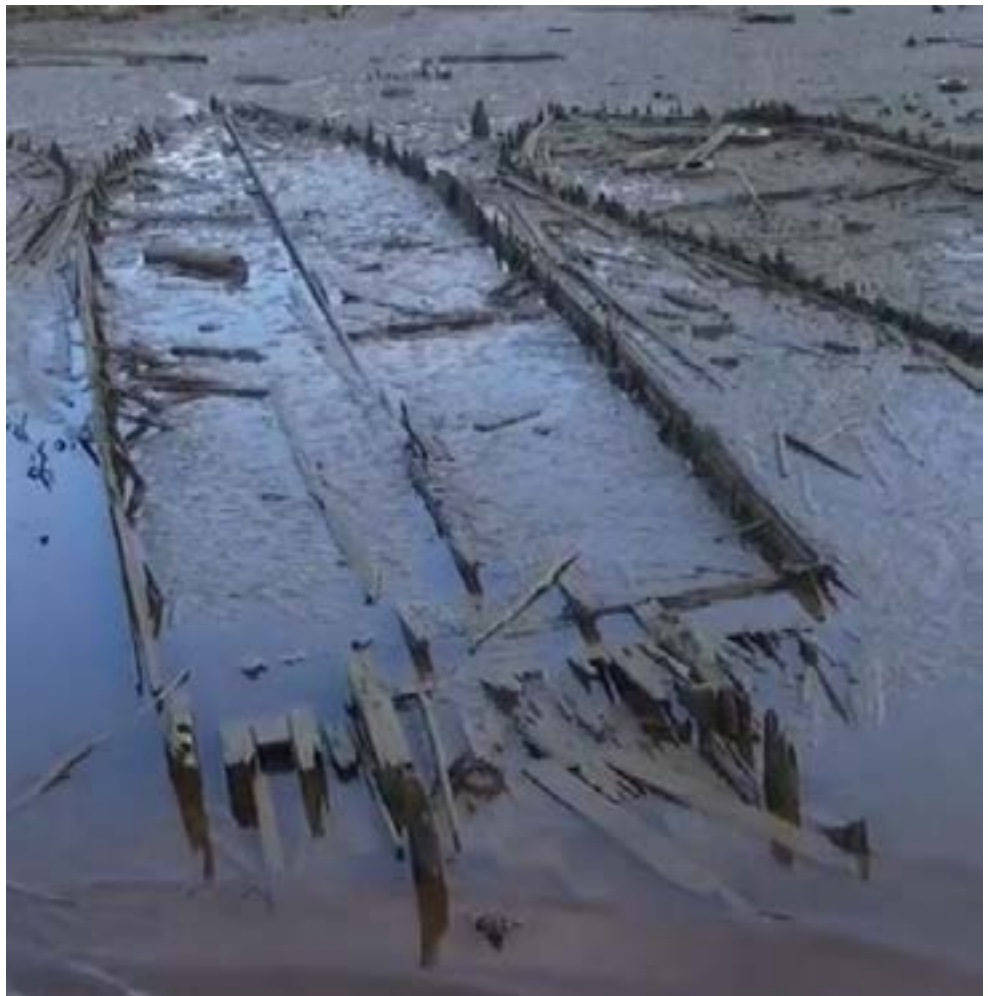
Figure 28.
Vessel 2 of Feature 5,
the Funkhouser Fleet.
Note the standing keelson.
(Courtesy of Kermit Hobbs)

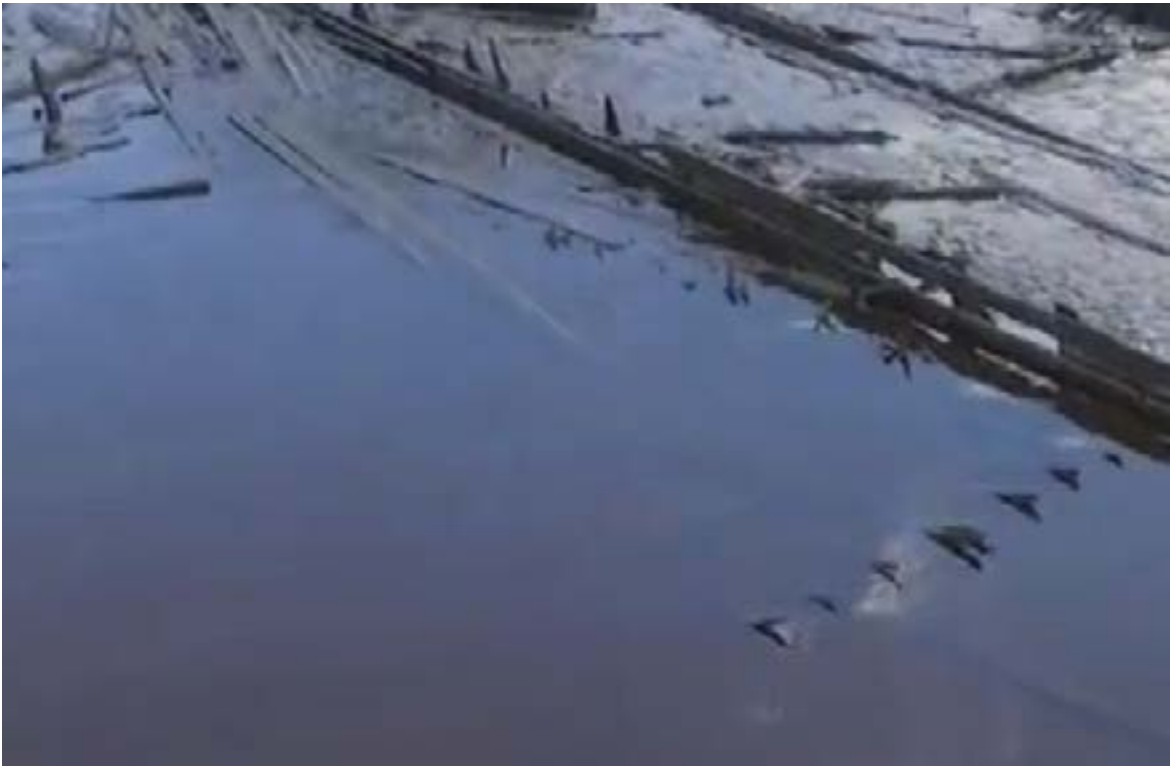
Figure 30. Vessel 3 of Feature 5, the Funkhouser Fleet. Frame ends are exposed in the right-hand side of the picture. (Courtesy Kermit Hobbs)

Vessel 3 appears to be a small barge or floating work platform (Figure 30). Seven heavily

eroded cant frames are present on the vessel's north end and frame heads appear in a line along the western edge. Probing indicates intact hull structure below the mud but all wood above the mud line is heavily deteriorated. No scantlings were recovered because of the poor condition of the wreck and inability to access the vessel's eastern side due to flooding during the October field phase. The vessel is estimated to be eight-meters long and three meters in breadth.

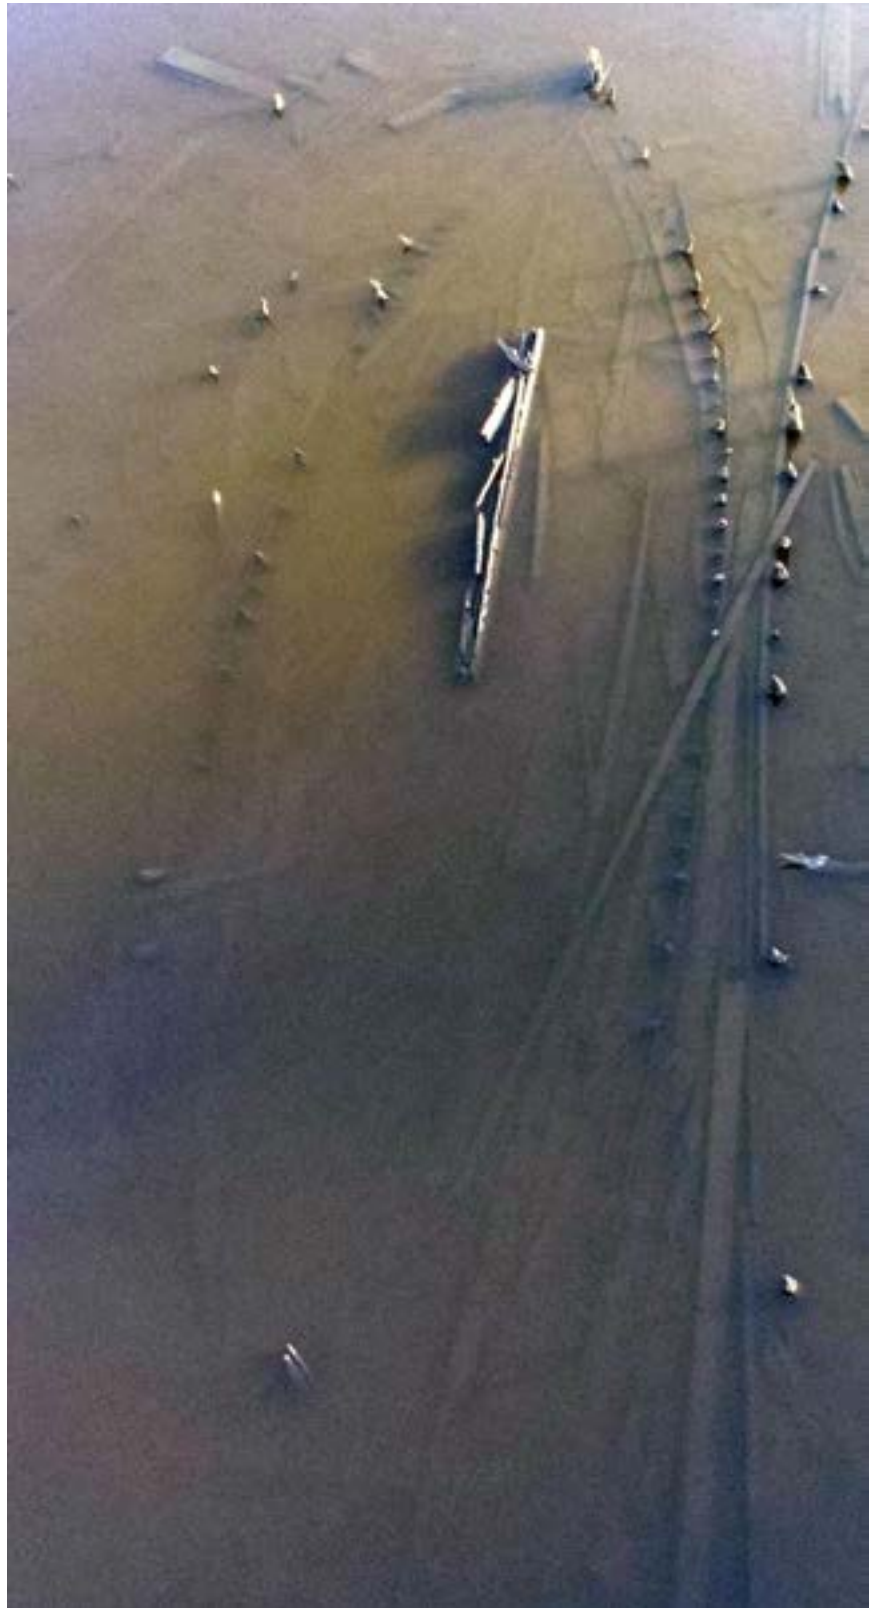
Figure 31. Vessel 4 of Feature 5, the Funkhouser Fleet. Construction elements and shape indicate that this vessel may be a Chesapeake Bay skipjack.

Vessel 4 is located immediately to the east of Vessel 2 and to the south of Vessel 3 (Figure 31). The bow section is relatively intact and hull remains extend aft but disappear into the mud at the stern. A centerboard trunk approximately 3.96 meters remains with the centerboard still inside. An iron lifting bridle was observed atop of the centerboard during the June 2019 visit but was not present during the October 2019 field phase. Overall vessel length, approximated due to the lack of a clear transom, is estimated to be 13.75 meters long with a breadth of 4.46 meters.

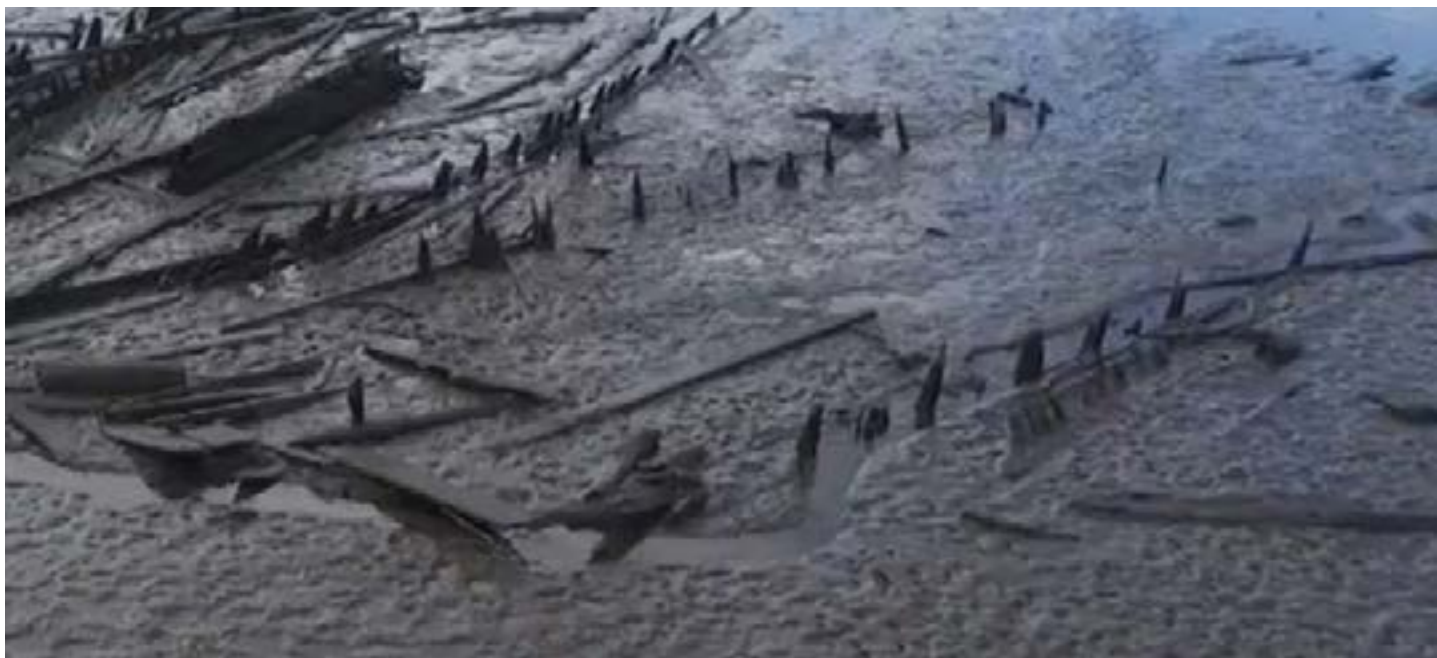
Figure 34.
Vessel 5 of Feature 5, the Funkhouser Fleet.

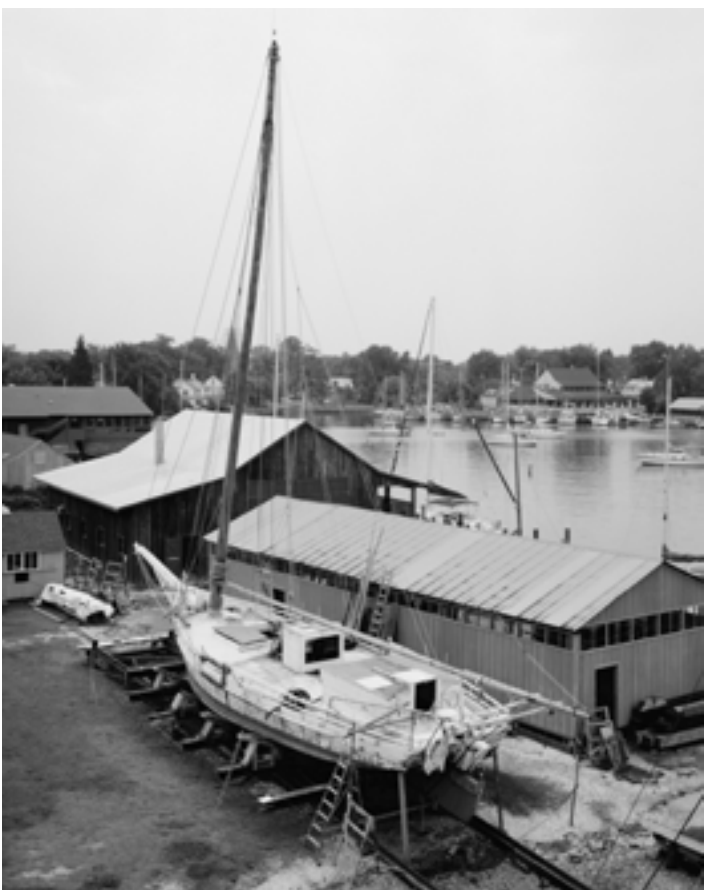
Figure 32. The skipjack E. C. Collier on the marine ways in 1988. Built in 1912, the E. C. Collier represents a traditional skipjack. (Courtesy of the Library of Congress)

Skipjacks were more economical to build and operate than the two-masted, round bottomed bugeyes. Sloop rigged, two men could handle a skipjack to drag an oyster dredge and cull the catch (Figure 32). Like bugeyes, skipjacks were

put to work offseason hauling truck crops such as watermelons, firewood, and other sundry cargos. Today, about thirty skipjacks remain, and in 1985 the skipjack became the state vessel of Maryland. Further documentation of this vessel is recommended.

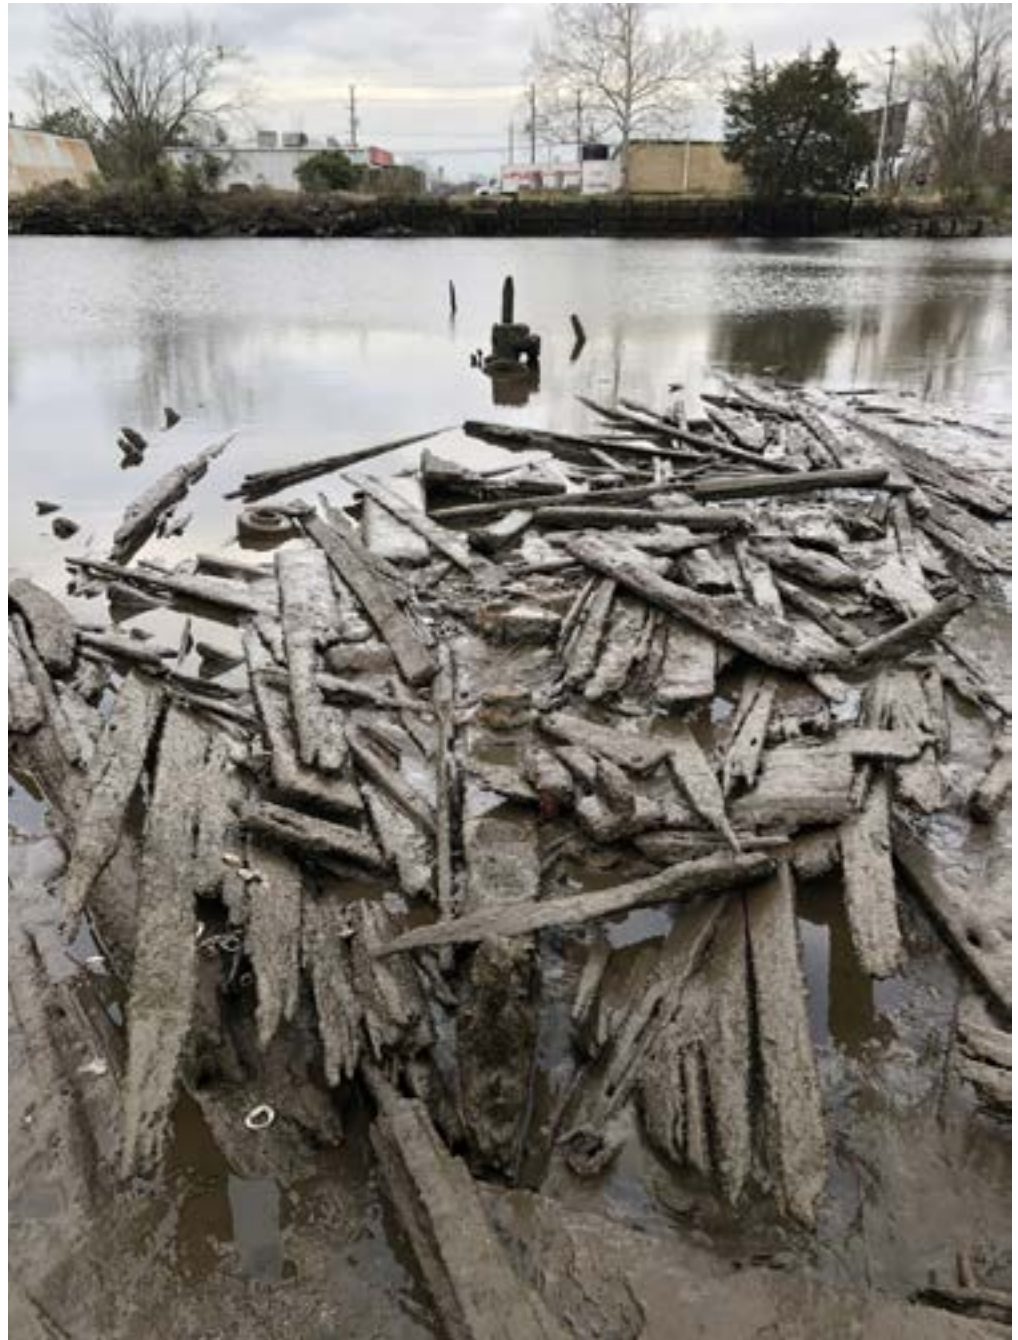
*Figure 35.
Vessel 6 of Feature 5,
the Funkhouser Fleet.
View is from bow to stern
and generally to the east. Note
the stem in the foreground,
keelson, outer planking,
and engine in the background.*

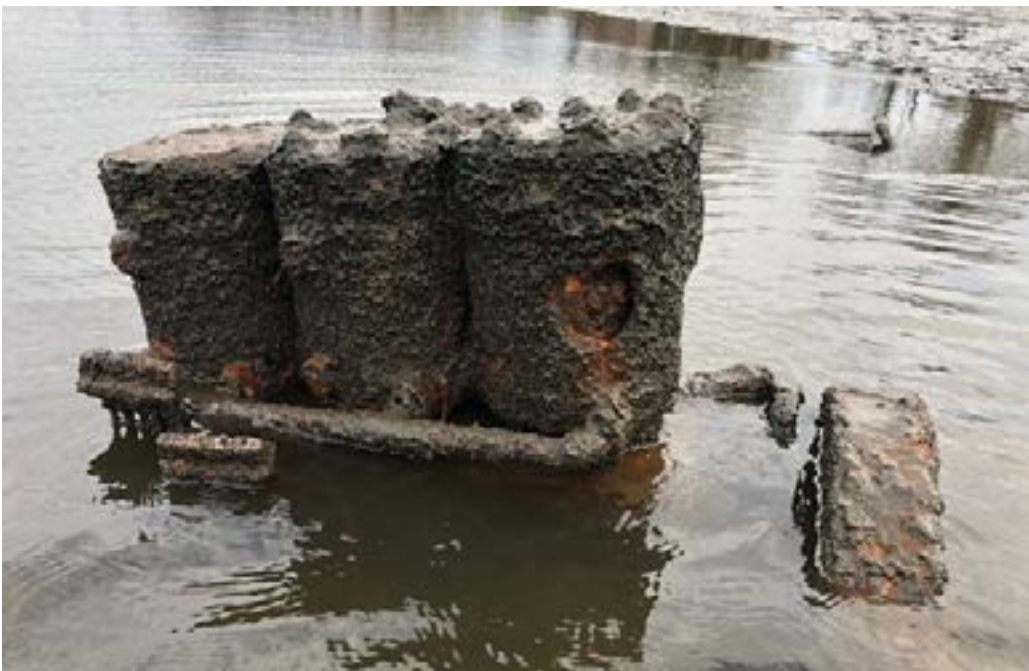
Sonar data indicated the presence of an engine on the wreck, which was confirmed during the March 10 site visit (Figure 36). The engine sits approximately 2.5 meters ahead of the stern and is a three-cylinder oil or gas engine likely

Figure 37. Three-cylinder engine on Vessel 6 of Feature 5. Note the flywheel, facing forward on the vessel.

manufactured prior to 1930 based on the style of casting an air space between each cylinder.

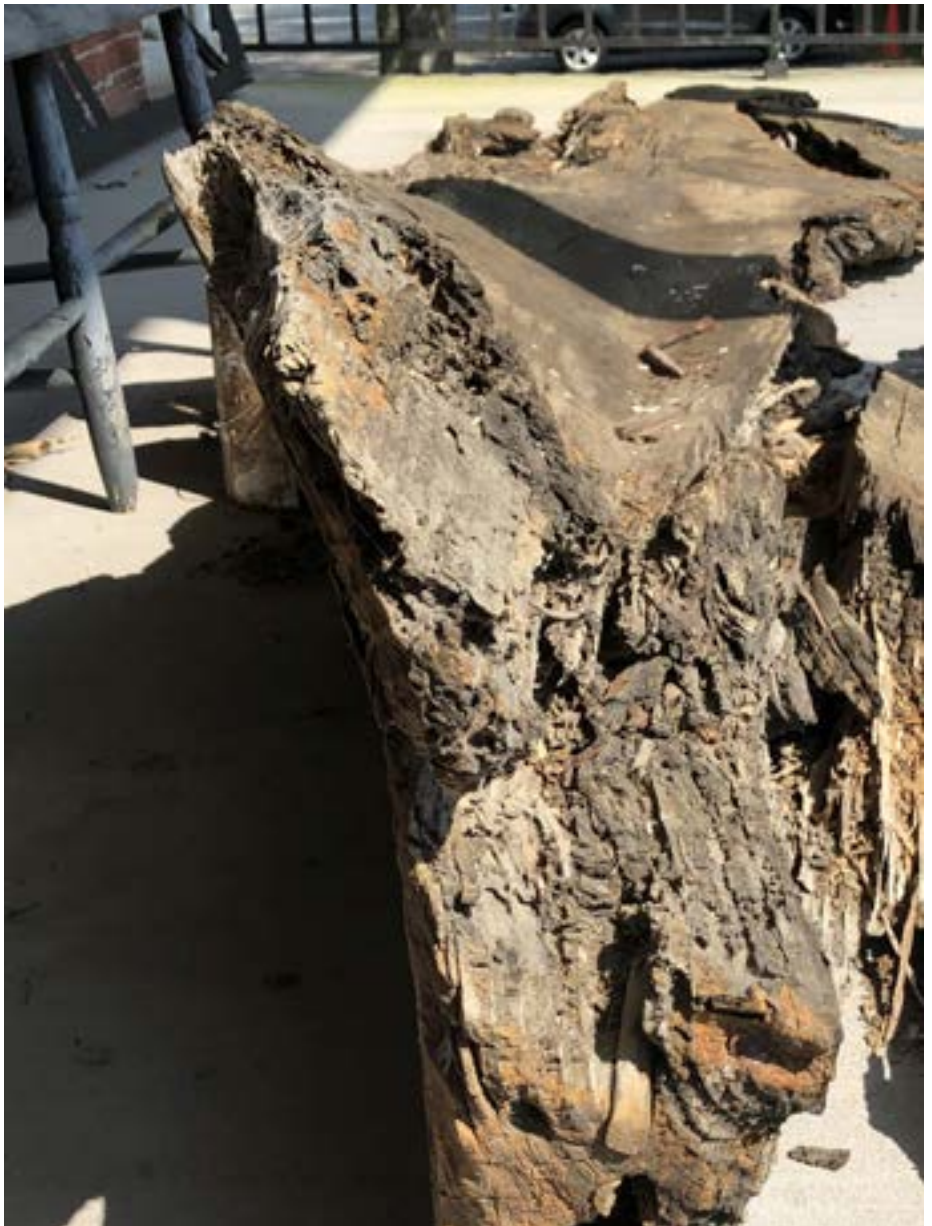
*Figure 38.
Feature 7, the keel log of a
log-bottomed boat found near the
Nansemond River. It now resides
at Riddick's Folly Museum.
Note the hole drilled for
a propeller shaft.*

6. Stern has a drilled through 2 inch diameter hole and other fabrication features for what may have been a propeller shaft. Boat may have had an engine but no mount for a motor found.

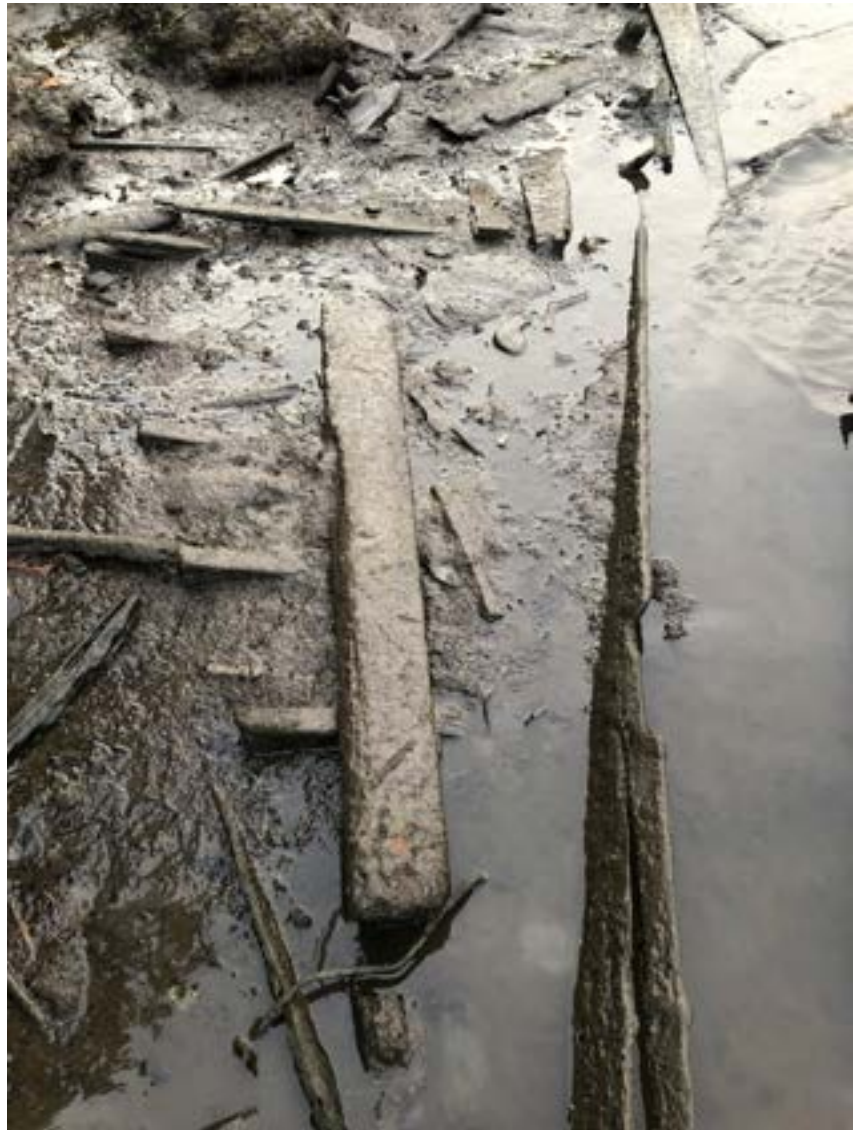
Feature 9 is the bow end of a small wooden boat and includes a keelson, five floors, and three planks (Figure 40). The vessel was constructed with a flat bottom, consistent with skiffs and sharpies of the late 19th century. Probing in the mud to the south of the vessel indicated the presence of additional hull remains. This vessel was not intensively recorded and deserves further documentation.

*Figure 40.
Feature 9, an
unidentified
flat-bottomed
skiff.*

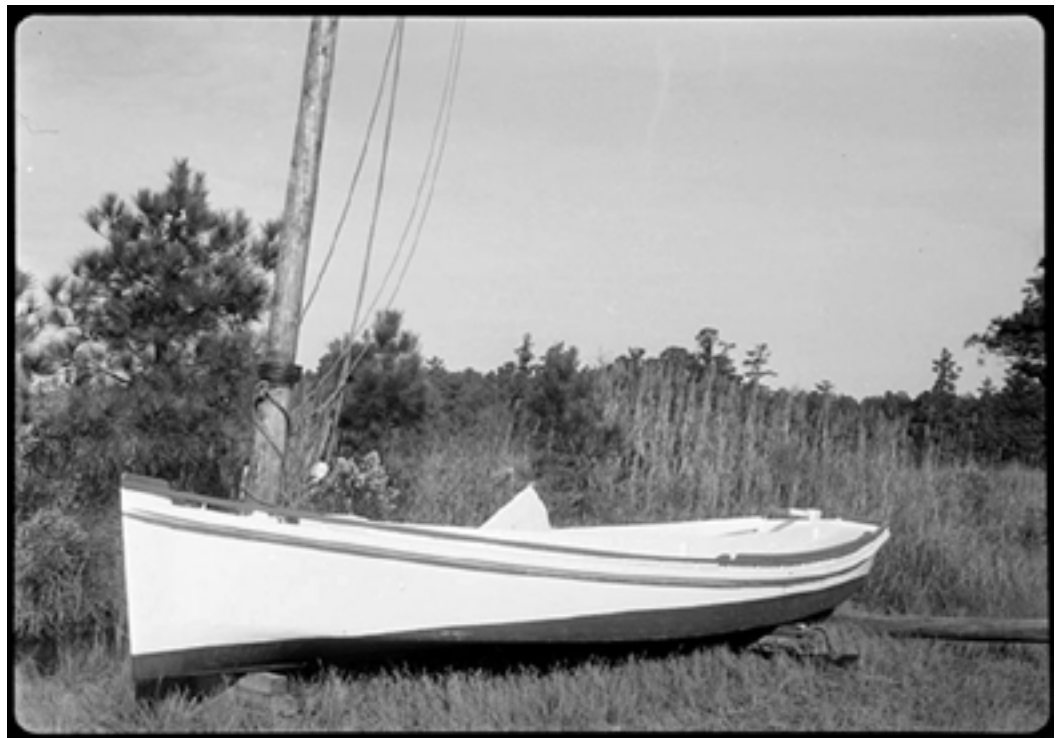
*Figure 41.
Crabbing skiff
documented by
M. V. Brewington in 1937.
(Courtesy of the Mariners'
Museum)*

The slight angle of planking at the keep indicated low deadrise consistent with crabbing skiffs common to the Chesapeake Bay region during the late 19th and into the mid-20th centuries. M. V. Brewington documented a crabbing skiff with similar elements during his 1937 survey of fishing craft around the Chesapeake Bay (Figures 41 and 42).

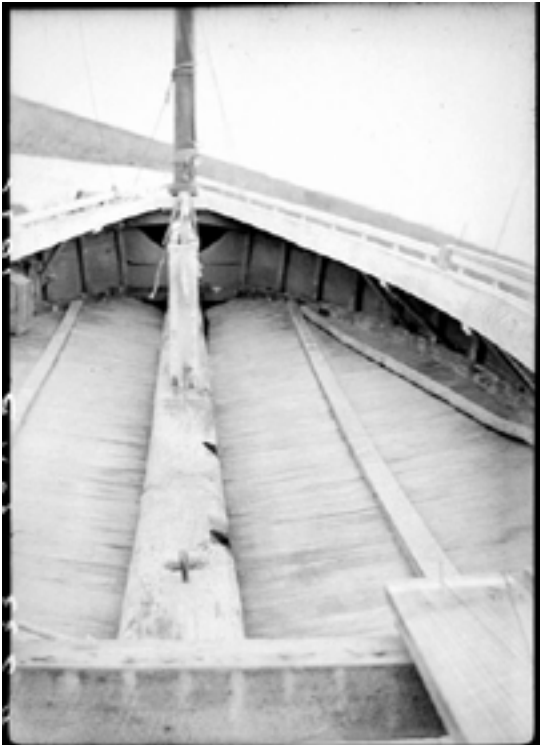
Figure 42.
Inset of photo taken by
M. V. Brewington of a
crabbing skiff interior
during a 1937 survey
of Chesapeake Bay
craft. Note the cross-
planked interior, similar
to planking recorded in
Feature 10.
