The Nansemond Ghost Fleet

Archaeological Investigations of a Vessel Abandonment Area in Suffolk, Virginia

ARCHAEOLOGICAL REPORT No. 24, DEPARTMENT OF HISTORIC RESOURCES
& Longwood Institute of Archaeology

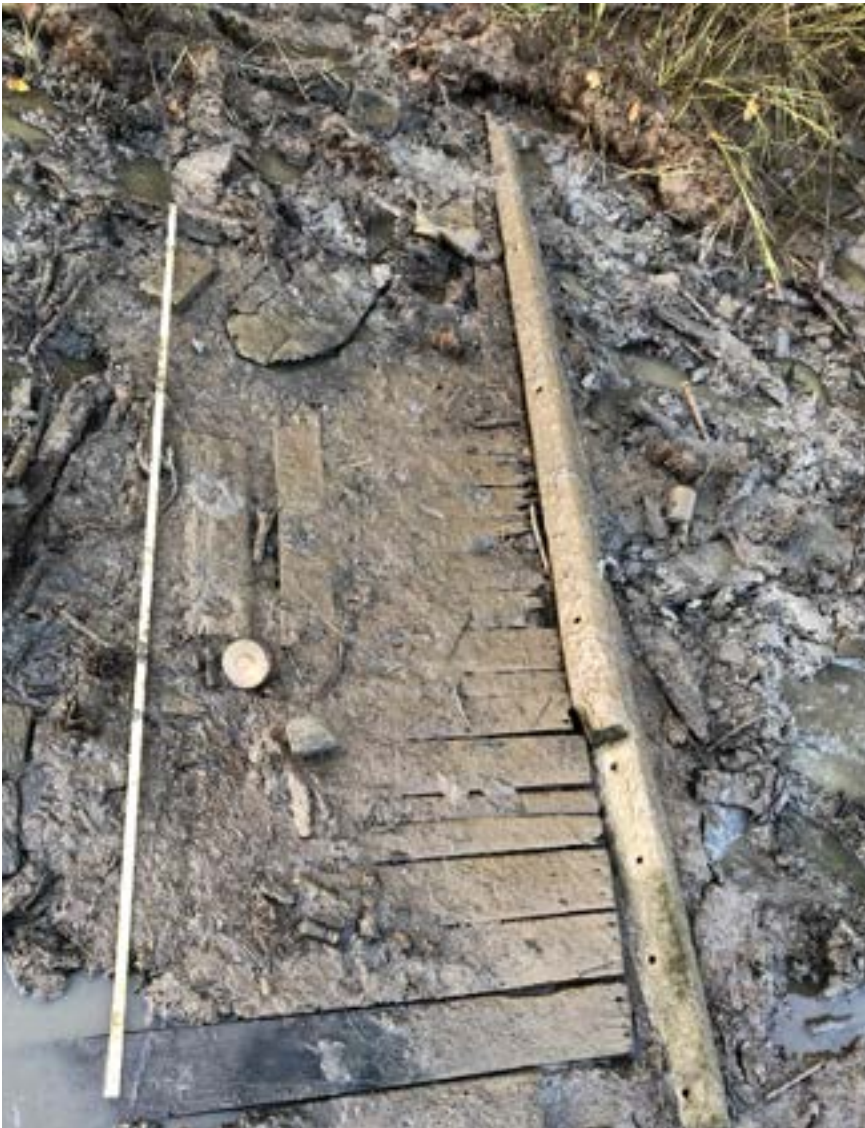
Hull remains comprising Feature 10 appear to be bottom planking and a keelson from a small wooden vessel with low deadrise. The vessel was photo recorded (Figure 43) on October 3, 2019 and a table of offsets (Figure 44) generated to document structural features.

Figure 43.
Feature 10, a wooden crabbing skiff hull.
Note the scarf joint in the keelson.

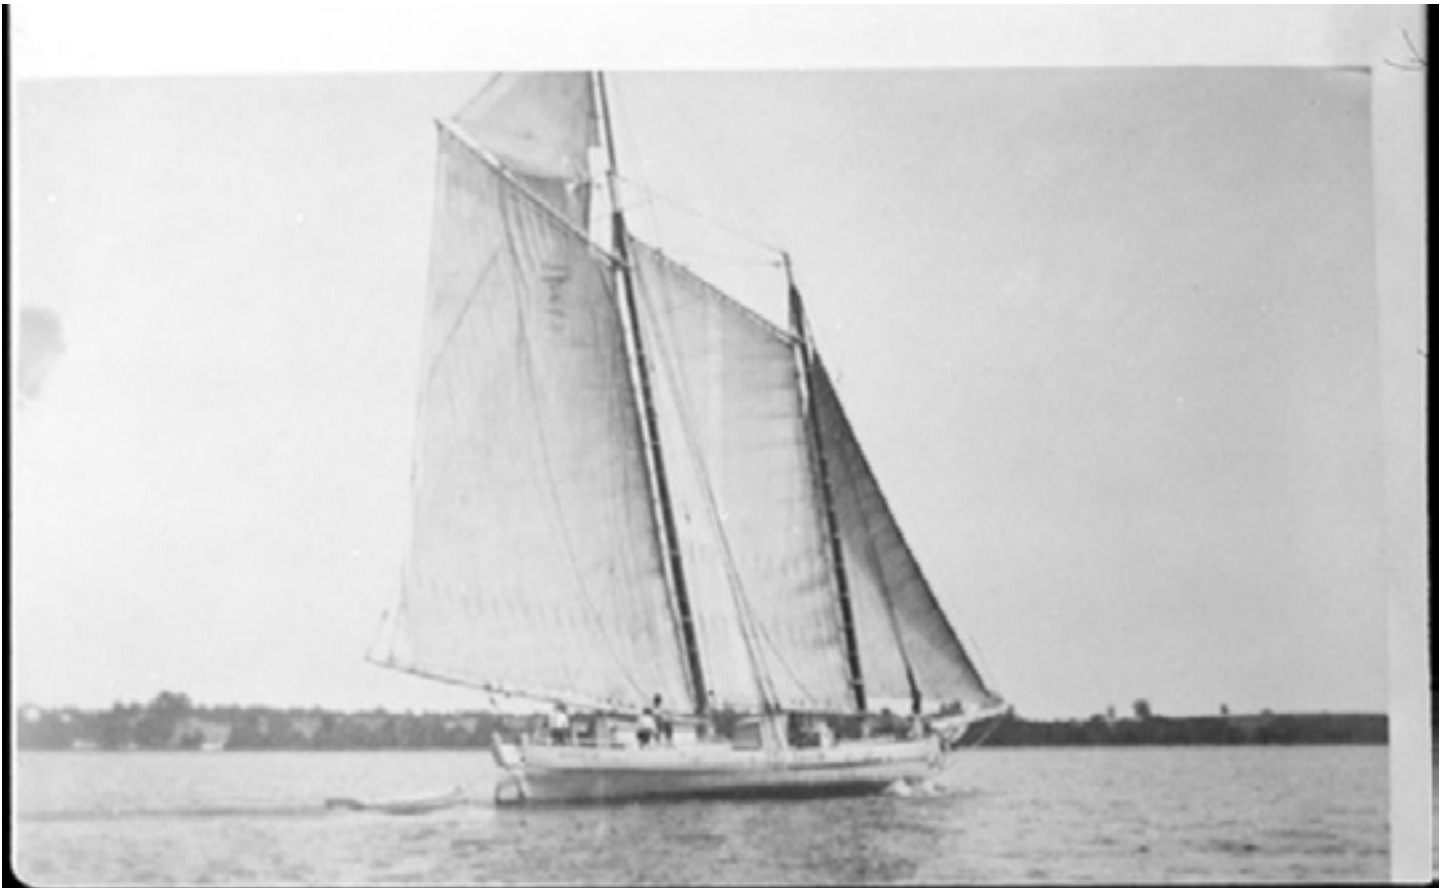
Figure 46. Inset of photograph taken by George Barrie in 1904 showing a square-rigged bugeye. Note the gaff-rigged sails and double-ended hull. This was one of only 37 known square-rigged bugeyes to be constructed. (Courtesy, Mariners' Museum)

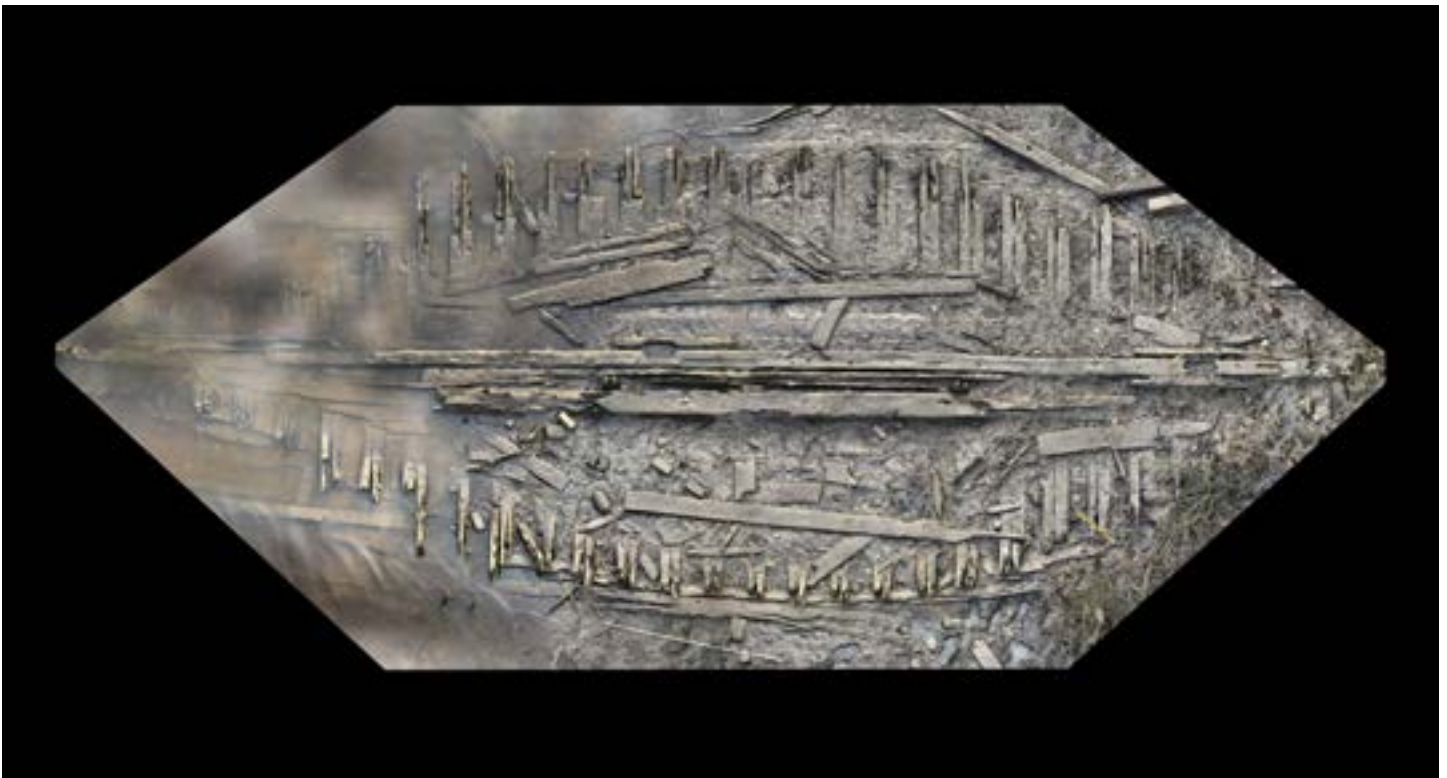
Figure 47. The Hobbs Wreck, Feature 11, shown in orthoimagery. The bow is oriented to the right in this photo and north is to the left. Note the mainmast step, located ahead of the aftermost extent of the centerboard trunk. This feature indicates a schooner, or square-rigged, bugeye.

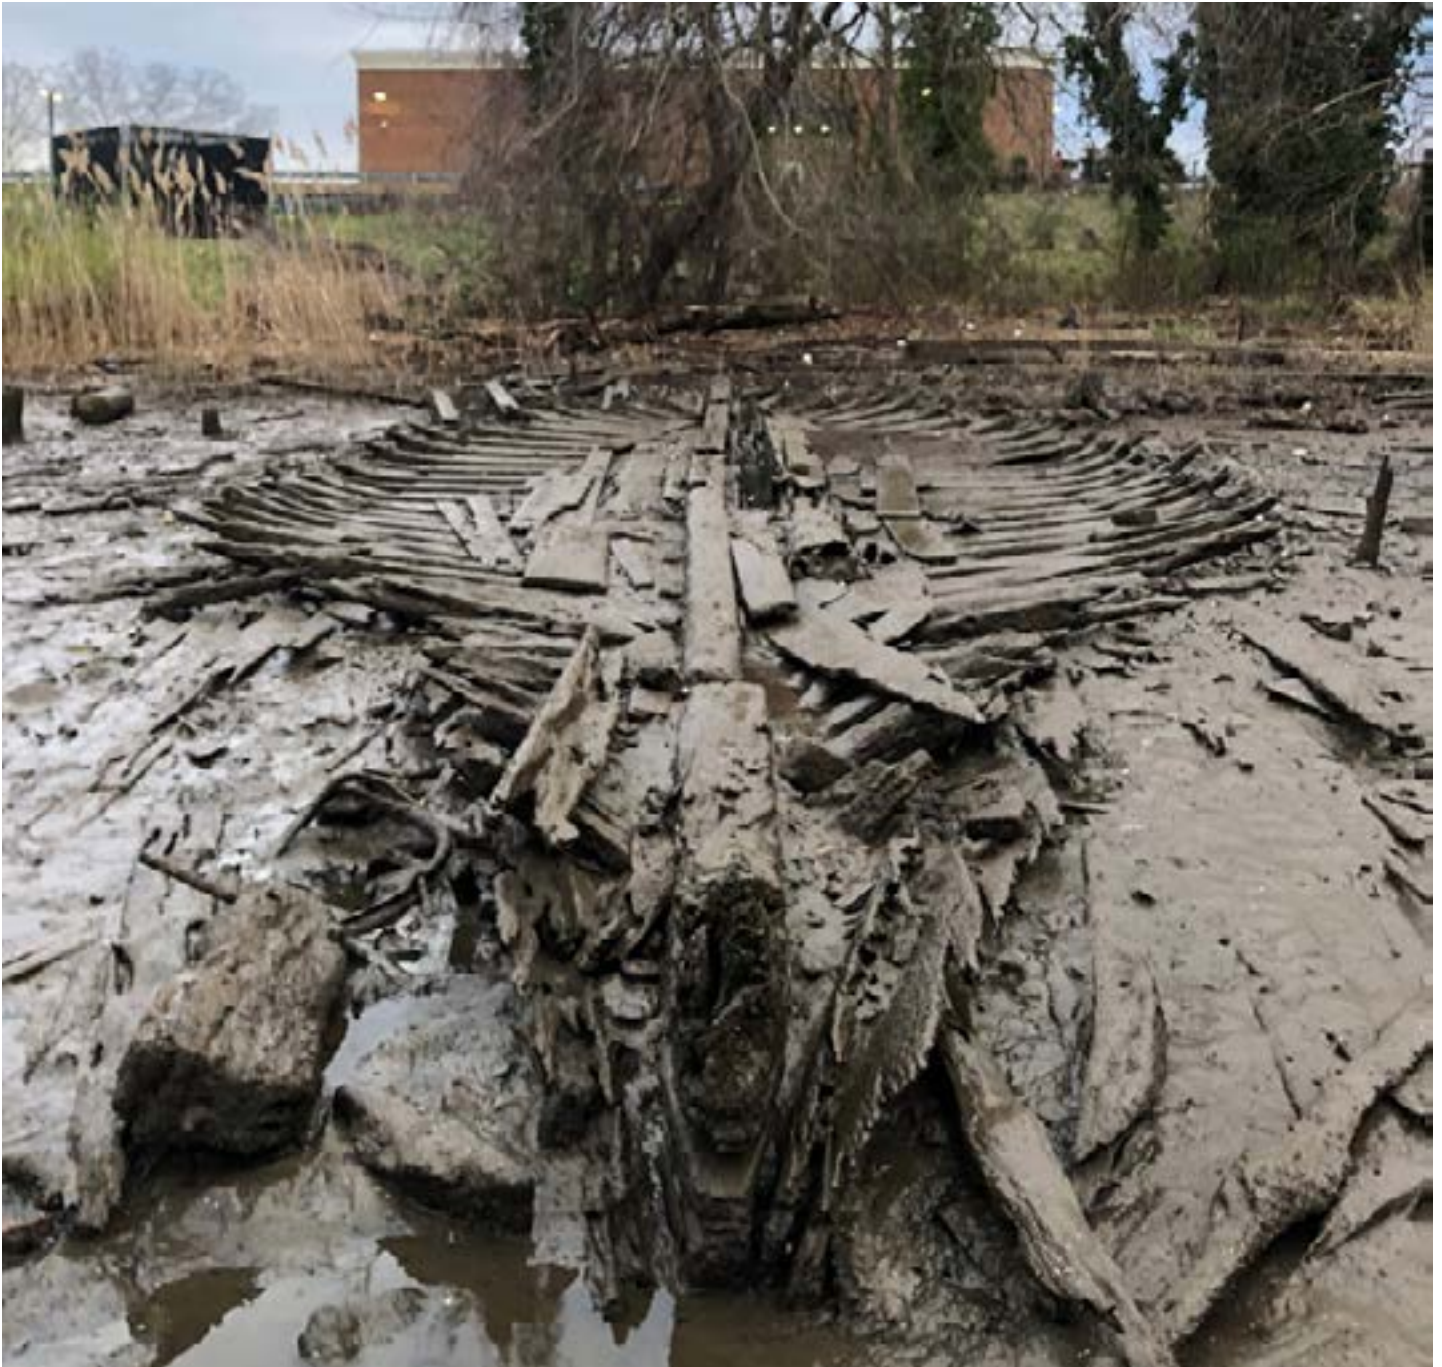
Figure 48. Feature 11, the Hobbs Wreck, looking from stern to bow. Note deadwood facing the camera, the sternpost fell away from the wreck sometime between February 13, 2020 and March 10, 2020. Note the flat nature of the lower hull, a feature common to bugeyes. While some additional flattening has occurred during the site formation process, this feature allowed bugeyes to transit shoal waters and access ports /docks in shallow creeks throughout the Chesapeake Bay region. The Constance Road Walgreens is seen in the background. View is to the south.

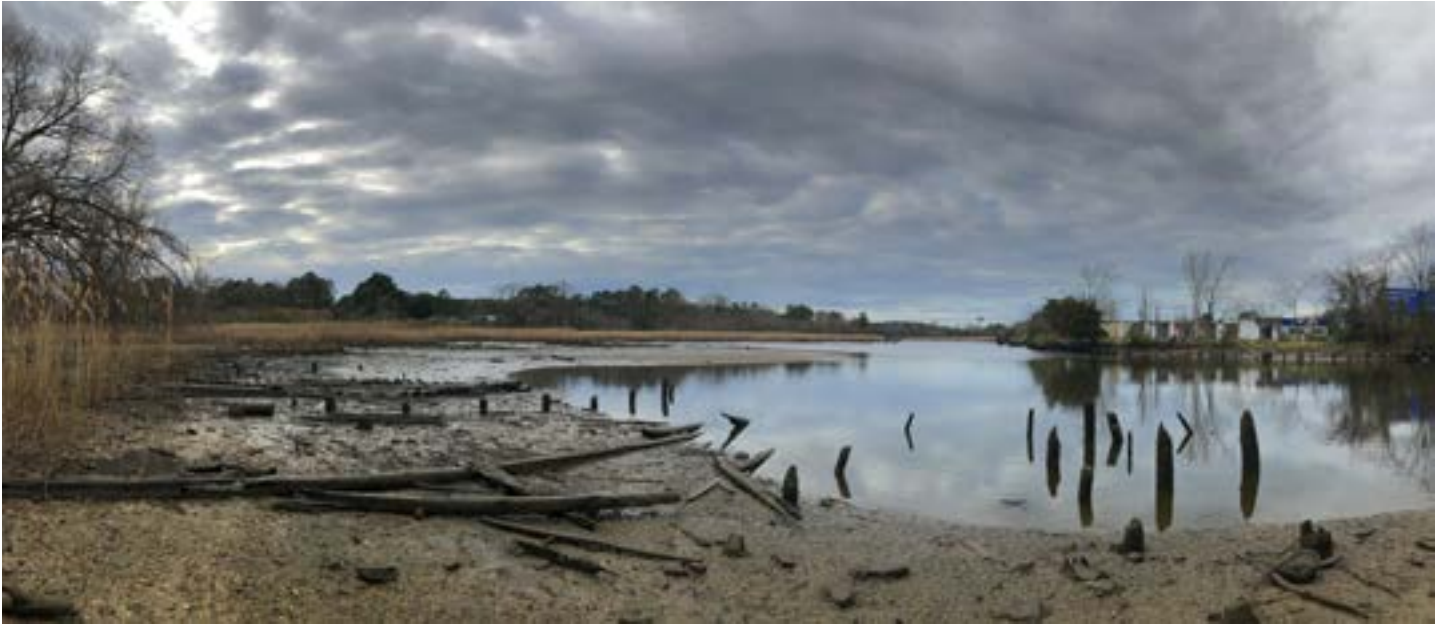
Figure 52. Feature 41, pilings associated with the McAnge Oyster Company wharf and processing facility. Note Feature 10, the Hobbs Site, in the left-hand background.

Adjacent and to the east of Feature 11, the Hobbs Wreck, is a series of pilings (Figure 52). From arrangement and positioning of the pilings, it is likely that the feature represents foundational structure of the McAnge oyster house of 1880-1904. Sanborn Fire Insurance Maps indicate a structure in the area with an angled face to front the river channel. By 1898, oyster floats occupied the river adjacent to the oyster house on the north and west (Figure 53). It is likely that after abandonment of the oyster house sometime around 1904 that the wharf remains became a convenient place to

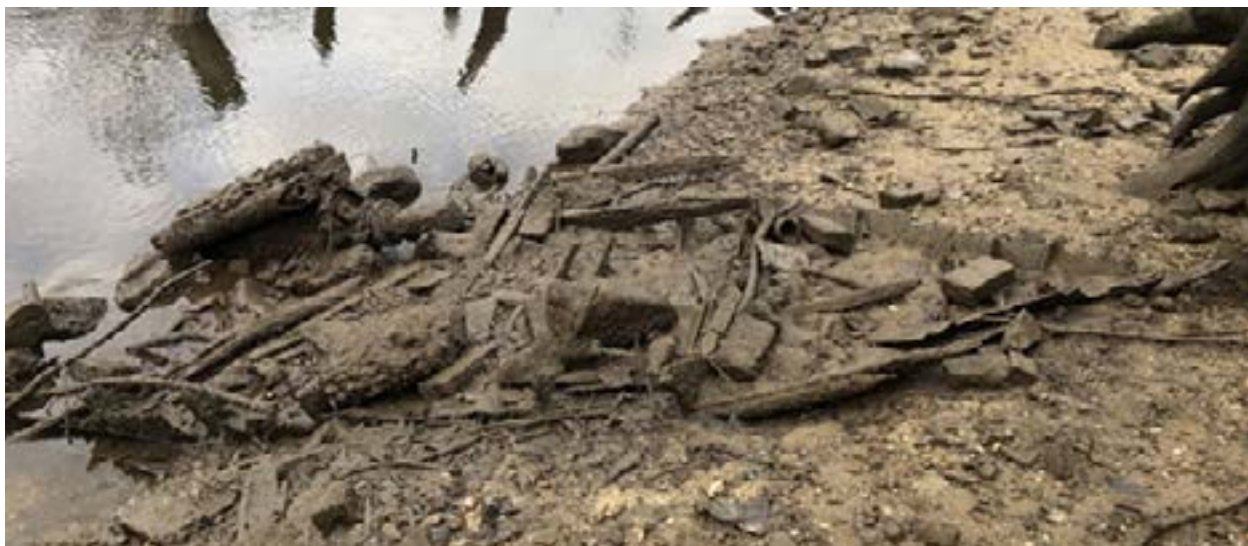
Figure 54. Powerboat on south bank west of the Main Street Bridge. Note the inline six-cylinder gasoline engine.

Feature 13 represents a small powered pleasure craft abandoned on the riverbank approximately 46 meters west of the Main Street Bridge (Figure 54). The vessel was identified on March 10, 2020 during a period of unusually high water. Since field crew were not visiting the site with the intent of capturing data, they made no measurements of the vessel. Observations of the vessel include a diagonally planked wooden hull, powered with an inline six-cylinder gasoline engine (Figure 55). The stern of the vessel was still submerged but the hull is estimated to be in excess of seven meters.

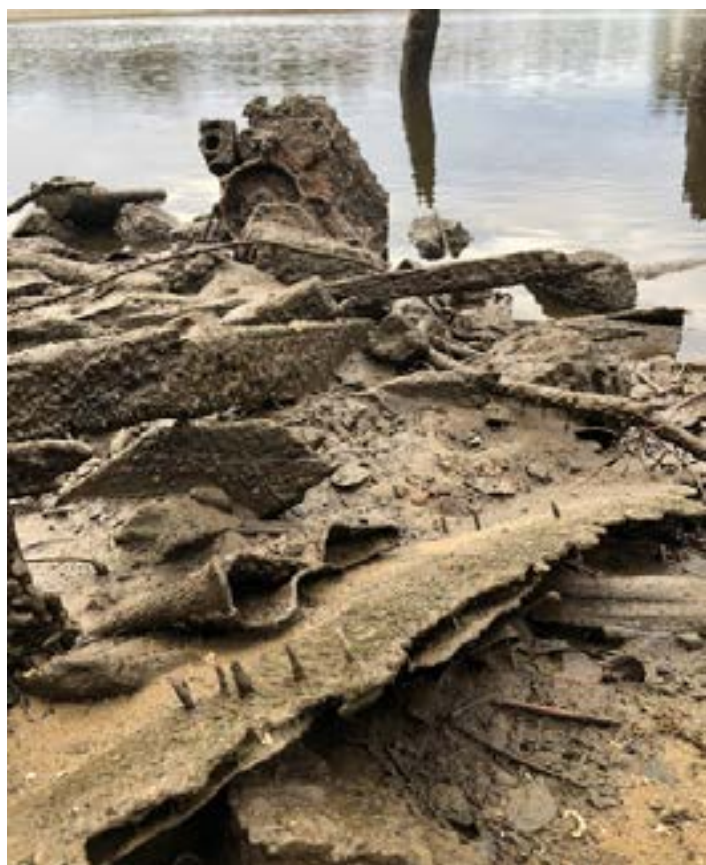
Diagonal planking, similar to cold molding, allowed boatbuilders to form a curving hull from diagonally laid, flexible, thin strips of wood. Canvas was often used between layers and treated with a waterproofing preservative to make the hull watertight. The thin nature of the strakes allows for compound curves to be formed without needing to splice planking. Less wood is wasted but diagonally planking small vessels necessitates a large amount of liquid adhesive, traditionally a formaldehyde-based glue or in modern times, epoxy resins. Cold molding using thin strakes and glue is a boatbuilding technique that was adapted from the aeronautical industry during World War II. The technique formed an exceptionally strong and lightweight hull, and it became a popular method of building pleasure craft prior to the advent of fiberglass hulls during the 1960s. Therefore, the Feature 13 boat likely dates to 1945-1970 and served as a speedboat on the Nansemond. Local informants in Suffolk mentioned the area above the Main Street Bridge

Figure 55. Detail of the Feature 13 boat. Note two layers of diagonally-laid planks and copper-alloy screws at frame stations. A frame is seen in the middle left-hand side of the picture and the engine is in the background.

being a popular place for waterskiing. Considering the relatively large engine for the vessel's size, operators likely used this type of boat to pull people on water skis.

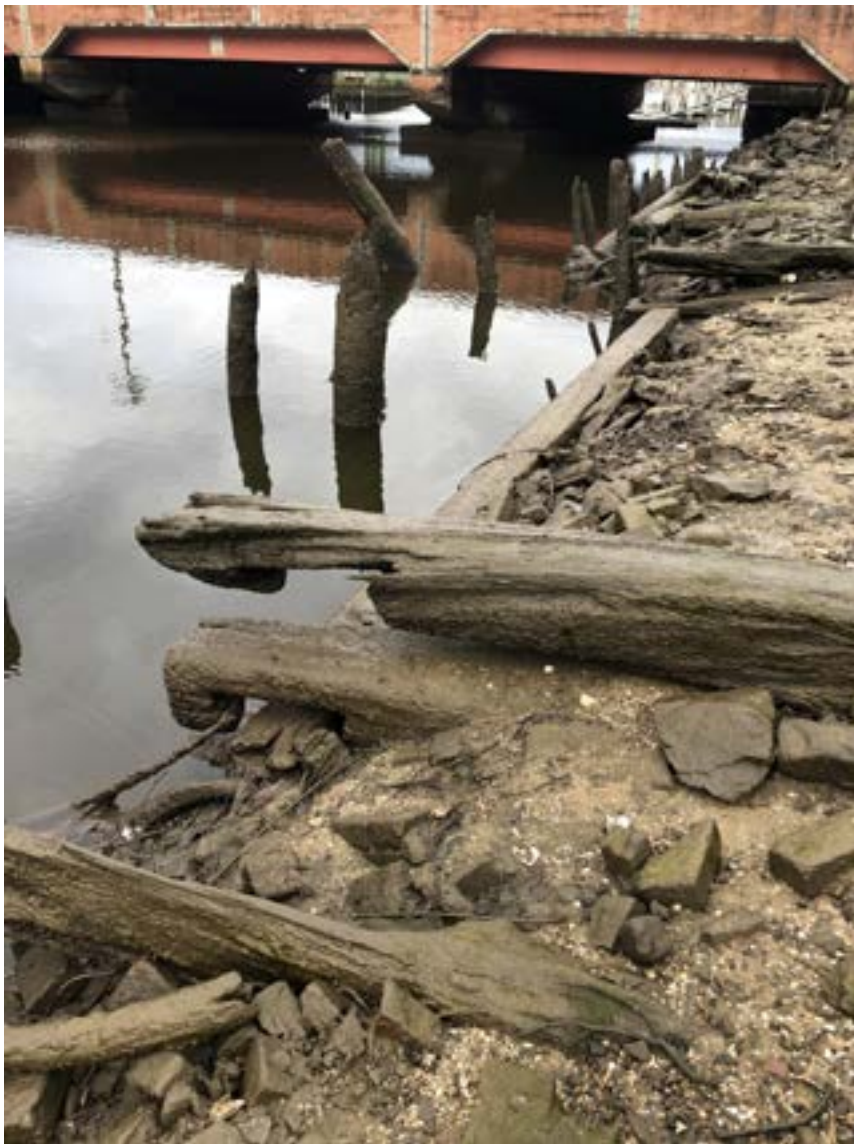
*Figure 56.
Cribbing west of the Main Street Bridge
exposed during an unusually low tide in March
2020.*

rubble, and rounded cobbles. Farther out into the river, round pilings supported an overhanging structure such as a wharf or oyster house.

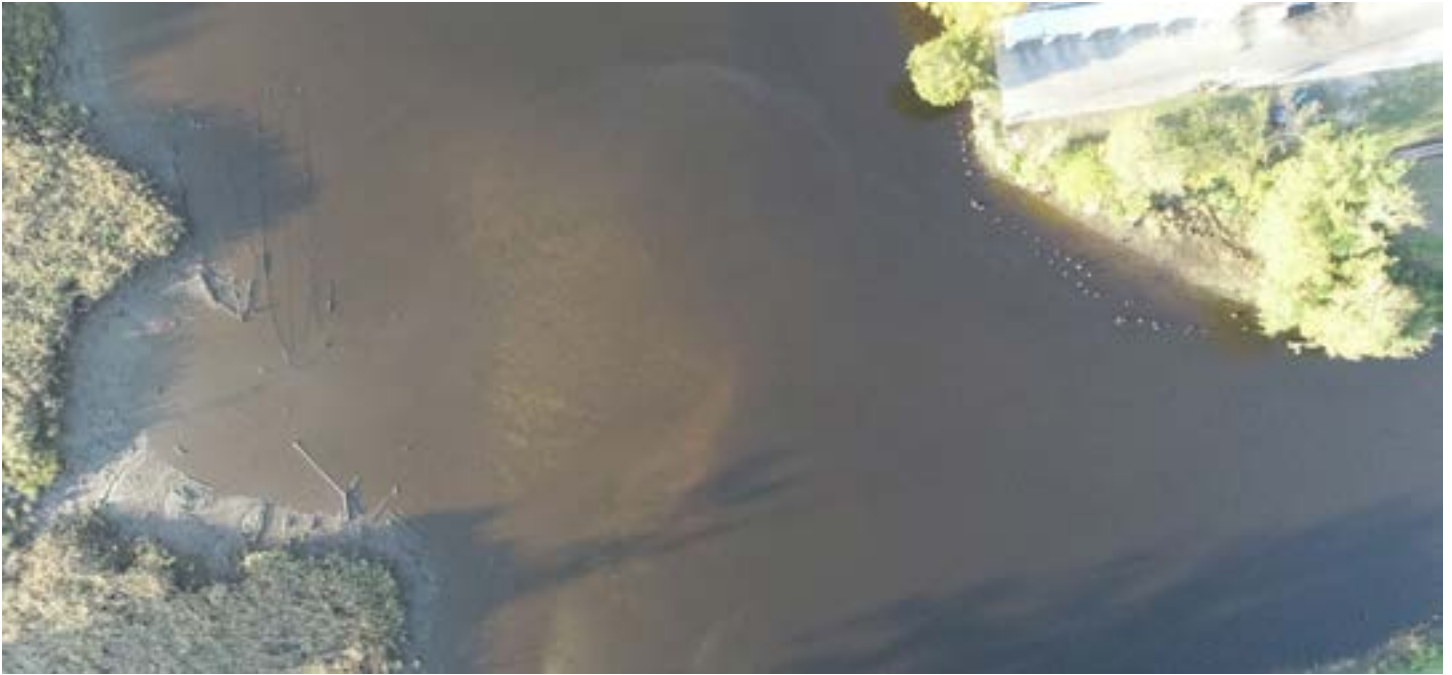
Figure 59. Feature 15 is seen in the right-hand portion of this aerial photo taken on October 14, 2019. A line of pilings can be seen wrapping the point of land immediately west of the Main Street Bridge. Feature 6, the Funkhouser Fleet, appears in the left-hand side of the photo. (Courtesy, Fairfield Foundation)

At the inside of the elbow in the Nansemond River, immediately upstream of the Main Street Bridge is a line of wooden pilings (Figure 59). Measuring approximately 46 meters in length, the continual line of pilings consists of two angles that comprise three faces of nearly-equal lengths. Some of the easternmost pilings have

horizontal fender boards still in place and the middle face of pilings is doubled. This area was examined from canoe on September 30 and October 1, 2019. Additional field examination and documentary work is recommended on this feature.

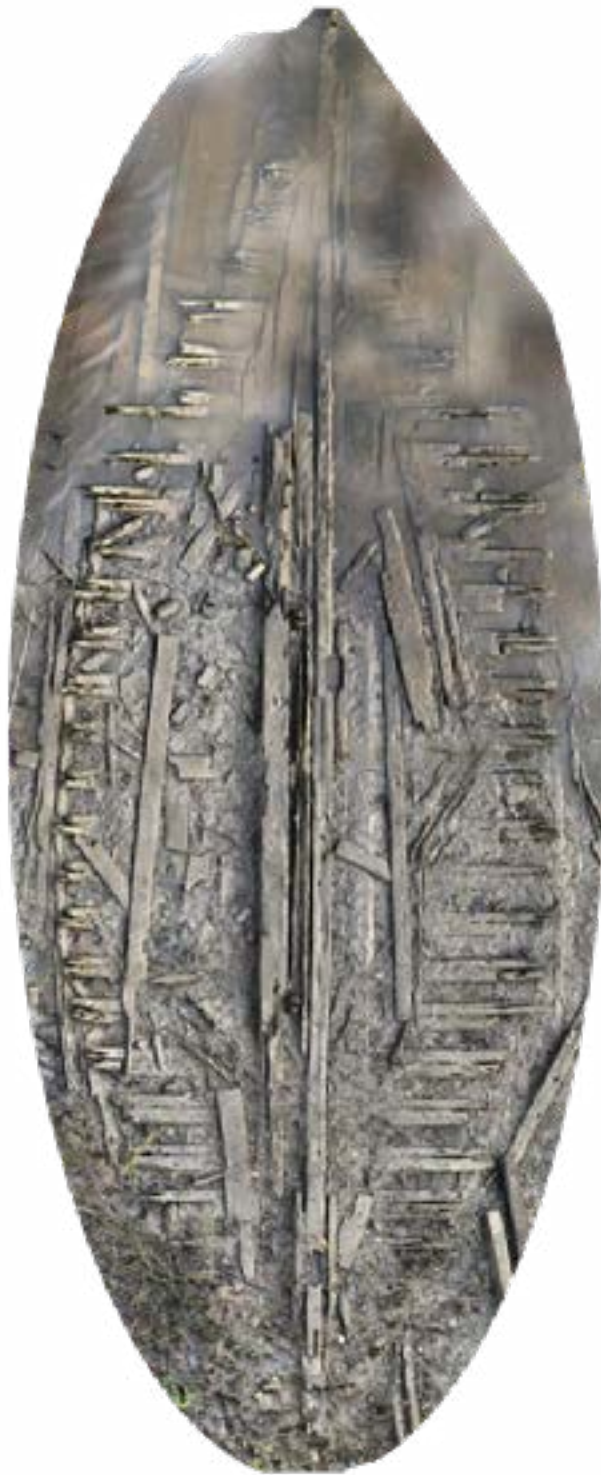
Figure 1. Hobbs Wreck 3D model from above. North, and stern, is up.

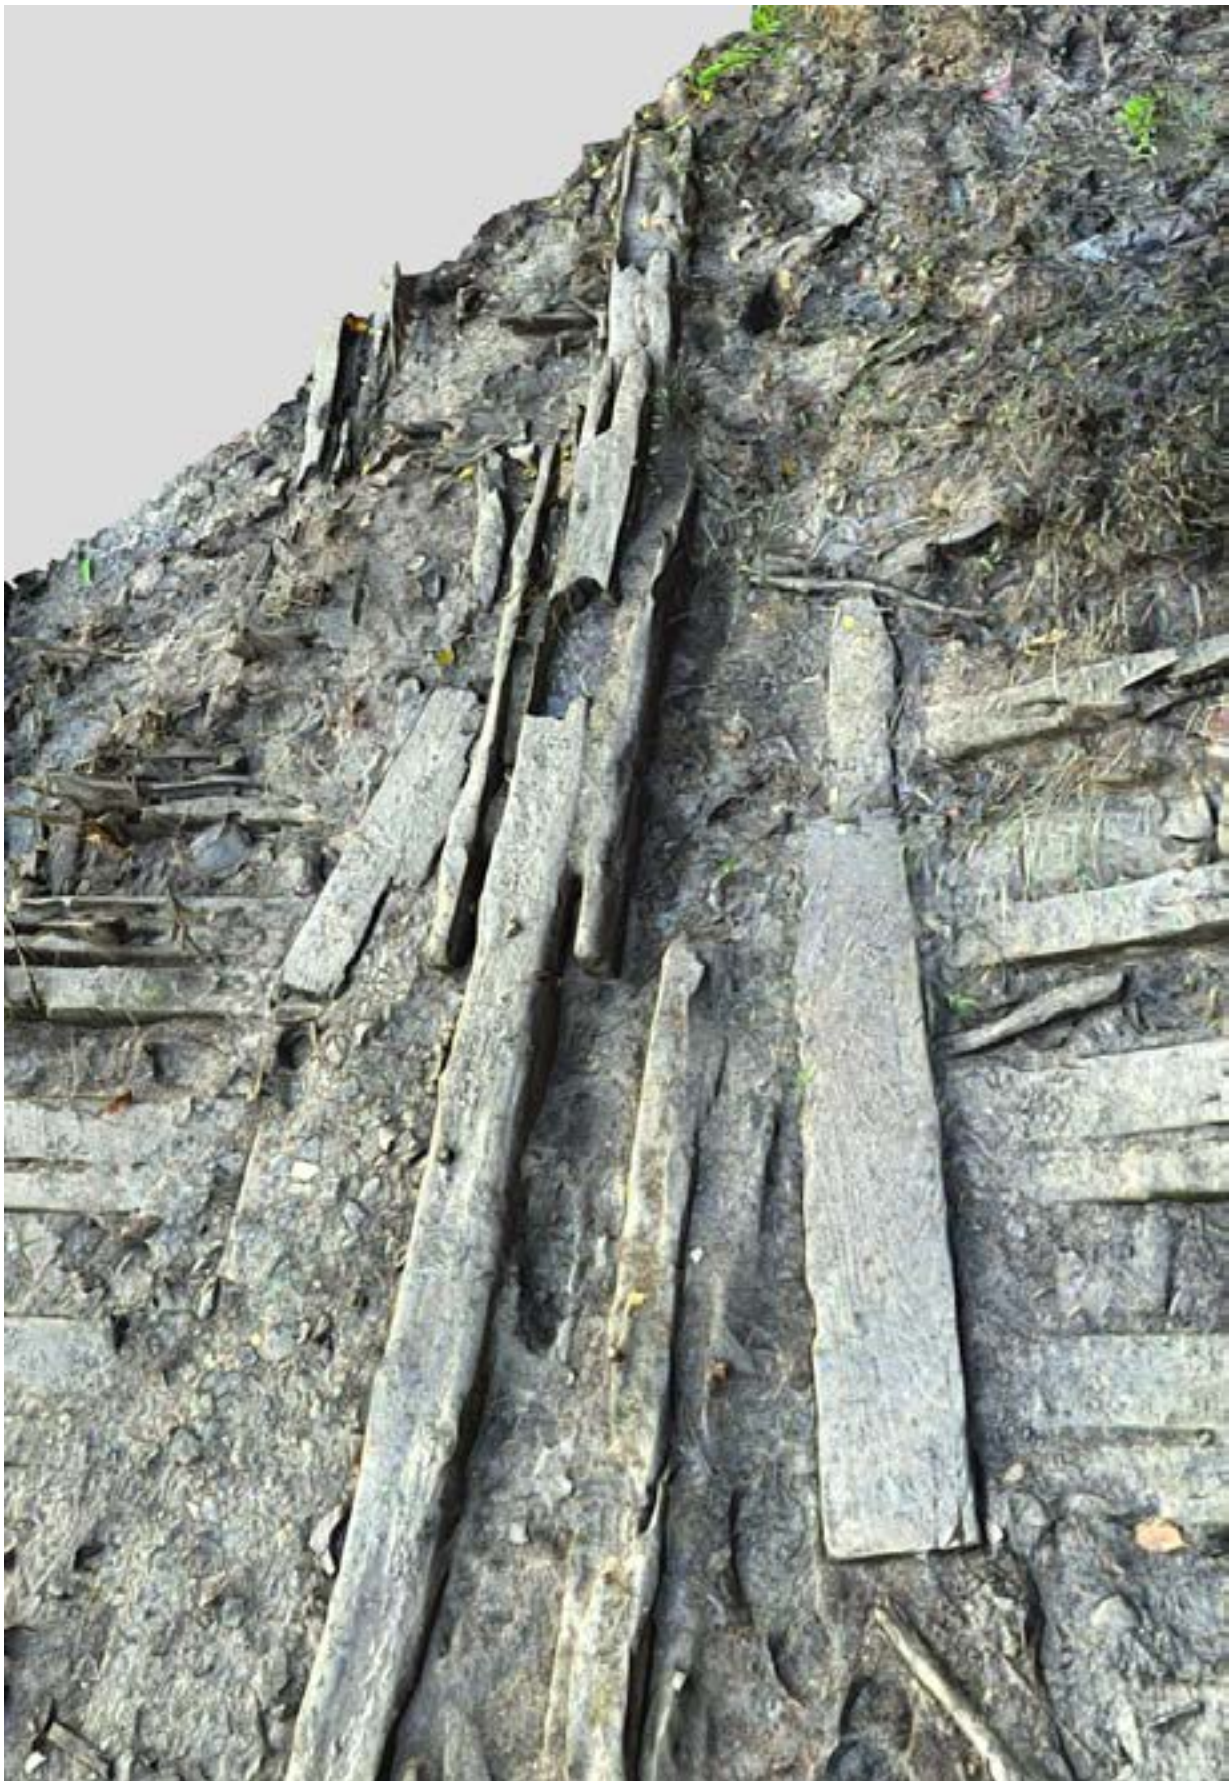
Figure 2. Bow view of the Hobbs Wreck.

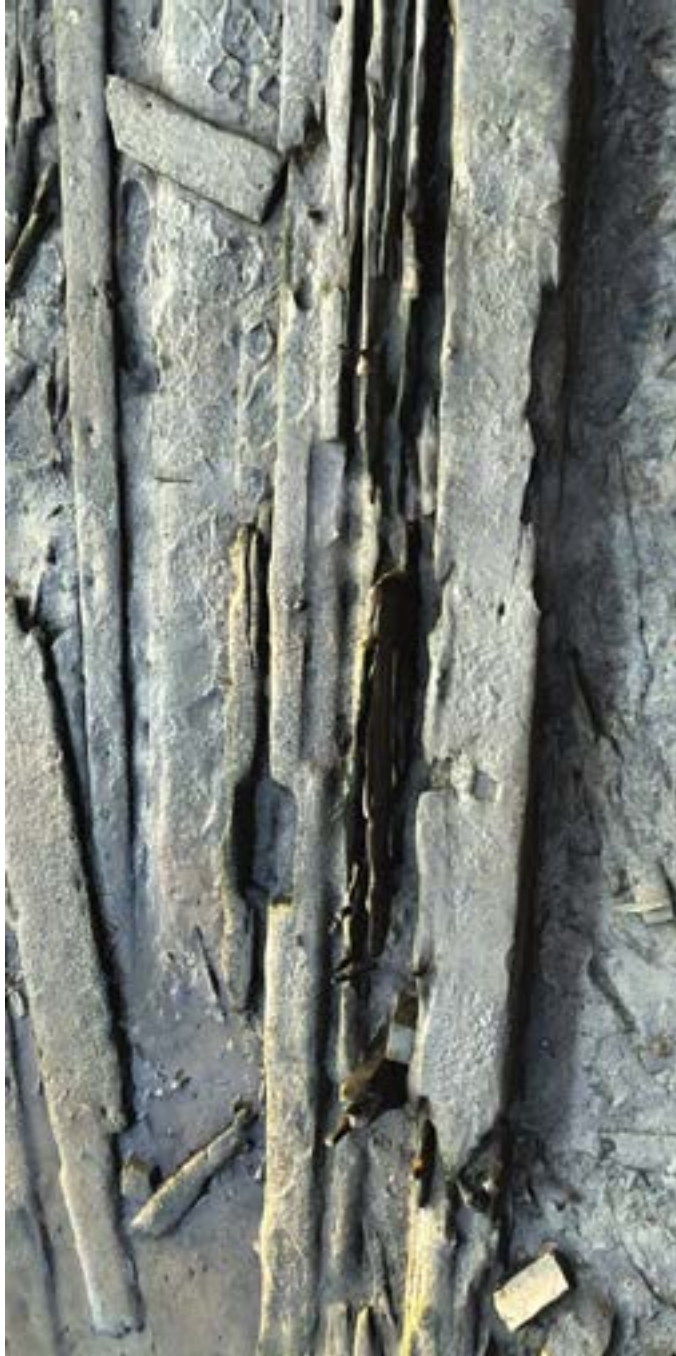
Figure 4. Closeup view of the Hobbs Wreck mainmast step. Note the step is placed off center from the keelson and strengthened by a cheek piece.

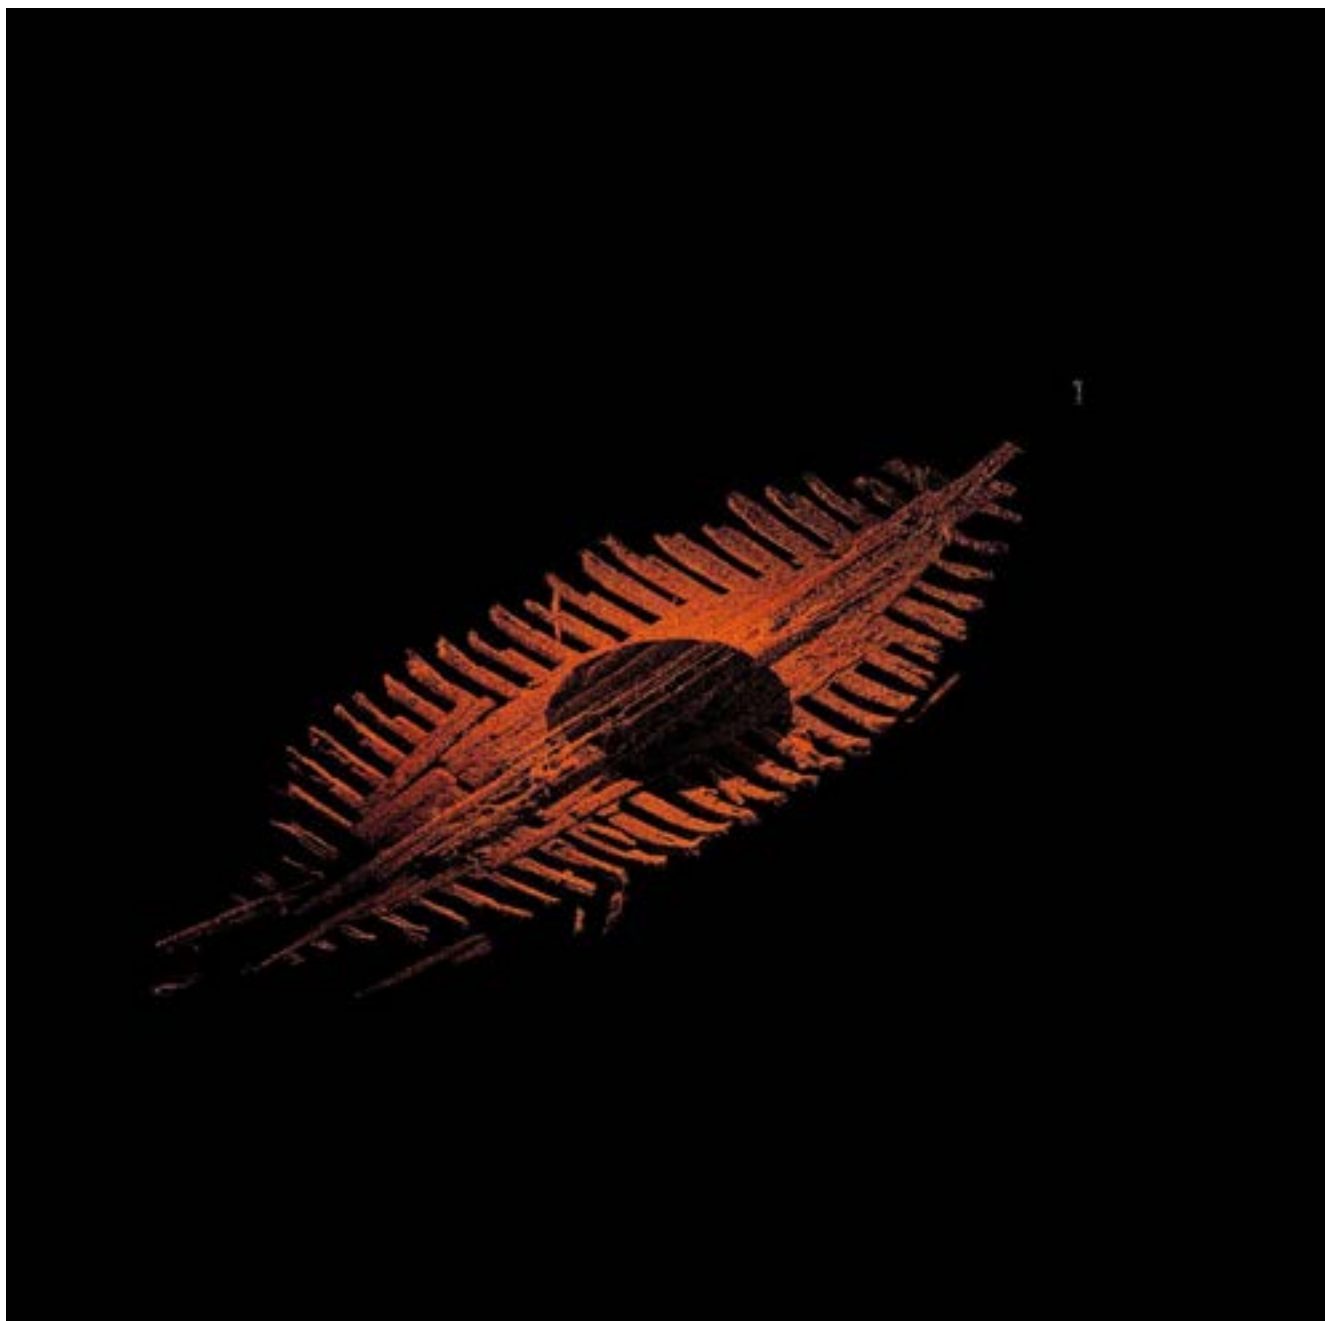
44SK0631 Hobbs Site Vessel – Feature 11. Orthographic view of a historic bugeye from starboard quarter.

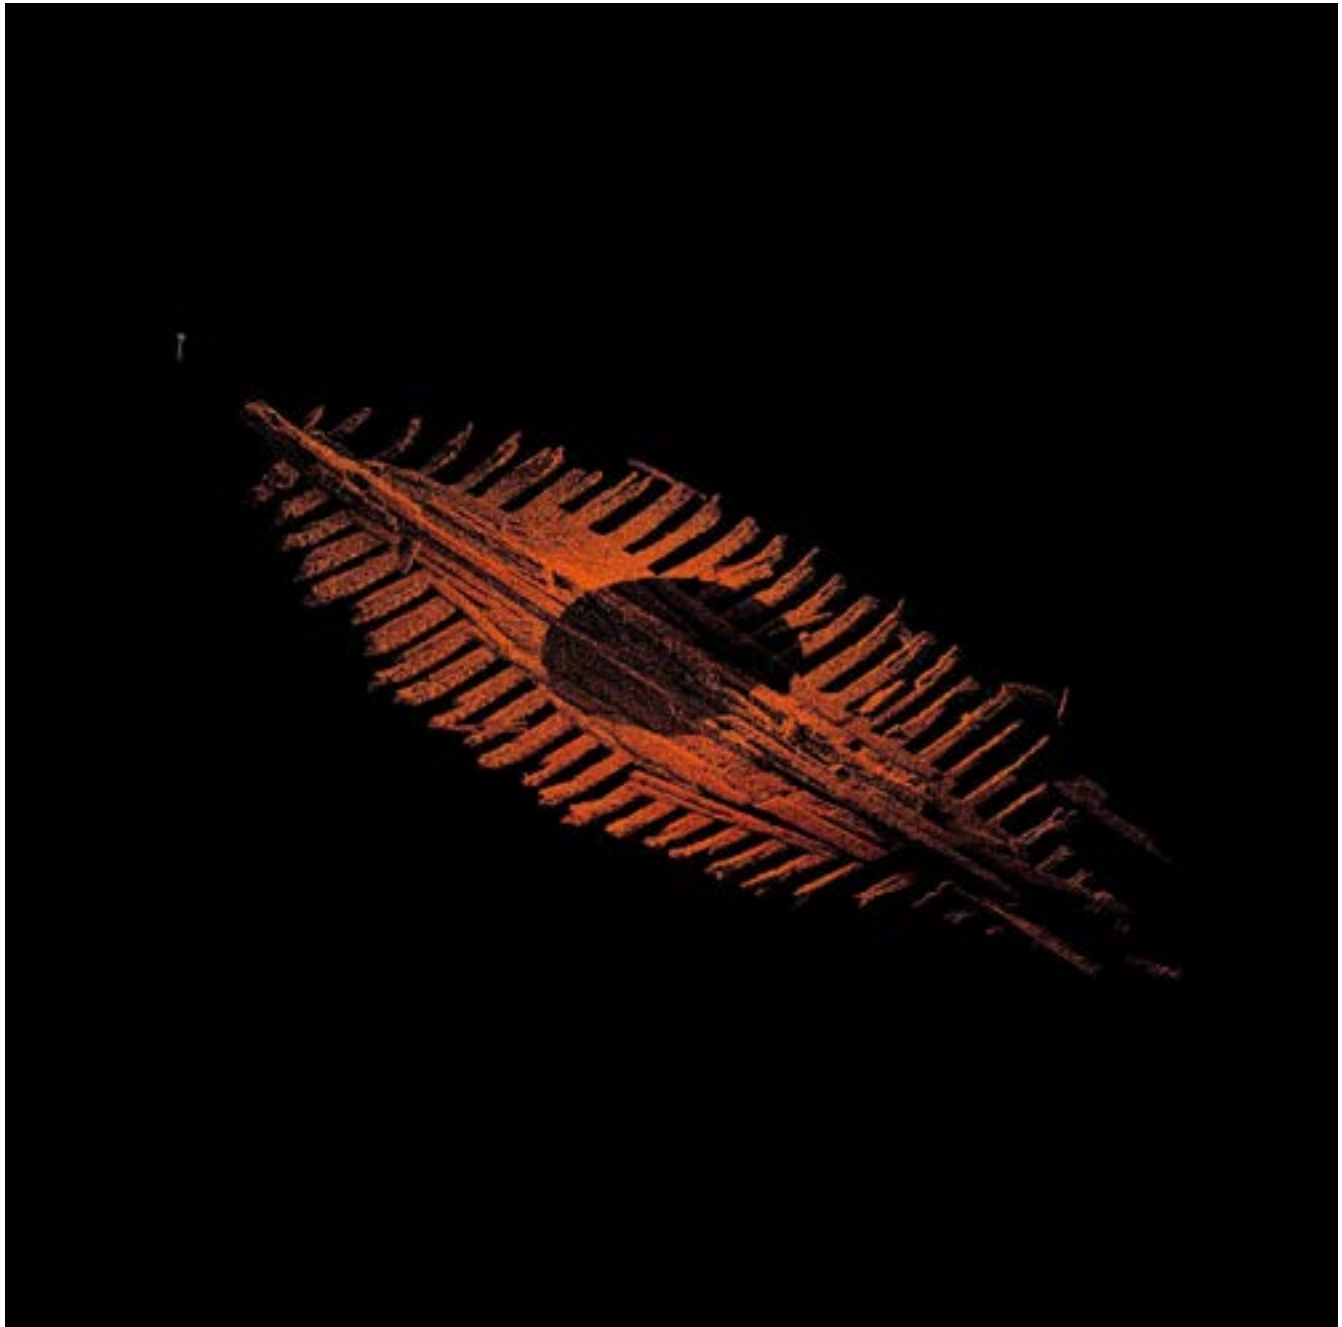
44SK0631 Hobbs Site Vessel – Feature 11. Orthographic view of a historic bugeye from port quarter.

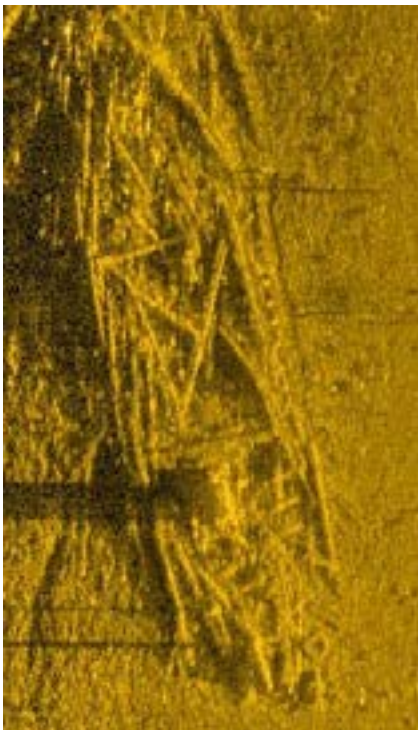
Name	Date	06/10/2019
NGF-A026	Time	16:23:42
Survey File	Event	0
R00013	X	894284.9
Capture File	Y	4075062.4
NGF-A026.JPG	WGS84 Latitude	36 44 21.8764 N
	WGS84 Longitude	076 35 5.7055 W
	Heading	198.1
	Fish Altitude	1.80
	Range to Target	12.7
	Height Above Bottom	0.0
	Length	23.9
	Width	5.6

Notes	Length: 23.9 Width: 5.6 1050 KHz
-------	---

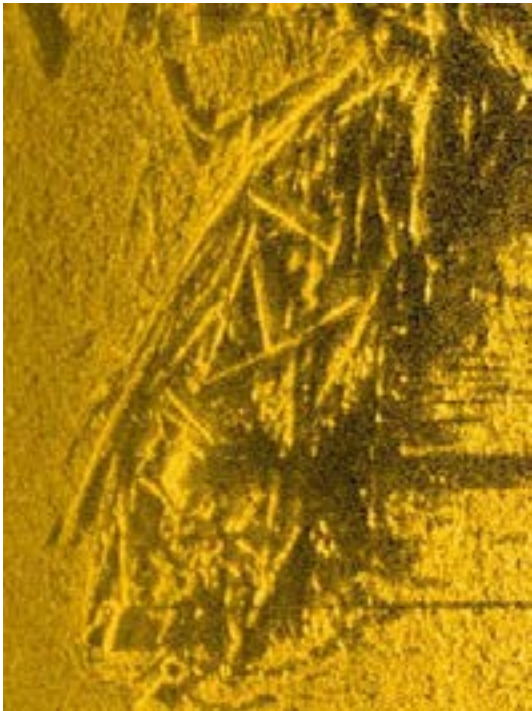
Name	Date	06/10/2019
NGF-A025	Time	16:26:57
Survey File	Event	0
R00015	X	894290.9
Capture File	Y	4075071.4
NGF-A025.JPG	WGS84 Latitude	36 44 22.1586 N
	WGS84 Longitude	076 35 5.4476 W
	Heading	221.4
	Fish Altitude	1.90
	Range to Target	10.9
	Height Above Bottom	0.1
	Length	22.6
	Width	6.1

Notes	Height: 0.1 Length: 22.6 Width: 6.1 1050 KHz
-------	--

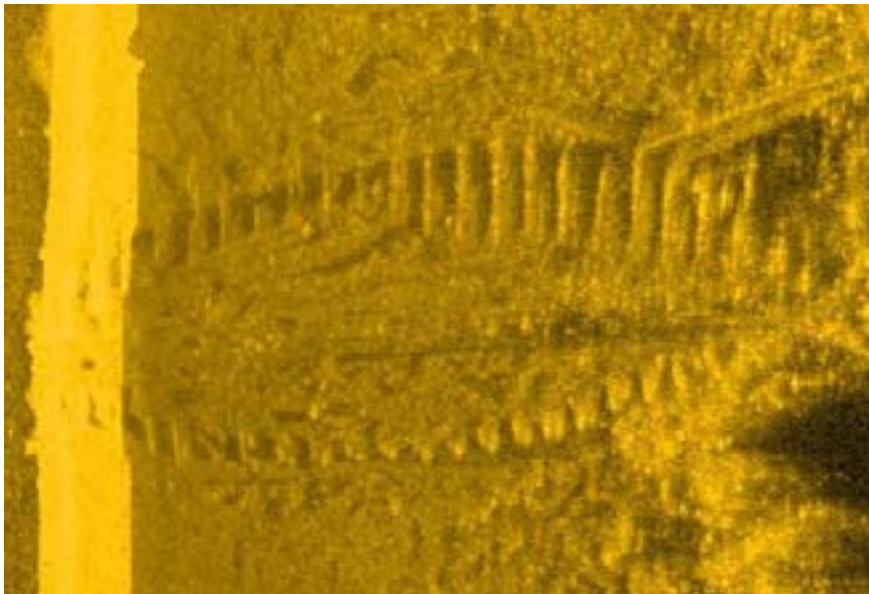
Name	Date	06/10/2019
NGF-A013	Time	14:24:36
Survey File	Event	0
R00023	X	894492.1
Capture File	Y	4075053.1
NGF-A013.JPG	WGS84 Latitude	36 44 21.2657 N
	WGS84 Longitude	076 34 57.3927 W
	Heading	66.0
	Fish Altitude	6.60
	Range to Target	14.7
	Height Above Bottom	0.0
	Length	8.1
	Width	8.5

Notes	Length: 8.1 Width: 8.5 1050 KHz
-------	--

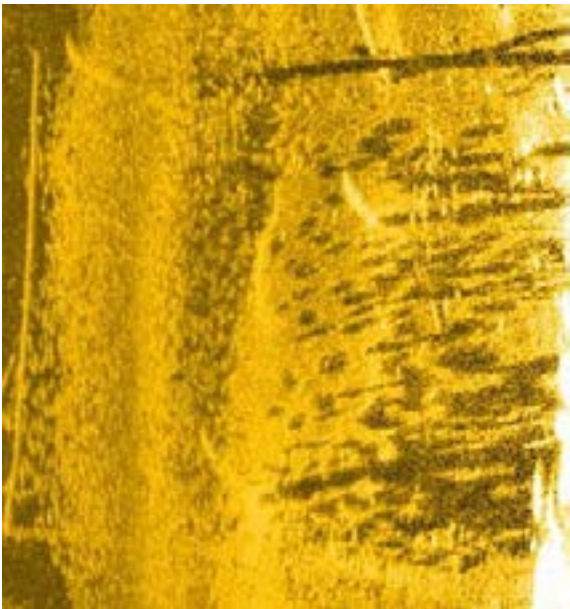
Name	Date	06/10/2019
NGF-A012	Time	14:26:30
Survey File	Event	0
R00023	X	894596.7
Capture File	Y	4075106.3
NGF-A012.JPG	WGS84 Latitude	36 44 22.8307 N
	WGS84 Longitude	076 34 53.0887 W
	Heading	69.8
	Fish Altitude	5.70
	Range to Target	10.3
	Height Above Bottom	0.4
	Length	15.8
	Width	16.6

Notes	Height: 0.4 Length: 15.8 Width: 16.6 1050 KHz
-------	--

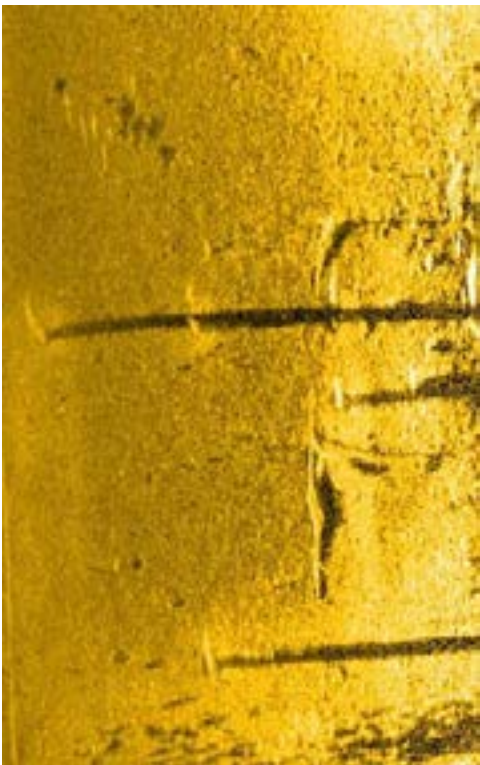
Name	Date	06/10/2019
NGF-A010	Time	14:30:21
Survey File	Event	0
R00023	X	894796.3
Capture File	Y	4075184.5
NGF-A010.JPG	WGS84 Latitude	36 44 25.0623 N
	WGS84 Longitude	076 34 44.9187 W
	Heading	76.8
	Fish Altitude	2.60
	Range to Target	15.2
	Height Above Bottom	0.0
	Length	11.9
	Width	1.0

Notes	Length: 11.9 Width: 1.0 1050 KHz
-------	---

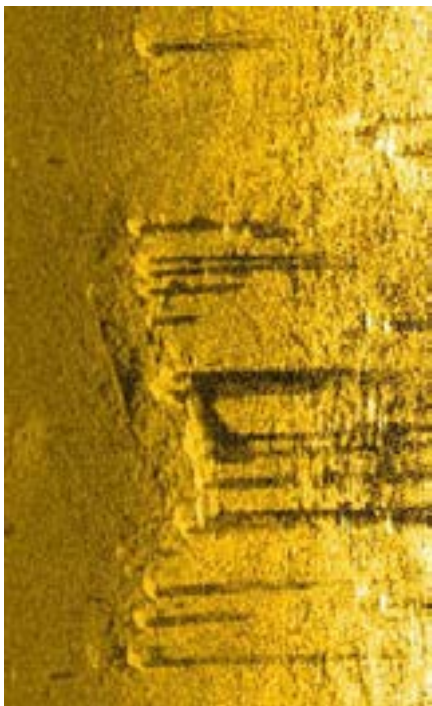
Name	Date	06/10/2019
NGF-A008	Time	14:31:29
Survey File	Event	0
R00023	X	894861.6
Capture File	Y	4075208.8
NGF-A008.JPG	WGS84 Latitude	36 44 25.7509 N
	WGS84 Longitude	076 34 42.2483 W
	Heading	69.0
	Fish Altitude	2.50
	Range to Target	15.0
	Height Above Bottom	0.0
	Length	19.5
	Width	7.2

Notes	Length: 19.5 Width: 7.2 1050 KHz
-------	---

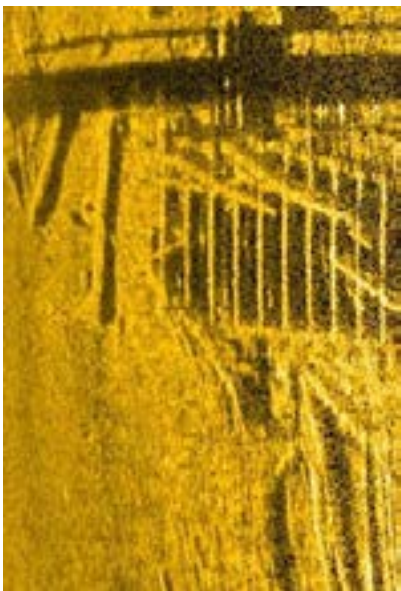
Name	Date	06/10/2019
NGF-A002	Time	14:49:55
Survey File	Event	0
R00023	X	895494.8
Capture File	Y	4075495.2
NGF-A002.JPG	WGS84 Latitude	36 44 34.0692 N
	WGS84 Longitude	076 34 16.2582 W
	Heading	344.3
	Fish Altitude	2.40
	Range to Target	15.4
	Height Above Bottom	0.0
	Length	10.1
	Width	7.3

Notes	Length: 10.1 Width: 7.3 1050 KHz
-------	---

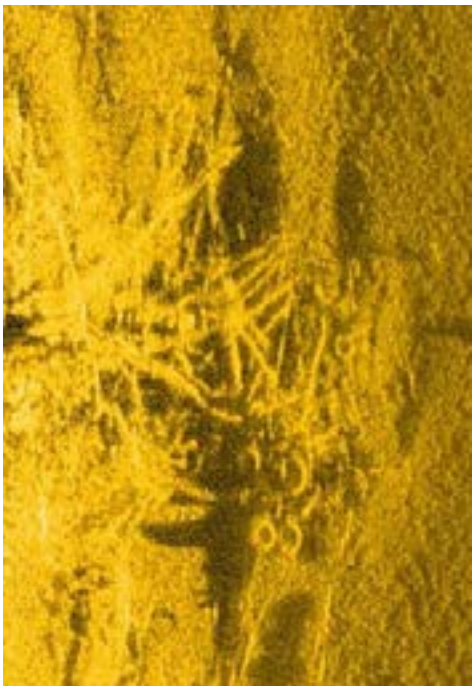
Name	Date	06/10/2019
NGF-A003	Time	14:41:11
Survey File	Event	0
R00023	X	895248.3
Capture File	Y	4075569.7
NGF-A003.JPG	WGS84 Latitude	36 44 36.8492 N
	WGS84 Longitude	076 34 26.0298 W
	Heading	76.6
	Fish Altitude	2.20
	Range to Target	7.3
	Height Above Bottom	0.0
	Length	8.2
	Width	3.1

Notes	Length: 8.2 Width: 3.1 1050 KHz
-------	--

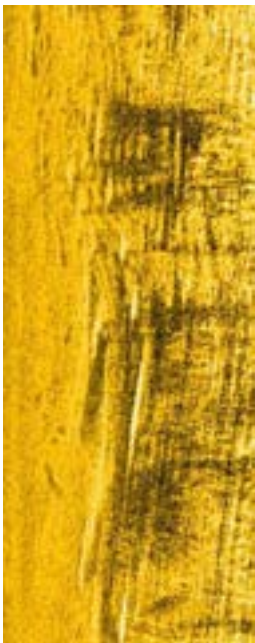
Name	Date	06/10/2019
NGF-A017	Time	15:22:41
Survey File	Event	0
R00006	X	894392.9
Capture File	Y	4075068.1
NGF-A017.JPG	WGS84 Latitude	36 44 21.8994 N
	WGS84 Longitude	076 35 1.353 W
	Heading	299.5
	Fish Altitude	5.40
	Range to Target	19.7
	Height Above Bottom	0.0
	Length	10.4
	Width	9.2

Notes	Length: 10.4 Width: 9.2 1050 KHz
-------	---
