# National Register of Historic Places Registration Form

3. State/Federal Agency Certification
	Not For Publication: $N/A$ Vicinity: $N/A$ County. Transgion
	2. Location Street & number:20-204 North Thomas Street City or town:Arlington State:VA
	Name of related multiple property listing: Garden Apartments, Apartment Houses and Apartment Complexes in Arlington County, Virginia: 1934-1954 (Enter "N/A" if property is not part of a multiple property listing
	Historic name: Windsor Apartments Other names/site number: Whitefield Commons; VDHR File Number 000-9823

Windsor Apartments is a garden apartment complex containing a total of four (4) buildings comprised of eleven red brick masonry structures that are joined together and have the following street addresses: 20-22 N. Thomas Street (Building 1); 100-104 N. Thomas Street (Building 2); 106-110 N. Thomas Street (Building 3); and 200-204 N. Thomas Street (Building 4). Typically, two or three dwelling units are located on each floor in each of the buildings. All four buildings are contributing and the property has no noncontributing resources. The complex was built by major Washington, D.C.- development company, Cooley & Gruver. Design

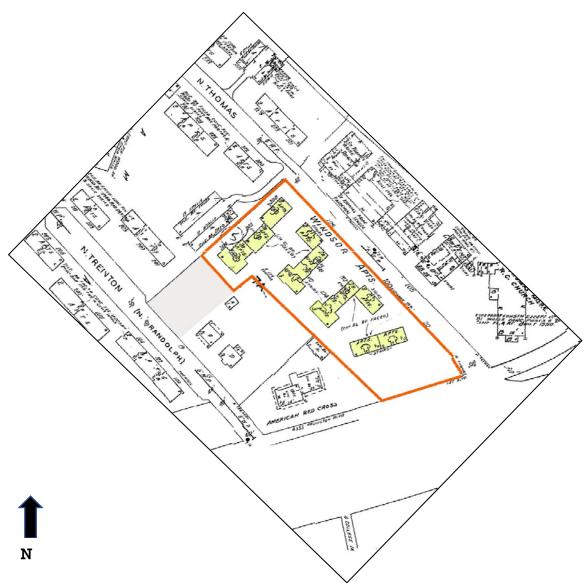
Fig. 3: Historic Map / Sanborn Map, Arlington County, Vol 2 Sheet 229, 1959;

- Windsor Apartments buildings (currently Whitefield Commons) are within the orange indicates historic boundary
- *Gray shaded area indicates extent of original bounds of property (formerly an overflow surface lot)*

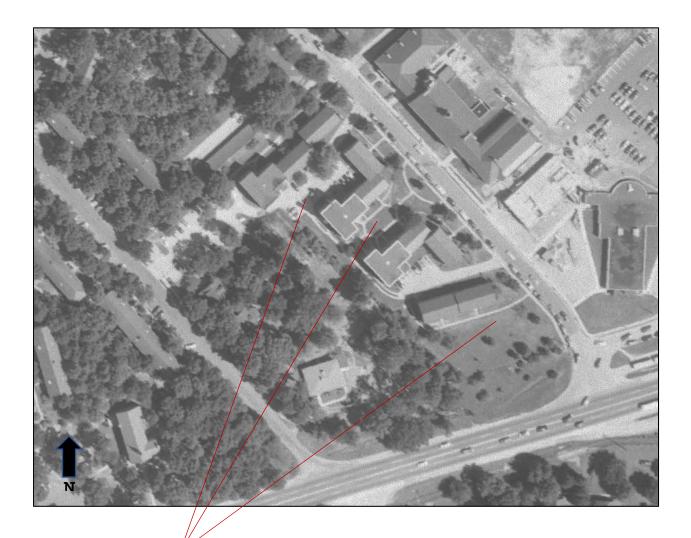
Fig. 4: Historic Aerial, 1951
red lines indicates Windsor Apartments, including hexagonal courtyard and parklet with
paved walkways

- c. Interior floor-plans are substantially unaltered.
  - d. Although original slate roofing material has been replaced with asphalt, based on historic aerial photographs, the historic roof forms are intact.

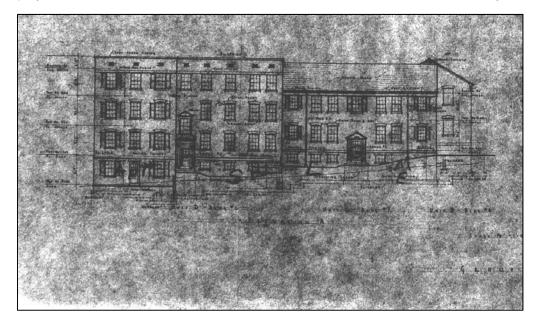
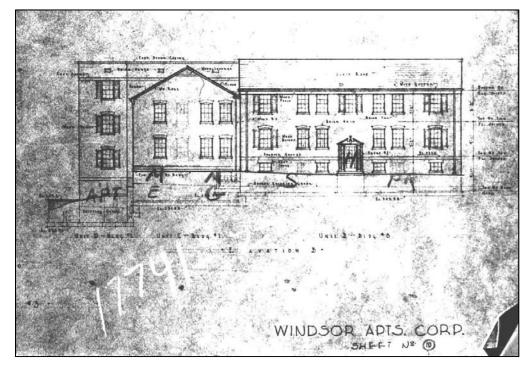
Fig. 5: Historic Drawing, Exterior Elevations "Windsor Apts. Corp," Sheet No. 10

(credit: George T. Santmyers Architect, 1943 as-built drawings available in Wesley Housing Development Corp. files, Alexandria, Virginia)

- b. Windows have been replaced, which is typical for this housing type; the fenestration pattern, sill, lintel or arch, and opening sizes, however, remain intact. In addition, based on historic elevation drawings, the replacement windows display the original 6/6 light pattern, continuing to reflect the property's Colonial Revival style influences.

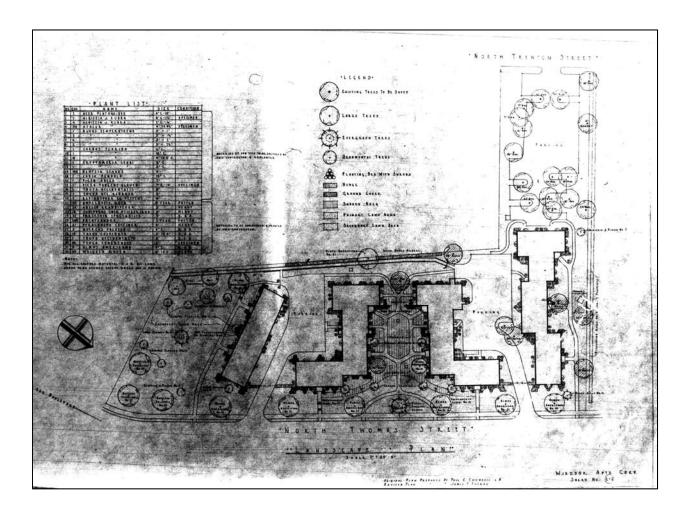
Fig. 6: Historic Drawing, Landscape Plan "Windsor Apts. Corp," Sheet No. L-1

(credit: George T. Santmyers Architect, 1943 as-built drawings available in Wesley Housing Development Corp. files, Alexandria, Virginia)

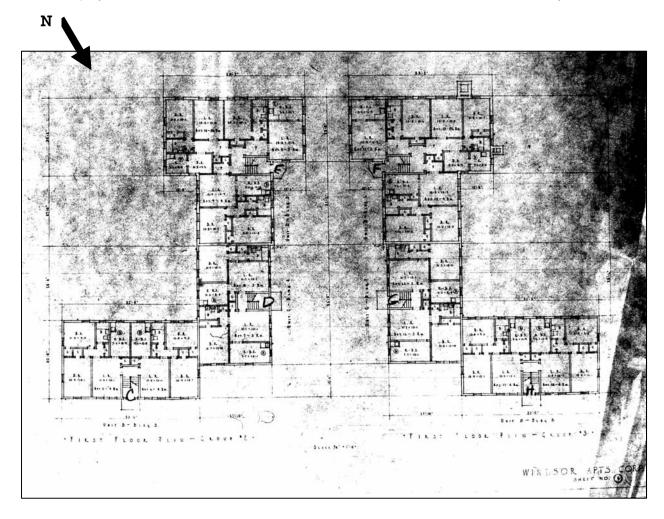
Fig. 7: Historic Drawing, First floor plans, central two buildings "Windsor Apts. Corp," Sheet No. 6

(credit: George T. Santmyers Architect, 1943 as-built drawings available in Wesley Housing Development Corp. files, Alexandria, Virginia) N

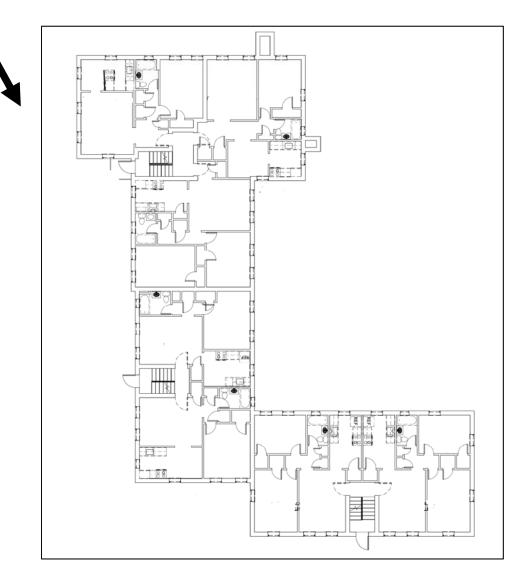
Fig. 8: Representative Interior Floor Plan, Current showing that historic floor-plans are intact (credit: Zavos Architecture & Design, 2019)
