National Register of Historic Places Registration Form

Historic name: Fulton, Andrew and Sarah, Farm

Other names/site number: Buddle Branch Heritage Farms; DHR ID# 098-5634

City or town: Austinville State: VA County: Wythe

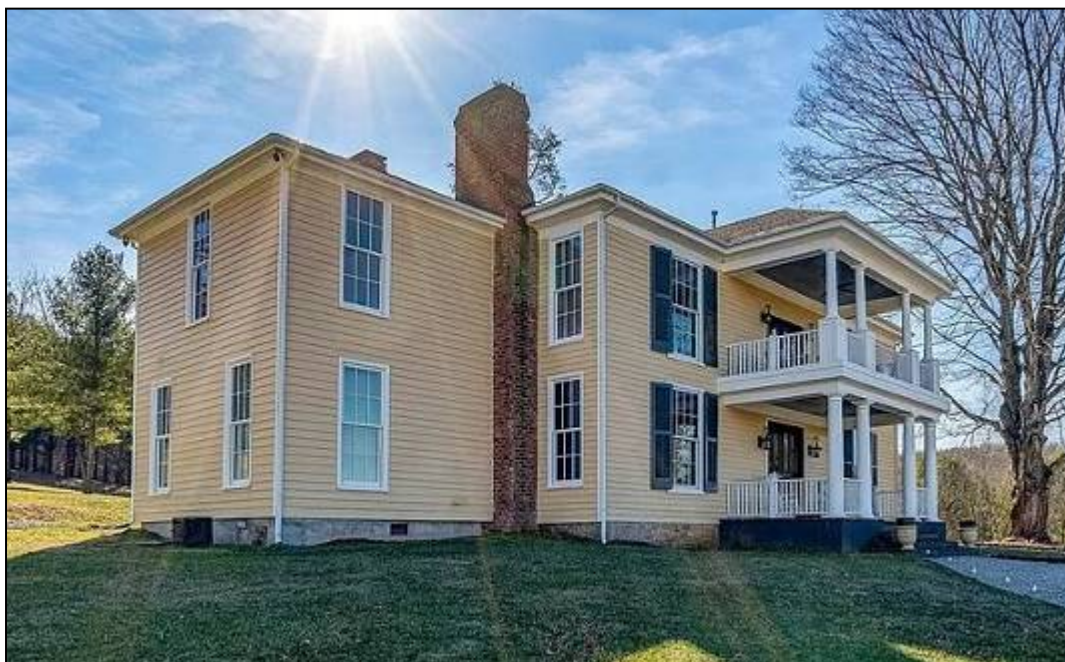
The rear entry has a French door sheltered by a modern one-story porch with Doric columns and a low-pitched hip roof. The porch stands on a brick-paved patio partly defined by a concrete and brick retaining wall. The four exterior end chimneys, two on each end, are partly overlapped by the end wings. They are stretcher-bond brick with stepped shoulders, stepped caps (which are likely twentieth-century modifications), and stepped bases. The southeast chimney is known to be an entirely modern reconstruction, based on a historic photo that does not show it. The other chimneys appear to be original. The materials and design of the reconstructed chimney are complementary to the three historic chimneys.

Flanking the main block are two-story, hip-roofed lateral wings, each with a single bay on the façade and rear elevation, and three bays on their respective side elevations (see above). The double-pile additions have similar stone foundations, weatherboard siding, and asphalt shingled roofs. The window openings are slightly taller and narrower than those of the main block, evidenced by the use of six-over-six sashes instead of eight-over-eight. A plain frieze board that encircles the main block just beneath the eaves extends as a narrower band around each wing. The similarity in materials and design indicate that the wings were constructed not long after the main block, certainly by the end of the 19th century.

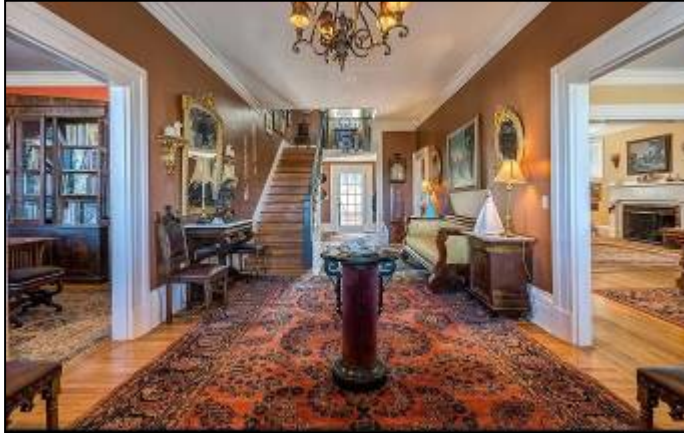
The principal feature of the main block's wide center passage is a two-run stair at the back (at left). The stair has modern square newel posts and iron balusters with furled ornament, but it retains its historic treads and risers, spandrel with vertical molded panels, and under-stair closet with two-panel door (at bottom). From the central passage, wide cased openings lead to the flanking parlors. The central passage also leads to the rear hall and rear entry.

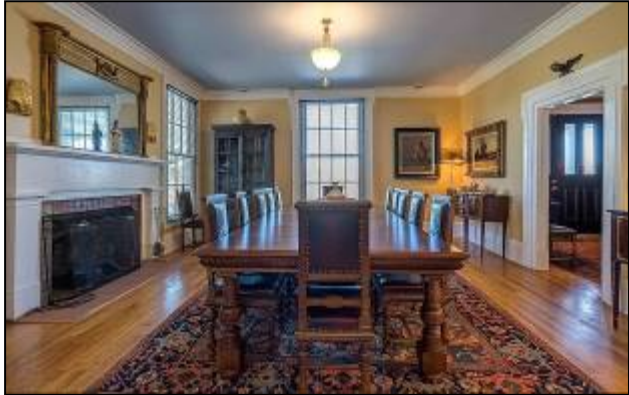
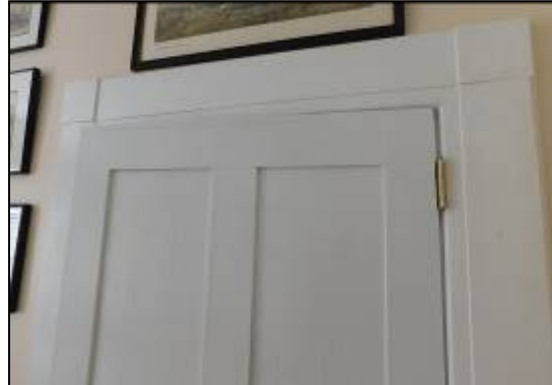
The mantels, all eight of which survive, are Greek Revival with pilaster and frieze forms, as shown in the image at left. Although most are relatively simple in detail, some are exceedingly plain, with block-like pilaster bases and fillet-molding pilaster caps. Others have more intricate pilaster caps with canted moldings and delicate fillet-molding neckings. A few mantels have shallow peaked backboards above the shelf, and one mantel has a shelf with rounded corners. The exception to the relative simplicity of the mantels is the one in the second-floor northeast room. The mantel has a frieze board with an elaborately sawn lower edge consisting of an ogee arch interrupted by pendant detail. The pilasters are symmetrically molded with a fluted appearance, and they support tablets at the ends of the frieze. The stack molding under the shelf has canted, cove, and convex moldings.
