National Register of Historic Places Registration Form

Historic name: Chatham

Other names/site number: VDHR #065-0005

City or town: Machipongo State: VA County: Northampton

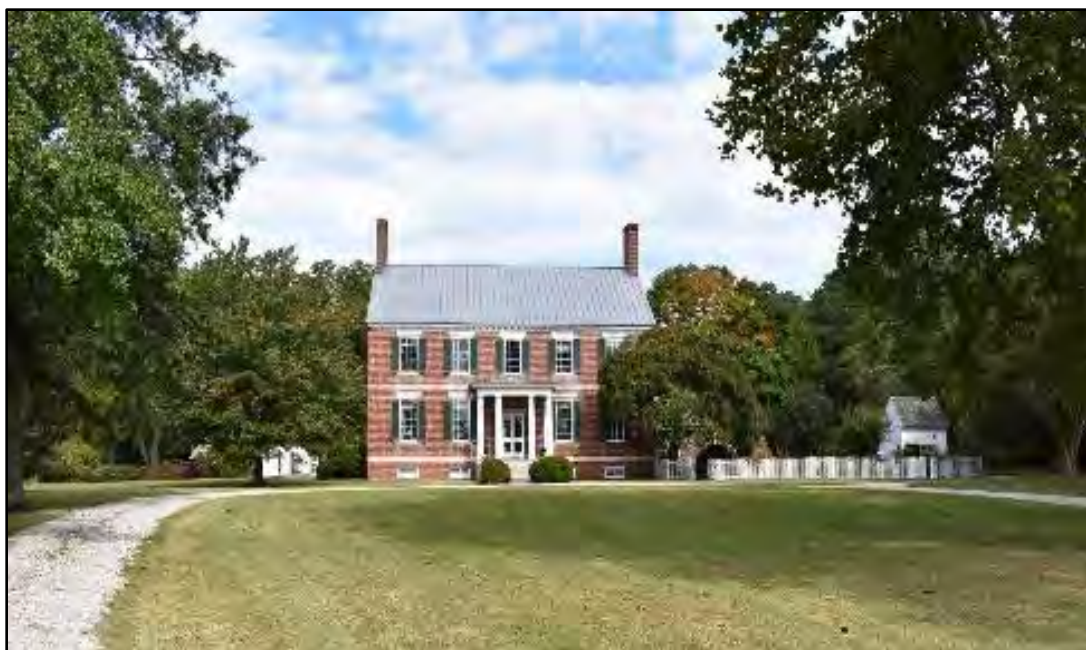
Figure 1. General view of Chatham looking north.

The two-and-a-half-story house stands on an English basement and has an attic level, is clad with red brick laid in a Flemish bond pattern on the front and rear, and is covered by a side gable roof clad with standing-seam, lead-coated copper with tall interior end chimneys. The footprint of the house is approximately 54 feet wide (excluding the kitchen wing) by 37.5 feet deep. The symmetrically arranged five-bay-wide landside (south) and waterside (north) elevations are distinguished by columned entrance porches raised on tall brick piers. The dwelling consists of a central, rectangular-shaped block and a one-story wing on the east end, which originally was built as a colonnade to connect the 1818 house to a two-story brick wing of uncertain date.⁴ The latter was damaged by fire in the late nineteenth century and removed in the 1930s. The colonnade was enclosed and converted into a kitchen. In 1857, a one-story frame wing was added to the west end of the house and was used as a doctor's office. That wing was removed in 1972. Little additional alteration occurred to the house until the mid-twentieth century when indoor plumbing was added. The current owners purchased the house in 1979, and in the early 2000s, undertook an extensive and careful restoration of the house.

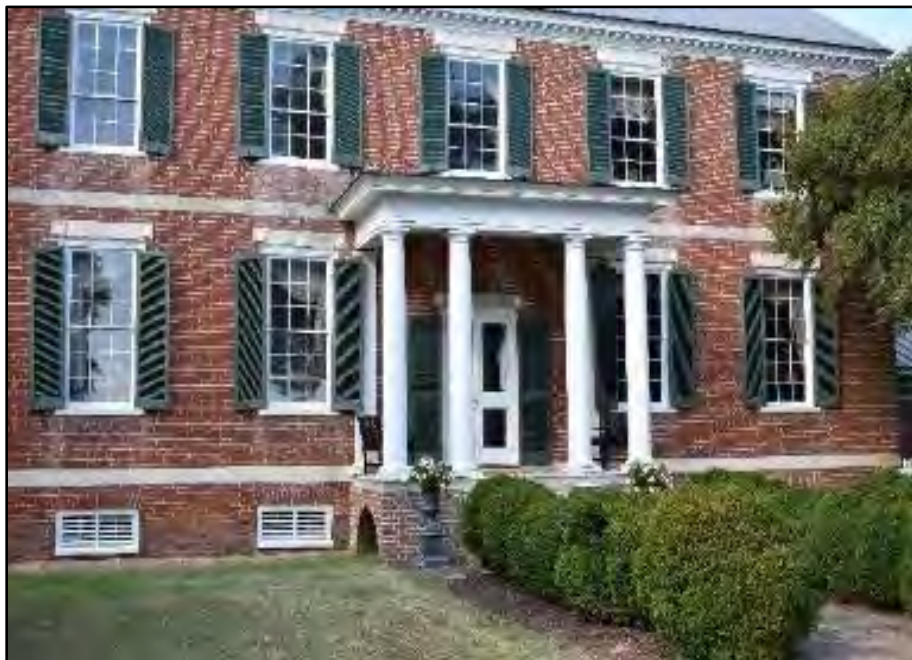
Figure 2. Detail of Chatham's south (landside) façade.

Chatham's exterior brick walls are laid in a Flemish bond pattern on the front (landside, south) and rear (waterside, north) elevations and in a three-course American bond pattern on the ends. The belt courses that extend along the first- and second-floor levels return slightly on the gable ends. As Eastern Shore historian Ralph T. Whitelaw notes, the belts are created by a one-half-inch-deep recess of the brick that was filled with stucco and finished flush with the brick wall. The deteriorated belt on the first story was replaced with a concrete belt during the recent rehabilitation; the original stucco belt survives on the second-floor level. The south (landside) façade is five bays wide (see Figure 1). The four openings at the basement level have brick jack arches and hold four-pane wood window sash protected by wood horizontal-louvered grills. The first story openings hold a centrally located entrance flanked by windows with nine-over-nine wood sashes (see Figure 2 below). The entrance consists of paneled double doors with custom-made storm doors. The exterior sides of the entrance doors are striking in their design: three horizontally-oriented rectangular panels above the brass knob and a vertically oriented rectangular panel at the bottom with raised concentric rectangles inside each panel. Both the front and back doors feature these panels, which are also found on the reveals of the entrance bay opening. On the interior (passage) side, the doors feature similar panels finished with wood graining.

The window openings that flank each side of the entrance bay have molded wood frames and feature wood sills, flat lintels formed in the same manner as the belt courses (replaced with concrete replicas where needed), and bull's eye paterae. Wood louvered shutters also are present. The five window openings on the second story, which hold slightly smaller nine-over-six sash, are similarly detailed.

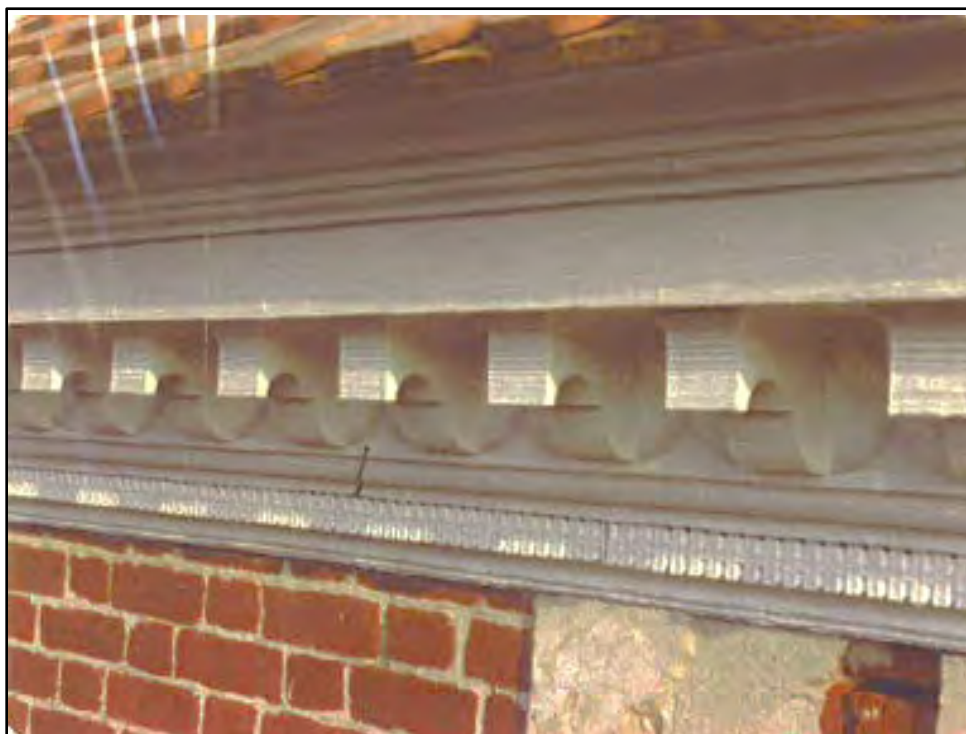
Figure 3. Detail of cornice, pre-restoration (ca. 1980).

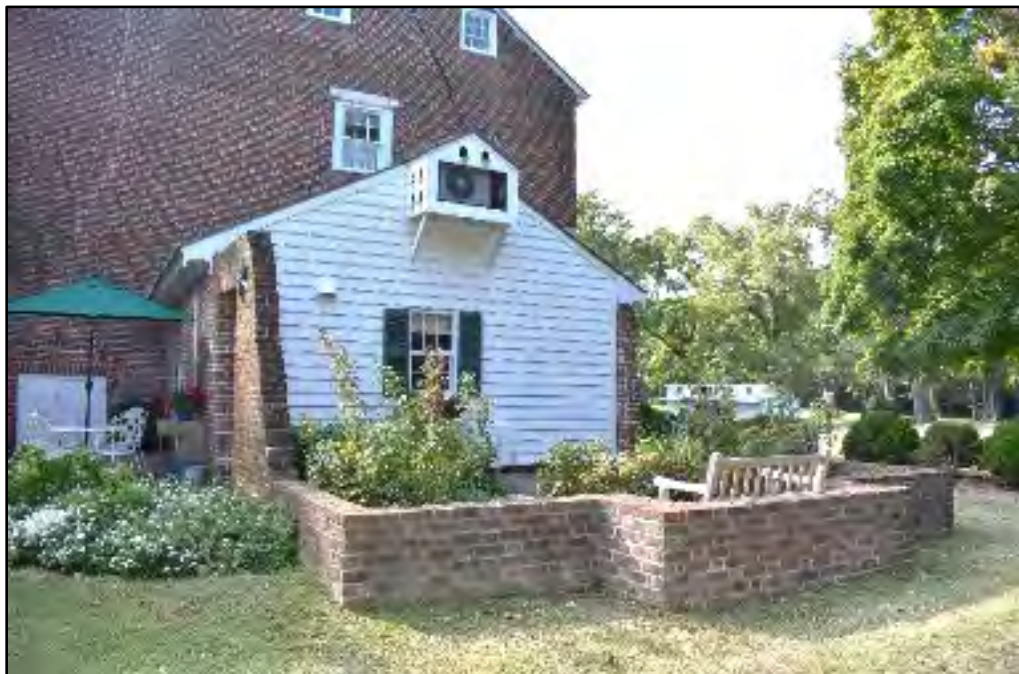
Figure 4. Looking northwest at east end of house, enclosed kitchen wing, and brick wall around kitchen garden.

The east end elevation holds three windows in the gable end that are identical to those on the west end elevation. The six-over-six window sash on the second level, which is located just off center, was formerly a door opening. This door, used by enslaved workers, was accessed by a walkway atop the brick colonnade that connected to the combined kitchen and slave dwelling. When the east end building burned (ca. 1880) and was later demolished (1930), the walkway was removed from the colonnade.

The size of the second-story door opening was reduced to a window and detailed in a manner similar to others on the house. The east elevation also holds a pair of wood plank doors at the lower southeast corner that access the basement. The opening is detailed with a brick jack arch and wood steps lead down into the basement.

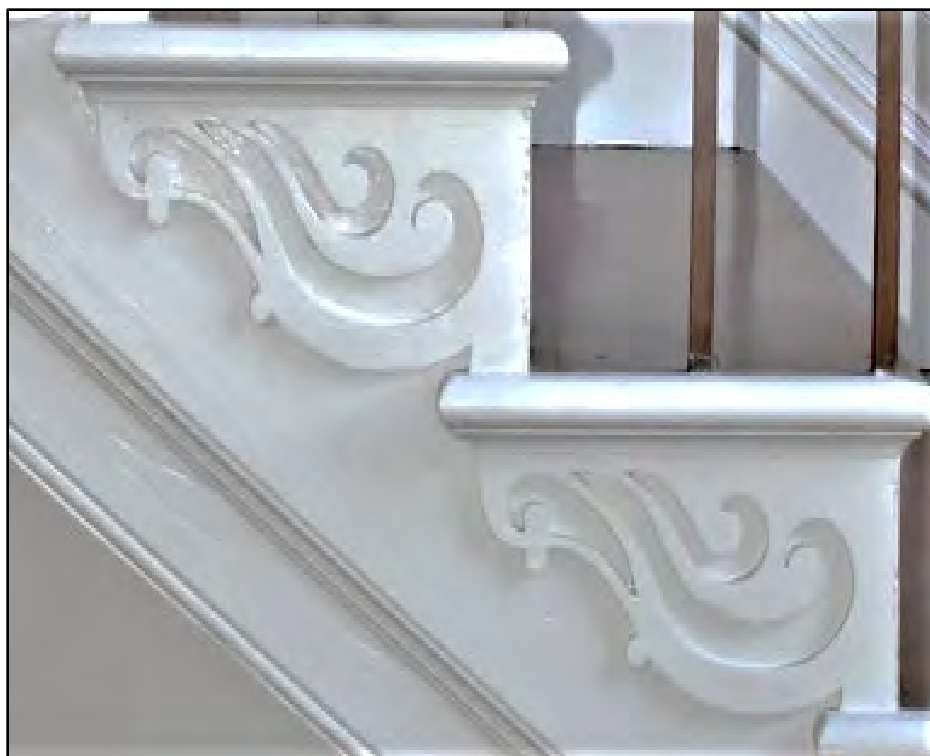
Figure 5. Stair stringer detail.

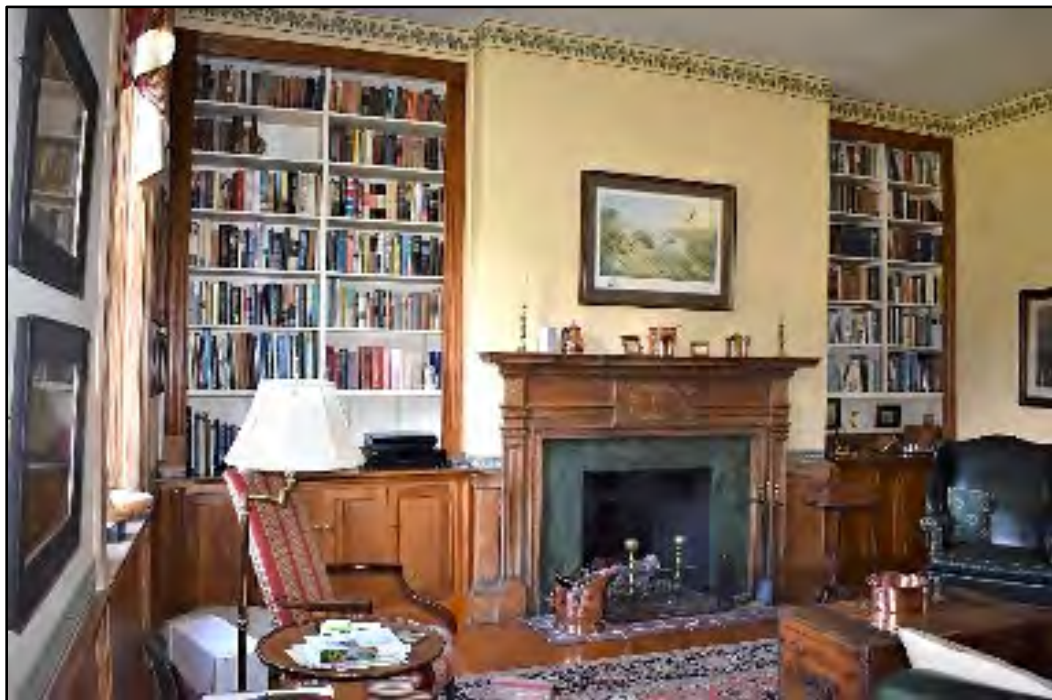
Figure 7. Library looking southeast.

The library is accessed from the center passage through a doorway behind the rise of the stair and from the dining room. The room holds two windows on the north wall and a fireplace on the east wall. The mantel is carved with sunburst and shell motifs, reeded pilasters, incised scrolls, and the same double-punched molding as seen on the exterior frieze (see Figure 7 below). The walls are finished with a tall, stained and grained baseboard, a single board, plain (rather than paneled) wainscot, and a chair rail.¹⁰ In the mid-twentieth century, when interior plumbing was installed in the house, a chase was built onto the south side of the projecting fireplace wall, thus concealing the new piping. The built-in bookcases on the west wall, installed by the current owners, are designed with the same trim and dimensions of the windows, which provides a feeling of balance and symmetry to the room.

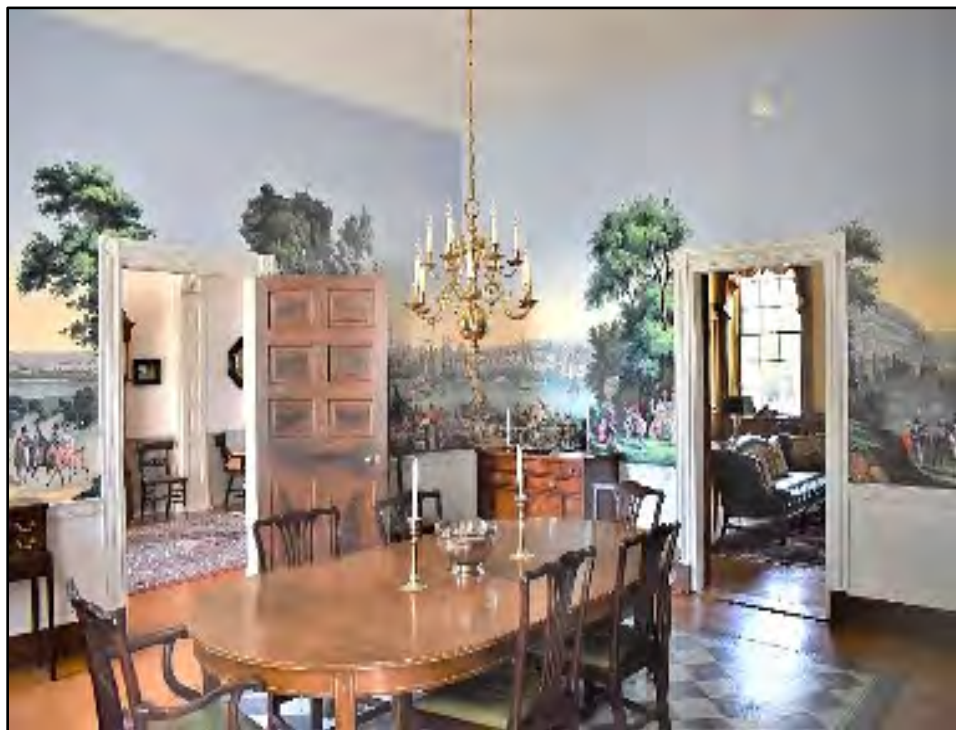
Figure 8. Dining Room looking northwest

The dining room is another bright space with two large windows on the south wall. The interior window openings here, and elsewhere on the first floor, are slightly splayed with reeding along the reveal.¹¹ Doors are present on three walls of the room: on the west to the central passage, on the north to the library, and on the east to the kitchen (the latter is an eight-panel swinging door). The doors in the dining room retain their original grained finishes, which were restored in 2000. The east wall also holds the fireplace, which has a gray marble mantel similar to the parlor except that the elements here are of the Doric order. Stained and grained baseboards and a plain, single-piece wainscot with chair rail adorn the plaster walls. The built-in cupboard on the south side of the fireplace is original. The floor here, as in the other rooms, is pine and is covered by a custom oilcloth designed by Miriam Riggs. The Zuber wallpaper, *Les Vues D'amérique Du Nord* (Scenes of North America), installed by the current owner, was selected for installation as a period-appropriate wall finish for the room (see Figure 8 below).¹² Each scene was

carefully positioned above the room's chair railing. Overpainting, completed by Ms. Riggs, artistically restored elements that had to be cropped for the installation; this generally occurred around door frames and in corners. The French paper replaced floral wallpaper that was installed during the Scott ownership in the early twentieth century.

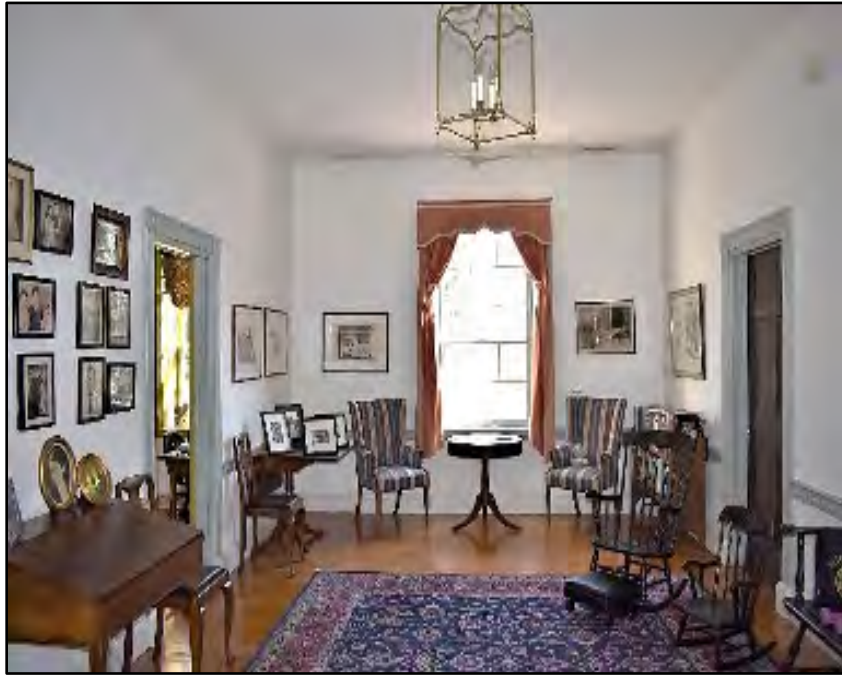
Figure 10. Upper Hall looking south.

The stair landing between the first and second floor provides a view to the creek through a tall arched window, the bottom of which extends below the chair rail and the top of which extends to the third-floor landing. The second floor holds a wide center hall with two rooms to each side that replicate the floor plan of the first floor (see Figure 10 below). Originally, the second floor held four rooms, three of which had fireplaces; the northeast room formerly was used as a service area and does not have a fireplace. On this floor, decoration is slightly less ornate than the first floor, but still reflects elegance and affluence. Plaster walls have baseboards and chair rails, but no wainscot. Doors are grained mahogany on the hall sides while the interior chamber sides are decoratively painted with glazed headers and stiles, grained panels, and false inlaid borders. The gray-green color of the center passage appears on the woodwork in the stairhall but changes to a darker blue-gray at the pilaster next to the top stair tread on the second floor. All trim in the upper stair hall was painted the darker color.¹⁴

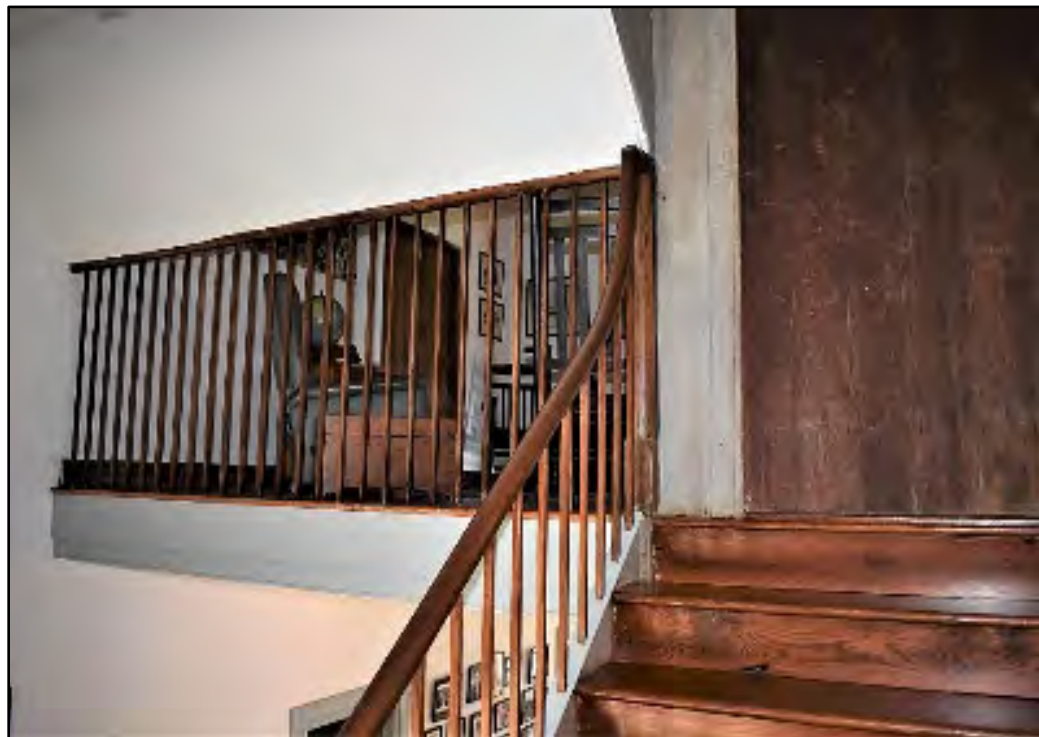
Figure 11. Third-floor ceiling extending to railing; plank door to right.

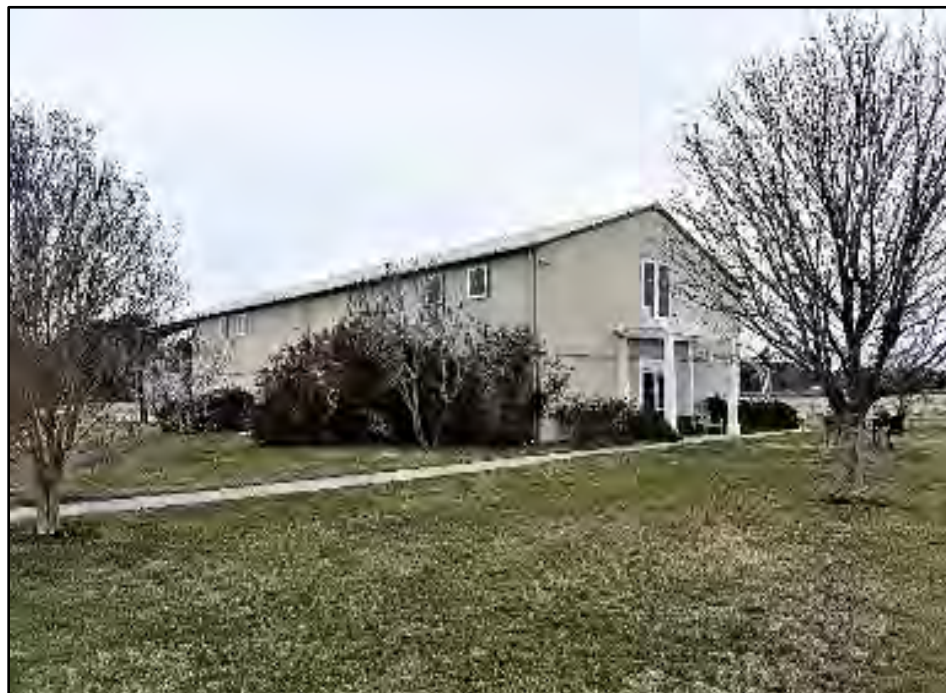
Figure 13. Chatham Vineyards winery.

In 2005, the present owners erected a 40-foot by 80-foot, steel frame winery building southwest of the main dwelling. The winery, known as Chatham Vineyard on Church Creek, is accessed from the entrance drive by an unpaved lane. The building stands at the edge of a cultivated field and serves as tasting room, production, and storage area. At present, the winery's vinifera vineyard annually produces between 5,000 and 6,000 cases of wine.

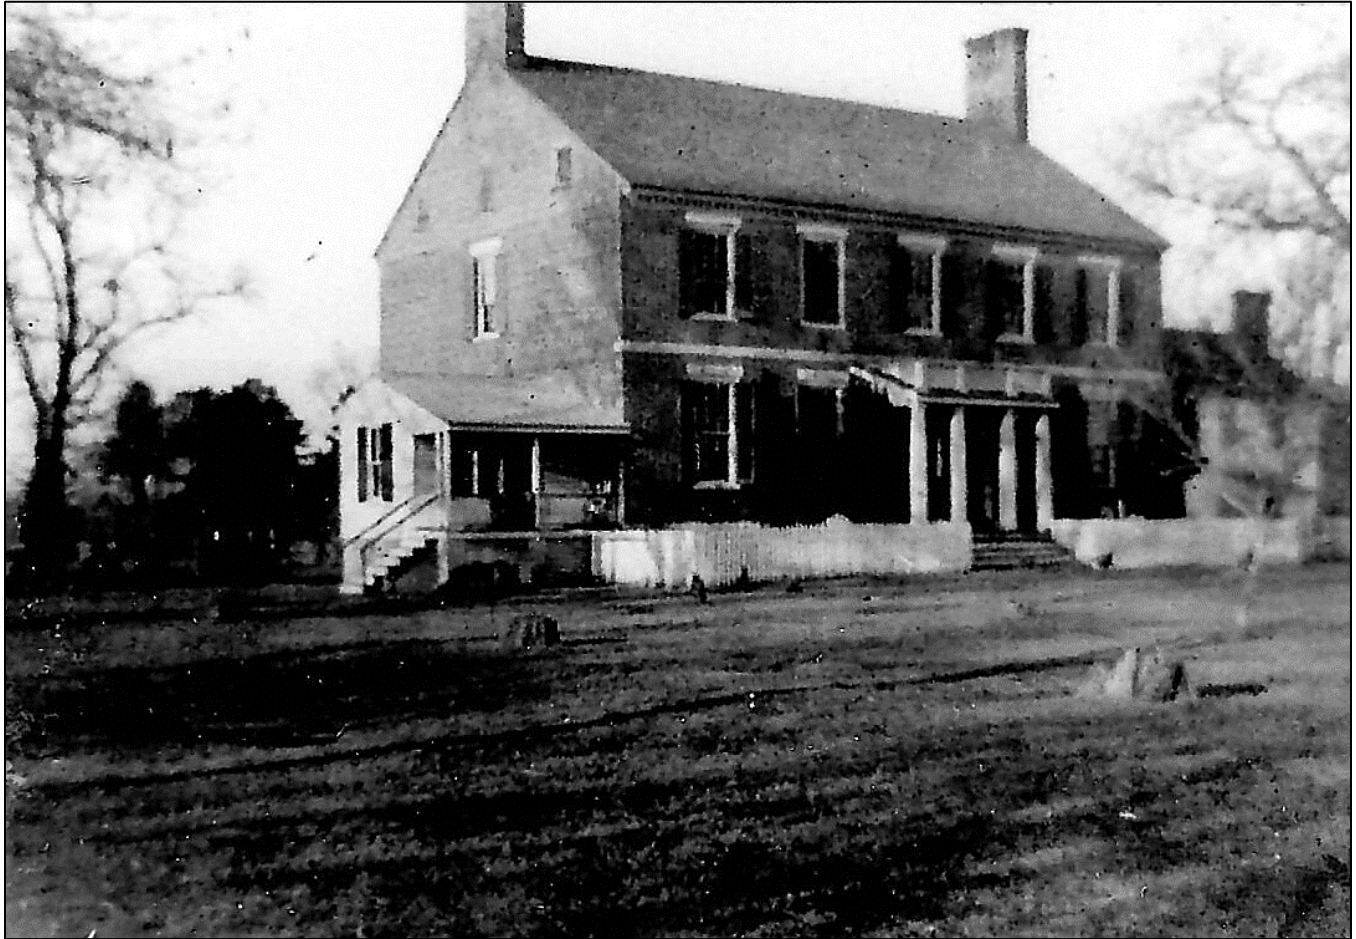
1. Chatham, looking northeast, [ca. 1920]. The east and west end wings appear to be in good condition in this photograph and may date to the early period of the Scott occupancy (1905-1969).
Source: Joan Wehner from Harriett Brockenbrough/Scott family collection.

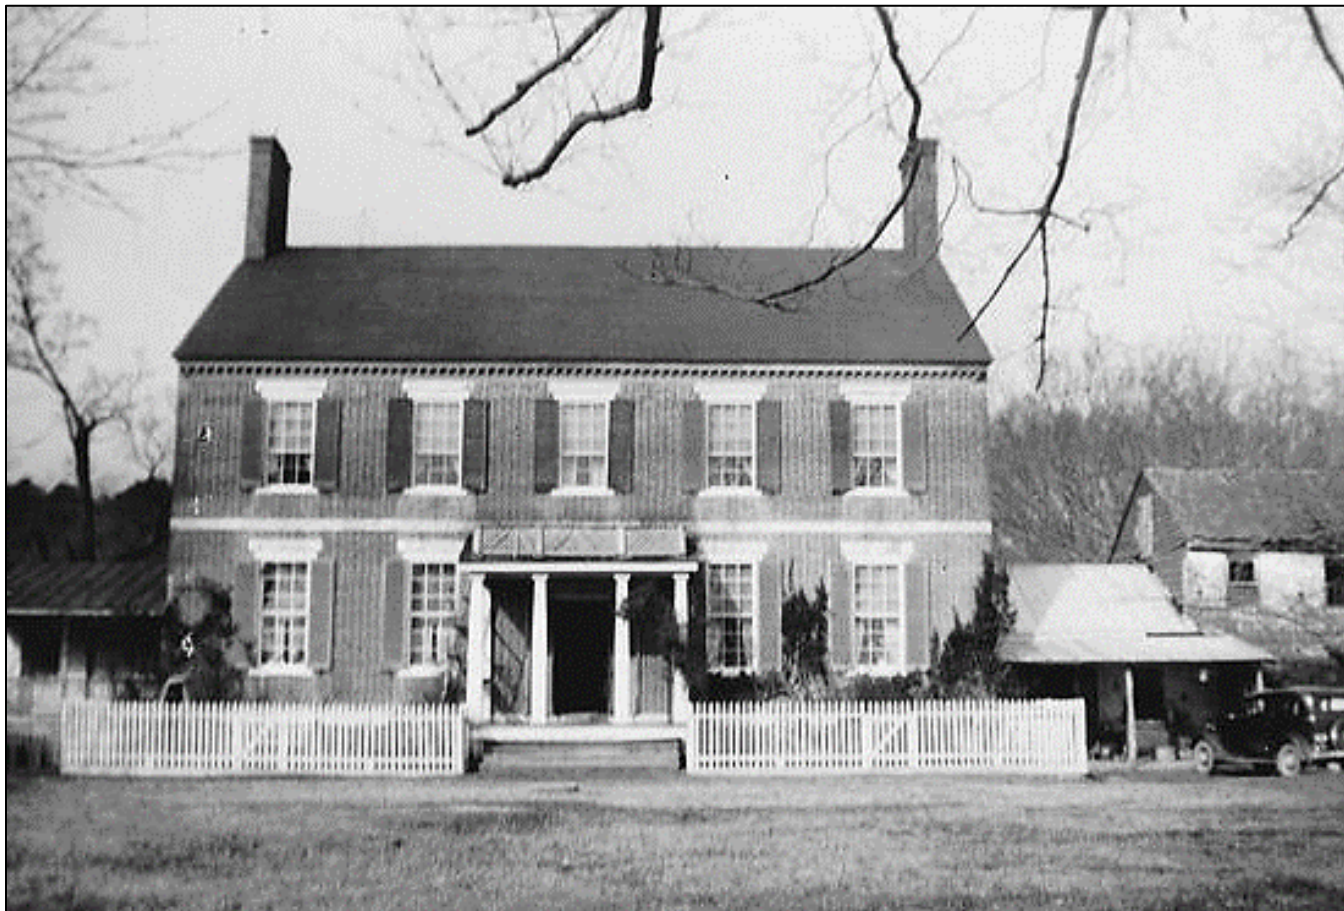
3. Chatham, looking south, [ca. 1938]. Note west end wing (doctor's office) and two-story brick east end wing are still extant. Source: Virginia Historical Inventory, Earl Van Ness and Mattie Scott, 'Chatam' (sic), NTH-20, Survey Report and Photograph, Library of Virginia, Richmond.

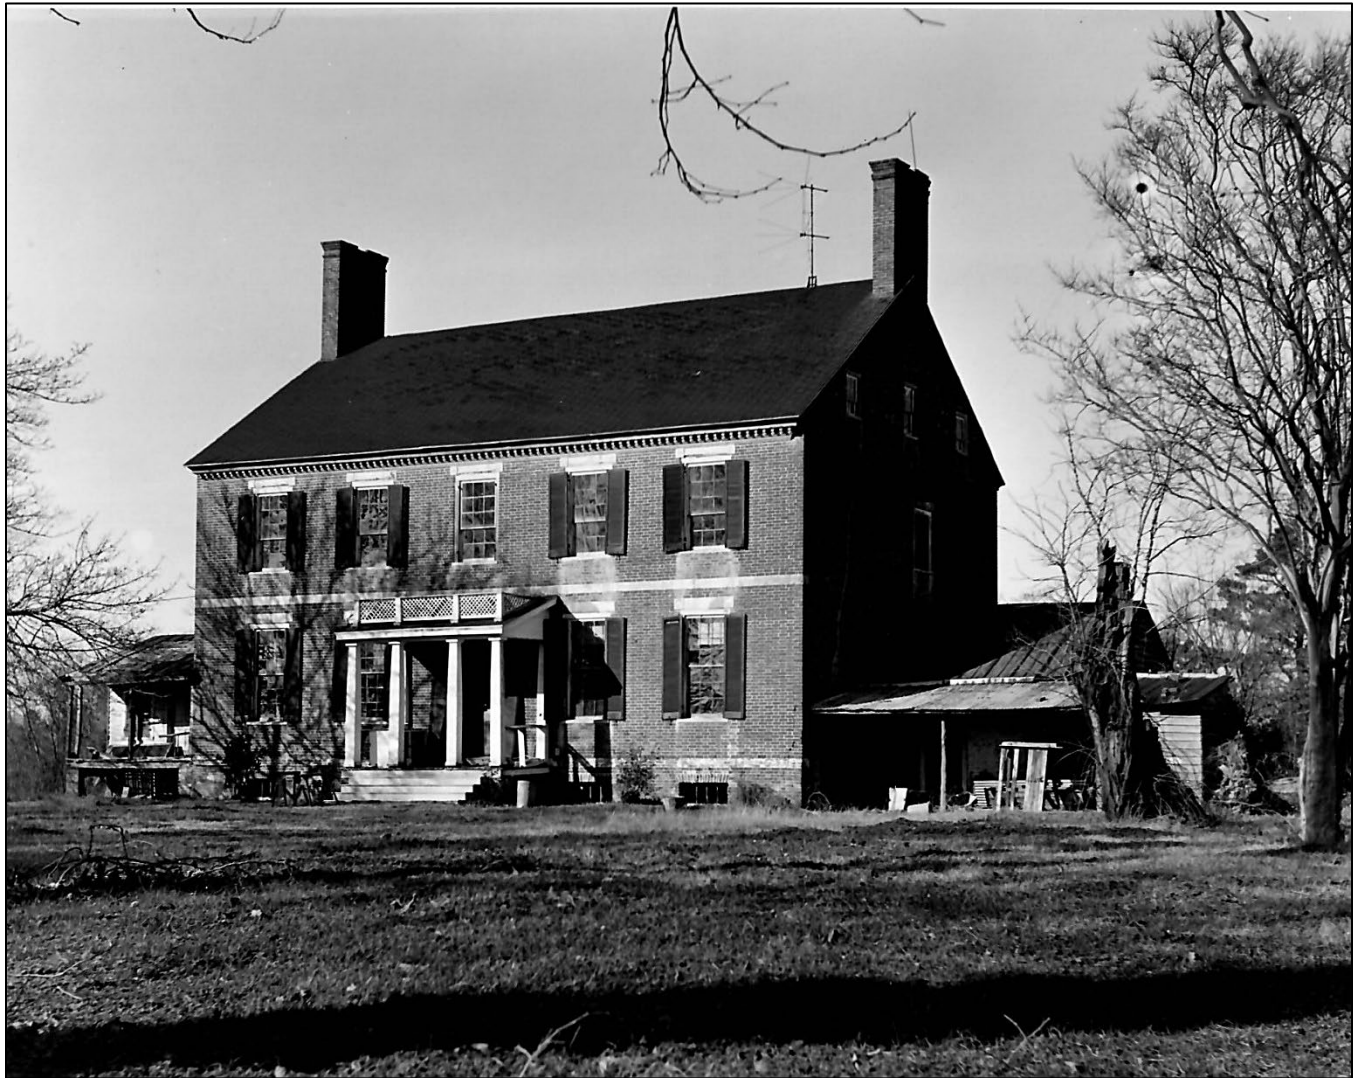
4. Chatham, looking northwest, 1972. Note that east end wing has been removed.
Source: F.O. Briggs Scrapbooks, Archives, Department of Historic Resources, Richmond, VA.

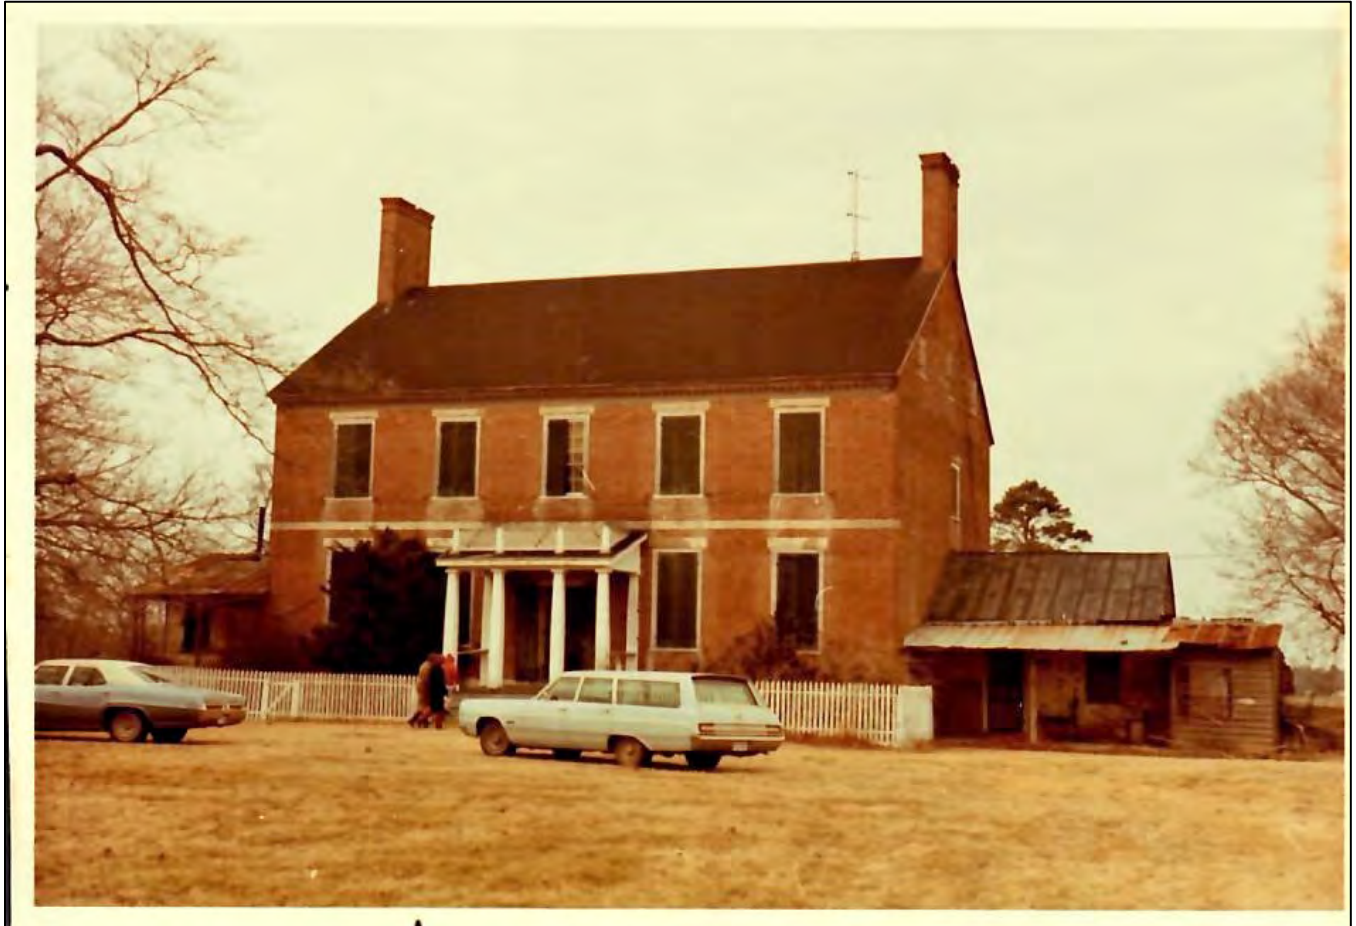
6. Chatham looking north, ca. 1972. Chatham about the time the Wehners purchased the property. Note small frame structure on the east (right) end of the house that was built by the Scotts and used for tool storage and a wind-break. Source: Joan Wehner.
