National Register of Historic Places Registration Form

Historic name: South Garden
 Other names/site number: 063-0031
 Name of related multiple property listing: N/A
 (Enter "N/A" if property is not part of a multiple property listing)

Street & number: 6331 Pocahontas Trail
 City or town: Providence Forge State: VA County: New Kent
 Not For Publication: Vicinity:

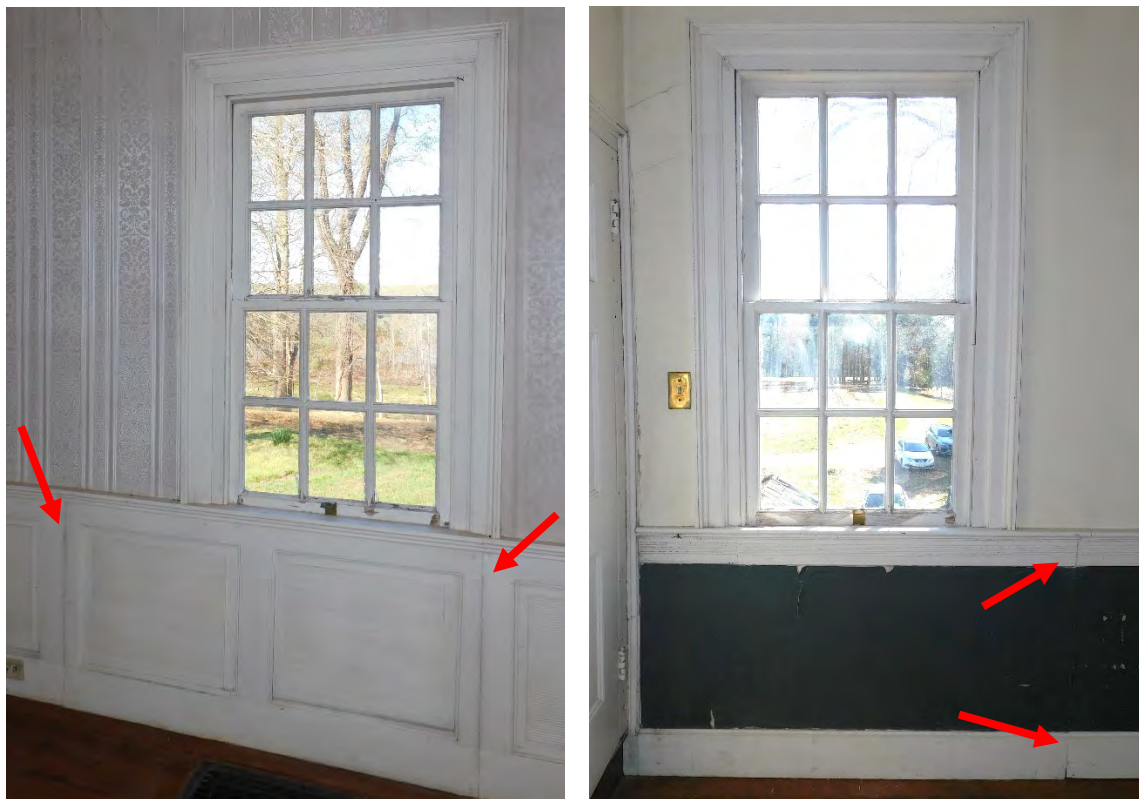
Figure 3: Break joints in the wainscot panels, chair rail, and baseboards below the windows on either end of the first and second floors of the Period I side passage indicate these areas were patched when historic doorways were infilled. Left: Period I First Floor Entry Hall, West Elevation. Right: Period I Second Floor Landing, East Elevation.

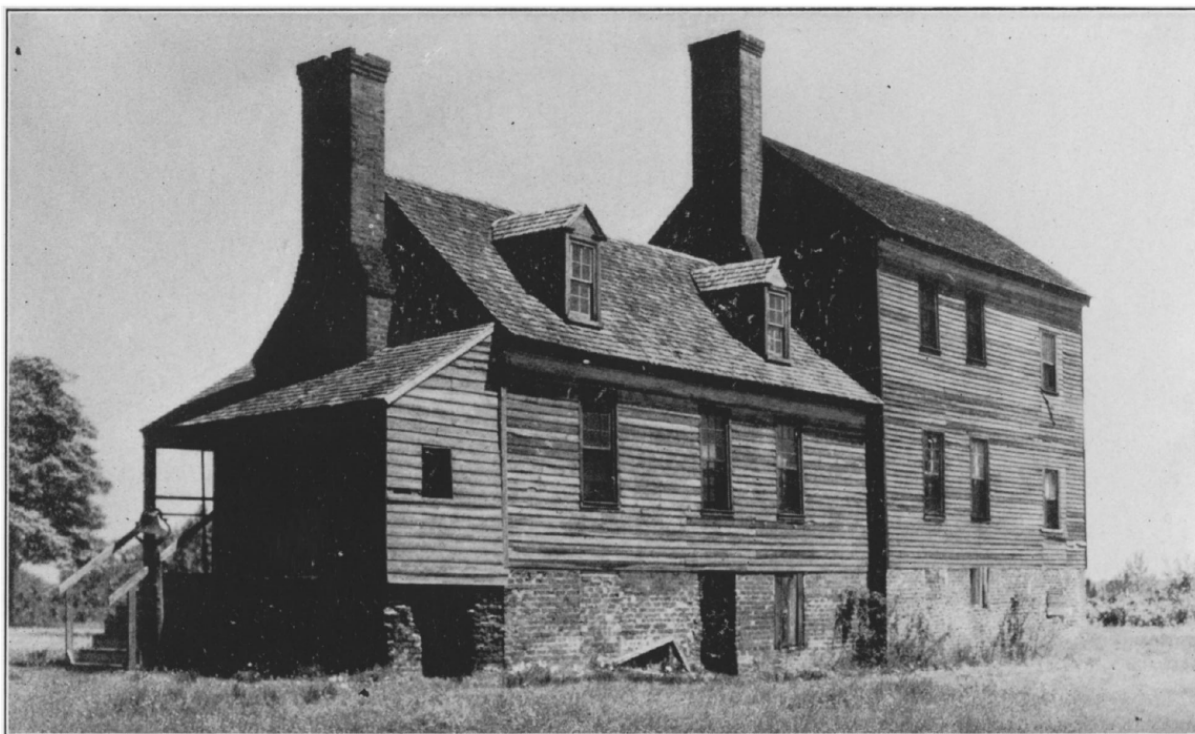
48. *South Garden, on Route 60 about five miles west of Providence Forge, New Kent County.*

Figure 4: South Garden ca. 1937, facing southeast. William and Mary Quarterly.

that light the rooms to the north (seen on the east elevation in Figure 2 and on the west elevation in Figure 4), indicate that these spaces have been patched. Doorways that once gave access to the porches on the east and west of the passage at both floor levels were removed sometime in the nineteenth century and replaced by windows on the west elevation (back) and a window on the second floor of the east elevation above the main entrance.

In a 1937 photograph (Figure 4) showing the west (rear) elevation of the house, there are straight joints in the weatherboards beneath the replacement windows on the first and second stories indicating that these early doorway openings have been patched. On the primary (east) elevation the main entrance door was retained and perhaps widened when these changes were made. Two prominent two-story porches would have given South Garden an even more imposing appearance during the antebellum period despite its modest plan of one room and a stair passage on the two main floors. Further research might determine whether the second-story porches were enclosed by roofs or were open with a balustrade or solid parapet.

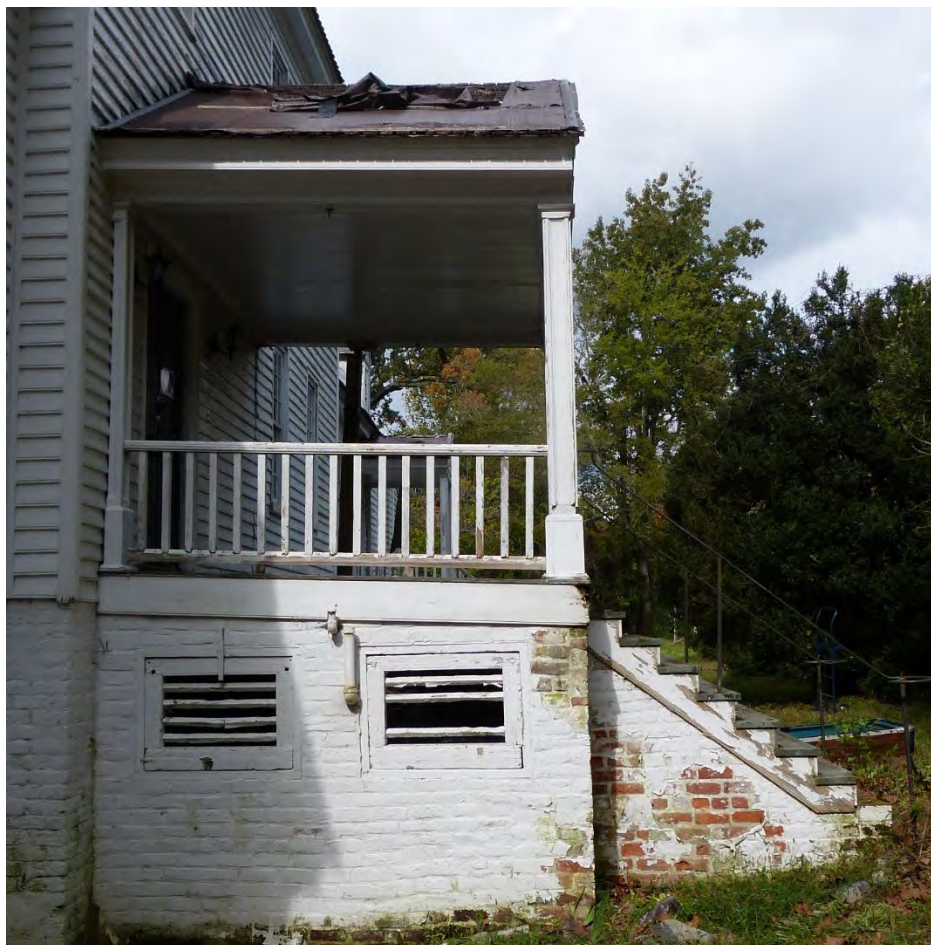
Figure 5: Wood slat windows in the mid-twentieth century porch base may have historically been cellar windows on the west elevation of the Period I basement.

removed and reset into the south brick wall of the new enlarged front porch foundations (see Figure 5). Period III's pier foundation was infilled to create a continuous brick foundation.

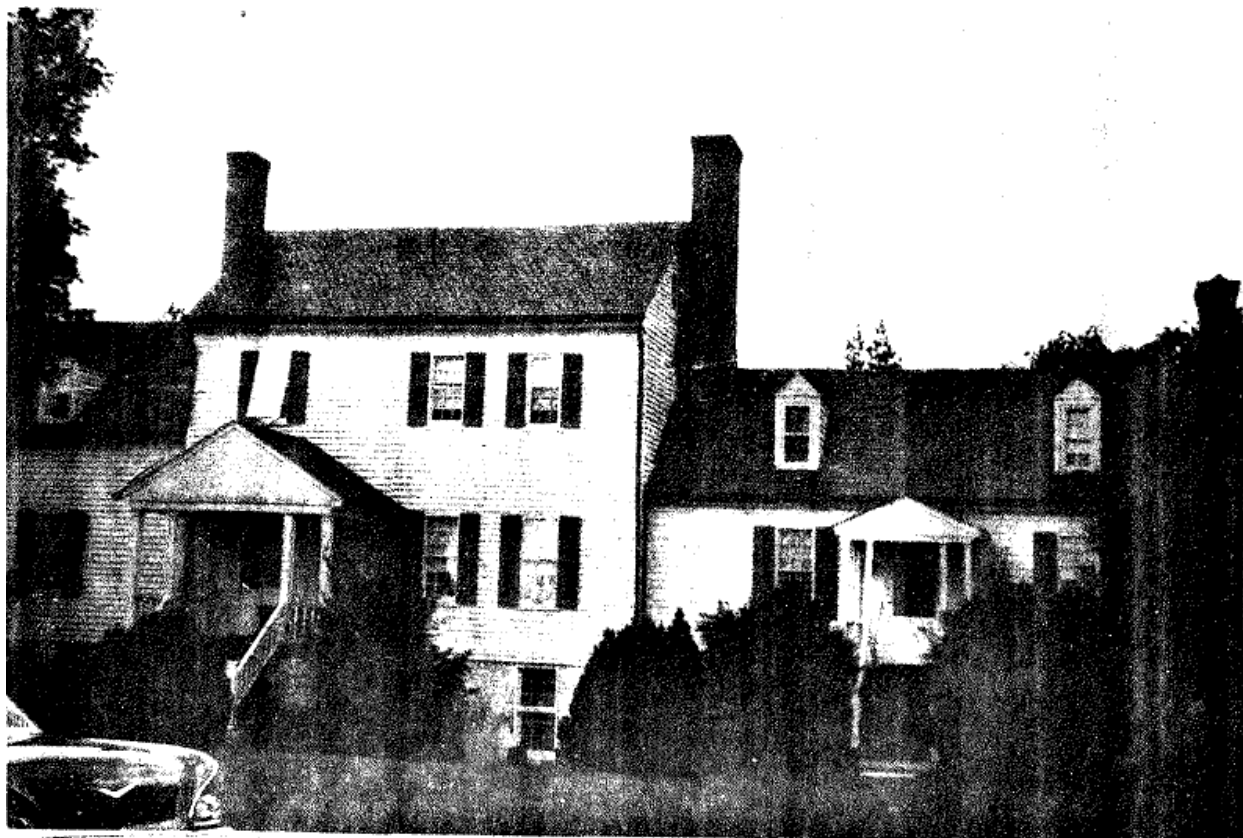
Figure 6: South Garden, 1958, facing west. HABS survey photo, courtesy of Virginia Department of Historic Resources.

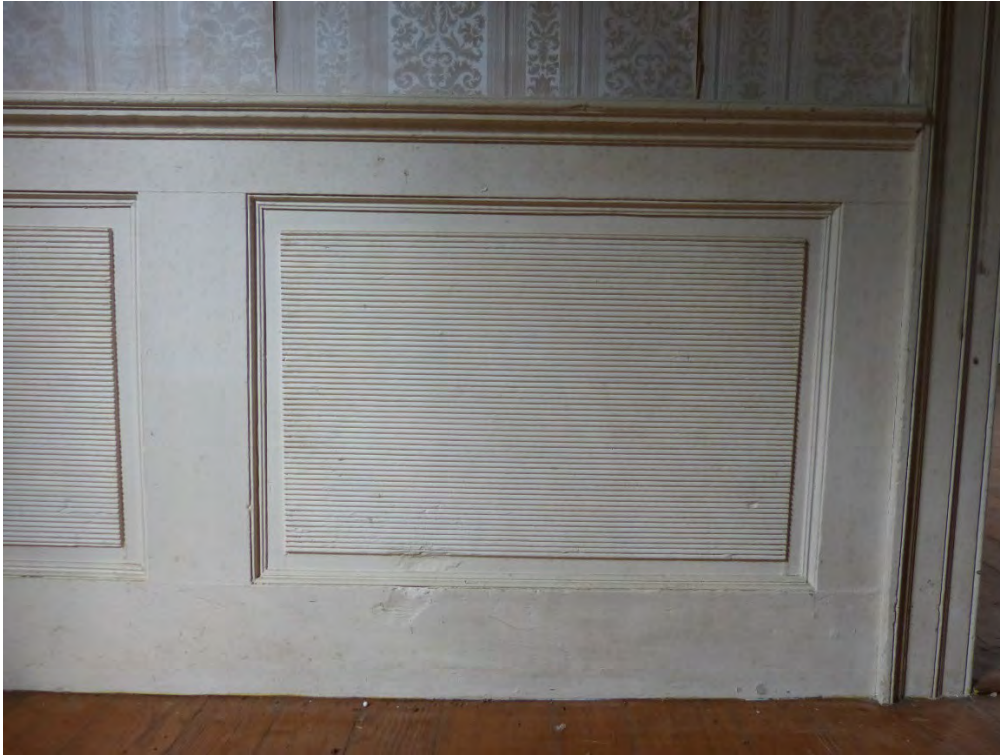
Figure 7: Period I Side Passage, reeded wainscot panels.

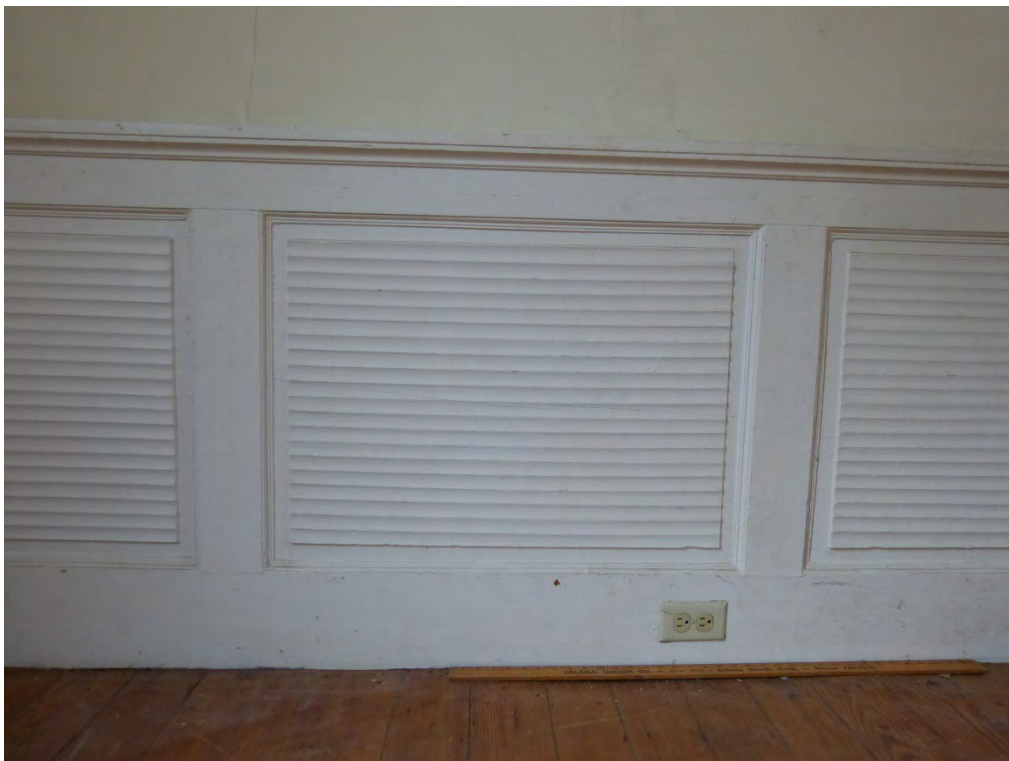
Figure 8: Period I Parlor, fluted wainscot panels.

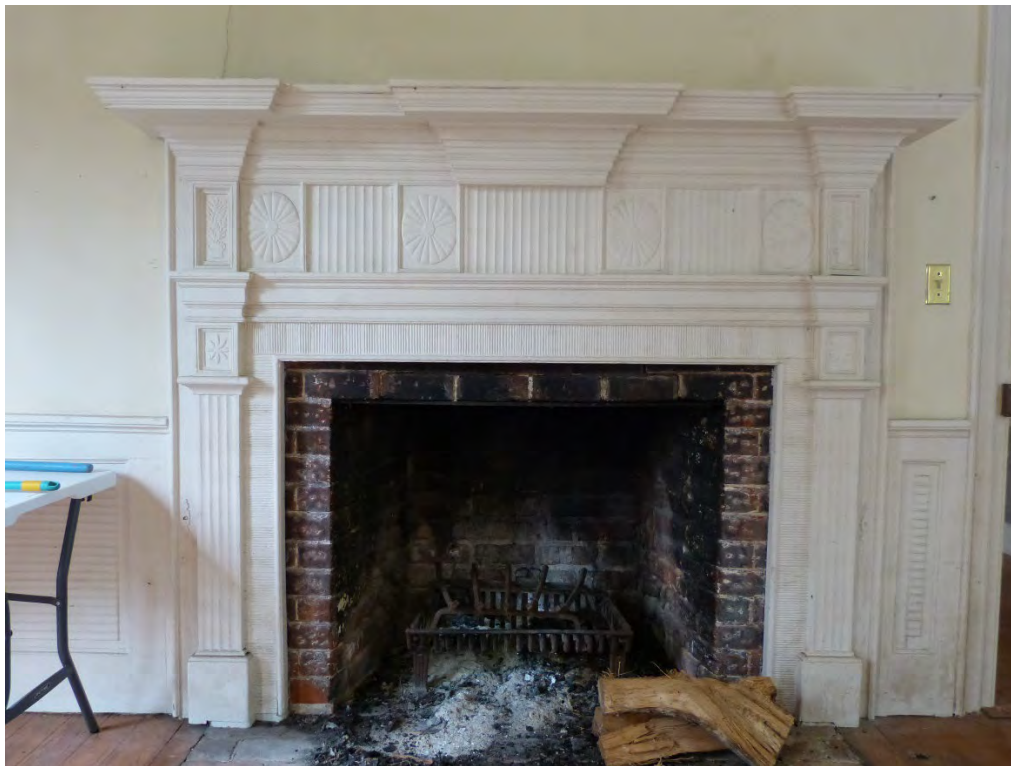
Figure 9: Period I Parlor, mantel.

At the north end of the parlor is a Neoclassical wooden mantel replete with fluted pilasters, and a highly decorative frieze of elongated, bas relief, sunburst paterae alternating with vertical fluted blocks and terminated at each end by carved foliage sprouting from an urn in the molded recess of the corner brackets. The mantel is terminated by a molded shelf. Several layers of paint now cover some of the intricate carving and obscure any early variegated paint schemes that may have emphasized these details. The room is lit by two, 15-light windows on the east and west walls.

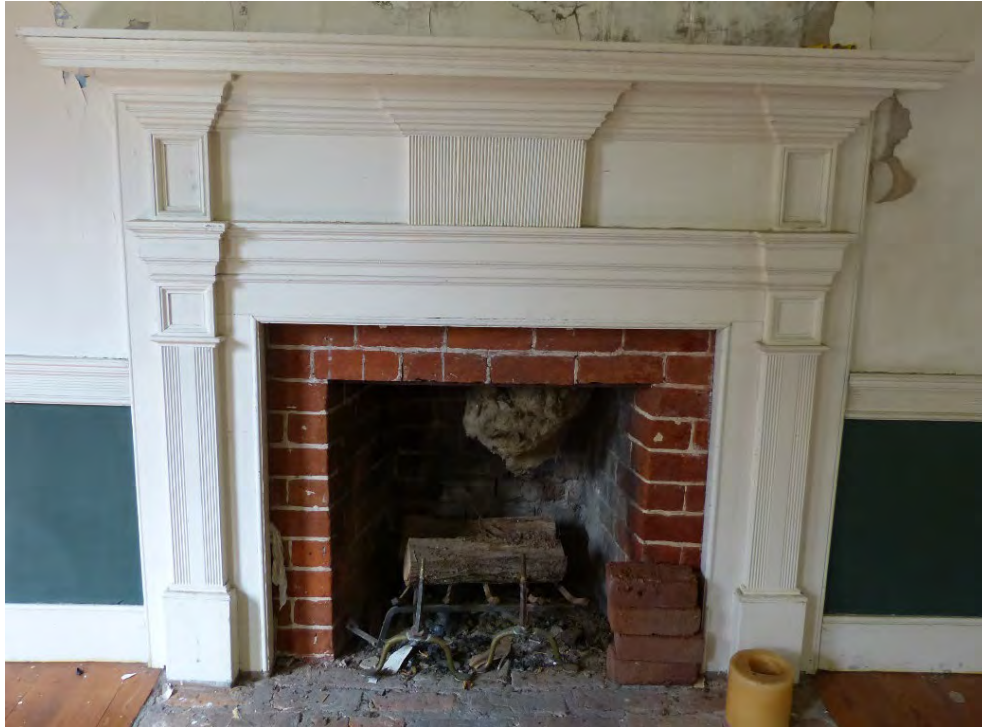
Figure 10: Period II Second Floor Bedroom, mantel.

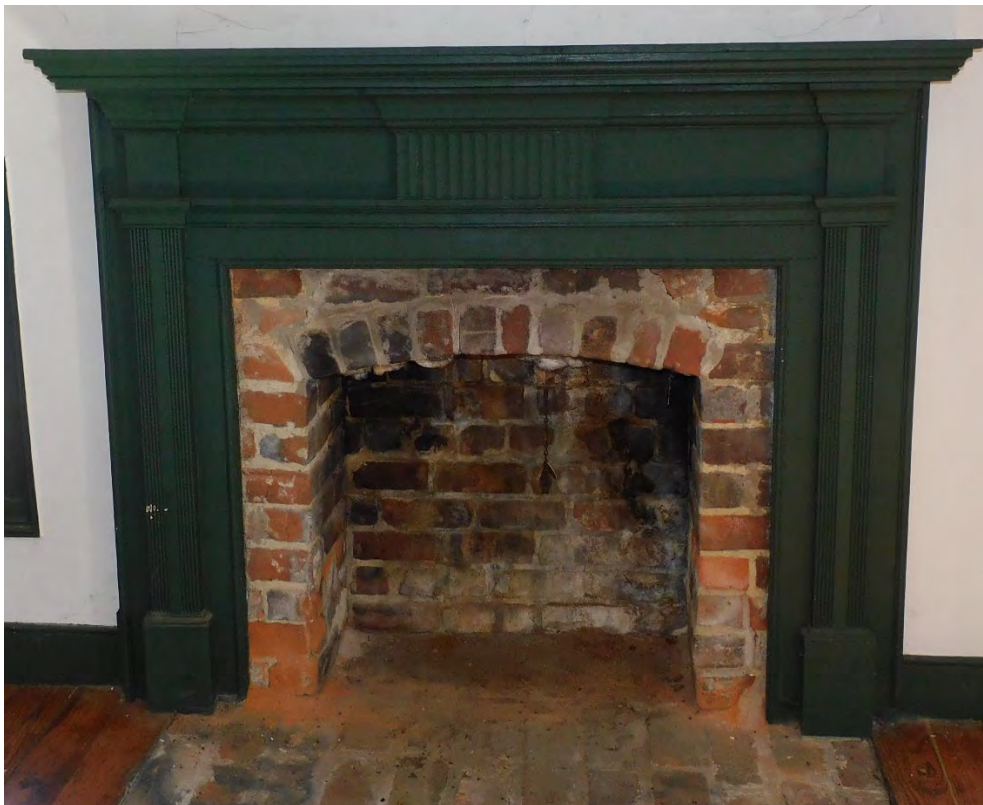
Figure 11: Period II Second Floor North Bedroom, mantel.
