PRELIMINARY INFORMATION FORM (PIF) for INDIVIDUAL PROPERTIES

Property name: Creek Hollow Farm (053-6284)

Property address: 38570 Cassia Lane

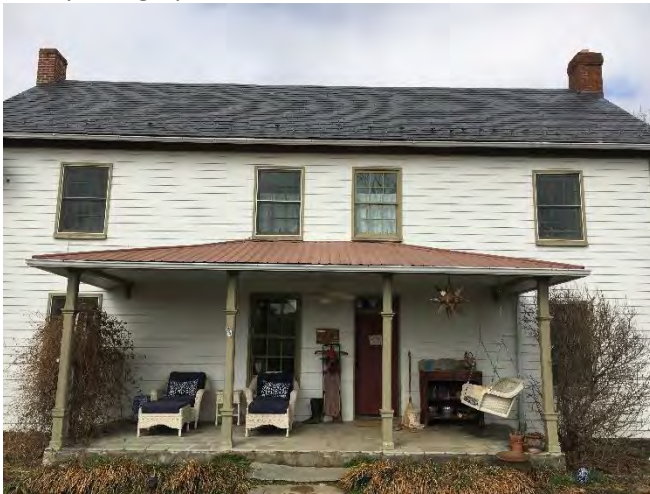
Photo 1 of 29: VA_LoudounCounty_CreekHollowFarm_0001
View: Primary dwelling, façade (south elevation), camera facing north
Photographer: Lori Kimball
Date photographed: March 2019

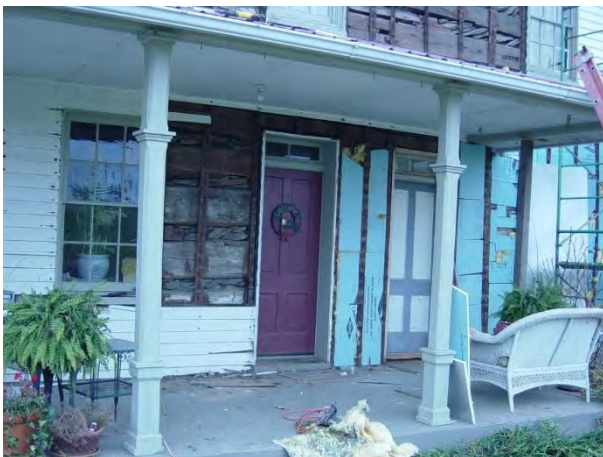
Photo 2 of 29: VA_LoudounCounty_CreekHollowFarm_0002
View: Primary dwelling, façade (south elevation), camera facing north, first story exposed during re-siding project in early 2000s, double entry doors visible
Photographer: Alan and Pattie Svedlow
Date photographed: early 2000s

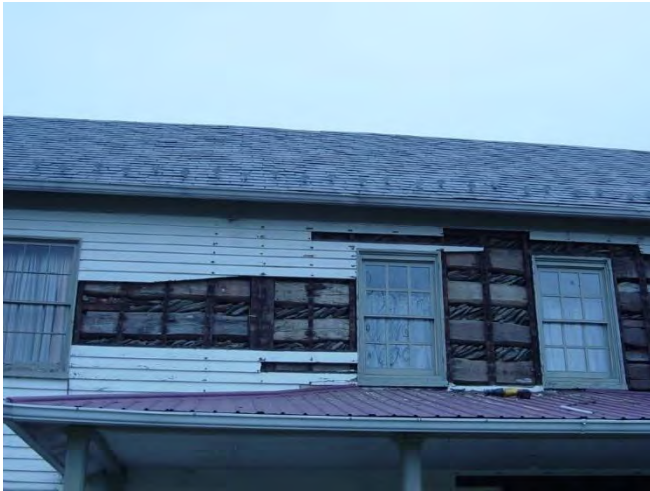
Photo 3 of 29: VA_LoudounCounty_CreekHollowFarm_0003

View: Primary dwelling, façade (south elevation), camera facing north, second story exposed during re-siding project, log construction

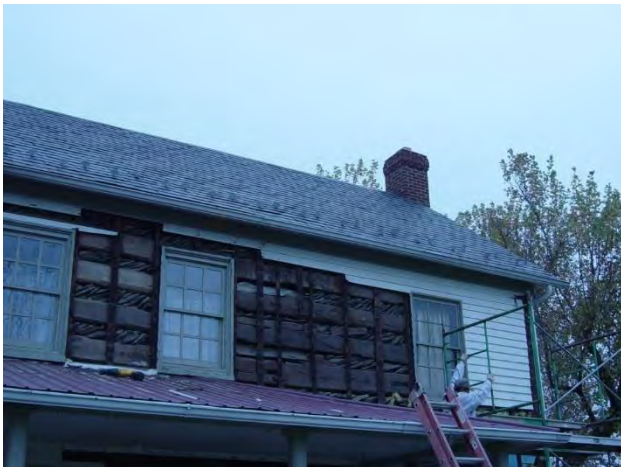
Photo 4 of 29: VA_LoudounCounty_CreekHollowFarm_0004

View: Primary dwelling, façade (south elevation), camera facing north, second story exposed during re-siding project, log construction

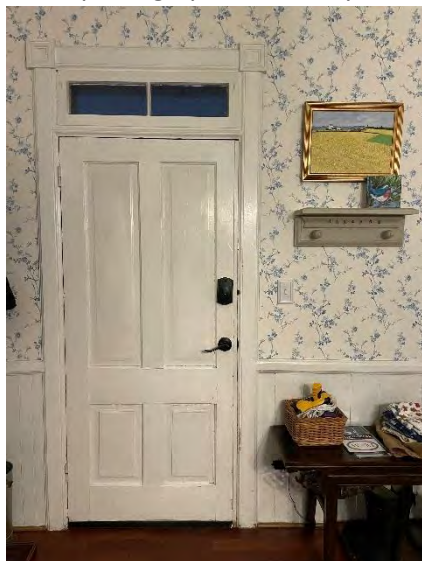
Photo 5 of 29: VA_LoudounCounty_CreekHollowFarm_0005

View: Entrance Hall door with ornamental trim

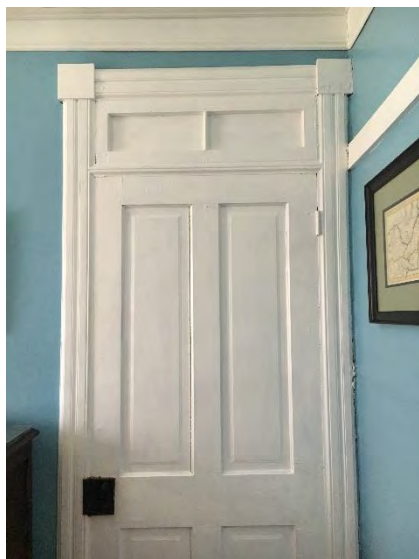
Photo 6 of 29: VA_LoudounCounty_CreekHollowFarm_0006

The I-house contains three rooms: a large center entrance hall with a winder staircase to the second floor; a parlor on the east, once accessed by the now unusable door; and a parlor on the west. The east parlor has beveled window and door molding with flat ornamental blocks at the top corners of the windows and doors. The original fireplace surround has beveled, oblong ornamentation. This room would have been the formal parlor as the west parlor is accessed from the entrance hall. The fireplace mantel has been replaced in the south parlor.

View: east parlor door with ornamental trim

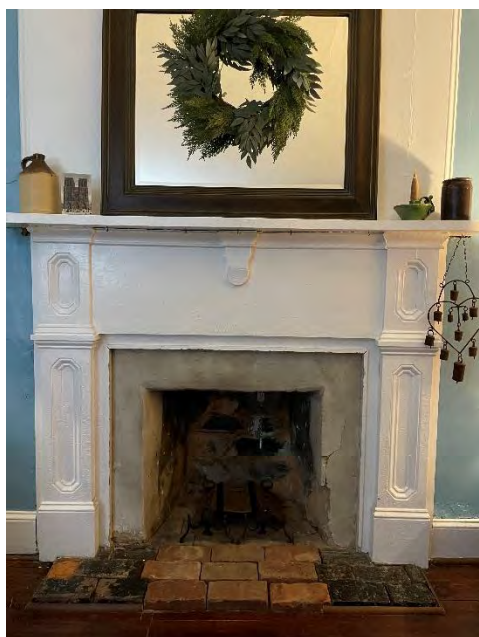
Photo 7 of 29: VA_LoudounCounty_CreekHollowFarm_0007
View: east parlor fireplace
Photographer: Natalie Metzler
Date photographed: January 2023

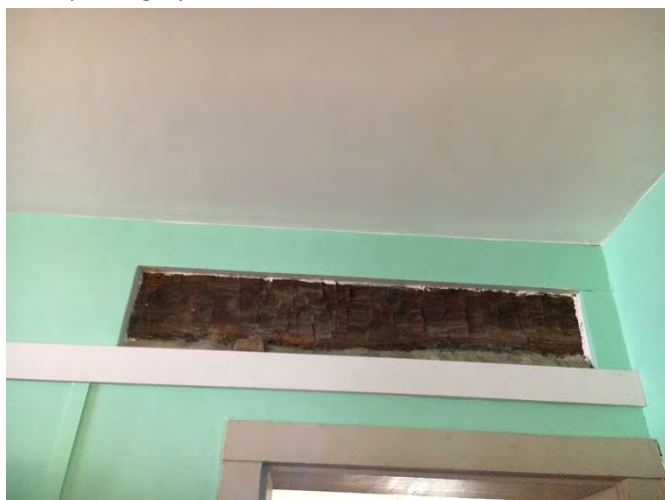
Photo 8 of 29: VA_LoudounCounty_CreekHollowFarm_0008
View: exposed hand-hewn log exposed in the kitchen
Photographer: Lori Kimball
Date photographed: March 2019

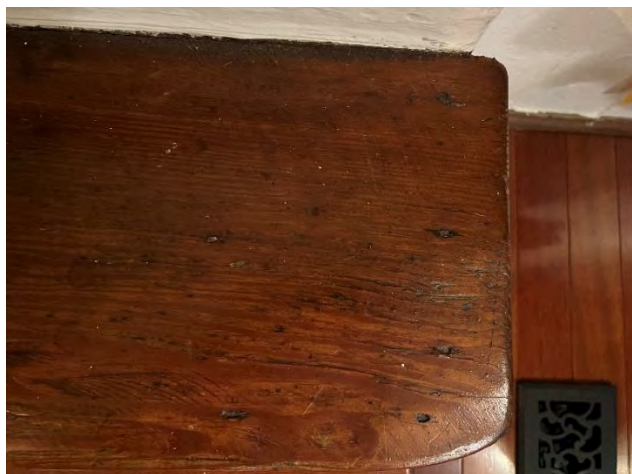
Photo 9 of 29: VA_LoudounCounty_CreekHollowFarm_0009

The entrance hall leads to a kitchen and dining room at the rear of the house. The dining room on the west side of the kitchen was once an open porch that was enclosed by a prior owner in 2010. There is an open porch on the east elevation, accessed through the kitchen. A winder staircase with visible hand wrought nails leads from the kitchen to the second floor. The kitchen is frame construction built on a stone foundation that is believed to predate the stone foundation of the I-house. Analysis by a historical tradesman in the early 2000s suggested the earlier building was taken down or burned down and was replaced with the frame structure that exists today.

View: exposed hand-wrought nails on kitchen staircase to second floor

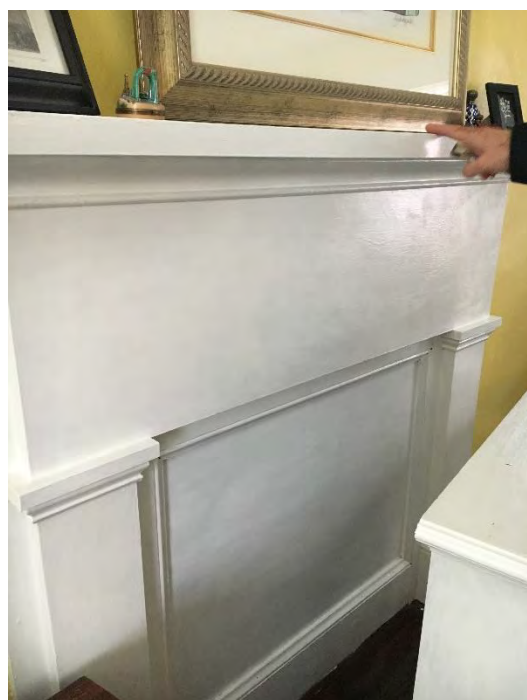
Photo 10 of 29: VA_LoudounCounty_CreekHollowFarm_0010

The master bedroom with original fireplace is located above the west parlor, and the adjacent bathroom is above the entrance hall. The hallway leads to a second bedroom with original fireplace above the east parlor. Like the mantel in the formal parlor on the first floor, the bedroom fireplaces exhibit a wide board panel supporting the shelf. A perpendicular hallway leads to a laundry room with original floorboards and a bedroom above the kitchen. A winder staircase in the hallway provides access to the attic. Several beams in the attic have exposed bark. A piece of wood carved with "1882" was found in the attic during an early 2000s renovation, suggesting modifications to the I-house, possibly as Samuel George's family was expanding.

View: fireplace mantel in master bedroom on 2nd floor

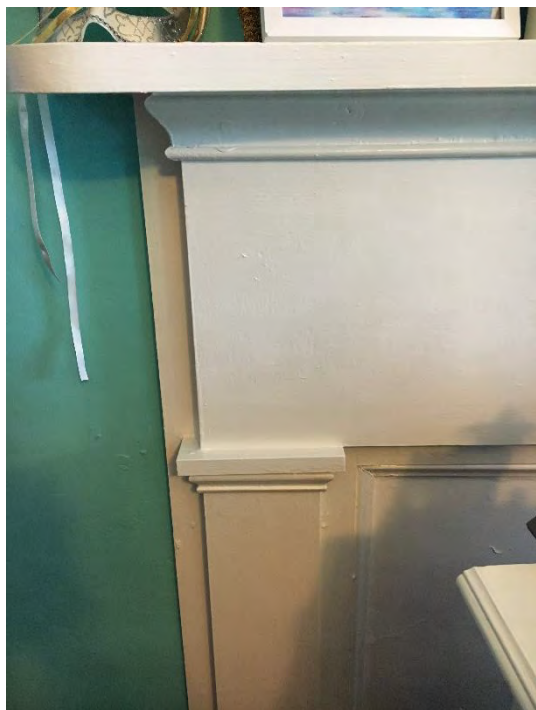
Photo 11 of 29: VA_LoudounCounty_CreekHollowFarm_0011
View: fireplace mantel in 2nd floor bedroom
Photographer: Lori Kimball
Date photographed: March 2019

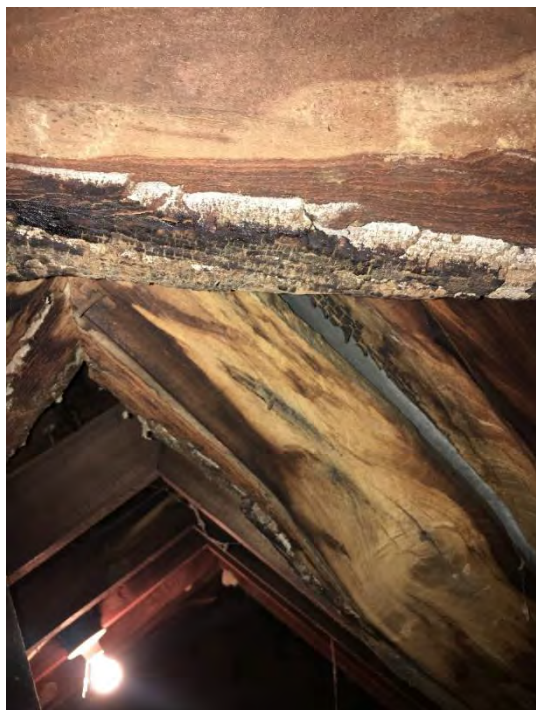
Photo 12 of 29: VA_LoudounCounty_CreekHollowFarm_0011
View: beam with exposed bark in attic
Photographer: Lori Kimball
Date photographed: March 2019

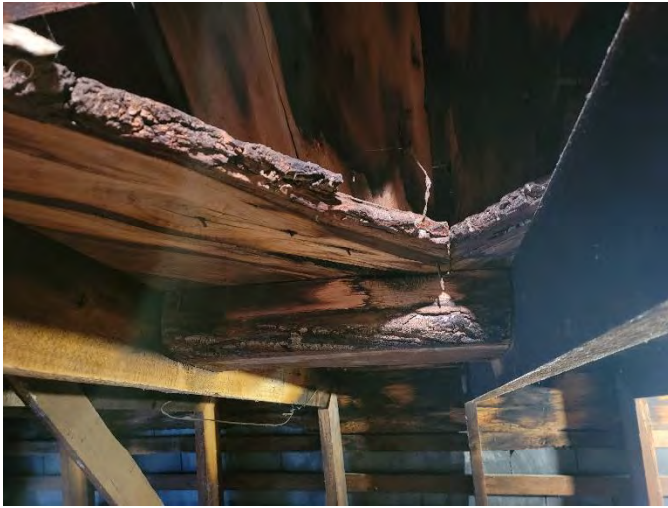
Photo 13 of 29: VA_LoudounCounty_CreekHollowFarm_0013

View: intersection of the kitchen and l-house, photographed in the attic, use of square nails

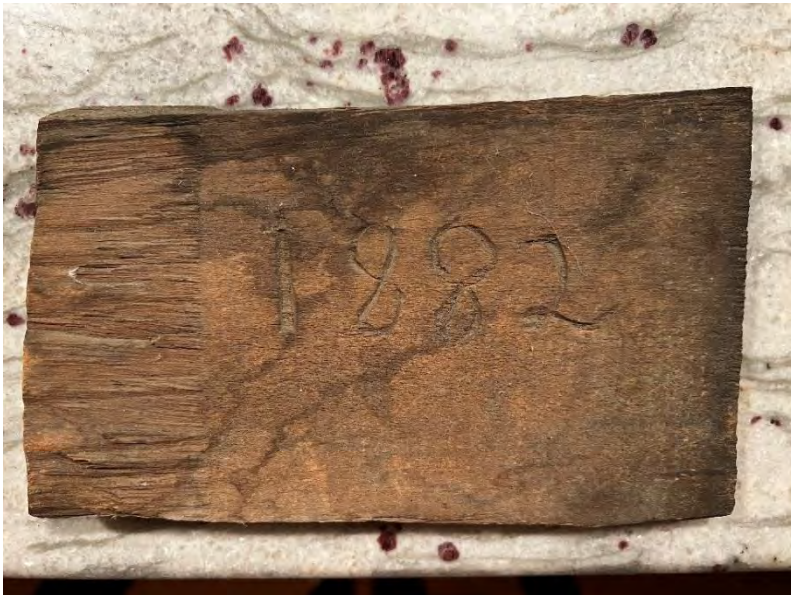
Photo 14 of 29: VA_LoudounCounty_CreekHollowFarm_0014

Samuel farmed the land, and over time, purchased his three siblings' interest in the property. He expanded his land holdings by acquiring adjacent or nearby farms. Modifications of some sort were made to the dwelling in 1882 as evidenced by the carved piece of wood found in the attic. Samuel became a full owner in 1891 after his mother's death the prior year. Land tax records indicate a new building was added in 1891, possibly the large frame barn that once stood across the creek.

View: wood carving found on a board in the attic

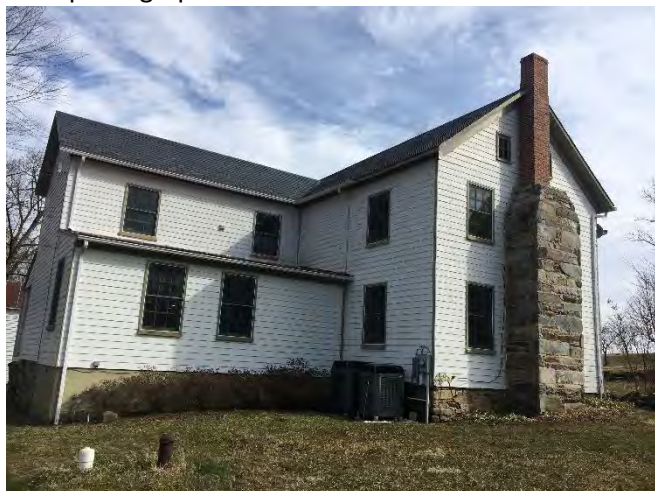
Photo 16 of 29: VA_LoudounCounty_CreekHollowFarm_0016

View: west and north elevations of house with springhouse and cookhouse in background (before restoration of outbuildings), camera facing east

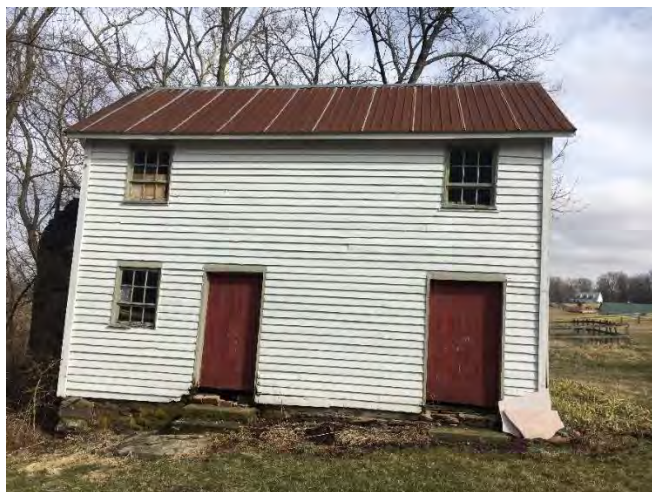
Photo 18 of 29: VA_LoudounCounty_CreekHollowFarm_0018

The cookhouse is the most significant of the contributing structures. It is a combination of frame construction and mortise and tenon around the fireplace. Two entrance doors lead to a large open area with a winder staircase to the second floor. A small room on the first floor has the original metal, long, sliding lock that closes off the room from the rest of the space. The large stone fireplace had a massive beam to support the chimney, representative of early- to mid-19th century construction. The fireplace had crumbled during the

View: cookhouse façade before restoration, camera facing east

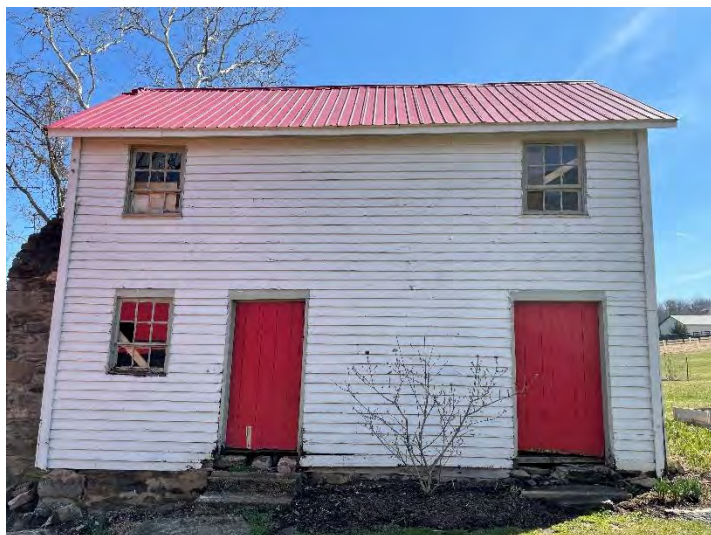
Photo 19 of 29: VA_LoudounCounty_CreekHollowFarm_0019
View: cookhouse façade after roof replacement, camera facing east
Photographer: Natalie Metzler
Date photographed: March 2022

20th century and was recently restored. A sub-floor was installed, and the original wide floorboards re-installed. The old standing seam metal roof was replaced with a new roof of the same materials. Hand wrought nails and other forged metal work are visible in the cookhouse, and hand-wrought metal pieces were found underneath the floorboards. It is not clear if part of the building had been modified in the late 19th-century, possibly enlarging it from a half-story structure to a two-story. Its pre-Civil War use was probably living and working space for the people enslaved by the George family. After the war, two African American men lived on the Samuel W. George property, and this outbuilding could have been their dwelling.

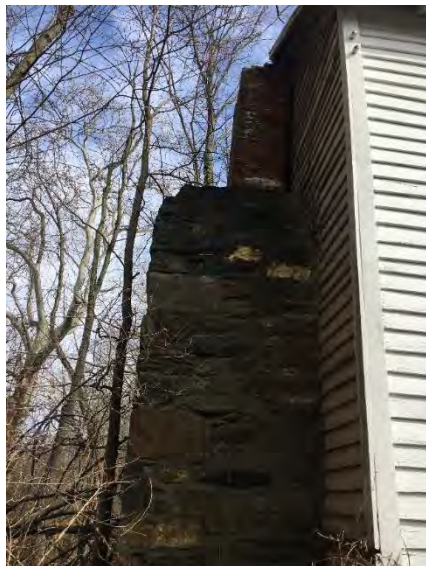
Photo 20 of 29: VA_LoudounCounty_CreekHollowFarm_0020
View: cookhouse chimney before restoration
Photographer: Lori Kimball
Date photographed: March 2019

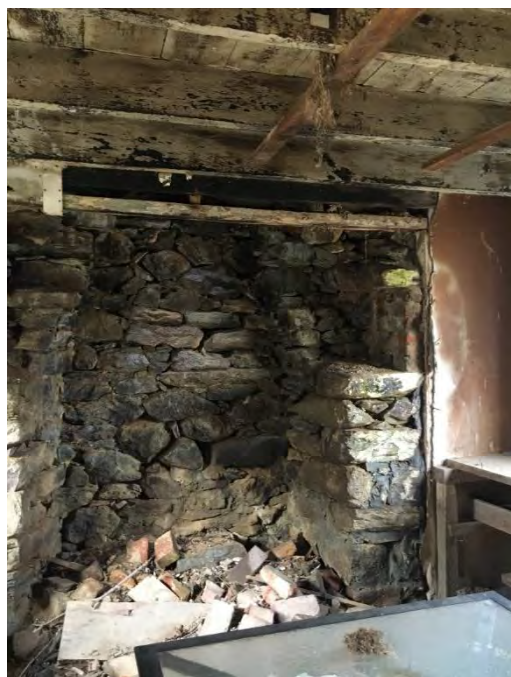
Photo 21 of 29: VA_LoudounCounty_CreekHollowFarm_0021

View: fireplace in cookhouse before restoration

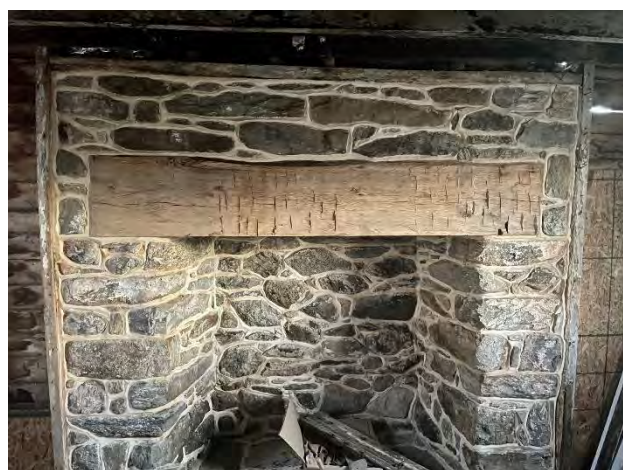
Photo 22 of 29: VA_LoudounCounty_CreekHollowFarm_0022

View: cookhouse fireplace after restoration

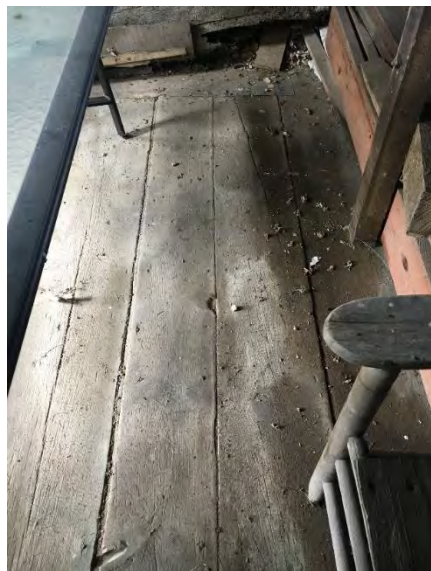
Photo 23 of 29: VA_LoudounCounty_CreekHollowFarm_0023

View: unfinished wide plank floorboards in cookhouse before restoration

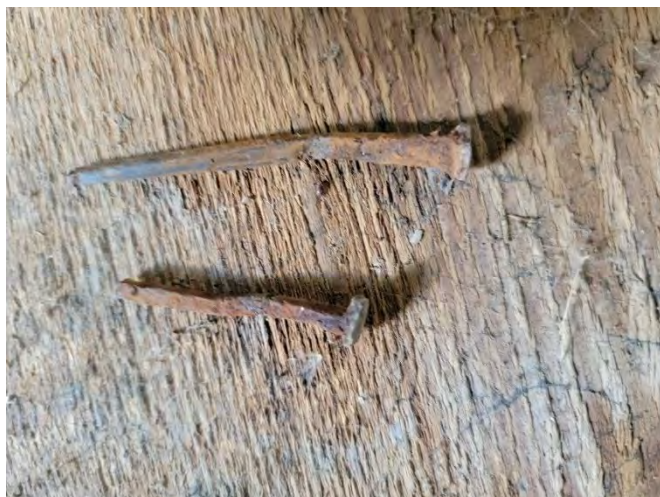
Photo 24 of 29: VA_LoudounCounty_CreekHollowFarm_0024

View: nails used in the cookhouse

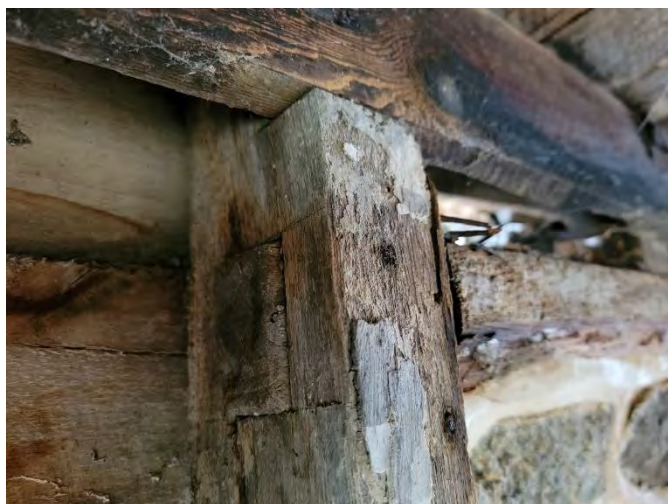
Photo 25 of 29: VA_LoudounCounty_CreekHollowFarm_0025

View: mortise and tenon construction around the cookhouse fireplace

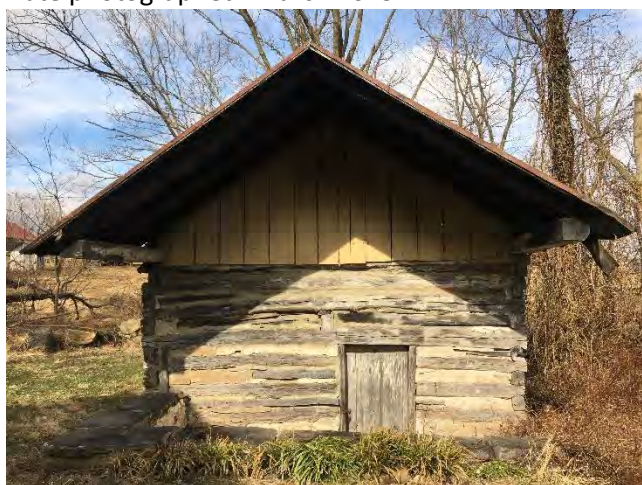
Photo 26 of 29: VA_LoudounCounty_CreekHollowFarm_0026

The one-story spring house is located behind the dwelling by the creek. It has rectangular hewn logs chinked with mortar. The standing seam metal roof forms a gable at the front, and the gables are clad in vertical boards. Estimated construction is early- to mid-1800s, and the building is in good condition.

View: spring house before restoration, camera facing north

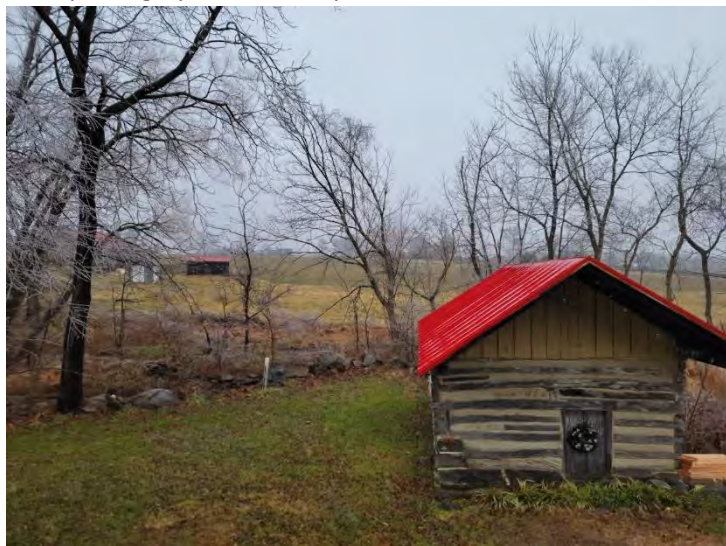
Photo 27 of 29: VA_LoudounCounty_CreekHollowFarm_0027

View: springhouse after roof replacement and restoration, camera facing north

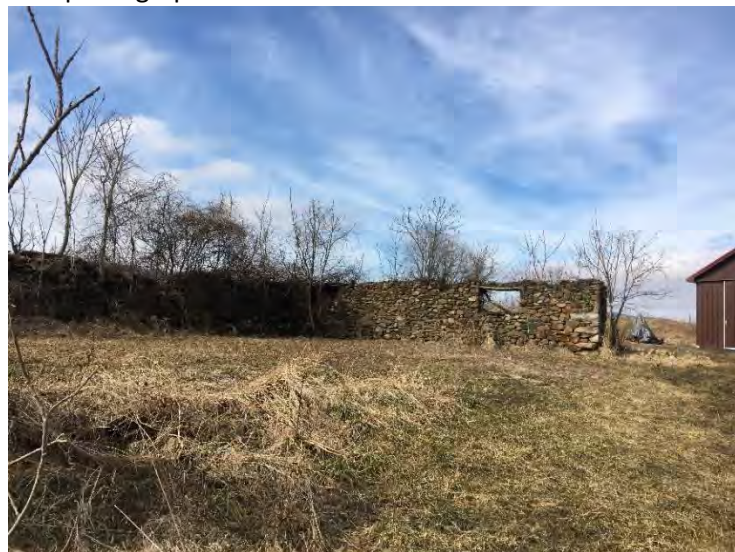
Photo 28 of 29: VA_LoudounCounty_CreekHollowFarm_0028

- One-story spring house of log construction – early- to mid-1800s – roof has been replaced – good condition – contributing
- Stone foundation remains of frame barn – ca. 1900 – non-contributing

View: stone foundation remains of ca. late 19th-century or early 20th-century barn, camera facing north
