DRAFT
HISTORIC STRUCTURES REPORT FOR
RETIREMENT
TOWN OF ABINGDON, VIRGINIA

25 July 2014

DAVIS BUCKLEY ARCHITECTS AND PLANNERS

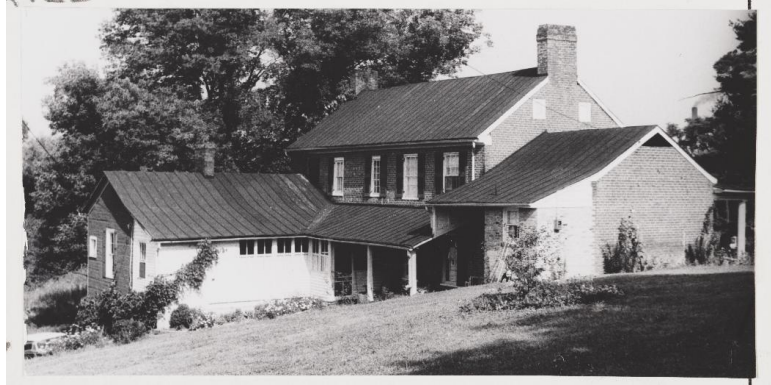
Figure A7: View of the rear, south façade of Retirement from 1937.
Source: Victoria Alice Gillam, WPA Virginia Historical Inventory, 4 March 1937.

Siding conditions in the 1937 photo suggest that the rear addition had been expanded west by 1937 (without altering the original roof), perhaps with the enclosure of an open porch, making it closer to twenty feet in width (See Figure A7).

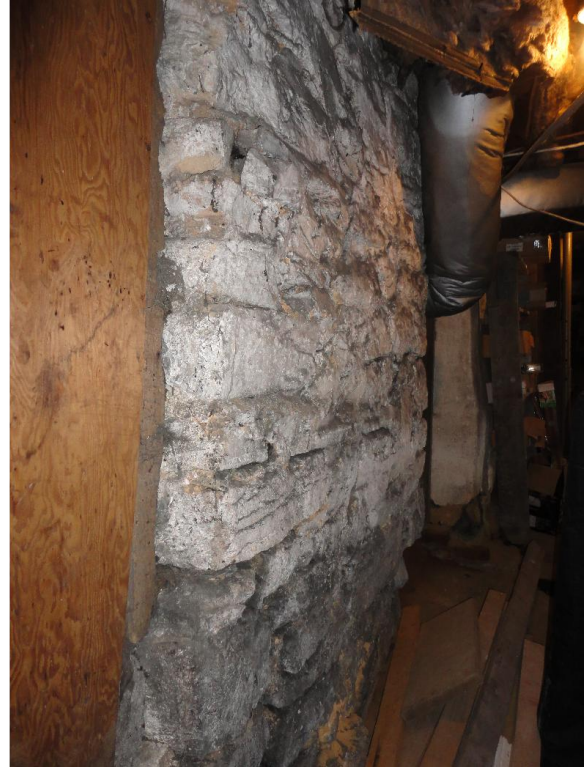
Figure A9: Original parged stone basement wall.

Built into the hill at the rear south façade, the two brick upper stories of the house sit upon a high basement. The basement level is of rough laid stone and brick, parged to create a smoother finish and improve the water resistance of the mortar joints of the foundations (Figure A9). Subsequent wood framed additions have subsumed this elevation at the basement and first floor levels, but much of the original fabric remains within the basement of Retirement. At the basement level, set into the foundation wall, a door opening stood roughly below the westernmost window, providing access to the basement from the rear work

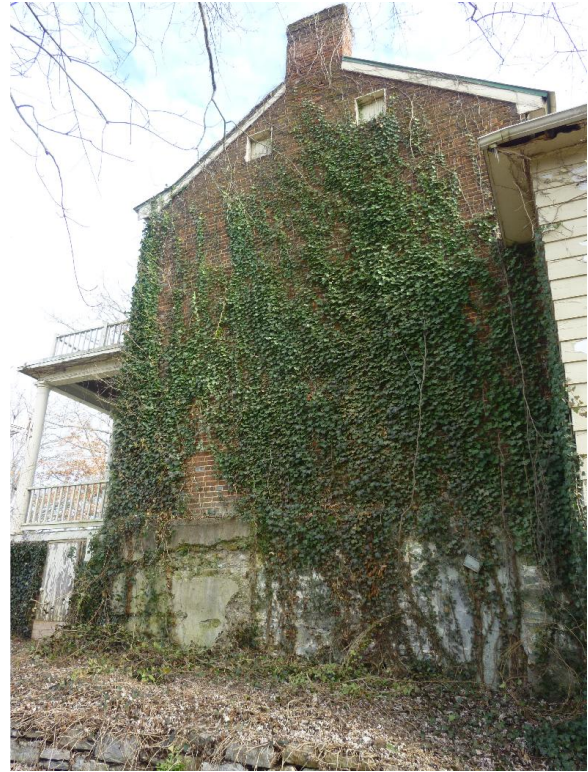
Figure A10: West Façade.

Set on land sloping to the south, the basement level of the west facade at Retirement I was rubble stone, perhaps parged (Figure A10). Later modifications and ivy growth on this side make it difficult to determine original conditions, but interior evidence suggests there were once windows or doors that stood to either side of the center chimney. Two full brick stories laid in common bond rise above the basement, but there are no windows at these elevations, and no stringcourses to define the floors. At the attic level, small unglazed wood casement windows stand on either side of the central chimney, which rises above the roof and culminates in a simple cap, with two courses of brick set proud of the main shaft of the chimney. A wood vergeboard likely covered the joint between the brick wall and the roof, although what currently exists is unlikely original.

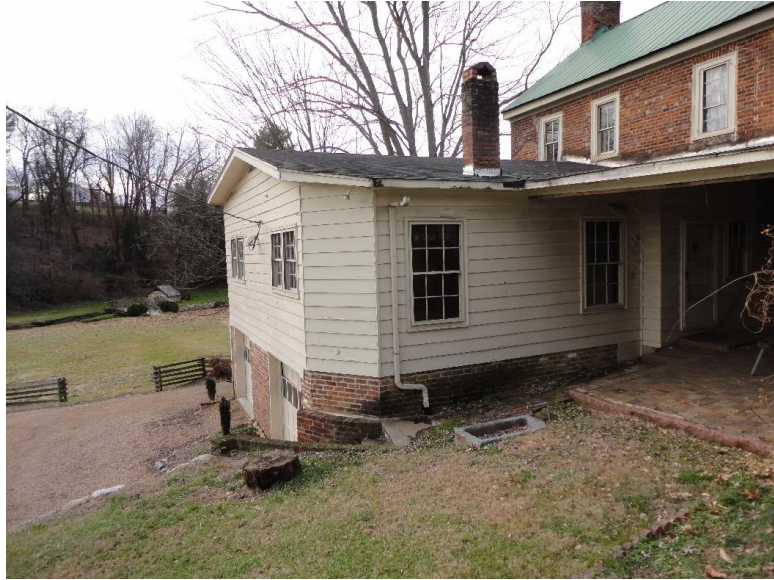
Figure A26: Evidence of the former peak of the rear addition roof visible in the masonry wall at the western window.

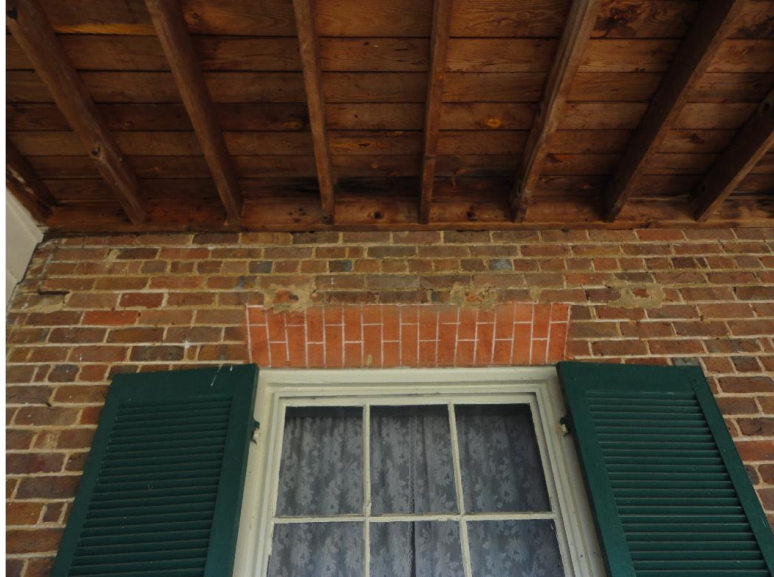
Figure A28: Brick tinting and mortar joint chalking at the south facade.

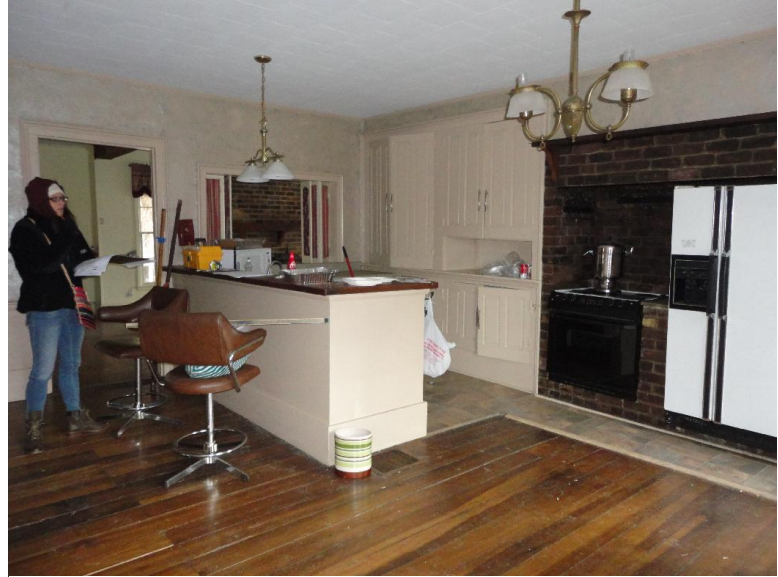
Figure A30: Kitchen 108. Brick hearth with the stove and refrigerator was removed in February 2014.

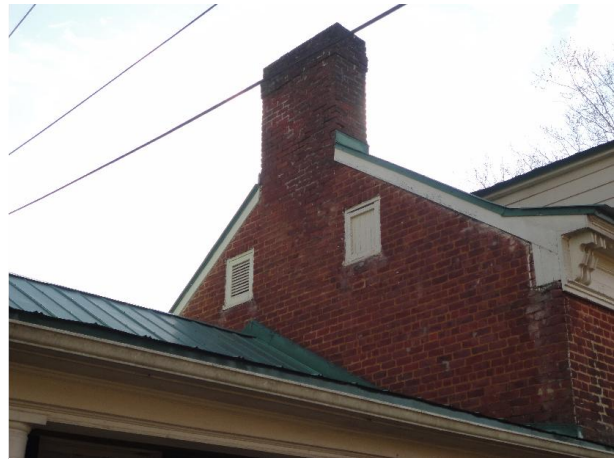
Figure A39: East chimney.

Wood roof eaves are likely deteriorated, although the ivy makes it difficult to see. The wood attic vent requires repair. The upper courses of the chimney show signs of water infiltration and displacement (Figure 39). The brick at the Judge's Chambers' bathroom, constructed in the twentieth century, is harder, and is in generally good condition, although ivy makes full observation difficult. The pressed wood siding on the east façade of the rear wood addition suffers soffit rot and paint failure.

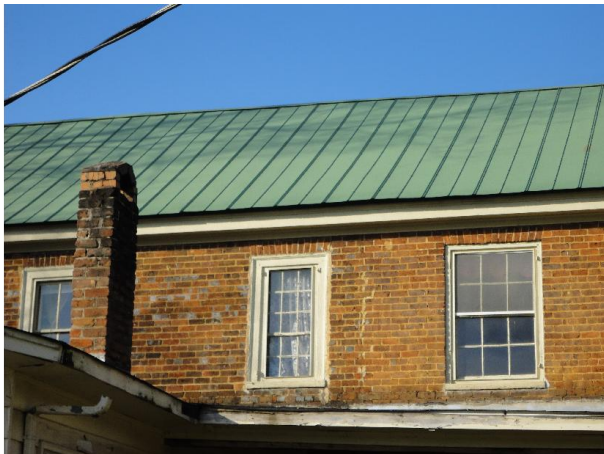
Figure A40: Visible joint between Retirement I and II.

Portland cement-based cracking failure is visible throughout the main masonry façade. The joint between the original building and the Fulkerson addition is plainly visible at the second floor (Figure A40). The heavy timbers

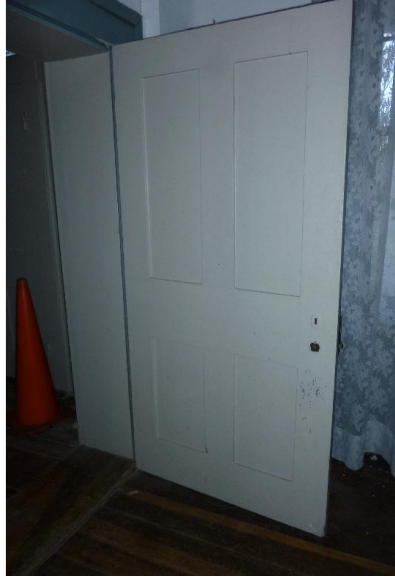
Figure A50: Door D10 showing flat panels.

- iii. D03 – Late twentieth century two paneled folding doors.
- b. First Floor
- i. Door D10: 4 panel door with raised panels facing into the Parlor (Room 101). There are cracks in the lower panels that should be filled and repainted (Figures A49 and A50).

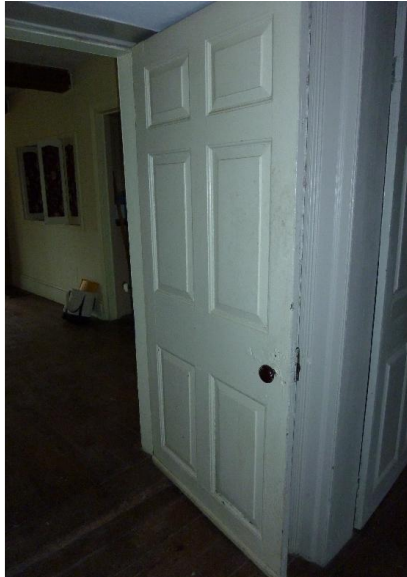
Figure A52: Door D13.

- iv. D13: A solid wood, six-paneled door with raised panels, matching D14, this is likely the original entry door for Retirement I, relocated to the new rear exit during the Retirement II project. While in need of repainting, the door is in good condition (Figure A52).

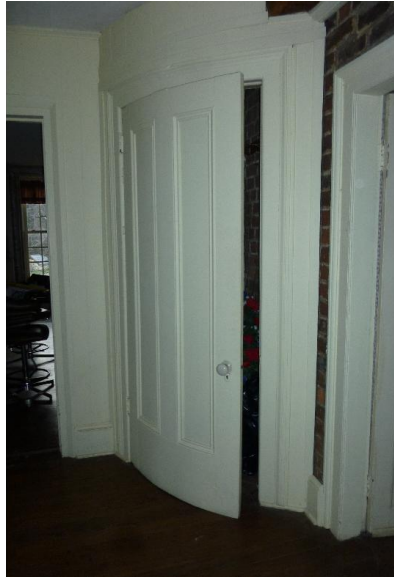
Figure A53: Door D16.

- vii. D16: Curved two paneled closet door salvaged from another house in the county (Figure A53). The door is well-maintained and in good condition.
- viii. D17: A four raised paneled door that does not resemble the Retirement II doors in proportion or panel profile. The door is well-maintained and in good condition.

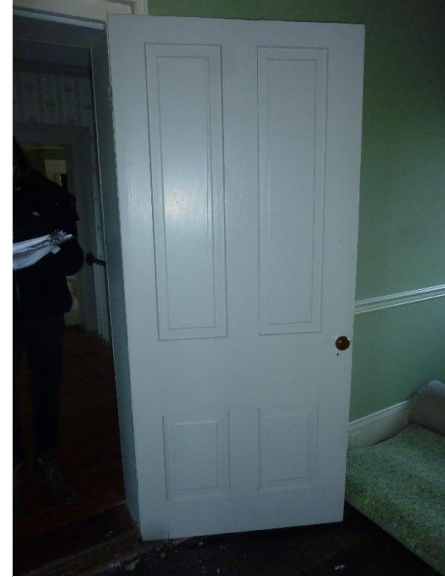
Figure A56: Door D25.

- xv. D24: Paired six raised-paneled closet doors, likely dating from the Dunn occupation (Figure A55). Doors in good condition.
- xvi. D25: A four-paneled, raised panel door (Figure A56). This door has raised panels on both sides, so of a higher level of finish than the door D10, dating from the Retirement II project. This door opening may have been in this location in the Retirement I phase, or it may have been relocated during the construction of Retirement II. The door is in good condition.

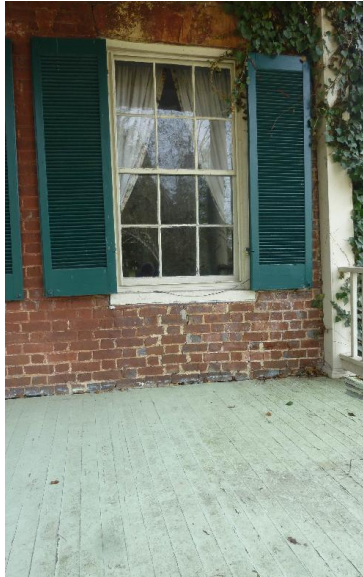
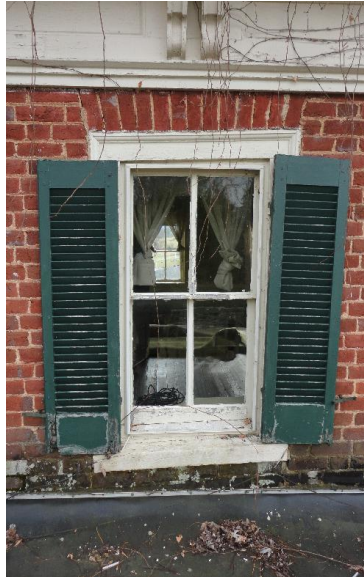
Figure A59: Window W100

Figure A60: Window W201.

Windows at Retirement were installed in five campaigns. All are wood windows. All windows are in fair to poor condition, requiring wood repair, reglazing and repainting (Figure A57). Wood window frames, and particularly sills, are in need of wood repair and repainting (Figure A58).

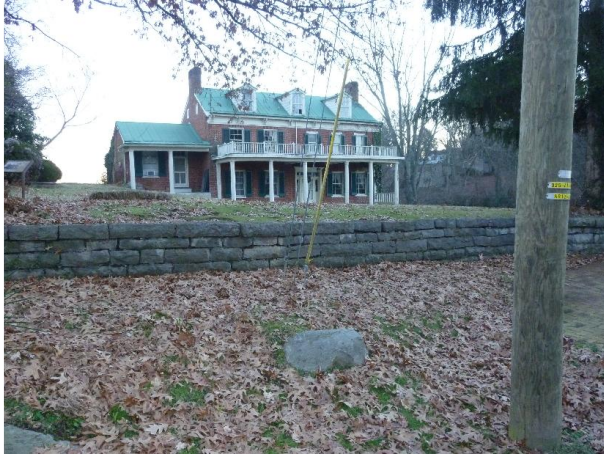
Figure A62: New metal roof.

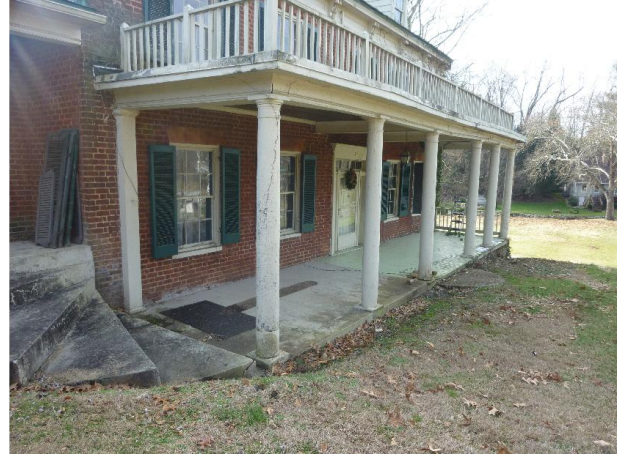
Figure A63: Front porch.

The wood elements of the porch are currently in poor condition (Figure 63). The western section of the porch suffers cracking related to the displacement at the northwest corner of the building. The bottom sections of most columns have been replaced, but all are rotted, and in need of repair and repainting (Figure A64). The wood flooring at the west side of the porch is warped and rotted. The concrete porch floor at the east end is in fair condition, but the curving concrete stairs leading up to the Judge's Chambers are cracked and failing (A65).

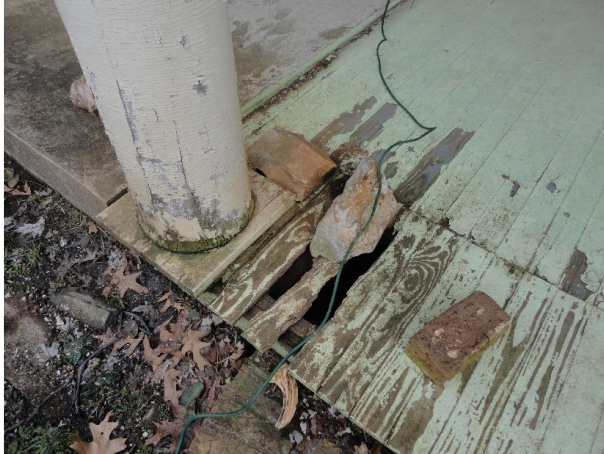
Figure A64: Rotted porch columns and flooring:

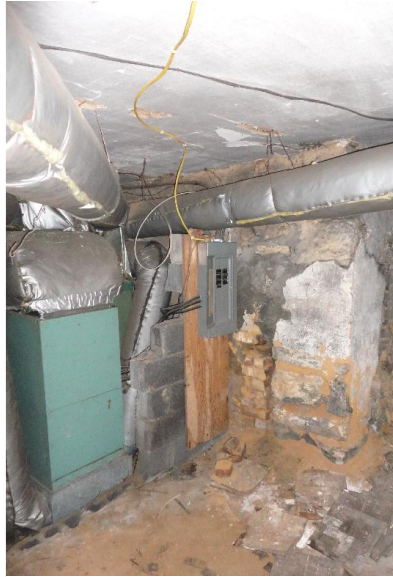
Figure A67: Furnace in Retirement I basement.

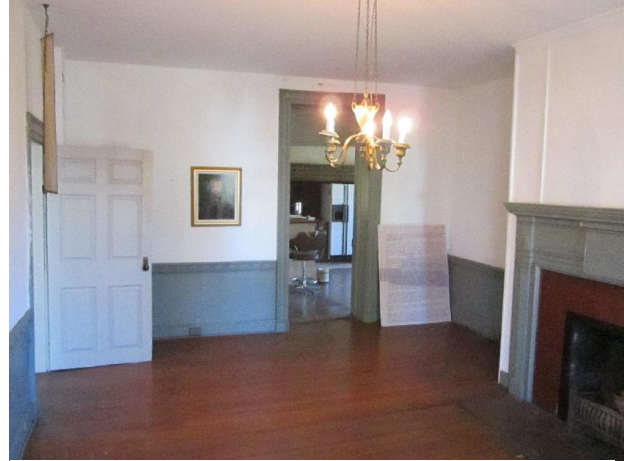
Figure A70: Living Room 109. *Source: LPA*

The walls and ceilings in Living Room 109 are wood lath and plaster, with an even-toned wood plank floor below (Figure A70). A wood baseboard and wainscot rises to a decorative chair rail, and two closets are tucked behind the fireplace on the west wall. There is no cornice trim. A hairline plaster crack on the west wall, runs to the northwest corner of the structure, which appears to be a result of the displacement at the northwest corner. There is also some minor paint failure above the door on the south wall.

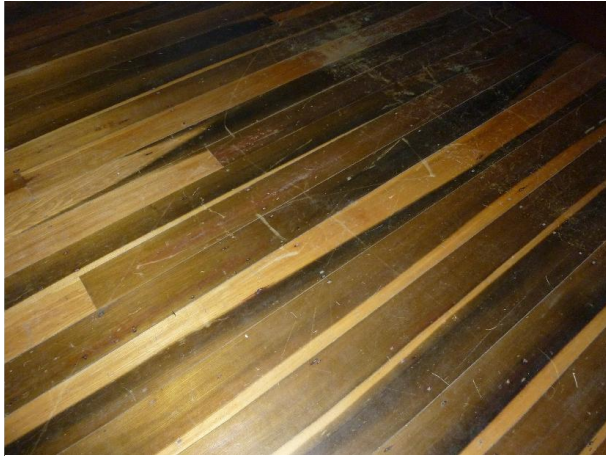
The Parlor has wood lath and plaster walls and ceilings. A baseboard and decorative chair rail encircle the room. The tone of the wood floor varies widely, suggesting it was always intended to be covered. The floor exhibits deep gouges, which may have resulted from bug infestation, as well as scratches related to use (Figure A71).

Figure A71: Varied tones and scratches Parlor 101 floor.

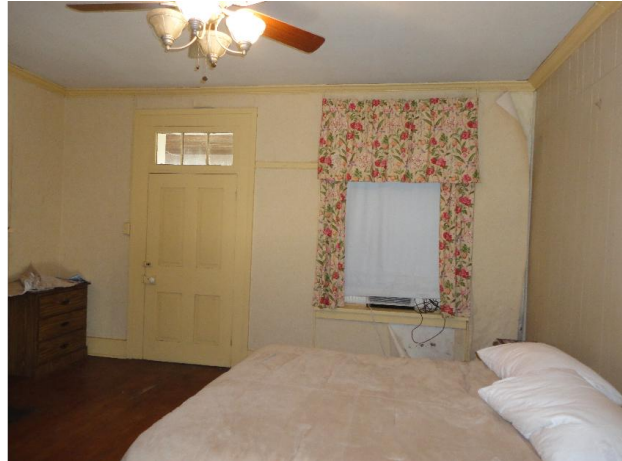
Figure A72: Judge's Chambers 102.

The north, south and west walls of the Judge's Chambers are plaster, with a high wood baseboard and a modest cornice trim, leading to a new gypsum ceiling (Figure A72). The east wall is finished with a faux-wood paneling. Twentieth century wood planks finish the floor. Mold is visible on several of the walls, and the new wall and floor finishes suggest prolonged water infiltration, likely primarily rising damp from below. Bookshelf and closet cabinetry is built into the wall south of the fireplace. The adjacent bathroom has vinyl tile flooring, a high tile pressed wood wainscot, gypsum walls and ceiling, and includes a sink, toilet and shower.

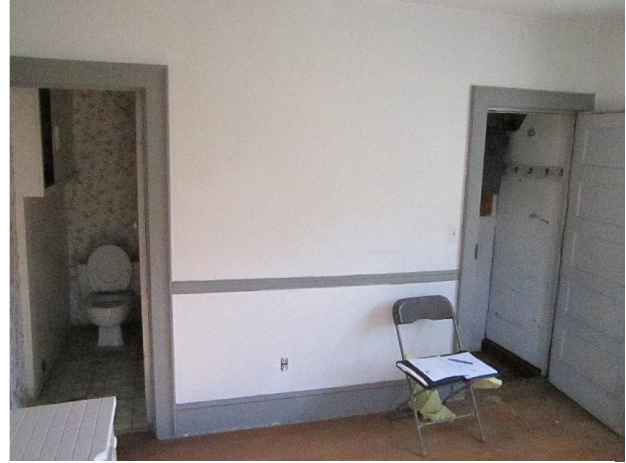
Figure A74: Servants Bedroom 107. *Source: LPA*

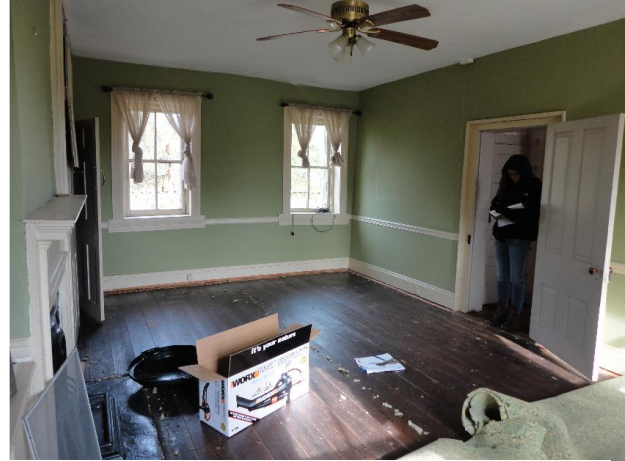
Figure A76: Bedroom 205

Dating from the Retirement I phase, this room was remodeled in the Dunn period. Plaster walls and ceilings remain, but modern baseboard and chair rail were installed and new trim was added around the windows (Figure A76). Carpeting was installed over the historic wood floor. A new desk and a new closet now flank the fireplace on the west wall. Closet 206 a large crack along the north wall evidences the systemic failure of the foundation at this northwest corner. Water infiltration is present in the wall.

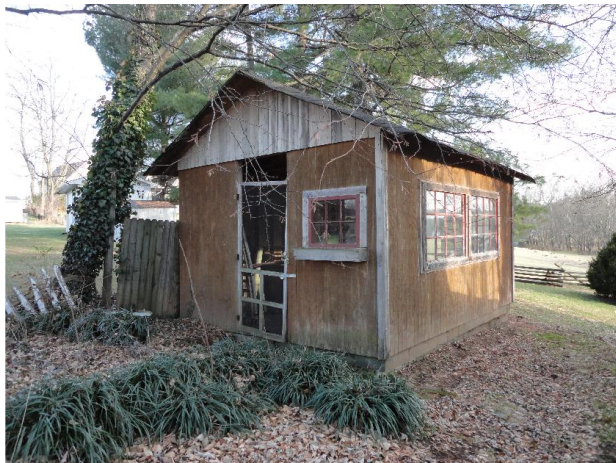
Figure A79: Storage shed.

The storage shed is located to the east of the Outbuilding (Figure A79). It is a wood structure on CMU foundation consisting of four windows and two doors. Canoes and other town items are currently being stored here. Lightly built, it appears to be in good condition. The stable is located down the hill and to the southeast of the Outbuilding (Figure A80). It is a wood structure that seems to be unused, and is in need of some wood repair.

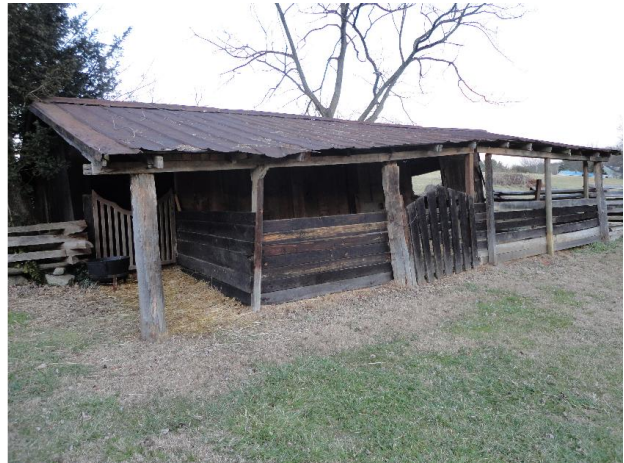
Figure A80: Stable

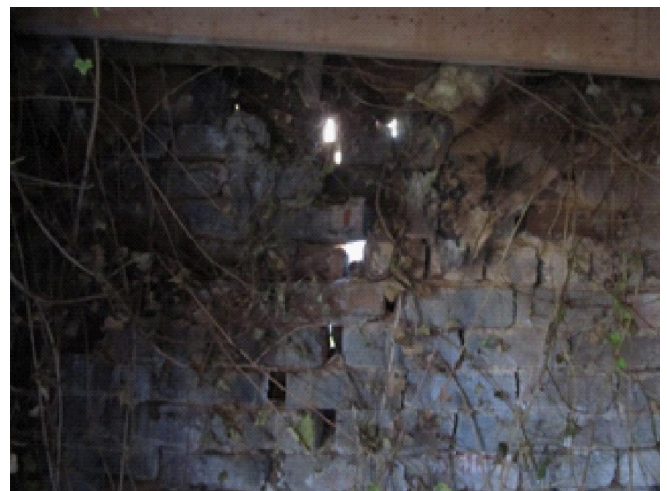
The west chimney is still in place and the foundation wall/flue protrudes into the floor space. The remnants of an abandoned chimney are still in place in the basement. The original foundation wall for the chimney is present and serves as floor support. The opening has since been infilled and is at the same location as the central staircase (Figure S2).

Figure S2: Foundation wall at front porch

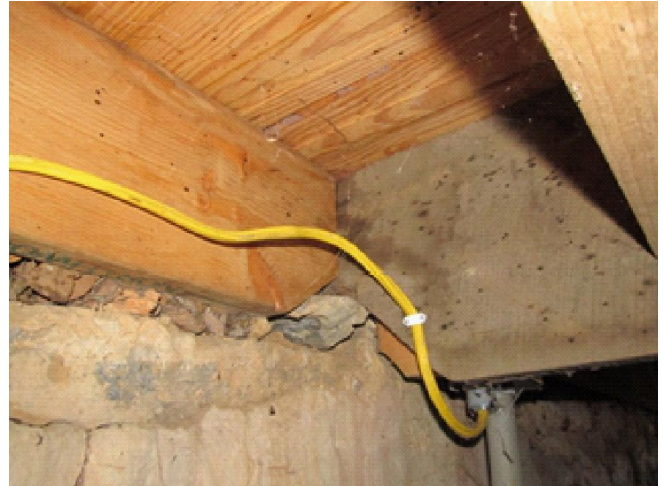
Figure S4: Porch framing

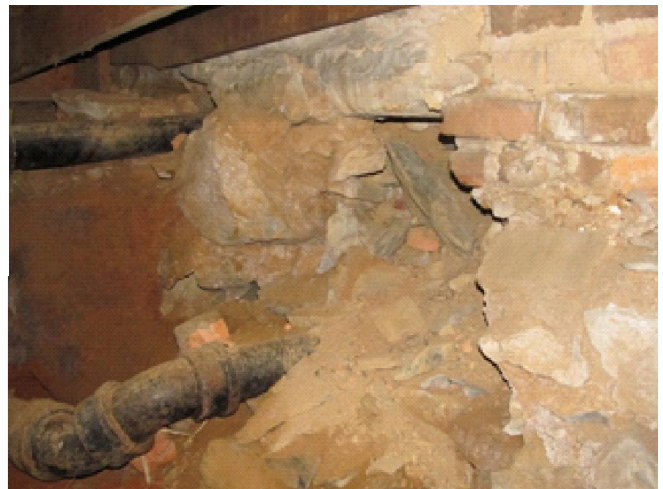
The header lintel above the exterior access door is in poor condition. Holes have been created within the main building (stone) foundation wall for pipes (Figure S5).

Figure S5: Pipes at access door at northwest corner of Retirement I.

iv. Improve/repair stone foundation walls that are exposed between the porch and main basement area. Particularly at the rough openings that were not parts of the original work (pipe penetrations). This may be accomplished with the addition of mortar to the joints and/or restacking stone. Areas at pipe penetrations require re-building and adding sleeves for pipe penetrations.

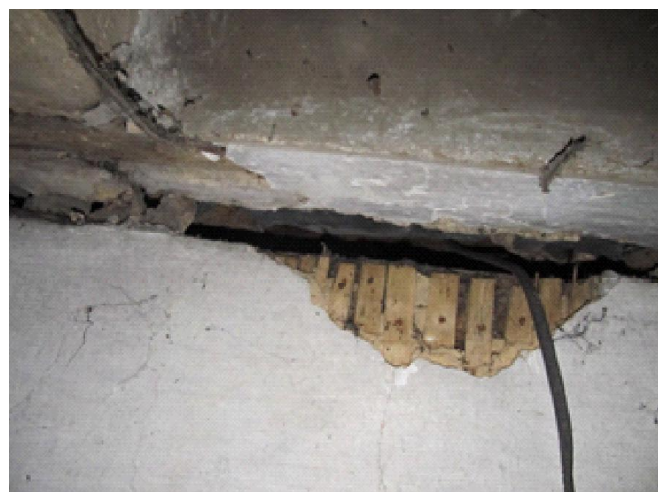
- Address bearing of girders upon post supports – most appear to be plain, unconnected bearing conditions. Some bearing posts appear to be offset or only partially supporting their beams/girders (Figure S6).
- The main heavy timber that bisects the building into two halves – this girder bears upon the chimney flue foundation wall on each end and partially upon a center support. This support should be strengthened or verified for adequate support. It is noted that the girder forms a ‘high point’ when walking on the floor. The framing to either side is slightly bowed.
- The typical beam to girder connection is a mortise/tenon connection. The joists have been trimmed to fit within a hole cut in the girder supports (Figure S7).

Figure S6: Bearing post condition.

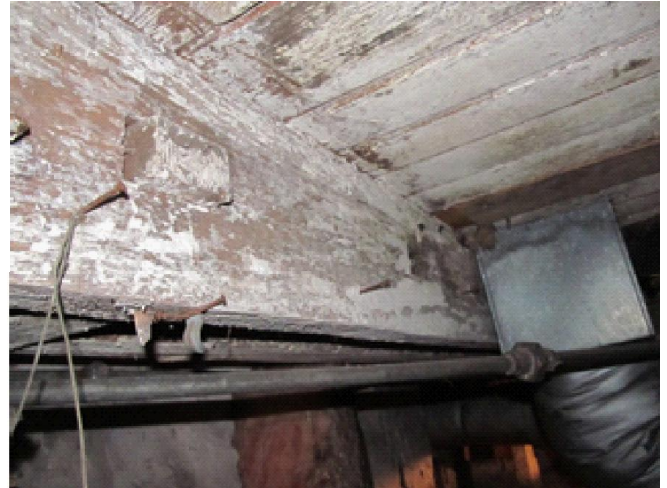
Figure S7: Mortise/tenon connection

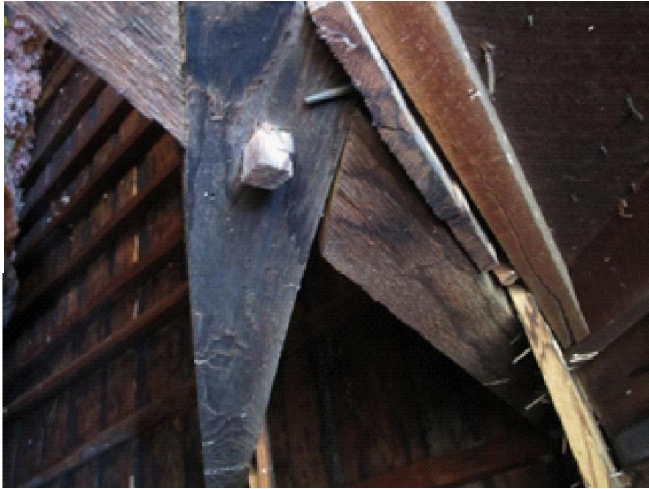
The attic is accessible through a closet ladder. The framing for this area is rough cut 3x8 rafters with wooden dowels and collar ties (Figure S10). The floor is framed using 3x8 joists. The framing appears sound – bearing connections (if any could not be verified) (Figure S11). Some gable brick is protruding into the attic space (Figure S12). Wood planking spans between rafters.

Figure S10: Attic framing at Retirement I

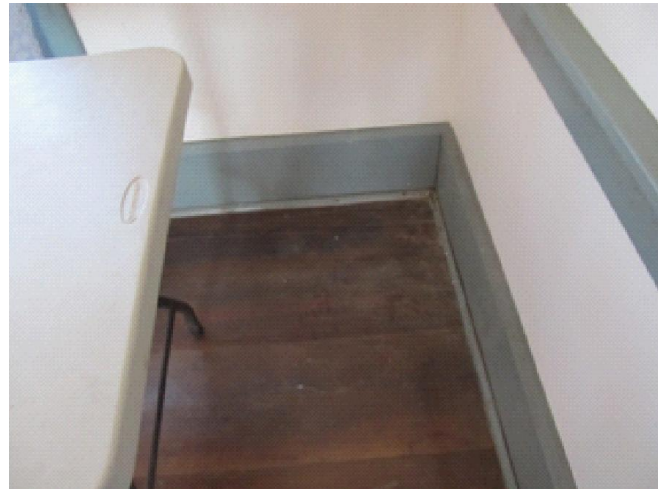
The floor framing is partially observable through a small opening in the original structure foundation wall at a duct penetration. Size and spacing was unattainable. It is noted that there is a distinct ‘soft spot’ in the floor at the northeast corner. (Figures S13 and S14). This is likely to water infiltration that has softened and rotted the subfloor framing.

Figure S13: Soft spot at northeast corner of Retirement II

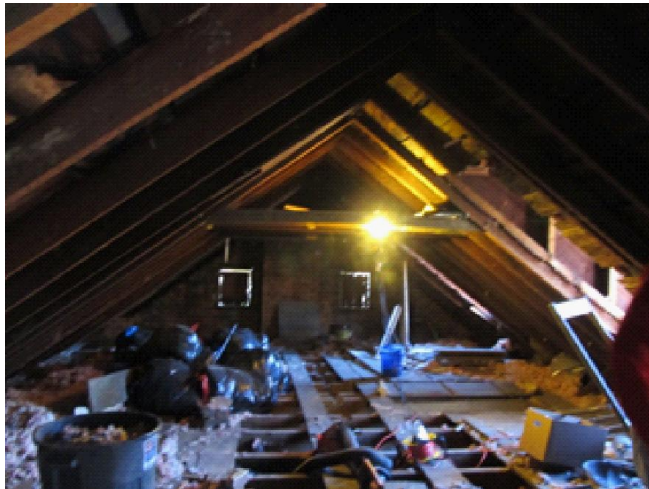
Figure S11: Attic framing

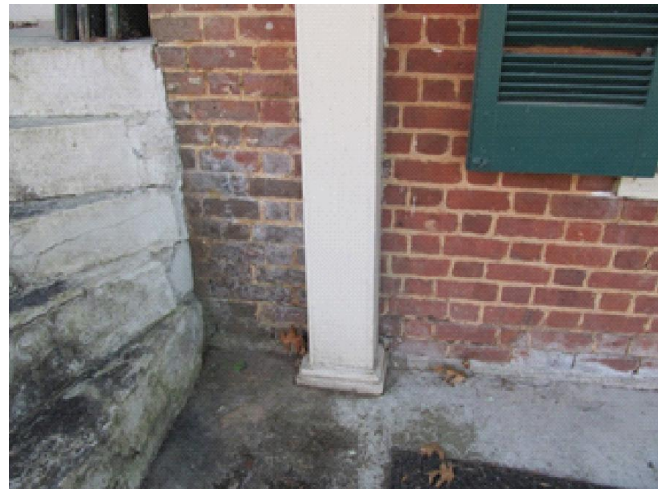
Figure S14: Rising damp at northeast corner of Retirement II

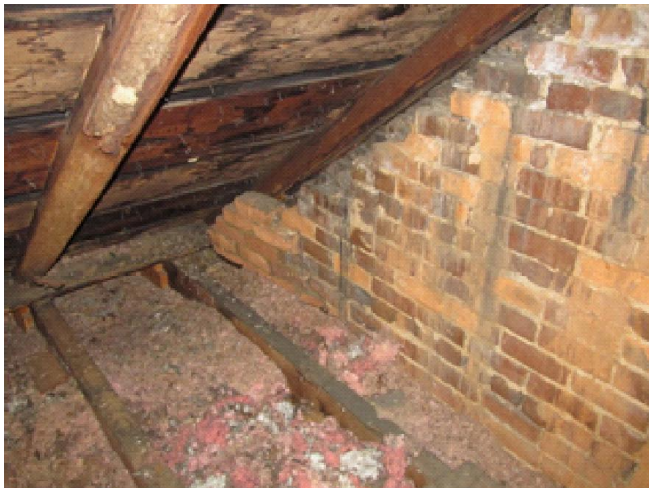
Figure S12: Gable end brick

vii. Re-build gable walls within the attic space. Again, use appropriate mortar materials to reset brick that are protruding into the attic space. Extent of loose brick is not known. Consider establishing a better tie-in between the gable brick walls and roof diaphragm.

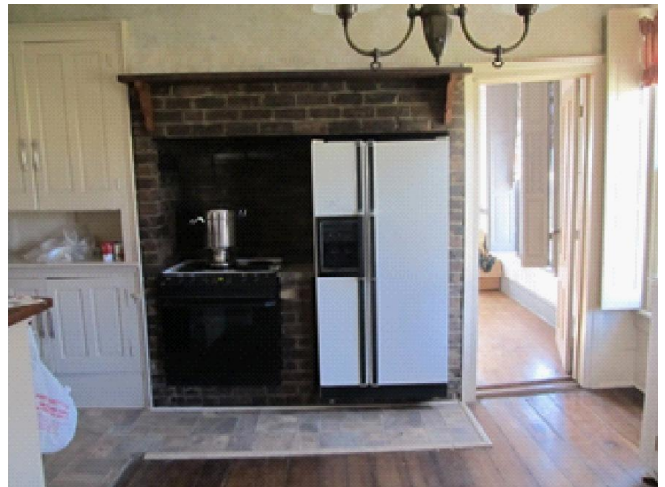
Figure S17: Unsupported brick fireplace, removed February 2014

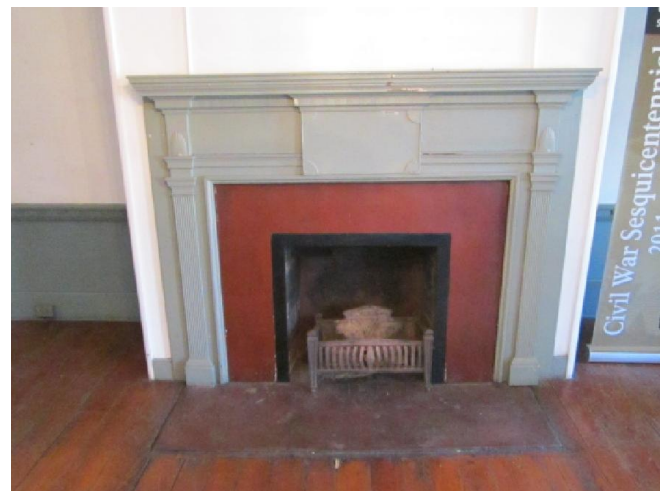
Figure M7

The Living Room 109, Parlor 101 and Judge's Chambers 102 each have fireplaces on the First Floor (Figure M7, M8, and M9). The fireplaces in the Living Room and Parlor Room appeared to have debris within the fireplace which had fallen down from within the chimney. The fireplace in the Judge's Chamber had insulation stuffed up inside the chimney. The condition inside the chimney's is unknown but most likely they have not been cleaned in many years.

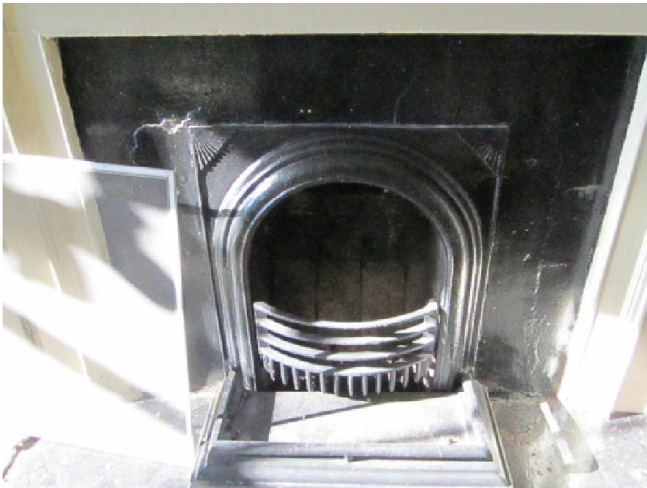
Figure M10

Bedroom 205 and Bedroom 202 on the Second Floor also have fireplaces (Figure M10 and M11). Bedroom 202 has a set of electric logs sitting on the grate which appear to be in poor condition. There was also insulation stuffed up inside the chimney. There were chimney bricks which had fallen down and become stuck inside the chimney immediately above the fireplace in Bedroom 205. The condition inside the chimney's is

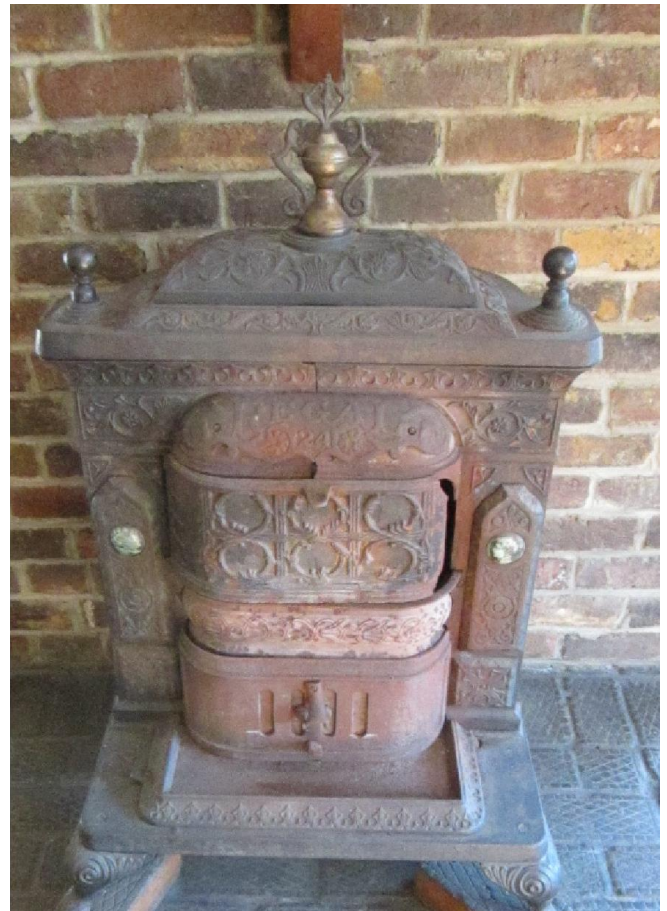
Figure M12

The Dining Room 104 has a decorative wood stove which is connected to the chimney with a 6" flue (Figures M12 and M13). The stove and connected flue appear to be in fair condition.

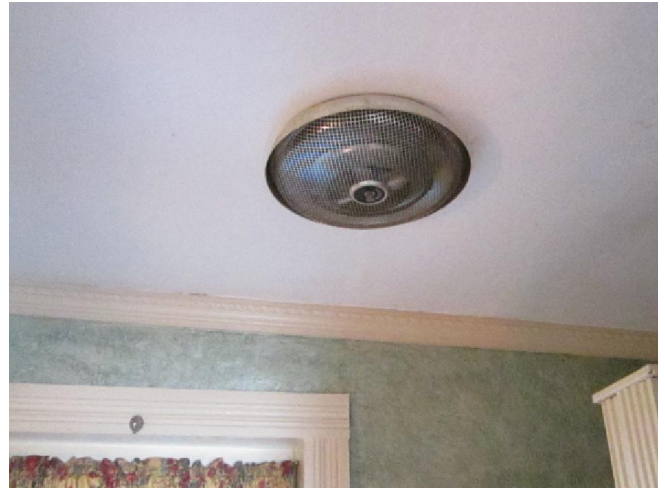
Figure M16

The Bathroom 201 has a combination exhaust fan and heater manufactured by Nutone (Figure M16). A thermostat on the wall would not energize the heater (Figure M17). There was no separate switch for the exhaust fan. If the exhaust fan was wired with the light switch then it did not energize when the lights were turned on. There was no exhaust fan in Bathroom 103 adjacent to the Judge's Chambers.

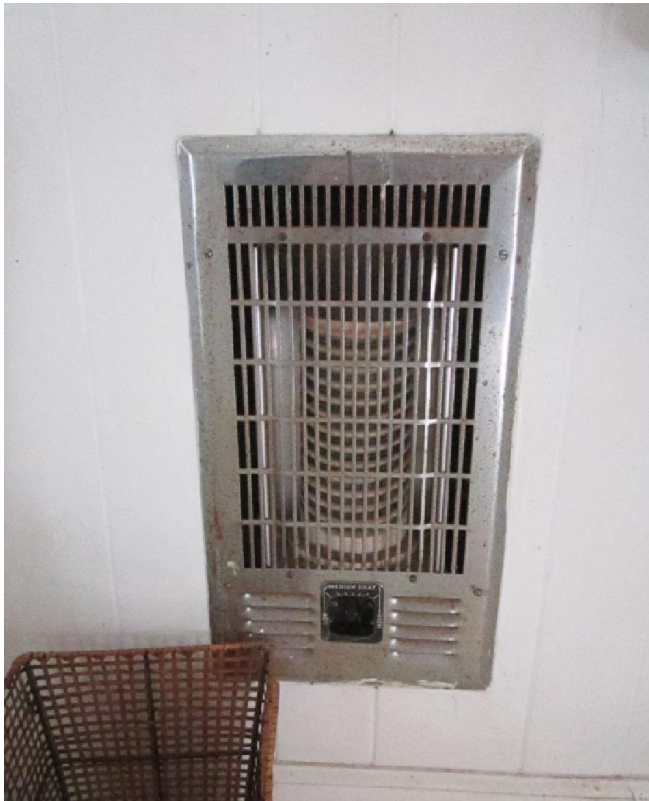
Figure M18

Bathroom 103 has an electric resistance wall heater recessed into the exterior wall (Figure M18). The heater has begun to rust and was in below average condition. Bathroom 105 did not have an exhaust fan and, although it has an exterior wall, there was no means for heating the space.

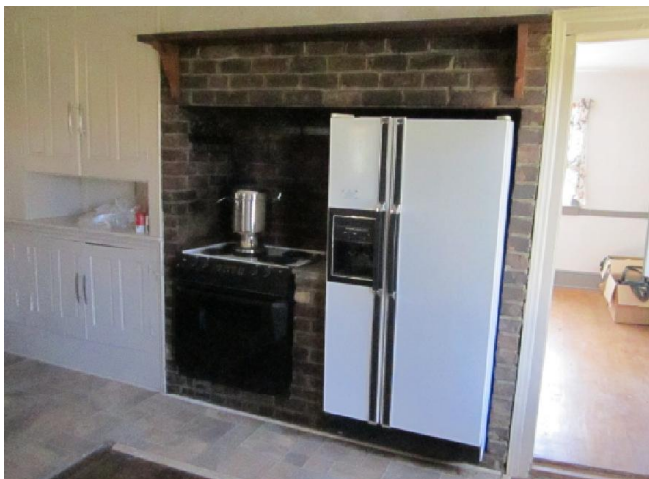
Figure M19

There is an electric cooking stove in Kitchen 108 which has been built into a brick enclosure (Figure M19). There is a Nutone exhaust fan located directly above the stove (Figure M20). The fan was very rusty and in poor condition. Note the fan has been installed in a plywood ceiling which steam can degrade over time (*Fireplace assembly removed February, 2014*).

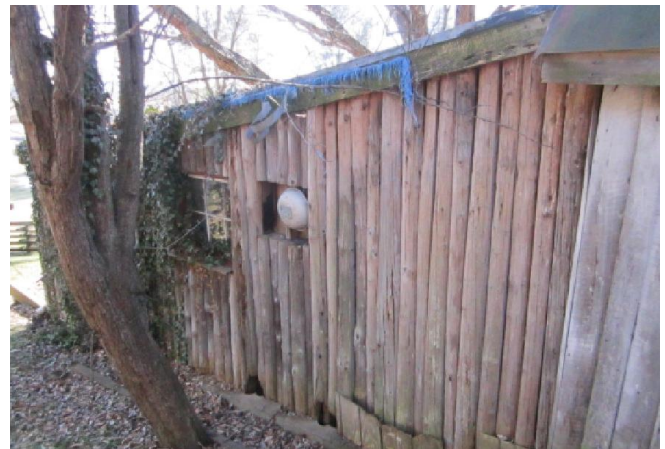
Figure M21

There are three other buildings on the property—the Outbuilding, the Storage Shed and the Stable. None of the buildings have any provisions for heat although it appeared at one time there was most likely a wood stove in the Outbuilding. There is a strap on the outside of the building indicating the possibility of a former exterior flue (Figure M21). There appears to be a previous flue connection inside the building as well (Figure M22).

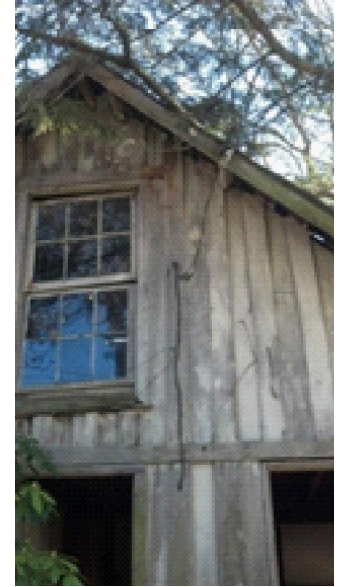
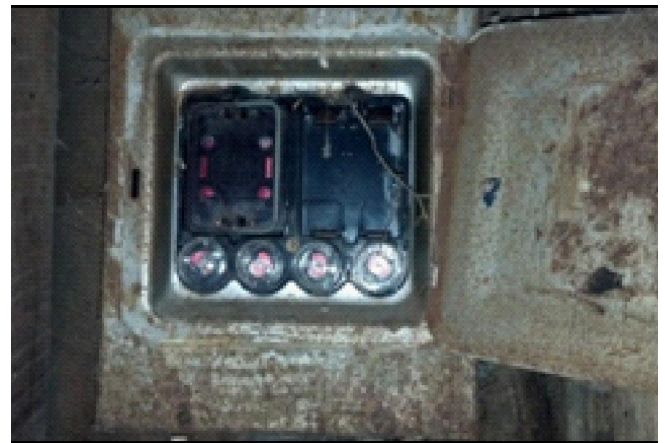
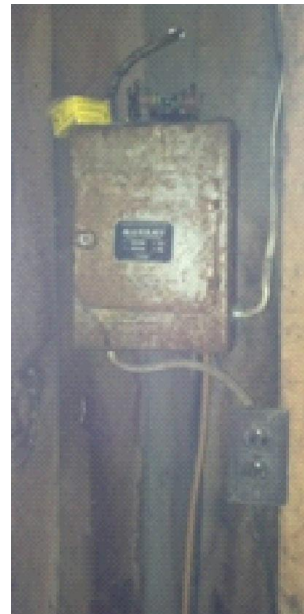
The electrical service to the Outbuilding, next to the utility pole, is routed overhead from the utility pole and extends down the side of the building and terminates into a service fuse box inside the building to the right of the front door (Figures E3-E5).

The service fuse box is in poor condition due to rusting. The service wiring running down the outside of the building to the fuse box is in fair condition. The shielding on the wiring is holding up, but this wiring should be installed in conduit along the exterior of the building to protect it from the elements. The wiring from the fuse box to the receptacles located throughout the outbuilding is Romex wiring which appears to be in good condition. However, the routing and supports for the wiring from the fuse box to the receptacles need to be corrected. The wiring in some locations is hanging from the wall and draped across the floor (Figures E6 and E7). Also note that there is no circuit directory in this fuse box labeling what fuses are connected to what circuits.

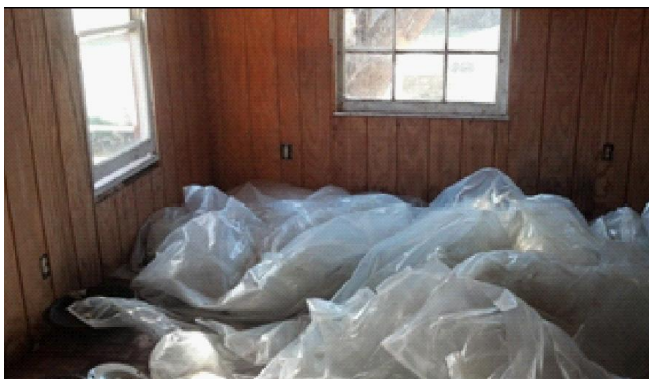
Figure E8

In some areas within this Outbuilding there are receptacles that are installed without coverplates (Figure E8). These coverplates should be provided for protection. The receptacles appear to be in good condition.

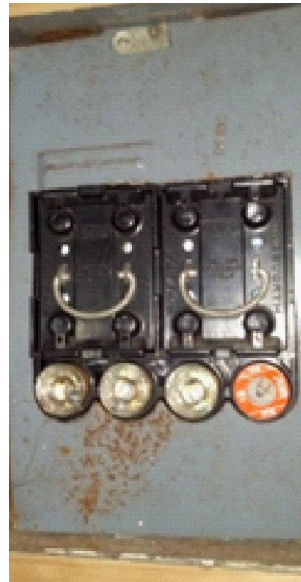
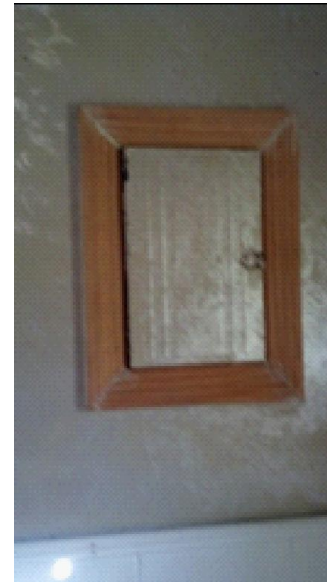
The electrical service to the Judge's Chambers extends overhead from the utility pole shown in Figure E1 to the locations (Figure E12). The service then runs along the exterior of the building, behind the ivy, where it enters the building into a recessed service fuse box (Figure E13 and E14). The service fuse box is located in the bathroom on the wall between the toilet and the

shower. The service fuse box is in poor condition due to rusting, which is likely due to the condensation created from the shower in the bathroom. The service wiring running down the outside of the building to the fuse box is in fair condition. The shielding on the wiring is holding up, but this wiring should be installed in conduit along the exterior of the building to protect it from the elements. Also note that there is no circuit directory in this fuse box labeling what fuses are connected to what circuits. An electrician would be able to verify these circuits and provide labels.

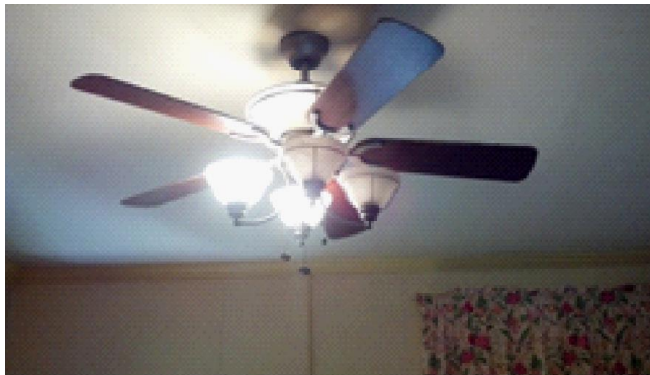
Figure E19

The light fixtures in the bathroom area of the Judge's Chambers are old incandescent light fixtures that are in fair condition (Figures E19 and E20). The light fixture in the bedroom area of the Judge's Chambers looks to be a newer ceiling fan with incandescent light kit that is in excellent condition (Figure E21). The wiring in the surface raceway is Romex wiring, which is in good condition. The engineer was unable to verify the type and condition of wiring above inaccessible ceilings and within wall back to service fuse box.

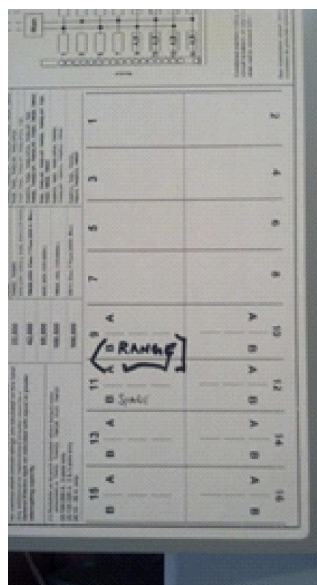
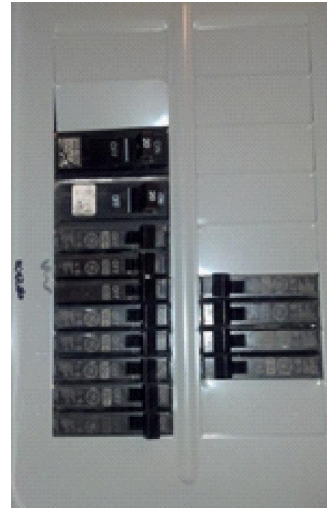
The electrical service to the House extends overhead from the utility pole shown in Figure E1 to the locations shown in Figure E22. The service enters the building through a weather head to a wireway above two service disconnect switches (Figure E23). The disconnect switch on the right is an older 200 Amp type switch that is in fair condition (Figure E24). This switch feeds a load center that is located in the basement of the house (Figure E25-E27). This load center is in good condition, but is dirty and starting to rust due to the unconditioned and dirt floor environment that it is located in. The disconnect switch on the left is a newer 100 Amp type switch that is in excellent condition (Figure E28). This switch feeds a load center that is also in excellent condition and that is located behind a sliding recessed wall panel in the bathroom adjacent to where these disconnect switches (Figure E29-E31).

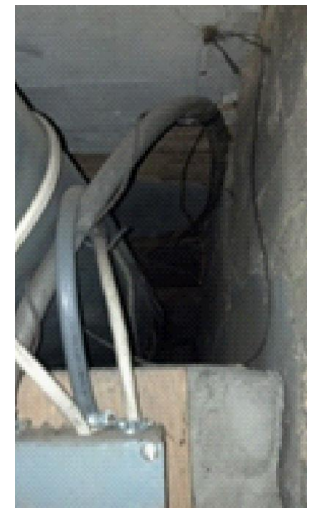
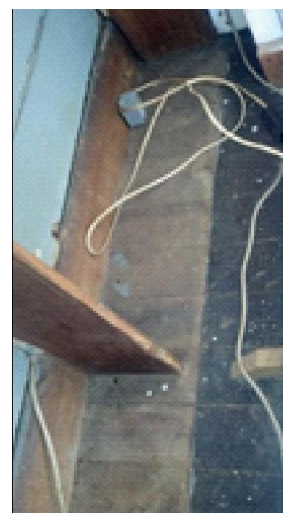
The wiring in the House varies (Figure E31-E42). Service entrance cable is used between the disconnect switches and the load centers. There is Romex, cloth covered wiring, metal covered wiring, metal clad cable, and even some knob and tube wiring from the load centers to HVAC equipment, receptacles, and lighting. The newer Romex wiring looks to be in good condition; however there are a number of locations where this wiring is not properly supported. The older wiring, such as the cloth covered wiring and knob and tube wiring, is in poor condition. There are also a number of junction
