DRAFT
HISTORIC STRUCTURES REPORT FOR
RETIREMENT
TOWN OF ABINGDON, VIRGINIA

25 July 2014

DAVIS BUCKLEY ARCHITECTS AND PLANNERS

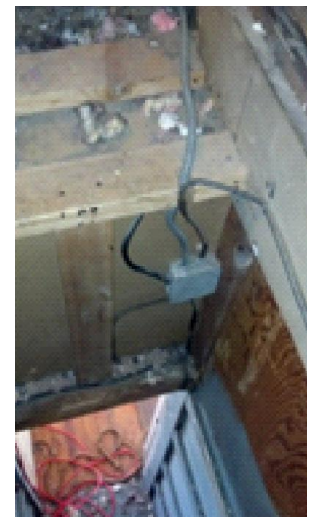
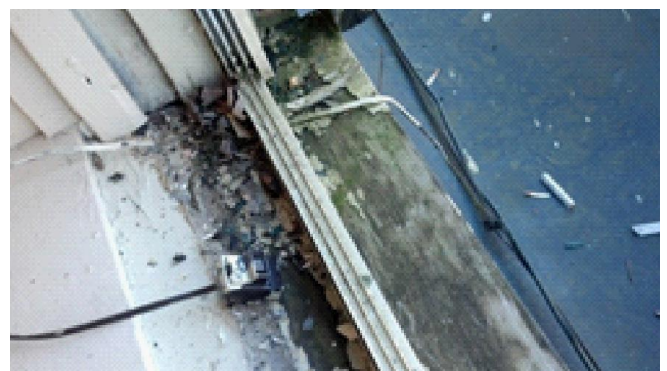
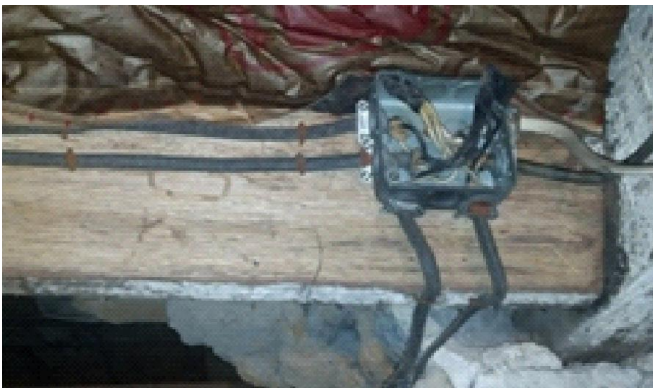
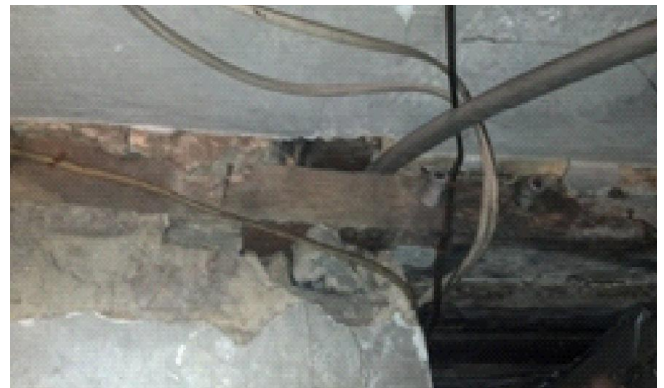
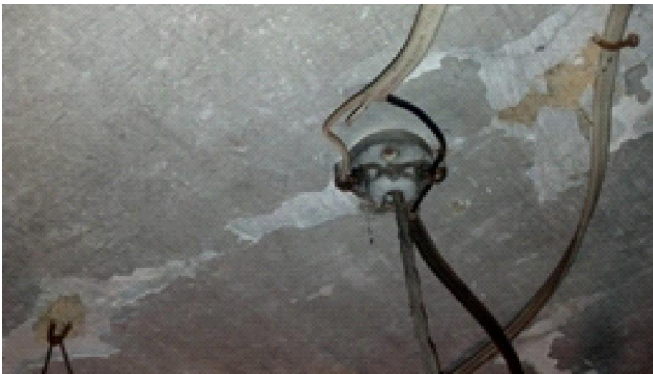
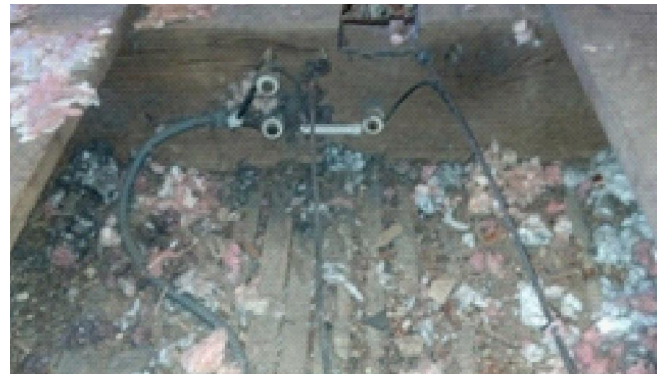
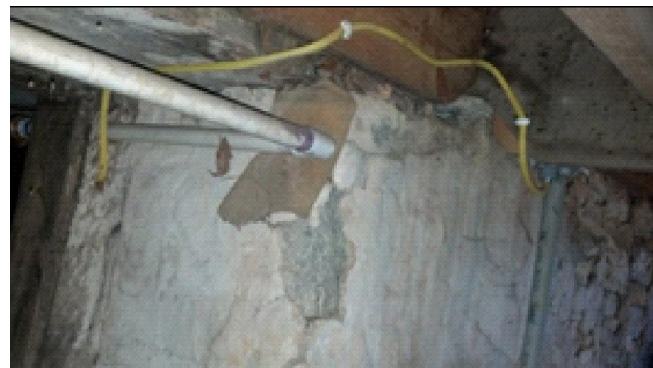
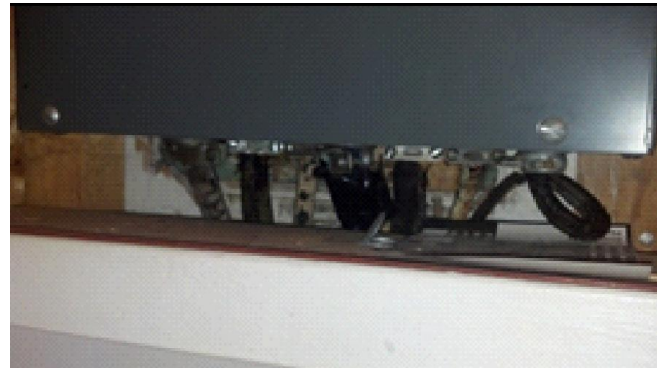
The wiring in the House varies (Figure E31-E42). Service entrance cable is used between the disconnect switches and the load centers. There is Romex, cloth covered wiring, metal covered wiring, metal clad cable, and even some knob and tube wiring from the load centers to HVAC equipment, receptacles, and lighting. The newer Romex wiring looks to be in good condition; however there are a number of locations where this wiring is not properly supported. The older wiring, such as the cloth covered wiring and knob and tube wiring, is in poor condition. There are also a number of junction

3. There are a number of locations where the wiring is not properly supported. This needs to be corrected. Older wiring, such as the cloth covered wiring and knob and tube wiring should be replaced or repaired.

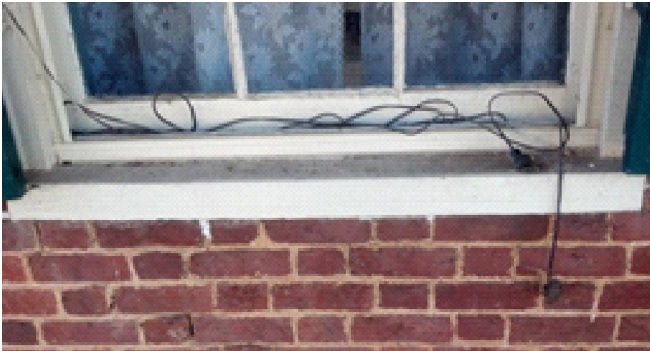
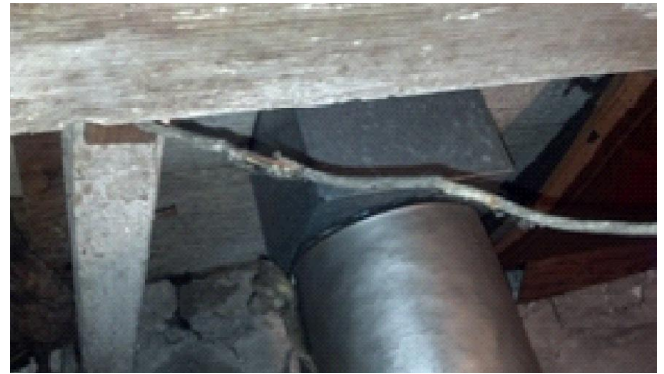
boxes that are not provided with code required protective coverplates. There is also a “made-up” extension cord that wraps from the first floor front windows to the second floor front windows (Figure E34 and E35). This cord appears to be used for powering holiday lights set in these windows. The “made-up” extension cord is in poor condition and is a potential fire hazard.

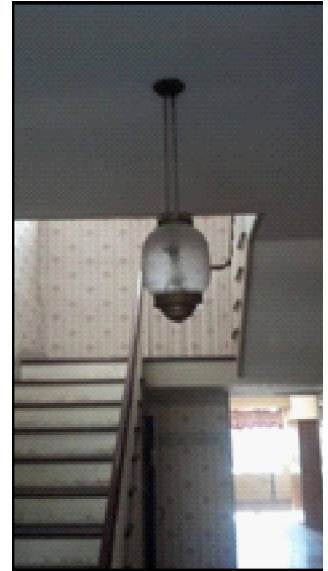
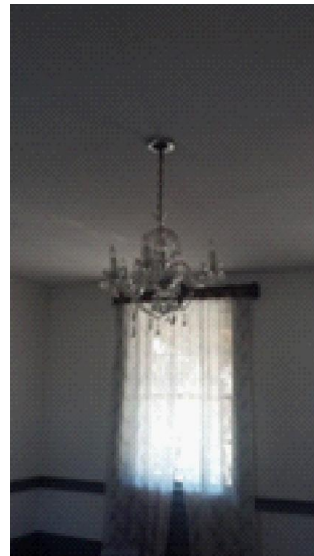
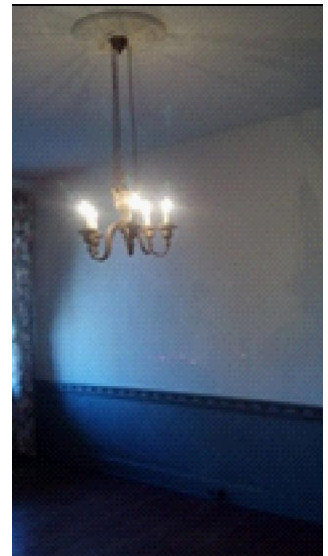
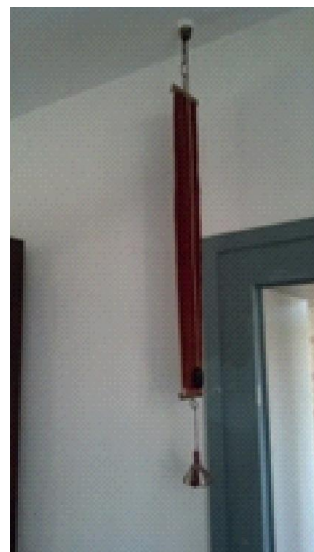
There is also an old pendant light fixture in the Entry Hall 100 (Figure E52). Old pendant chandeliers are located in Parlor 101 and Living Room 109 (Figure E53 and E54). In each of these two rooms is a banner and a cord with a light switch at the end hanging from the ceiling that controls these chandeliers (E55). These light fixtures are incandescent and appear to be in poor to fair condition.

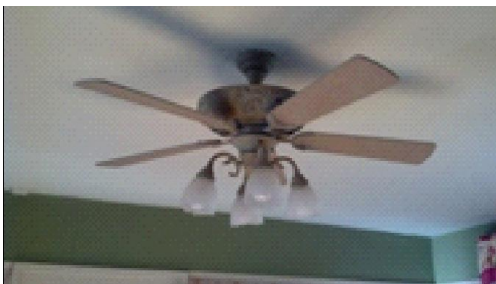
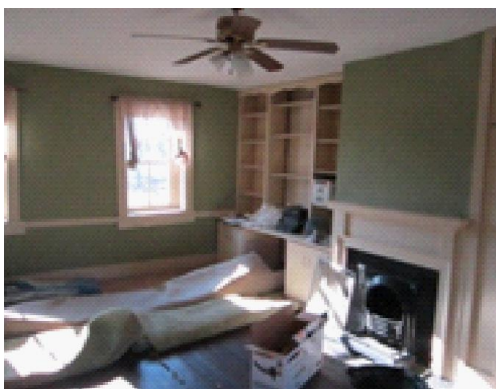
The light fixtures in the bedrooms on the second floor are ceiling fans with light kits (Figure E49 and E50). There are pull switches located on the ceiling above the door in each bedroom for the lights, which are in poor condition. In the bathroom on the second floor are two pendant light fixtures that hang down over the vanity. There is a pendant light fixture that hangs down over the second floor landing (Figure E51). All the light fixtures on the second floor are incandescent and appear to be in good condition, but they should be examined further for any unseen damage.

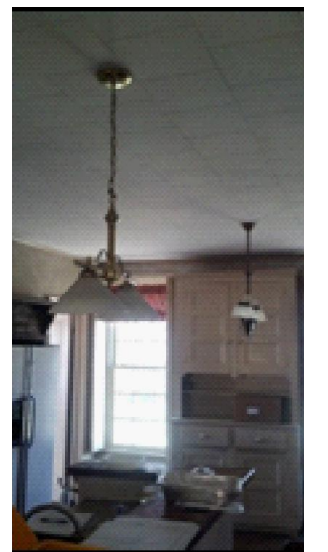
Figure E56

There is a pendant light fixture Kitchen 108 (Figure E56). These light fixtures are incandescent and are in good condition. There is also a fluorescent strip

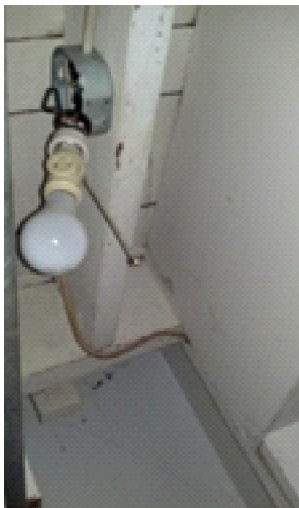
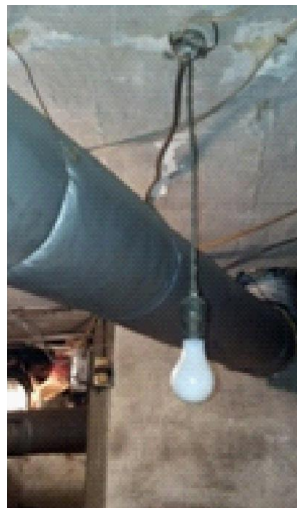
light that is located above the range, which is in good condition (*Removed, February 2014*). Figures E57 and E58 show incandescent based light fixtures that are typical throughout the rest of the first floor, garage and basement areas. There are a number of these incandescent based light fixtures that are in poor condition.

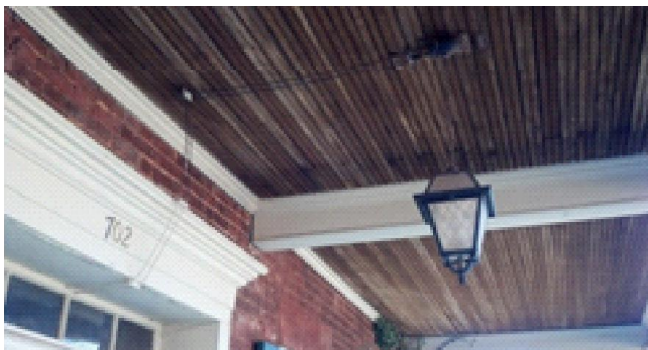
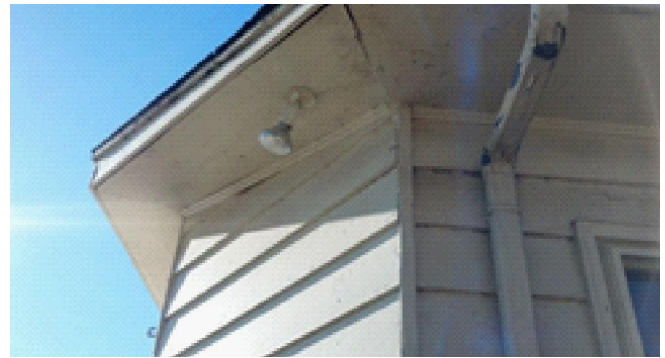
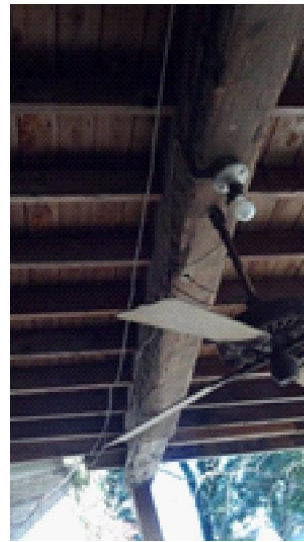
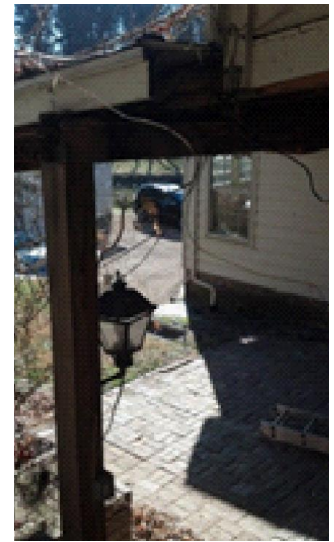
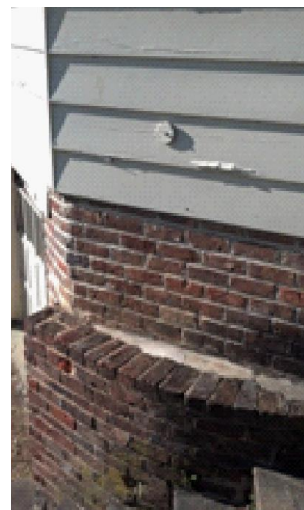
Figures E59 through E63 show the various types of exterior light fixtures on the House. There is a traditional style lantern on the front porch, flood light above the stairs from the garage door to the back patio, ceiling fan and incandescent based below the back patio, and a traditional style wall lantern on the back patio. The lanterns on the front porch and back patio are in poor condition and should be examined further for any unseen damage. The wiring should also be investigated further.

The ceiling fan on the back patio is in poor condition and should be replaced with an exterior type ceiling fan that is rated (UL listed) for exterior use. This incandescent based lamp next to the ceiling fan is not rated for exterior use. The flood light appears to be in good condition, but is not located in an easily accessible location. Figure E63 shows an exterior light switch next to the stairs between the garage and the back patio, which does not comply with UL guidelines.

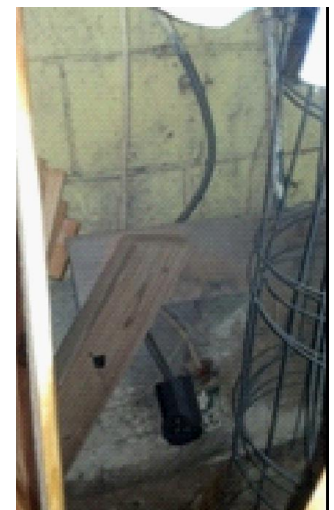
Figure E64 shows some cords with special purpose receptacles on them that appear to be to some old ranges that are hanging down in the back of Garage 002. Controllers, starters, and disconnect switches for various types of connections to HVAC equipment are located in the mechanical room in the basement (Figures E65-E68). These devices appear to be used and are in poor condition. Figure E67 shows a spliced connection to the water heater located in Storage 006 in the basement, which does not meet code requirements. A disconnect was not provided at the water heater either as is required by code. These issues at the water heater need to be corrected.

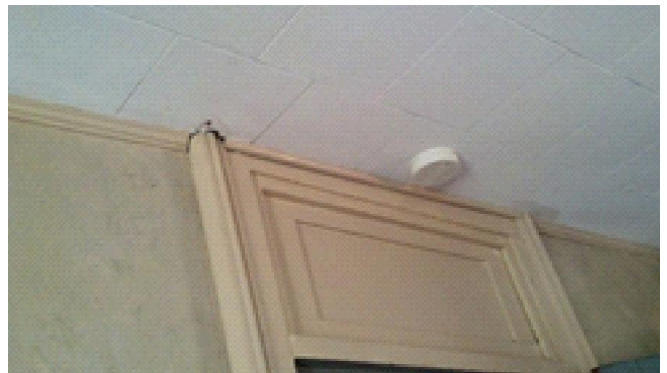
Figure E72

There are two smoke detectors in the House, which are located in Kitchen 108 and Dining Room 104 (Figures E72 and E73).

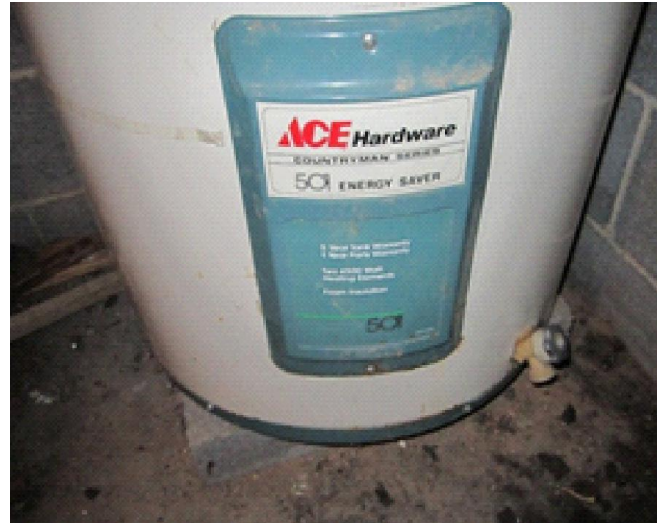
Figure P1

Existing water heater is a 52 gallon capacity electric unit which is in fair condition (Figures P1 and P2).

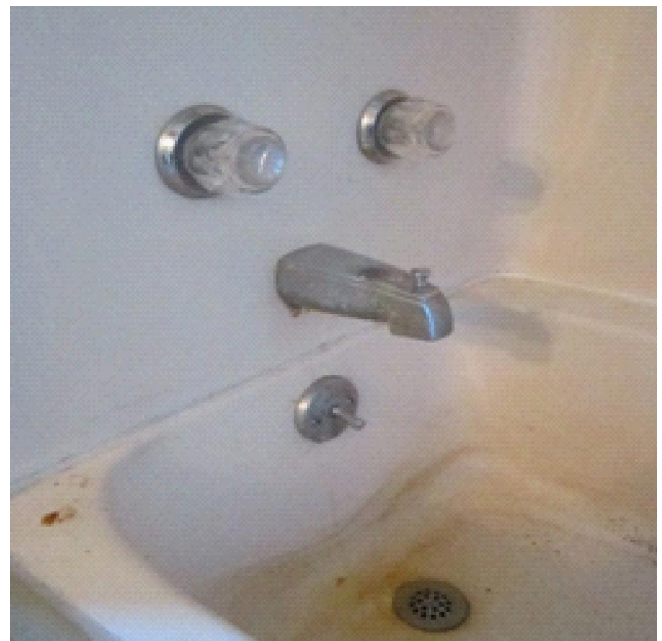
Figure P3

The Bathroom 201 has countertop lavatory and tank type water closet, both of which are in good condition, and a fiberglass tub/shower unit with glass doors which is in fair condition (Figures P3- P6). Sink has a mixture of chrome plated copper tailpiece and PVC p-trap, with PVC piping connecting to galvanized steel rough-in at the floor below the counter (Figures P7 and P8). Domestic water piping serving these fixtures is also galvanized steel, with chrome plated copper runout pipes connecting to the fixtures (Figure P6). There is no thermostatic mixing valve on the hot water to the lavatory.

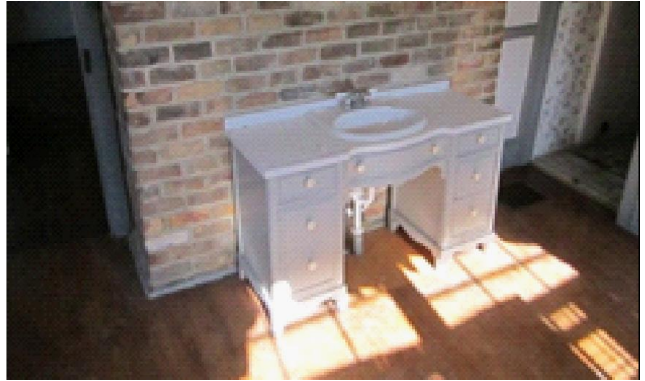
Figure P11

Servant's Bedroom 107 includes a countertop lavatory in the room and a separate toilet room for the water closet (*lavatory removed February, 2014*). Piping below the lavatory includes a chrome plated copper tailpiece connecting to a PVC P-trap and down pipe, which connects to a galvanized steel riser pipe at the floor (Figure P11). The tank type water closet is in fair condition (Figure P12). There is no top for the tank.

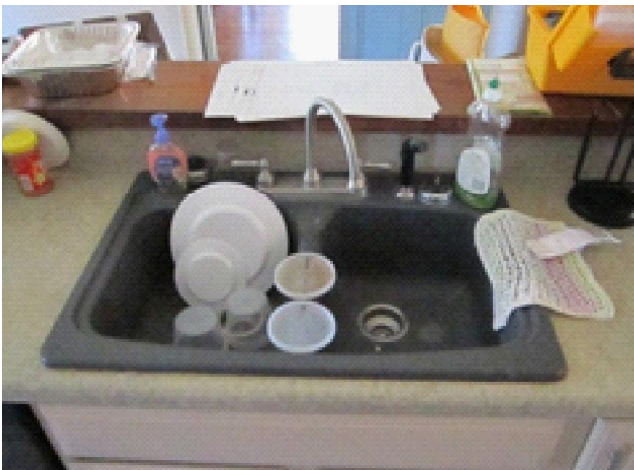
Figure P9

Kitchen 108 plumbing includes a 2 compartment island sink with sprayer which is in good condition (Figure P9). Piping serving the sink is PVC to and including the P-trap, connecting to galvanized steel at the floor. Domestic water runouts are flexible hose connected to copper supply piping (Figure P10). The water hose to the sprayer is disconnected. A water connection is provided for the refrigerator/freezer ice and water

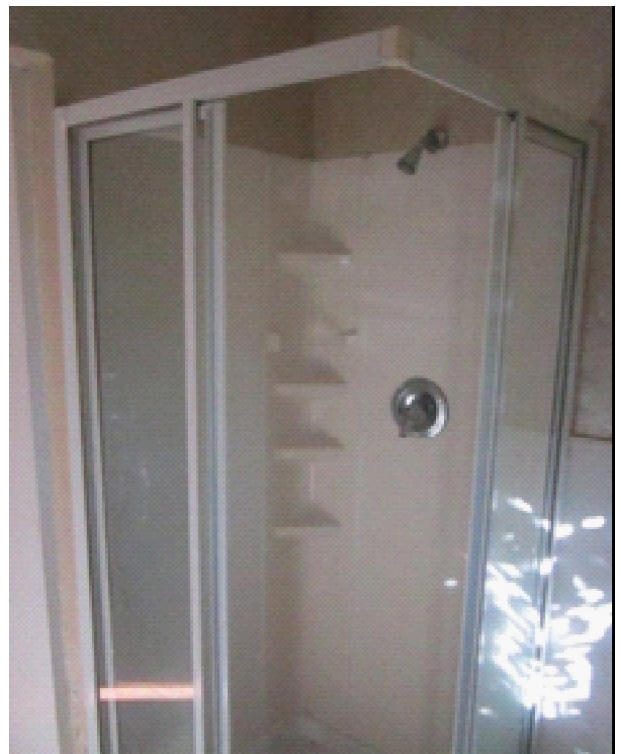
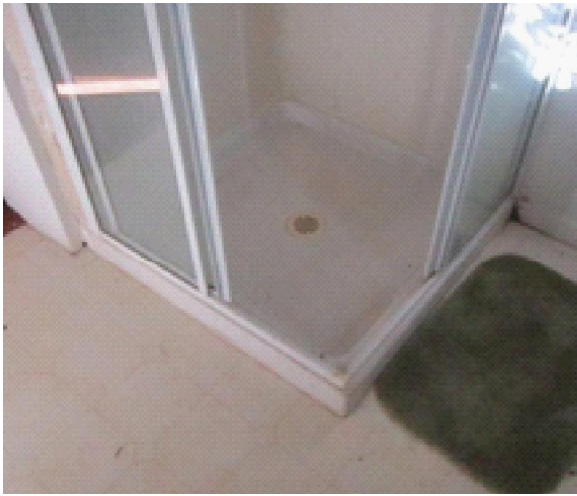
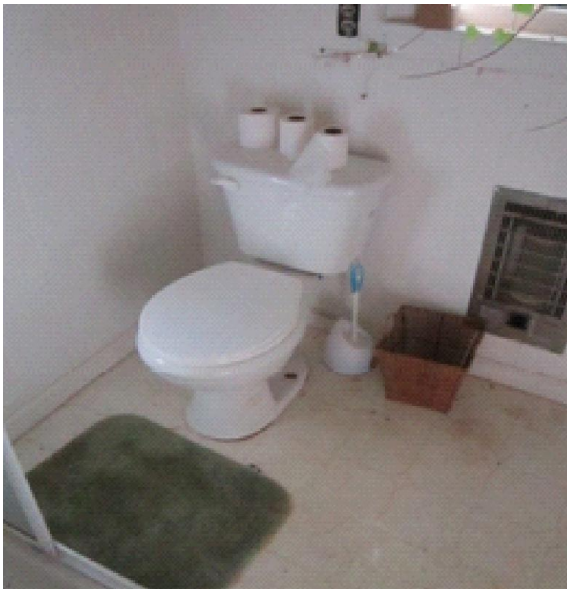
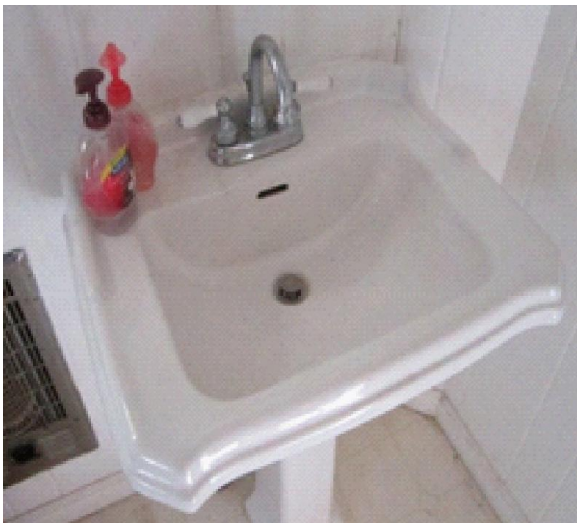
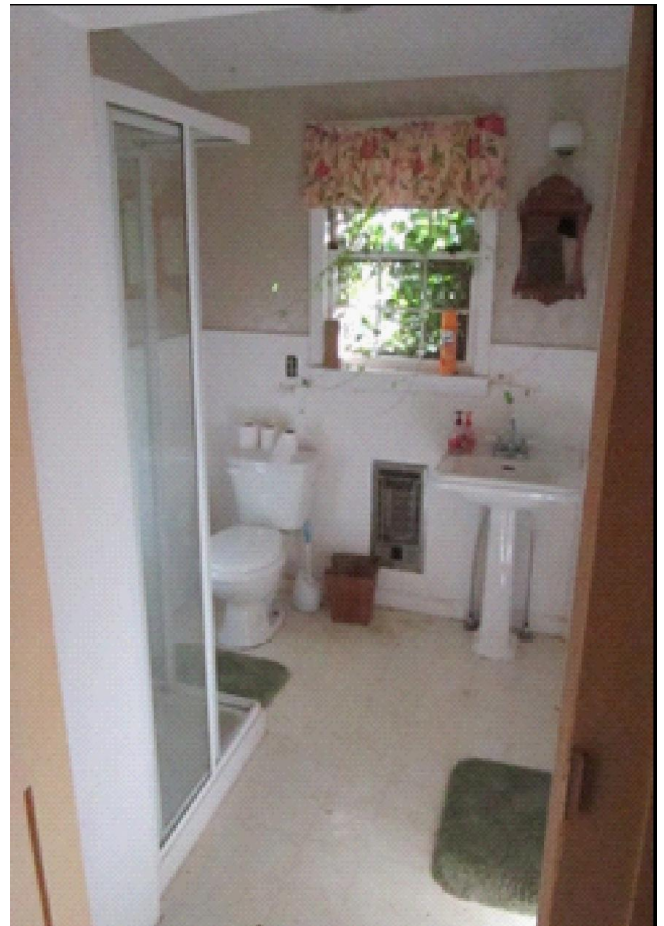
The Judge's Chambers bathroom includes a pedestal lavatory, a tank type water closet and a shower enclosure (Figure P13-P17). These fixtures appear to be in good condition. Waste piping is PVC, and domestic water piping is chrome plated copper runouts connected to copper supply piping at the floor (Figure P18).

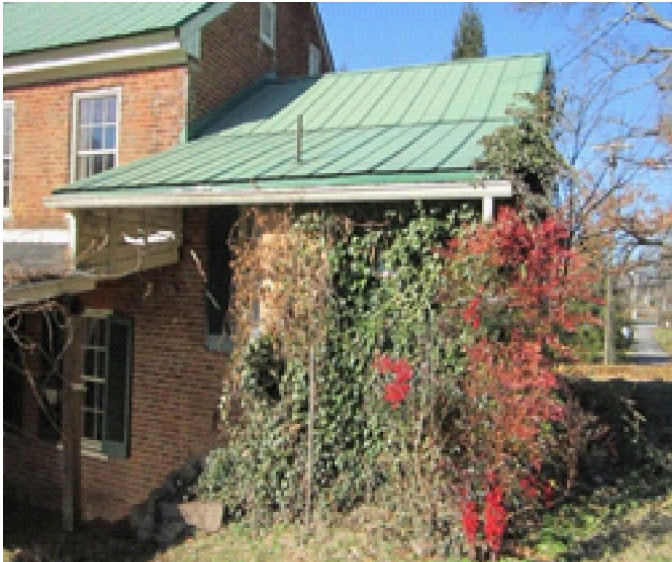
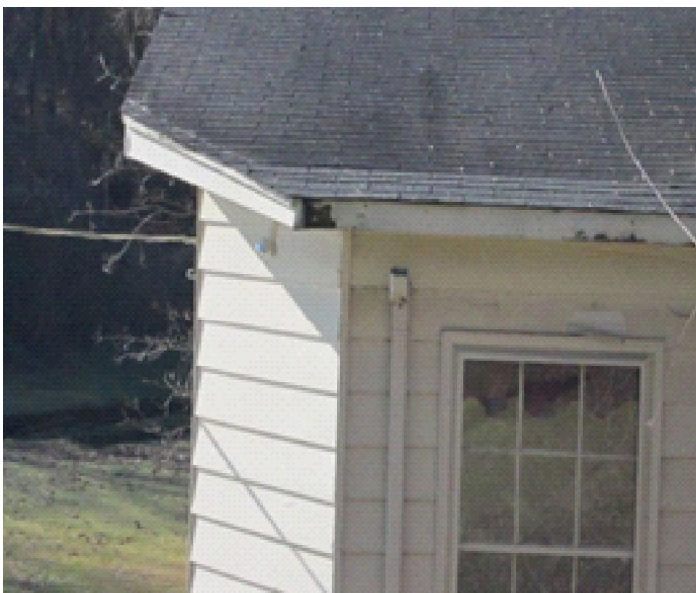
Exterior gutters and downspouts channel storm drainage from some sections of the roof, other sections are missing gutters while the downspouts remain (Figure P19 and P20).

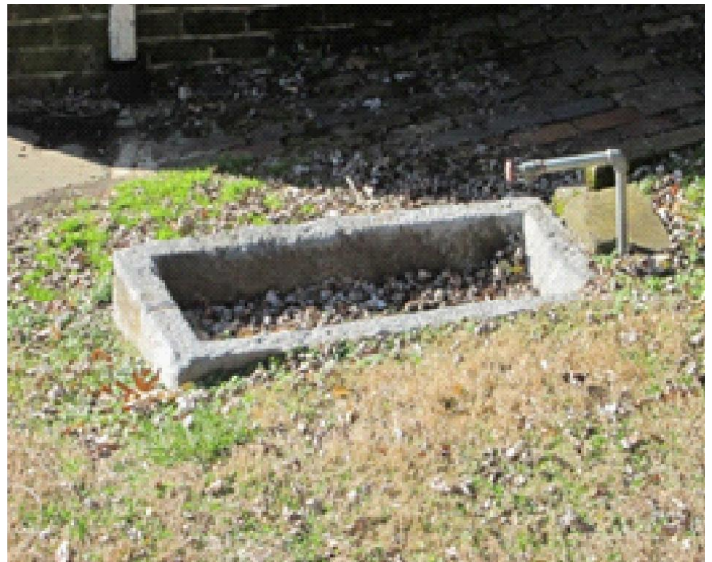
Figure P21

There is an exterior water hose bib and piping above grade next to the garage addition in back of the building (Figure P21). This arrangement is not freeze-proof and must be drained before freezing conditions are present.

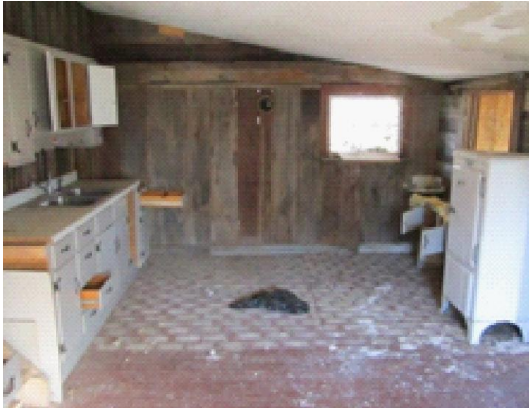
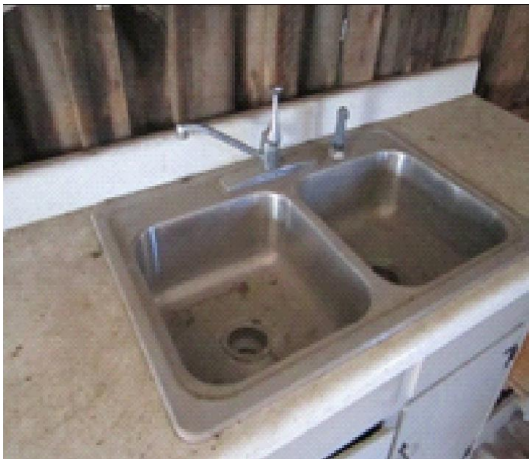
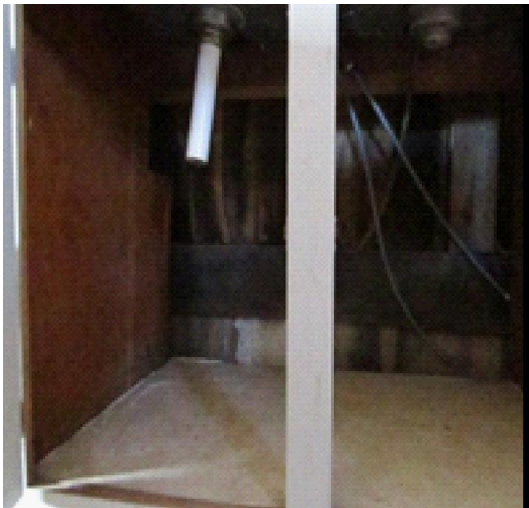
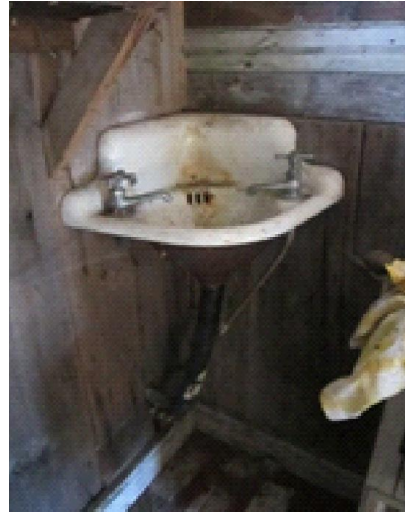
The wood structure in back of the property includes a 2 compartment countertop sink and a corner mount lavatory. These fixtures do not appear to be in working order (Figure P23-P26) There may no longer be water service to this building.

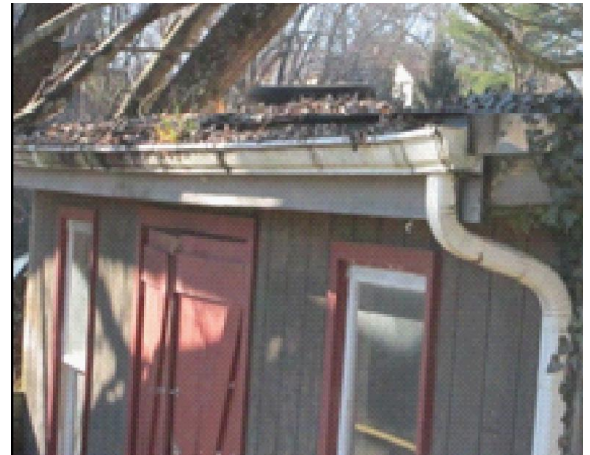
Figure P27

A gutter and a downspout channel storm water off one end of this building. The gutter is full of vegetation (Figure P27).
