# Removal Report on Jordan's Point Concrete Dam and Timber Crib Dam: May 23-25, and May 28-30, 2019

Prepared for: The Virginia Department of Game  
and Inland Fisheries

Prepared by: Maral S. Kalbian, LLC  
Maral S. Kalbian, Architectural Historian  
Contributor: Dan Pezzoni, Architectural Historian  
September 6, 2019

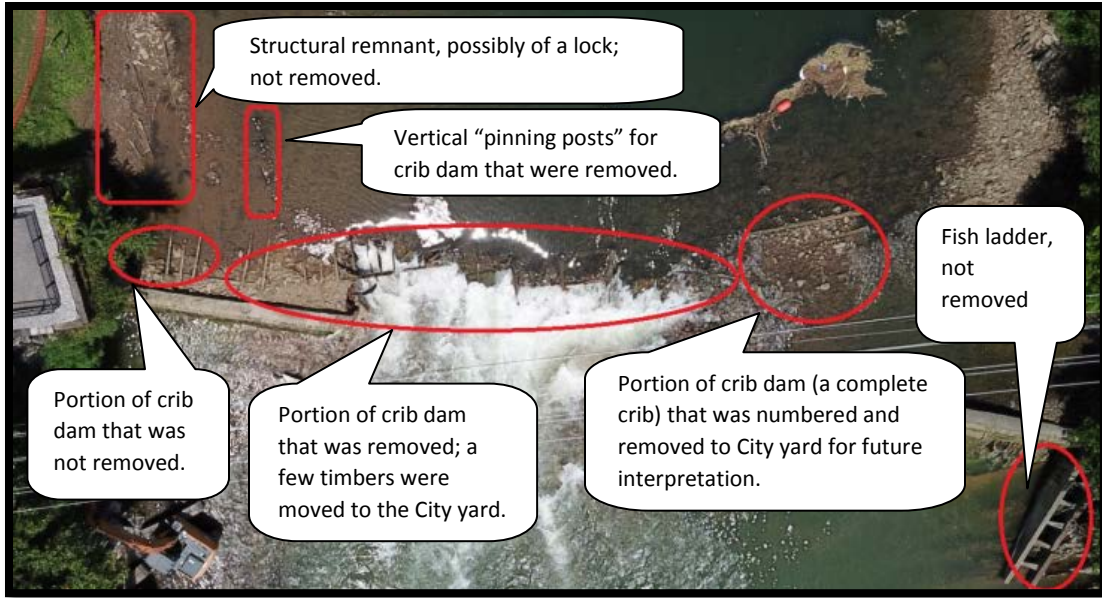
**Figure 3: Adapted aerial detail of undocumented resources that became apparent after the Jordan's Point concrete dam was breached (May 24, James Fulcher).**

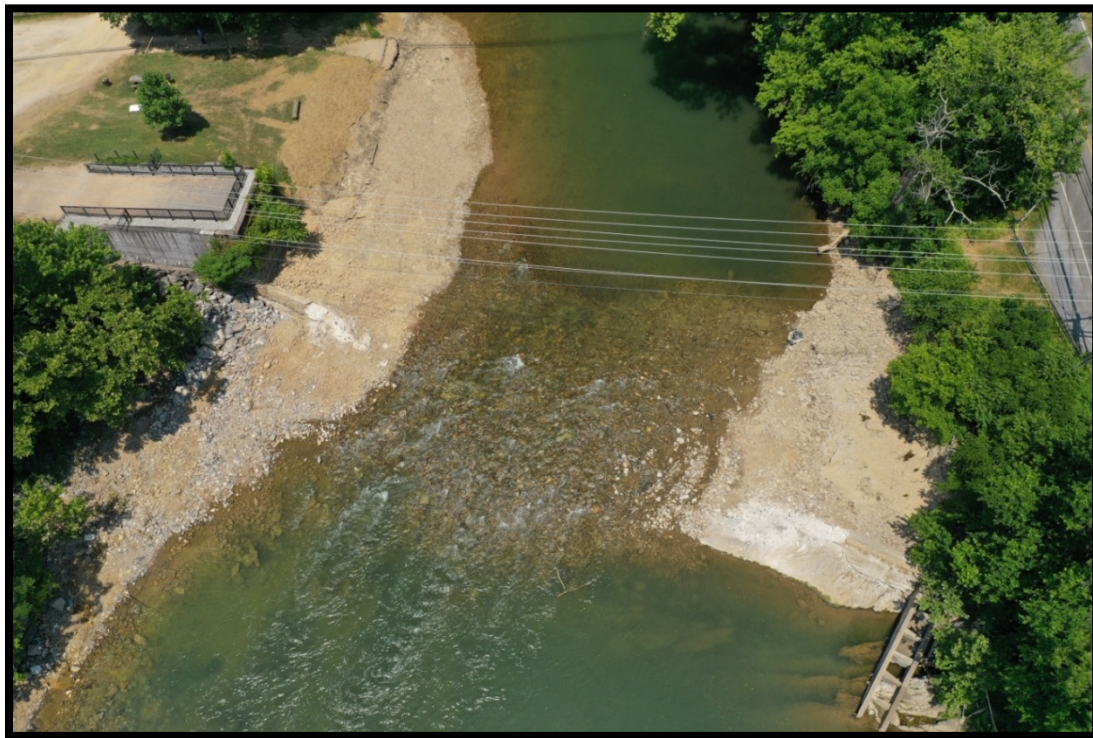
**Figure 4: Aerial view showing completed project. Note that parts of the concrete dam on the south side as well as on the north side (along with the fish ladder) remain. The portion of the crib dam at the southern abutment has been covered as has some of the structural remnant. (David Pfaff, W&L University)**

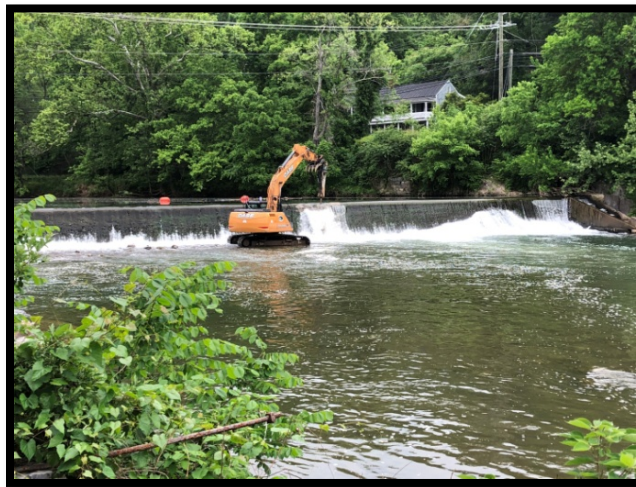
**Figure 14: Beginning of removal, view from downstream (May 23).**

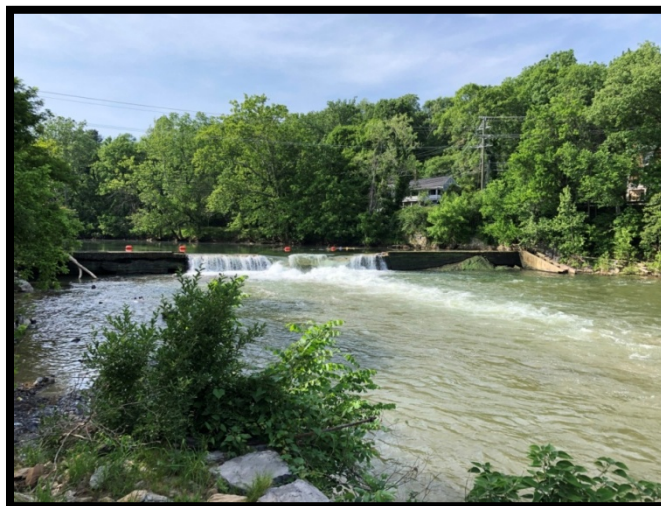
**Figure 15: End of day on May 23, 2019, showing breached dam.**

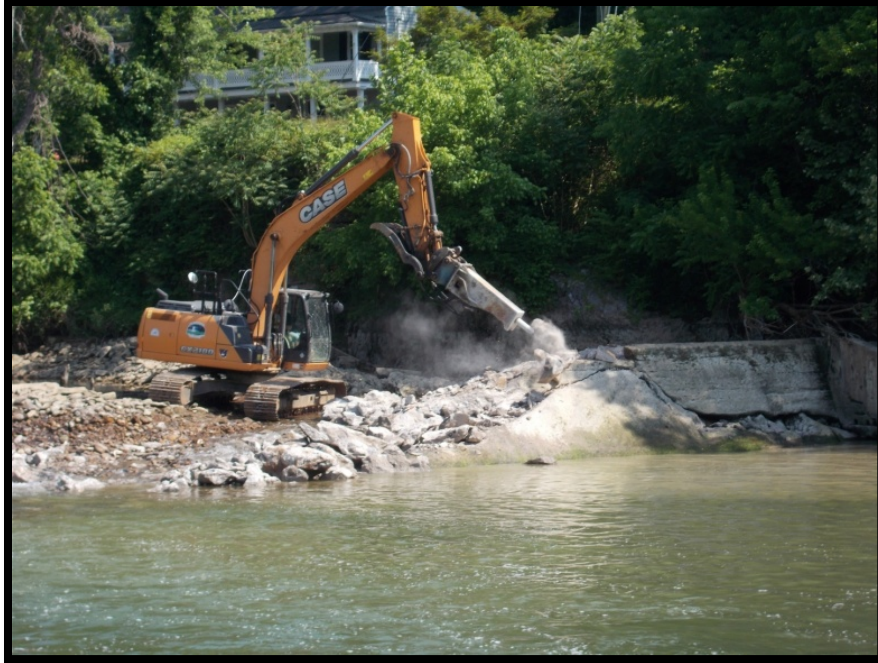
**Figure 18: May 25 view of removal of concrete near bedrock and fish ladder at north bank.**

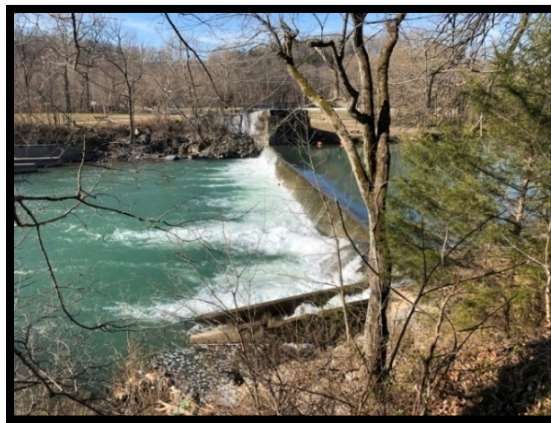
Farther north near the bank is an approximately 32-foot long, concrete, pool-and-weir fishway that extends downstream.<sup>19</sup> It has six steps before it peaks at the top of the dam. Currently in poor and non-functional condition, the floor of the structure is missing in several places and parts of the side walls are cracked. Surprisingly the fish ladder (or “fishway”) was not mentioned in any of the historical materials consulted as part of this study and there is no evidence to suggest that it was a later addition to the dam. The fish ladder was not removed as part of the dam project and has been left in place for interpretive purposes.

**Figure 20: View fish ladder taken from downstream, north bank. (February 2019).**

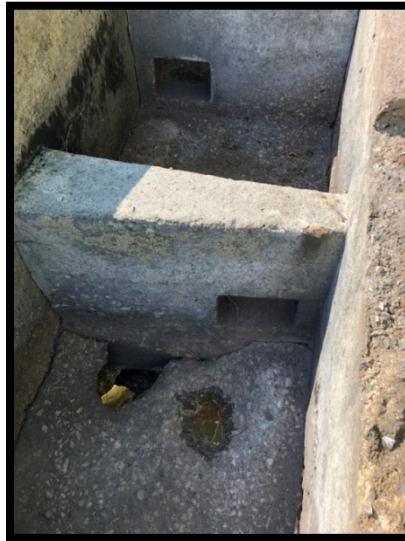
**Figure 22: Interior view of the fish ladder showing the pools and the offset orifices in the cross walls to allow for fish passage (May 24).**

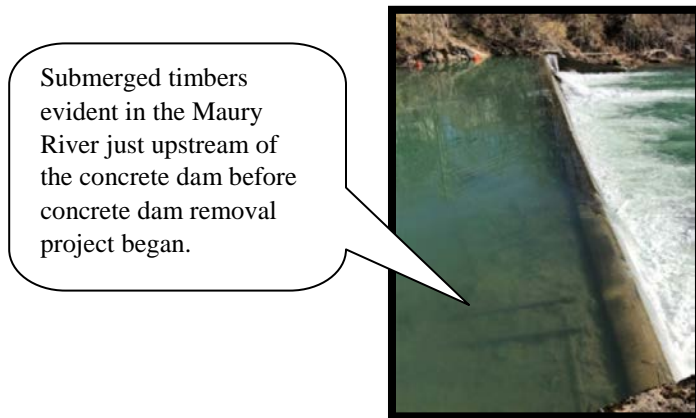
**Figure 25: Visual evidence of wooden structure in Maury River (February 2019).**

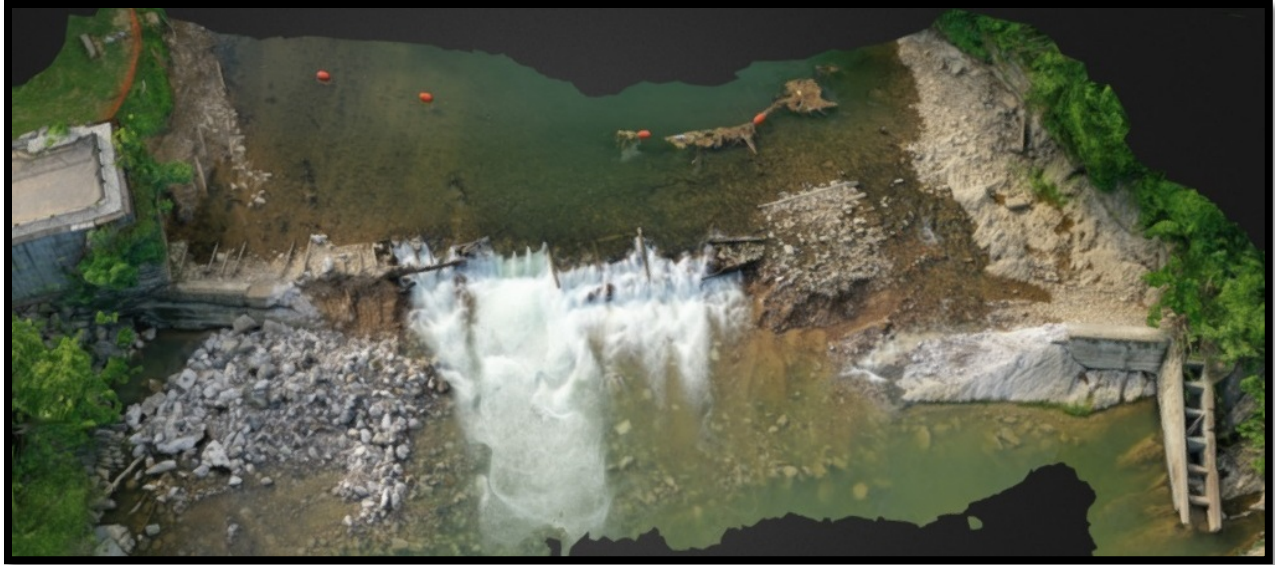
**Figure 27: 3-D image of the site made on May 25, 2019, showing completion of partial removal of concrete dam and exposure of wooden crib dam (Courtesy of David Pfaff, W&L University, Integrative and Quantitative Center).**

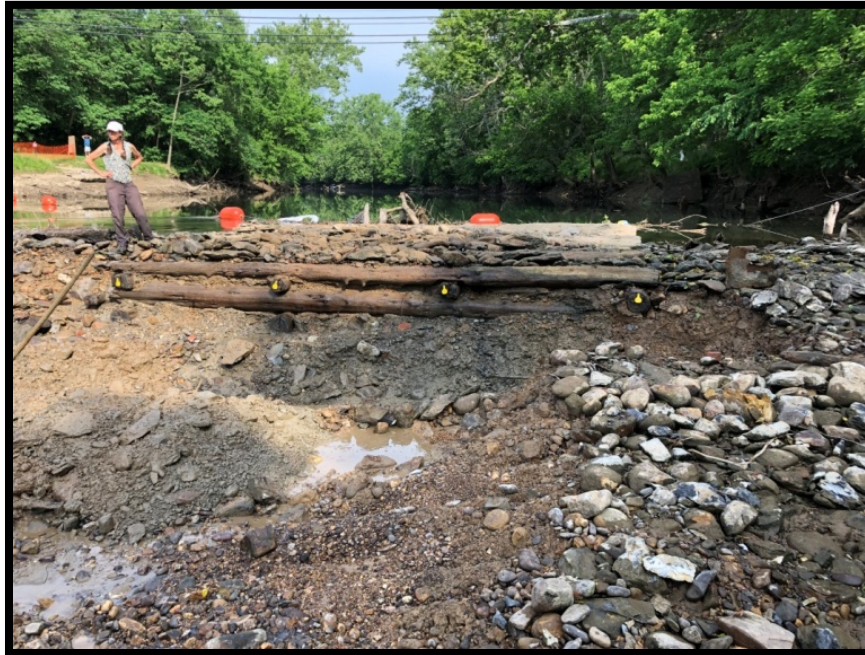
Section D of the crib dam was found to be an intact, rectangular log crib made up of six layers of four logs each, ranging in length from twelve feet to twenty-two feet, and filled with large river stones. The longer wooden crib members were laid perpendicular to the river, while the shorter ones were parallel. This crib was different from the other sections of the crib dam as the members were not hewn or rough cedar but instead rounded logs of cedar. It appears that Section D may have been a later addition to the crib dam, perhaps when a section had washed out or even part of one of the coffer dams constructed while the concrete dam was being built. The pieces were carefully numbered and moved to the City's public works yard on May 29 and 30 for potential use in future historical interpretation.

**Figure 30: East side of Section D crib that was numbered and salvaged (May 29, 2019).**

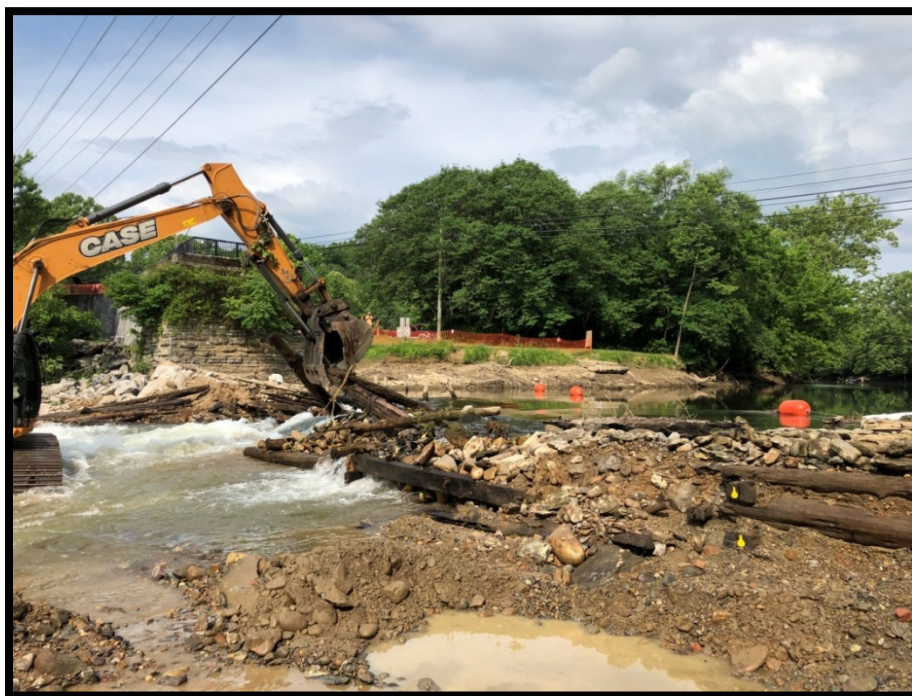
A surprising surviving feature of the crib dam was the vertical wooden planking that was submerged on the upstream side of some of the cribs (Sections B, C and E). Some of these planks were removed when Sections B and C were demolished, while evidence suggests there are others along Section E and perhaps parts of Section A. The planking was observed to have been applied at approximately a 60-degree angle, not strictly vertical. Several vertical posts that were initially thought to be associated with the old bridge turned out instead to be parts of the crib dam and are believed to have helped secure it in place upstream. These posts measured approximately ten feet long each with a diameter of eight inches. Two that were located on the north side of Section C and D and four upstream from Section B were removed. The bottoms of these vertical posts had worked speared ends, while the tops were flat, although deteriorated by the river flow. The majority of cut nails observed on the timbers appear to date to the pre-ca. 1890 period.

**Figure 31: Removal of Sections B and C of the crib dam (May 29, 2019).**

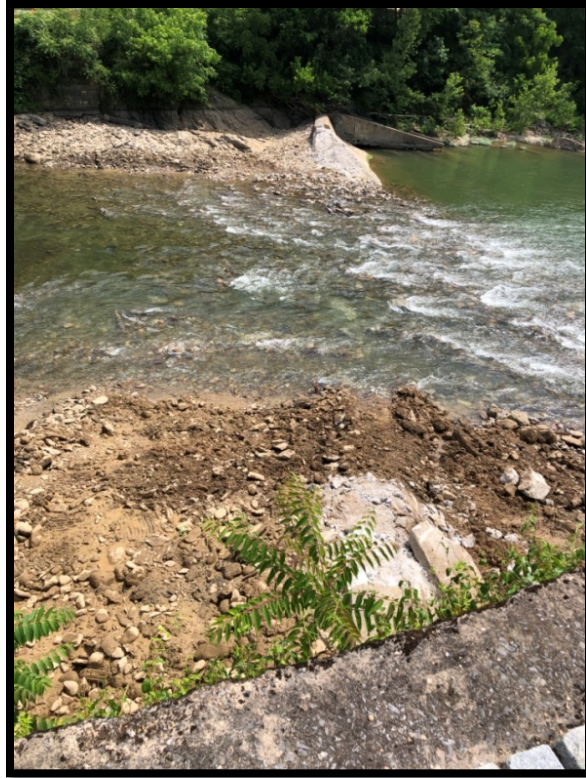
**Figure 34: View from south abutment after completion of dam demolition (May 30, 2019).**

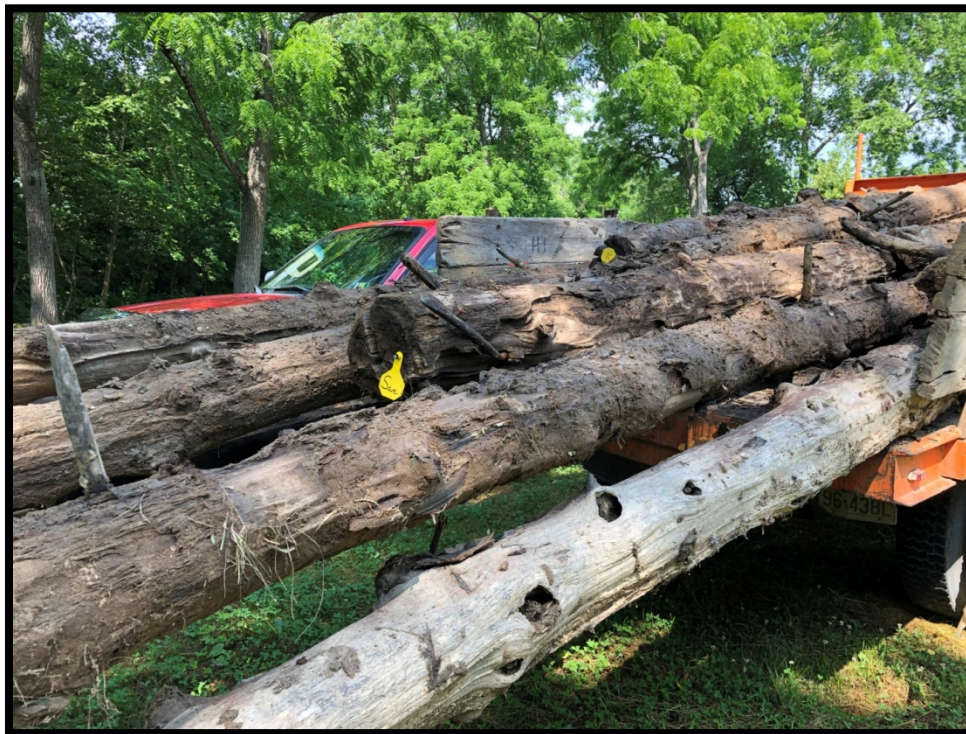
**Figure 35: Logs from the Crib Dam being moved to City Yard (May 29, 2019).**

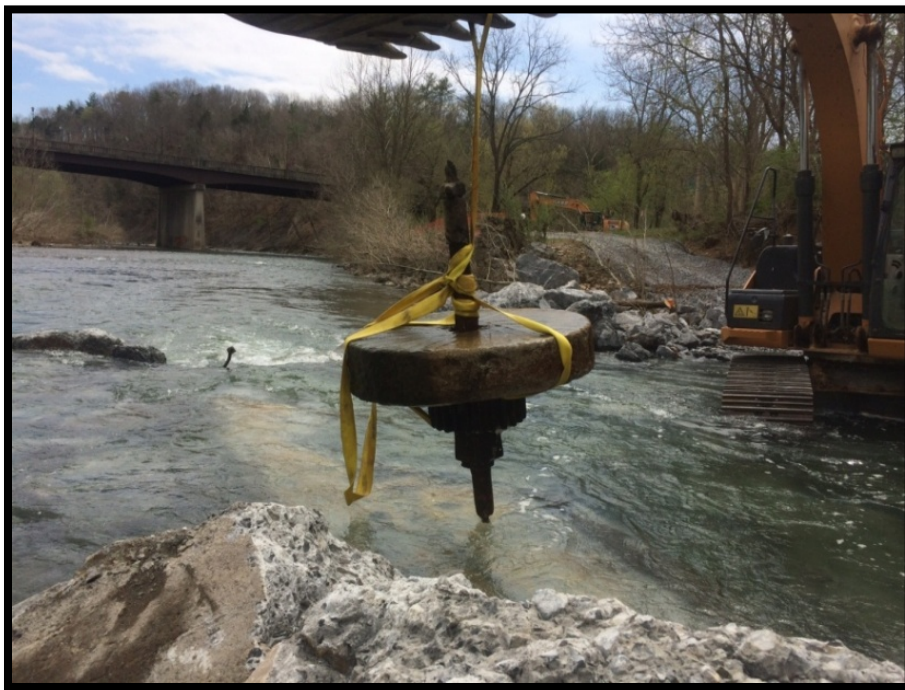
As part of the mitigation measures stipulated in the MOA, on April 11, with the assistance of a scuba diver and heavy equipment, two millstones were recovered from the Maury River, about 75 feet downstream of the Jordan's Point Dam. These millstones were identified during the 2007 engineering analysis of the dam by Comprehensive Construction Services, Inc. One of the millstones measures four feet in diameter and is about 9 ½ inches thick. It has a three-inch square metal rod approximately 20 inches long on the dressed side, which extends about six inches on the underside. The hand-stitching on the bands of the stone have a nicely visible dress pattern. The pattern suggests the stones rotated in a clockwise direction, usually indicative of “flour” or wheat stones.<sup>31</sup>

**Figure 38: Removal of millstone from Maury River on April 11, 2019.**

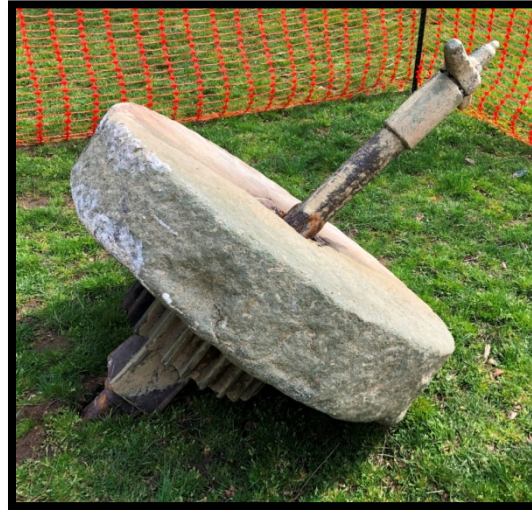
The smaller millstone measures 43 inches in diameter and is also about 9 ½ inches thick. It has a metal shaft that is chamfered and which is attached to a spur gear drive (cast iron) on the underside. The cast “spur” gears have an interesting arrangement, where the spur gear is disengaged from its driving gear by raising the gear out of mesh, to allow other machinery to run when not milling. The gearing, shaft, and drivers all appear to be cast iron, and probably date to the late 1800s. The gear works do not appear to be of the work of the Fitz Waterwheel company, which was the largest and longest surviving producer of this vintage of works.<sup>32</sup>

**Figure 39: Millstone pulled from the Maury River with intact gearing (April 11, 2019).**

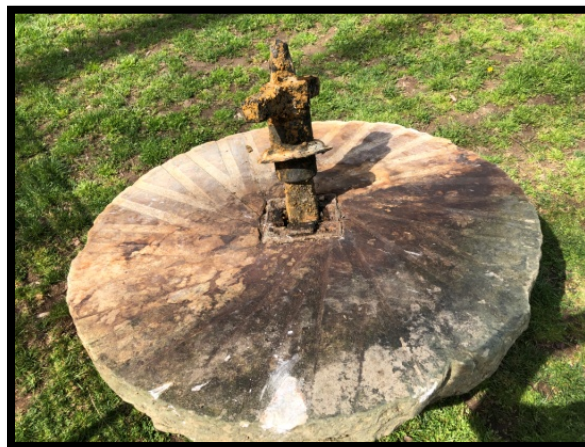
The two stones that were removed from the river are of conglomerate sandstone and probably came from the Brush Mountain Millstone Quarry in nearby Montgomery County, Virginia.<sup>33</sup> This conglomerate is a “white or gray siliceous sandstone containing round quartz pebbles of various sizes”<sup>34</sup> that is particularly well suited for grain milling stones. Although it is not known for certain from which mill or mills these stones came, it is highly probable that it was from the gristmill that operated at Jordan’s Point. One of these millstones is now located in front of the Miller's House Museum, and the second millstone is destined for the Frontier Culture Museum in Staunton, Virginia.

**Figure 40: Second millstone salvaged from the Maury River. Note the fine dressed pattern (April 11, 2019).**
