DROMGOOLE HOUSE HISTORIC STRUCTURE REPORT

Old Brunswick Circuit Foundation
Valentines, Virginia

Report by Glavé & Holmes Architecture

March 25, 2022

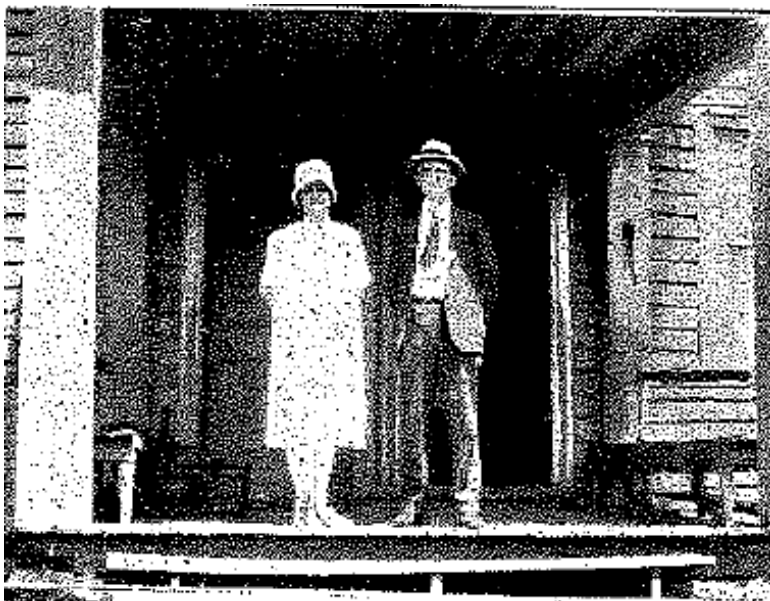
This historic photograph from 1929 shows the porch with protective placement of two side benches to prevent people from falling off the sides of the porch.

The porch needs a great deal of repair to make it safe for use by visitors. The foundation is fragmentary, the flooring is loose and unreliable, and the stairs are not usable by visitors. There are no porch railings, which is a hazard, even though the project probably doesn't need to meet code as an existing historic building. The historic photograph from 1929 on page 21 shows the porch with protective placement of two side benches to prevent people from falling off the sides of the porch.

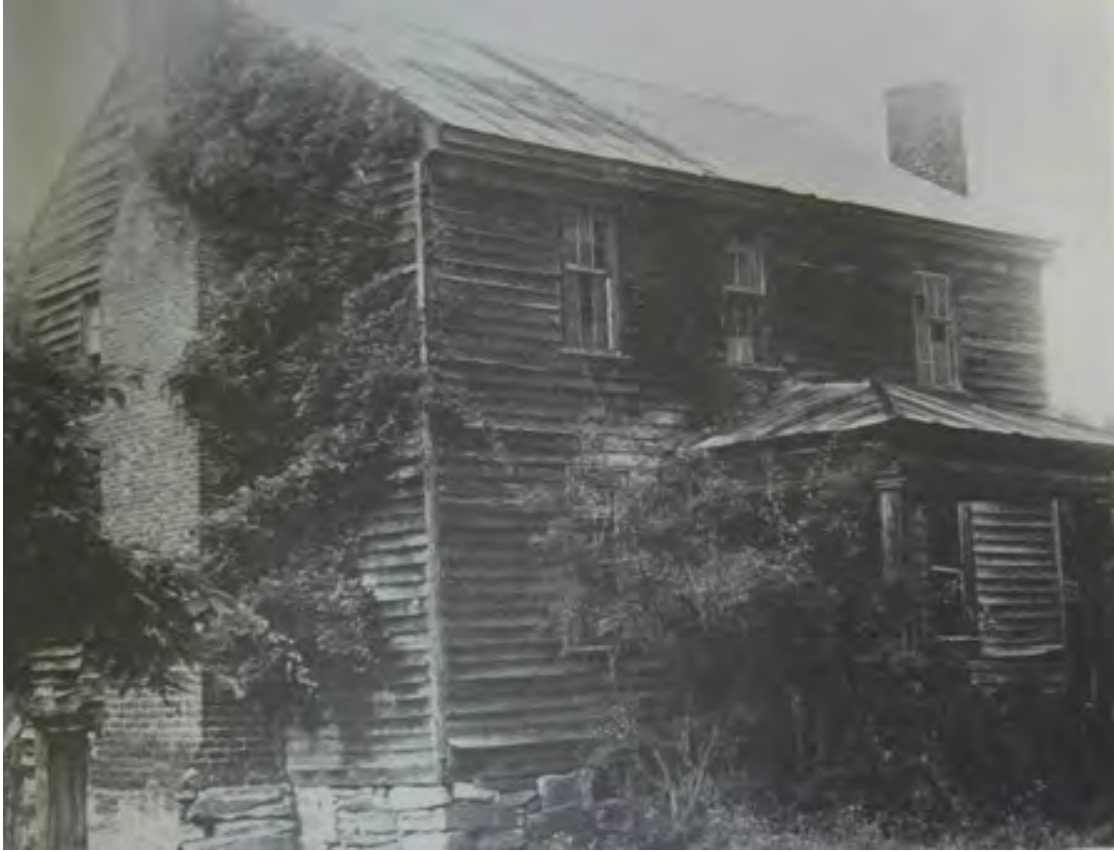
Southwest corner from the southwest showing repaired foundation, 1970s [Corker, Collection Old Brunswick Circuit Foundation].

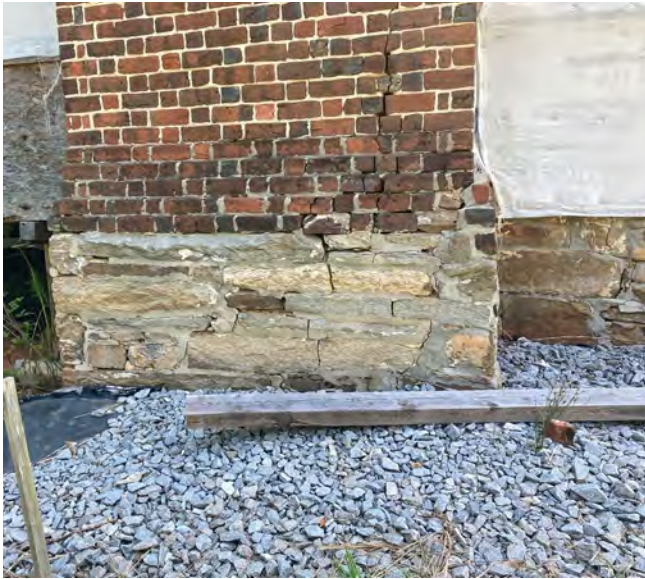
Dromgoole House, west chimney base (left) and western angle of front porch (right).

- West Chimney
 - * Rebuild from shoulder up (cracks and outward shift/lean). Document and salvage the decorative diapering pattern and put back to match existing.

- * Base appears to have been an outer wythe of mortared masonry with inner rubble fill which has become loose. Rebuild base in sections with clay bricks at interior, exterior wythe of stone masonry to match original. Similar to construction of main walls. Add new concrete footing installed in segments after repairing structural crack with stainless steel helical ties.

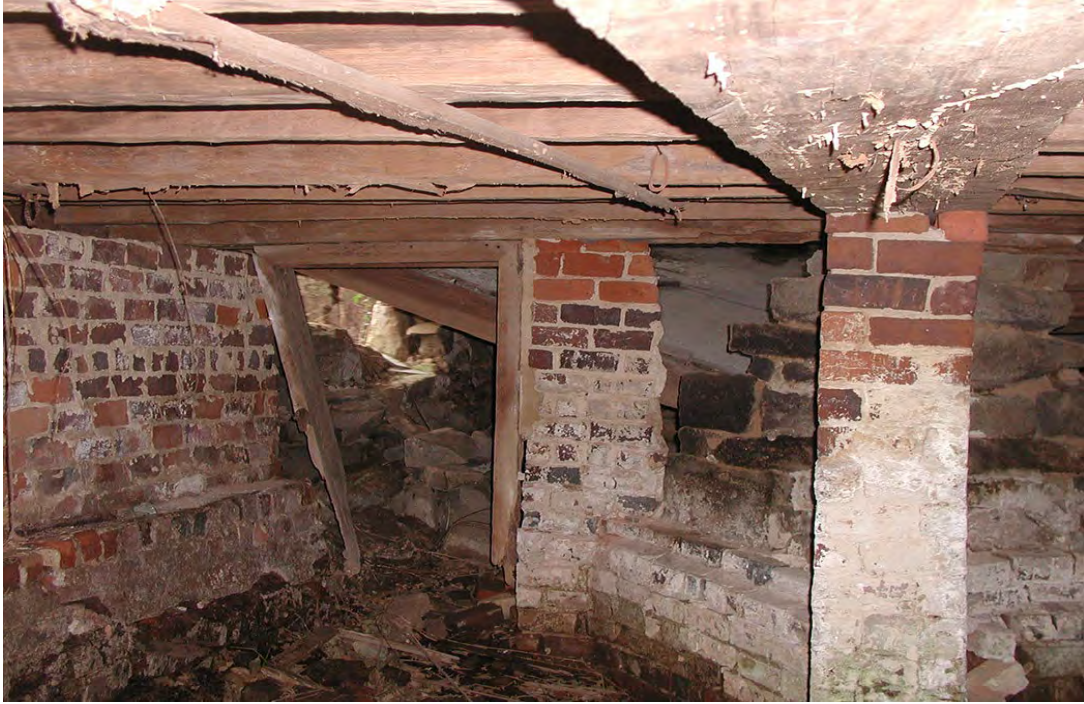
Basement- view of the north half of the Basement looking east showing the diagonal pier and added brick partition to the right. The door frame, no longer in place after the repairs of 2013, connected the room on the east side of the Basement with the room(s) on the west.

- Provide a crawl space entry to the north side of the west chimney. Recreate the likely form of a historic basement bulkhead at that location.
- The section of brick cross wall on the interior should be preserved in place and the Basement filled with gravel to the level of the original crawl space.

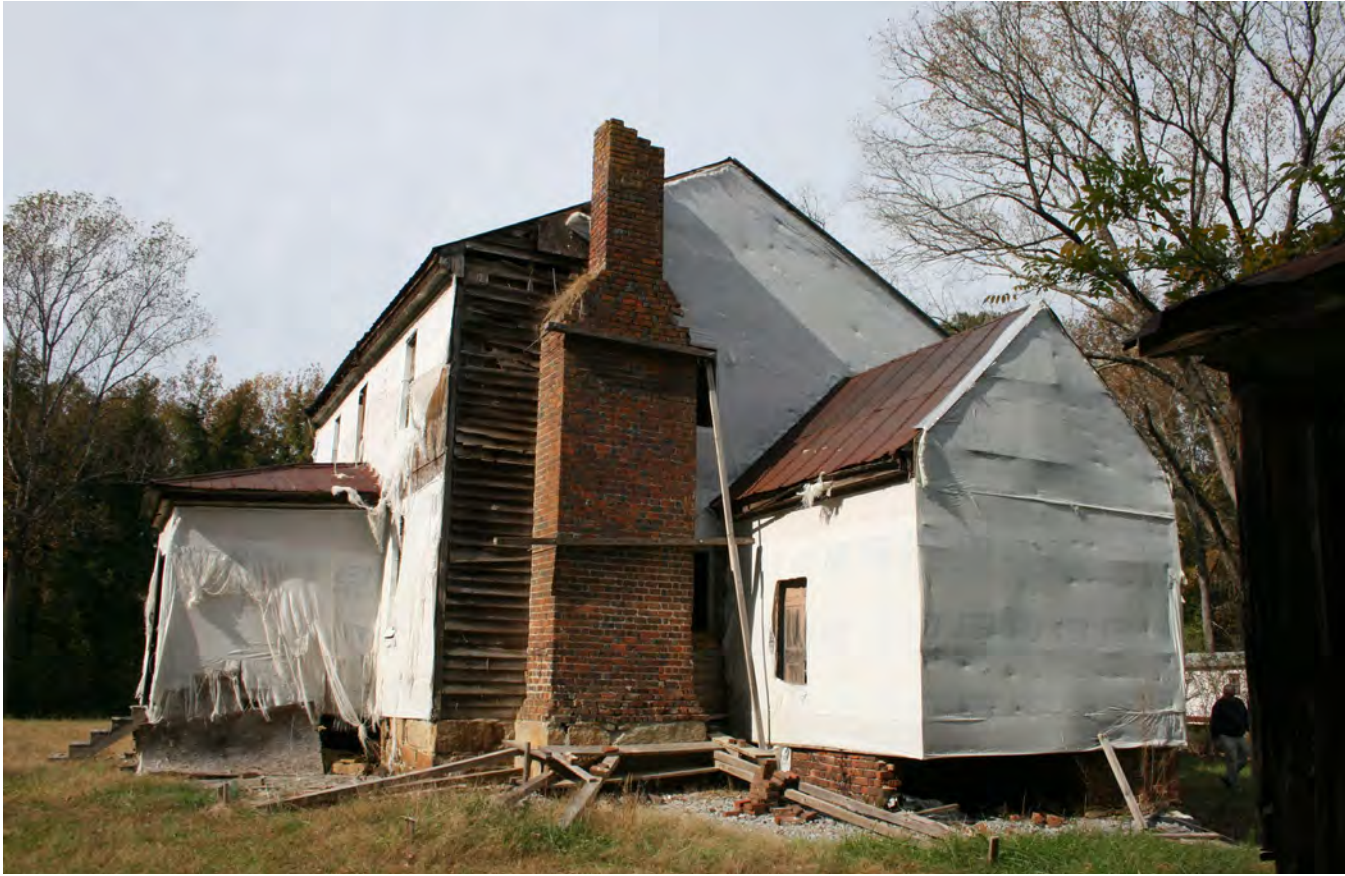
The foundation is in very poor condition. At some point after the crawl space floor was lowered, the exterior foundation wall, which was made up of an inner and outer layer separated by a rubble or mud-filled core, began to fail and was rebuilt, probably in phases over many years, as an uncoursed veneer reusing the original stones. A photograph from 1960s (page 29) shows a missing section of stone at the southwest corner before it was repaired. The only original section of properly coursed stone survives under the front porch. The rest of the foundation appears to have been rebuilt over several years using original materials. The inner layer of the foundation also failed. The inner layer of stone at the east end was rebuilt in the twentieth century, and most of the rest of the inner layer and about half of the outer layer has fallen. Thanks to local experts, the building has been shored up and the east chimney partially stabilized. The west chimney exhibits serious cracking and evidence of bulging subsidence, indicating a pressing need for stabilization and repair. The interior foundation wall at the west chimney has entirely collapsed. The building has very little lateral system at the base especially on the north side and its gravity supports are patched together. Foundation repairs should move ahead as soon as possible to minimize risk of losing the building or a more thorough and professional shoring system should be put in place.

Foundation, west end, south elevation (above) and west end of porch (below), 2021.

- Remove and rebuild the entire foundation, except for intact portions of the south porch foundation and the central section of the south wall under the south porch, which appear to be structurally competent.

- Sections of foundation should be underpinned, repaired, and repointed using appropriately formulated lime-based mortar to permit moisture movement and evaporation.

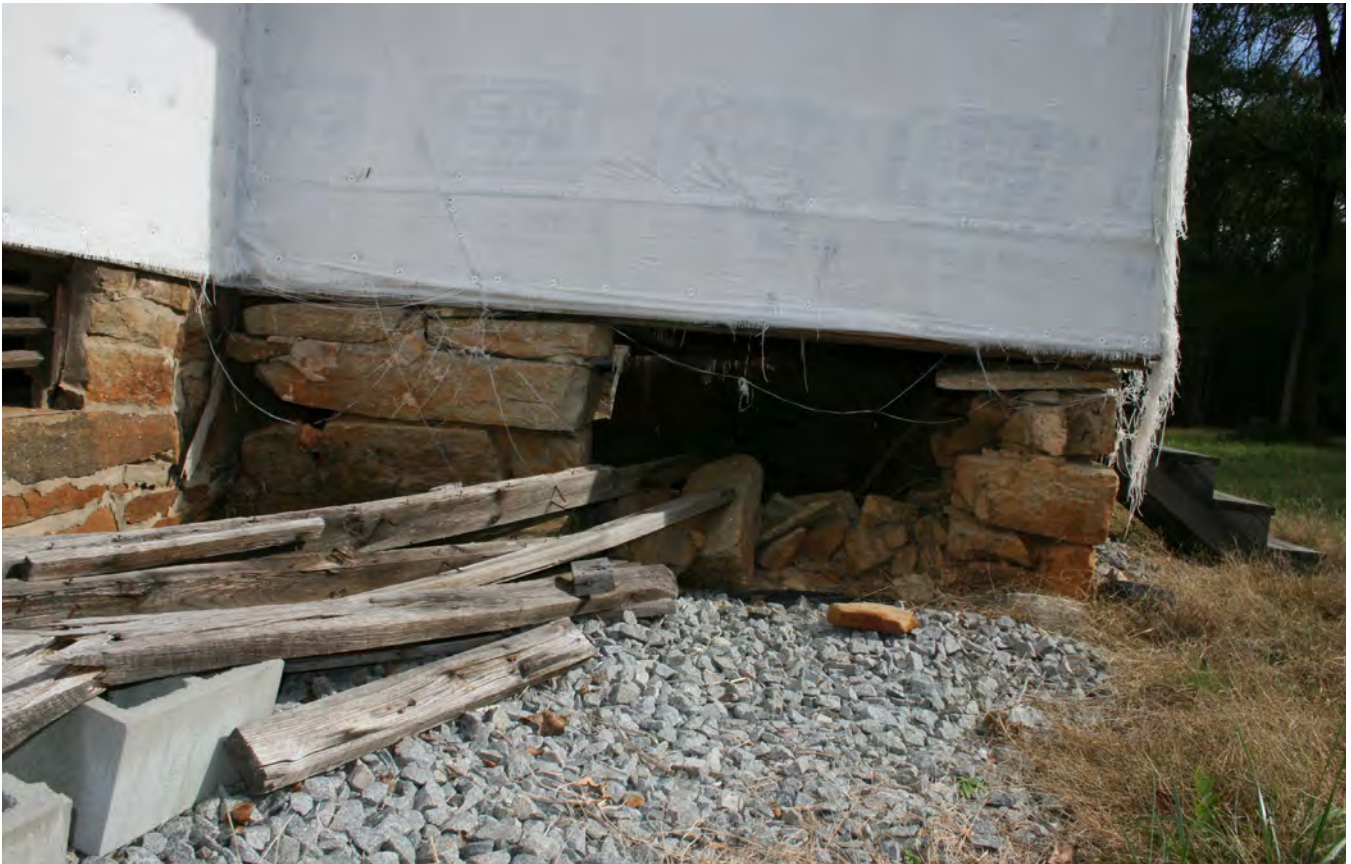
The chimney at the east end was moving and collapsing at the base, as the outer layer of stone was forced to carry most of the weight of the brick chimney shaft above. Tom King repaired the base of the chimney and filled the void at the interior with concrete grout. The west chimney has similar problems that have not been addressed. Cracking and bulging at the base indicate that the stone outer face does not have capacity to carry the weight of the brick above. At both chimneys, the tile that originally shed water is missing from the shoulders and the upper shaft has lost integrity.

Base of east chimney (above) and East Wing foundation from the southeast (below), 2021.

- * Previous repairs have poured concrete into interior to tie together. While not ideal as far as reversibility, this may have been determined necessary in earlier years to stabilize the brick above. Now that it is presumed to be solidly adhered with the concrete, consider underpinning to mitigate future movement.

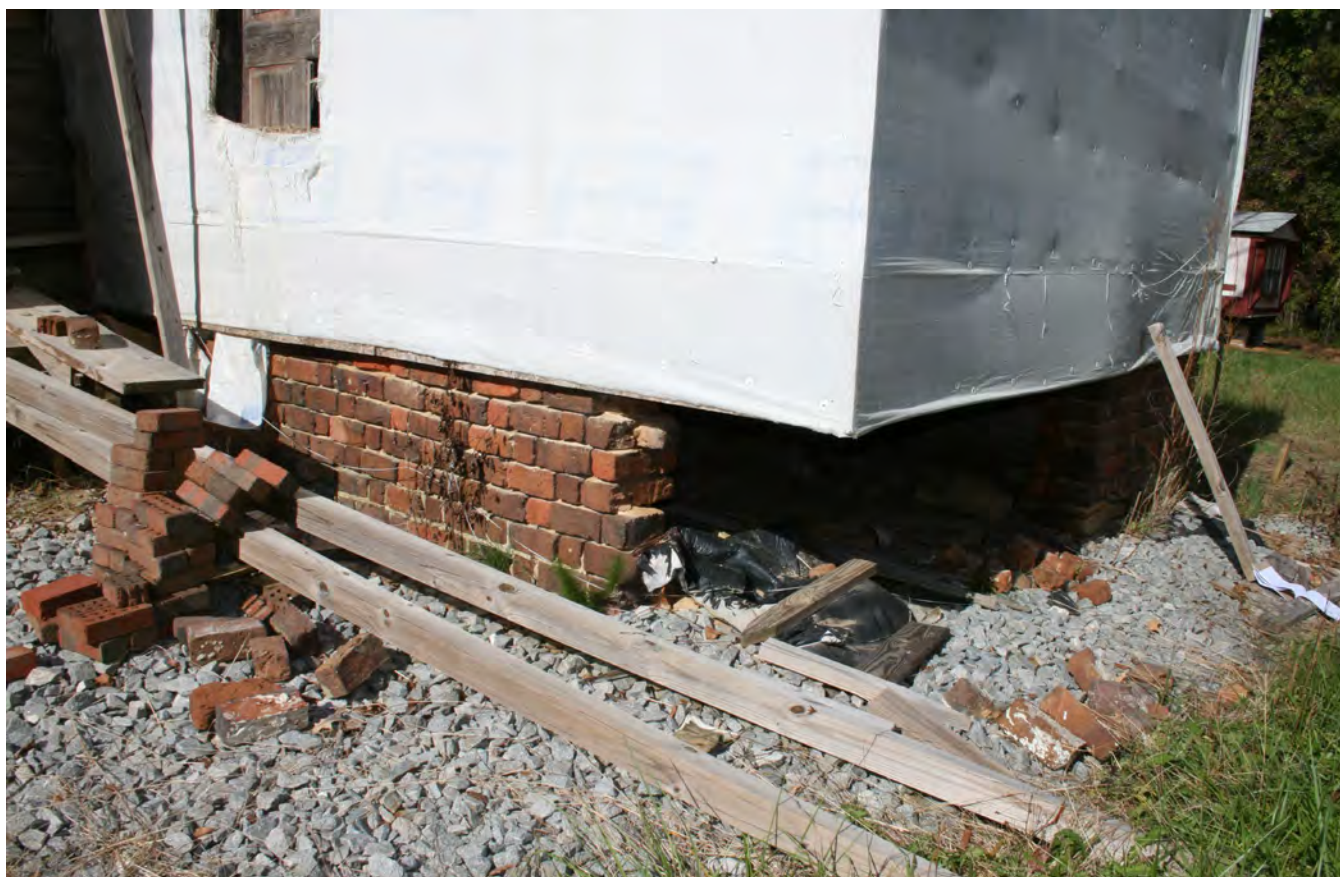
The exterior of the wing is in poor condition. Some of the weatherboards and trim elements are possibly reusable in place, particularly on the south, where they were protected for many years by the porch. The window sashes are missing. The floor framing is partially collapsed and the floor damaged. The north foundation wall is intact, although damaged by cracking. The east end and south foundation walls are in poor condition or missing entirely. The roof is sheathed with an unusual 2-V surface-nailed metal roof.

- Intact sections of the brick foundation (particularly under the north wall) should be repaired in place. Other damaged and missing sections of the brick foundation should be rebuilt on new footings using brick salvaged from the site.

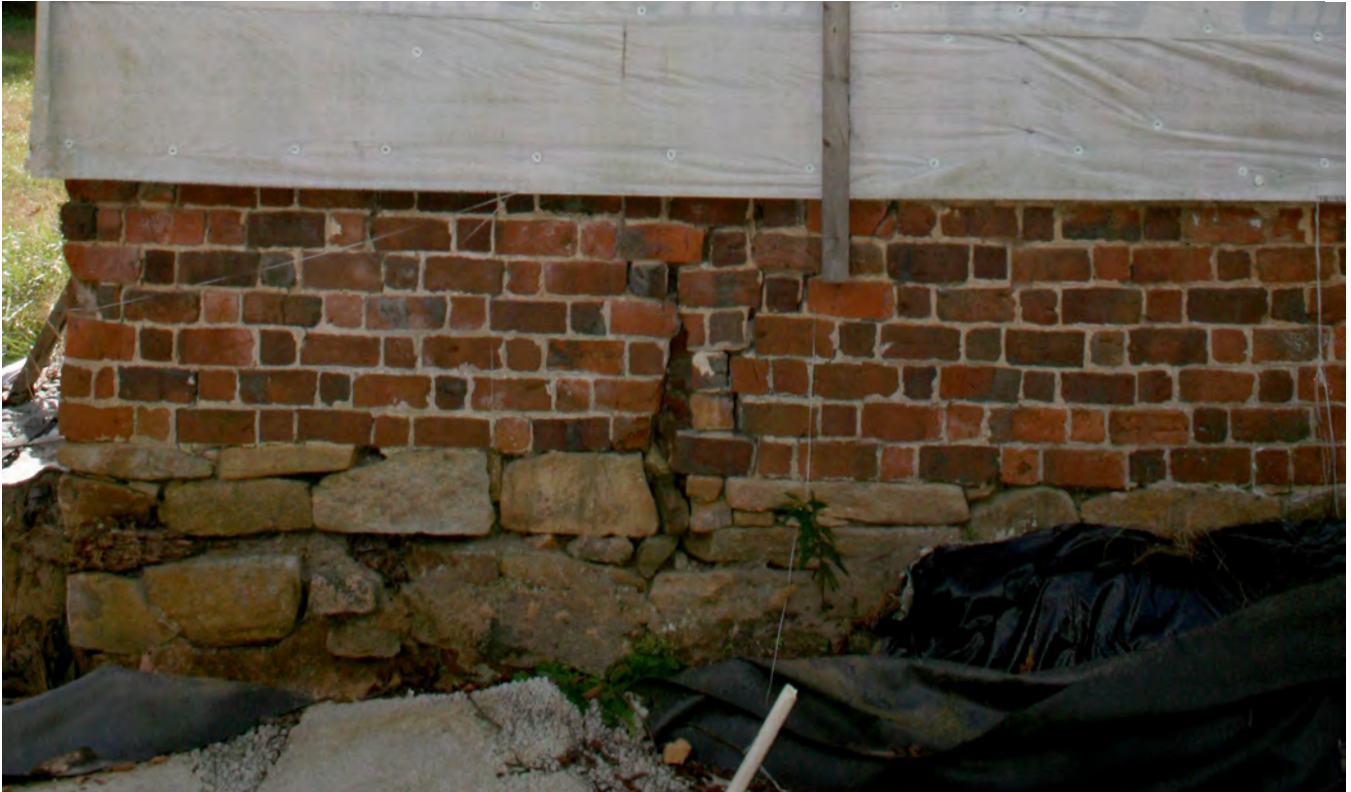
Foundation, north elevation, East Wing (above) and junction between East wing and main house foundation (below), 2021.

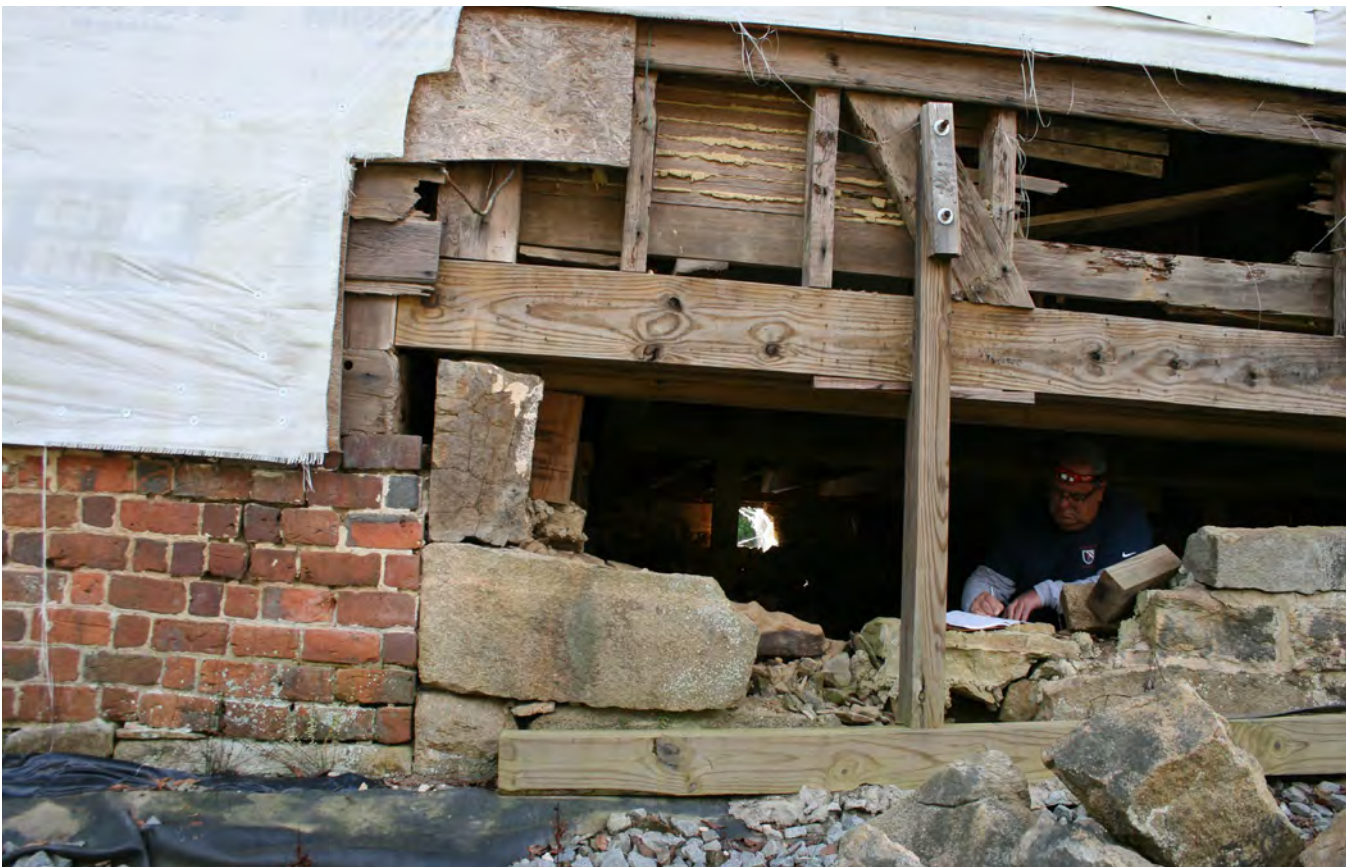
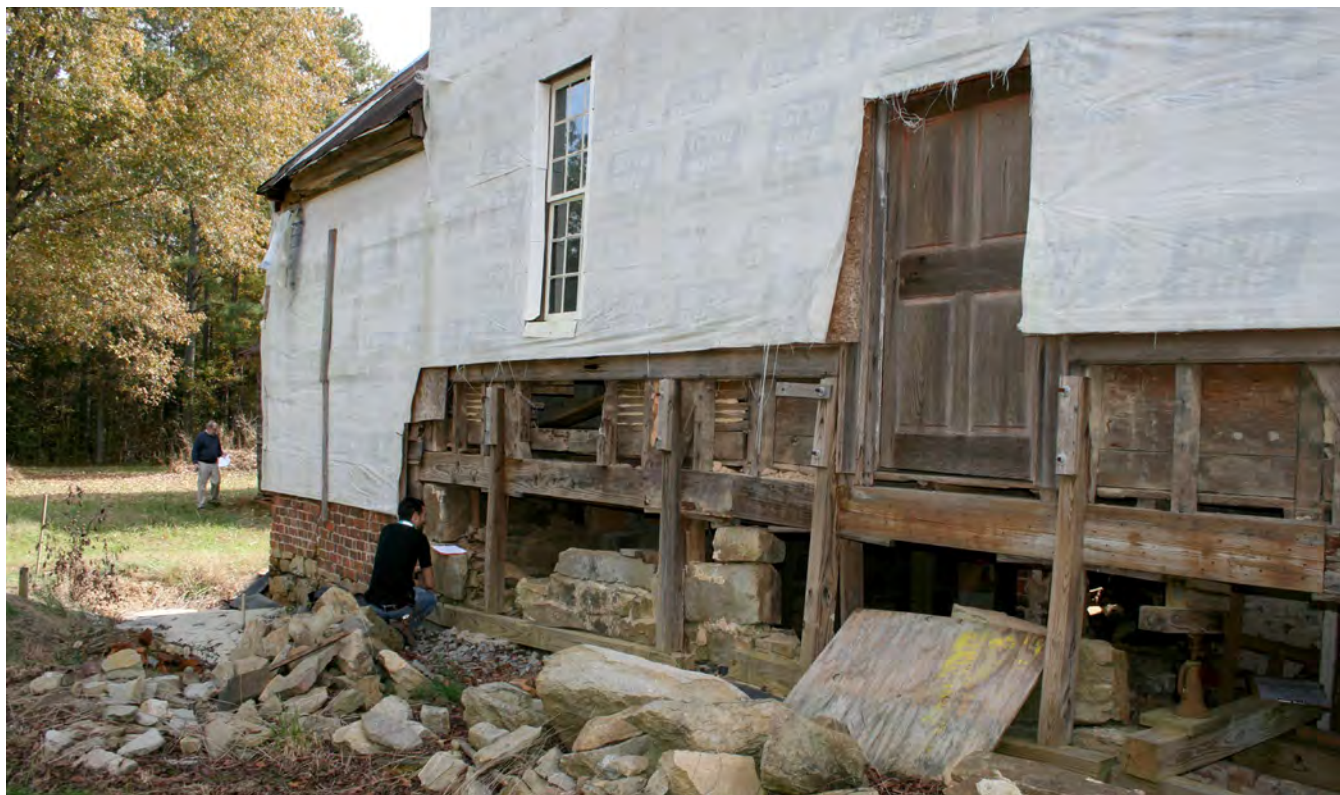
North elevation looking southeast (above) and shoulders and diaper ornament, west chimney (below), 2021.

This chimney might not be standing but for the support provided by the house framing. The stone foundation below grade has been pushed in from west to east (exterior to interior) by hydrostatic pressure from the ground outside and the stone base within the crawlspace has deteriorated to the point of exposing the stone rubble piled within the base of the chimney. The inward movement at the bottom of the stone base has created an outward bulge above grade where the brick masonry begins on the chimney exterior.

It also appears that the west face of the chimney has settled which has exacerbated the bulging of the masonry and caused the masonry on the sides of the chimney to run out of level sloping away from the house. There appear to have been some repairs done at the base of the chimney which might make it difficult to support the structure without opening the chimney where necessary to assess how the interior wythes of brick are bonded into the outer wythes.

The upper part of the chimney needs to be removed and rebuilt. The upper part should be removed prior to the underpinning so that the overall weight of the chimney can be reduced prior to starting that process. If the condition of the chimney requires it to be dismantled, the “diapering” pattern in the chimney breast should be carefully documented and all of the brick pieces should be numbered and saved for reuse during the rebuild. All loose brick at the shoulders should be removed for safety reasons and salvaged for reuse.

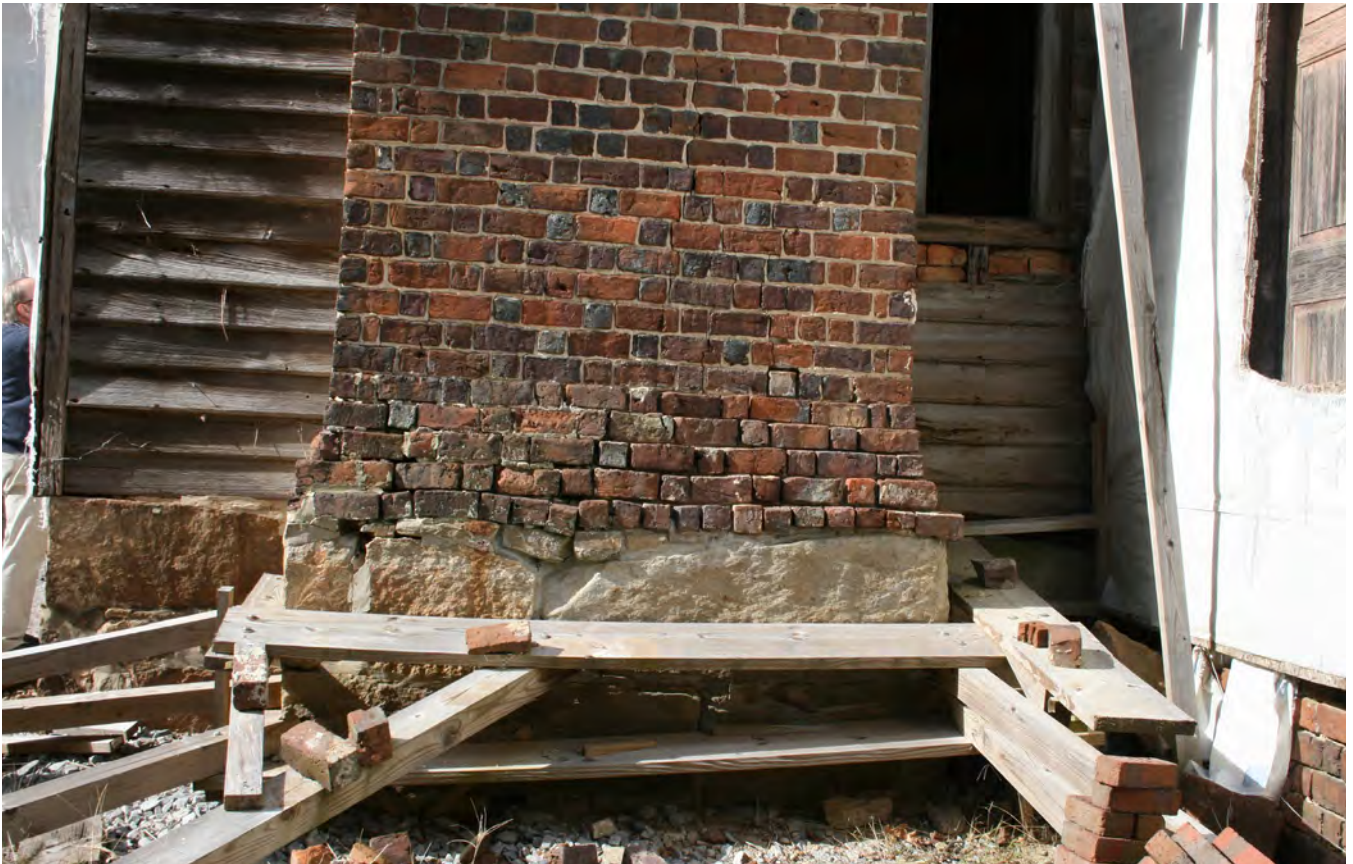
East Chimney looking south at shoulder level showing damage (above) and east chimney base looking east (below), 2021.

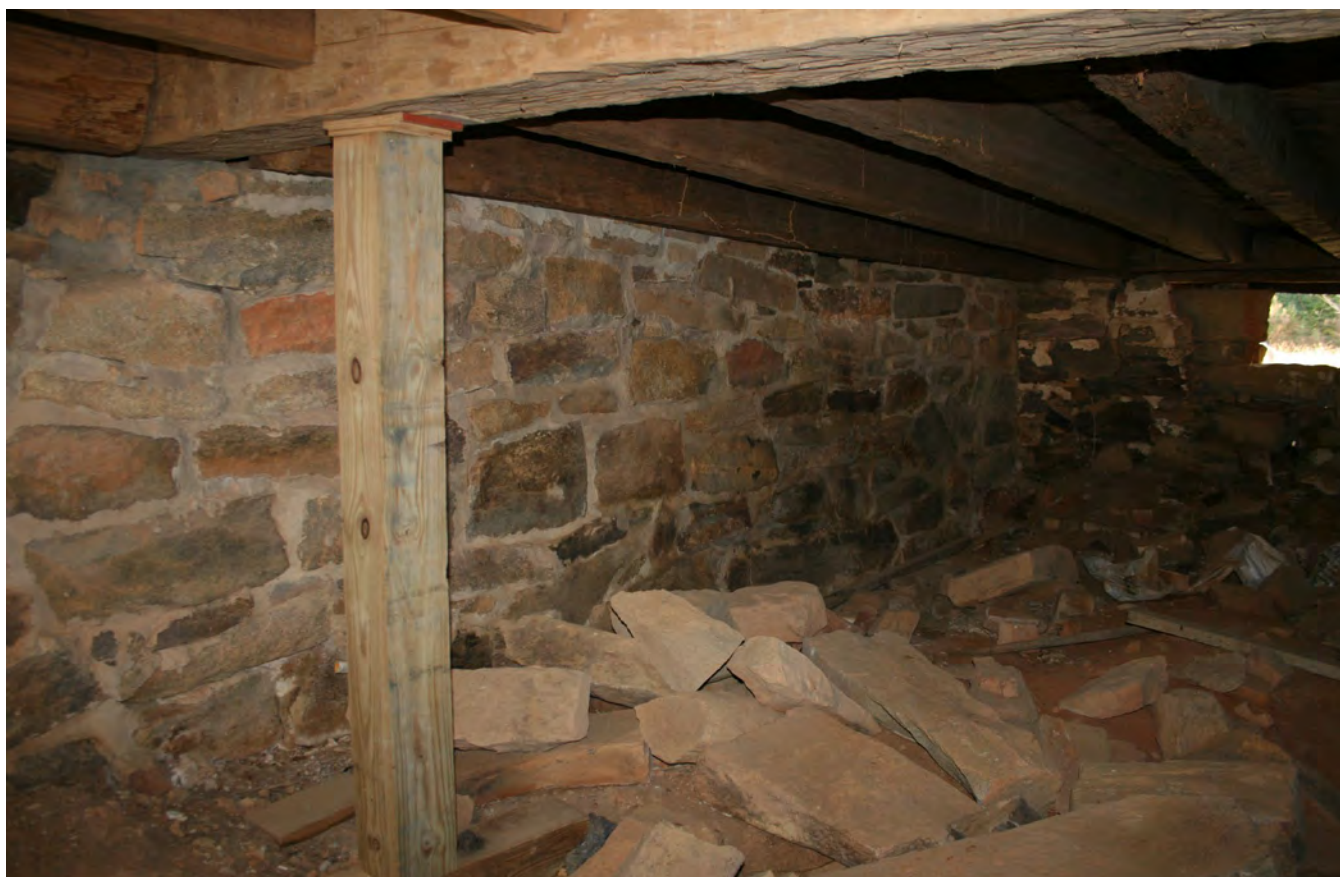
Basement, original stone pier looking southwest (above) and eastern room looking southeast at rebuilt stone wall (below), 2021.

This original section of stone wall is a good indicator of how the rest of the wall was originally built and why it was doomed to have problems from the beginning. Although the foundation wall may be 18”-24” deep in some places, the beam/plate that supports the frame of the house is only 10” deep. This means that the weight of the entire house is concentrated on only 10” of stone wall that is balancing on rubble and chinking. These stone wedges do not provide the interlocking bond that larger pieces do when they overlap each other.

When the foundation wall is rebuilt, it is important that any attempt to replicate the appearance of the foundation stone as seen in this one section of original foundation should implement a method of stone assembly that maintains the appearance style while also giving the wall more structural overlap.

We recommend that the available stone on site is used in combination with suitable brick to build an interlocking stone and brick wall with stainless steel helical tie rods placed at regular intervals to provide support between the stone veneer on the exterior and the masonry within the crawlspace. The veneer would be built to replicate the original masonry as described above but the stones will be woven to backup masonry comprised of brick and stone as needed. The use of brick will provide units of masonry small enough to adapt to the irregular stone shapes but large enough to overlap and provide structural overlap within the masonry wall. The walls should be built using a lime mortar to provide for consistent evaporation of water within the wall and to promote the self-healing of micro-cracks that may develop with the uneven pressures of the stone assembly.
