An Architectural Survey of King William County

(Cost Share 2014)

Stantec Consulting Services,
formerly CRI
1049 Technology Park Drive
Glen Allen, Virginia 23059

July 24, 2014

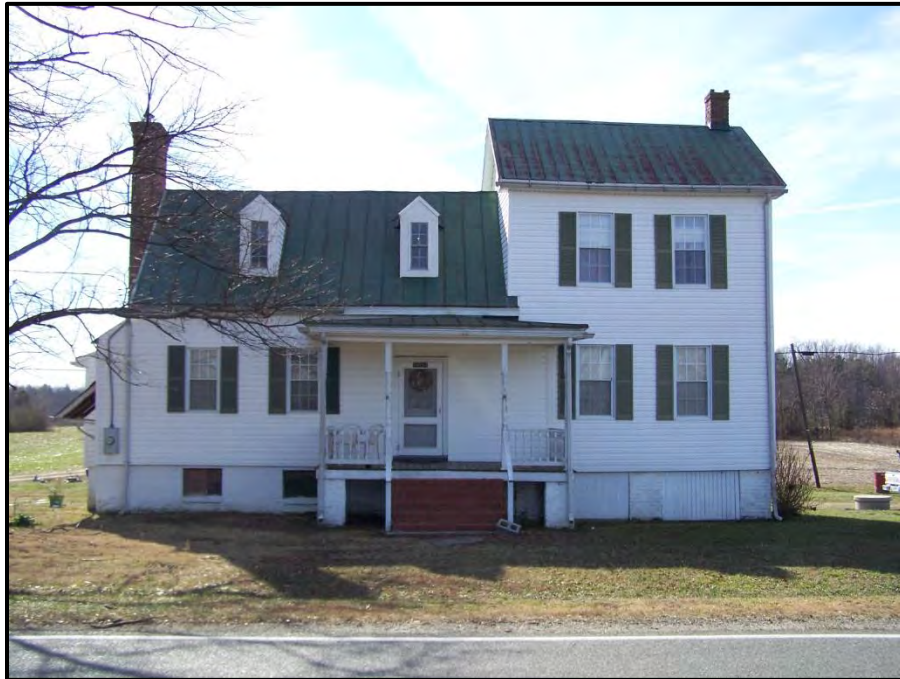
Figure 23. House (c. 1750; VDHR #050-5061), 19894 King William Road, View Looking Southwest.

Seventeen resources, one newly recorded and 16 previously recorded, dating to the eighteenth century were documented during the current survey. Two have been demolished since previous surveys; Rumford Academy (VDHR #050-0001) and Sloe Grove (VDHR #050-0112). One primary resource, the dwelling at Edge Hill/Cockrantown (VDHR #050-0121), has also been demolished. The surviving eighteenth century resources documented during the survey are all domestic with the exception of the Aquinton Church (VDHR #050-0002) and include Bear Garden (c. 1725; VDHR #050-0005; Figure 18), Belleview (c. 1770; VDHR #050-0006), the Captain Silas Duncan House (c. 1770; VDHR #050-0019; Figure 19), Smyrna (c. 1750; VDHR #050-0066; Figure 20), Brighton (c. 1765; VDHR #050-0007; Figure 21), Greenmount Farm (c. 1770; VDHR #050-0029), The Grove (VDHR #050-0030), Marle Hill (c. 1770; VDHR #050-0043; Figure 22), Edge Hill (c. 1770; VDHR #050-0055), Pleasant Green (1760; VDHR #050-0056; Figure 24), Catalpa Grove (c. 1780; VDHR #050-0087), Chestnut Grove (c. 1700; VDHR #050-0088), and a house located at 19894 King William Road (c. 1750; VDHR #050-5061; Figure 23).

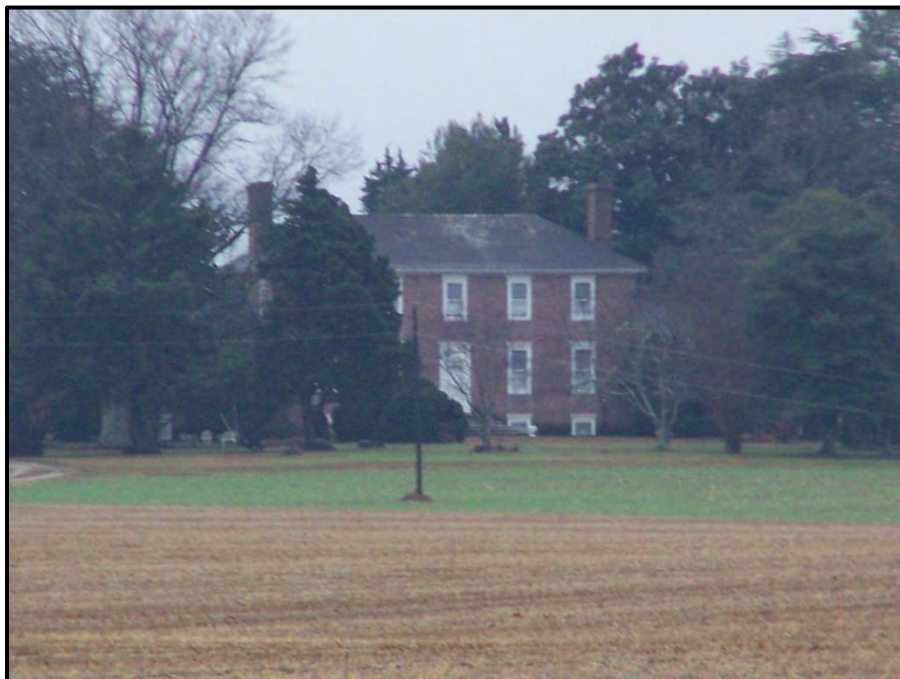
Figure 24. Pleasant Green (c. 1760; VDHR #050-0056), 468 Pleasant Green Lane, View Looking Southwest.

story, with a slightly lower one-and-a-half-story wing, a configuration which appears to be a regional architectural variation. Gable-roofed dormers on the front roof slope of the one-and-a-half-story examples were common, however, not on the two-story examples with the one-and-a-half-story wing. While most of the eighteenth century dwellings surveyed were frame construction, the two-story hipped-roof Pleasant Green (VDHR #050-0056; Figure 24) was brick construction.

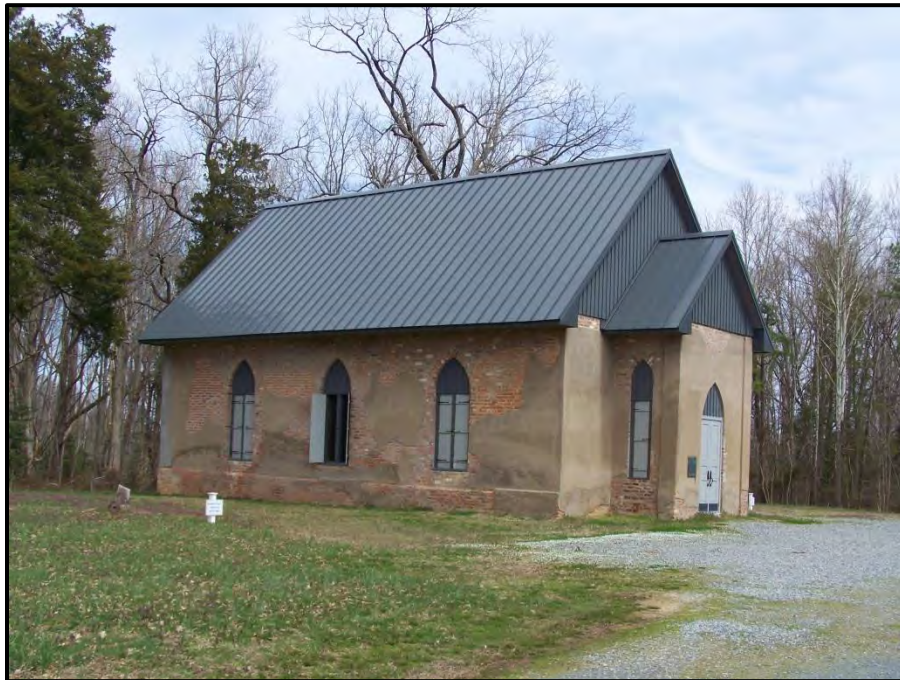
Figure 25. Acquinton Church (VDHR #050-0002), 5703 Acquinton Church Road, View Looking Northeast.

The original Acquinton Church, constructed in 1734, was a larger building than the present structure. The remaining section, the north wing, was built between 1755 and 1765, which created a cruciform plan. Originally the church was constructed for an Anglican/Episcopalian parish. From 1800 to the Civil War, however, the church was utilized by a number of sects including Methodist and Baptist congregations. After 1870 the majority of the church was demolished with the exception of the north wing and remodeled. The remodeling of the building included reconfiguring the rounded arched windows into Gothic Revival pointed arch windows (Chaffman in Davis 2012; http://www.kingwilliamhistory.org/acquinton_church). Currently the church retains its c. 1870 configuration, however, the building, which lay in ruins, was restored in 2010. As part of the restoration of the church the roof was reconstructed and the pointed arches of the windows in-filled (Figure 25). To the northeast of the remaining portion of the church building are the remains of the Acquinton Church Glebe (demolished; VDHR #050-0097) and a cemetery (Figure 26). The earliest grave marker dates to 1901.

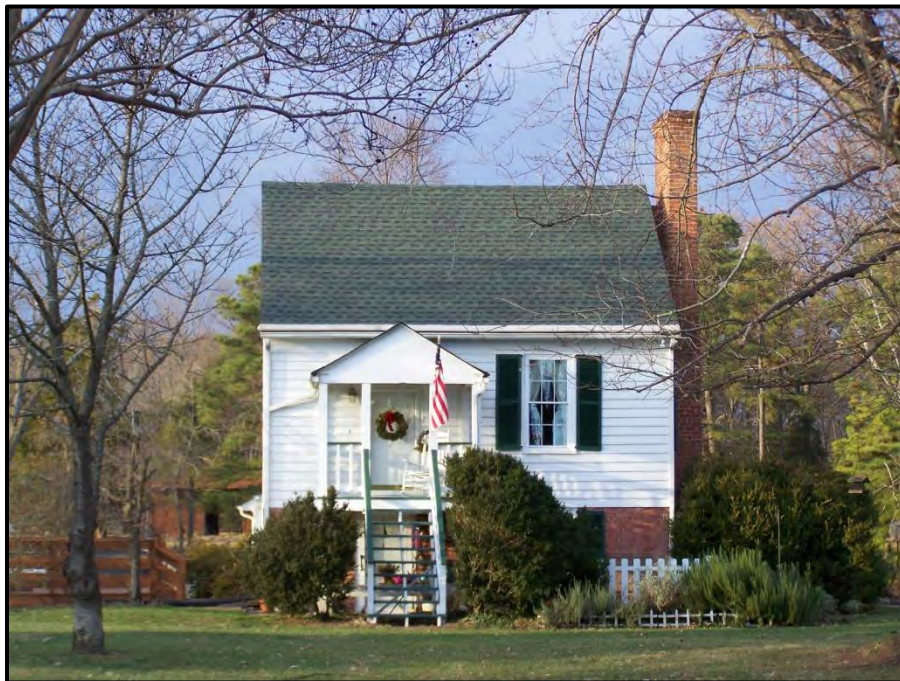
Figure 27. Fox House (c. 1830; VDHR #050-0033), 47 Mangohick Circle, View Looking Northwest.

Dwelling surveyed during the current effort varied widely in terms of number of stories as well as roof lines, sheathing materials and configuration. The smallest of the dwellings surveyed is Fox House (VDHR #050-0033; Figure 27). The house is constructed on a raised brick foundation and features two bays and an exterior end brick chimney. Woodlawn (VDHR #050-0125; Figure 30), a c. 1830 dwelling located at 3881 Smokey Road, in contrast to Fox House, is a one-and-a-half-story frame dwelling which has been expanded by the addition of two gable-roofed wings. The dwelling also features exterior end brick chimneys. Notable for their architectural integrity as late nineteenth century dwellings, both the c. 1870 house (VDHR #050-0179; Figure 28) located at 2 Route 624 and the c. 1880 house (VDHR #050-5038; Figure 29) located at 501 Locust Hill Road retain their original two-over-two wood double-hung sash windows, weatherboard sheathing, diamond point wood shingles in the projecting front gable and, in the case of VDHR #050-0179, turned wood porch posts.

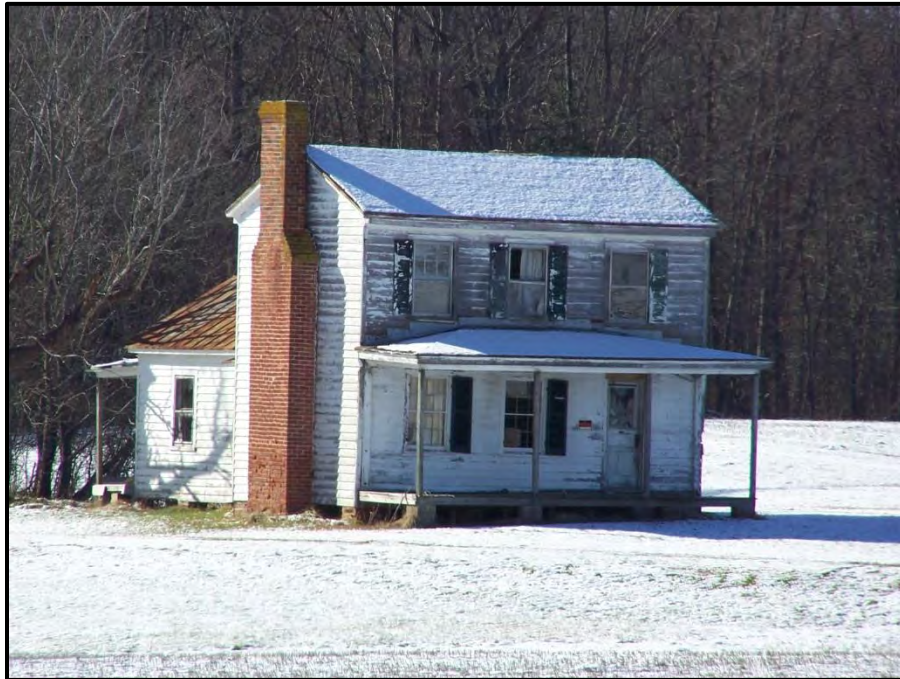
Figure 32. House (c. 1870; VDHR #050-5035), 2692 West River Road, View Looking West.

The two-story nineteenth century dwellings surveyed tended to be more vernacular in appearance and include a house (c. 1870; VDHR #050-5035; Figure 32), 2692 West River Road;

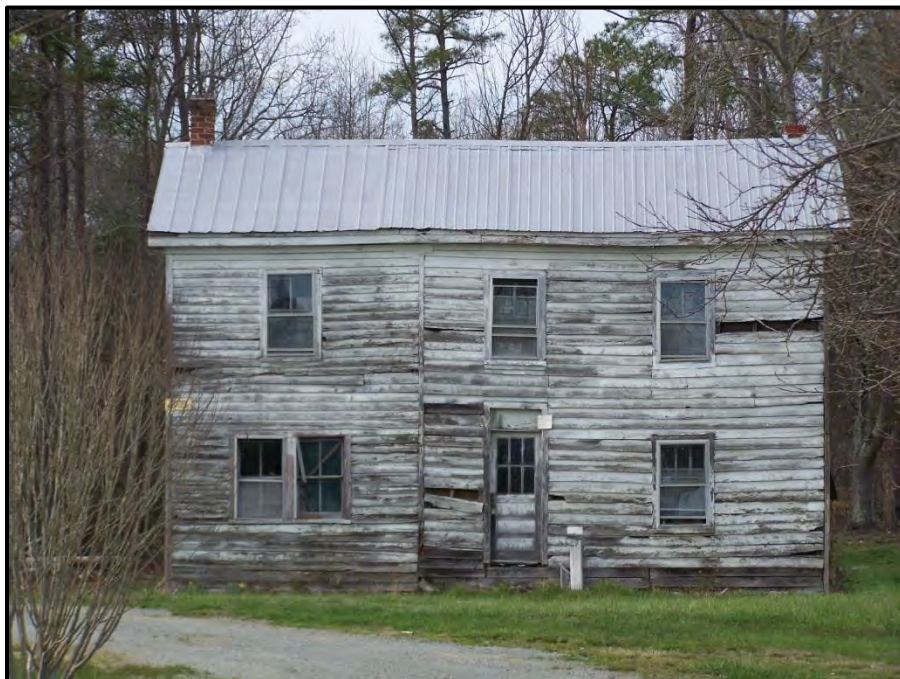
Figure 33. House (c. 1870; VDHR #050-0165), 21101 King William Road, View Looking North.

the house (c. 1870; VDHR #050-0165; Figure 33) located at 21101 King William Road; Allmond House, also noted as the residence of the last queen of the Mattaponi (VDHR #050-0105; Figure 34), 1538 Mattaponi Reservation Circle; a house (c. 1880; VDHR #050-5031; Figure 35) located at 206 Edgar Road; Tanyard (c. 1830; VDHR #050-0123; Figure 36) at 1447 Smokey Road; Fairview (c. 1850; VDHR #050-5059; Figure 37) **located at 2270 Nelson's Bridge Road**; and Duane Farm (c. 1890; VDHR #050-5033; Figure 38) at 4929 Herring Creek Road. Sheathing varied and included both weatherboards and synthetic siding while rooflines included side gable and hipped. Outbuildings associated with these nineteenth century resources include sheds, garages, vehicle sheds, and in some cases small agriculturally related outbuildings.

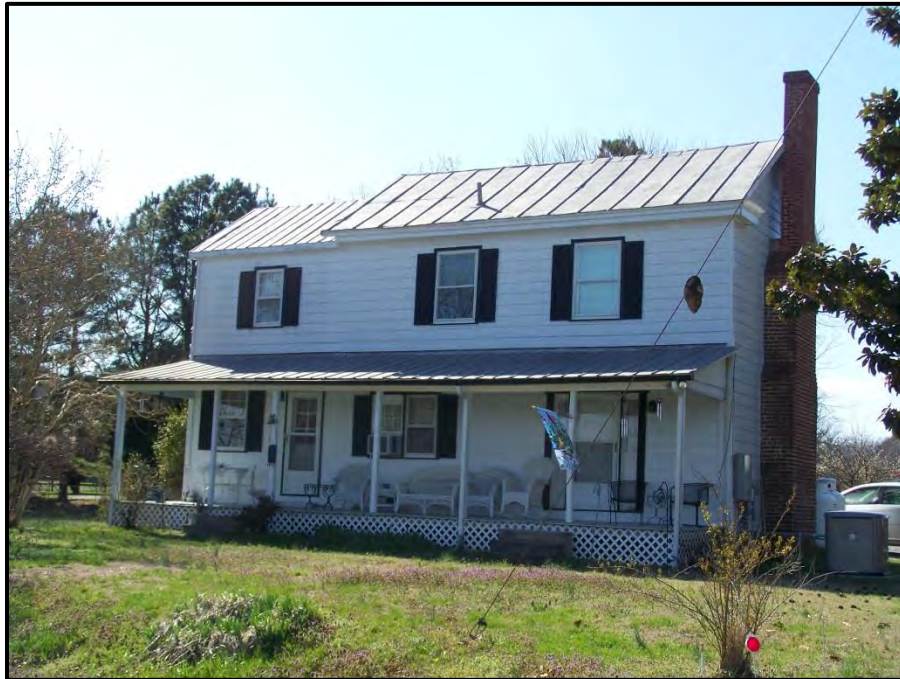
Figure 34. Allmond House – Mattaponi Reservation (VDHR #050-0105), 1538 Mattaponi Reservation Circle, View Looking West.

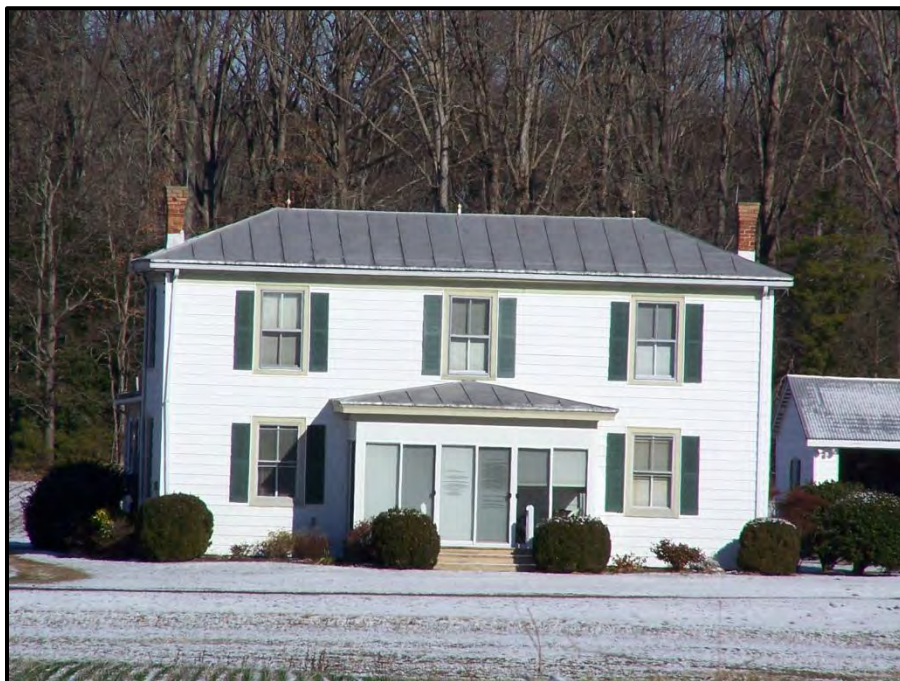
Figure 35. House (c. 1880; VDHR #050-5031), 206 Edgar Road, View Looking Northeast.

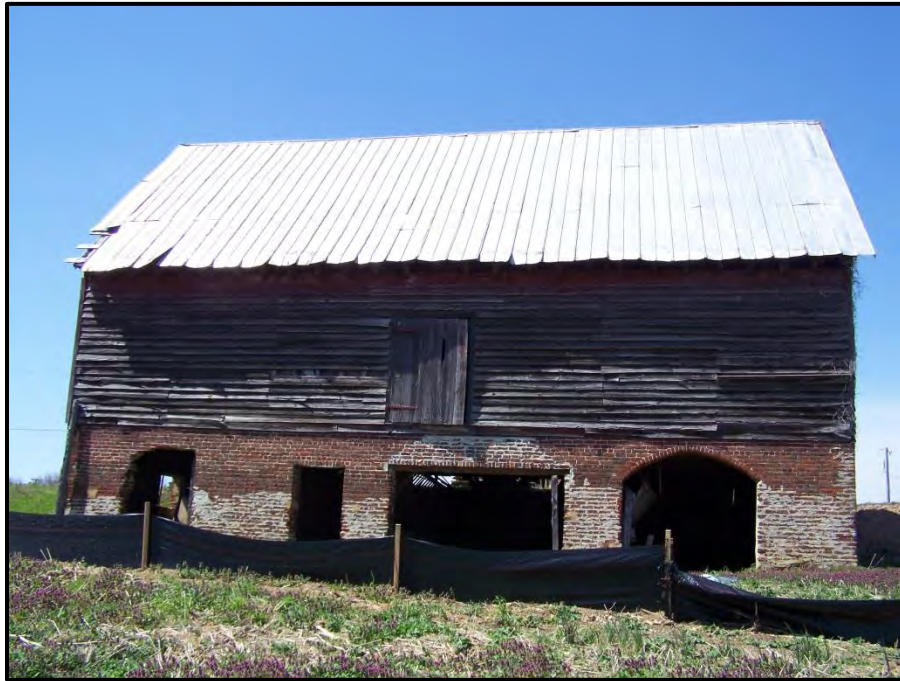
Figure 39. Presley Barn (VDHR #050-0136), North Carolina Road, View Looking Northwest.

The c. 1830s Presley Barn (VDHR #050-0136) located along Carolina Road is currently being stabilized, presumably to preserve the building. Additional more modern barns on the property have been demolished. The barn is an example of a banked frame barn with a raised brick foundation laid in a three course American bond pattern. Several openings pierce the brick foundation including a rounded arch carriage entrance (Figure 39).

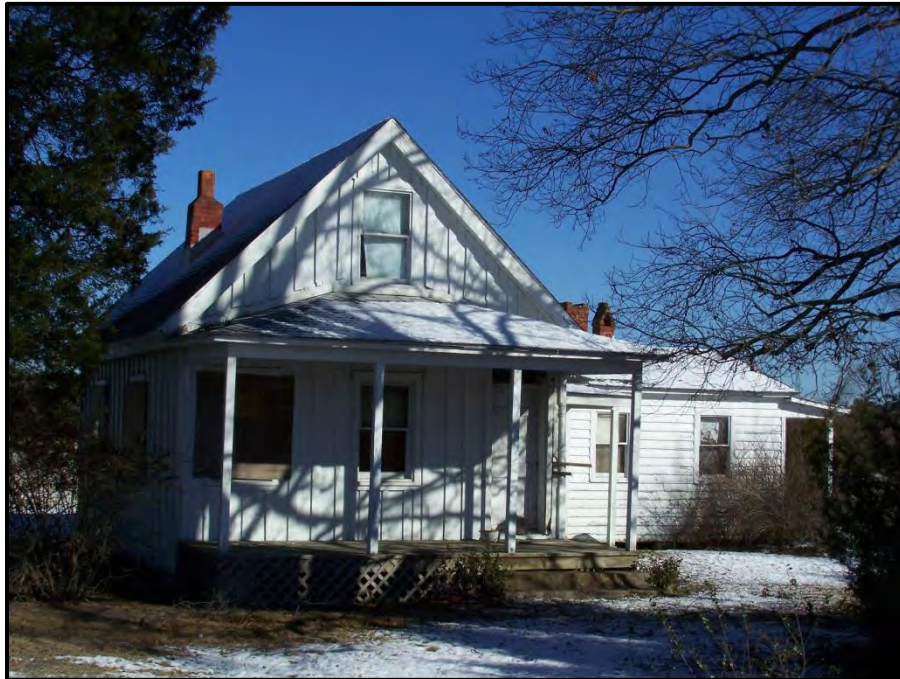
Figure 40. Store (VDHR #050-5034), West River Road, View Looking Northeast.

Two stores were surveyed including the c. 1890 building (VDHR #050-5034; Figure 40) located on West River Road and the store associated with Duane Farm (VDHR #050-5033; Figure 41). The stores vary distinctly in style. The store located on West River Road is a one-and-one-half-story three-bay building sided in board-and-batten siding. Supporting the building are brick piers with concrete piers supporting a later addition to the rear of the store. A hipped roof shelters the front entry which consists of a raised panel wood door with a two-light transom. The original block also features an interior brick flue and one-over-one double-hung sash wood windows.

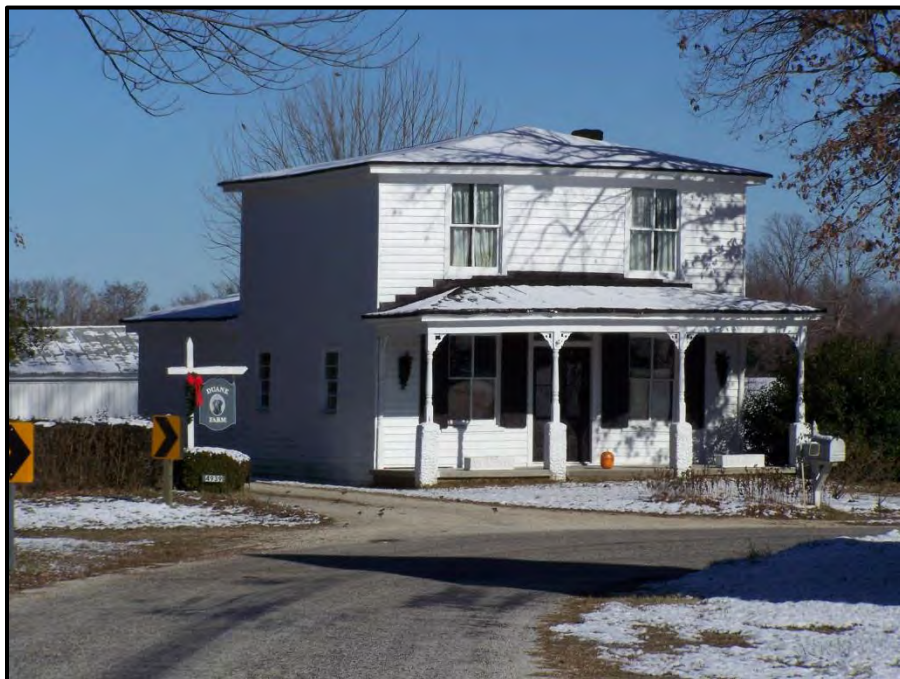
The Duane Store, in contrast to the West River Road store is a much larger two-story three-bay building clad in weatherboards with a hipped roof covered in seamed metal. Similar to the West River Store the building also features an interior brick flue. Entry into the store is through a pair of wood raised panel doors flanked by single-light sidelights surmounted by a two-light transom. Providing shelter to the front of the store is a three-bay porch which features turned wood posts on rustic stuccoed concrete piers and features scroll sawn corner braces. The store also retains its original two-over-two double-hung sash wood windows.

Figure 41. Duane Store (VDHR #050-5033), 4929 Herring Creek Road, View Looking Northeast.

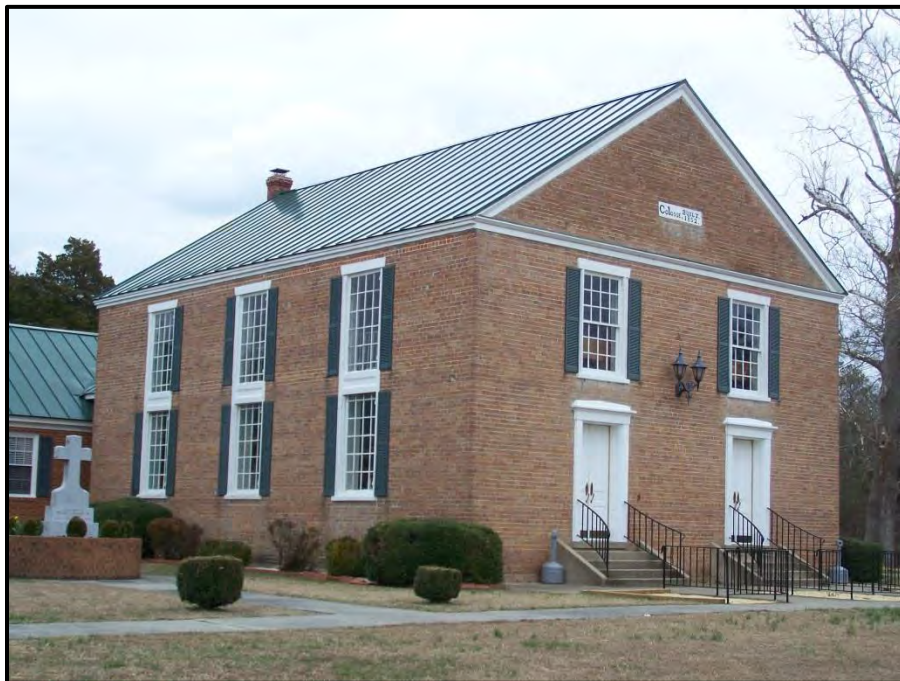
Figure 42. Colosse Baptist Church (1852; VDHR #050-0015), 23891 King William Road, View Looking East.

The seven churches surveyed include the previously recorded Colosse Baptist Church (VDHR #050-0015; Figure 42) and the Jerusalem Christian Church (VDHR #050-0036; Figure 43) and the newly recorded Providence Baptist Church (VDHR #050-5036; Figure 44), **St. David's** Church (VDHR #050-5050; Figure 45), McKendree Methodist Church (VDHR #050-5055; Figure 46), St. James Presbyterian Church (VDHR #050-5064; Figure 47), and the Mt. Olive Baptist Church (VDHR #055-5066; Figure 48). The two earliest churches, Colosse Baptist Church and the Jerusalem Christian Church, are front gable buildings constructed of brick and are relatively unadorned. The remaining five churches are frame construction, clad in a variety of sheathing materials, and features Gothic-style pointed arch windows, with the exception of the Providence Baptist Church and a steeple/bell tower above the front entry, with the exception of the Mt. Olive Baptist Church which features two square towers at the corners of the building. Several examples feature a one-story enclosed, gable-roofed entry.

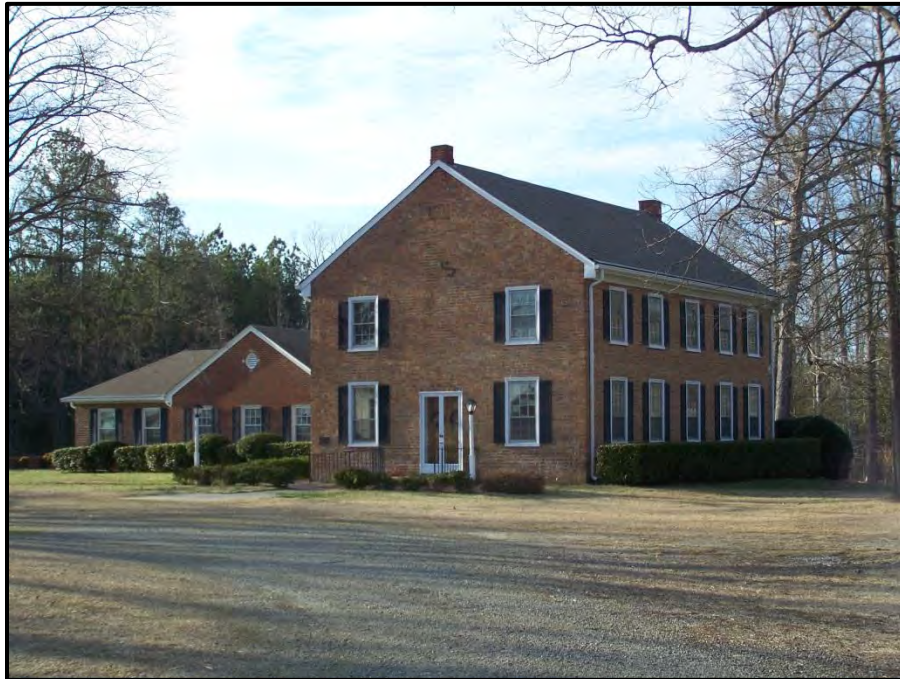
Figure 43. Jerusalem Christian Church (VDHR #050-0036), Powhatan Trail, View Looking Northwest.

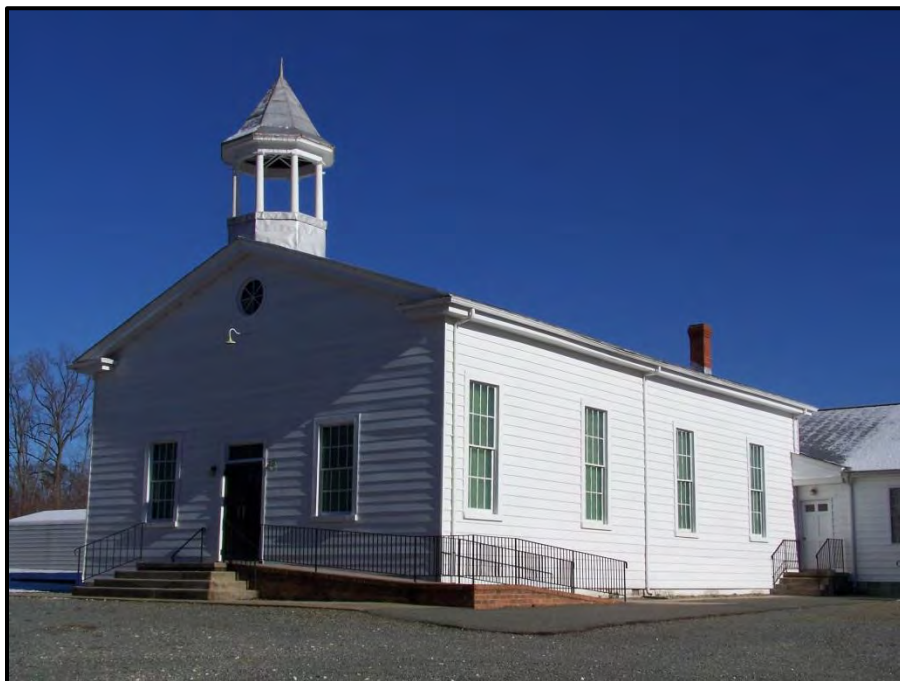
Figure 44. Providence Baptist Church (VDHR #050-5036), 4570 Dorrell Road, View Looking East.

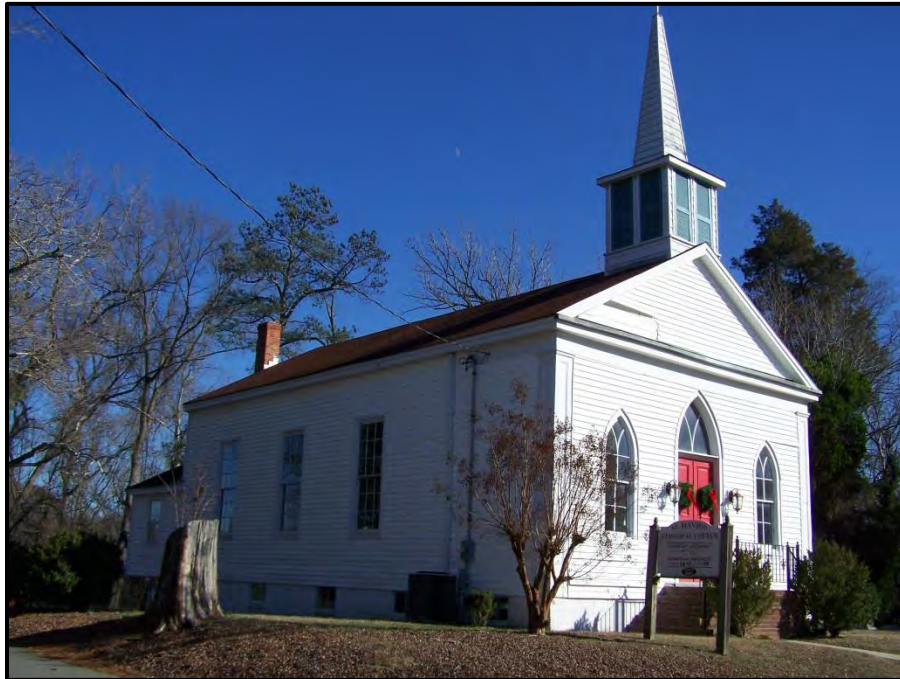
Figure 45. St. David's Church (VDHR #050-5050), 11291 W. River Road, View Looking East.

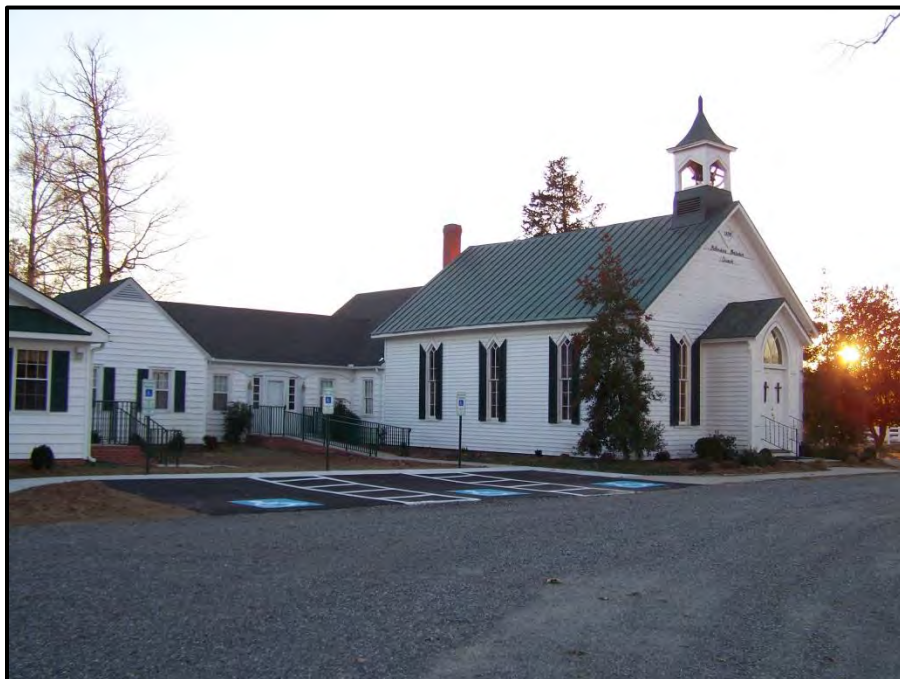
Figure 46. McKendree Methodist Church (VDHR #050-5055), 4347 Manfield Road, View Looking Southwest.

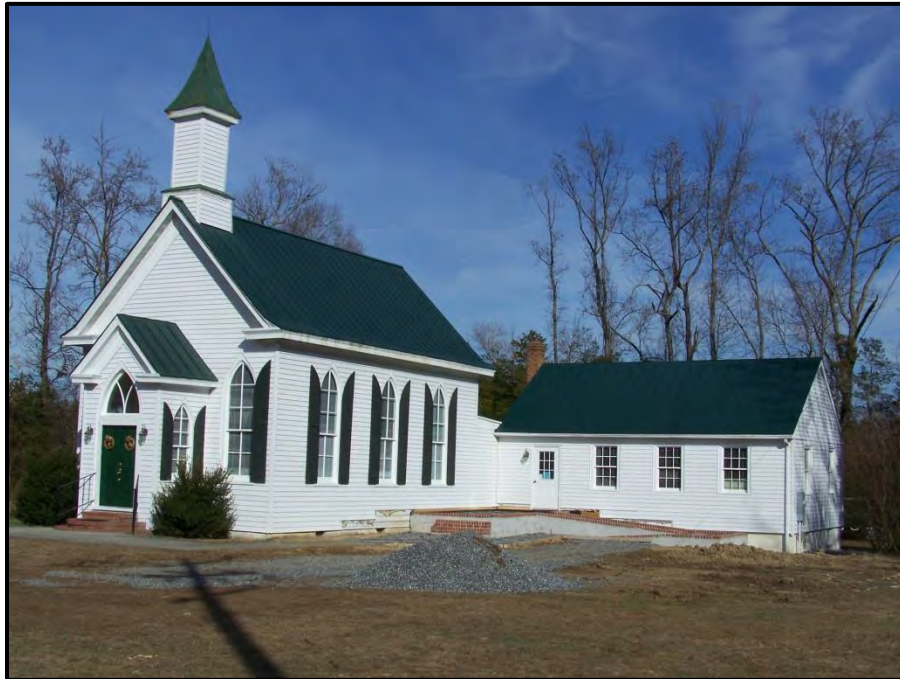
Figure 47. St. James Presbyterian Church (VDHR #050-5064), 411 Courthouse Lane, View Looking North.

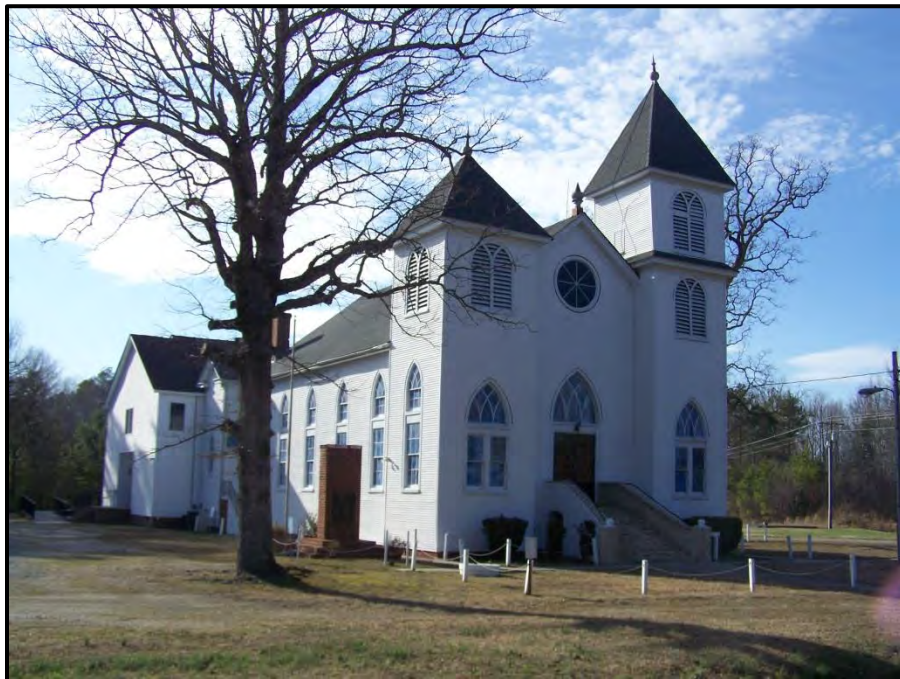
Figure 48. Mt. Olive Baptist Church (VDHR #050-5066), 2000 Mt. Olive Cohoke Road, View Looking Northwest.

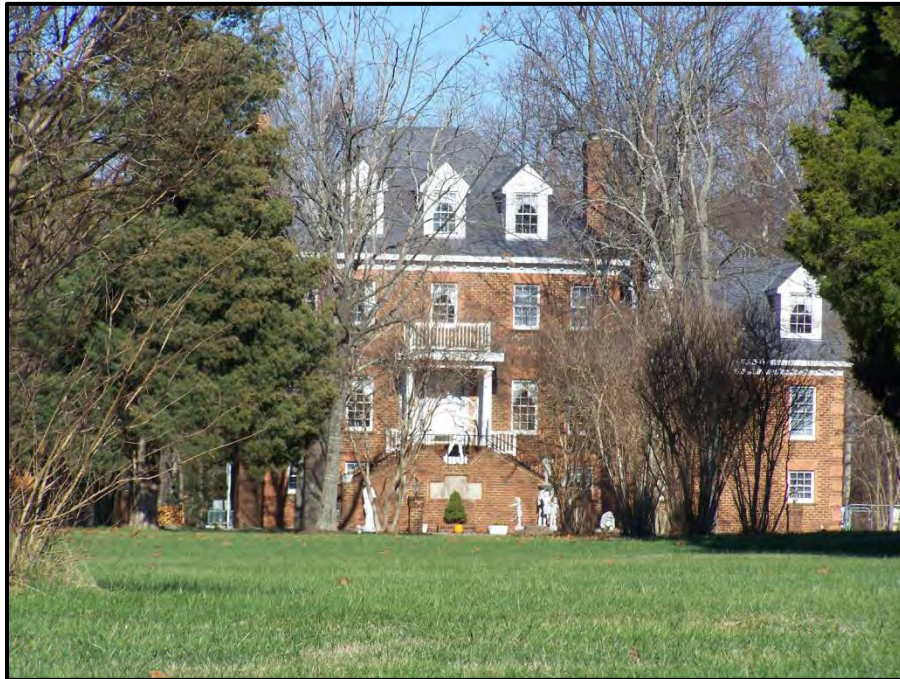
Figure 63. Fontainebleau (c. 1845; Rebuilt 1930; VDHR #050-0025), 1377 Acqinton Church Road, View Looking Northeast.

The most ornate of the two-story dwellings surveyed, however, is Fontainbleau (c. 1845; Rebuilt in 1930; VDHR #050-0025; Figure 63) located 1377 Acquinton Church Road. The original dwelling burned in the 1930s and was rebuilt. The property features a large number of statues, which **dot the property's landscape**.

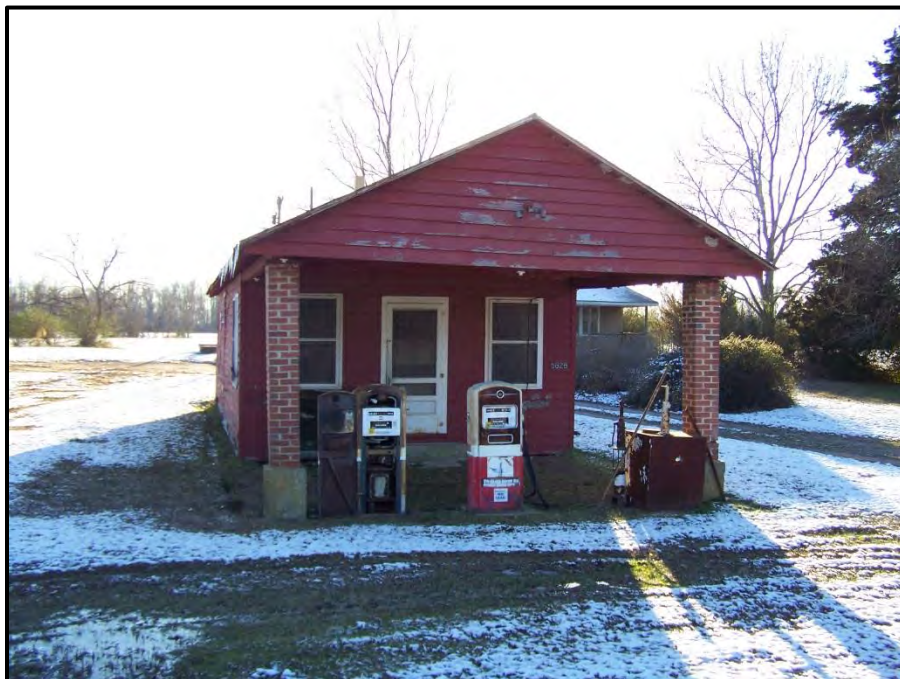
Figure 67. Store (c. 1920; VDHR #050-5039), 5828 West River Road, View Looking Southwest.

The current survey documented ten early to mid-twentieth century commercial buildings – mainly turn-of-the-century or early twentieth century building many which formerly served as small local community stores, a number of which still retain old gas pumps out front (Figures 64-68). The early shops/stores surveyed were frame construction with front gable roofs, with the exception of the store located at 19840 King William Road (Figure 68) which is construction with a hipped-roof, and a variety of siding including weatherboard and vinyl. Those retaining the gas pumps outside were constructed with the gable roof extended out to provide limited cover to customers stopping to get fuel for automobiles. Additional commonalities of these buildings include interior brick flues and two-over-two wood double-hung sash windows, although in the case of the c. 1920 store (VDHR #050-5039), 5828 West River Road, the windows are six-over-six wood sashes (Figure 67).

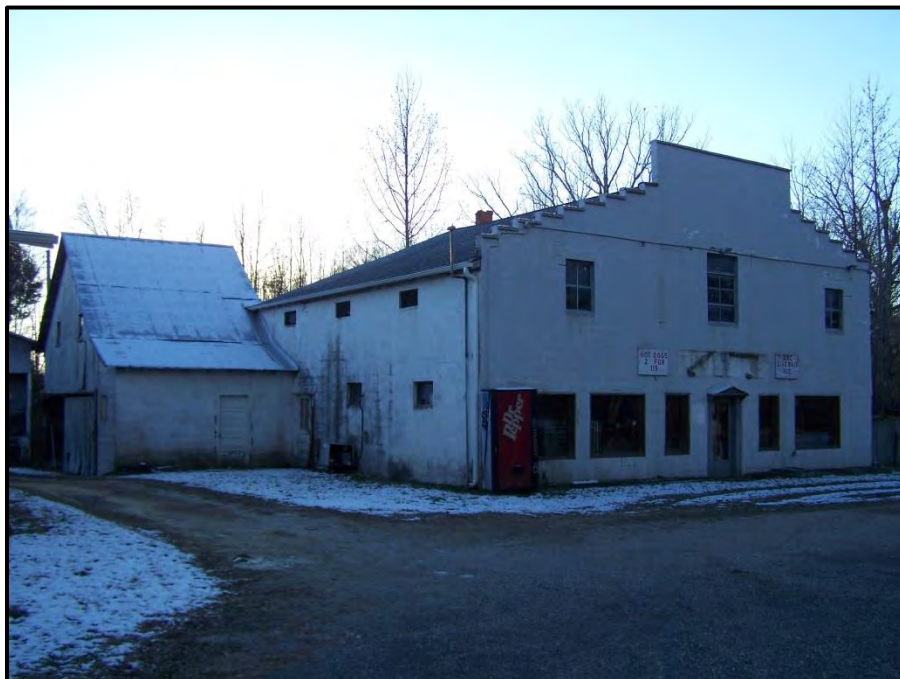
Figure 69. Store (c. 1940; VDHR #050-5040), 5698 West River Road, View Looking West.

Three of the ten commercial buildings recorded date to the 1940s and 1950s and include a store (VDHR #050-5040; Figure 69) located at 5698 West River Road; the Aylett Esso Station (VDHR #050-5048; Figure 70), also c. 1940, located at 8279 Richmond-Tappahannock Highway; and Kent's Super Market (c. 1950; VDHR #050-5065), 20623 King William Road (Figure 71). **The mid-century stores were masonry construction, mainly concrete block. In the case of Kent's Market, the concrete block is covered with a brick veneer on the front façade. All three were also constructed with variety of parapet configurations. Windows included either multi-light metal or commercial style fixed single light windows.**

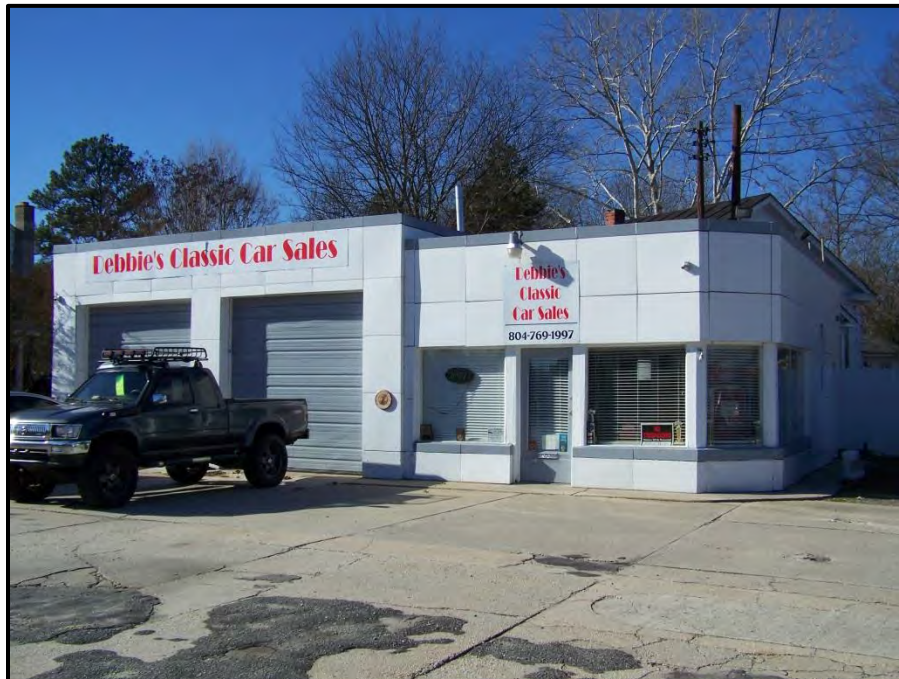
Figure 70. Aylett Esso Station (c. 1940; VDHR #050-5048), 8279 Richmond-Tappahannock Highway, View Looking West.

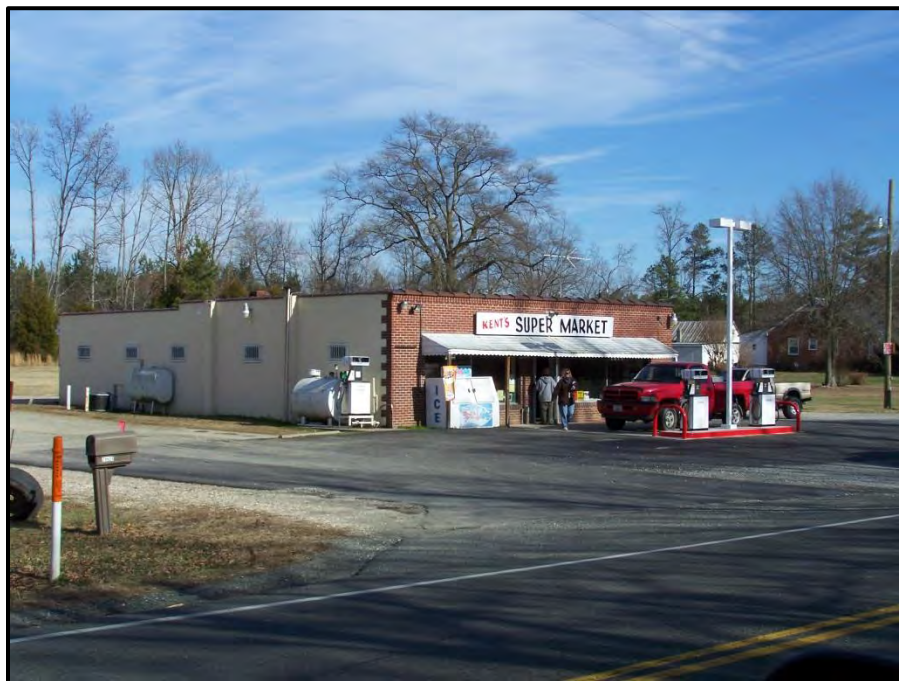
Figure 71. Kent's Super Market (c. 1950; VDHR #050-5065), 20623 King William Road, View Looking East.

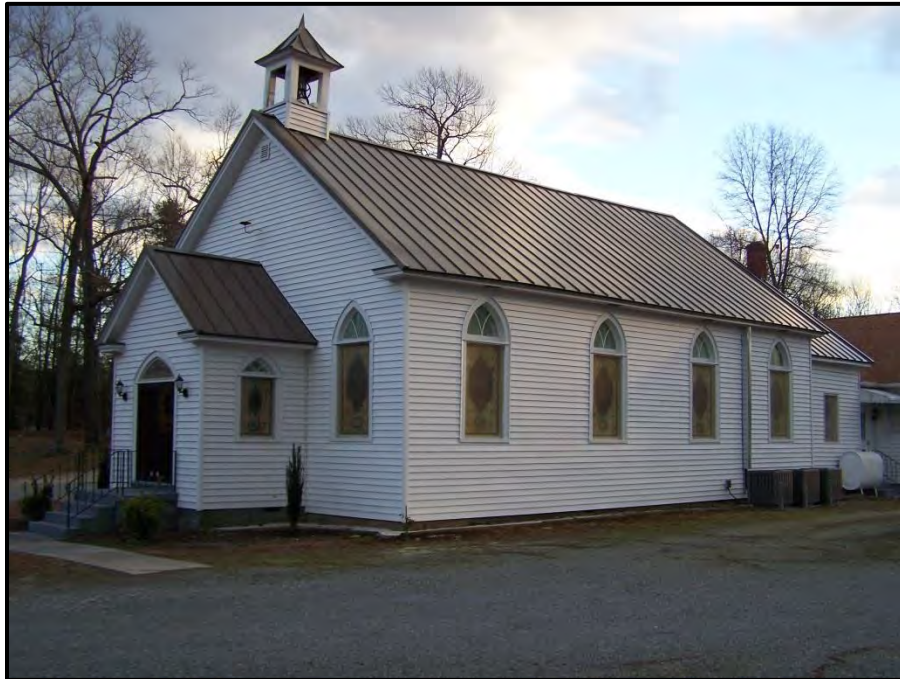
Figure 72. St. Paul Baptist Church (c. 1900; VDHR #050-5043), 1995 Globe Road, View Looking South.

Three churches, with associated cemeteries, dating to the early twentieth century were newly recorded and include St. Paul Baptist Church (VDHR #050-5043; Figure 72), Brett-Reed Memorial Presbyterian Church (VDHR #050-5068; Figure 74), and the Mattaponi Indian Baptist Church (VDHR #050-5075; Figure 76). While similar in original configuration, the three churches vary in architectural detail. Two of the churches; St. Paul and Brett-Reed, include **Gothic-style pointed arch windows, however, where St. Paul's has a three-bay pedimented portico with large wood columns, Brett-Reed has a simple gable-roofed enclosed entry, as does the Mattaponi Baptist Church.** All three buildings feature a pyramidal bell tower **extending above the roof line over the church's entry. Additions to the churches, resulting from the growth of congregations, are utilized in all three examples, with Brett-Reed having the largest building expansion of the three.**

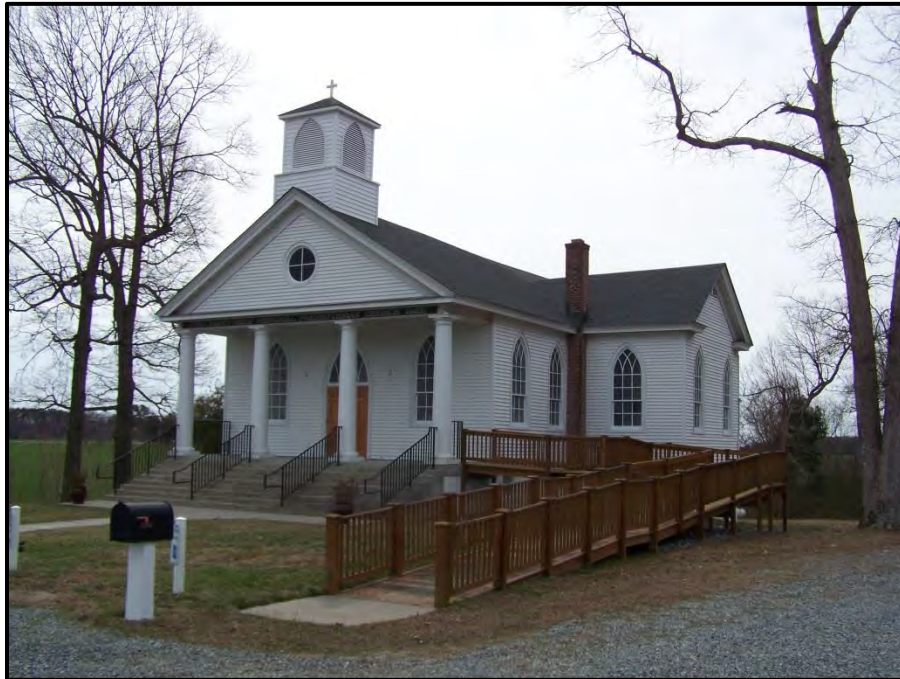
Figure 74. Brett-Reed Memorial Presbyterian Church (c. 1925; VDHR #050-5068), 29680 King William Road, View Looking Southeast.

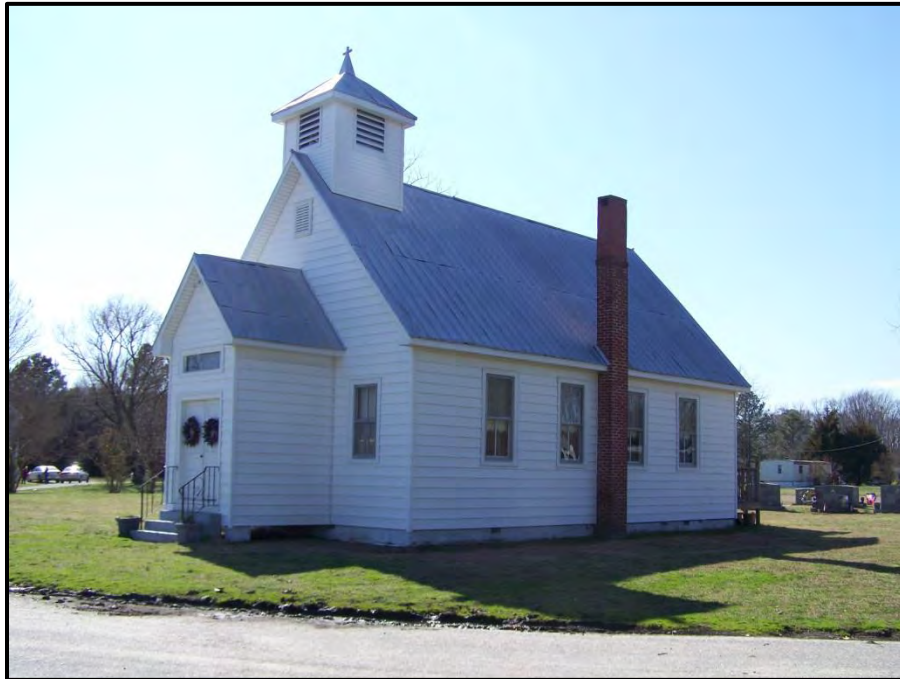
Figure 76. Mattaponi Indian Baptist Church (c. 1932; VDHR #050-5075), Mattaponi Reservation Circle, View Looking West.

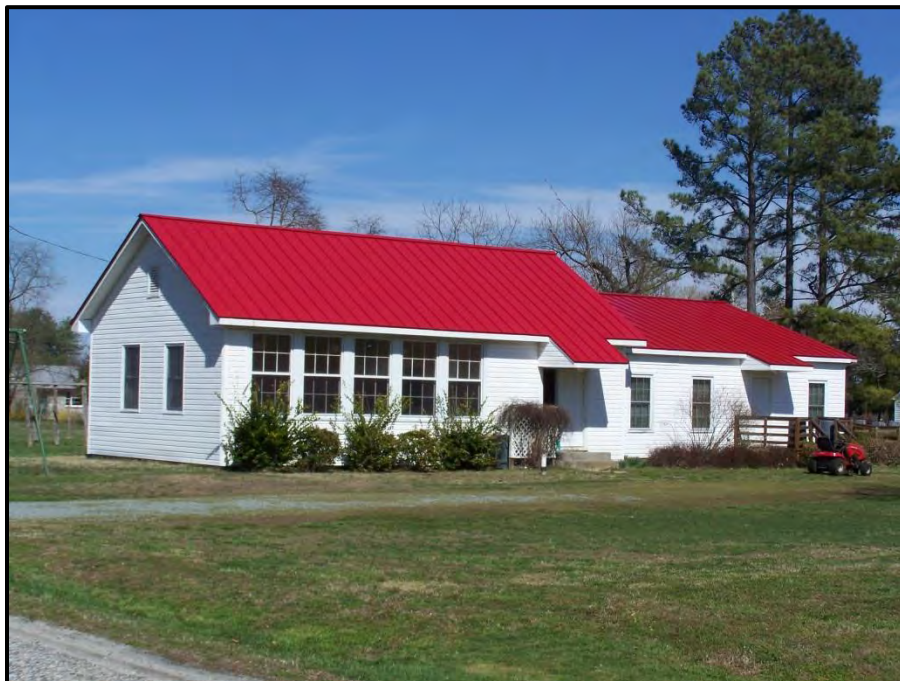
Figure 79. Mattaponi Indian School (1929; VDHR #050-0106), Mattaponi Reservation Circle, View Looking East.

Five schools dating to the early twentieth century were documented. Two of the schools are previously recorded and include the 1929 Mattaponi Indian School (VDHR #050-0106; Figure 79) and the 1906 Pamunkey Indian School (VDHR #050-0110; Figure 80). The Mattaponi School is a one-story, frame, multi-bay building constructed on concrete block piers. The exterior walls, previously recorded as sheathed with weatherboards, are now sheathed in vinyl siding. Aside from the addition of vinyl siding the building appears to retain its architectural features as previously surveyed including its six-over-six wood double-hung sash windows.

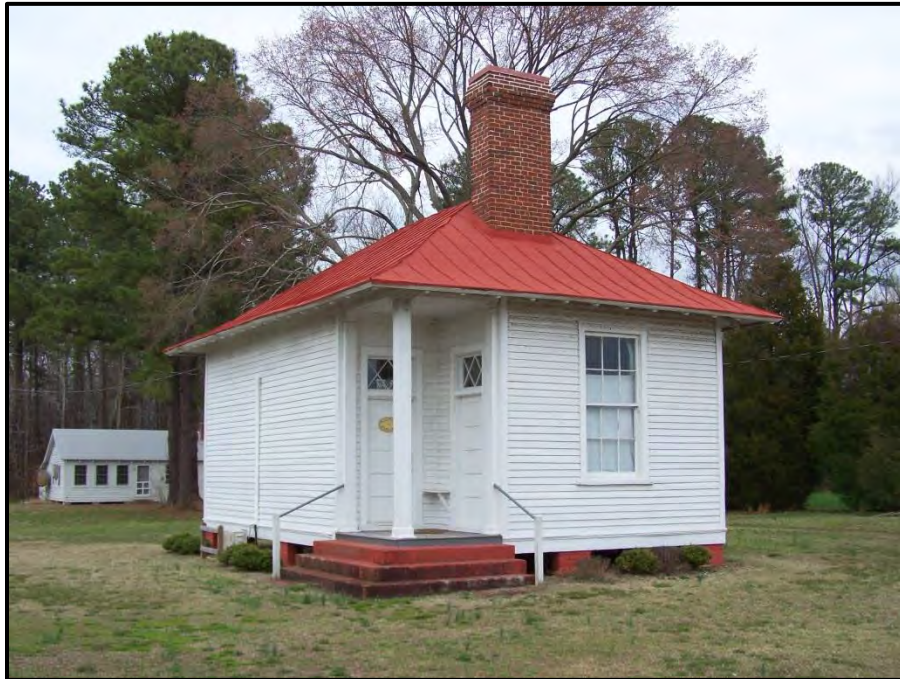
Figure 80. Pamunkey Indian School (1906; VDHR #050-0110), Lay Landing Road, View Looking Northeast.

The Pamunkey Indian School, built in 1906, operated as a school until 1954. Subsequent to the school’s closure, the building was utilized as a crafts center and trading post. **Since the previous survey in 1979 the building has been restored with particular attention to maintaining original character defining features including the five cross-panel doors, diamond pane transoms, and six-over-six wood double-hung sash windows** The school, in the opinion of the surveyor, is therefore recommended as eligible to the NRHP under Criterion C for its architectural merit and is also recommended for listing under Criterion A for its association with events that have made a significant contribution to the broad patterns of history under Education and Ethnic Heritage (Native American) of the Pamunkey Indian Tribe. The resource and its surrounding landscape may also be eligible under Criterion D for its potential to yield important information in history or prehistory of the Native American population of the surrounding area.

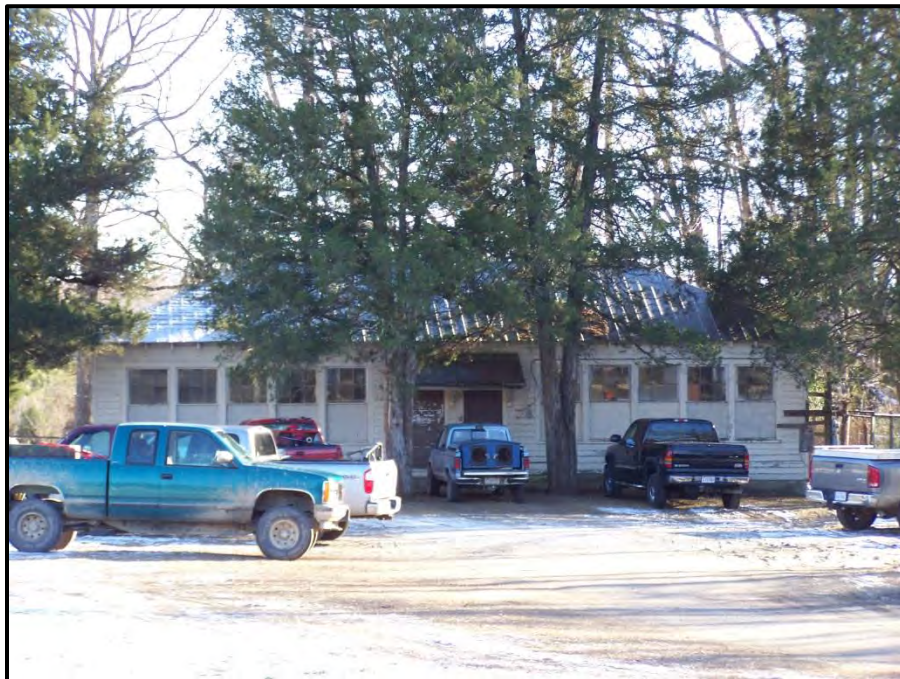
Figure 81. Beulahville School (VDHR #050-5037), Dorrell Road, View Looking Southeast.

Three are newly recorded and include the c. 1920 Buelahville School (VDHR #050-5037; Figure 81) located on Dorrell Road, the Enfield Colored School (c. 1900; VDHR #050-5056; Figure 82), **Dabney's Mill Road, and a school (VDHR #050-5067; Figure 83)** located at 2439 Mt. Olive Cohoke Road. The Beulahville School is a frame structure clad in weatherboard with a hipped roof covered in seamed metal. The façade has a pair of centrally located recessed panel wood doors sheltered by a shed roof awning supported by knee brackets. Banks of five double-hung

The Beulahville School is a good example of a frame early twentieth century rural school and retains a high degree of architectural integrity including original banks of windows, double front entries and weatherboard siding, among other features. The resource also maintains its integrity of design, as well as its rural setting and association. Therefore the resource is recommended as potentially eligible for individual listing on the NRHP under Criterion A for broad patterns of history as an example of the development of rural school architecture and under Criterion C for its architectural merit.
