An Architectural Survey of King William County

(Cost Share 2014)

Stantec Consulting Services,
formerly CRI
1049 Technology Park Drive
Glen Allen, Virginia 23059

July 24, 2014

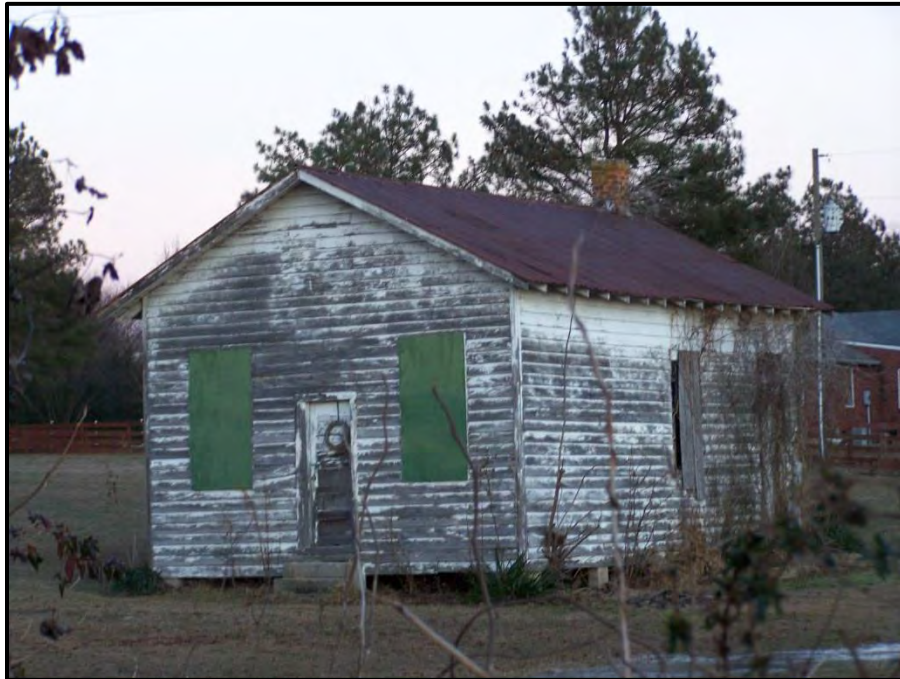
Figure 82. Enfield Colored School (c. 1900; VDHR #050-5056), Dabney's Mill Road, View Looking East.

Three are newly recorded and include the c. 1920 Buelahville School (VDHR #050-5037; Figure 81) located on Dorrell Road, the Enfield Colored School (c. 1900; VDHR #050-5056; Figure 82), **Dabney's Mill Road, and a school (VDHR #050-5067; Figure 83)** located at 2439 Mt. Olive Cohoke Road. The Beulahville School is a frame structure clad in weatherboard with a hipped roof covered in seamed metal. The façade has a pair of centrally located recessed panel wood doors sheltered by a shed roof awning supported by knee brackets. Banks of five double-hung

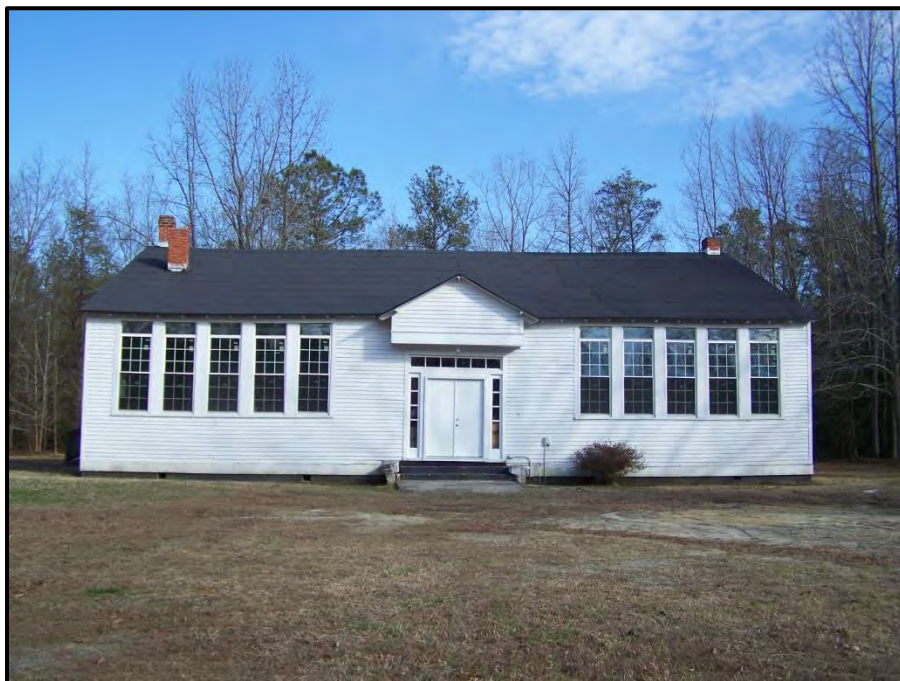
Figure 83. School (c. 1920; VDHR #050-5067), 2439 Mt. Olive Cohoke Road, View Looking Southeast.

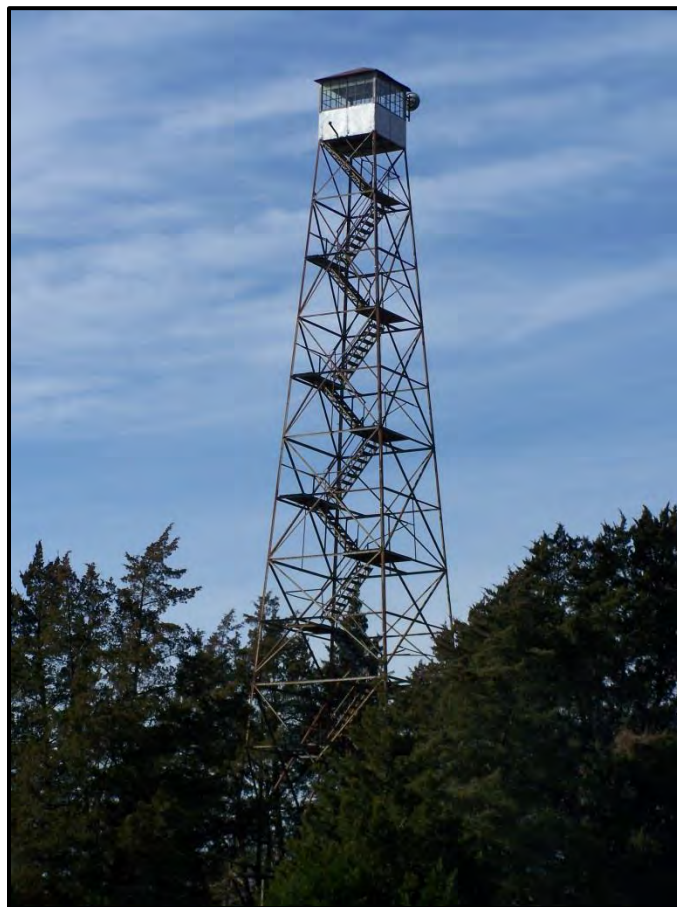
Figure 84. Fire Tower (c. 1935; VDHR #050-5062), King William Road, View Looking West.

One structure was surveyed during the current survey; a c. 1935 fire tower (VDHR #050-5062; Figure 84). The fire tower is a tall tapering metal truss structure with a square plane metal frame lookout cab at the top. The lookout cab is clad with metal sheeting and features multiple-light metal fixed windows across each elevation. The lookout cab has a pyramidal roof covered in seamed metal and is accessed by an open metal staircase located within the metal truss structure (Figure 85). The King William Fire Warden position was created in 1933 and the first fire tower was constructed shortly after.

The c. 1935 Fire Tower (VDHR #050-5062) resource in the opinion of the surveyor is recommended potentially eligible for individual listing on the NRHP under Criterion A, broad patterns in history as part of the development of advances in fire prevention, and Criterion C, Distinctive Characteristics of Architecture as an intact and surviving example of an early twentieth century metal fire tower that retains a high degree of architectural integrity.

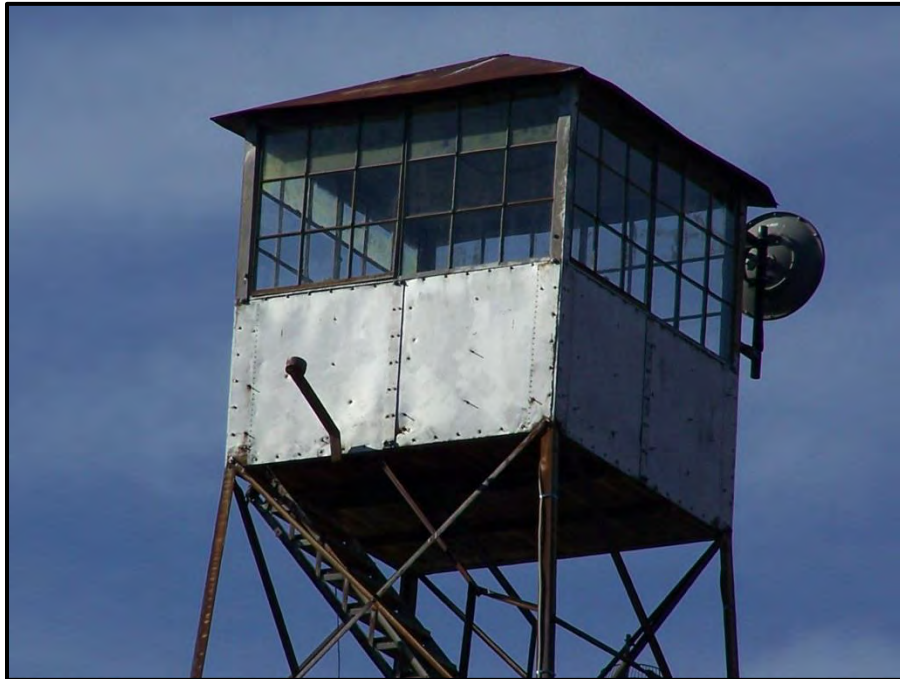
Figure 85. Fire Tower (c. 1935; VDHR #050-5062), King William Road, View Looking West.

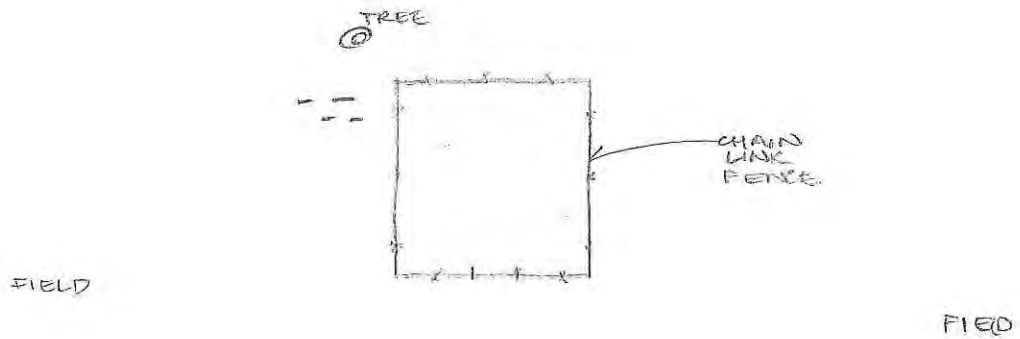
050-5019
 LANGSHIRE CEMETERY
 POWHATAN TRAIL (RT 633)
 KING WILLIAM CO, VA
 4/3/14
 NTS N ERC

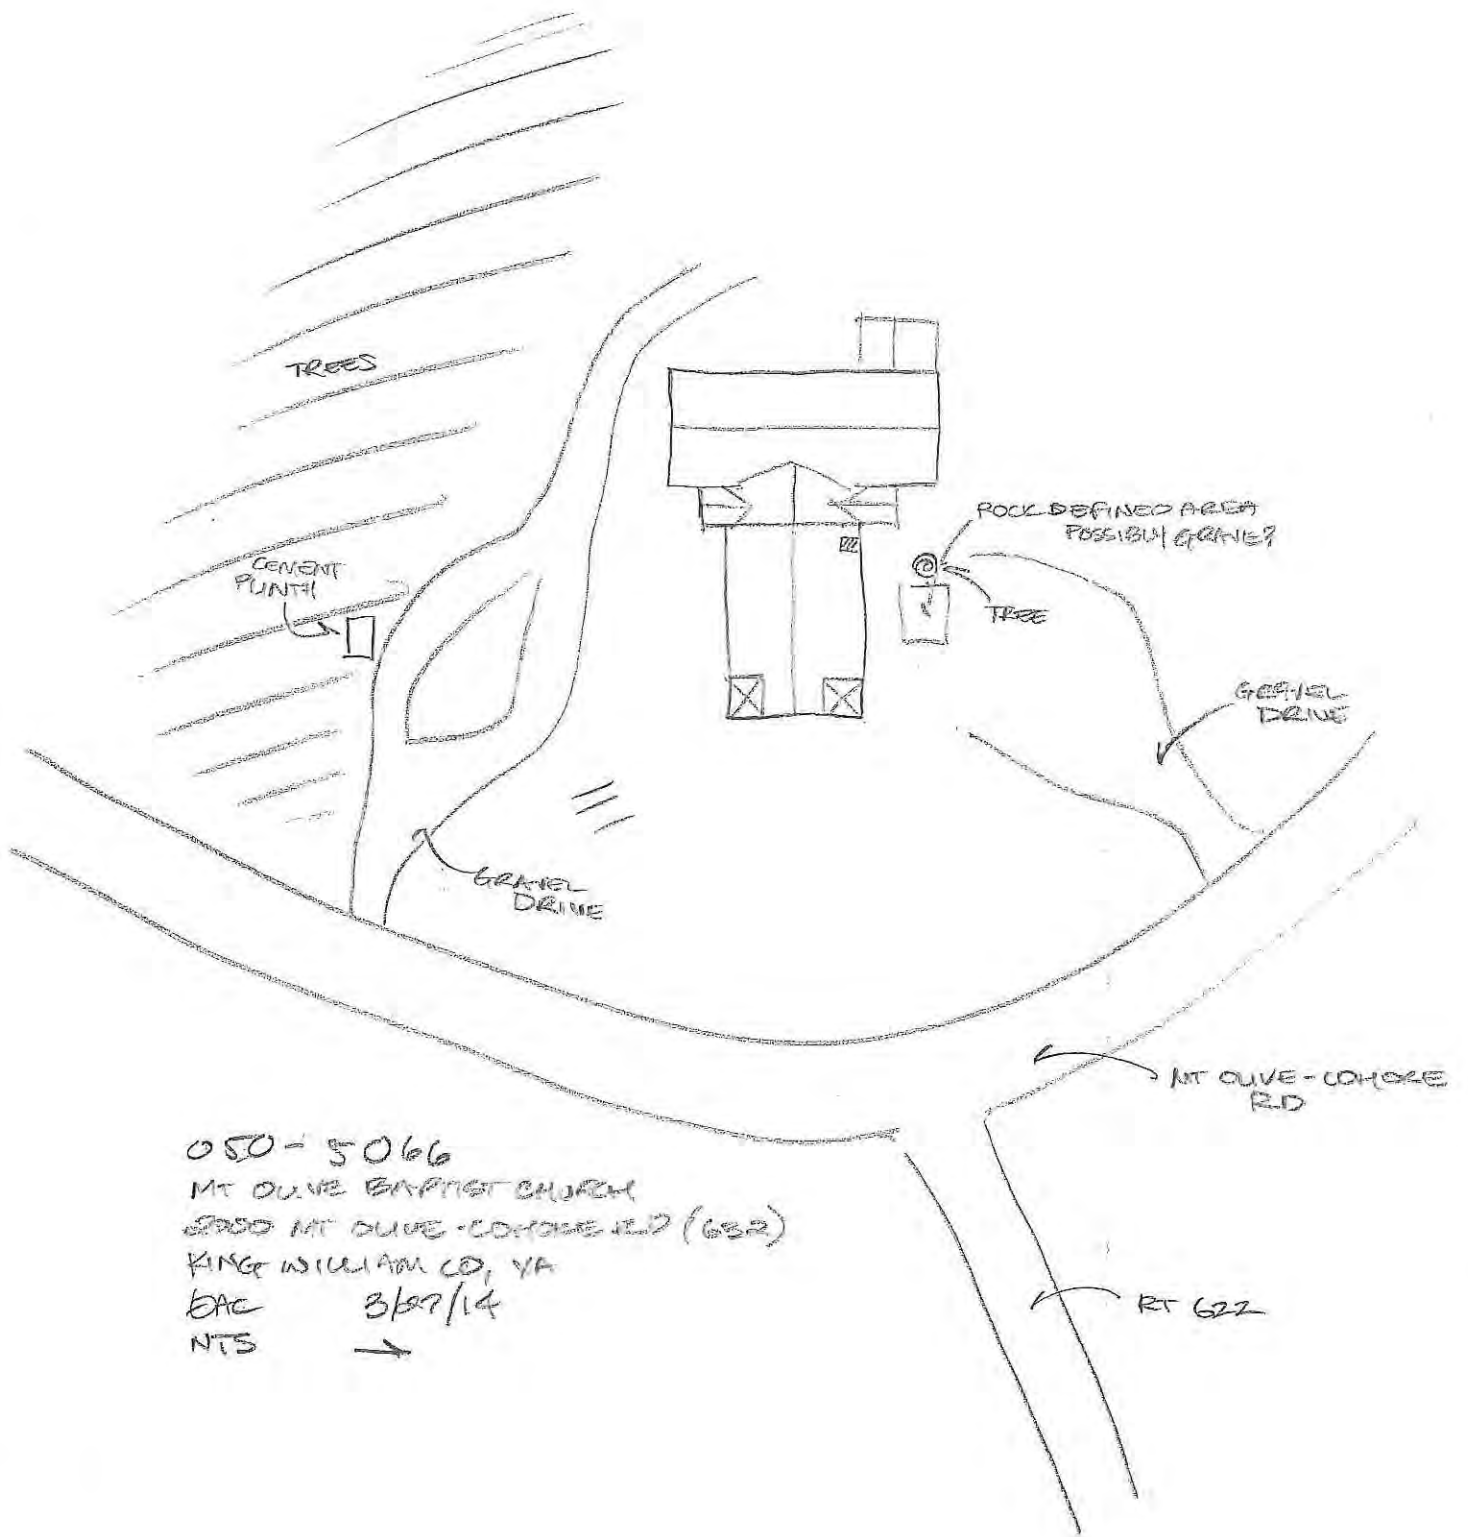
050-5066
 MT OLIVE BAPTIST CHURCH
 6800 MT OLIVE - COHORE RD (682)
 KING WILLIAM CO, VA
 EAC 3/27/14
 NTS →

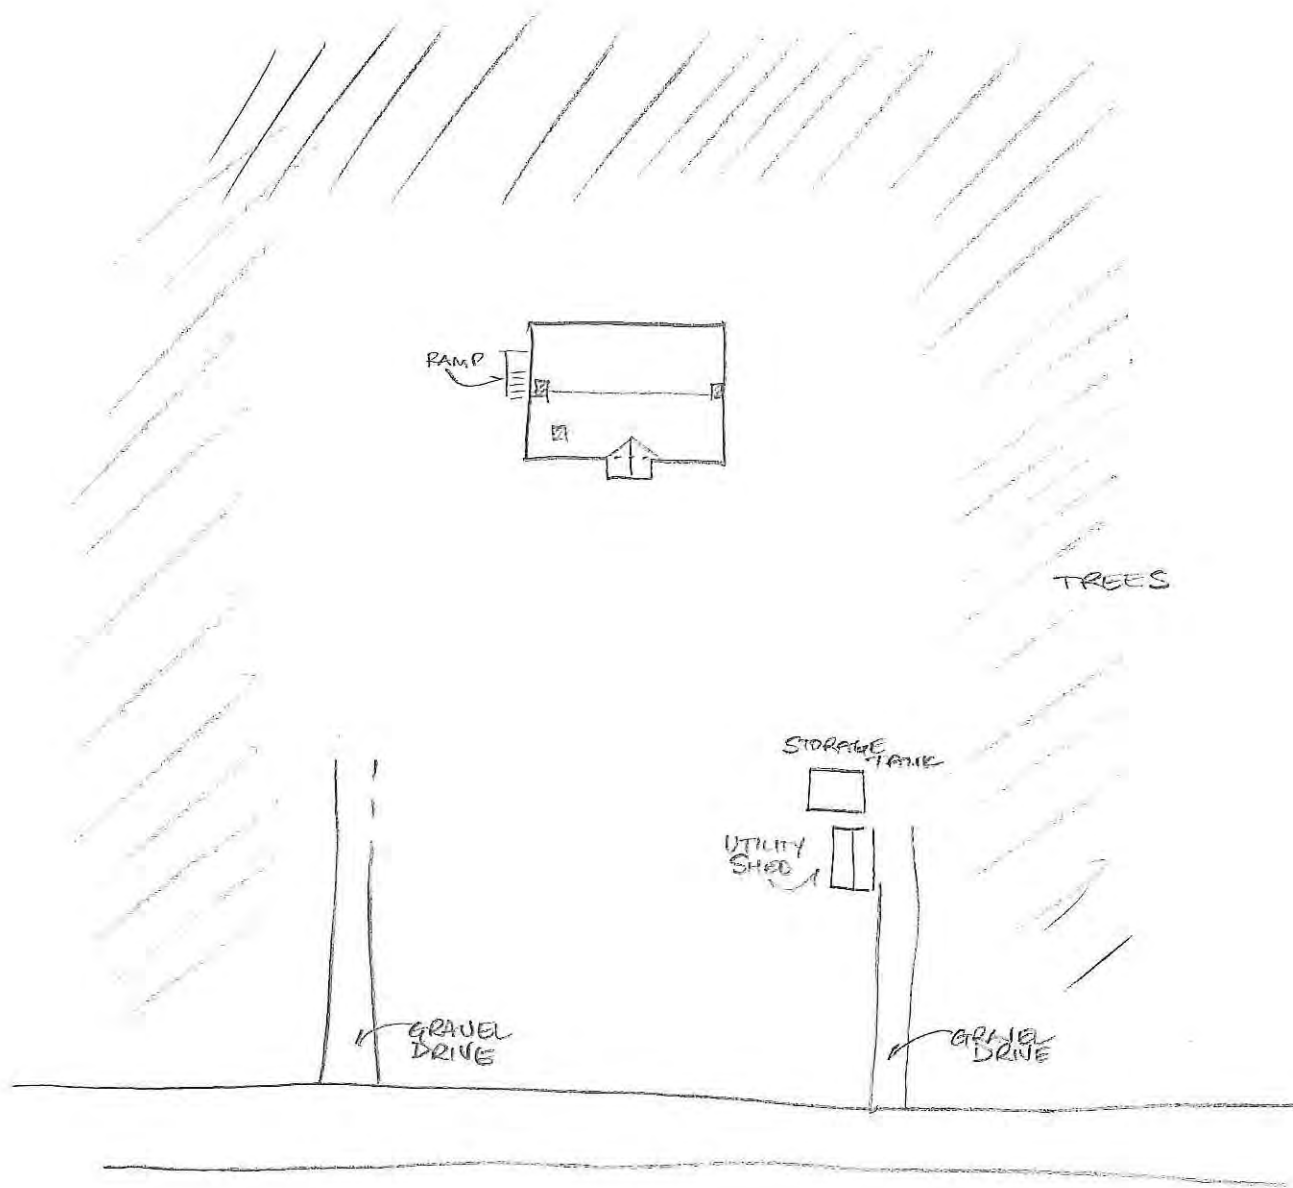
OSO-5067
 SCHOOL @
 2439 Mt Olive-Choke Rd (RT 632)
 KING WILLIAM CO., VA
 3/27/14 EAC
 NTS

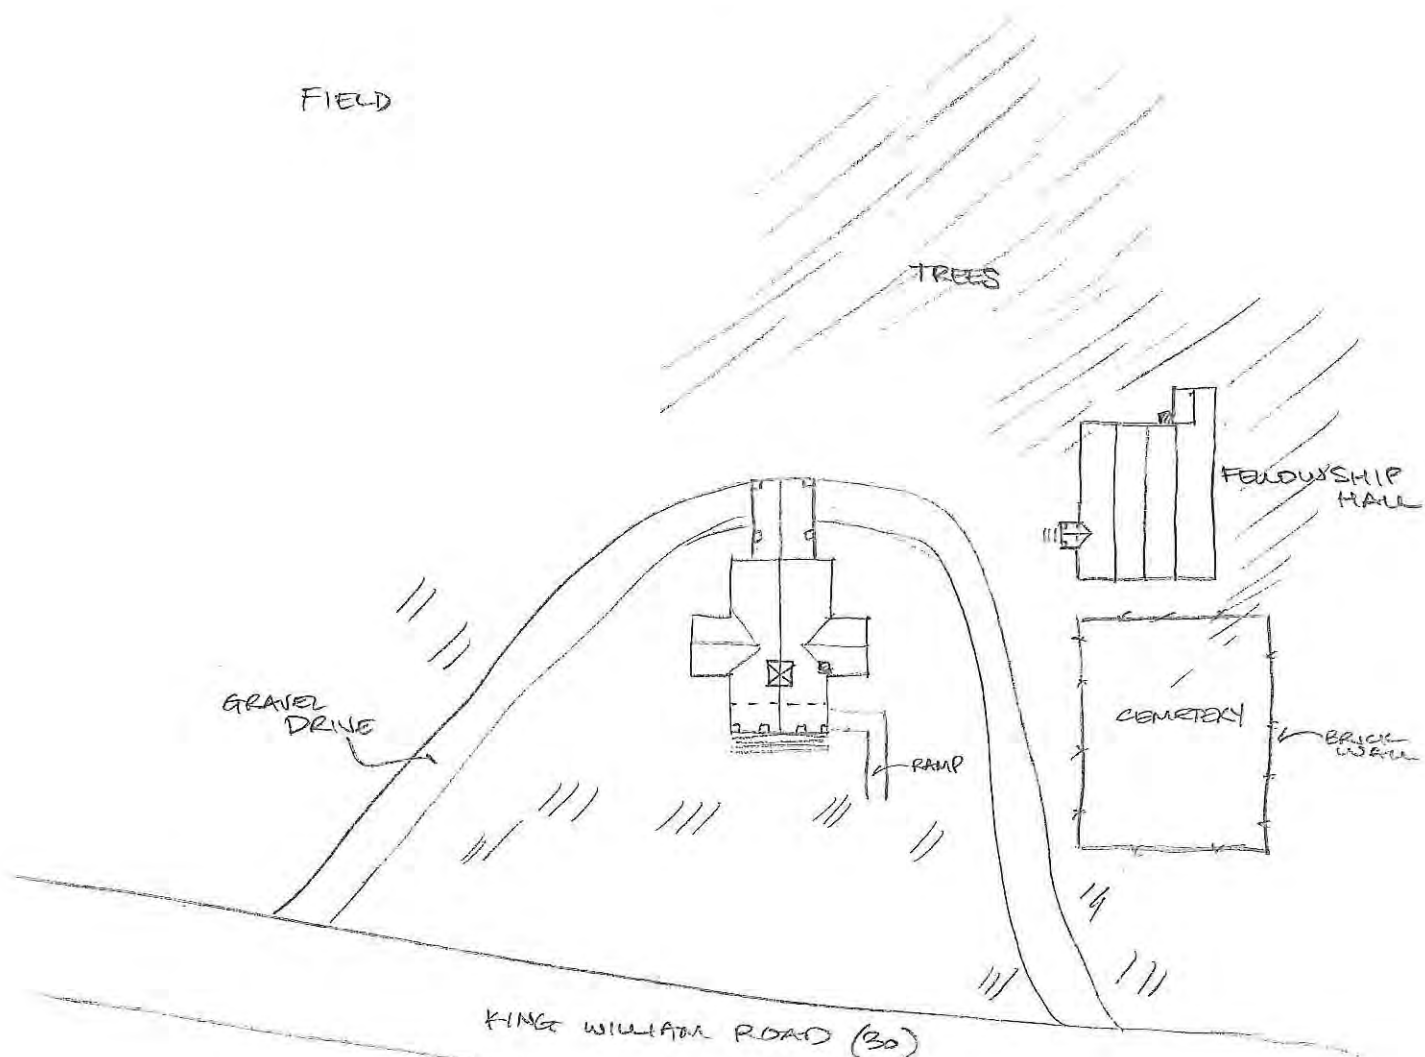
050-5068
 BRETT-REED MEMORIAL PRESBYTERIAN CHURCH
 291680 KING WILLIAM RD (R3 30)
 KING WILLIAM CO, VA
 5/28/14 DAC
 NTS

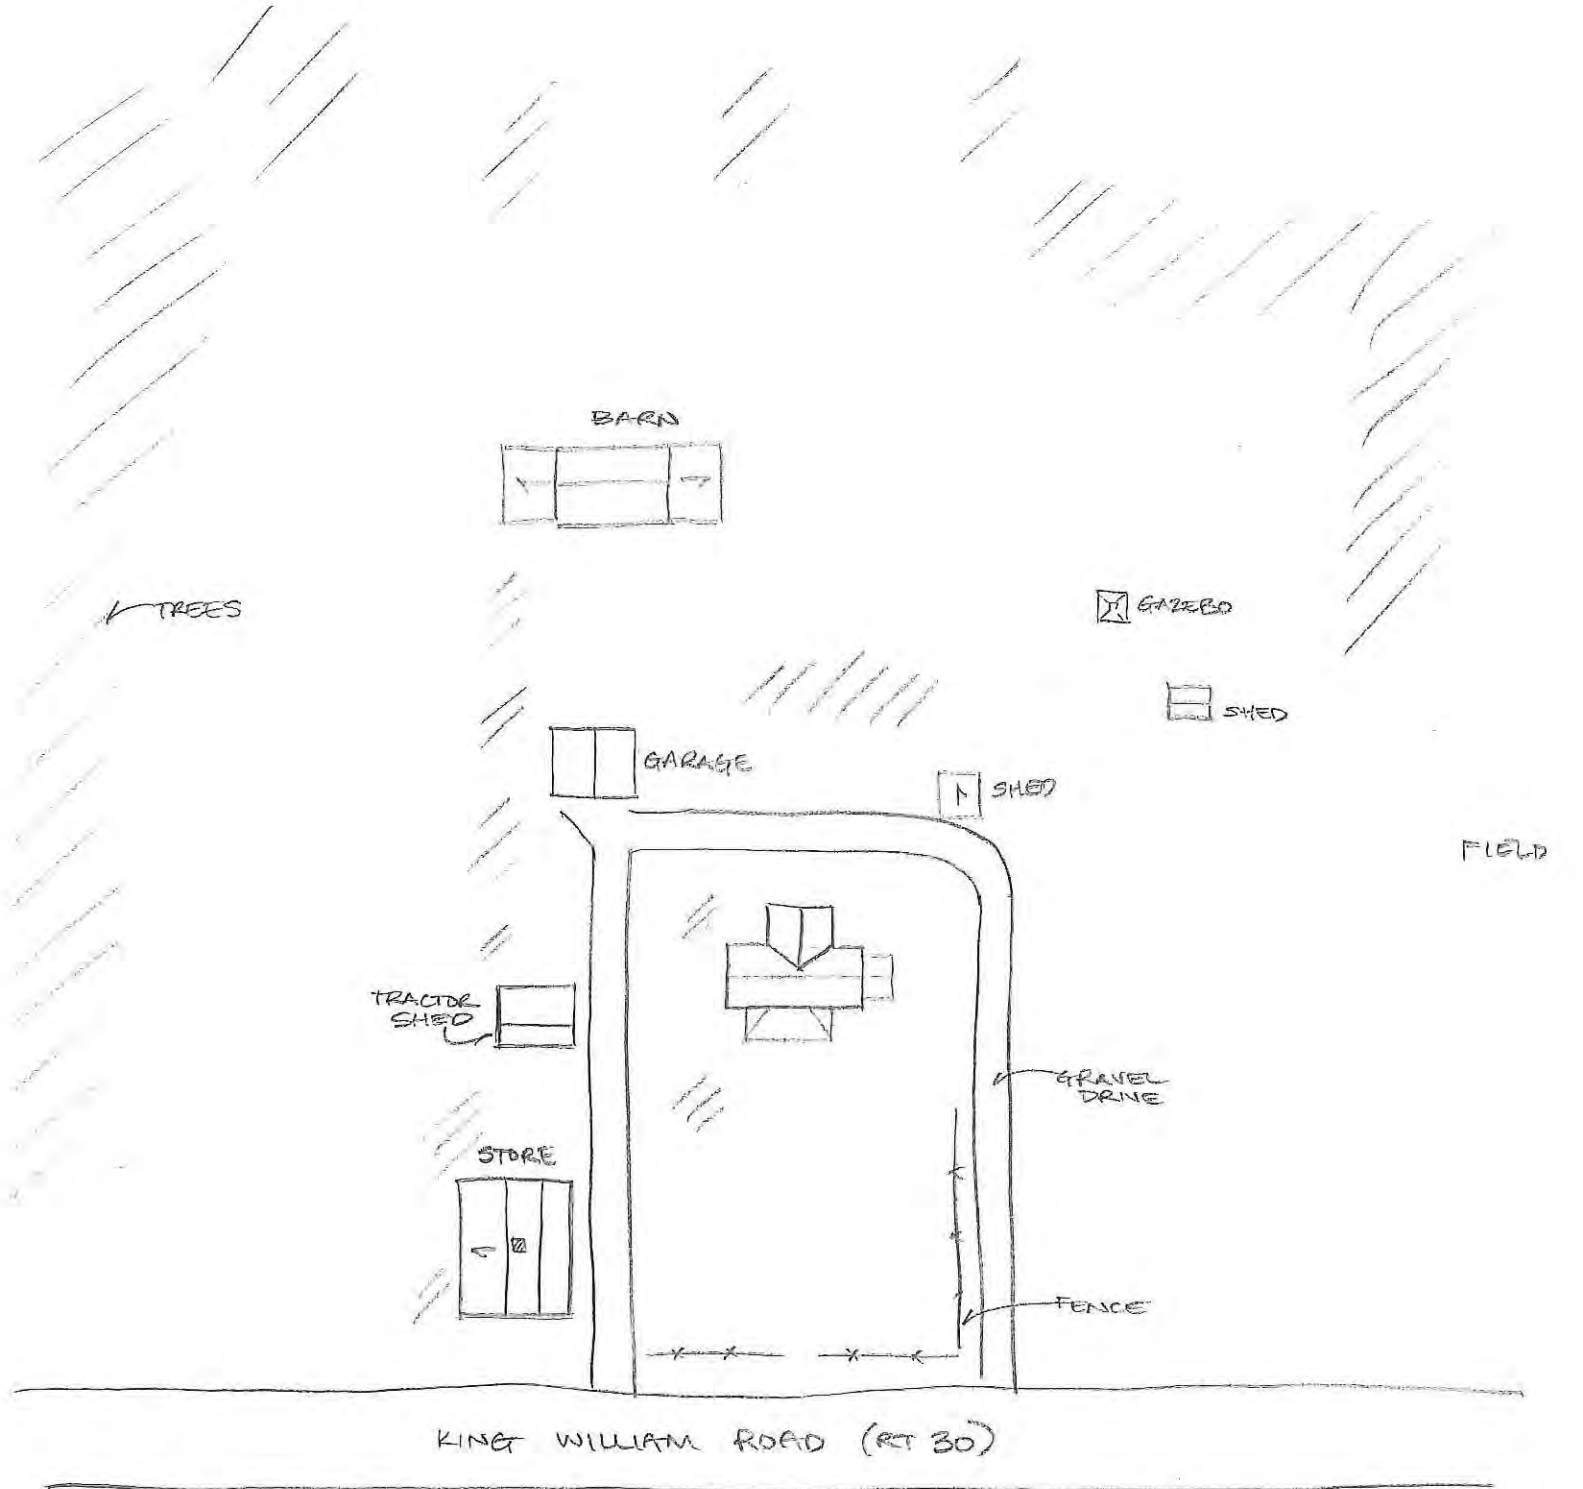
050-5069
 MARTIN'S STORE
 29557 KING WILLIAM RD (RT 30)
 KING WILLIAM CO., VA
 3.28.14 EAC
 NTS

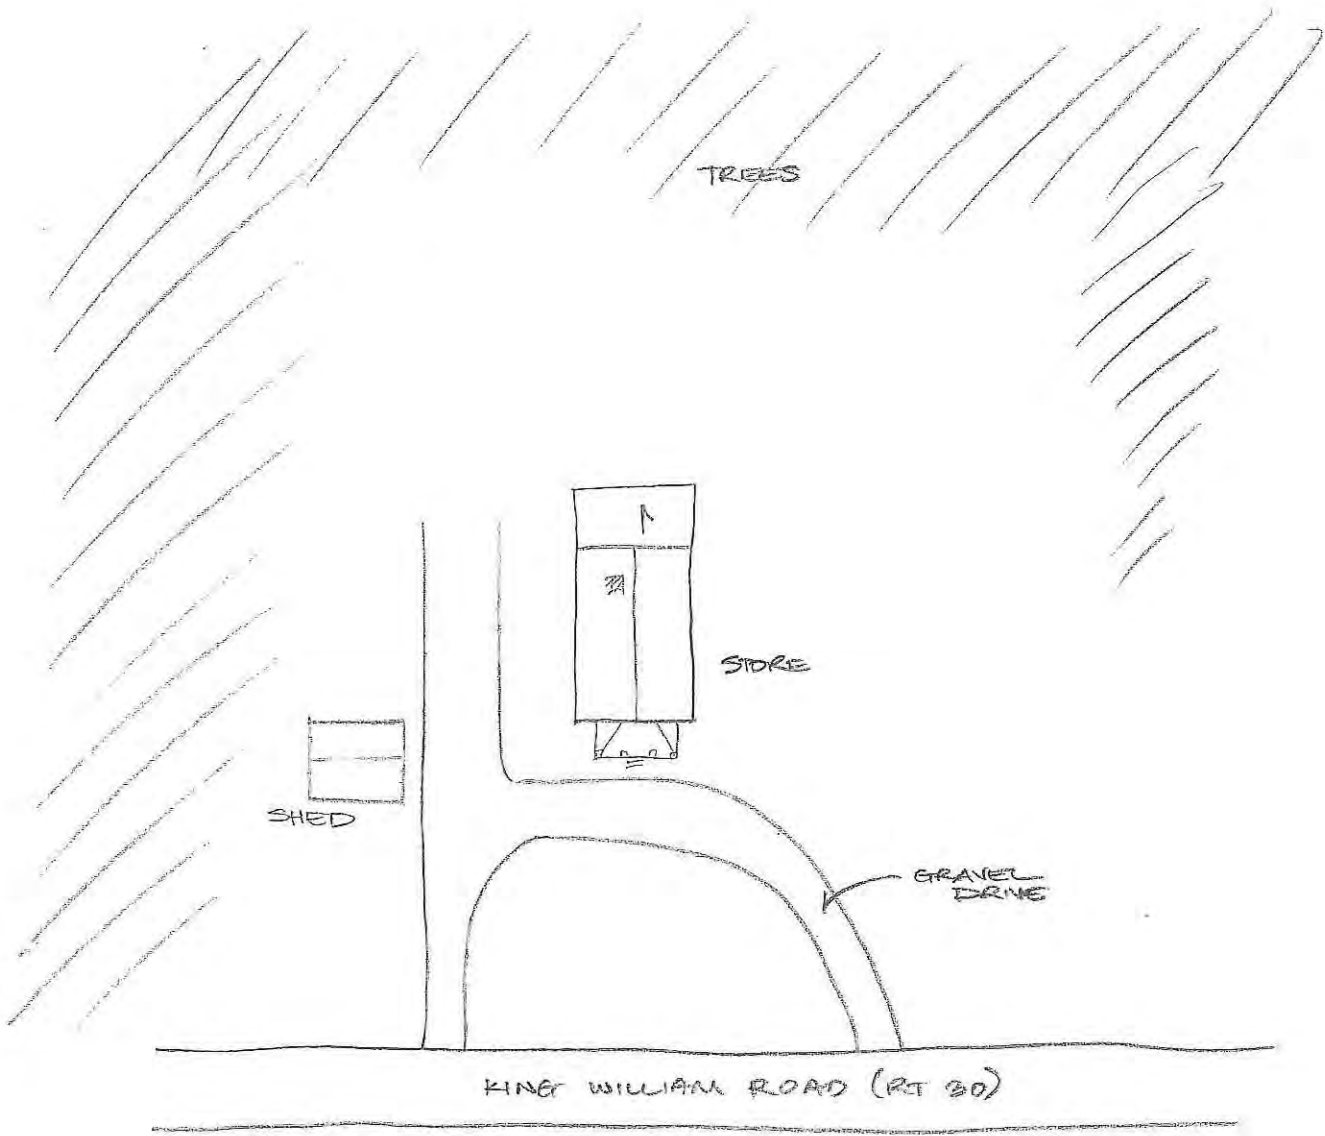
050-5090
"TRIPLE D TALK & FEED" STORE
28218 KING WILLIAM RD (RT 30)
KING WILLIAM CO, VA
3.28.14 EAC
NTS

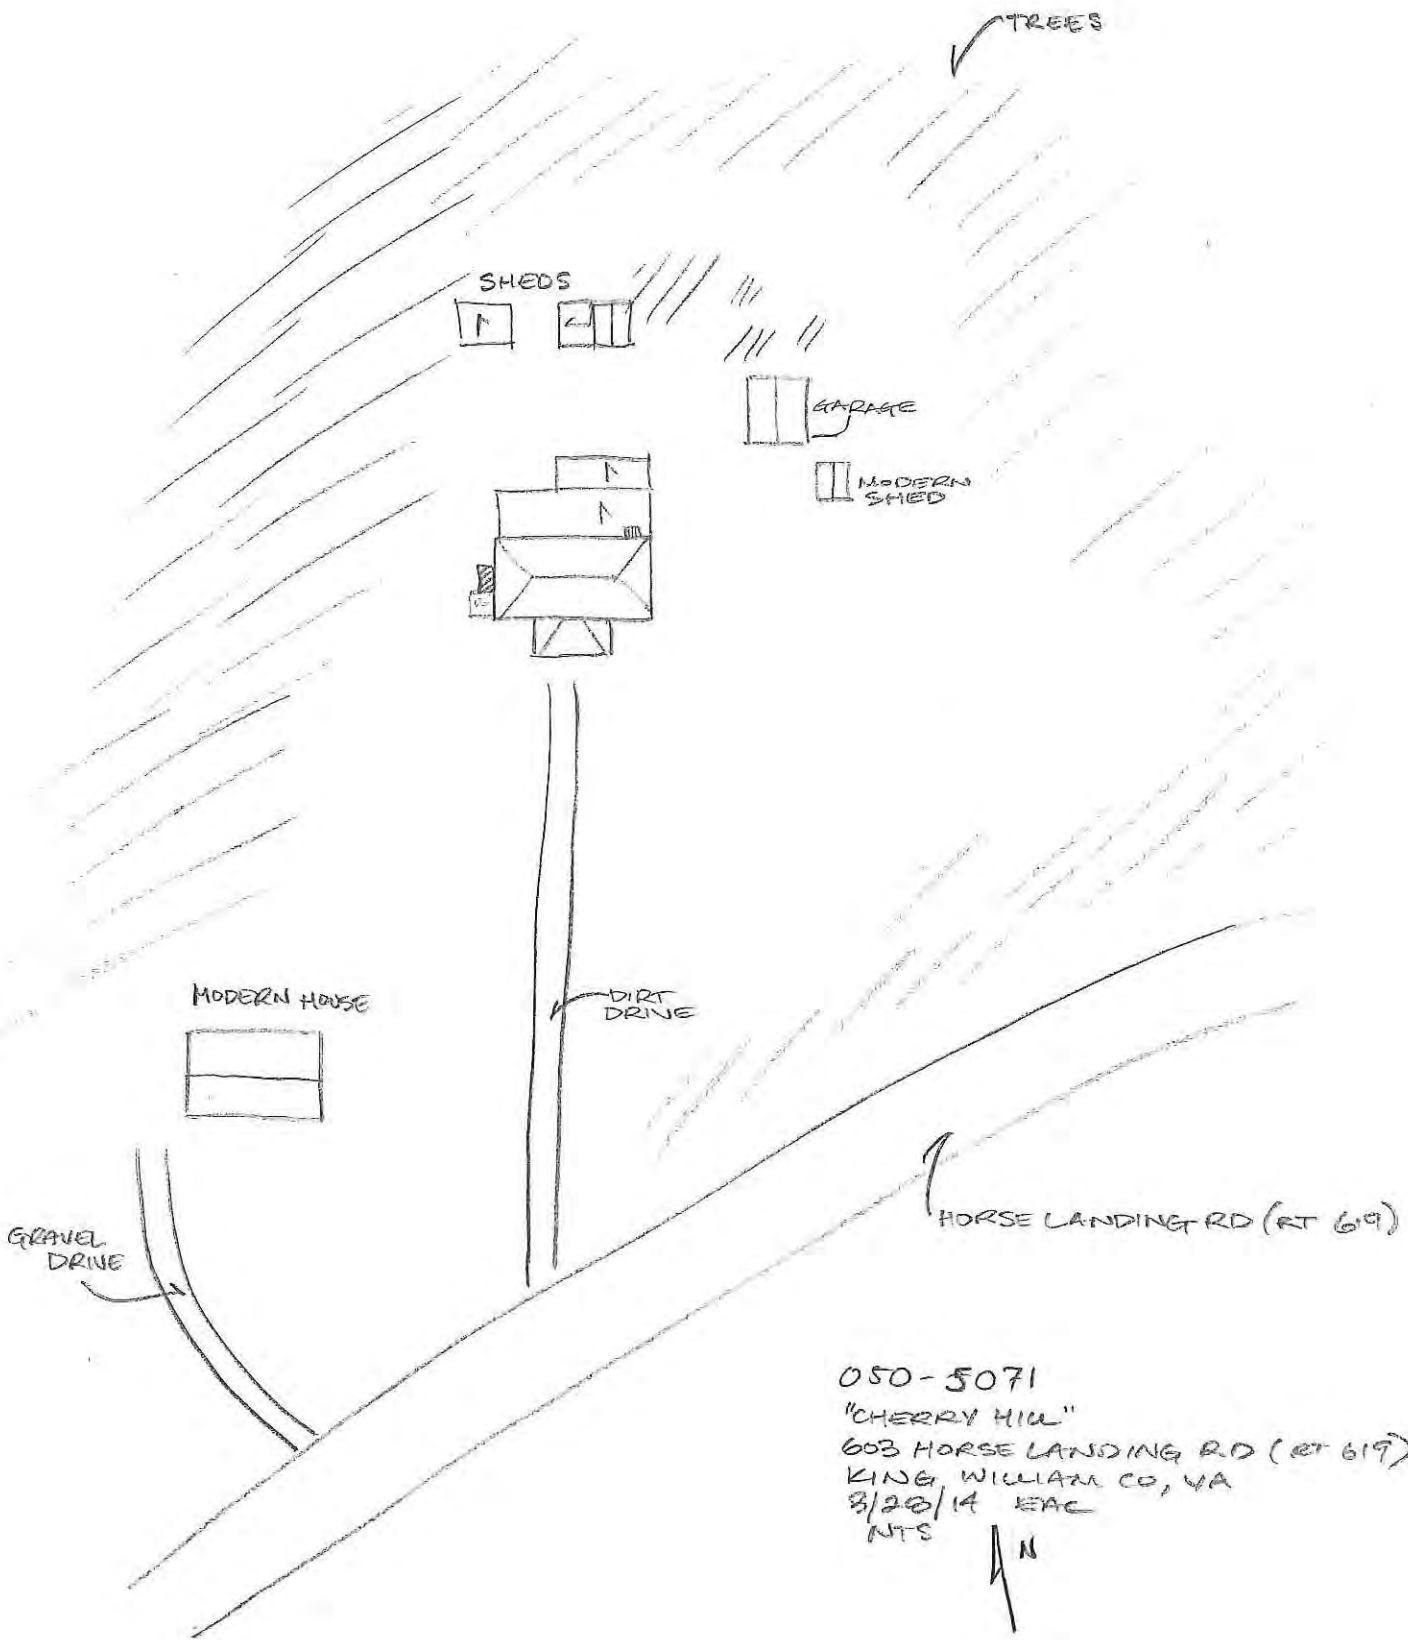
050-5071
"CHERRY HILL"
603 HORSE LANDING RD (RT 619)
KING WILLIAM CO, VA
3/28/14 EAC
NTS

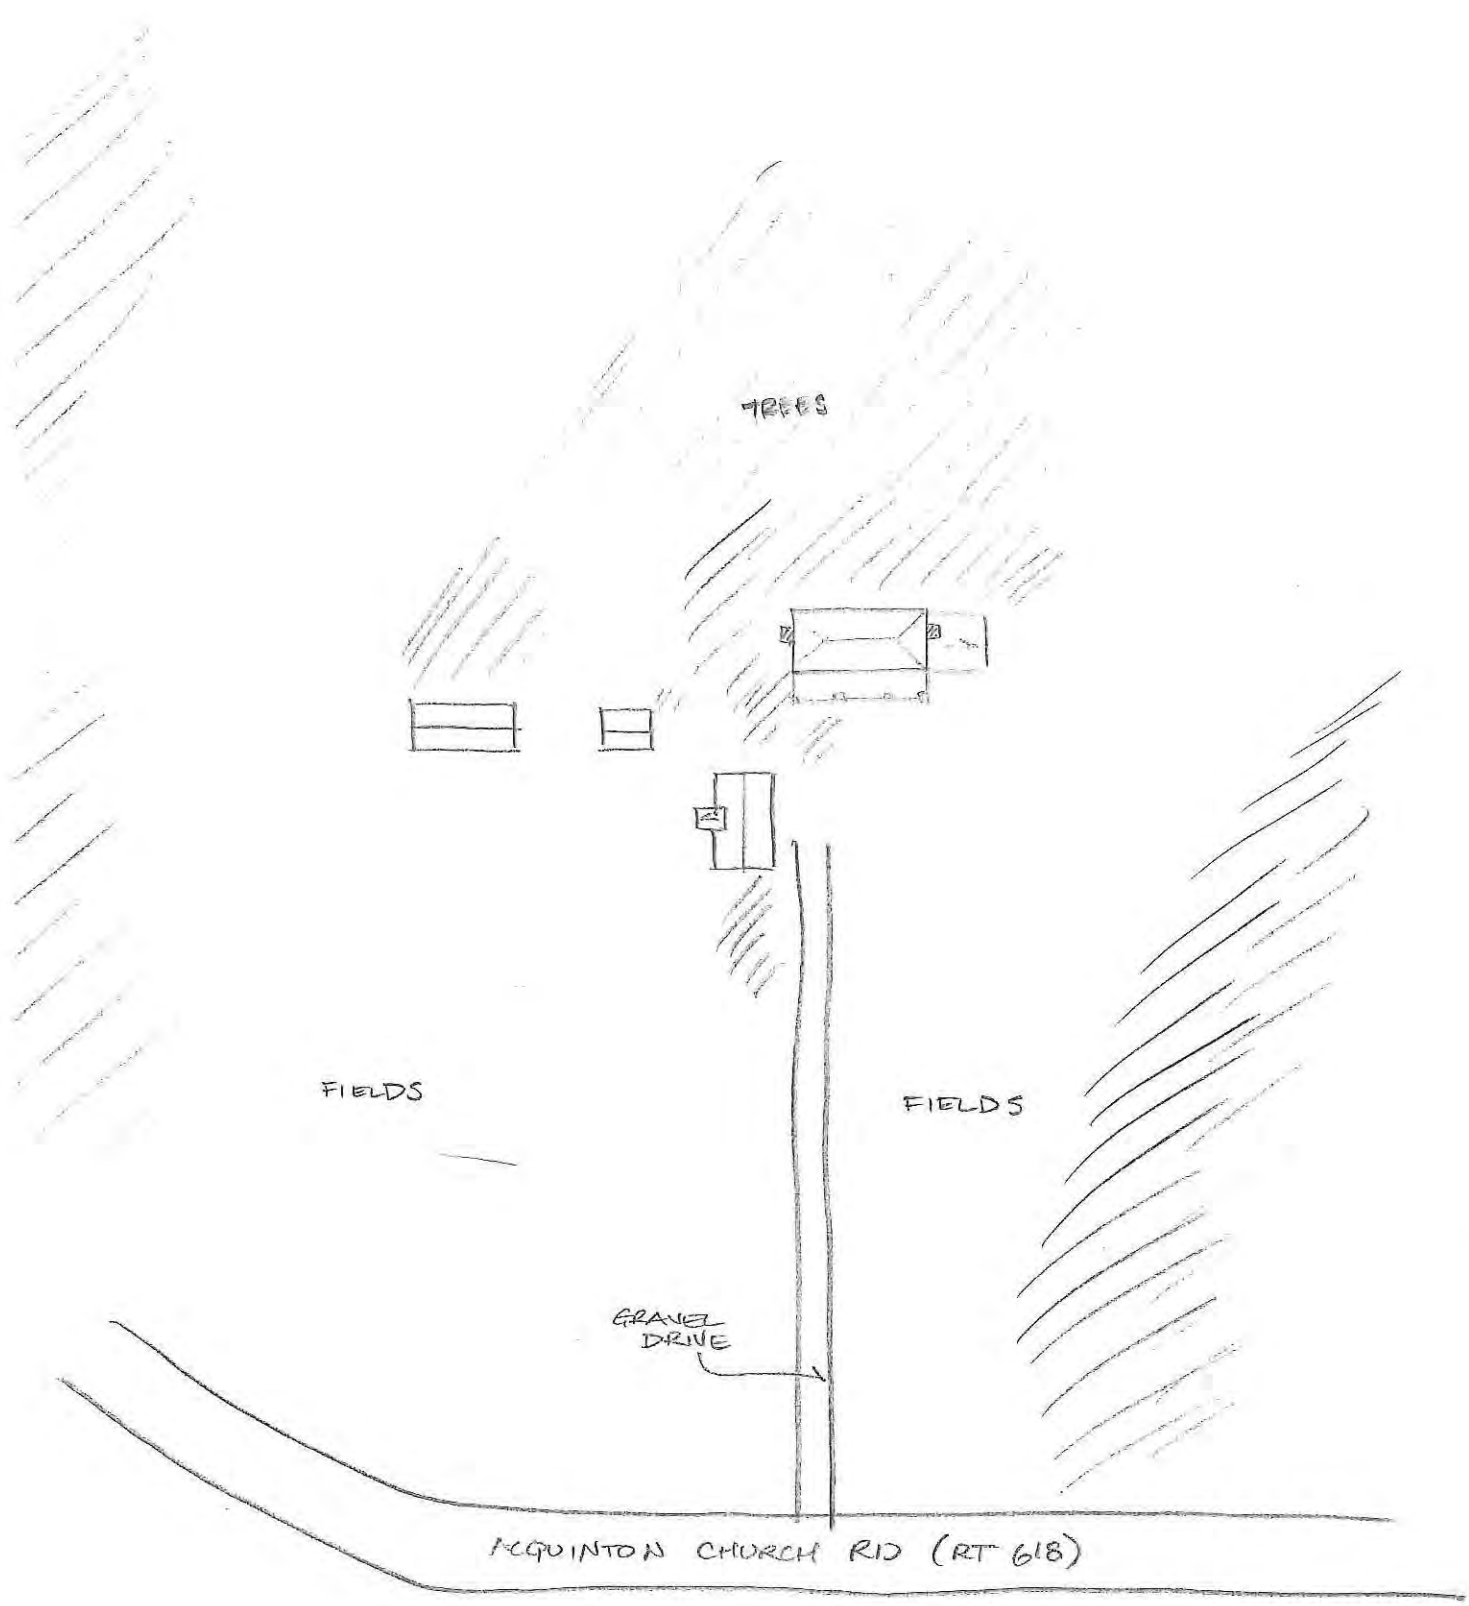
050-5072 "DOVE'S NEST"
2225 McQUINTON CHURCH RD (RT 618)
KING WILLIAM CO, VA
3.28.14 EAC
NTS

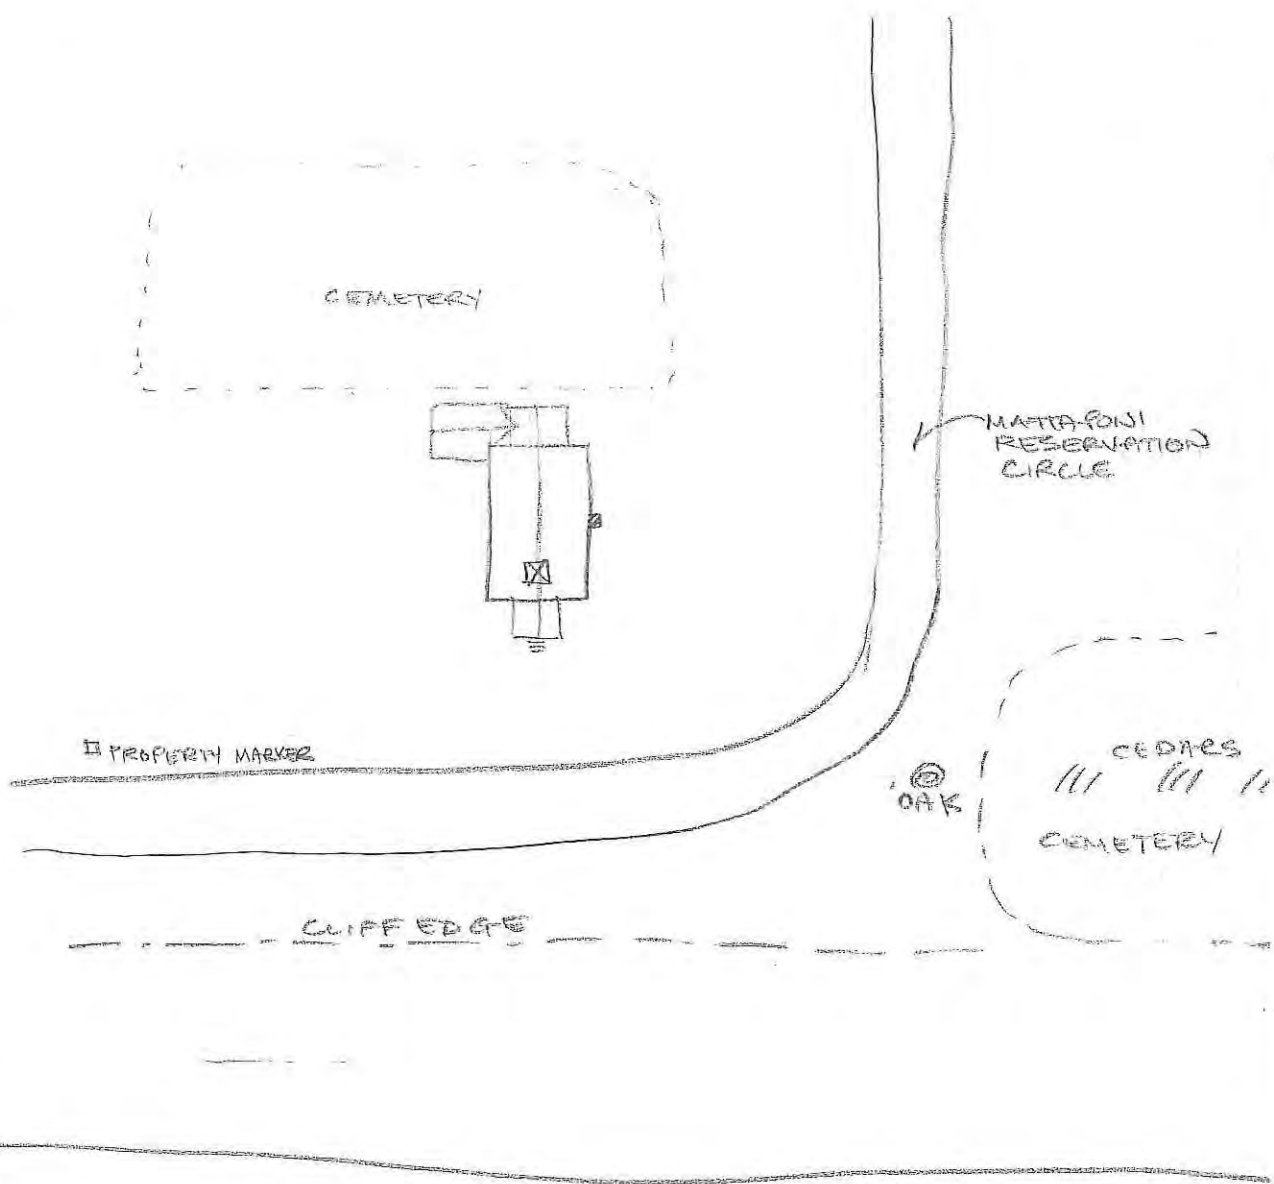
050-8075
 MATTAPONI INDIAN BAPTIST CHURCH
 ? MATTAPONI RESERVATION CIRCLE
 KING WILLIAM CO, VA
 4.1.19 ETC
 MTS ↗ N

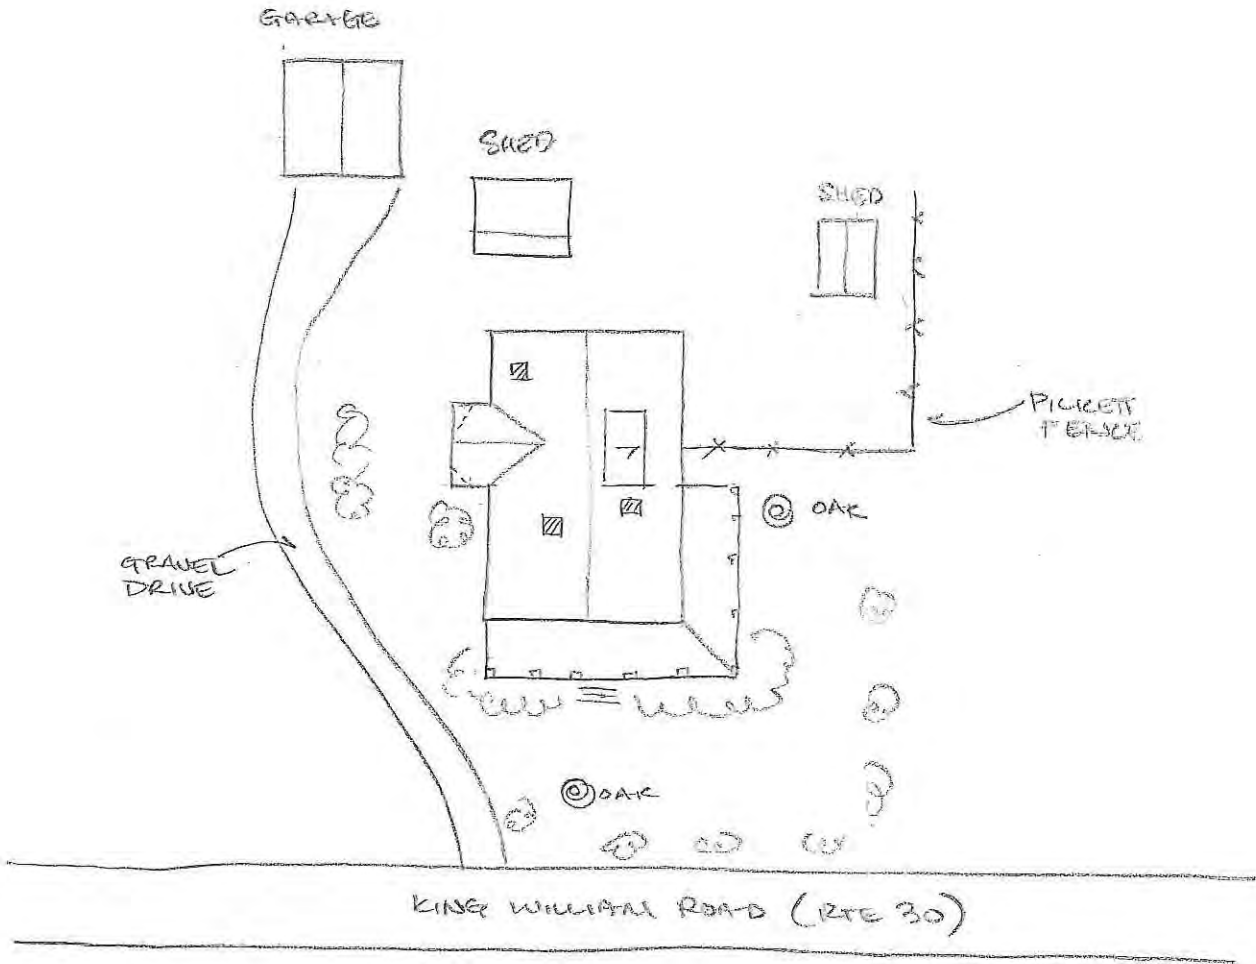
050-5030
HOUSE,
865 KING WILLIAM RD (RTE 30)
KING WILLIAM CO., VA
1.3.13 EAL
NTS

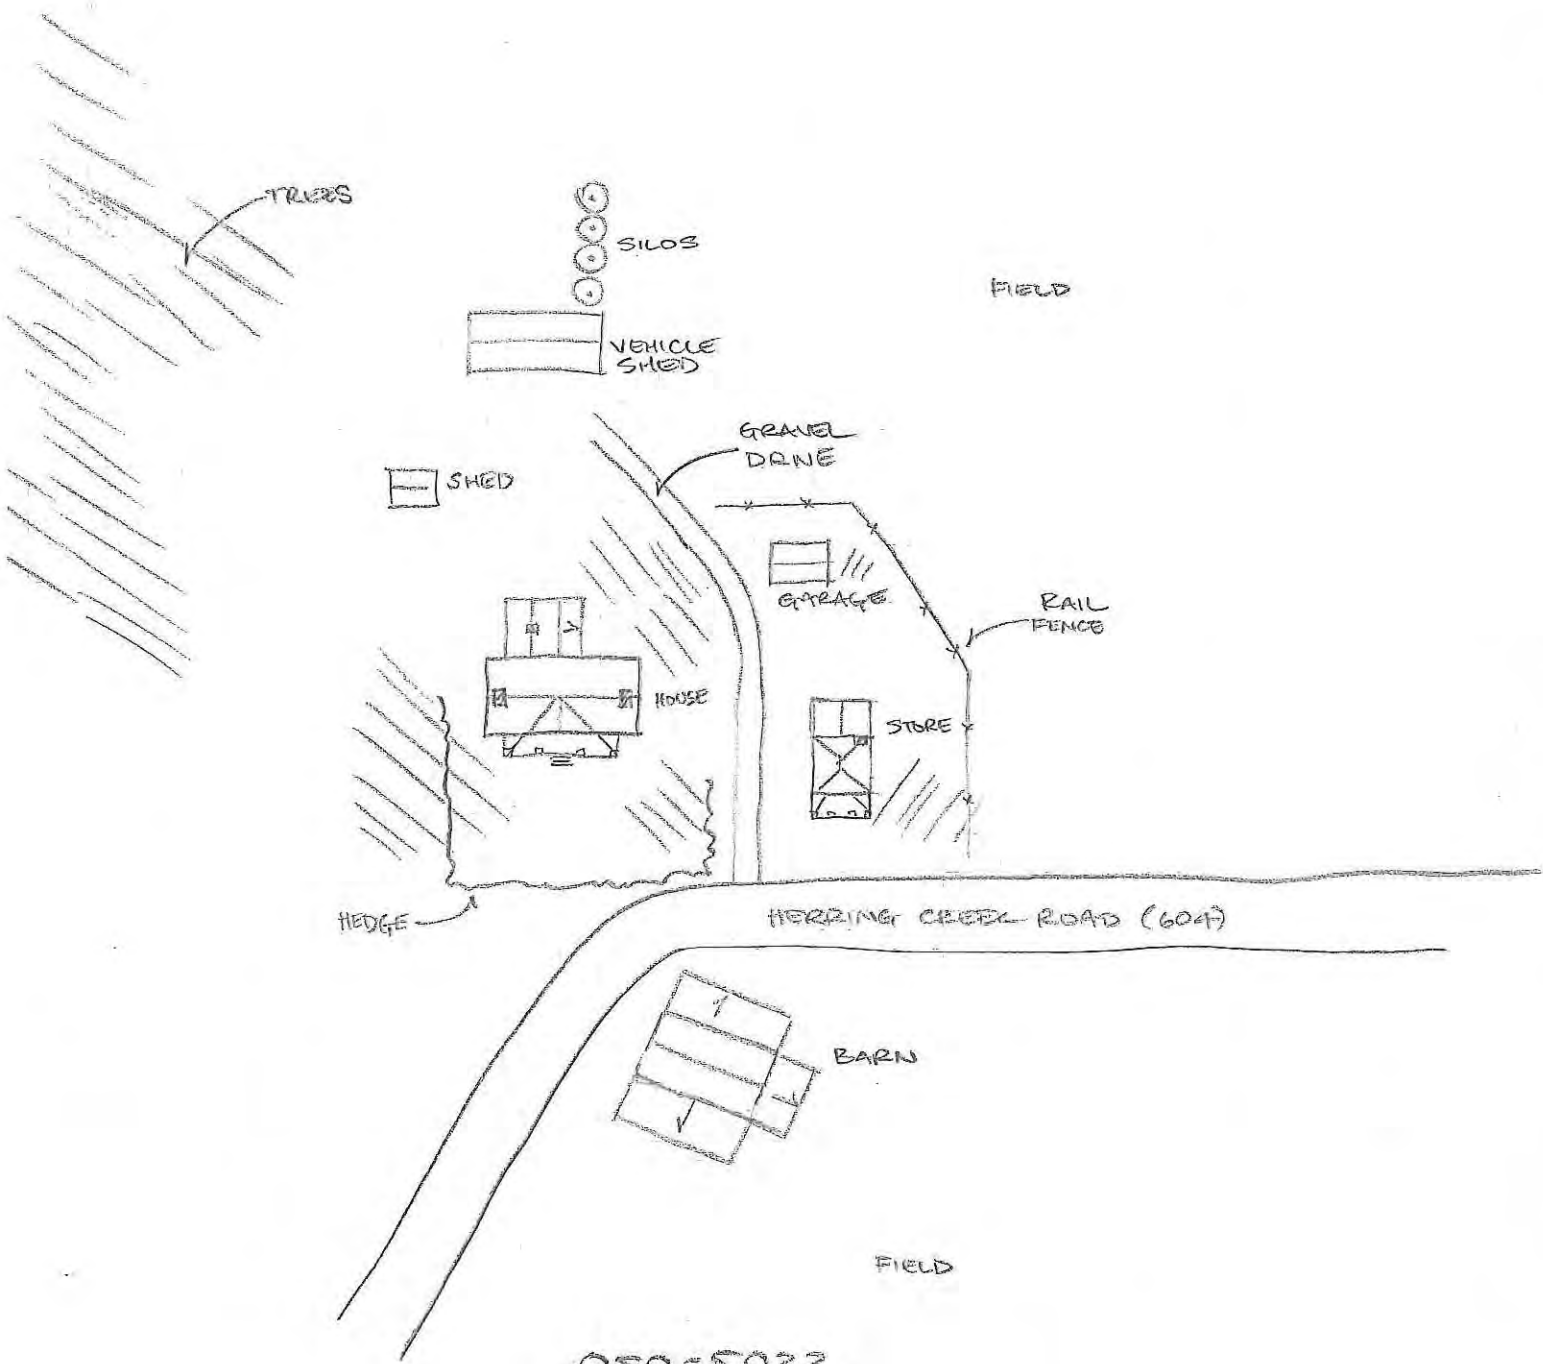
050-5033
 DUANE FARM & STORE
 4929 HERRING CREEK RD (604)
 KING WILLIAM CO, VA
 1.3.13 EAL
 NTS

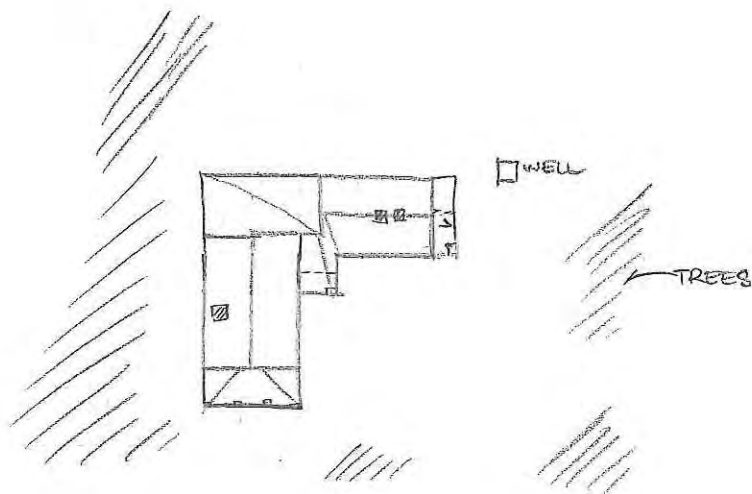
0.50-5034
STORE,
? W RIVER ROAD (600)
KING WILLIAM CO, VA
