An Architectural Survey of King William County

(Cost Share 2014)

Stantec Consulting Services,
formerly CRI
1049 Technology Park Drive
Glen Allen, Virginia 23059

July 24, 2014

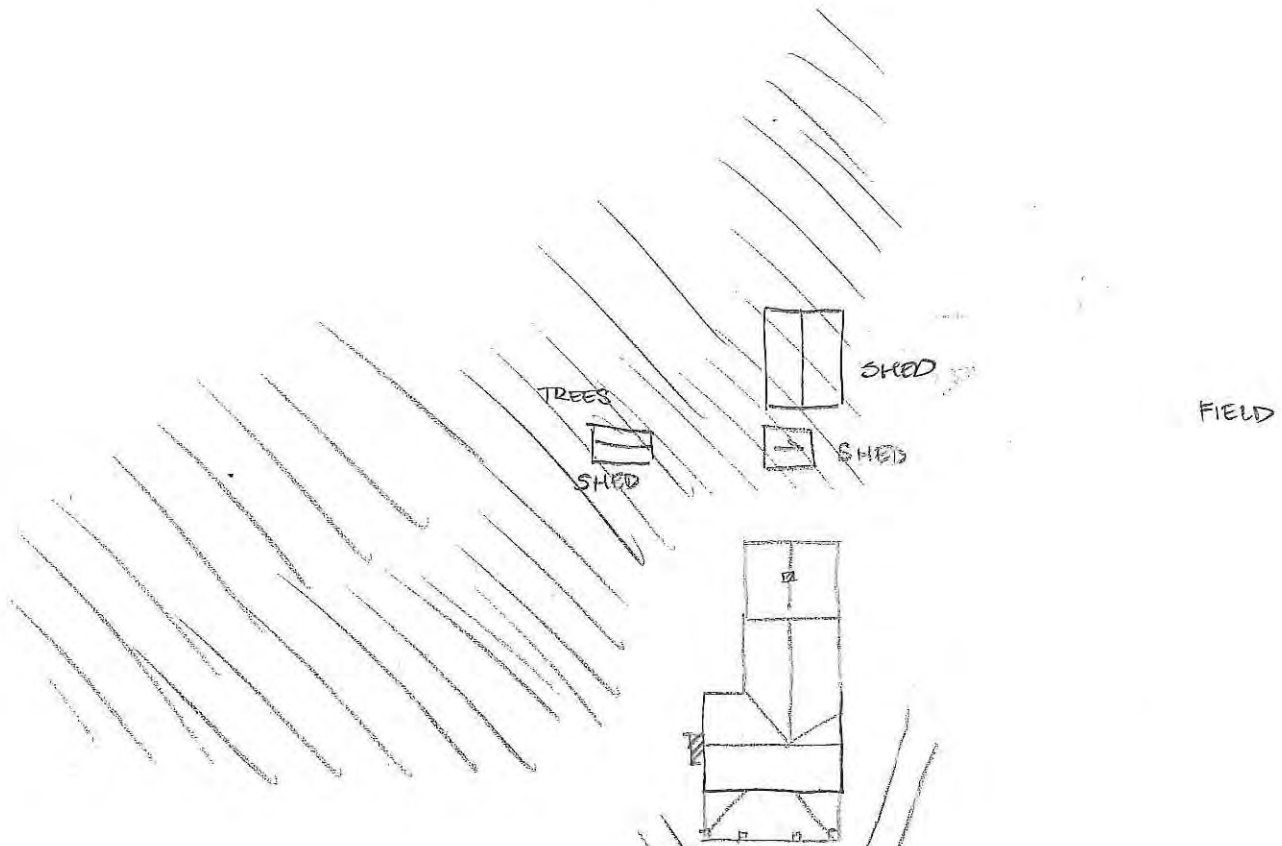
050-5035
"MELVILLE"
2692 W. RIVER ROAD (600)
KING WILLIAM CO, VA

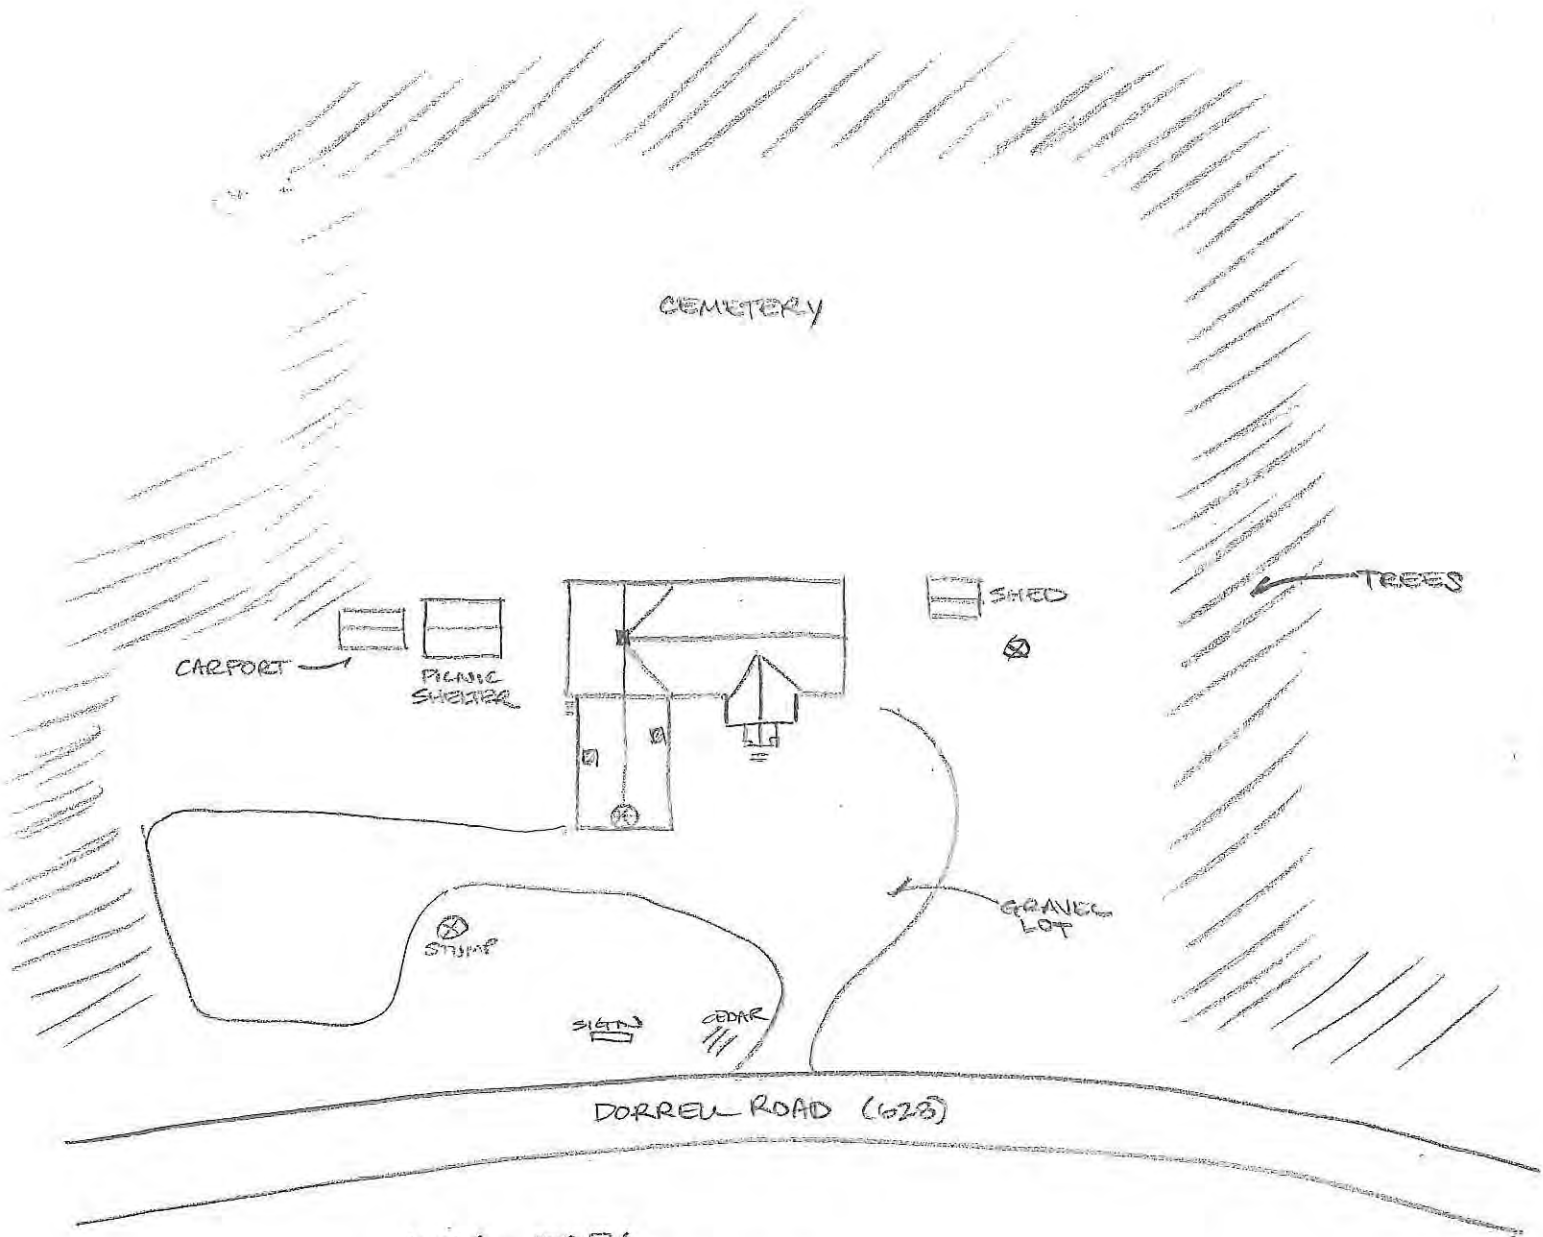
050-5036
 PROVIDENCE BAPTIST CHURCH
 4570 DORRELL ROAD (628)
 KING WILLIAM CO, VA

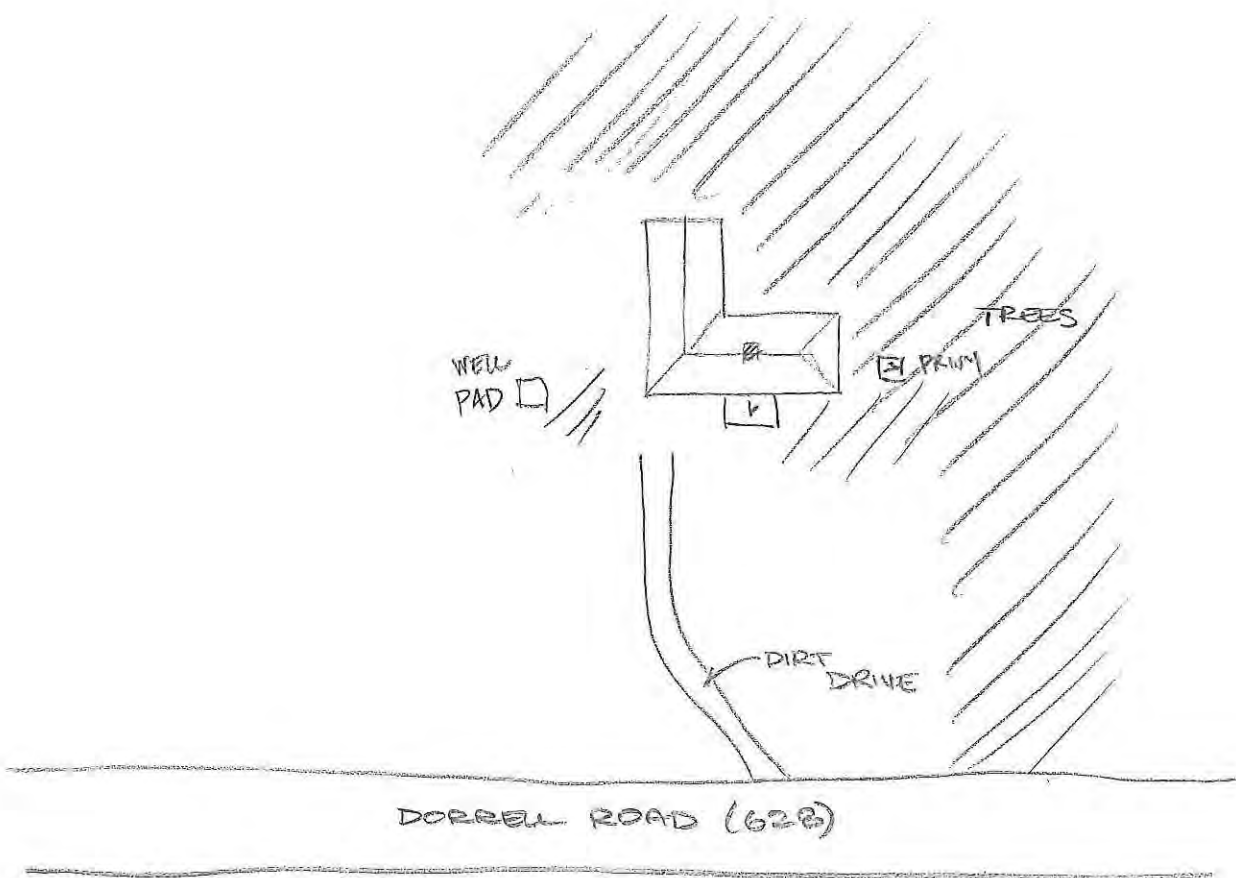
050-5037
 BENJAMINE COLORED SCHOOL
 ? DORRELL ROAD (628)
 KING WILLIAM CO, VA
 EAL
 NTS

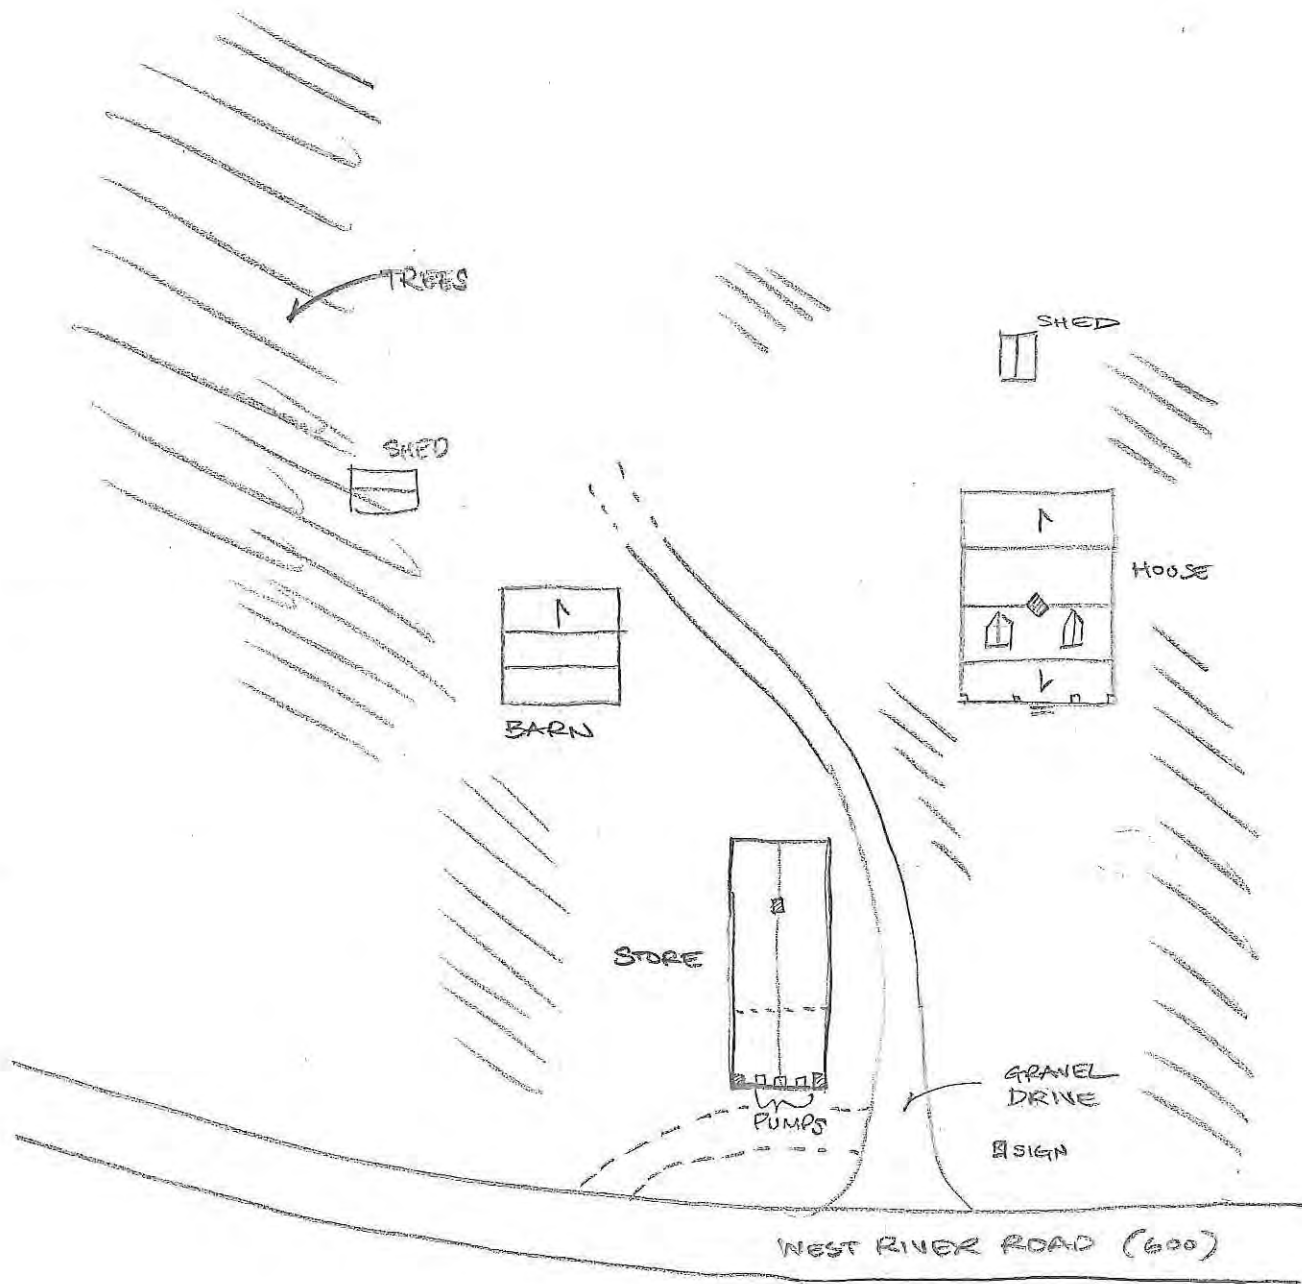
050-5039
STORE / (GAS STATION) @

5828 W RIVER ROAD (600)

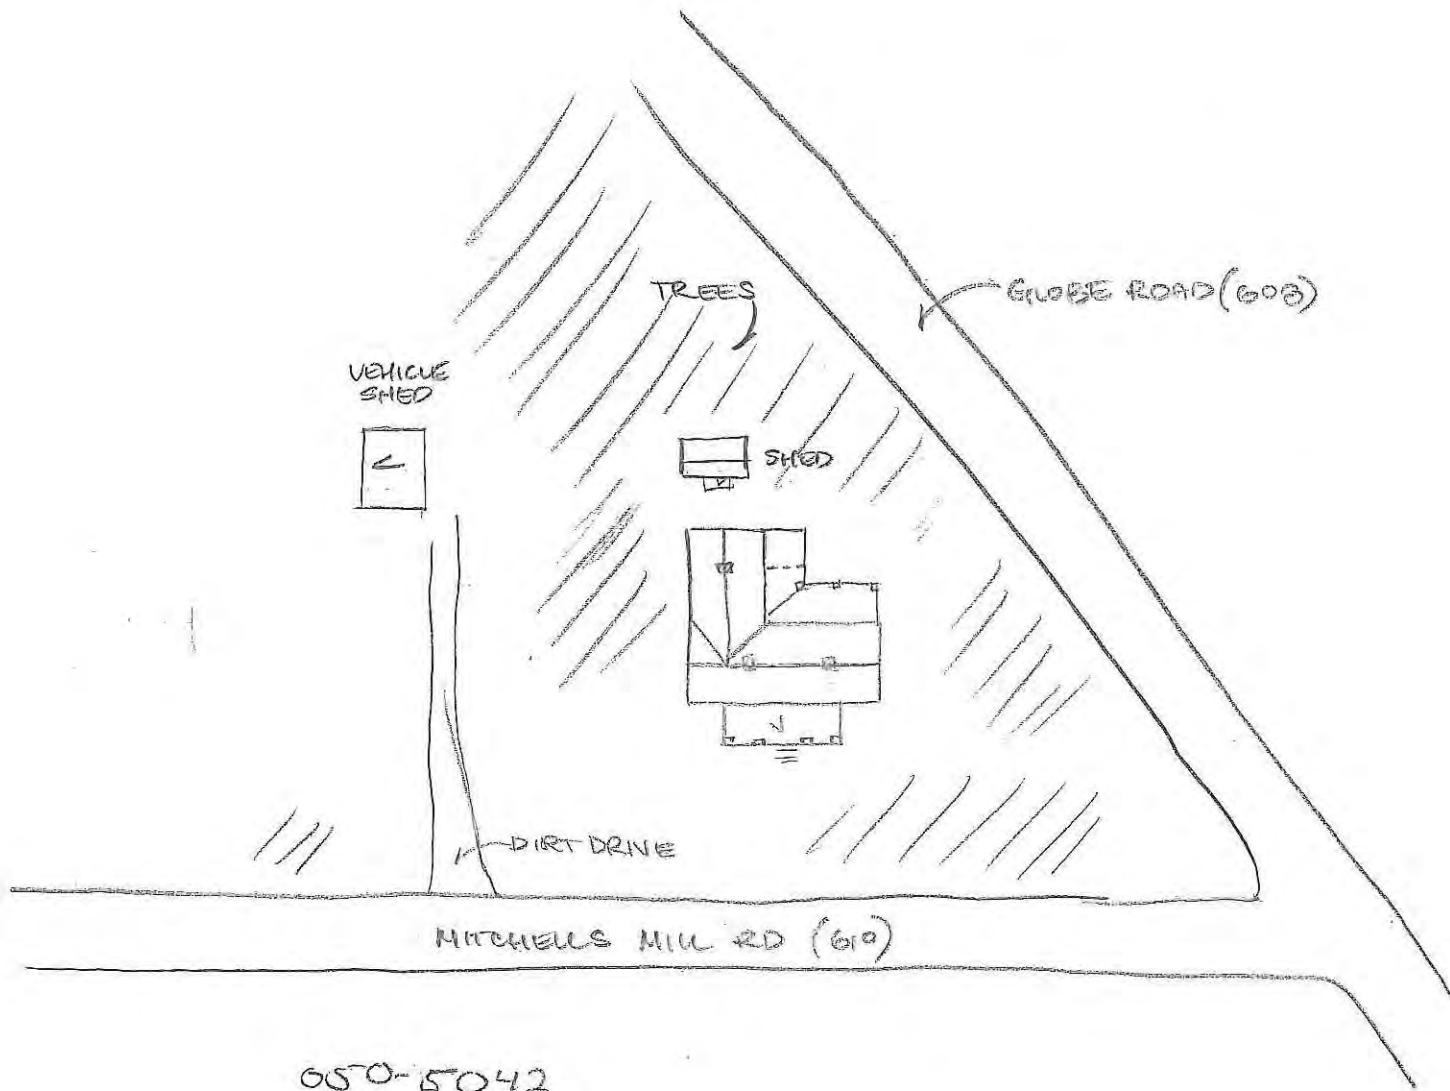
650-5042
HOUSE,
24 MITCHELLS MILL RD (610)
KING WILLIAM CO, VA
1.6.14 EAL
NTS

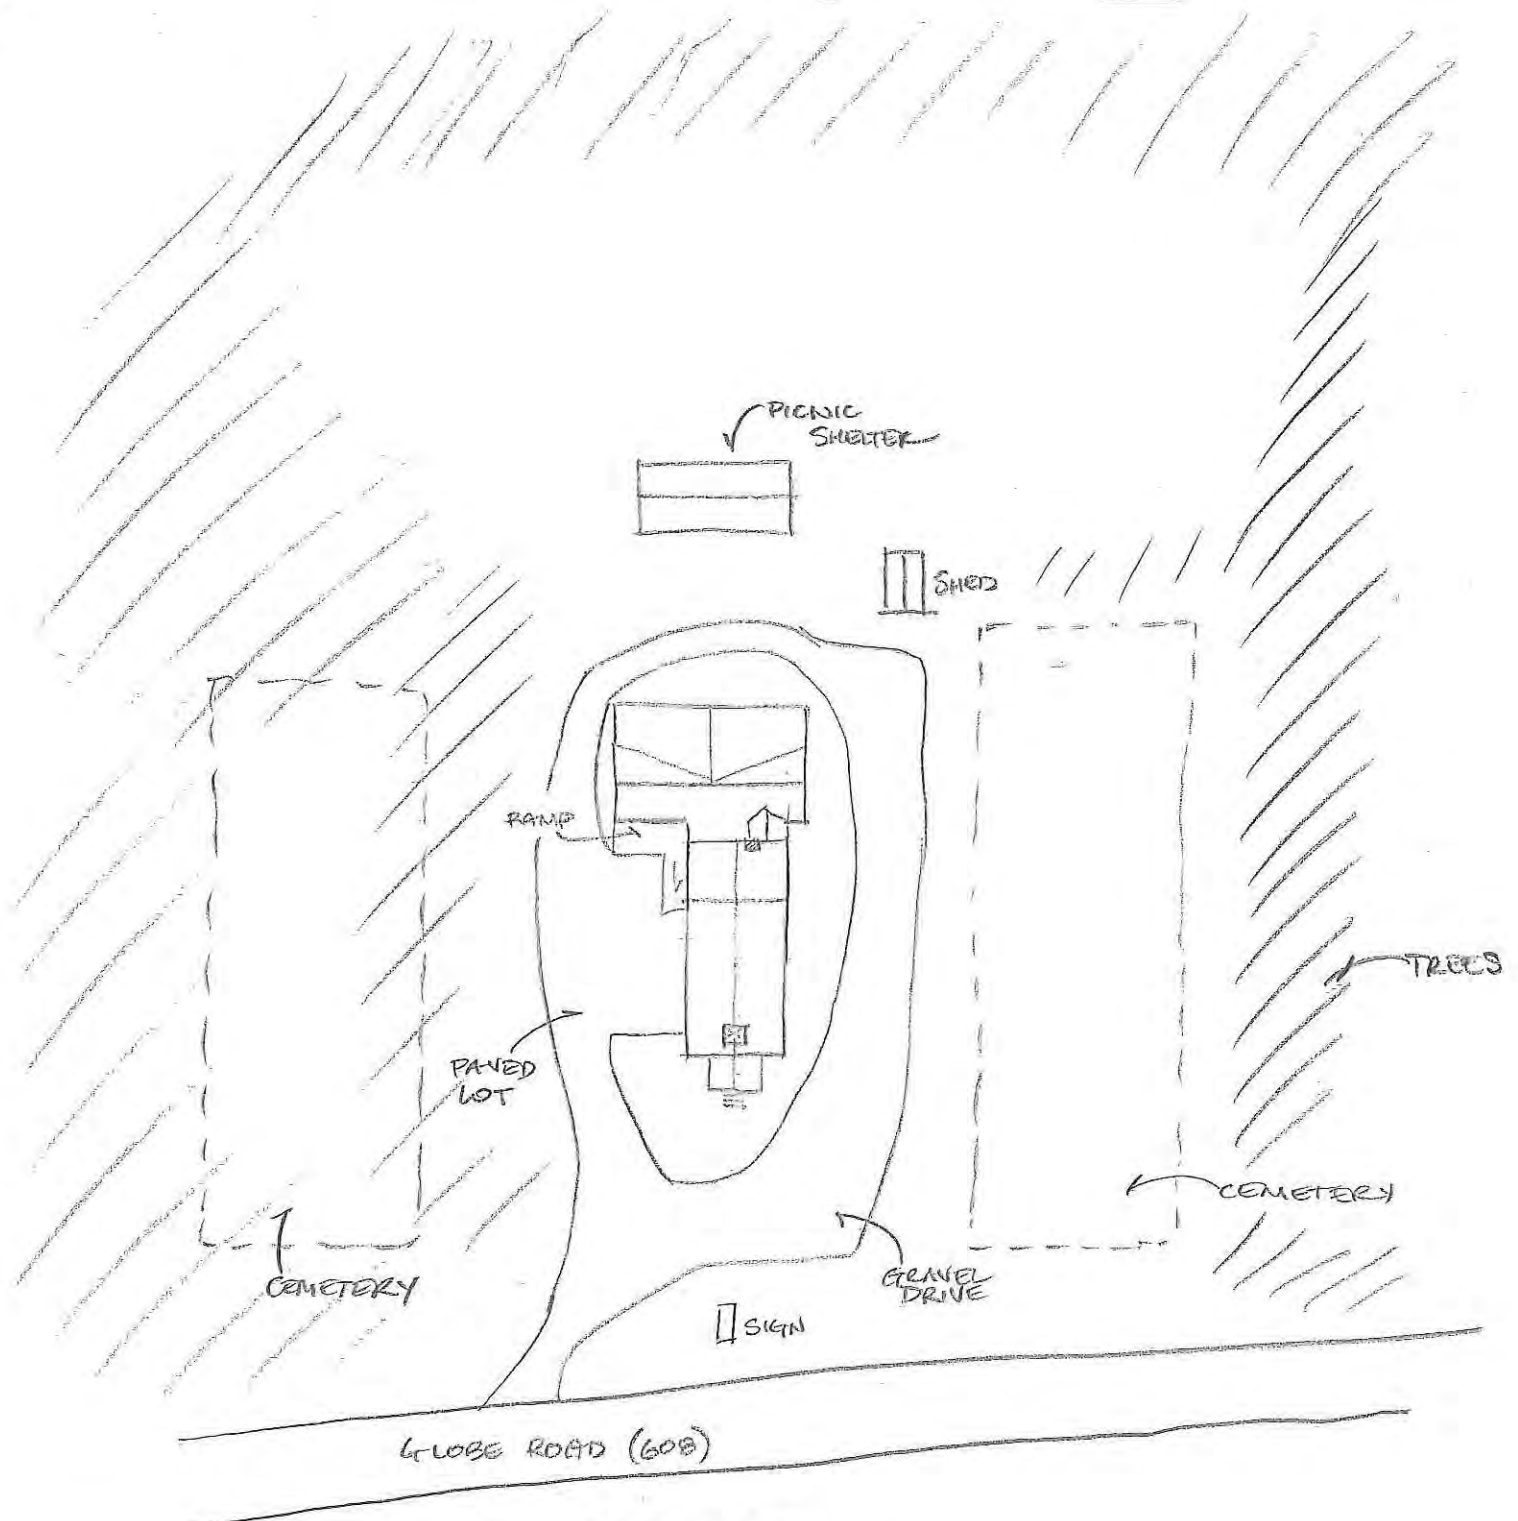
0.50-5043
 ST PAUL BAPTIST CHURCH
 1995 GLOBE RD (608)
 KING WILLIAM CO, VA
 1.6.14 EAL
 NTS

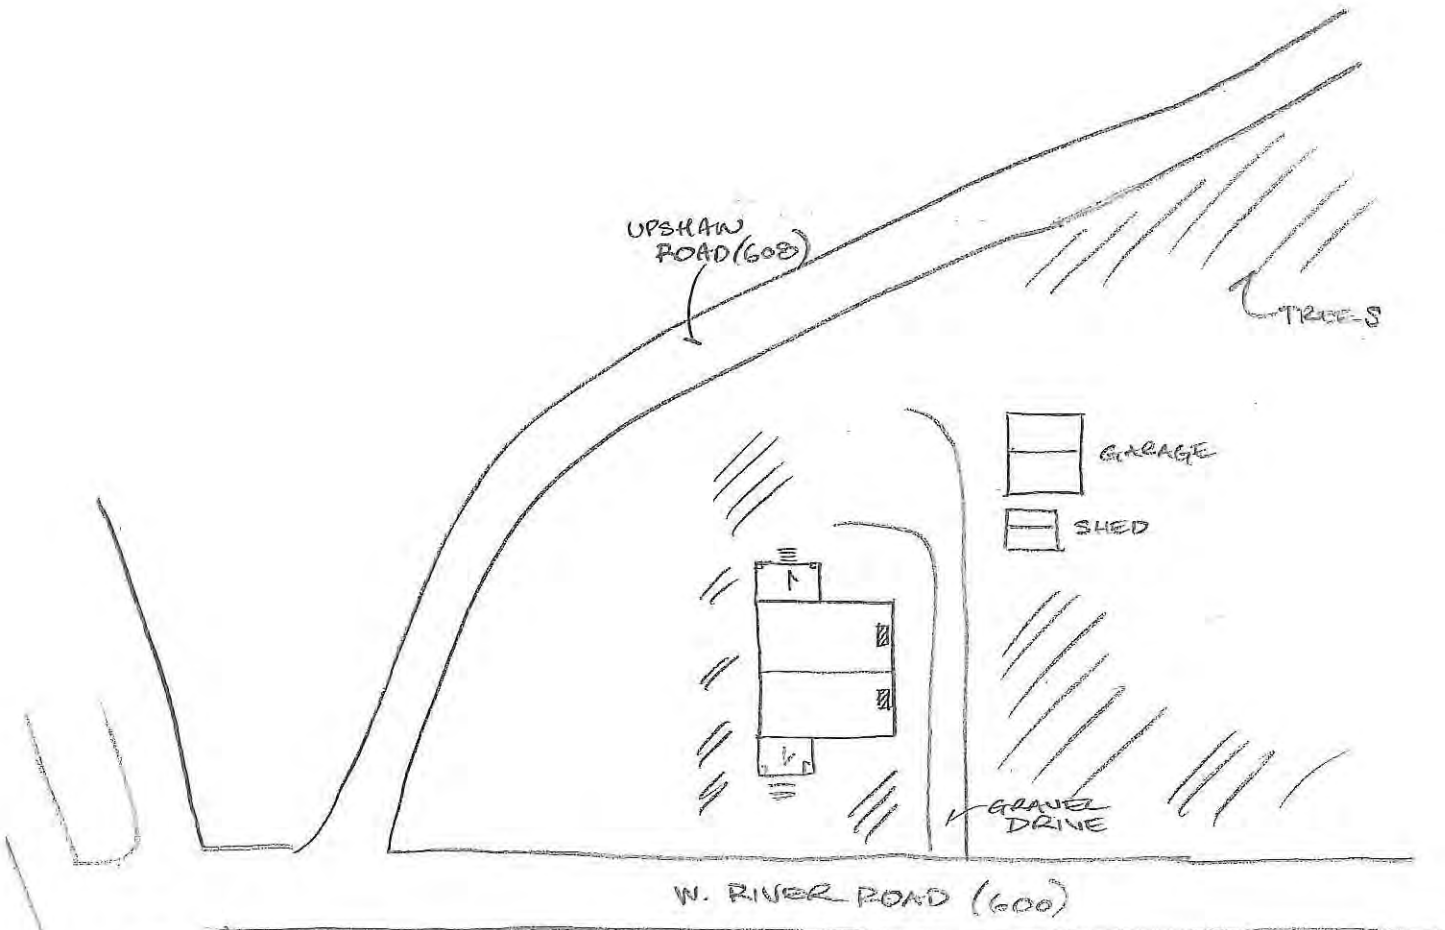
080-5045
 HOUSE AT
 11124 W. RIVER ROAD (600)
 KING WILLIAM CO, VA
 1/7/14 EAL
 NTS

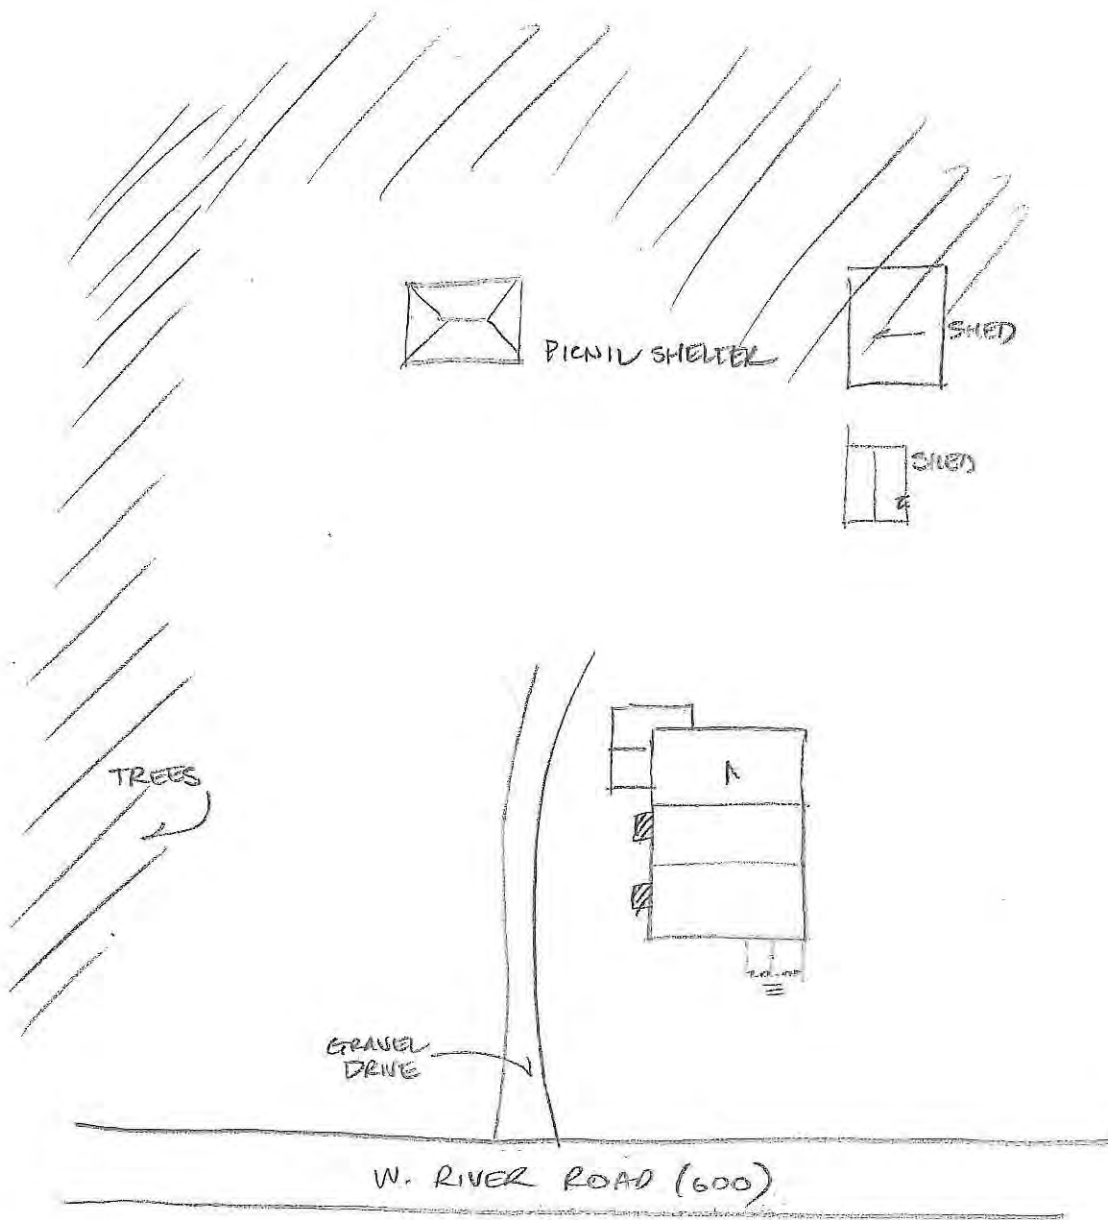
050-5046
 HOUSE AT
 1117 W RIVER ROAD (600)
 KING WILLIAM CO, VA
 1.7.14 EAL
 NTS

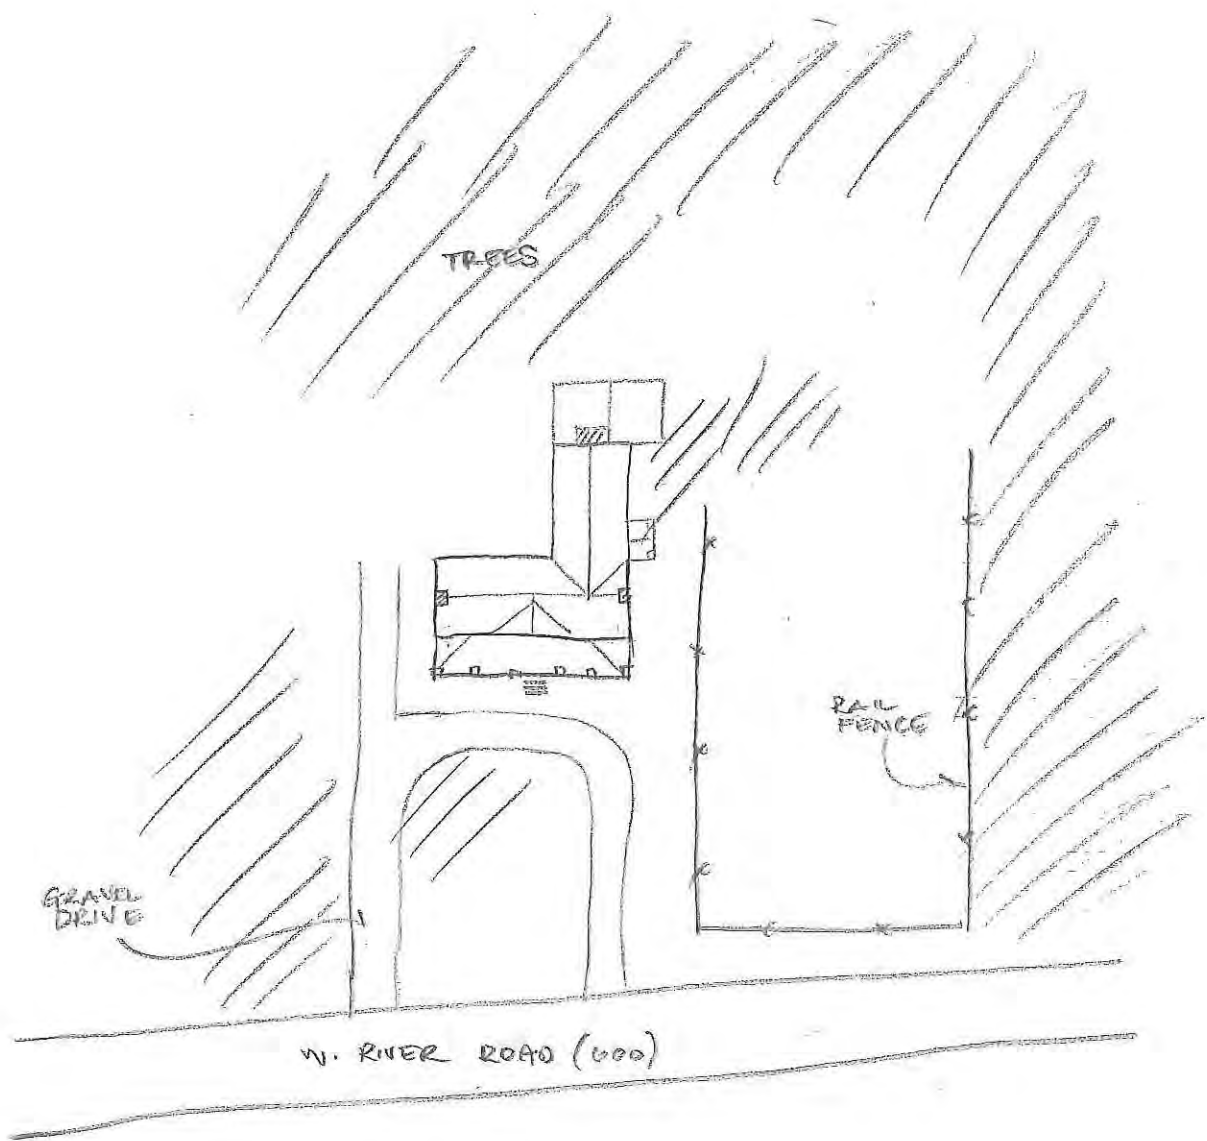
OSO-5047
 HOUSE @
 1002 W RIVER RD (600)
 KING WILLIAM CO, VA
 1.7.14 T.E.L.
 NTS

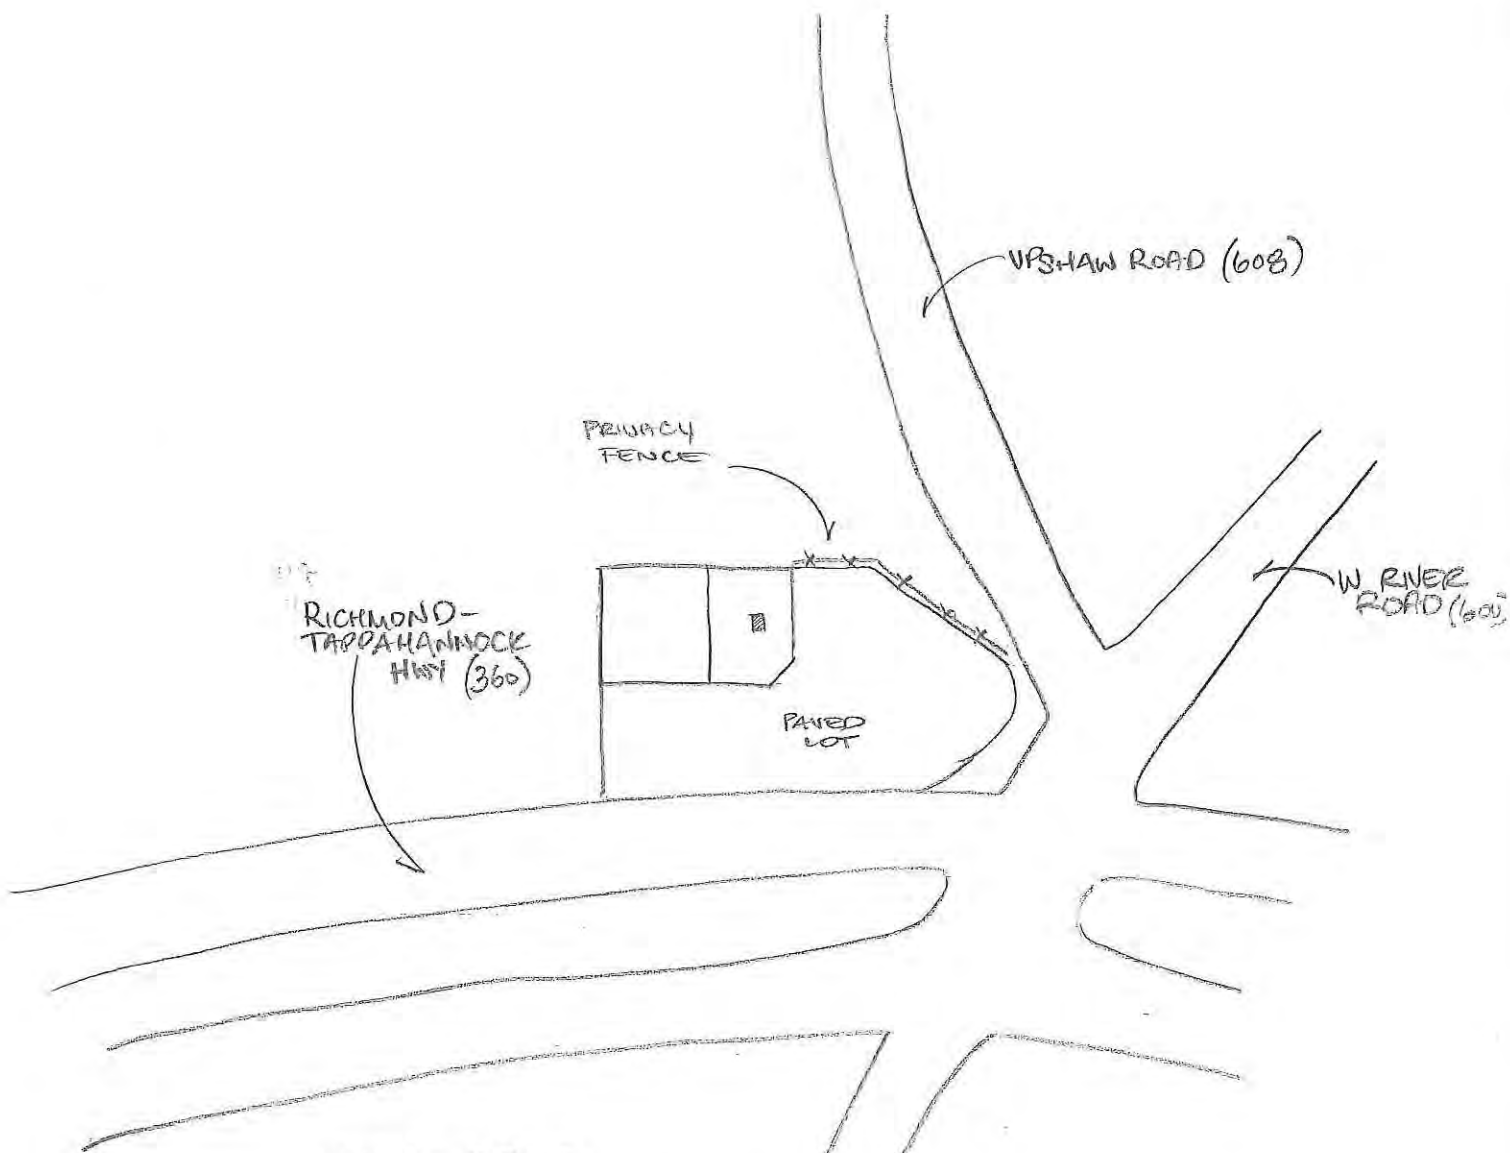
050-5048
A/LET. ESSO STATION (FORMERLY)
8279 RICHMOND-TAPPANNOCK HWY (360)
KING WILLIAM CO, VA
1.7.14 EAL
NTJ N

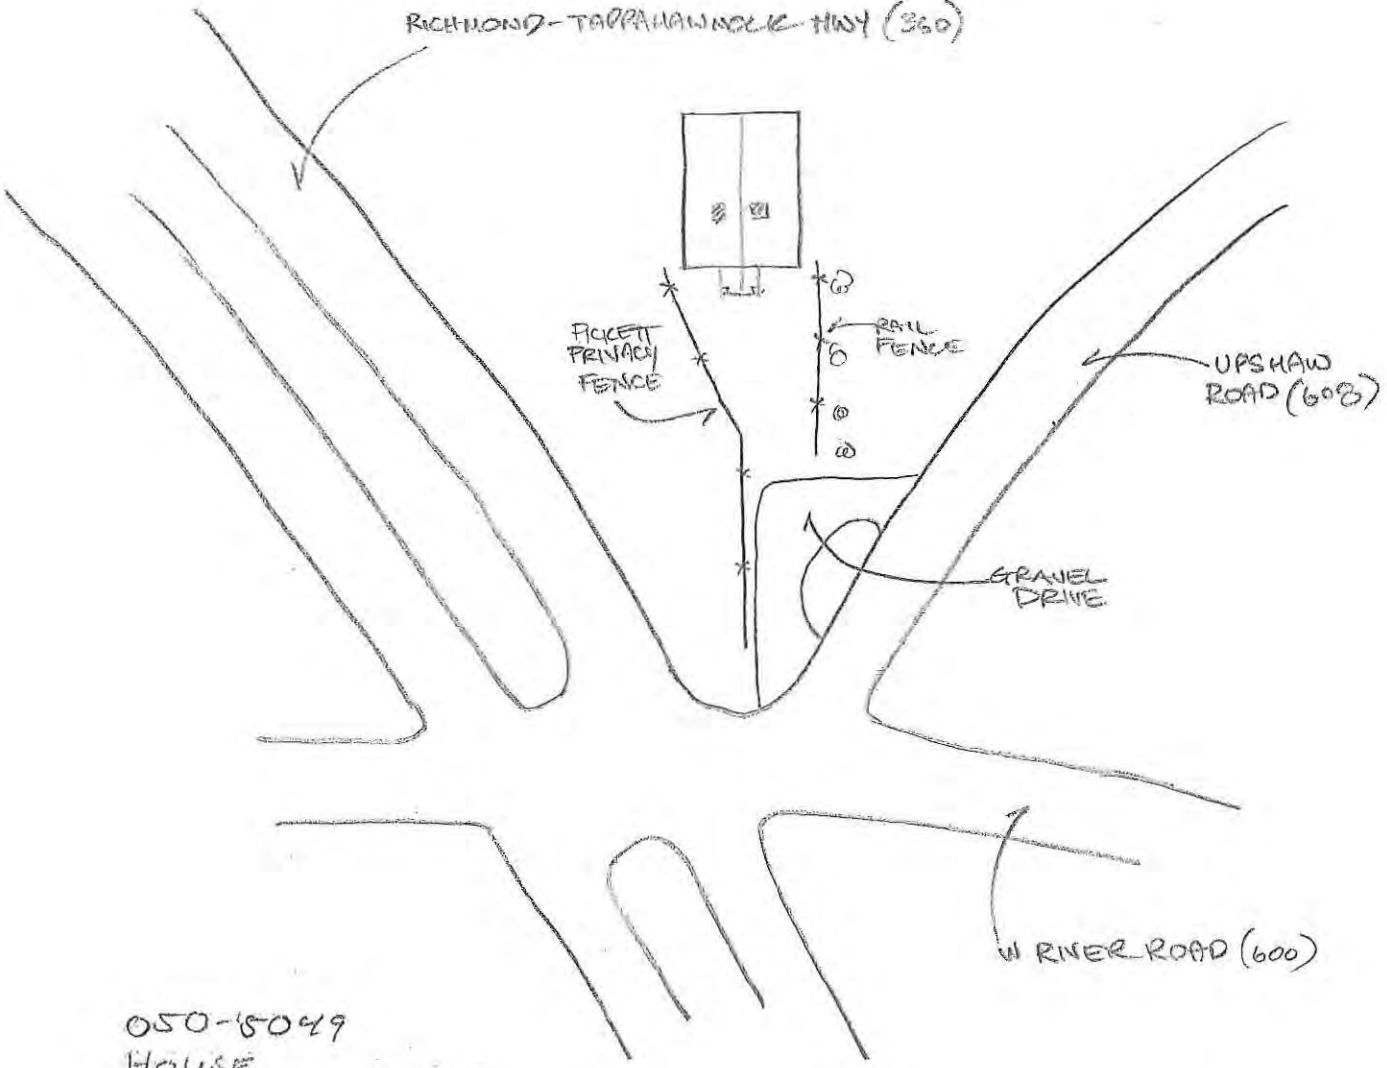
050-18049
HOUSE
4668 UPSHAW RD (608)
KING WILLIAM CO, VA
1.7.14 EAL
NTS

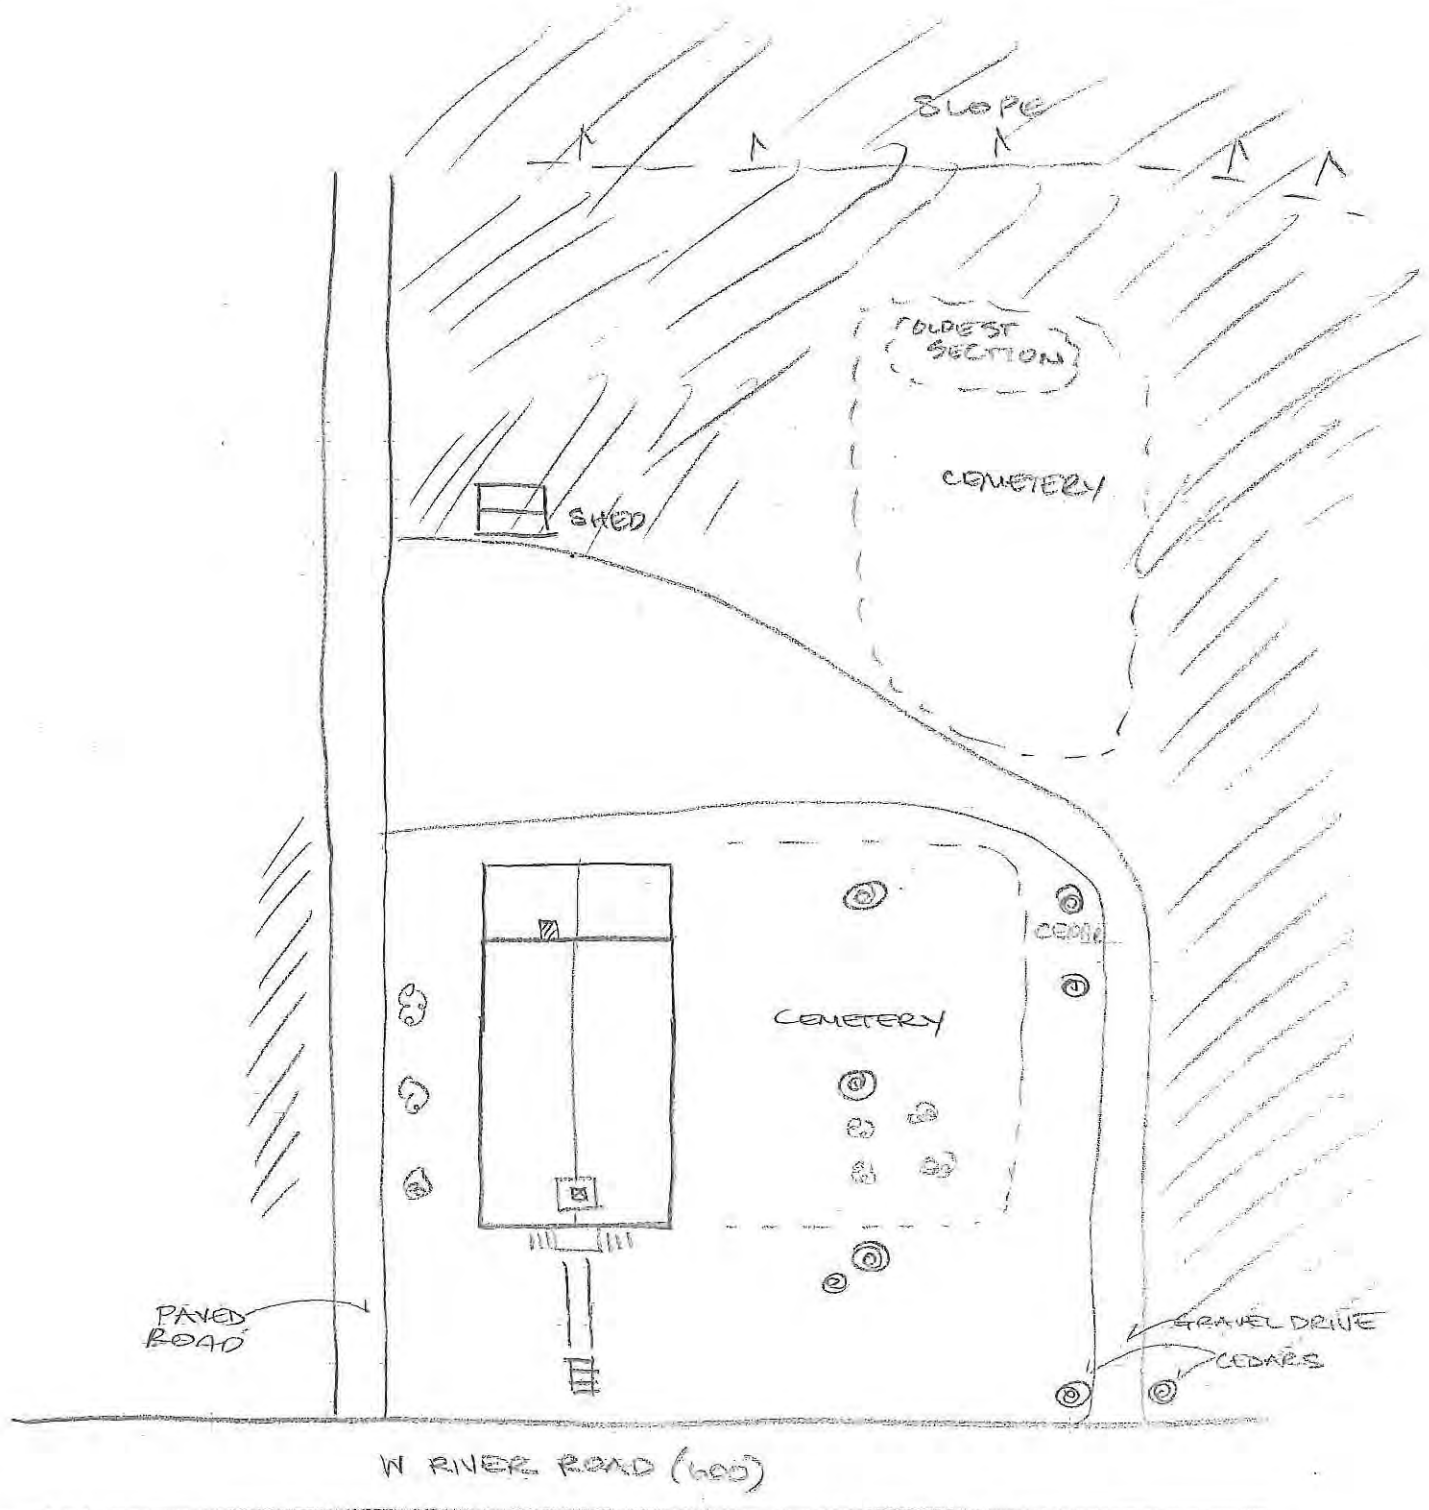
050-5050
 ST DAVID'S CHURCH
 N. RIVER ROAD (600)
 KING WILLIAM CO, VA
 1/7/14 EAC
 NTS

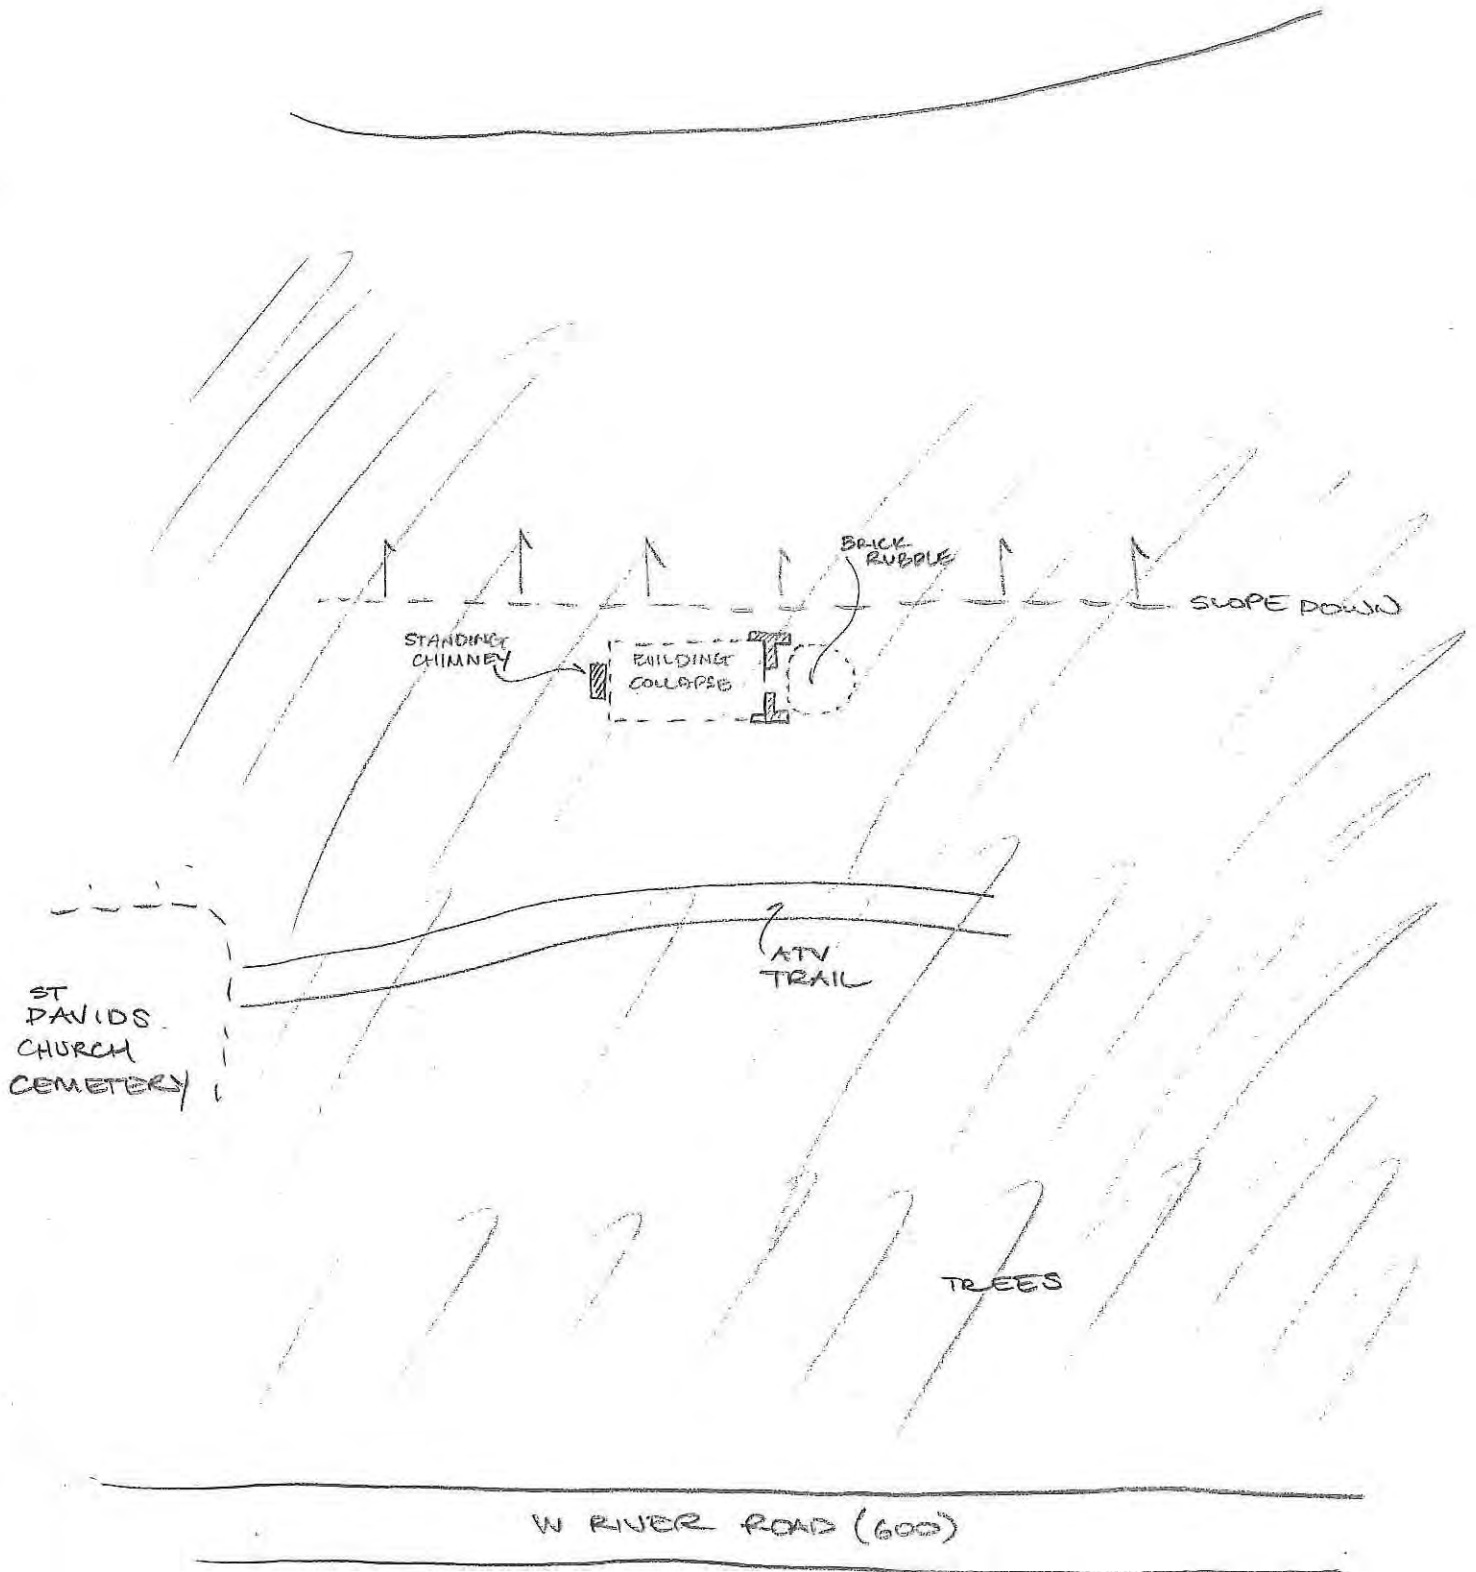
050-5051
RUINS,
OFF W. RIVER ROAD (600)
KING WILLIAM CO, VA
1-7-14 EAL
NTS
