An Architectural Survey of King William County

(Cost Share 2014)

Stantec Consulting Services,
formerly CRI
1049 Technology Park Drive
Glen Allen, Virginia 23059

July 24, 2014

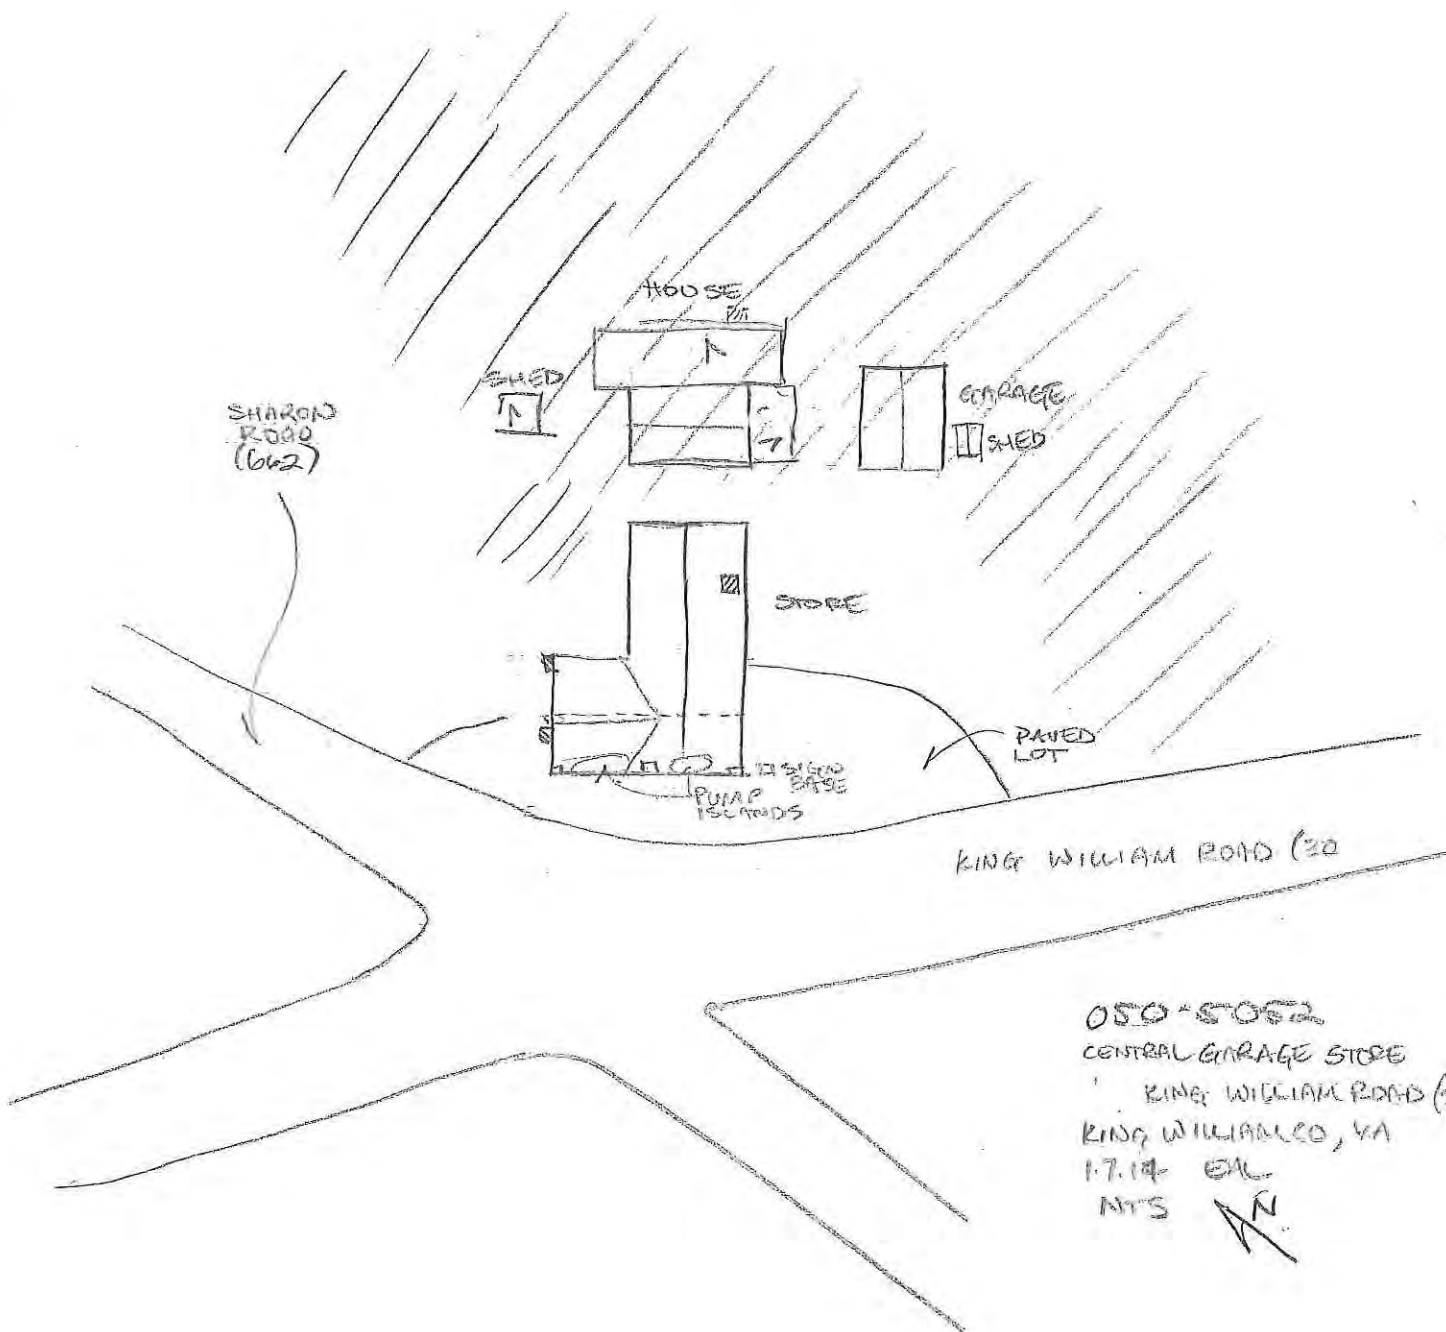
OSO-5062
 CENTRAL GARAGE STORE
 KING WILLIAM ROAD (30)
 KING WILLIAM CO, VA
 1.7.14 EAL
 NTS

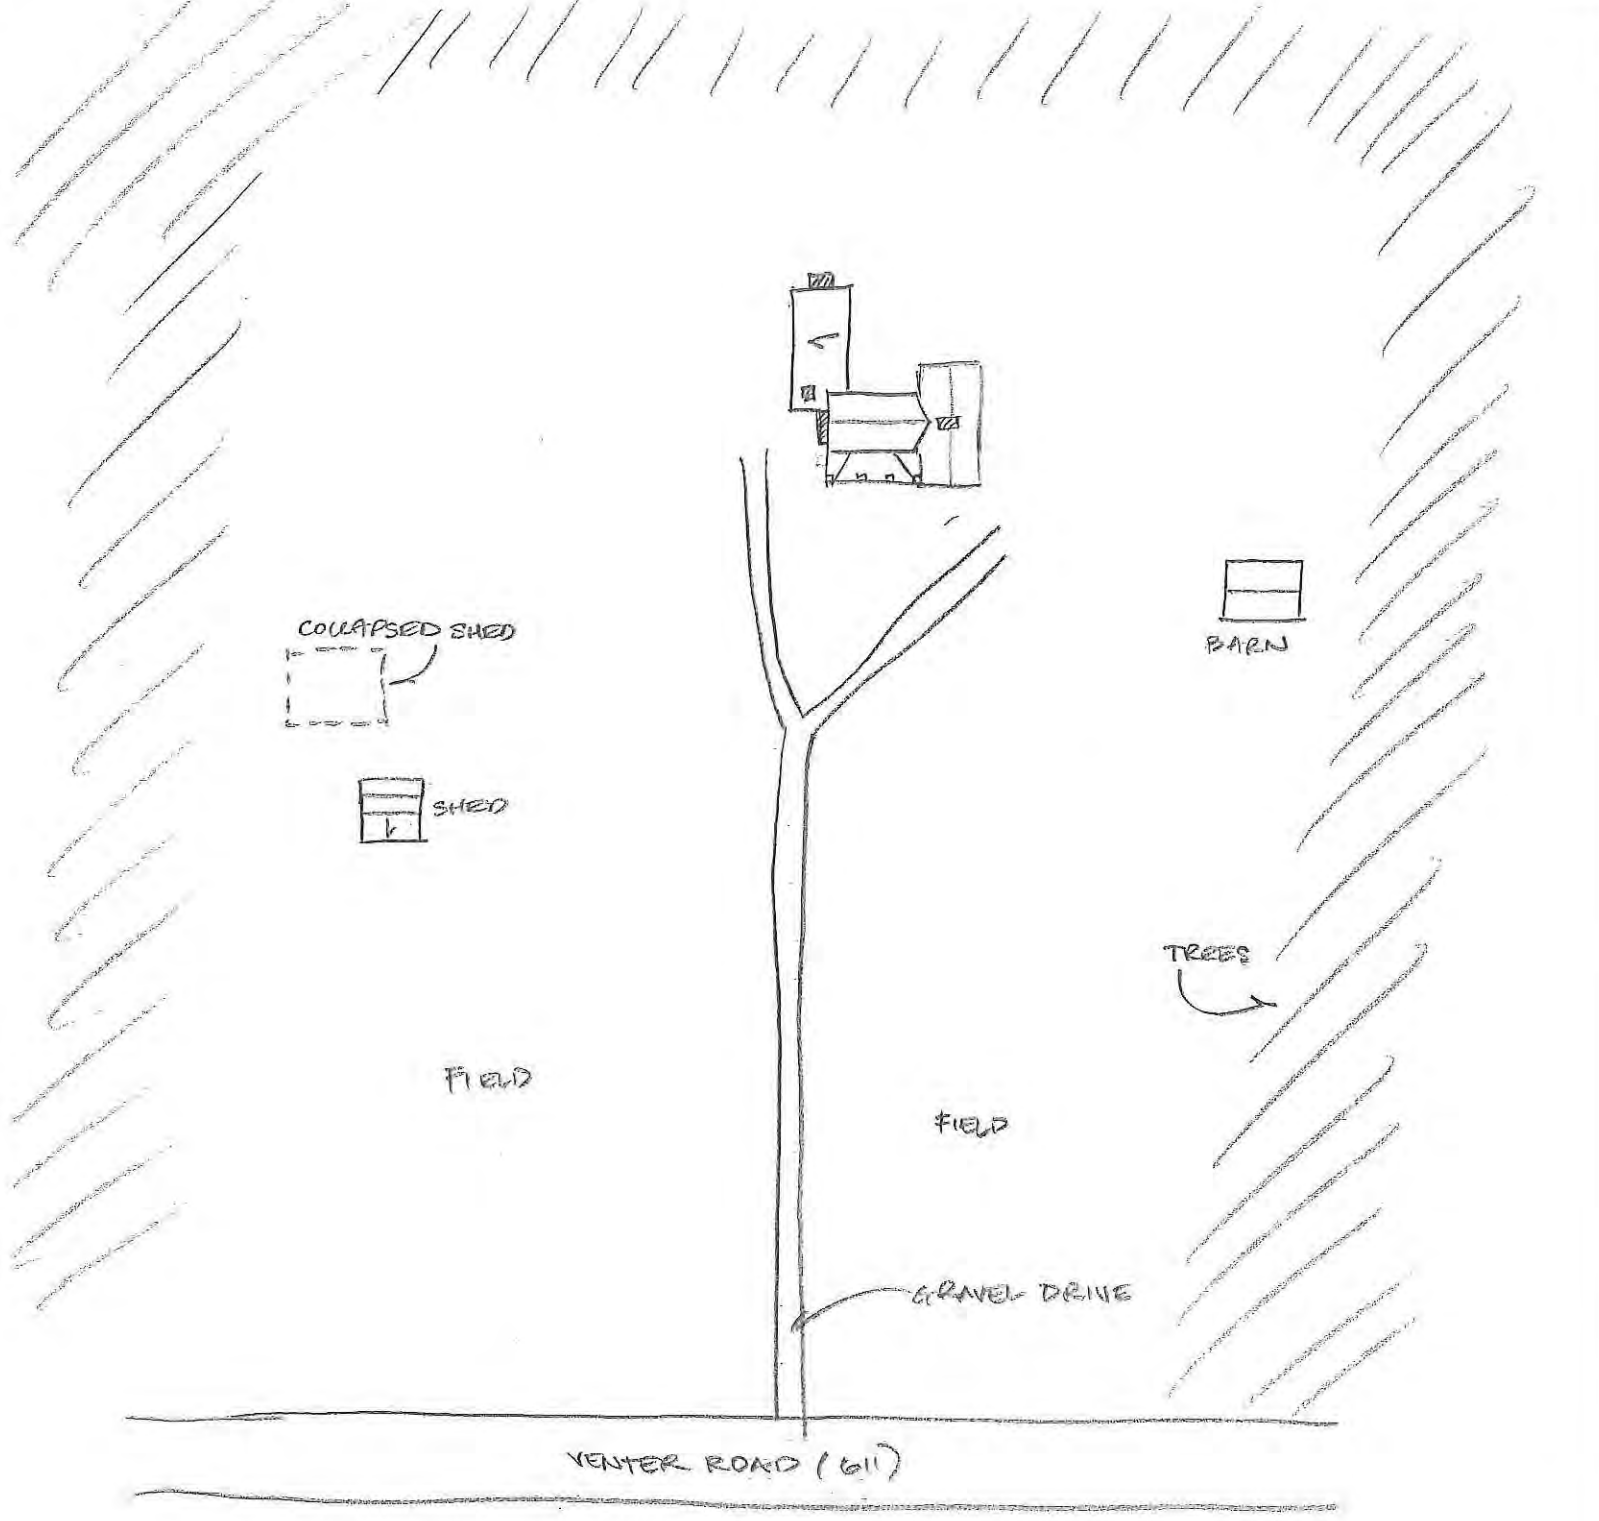
OSU-5053
 "MILTOP"
 1078 VENTER ROAD (611)
 KING WILLIAM CO, VA
 1.7.14 EAL
 NTS

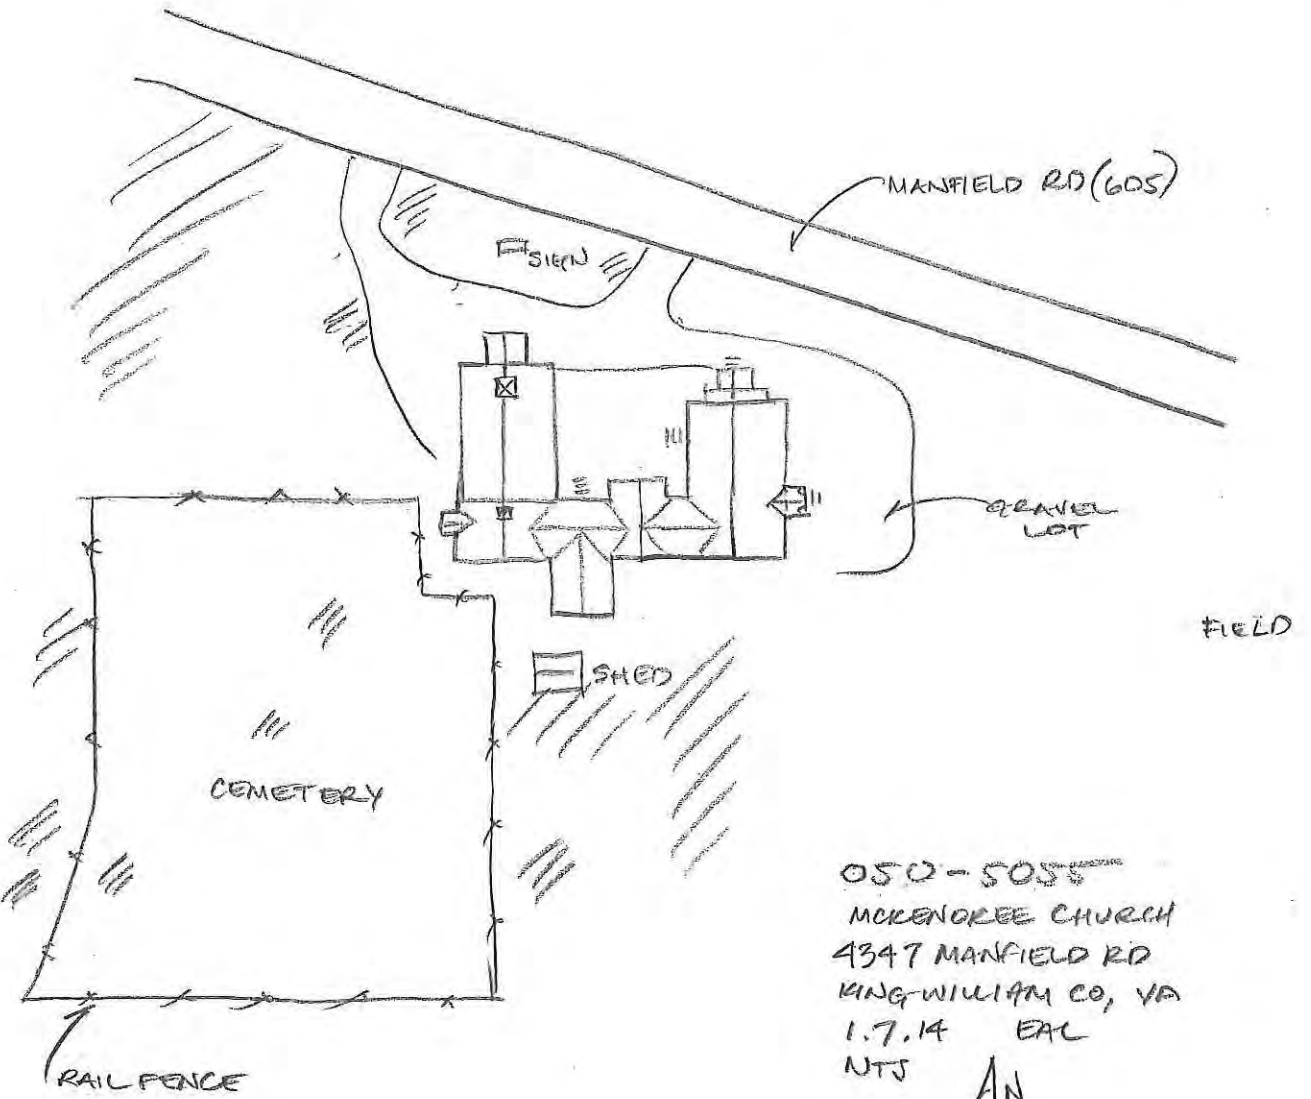
050-5055
MCKENOREE CHURCH
4347 MANFIELD RD
KING WILLIAM CO, VA
1.7.14 EAL
NTJ

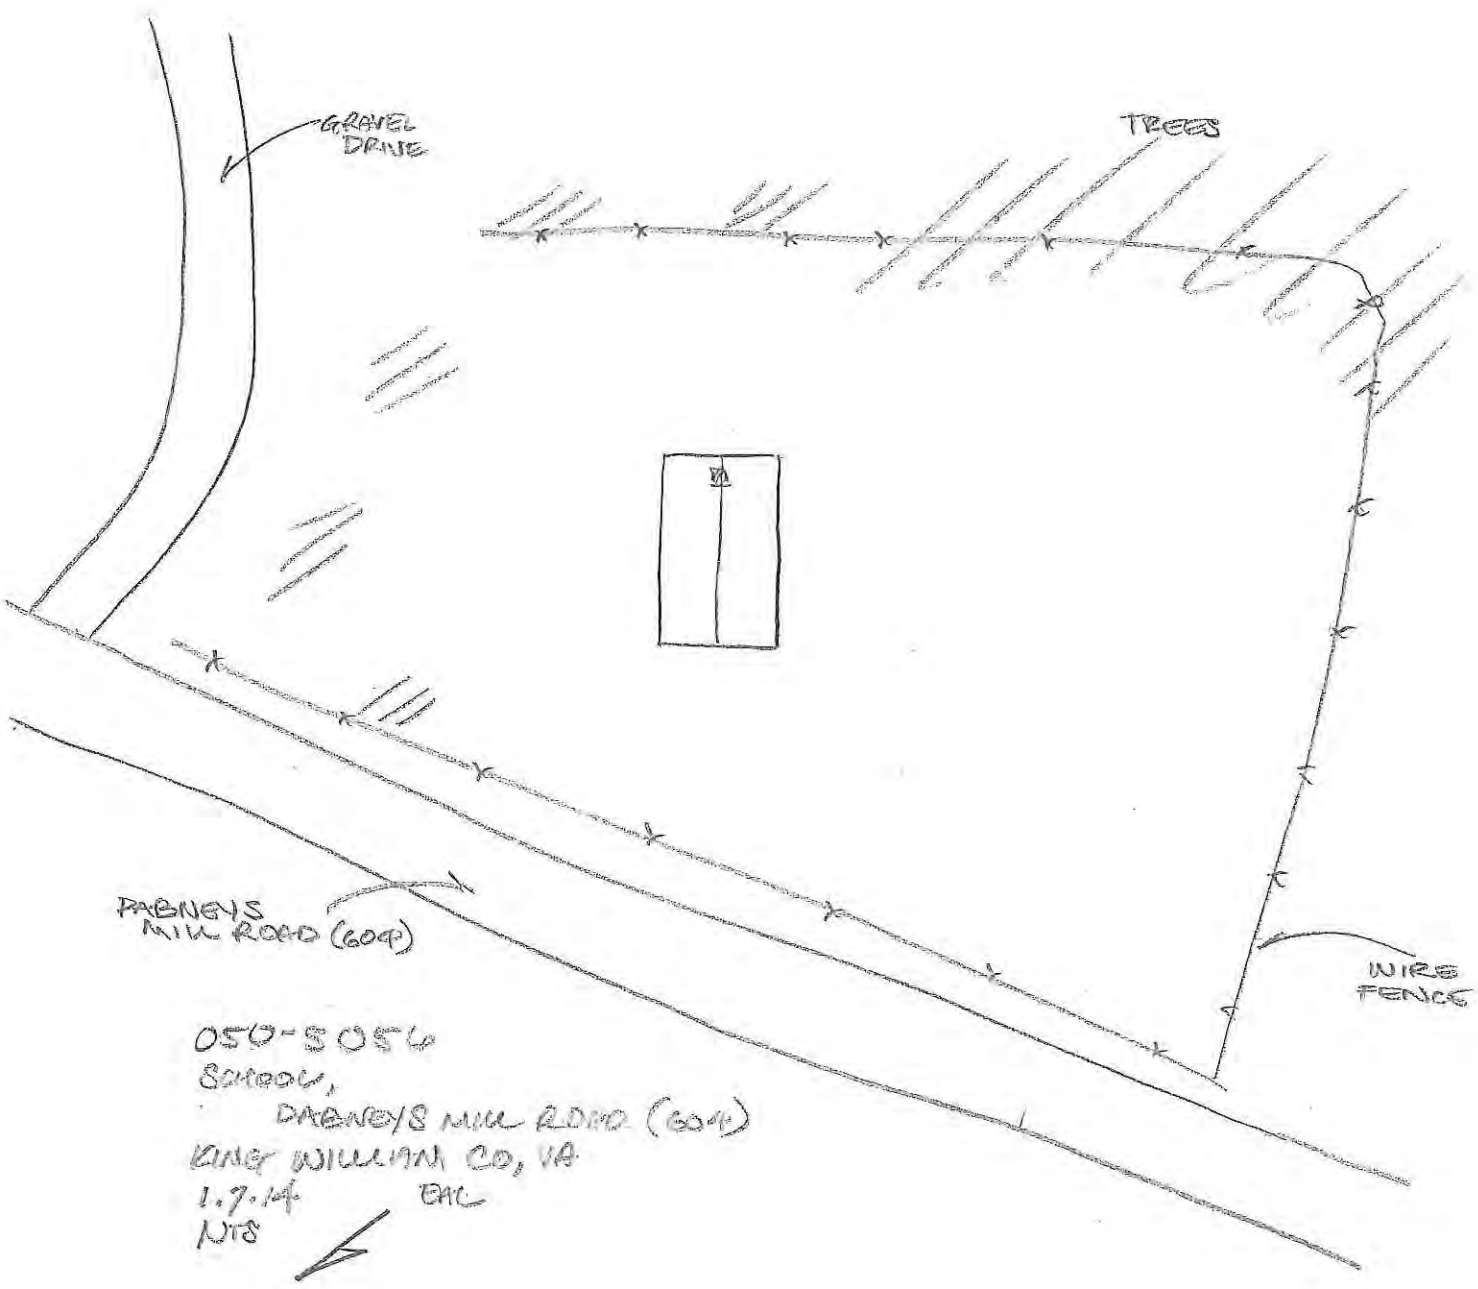
050-5056
SCHOOL,
FABNEY'S MILL ROAD (604)
KING WILLIAM CO, VA
1.7.14 EAC
NTS

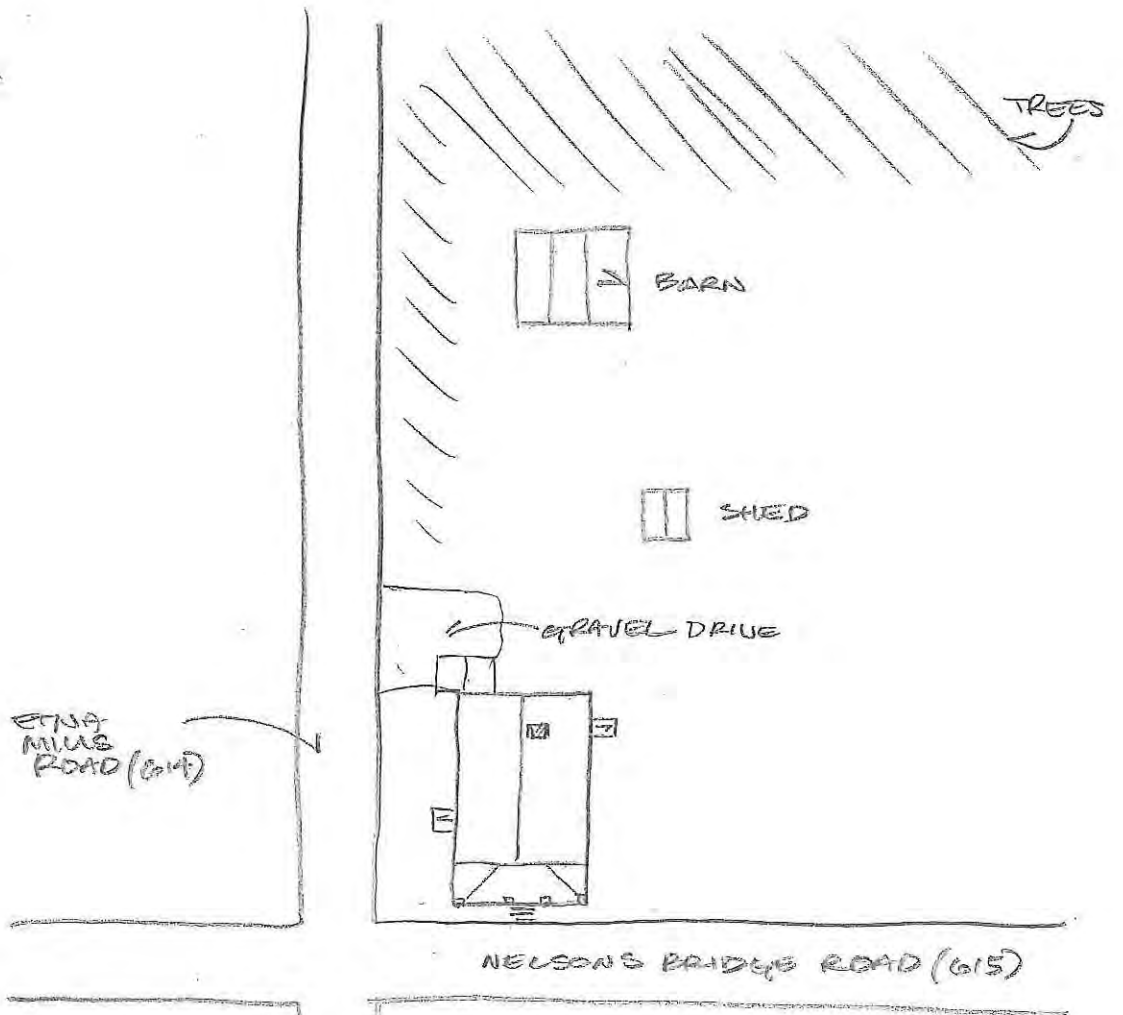
050-5058
 F&G STORE
 2211 NELSONS BRIDGES ROAD (615)
 KING WILLIAM CO, VA
 1.8.14 EAL
 NTS

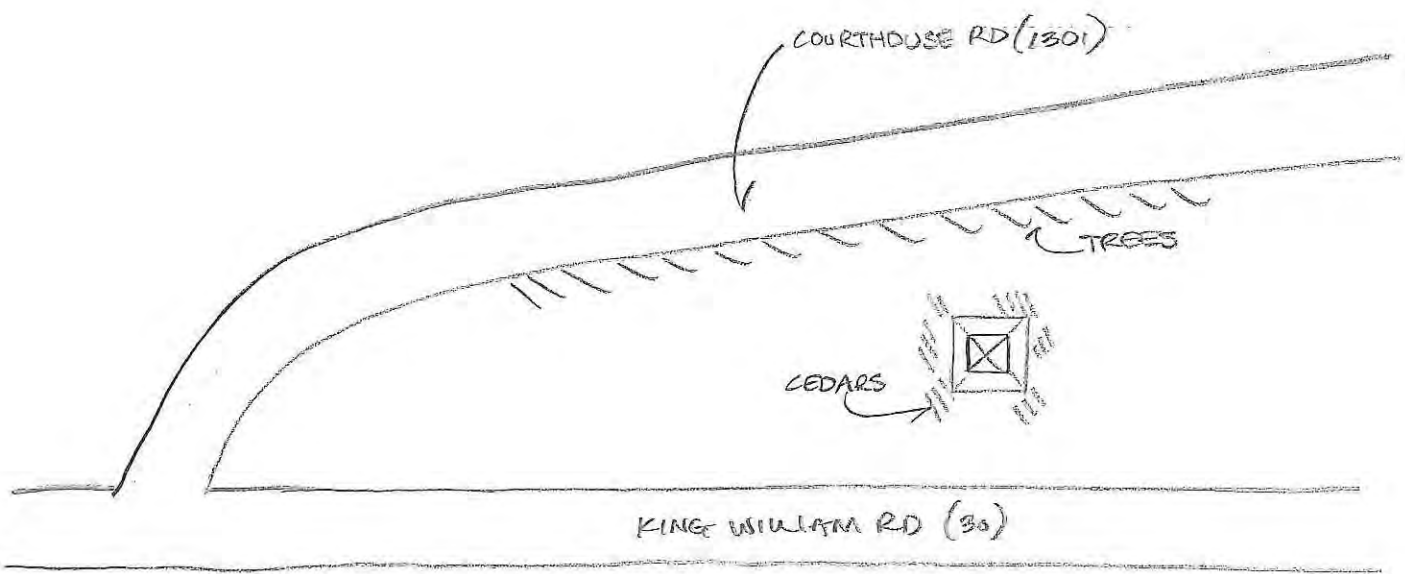
050-5062
 FOREST FIRE LOOKOUT TOWER
 OFF KING WILLIAM RD (30)
 KING WILLIAM CO, VA
 1-8-14 EAL
 NTS

Additional Property Information	
Architecture Setting:	Village
Acreage:	No Data
Site Description: January 2014: The fire tower is set on a narrow level lot between Courthouse and King William roads. The boundary along Courthouse Road is edged in trees. Cedars are planted around the base of the fire tower and a manicured lawn covers the lot.	
Surveyor Assessment: January 2014: The architectural resource in the opinion of the surveyor is recommended potentially eligible for individual listing on the NRHP under Criterion A, broad patterns in history as part of the development of advances in fire prevention, and Criterion C, Distinctive Characteristics of Architecture as an intact and surviving example of an early twentieth century metal fire tower that retains a high degree of architectural integrity.	
Surveyor Recommendation:	Recommended Potentially Eligible
Ownership	
Ownership Category	Ownership Entity

Primary Resource Information	
Resource Category:	Other
Resource Type:	Fire Tower
Date of Construction:	1935Ca
Historic Time Period:	World War I to World War II (1917 - 1945)
Historic Context(s):	Transportation/Communication
Architectural Style:	Other
Form:	No Data
Number of Stories:	1.0
Condition:	Good
Interior Plan:	No Data
Threats to Resource:	None Known
Architectural Description: January 2014: The fire tower is a tall tapering metal truss structure with a square plane metal frame lookout cab at the top. The lookout cab is clad with metal sheeting and features multiple-light metal fixed windows across each elevation. The lookout cab has a pyramidal roof covered in seamed metal. The lookout cab is accessed by an open metal staircase located within the metal truss structure. The King William Fire Warden was created in 1933 and the first fire tower was constructed shortly after. This fire tower bears resemblance to the Prince George Forest fire lookout tower.

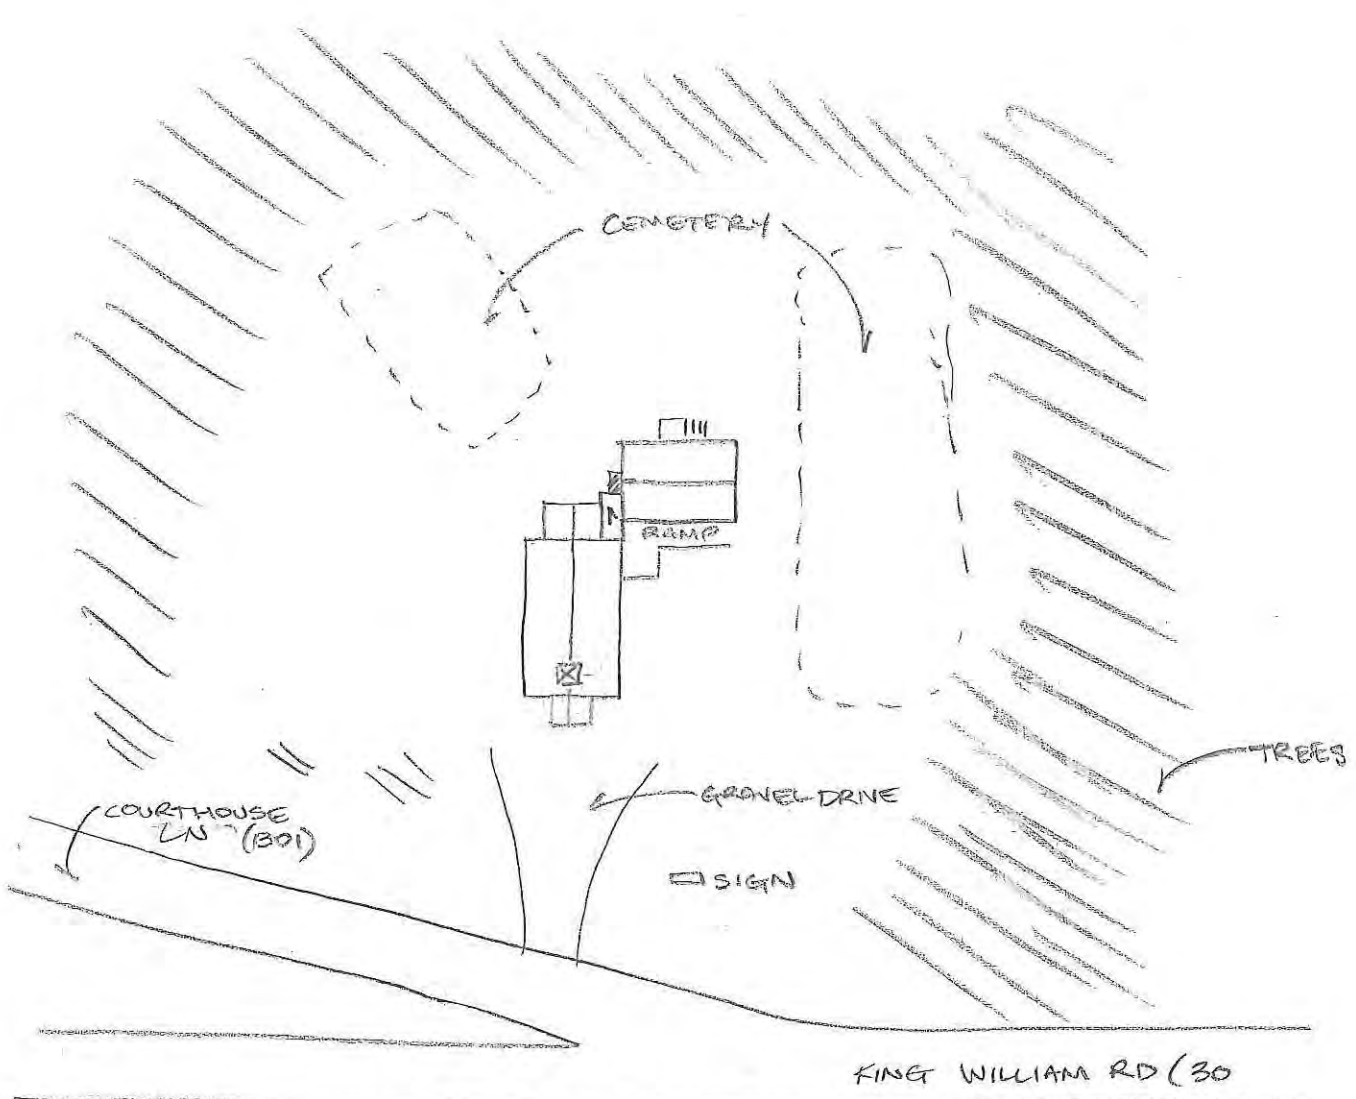
050-5064
 ST JAMES PRESBYTERIAN CHURCH
 411 COURTHOUSE LN (301)
 KING WILLIAM CO, VA
 L.B.H. EAL
 NTS

Additional Property Information	
Architecture Setting:	Village
Acreage:	No Data
Site Description: January 2014: The church is set close to and faces the road on a level lot surrounded by manicured lawn. The property is tree lined on the north, east, and south edges. Landscaping consists of occasional shrubs and trees. A gravel drive leads from the road to the front of the church. A cemetery occupies areas southeast of and north of the church. The cemetery is the only secondary resource associated with the church.	
Surveyor Assessment: January 2014: The architectural resource is typical of the late nineteenth century in King William County and in the opinion of the surveyor should not be considered individually eligible for the NRHP under Criterion A, B, C or D. There is no known association with important people or events and the resource is a typical example of this time period. The design and workmanship are undistinguished and the materials stock. In addition, the resource has been altered from its original appearance.

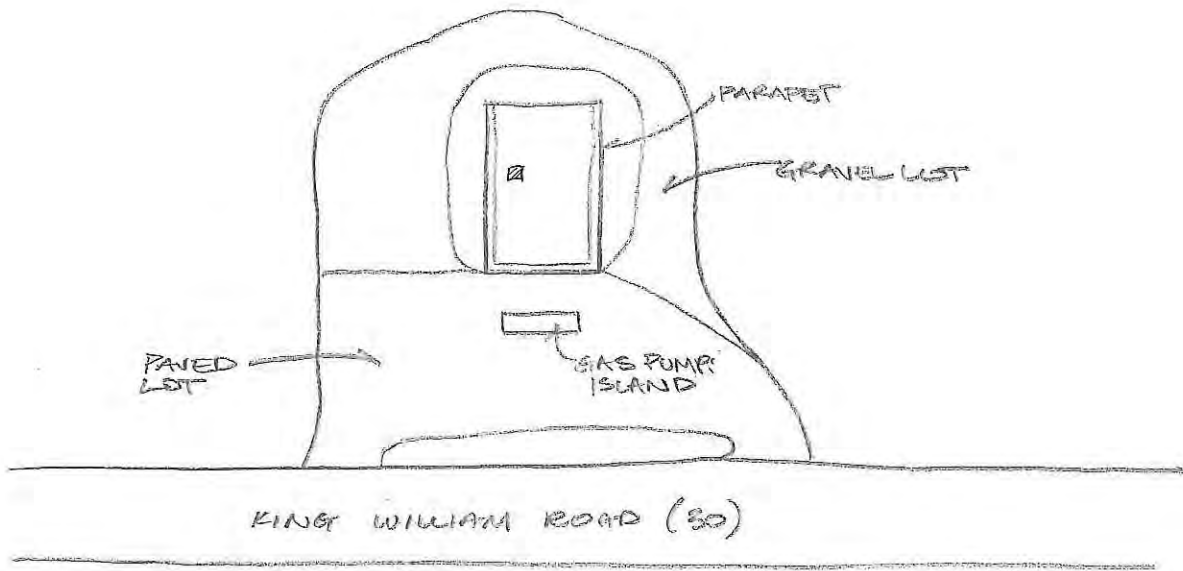
050 - 5065
 KENT'S SUPER MARKET
 20623 KING WILLIAM RD (30)
 KING WILLIAM CO, VA
 1.8.14 EAL
 NTS AN
