National Register of Historic Places
Registration Form

historic name Cahas Mountain Rural Historic District
other names/site number VDHR Site No. 33-393

Cahas Mountain Rural Historic District
Franklin Co., Va.

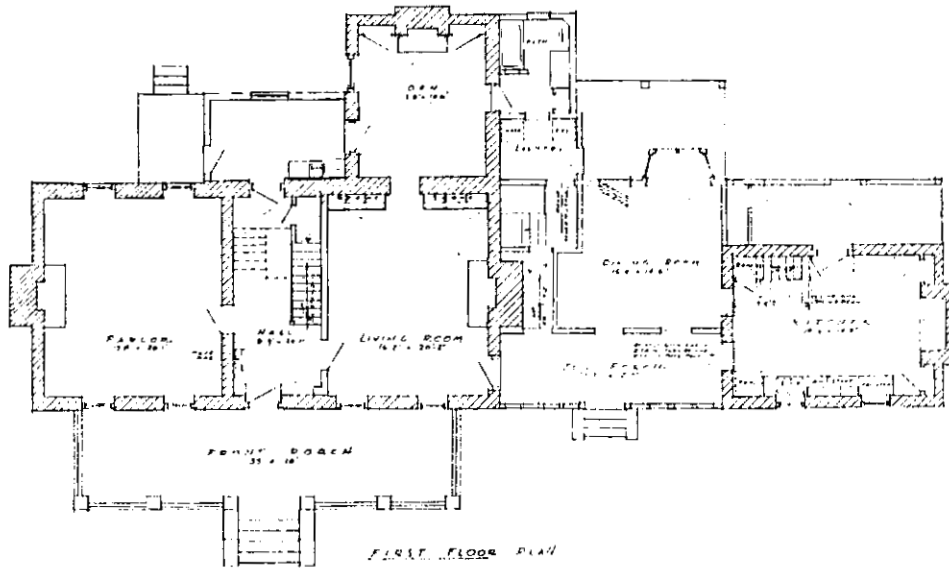
Exhibit A. John and Susan Boon House first-floor plan. Hatched areas indicate brick construction. Adapted from a plan by R. Calvin Nelson.

Two-story Federal house with a one-room-deep center-passage plan, a symmetrical five-bay facade, and a slate-shingled side-gable roof. The house is constructed of Flemish bond brickwork on a fieldstone foundation and has exterior gable-end brick chimneys, an originally detached, gabled, one-story brick kitchen wing, and a one-story gabled brick ell. Nine-over-nine sash windows on the first story and six-over-six sash windows on the second story have jack-arched heads, and the front entry has a four-light transom. A one-story porch was built across the front in the 1920s or 1930s. The porch is supported by Craftsman brick and wood columns linked by balustrades and it has a hip roof with a center gable featuring an arched pierced vent. Other exterior features include six-light gable windows, a heavy wood cornice, a two-story weatherboarded frame addition linking the brick kitchen to the northwest gable-end of the main house, unobtrusive two-story frame additions to the rear, and a modern trellised patio.

The interior features plaster-and-lath and plaster-on-brick wall and ceiling finishes and wood floors. Rising in the center passage is a stair with turned newels. The rooms flanking the passage on the first and second floors have Federal mantels, molded door and window trim, six-panel doors (some with wrought iron hardware such as strap hinges, nails, etc.). The kitchen, with garret quarters above, retains beaded ceiling joists and a large walk-in cooking fireplace with arched iron lintels. (This room has been compatibly renovated to house a modern kitchen). The rear brick ell was apparently used as a dining room, as suggested by the pair of built-in linen presses or china closets that flank the fireplace. The original decorative finishes in the house included graining and marbling, vestiges of which survive. The roof is constructed of hewn
