National Register of Historic Places
Registration Form

historic name Chopawamsic RDA - Camp (2) Mawavi Historic District
other names/site number Prince William Forest Park

Name of related multiple property listing:
ECW Architecture at Prince William Forest Park, 1933-42

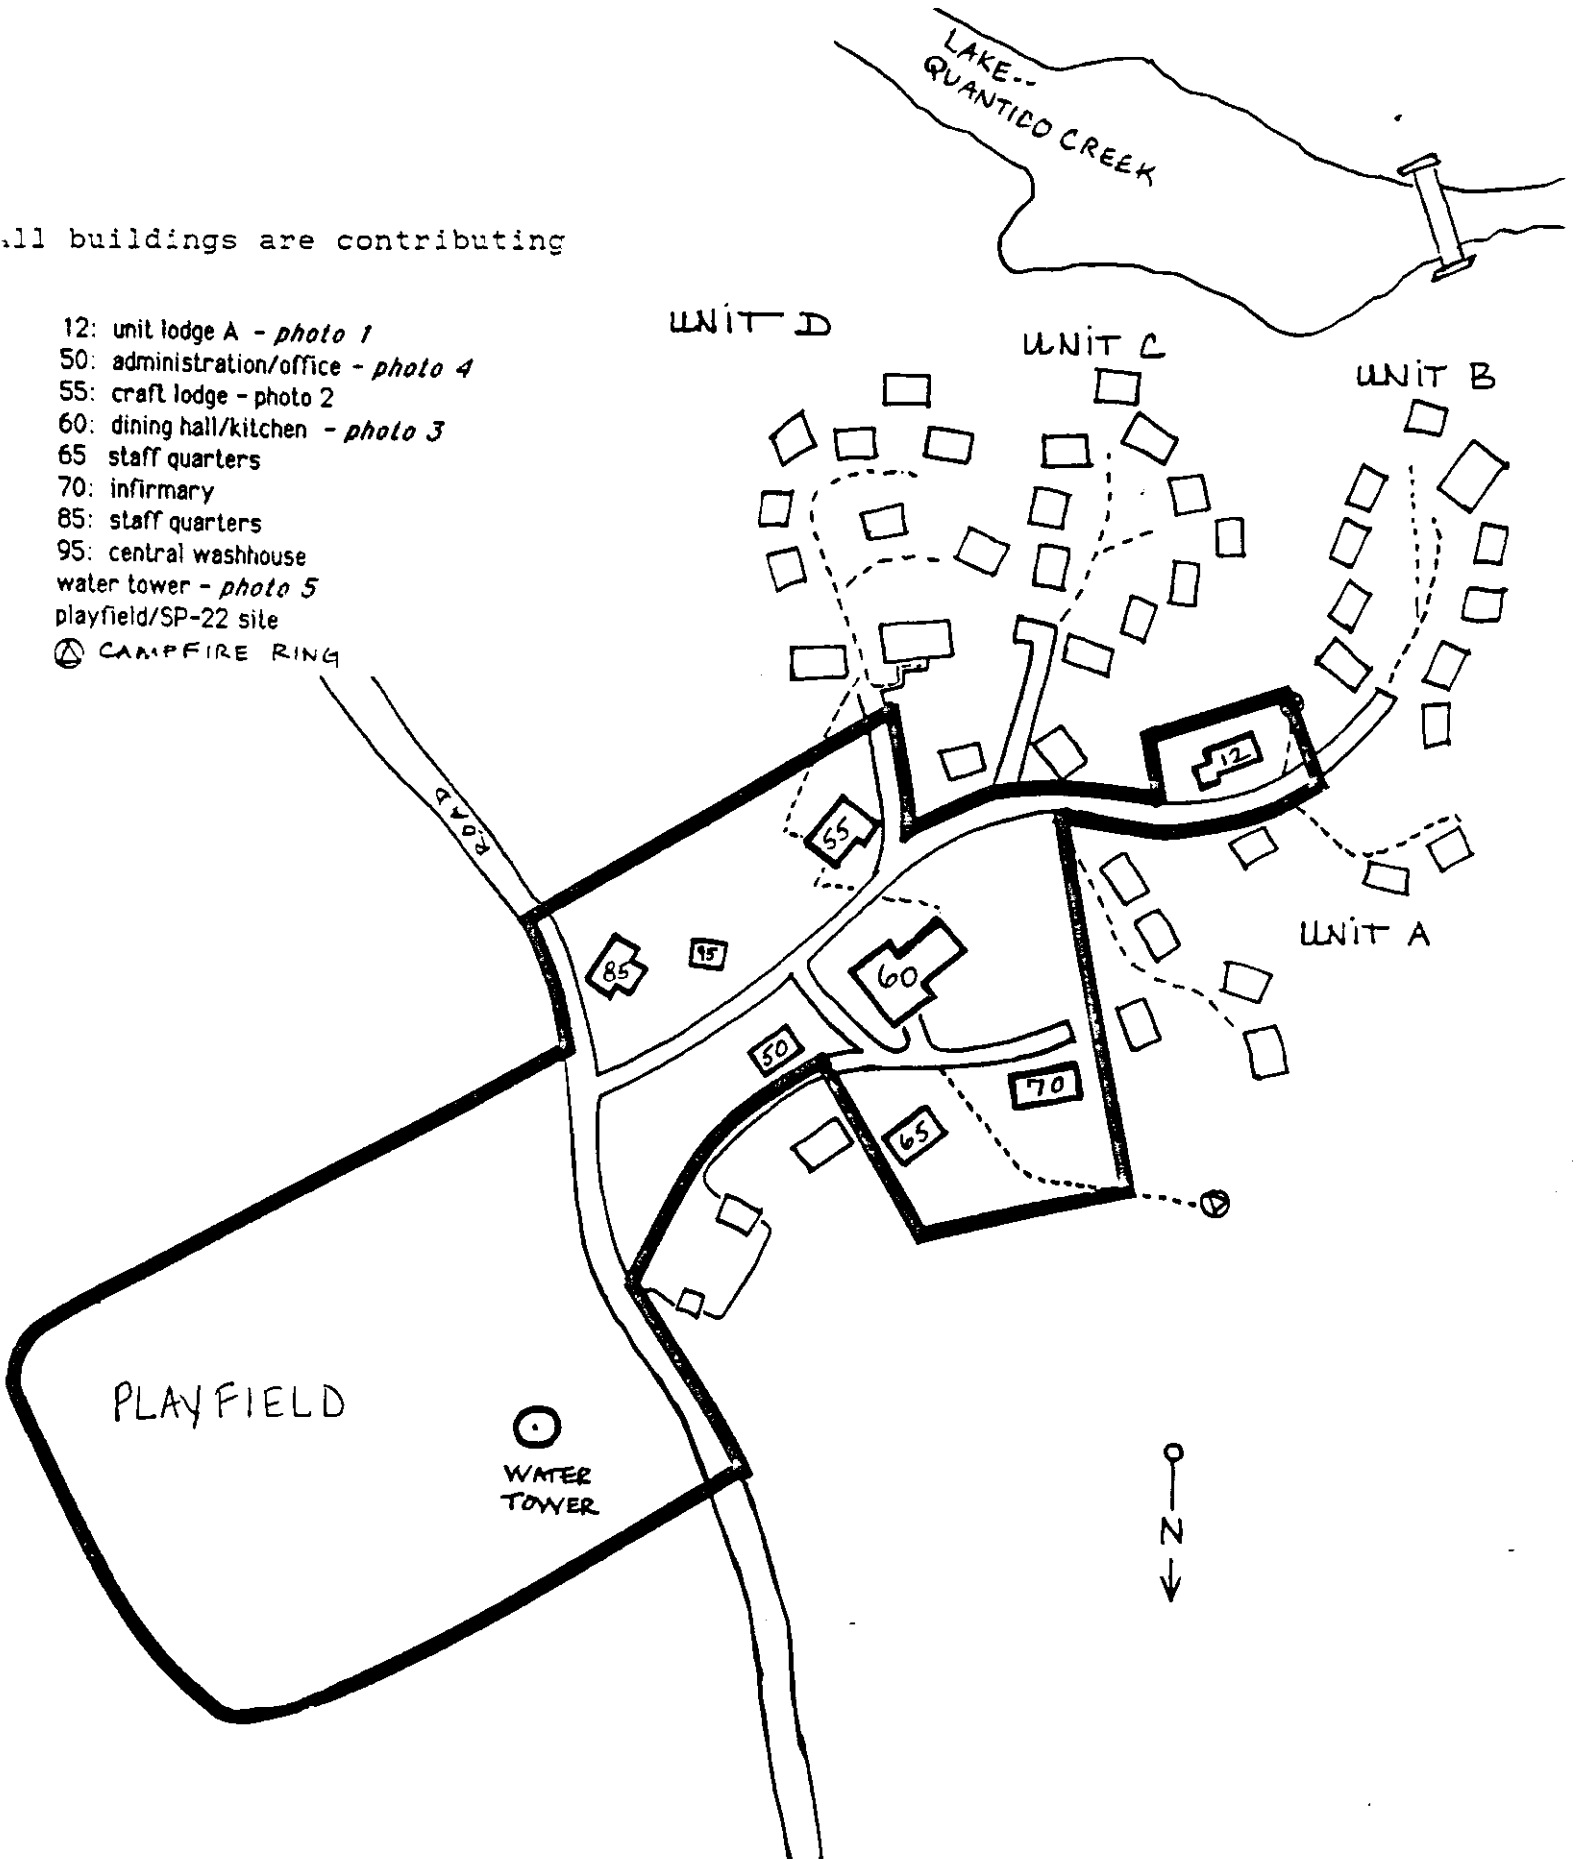
MAP 5: PROPOSED CAMP (1) GOODWILL HISTORIC DISTRICT

- 12: unit lodge A - photo 1
- 50: administration/office - photo 4
- 55: craft lodge - photo 2
- 60: dining hall/kitchen - photo 3
- 65: staff quarters
- 70: infirmary
- 85: staff quarters
- 95: central washhouse
- water tower - photo 5
- playfield/SP-22 site
- ⊙ CAMPFIRE RING

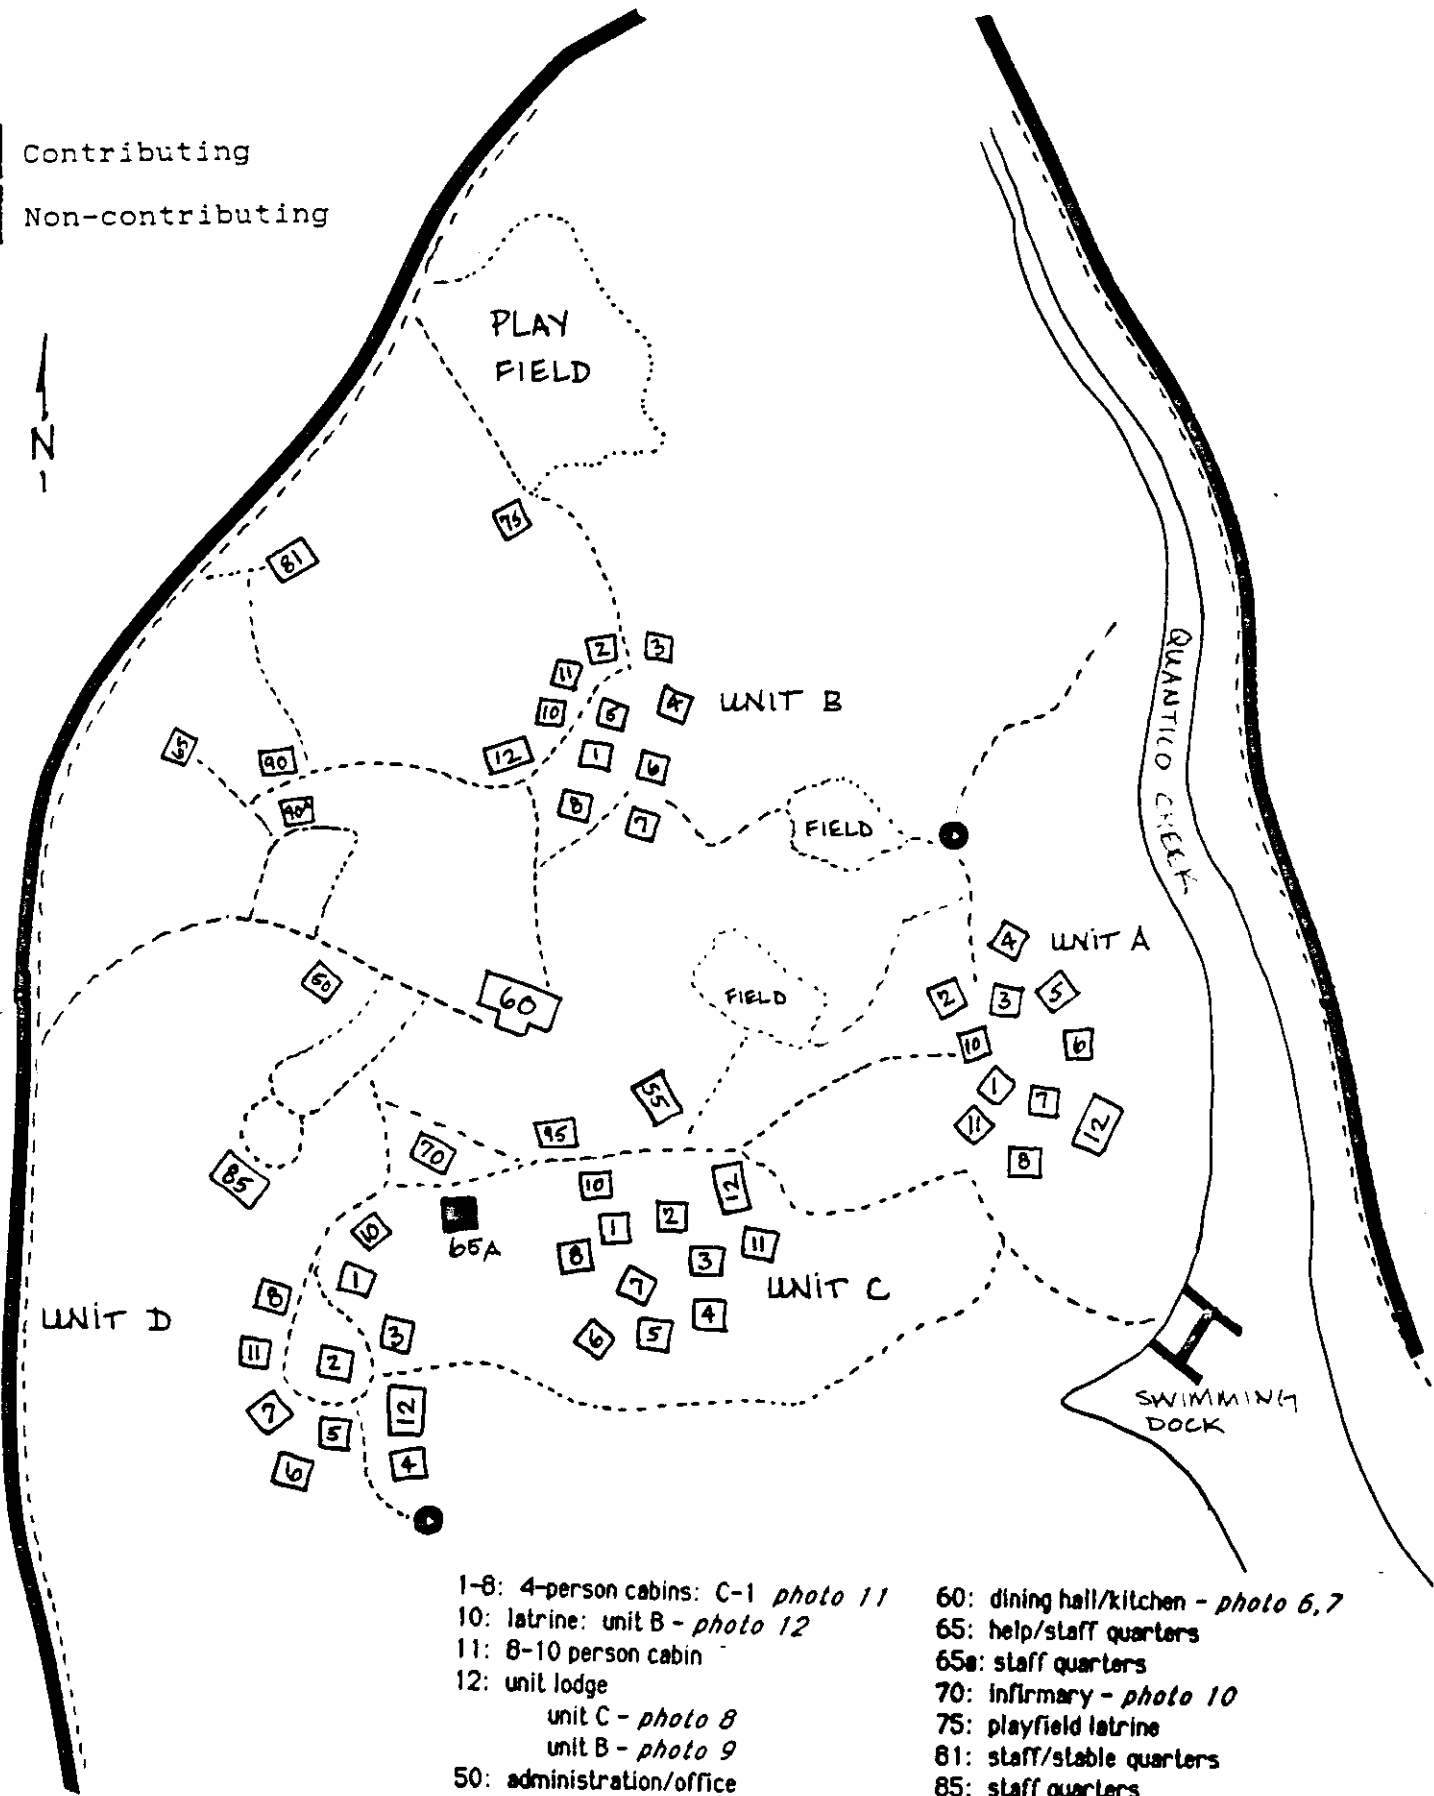
**MAP 6: PROPOSED CAMP (2) MAWAVI
HISTORIC DISTRICT**

- 1-8: 4-person cabins: C-1 *photo 11*
 - 10: latrine: unit B - *photo 12*
 - 11: 8-10 person cabin
 - 12: unit lodge
unit C - *photo 8*
unit B - *photo 9*
 - 50: administration/office
 - 51: boathouse
 - 55: craft shop
 - 60: dining hall/kitchen - *photo 6, 7*
 - 65: help/staff quarters
 - 65a: staff quarters
 - 70: infirmary - *photo 10*
 - 75: playfield latrine
 - 81: staff/stable quarters
 - 85: staff quarters
 - 90-90a: storage
 - 95: central washhouse - *photo 13*
 - Dam 2/5: *photo 14*
- △ CAMPFIRE RING

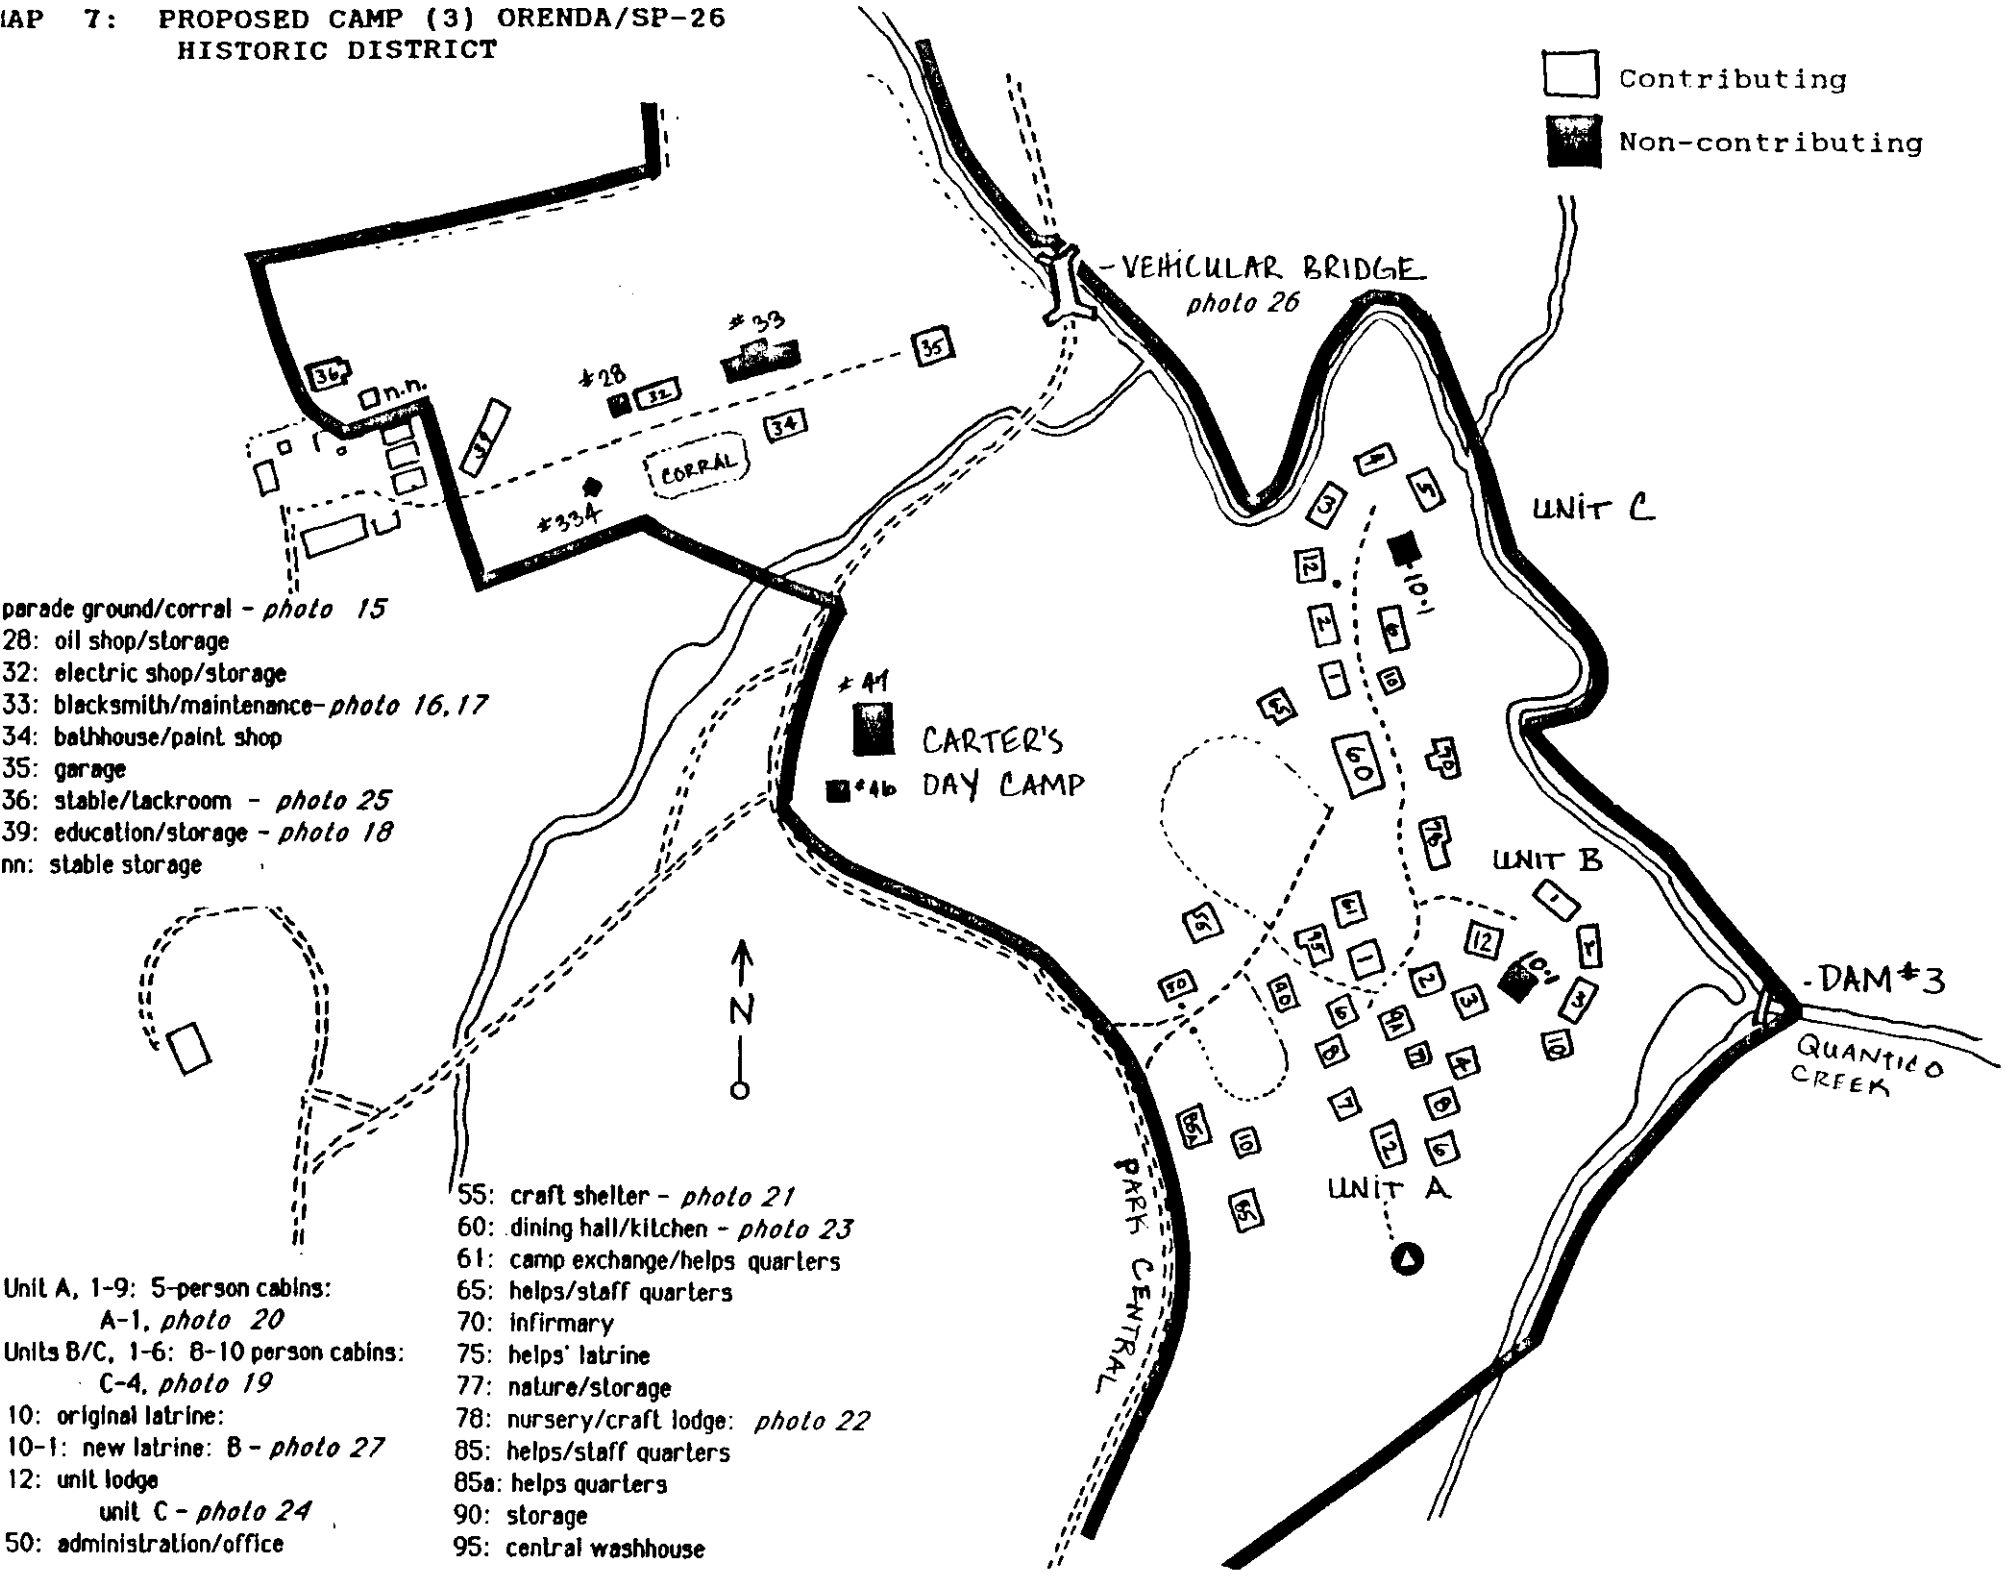
IAP 7: PROPOSED CAMP (3) ORENDA/SP-26
HISTORIC DISTRICT

- parade ground/corral - photo 15
- 28: oil shop/storage
- 32: electric shop/storage
- 33: blacksmith/maintenance - photo 16.17
- 34: bathhouse/paint shop
- 35: garage
- 36: stable/tackroom - photo 25
- 39: education/storage - photo 18
- nn: stable storage

- 55: craft shelter - photo 21
- 60: dining hall/kitchen - photo 23
- 61: camp exchange/helps quarters
- 65: helps/staff quarters
- 70: infirmary
- 75: helps' latrine
- 77: nature/storage
- 78: nursery/craft lodge: photo 22
- 85: helps/staff quarters
- 85a: helps quarters
- 90: storage
- 95: central washhouse

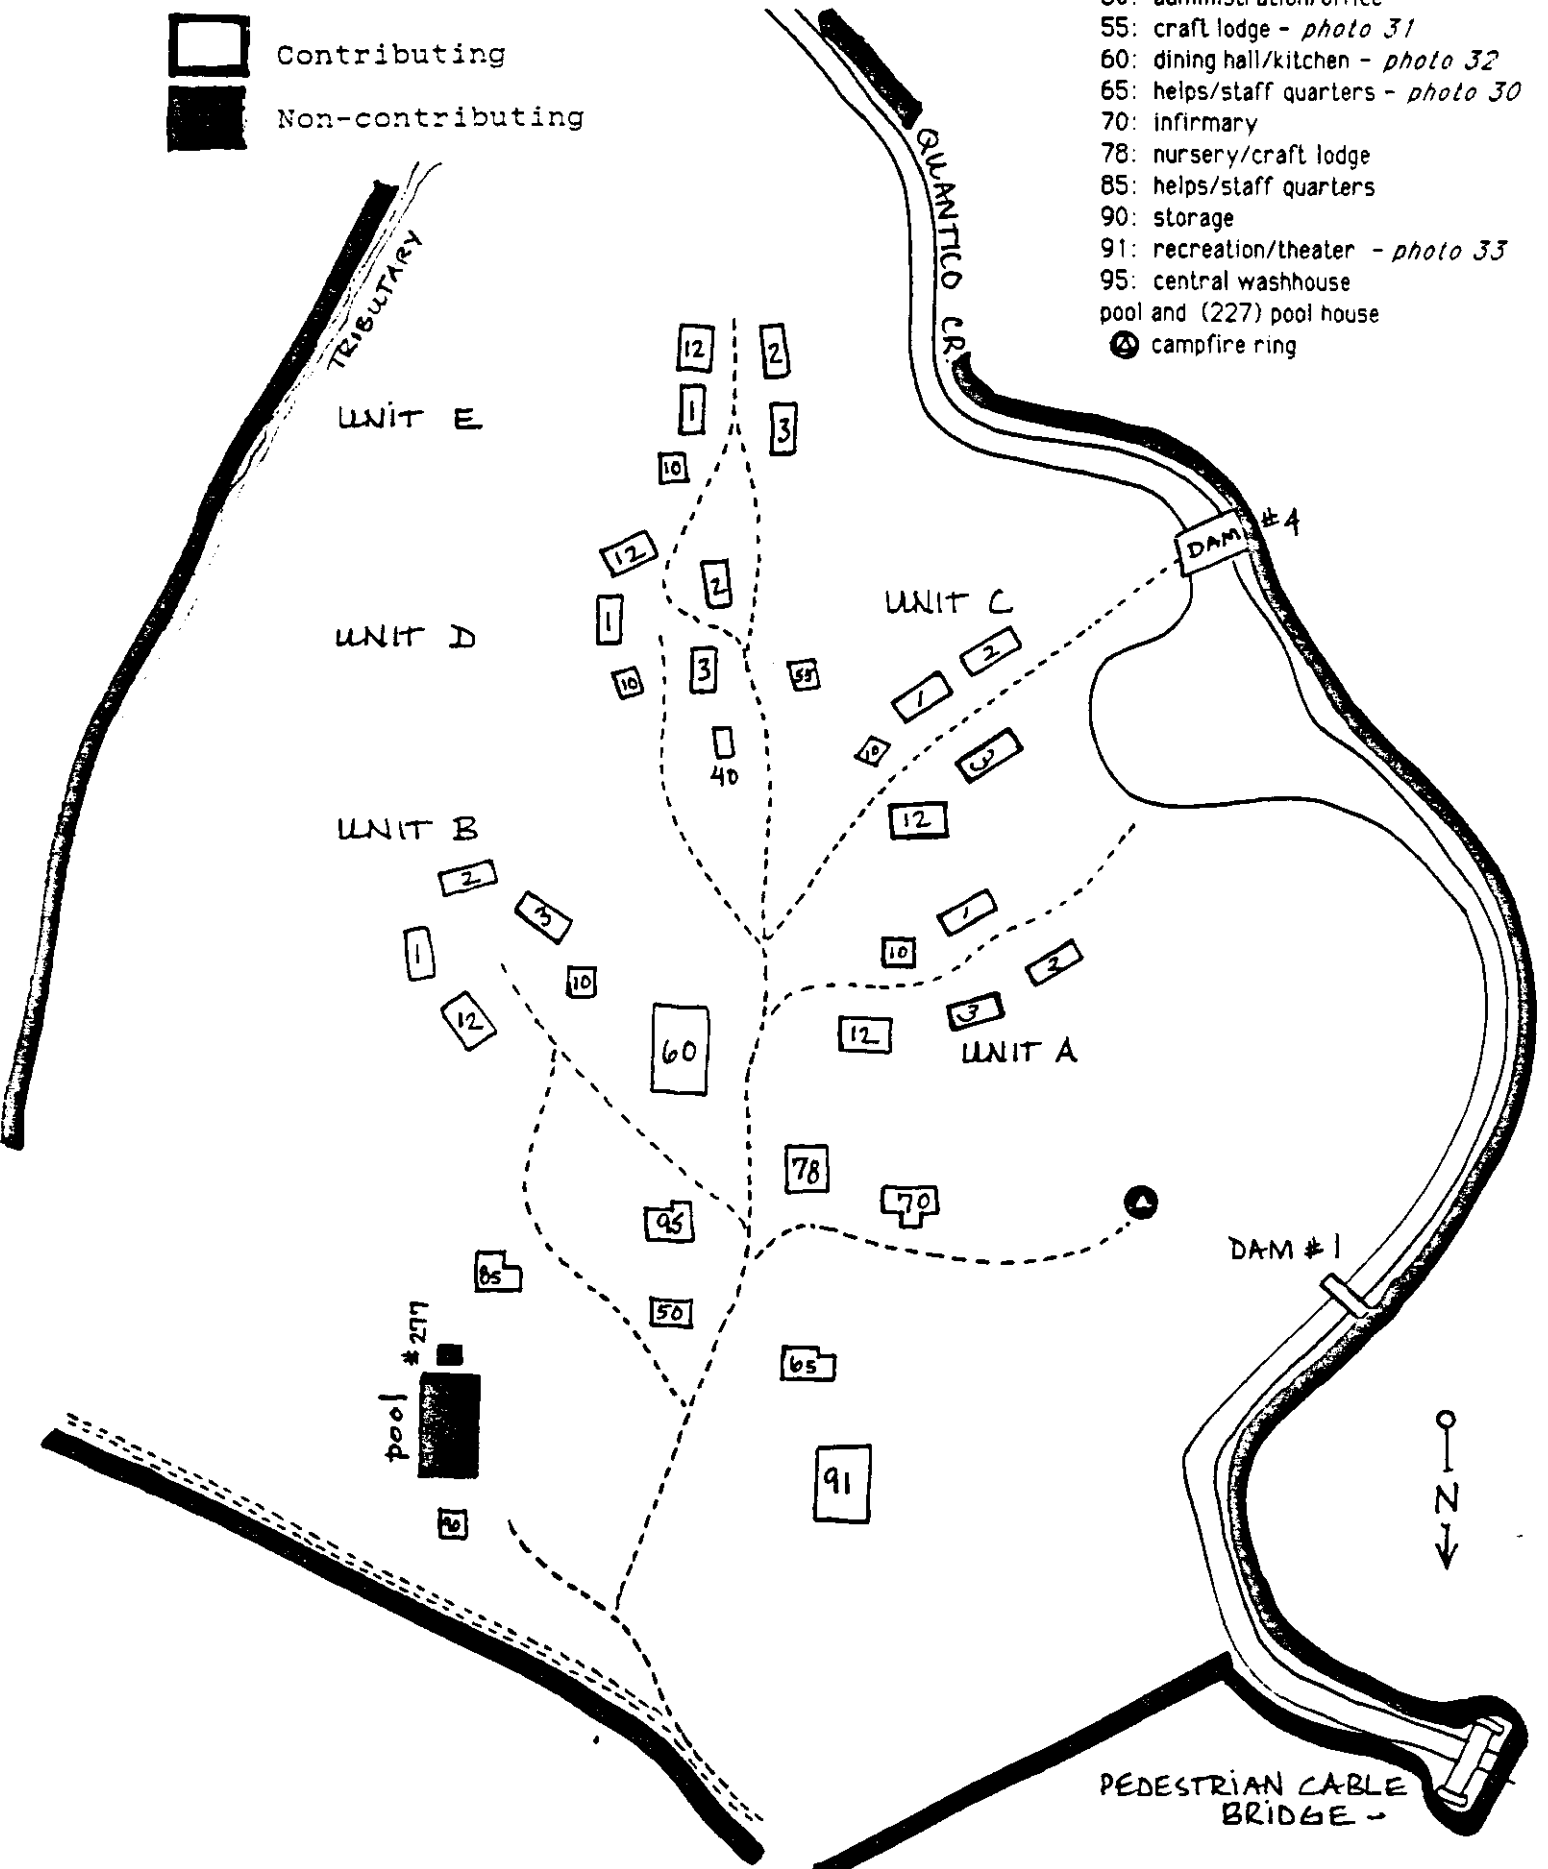
MAP 8: PROPOSED CAMP (4) PLEASANT HISTORIC DISTRICT

- 1-3: 8-10 person cabins
- 10: latrine - *photo 29*
- 12: unit lodge, E w/cabin - *photo 28*
- 40: storage
- 50: administration/office
- 55: craft lodge - *photo 31*
- 60: dining hall/kitchen - *photo 32*
- 65: helps/staff quarters - *photo 30*
- 70: infirmary
- 78: nursery/craft lodge
- 85: helps/staff quarters
- 90: storage
- 91: recreation/theater - *photo 33*
- 95: central washhouse pool and (227) pool house
- ⊙ campfire ring

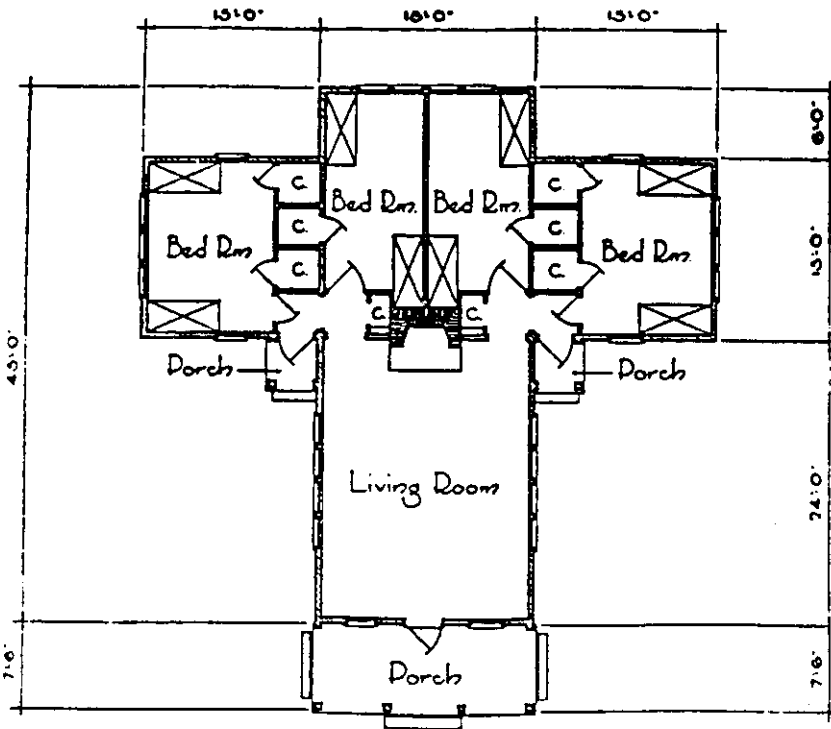
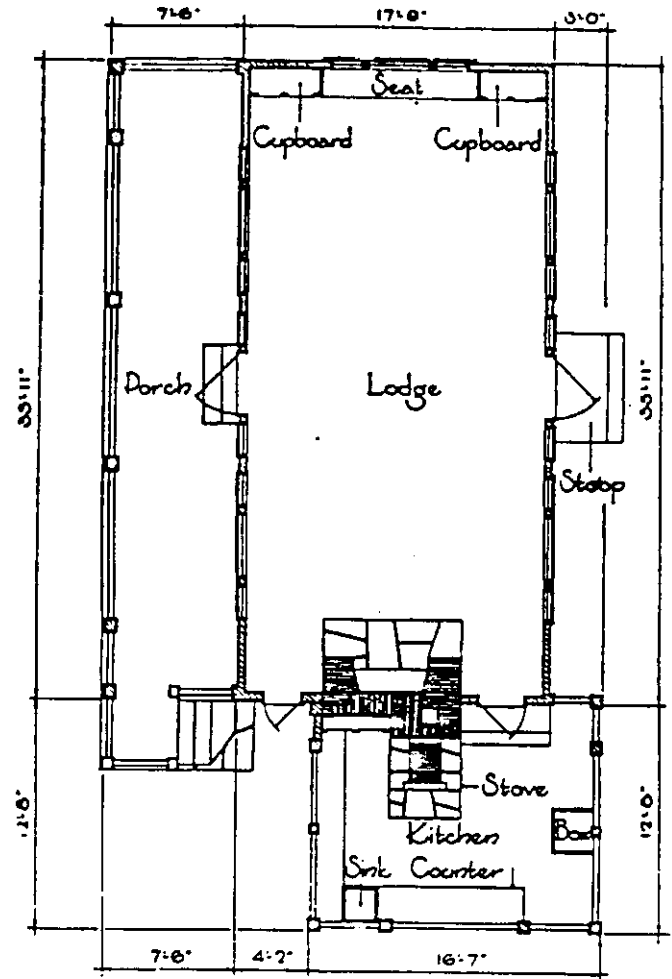
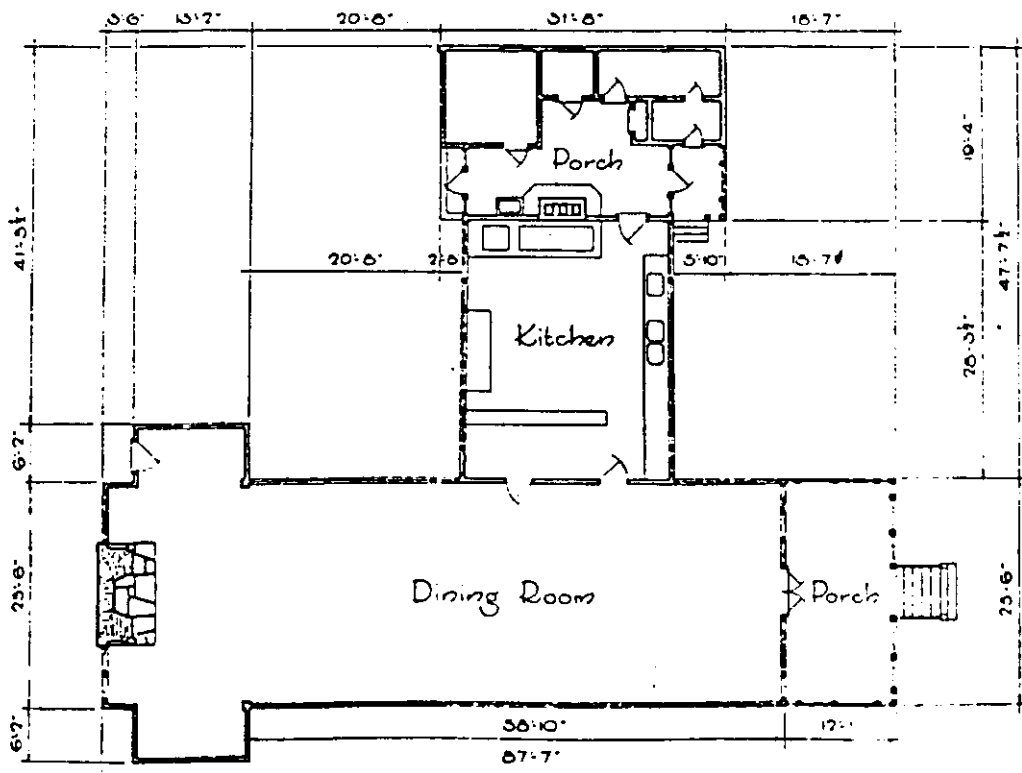
ILLUSTRATION 1: PLANS FOR CAMP (2) MAWAVI
 (from Park and Recreation Structures, Good)

top left: staff quarters
 top right: unit lodge
 bottom: dining hall/kitchen

Five structures at Chopawamsic's Camp (2) Mawavi appear in Good's Park and Recreation Structures (1935, reissued in 1938) as model facilities: the kitchen/dining hall, unit lodge, administration building, infirmary, and staff quarters (illustrations 1-2). The unit lodge and staff quarters were also issued as model plans in the Portfolio of Buildings for Organized Camps in 1937. The dining hall (1936, photos 6-7) is a substantial 3,690 square feet, organized on a T-plan with the largest arm devoted to the dining room that features a stone hearth and entrance porch. The kitchen area adjoins the dining room on the service side, and on the other by a storage/pantry set of spaces. There is a clear division of spaces, and the eating area is ventilated by nearly continuous bands of windows. It represents "more than the minimum requirements" due to features like bay windows flanking the fireplace and large porch, non-essentials that nonetheless contribute to the buildings' attractiveness.¹⁸ It was constructed at a cost of \$5,883, and served as a model (flopped over) for the one built at Camp (1) Goodwill a year later for \$3,165.¹⁹

The unit lodge (1936, photos 8-9) type here offers more than adequate features, including the full rear porch--sometimes added as a "superfluity in a hillside location that offers a view. It is one item which may be omitted without hampering the use of the building," although all four units of Camp (2) Mawavi have them; each cost about \$245.²⁰ The slightly banked ridge siting, low-pitched gable roofs, and texture of the hefty exterior stone chimneys, vertical casement windows, and full porches make this building type one of the most cohesively rustic and romantic in the park.
