National Register of Historic Places Registration Form

Historic name: Bowman, Jacob, House

Other names/site number: DHR#085-0207

Street & number: 2470 Polk Road

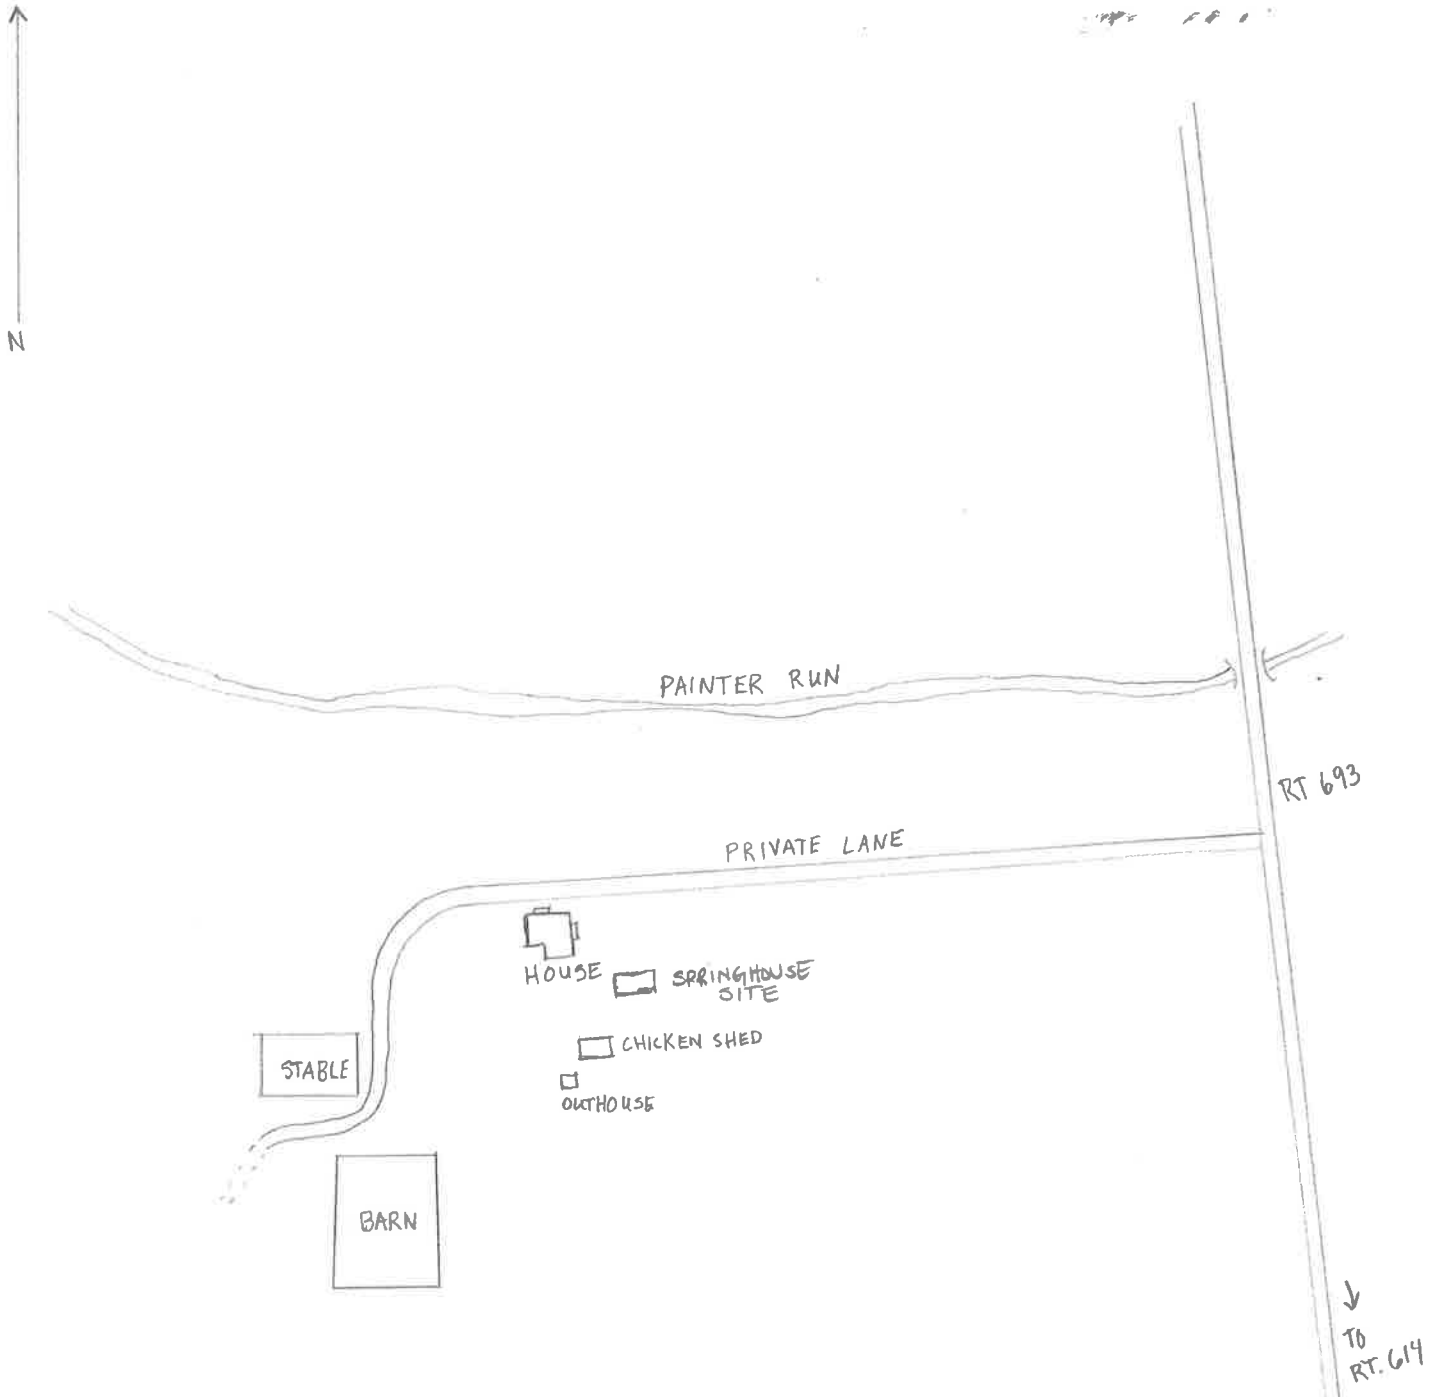
SKETCH MAP

All resources are contributing

SITE PLAN

The Jacob Bowman House has a total of five contributing architectural resources and one contributing site. The contributing resources are from the property's period of significance, ca. 1840 through 1966.

1. House, ca. 1840. Contributing Building
2. Bank Barn, ca. 1880. Contributing Building
3. Stable, ca. 1880. Contributing Building
4. Chicken Shed/Coop, ca. 1920. Contributing structure
5. Outhouse/Privy, ca. 1920. Contributing Building
6. Springhouse foundation/remains, ca. 1850. Contributing Site

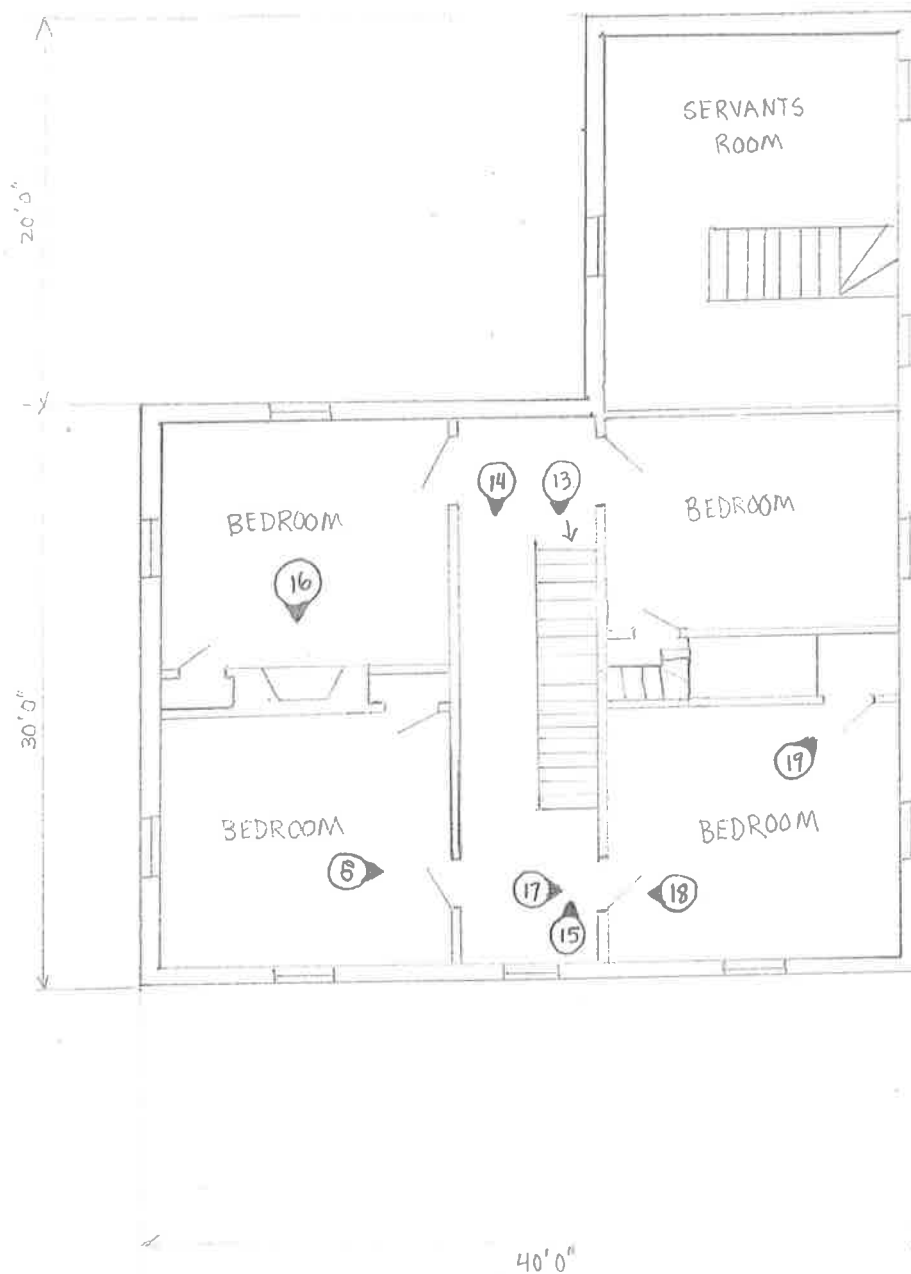
PHOTO KEY
Dwelling Interior - 2nd Floor

FLOOR PLANS, PHOTO LOCATIONS
