National Register of Historic Places Registration Form

Historic name: Goodman, Charles M., House

Other names/site number: VDHR file #100-5265

Street & number: 510 North Quaker Lane

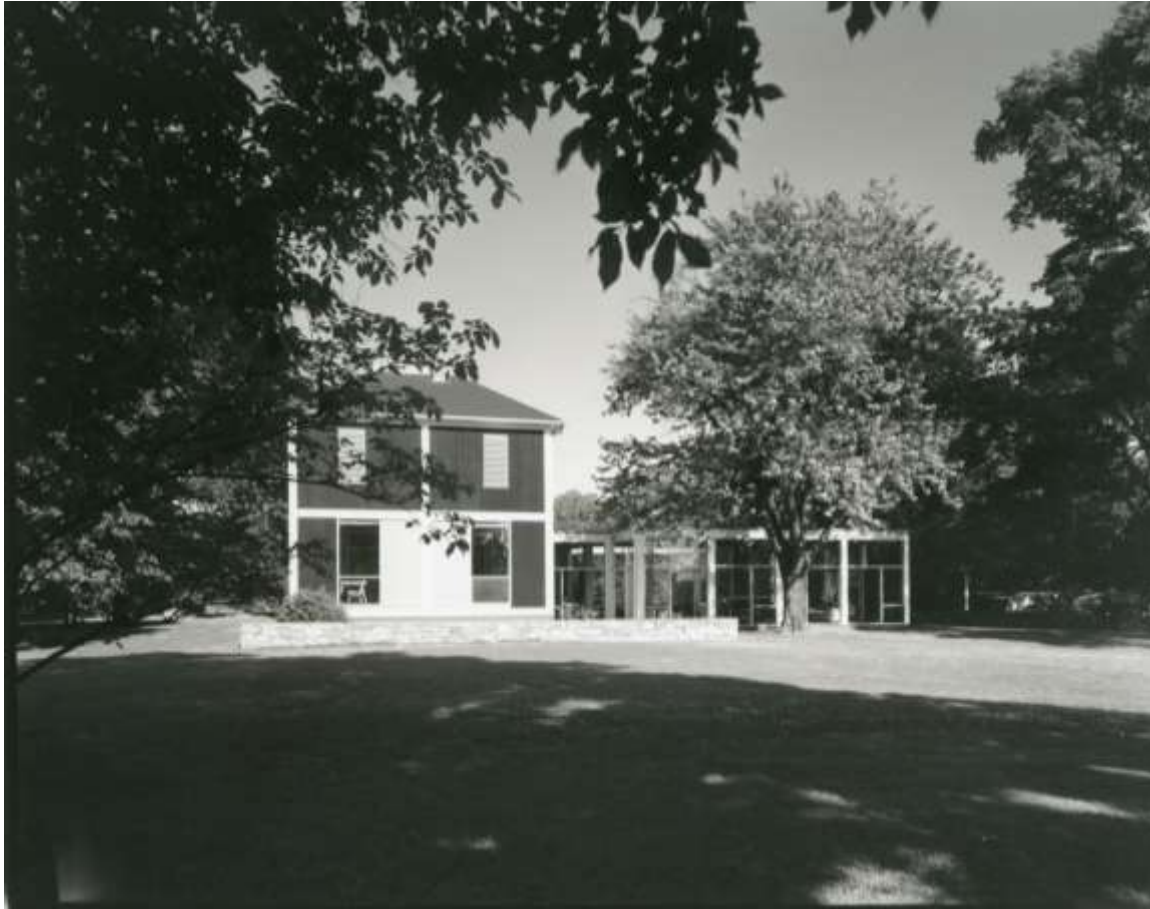
1 of 11: The Charles M. Goodman House, ca. 1954, showing the eastern façade. The original farmhouse (left) was constructed between 1873 and 1879. Goodman remodeled the house and added a glass pavilion (right) to the house between 1953 and 1954. From the Robert C. Lautman Photography Collection, box 33, courtesy of the National Building Museum, Washington, D.C.

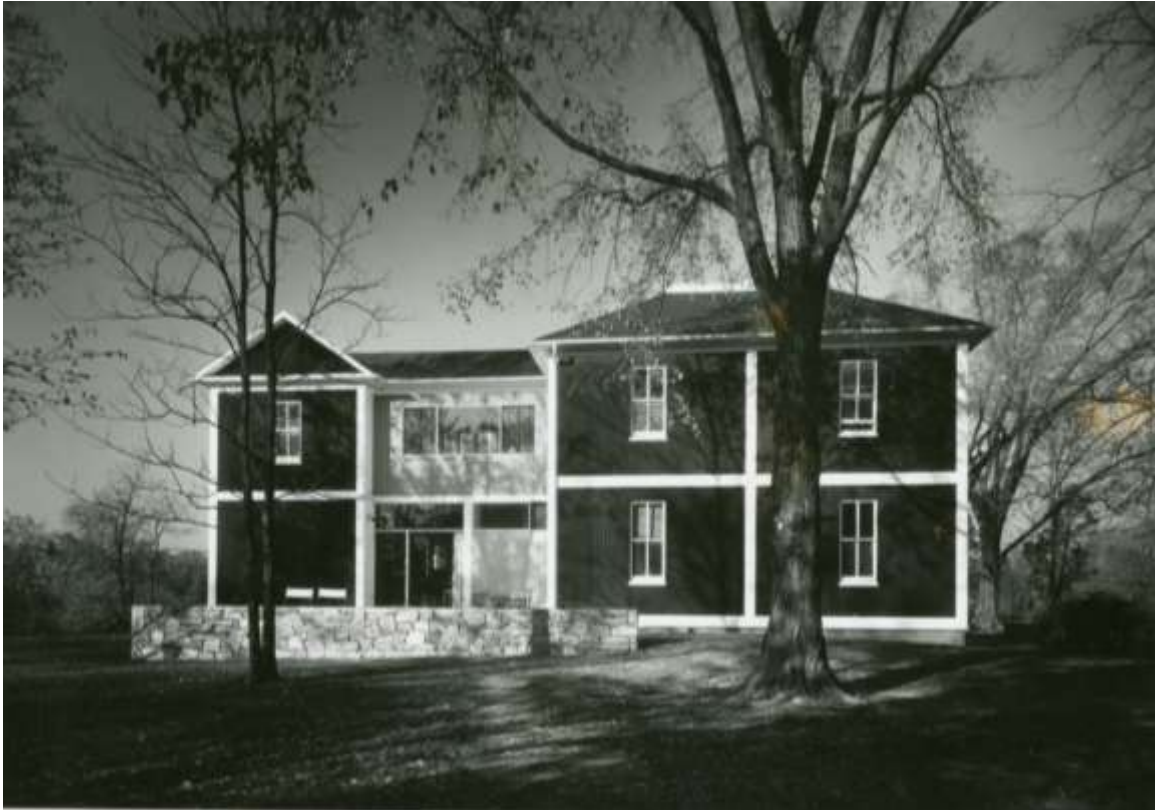
6 of 11: Photograph of southern façade of farmhouse post Goodman renovation, ca. 1954, showing the original farmhouse (right) and the additions of the hyphen (center) and gabled structure (left). From the Robert C. Lautman Photography Collection, box 33, courtesy of the National Building Museum, Washington, D.C.

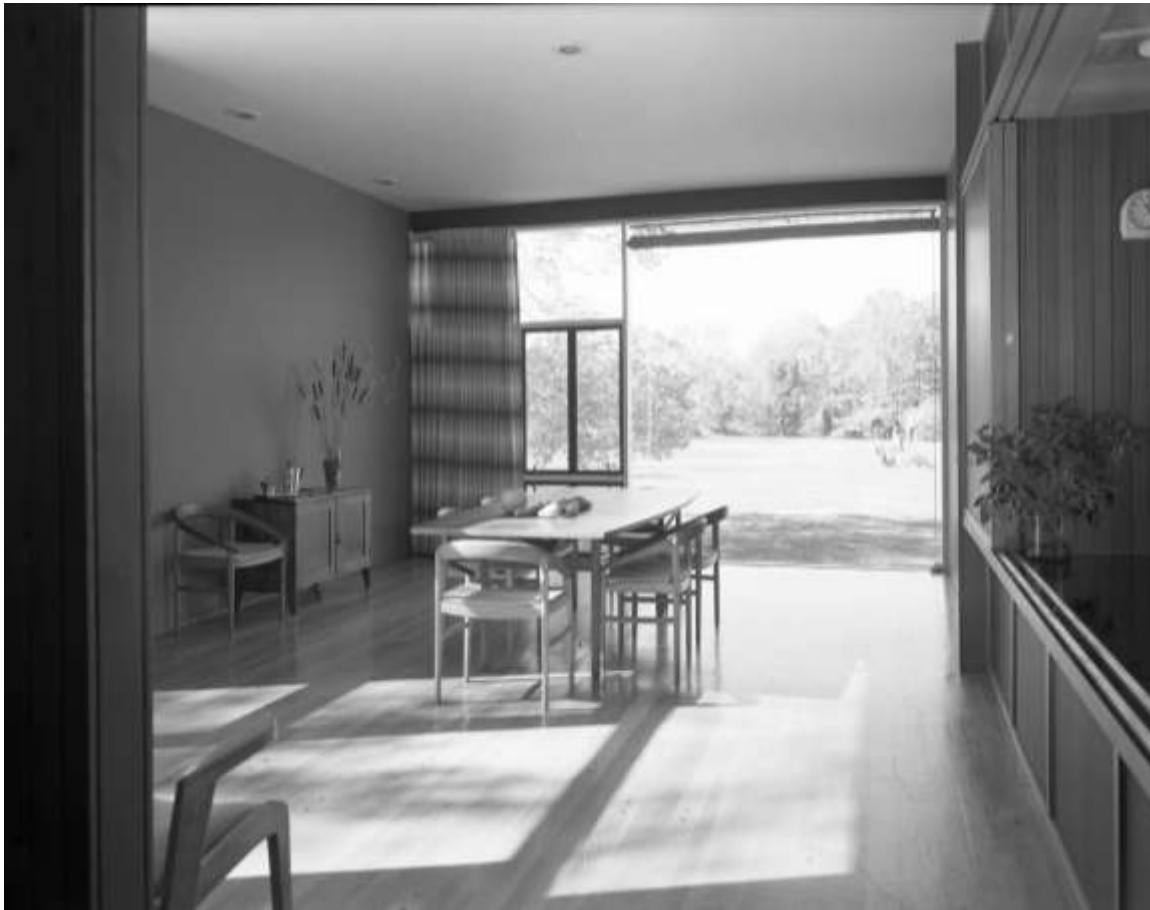
7 of 11: View of dining room looking west through the plate glass to a large lawn, ca. 1954. This image shows rails to the right which allowed panels to be closed across the pass through to the kitchen. The dining table is by Jens Risom and the dining chairs are by Hans Wegner. Note that additional furniture was later placed in this room, as visible in figure 21. From the Robert C. Lautman Photography Collection, box 35, courtesy of the National Building Museum, Washington, D.C.

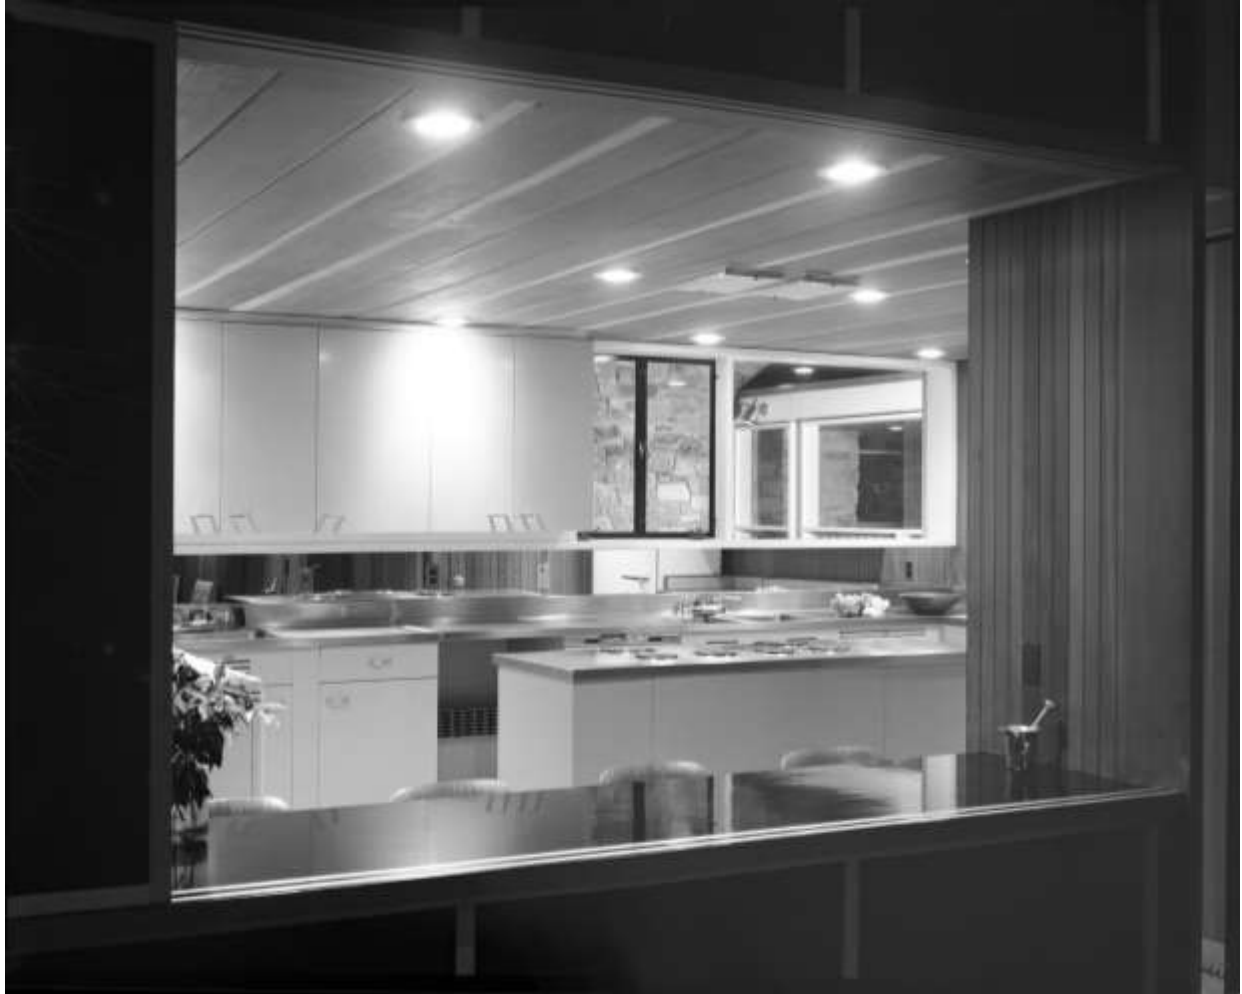
8 of 11: View of kitchen with white St. Charles steel cabinets, simple metal pulls, mirrored back splash, stainless steel countertops, and wide plank wood paneling on the ceiling with industrial fans over the cooktop, ca. 1954. From the Robert C. Lautman Photography Collection, box 35, courtesy of the National Building Museum, Washington, D.C.

courtyard, and covered terrace.⁹ In the kitchen addition, which was tucked along the northern side of the hyphen of the old farmhouse, Goodman created a thoroughly modern space made from prefabricated industrial materials. Goodman selected white steel St. Charles cabinets that ran along three of the kitchen walls with simple metal pulls, stainless steel countertops, and a mirrored backsplash, in the words of Goodman himself, “to make the kitchen surfaces look bigger and to help light them up.”¹⁰ An island contained the cooktop, and overhead were two large industrial exhaust fans. Goodman continued his experimentation with wood paneling in the kitchen, here using wide 1-by-10 v-joint paneling on the ceiling.
