**NINTH PHASE OF AN ARCHITECTURAL SURVEY
IN
ARLINGTON COUNTY, VIRGINIA**

Final Report

**Prepared by
E.H.T. Tracerics, Inc.
1121 Fifth Street, N.W.
Washington, D.C. 20001
202/393-1199**

**(Contact: Michael Leventhal, Historic Preservation Coordinator 703/228-3813)
September 2006**

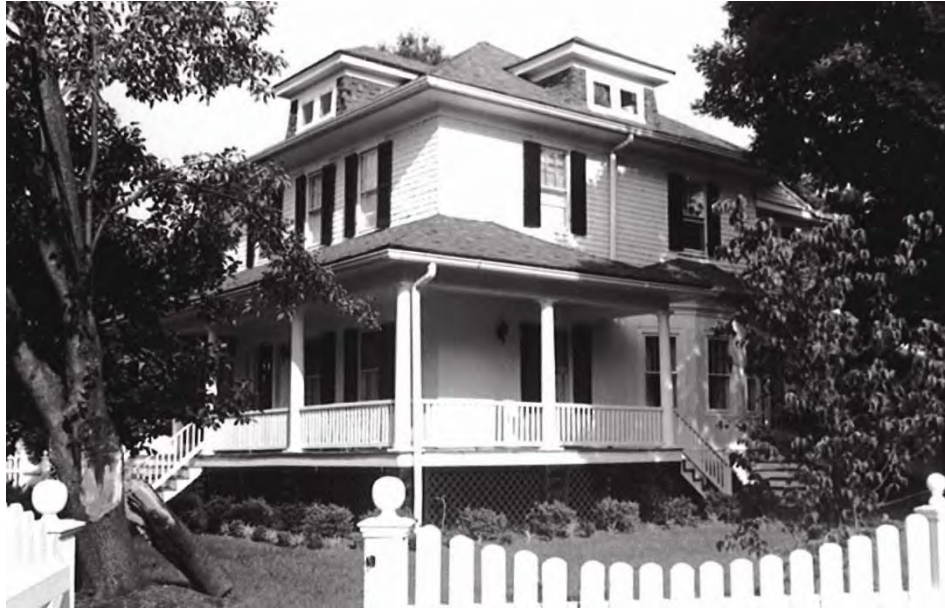
Figure 1: Single Dwelling, 4805 24th Street North, 000-3669 (EHT Tracerics, 2006)

The American Foursquare at 4805 24th Street North was constructed circa 1910 with many Colonial Revival-style details. Set on a concrete-block foundation, the wood-frame structure has been clad with stucco on the first story, while the second story is covered with square-butt wood shingles. The hipped roof, replete with wide overhanging eaves, is symmetrically pierced on the primary south and east elevations by hip-roofed dormers, a feature typical of the style. The single window openings hold 6/1 double-hung, wood-sash windows framed by narrow wood sills, louvered shutters, and projecting lintel caps. A one-story canted bay, located in the northernmost section of the east elevation, has a half-hipped roof, ogee-molded cornice, and 6/1 double-hung, wood-sash windows. The wrap-around porch is set on rock-faced concrete blocks, which were popular in the period between 1910 and 1930, and has tapered Tuscan columns supporting a half-hipped roof with wide overhanging eaves.

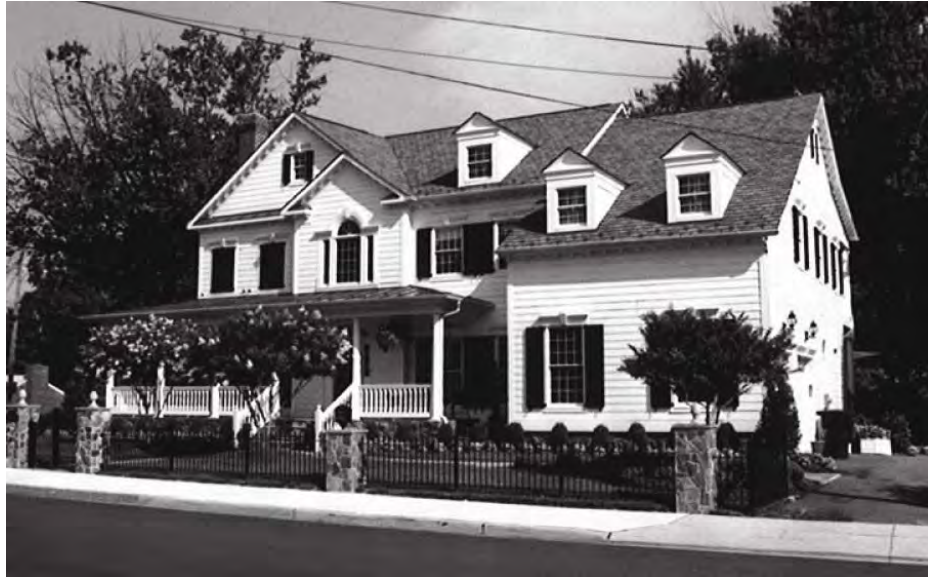
Figure 2: Single Dwelling, 5367 27th Street North, 000-4101 (EHT Tracerics, 2006)

Although enlarged by an imposing addition on the east elevation, the single-family dwelling at 5367 27th Street North is an excellent example of the more high-style elements associated with early Colonial Revival architecture. Completed circa 1915, the wood-frame structure is clad in weatherboard siding with narrow corner boards. It stands two-and-a-half stories in height on an uncoursed stone foundation. The rectangular form of the main block is enhanced by the slightly projecting entry bay on the façade. The first story of the central entry bay holds a paneled single-leaf wood door framed by a fanlight and three-light sidelights. The second story of the bay is ornately finished by a Palladian window with projecting ogee-molded lintel, keystone, and square-edged surrounds. Similarly, the 4/4, 6/6, and 8/8 double-hung, wood-sash windows of the main block are framed by projecting ogee-molded lintel caps and square-edged surrounds with wood sills. The wrap-around porch has tapered Tuscan columns with turned balusters. The side-gabled roof, open tympanum of the projecting entry bay, and the closed tympanum of the front gable are finished with a narrow boxed cornice, overhanging eaves, raked cornice, and modillions.

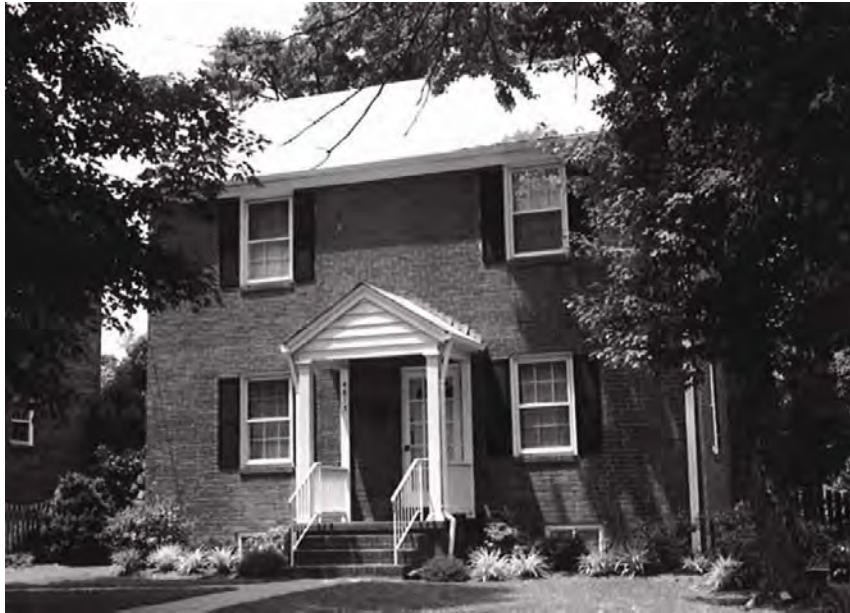
Figure 3: Single Dwelling, 4613 23rd Street North, 000-3492 (EHT Tracerics, 2006)

The two-and-a-half-story house at 4613 23rd Street North (000-3492) in Old Dominion is an excellent example of the more modest Colonial Revival-style dwellings surveyed throughout northern Arlington County. The house was constructed in 1939 by home-building company of W. E. Morgan and Son, which maintained offices in Clarendon. Set on a solid masonry foundation, the structure is faced in brick laid in six-course Flemish bond. The side-gabled roof has an ogee-molded cornice, bed molding, and a raked cornice on the gable ends. It has a central entry flanked by single 6/6 double-hung, wood-sash windows. The entry is located slightly off-center, alluding to the interior floor plan.

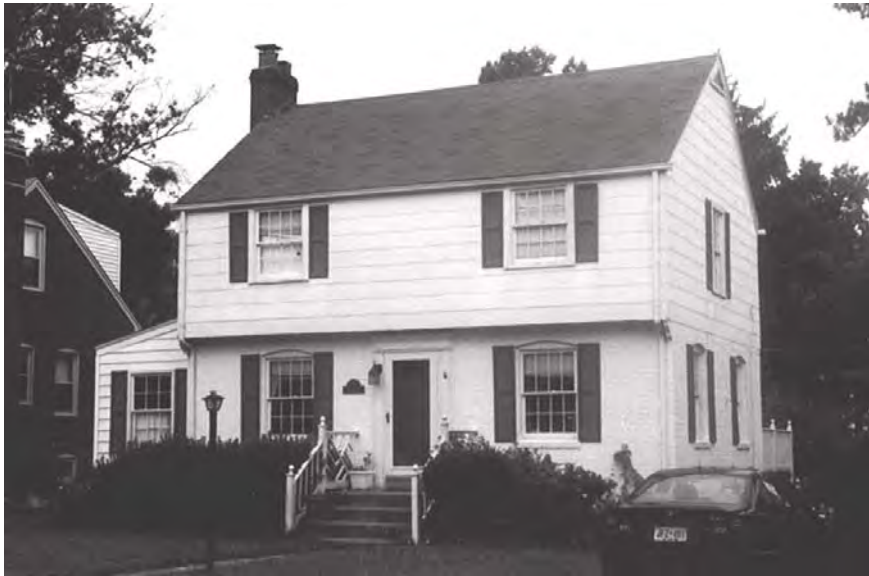
Figure 4: Single Dwelling, 5205 25th Road North, 000-3959 (EHT Tracerics, 2006)

A variation to the minimally detailed, rectangular two-and-a-half-story Colonial Revival-style dwelling was noted at 5205 25th Road North (000-3959), built in 1943 by builder E.W. Horton. Similar to contemporaneous Colonial Revival-style dwellings in northern Arlington County, the structure is three bays wide and two bays deep with symmetrical

fenestration. The first story is masonry clad in brick, while the second story is wood frame covered in asbestos shingles. The second story has an overhang or jetty, a feature of early Colonial houses constructed throughout the 1600s. In England, the deep jetty was used to provide shelter over the street-level market stalls. Yet, the American interpretation of the overhang is shallower (four to six inches deep) and was purely a decorative holdover.⁶ Rather than the corner drop or pendant that often ornamented the corners of the jetty, the overhang on the house at 5205 25th Road North is finished with solid scrolled brackets.

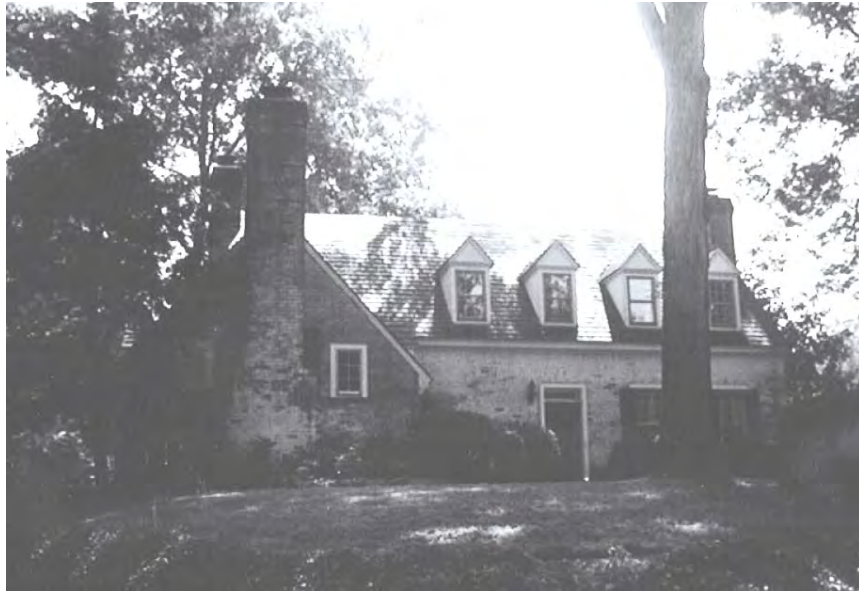
Figure 5: Single Dwelling, 4001 24th Road North, 000-3772 (EHT Tracerics, 2006)

One of the most unique Colonial Revival-style dwellings documented during the Phase IX survey is the single-family dwelling at 4001 24th Road North (000-3772). The influence of eighteenth-century Colonial architecture is reflected in the form of the structure rather than through the applied ornamentation such as the entry surround. Completed in 1940 by builder Charles W. Brawner, the one-and-a-half-story structure is constructed of concrete blocks clad in brick laid in six-course American bond. The unaltered dwelling has an L-shaped plan that is illustrative of the evolution of the eighteenth-century Colonial form plus projecting wing. The main block of the one-and-a-half-story house has a Cape Cod-like form extending five bays in width. A more diminutive one-and-a-half-story wing projects westward from the fifth bay of the façade. The structure is covered by a side-gabled roof pierced by four front-gabled dormers that are symmetrically placed over the entry and window openings of the first story. A single front-gabled dormer pierces the roof of the wing. Double-shouldered brick chimneys extend from the side elevations of the main block and from the west elevation of the projecting wing.

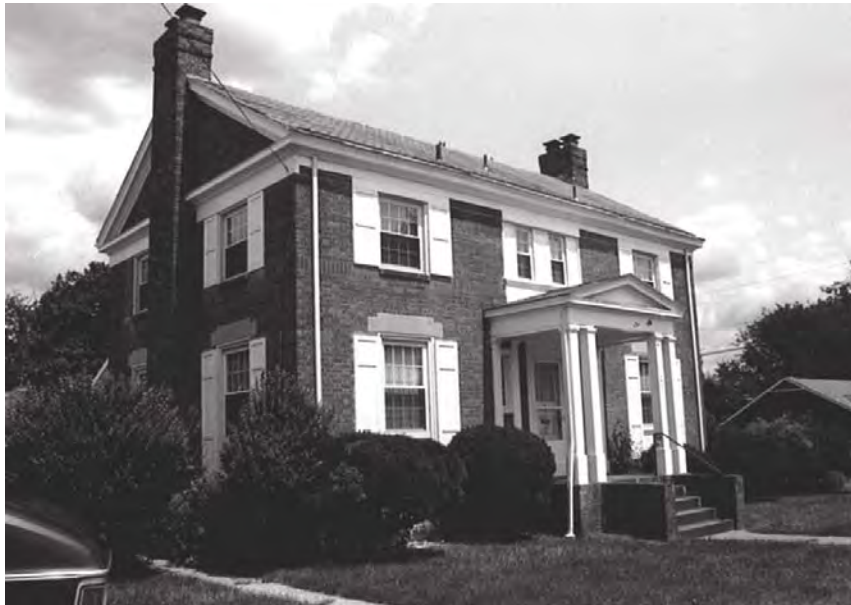
Figure 6: Single Dwelling, 2421 North Glebe Road, 000-3663 (EHT Tracerics, 2006)

The three-bay-wide dwelling at 2421 North Glebe Road (000-3663) was constructed in 1947 and served as the manse for the Grace Evangelical United Brethren Church. The imposing two-and-a-half-story building is constructed of concrete blocks faced in a six-course Flemish-bond brick with white wood detailing. Architectural detailing indicative of the Colonial Revival style includes the central entry flanked by three-light sidelights. The wide wood surround includes Tuscan pilasters and a flat frieze board. The projecting portico has a shallow-pitched front-gabled roof supported by paired Tuscan pilasters and posts. The wide frieze board is finished by an ogee bed molding, slightly overhanging ogee-molded cornice, and enclosed tympanum with a raked cornice. The 8/8 double-hung, wood-sash windows that flank the central entry are framed by recessed panels with a raised cross pattern, paneled wood shutters, and a stepped stone lintel. The detailing on the window openings of the façade is continued on the side elevations. Two narrow 4/4 double-hung, wood-sash windows on the second story, directly over the main entry, are set within a wide wood-clad surround with a projecting ogee-molded string course reading as a continuous sill and a narrower molding acting as an architrave to the lintel. The narrow boxed cornice that adorns the side-gabled roof on all four elevations of the

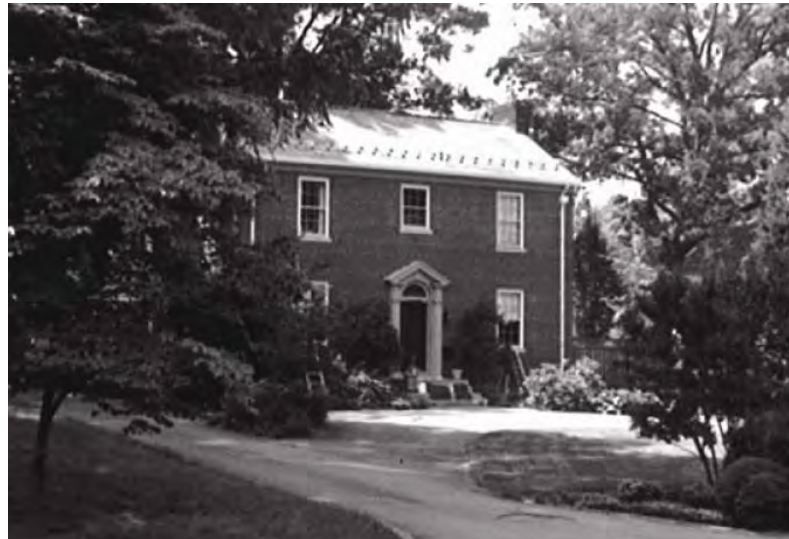
Figure 7: Single Dwelling, 4938 Rock Spring Road, 000-4107 (EHT Tracerics, 2006)

Another representative example is the house at 4938 Rock Spring Road (000-4107), which was erected circa 1930 on a one-acre lot. In 1935, the property was home to H.W. Haller. The masonry structure, extending three bays in width, is clad in brick laid in seven-course American bond. The shallow-pitched side-gabled roof is edged by a narrow ogee cornice with a thin frieze. The central entry is finished with a Georgian-inspired surround of wood with Tuscan pilasters, molded architrave and frieze board, open tympanum framing the finely detailed fanlight window, dentil molding, returns, and keystones. The entry holds a wooden door with six molded panels. The symmetrically placed window openings of the first and second stories have 6/6 double-hung, wood-sash with rowlock sills and flat soldier-coursed lintels. A smaller window is located directly over the central entry. An exterior-end chimney with a corbelled cap rises from the west side elevation.

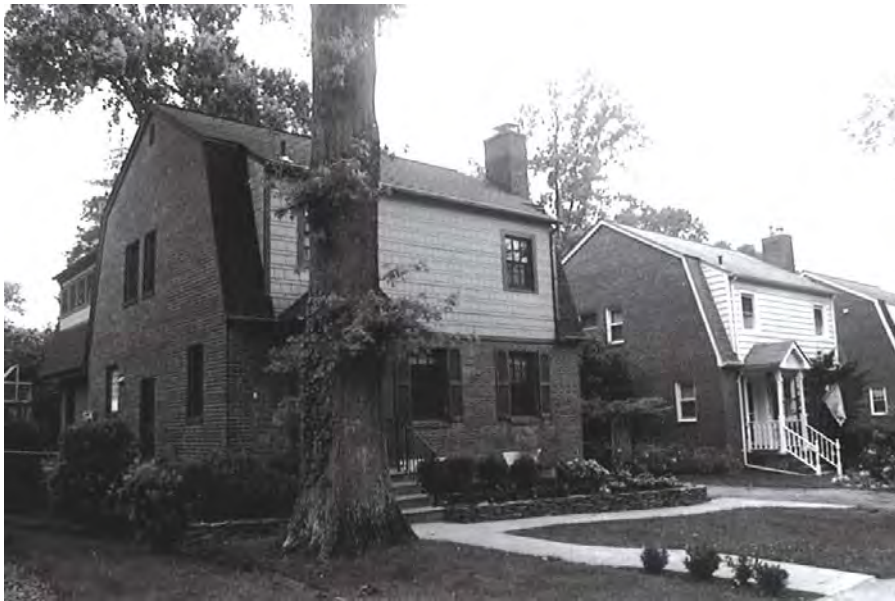
Figure 8: Single Dwellings, 2400 Block of North Florida Street (EHT Tracerics, 2006)

The Dutch Colonial Revival style, distinguished by a gambrel roof, is a variation of the Colonial Revival style that recalls eighteenth-century architecture. Eleven examples of the Dutch Colonial Revival were noted in the Phase IX survey of Arlington County, particularly in the neighborhoods of Arlingwood, Old Dominion, and Riverwood. The row of modest Dutch Colonial Revival-style dwellings in the 2400 block of North Florida Street of the Garden City subdivision in Riverwood is indicative of those recorded in Arlington County. Constructed by property owner and home-builder J.L. Douglas in 1939, the group of Dutch Colonial Revival-style dwellings presents the symptomatic imposing gambrel roof and expansive shed-roof dormer. The two-story structures are constructed of masonry clad in brick with exterior-end chimneys. The three-bay-wide

facades have side-entry openings and single 6/6 double-hung, wood-sash windows. Ornamentation on the Douglas-built dwellings is restricted to the entry surround or portico and the cladding of the shed-roof dormer. As with the contemporaneous modest Colonial Revival-style dwellings, the entry surround is composed of Tuscan pilasters, a simple frieze board, and projecting ogee-molded lintel cap. The porticos are finished with either a front-gabled or flat roof supported by turned or square posts. The cladding of the shed-roof dormers, which are pierced at either end by small 6/6 double-hung windows, includes square-butt wood shingles, staggered wood shingles, weatherboard siding, or synthetic siding such as aluminum or vinyl.

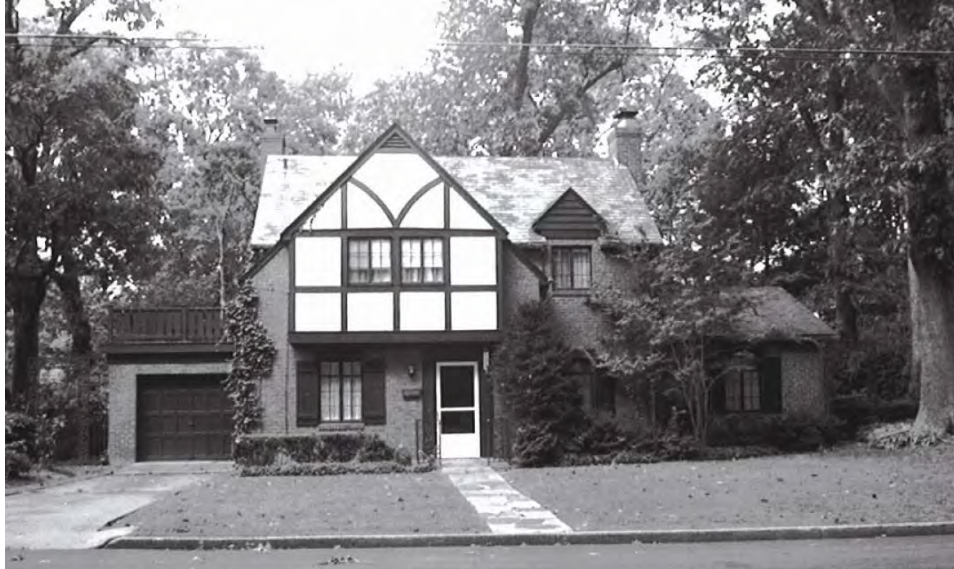
Figure 9: Single Dwelling, 3069 North Pollard Street, 000-3393 (EHT Tracerics, 2006)

The house at 3069 North Pollard Street (000-3393) is an excellent representative of the Tudor Revival style as it is illustrated in *Bellevue Forest*. Built in 1940 by R.B. Shull, the dwelling stands two stories in height. It is constructed of concrete block faced in stretcher-bond brick. Indicative of a suburban Tudor Revival-style house, the rectangular main block is augmented by a front-gabled projection that serves as the entry bay. The one-and-a-half-story projecting bay is embellished by a squared second-story overhang. Constructed of wood frame, the cantilevered overhang is finished with stucco and false half-timbering. The window openings consist of narrow paired wood casements with six and eight lights. The second story of the façade is pierced by a wall dormer with a front-gabled roof and paired six-light casement windows. Characteristic of mid-twentieth-century suburban dwellings, the rectangular main block is augmented by one-story wings, one of which serves as the garage.

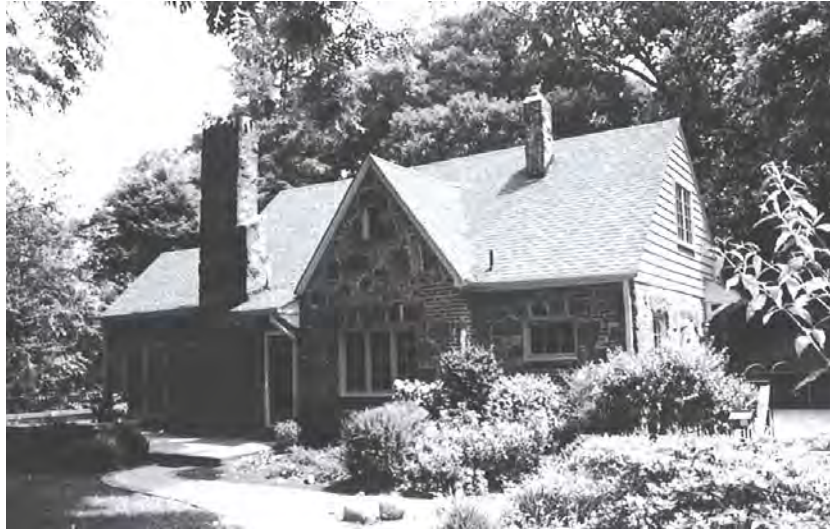
Figure 10: Single Dwelling, 4019 North Randolph Street, 000-3427 (EHT Tracerics, 2006)

Another archetypical example, albeit more modest in massing, is the single-family dwelling at 4019 North Randolph Street (000-3427) in Arlingwood. The structure stands one-and-a-half stories in height with a rectangular form supplemented by a projecting front-gabled bay. Constructed circa 1930, the building is concrete block clad in a six-course American-bond brick. Rough cut stones are randomly placed in the gable end on the façade and also act as quoins, surrounds, and lintels. The paired and triple casement windows are wood with eight lights and are set on rowlock brick sills. The chimney, located on the façade immediately adjacent to the main entry opening, is constructed of brick with rough cut stones. The stack is stepped and topped by a stone cap with square chimney pots.

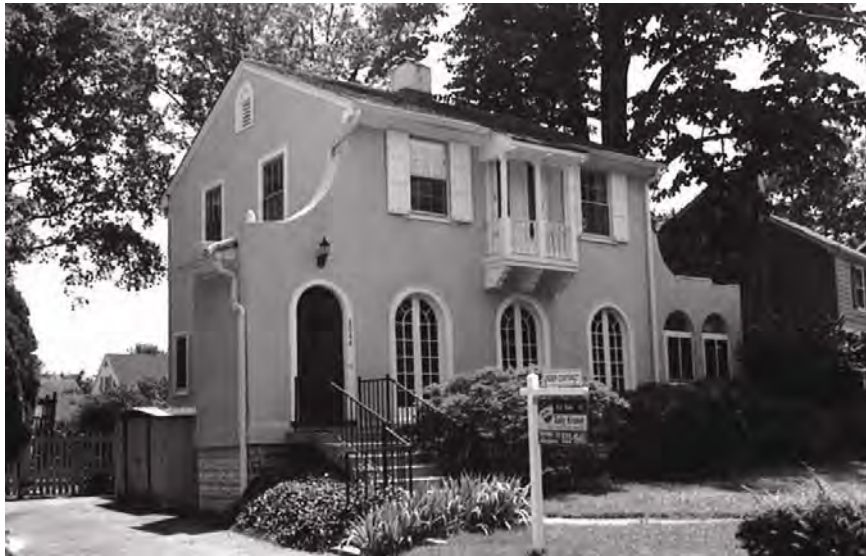
Figure 13: Single Dwelling, 4644 24th Street North, 000-3571 (EHT Tracerics, 2006)

The single-family dwelling at 4644 24th Street North (000-3571) in Old Dominion was constructed circa 1940. The main block has a rectangular form extending three bays wide and two bays deep under a side-gabled roof. Standing two-and-a-half stories, the dwelling sits on a slightly raised foundation of rock-faced concrete blocks. The structure is concrete block that is now clad in stucco. Original elements of the dwelling are the 6/6 double-hung windows, now flanked by paneled shutters, and the short interior chimney that has been clad in stucco. Spanish-inspired alterations include the addition of an entry bay on the northern part of the east elevation and a one-story wing with a flat roof on the

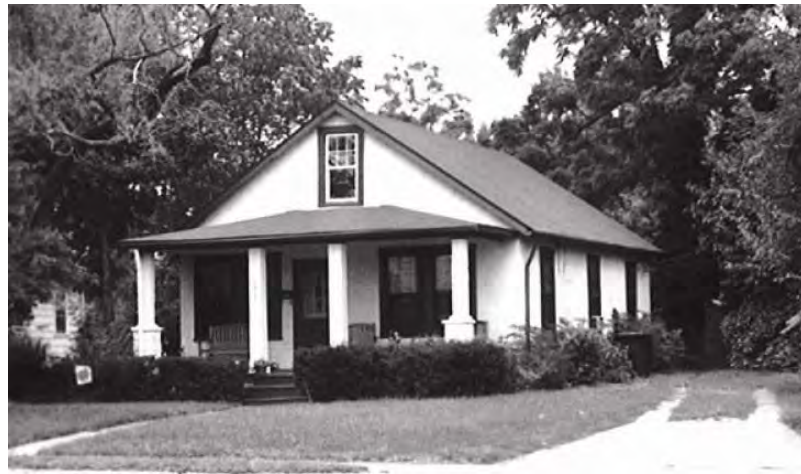
Figure 14: Single Dwelling, 2529 North Glebe Road, 000-3667 (EHT Tracerics, 2006)

Many of the Craftsman-style examples documented in northern Arlington County present minimal ornamentation indicative of the style. For example, the one-and-a-half-story structure at 2529 North Glebe Street (000-3667), completed in the latter part of the 1920s, has a full-width porch supported by Tuscan posts set on rock-faced concrete-block piers, single and paired 6/1 windows, and overhanging eaves. Yet, the building is

symmetrically fenestrated and lacks the applied ornamentation often associated with the Craftsman style. Similarly, the neighboring one-and-a-half-story dwelling at 2531 North Glebe Street (000-3668), dating from the late 1920s, has single and triple window openings with 6/1 wood-sash, a full-width porch inset under the main hipped roof, tapered Tuscan posts on stuccoed piers, and overhanging eaves. Again, the structure is predominately symmetrically pierced and has no applied stylistic ornamentation. Other examples of the Craftsman style were noted at 4835 24th Road North (000-3674), 4770 25th Street (000-3722), 2418 North Columbus Street (000-3820), and 5253 26th Street North (000-4086).

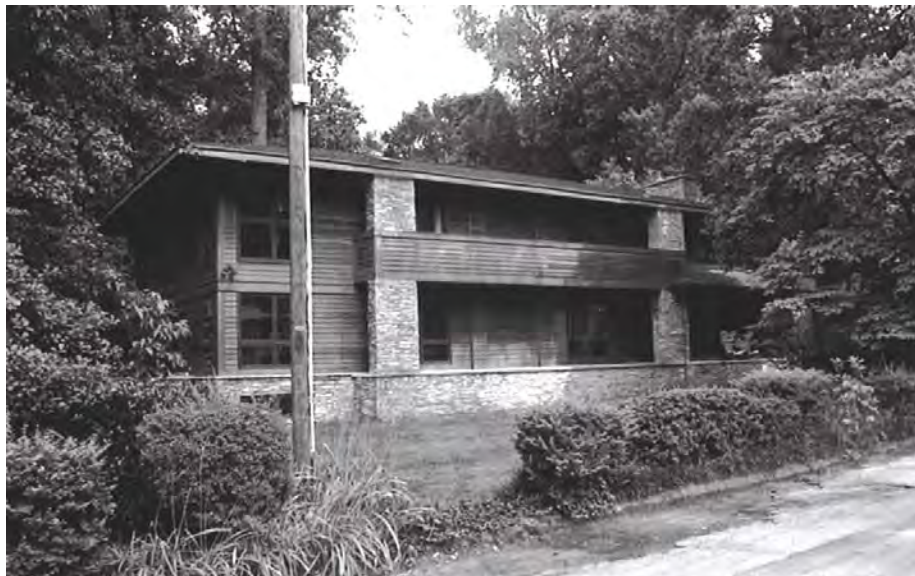
Figure 16: Single Dwelling, 2431 North Edgewood Street, 000-3746 (EHT Tracerics, 2006)

The two-story dwelling at 2431 North Edgewood Street (000-3746), built in the late 1920s, illustrates the Prairie School influence through its low-to-the-ground horizontal appearance, which is presented by the shallow-pitched hipped roof and expansive overhanging eaves. The horizontality of the structure is also exemplified through the raised foundation wall composed of coursed cut stone, the narrow square-cut coping that acts as a watertable, the dark stained weatherboard siding and banding, and the solid balustrade of the second-story porch. The inset two-story porch is supported by a coursed cut stone chimney and pier, two elements that provide a strong verticality to the massing. The stone foundation wall acts as a solid balustrade for the first story of the porch. The symmetrically placed window openings, now holding replacement metal sash, have wide mullions that further emphasizes the horizontal plane of the structure. The garage, attached by an open breezeway, has a cut stone foundation, dark stained weatherboard siding, and narrow rectangular window openings set directly under the broad eaves of the low-pitched roof.

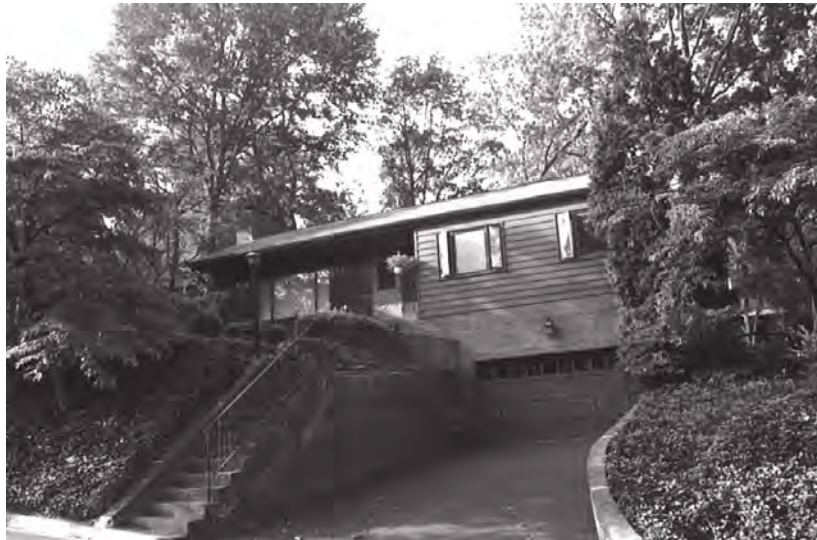
Figure 17: Single Dwelling, 3110 North Pollard Street, 000-3398 (EHT Tracerics, 2006)

In form, Modern Movement dwellings in northern Arlington County were ranch houses, often utilizing the sloping grade of their site to capture additional living space at the rear and/or garages in the lower story. Examples noted include the late 1940s to early 1950s houses at 3080 North Pollard Street (000-3396), 3110 North Pollard Street (000-3398), 3170 North Pollard Street (000-3406), and 3187 North Pollard Street (000-3408). Each structure stands one story in height with low-to-the-ground horizontality. The side-gabled roofs have narrow cornices and broad eaves. Cladding material is mixed and includes brick veneers, stucco, and weatherboard siding. Fenestration consists of short rectangular window openings. The most common opening is the picture window flanked by smaller double-hung or casement sash. Attached garages are common with Modern Movement ranch houses from the mid-1950s. The siting of the structures within the sloping landscape allowed for below-grade garages at 3110 North Pollard Street and 3187 North Pollard Street.

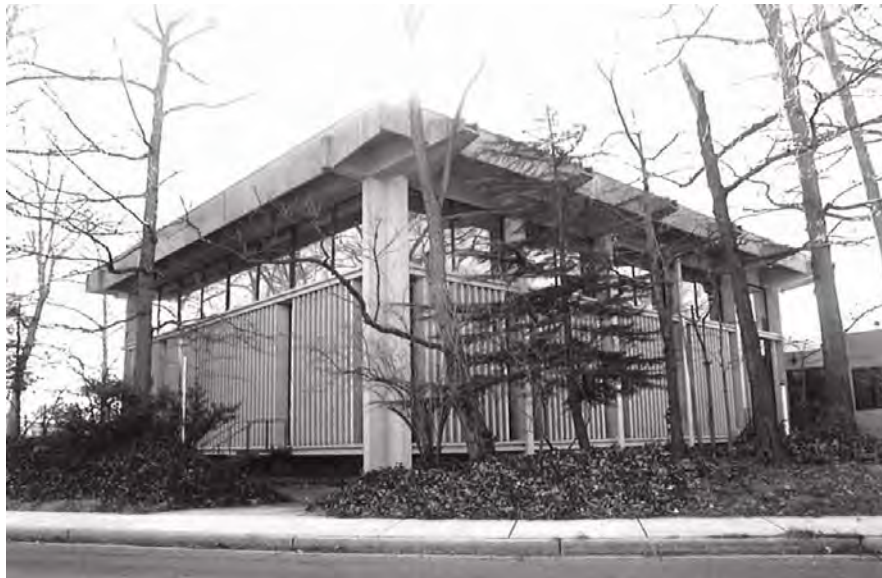
**Figure 18: Unitarian Universalist Church of Arlington, 4444 Arlington Boulevard, 000-3424
(EHT Tracerics, 2006)**

The Unitarian Universalist Church of Arlington is located at 4444 Arlington Boulevard in the neighborhood of Barcroft. The tall one-story (reading as two stories) structure was designed by prominent modern architect Charles M. Goodman in 1962. It is set on a solid foundation with fluted concrete panels running vertically the height of the first story. Clerestory windows with vertical mullions illuminate the interior of the structure from above the panels, which are supported by a reeded base and cap that read like a water table and belt course. Large T-shaped posts at the four corners of the structure support the flat roof. The roofing has a broad overhang with projecting rafter ends on three of the elevations. The primary entry is hidden on the northeast elevation, reached by concrete side-entry stairs as well as via the rooftop deck created by the 1994 addition constructed on the southern corner of the structure. The entry features double-leaf glass doors set in a metal frame surrounded by three-light sidelights and a one-light transom.

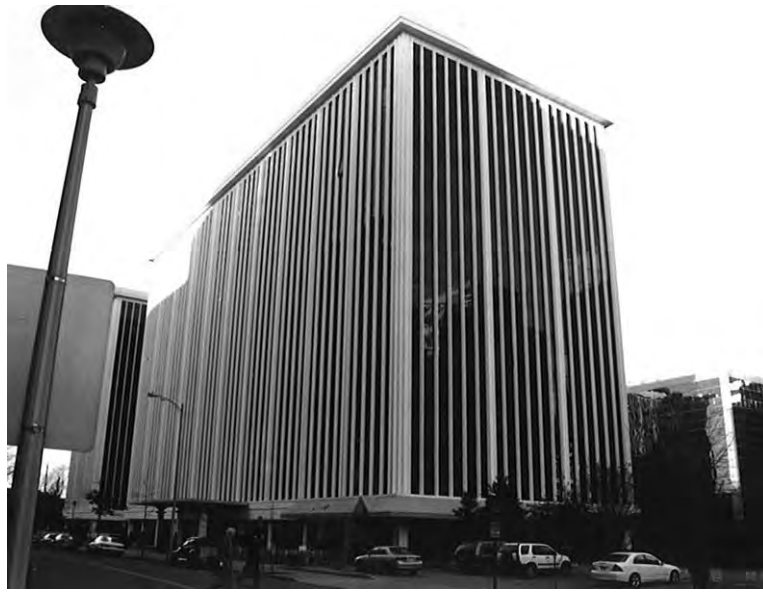
Figure 19: Oakhill Office Building, 1401 Wilson Boulevard, 000-3422 (EHT Tracerics, 2006)

effect over the pedestrian plaza and parking garage. Characteristic of Modern architecture from the 1950s to the 1980s in the United States, the Oakhill Office Building has been eschewed of all ornamentation, whether applied or inherent in the materials. The movement from the concrete and steel piers to the glass windows is plain and as featureless as possible. The piers are intentionally not presented as columns and clearly lack a base and capital. Rather, the materials and the structural techniques display twentieth-century technology, which is in contrast to the techniques and materials characteristic of earlier commercial structures and office buildings. Moreover, the structure itself is displayed, illustrating what the building is made of and how it was put together. The design of Modern architecture like that demonstrated at the Oakhill Office Building and Unitarian Universalist Church of Arlington allowed for free-flowing spaces in, around, and through the buildings, a concept ideal for churches and high-rise office buildings.

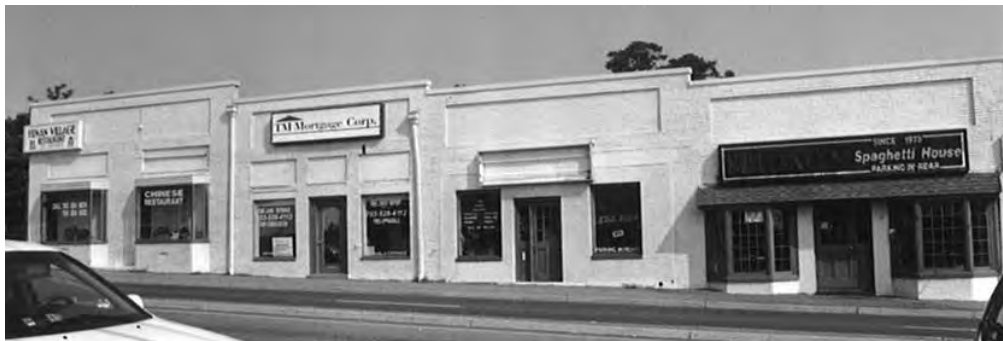
Figure 22: Commercial Buildings, 4763-4775 Lee Highway, 000-3588 (EHT Tracerics, 2006)

The most distinctive commercial buildings are found along the 4700 block of Lee Highway, canted around the northwestern corner of its intersection with North Glebe Road. This stylized group of masonry buildings is constructed of concrete block with a six-course Flemish-bond brick veneer that has been painted white. The grouping is made

up of three structures. Dating from circa 1939, the one-story building at 4745-4753 Lee Highway (000-3585 and 3586) has flat parapets with applied ogee-molded cornices and simple friezes anchored by pointed-arch pilasters with recessed panels and corbelling. The pilasters act as dividers between the two individual storefronts and add a stylistic emphasis to the canted corner entry. The entries and show windows are varied, illustrating flush center and recessed canted single-store arrangements. A separate abutting storefront at 4755 Lee Highway (000-3587) is contemporaneous, having been constructed circa 1939. Originally providing two stores, the façade presents a flush center double-store arrangement topped by a low stepped parapet. Applied ornamentation includes two concrete swags set symmetrically over the two-light picture windows. The adjacent commercial building at 4763-4775 Lee Highway (000-3588) was also completed circa 1939. The masonry building is clad in six-course American-bond brick with a parapet that steps upward as the buildings extend west. The four individual storefronts are highlighted by recessed panels that extend the full width of each store. The two westernmost stores have two tiers of recessed panels because of the slight slope in Lee Highway as it travels westward. The entries and show windows are symmetrically placed with two flush center single-store arrangements flanked by flush bay windows.

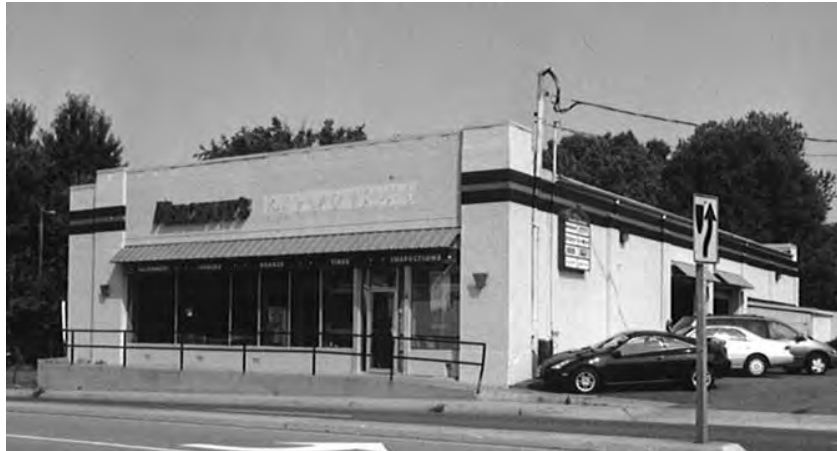
Figure 23: Commercial Building, 4801 Lee Highway, 000-3389 (EHT Tracerics, 2006)

In contrast, vehicular openings penetrate the east elevation of the building at 4801 Lee Highway as it is used as an automobile repair shop. Faced in six-course American-bond brick, the building was constructed in 1947. The façade along Lee Highway, however, retains its plate-glass show windows set in metal mullions and flush-side entry opening. A standing-seam metal awning projects slightly over the windows and entry. The implication of pilasters is presented by the recessing of the central bay in which the windows and entry are located. This also provides an expansive area for tall signage to entice those driving by. Reflecting a trait of the Streamline Moderne style, the upper portion of the building just below the parapet is painted to mimic a racing stripe, thus signifying the building's use is related to the automobile.

Freestanding examples of commercial buildings identified in the Phase IX survey area generally front major transportation corridors and provide off-street parking to the side and rear. The buildings at 5555 Lee Highway (000-4147) and 4801 Lee Highway (000-3389) are one-story masonry structures that are located along the front lot lines of the properties. Parking is provided on either side of the structures, with vehicular access to the rear of the properties as well. This form of siting provides passing motorists with easy entry from and egress to the highly traveled Lee Highway. The side elevations of freestanding commercial buildings, despite being visible to parking clientele, were not typically fenestrated with show windows or primary entries. Rather the side or rear elevations include only entries that allow for deliveries. Narrow window openings have been added to the southwest side elevation of 5555 Lee Highway, which was completed in 1948. A double-leaf commercial entry door penetrates the center of the elevation, providing easier access from the parking lot for patrons. This change in the original fenestration is most likely the direct result of the alteration of the primary entry opening fronting Lee Highway, which is no longer arresting the attention of motorists passing by at high speeds. The original opening is sheltered by a new glass and steel structure that

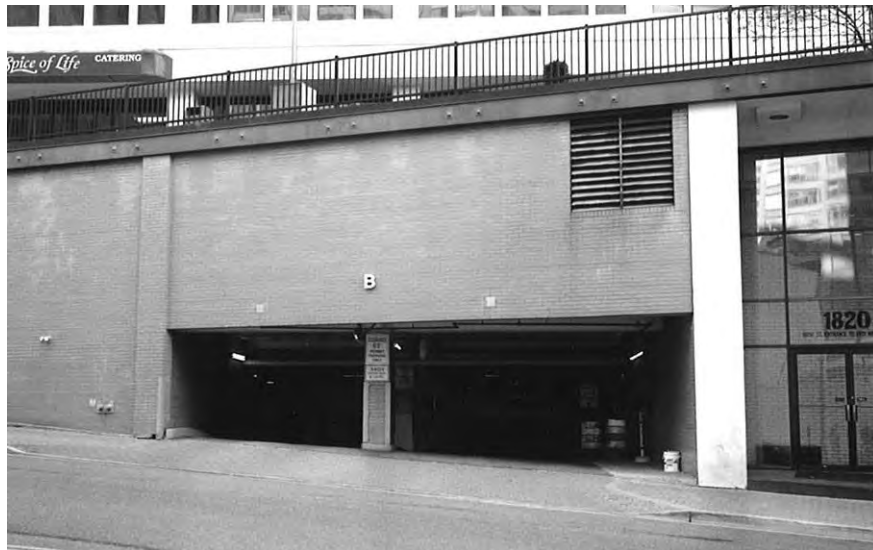
Figure 24: Parking Garage B on North Nash Street, Oakhill Office Building, 1401 Wilson Boulevard, 000-3422 (EHT Tracerics, 2006)

Parking for the two office buildings is also contrasting. Oakhill Office Building provides several levels of indoor, off-street parking located in the basement of the high-rise structure. The office building's location in the heart of Rosslyn largely dictated the need for parking within the structure, while the commercial building at 4625 Old Dominion Drive is able to offer exterior, off-street parking that proves more applicable to its location at the intersection of Old Dominion Drive and North Abington Street just north

of Lee Highway in Old Dominion. The interior parking garage of the Oakhill Office Building provides not only shelter for automobiles, but was the site of secret meetings between *Washington Post* reporter Bob Woodward and FBI informant W. Mark Felt, who was known as “Deep Throat.” These meetings, which occurred numerous times about “2 a.m. on the bottom level” of the parking garage, made public the illegal activities of President Richard M. Nixon and his staff during a period of American history that has become known as the Watergate scandal (1972-1974).¹³ The meeting place, identified by Woodward as parking space 32D, is located in Parking Garage B, one of three under the property which is accessed from Nash Street. It is a paved parking space, about 150 square feet in area, and currently demarked only by a “temporary” historical marker of paper attached to a structural concrete post. Parking space 32D occupies a corner in the lower level of the garage and is adjacent to an exit door that leads up a secluded stairwell and then onto the street, making it easy for Deep Throat to slip away safely after each rendezvous. Additional facts related to this property’s association with the Watergate scandal are explained under the Government/Law/Politics theme of this report.

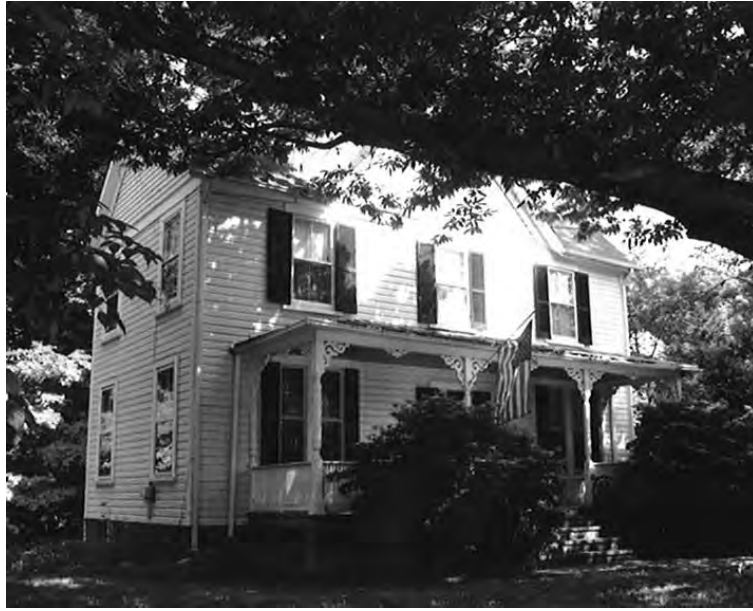
Figure 25: Single Dwelling, 3856 North Glebe Road, 000-3441 (EHT Tracerics, 2006)

Built circa 1910, the modest wood-frame house at 3856 North Glebe Road (000-3441) predates the platting of Stafford-Albemarle-Glebe, which was subdivided and improved in the third quarter of the twentieth century. The building's construction prior to the subdivision of this area appears to be the direct result of its siting adjacent to the neighborhood of Old Glebe. This residential neighborhood was transformed from a rural truck farm community improved by large-scale summer homes in the second half of the nineteenth century to numerous planned subdivisions beginning in the 1930s. The two-and-a-half-story structure is characteristic in form, design, and siting to the summer houses that populated Old Glebe, particularly along North Glebe Road. Constructed of wood frame clad in German siding, the building presents an I-house plan and is symmetrically pierced, a feature indicative of the twentieth-century Colonial Revival style. The main block, only slightly enlarged by a one-story addition on the northern end of the northwest rear elevation, is three bays wide and two bays deep with a central entry. The nearly full-width front porch is three bays wide and stands one story in height. Set on brick piers, the porch reflects the stylistic influences of the Queen Anne style with turned posts, narrow square balusters, and scrolled sawn brackets. Interior-end brick chimneys and window openings in the side elevations signify the locations of the fireplaces in the parlors flanking the central hall.

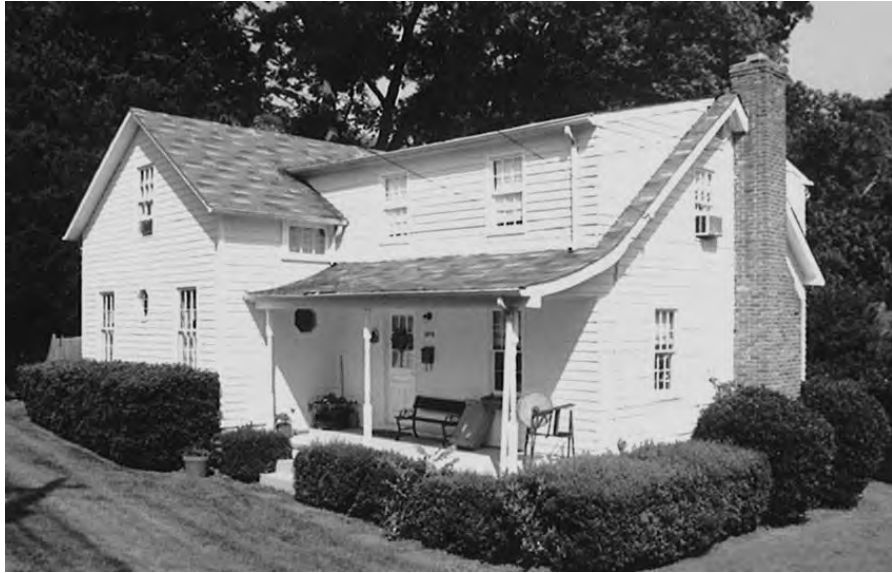
Although it has been noted during previous survey efforts that the residential buildings from this period that remain extant are commonly altered and enlarged, those documented in Phase IX present few additions and little alterations to character-defining features. The structure at 3816 North Glebe Road (000-3442), which dates from circa 1910, appears to be one of the few examples of the enlargement of an original structure. The vernacular dwelling has an L-shaped form created by a side-gabled main block with inset full-width front porch and front-gabled wing that extends beyond the façade. The one-and-a-half-story structure is built of wood frame clad in weatherboard siding. It is

Figure 26: Single Dwelling, 3816 North Glebe Road, 000-3442 (EHT Tracerics, 2006)

recommended that an intensive-level survey be conducted to determine which portion of the structure is original or if it was constructed originally with this form. The side-gabled portion with its sloping roof that covers the inset porch is similar to the later adaptations of the twentieth-century Cape Cod.

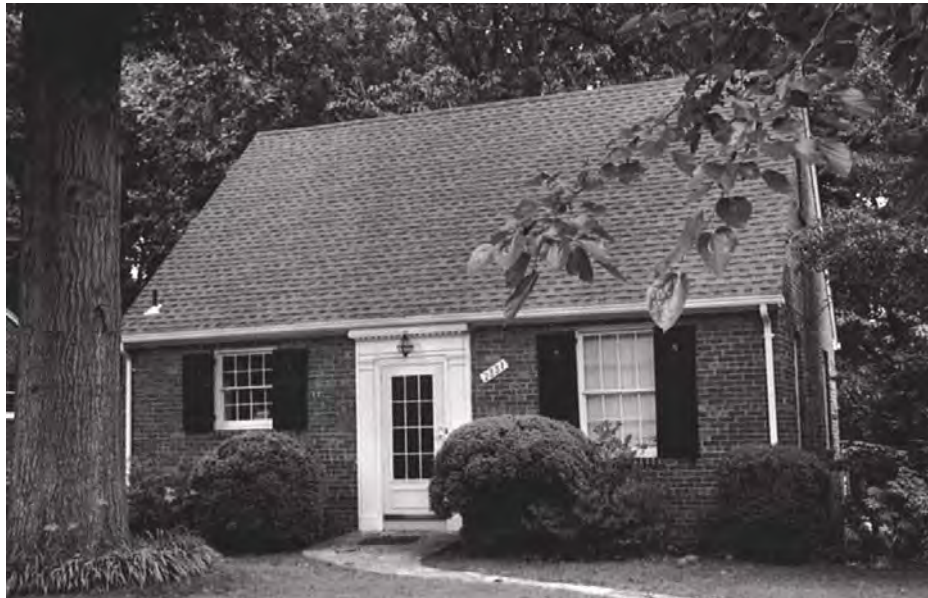
Figure 27: Single Dwelling, 2331 North Wakefield Street, 000-3487 (EHT Tracerics, 2006)

The minimal ornamentation of the Colonial Revival style was also noted on a substantial number of Cape Cod houses, a common domestic suburban form. The 1940 house at 2331 North Wakefield Street (000-3487), constructed by builder L. Johnson, is a modest Cape Cod structure that is three bays wide and two bays deep. The one-and-a-half-story dwelling is covered by a steeply pitched side-gabled roof. The imposing roof is devoid of dormers, which were a common projection on most Cape Cod structures of the mid-twentieth century that allowed daylight and ventilation to the upper story. To the contrary, the steep pitch of the roof and the lack of dormers at 2331 North Wakefield Street are more indicative of early Colonial structures dating from the seventeenth century.

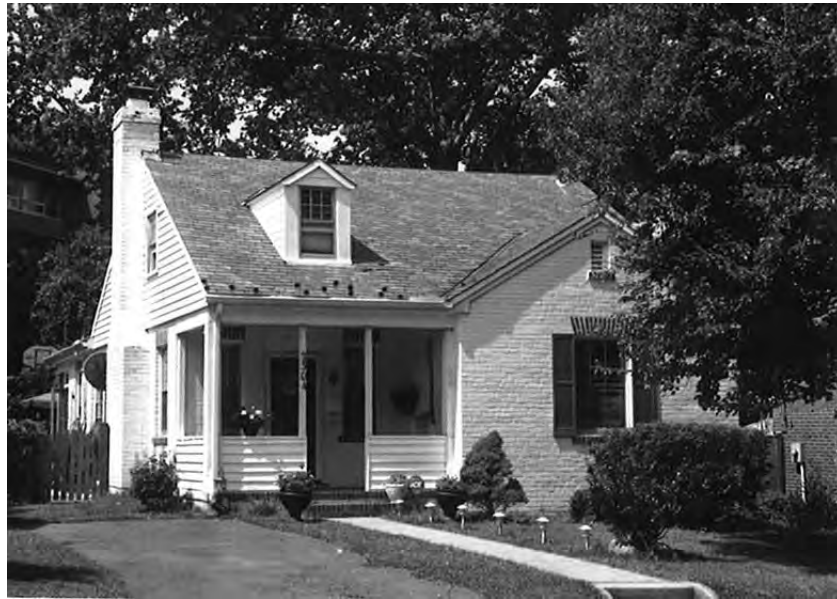
An adaptation of the Cape Cod is the small L-shaped house that is augmented by an inset front porch. The main block of the structures, which are typically masonry clad in brick with accents of synthetic siding, are covered by side-gabled roofs. Like the traditional Cape Cod structure, the dwellings are one-and-a-half stories in height with gable-end window openings and dormers. However, a front-gabled bay projects from one half of the façade. This projecting bay is one bay wide, often pierced at the center by a single double-hung or paired casement window. Examples were noted of an exterior chimney flanked by small window openings marking the front-gabled bays. The inset porches are created by the continued sloping of the side-gabled roof over the main block. The location of the projecting front-gabled bay required the reorientation of the openings of the main block. Consequently, the central-entry and window openings were asymmetrically placed against the projecting bay and dormer. The dwellings at 4623 24th

Street North (000-3541) and 2304 North Florida Street (000-4132), dating from 1940 and 1936 respectively, are excellent examples of this modest domestic form.

Figure 28: Single Dwelling, 2304 North Florida Street, 000-4132 (EHT Tracerics, 2006)

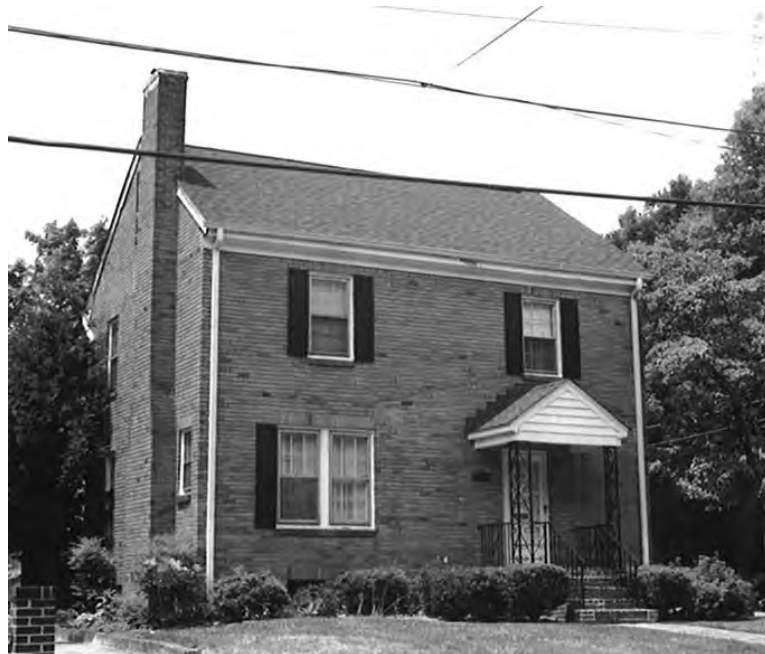
Figure 29: Single Dwelling, 2340 North Wakefield Street, 000-3504 (EHT Tracerics, 2006)

2340 NO. WAKEFIELD ST.
LEE HEIGHTS, ARLINGTON VA.
BARGAIN—New six-room brick house, full two stories, two
baths, full basement, hot-water heat and garage; on corner lot,
55x116. Cement walks and improved streets. Price only
\$7,800.50--\$750.00 down, balance at \$65 mo. This house is
open for inspection. Drive out Lee Highway to No. Wakefield
st., turn rt. to 24th st.
Owners: W.E. Morgan & Son.
Clarendon 646-J¹⁷

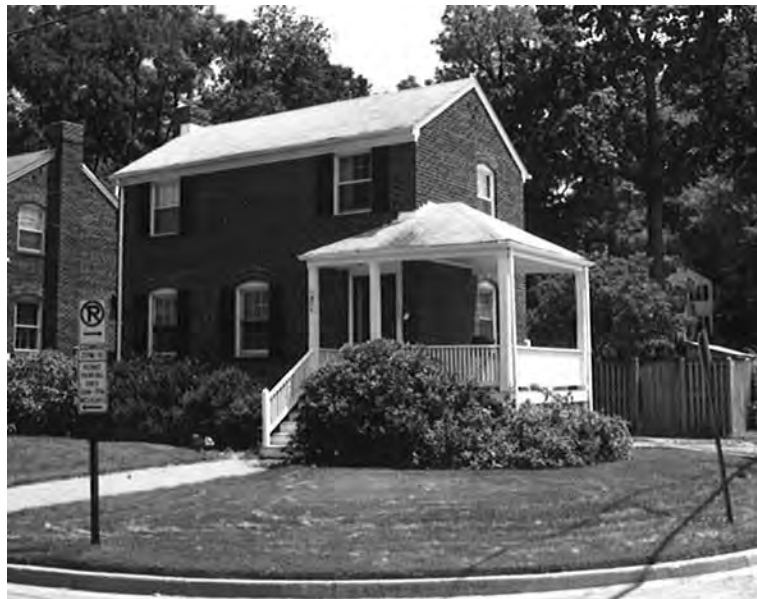
An enclave of nearly identical domestic buildings representatives of the rectangular, box-like structure that has come to typify suburban residential neighborhoods developed in the 1940s is located in the center of Yorktown. Produced by the Standard Construction Company, the buildings on 26th Road North, 27th Road North, 28th Road North, North Florida Avenue, North Yorktown Boulevard, and North Edison Street have a side-gabled form standing two stories in height. Variations to the form are presented through the location of the exterior chimney, use of wall dormers, and the supporting materials of the porches. The single most character-defining feature of these dwellings is the wrapping corner porch. This one-story, wood-frame feature has been identified in Westover and Arlington Forest, but does not ornament each of the buildings in those subdivisions as it does in Yorktown. The porches wrap one bay around the corners of the structure, dually serving as an entry portico and small side porch. Although this domestic form is traditionally symmetrically fenestrated, particularly on the façade, the Yorktown examples are asymmetrically pierced with three openings on the first story and two openings on the second story. The side-entry opening on each dwelling is set exceptionally close to the corner of the structure under the porch. Two window openings illuminate the remaining bays of the façade's first story. The window openings in the outer bay are symmetrically placed on the first and second stories, although the window opening over the side entry is asymmetrically positioned. Further, the window openings on the side elevation are located in the exposed bay rather than being shaded by the porch.

Figure 30: Single Dwelling, 5222 27th Road North, 000-4011 (EHT Tracerics, 2006)

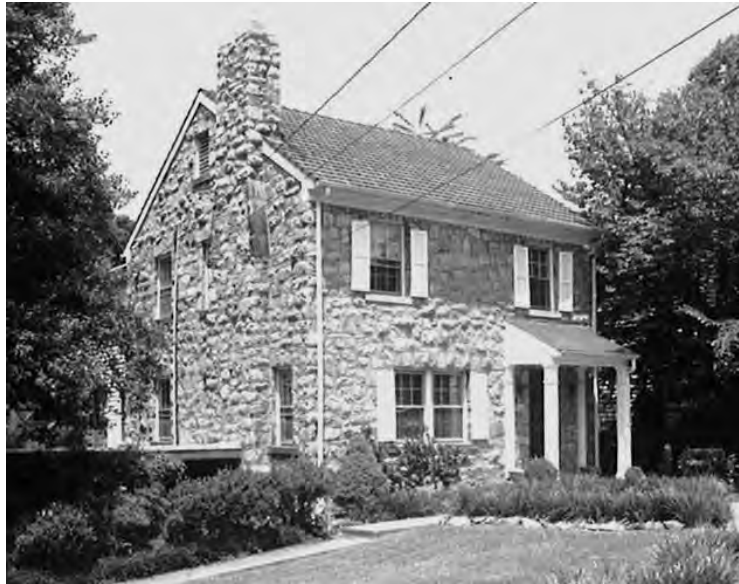
Figure 31: Single Dwelling, 4637 24th Street North, 000-3538 (EHT Tracerics, 2006)

A curious illustration of the rectangular, box-like structure is the dwelling at 4637 24th Street North (000-3538), which was constructed in 1940. The building presents the typical elements of this domestic form such as the side entry covered by a shed-roof portico, single and paired window openings with 6/6 double-hung sash, and an exterior-side chimney that rises beyond the side-gabled roof. However, unlike most of the examples, the house at 4637 24th Street North is constructed of concrete block clad in an uncoursed rough-cut stone. The use of this cladding material rather than the traditional brick veneer gives the dwelling a rustic appearance, which is further employed by the planned landscape design. The application of stone is not uncommon in Arlington County, as several of the residential buildings were veneered in a smooth stone, both coursed and uncoursed, that was cut and dressed. The stone cladding at 4637 24th Street North, however, is rough cut. During the New Dominion Period (1946-present), the stone veneers were more often just applied to the facades, while side and rear elevations were clad in brick.
