**NINTH PHASE OF AN ARCHITECTURAL SURVEY
IN
ARLINGTON COUNTY, VIRGINIA**

Final Report

**Prepared by
E.H.T. Tracerics, Inc.
1121 Fifth Street, N.W.
Washington, D.C. 20001
202/393-1199**

**(Contact: Michael Leventhal, Historic Preservation Coordinator 703/228-3813)
September 2006**

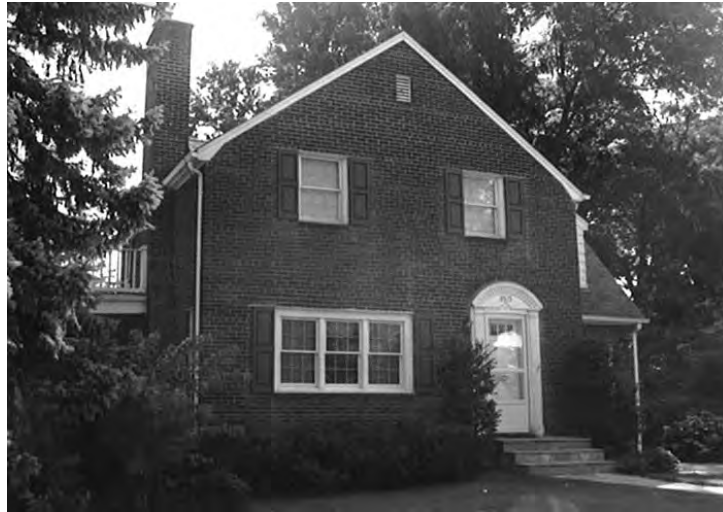
Larger domestic forms were documented in the survey area, although not often. The house at 2615 North Florida Street (000-4082) in Yorktown is a good example of the large domestic buildings identified during the survey. Constructed in 1941 by builder J.M. Donohue, the house stands two-and-a-half stories in height with a front-gabled form facing North Florida Street. Although the front-gabled form has been documented throughout Arlington County, this masonry structure presents a wider façade with greater massing and scale than traditionally employed by wood-frame front-gabled dwellings. The first story is pierced by a triple 6/6 double-hung window and a side entry opening enframed by a Colonial Revival surround that includes Tuscan pilasters and a semi-circular arched stepped lintel. The second story is plainly fenestrated with two wide 6/6 window openings. Characteristic of many of the larger dwellings from this period, the main block is flanked by one-story wings – one with a side-gabled roof pierced by a

dormer and one with a flat roof finished by a balustrade of square posts. Moreover, the house is set back from the street, sited on a spacious corner lot.

Figure 32: Single Dwelling, 2615 North Florida Street, 000-4082 (EHT Tracerics, 2006)

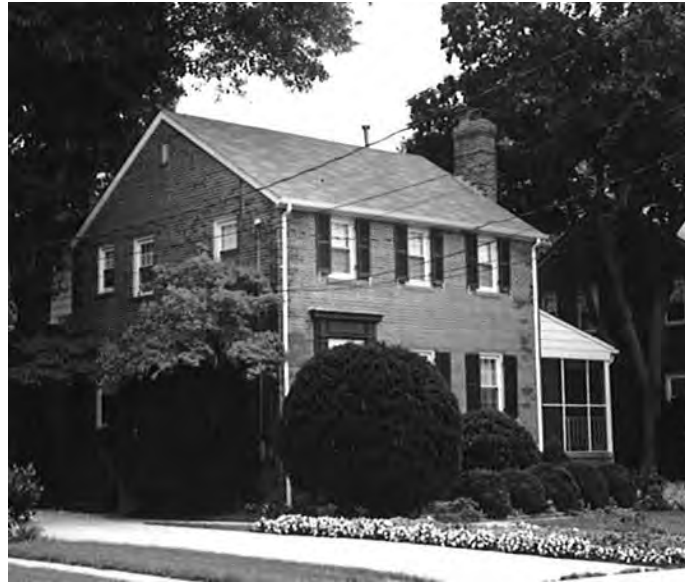
Construction of modest single-family dwellings continued through the New Dominion Period, especially in Stafford-Albemarle-Glebe, Yorktown, and Old Dominion. The single-family dwelling at 2243 North Columbus Street (000-3646) in Old Dominion is an excellent illustration of the modest housing erected throughout Arlington County during this period. The two-story structure, dating from 1947, is square in form with a side entry. Reflecting the Colonial Revival style, the building is constructed of concrete block that is faced with six-course American-bond brick. The low-pitched side-gable roof, clad in asphalt shingles, has a shallow molded cornice on the façade and raked cornice on the side elevations. A large corbelled cap exterior chimney rises from the side elevation. The window openings on the façade are marked by standard-sized 6/6 double-hung sash, while the more private spaces at the rear and side of the house are illuminated by smaller window openings. A one-story screened wing projects from the side elevation. This porch wing is constructed of wood frame and has a shed roof. The neighboring houses along North Columbus Street, as well as throughout Yorktown, are nearly identical in massing, form, and style with minimal variations to lintels, surrounds, and porch

supports. The plans are often mirror images in an effort to distract one's attention from the repetition of the dwellings.

Figure 33: Single Dwelling, 2243 North Columbus Street, 000-3646 (EHT Tracerics, 2006)

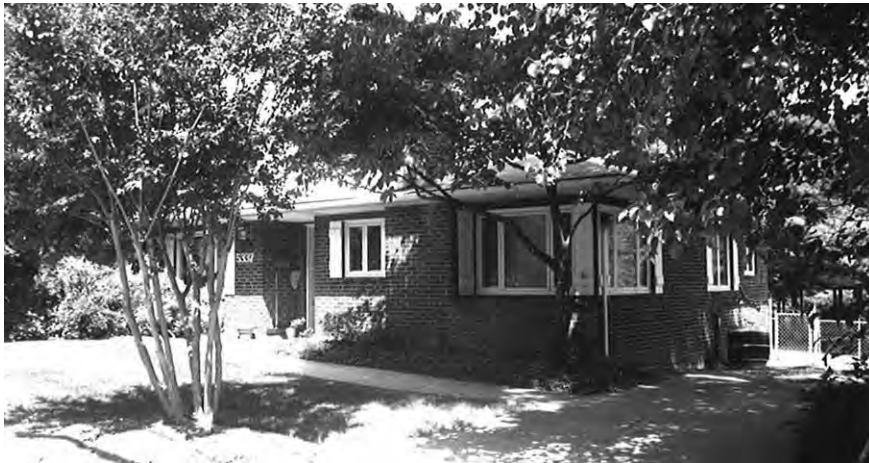
Figure 34: Single Dwelling, 5337 26th Street North, 000-4072 (EHT Tracerics, 2006)

An adaptation of the ranch house that illustrates the need for smaller unpretentious construction specifically targeted for the middle class is the structure located at 5337 26th Street North (000-4072). Dating from circa 1948, this Yorktown dwelling is constructed of concrete block faced in six-course Flemish-bond brick. It stands one story in height with a hipped roof that provides shelter to the many window openings with its wide overhanging eaves. The single-leaf entry is recessed and largely hidden from view. A large interior chimney rises through the roof from the center of the façade. Indicative of the Modern Movement are the window openings that wrap around the corner of the structure. The sash includes a fixed picture window flanked by casement or crank windows. Paired casement windows of various sizes provide additional illumination.

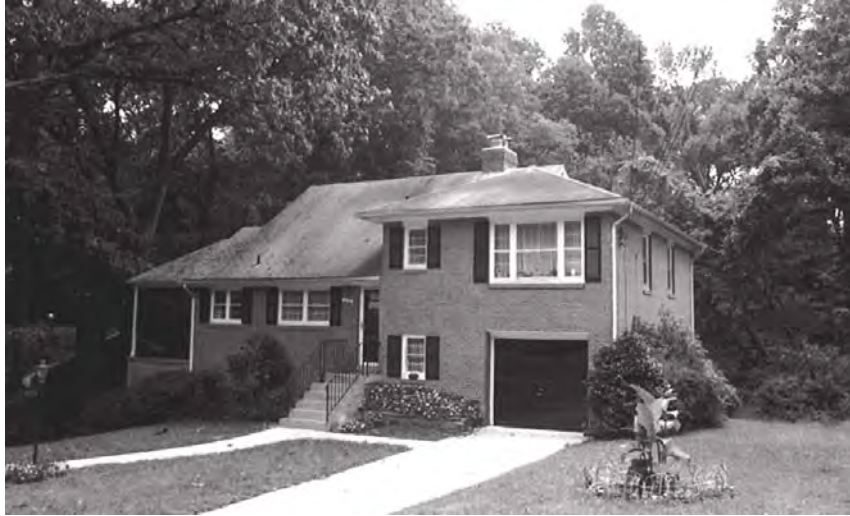
No authentic examples of split-level houses were recorded during this survey phase, although variations to the popular mid-twentieth-century domestic form were noted. One such example is the house at 3030 North Pollard Street (000-3388), which was erected in

1951 by A.L. Jones. Rectangular in plan, the building stands one story in height with a split-level plan that allows for the private areas such as the bedrooms to be located on an upper story. The upper story, which projects slightly from the façade of the main block, is within a two-story bay that includes the garage in the first story and living space in the second story. This bay is covered by a shallow-pitched hipped roof that extends just below the ridge line of the main side-gabled roof. The concrete-block structure, clad in all-stretcher-bond brick, is asymmetrically fenestrated with single, paired, and picture windows flanked by smaller double-hung sash.

Figure 35: Single Dwelling, 3030 North Pollard Street, 000-3388 (EHT Tracerics, 2006)

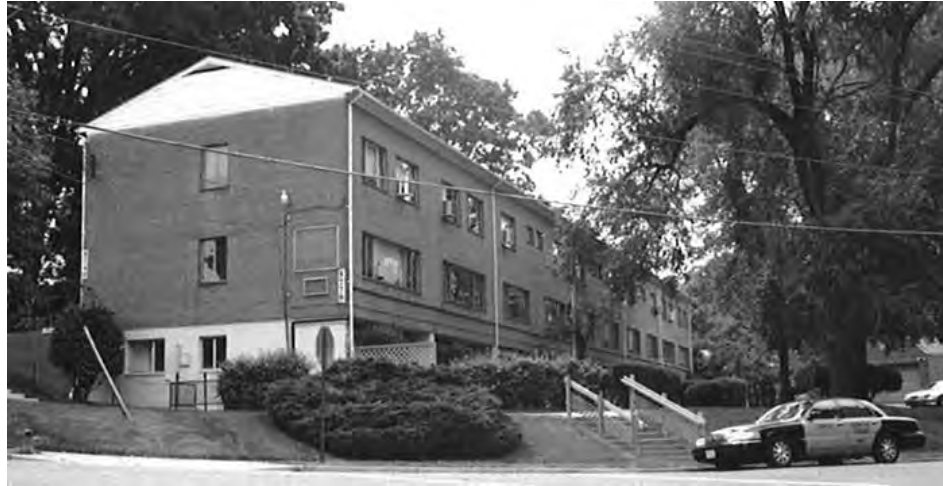
Figure 36: Apartment Building, 5778 16th Street North, 000-3259 (EHT Tracerics, 2006)

The building at 5778 16th Street North is two stories high with a low-pitched gable roof. It provides ten dwelling units, and unlike the majority of the low-rise apartment buildings identified in Arlington County from this period, with the exception of those within the immediate neighborhood, each unit has its own entry. Like the surrounding Westover Apartments constructed by Mace Properties in 1939, the building is banked slightly into the sloping site. Further, both the Westover Apartments and the building at 5778 16th Street North are set on raised cinder-block foundations, and are constructed of steel framing with cinder-block walls faced in six-course American-bond brick.

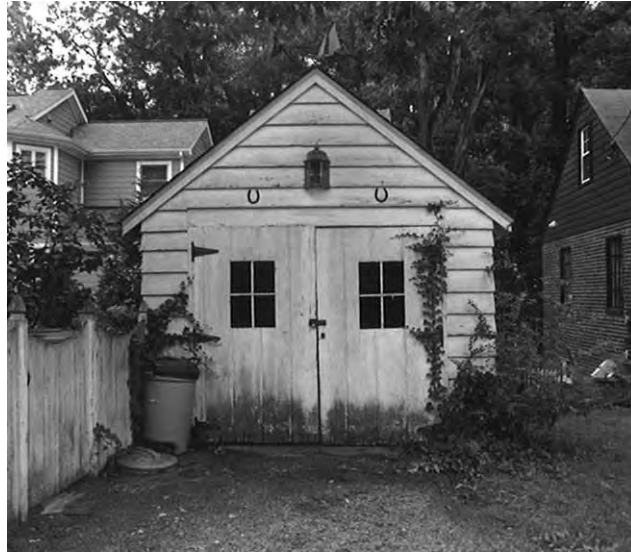
Figure 37: Garage, 4910 25th Street North, 000-3806 (EHT Tracerics, 2006)

The one-story wood-frame garage at 4910 25th Street North (000-3806) was constructed in the third quarter of the twentieth century, nearly twenty years after the completion of the main dwelling. This non-historic garage is one of the few examples where the style and material of the outbuilding does not mimic that of the main dwelling, which is constructed of concrete block clad in brick. Moreover, the garage is located in front of the house close to the street, rather than at the rear of the property where these secondary resources are traditionally located. The front-gabled garage is clad in wide weatherboard siding that lacks corner boards. The roof, which is covered in asphalt shingles, has a raked cornice. The original double-leaf doors on the façade of the structure are composed of wide vertical boards pierced by four-light fixed windows. The doors swing out with heavy strap hinges. A paved drive leads from the street to the garage in the northeast corner of the property. A second unpaved drive is located to the northwest of the house.

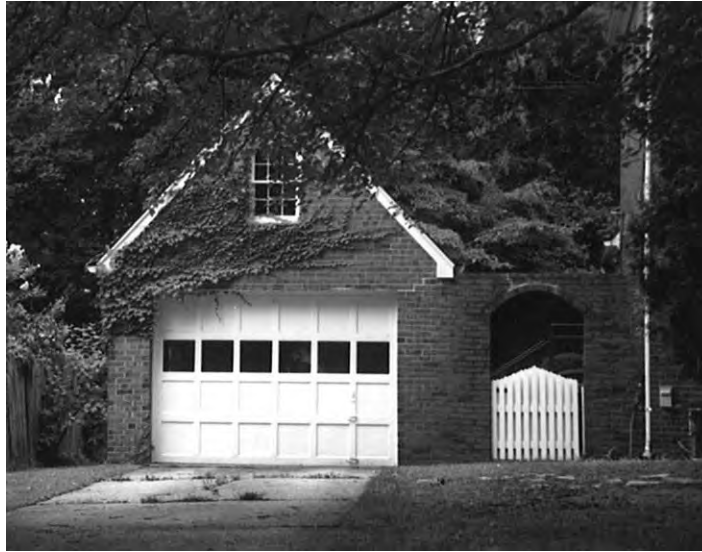
Figure 38: Garage, 2507 North Florida Avenue, 000-3972 (EHT Tracerics, 2006)

The one-and-a-half-story garage at 2507 North Florida Avenue (000-3972) is constructed of concrete block faced in six-course Flemish-bond brick. Dating from 1951, the garage has a steep front gable pierced by a roll-up paneled garage door on the first story and 6/6 double-hung window opening in the half story. The main dwelling, constructed of masonry clad in brick, was completed in 1931. The garage was attached to the main dwelling by a brick wall perforated by a segmentally arched opening that holds a wooden gate. Although the garage and the main dwelling were constructed twenty years apart, they are consistent in massing, materials, and style. Other examples of garages include those at 4623 23rd Street North (000-3495), 4664 24th Street North (000-3531), and 4834 24th Street North (000-3611),

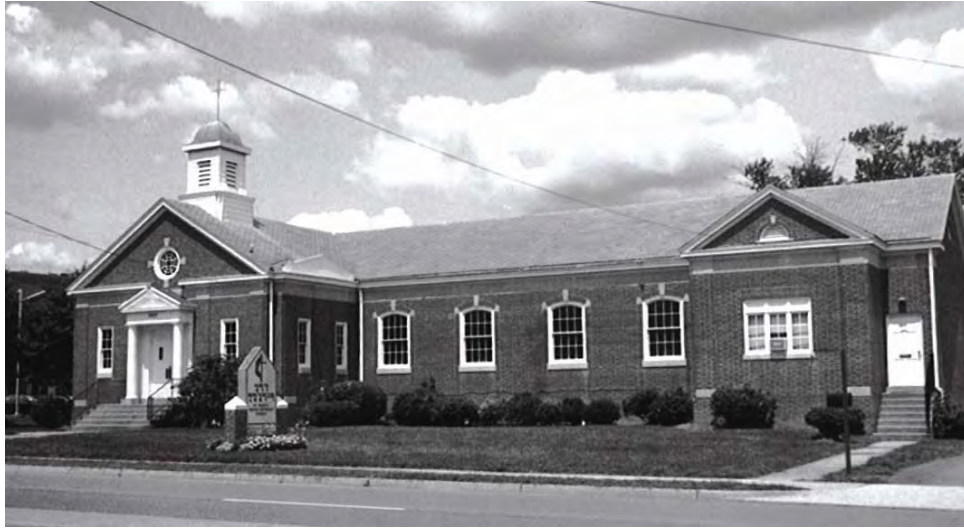
Figure 40: St. Mark's United Methodist Church, 2425 North Glebe Road, 000-3693 (EHT Tracerics, 2006)

St. Mark's United Methodist Church at 2425 North Glebe Road (000-3693) was erected in 1947, during the height of the Colonial Revival style in suburban communities like Old Dominion. The building was originally utilized by the Evangelical United Brethren as a church. The main block of the masonry structure, which is clad in Flemish-bond brick, has an open nave plan with a rectangular form. Subsequent additions include a one-story masonry structure with a flat roof on the east elevation and a one-story masonry structure set on the south elevation. As a result of the addition to the south elevation, the building has a T-shaped plan. Colonial Revival-style elements presented on the church include the classically inspired entry surround on the façade of the main block. The projecting surround, accessible by concrete steps, reads as a portico with a broken pediment set on a wide architrave that is supported by Tuscan columns. Symmetrically placed 4/4 double-hung, wood-sash window openings with concrete sills flank the entry opening and pierce the side elevations of the main block. A concrete watertable acts as the base for the projecting brick piers that terminate at the classical entablature, which includes a wide concrete-clad architrave and narrow ogee-molded cornice. The front gable of the façade has a raking ogee cornice and large oculus window in the center of the tympanum. The multi-light window has an ogee-molded surround and four concrete keystones. A wood-frame cupola with a bell-shaped roof and louvered vents rises from the western end of the roof, over the façade. The one-story addition on the south elevation is also Colonial Revival in style, presenting several of the same stylistic features as the original main block. The large segmentally arched openings on the west elevation have 8/8 double-hung, wood-sash windows, each with a concrete sill and soldier-coursed brick lintel with concrete keystone and impost. The enclosed gable on the projecting bay at the southern end of the addition has a molded ogee cornice that is wider than that on the original main block. The tympanum is pierced by a semi-circular arched opening filled with wooden louvers and framed by a soldier-course lintel with concrete keystone.
