# Bedford County Farm Survey Report

# **Bedford County Farm Survey Report**

The Bedford County Farm Survey, conducted in 2013-14, was funded by the Bedford Historical Society (BHS) and the Virginia Department of Historic Resources (DHR) and was administered jointly by DHR and Bedford County. The survey was undertaken by Landmark Preservation Associates of Lexington. The survey covered most areas of the county and was undertaken in two phases: a windshield documentation that characterized the historic resources of nearly three hundred farm properties and a reconnaissance survey of eighty-two properties representing a range of resource periods, building types, and associations.

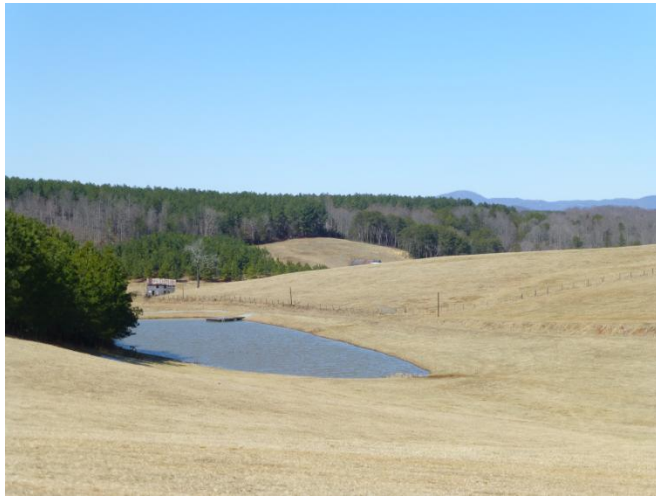
Figure 2. A representative Bedford County farm landscape at the Hicks Farm (009-5378) in the Moneta vicinity: rolling hayfields encompassed by wooded slopes, the Blue Ridge in the distance.

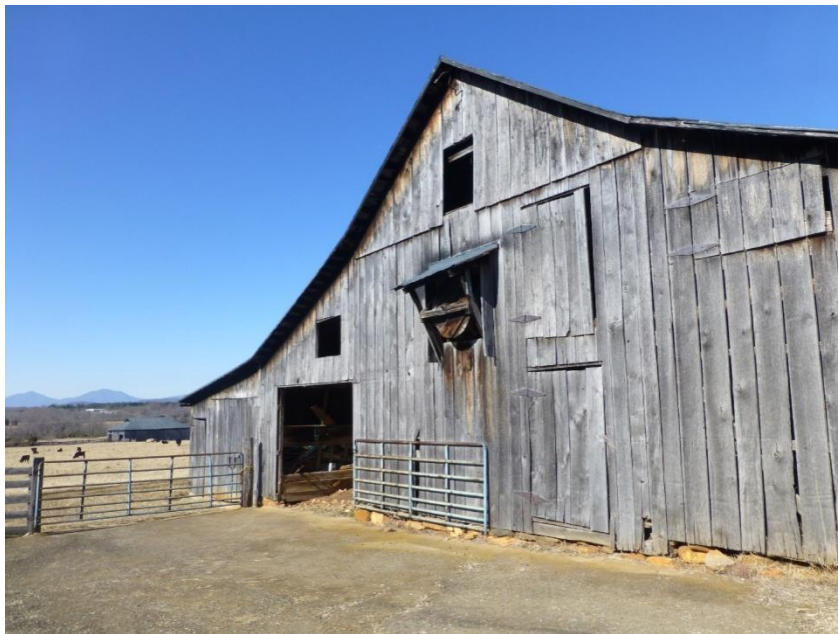
Figure 3. The horse barn at Rothsay Farm (009-5351).

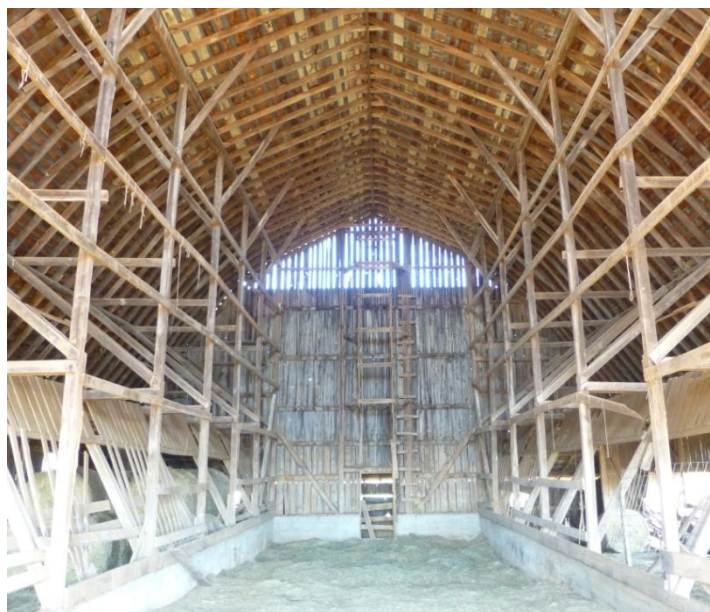
Figure 4. A large haymow at Redlands Farm (009-0187).

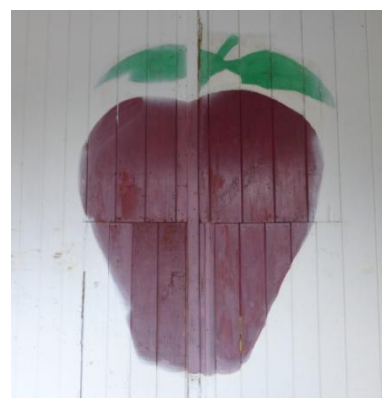
Figure 5. Painting on the doors of the Logwood Apple Packing House (009-5117).

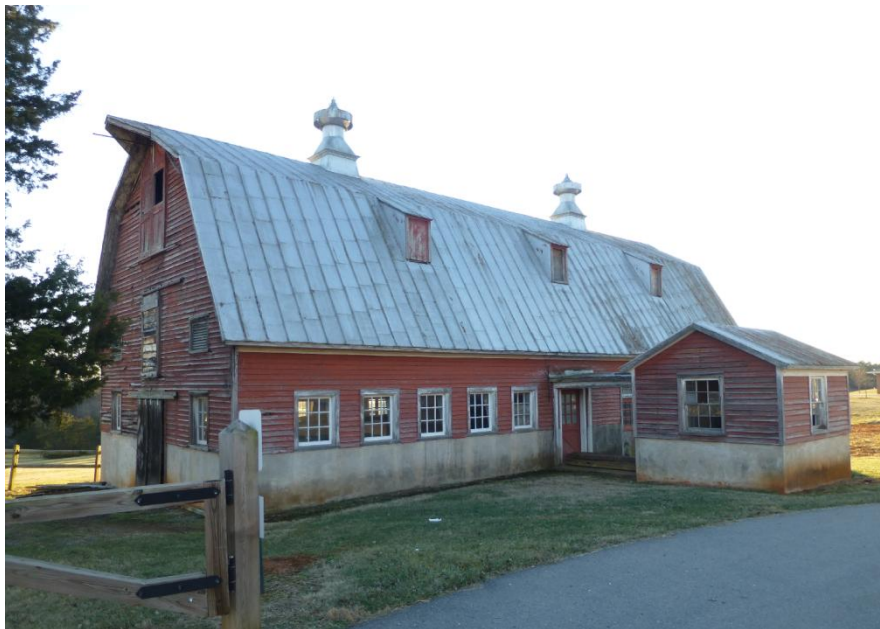
Figure 6. The County Farm Barn (009-5031), a 1936 dairy barn.

Bedford County may have lagged somewhat behind the more urbanized areas described by McMurry but the trend was present and survey evidence suggests the makeover of numerous farms during the postwar period to accommodate modern dairy production. By 1949 dairying was the county’s leading agricultural specialization

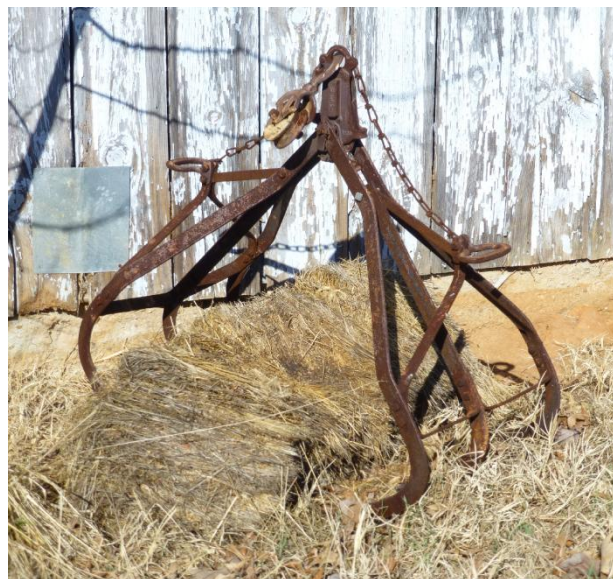
Figure 7. A hayfork outside the barn on the Simmons Farm (009-5381).

The county's multipurpose barns tend to be the farm buildings where various technological advances are most often found. Principal among these, at least in number, are hay carriers, and most surviving examples utilize grappling-type hay forks. A clue to the presence or former presence of a hay fork system is provided by the hay bonnets or hoods that project from the roof peaks of many frame and masonry barns. Generally hay bonnets have a small triangular or wedge form sufficient only to shelter the boom that supports the short extension of the hay fork track outside the barn, however the 1920s Spradlin Barn (009-5368), a small frame hay and stock barn, features a full strut-supported extension of the gable roof which in addition to protecting the hay fork rail may have served to shelter a hay wagon parked below during off-loading. The log barn on the farm at 2588 Saunders Road (009-5376) is interesting as a fusion of the age-old vernacular tradition of log construction and a hay bonnet indicative of technological innovation. A multipurpose barn that utilized the old-fashioned hand-pitched hay loading method is the small early twentieth-century stock and hay barn on the Jeter Farm (009-5380) where the hay was loaded into the mow from a wagon or truck parked in the drive-in bay beside the mow.

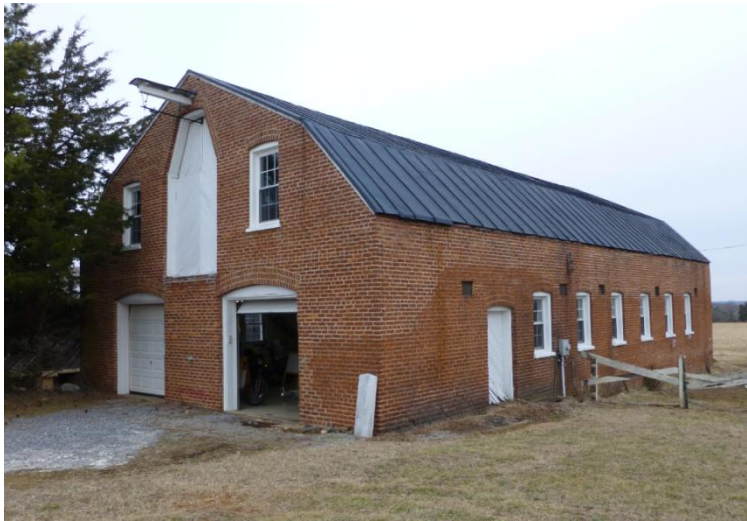
Figure 8. The horse barn at Savenac (009-0030).

Among the county's early gambrel-roofed multipurpose barns is the horse barn at Savenac (009-0030) which may have been built in the 1910s when horse raiser Dean Starks acquired the property. The barn is representative of transitional gambrel forms. The roof is supported by a row of heavy posts at the breakpoints and the posts in turn are reinforced by cross-braces that tie in to the floor structure and

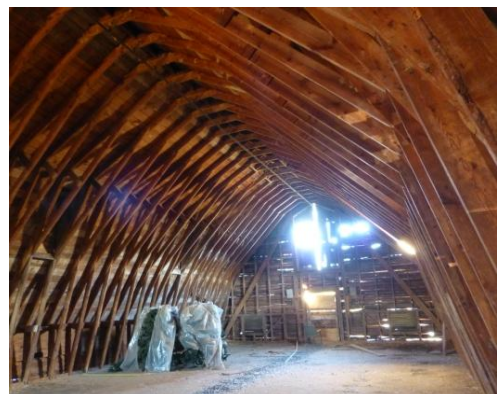
Figure 9. The self-supporting structure of the gambrel roof on the County Farm Barn (009-5031).

Hay fork systems like Loudon's worked best in haymows that were free of obstruction from the crossbeams of old-fashioned heavy timber construction. The old construction methods were becoming less tenable as mechanized lumbering gradually reduced the availability of large timbers. The solution, perfected in the Midwest and gradually adopted in east coast areas like Bedford County, was the development of roof forms constructed from lighter members that

dispensed with crossbeams and were in their later iterations self-supporting. Two forms were introduced in the 1880s and 1890s. The form known to barn researchers as the Open Center/Wing Joist form supported the haymow roof from the sides but still required heavy posts under the purlins at the breakpoints of the gambrel. Another approach, the Shawver Truss form, reinterpreted the barn's wall and roof structure as a series of trusses that tilted inward to meet at the ridge and spanned the haymow space from wall to wall without intermediate posts. Ohio inventor John L. Shawver noted of his truss roof form, "the principle of its construction has been in use many years in bridge engineering." In 1902 Shawver estimated (perhaps with some exaggeration) 5,000 barns had been constructed according to his design. Further advances in the early twentieth century simplified the truss form by utilizing smaller-length members built up to create the trusses, an approach that borrowed from balloon-frame construction.<sup>12</sup>

A roof similar to that which covers the County Farm Barn was built by the Spradlin family at its newly-

established Triple Hills Farm (009-5367) in 1944-45. According to family tradition, farm owner C. W. Spradlin had trouble finding a barn builder who could build the kind of barn he wanted until he found a twenty-three-year-old carpenter named Marvin Saunders who was up to the task. The barn's virtually self-supporting gambrel roof is even more economical of lumber than the County Farm Barn roof, although the area spanned appears to be narrower. The tradition about the barn's construction suggests the advanced roof forms were still relatively unknown to county barn builders as late as the 1940s. Another example appears at Terrapin View Farm (009-5395).

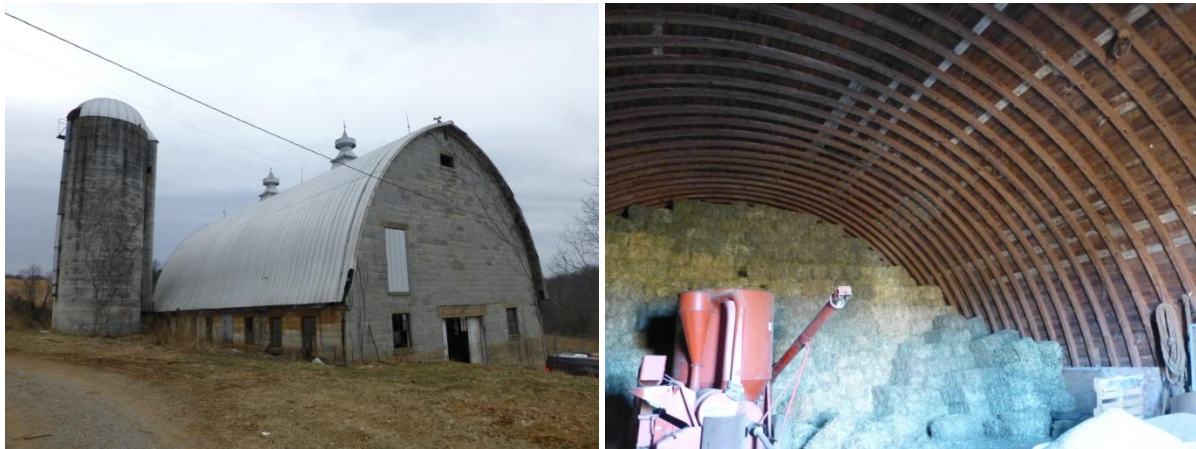
The epitome of the self-supporting form was the so called Gothic Arch roof popular from the 1910s through the 1950s. The Gothic Arch roof, which has the curved and pointed profile of the Gothic lancet arch, is represented in the survey by the roof on the 1947 cinder block dairy barn at Parkdale Farm (009-5107). Gothic barn roofs and roofs with continuous curves typically utilized thin wood sections that were bent, layered in multiple plies, and glued and/or nailed together to create curved rafters. The technique was first publicized in 1916 and by the 1930s was widely adopted by progressive farmers. The barrel-vaulted bentwood-rafter haymow of the ca. 1950 barn at Groveland (009-5404) is a premier example of the form.<sup>13</sup>

Figure 10. The Gothic Arch roof of the dairy barn on the Parkdale Farm (009-5107).

Figure 11. Bentwood rafters in the barrel-vaulted haymow of the barn at Groveland (009-5404).

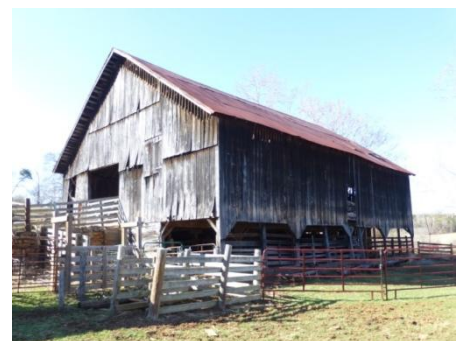
Not all multipurpose barns of the first half of the twentieth century adopted the gambrel form. Many, especially the smaller examples, retained the traditional gable form. Bedford County has a number of interesting barns that are variants of the bank barn form. Bank barns are traced to German-speaking lands in Europe and were introduced to Virginia by Germans who primarily settled west of the Blue Ridge. The twentieth-century barn on the Carner-Croft Farm (009-5123) is one of the county's rare examples of the fully realized bank barn form. Another is the ca. 1920 barn on the Nance Farm (009-5402).

Figure 12. The bank barn on the Nance Farm (009-5402).

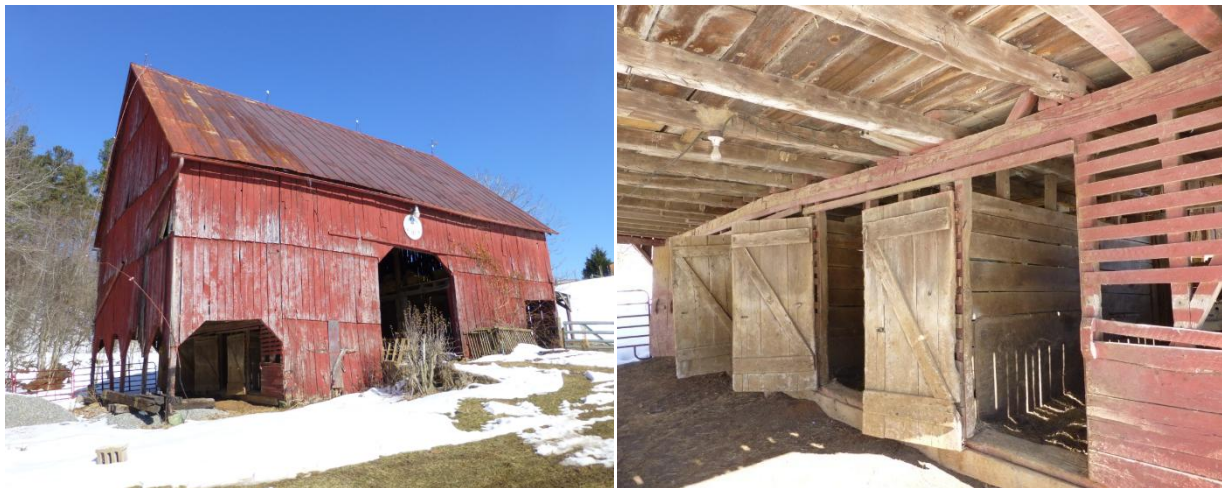
A number of barns were built in what may be called a half-bank form. An example of the form is the frame barn on the Blair Farm (009-5375) which was probably built in the early decades of the twentieth century although it reuses hewn timbers from an earlier building (possibly a barn). Not only does the Blair barn have a half-bank form, its design is split-level; the south end, to the left of the center drive-through, has lower-level animal stalls the upper portions of which rise several feet above the drive-through floor, whereas the north end is level with the drive-through. The Blair barn is also notable for various provisions for the care of the animals housed in the lower level such as a porch-like drive-through in front of the stalls; latticed openings on front of the stalls to facilitate ventilation; and openings at the back of the stalls above the center drive-through floor through which hay from the mow above could be easily forked to the animals below.

Figure 13. The partial bank barn on the Blair Farm (009-5375).

Figure 14. Animal stalls under the haymow of the barn on the Blair Farm (009-5375).

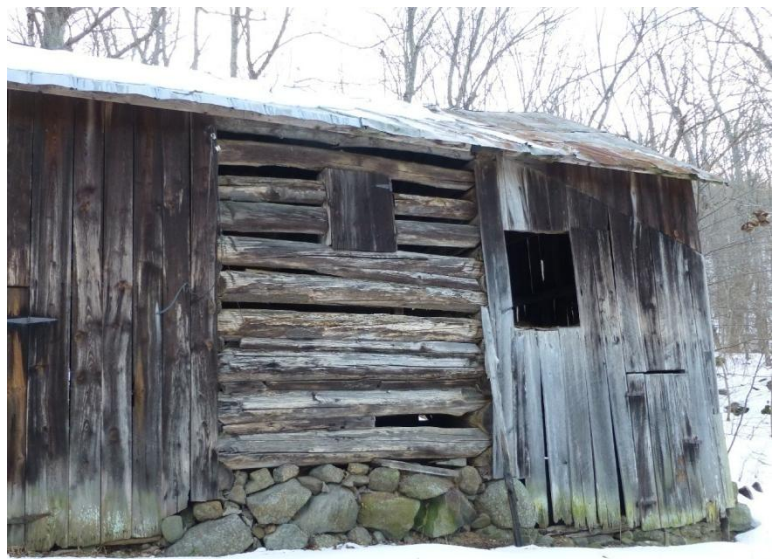
Figure 15. The nineteenth-century log core of the barn on the Elliott Farm (009-5272).

period from which most log hay barns appear to survive, and the spaces between the logs provided ample air flow to the loosely piled hay. One of the oldest barns identified in the survey, that on the Elliott Farm (009-5272) at Reba, which appears to date to the 1880s although it may have older fabric, has as its core a stoutly constructed v-notched log haymow that perches high on a boulder and rubble foundation. The frame stock shed that attaches to its side is constructed with cut nails and, although it may have been built at the same time as the log portion, reads as secondary. Over time the Elliott barn was enlarged by two additional frame sections to create a linear four-part composition. The barn's location on the heavily wooded flanks of the Blue Ridge, relatively far from the railroads that served Bedford County in the late nineteenth century and in an area where tanbark production and the creation of new arable ground through the practice of "deadening" were still occurring, probably accounts for the relatively large logs used in the barn's construction. Reminiscent of the log/frame hay/stock combination seen in the Elliott barn is the hay and stock barn on the Dooley Farm (009-5384).

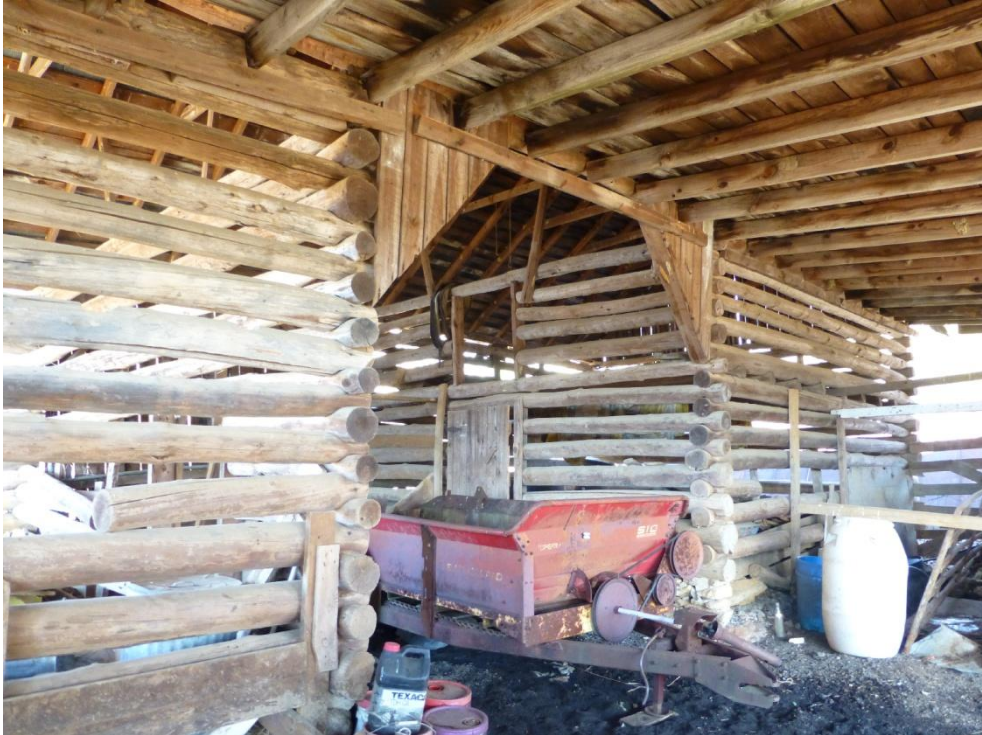
Figure 16. The double-crib log barn on the Key-Shackford Farm (009-5377).

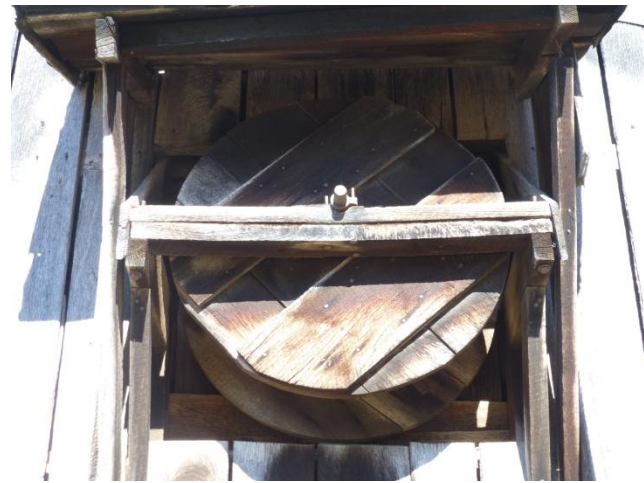
Figure 17. The pulley-like apparatus on the horse barn at the Rothsay Farm (009-5351).

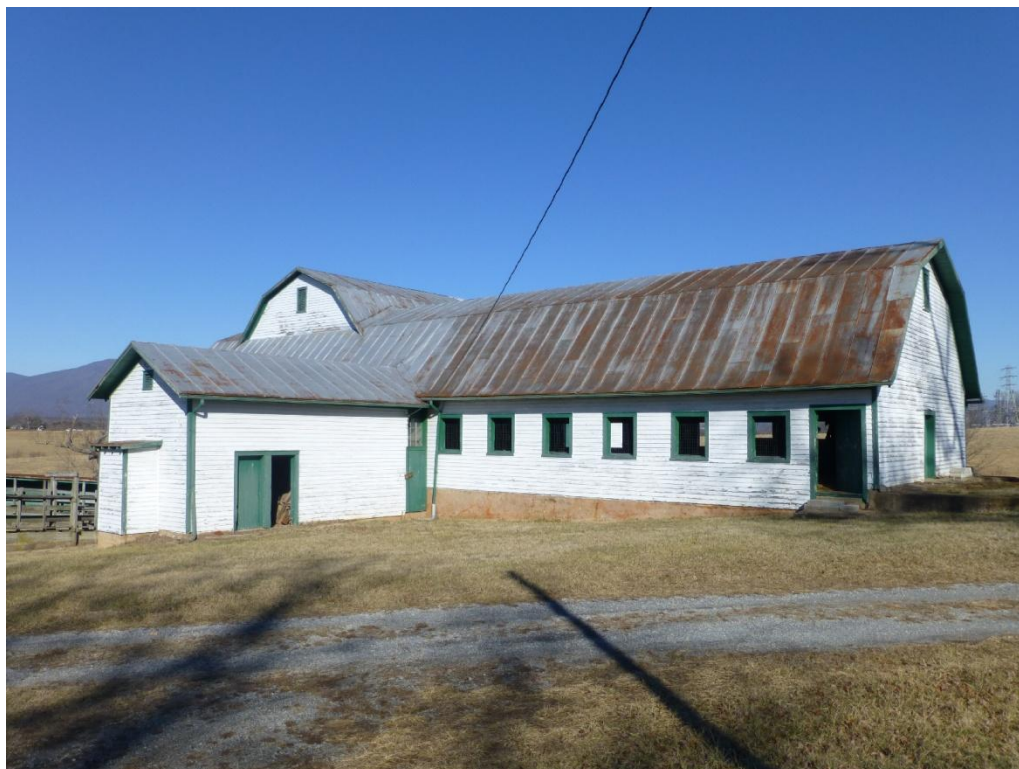
Figure 18. The barn on the Wright Farm (009-5352).

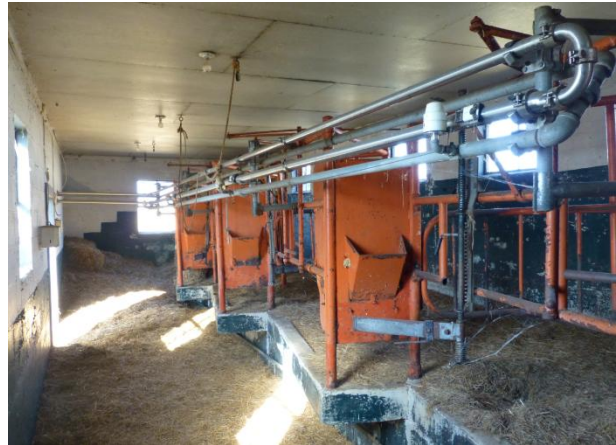
Figure 19. Interior of the early 1950s milking parlor on the Wright Farm (009-5352) showing mechanized piping system.

At its peak in the mid-1940s the Wright Farm's milking parlor accommodated a herd of eighty-six cows at a single milking. Larger still was the herd at nearby Redlands (009-0187) which numbered as many as three hundred to four hundred head. The milking parlor at Redlands, which may be contemporaneous with the one on the Wright Farm, shares with it specialized features such as a milk house wing replete with boiler and cooler and an additional engine room wing with two motors intact. The milking parlor proper is spanned by a roof with a complicated structure of scissor trusses and tension rods.

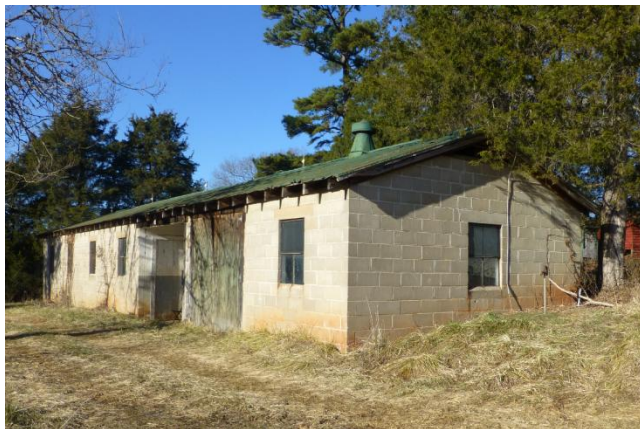
Not all of the county's dairy herds were as large as the ones at the Wright Farm and Redlands and not all farm owners required sophisticated facilities. In fact, on at least two farms in the survey, the Agee Farm (009-5371) and the Howell Farm (009-5346), milking was done outdoors until the 1950s when the farm owners built small frame milking parlors (to the relief of their hard-worked sons). Milking parlors might be housed in sheds attached to preexisting barns, as was the case on the Ashwell-Ayers Farm (009-5356) where a frame milking parlor was added to a 1930s log hay barn in the 1950s. A similar frame shed on the log Watson Barn (009-5361) has attributes of a milking parlor.

Figure 20. The milking parlor on the Cridlin Farm (009-5348).

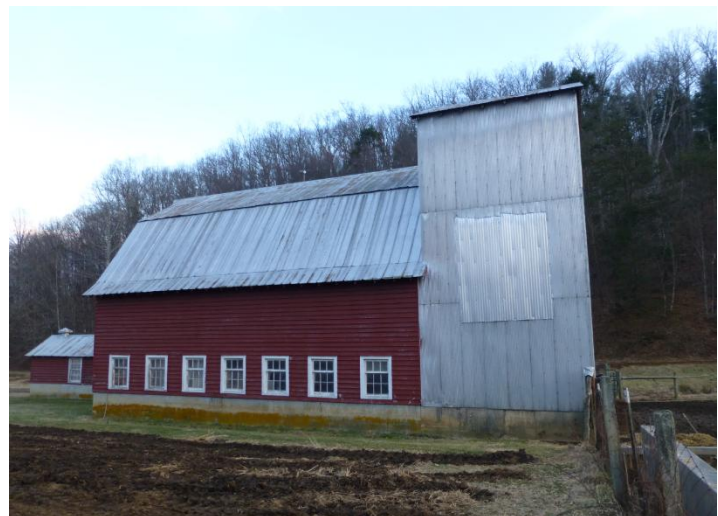
Figure 21. The enclosure that shelters the wooden stave silo on the Tanner Farm (009-5138) is prominent in this view of the farm’s dairy barn.

The Tanner silo is one of the last wooden stave silos to survive in the county. Wood was the early favorite in American above-ground silo construction; the barn constructed at Virginia Tech in 1899 had wooden stave silos which were promoted, along with other aspects of the barn’s construction, in the bulletins of the

Virginia Agricultural Experiment Station. Three wooden stave silos formerly stood on the Wright Farm (009-5352). The Wright silos were taken down about 1948 and the staves reused inside the barn for flooring and grain bins, though the circular concrete foundations of the two silos that stood at the end of the barn remain. These two silos were presumably built along with the barn in 1927, though it is possible they were constructed earlier in conjunction with a barn that stood at the same location. The third wooden stave silo stood apart.<sup>20</sup>

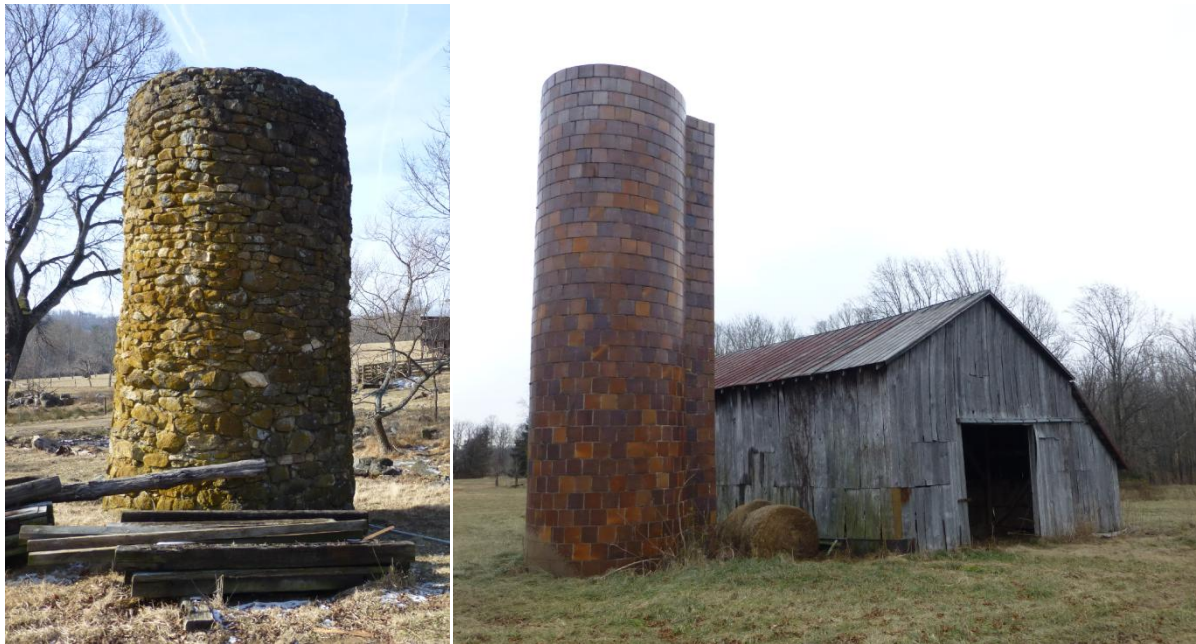
Wood construction gradually gave way to more durable materials. The attractive stone and poured concrete silo on the Arrington Farm (009-5355) was built by brothers Harry, Onyx, Morris, and Joseph Arrington in the mid-1930s when the four were boys or young men. The barn attached to the Arrington silo is now gone. Charles Ervin Woolfolk also built a stone silo in the 1930s at his farm just outside Bedford (009-5388). Concrete was the most popular silo material in the county. Early examples, such as the silo attached to the ca. 1935 barn on the Simmons Farm (009-5381), were poured in forms, however most surviving historic-period concrete silos were built from prefabricated concrete staves that slotted together and were held in place by steel tension rings. The example on the Cridlin Farm (009-5348) was built with components (the concrete staves or perhaps only the domical metal roof) manufactured by the Marietta Silos company of Marietta, Ohio, as indicated by the metal logo on its weathervane.

Figure 22. The stone silo on the Arrington Farm (009-5355).

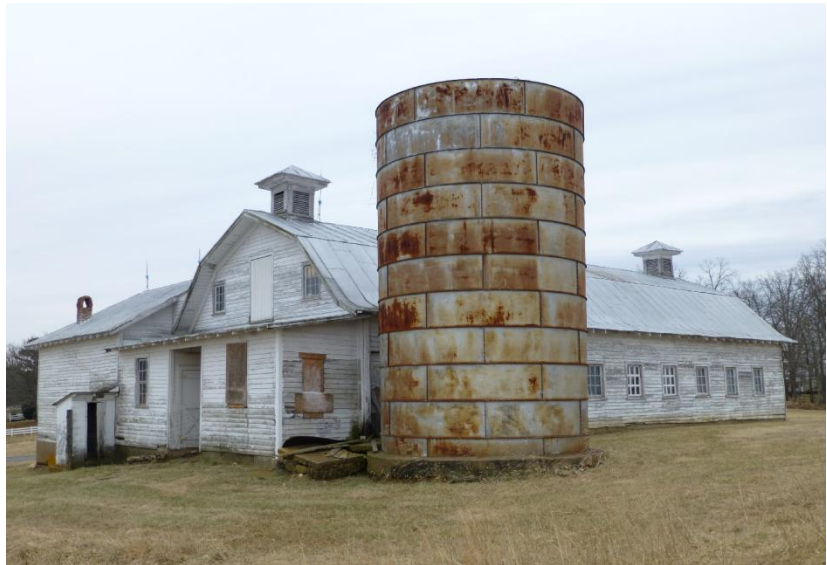
Figure 24. The steel silo beside the Hurt Barn (009-5362).

Not all silos were built with roofs—many farmers got good results even when their silage was exposed. Those silos that were roofed were often domed, the roof form characteristic of the later concrete stave silos, or they were capped with low-pitched conical roofs, as is the case for the ca. 1950 cinder block silo on the Blair Farm (009-5375). A conical silo roof

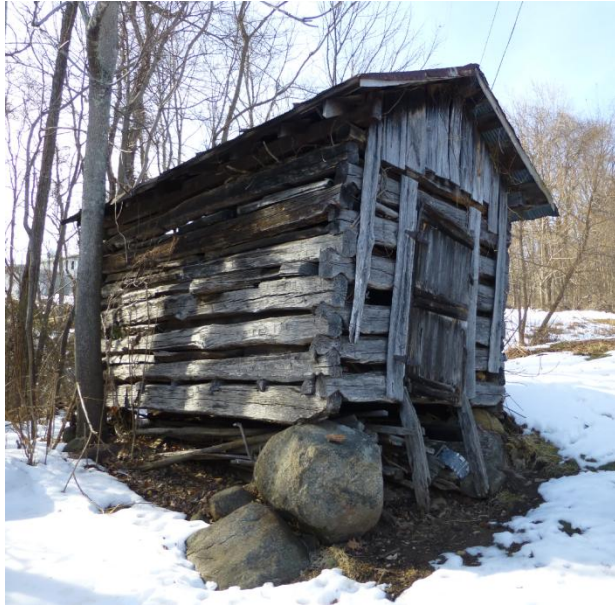
Figure 25. The “old” corncrib on the Agee Farm (009-5371).

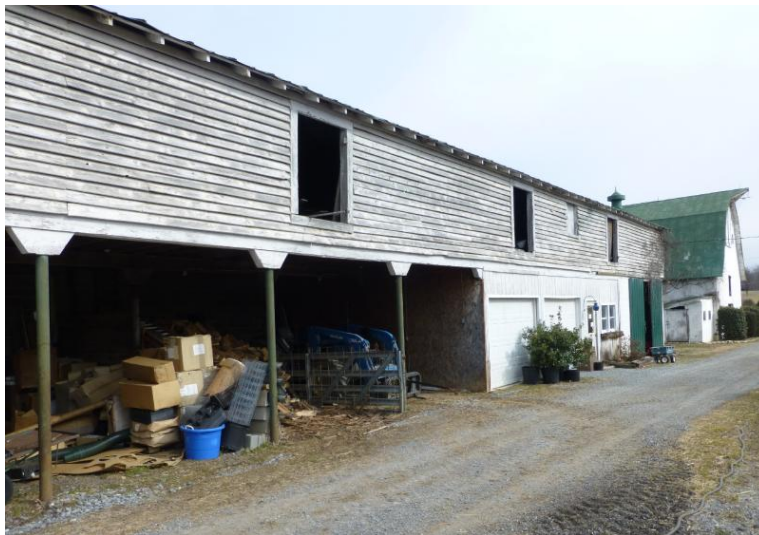
Figure 26. The large corncrib at Wipledale Farm (009-5344).

An exception to the generally small size of the county's corncribs is the corncrib at Wipledale Farm (009-5344), a building on the scale of a dairy barn that may have been built in the 1930s. The corn storage area occupies the second floor of the long building, the first floor utilized as a machine shed. The corncrib level's horizontal siding boards, like weatherboards in appearance, are separated one from the other by spacer blocks to enhance air flow, a construction feature that gives the building superior ventilation but sheds the rain. The survey recorded several examples of prefabricated metal corncribs with perforated sides. The ones on the Tanner Farm (009-5138) and Terrapin View Farm (009-5395) are circular in form. The Tanner Farm corncrib features a center ventilation shaft that rises to a cupola at the apex of the conical roof whereas the corncrib at Terrapin View Farm has the name "Buckeye" embossed on its door, possibly an indication the structure was fabricated by the Buckeye Manufacturing Company in Anderson, Indiana. Berkeley (009-0025) has two metal specimens similar in concept but with oblong forms. Something of the inventive quality of these manufactured corncribs is evoked by the early twentieth century corncrib on the Anderson Farm (009-5399), notable for the hopper-like scoop in its gable which funneled tossed corncobs to the interior.

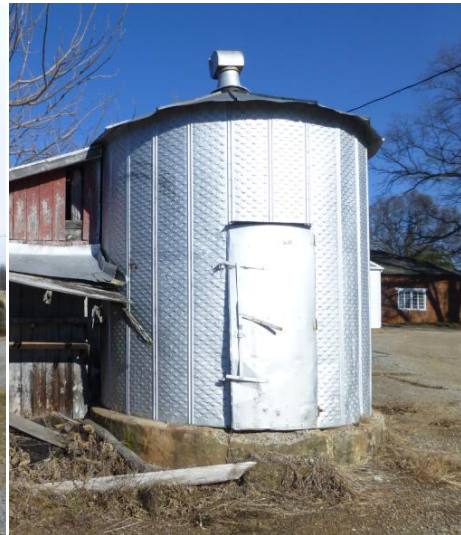
Figure 27. A prefabricated metal corncrib at Berkeley (009-0025).

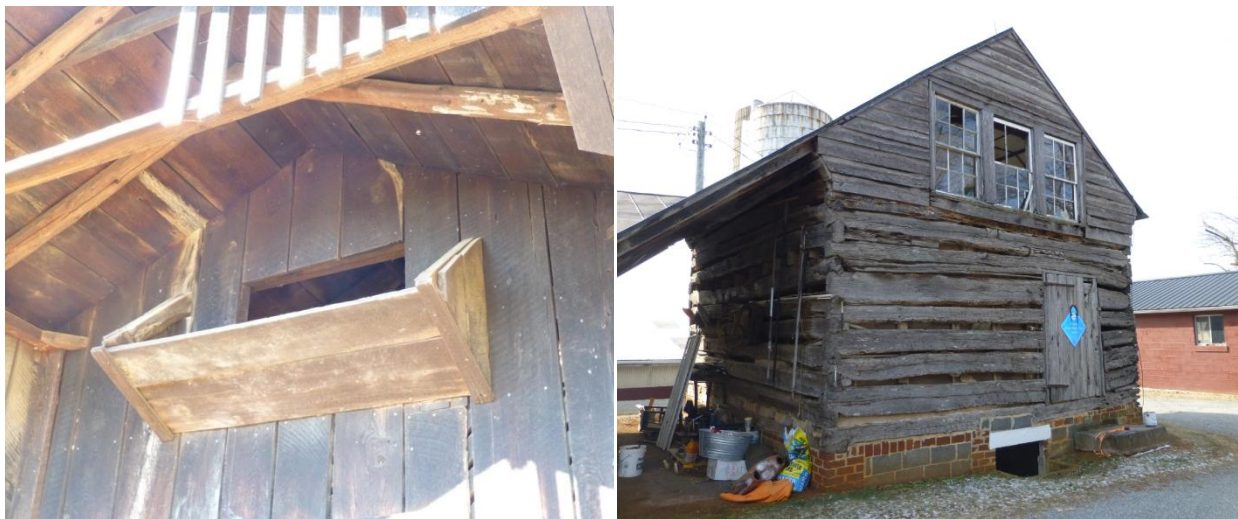
Figure 28. The hopper in the gable of the corncrib on the Anderson Farm (009-5399).

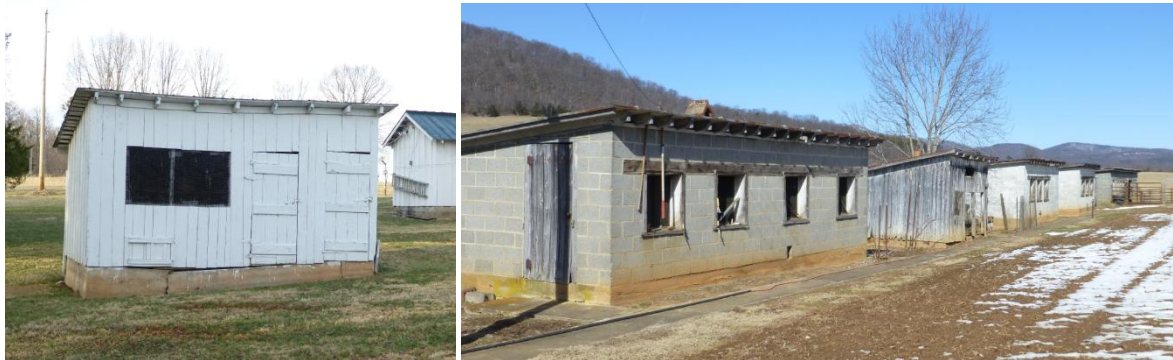
Figure 31. A frame chicken house of standard shed-roofed form on the Updike Farm (009-5394).  
Figure 32. A row of chicken houses on the Markham Farm (009-5372).

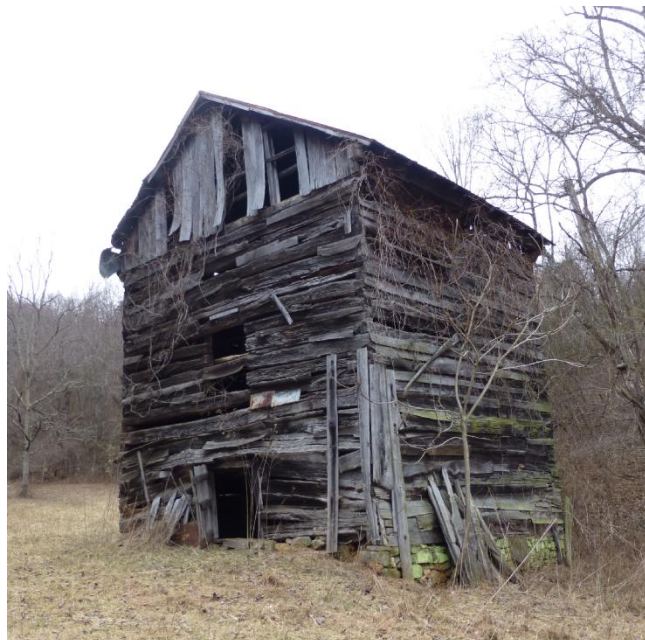
Figure 33. The McDaniel Tobacco Barn (009-5366).

The county's oldest known tobacco barn, the McDaniel Tobacco Barn (009-5366), is believed to date to 1851-52 and stands on what was at the time the farm of Albert McDaniel. The 1850s date seems probable given the specificity of the oral tradition and also the cut nails visible in the door jamb. The relatively large v-notched log barn, which measures approximately twenty-one and a half feet to a side, has the tall profile of the tobacco barn form and its stone foundation lacks fireboxes confirming it as a fire-cure barn. Smoke residues on some of the lower tier poles and walls of the barn provide evidence of the fires used to cure the leaf. A feature of the barn also observed in an early twentieth century fire-cure barn on the Hicks Farm (009-5378) is the placement of the outermost tier poles within inches of the walls (the outermost poles in fire-cure barns are generally spaced several feet from the walls). The Hicks barn, also constructed of v-notched logs, has a small unglazed window opening that may have been used to read a thermometer. The heat inside tobacco barns was modulated for optimal curing, and a window for reading a thermometer was described for just such a purpose in 1831.<sup>25</sup>

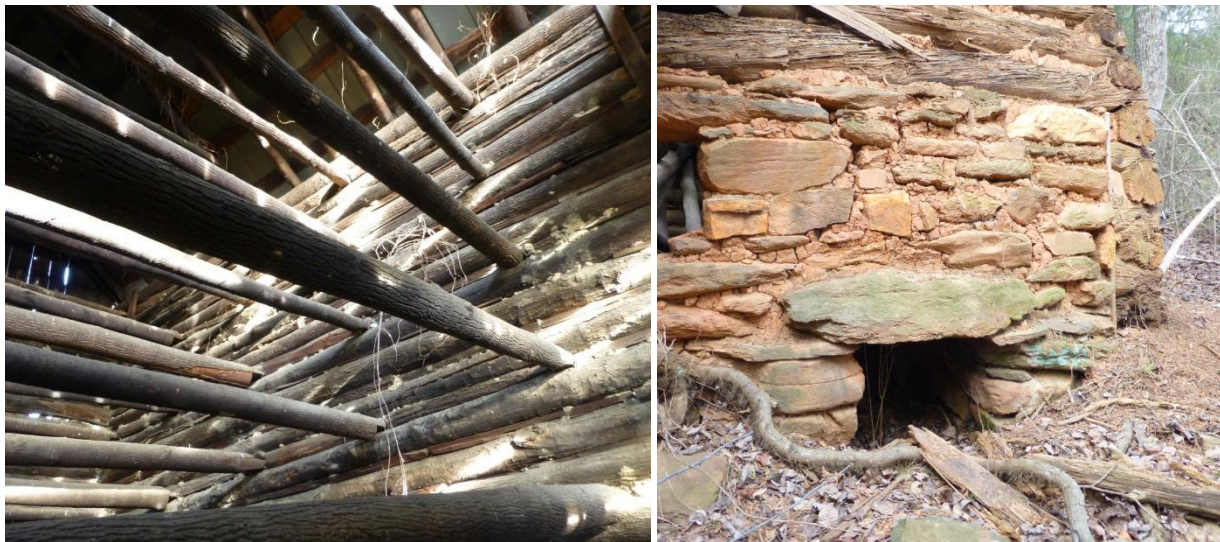
Although flue curing was not as common in the county at large, flue-cure barns appear to survive in disproportionately greater numbers compared to fire-cure barns, although some fire-cure barns may be masquerading as hay barns. Flue-cure barns may have been, on average, smaller than fire-cure barns, so more may have been built on farms that grew flue-cure tobacco, boosting their overall numbers. Flue-cure barns, when they occur, are more often in groupings of two or more. On the Martin Farm (009-5359) three flue-cure barns survive of an original five, all or most all built in the 1920s. Or perhaps tobacco growing continued longer in the county's flue-curing section, keeping flue-cure barns in operation longer and contributing to their survival to the present.

Figure 34. Tier poles inside a tobacco barn on the Martin Farm (009-5359).

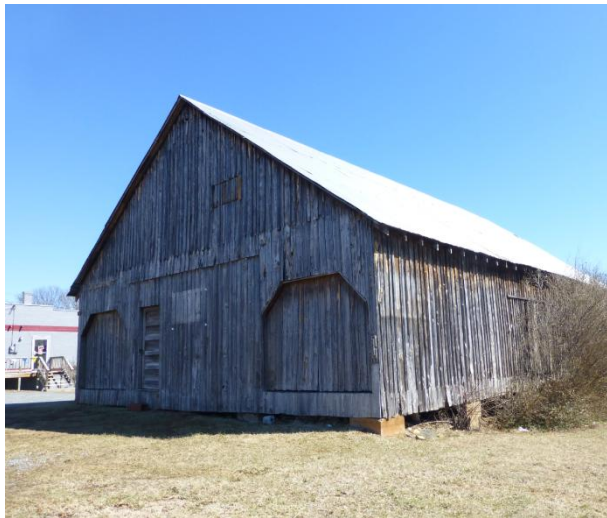
Figure 36. The Peters Tomato Cannery (009-5379).

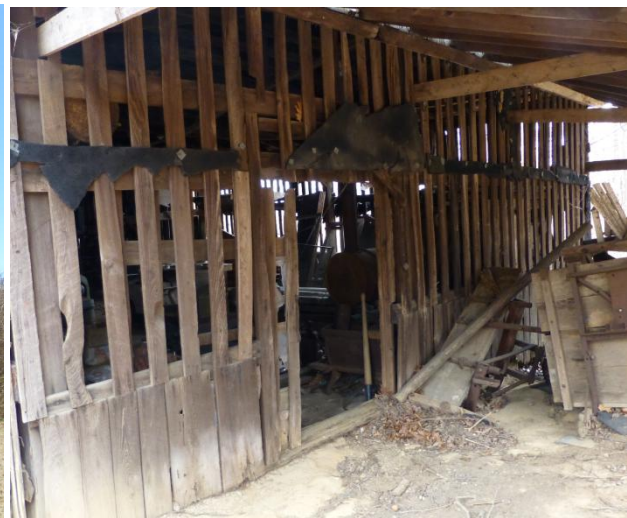
Figure 37. The slatted wall of the tomato cannery on the Arrington-Gross Farm (009-5112).

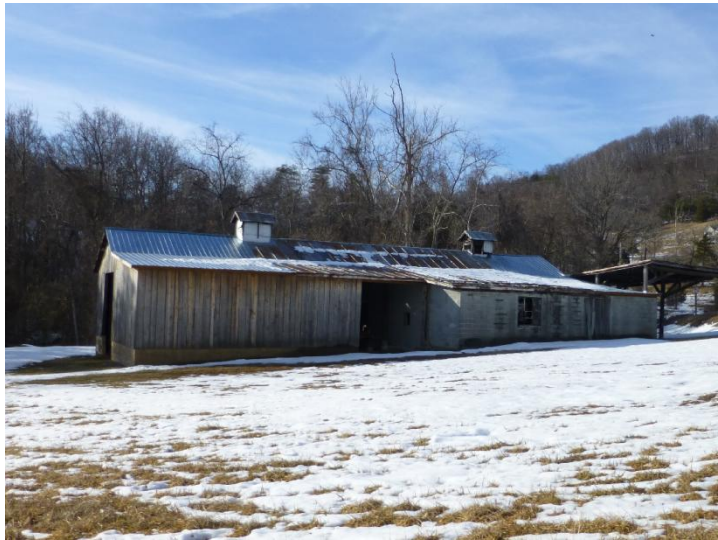
Figure 38. The Johnson Tomato Cannery (009-5374).

Another well-preserved cannery is the Johnson Tomato Cannery (009-5374) located on Sheep Creek. The earliest section, the storage and shipping shed, dates to the 1930s or possibly 1929; the original cannery end of the building was destroyed by fire and replaced in cinder block in the 1950s. Because the area where the workers

worked was enclosed the scalding vat and boiler stood under an open shed at the building's north end and the scalded tomatoes passed into the building on a conveyor for peeling. An interesting feature of the cannery is its roof which incorporates log beams in its construction. Similar construction spans the original and 1950s sections, suggesting the possibility that the roof over the 1950s section survived the fire that destroyed the fabric under it. A concrete trough formerly channeled creek water to the interior and troughs in the concrete floor—present troughs and traces of former ones—lead to a drain that emptied into the creek. The Johnson cannery had one other feature that enhanced the comfort of the workers: louvered roof-ridge cupolas that drew air through the building and exhausted heat to the outdoors. Although the cannery, like the county's other surviving canneries, is no longer in operation, it was partially restored in recent years by the late Billie Cutshaw and is maintained by current owner Marie Cutshaw.<sup>26</sup>

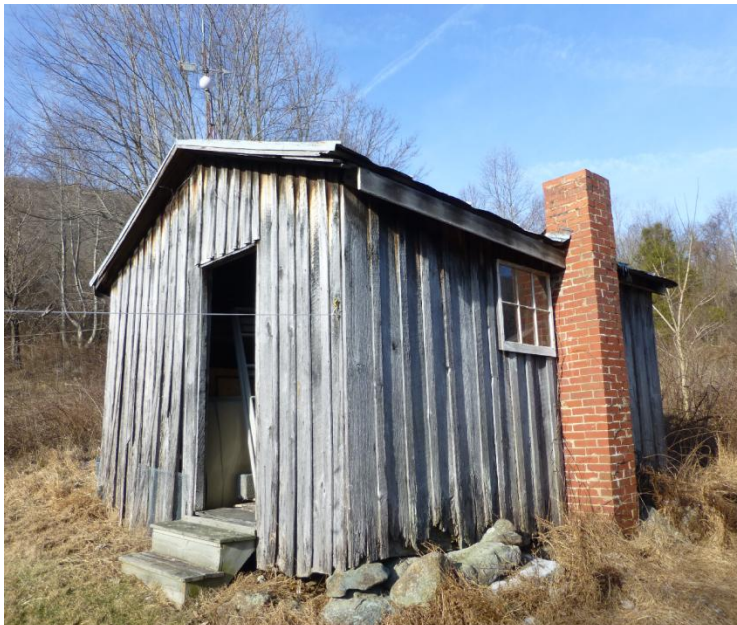
Figure 40. The apple picker's cabin on the Watson Farm (009-5354).

Apple growing was not as extensive an agricultural specialization as tomato growing and canning but it nevertheless made a mark on the county's architectural landscape. An early example of apple-related buildings was the log apple barn W. C. Hatcher built ca. 1916 on his Twin Oaks Farm. A surviving log apple barn on the Johnson-Dooley Farm (009-5386), high on the slopes of Campbell Mountain near Peaks of Otter, was fashioned out of logs from a tobacco barn at some date prior to 1966. Another building associated with apple growing is the apple picker's cabin on the Watson Farm (009-5354, a small one-room board-and-batten bunk house, perhaps dating to the 1920s-1950s period, which retains crude built-in bunk beds.<sup>27</sup>

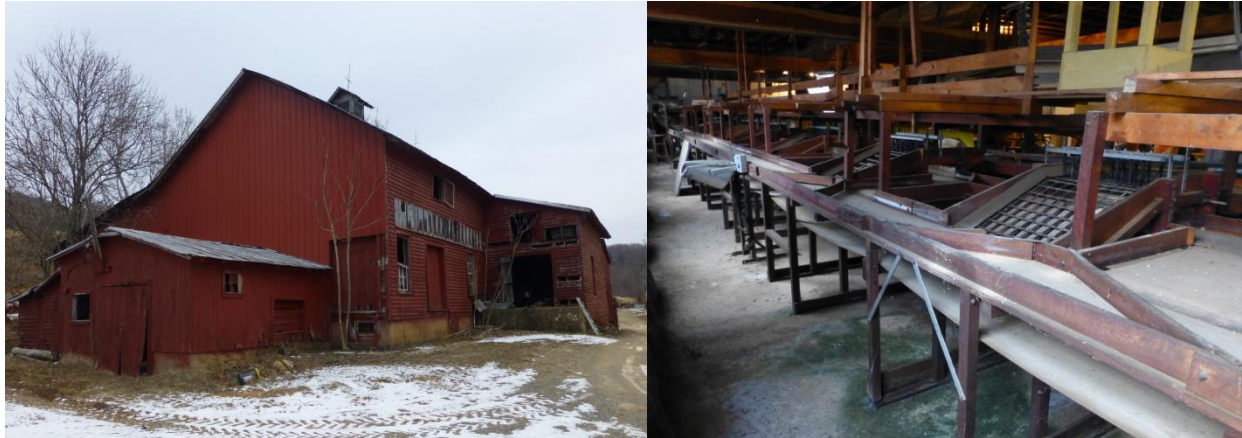
More imposing than the apple barns and picker cabins were the packing houses associated with the larger orchards. Among the oldest of these is the packing house at Hunting Creek Farm (009-5343) which was probably built in the 1920s. The large two-story building, sided with weatherboards and set on poured concrete and stone foundations, has something of the

appearance of a large barn of the era though inside the difference is immediately apparent. The complicated conveyor-belt apparatus used for grading the apples extends the length of the main space. Slatted slides, apparently for feeding boxes to the packers who worked by the belts, connect to the second floor where the boxes were stored. The Hunting Creek operation ranked among the county's top four apple growers in 1949.<sup>28</sup>

Figure 41. The apple packing house at Hunting Creek Farm (009-5343).
