### NATIONAL REGISTER OF HISTORIC PLACES REGISTRATION FORM

historic name: Ellwood  
other names/site number: Leeland; Lawrence Lee House DHR File No.: 053-0639

Ellwood is a two-and-one-half-story, Colonial Revival-style mansion designed by nationally known architect Waddy Butler Wood and built in 1911-12 by W. M. Kimmel for Lawrence Rust Lee.<sup>1</sup> The mansion is located approximately two miles west of Leesburg, Virginia, in Loudoun County on a hill overlooking the town of Leesburg with open extended views of Ball's Bluff Battlefield and the Potomac River. Ellwood is set in a grove of large oak trees upon a three-hundred-foot man-made terrace. The mansion is on a rise just above the Civil War fort, Fort Johnston, which at one time was part of the estate.<sup>2</sup> It presently consists of ten acres of land including woods, gardens and open space that protect the house and its views from the suburban encroachment of Leesburg. The setting is pleasant, and the mature trees on the west side add to the graciousness of the approach, while the views on the east side are unobstructed. The two-and-one-half-story main structure has a five-part symmetrical plan consisting of a main

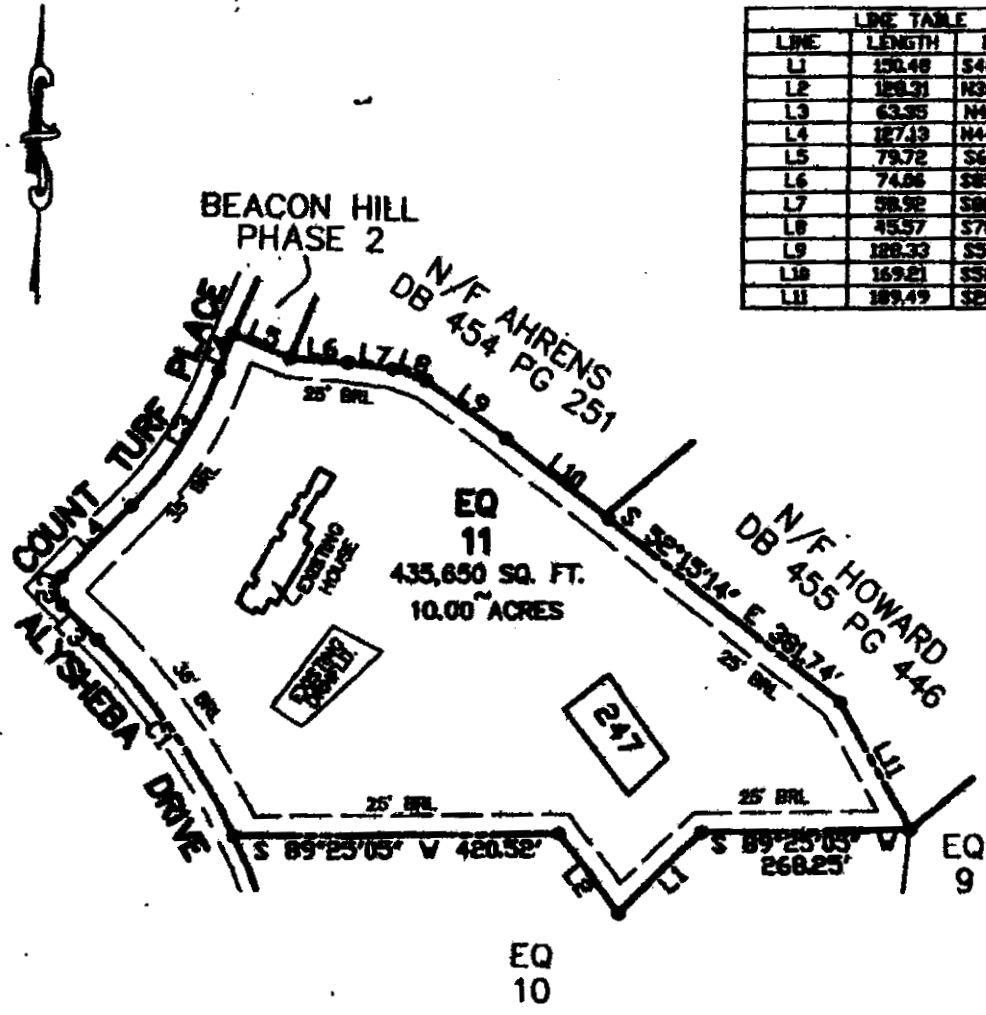
**EXHIBIT PLAT**  
**EQUESTRIAN LOT 11**  
**BEACON HILL**  
 CATOCTIN MAGISTERIAL DISTRICT  
 LOUDOUN COUNTY, VIRGINIA  
 DEED BOOK 1675 PAGE 861

SCALE: 1"=200' DATE: 5/15/00

The boundaries of Ellwood are indicated on the accompanying base map. Ellwood is Equestrian Lot 11, Beacon Hill, Catoctin Magisterial District, Loudoun County, Virginia, Deed Book 1675, Page 861.
