National Register of Historic Places Registration Form

3	3. State/Federal Agency Certification	
S	City or town: Danville State: VA County: Pittsylvania Not For Publication: N/A Vicinity: X	
(Enter "N/A" if property is not part of a multiple property listing	
N	Name of related multiple property listing: N/A	
	Other names/site number: DHR ID# 071-0020

Oak Ridge

Pittsylvania County, Virginia

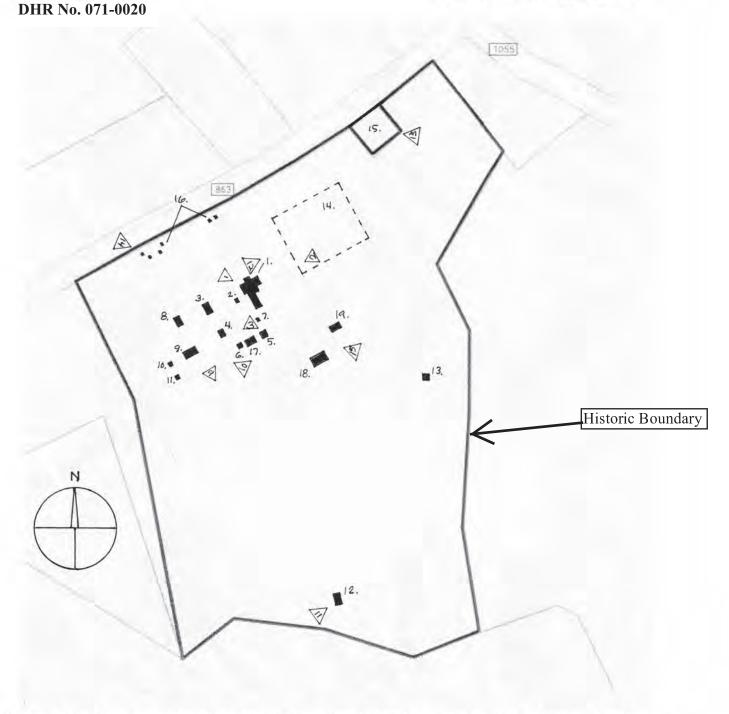
Map not to scale; resource locations approximate. Number and direction of view of nomination photos indicated by triangular markers. Resources keyed to nomination inventory as follows:

The following inventory lists the contributing and non-contributing resources associated with Oak Ridge. The three non-contributing resources all postdate the property's period of significance. The resources are keyed to the attached Sketch Map by the numbers shown below.
