**NATIONAL REGISTER OF HISTORIC PLACES
REGISTRATION FORM**

historic name Riverside

Riverside
Warren County, Virginia

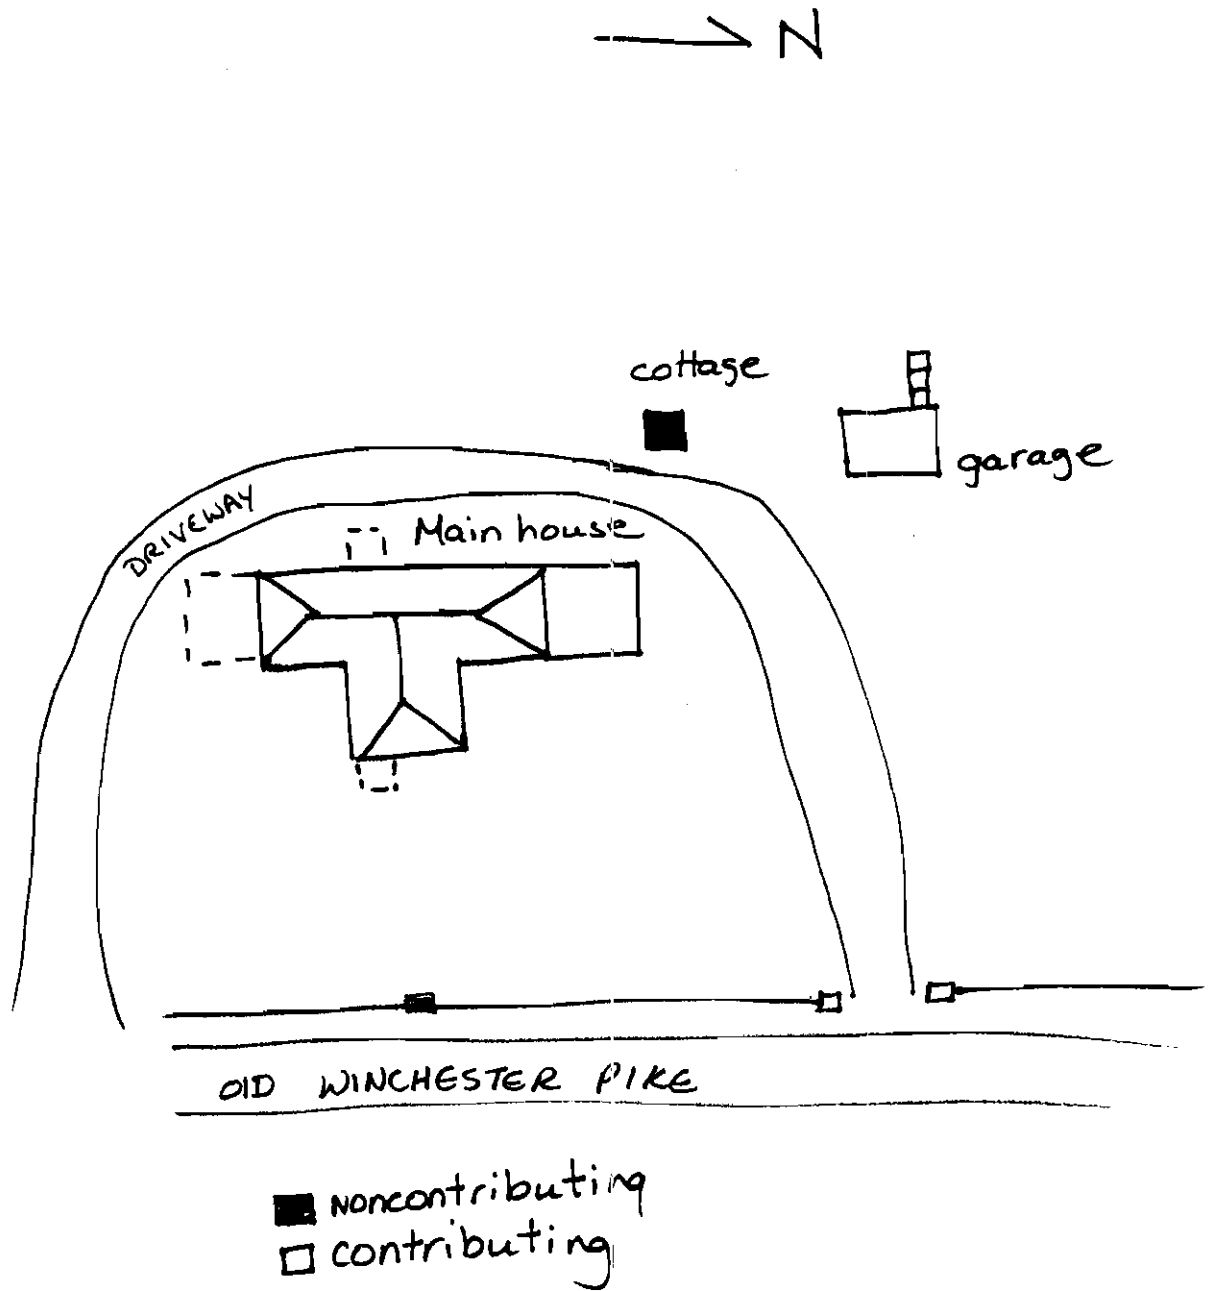
SITE PLAN

M. Kalbian
Not to scale

The outbuildings at Riverside include an early-twentieth-century garage and an early-1930s brick maid quarters (Photo 16). The frame garage is clad in German-lap siding and has a hipped roof of standing-seam metal. It rests on a low formed-concrete foundation and has side sliding batten garage doors and six-over-six-sash windows. Centered along the south elevation are two paneled doors that lead into a storage room to the right, and a potting shed to the left. They are sheltered by a one-bay, shed-roofed porch with a standing-seam metal roof. To the rear is an attached chicken coop, outhouse and shed, all of which are in poor condition. The brick building referred to as the maid quarters was constructed in the early 1930s and made to resemble the original summer kitchen. It is considered noncontributing as it postdates the property's period of significance.

Although at one time the Riverside property encompassed a much larger tract of land, the farm has since been split. The house now sits on a two-and-one-half-acre tract of land and does not include the surviving late-nineteenth-century agricultural outbuildings historically associated with the property. Only the current acreage associated with the house is included in the boundaries for this nomination.
